# Le Mars Municipal Airport

## Pavement Management Report

**AUGUST 2026**

# LE MARS MUNICIPAL AIRPORT PAVEMENT MANAGEMENT REPORT

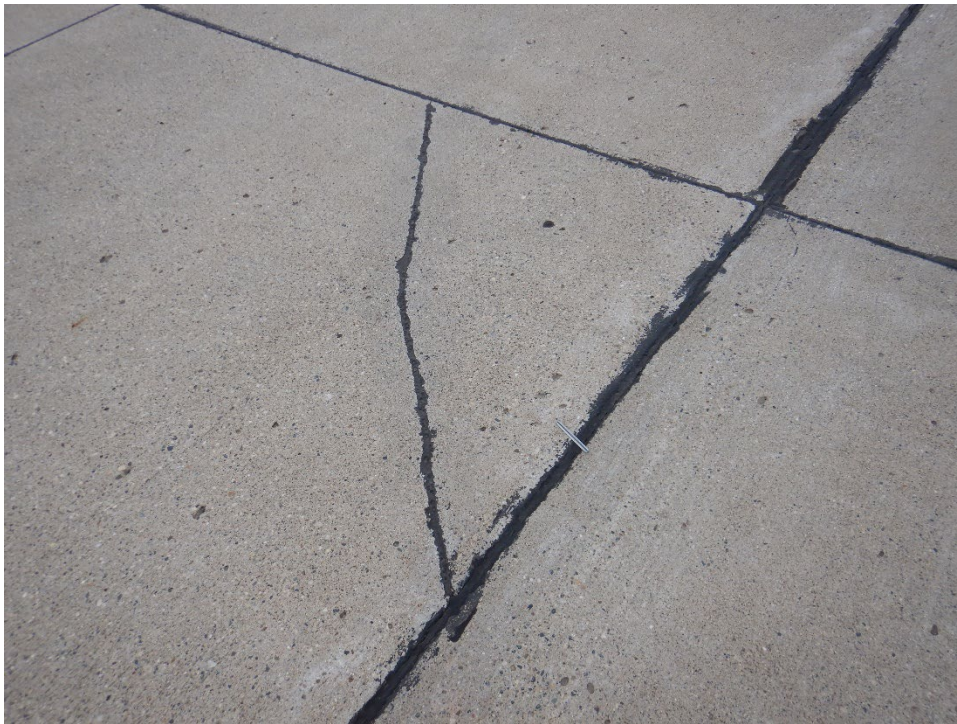
A01LE-01. Corner Break (Sample Unit No. 03).

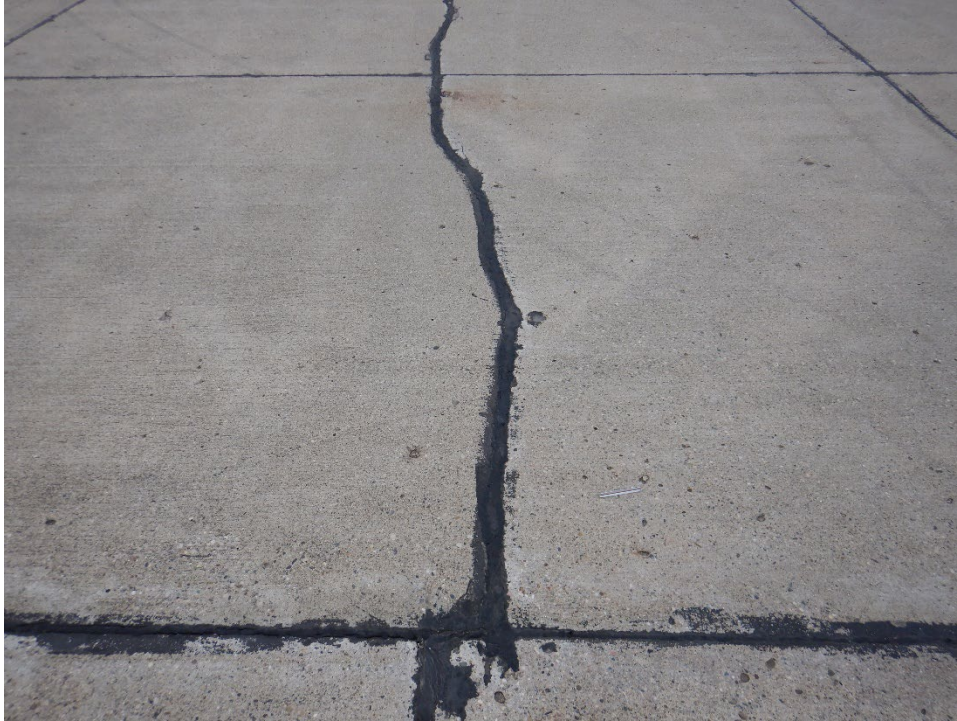
A01LE-01. LTD Cracking (Sample Unit No. 03).

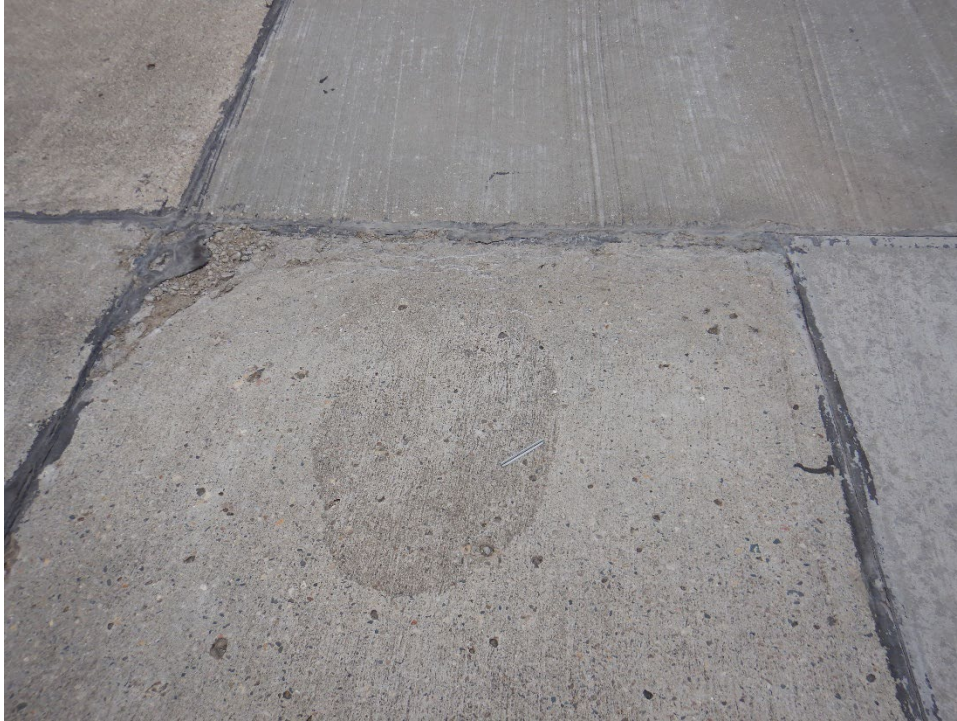
A01LE-02. Durability Cracking (Sample Unit No. 05).

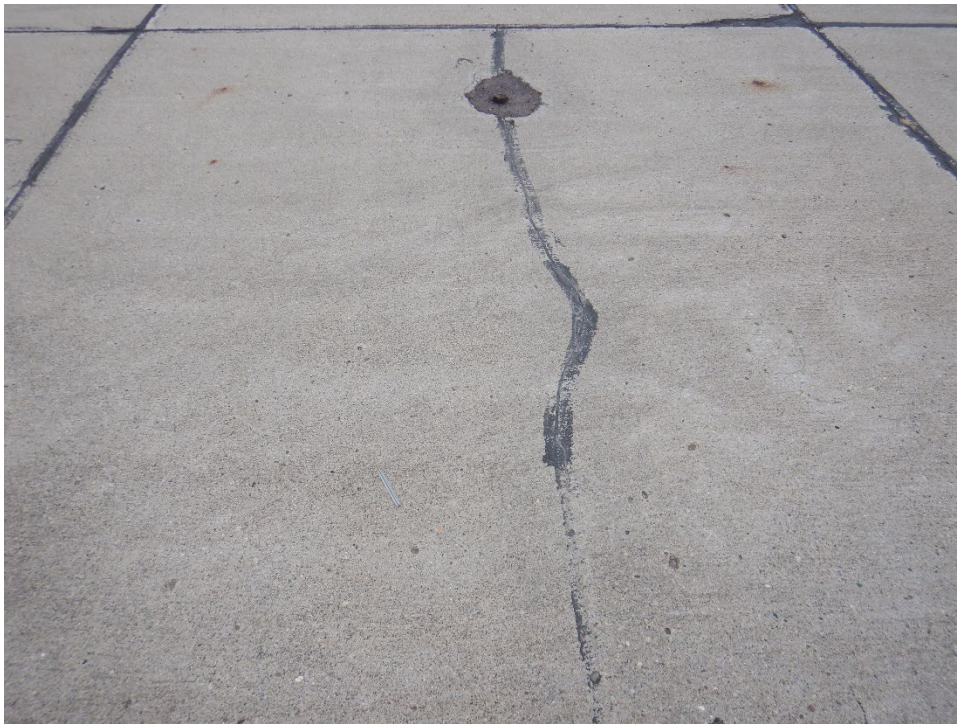
A01LE-02. LTD Cracking (Sample Unit No. 05).

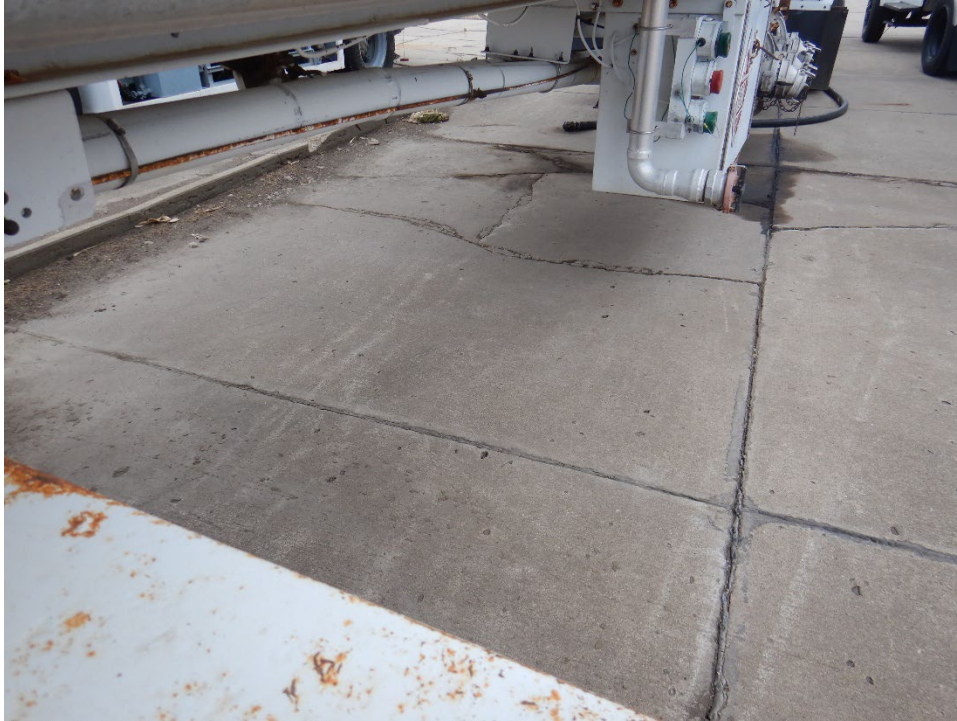
A01LE-02. Shattered Slab (Sample Unit No. 04).

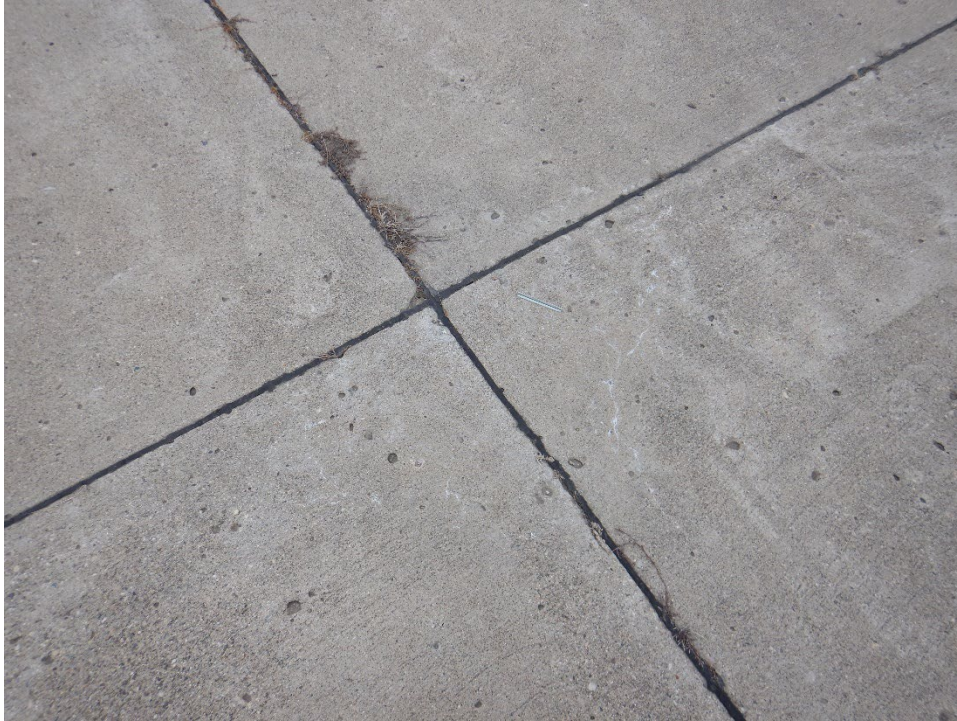
Le Mars Municipal Airport was inspected on March 2, 2026. Thirteen pavement sections were defined during the inspection. Alkali-silica reaction (ASR) was recorded at this airport according to the PCI procedure where evidence of a precipitate was observed within some of the cracking in the concrete surface. It should be noted that laboratory testing in the form of petrographic analysis is the only definitive way to validate the presence of ASR; however, the formation of a precipitate is evidence of a reaction consistent with this type of materials-related distress.

R18LE-01. ASR (Sample Unit No. 01).

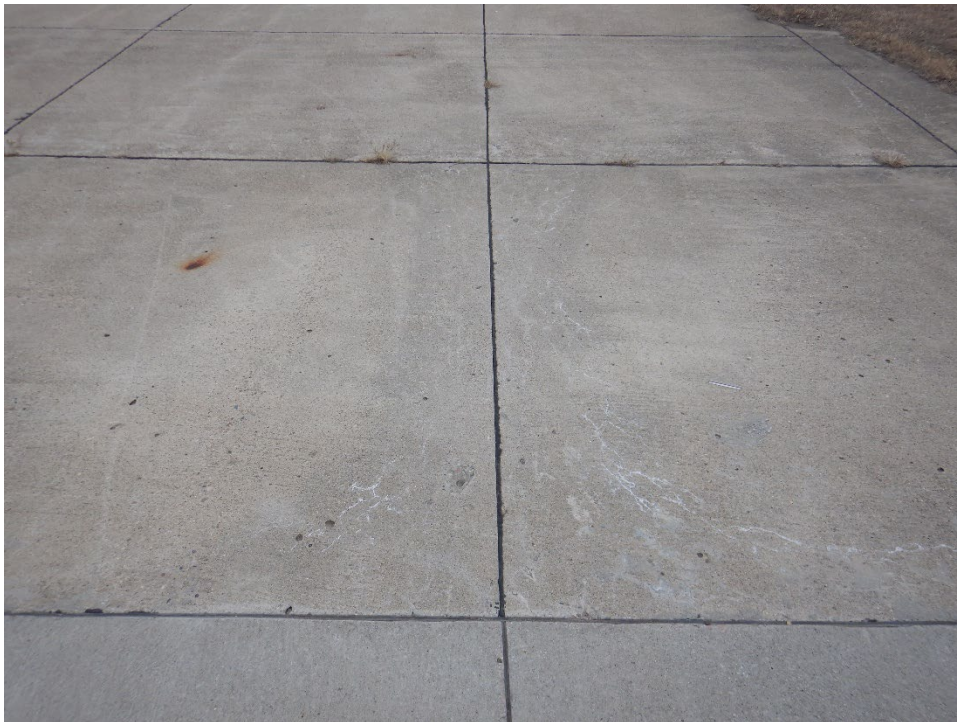
R18LE-01. ASR (Sample Unit No. 02).

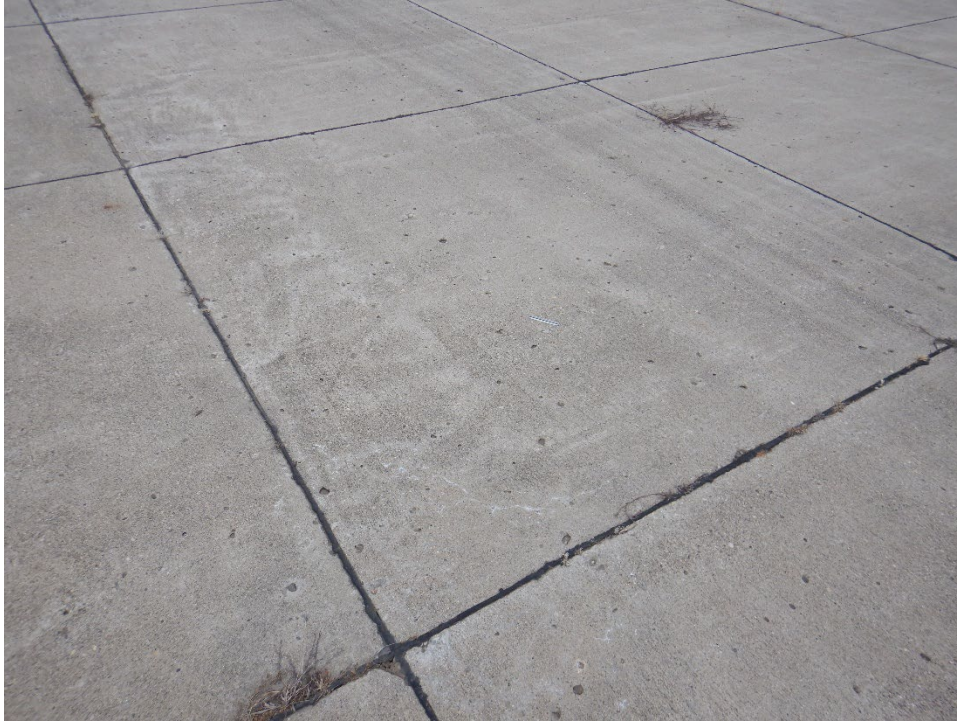
R18LE-01. Popouts (Sample Unit No. 01).

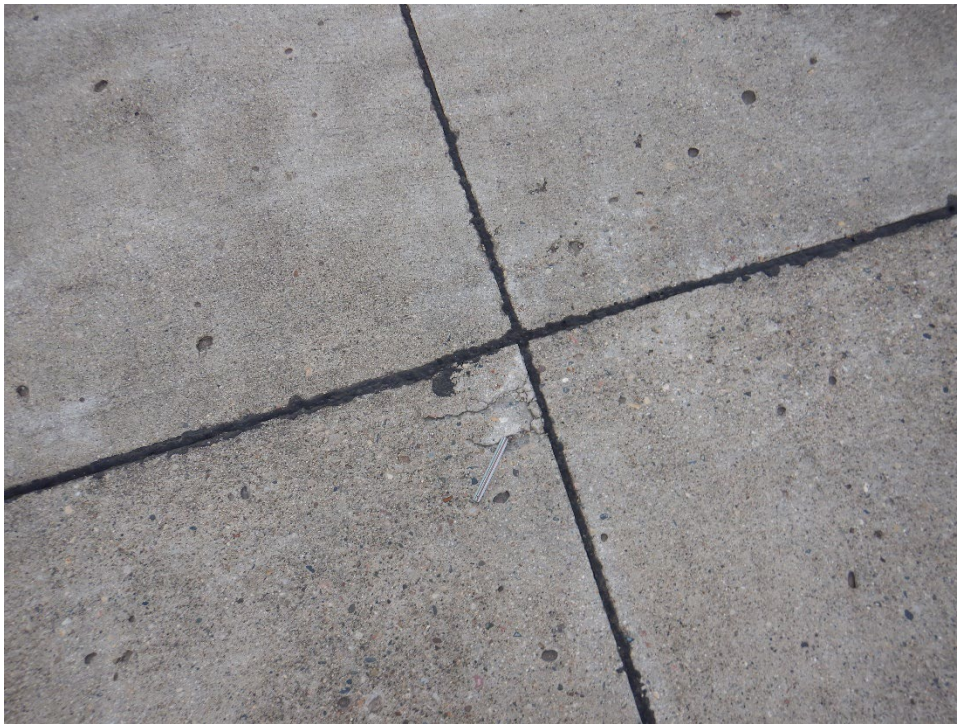
| <b>Distress Type</b> | <b>Probable Cause of Distress</b> |
|---|---|
| Spalling<br>(Joint and Corner) | Excessive stresses at the joint caused by infiltration of incompressible materials or traffic loads; weak concrete at the joint combined with traffic loads. |

R18LE-03. Corner Spalling (Sample Unit No. 02).

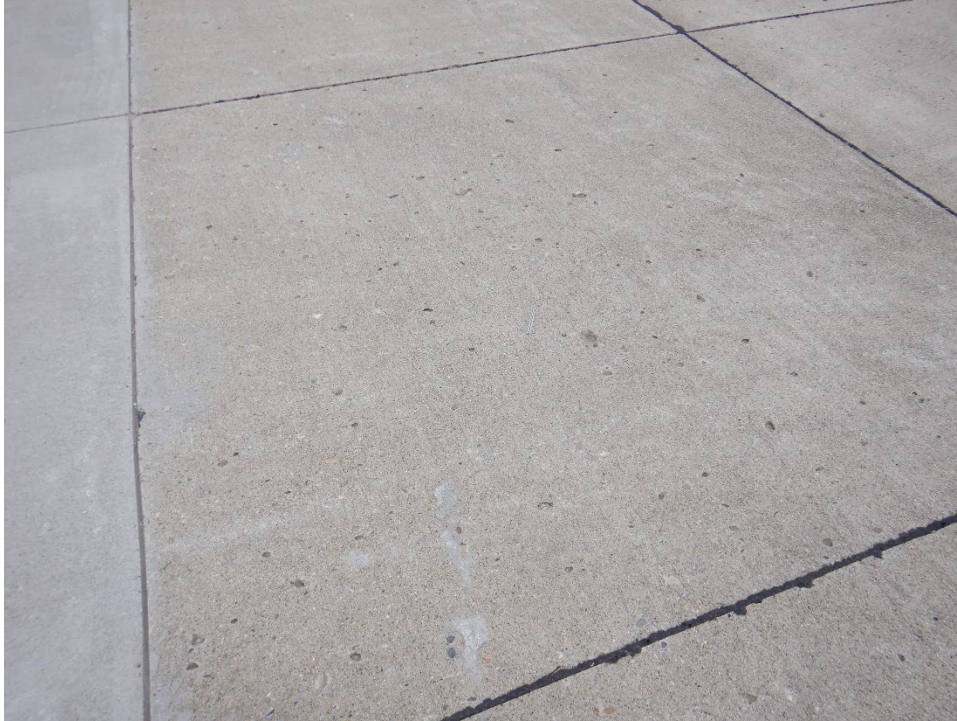
R18LE-03. Popouts (Sample Unit No. 02).

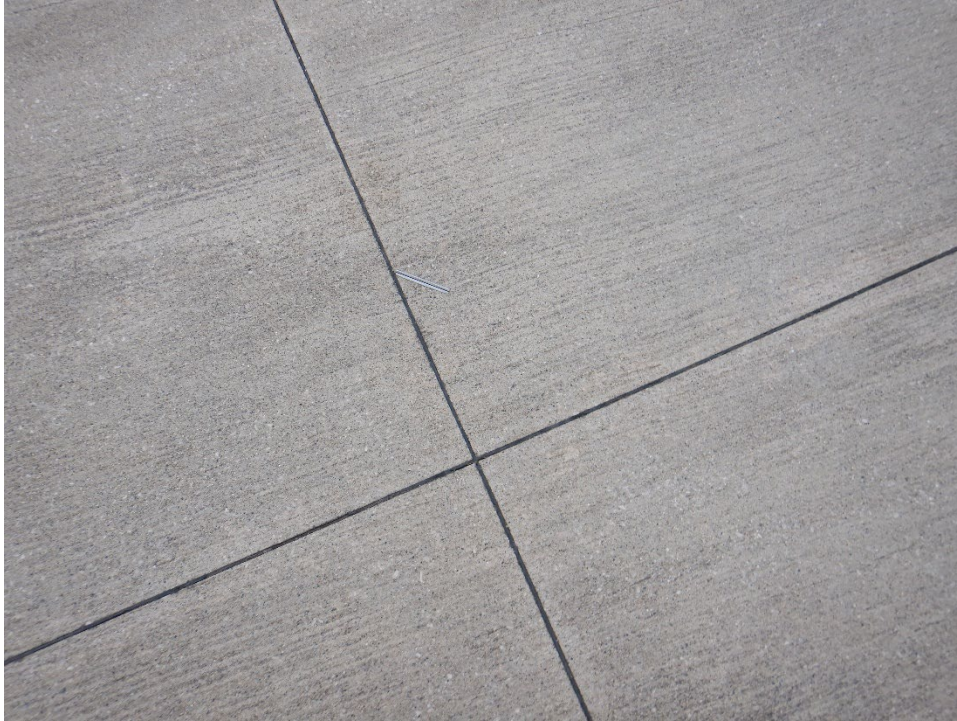
| <b>Distress Type</b> | <b>Probable Cause of Distress</b> |
|---|---|
| Joint Seal Damage | Stripping of joint sealant, extrusion of joint sealant, weed growth, hardening of the filler (oxidation), loss of bond to the slab edges, or absence of sealant in the joint. |

R18LE-04. Joint Seal Damage (Sample Unit No. 01).

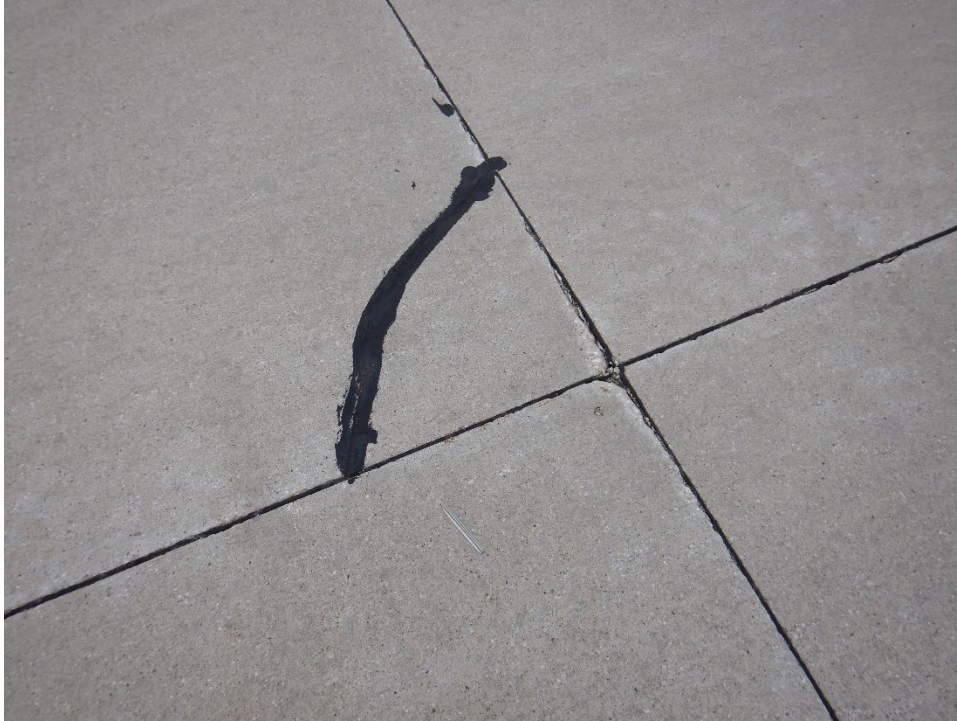
R18LE-05. Corner Break (Sample Unit No. 05).

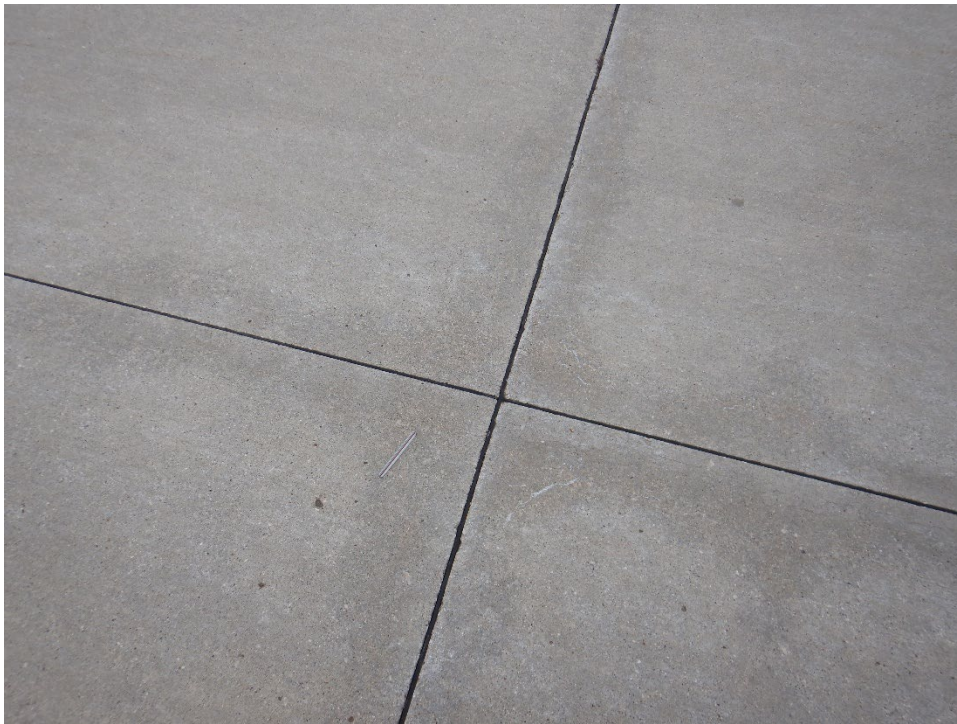
| <b>Distress Type</b> | <b>Probable Cause of Distress</b> |
|---|---|
| Durability Cracking | Concrete's inability to withstand environmental factors, such as freeze–thaw cycles. |

R18LE-05. Durability Cracking (Sample Unit No. 02).

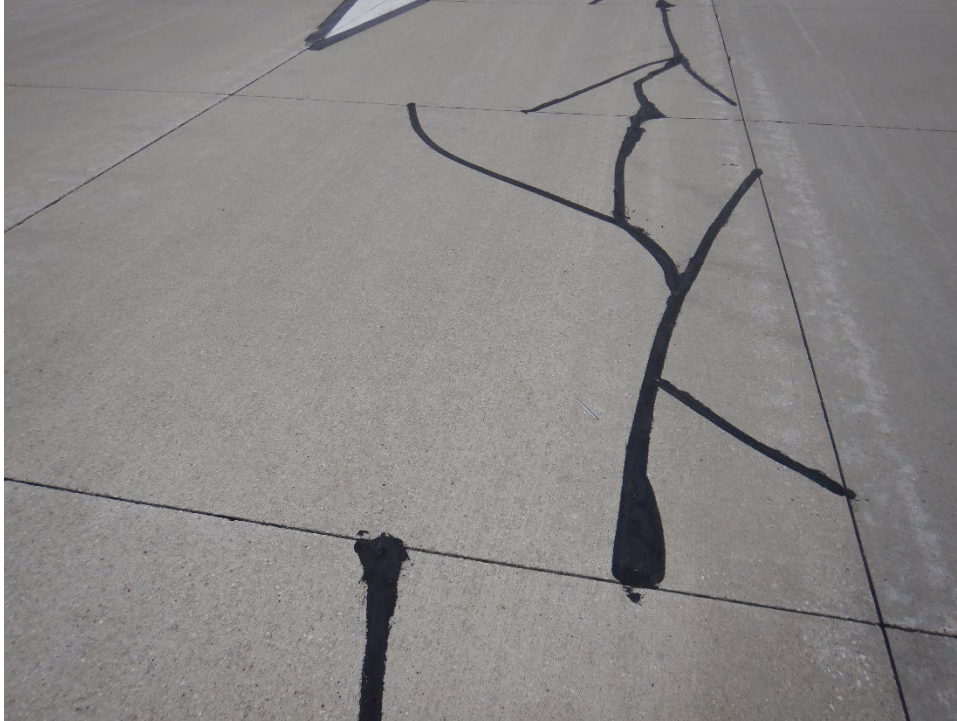
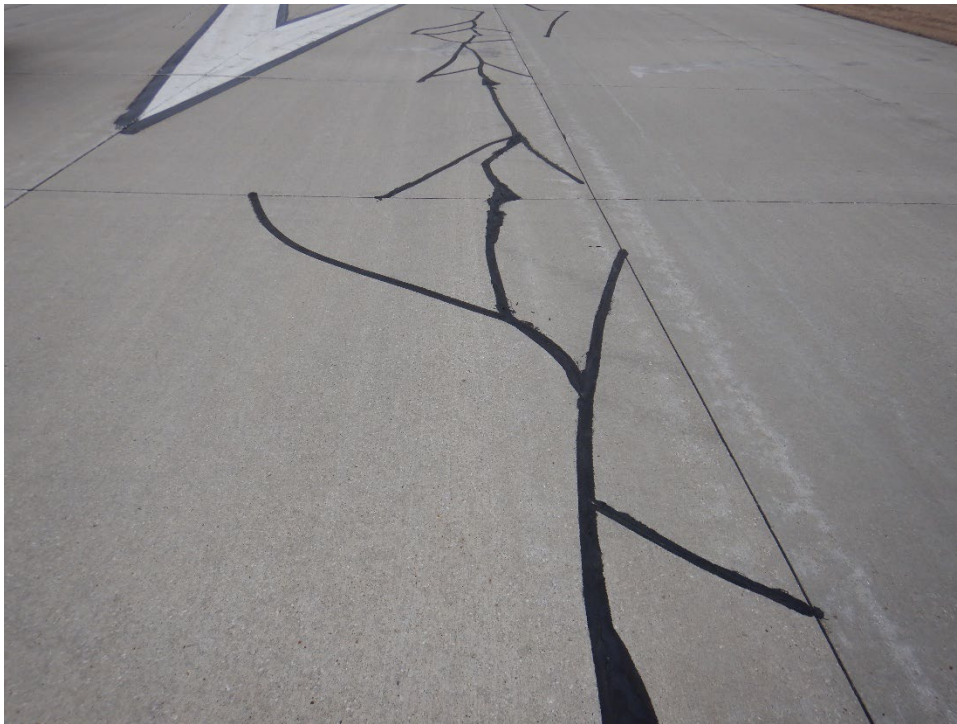
R18LE-05. Shattered Slab (Sample Unit No. 05) (1).

R18LE-05. Shattered Slab (Sample Unit No. 05) (2).

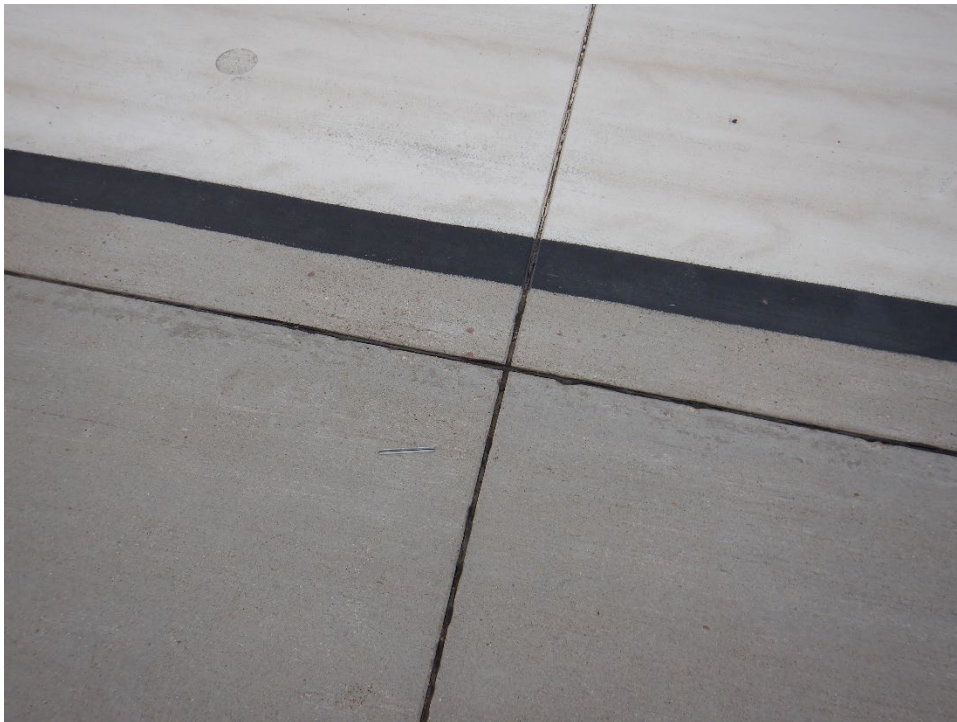
R18LE-06. Joint Seal Damage (Sample Unit No. 03).

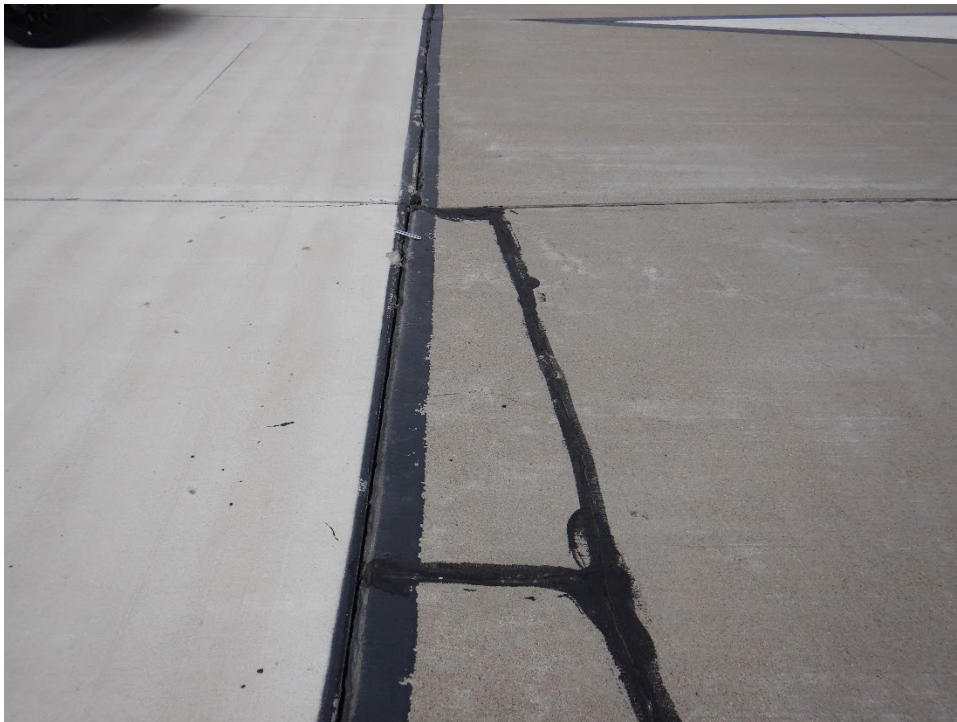
R18LE-07. Faulting (Additional Sample Unit No. 01).

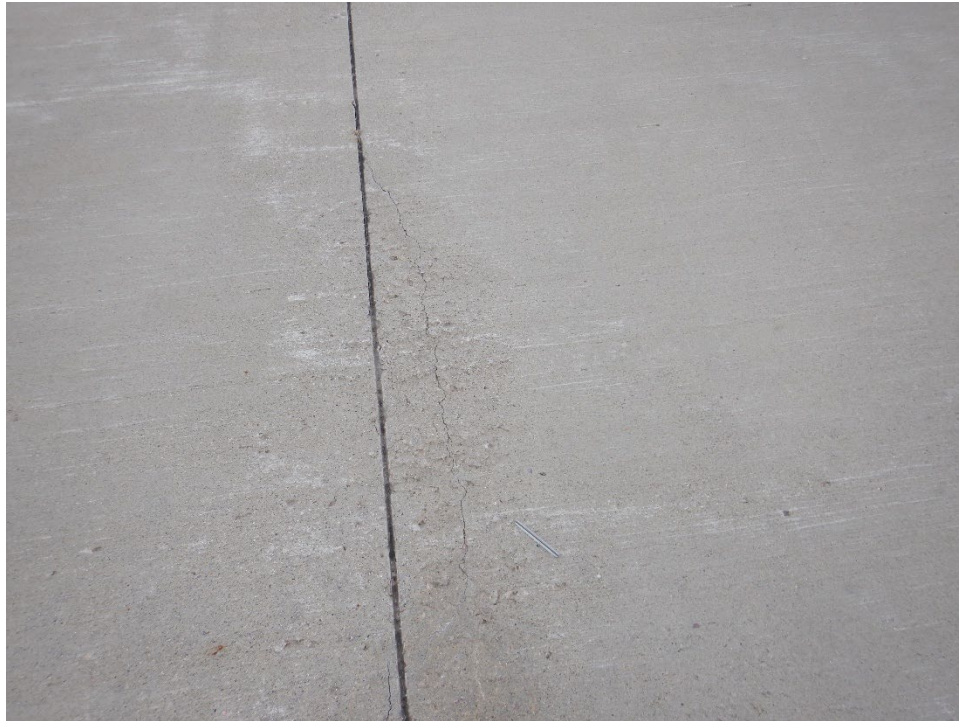
R18LE-07. Joint Spalling (Sample Unit No. 08).

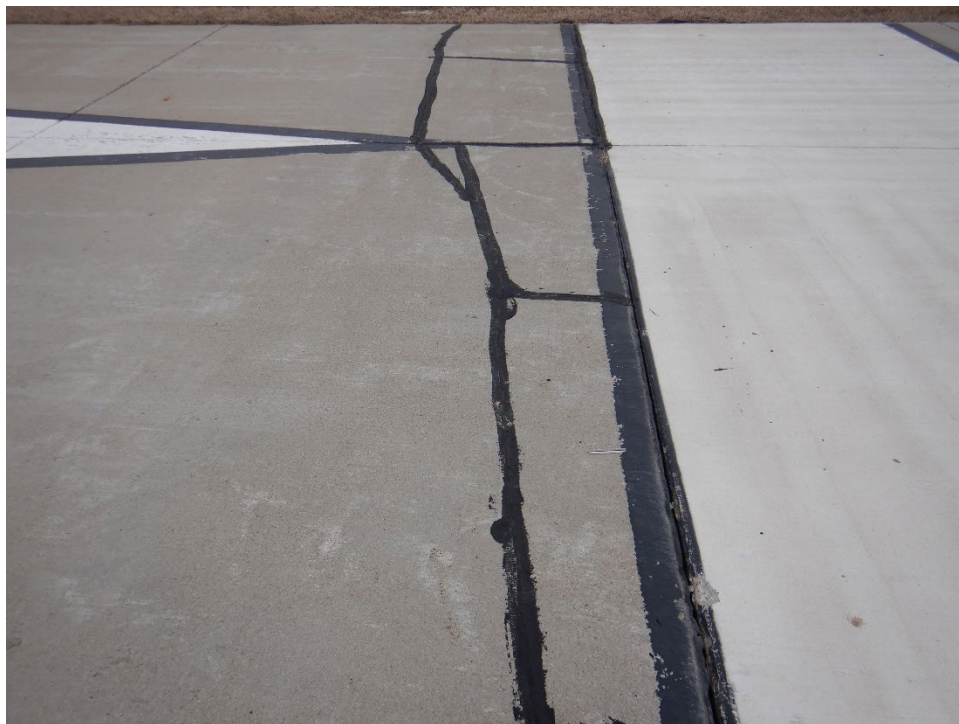
| <b>Distress Type</b> | <b>Probable Cause of Distress</b> |
|---|---|
| LTD Cracking | Combination of load repetition, curling stresses, and shrinkage stresses. |

R18LE-07. LTD Cracking (Additional Sample Unit No. 01).

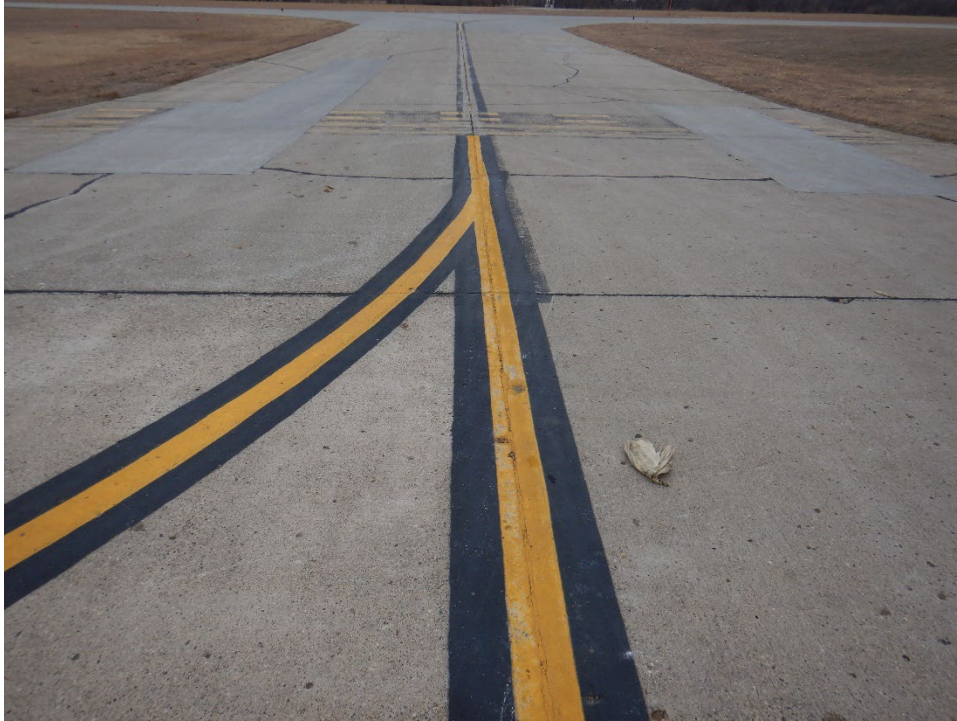
T01LE-01. Overview.

Taxiway 01 was defined by one section. Section 01 was in *Poor* condition with medium-severity corner break and joint spalling, high-severity joint seal damage, low-severity large patching and small patching, low- and medium-severity LTD cracking, popouts, medium- and high-severity shattered slab, and shrinkage cracking identified throughout.

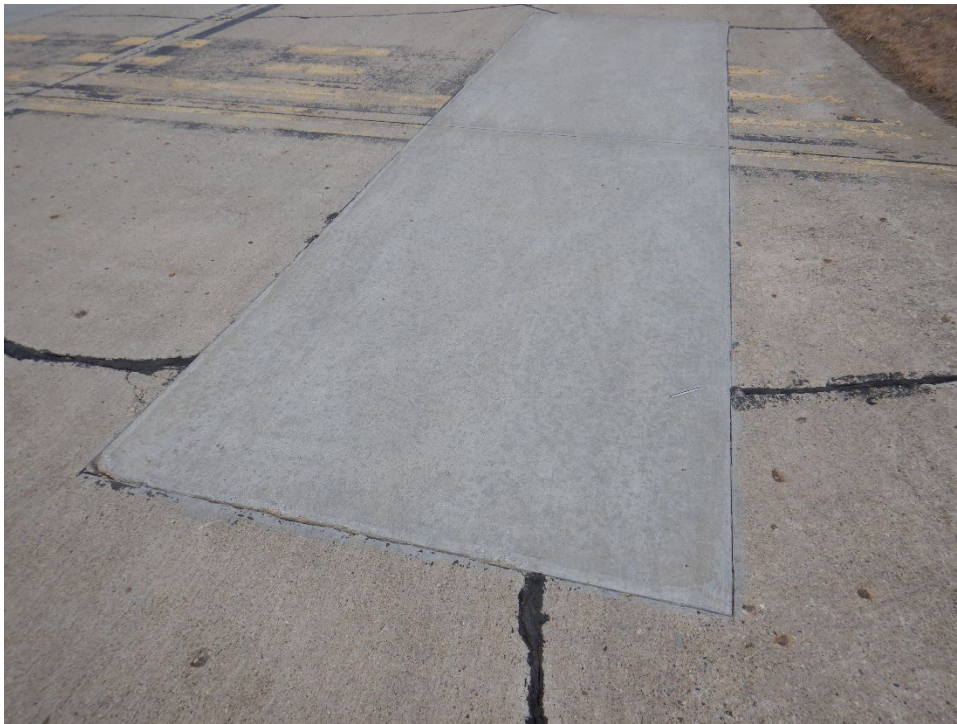
T01LE-01. Large Patching (Sample Unit No. 01).

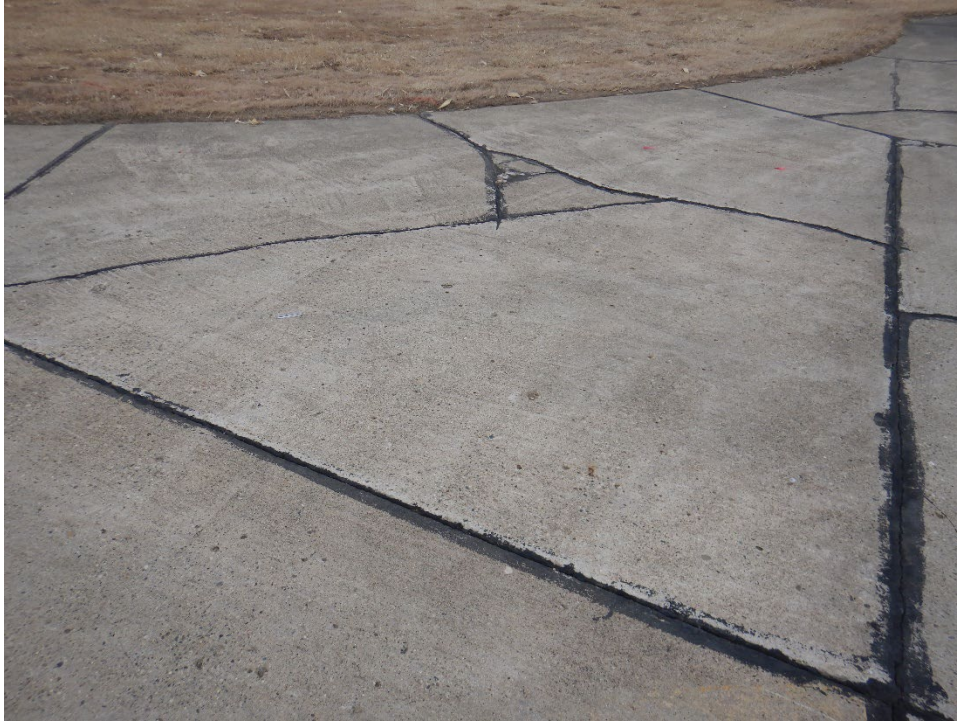
T01LE-01. Shattered Slab (Sample Unit No. 01).

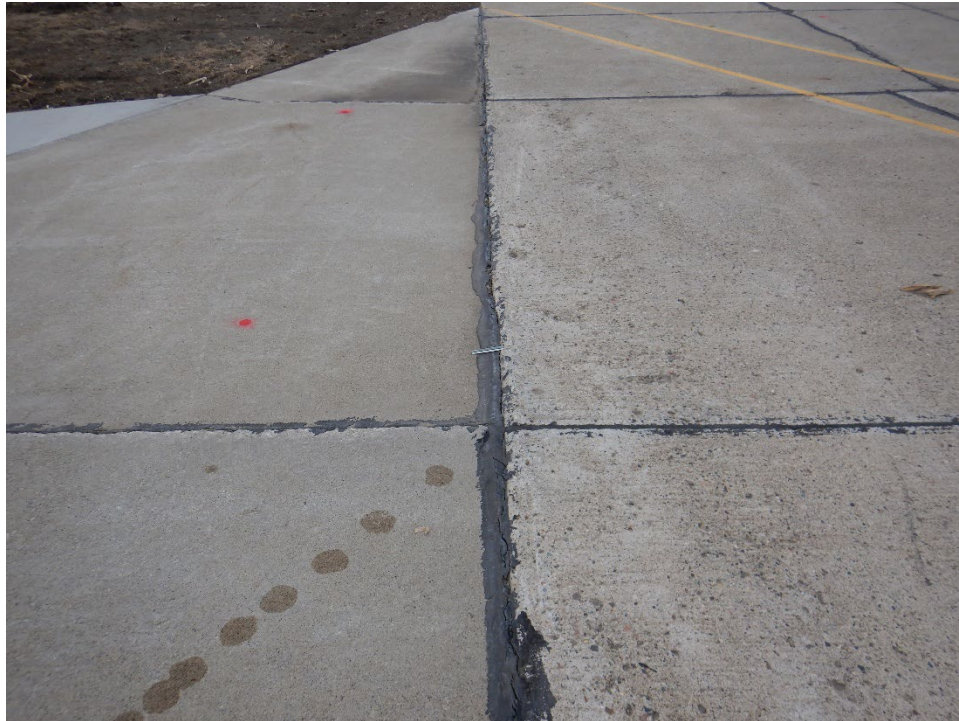
TH01LE-01. Faulting (Sample Unit No. 01).

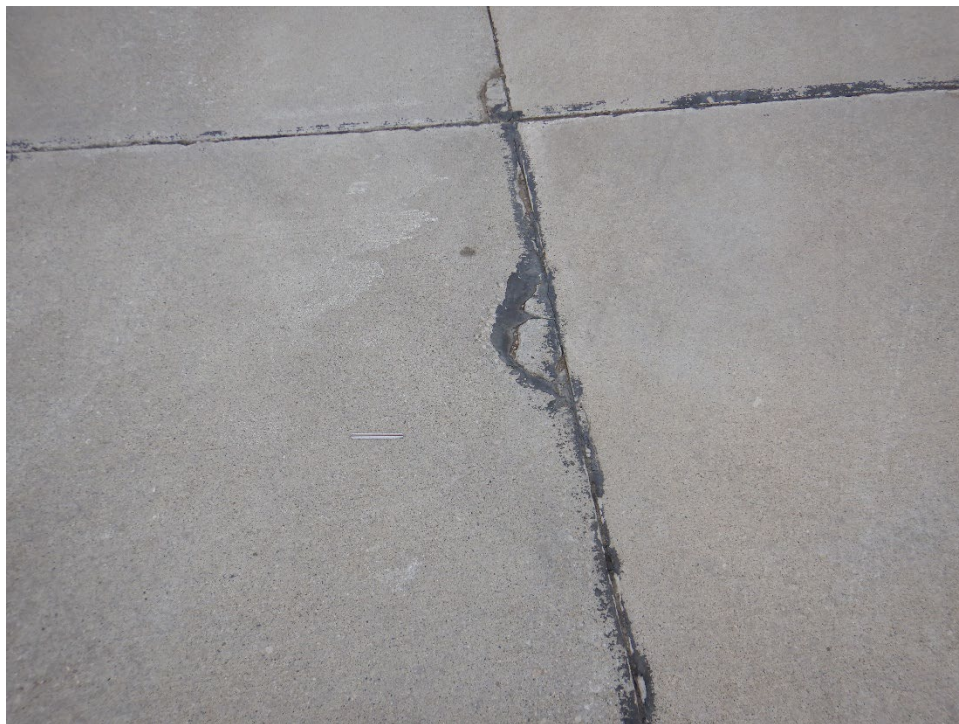
TH01LE-01. Joint Spalling (Sample Unit No. 01).

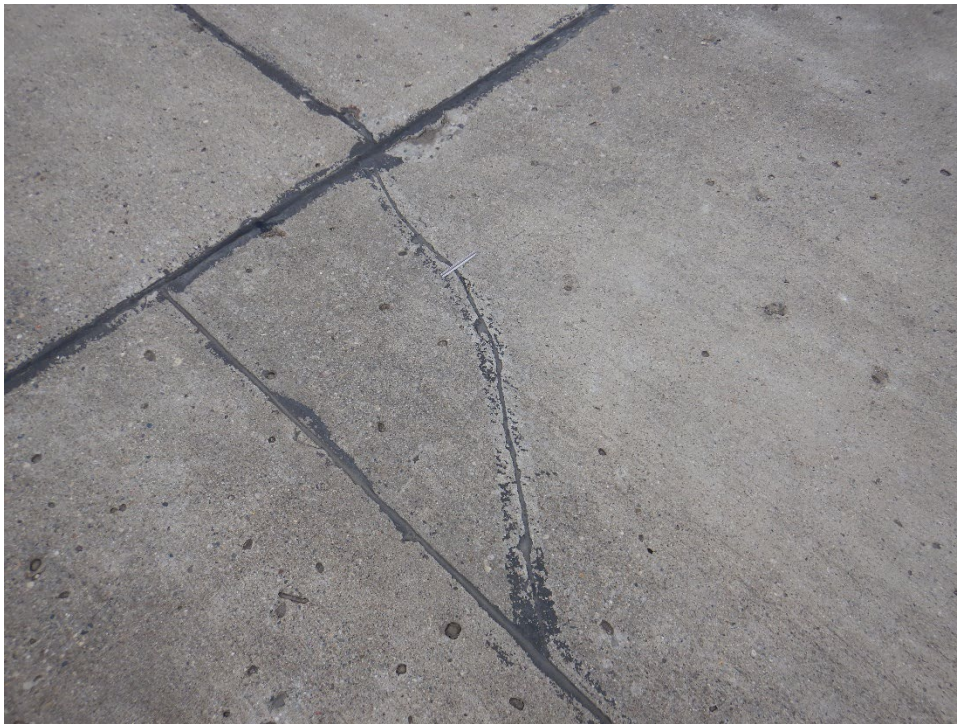
TH01LE-02. Corner Break (Sample Unit No. 01).

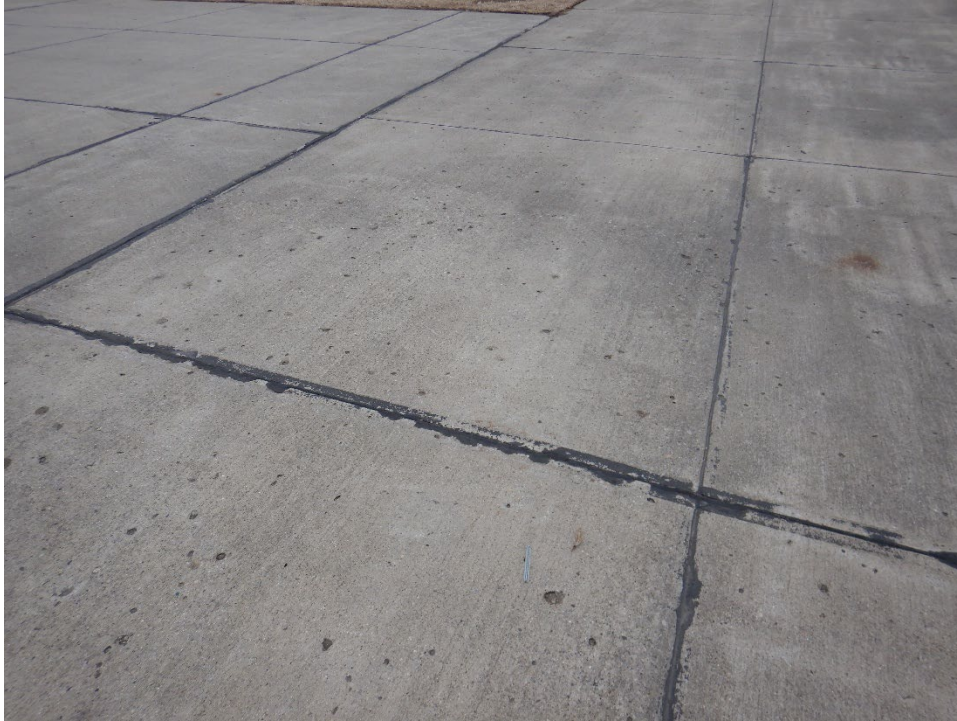
TH01LE-02. Popouts (Sample Unit No. 01).

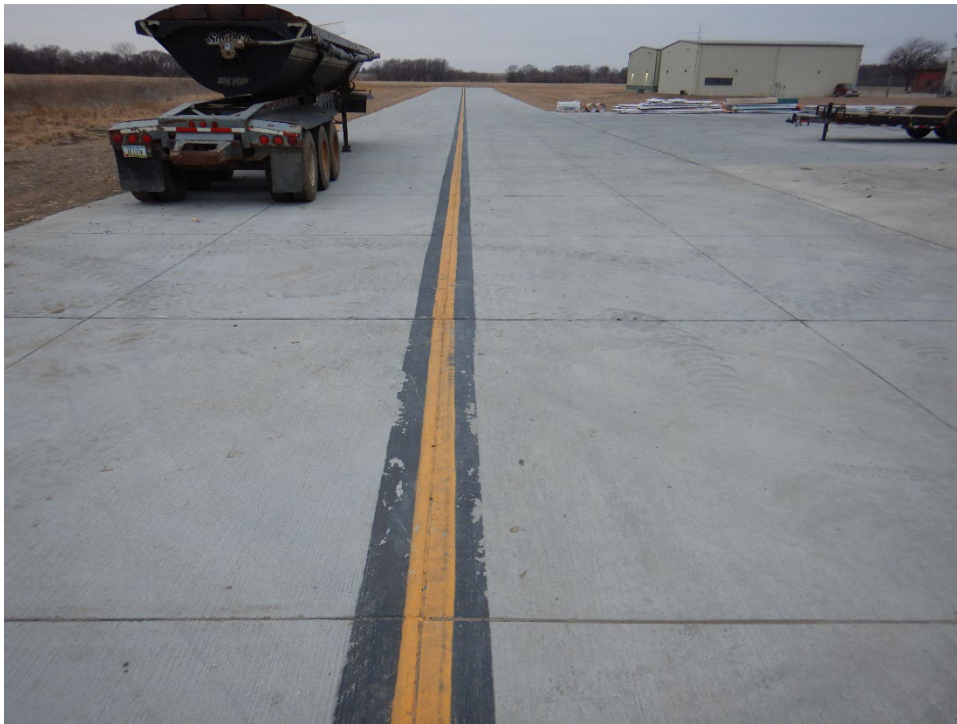
TH02LE-01. Overview.

T-hangar 02 consisted of one section that was in *Excellent* condition with no distress noted at the time of inspection.
