# Manchester Municipal Airport

## Pavement Management Report

**AUGUST 2025**

# MANCHESTER MUNICIPAL AIRPORT PAVEMENT MANAGEMENT REPORT

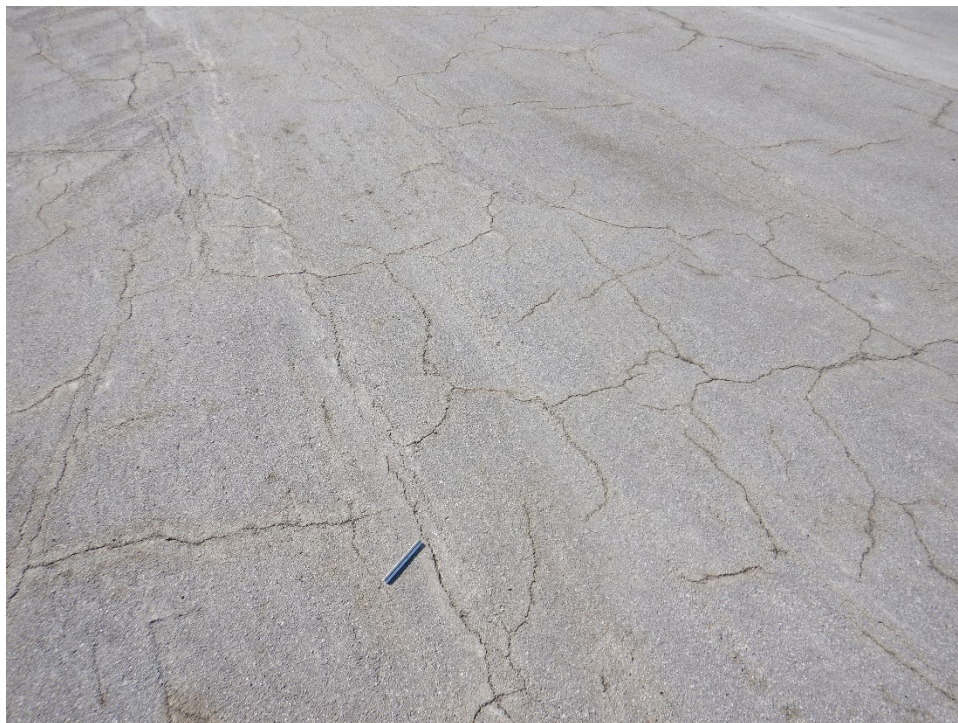
Apron 01 was defined by one section. Low-severity block cracking and low- and medium-severity alligator cracking and L&T cracking were identified in this section. The alligator cracking was observed along the edge of the pavement. The low-severity block cracking and L&T cracking were unsealed. The medium-severity L&T cracking was due to either unsatisfactory crack sealant or the development of secondary cracking.

A01C2-01. Block Cracking (Sample Unit No. 01).

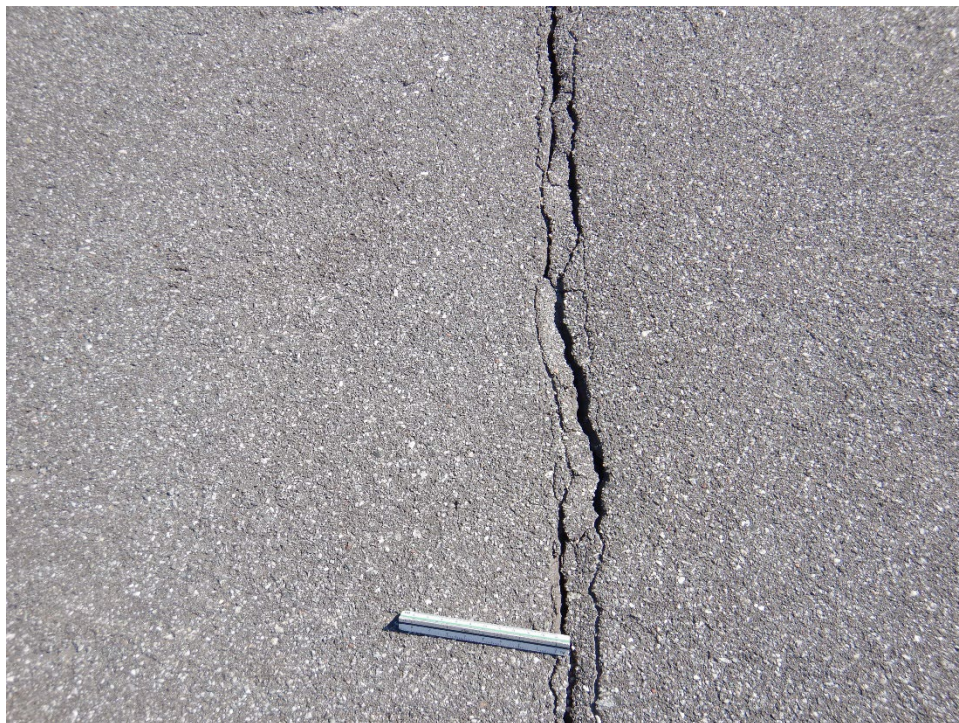
Apron 02 consisted of three sections. Section 01 contained low-severity alligator cracking, low- and medium-severity L&T cracking, and high-severity raveling. The low-severity L&T cracking was unsealed, while the medium-severity L&T cracking was due to either unsatisfactory crack sealant or unsealed crack widths that exceeded 1/4 inch. Medium-severity alligator cracking, low-severity depression, low- and medium-severity L&T cracking, and high-severity raveling were identified in Section 02. The low-severity L&T cracking was unsealed, while the medium-severity L&T cracking was due to crack sealant that was no longer satisfactory. In Section 03, low- and medium-severity L&T cracking, oil spillage, and high-severity raveling were identified. The low-severity L&T cracking was unsealed, and the medium-severity L&T cracking was unsealed with crack widths greater than 1/4 inch.

A02C2-01. L&T Cracking (Sample Unit No. 01).

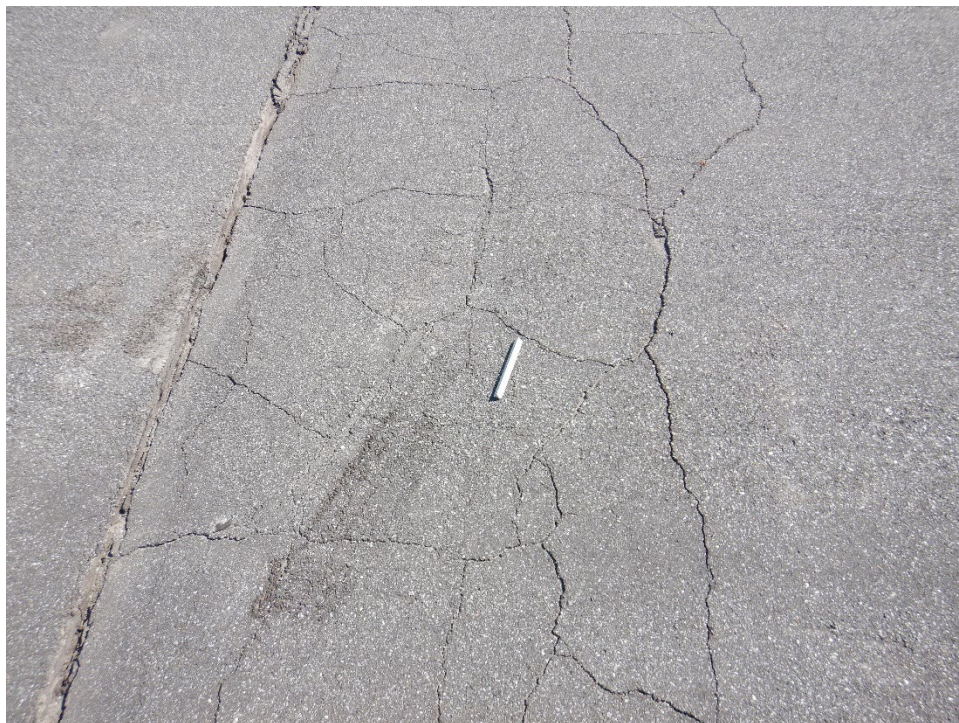
A02C2-02. Alligator Cracking (Sample Unit No. 02).

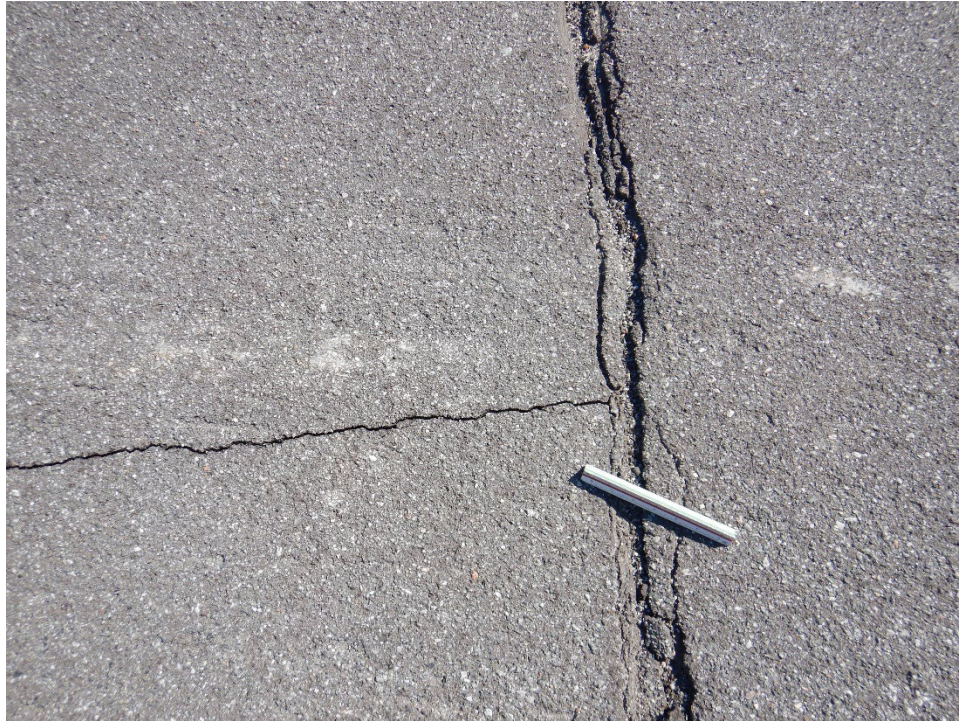
A02C2-02. L&T Cracking (Sample Unit No. 01).

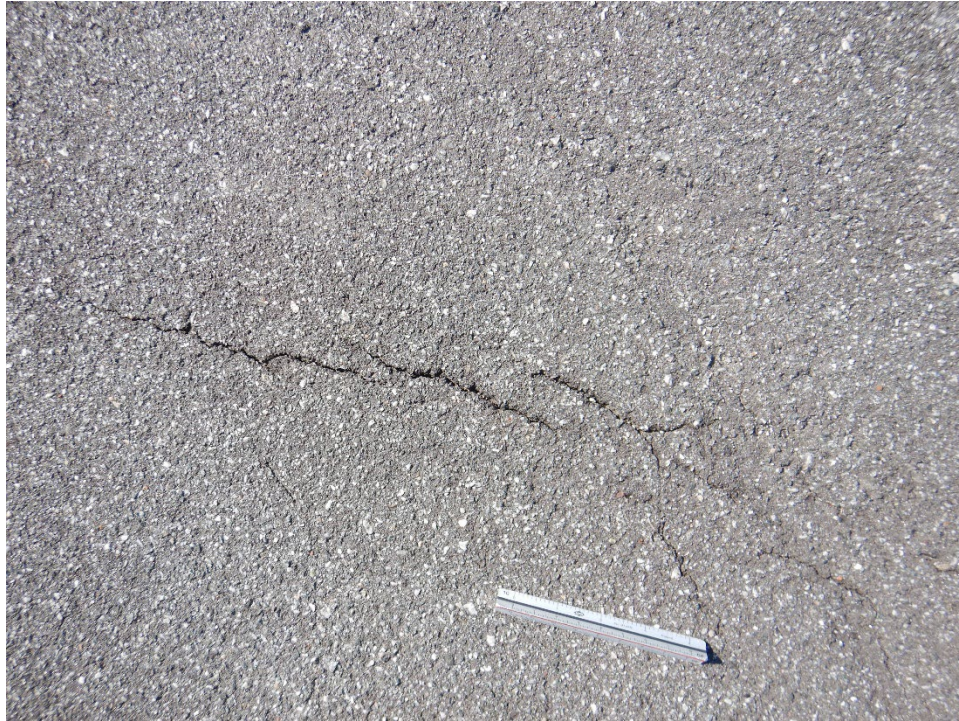
A02C2-03. L&T Cracking (Sample Unit No. 06) (1).

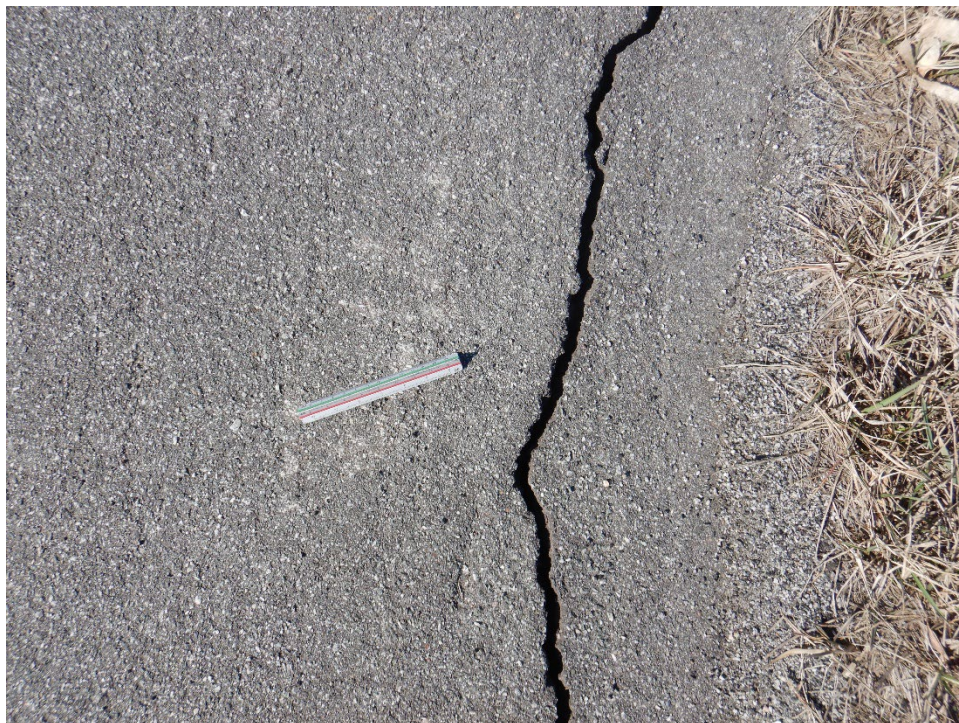
A02C2-03. L&T Cracking (Sample Unit No. 06) (2).

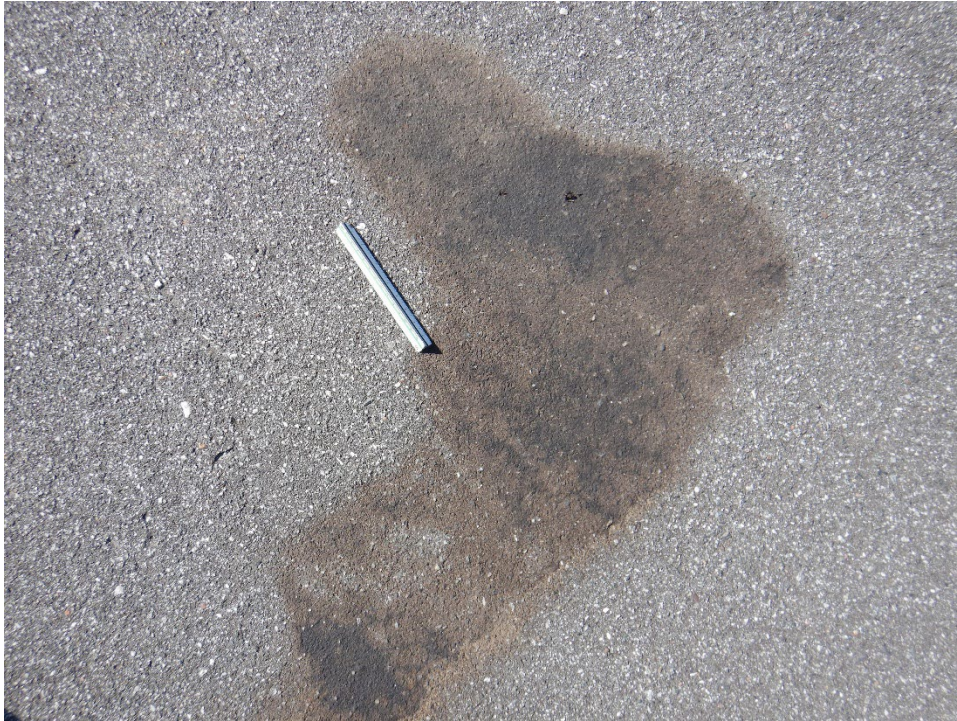
A02C2-03. Oil-Fuel Damage (Sample Unit No. 05).

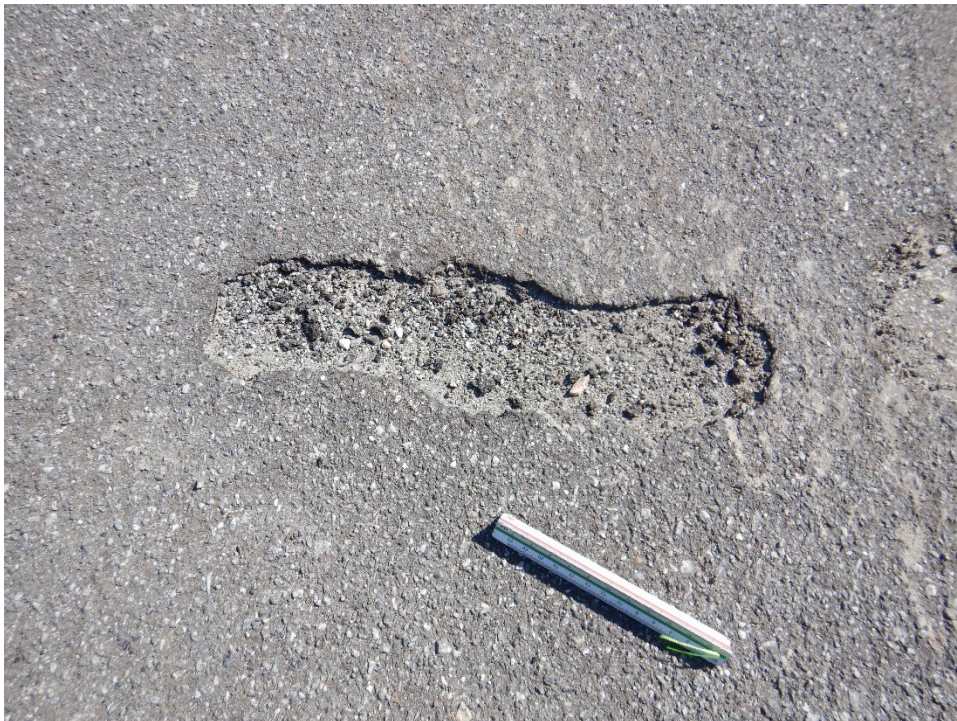
A02C2-03. Raveling (Sample Unit No. 03).

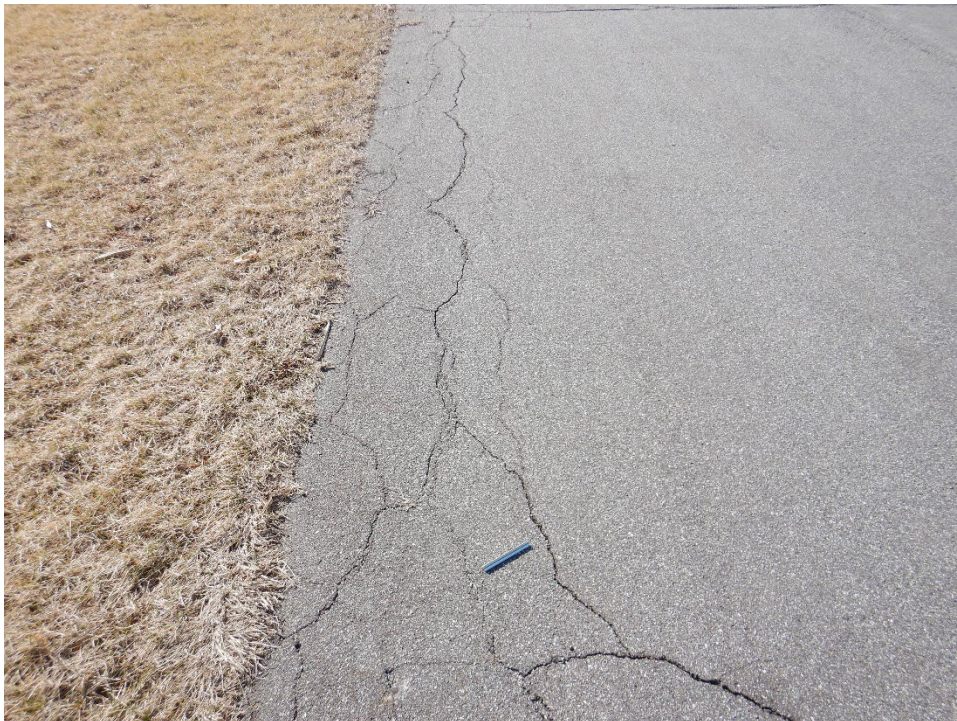
Runway 18/36 was defined by two sections. In Section 01, low- and medium-severity alligator cracking and longitudinal and transverse (L&T) cracking were observed. The low-severity L&T cracking was both unsealed and sealed and the medium-severity L&T cracking was due to either the development of secondary cracking, unsealed crack widths that exceeded 1/4 inch, or unsatisfactory crack sealant. All severities of L&T cracking and low- and medium-severity patching and depression were identified in Section 02. The low-severity L&T cracking was unsealed; the medium-severity L&T cracking was due to unsatisfactory crack sealant; and the high-severity L&T cracking was noted in areas where secondary cracking was wider than 1 foot.

R18C2-01. Alligator Cracking (Sample Unit No. 27).

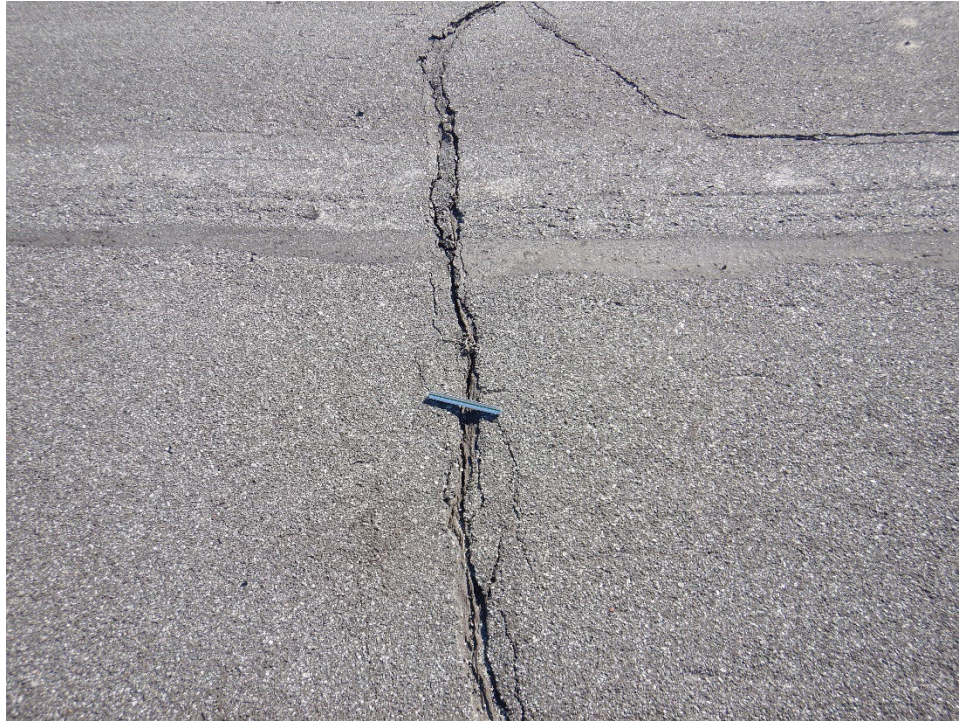
R18C2-01. L&T Cracking (Sample Unit No. 03).

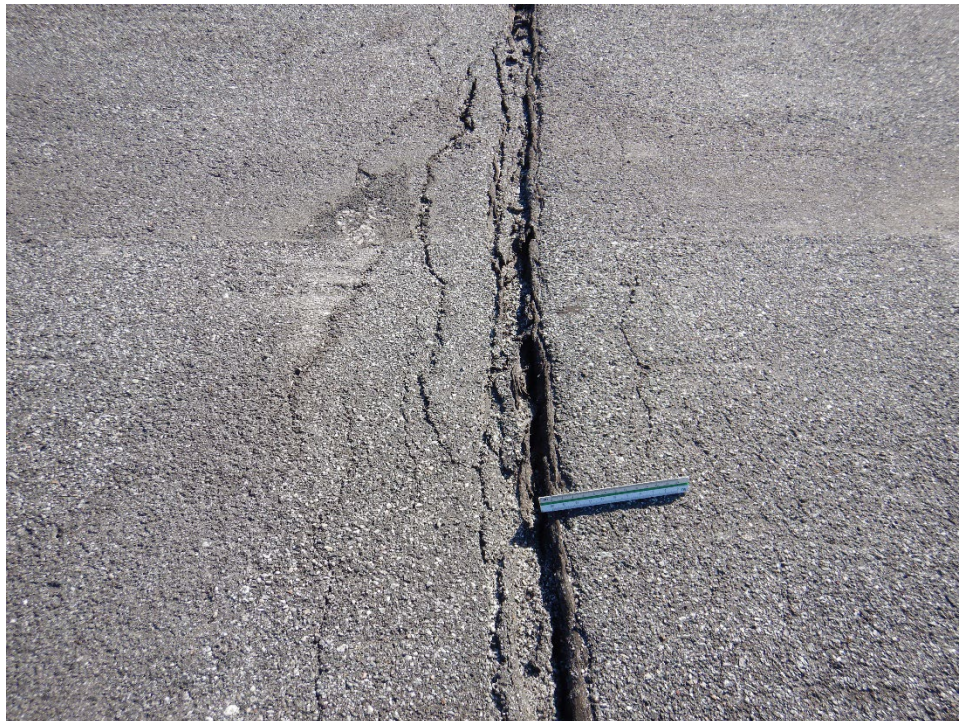
R18C2-01. L&T Cracking (Sample Unit No. 11).

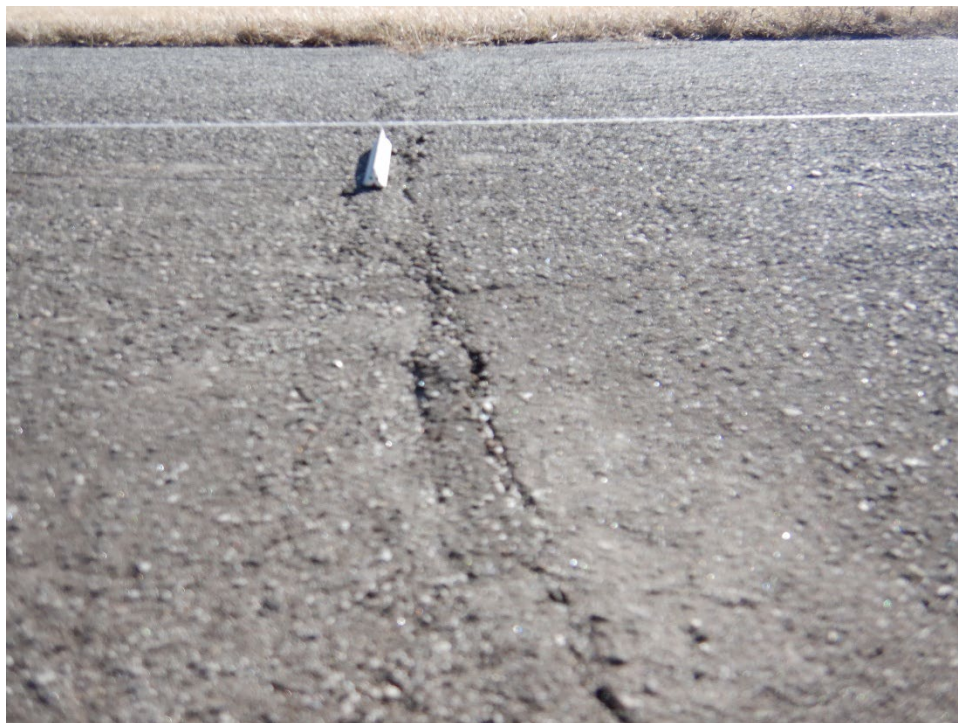
R18C2-02 Depression. (Sample Unit No. 05).

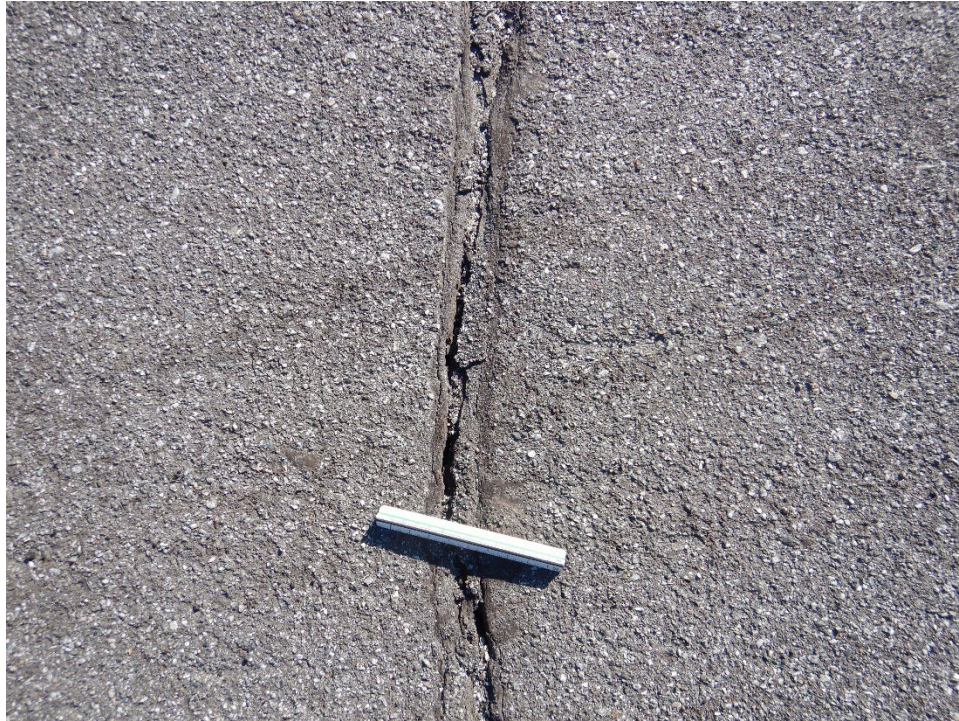
R18C2-02. L&T Cracking (Sample Unit No. 01).

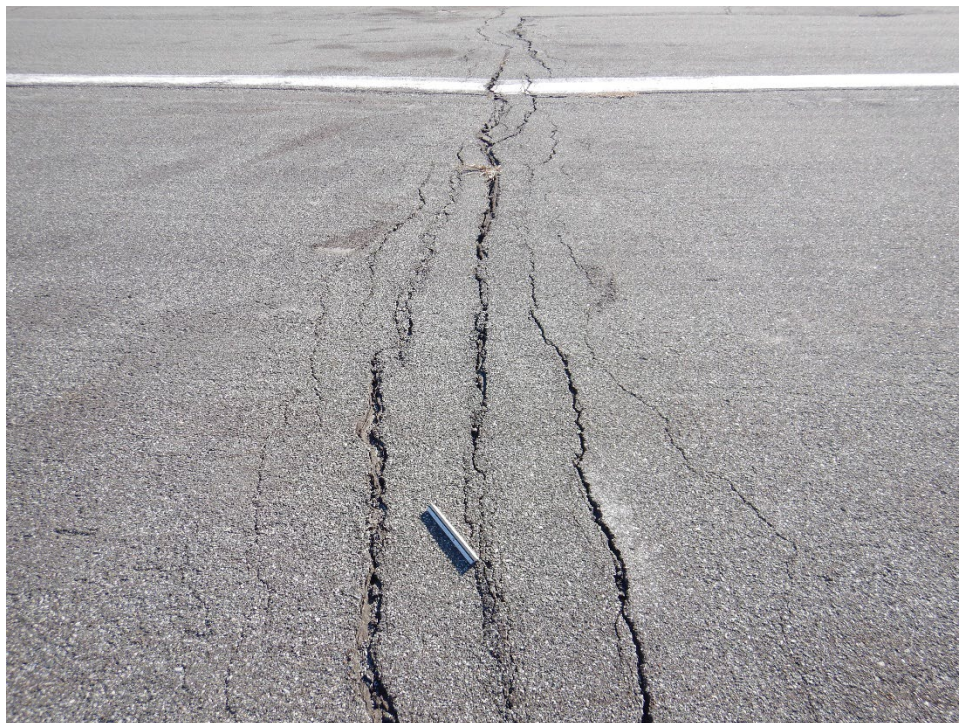
R18C2-02. L&T Cracking (Sample Unit No. 05).

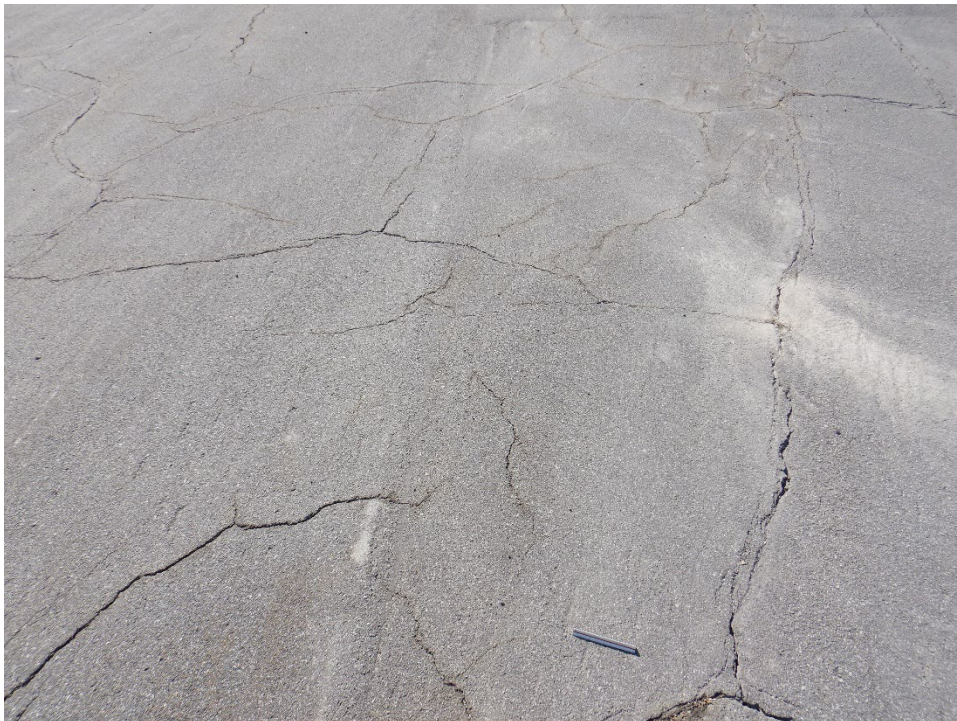
The taxiway consisted of two sections. Section 01 was in Poor condition. The distresses identified during the inspection included medium-severity alligator cracking, low-severity block cracking, and low- and medium-severity L&T cracking. The low-severity block cracking was sealed, while the low-severity L&T cracking was unsealed. The medium-severity L&T cracking was due to either unsatisfactory crack sealant or unsealed crack widths greater than 1/4 inch. Low- and medium-severity L&T cracking were observed in Section 02. The low-severity L&T cracking was unsealed, and the medium-severity L&T cracking was due to unsatisfactory crack sealant.

T01C2-01. Block Cracking (Sample Unit No. 02).

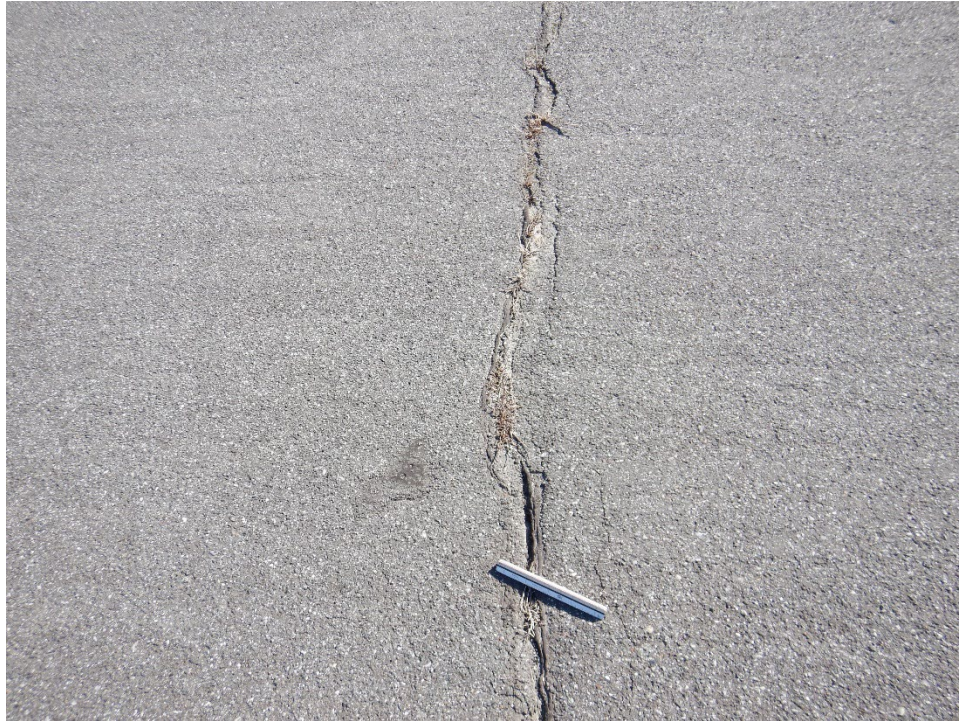
T01C2-01. L&T Cracking (Sample Unit No. 02).

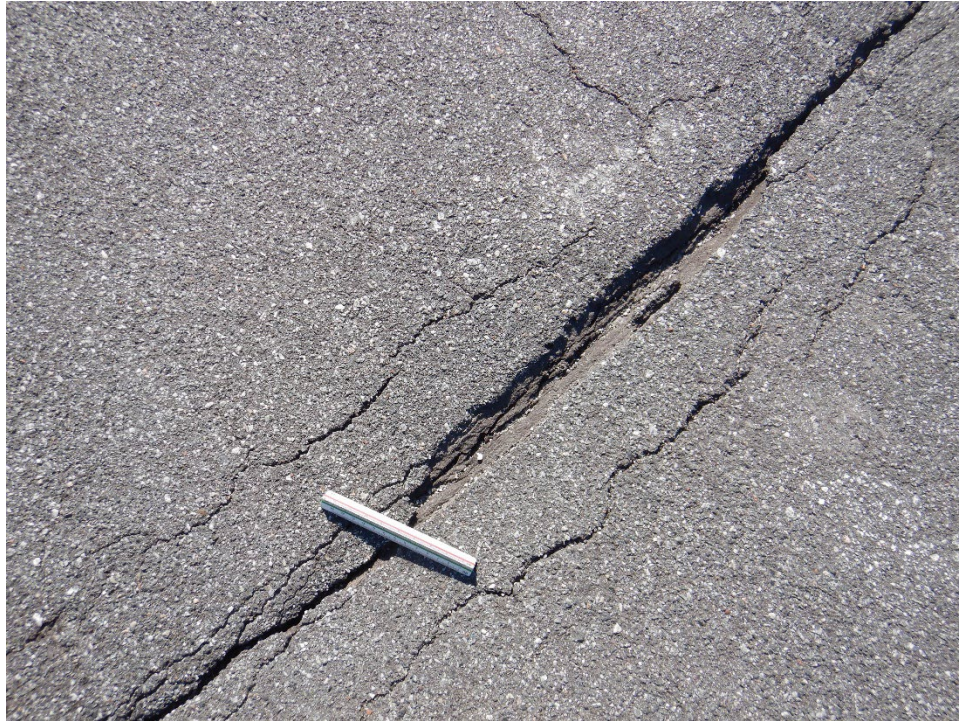
T01C2-02. L&T Cracking (Sample Unit No. 01).

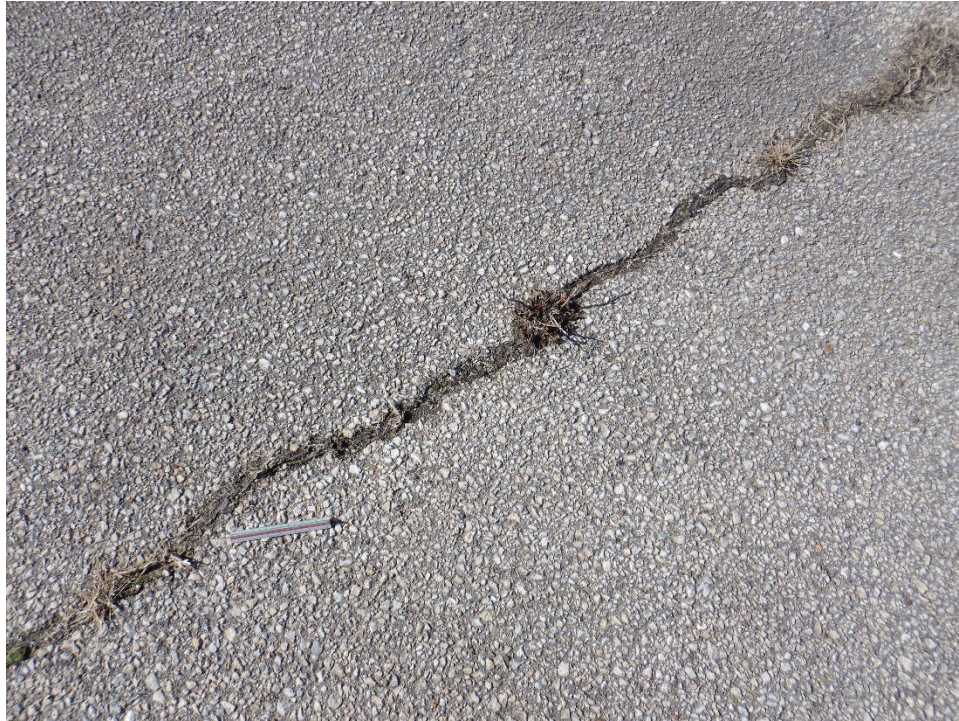
The T-hangar area was defined by one section that contained low- and medium-severity L&T cracking and medium-severity weathering. The low-severity L&T cracking was unsealed, while the medium-severity L&T cracking was unsealed with crack widths that exceeded 1/4 inch.

TH01C2-01. L&T Cracking (Sample Unit No. 01).
