# Mapleton-James G Whiting Memorial Field Airport

## Pavement Management Report

**JULY 2024**

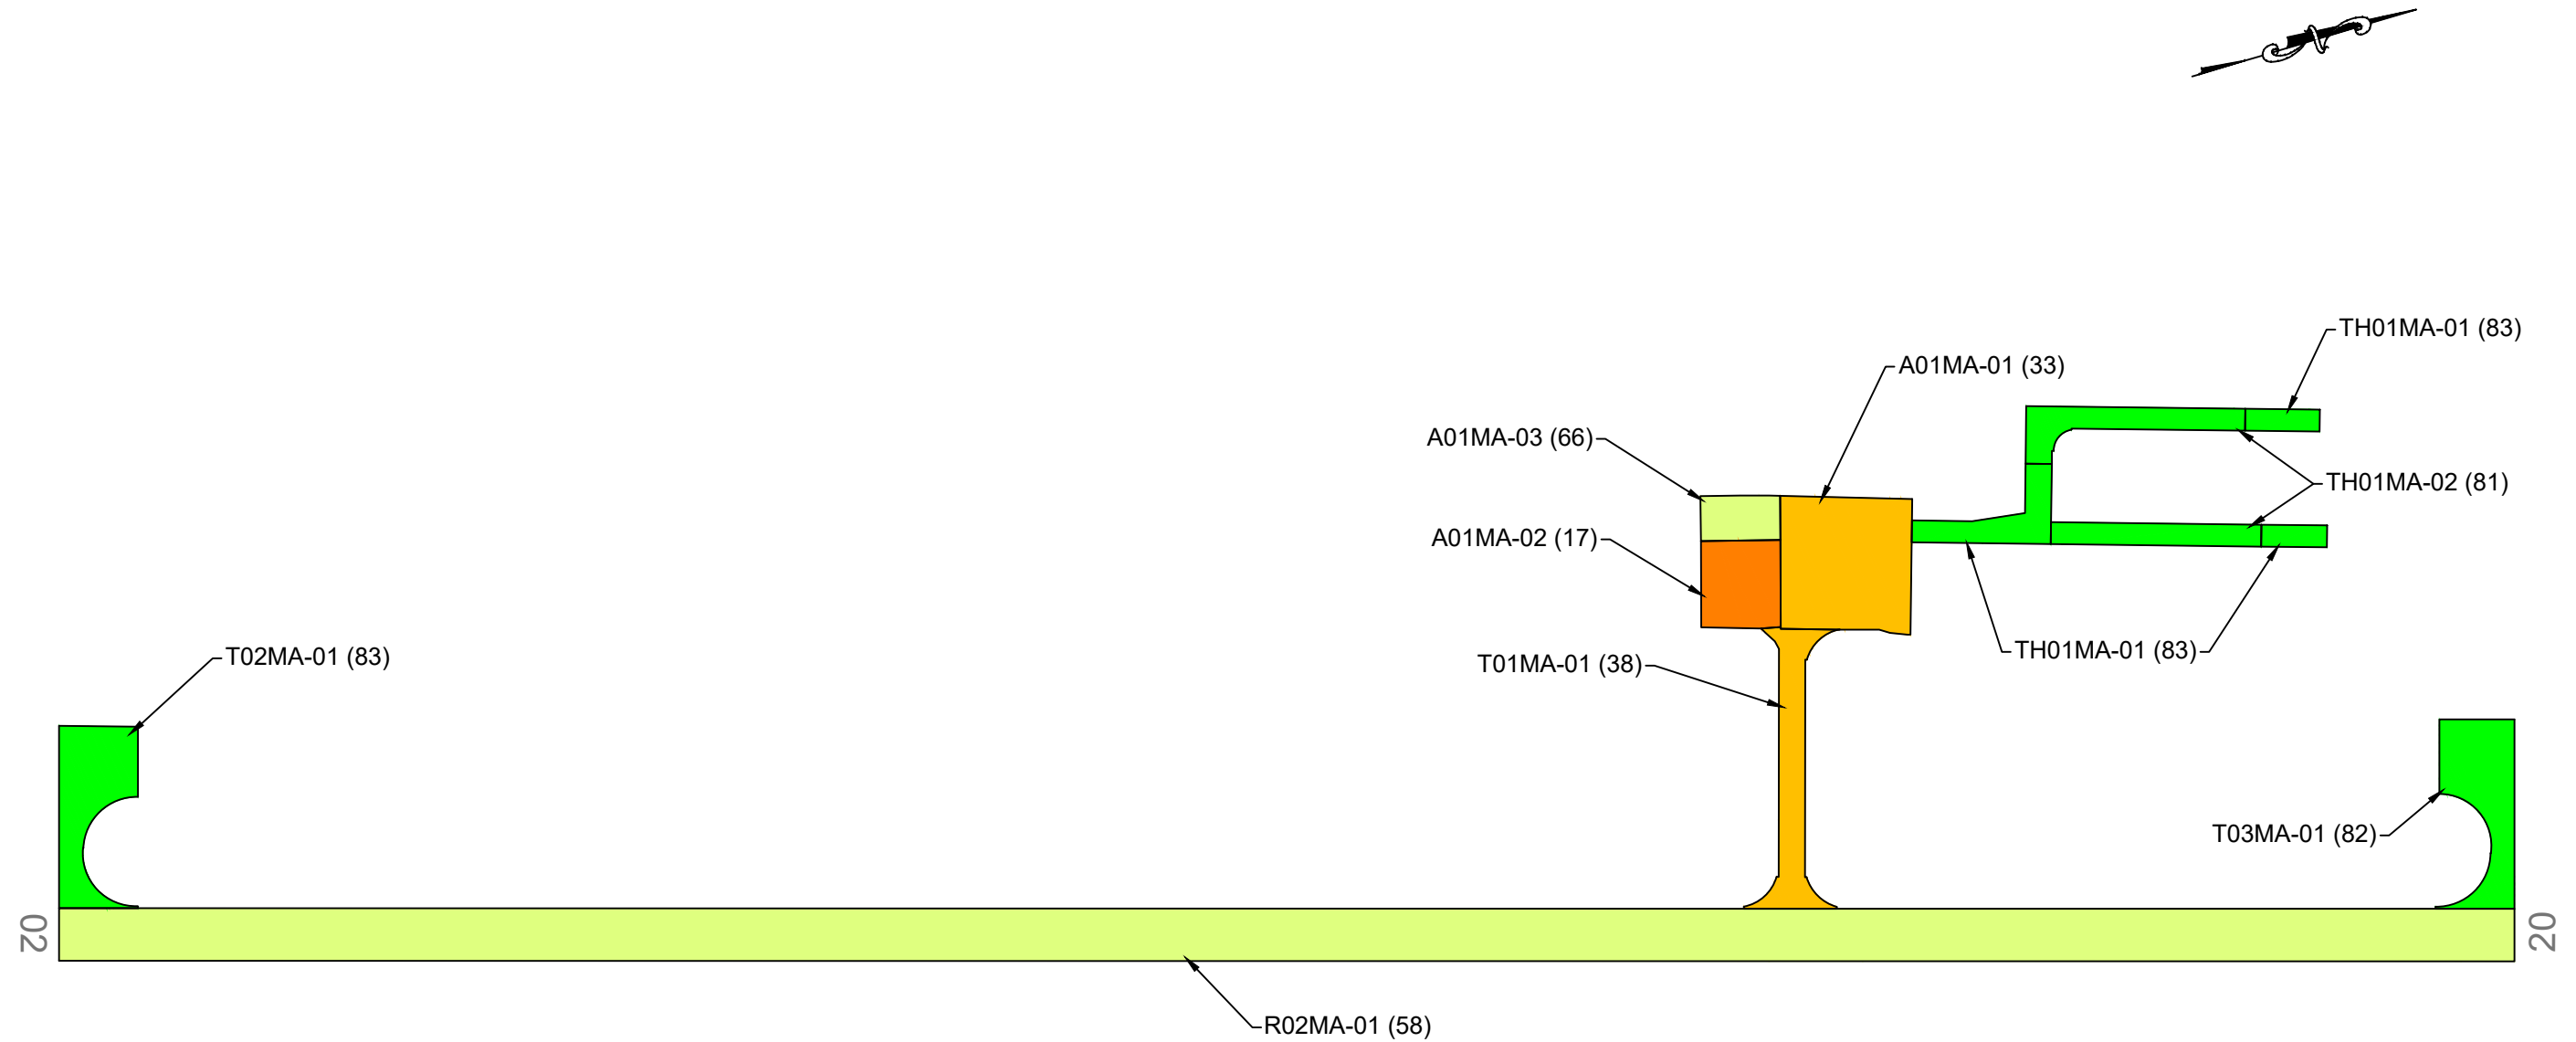
FIGURE 8. PCI MAP.

The pavements at Mapleton-James G Whiting Memorial Field Airport were inspected in November 2023. The 2023 area-weighted condition of Mapleton-James G Whiting Memorial Field Airport is 58, with conditions ranging from 17 to 83 (on a scale of 0 [failed] to 100 [excellent]). During the previous pavement inspection in 2020, the area-weighted PCI of the airport was 68.

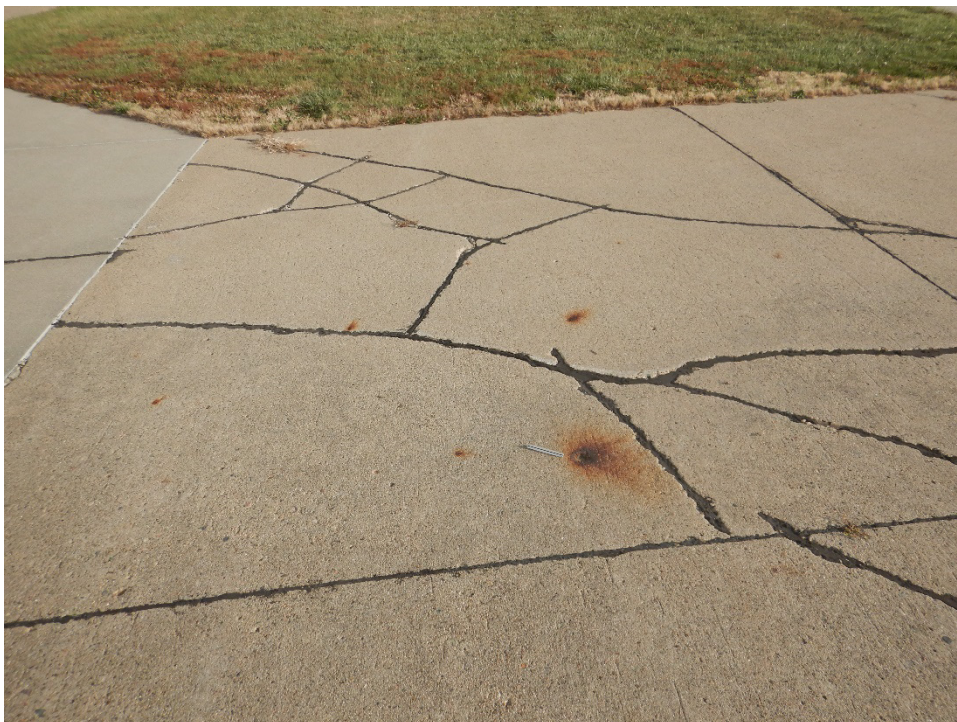
A01MA-01. Shattered Slab (Sample Unit No. 01).

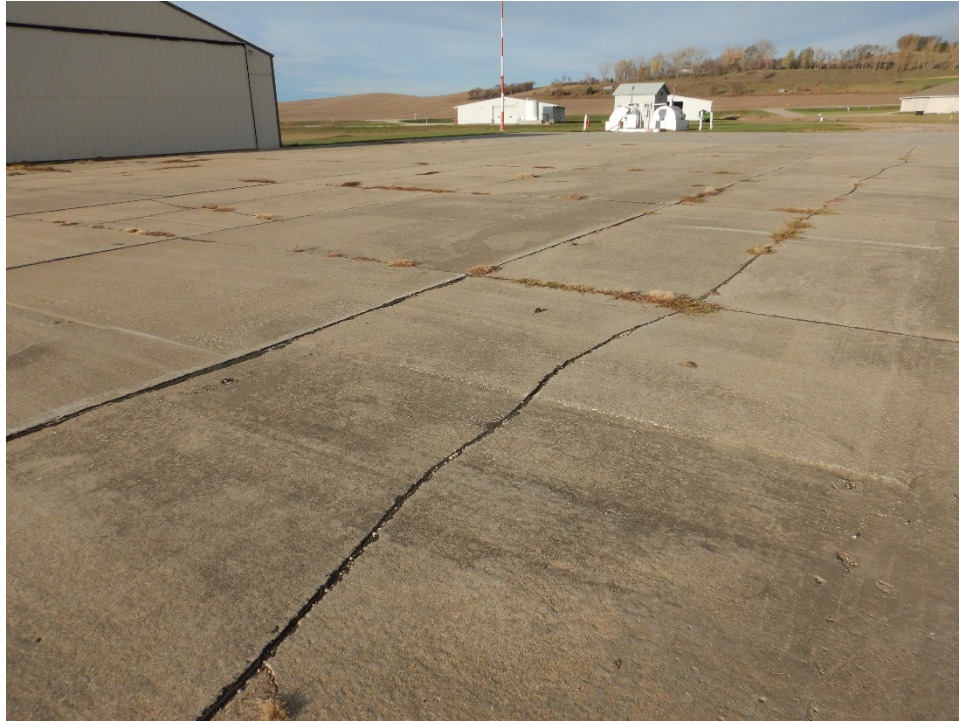
A01MA-02. Overview.

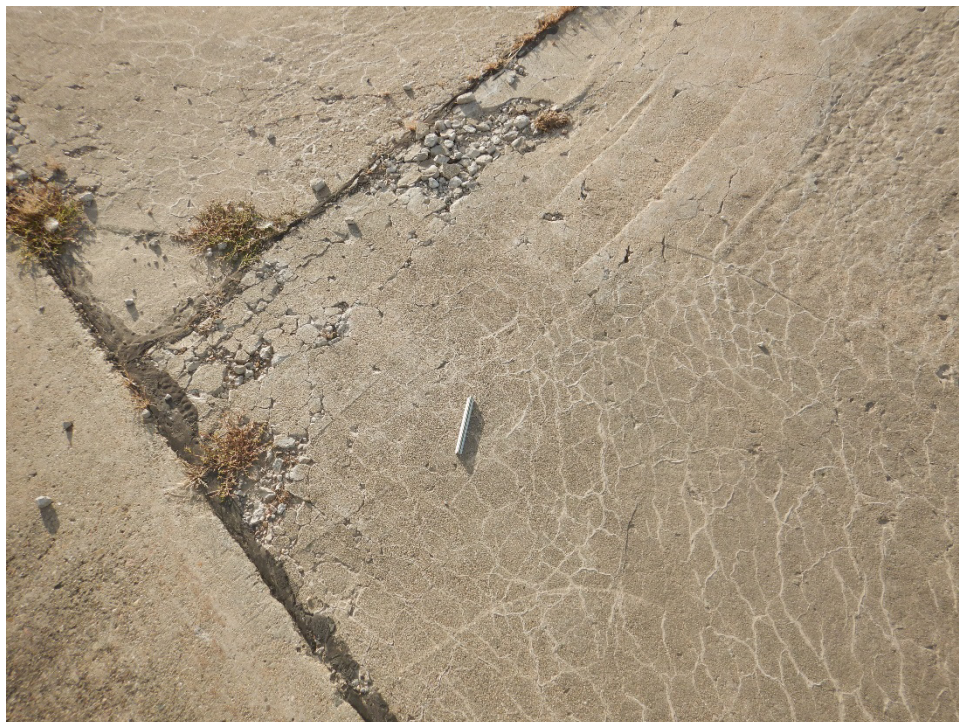
A01MA-02. ASR (Sample Unit No. 02).

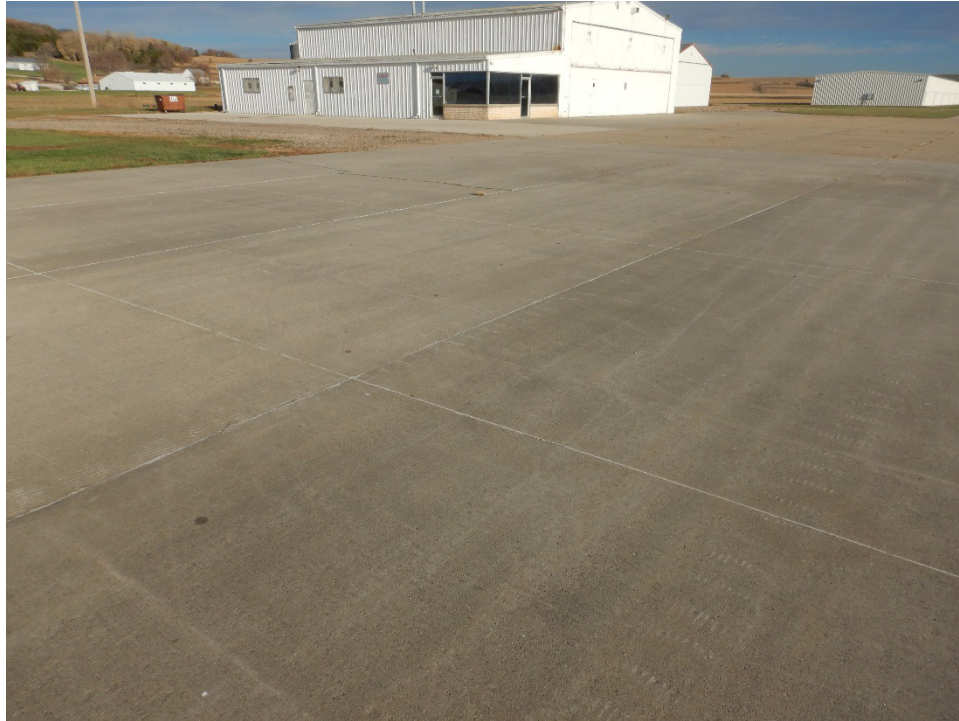
A01MA-03. Overview.

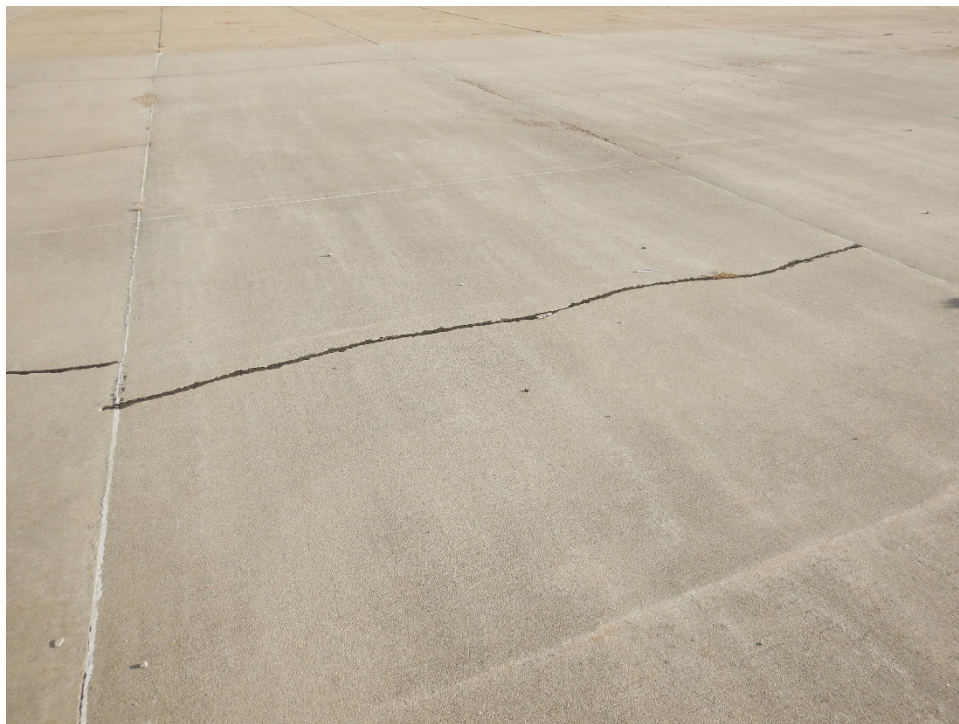
A01MA-03. LTD Cracking (Sample Unit No. 02).

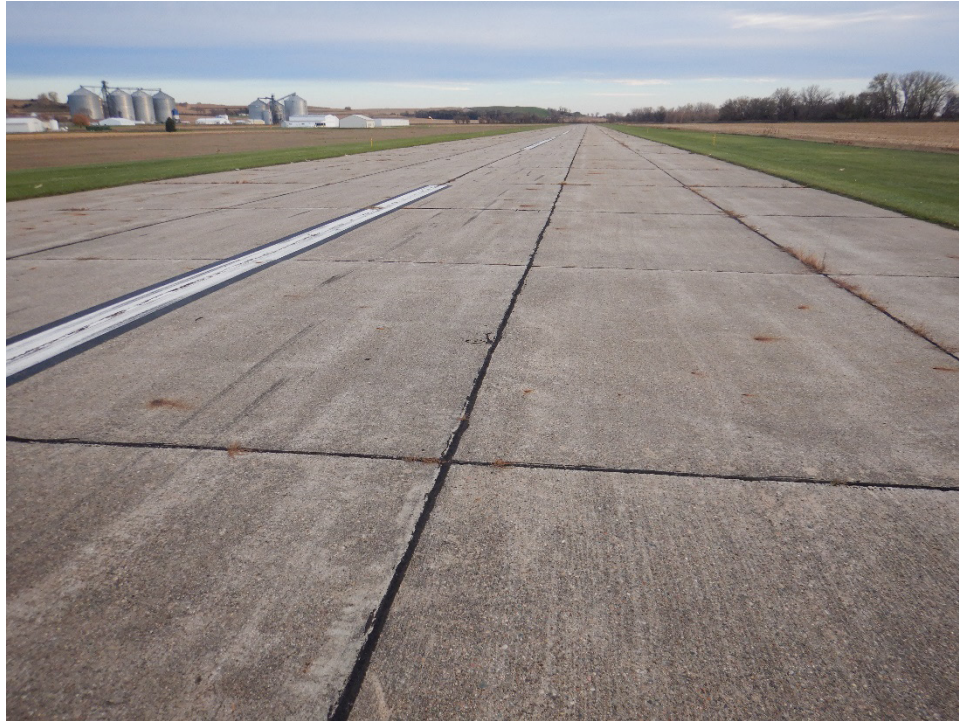
Runway 02/20 consisted of one section. Low-severity ASR, large patching, scaling, and small patching; low- and medium-severity faulting, joint spalling, and longitudinal, transverse, and diagonal (LTD) cracking; medium-severity corner break, corner spalling, and shattered slab; high-severity joint seal damage; and shrinkage cracking were recorded in Section 01.

R02MA-01. Overview.

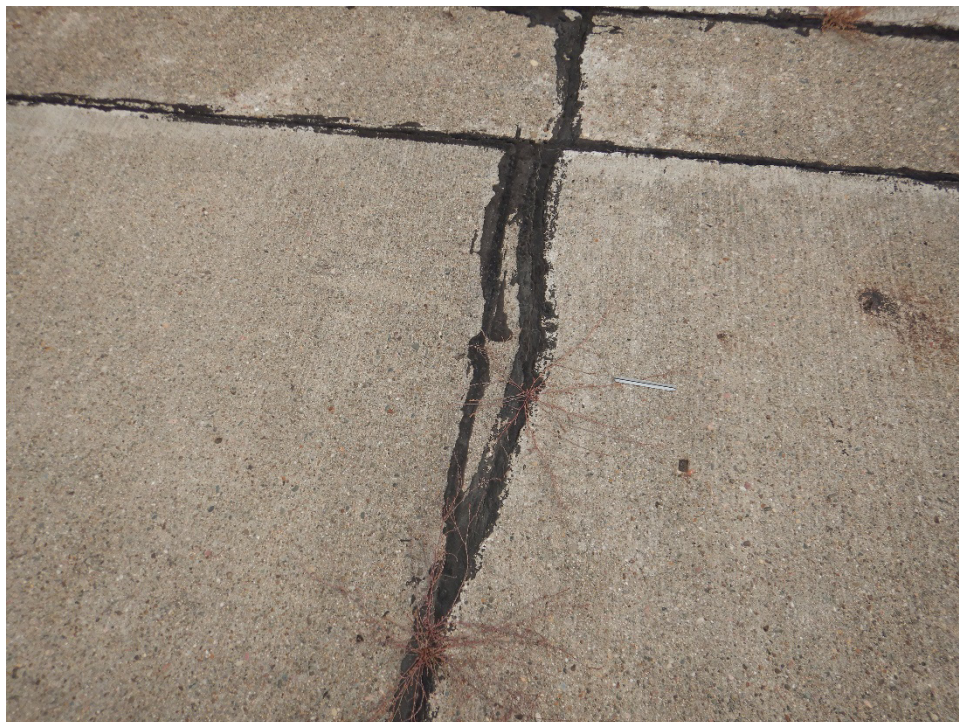
R02MA-01. Joint Spalling (Sample Unit No. 17).

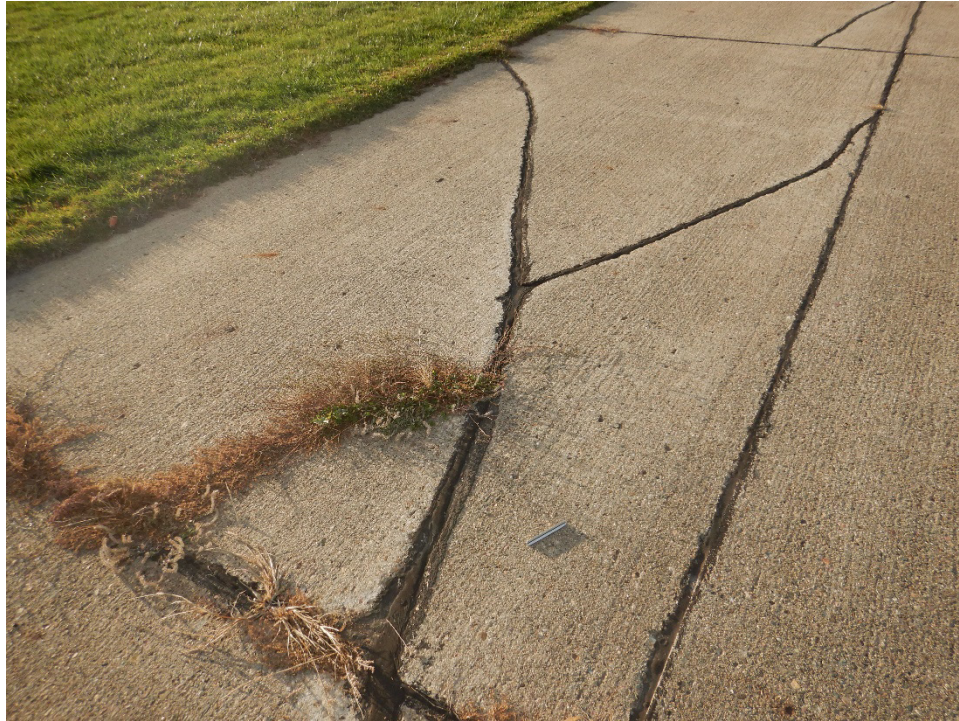
R02MA-01. Shattered Slab (Sample Unit No. 22).

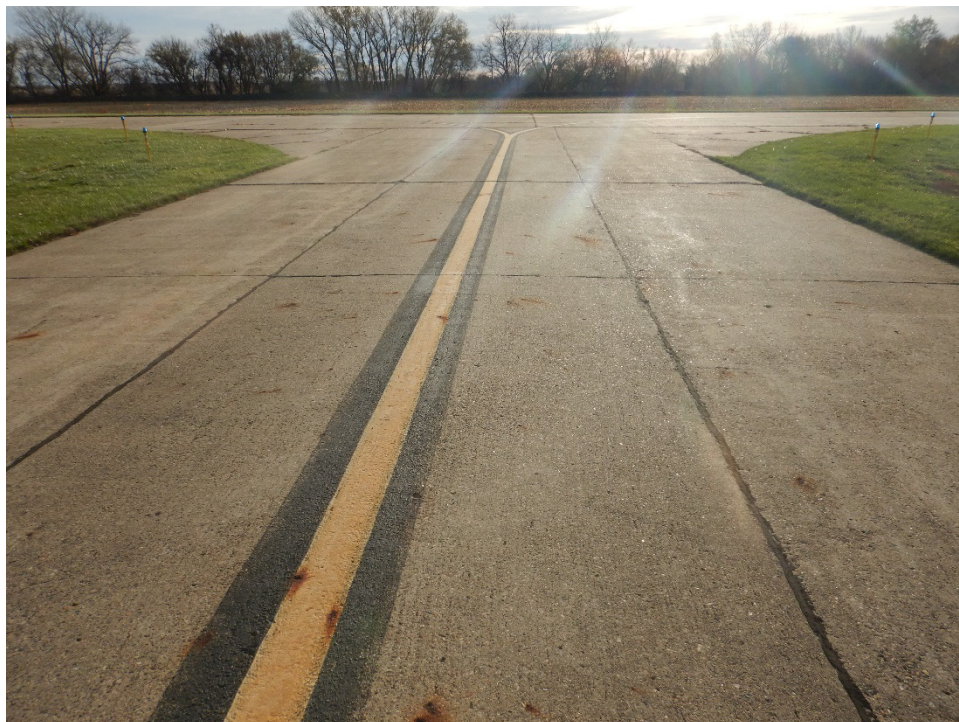
T01MA-01. Overview.

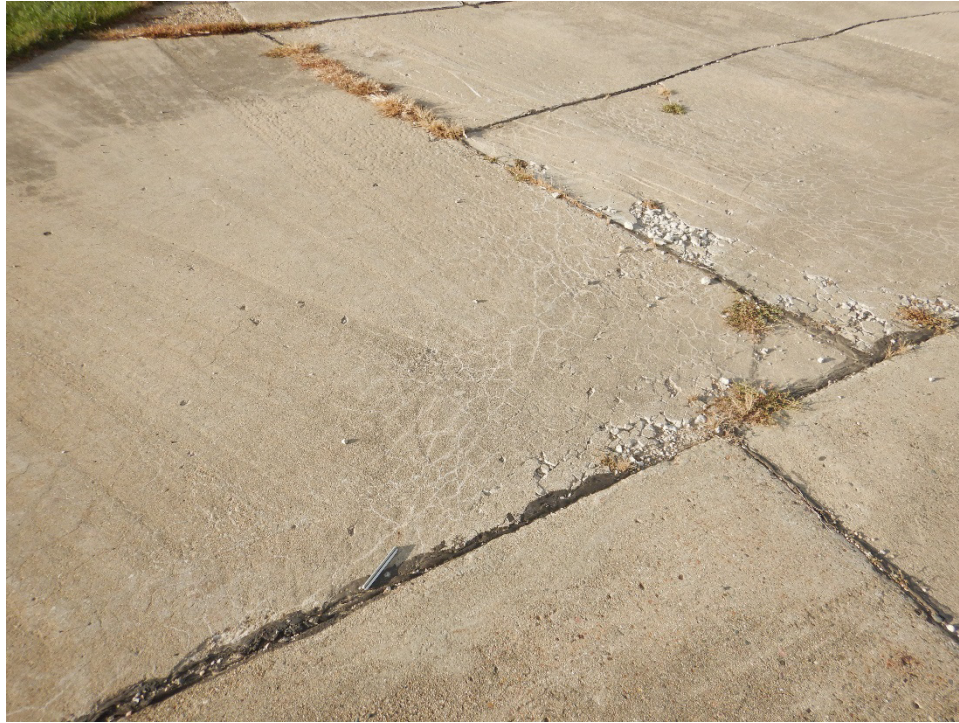
T01MA-01. ASR (Sample Unit No. 01).

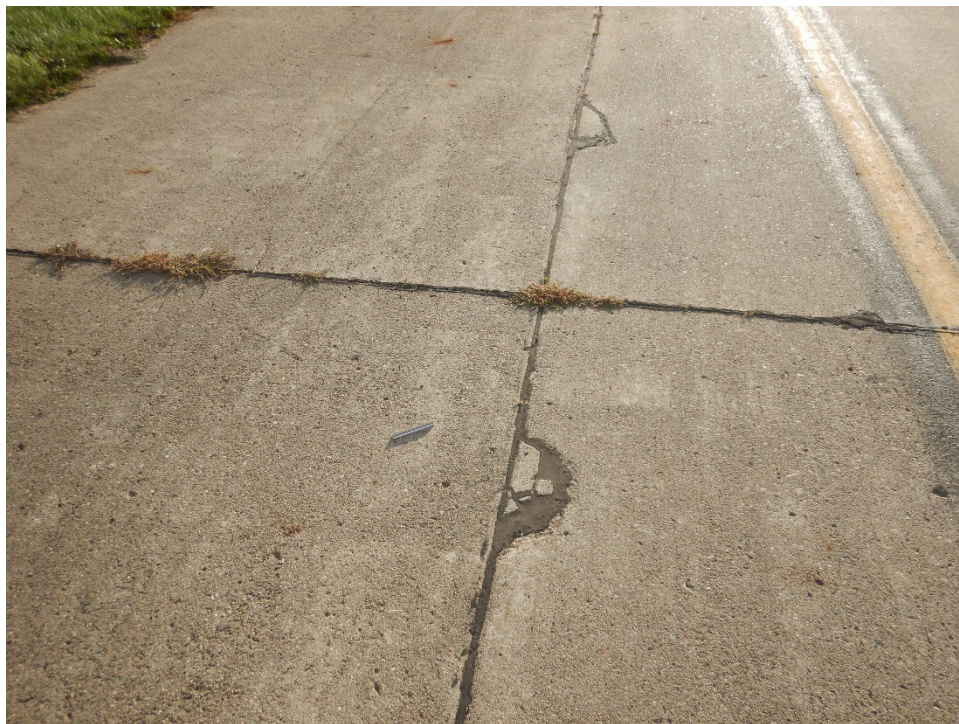
T01MA-01. Joint Spalling (Sample Unit No. 02).

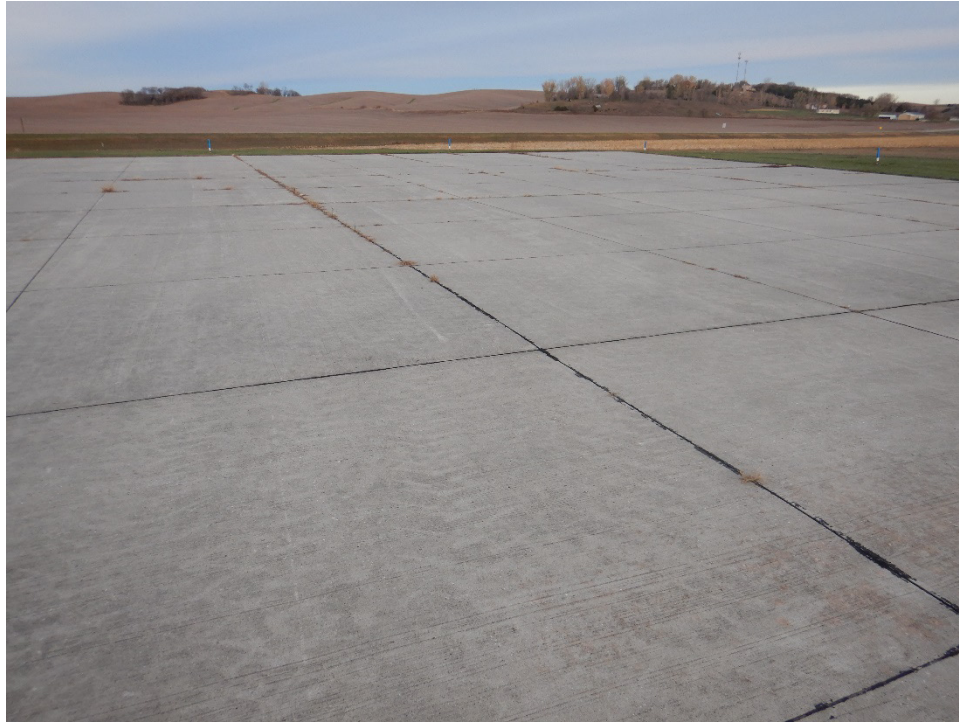
Taxiway 02 contained one section that connected to the Runway 02 approach. Low-severity joint spalling, medium-severity LTD cracking, and high-severity joint seal damage were recorded in Section 01.

T02MA-01. Overview.

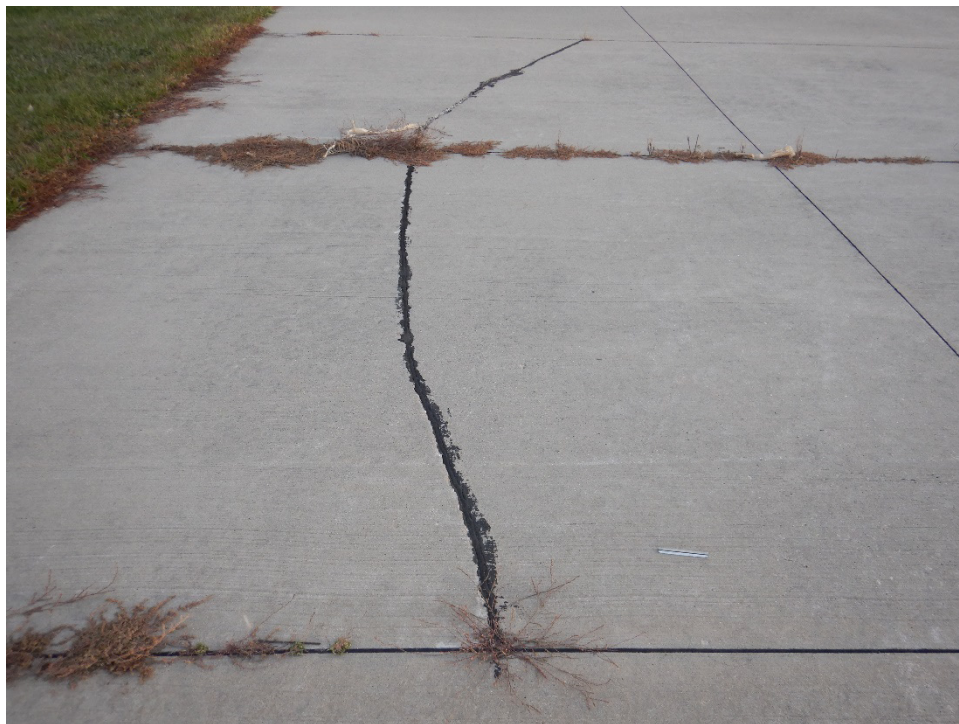
T02MA-01. LTD Cracking (Sample Unit No. 02).

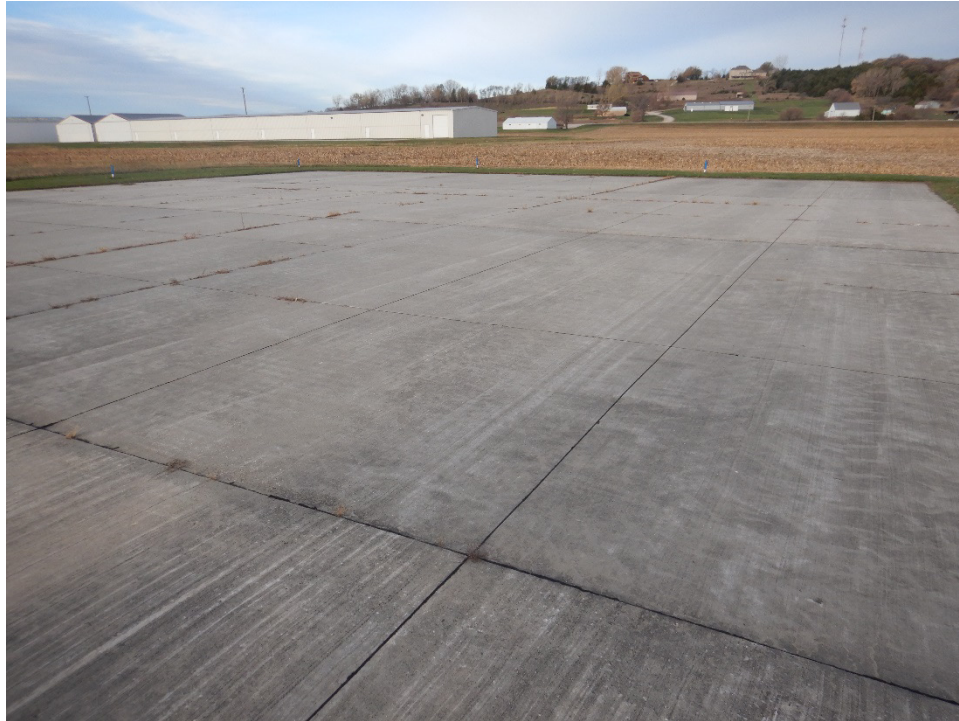
Taxiway 03 consisted of one section, located at the Runway 20 approach. Areas of low-severity faulting, medium-severity joint spalling and LTD cracking, and high-severity joint seal damage were observed in Section 01.

T03MA-01. Overview.

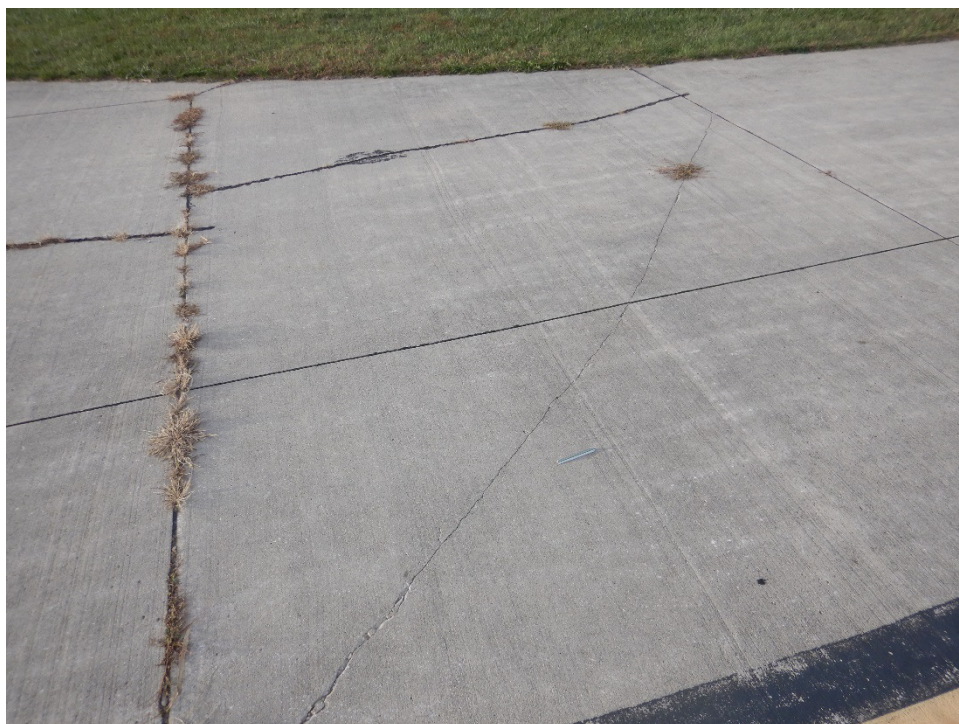
T03MA-01. LTD Cracking (Sample Unit No. 02).

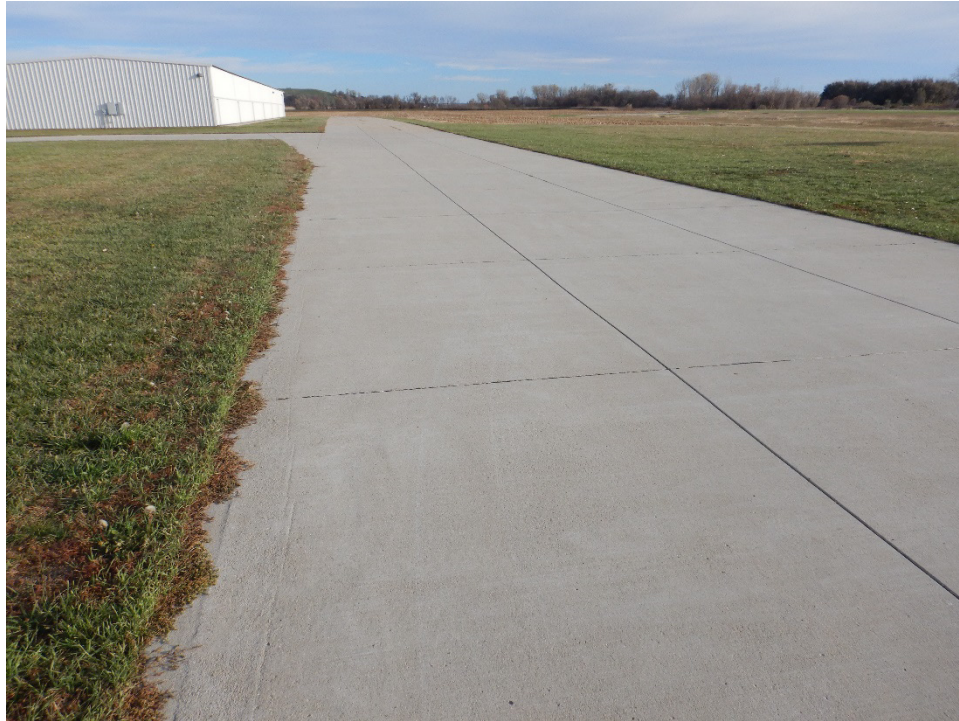
The T-hangar area contained two sections. Medium-severity LTD cracking and high-severity joint seal damage were recorded in Section 01. Areas of low- and medium-severity LTD cracking, medium-severity corner spalling and joint spalling, and high-severity joint seal damage were observed in Section 02.

TH01MA-01. Overview.

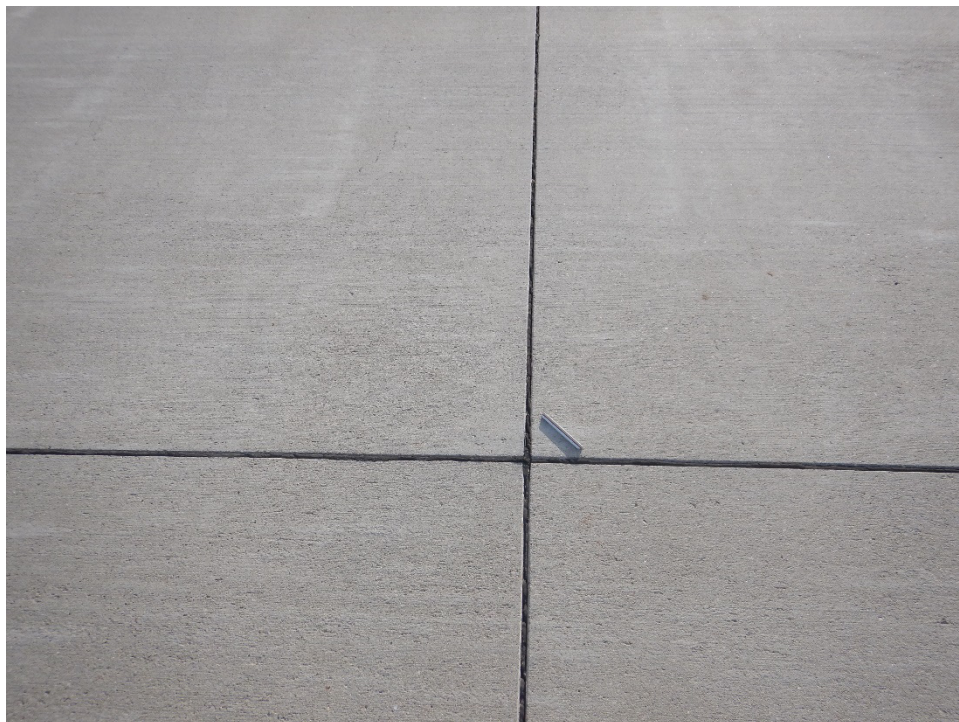
TH01MA-01. Joint Seal Damage (Sample Unit No. 04).

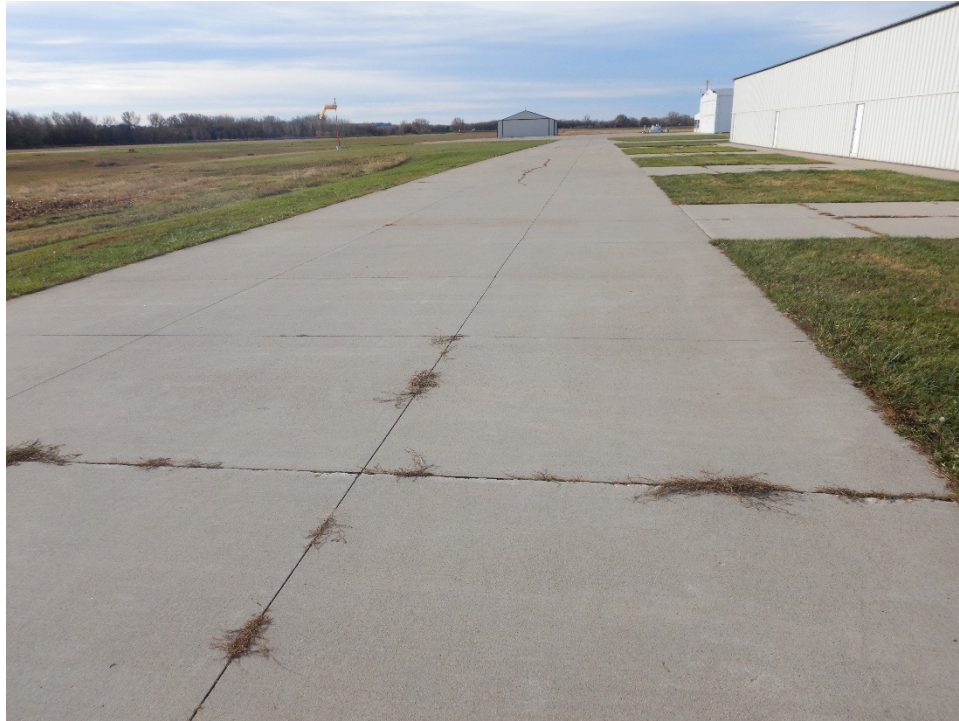
TH01MA-02. Overview.

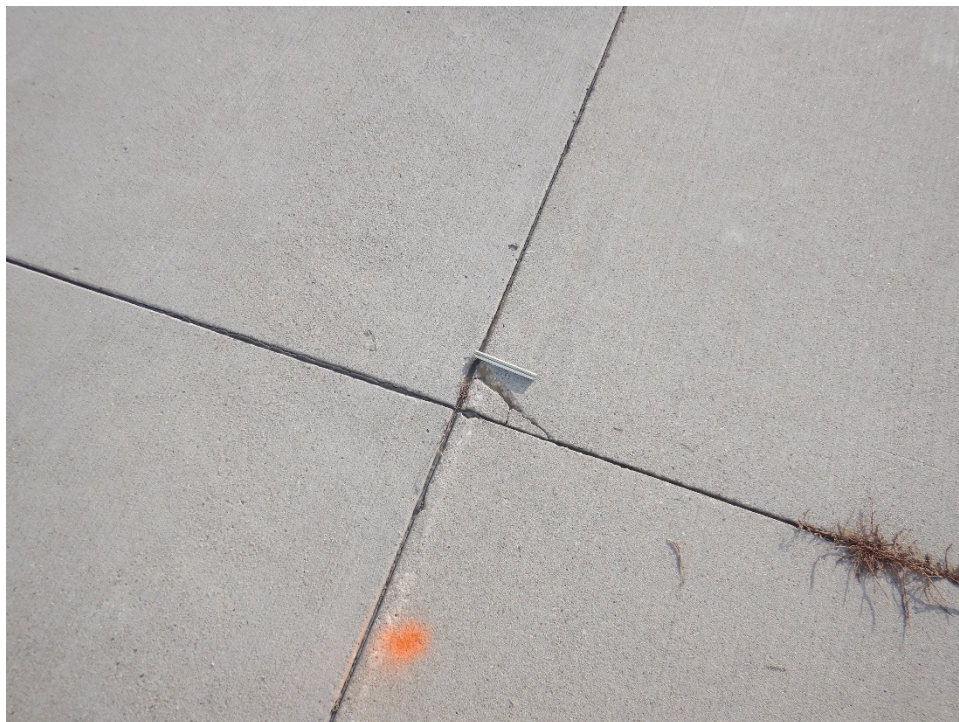
TH01MA-02. Corner Spalling (Sample Unit No. 10).
