# Marion Airport

## Pavement Management Report

**AUGUST 2025**

## PAVEMENT MANAGEMENT REPORT

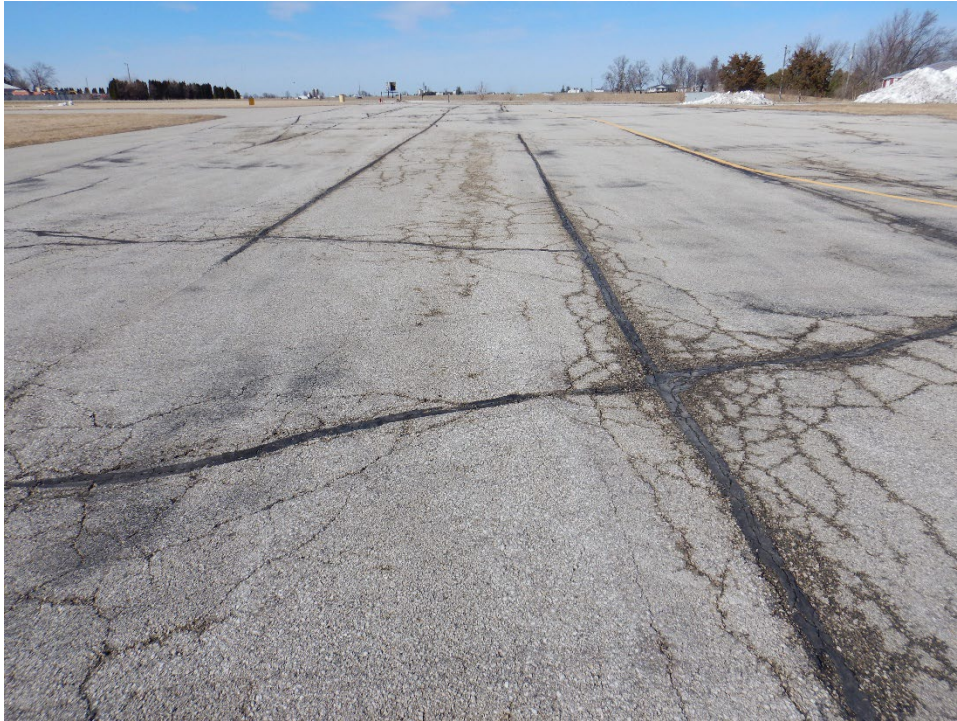
The apron area consisted of two sections. Section 01 was in *Poor* condition and contained medium-severity alligator cracking and weathering, low- and medium-severity L&T cracking, and high-severity raveling. The low-severity L&T cracking was both sealed and unsealed, while the medium-severity L&T cracking was due to either crack sealant that was in an unsatisfactory condition, the development of secondary cracking, or unsealed crack widths that exceeded 1/4 inch. In Section 02, low- and medium-severity L&T cracking and low-severity weathering were recorded. The low-severity L&T cracking was both sealed and unsealed and the medium-severity L&T cracking was recorded either when the crack sealant was unsatisfactory or the unsealed crack widths were greater than 1/4 inch.

A01MR-01. Overview.

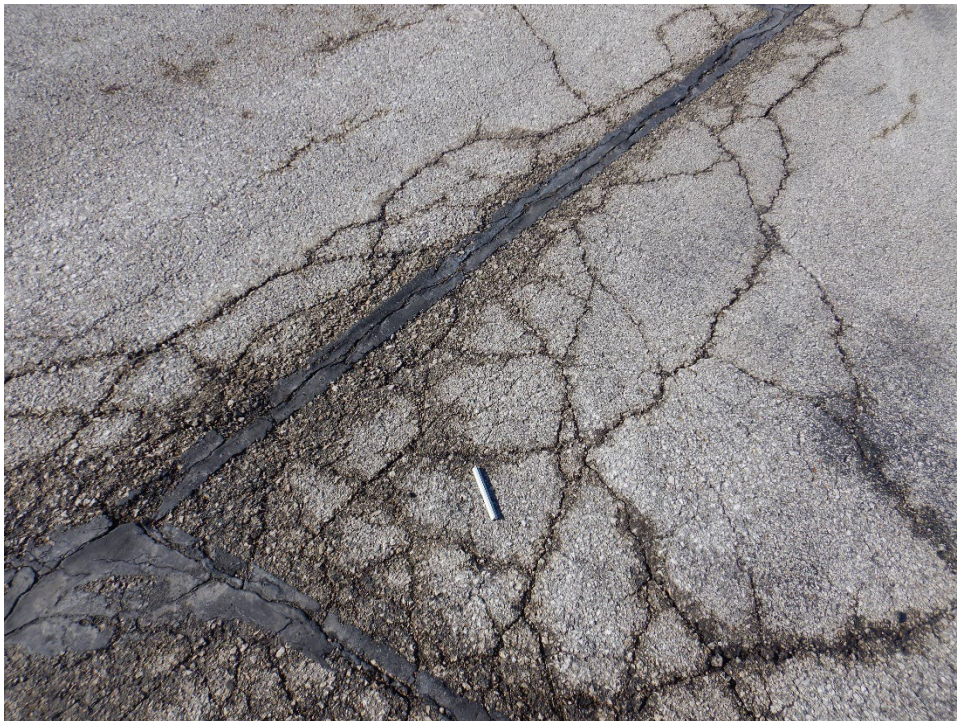
A01MR-01. Alligator Cracking (Sample Unit No. 05).

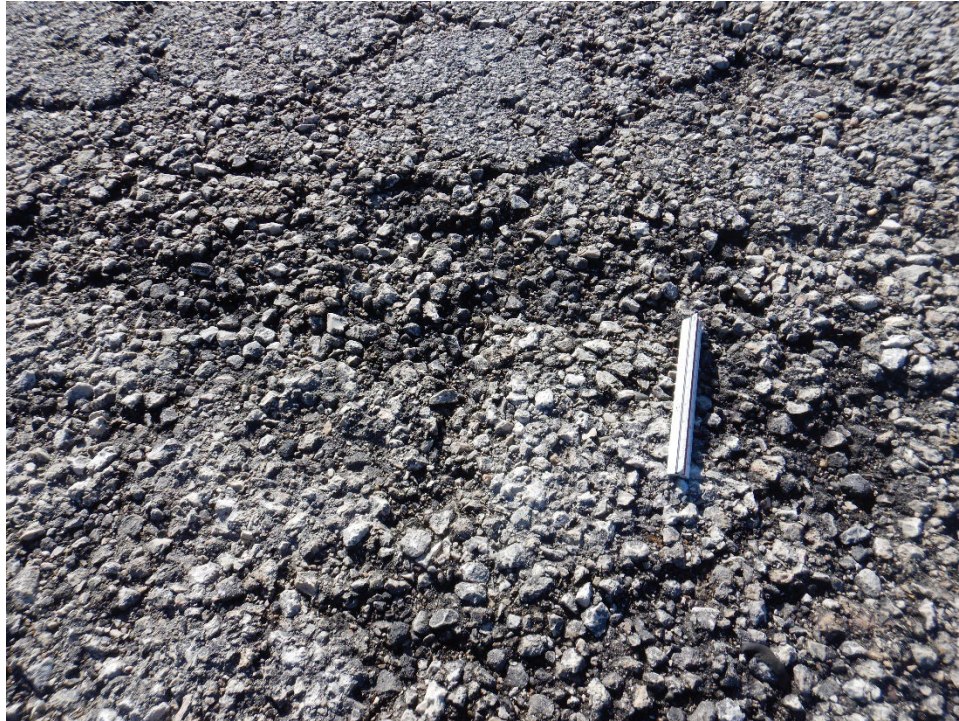
A01MR-01. Raveling (Sample Unit No. 04).

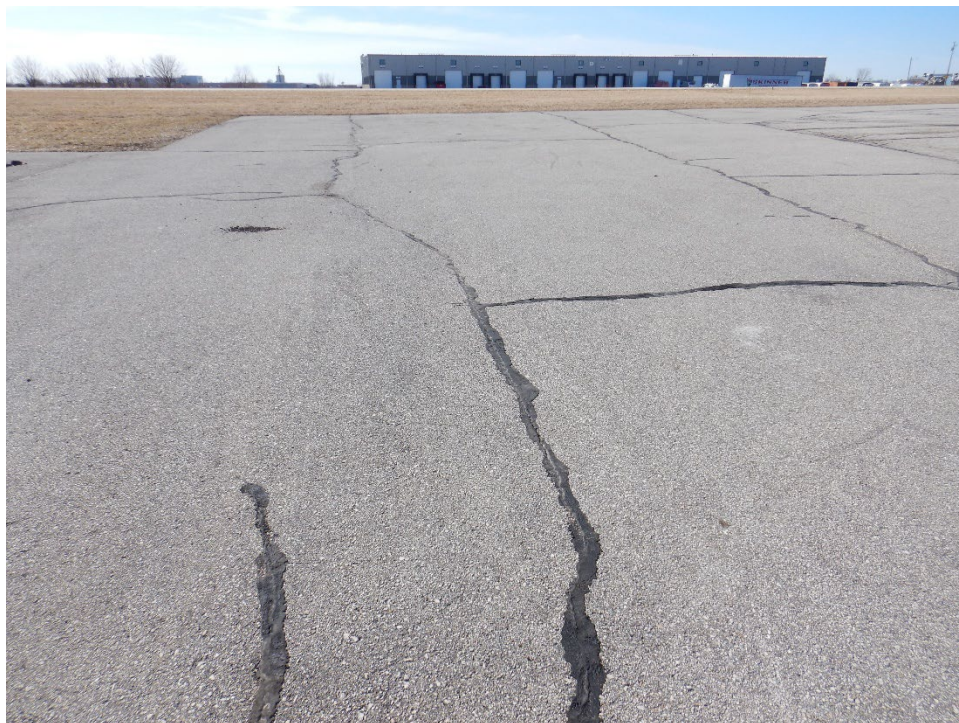
A01MR-02. Overview.

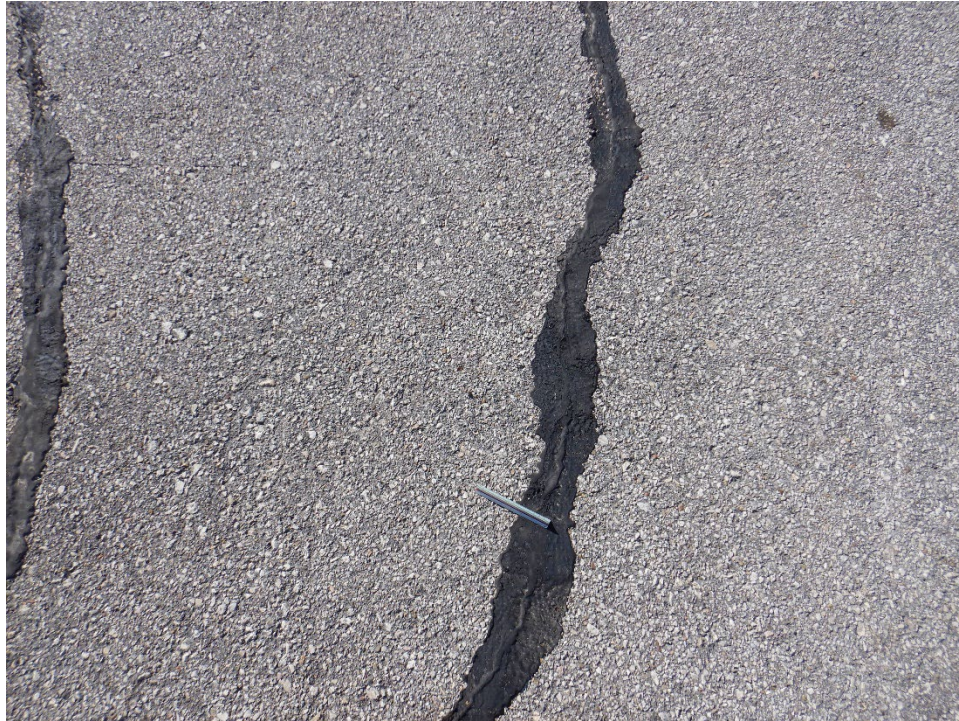
A01MR-02. L&T Cracking (Sample Unit No. 02).

| Branch | Section | Distress Type | Severity | Distress Quantity | Distress Unit | Maintenance Action | Unit Cost | 2025 Estimated Cost |
|---|---|---|---|---|---|---|---|---|
| A01MR | 02 | L&T Cracking | Medium | 59 | Ft | Crack Sealing - AC | \$2.72 | \$160 |

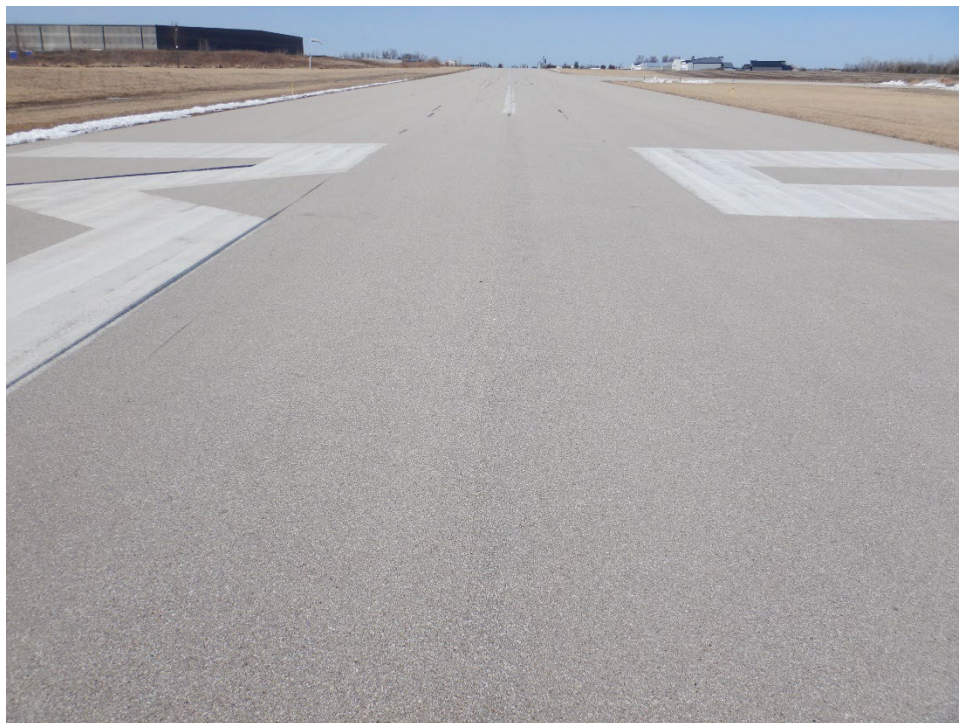
Runway 17/35 consisted of four sections. In Section 01, low-severity patching and weathering were observed. Low-severity longitudinal and transverse (L&T) cracking and weathering were observed in Section 02. The low-severity L&T cracking was unsealed. An atypical area of low-severity patching was observed and recorded as an additional sample unit in accordance with ASTM D5340. Section 03 contained areas of low- and medium-severity L&T cracking, high-severity raveling, and low-severity swelling and weathering. The low-severity L&T cracking was both sealed and unsealed, while the medium-severity L&T cracking was recorded where either the crack sealant was in unsatisfactory condition or unsealed crack widths exceeded 1/4 inch. An isolated area of high-severity raveling was recorded where mechanical damage was observed. In Section 04, low- and medium-severity L&T cracking, low-severity patching and weathering, and medium-severity raveling were identified. The low-severity L&T cracking was unsealed, while the medium-severity L&T cracking was due to unsealed crack widths greater than 1/4 inch.

R17MR-01. Overview.

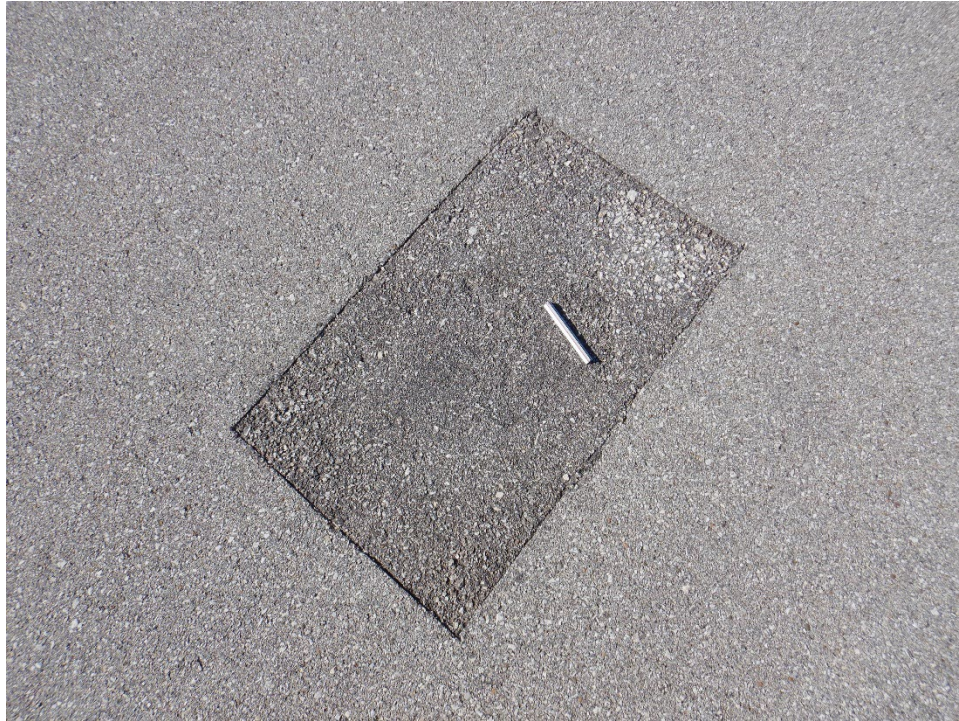
R17MR-01. Patching (Sample Unit No. 08).

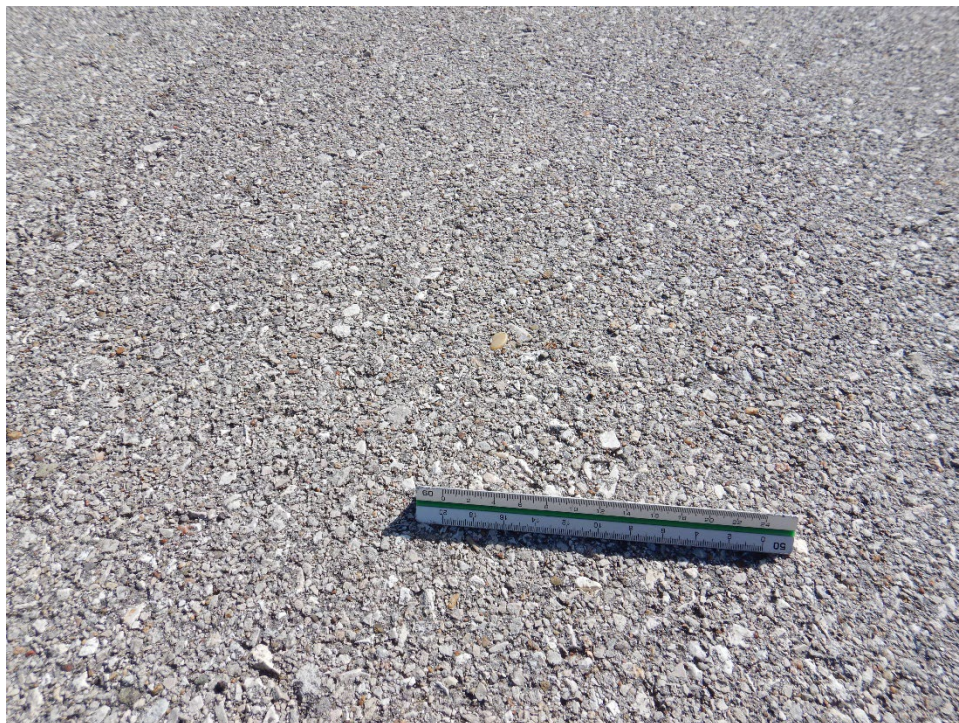
R17MR-01. Weathering (Sample Unit No. 15).

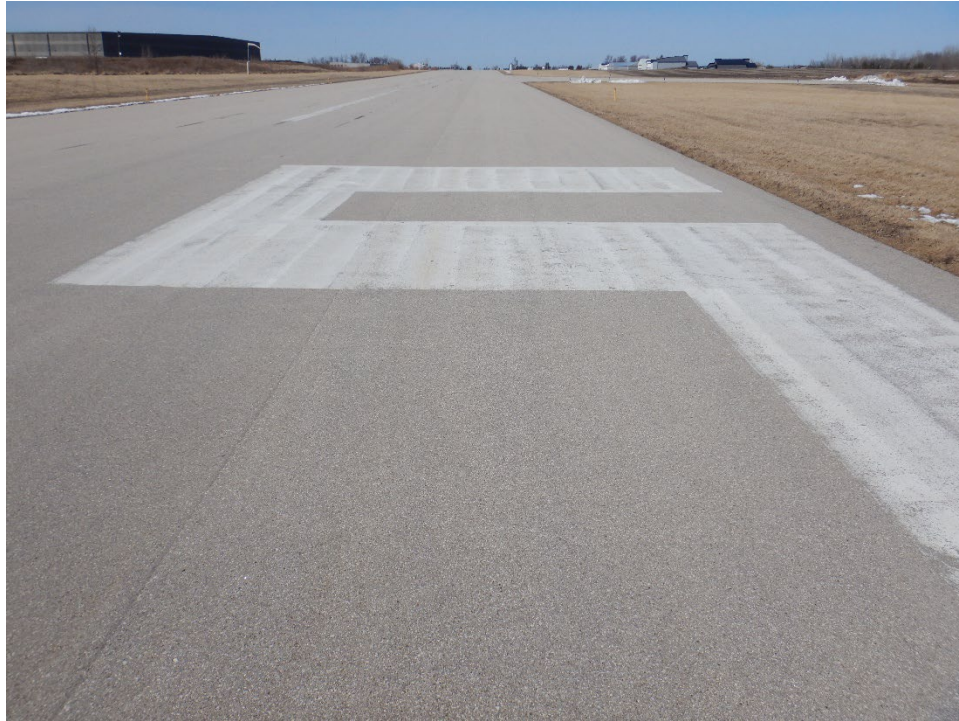
R17MR-02. Overview.

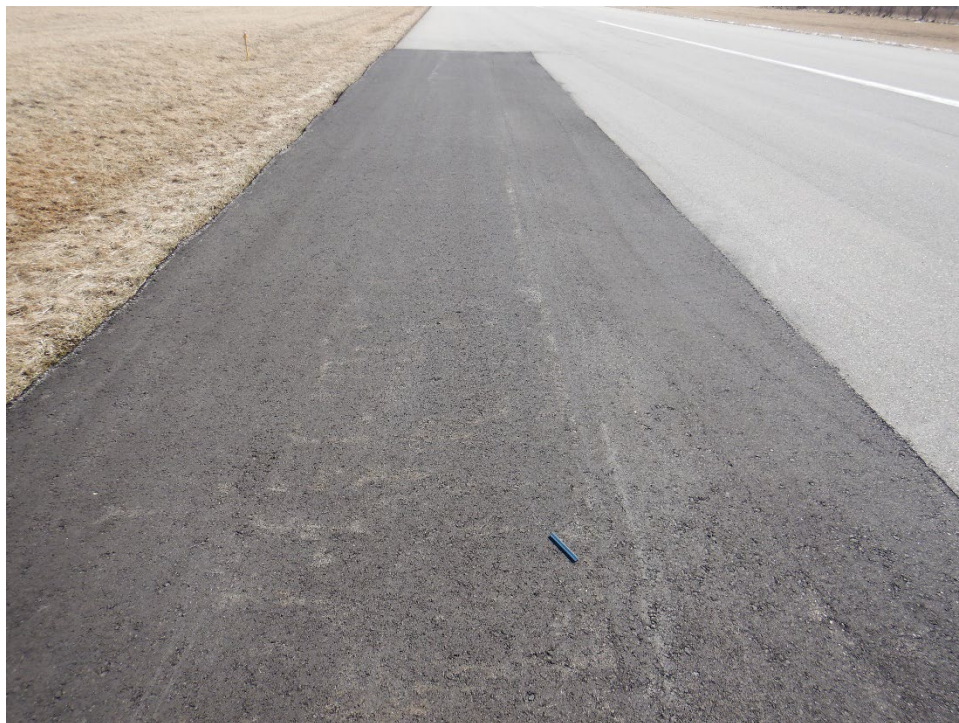
R17MR-02. Patching (Additional Sample Unit No. 08).

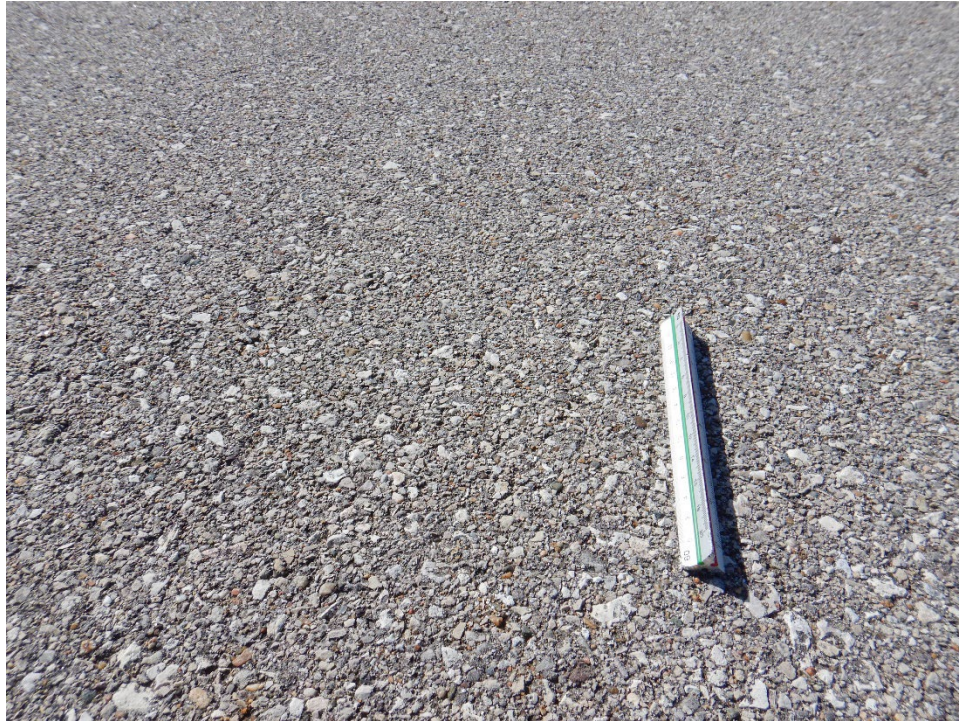
R17MR-02. Weathering (Sample Unit No. 35).

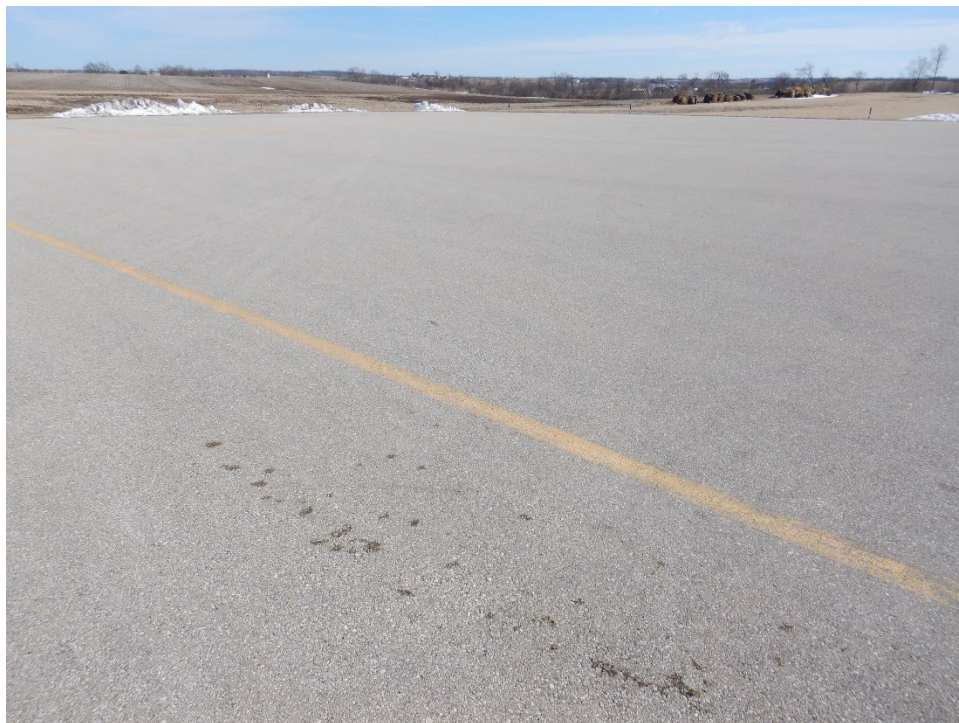
R17MR-03. Overview.

| Branch | Section | Distress Type | Severity | Distress Quantity | Distress Unit | Maintenance Action | Unit Cost | 2025 Estimated Cost |
|---|---|---|---|---|---|---|---|---|
| R17MR | 03 | L&T Cracking | Medium | 50 | Ft | Crack Sealing - AC | \$2.72 | \$136 |

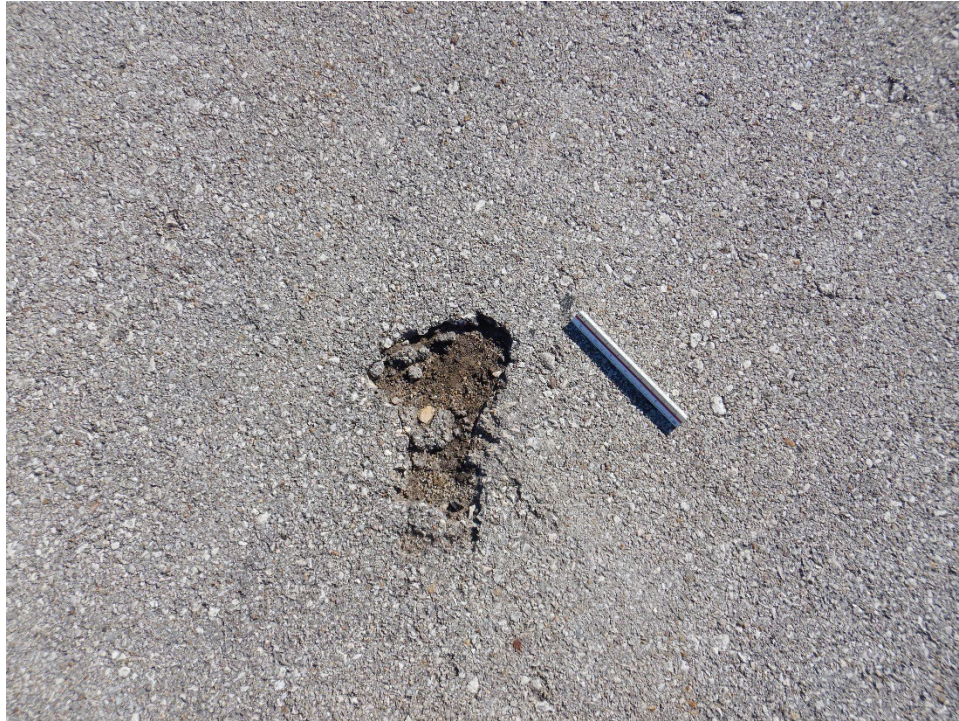
R17MR-03. Raveling (Sample Unit No. 06).

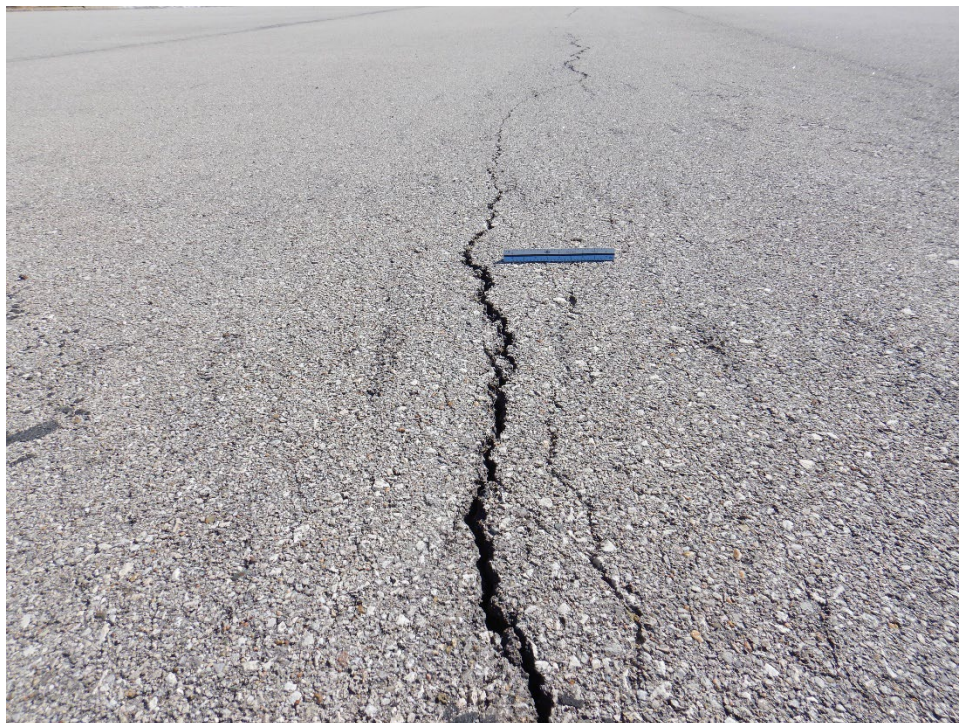
R17MR-03. Swelling (Sample Unit No. 06).

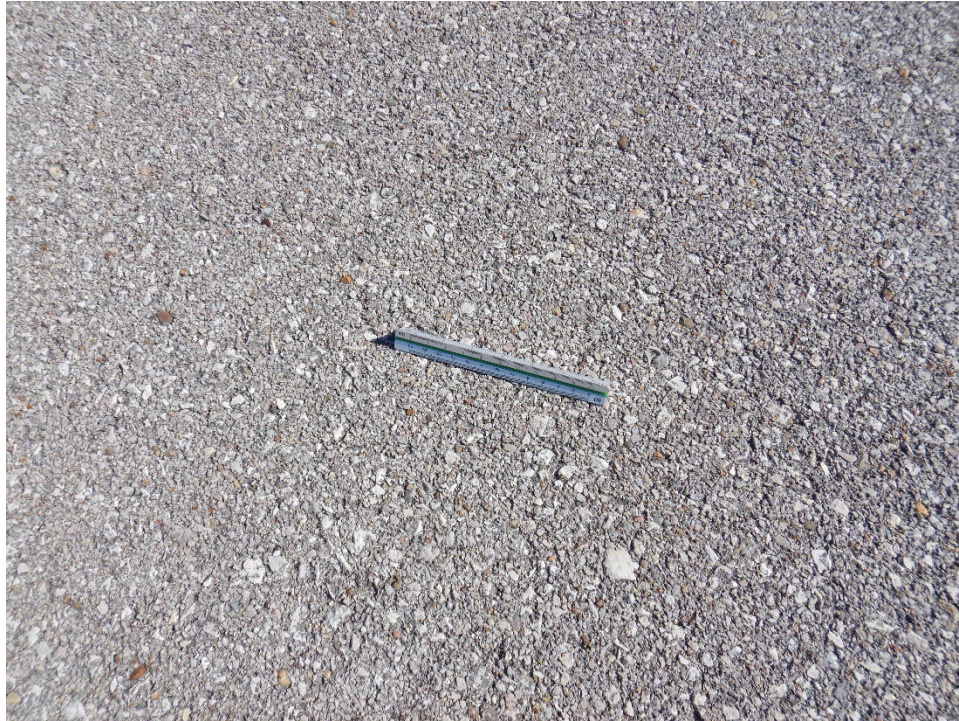
R17MR-03. Weathering (Sample Unit No. 03).

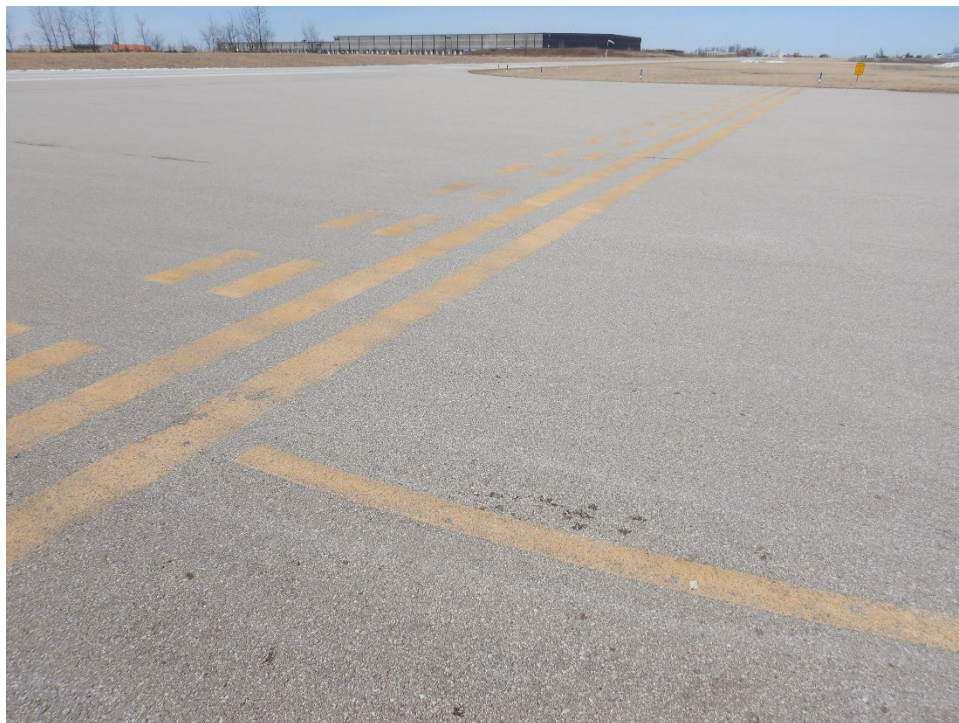
R17MR-04. Overview.

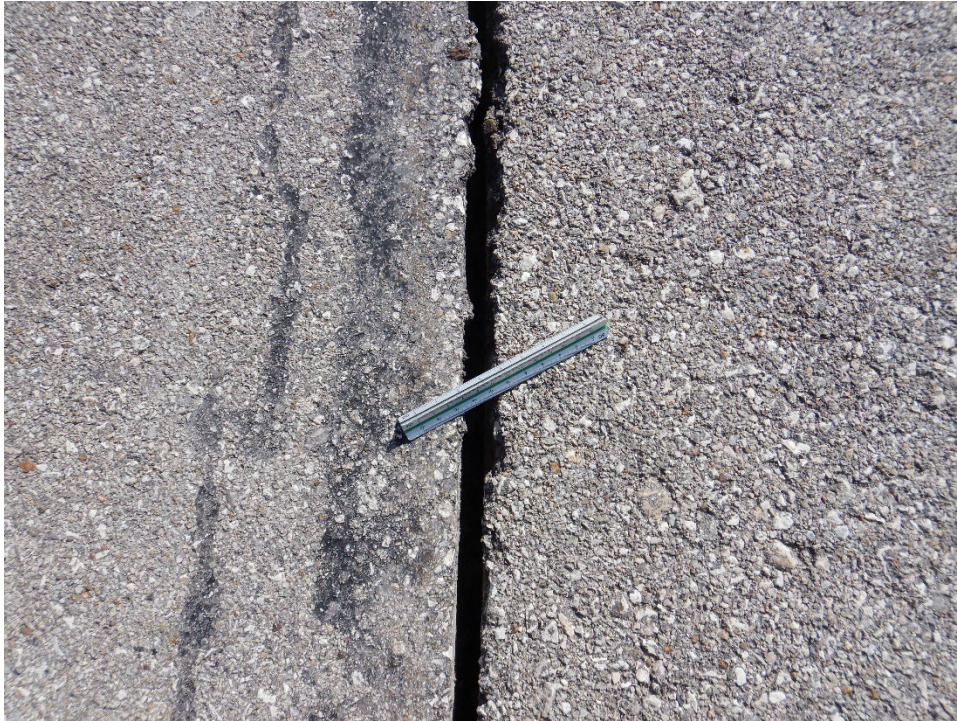
R17MR-04. L&T Cracking (Sample Unit No. 04).

| Branch | Section | Distress Type | Severity | Distress Quantity | Distress Unit | Maintenance Action | Unit Cost | 2025 Estimated Cost |
|---|---|---|---|---|---|---|---|---|
| R17MR | 04 | L&T Cracking | Medium | 87 | Ft | Crack Sealing - AC | \$2.72 | \$237 |

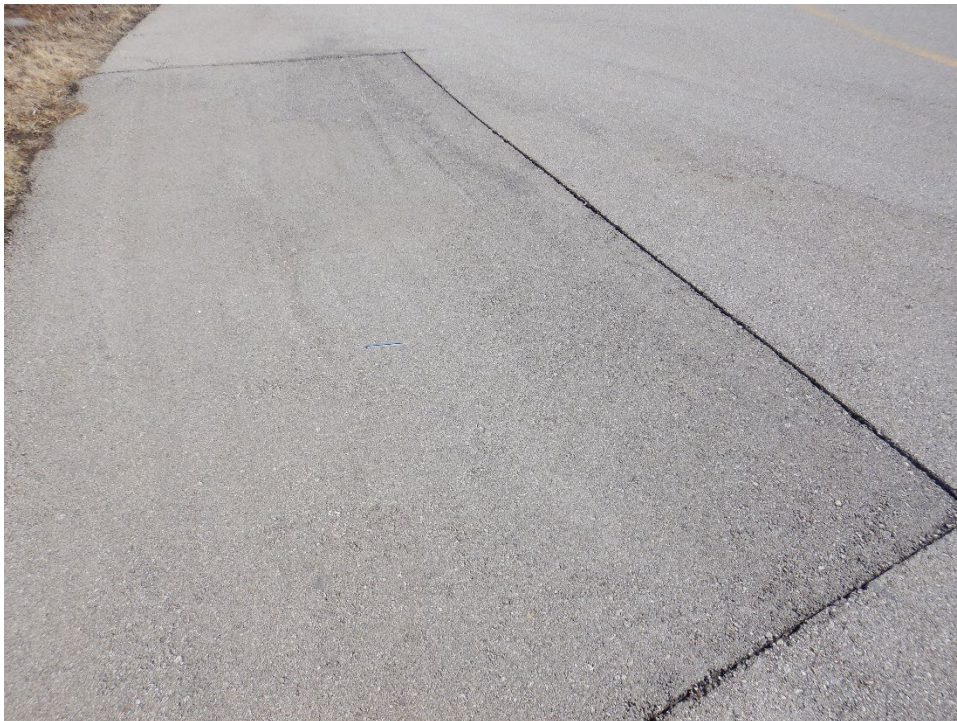
R17MR-04. Patching (Sample Unit No. 01).

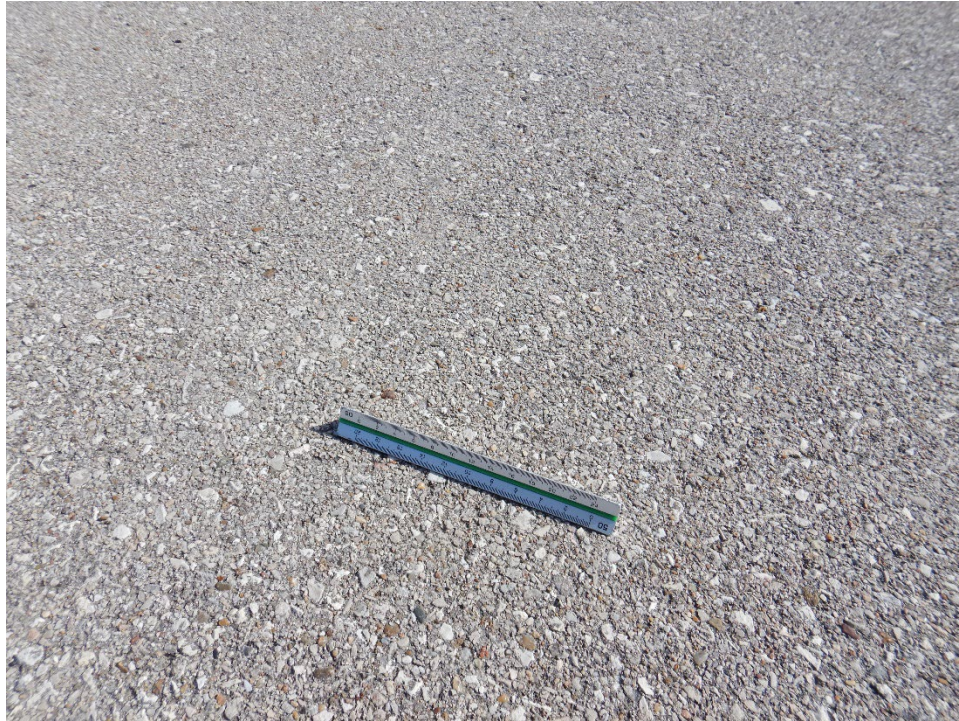
R17MR-04. Weathering (Sample Unit No. 04).

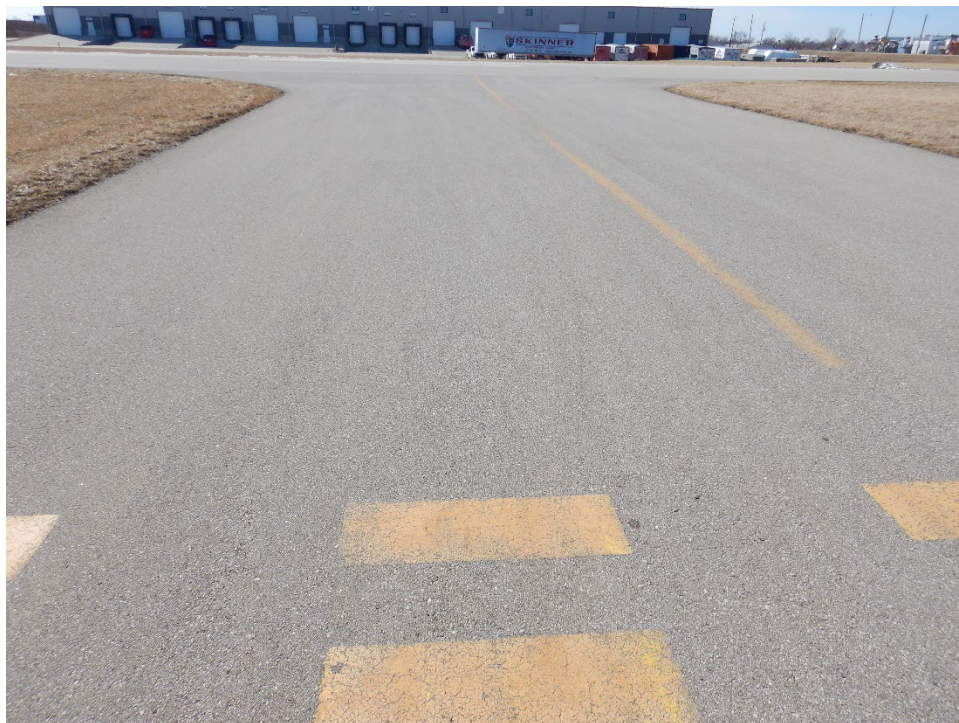
The taxiway was defined by one section that contained areas of low-severity L&T cracking and weathering. The low-severity L&T cracking was unsealed.

T01MR-01. Overview.

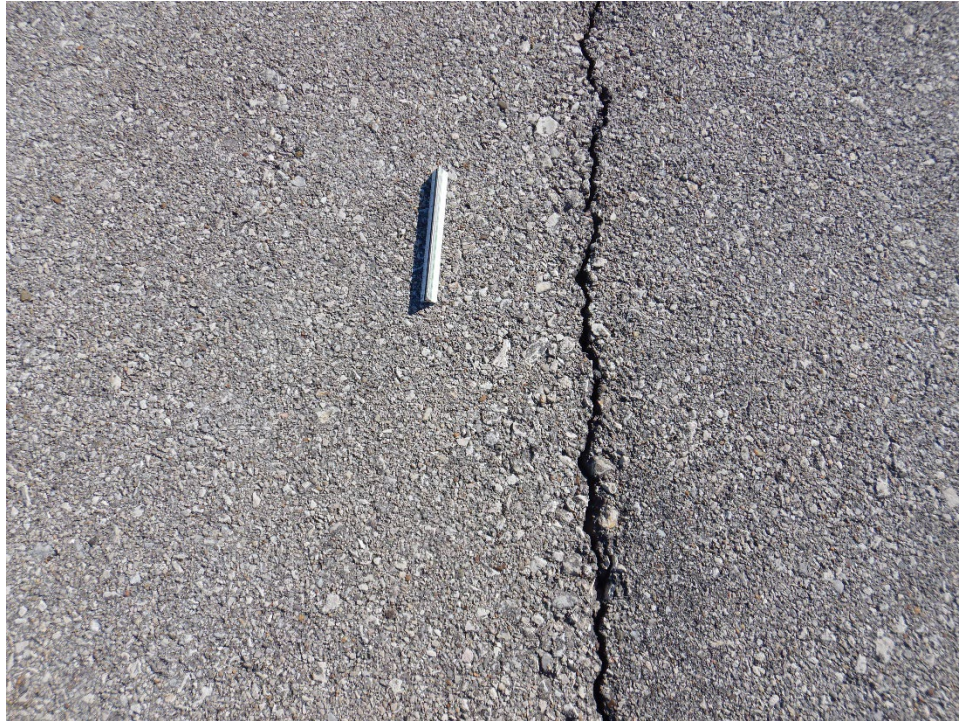
T01MR-01. L&T Cracking (Sample Unit No. 01).
