Marshalltown Municipal Airport

#### AUGUST 2025

# MARSHALLTOWN MUNICIPAL AIRPORT PAVEMENT MANAGEMENT REPORT

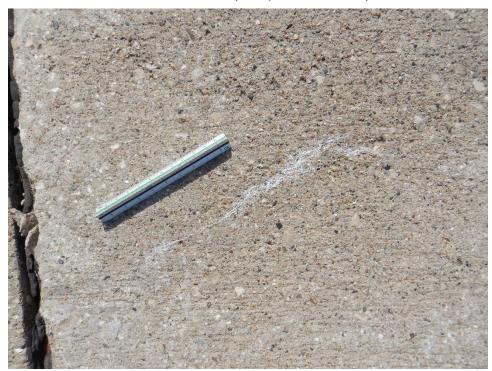
A01MT-01. ASR (Sample Unit No. 11).

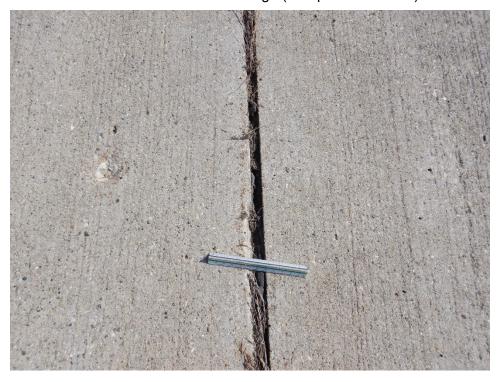
A01MT-01. Joint Seal Damage (Sample Unit No. 04).

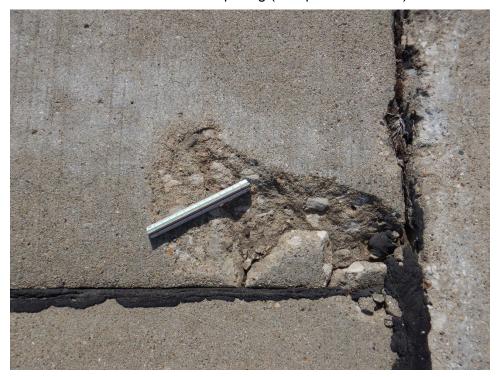
A02MT-01. Corner Spalling (Sample Unit No. 18).

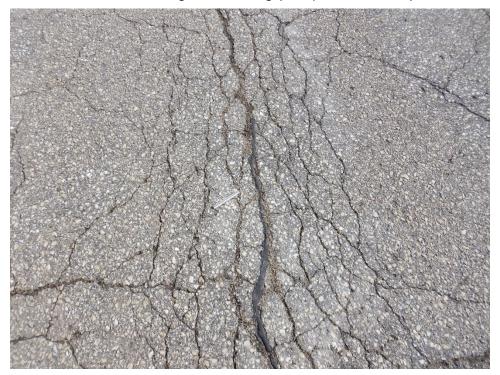
A02MT-02. Alligator Cracking (Sample Unit No. 02).

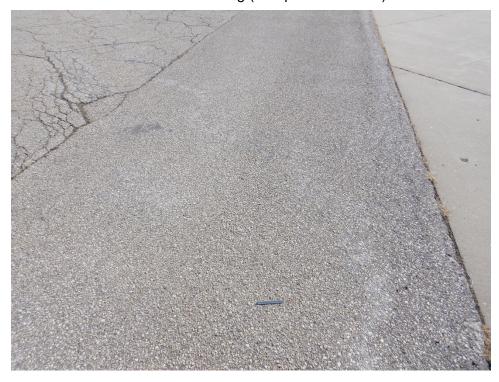
A02MT-02. Patching (Sample Unit No. 02).

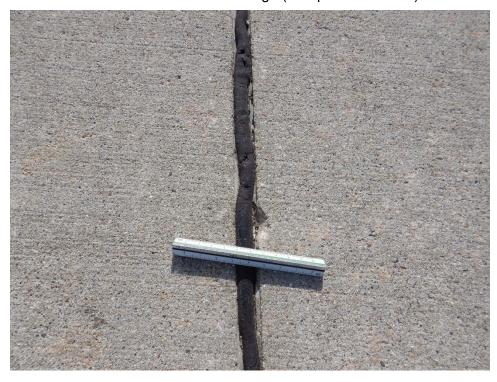
A03MT-01. Joint Seal Damage (Sample Unit No. 04).

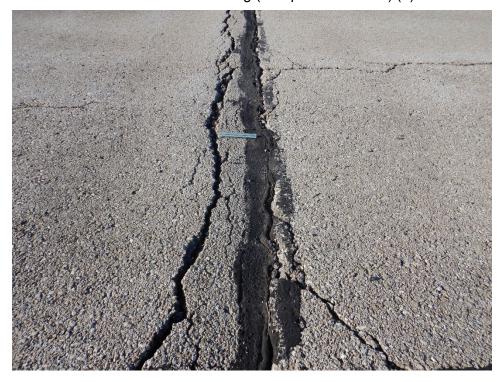
R13MT-01. L&T Cracking (Sample Unit No. 19) (1).

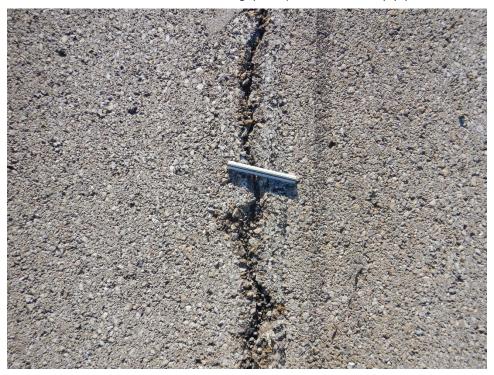
R13MT-01. L&T Cracking (Sample Unit No. 19) (2).

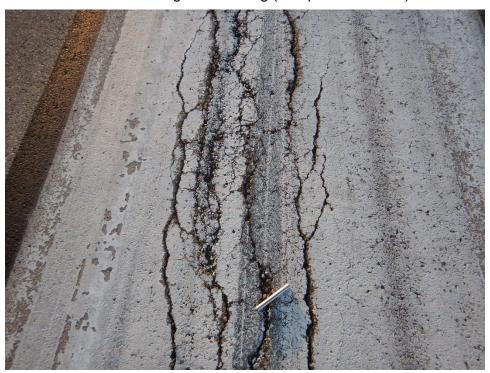
R13MT-02. Alligator Cracking (Sample Unit No. 75).

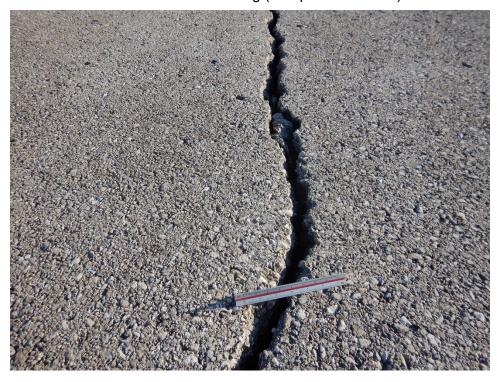
R13MT-02. L&T Cracking (Sample Unit No. 15).

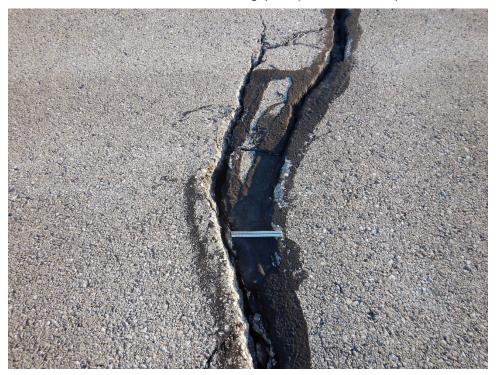
R13MT-02. L&T Cracking (Sample Unit No. 65).

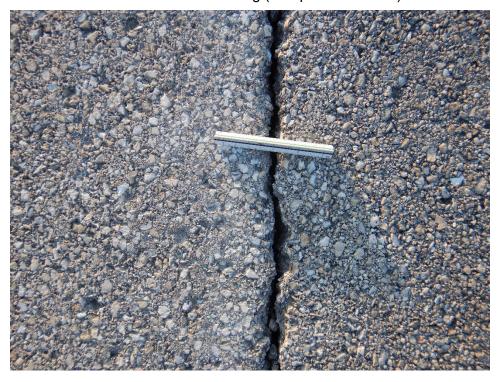
R13MT-02. L&T Cracking (Sample Unit No. 75).

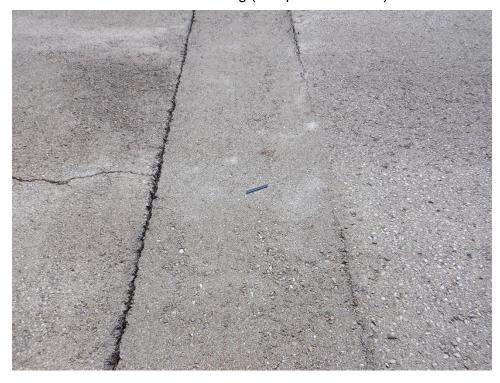
R13MT-03. Patching (Sample Unit No. 01).

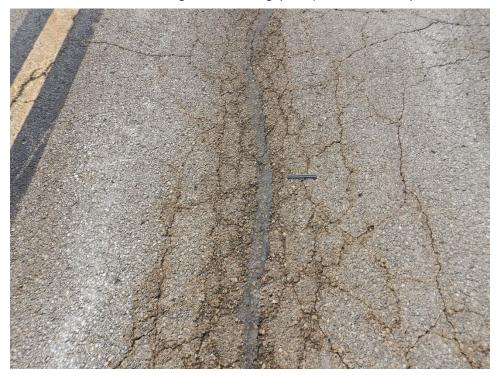
R13MT-04. Alligator Cracking (Sample Unit No. 02).

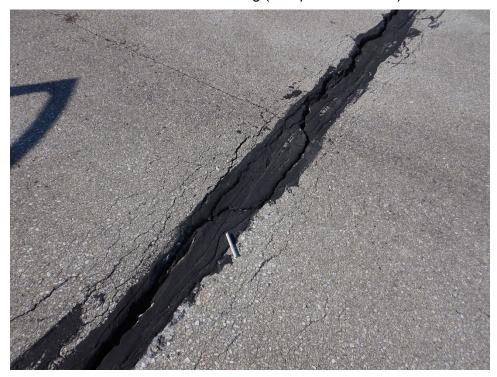
R18MT-01. L&T Cracking (Sample Unit No. 10).

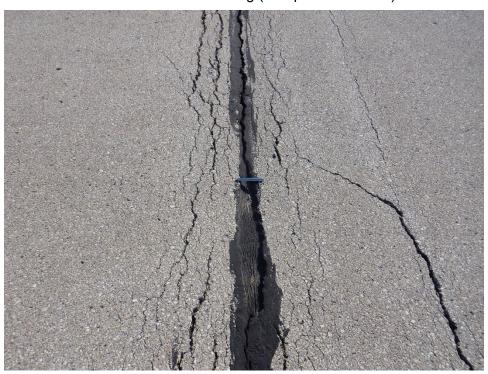
R18MT-01. L&T Cracking (Sample Unit No. 18).

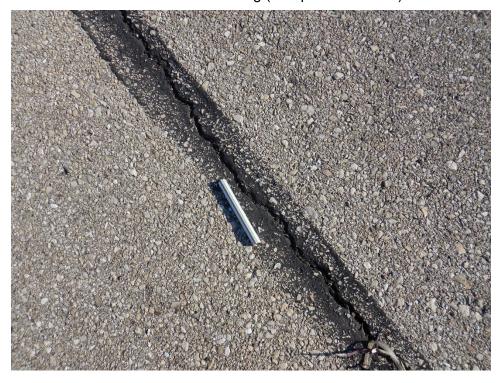
R18MT-02. L&T Cracking (Sample Unit No. 03).

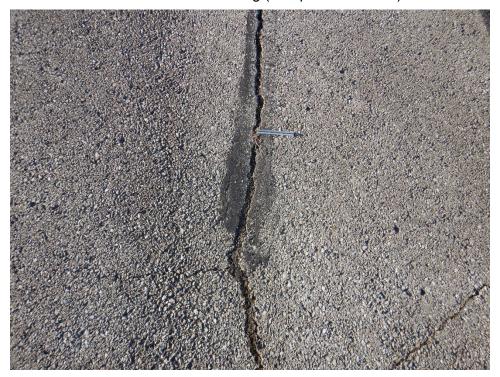
R18MT-03. L&T Cracking (Sample Unit No. 02).

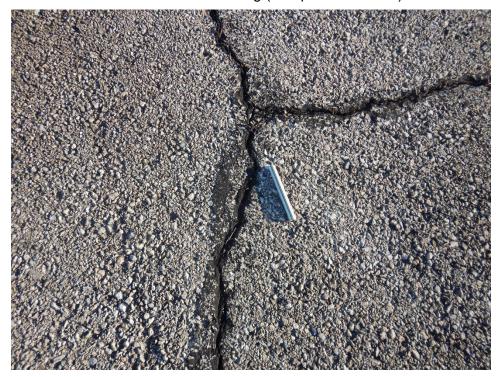
R18MT-04. L&T Cracking (Sample Unit No. 02).

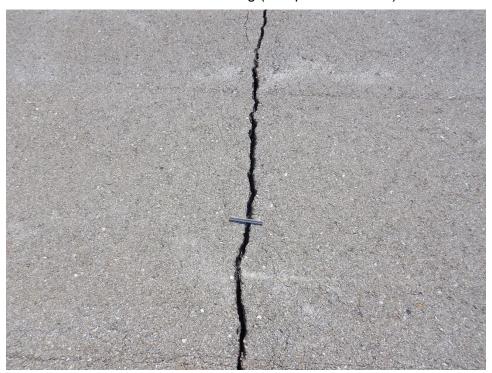
T01MT-01. L&T Cracking (Sample Unit No. 02).

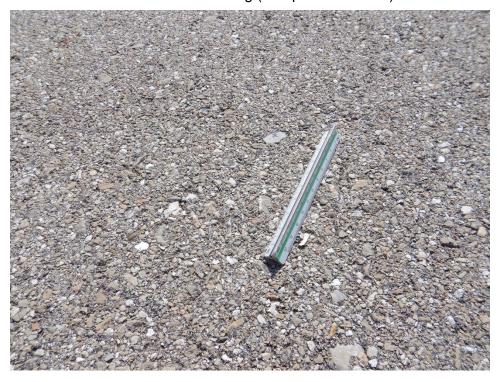
T01MT-01. Weathering (Sample Unit No. 08).

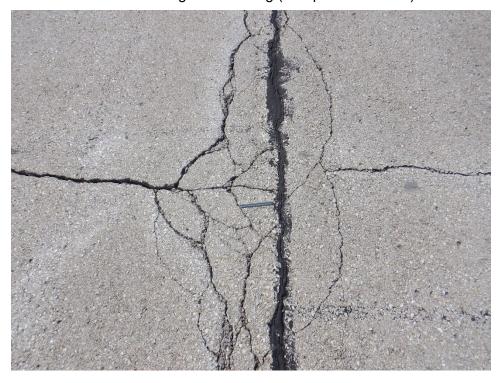
T02MT-01. Alligator Cracking (Sample Unit No. 05).

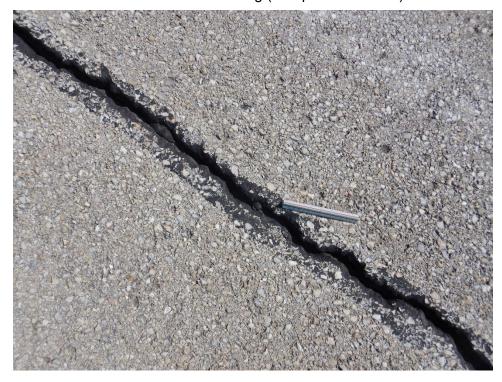
T02MT-02. L&T Cracking (Sample Unit No. 01).

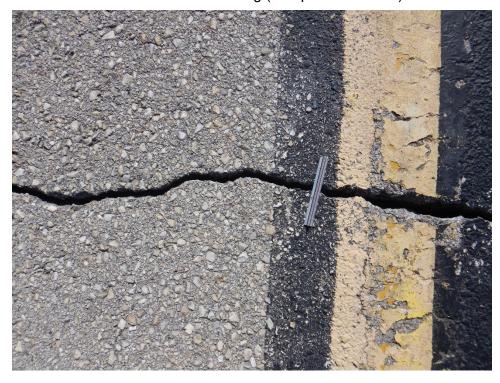
T03MT-01. L&T Cracking (Sample Unit No. 03).

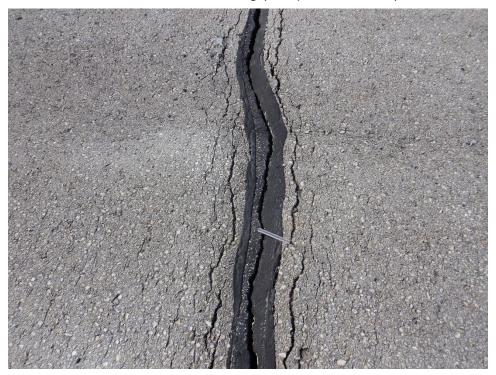
T03MT-01. L&T Cracking (Sample Unit No. 10).

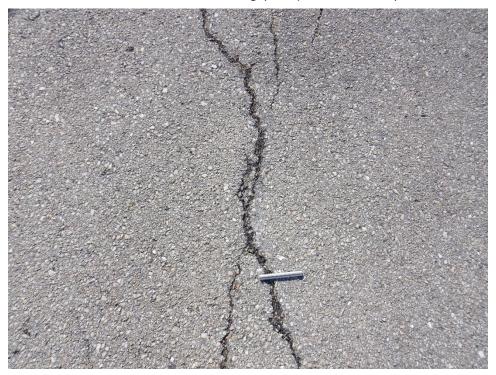
T03MT-02. L&T Cracking (Sample Unit No. 01).

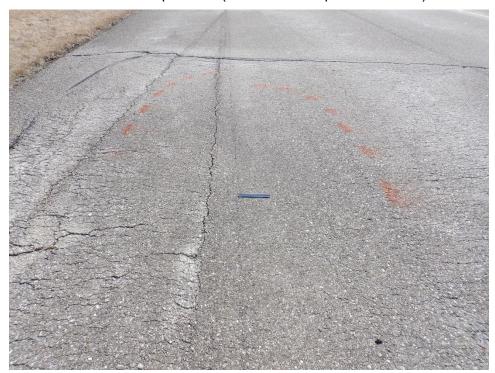
T03MT-03. Depression (Additional Sample Unit No. 05).

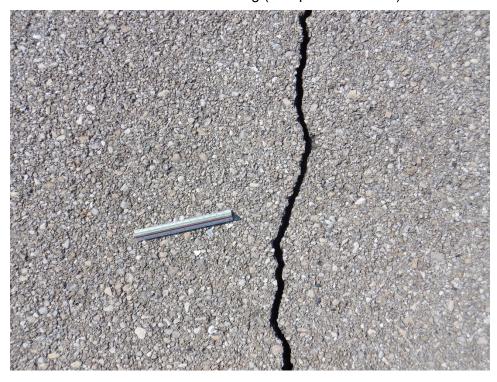
T03MT-03. L&T Cracking (Sample Unit No. 04).

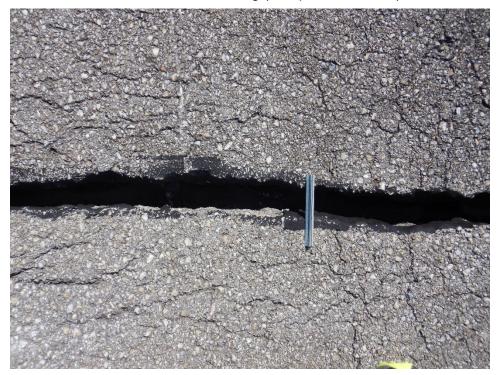
T03MT-03. L&T Cracking (Sample Unit No. 08).

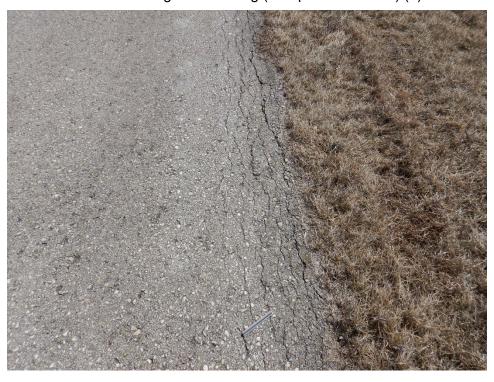
T04MT-01. Alligator Cracking (Sample Unit No. 05) (1).

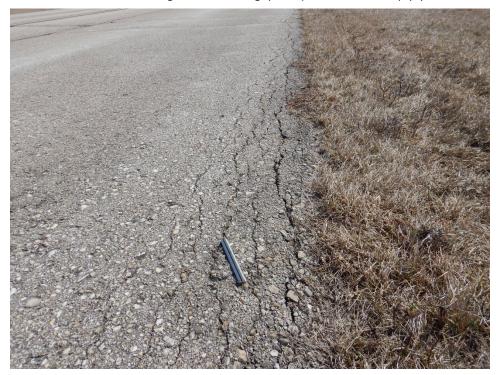
T04MT-01. Alligator Cracking (Sample Unit No. 05) (2).

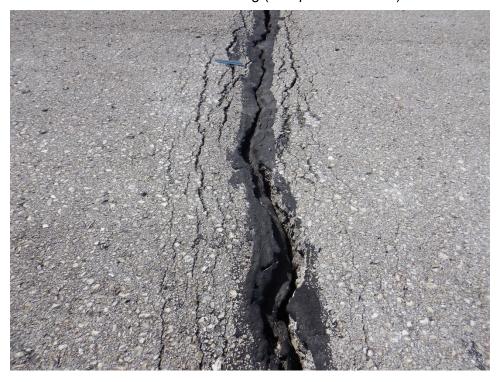
T04MT-01. L&T Cracking (Sample Unit No. 03).

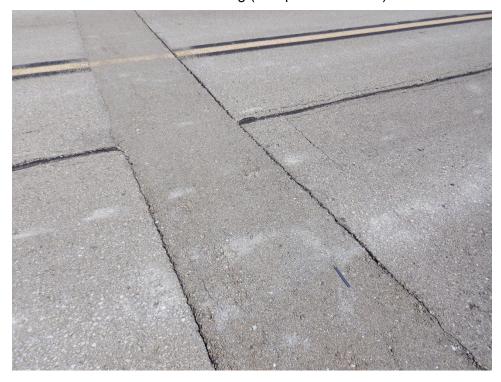
T04MT-01. Patching (Sample Unit No. 05).

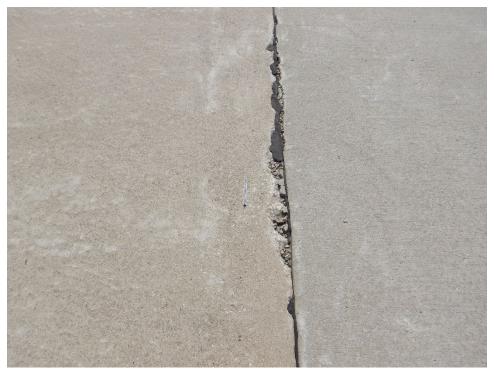
TH01MT-01. Joint Spalling (Additional Sample Unit No. 04).

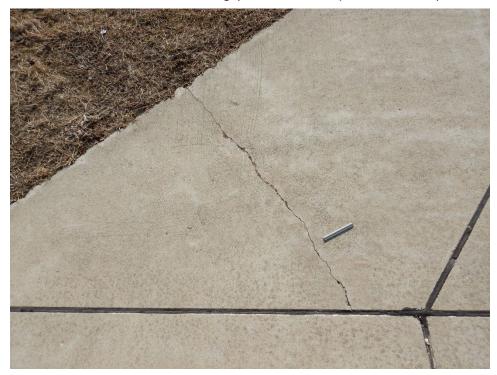
TH01MT-01. LTD Cracking (Additional Sample Unit No. 04).

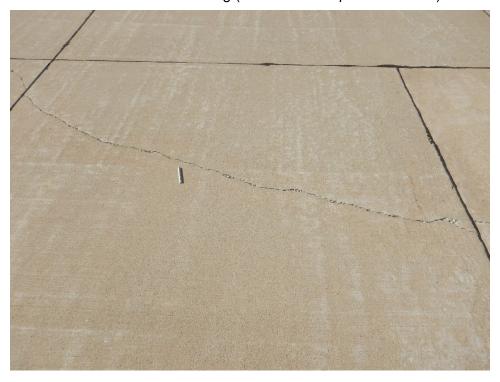
TH01MT-01. LTD Cracking (Additional Sample Unit No. 07).

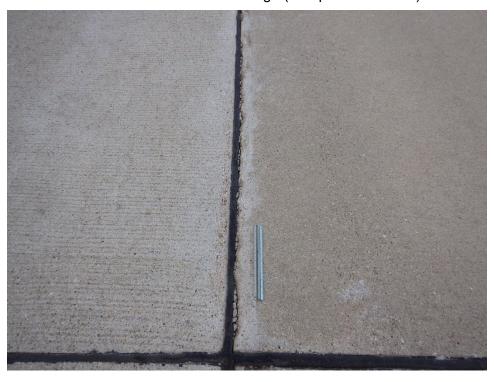
TH01MT-02. Joint Seal Damage (Sample Unit No. 03).

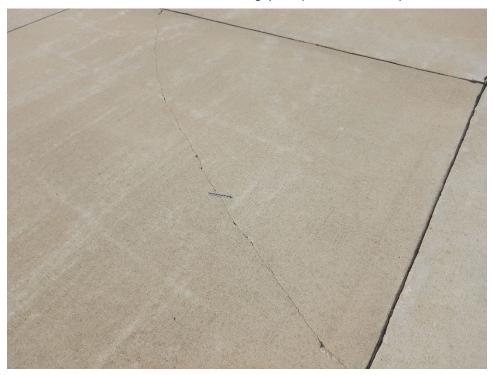
TH01MT-02. LTD Cracking (Sample Unit No. 02).

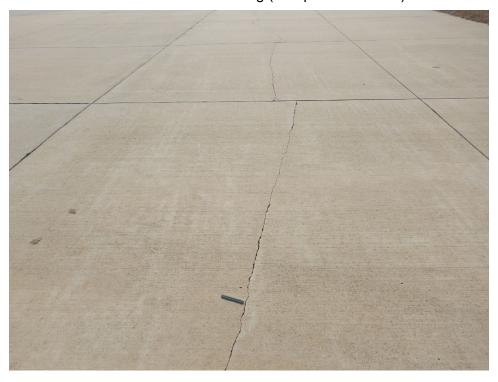
TH01MT-02. LTD Cracking (Sample Unit No. 05).

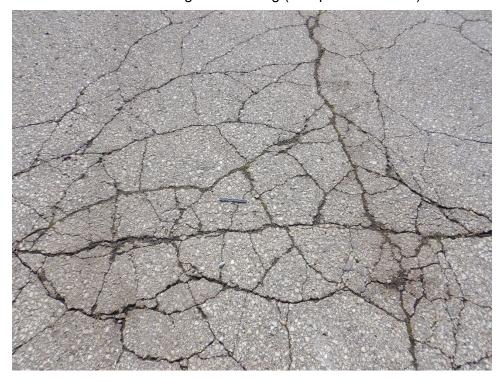
TH02MT-01. Alligator Cracking (Sample Unit No. 01).

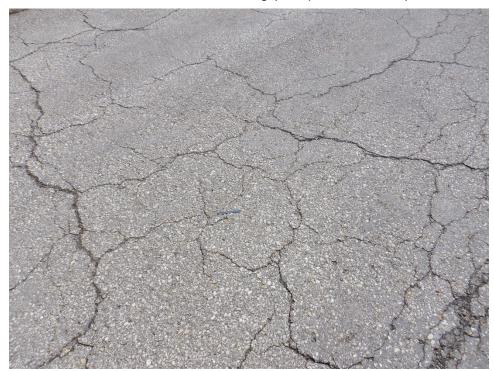
TH02MT-01. Block Cracking (Sample Unit No. 01).
