# Milford-Fuller Airport

## Pavement Management Report

**AUGUST 2025**

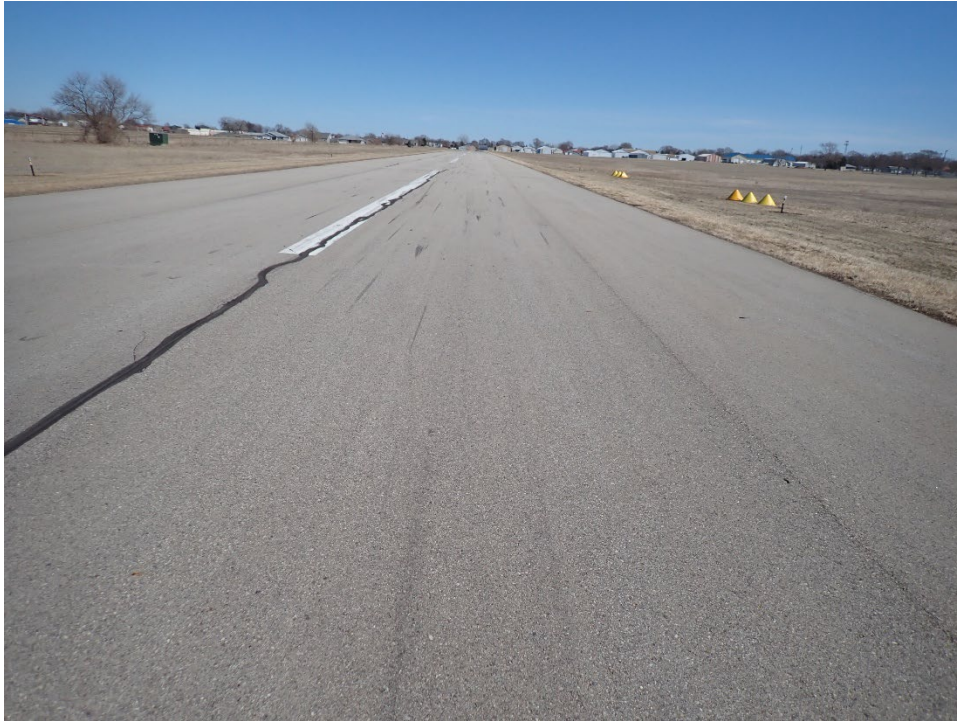
R09MD-01. Overview.

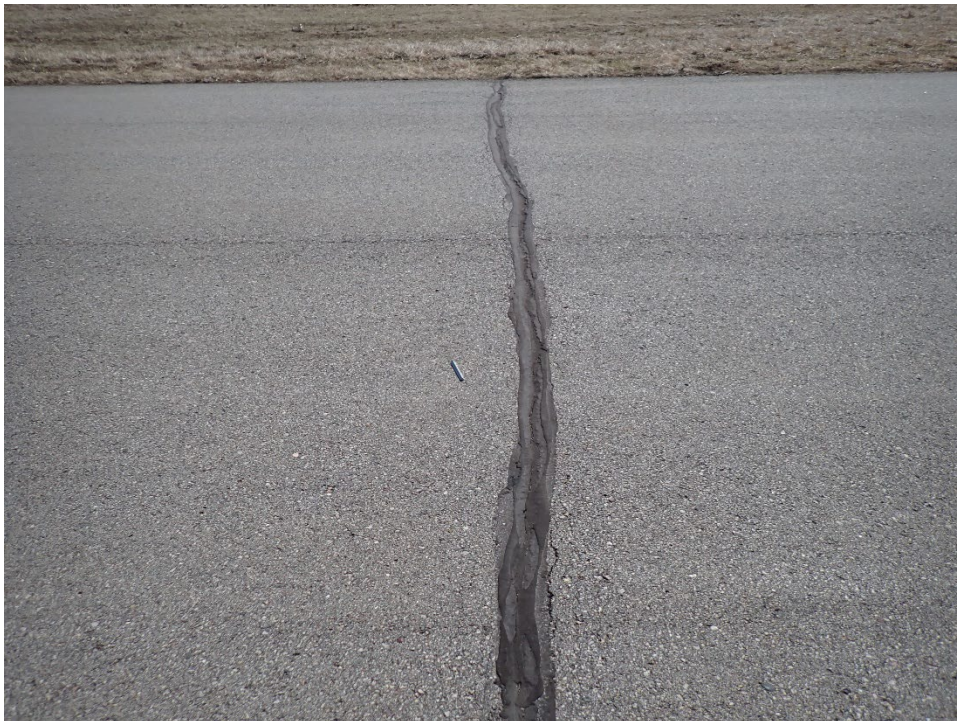
Runway 09/27 was defined by three sections. Sections 01, 02, and 03 were in similar conditions. Low-severity weathering was noted throughout all three sections. Additionally, low-severity longitudinal and transverse (L&T) cracking, most of which was sealed, was recorded along with smaller amounts of medium-severity L&T cracking that were identified where either the crack sealant was no longer in satisfactory condition or secondary cracking had developed. Isolated areas of high-severity raveling due to mechanical damage were also observed in Sections 02 and 03.

R09MD-01. L&T Cracking (Sample Unit No. 18).

| Branch | Section | Distress Type | Severity | Distress Quantity | Distress Unit | Maintenance Action | Unit Cost | 2025 Estimated Cost |
|---|---|---|---|---|---|---|---|---|
| R09MD | 01 | L&T Cracking | Medium | 188 | Ft | Crack Sealing - AC | \$2.72 | \$512 |

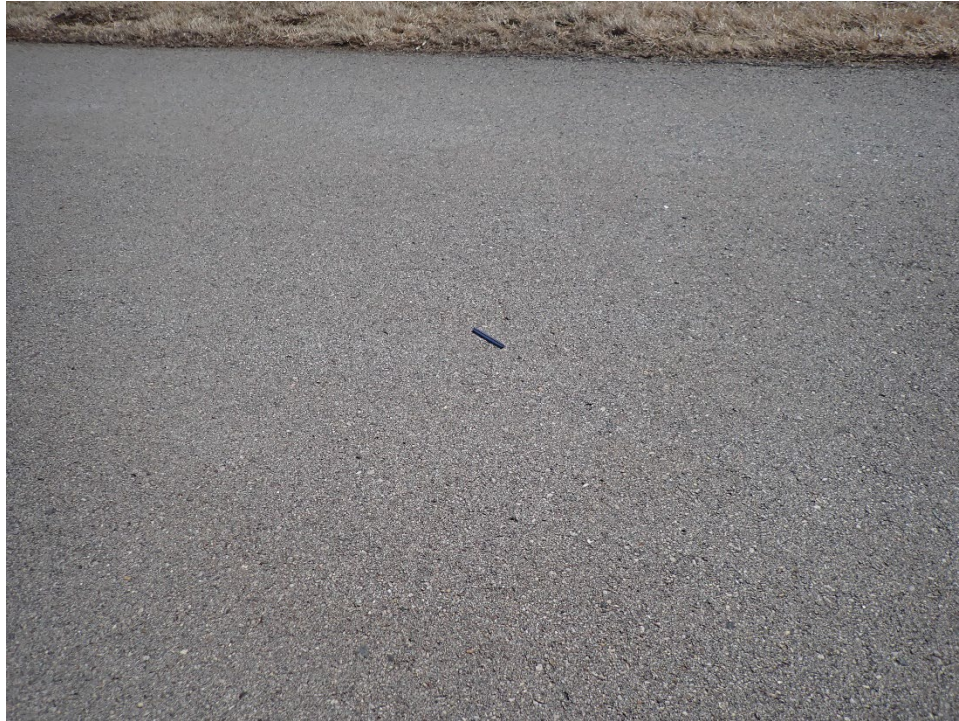
R09MD-01. Weathering (Sample Unit No. 14).

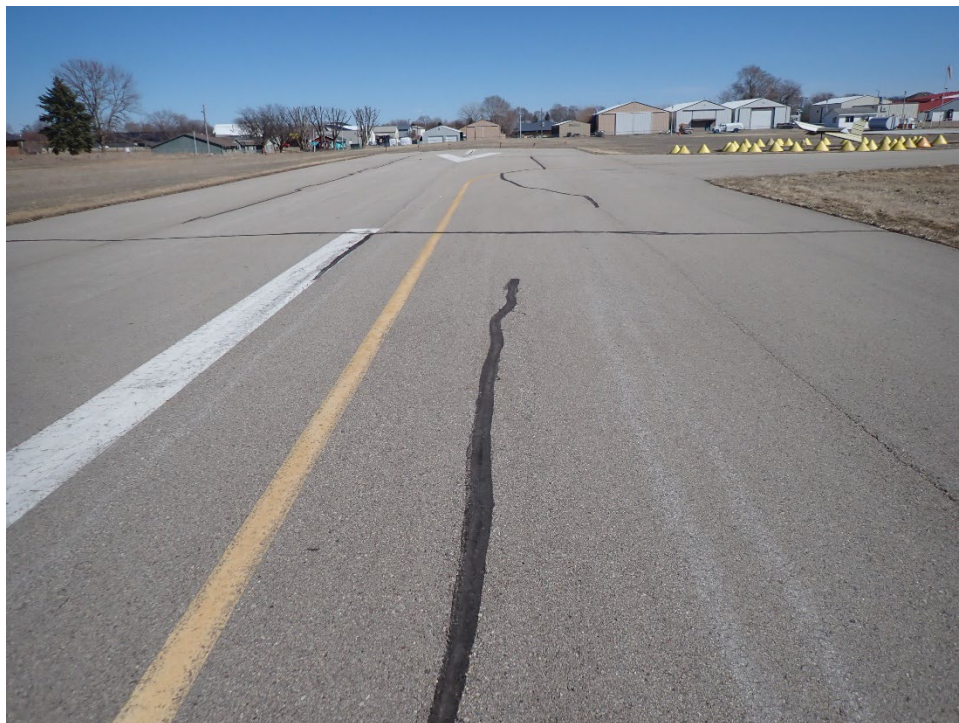
R09MD-02. Overview.

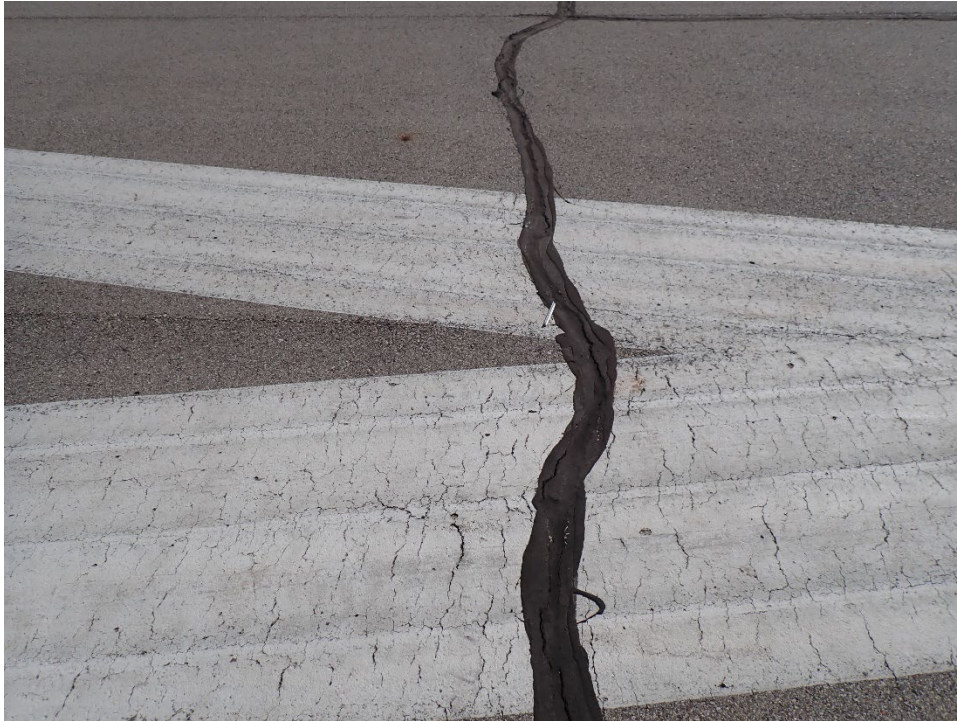
R09MD-02. L&T Cracking (Sample Unit No. 01).

| Branch | Section | Distress Type | Severity | Distress Quantity | Distress Unit | Maintenance Action | Unit Cost | 2025 Estimated Cost |
|---|---|---|---|---|---|---|---|---|
| R09MD | 02 | L&T Cracking | Medium | 22 | Ft | Crack Sealing - AC | \$2.72 | \$60 |

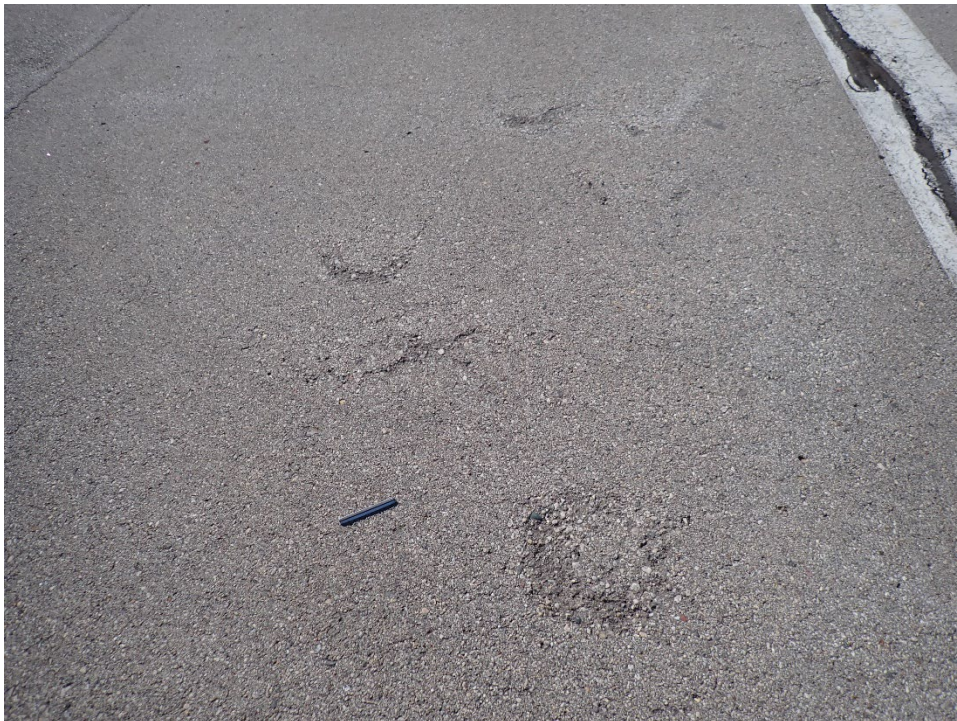
R09MD-02. Raveling (Sample Unit No. 01).

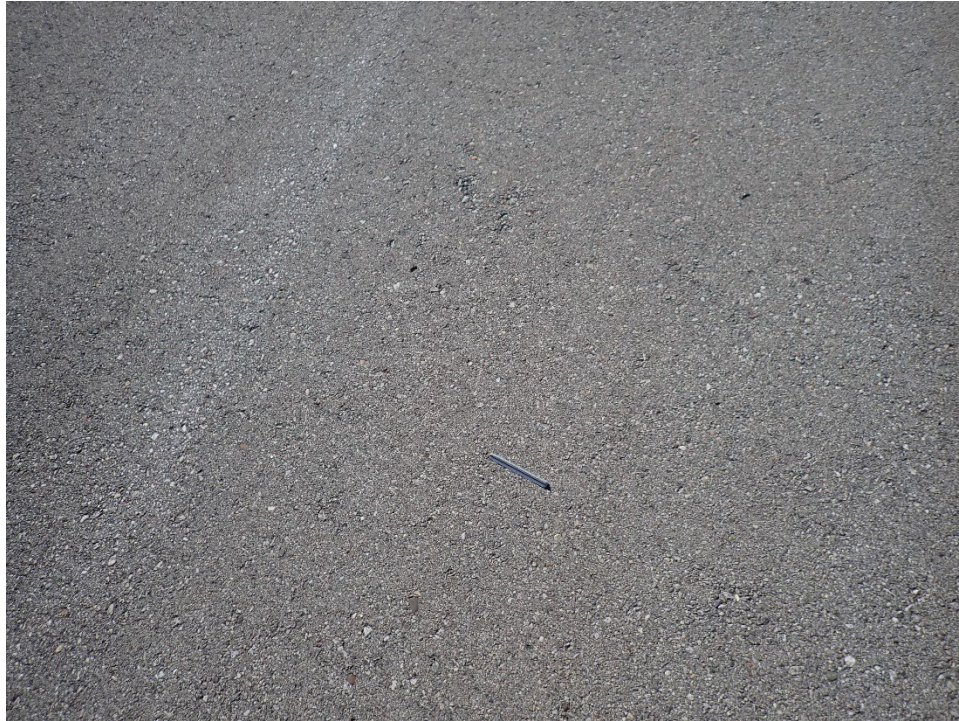
R09MD-02. Weathering (Sample Unit No. 01).

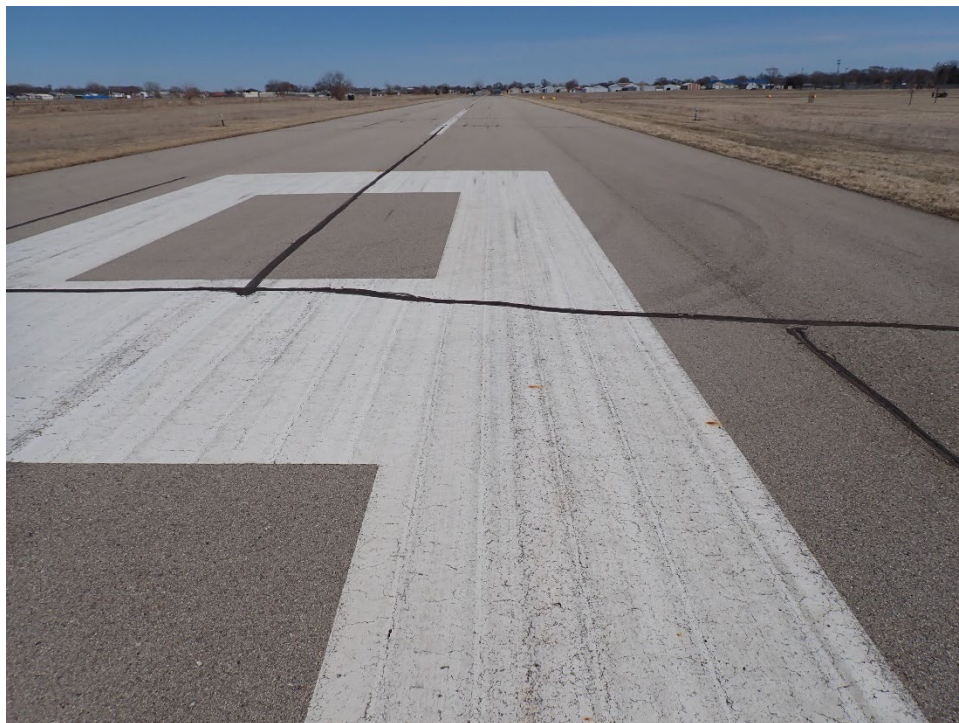
R09MD-03. Overview.

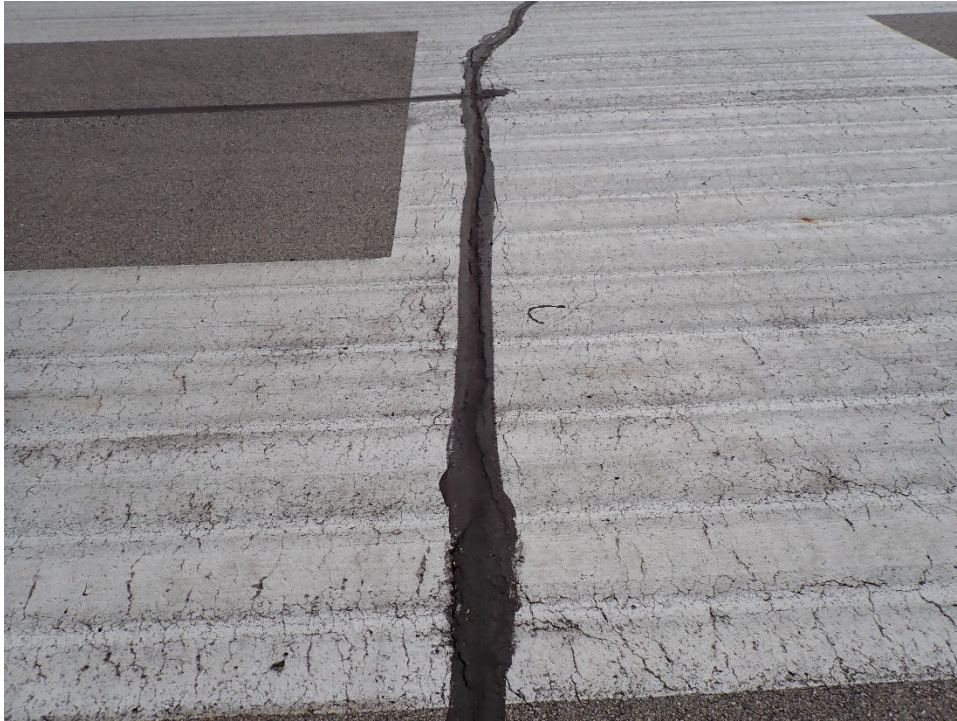
R09MD-03. L&T Cracking (Sample Unit No. 02).

| Branch | Section | Distress Type | Severity | Distress Quantity | Distress Unit | Maintenance Action | Unit Cost | 2025 Estimated Cost |
|---|---|---|---|---|---|---|---|---|
| R09MD | 03 | L&T Cracking | Medium | 17 | Ft | Crack Sealing - AC | \$2.72 | \$46 |

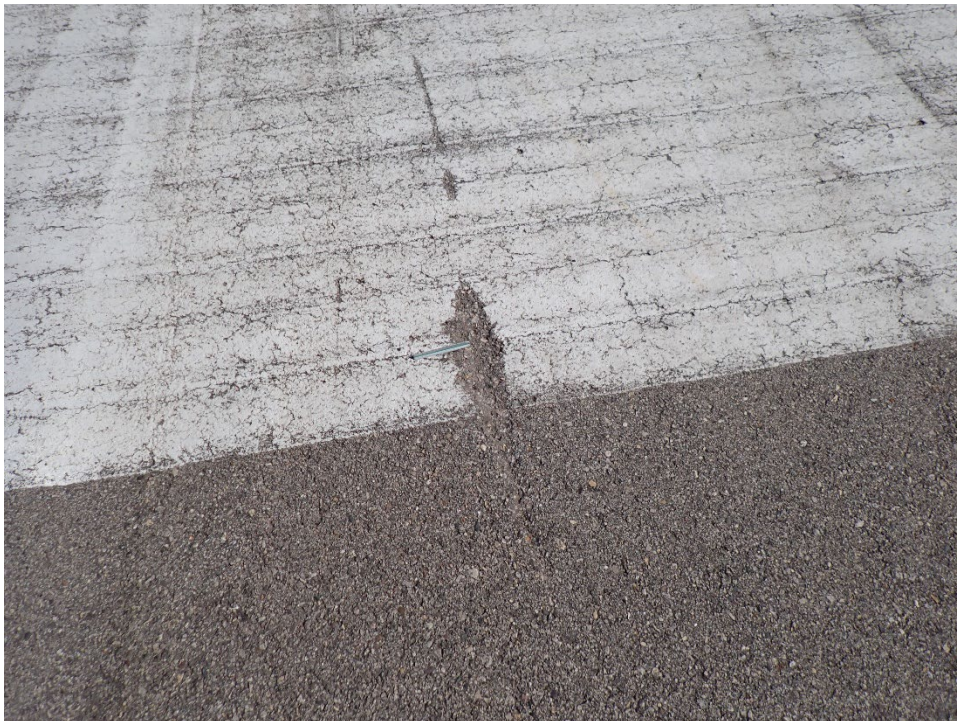
R09MD-03. Raveling (Sample Unit No. 01).

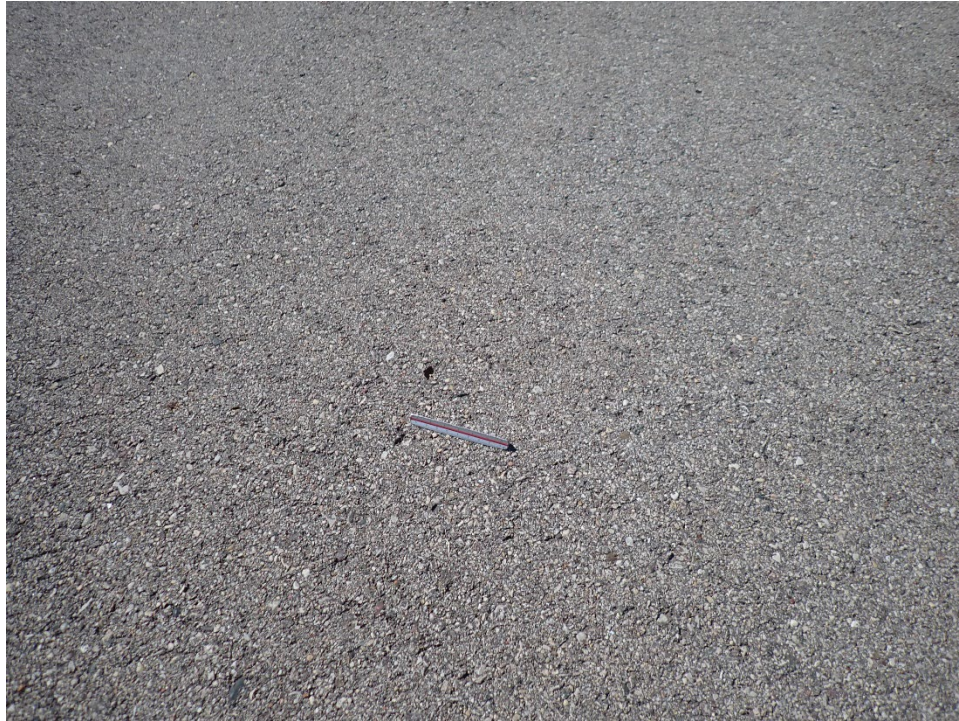
R09MD-03. Weathering (Sample Unit No. 03).

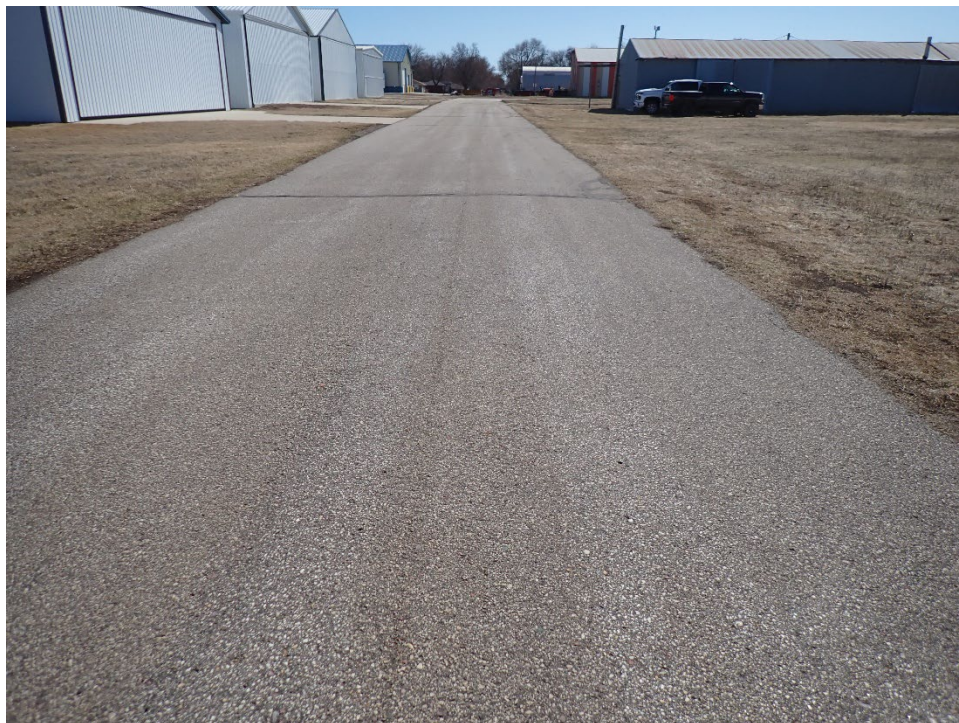
T01MD-01. Overview.

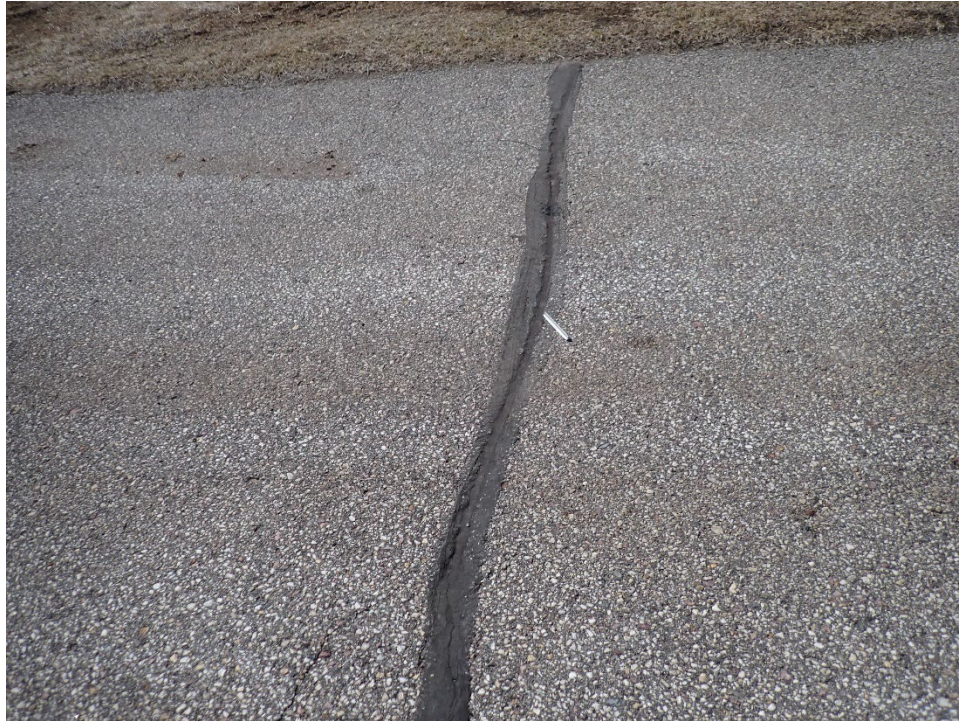
The taxiway contained two sections. Low-severity, sealed L&T cracking was recorded in Section 01, along with medium-severity L&T cracking that was due to either unsatisfactory crack sealant or the development of secondary cracking. Small areas of low- and medium-severity alligator cracking were also observed at the edge of the taxiway. Additionally, low-severity raveling and low- and medium-severity weathering were identified. In Section 02, areas of low-severity alligator cracking located at the edge of the pavement; low-severity L&T cracking, both sealed and unsealed; and low-severity weathering were recorded at the time of the inspection.

T01MD-01. L&T Cracking (Sample Unit No. 02).

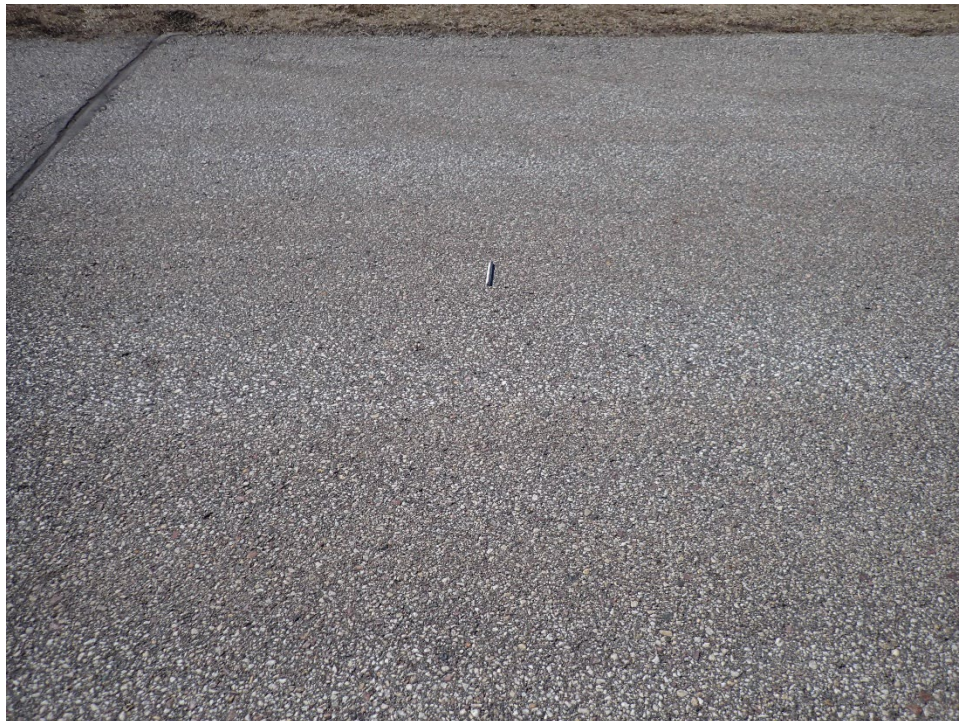
T01MD-01. Raveling (Sample Unit No. 02).

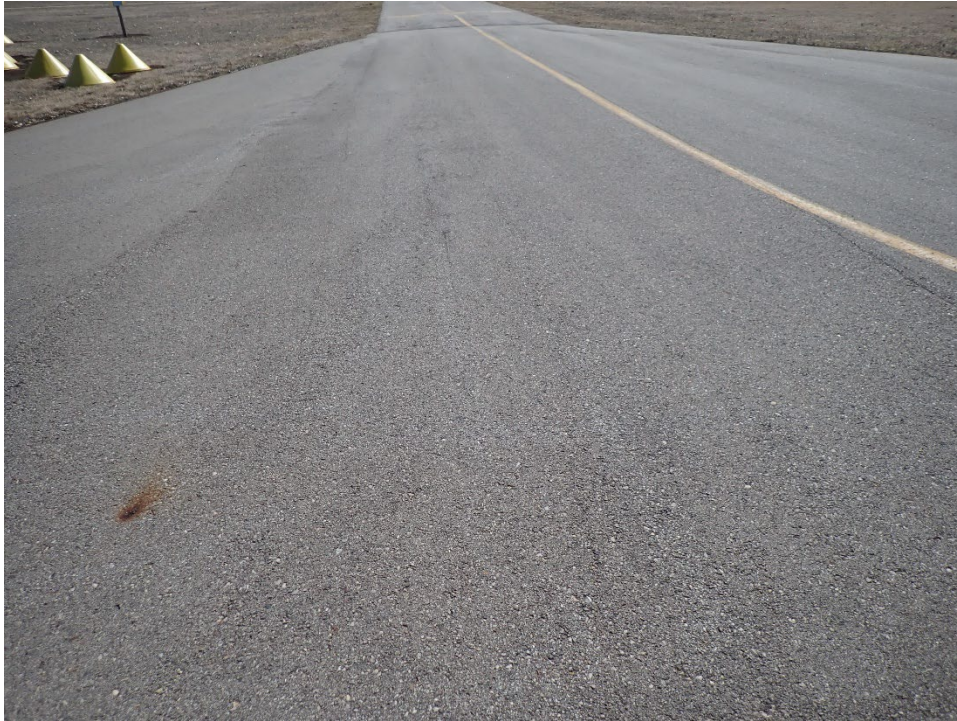
T01MD-02. Overview.

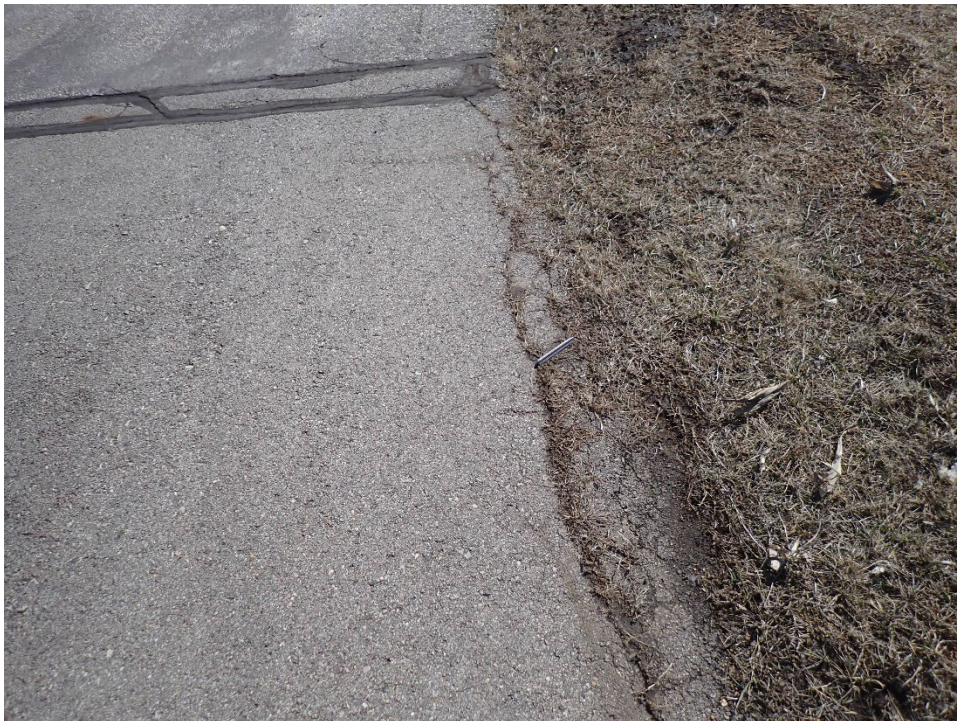
T01MD-02. Alligator Cracking (Sample Unit No. 01).

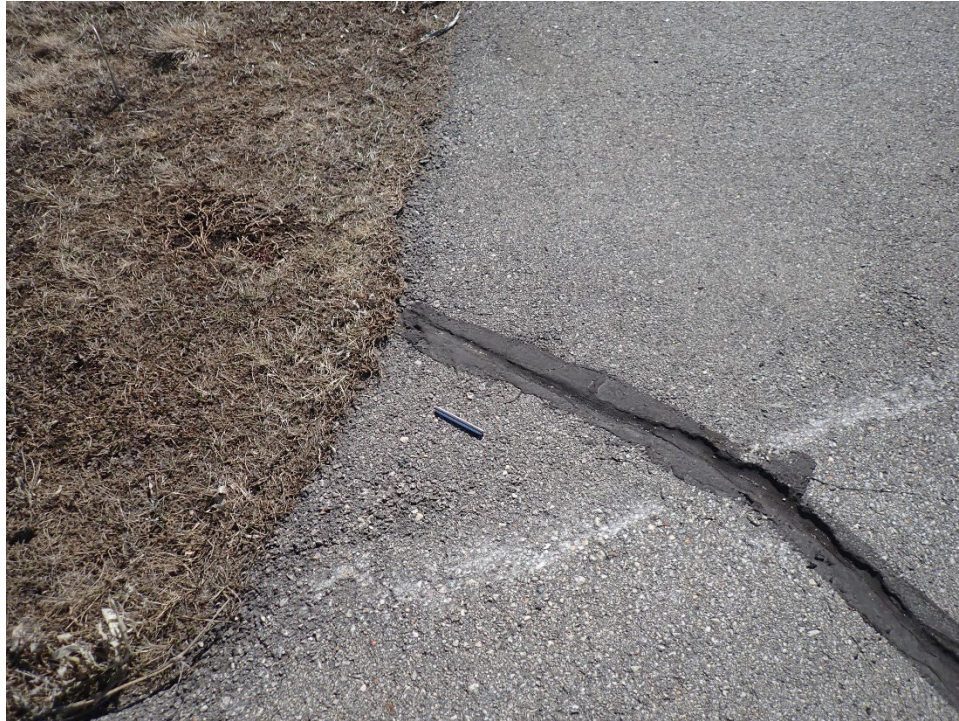
T01MD-02. L&T Cracking (Sample Unit No. 01).

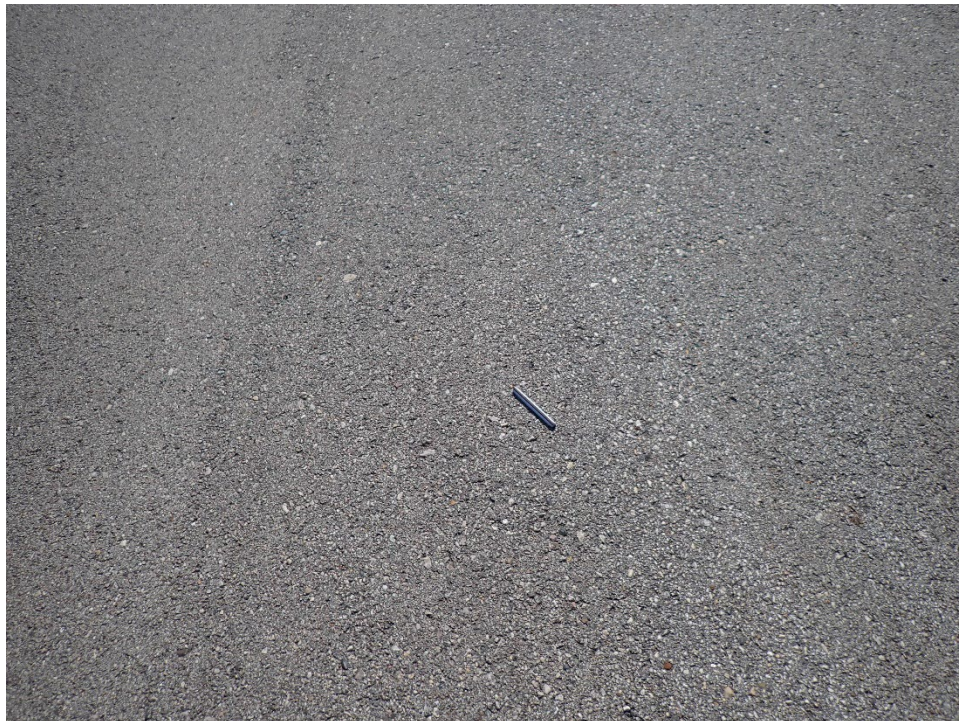
T01MD-02. Weathering (Sample Unit No. 01).
