# New Hampton Municipal Airport

## Pavement Management Report

**AUGUST 2025**

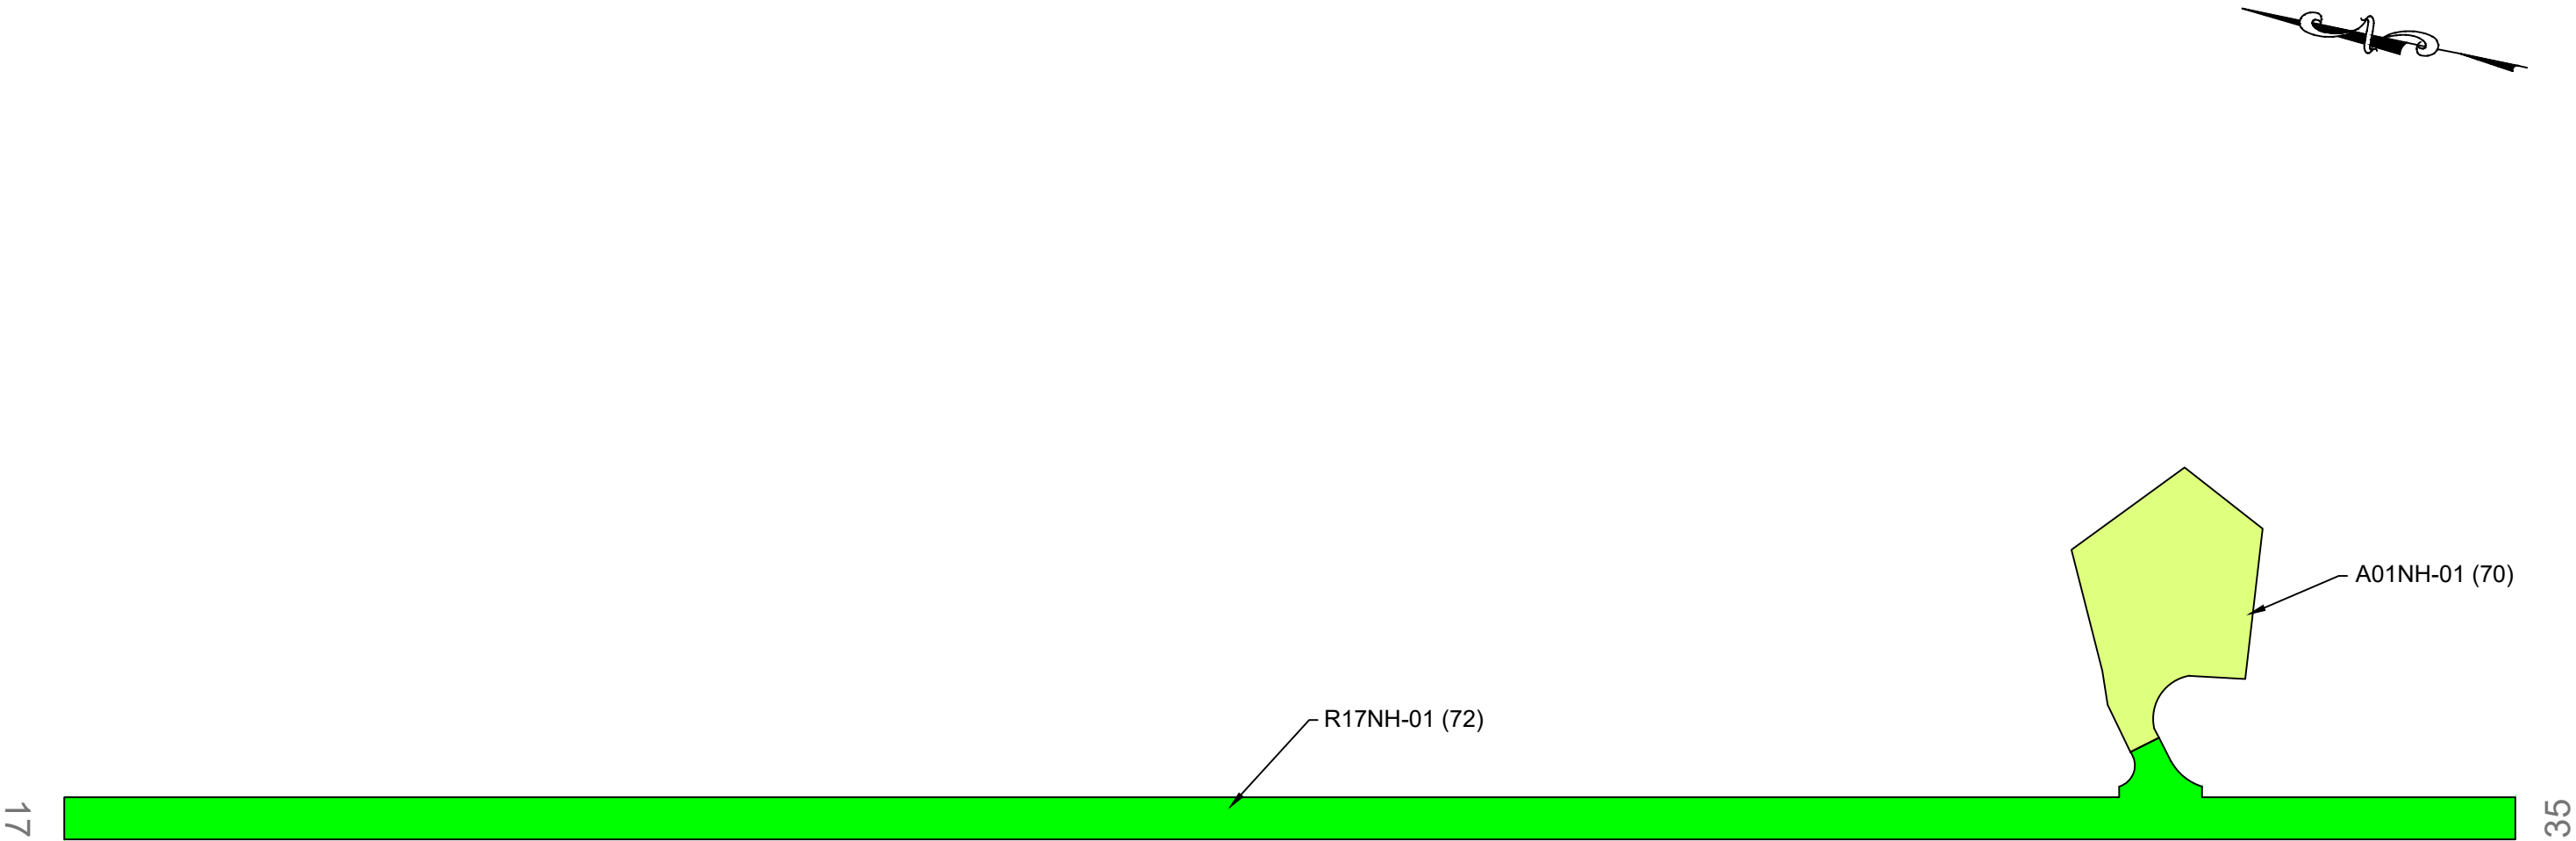
FIGURE 8. PCI MAP.

The pavements at New Hampton Municipal Airport were inspected in March 2025. The 2025 area-weighted condition of New Hampton Municipal Airport is 72, with conditions ranging from 70 to 72 (on a scale of 0 [failed] to 100 [excellent]). During the previous pavement inspection in 2018, the area-weighted PCI of the airport was 98.

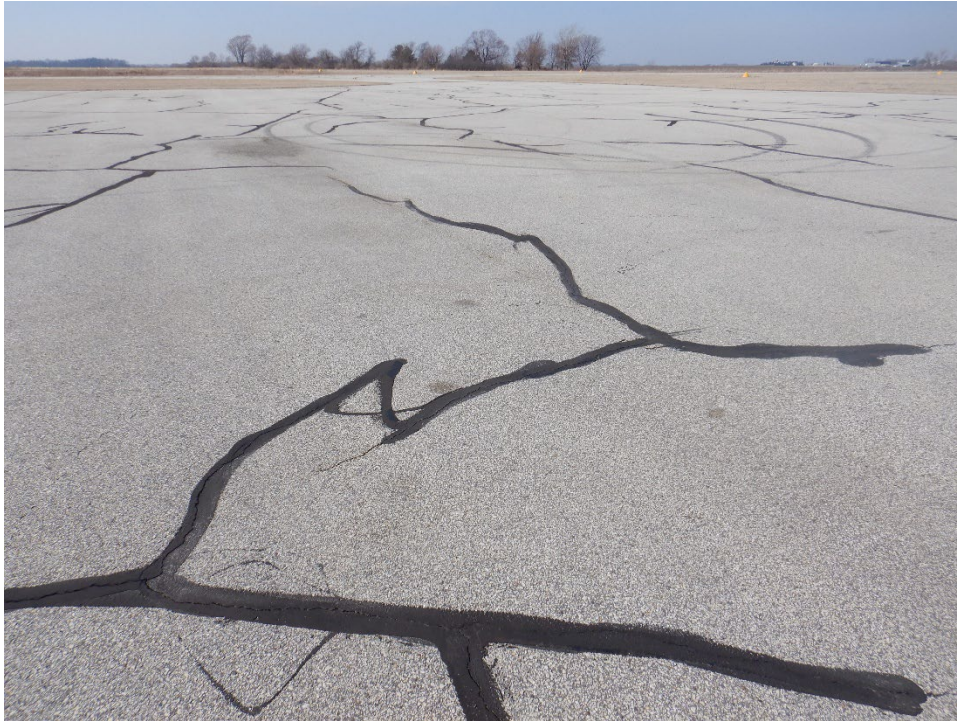
A01NH-01. Overview.

The apron area was defined by one section. Section 01 contained areas of low- and medium-severity L&T cracking, along with low-severity weathering noted throughout.

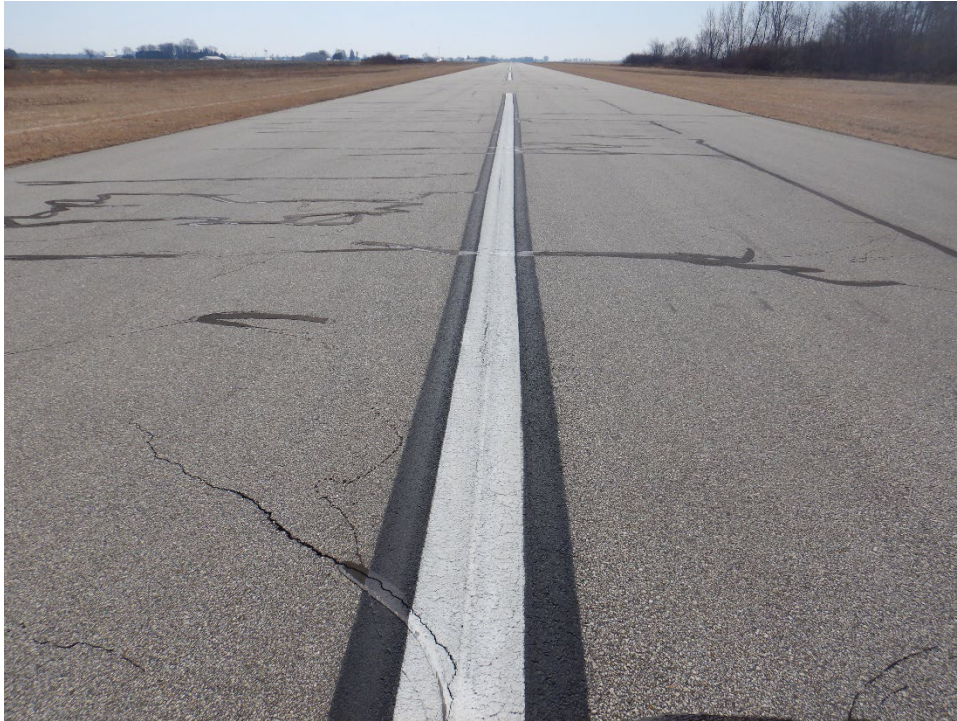
R17NH-01. Overview.

Runway 17/35 consisted of one section that contained areas of low-severity alligator cracking and weathering, low- and medium-severity longitudinal and transverse (L&T) cracking, and oil spillage. Some low-severity alligator cracking was recorded in the wheel path. The low-severity L&T cracking was observed in both the unsealed and sealed conditions, while the medium-severity L&T cracking was recorded where crack sealant was no longer performing satisfactorily.
