# Newton Municipal Airport - Earl Johnson Field

## Pavement Management Report

**AUGUST 2025**

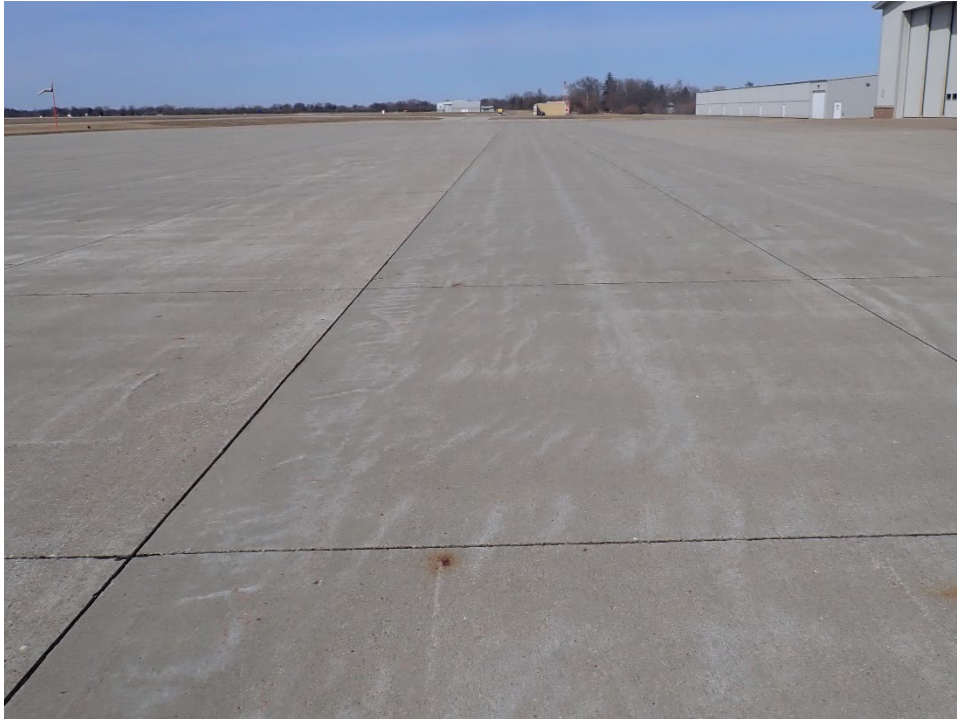
A03NE-01. Overview.

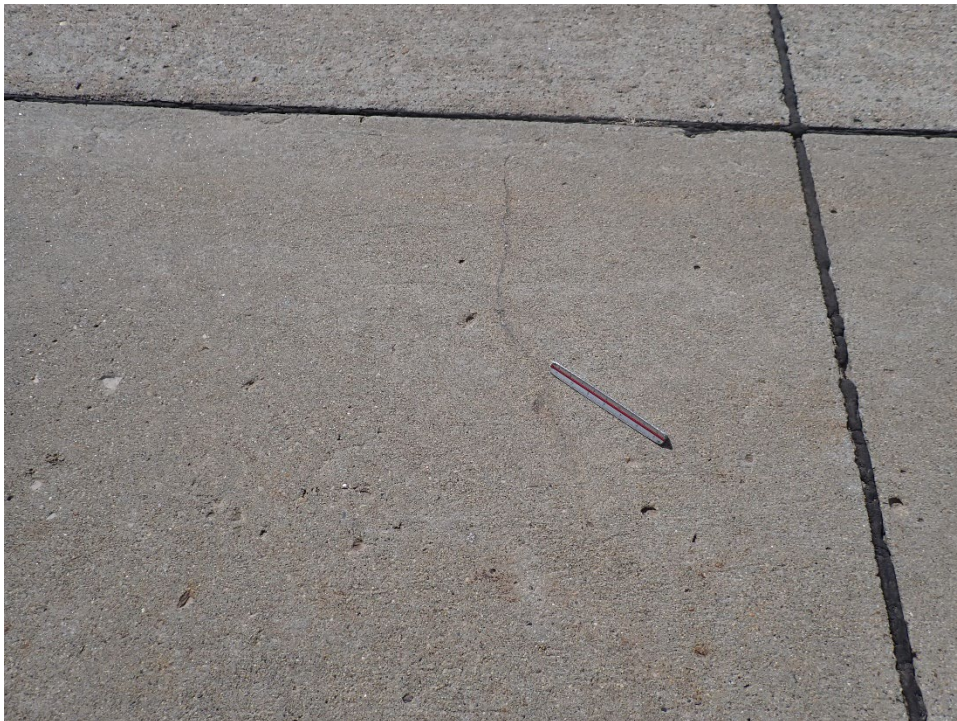
The apron area consisted of four sections. Various distresses were identified in Section 01 including low-severity ASR, LTD cracking, and corner spalling; high-severity joint seal damage; and all severities of joint spalling. An atypical area with a low-severity small patching and a high-severity large patching was inspected as an additional sample unit according to ASTM D5340. In Section 02, high-severity joint seal damage was observed throughout in addition to smaller quantities of low-severity faulting, medium-severity joint spalling, and shrinkage cracking. Section 03 contained low- and medium-severity corner spalling along with medium- and high-severity joint seal damage. All severities of joint seal damage were identified in Section 04.

A03NE-01. ASR (Sample Unit No. 17).

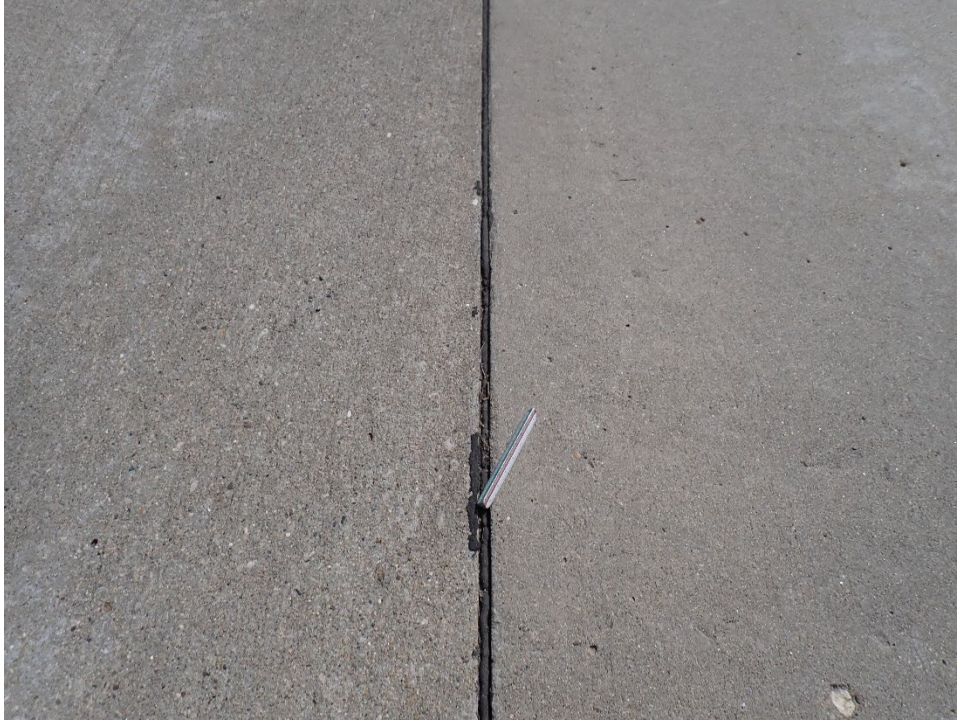
A03NE-01. Joint Seal Damage (Sample Unit No. 15).

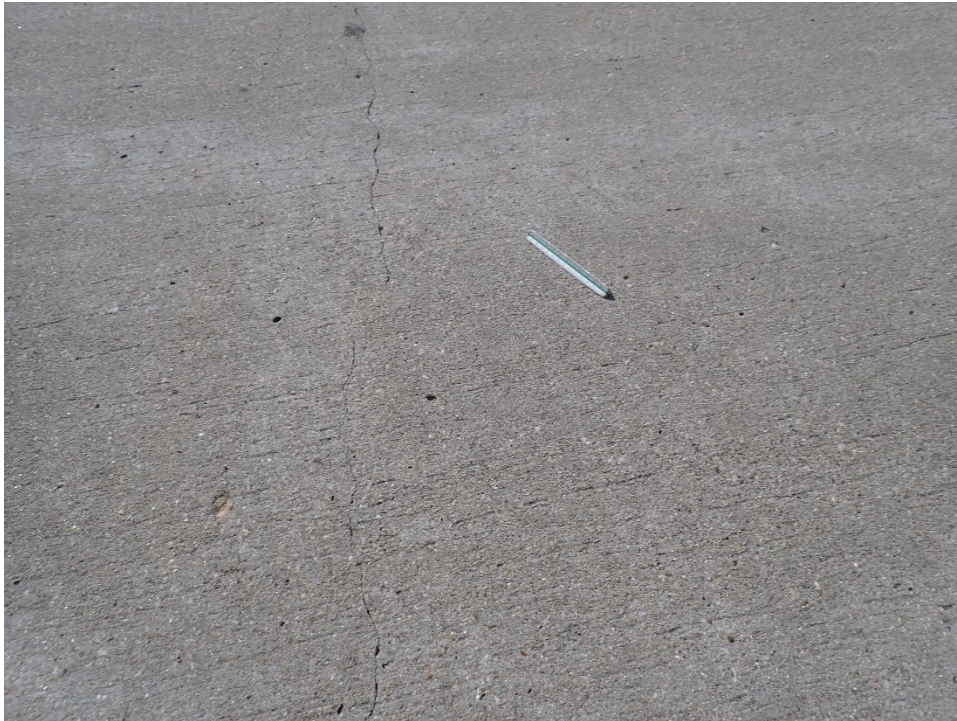
A03NE-01. LTD Cracking (Sample Unit No. 15).

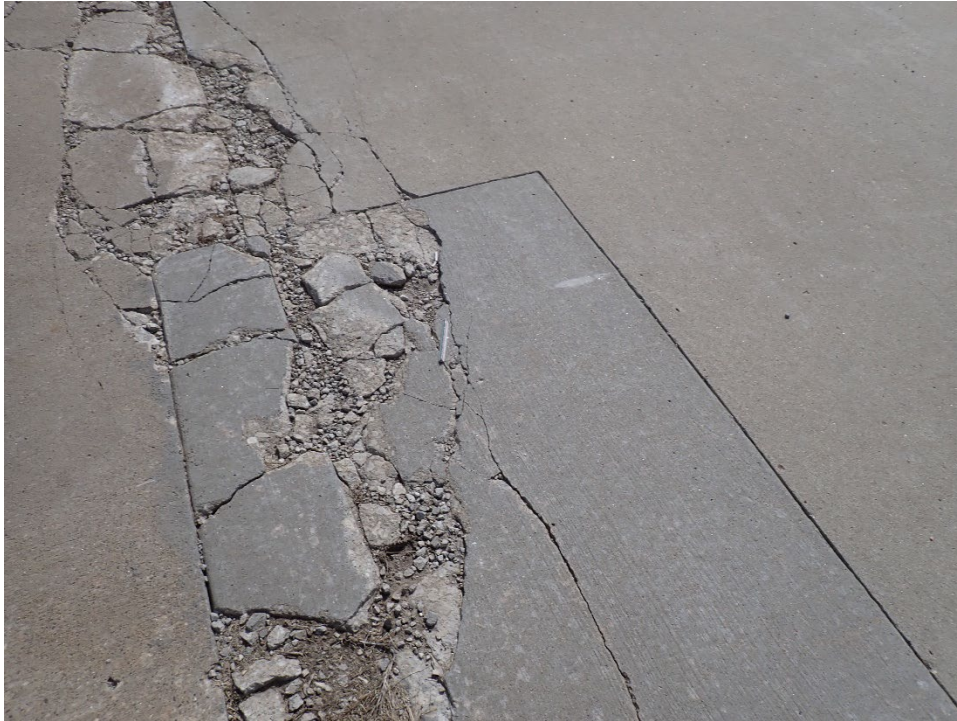
A03NE-01. Large Patching (Additional Sample Unit No. 16).

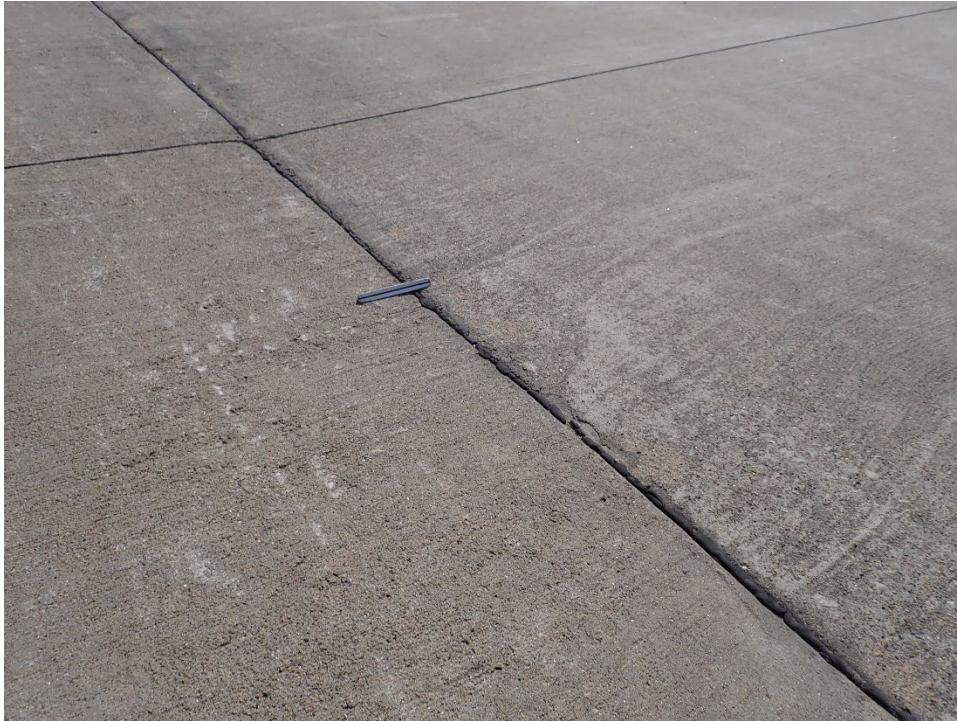
A03NE-02. Faulting (Sample Unit No. 06).

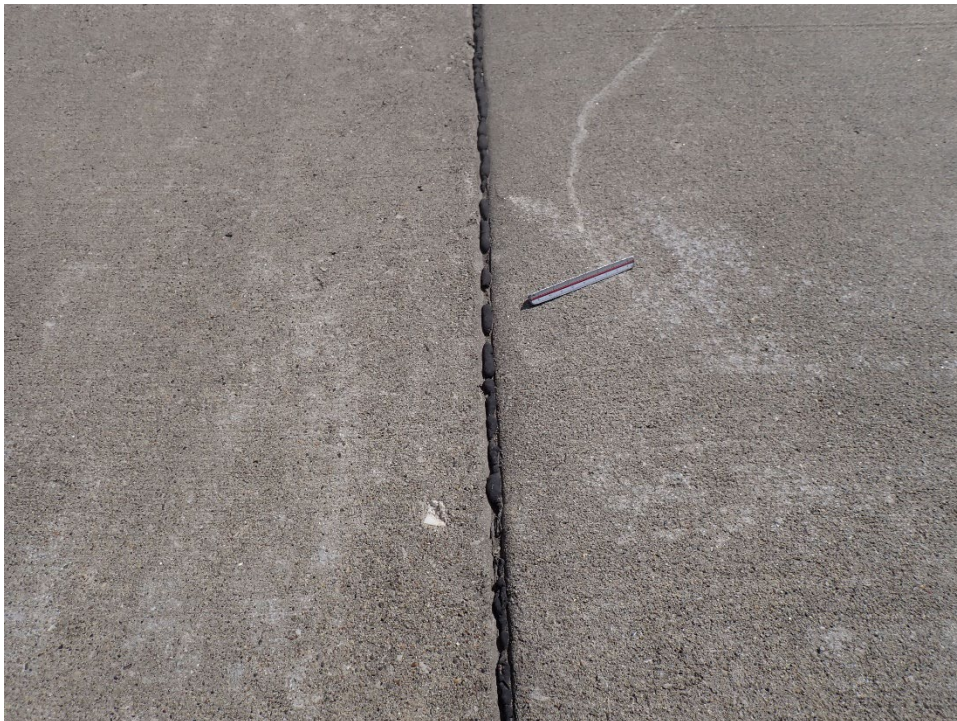
A03NE-02. Joint Seal Damage (Sample Unit No. 10).

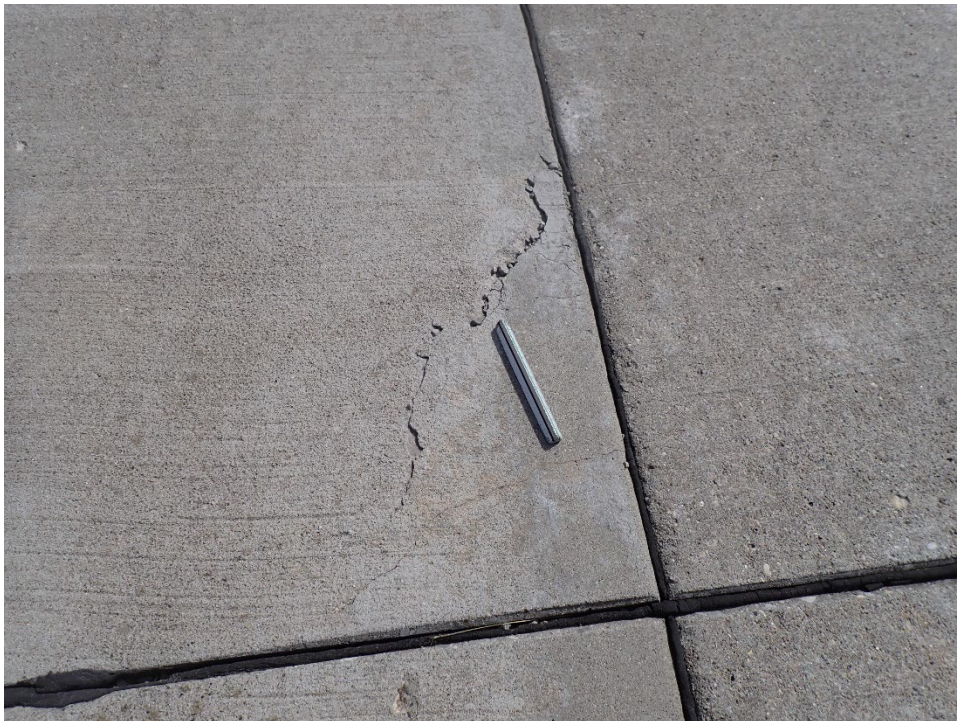
A03NE-03. Corner Spalling (Sample Unit No. 04).

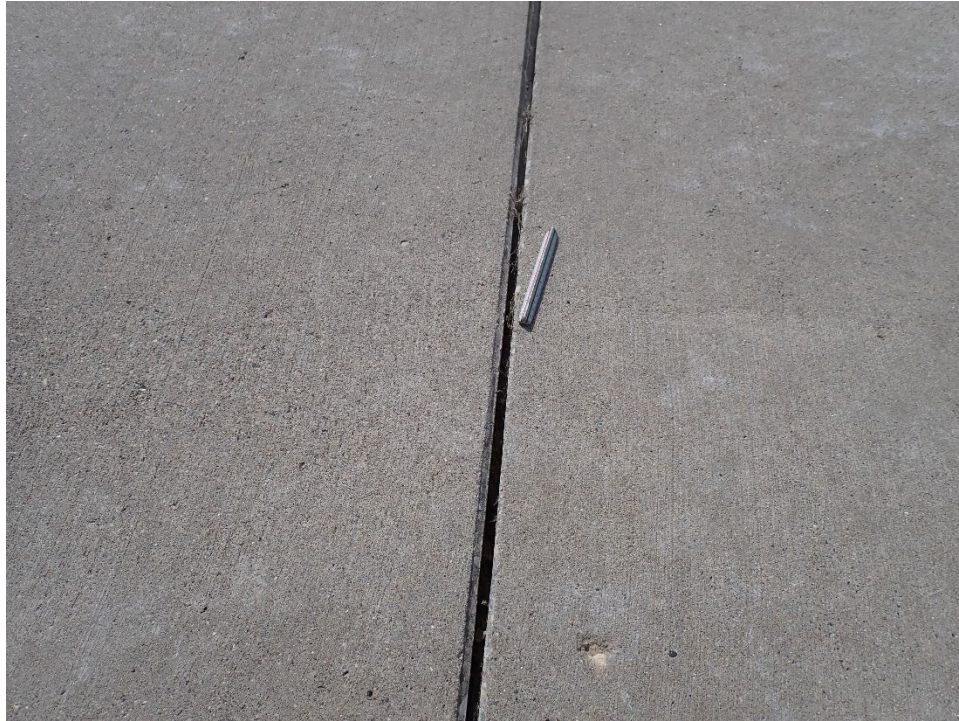
A03NE-03. Joint Seal Damage (Sample Unit No. 10).

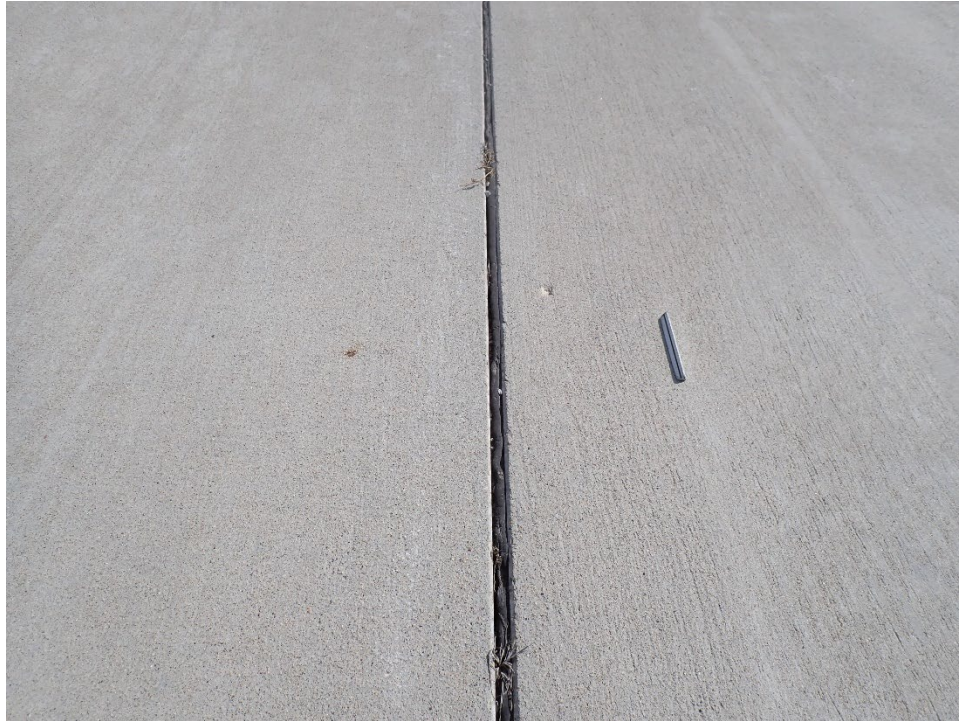
A03NE-04. Joint Seal Damage (Sample Unit No. 03).

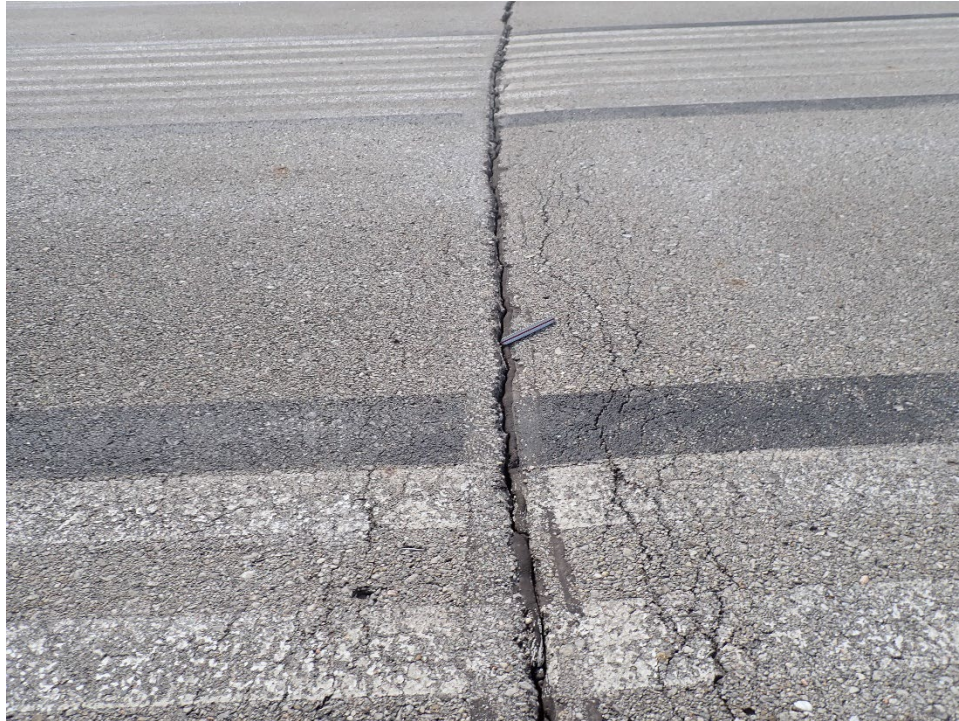
Runway 14/32 contained three sections. All severities of longitudinal and transverse (L&T) cracking and medium-severity weathering were recorded in all sections. The low-severity L&T cracking was unsealed, while the medium-severity L&T cracking was recorded where either unsealed crack widths exceeded 1/4 inch, crack sealant was no longer preventing water from penetrating into underlying pavement layers, or secondary cracking associated with the primary crack was observed. The high-severity L&T cracking was recorded in areas where the cracking had deteriorated, producing areas of parallel secondary cracking wider than 1 foot. In addition, small areas of high-severity weathering were recorded in Section 01, and high-severity raveling was observed in Section 03. Additionally, both Sections 01 and 03 contained areas of low-severity alligator cracking located in the wheel path.

R14NE-01. L&T Cracking (Sample Unit No. 01).

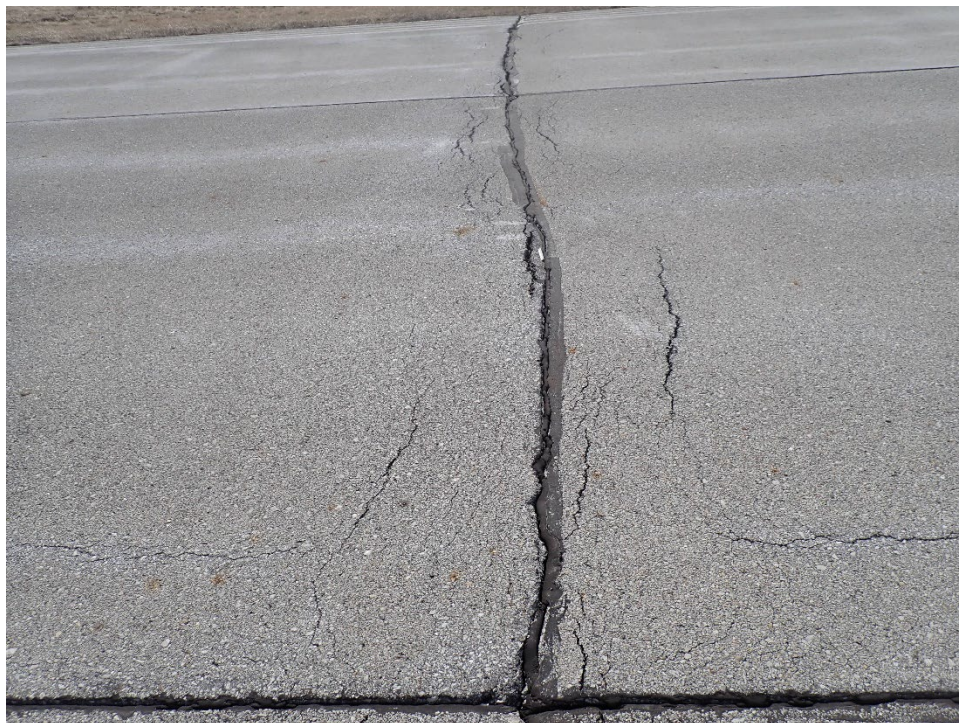
R14NE-01. L&T Cracking (Sample Unit No. 08).

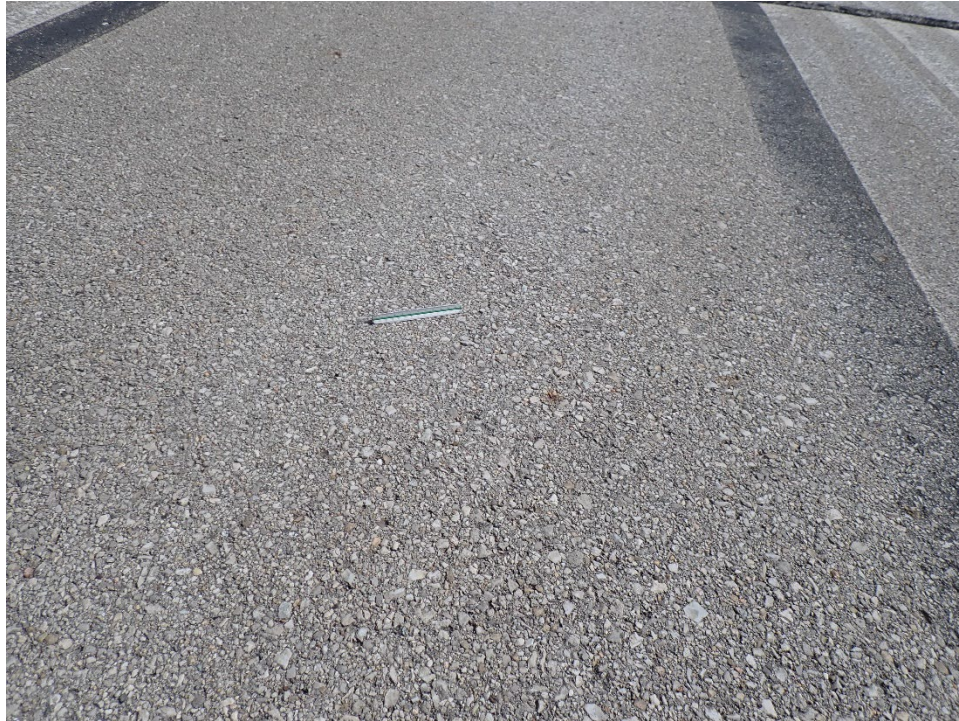
R14NE-01. Weathering (Sample Unit No. 01).

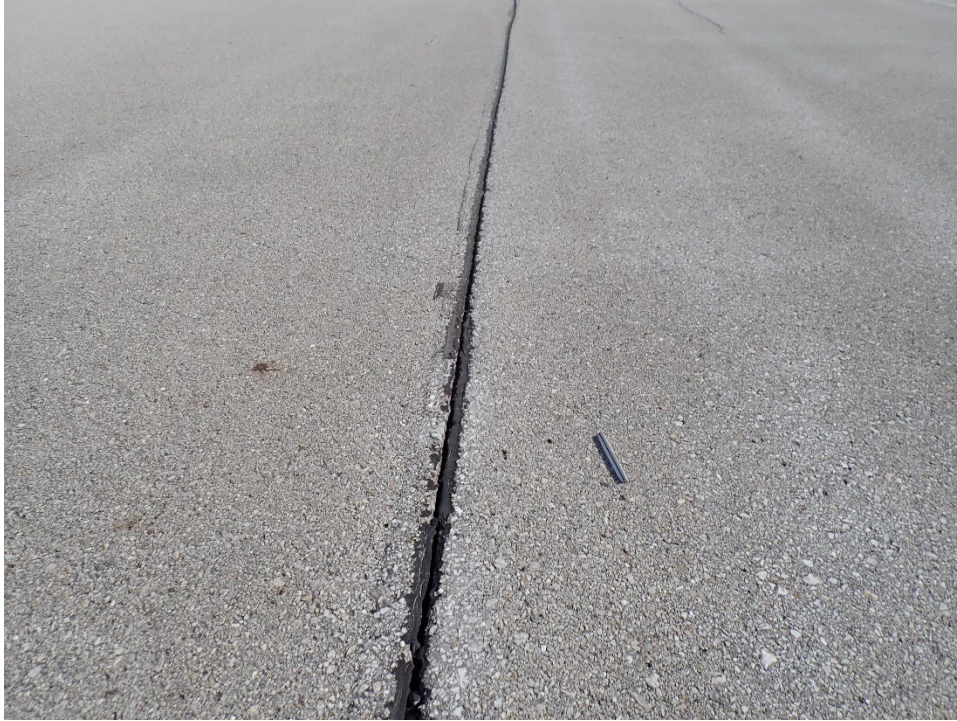
R14NE-02. L&T Cracking (Sample Unit No. 02).

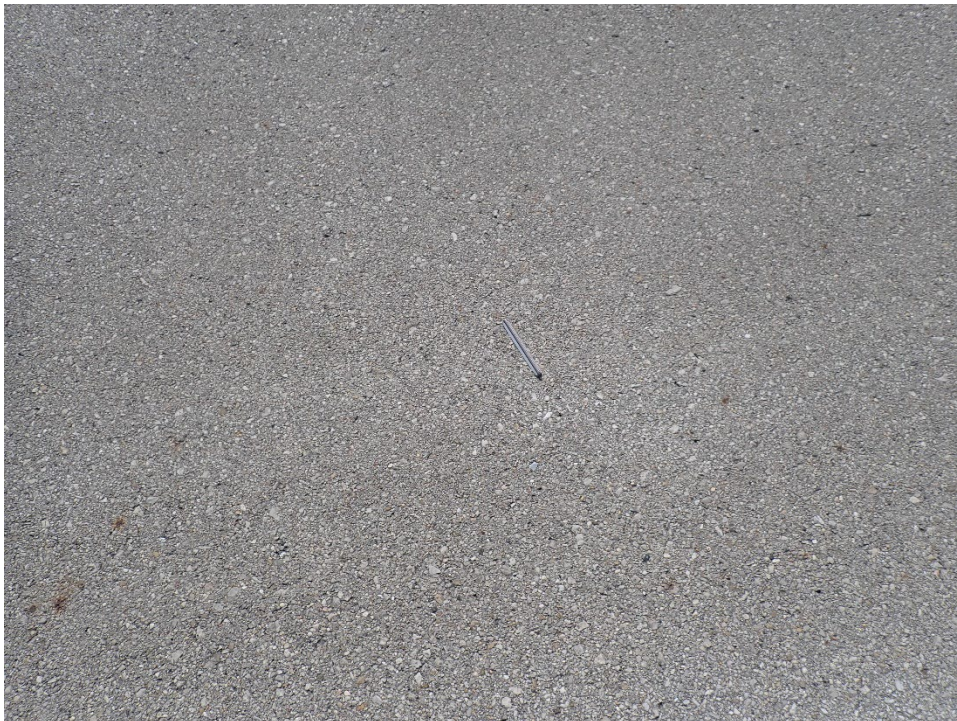
R14NE-02. Weathering (Sample Unit No. 02).

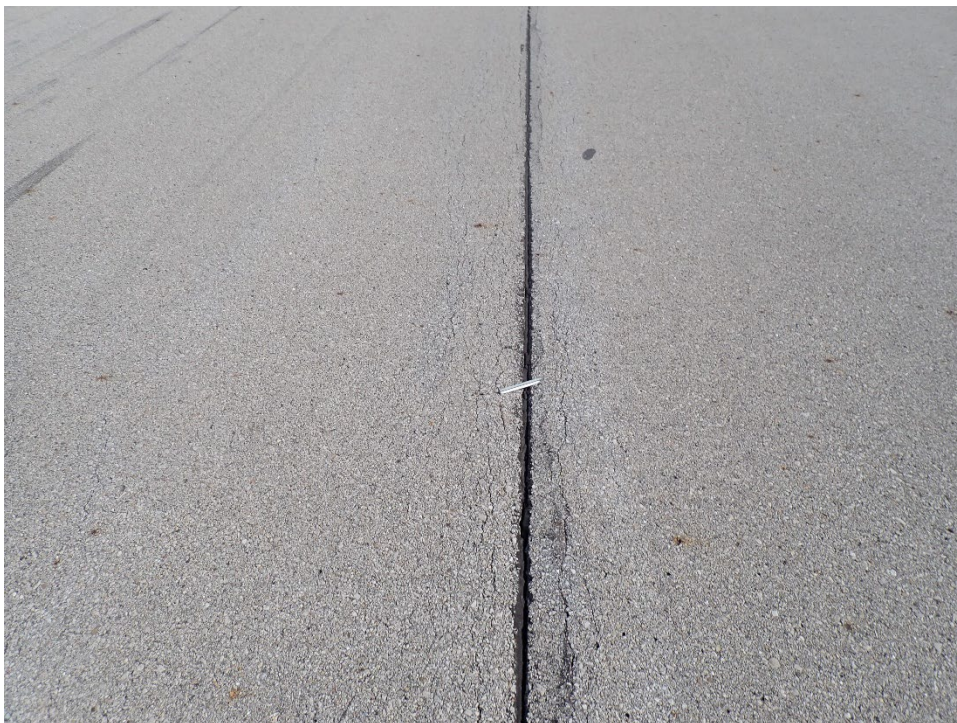
R14NE-03. Alligator Cracking (Sample Unit No. 04).

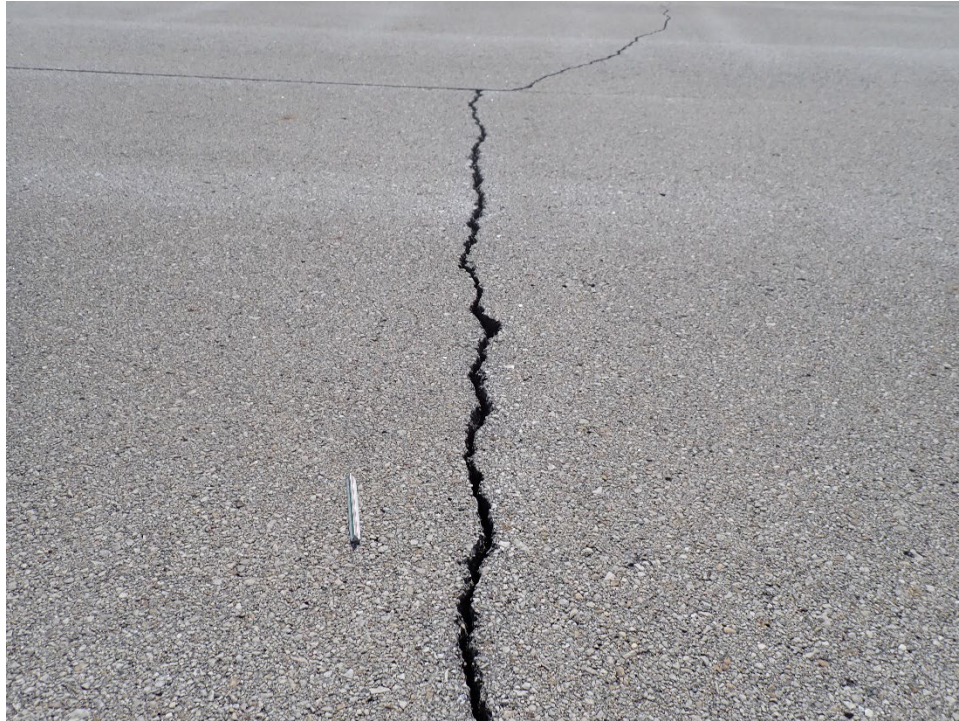
R14NE-03. L&T Cracking (Sample Unit No. 04).

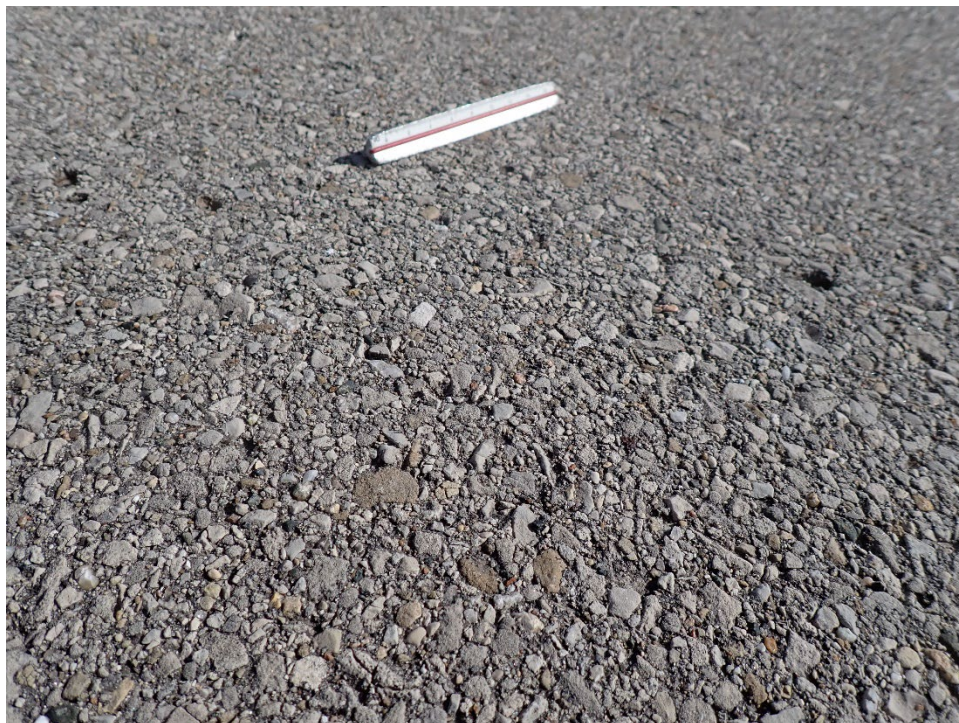
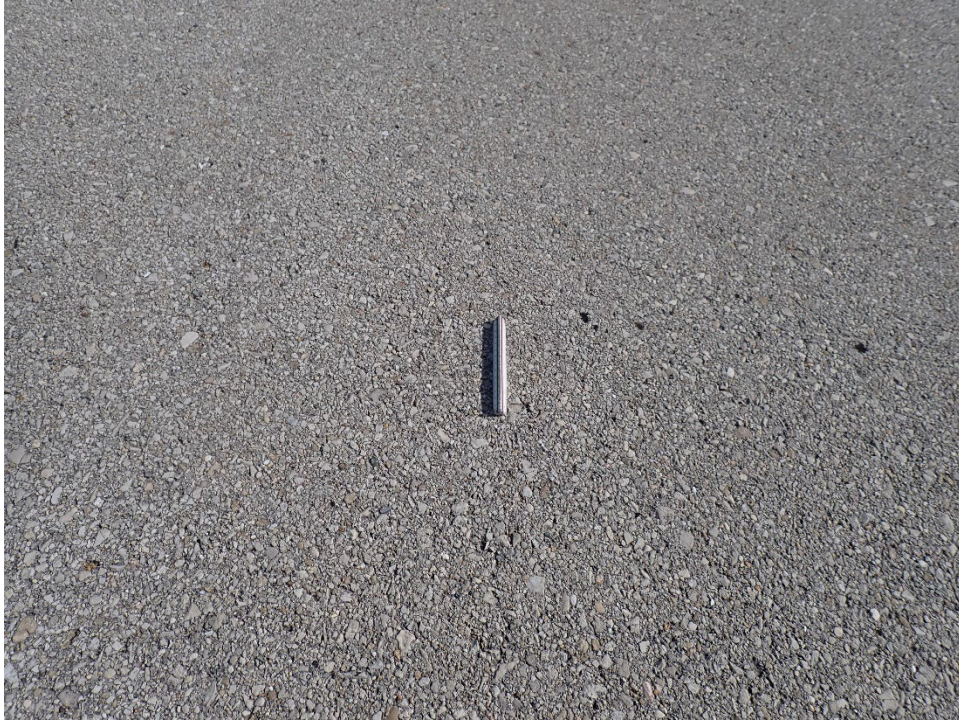
R14NE-03. Weathering (Sample Unit No. 04) (1).

R14NE-03. Weathering (Sample Unit No. 04) (2).

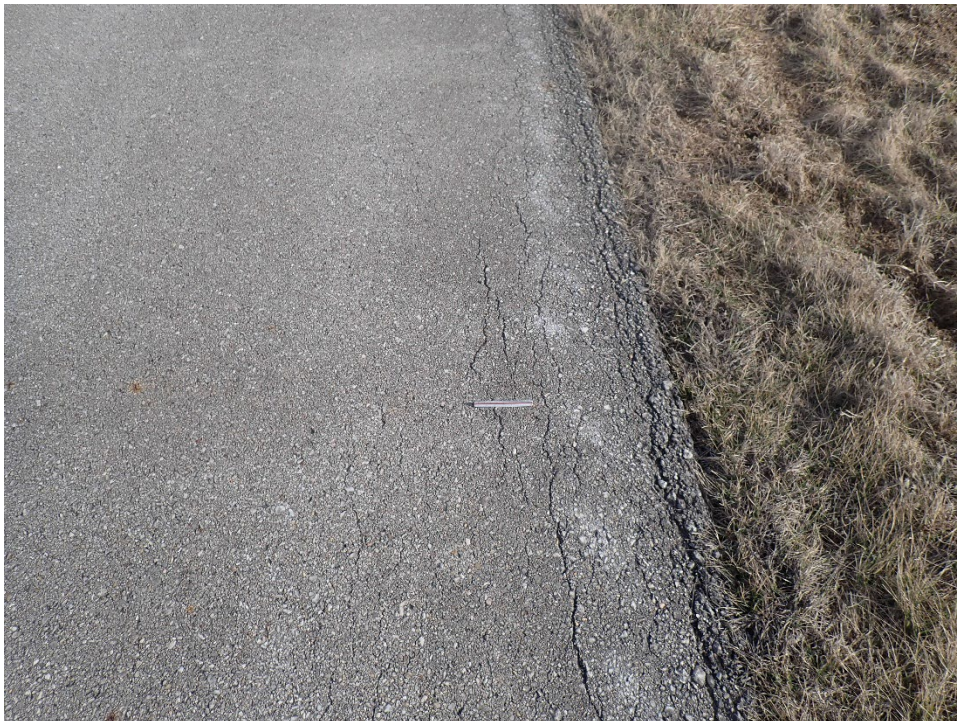
Taxiway 03 consisted of one section. In Section 01, all severities of L&T cracking, low-severity alligator cracking located at the edge of the pavement, medium-severity weathering, and high-severity raveling were observed. The low-severity L&T cracking was both sealed and unsealed and the medium-severity L&T cracking was recorded where either unsealed crack widths exceeded 1/4 inch, crack sealant was no longer performing satisfactorily, or secondary cracking had developed. The high-severity L&T cracking was noted where secondary cracking pattern was wider than 1 foot.

T03NE-01. Alligator Cracking (Sample Unit No. 01).

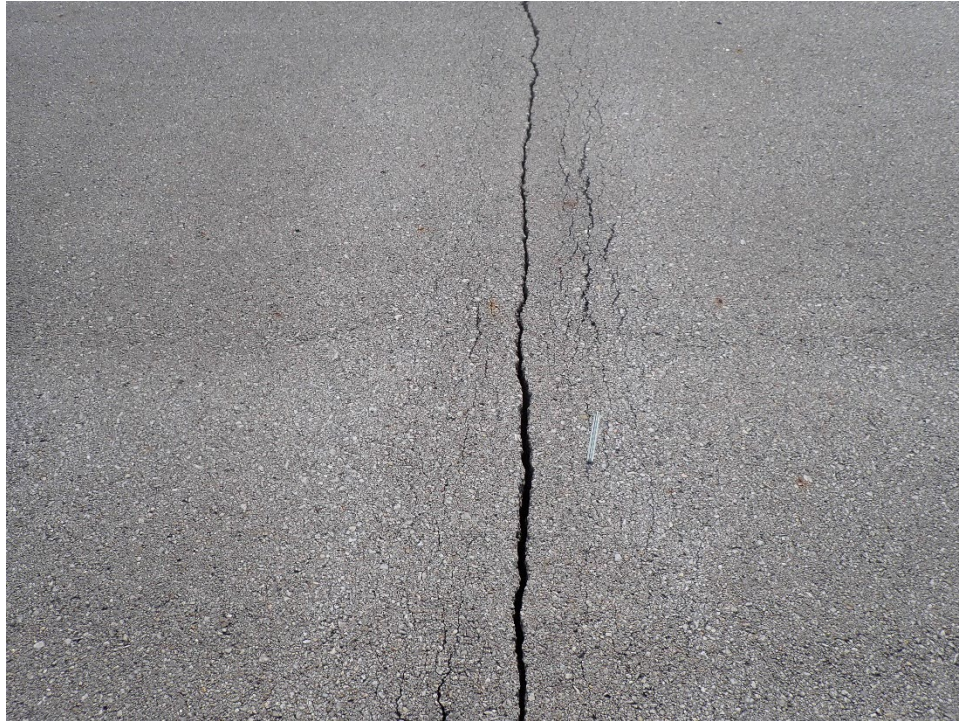
T03NE-01. L&T Cracking (Sample Unit No. 01).

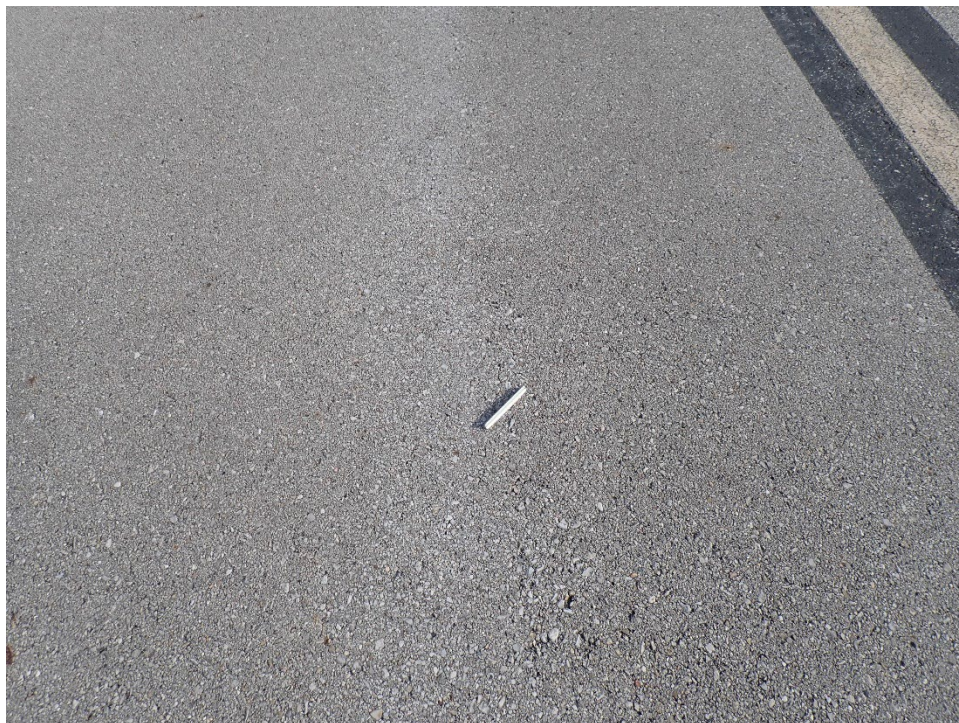
T03NE-01. Weathering (Sample Unit No. 01).

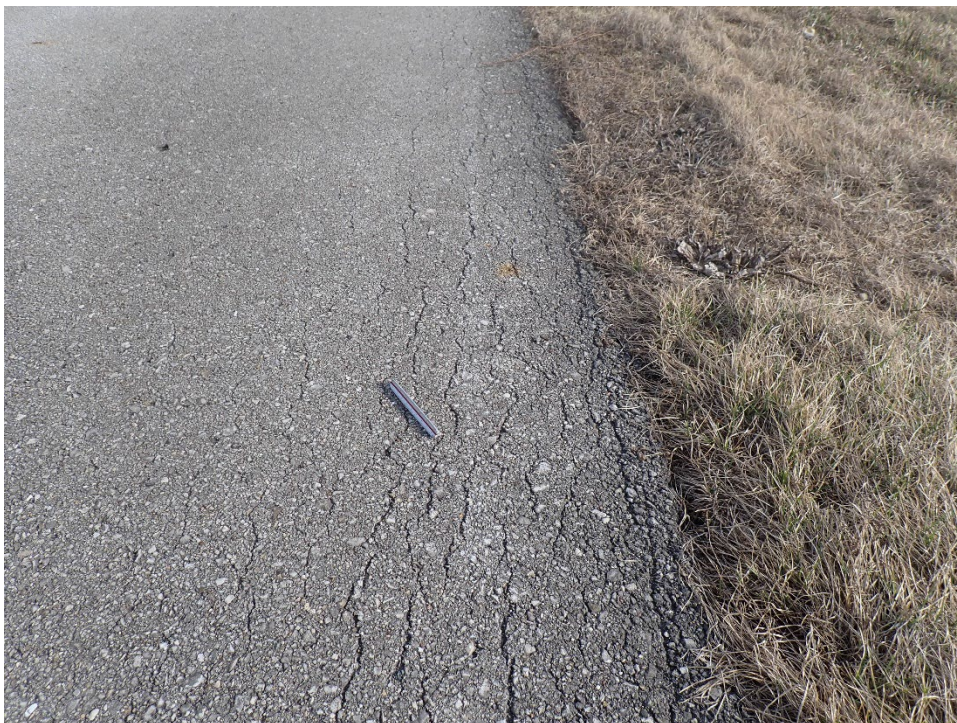
Taxiway 05 was defined by one section with low-severity alligator cracking, all severities of L&T cracking, and low- and medium-severity weathering. The low-severity L&T cracking was unsealed, while the medium-severity L&T cracking was recorded where either unsealed crack widths exceeded 1/4 inch, crack sealant was no longer preventing water from penetrating into underlying pavement layers, or secondary cracking had developed. The high-severity L&T cracking was due to secondary cracking that was wider than 1 foot.

T05NE-01. Alligator Cracking (Sample Unit No. 10).

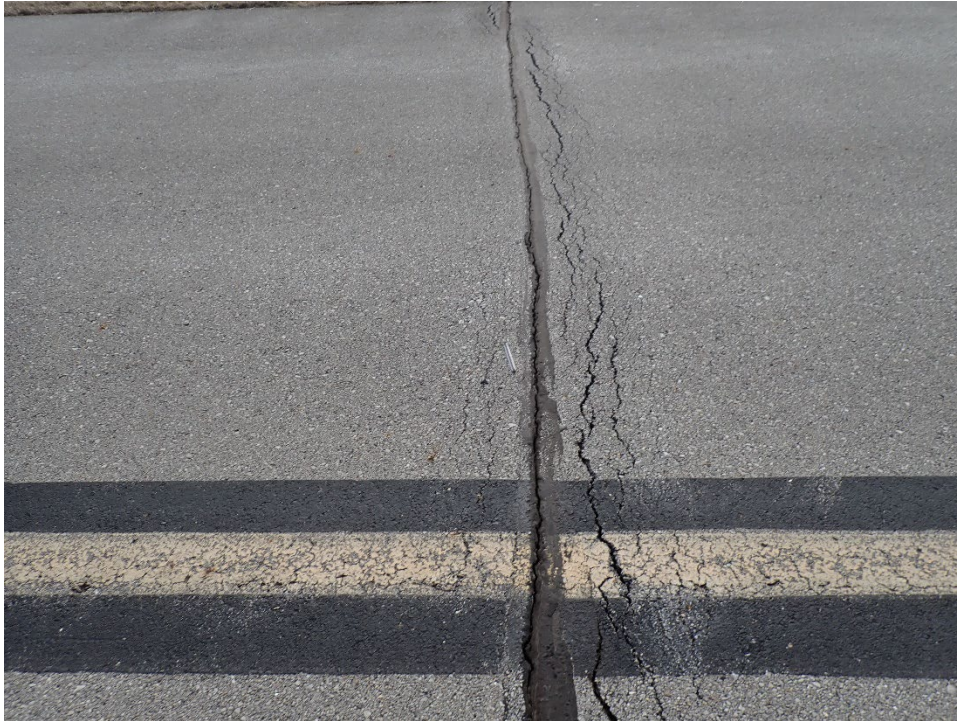
T05NE-01. L&T Cracking (Sample Unit No. 20).

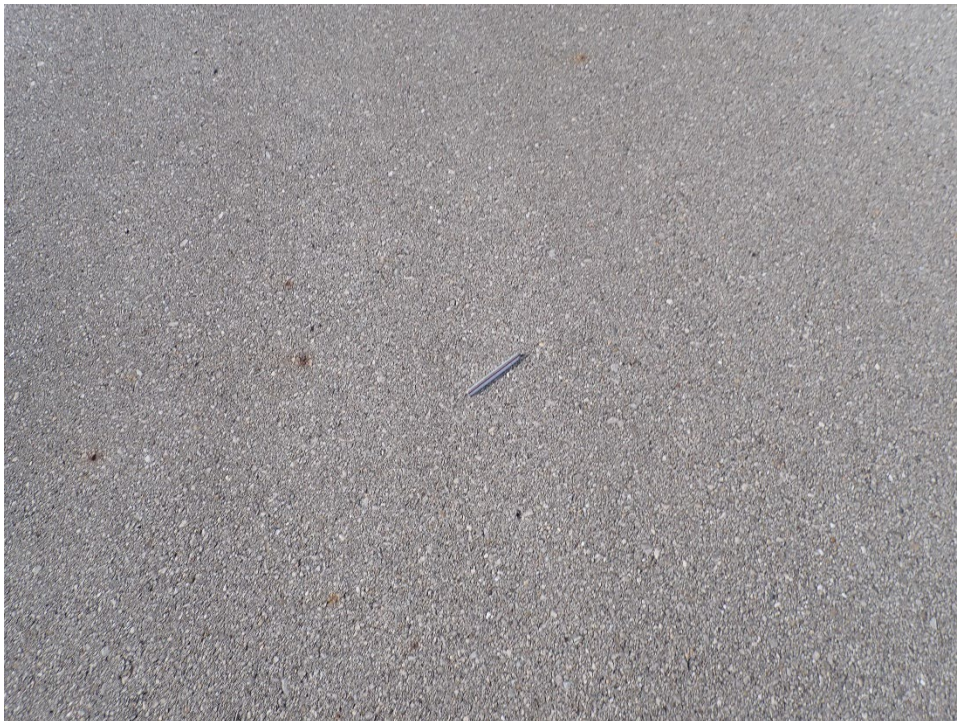
T05NE-01. Weathering (Sample Unit No. 20).

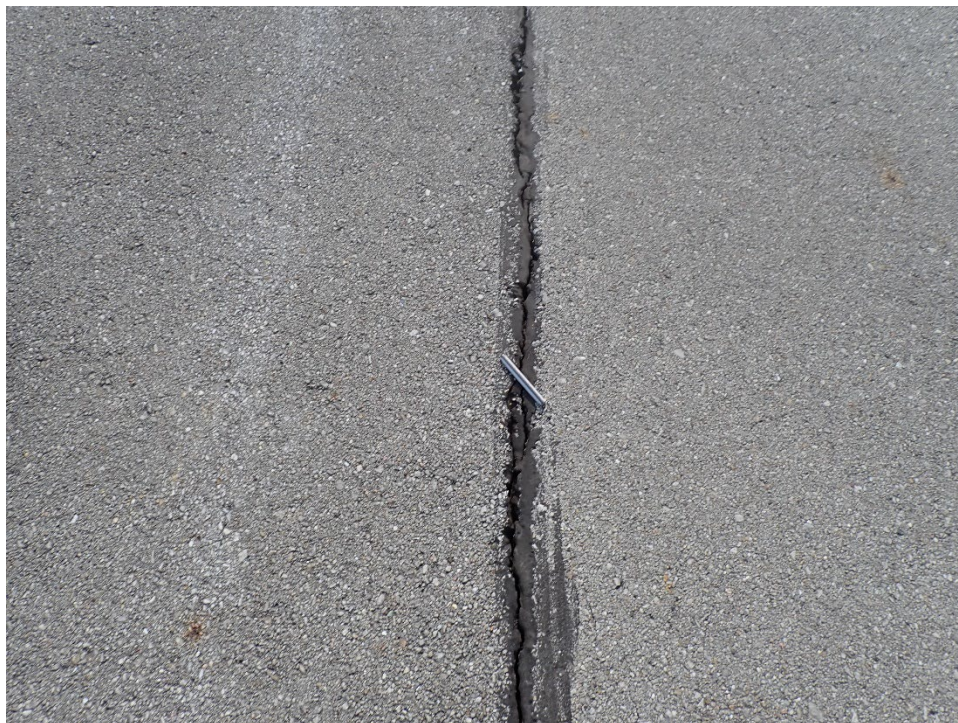
Taxiway 06 consisted of one section. In Section 01, areas of all severities of L&T cracking, medium-severity weathering, and low-severity alligator cracking that was located at the edge of the pavement were observed. The low-severity L&T cracking was unsealed, and the medium-severity L&T cracking was due to either unsealed crack widths that exceeded 1/4 inch, unsatisfactory crack sealant, or the development of secondary cracking. High-severity L&T cracking was identified where the secondary cracking pattern was greater than 1 foot.

T06NE-01. L&T Cracking (Sample Unit No. 01).

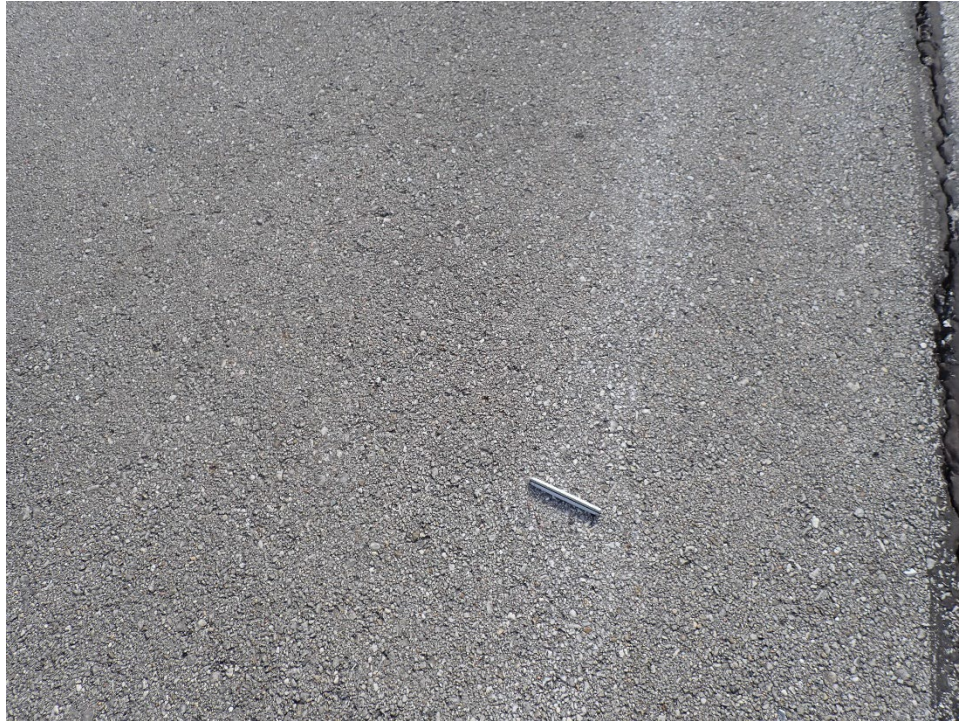
T06NE-01. Weathering (Sample Unit No. 01).

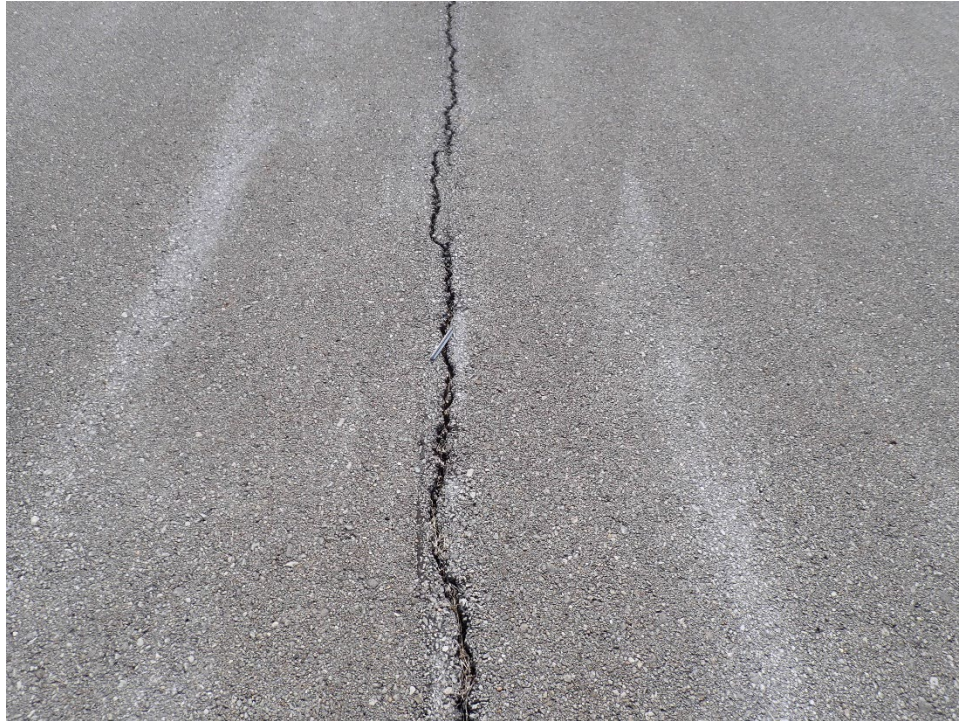
Taxiway 07 contained one section that had areas of medium-severity weathering and all severities of L&T cracking noted at the time of inspection. The low-severity L&T cracking was unsealed, and the medium-severity L&T cracking was recorded where either unsealed crack widths exceeded 1/4 inch or secondary cracking had developed. In addition, small areas of

T07NE-01. L&T Cracking (Sample Unit No. 01).

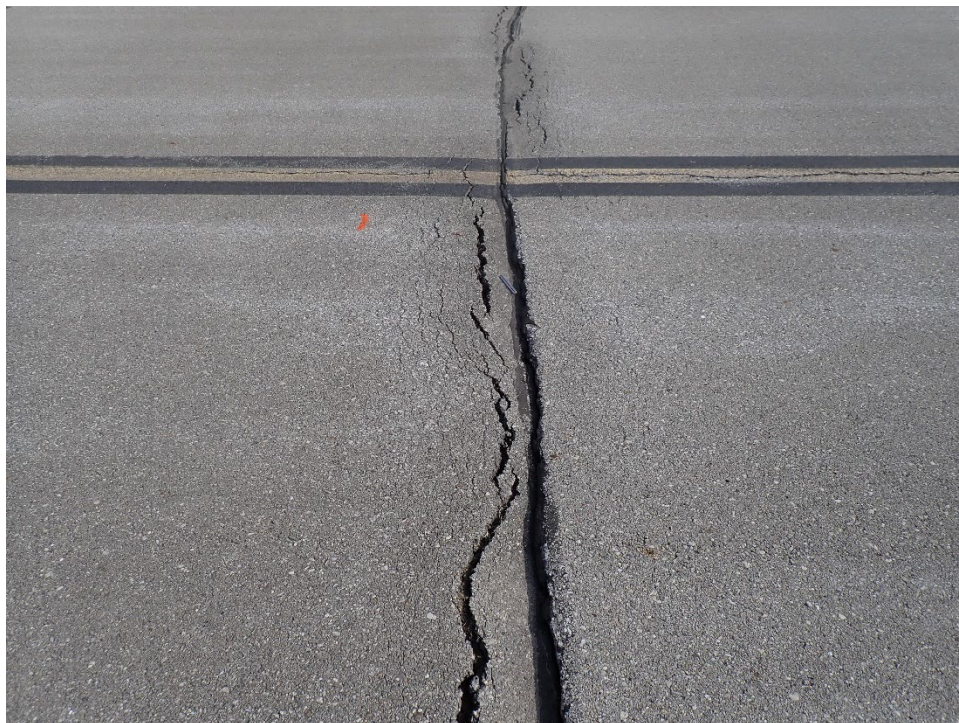
T07NE-01. L&T Cracking (Sample Unit No. 02).

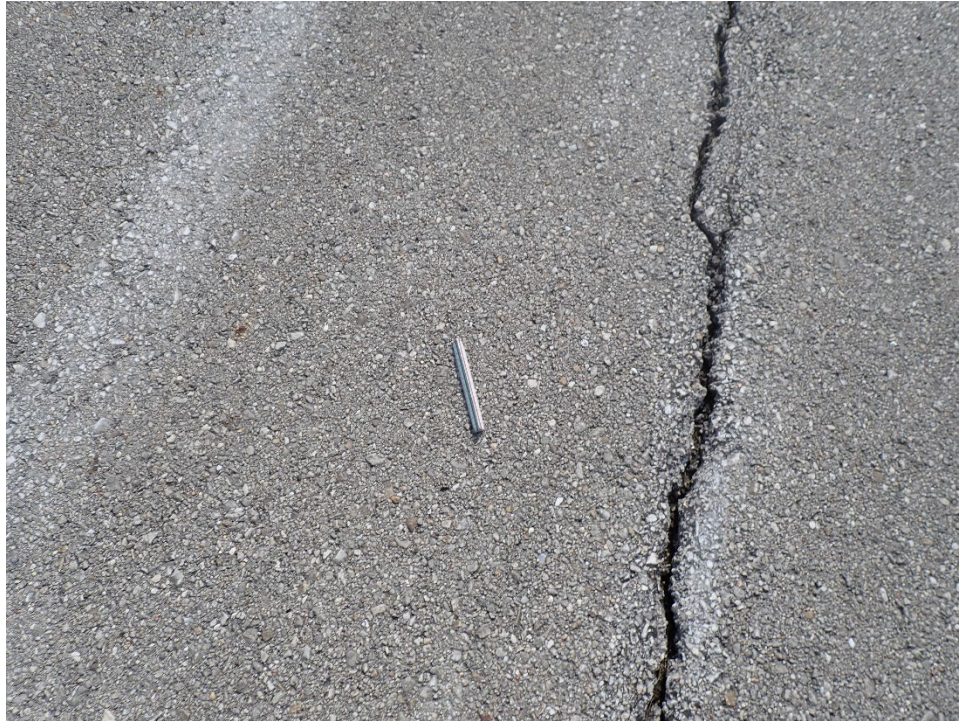
T07NE-01. Weathering (Sample Unit No. 01).

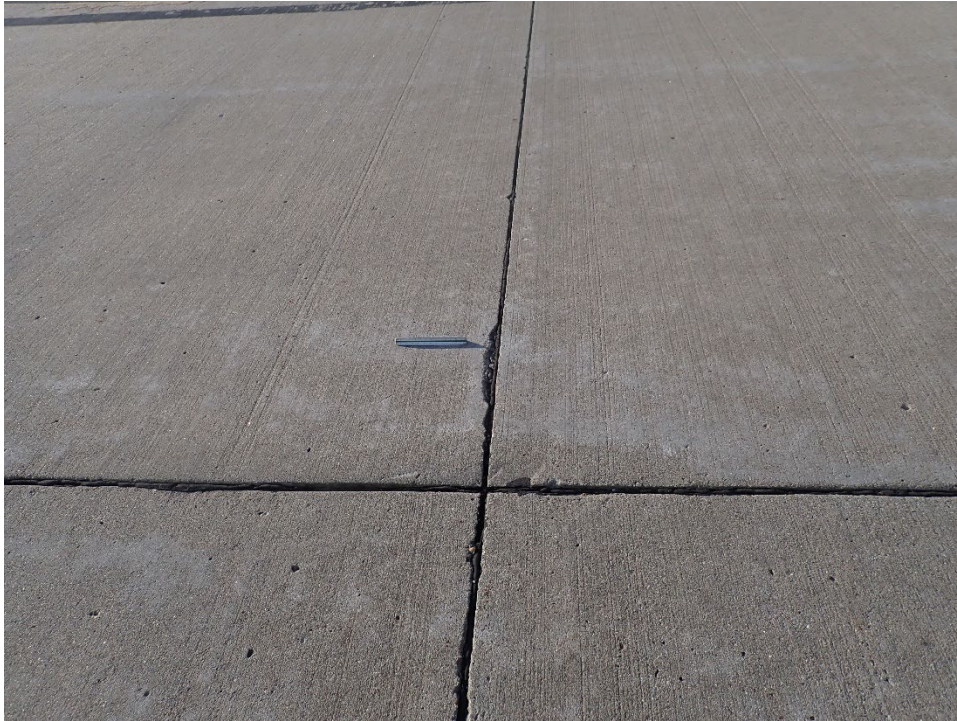
Taxiway 08 was defined by two sections. Low-severity corner spalling, high-severity joint seal damage, medium-severity joint spalling, and shrinkage cracking were recorded in Section 01. In Section 02, high-severity joint seal damage was observed throughout along with small amounts of low-severity longitudinal, transverse, diagonal (LTD) cracking.

T08NE-01. Joint Seal Damage (Sample Unit No. 01).
