# Newton Municipal Airport - Earl Johnson Field

## Pavement Management Report

**AUGUST 2025**

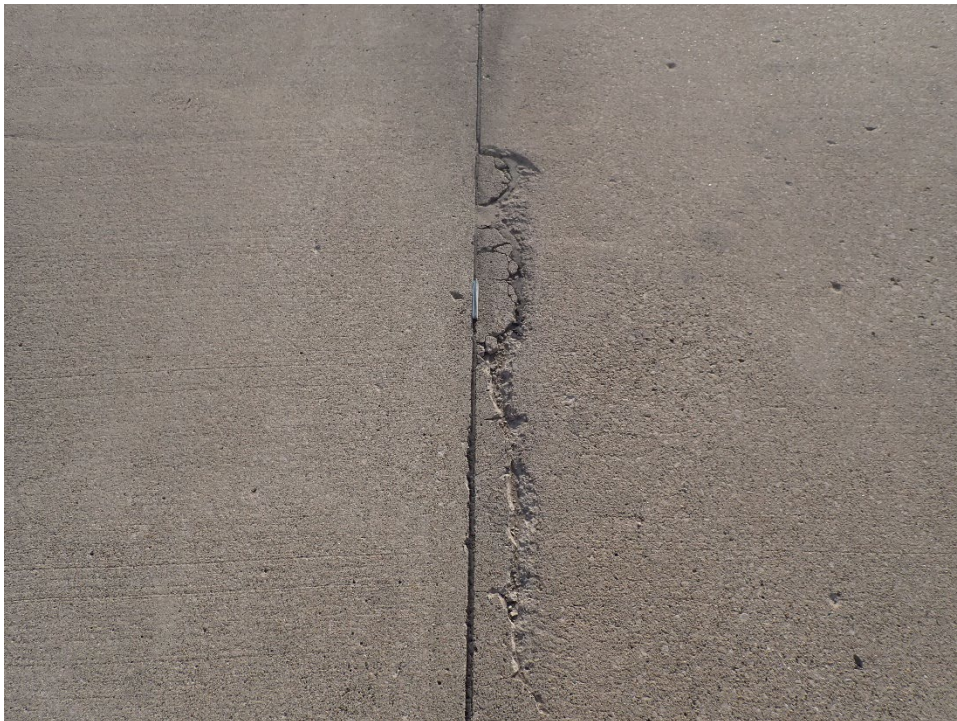
T08NE-01. Joint Spalling (Sample Unit No. 01).

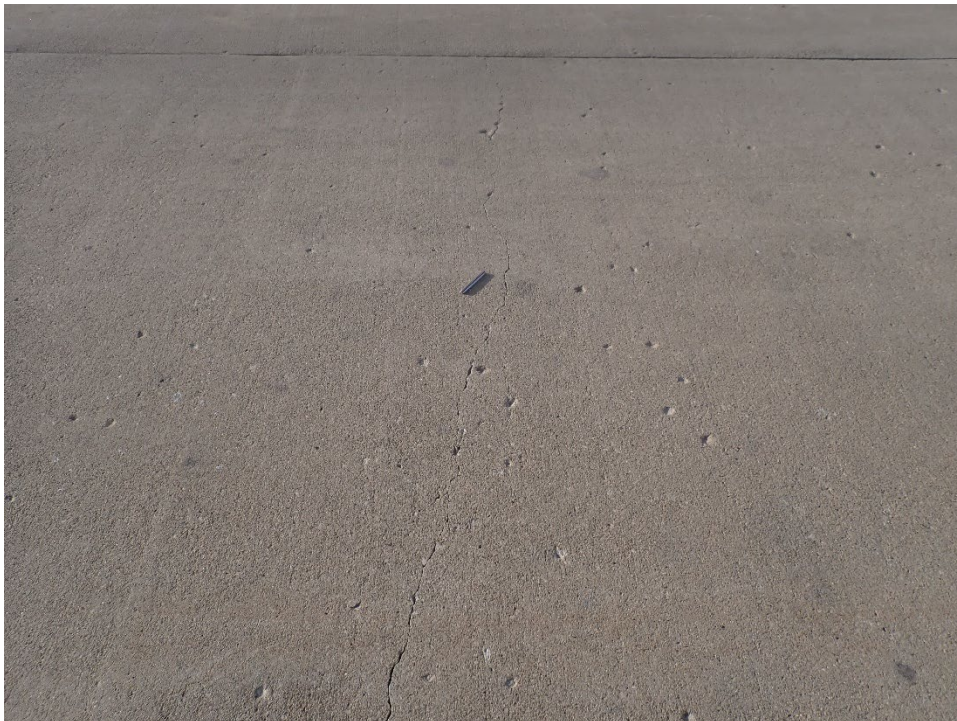
T08NE-02. LTD Cracking (Sample Unit No. 01).

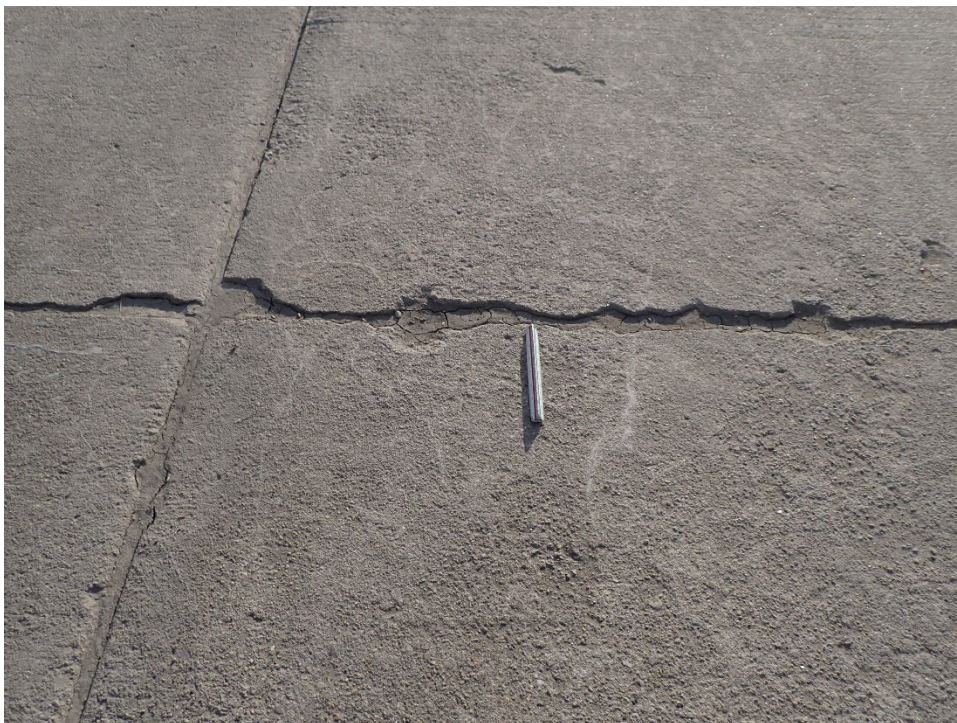
T-hangar 01 contained one section. Various distresses were recorded, including low-severity ASR; medium- and high-severity corner spalling and joint spalling; high-severity joint seal damage; and low- and medium-severity large patching and LTD cracking.

TH01NE-01. ASR (Sample Unit No. 03).

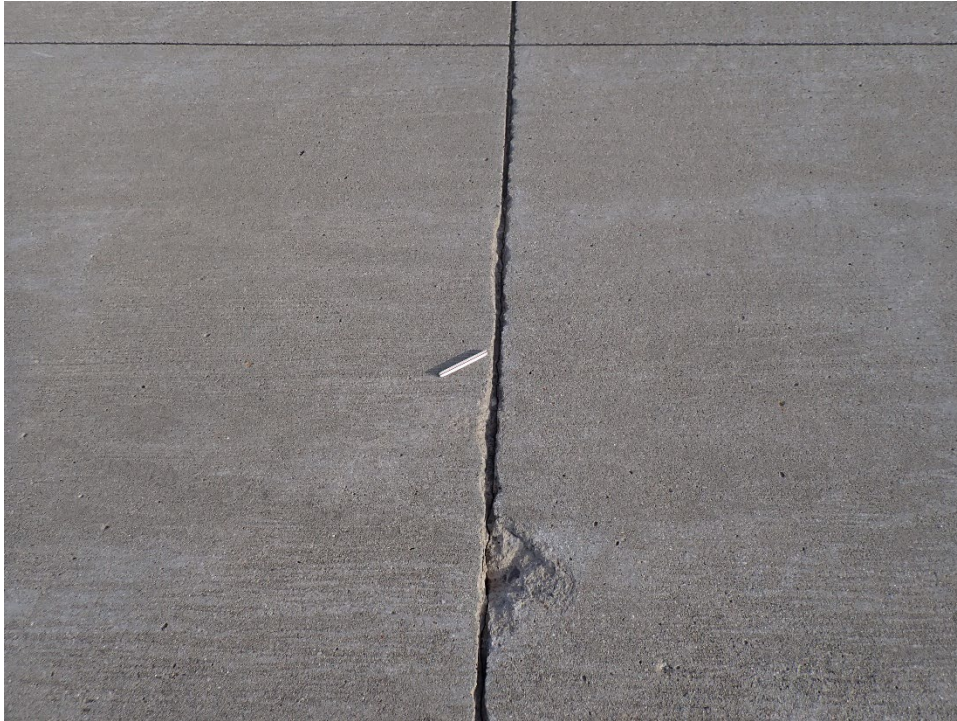
TH01NE-01. Joint Spalling (Sample Unit No. 03).

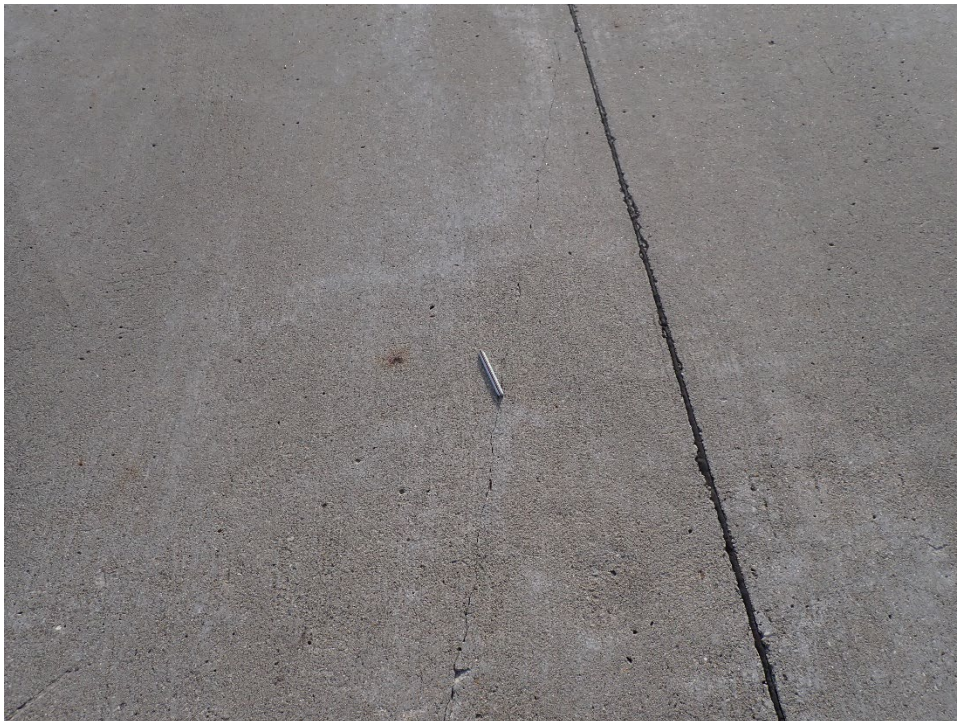
TH01NE-01. LTD Cracking (Sample Unit No. 03).

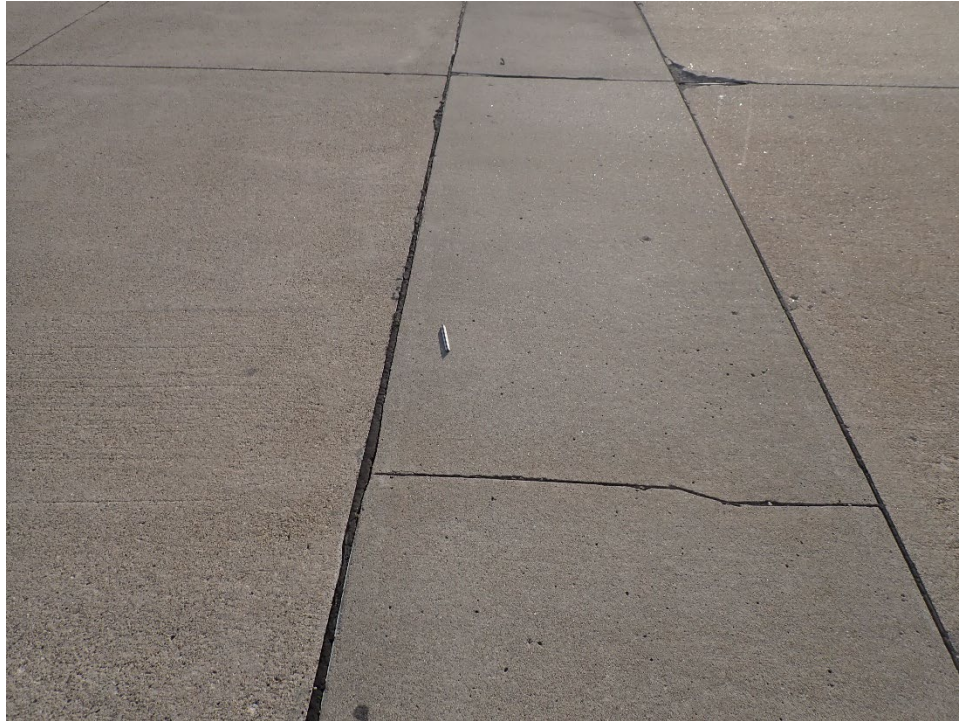
TH01NE-01. Large Patching (Sample Unit No. 03).

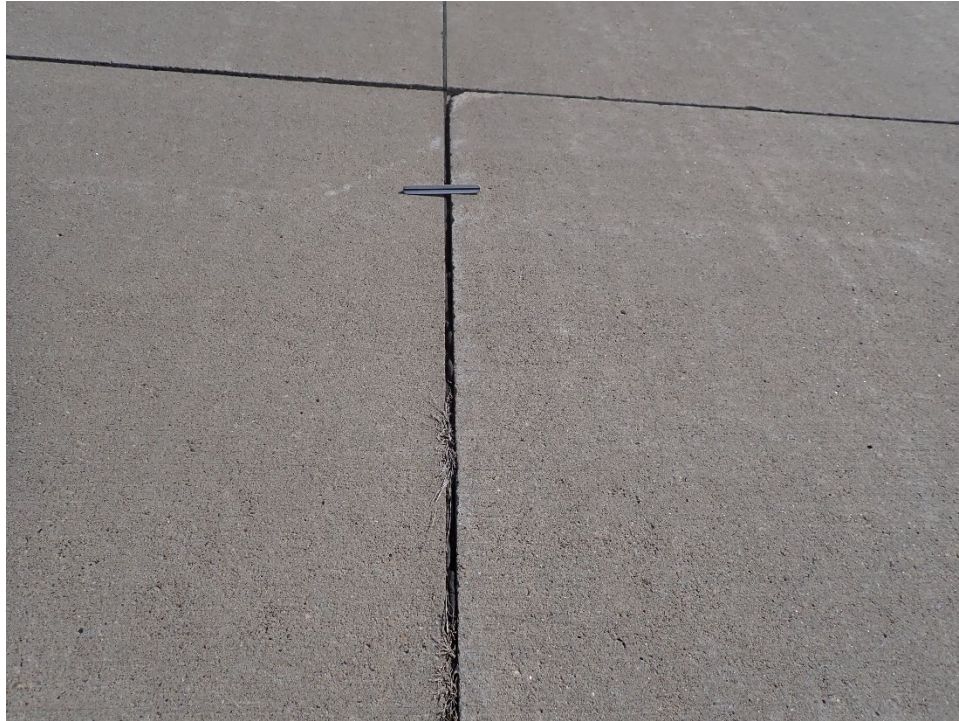
T-hangar 02 was defined by one section with low-severity faulting, high-severity joint seal damage, and low- and medium-severity LTD cracking.

TH02NE-01. Faulting (Sample Unit No. 04).

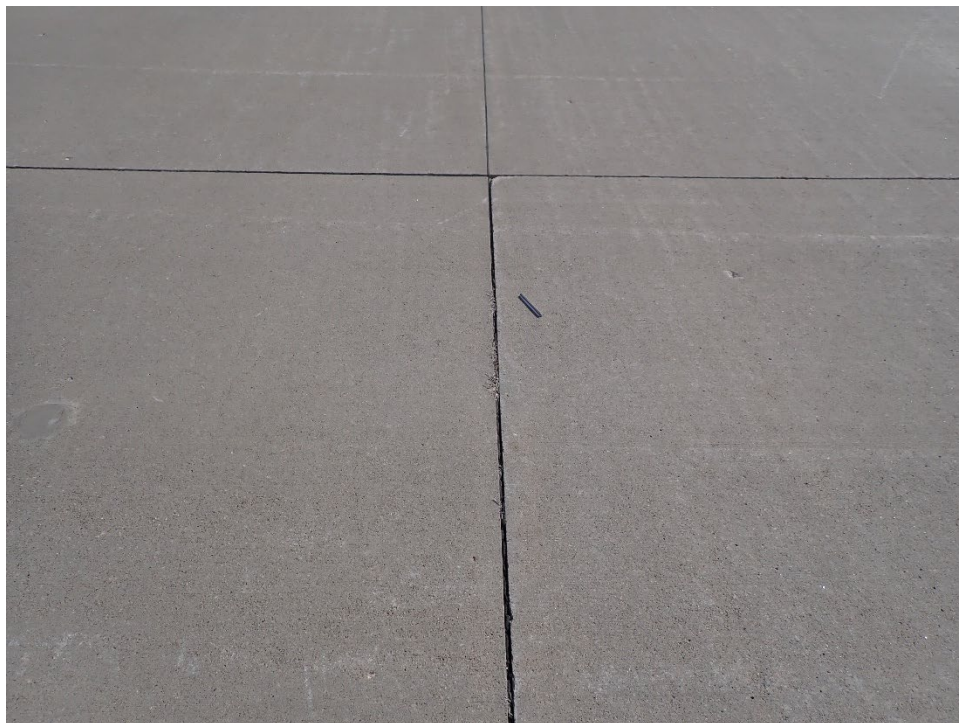
TH02NE-01. Joint Seal Damage (Sample Unit No. 04).

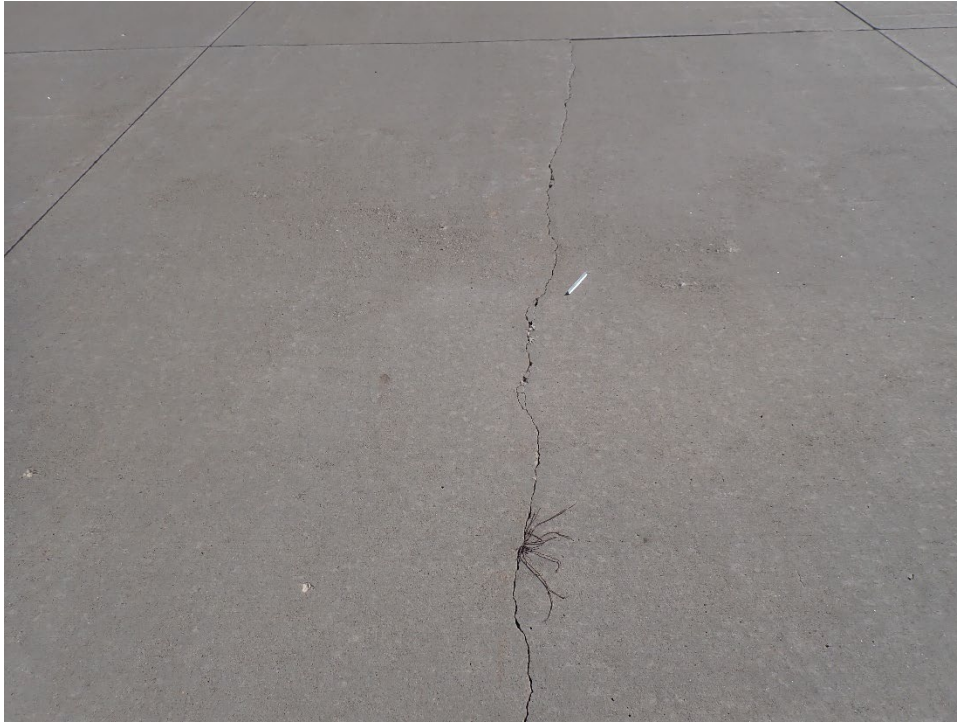
TH02NE-01. LTD Cracking (Sample Unit No. 04).

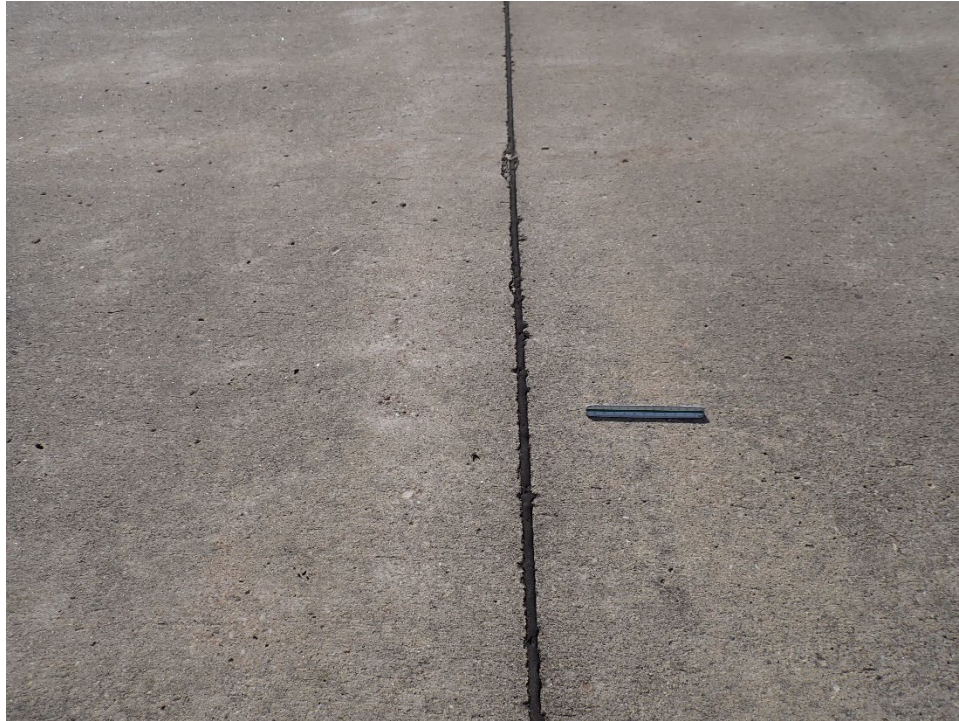
T-hangar 03 consisted of one section with low-severity faulting and small patching, medium- and high-severity joint seal damage, all severities of joint spalling, and shrinkage cracking.

TH03NE-01. Joint Seal Damage (Sample Unit No. 02).

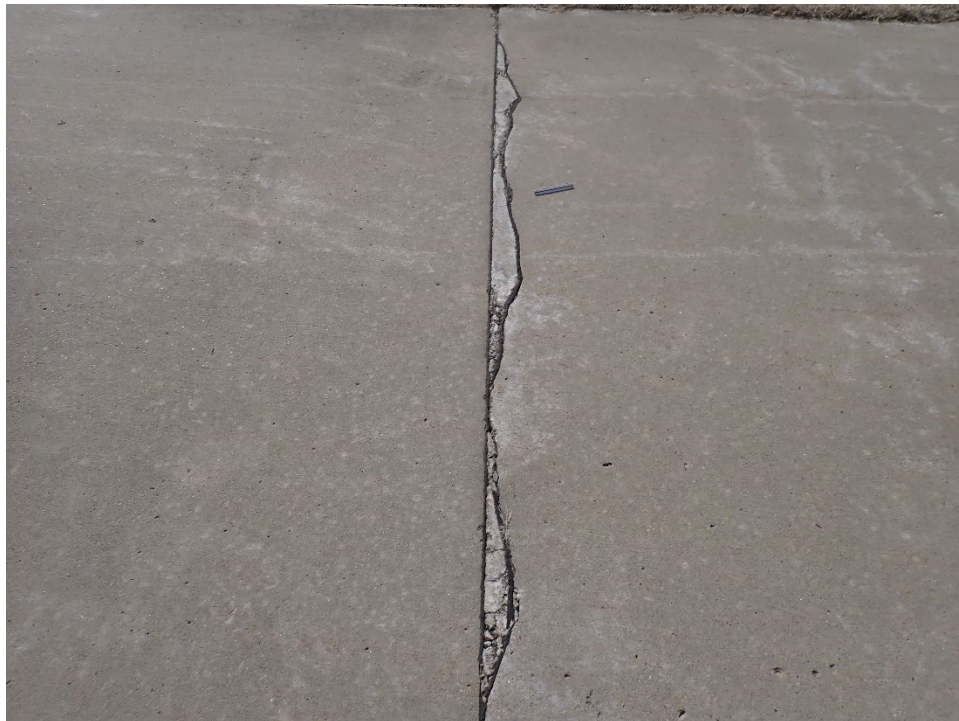
TH03NE-01. Joint Spalling (Sample Unit No. 09).
