# Northeast Iowa Regional Airport

## Pavement Management Report

**AUGUST 2026**

# NORTHEAST IOWA REGIONAL AIRPORT PAVEMENT MANAGEMENT REPORT

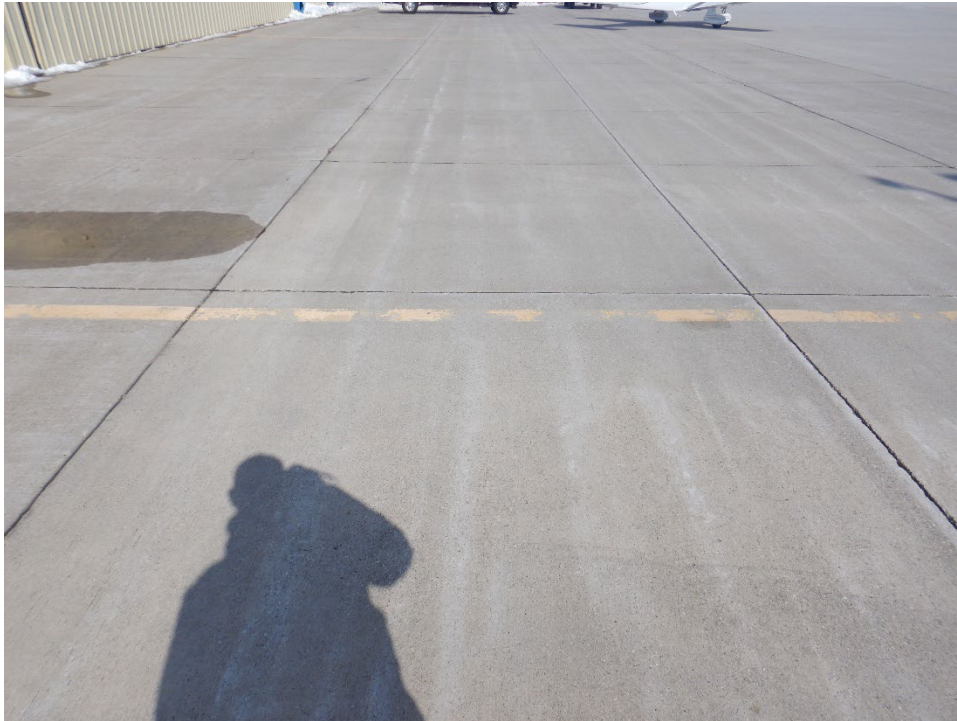
A01CC-01. Overview.

Apron 01 consisted of one section. Low- and medium-severity corner break and joint spalling, medium-severity corner spalling and LTD cracking, low-severity faulting and small patching, and high-severity joint seal damage were identified in Section 01.

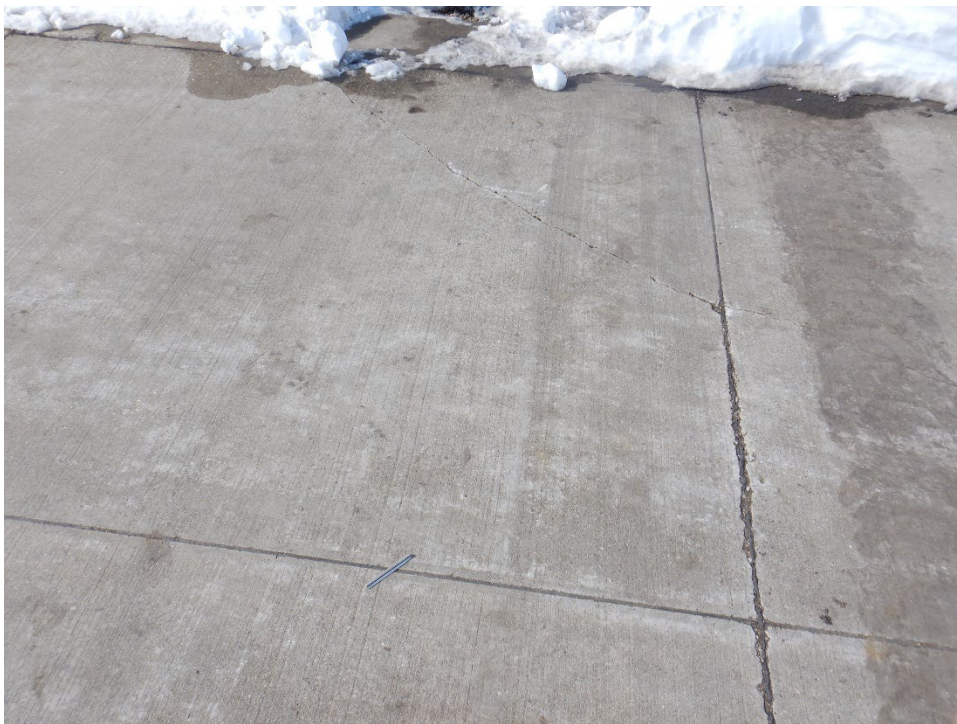
A01CC-01. Corner Break (Sample Unit No. 03).

| Branch | Section | Distress Type | Severity | Distress Quantity | Distress Unit | Maintenance Action | Unit Cost | 2026 Estimated Cost |
|---|---|---|---|---|---|---|---|---|
| A01CC | 01 | Corner Break | Low | 1 | Slabs | Crack Sealing - PCC | \$3.35 | \$39 |

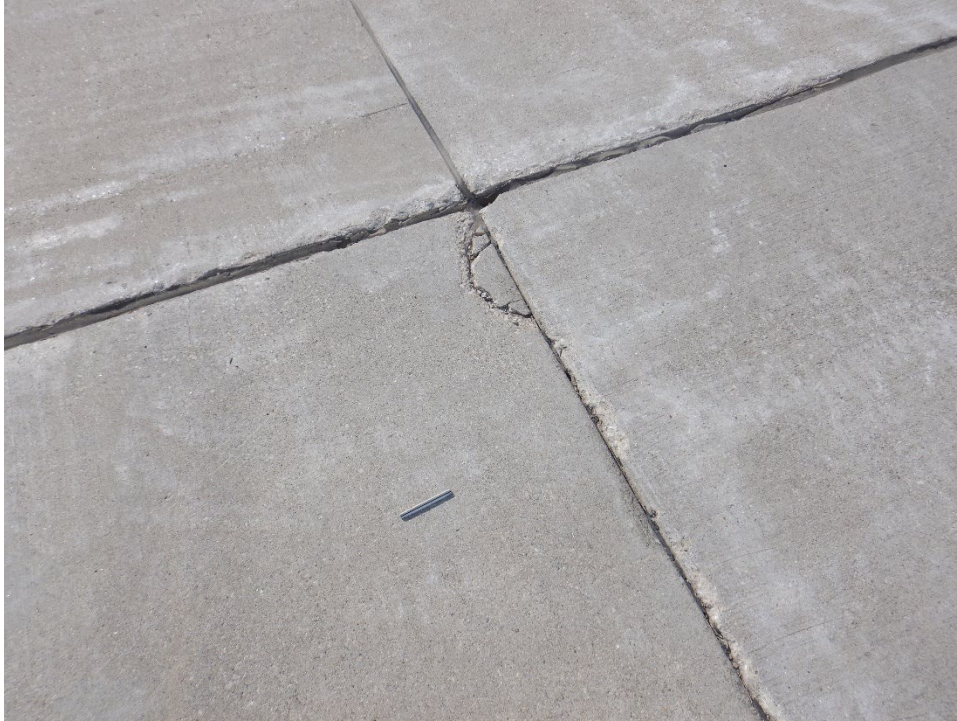
| <b>Distress Type</b> | <b>Probable Cause of Distress</b> |
|---|---|
| Spalling<br>(Joint and Corner) | Excessive stresses at the joint caused by infiltration of incompressible materials or traffic loads; weak concrete at the joint combined with traffic loads. |

A01CC-01. Joint Spalling (Sample Unit No. 01).

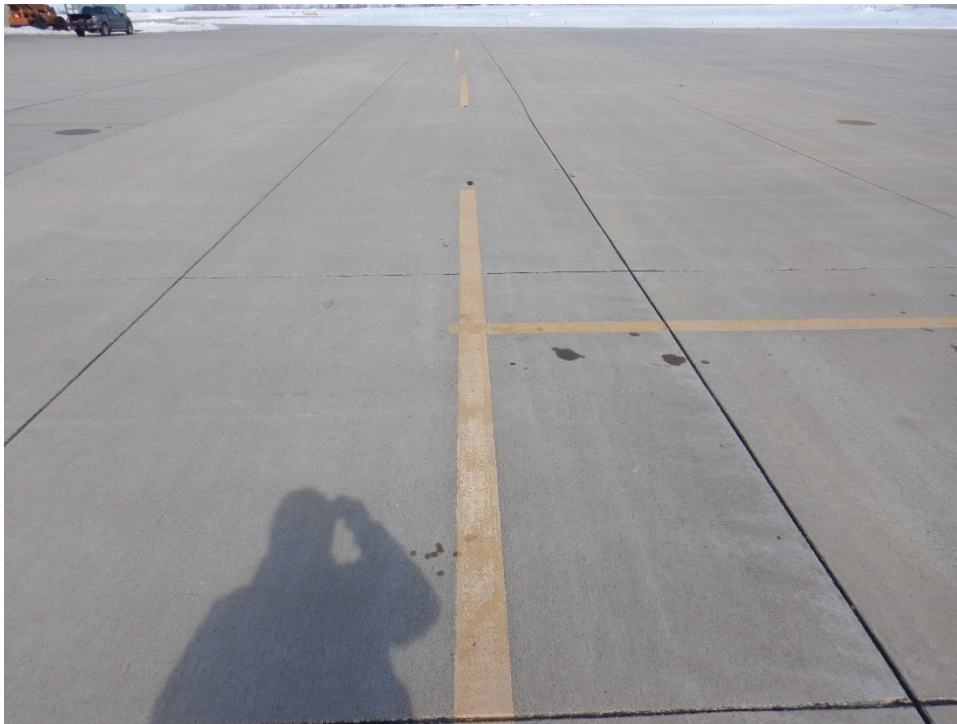
A03CC-01. Overview.

Apron 03 contained one section. Section 01 had low-severity corner break, faulting, joint spalling, and LTD cracking; medium-severity joint seal damage; and shrinkage cracking recorded during the inspection.

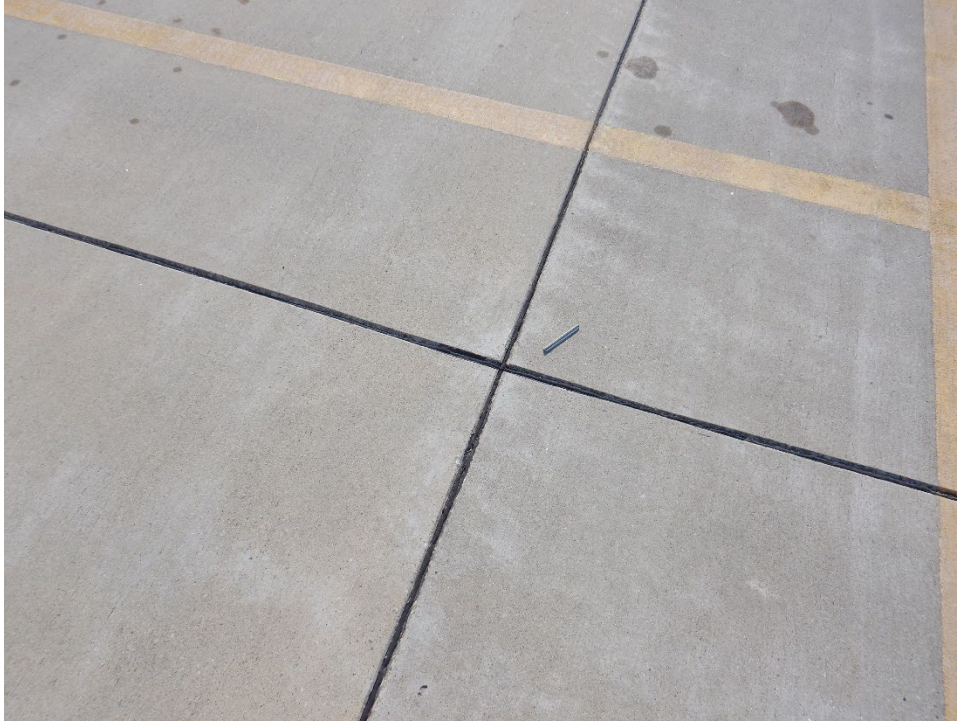
| <b>Distress Type</b> | <b>Probable Cause of Distress</b> |
|---|---|
| Joint Seal Damage | Stripping of joint sealant, extrusion of joint sealant, weed growth, hardening of the filler (oxidation), loss of bond to the slab edges, or absence of sealant in the joint. |

A03CC-01. Joint Seal Damage (Sample Unit No. 07).

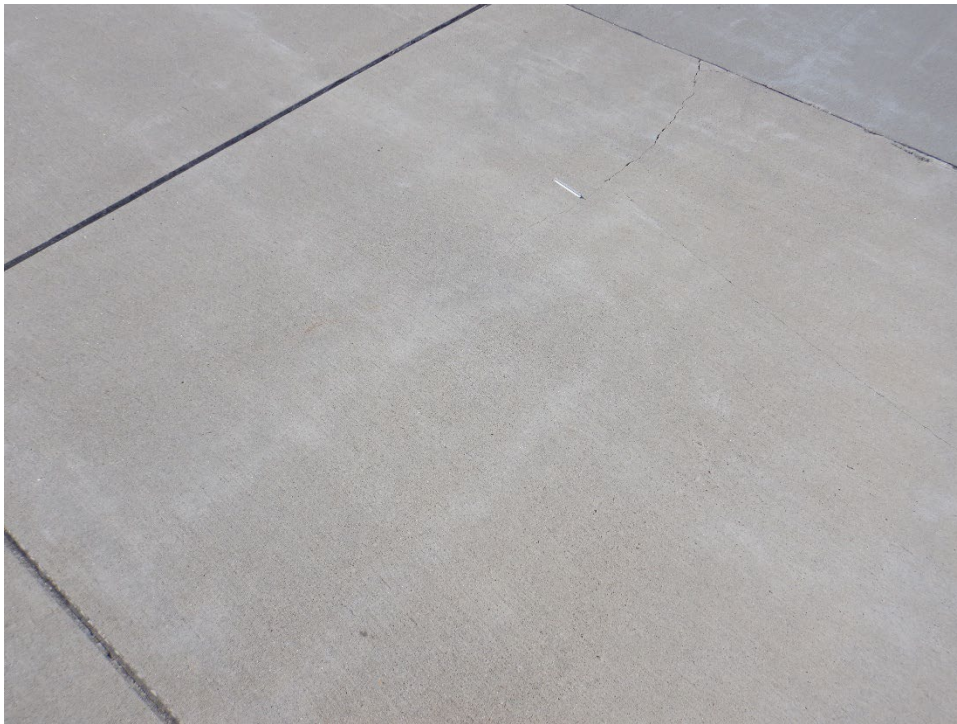
| <b>Distress Type</b> | <b>Probable Cause of Distress</b> |
|---|---|
| LTD Cracking | Combination of load repetition, curling stresses, and shrinkage stresses. |

A03CC-01. LTD Cracking (Sample Unit No. 07).

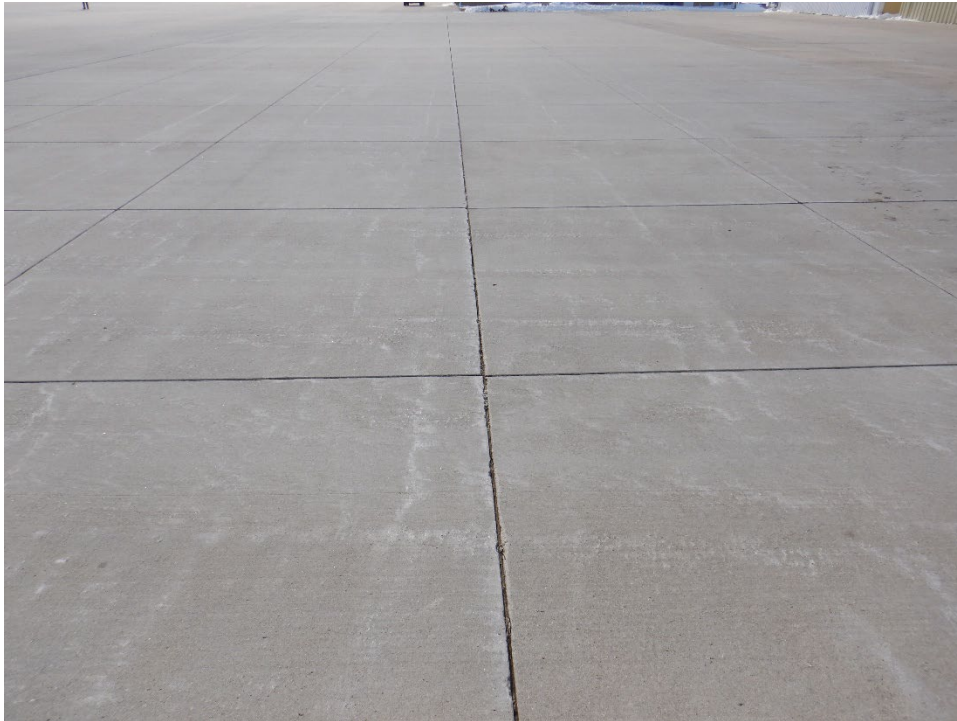
A04CC-01. Overview.

Apron 04 was defined by one section. Low- and medium-severity LTD cracking and low-severity corner break, faulting, joint spalling and joint seal damage were observed in Section 01.

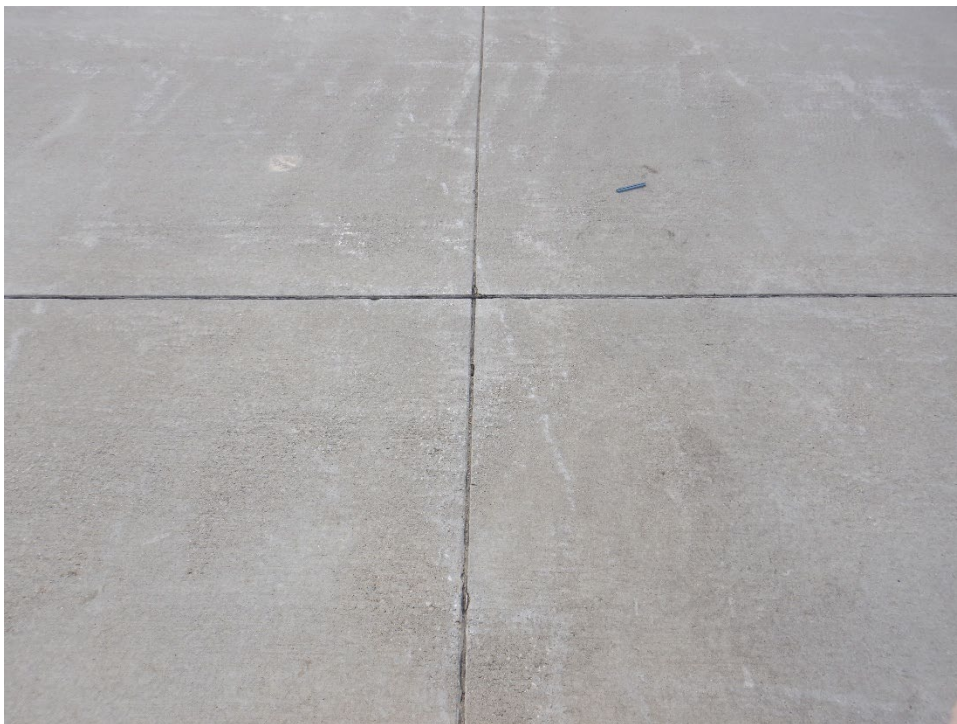
A04CC-01. Joint Seal Damage (Sample Unit No. 10).

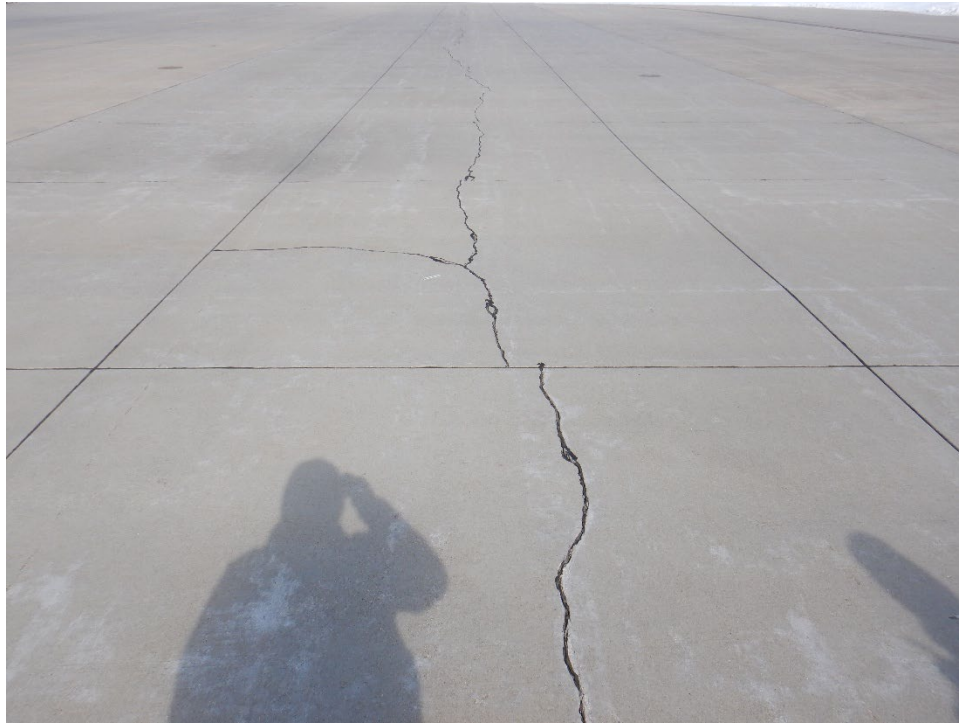
A04CC-01. LTD Cracking (Sample Unit No. 14).

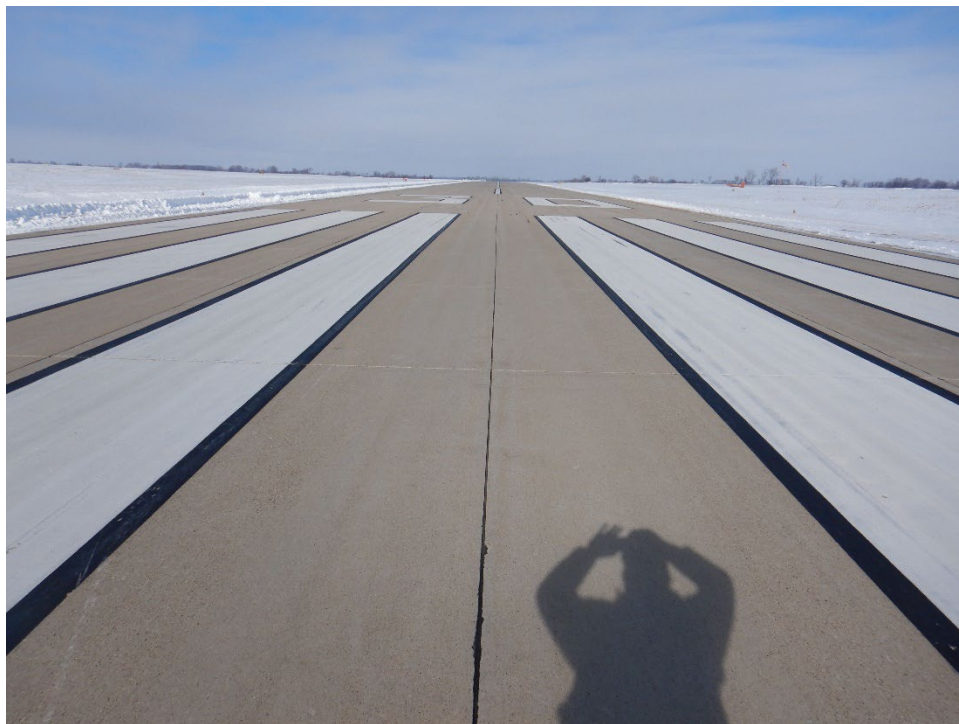
R12CC-01. Overview.

Runway 12/30 consisted of one section. Section 01 was in *Excellent* condition with areas of medium-severity corner and joint spalling and low-severity corner break, faulting, joint seal damage, and small patching.

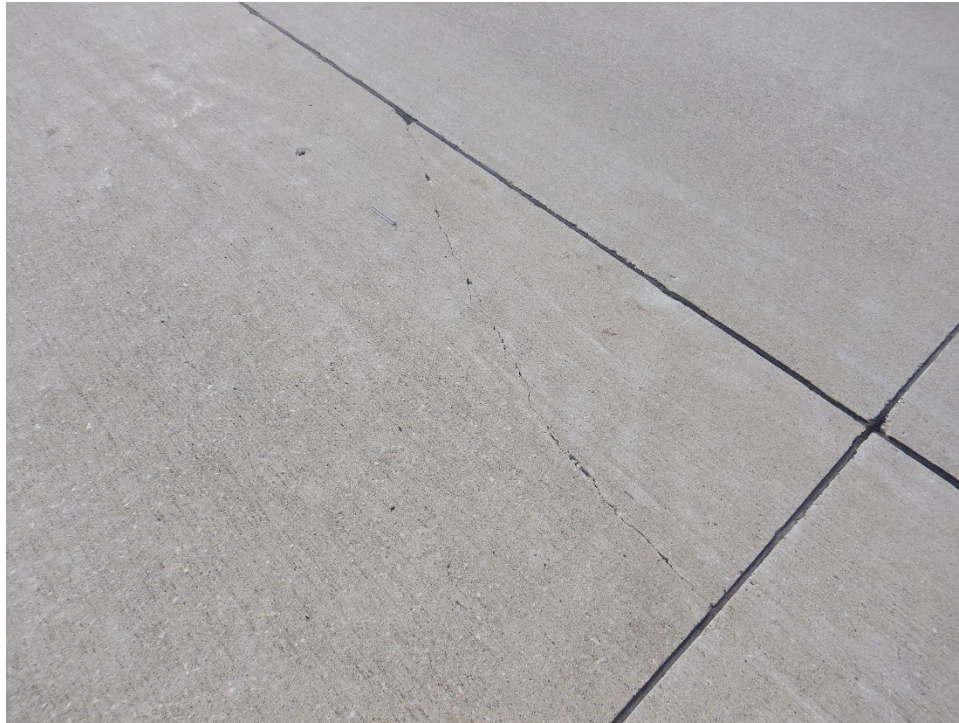
R12CC-01. Corner Break (Sample Unit No. 20).

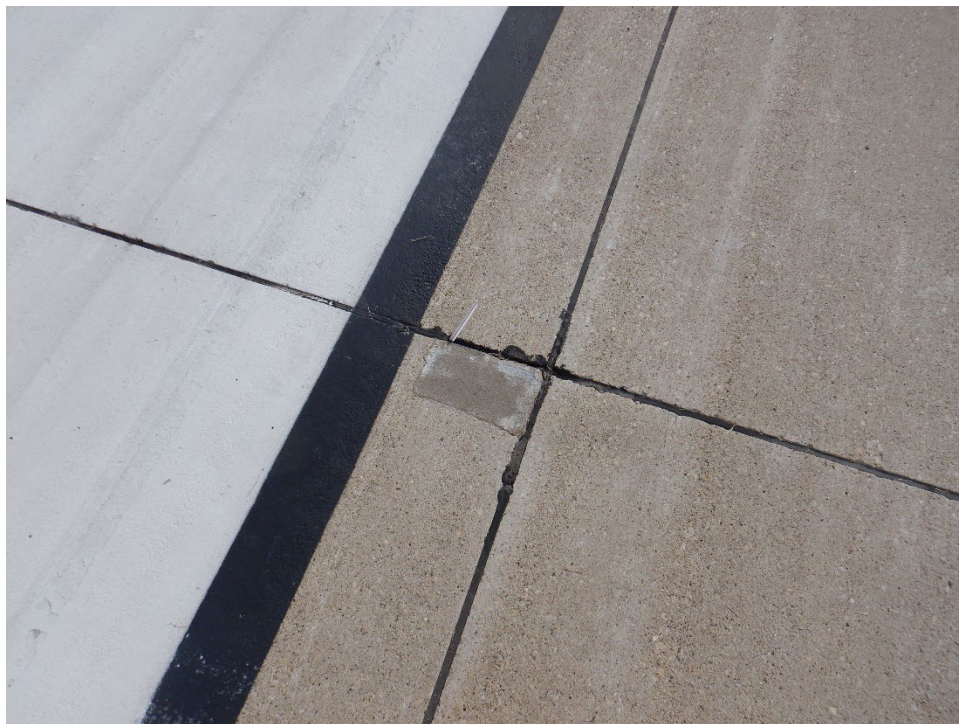
R12CC-01. Small Patching (Sample Unit No. 67).

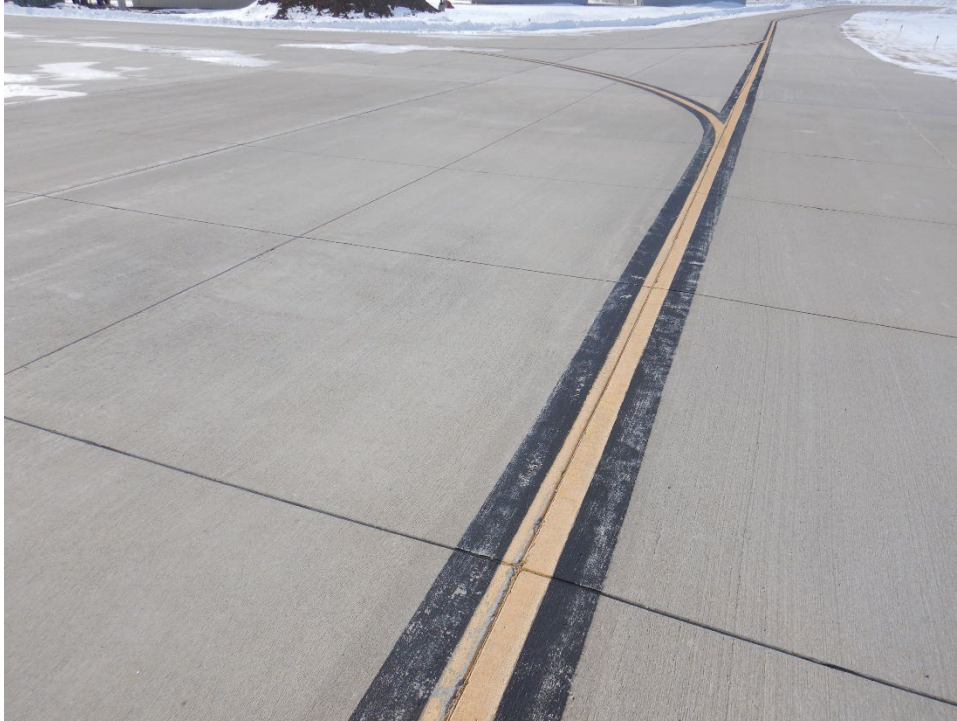
T03CC-01. Overview.

Taxiway 03 was defined by one section in *Excellent* condition with medium-severity corner spalling and low-severity longitudinal, transverse, and diagonal (LTD) cracking identified during the inspection.

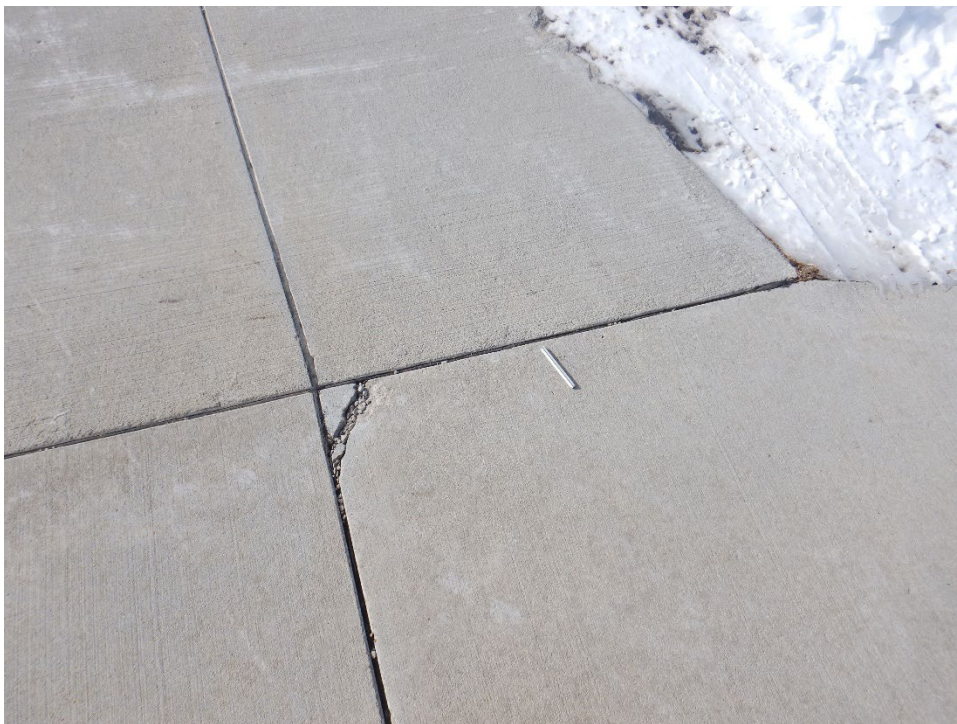
T03CC-01. Corner Spalling (Sample Unit No. 02).

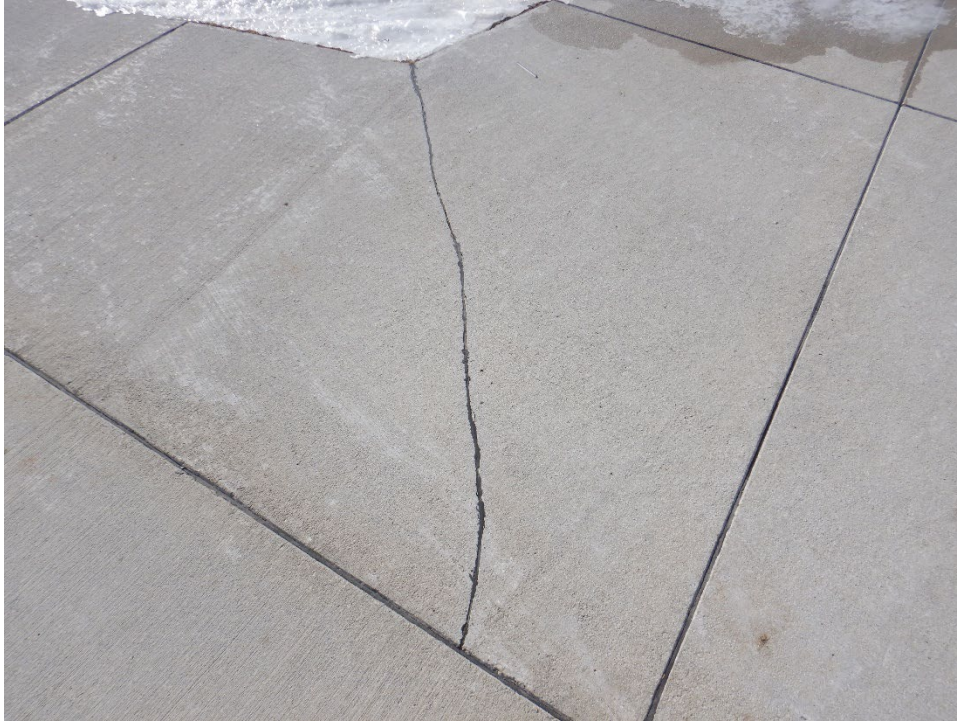
T03CC-01. LTD Cracking (Sample Unit No. 25).

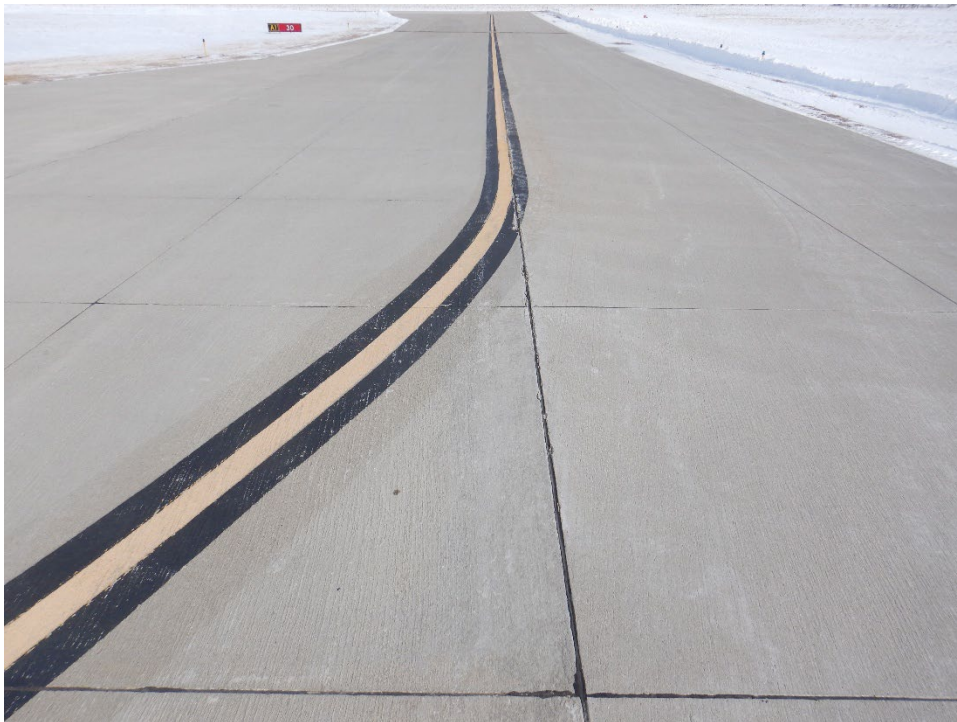
TA1CC-01. Overview.

Taxiway A1 consisted of one section. Section 01 was in *Excellent* condition with shrinkage cracking observed.

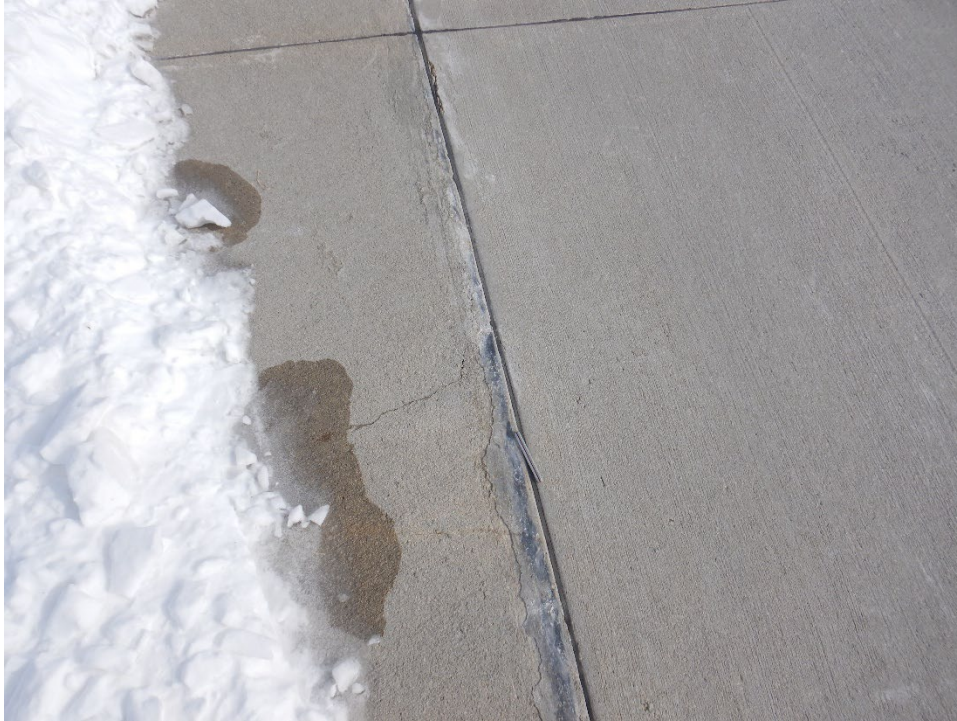
| <b>Distress Type</b> | <b>Probable Cause of Distress</b> |
|---|---|
| Shrinkage Cracking | Setting and curing of the concrete. |

TA1CC-01. Shrinkage Cracking (Sample Unit No. 02).

| <b>Distress Type</b> | <b>Severity Level</b> | <b>Maintenance Action</b> |
|---|---|---|
| Shrinkage Cracking | N/A | Monitor |

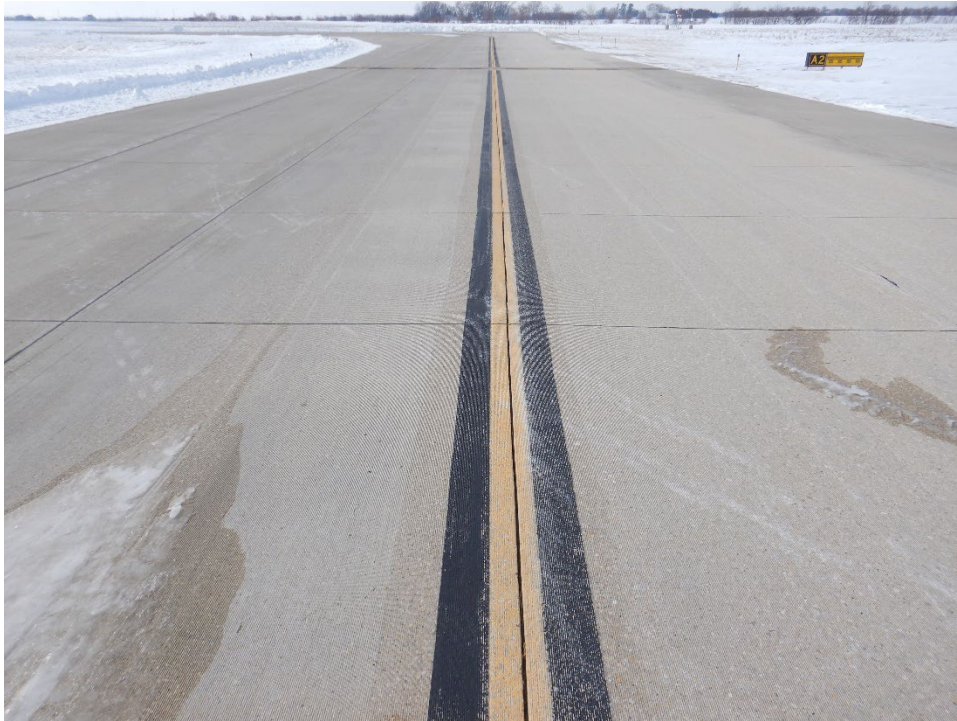
TA2CC-01. Overview.

Taxiway A2 was defined by one section in *Excellent* condition. Low-severity faulting and low- and medium-severity joint seal damage were recorded in Section 01.

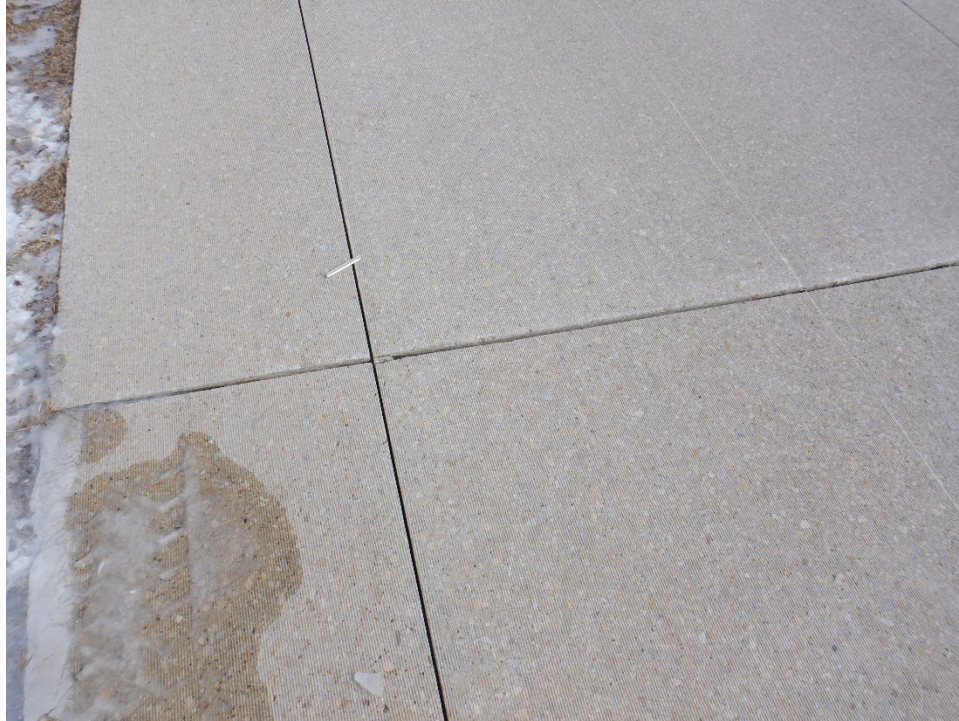
TA2CC-01. Joint Seal Damage (Sample Unit No. 09).

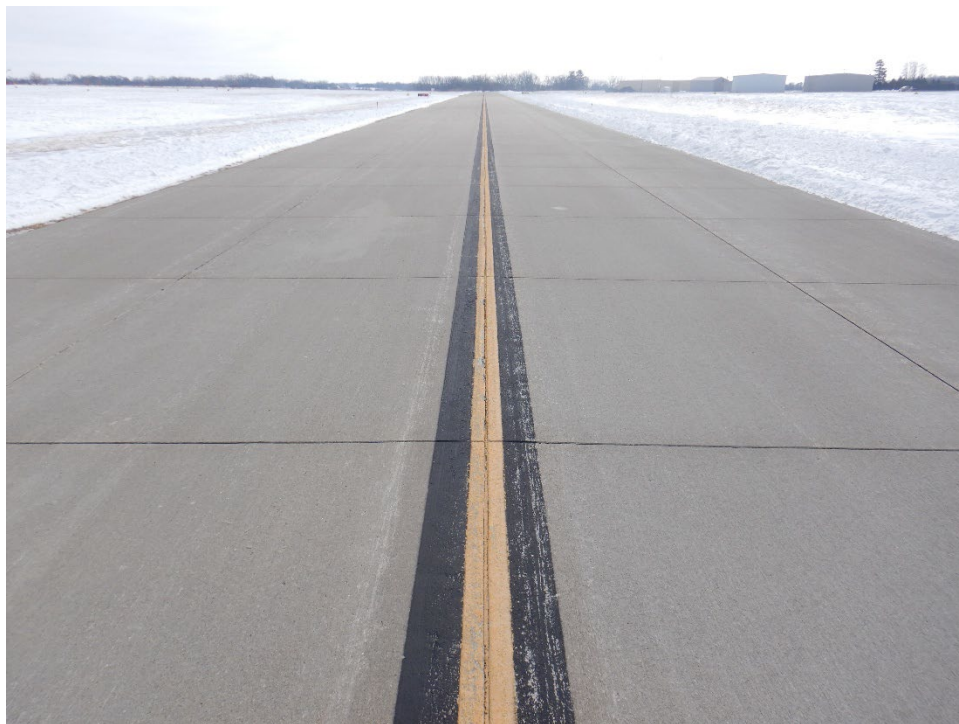
TACC-01. Overview.

Taxiway A contained one section that was in *Excellent* condition. No distress was noted at the time of inspection.

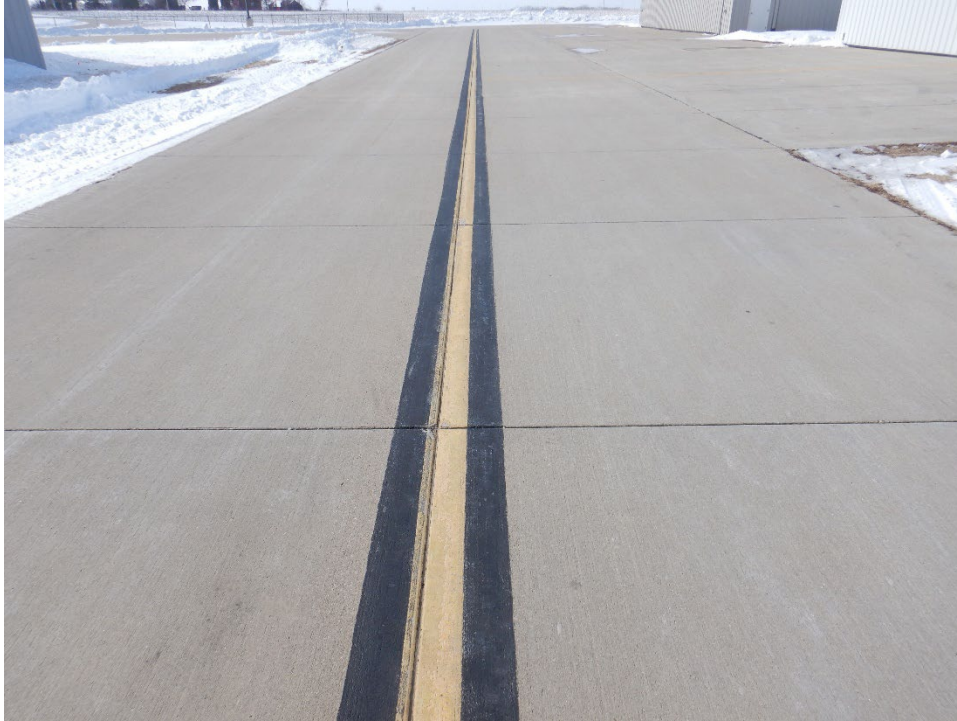
TH01CC-02. Overview.

The T-hangar area consisted of one section. Section 02 was in *Excellent* condition with low-severity corner break, corner spalling, joint seal damage, joint spalling, and small patching noted during the inspection.

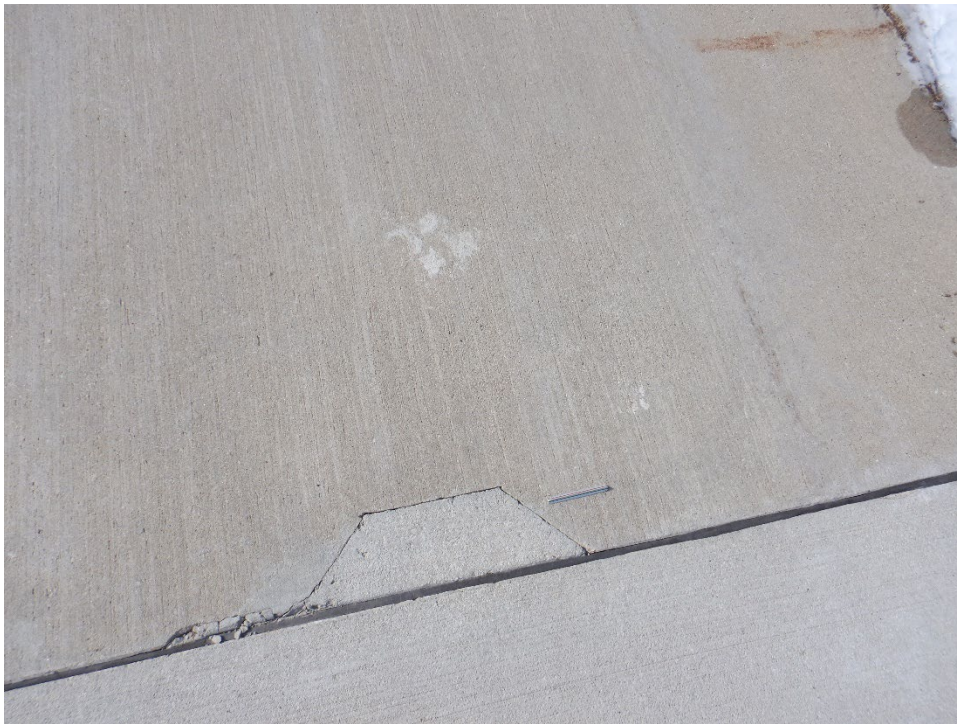
TH01CC-02. Small Patching (Sample Unit No. 01).
