# Oelwein Municipal Airport

## Pavement Management Report

# OELWEIN MUNICIPAL AIRPORT PAVEMENT MANAGEMENT REPORT

As part of this project, pavement conditions at Oelwein Municipal Airport were visually assessed in February 2026 using the Pavement Condition Index (PCI) procedure. During a PCI inspection, the types, severities, and amounts of distress present on the pavement surface are quantified. This information is then used to develop a composite index that represents the overall condition of the pavement in numerical terms, ranging from 0 (*Failed*) to 100 (*Excellent*). The PCI provides an overall measure of condition and an indication of the level of work that will be required to maintain or repair a pavement. The distress information also provides insight into what is causing the pavement to deteriorate, which is the first step in selecting the appropriate repair action to correct the problem.

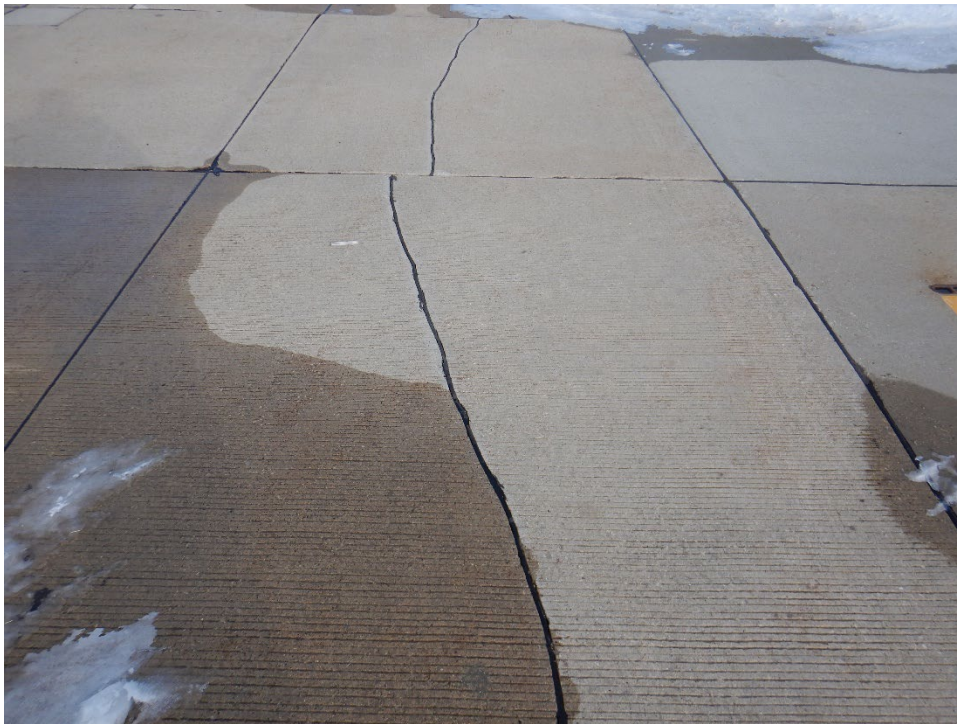
The apron area contained one section. Section 01 had areas of low-severity corner break, corner spalling, faulting, joint seal damage, joint spalling, large patching, and small patching; low- and medium-severity LTD cracking; and shrinkage cracking observed during the inspection.

A01OE-01. LTD Cracking (Sample Unit No. 19).

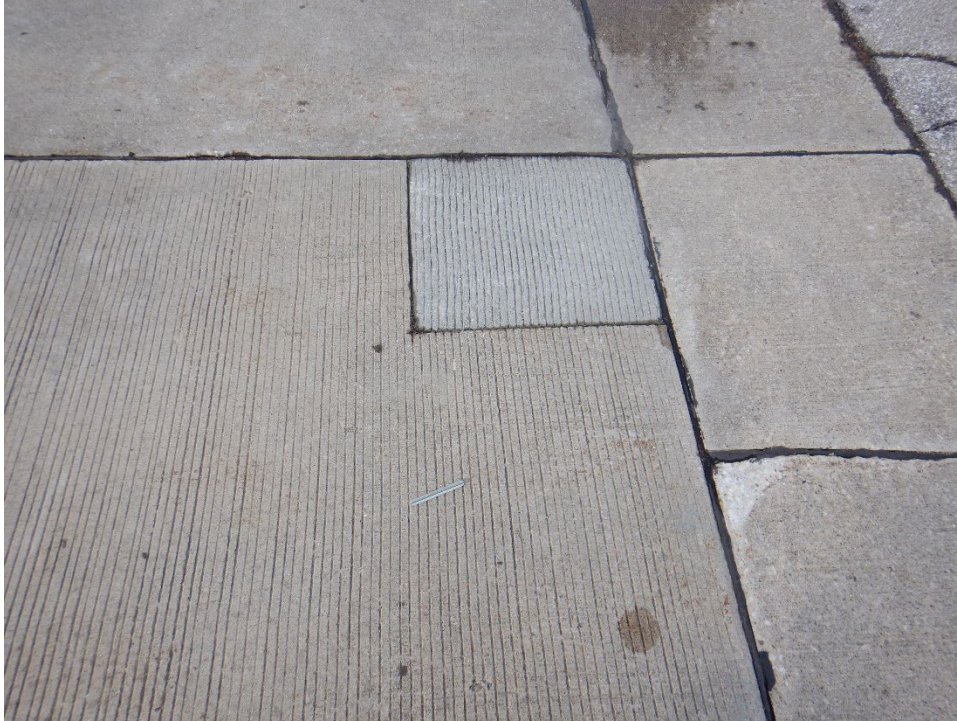
A01OE-01. Small Patching (Sample Unit No. 19).

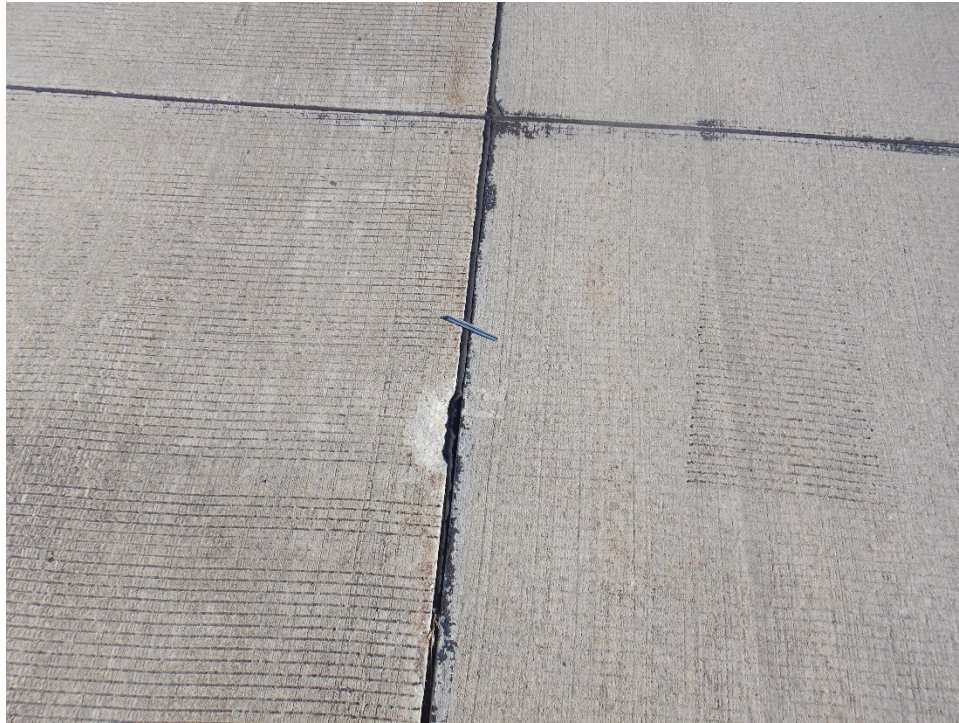
Runway 13/31 was defined by one section in *Excellent* condition. Areas of low- and medium-severity joint spalling and low-severity corner spalling, joint seal damage, small patching, and large patching were identified in Section 01. Atypical areas of low-severity longitudinal, transverse, and diagonal (LTD) cracking were observed and recorded as additional sample units in accordance with ASTM D5340.

R13OE-01. Joint Spalling (Sample Unit No. 98).

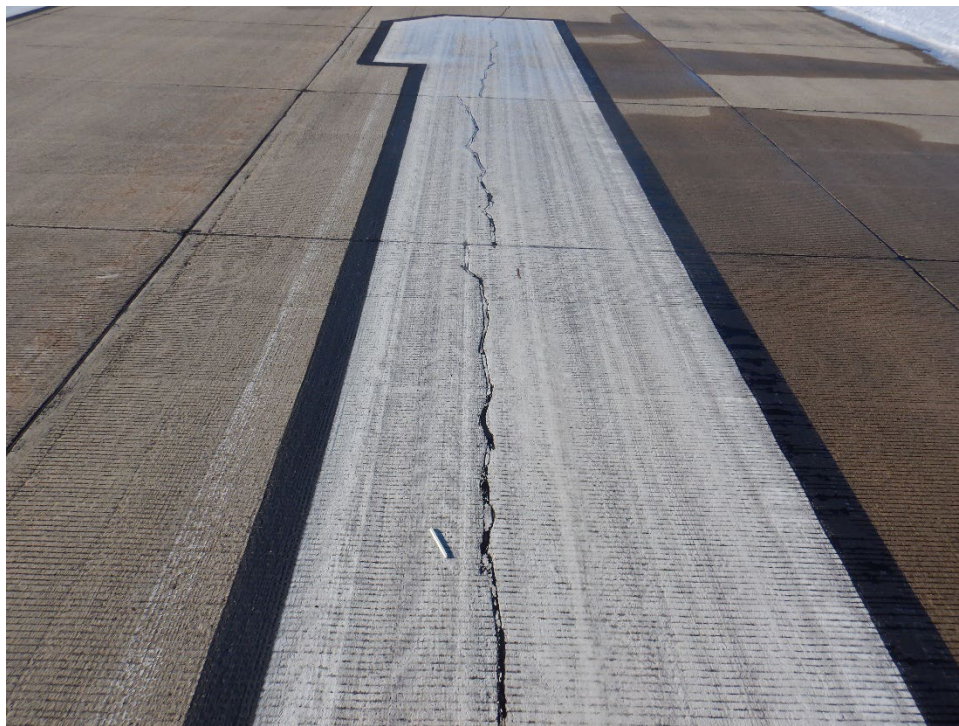
R13OE-01. LTD Cracking (Additional Sample Unit No. 97).

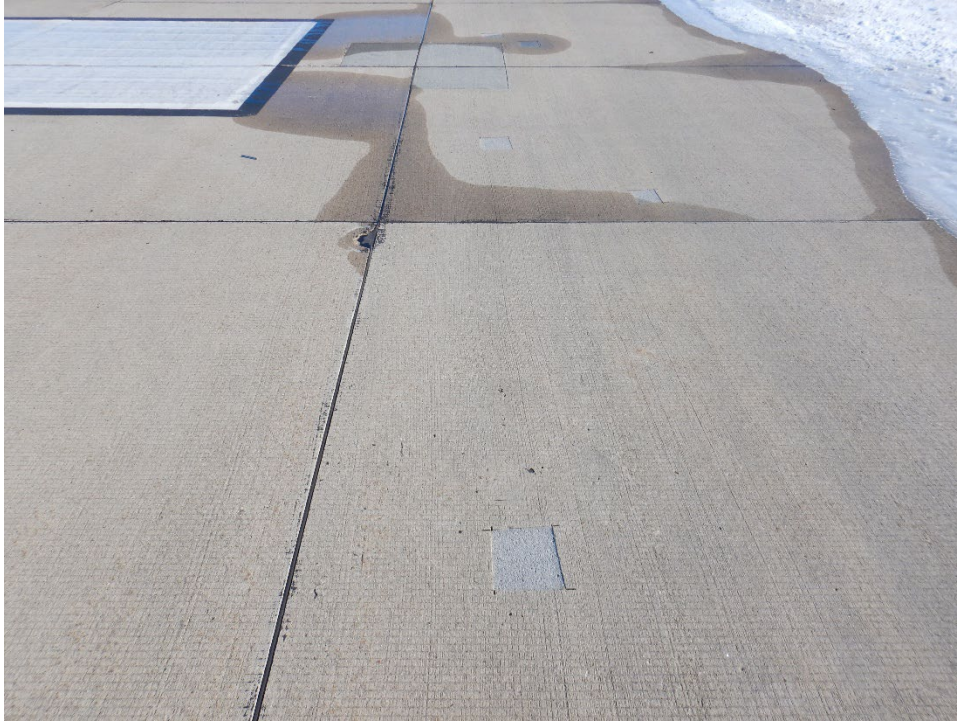
R13OE-01. Small Patching (Additional Sample Unit No. 96).

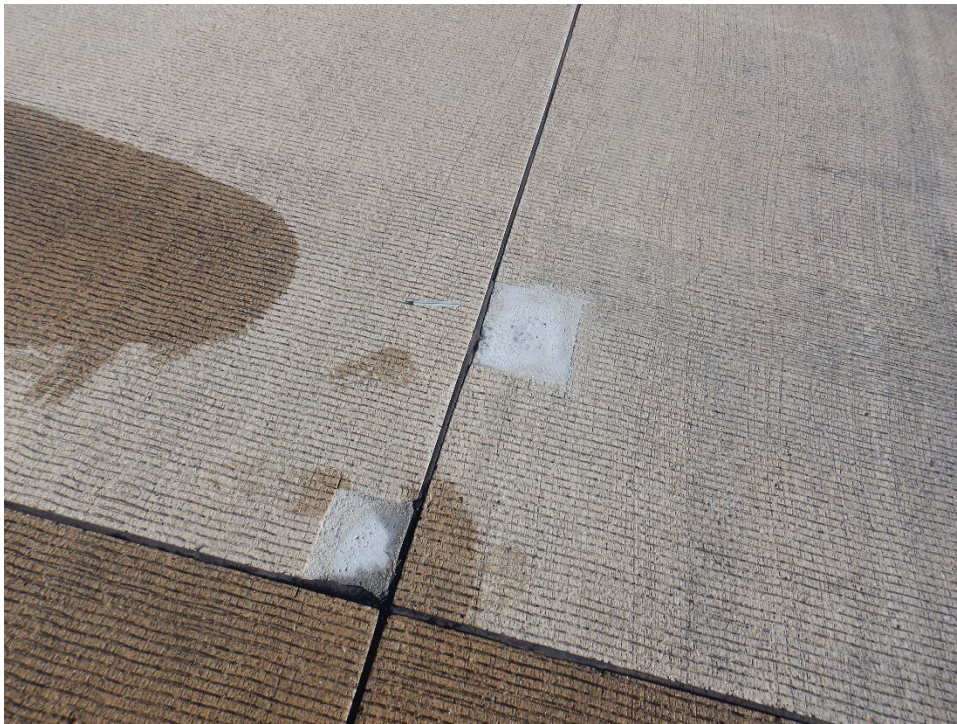
R13OE-01. Small Patching (Sample Unit No. 08).

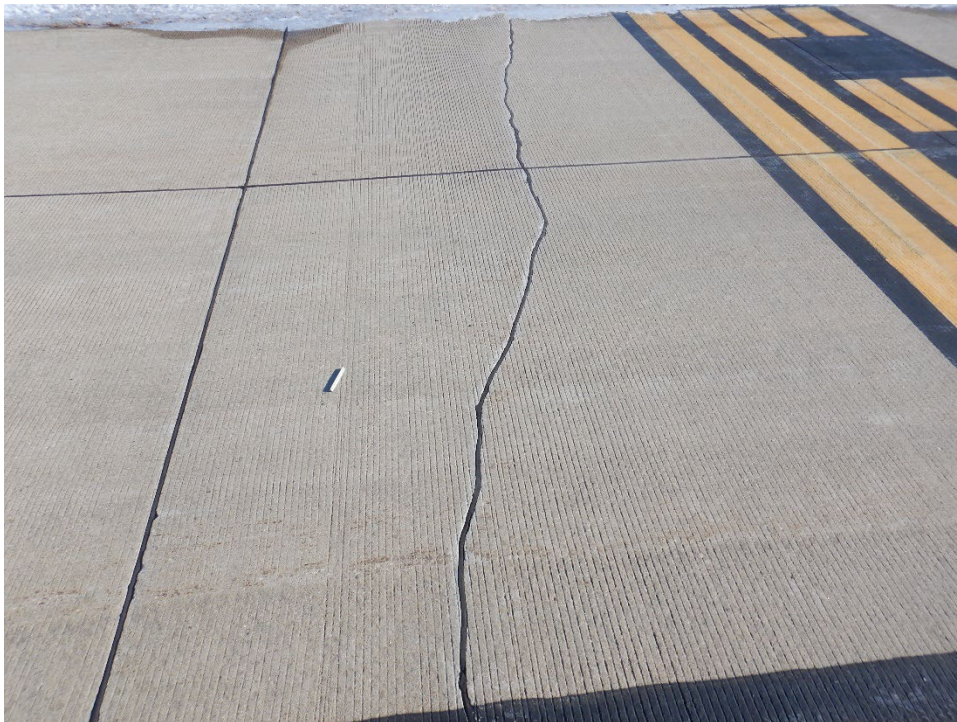
The taxiway consisted of two sections. Medium-severity LTD cracking and low-severity corner spalling, joint seal damage, large patching, and small patching were observed in Section 01. Section 02 contained low- and medium-severity longitudinal and transverse (L&T) cracking and low-severity weathering. The low-severity L&T cracking was unsealed, and the medium-severity L&T cracking was recorded where unsealed crack widths were greater than ¼ inch.

T01OE-01. LTD Cracking (Additional Sample Unit No. 013).

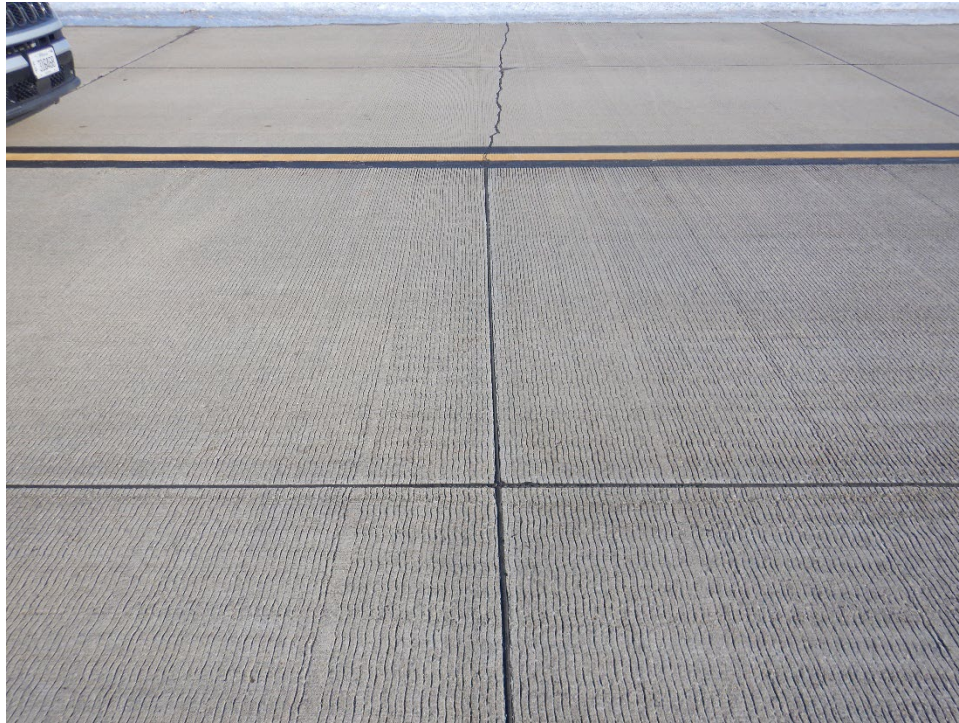
T01OE-01. LTD Cracking (Sample Unit No. 07).

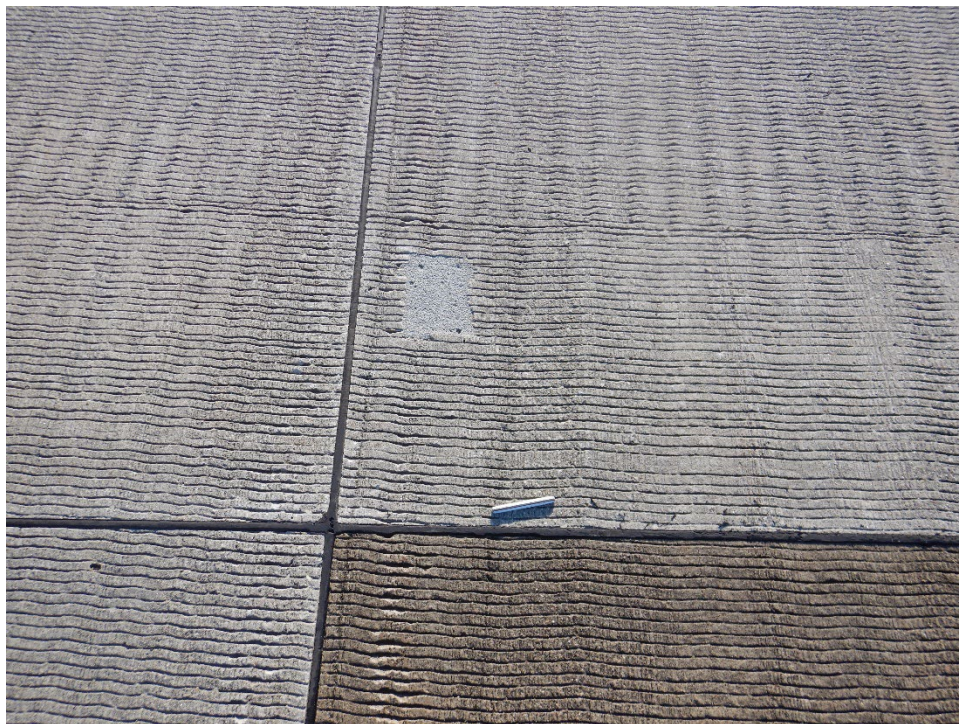
T01OE-01. Small Patching (Sample Unit No. 03).

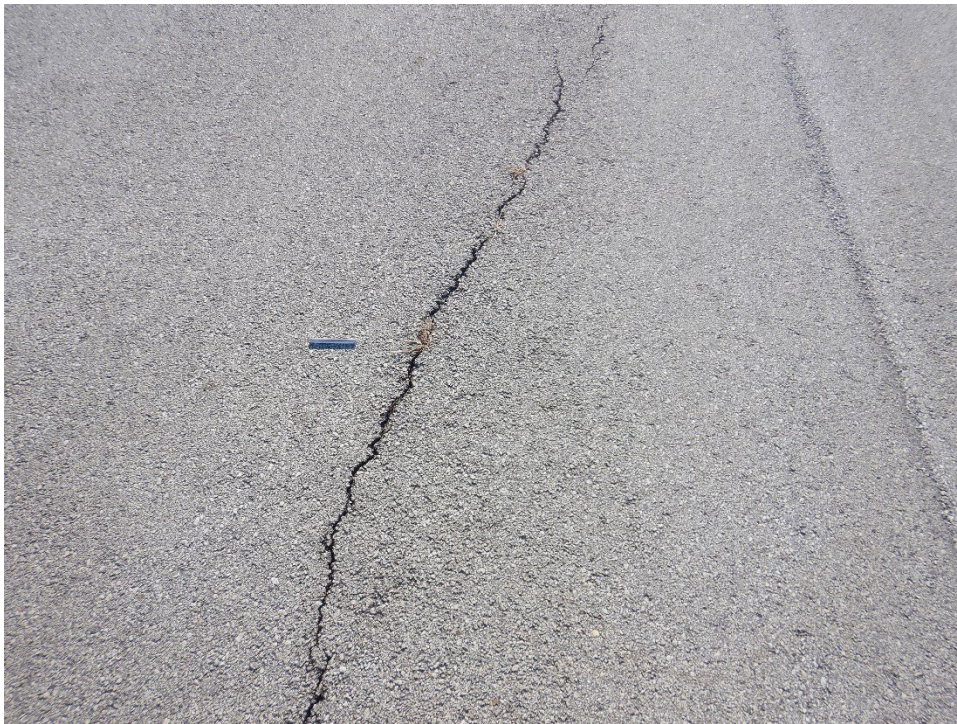
T01OE-02. L&T Cracking (Sample Unit No. 01).

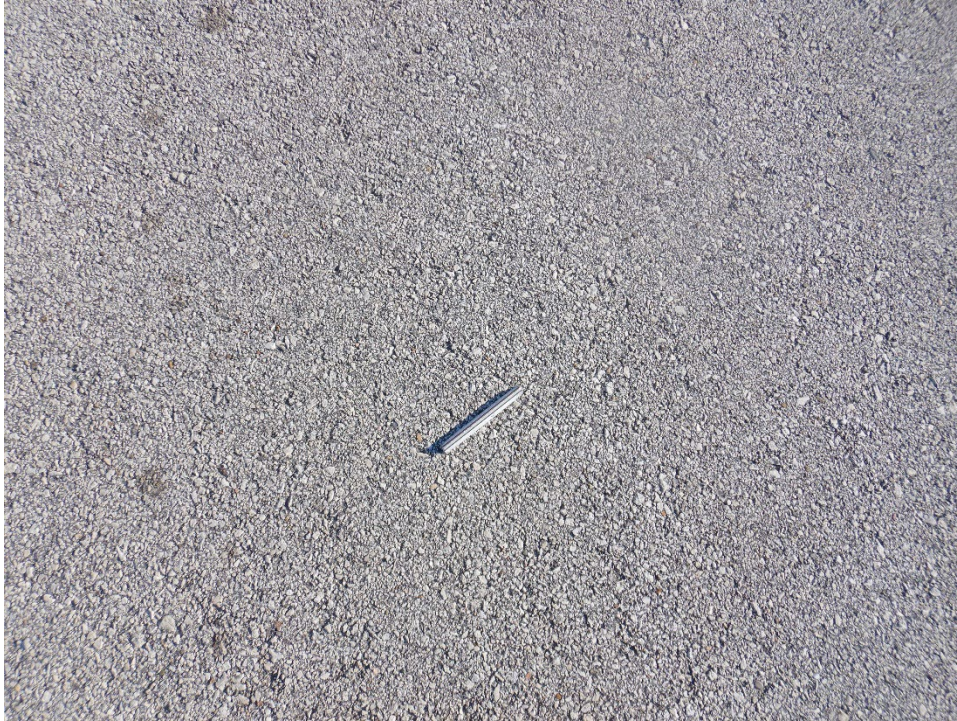
T01OE-02. Weathering (Sample Unit No. 01).

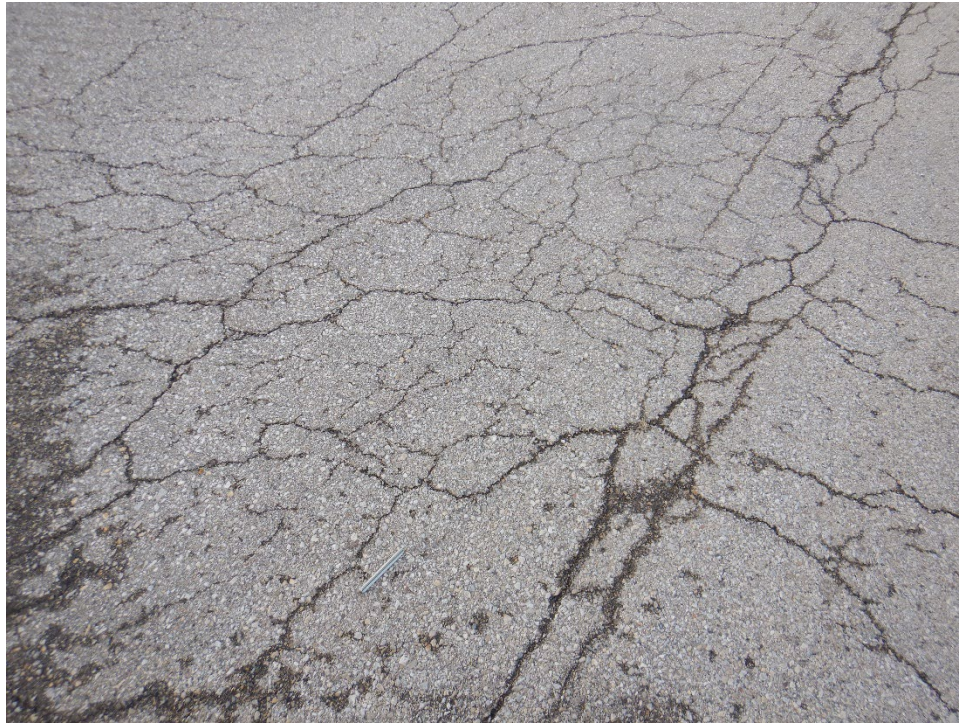
The T-hangar area consisted of four sections. Medium-severity alligator cracking, low- and medium-severity block cracking, all severities of L&T cracking, and low-severity weathering were recorded in Section 01. Section 02 was in *Poor* condition with medium-severity alligator cracking and weathering, low- and high-severity depression, low- and medium-severity L&T cracking, high-severity patching, and low-severity rutting and swelling identified during the inspection. Section 03 contained medium-severity alligator cracking and weathering, low-severity block cracking and depression, and low- and medium-severity L&T cracking. In Sections 01, 02, and 03, the low-severity cracking was unsealed, the medium-severity cracking was due to unsealed crack widths greater than ¼ inch, and the high-severity cracking was recorded where the crack width was greater than 3 inches. Low- and medium-severity corner break and LTD cracking, medium-severity corner spalling, and high-severity joint seal damage were identified in Section 04.

TH01OE-01. Alligator Cracking (Sample Unit No. 01).

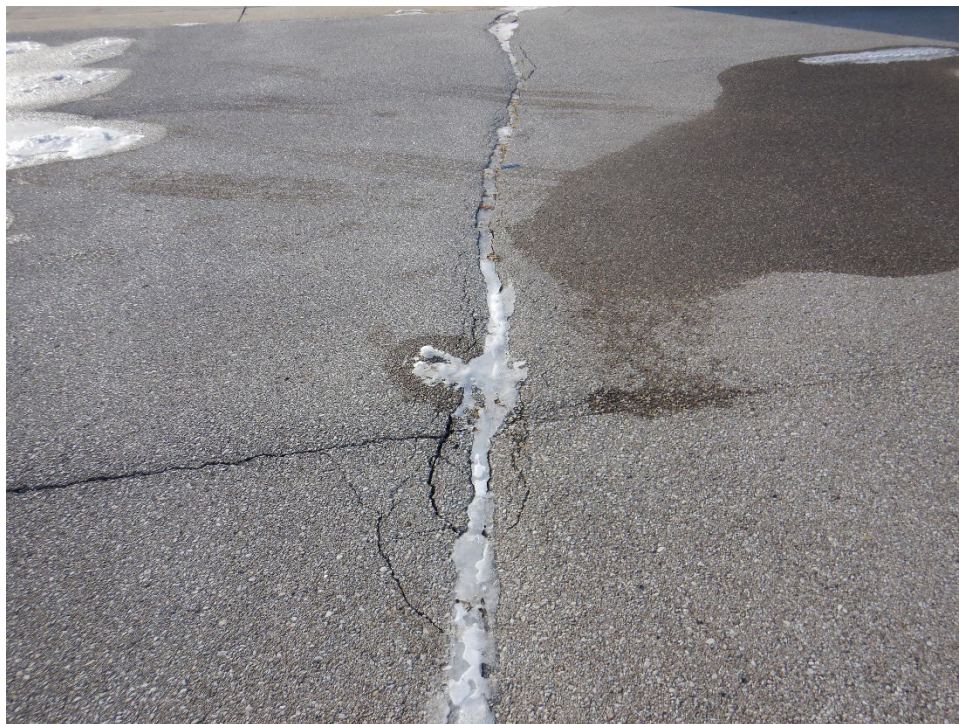
TH01OE-01. L&T Cracking (Sample Unit No. 02).

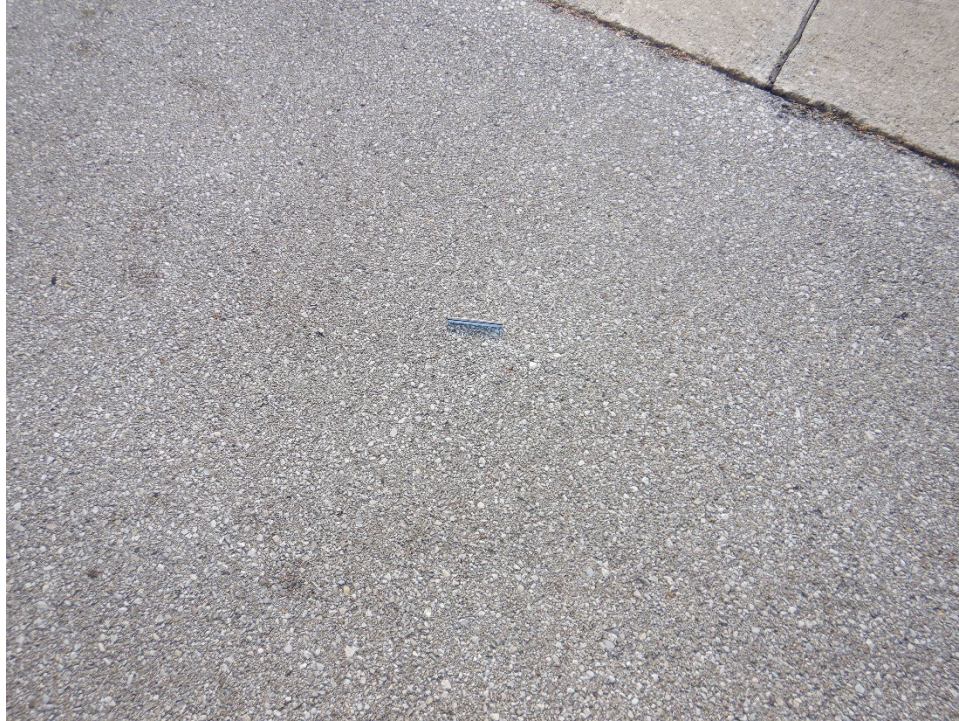
TH01OE-01. Weathering (Sample Unit No. 02).

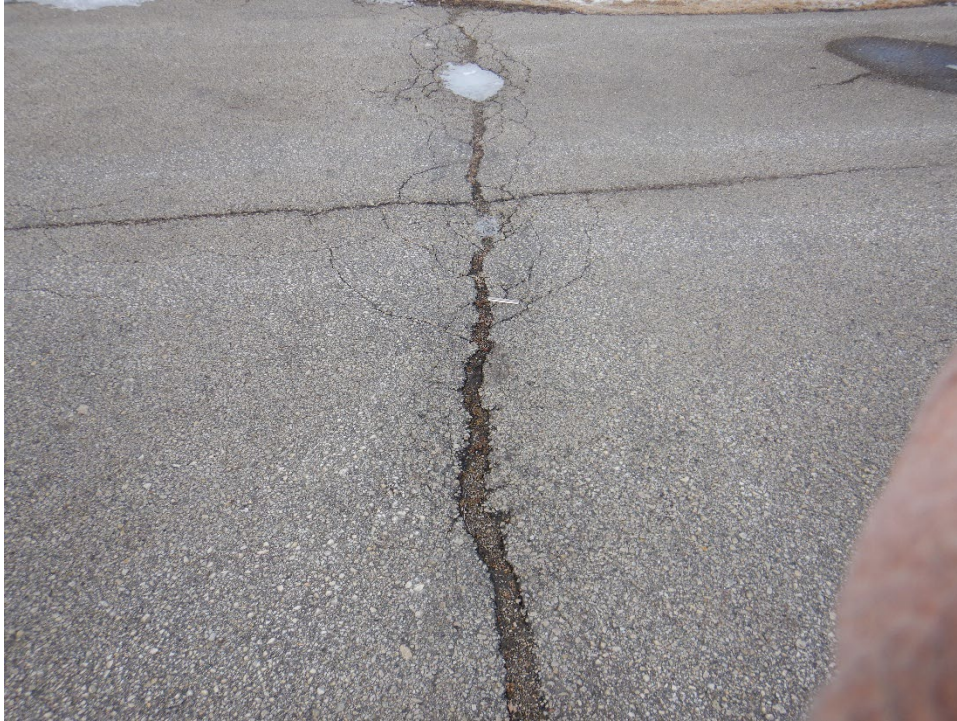
TH01OE-02. Alligator Cracking (Sample Unit No. 01).

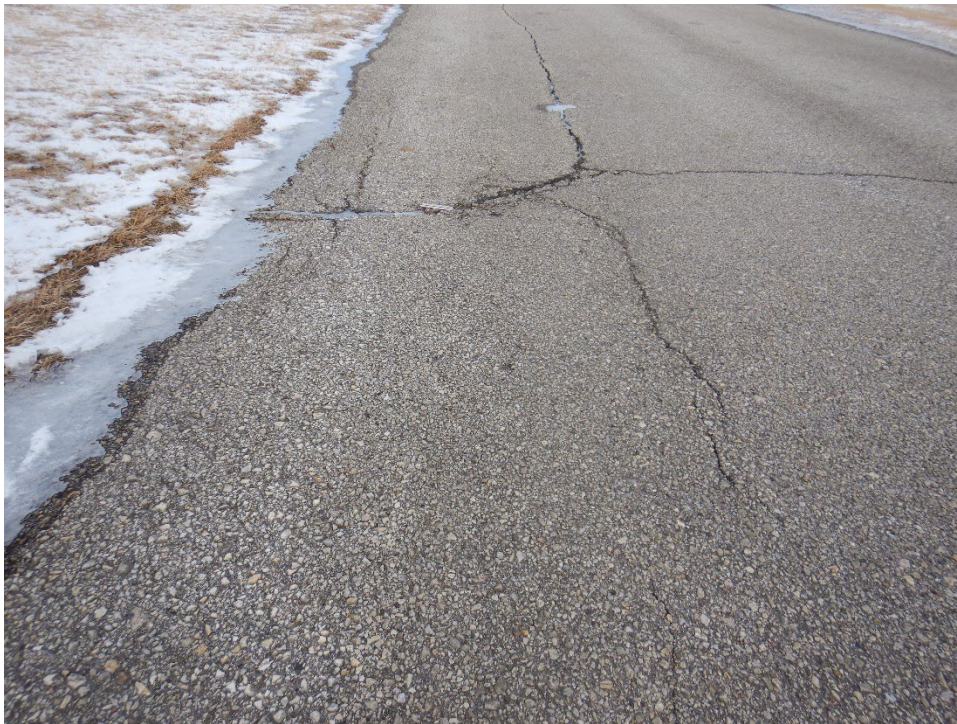
TH01OE-02. Depression (Sample Unit No. 02).

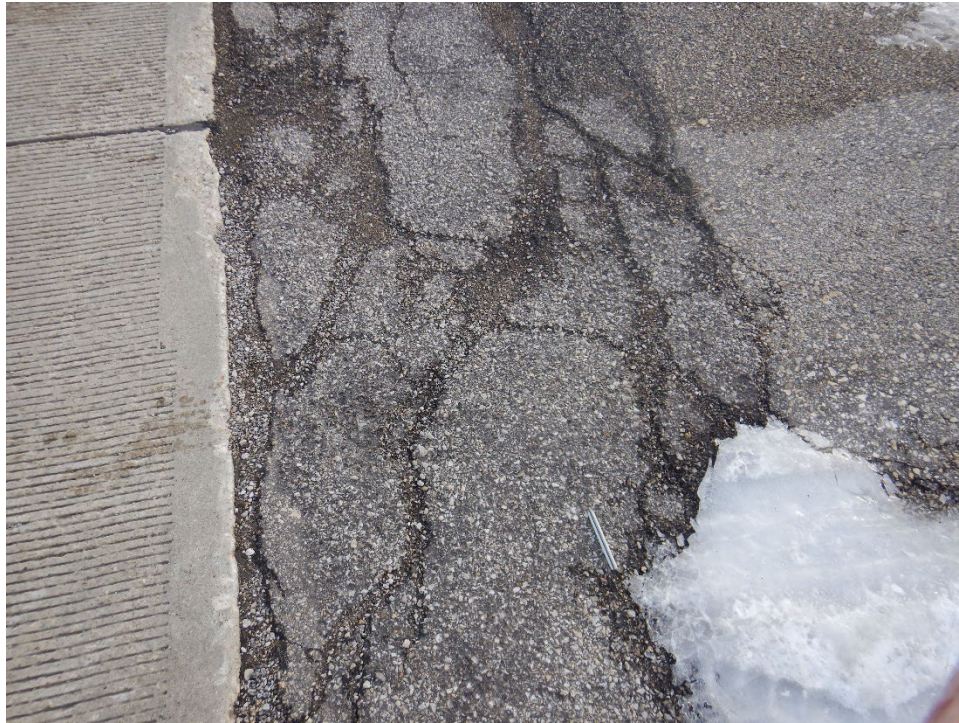
TH01OE-02. Patching (Sample Unit No. 02).

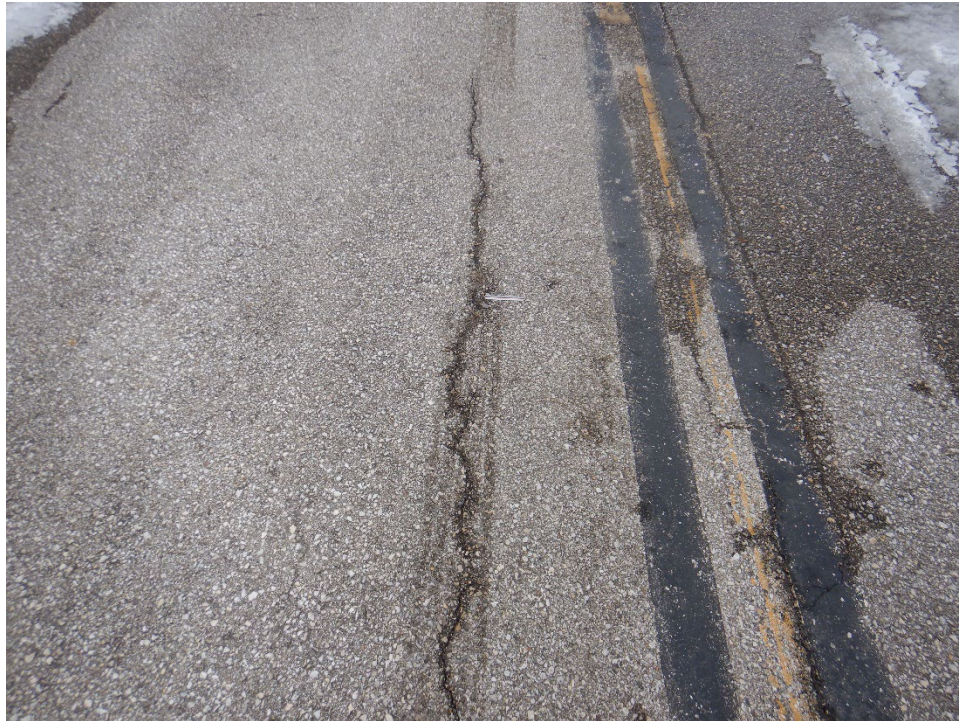
TH01OE-03. L&T Cracking (Sample Unit No. 02).

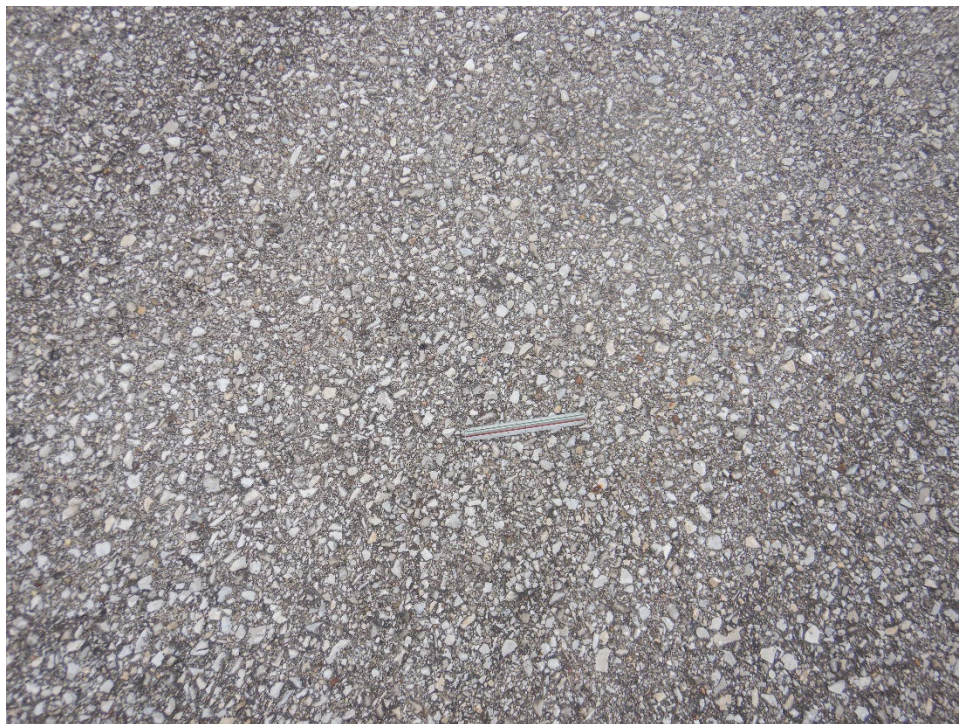
TH01OE-03. Weathering (Sample Unit No. 02).

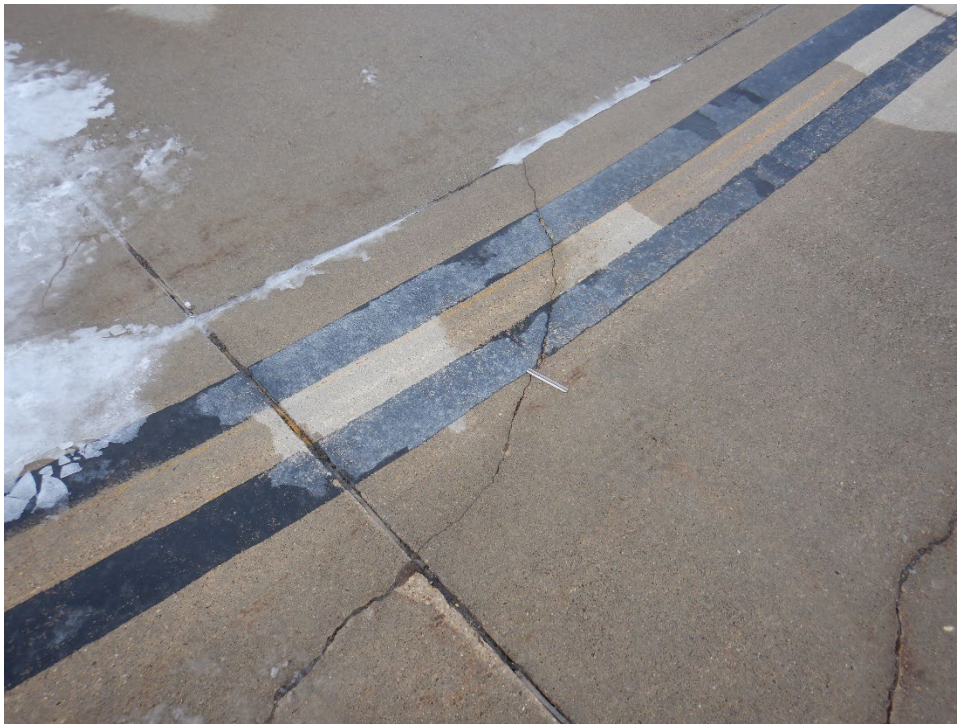
TH01OE-04. Corner Break (Sample Unit No. 03).

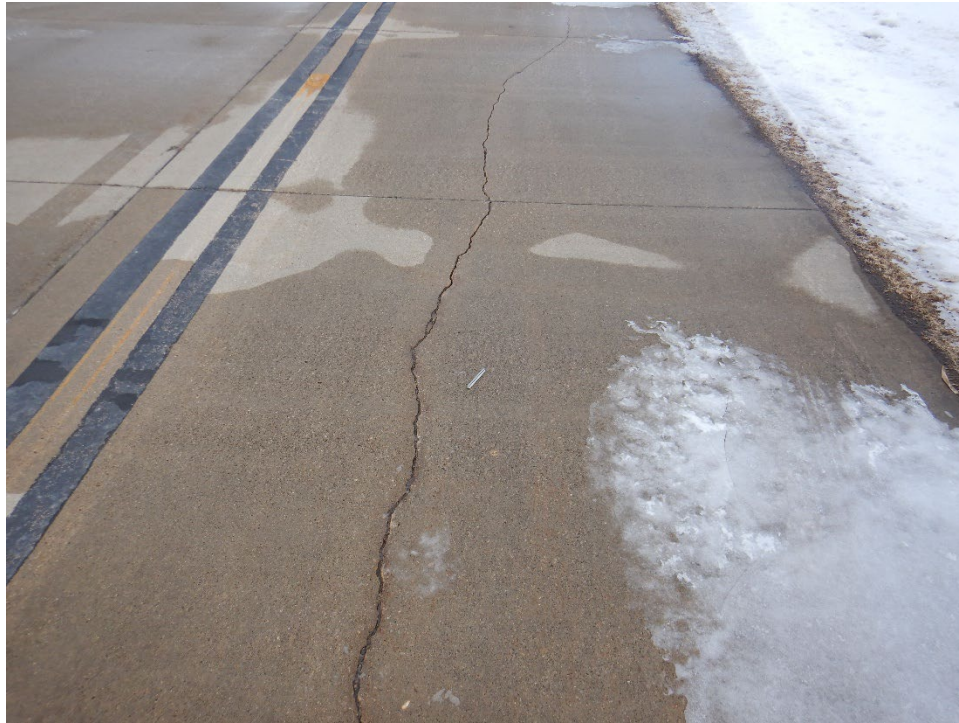
TH01OE-04. LTD Cracking (Sample Unit No. 03).
