# Osage Municipal Airport

## Pavement Management Report

**AUGUST 2025**

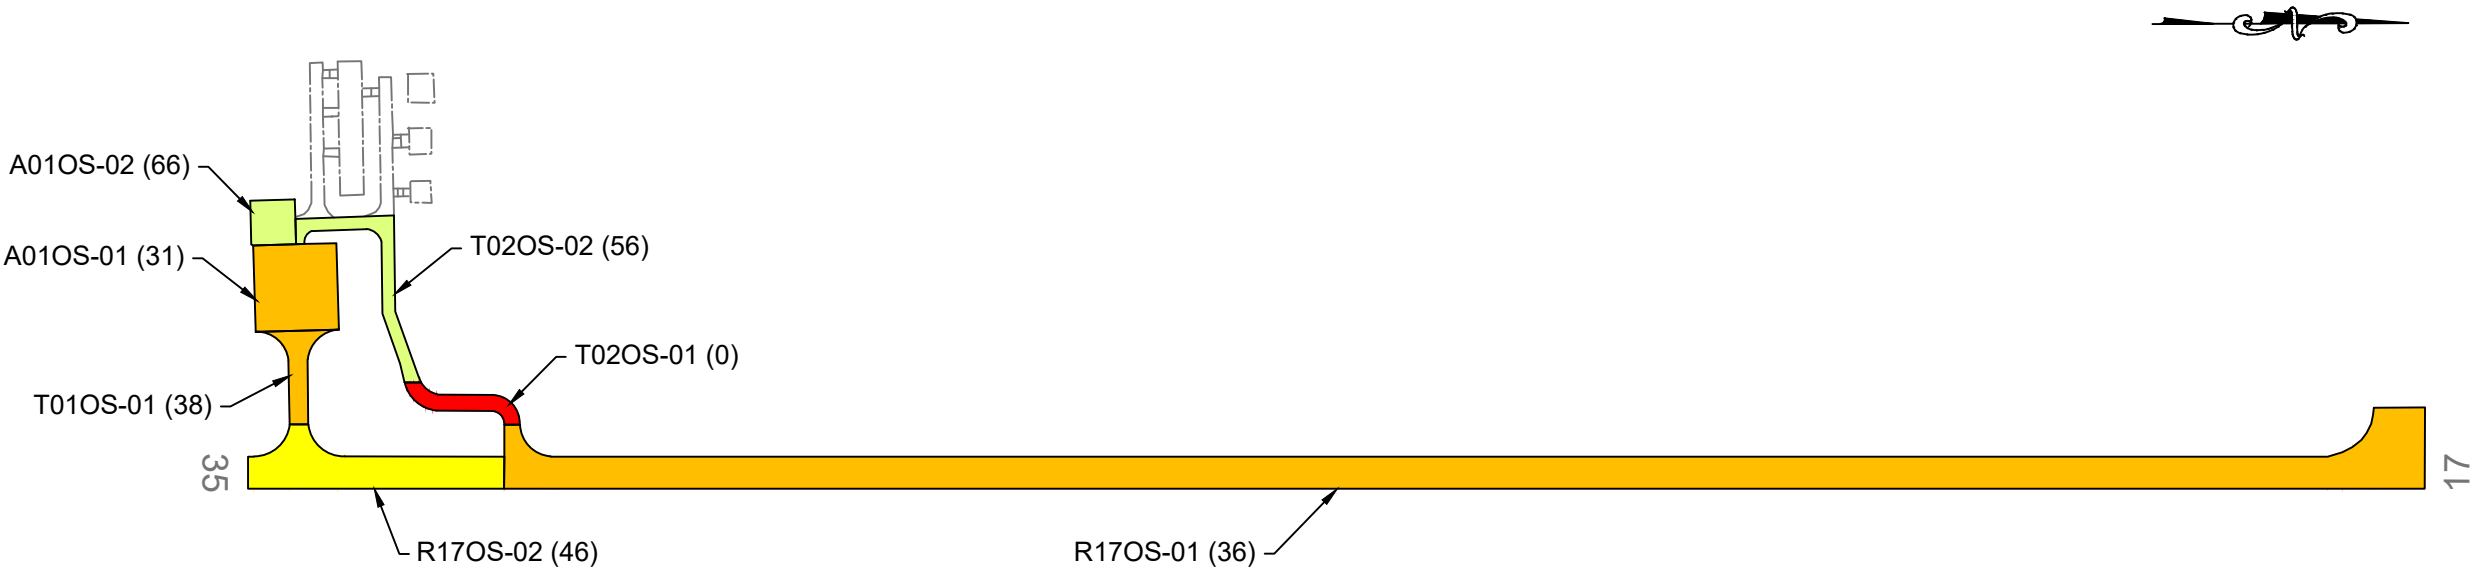
FIGURE 8. PCI MAP.

The pavements at Osage Municipal Airport were inspected in March 2025. The 2025 area-weighted condition of Osage Municipal Airport is 37, with conditions ranging from 0 to 66 (on a scale of 0 [failed] to 100 [excellent]). During the previous pavement inspection in 2018, the area-weighted PCI of the airport was 43.

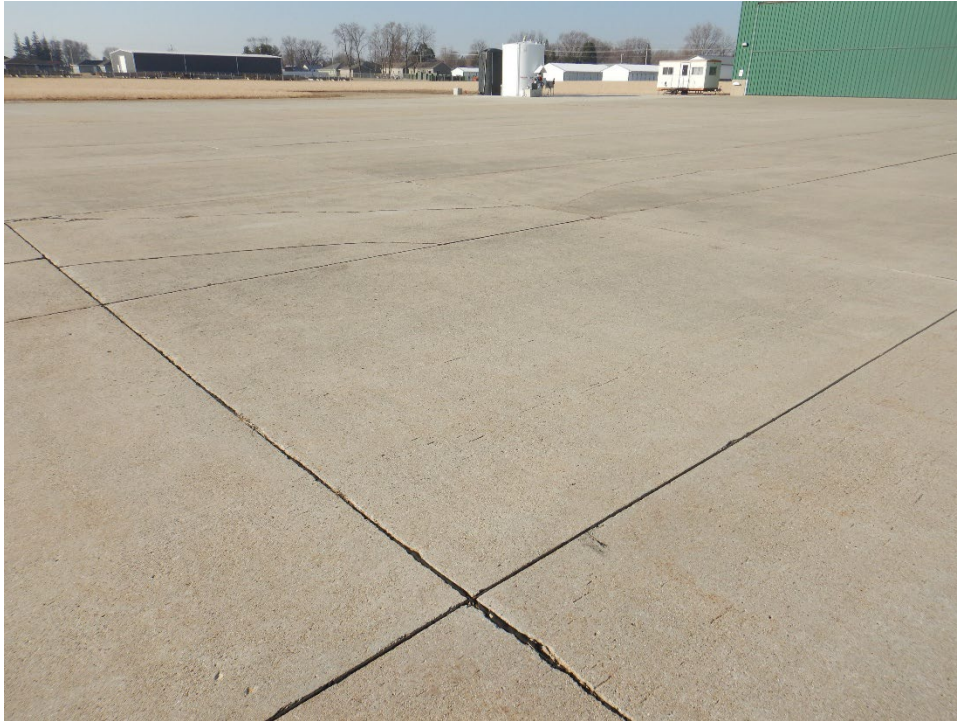
| Branch | Section | Surface Type | Section Area (sf) | LCD | 2025 PCI | % Distress Due to Load | % Distress Due to Climate/Durability | % Distress Due to Other | Type of Distress |
|---|---|---|---|---|---|---|---|---|---|
| A01OS | 01 | PCC | 17,550 | 6/1/1980 | 31 | 44 | 12 | 44 | ASR, Corner Break, Corner Spalling, Faulting, Joint Spalling, Joint Seal Damage, LTD Cracking, Shrinkage Cracking |

A01OS-01. Overview.

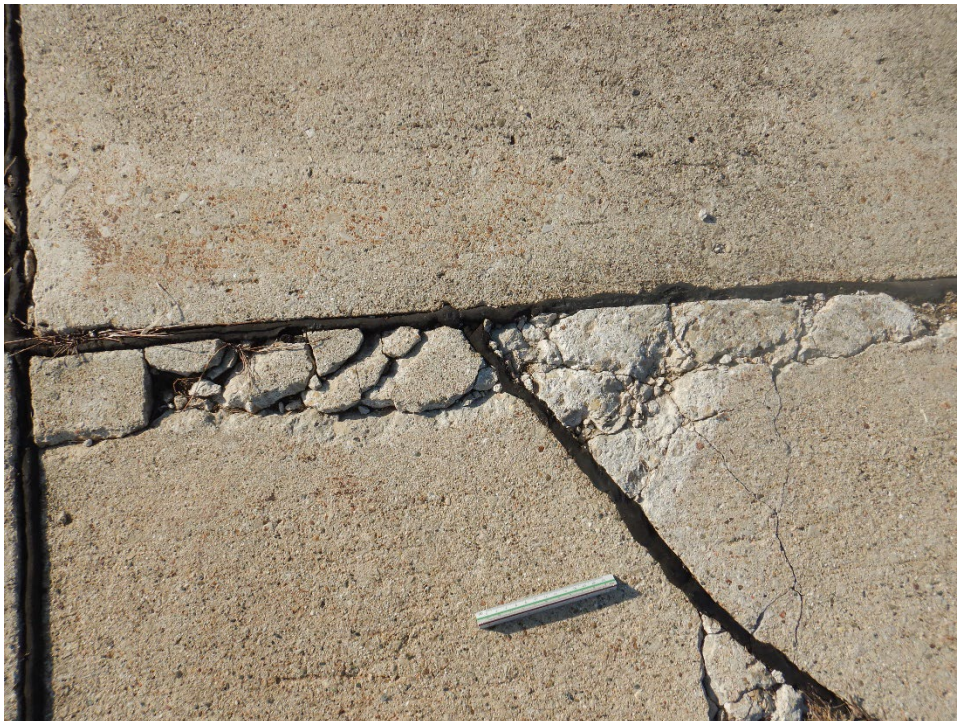
A01OS-01. Joint Spalling (Sample Unit No. 01).

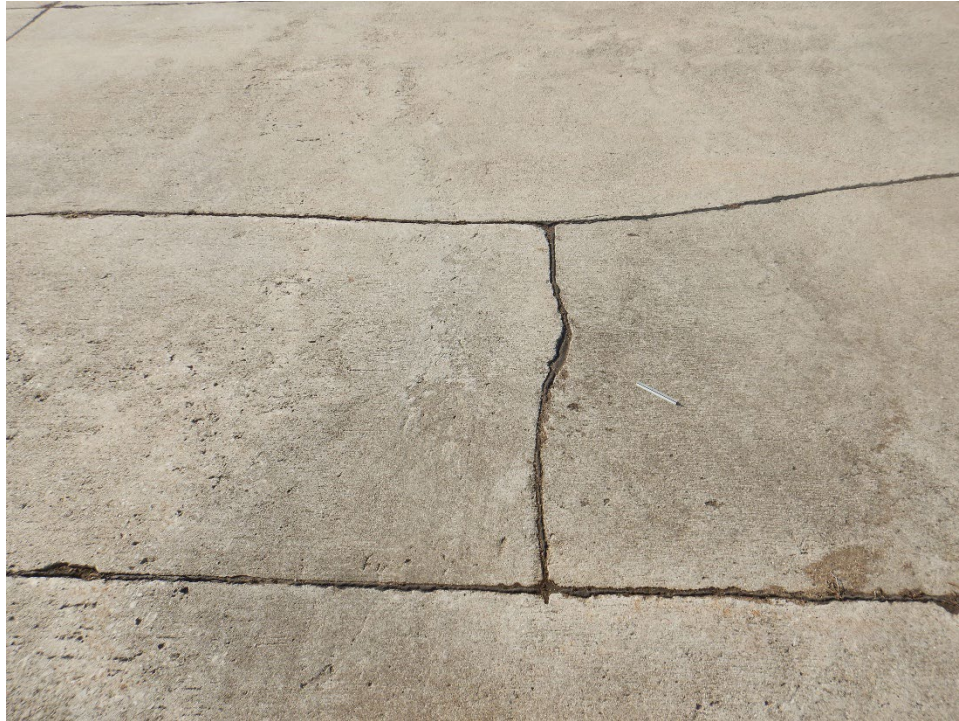
A01OS-01. LTD Cracking (Sample Unit No. 01).

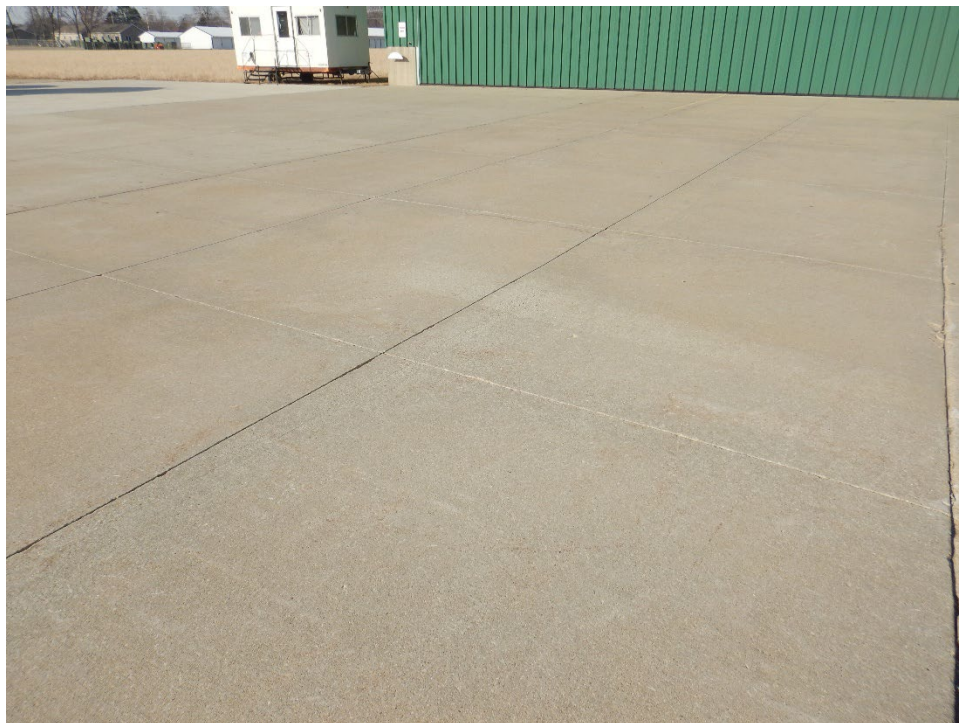
| Branch | Section | Surface Type | Section Area (sf) | LCD | 2025 PCI | % Distress Due to Load | % Distress Due to Climate/Durability | % Distress Due to Other | Type of Distress |
|---|---|---|---|---|---|---|---|---|---|
| A01OS | 02 | PCC | 4,900 | 1/1/2006 | 66 | 52 | 24 | 24 | Corner Break, Corner Spalling, Faulting, Joint Spalling, Joint Seal Damage, LTD Cracking, Shattered Slab, Shrinkage Cracking |

A01OS-02. Overview.

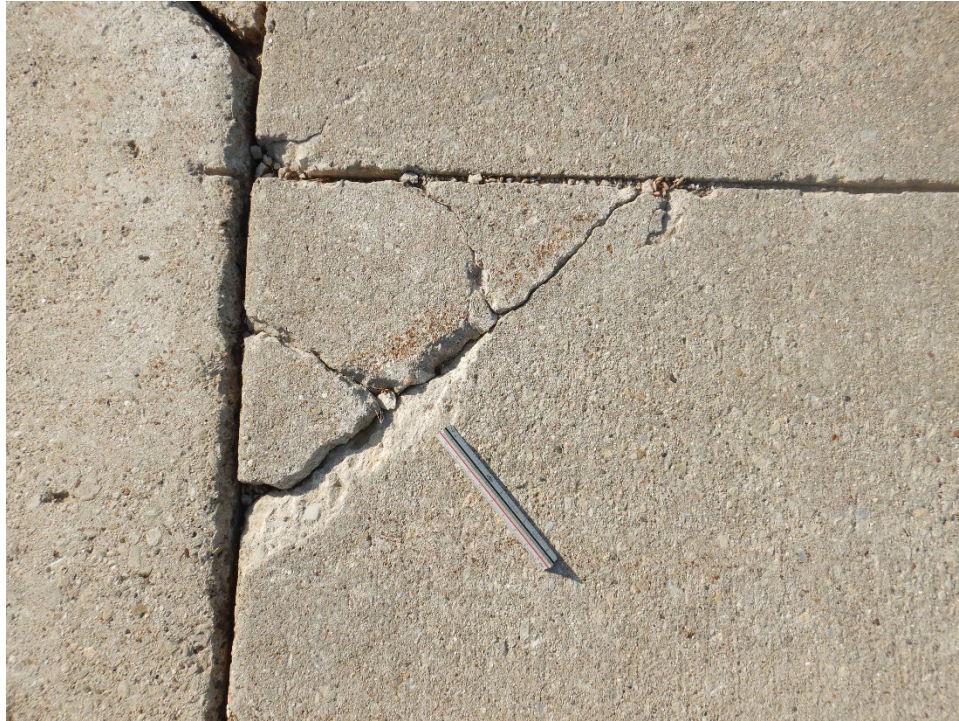
A01OS-02. Corner Spalling (Sample Unit No. 02).

| Branch | Section | Distress Type | Severity | Distress Quantity | Distress Unit | Maintenance Action | Unit Cost | 2025 Estimated Cost |
|---|---|---|---|---|---|---|---|---|
| A01OS | 02 | Corner Spalling | Medium | 1 | Slabs | Patching - PCC Partial Depth | \$40.74 | \$110 |

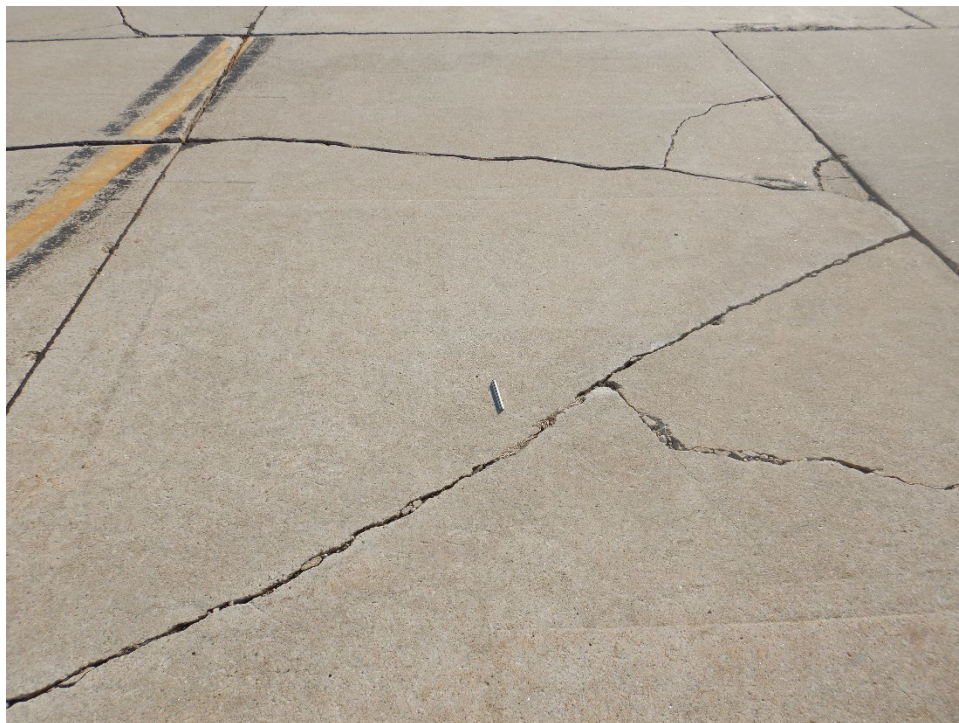
A01OS-02. Shattered Slab (Sample Unit No. 02).

| Branch | Section | Distress Type | Severity | Distress Quantity | Distress Unit | Maintenance Action | Unit Cost | 2025 Estimated Cost |
|---|---|---|---|---|---|---|---|---|
| A01OS | 02 | Shattered Slab | Low | 1 | Slabs | Crack Sealing - PCC | \$3.27 | \$66 |
| A01OS | 02 | Shattered Slab | Medium | 1 | Slabs | Slab Replacement - PCC | \$18.19 | \$1,809 |

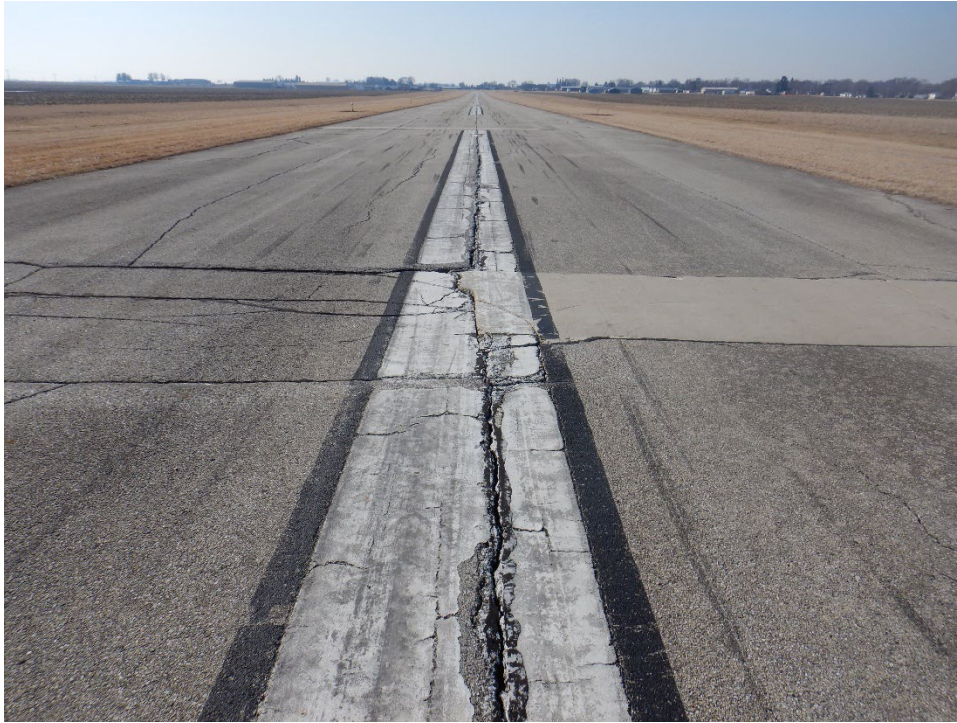
Runway 17/35 consisted of two sections. Section 01 was in *Poor* condition with medium-severity depression, weathering, and shoving; medium- and high-severity joint reflection cracking; low- and medium-severity longitudinal and transverse (L&T) cracking and swelling; low- and high-severity patching; and all severities of raveling observed. The low-severity L&T cracking was unsealed, and the medium-severity L&T cracking was recorded due to either the development of secondary cracking, unsealed crack widths that exceeded 1/4 inch, or unsatisfactory crack sealant. Section 02 contained similar distresses including medium-severity joint reflection cracking and weathering, low- and medium-severity L&T cracking and swelling, and high-severity raveling.

R17OS-01. Overview.

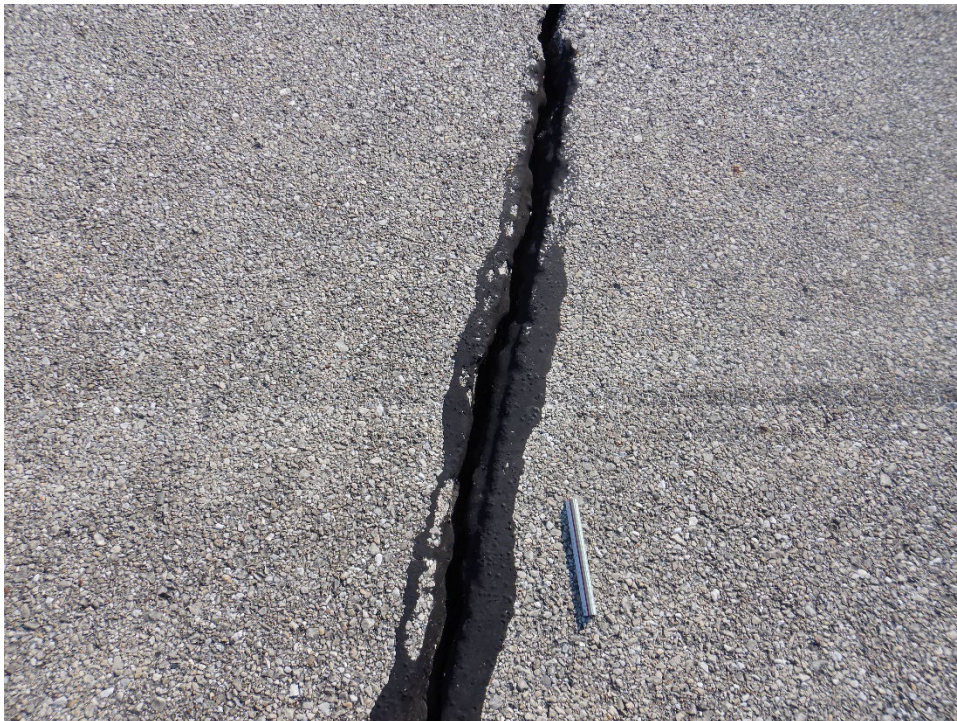
R17OS-01. L&T Cracking (Sample Unit No. 04).

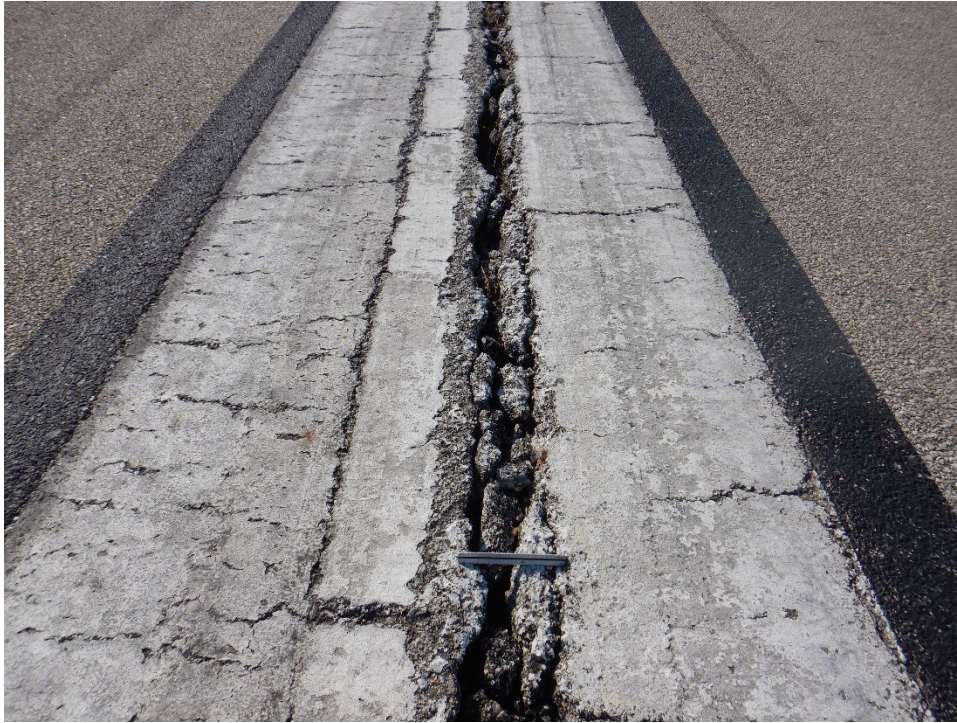
R17OS-01. L&T Cracking (Sample Unit No. 20).

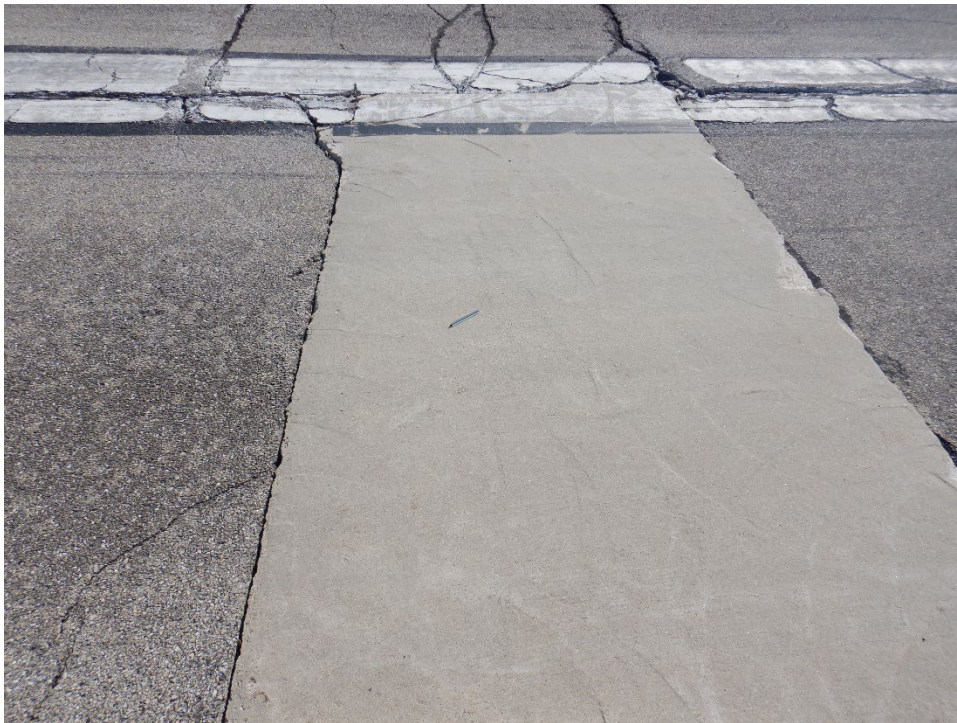
R17OS-01. Patching (Sample Unit No. 04) (1).

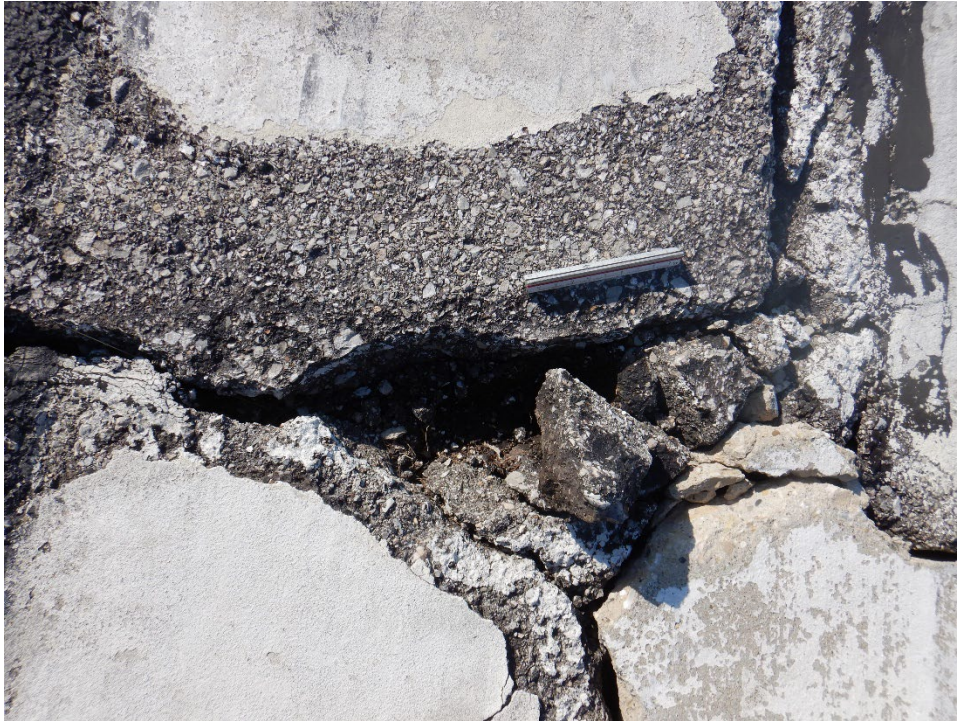
R17OS-01. Patching (Sample Unit No. 04) (2).

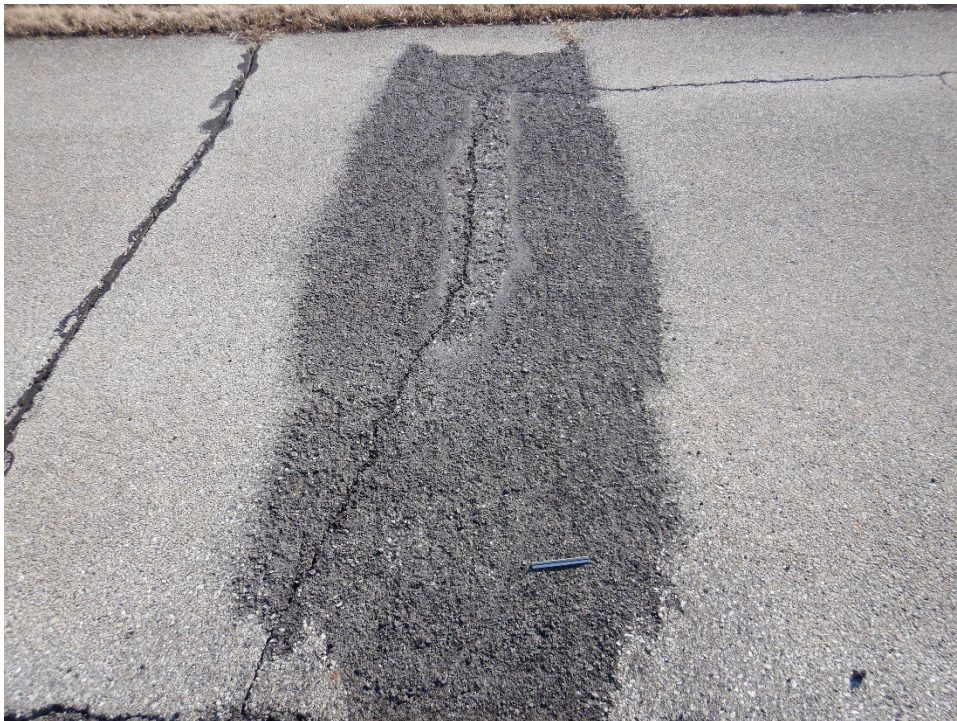
R17OS-01. Raveling (Sample Unit No. 08).

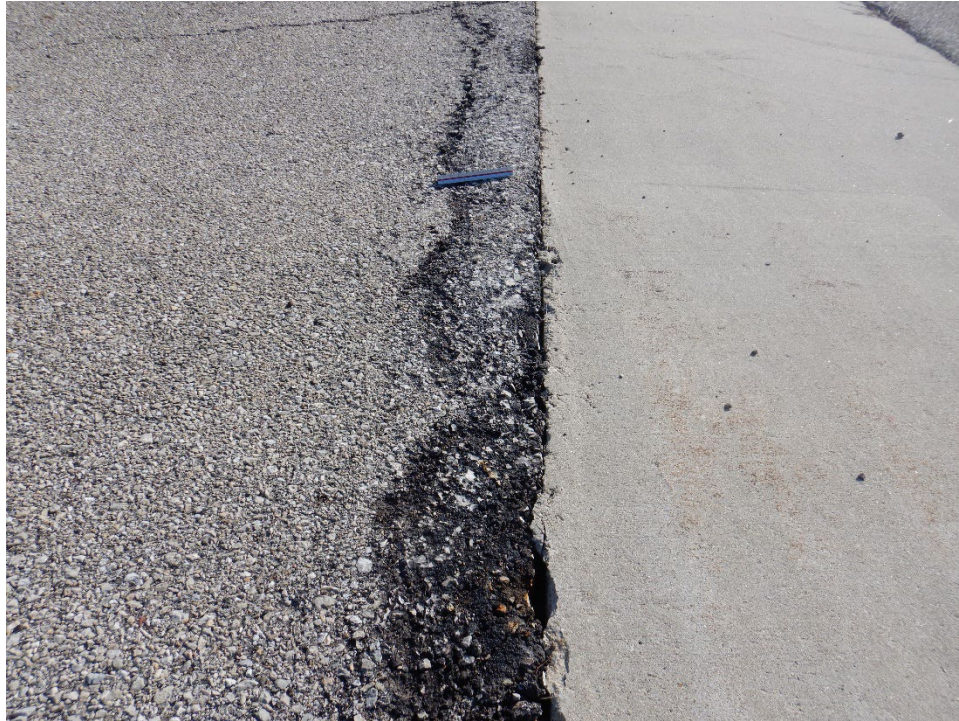
R17OS-01. Shoving (Sample Unit No. 08).

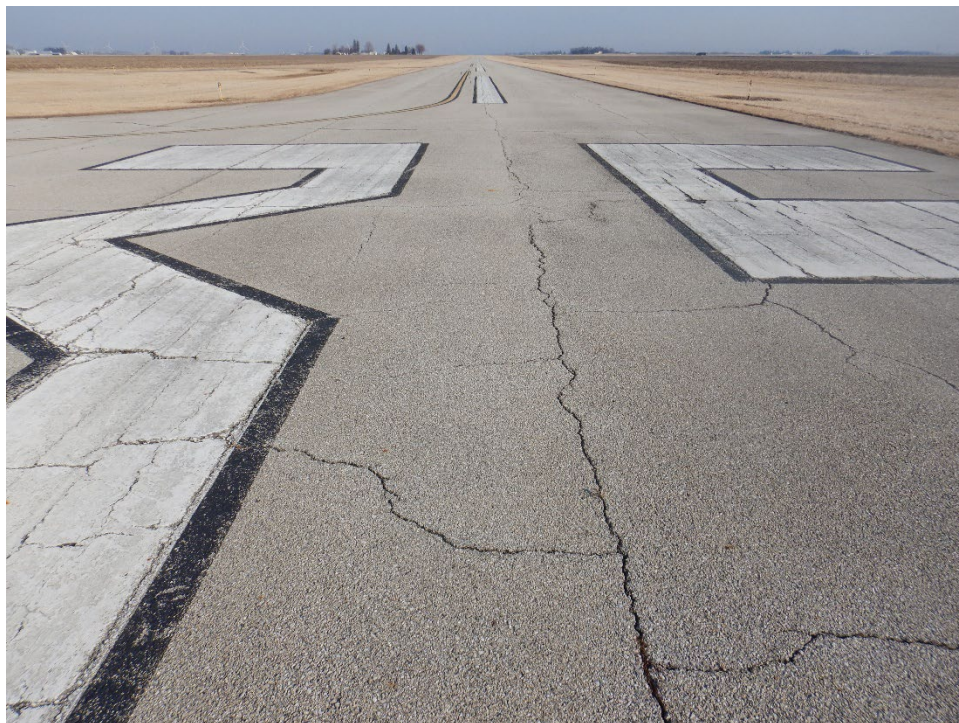
R17OS-02. Overview.

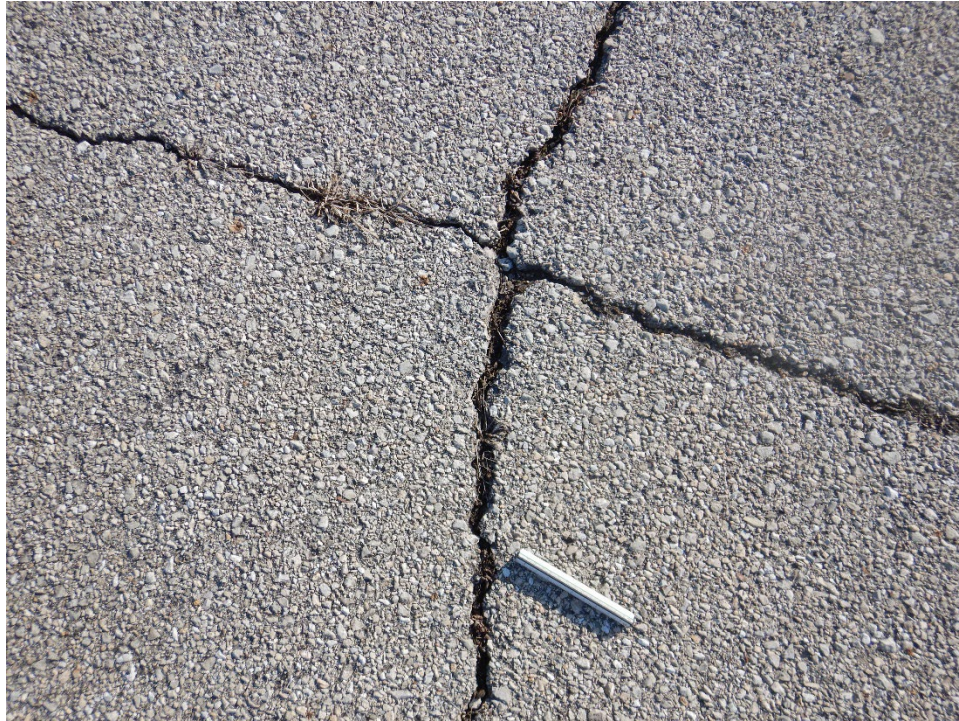
R17OS-02. L&T Cracking (Sample Unit No. 04).

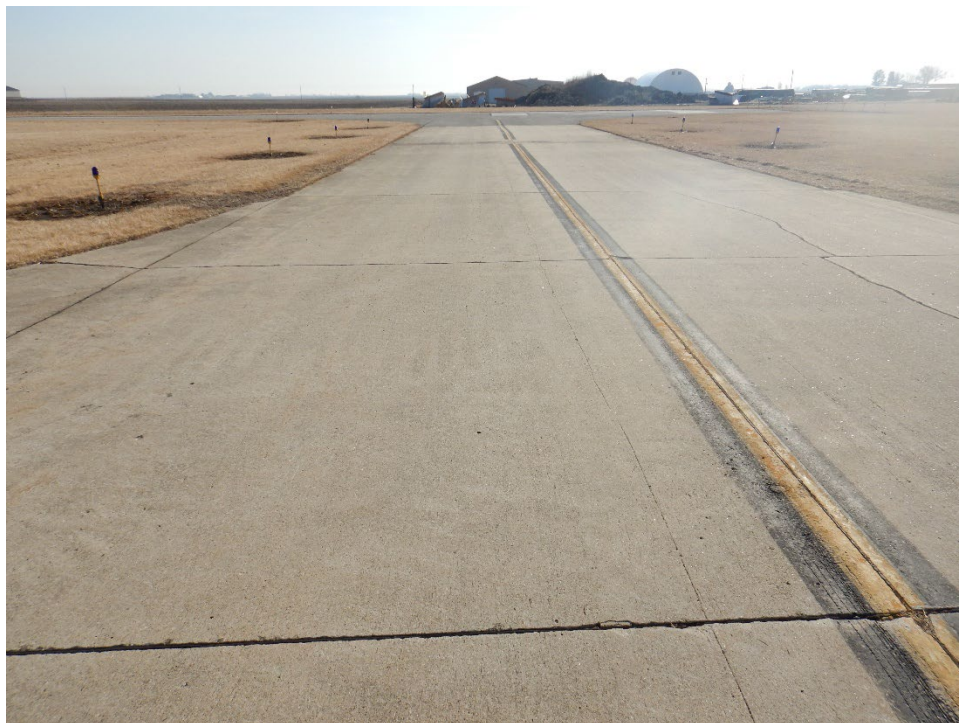
Taxiway 01 was defined by one section that was in *Poor* condition. Section 01 contained low- and medium-severity ASR and longitudinal, transverse, and diagonal (LTD) cracking; low- and high-severity corner break; high-severity joint seal damage; medium-severity joint spalling; and low-severity shattered slab.

T01OS-01. Overview.

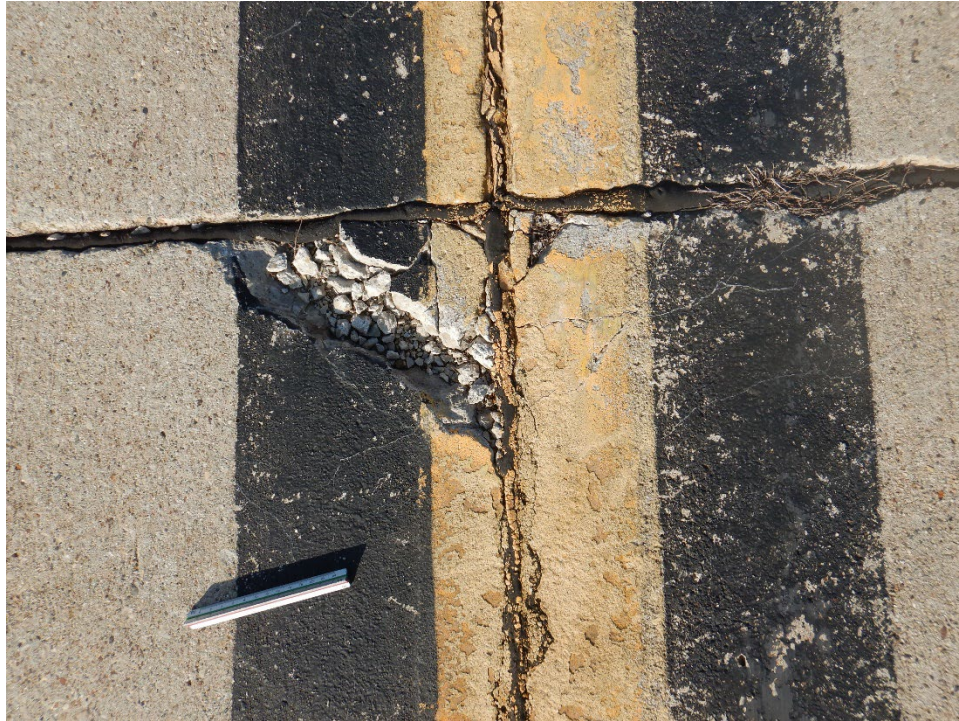
Osage Municipal Airport was inspected on March 13, 2025. There were seven pavement sections defined during the inspection. Alkali-silica reaction (ASR) was recorded at this airport according to the PCI procedure. The ASR was recorded where evidence of a precipitate was observed within some of the cracking in the PCC surface. It should be noted that laboratory testing in the form of petrographic analysis is the only definitive way to validate the presence of ASR; however, the formation of a precipitate is evidence of a reaction consistent with this type of materials-related distress.

T01OS-01. ASR (Sample Unit No. 01).

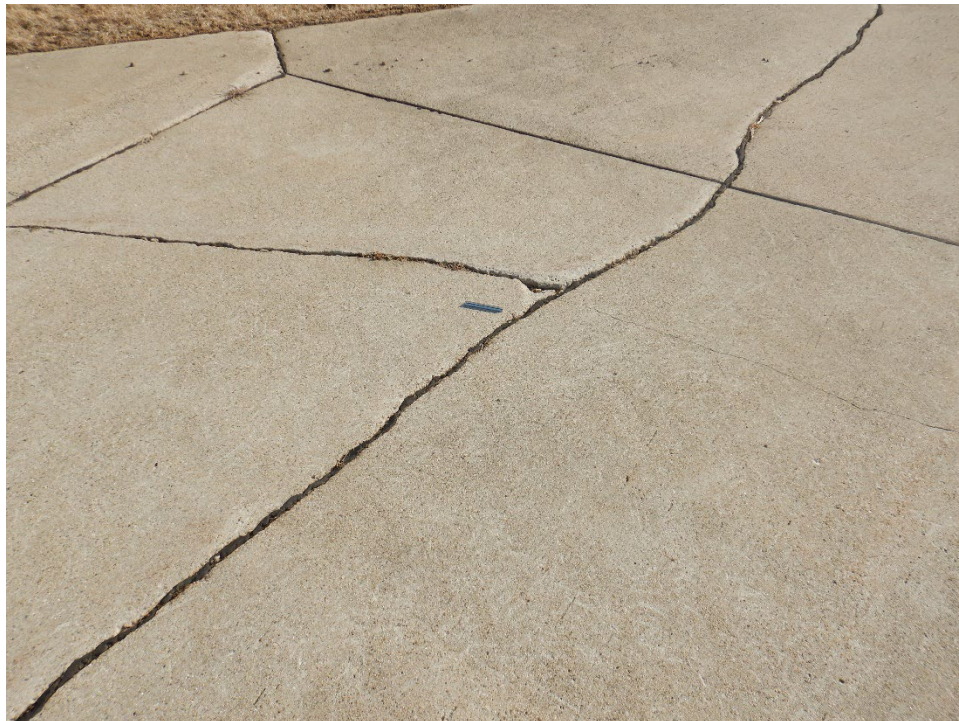
T01OS-01. Shattered Slab (Sample Unit No. 01).

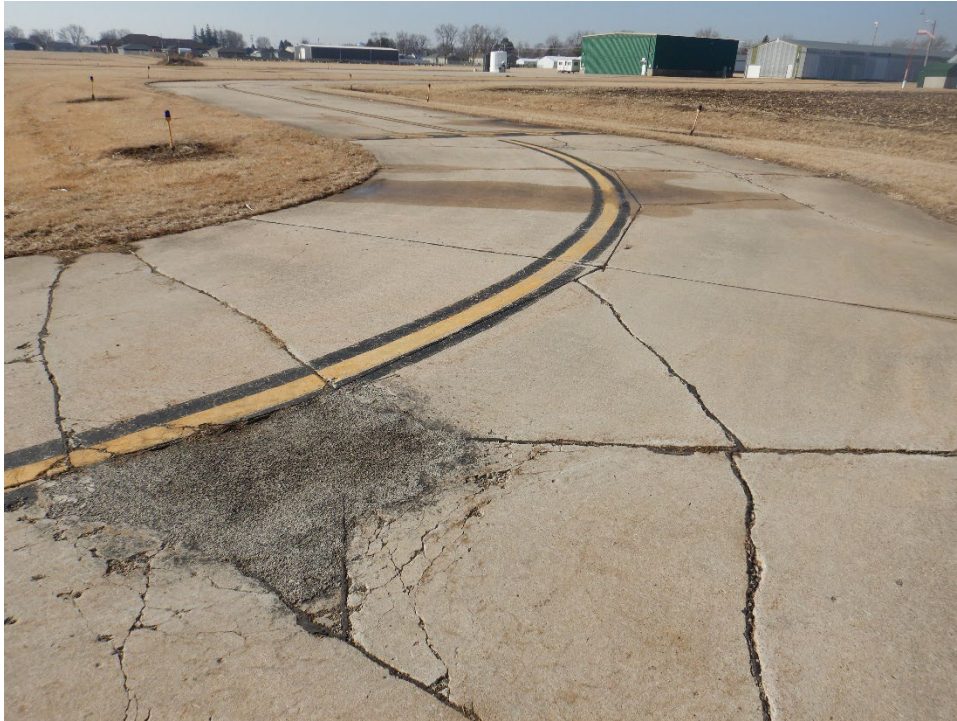
Taxiway 02 contained two sections. Section 01 was in *Poor* condition with low- and high-severity ASR, high-severity joint seal damage, medium-severity LTD cracking, and medium- and high-severity shattered slab recorded. Section 02 contained low-severity corner break and joint spalling, low- and medium-severity faulting and LTD cracking, high-severity joint seal damage, and medium- and high-severity shattered slab.

T02OS-01. Overview.

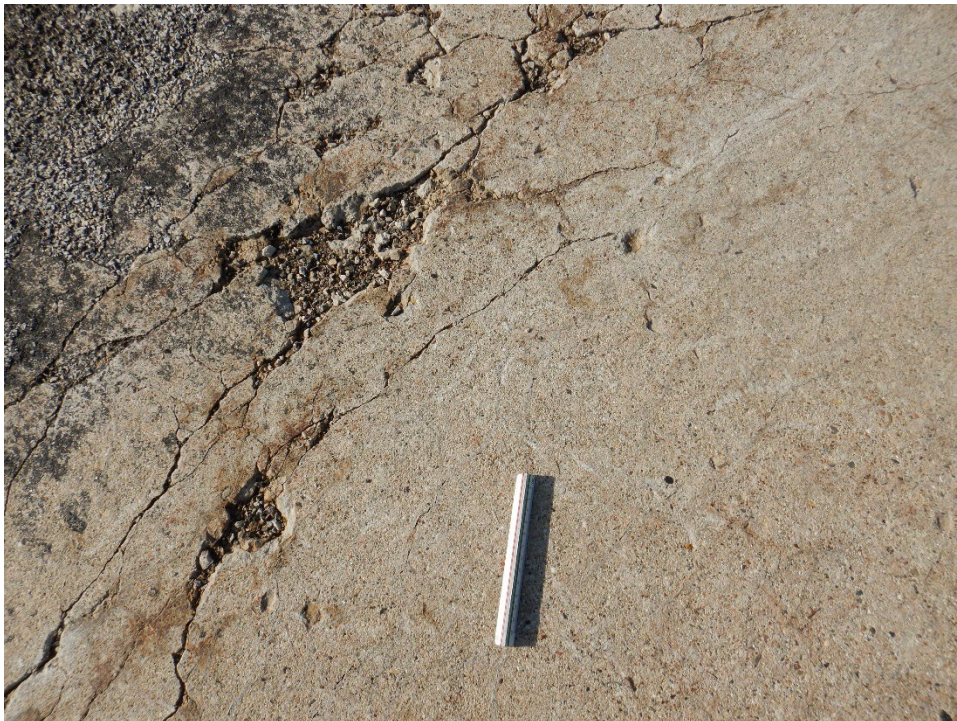
T02OS-01. ASR (Sample Unit No. 01) (1).

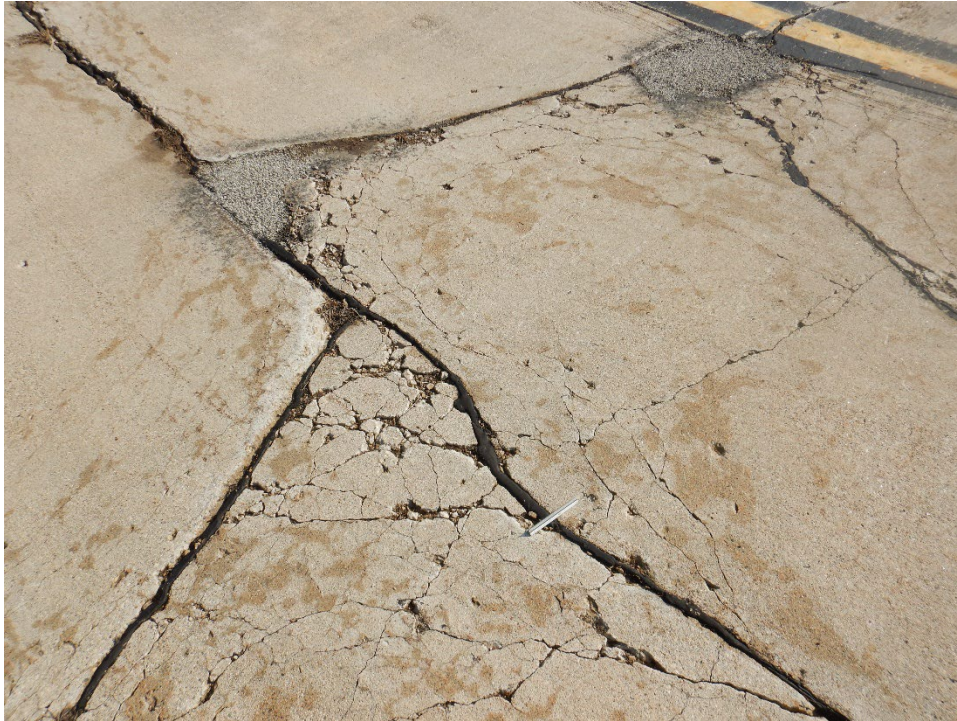
T02OS-01. ASR (Sample Unit No. 01) (2).

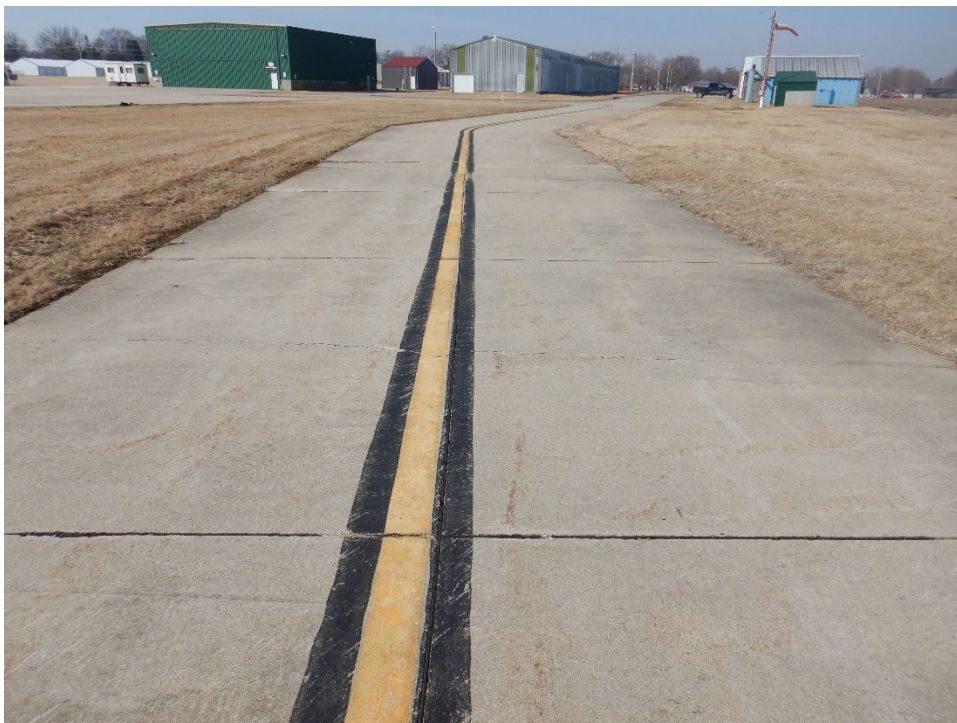
T02OS-02. Overview.

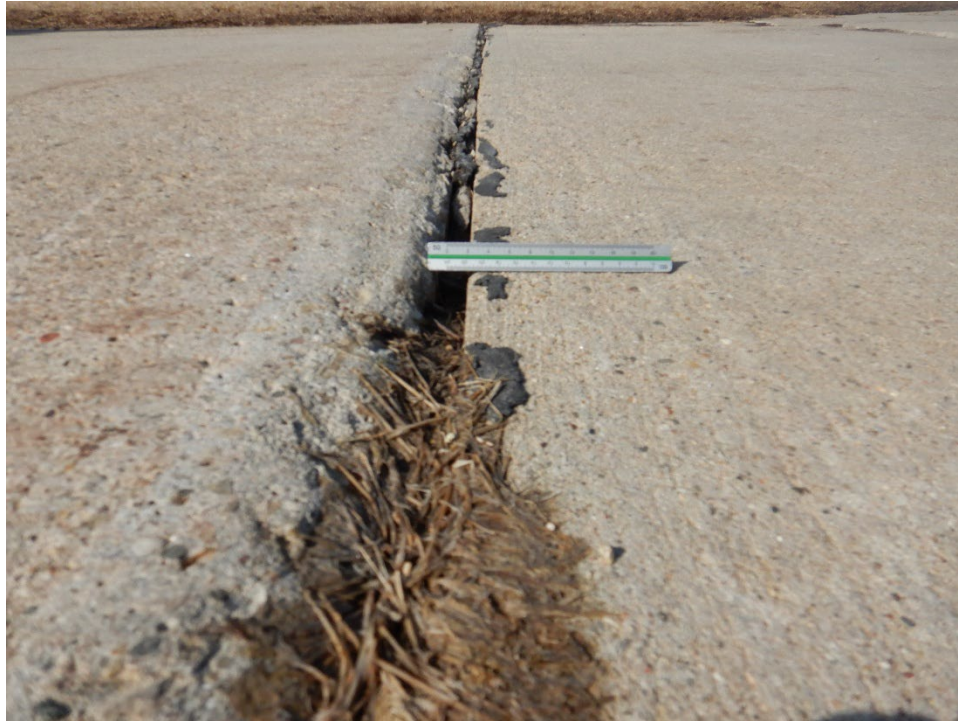
T02OS-02. Faulting (Sample Unit No. 03).

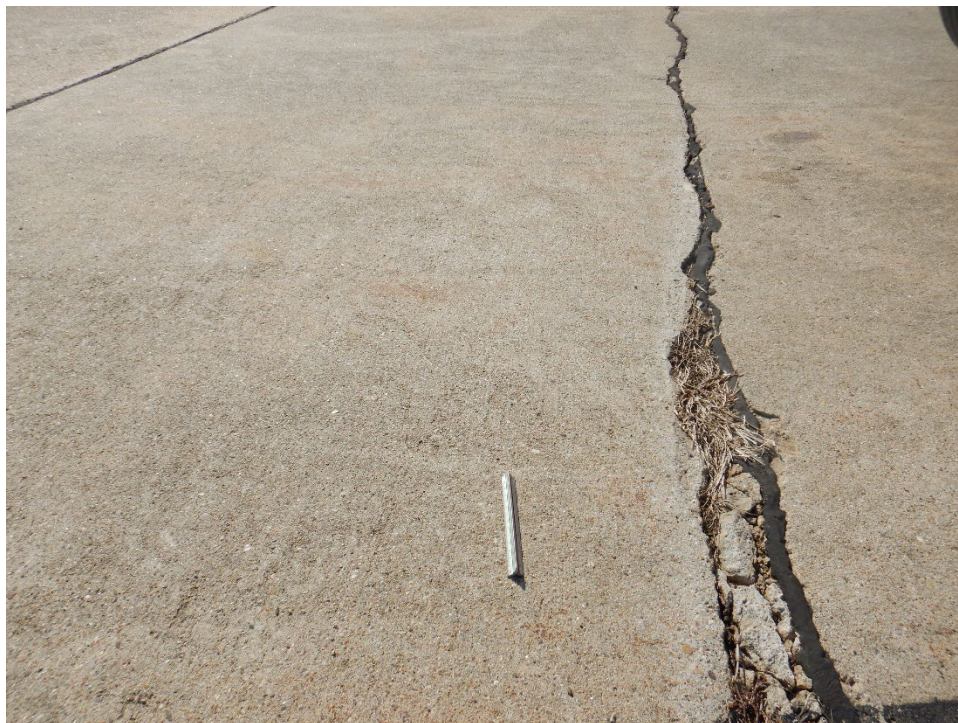
T02OS-02. LTD Cracking (Sample Unit No. 01) (1).

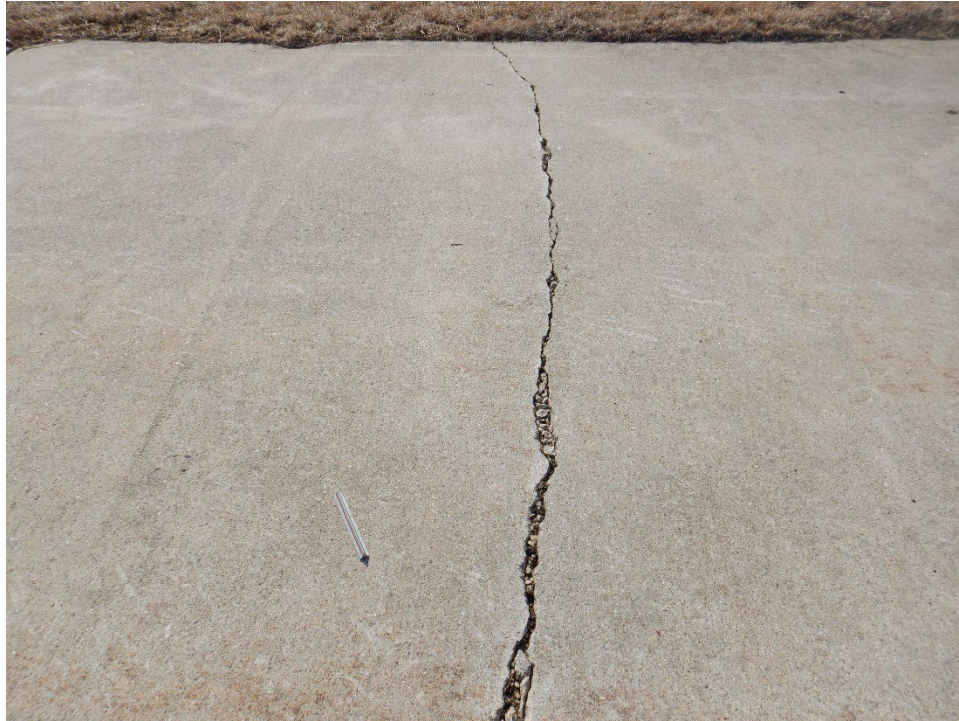
T02OS-02. LTD Cracking (Sample Unit No. 01) (2).

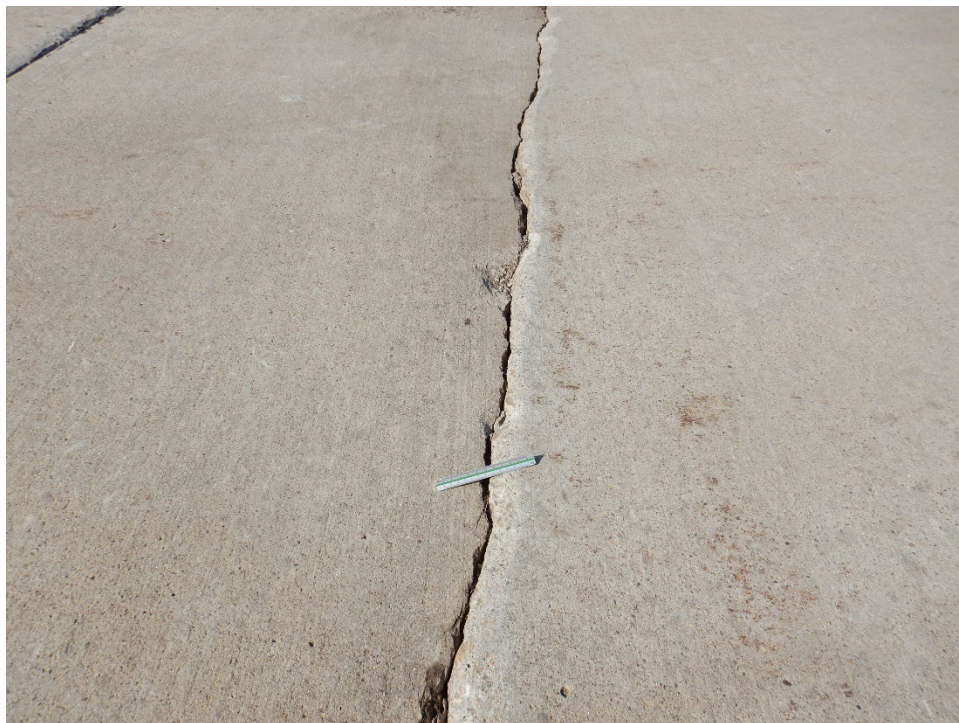
T02OS-02. LTD Cracking (Sample Unit No. 03).
