# Osceola Municipal Airport

## Pavement Management Report

**AUGUST 2025**

# OSCEOLA MUNICIPAL AIRPORT PAVEMENT MANAGEMENT REPORT

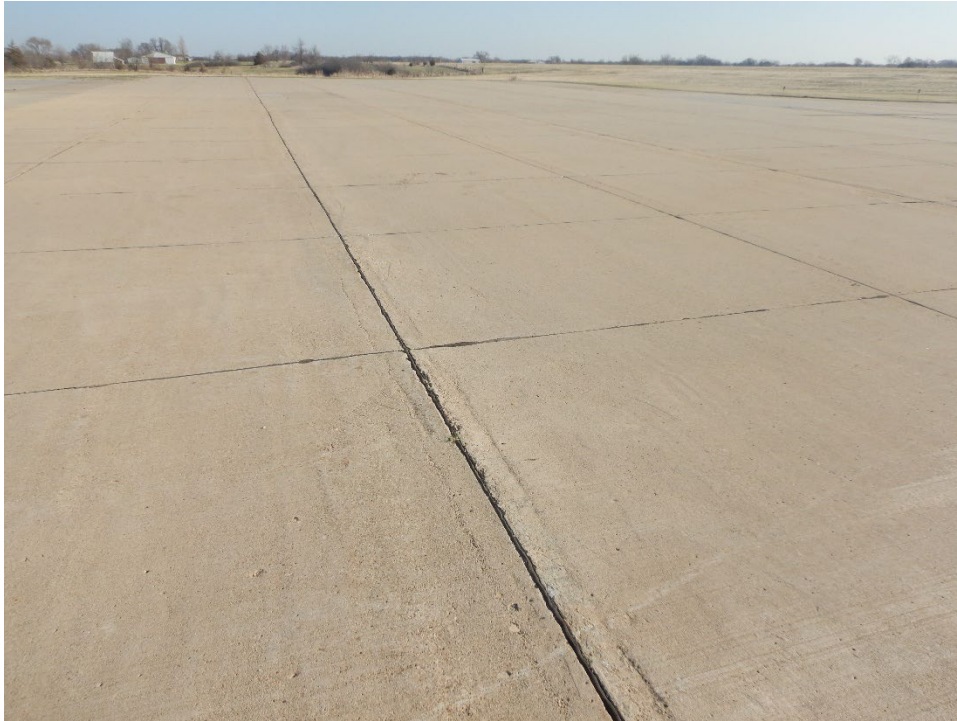
The apron area contained two sections. Section 01 was connected to Taxiway 01. In Section 01, low- and medium-severity ASR, corner break, and LTD cracking; all severities of corner spalling and shattered slab; low-severity faulting, small patching, and large patching; high-severity joint seal damage; medium-severity joint spalling; and shrinkage cracking were observed. Medium-severity corner break, shattered slab, and joint seal damage; low- and medium-severity corner spalling; and low-severity faulting and LTD cracking were noted in Section 02.

A01OA-01. Overview.

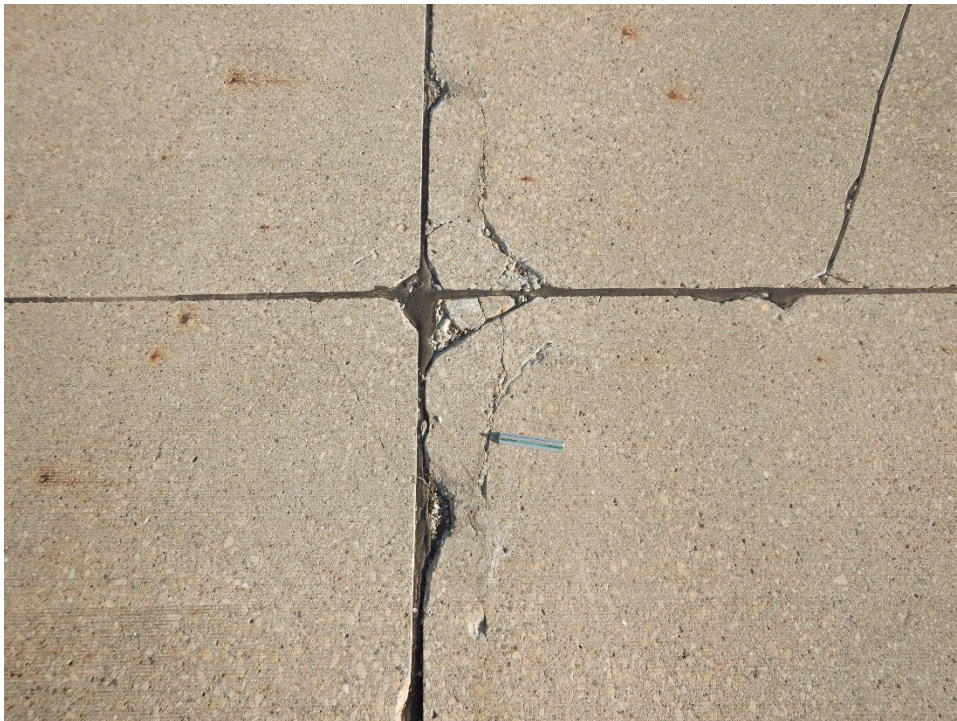
A01OA-01. ASR (Sample Unit No. 05).

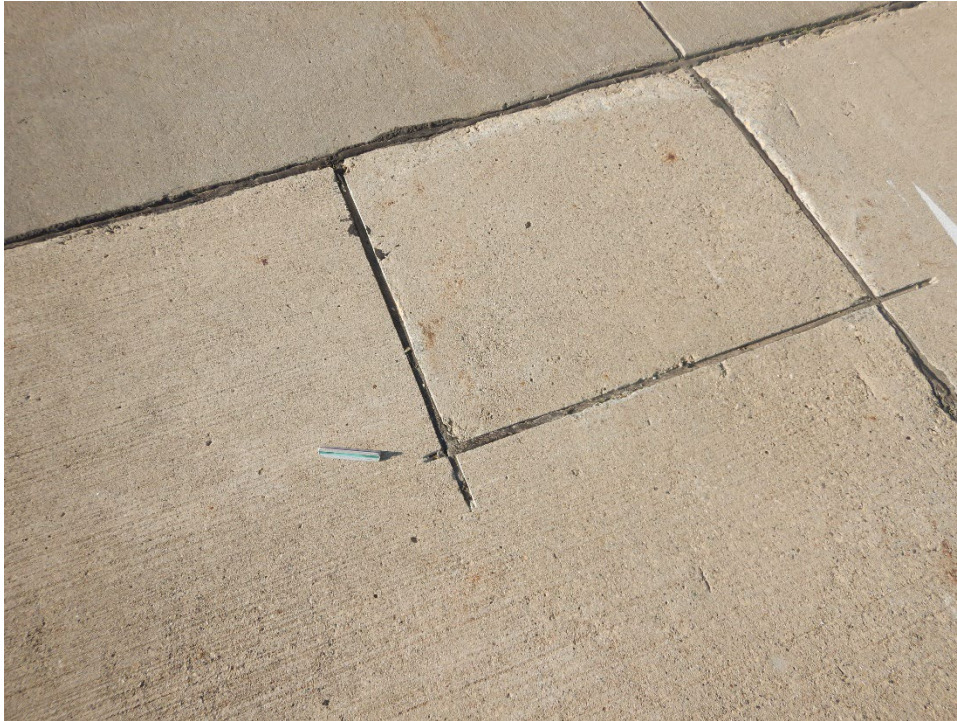
A01OA-01. Large Patching (Sample Unit No. 05).

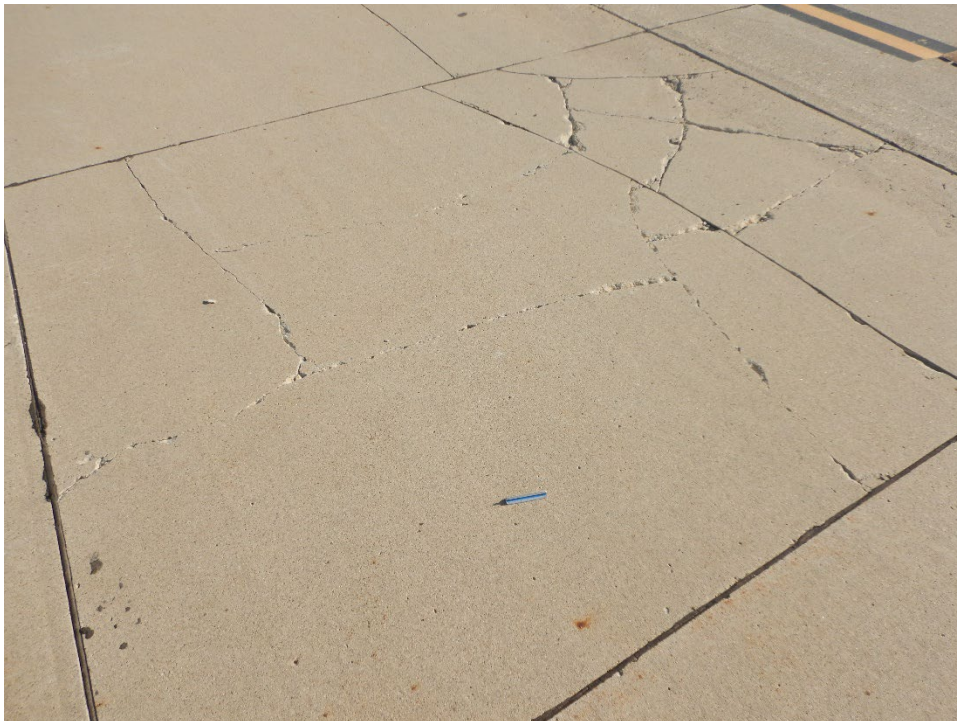
A01OA-01. Shattered Slab (Sample Unit No. 01).

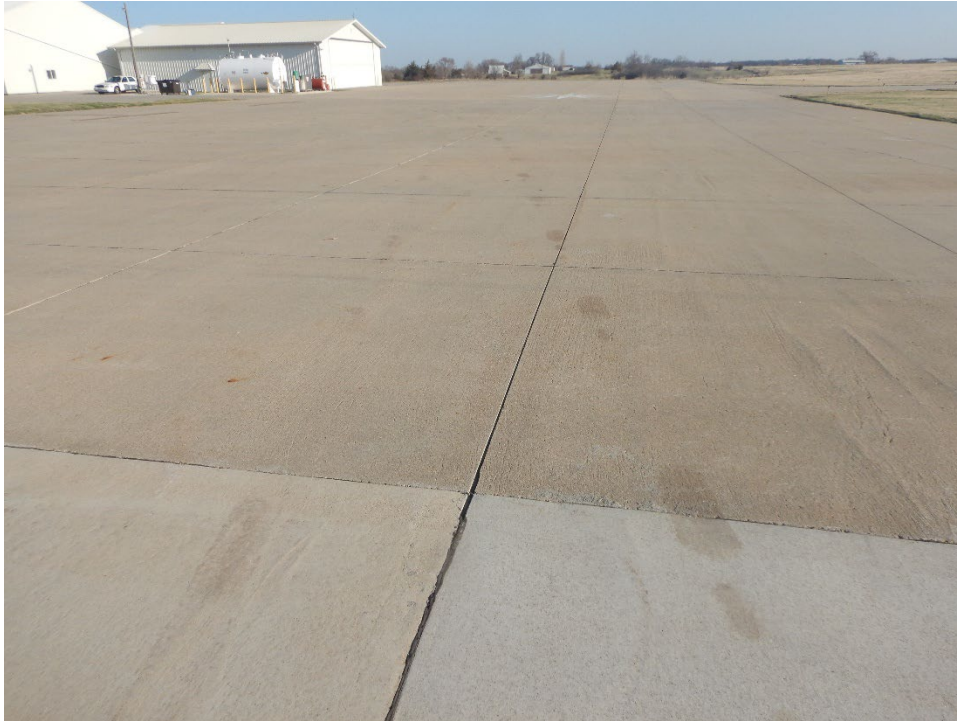
A010A-02. Overview.

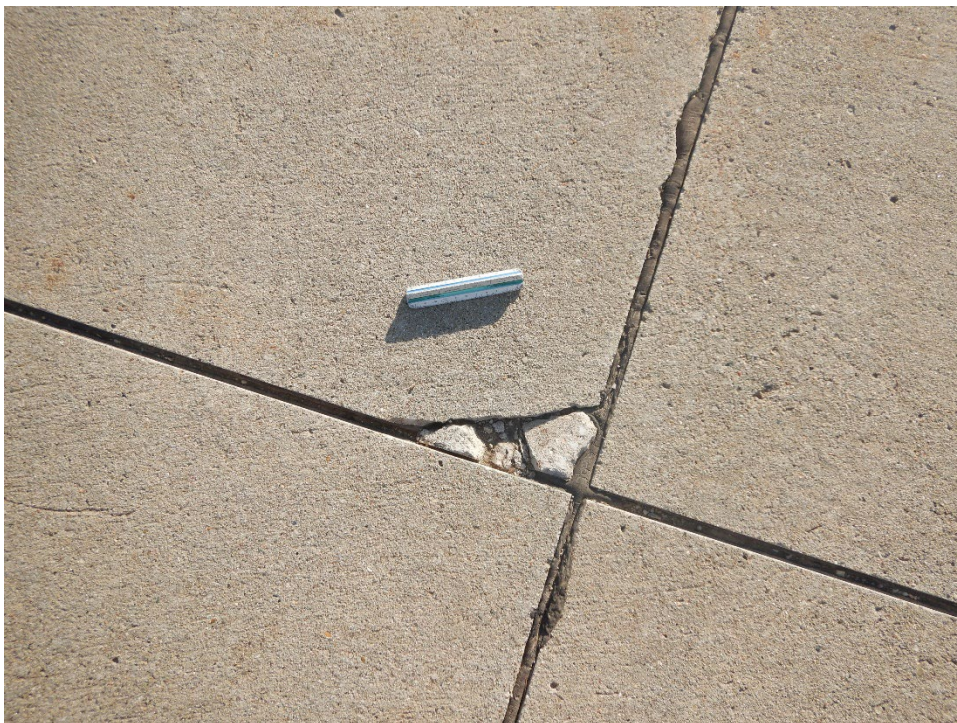
A010A-02. Corner Spalling (Sample Unit No. 06).

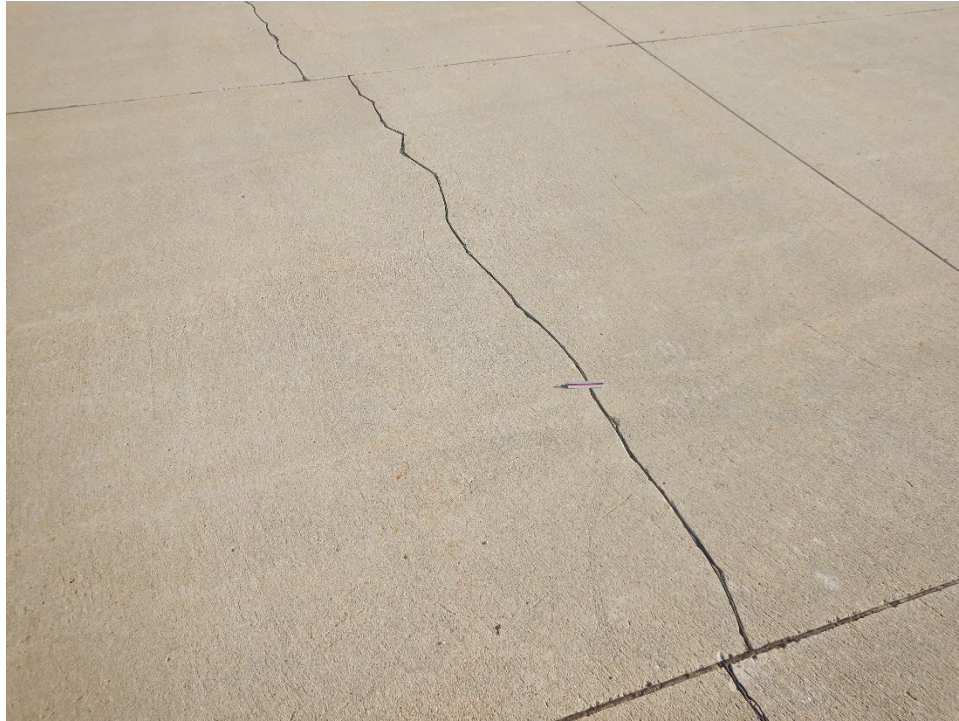
A01OA-02. LTD Cracking (Sample Unit No. 06).

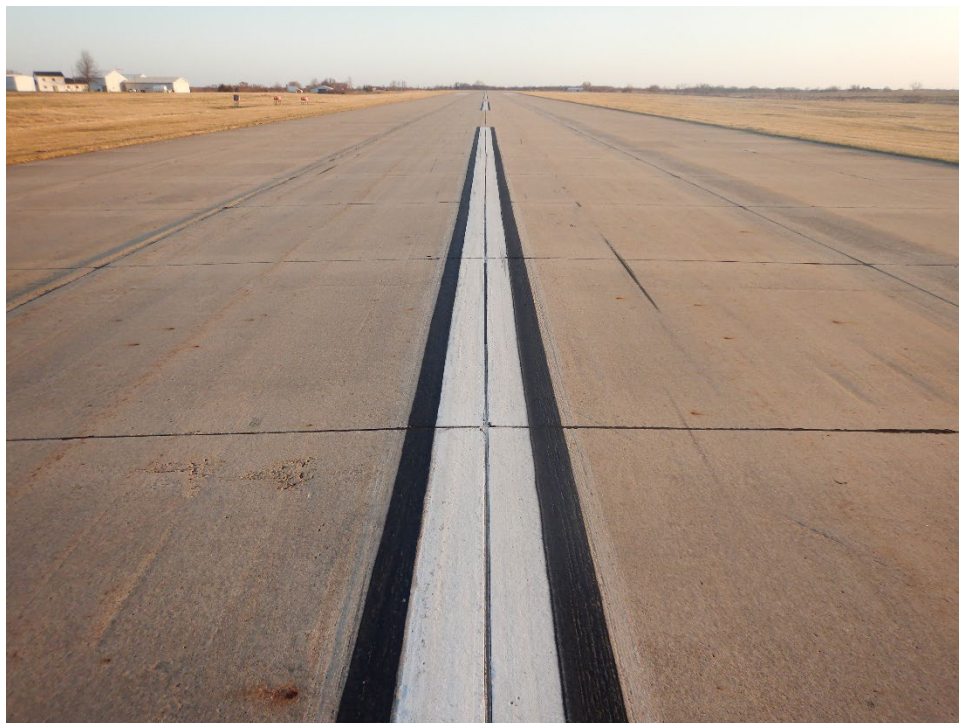
Runway 18/36 consisted of one section that had low-severity ASR, small patching, and joint seal damage; medium-severity corner break; all severities of corner spalling; low- and medium-severity faulting; and medium- and high-severity joint spalling.

R18OA-01. Overview.

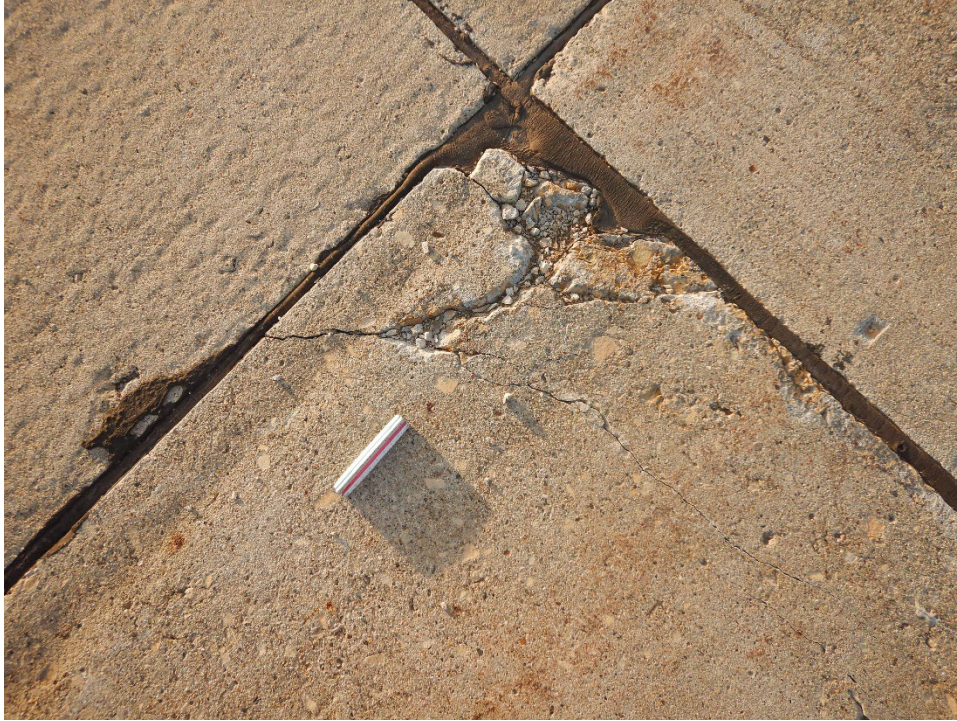
R18OA-01. Corner Spalling (Sample Unit No. 39).

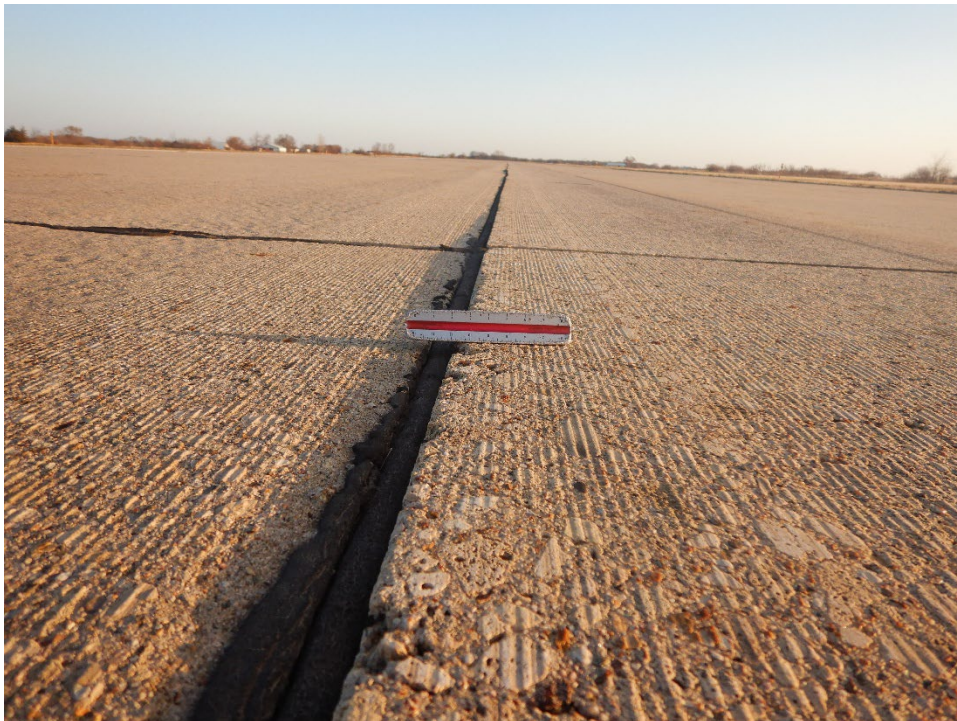
R18OA-01. Faulting (Sample Unit No. 57).

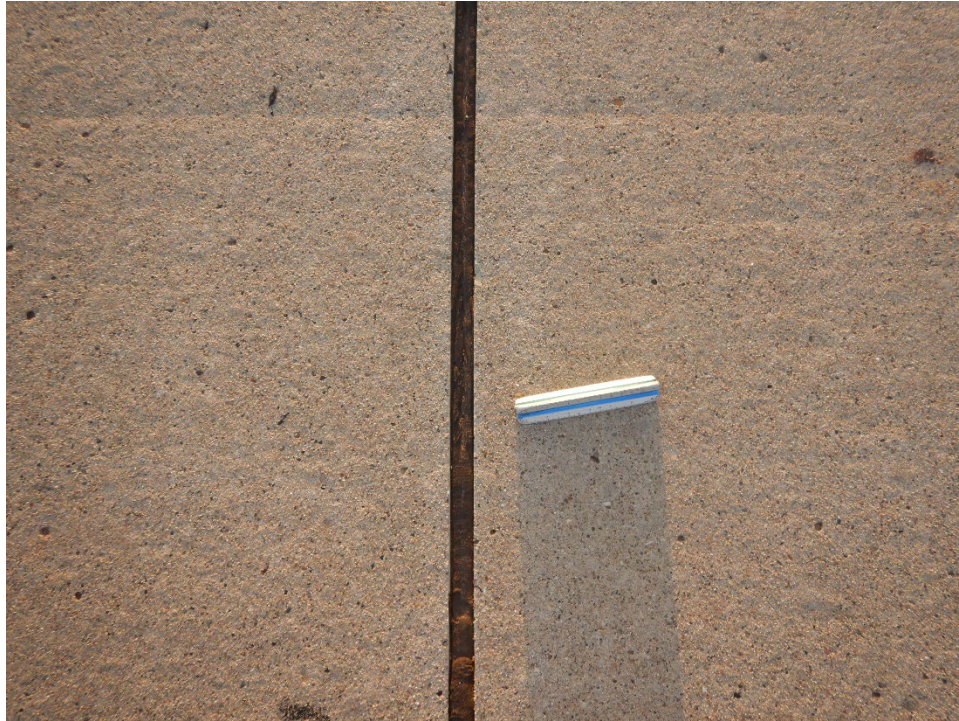
R18OA-01. Joint Seal Damage (Sample Unit No. 75).

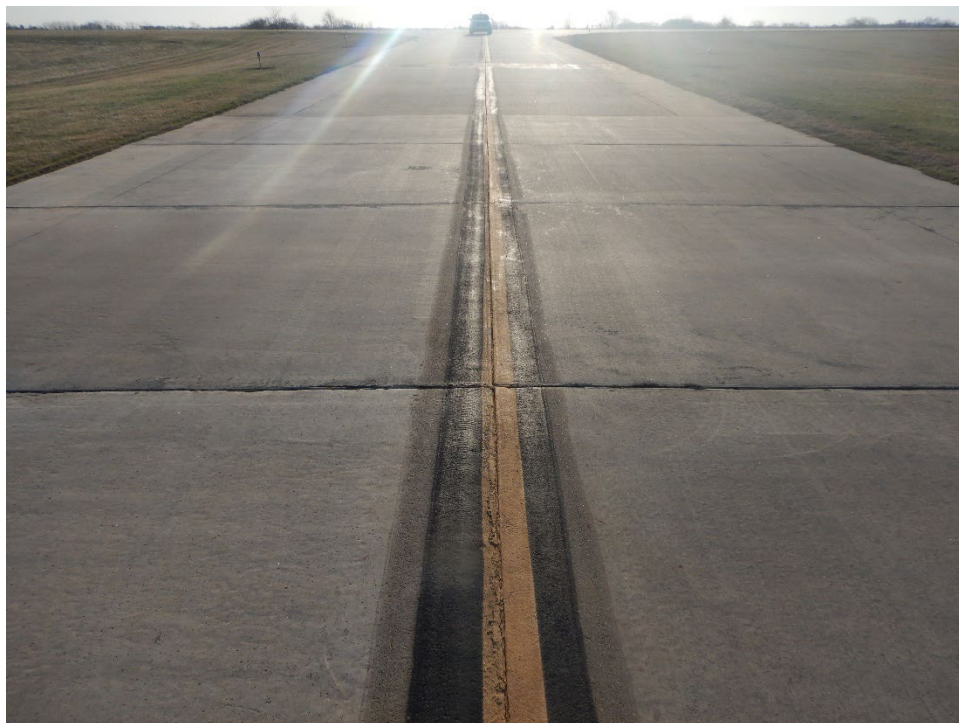
The taxiway was comprised of two sections. Section 01 connected the main apron to Runway 18/36 and was in *Excellent* condition. Low-severity joint seal damage; low-severity longitudinal, transverse, and diagonal (LTD) cracking; and shrinkage cracking were identified. An atypical area of medium-severity corner break, medium-severity corner spalling, and low-severity small patching was observed and recorded as an additional sample unit in accordance with ASTM D5340. Section 02 was recently constructed and also in *Excellent* condition with no distress noted at the time of inspection.

T01OA-01. Overview.

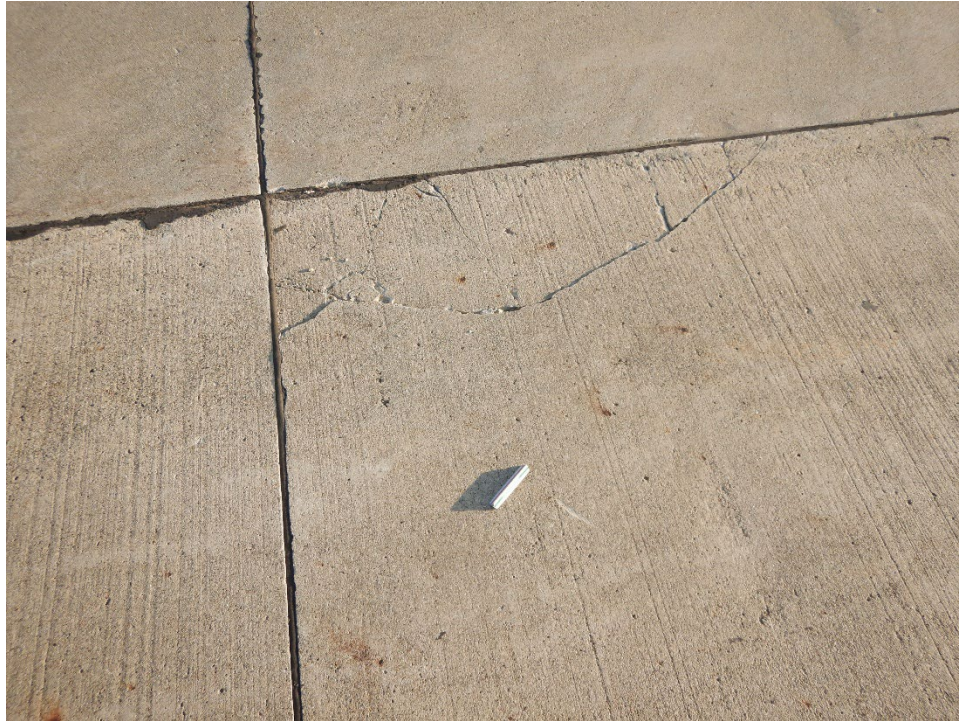
T01OA-01. Corner Spalling (Additional Sample Unit No. 06).

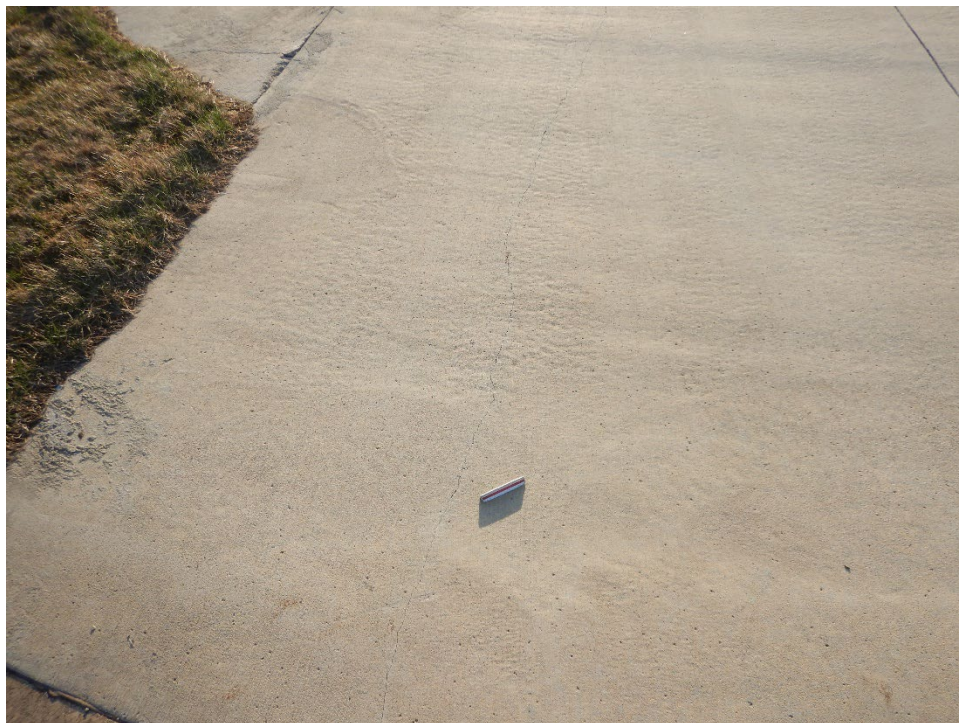
T01OA-01. LTD Cracking (Sample Unit No. 02).

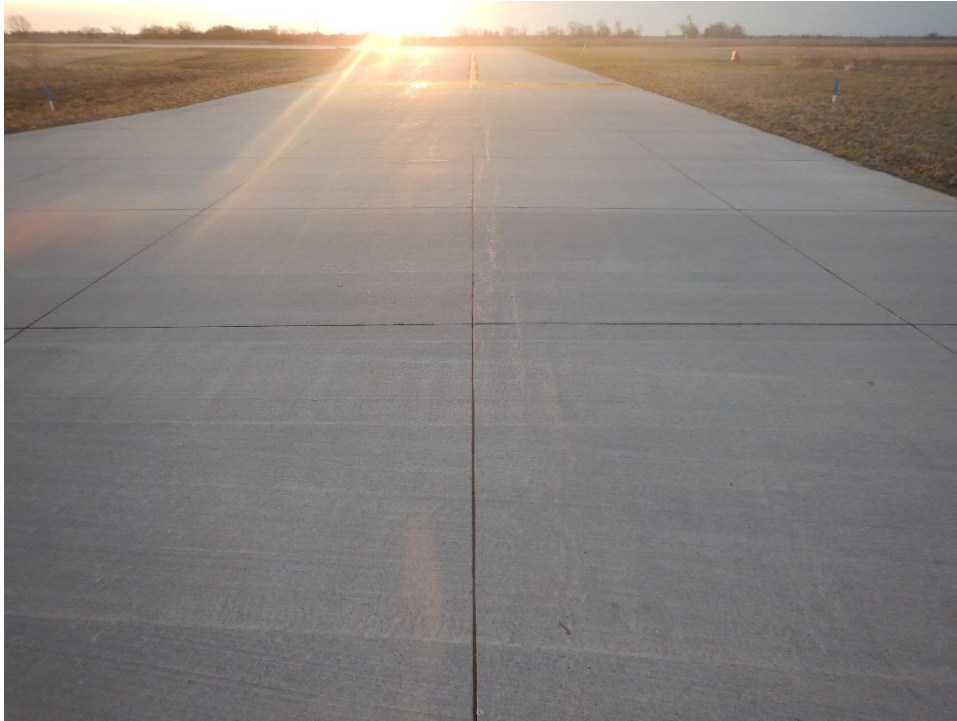
T010A-02. Overview.

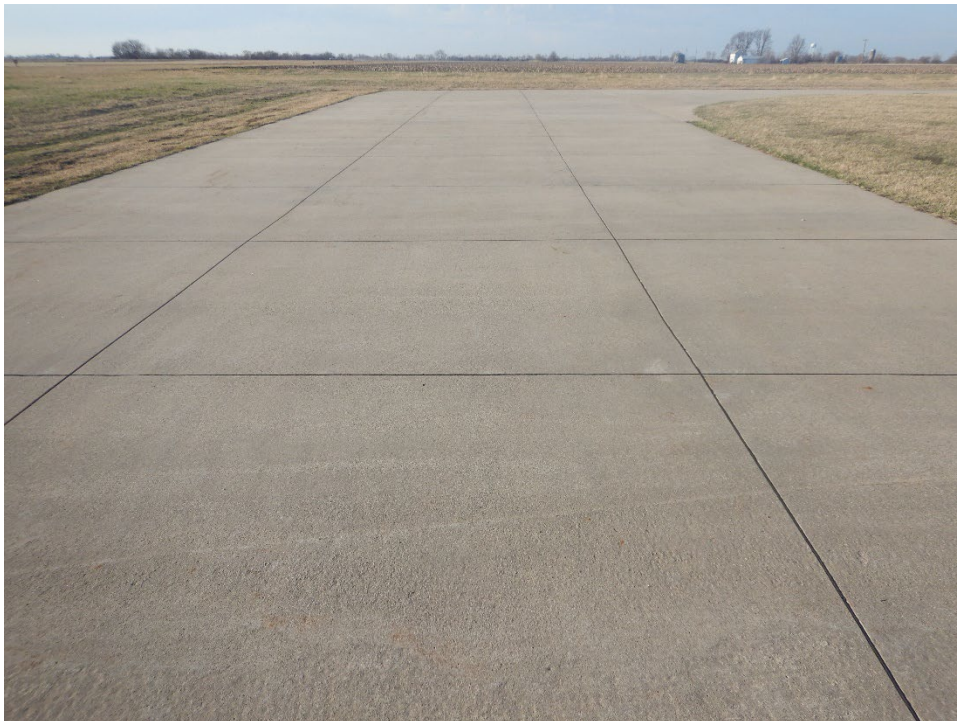
T-hangar 01 was comprised of two sections. Low-severity ASR, corner spalling, faulting, and joint seal damage were recorded in Section 01. In Section 02, low-severity ASR, corner break, and faulting; high-severity joint seal damage; and medium-severity joint spalling were observed. An atypical area of low-severity LTD cracking was observed and recorded as an additional sample unit in accordance with ASTM D5340.

TH010A-01. Overview.

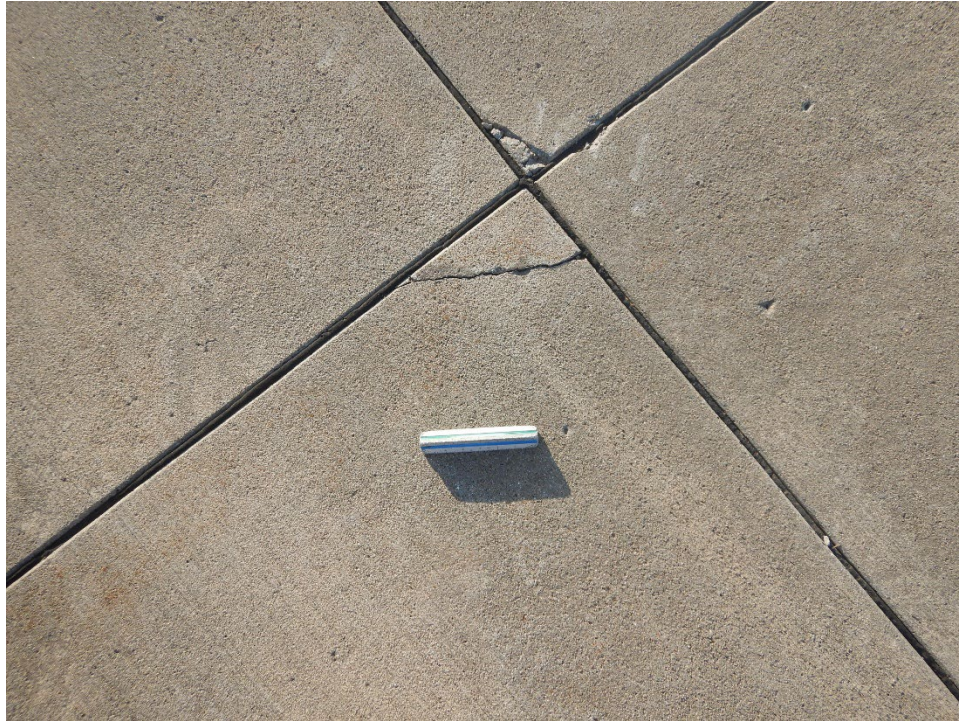
TH01OA-01. Corner Spalling (Sample Unit No. 02).

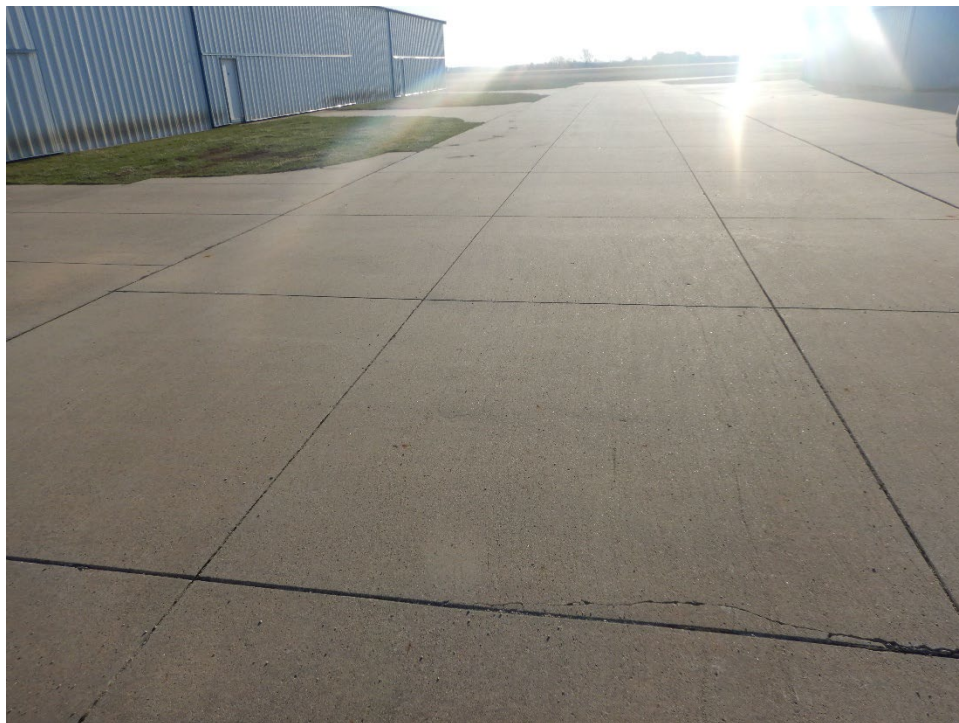
TH01OA-02. Overview.

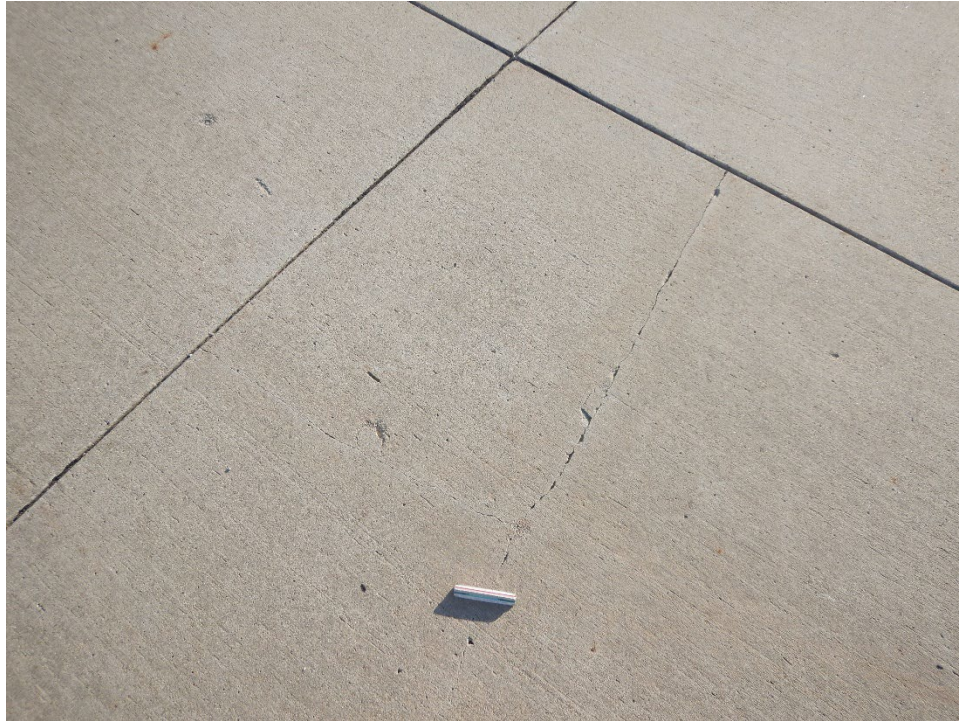
TH01OA-02. Corner Break (Sample Unit No. 02).

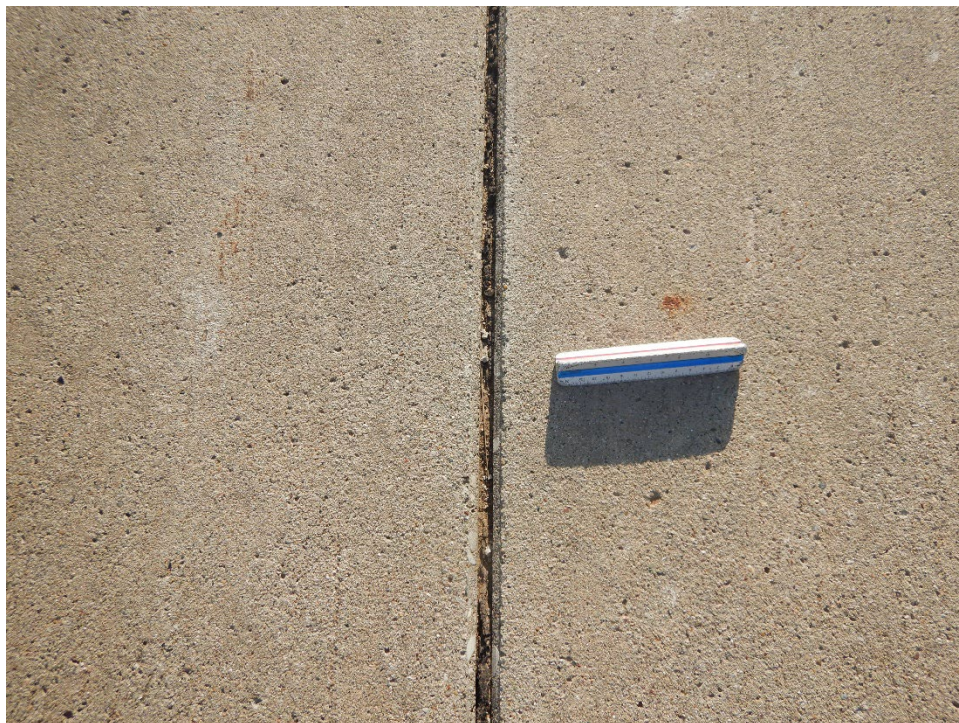
TH01OA-02. Joint Seal Damage (Sample Unit No. 06).

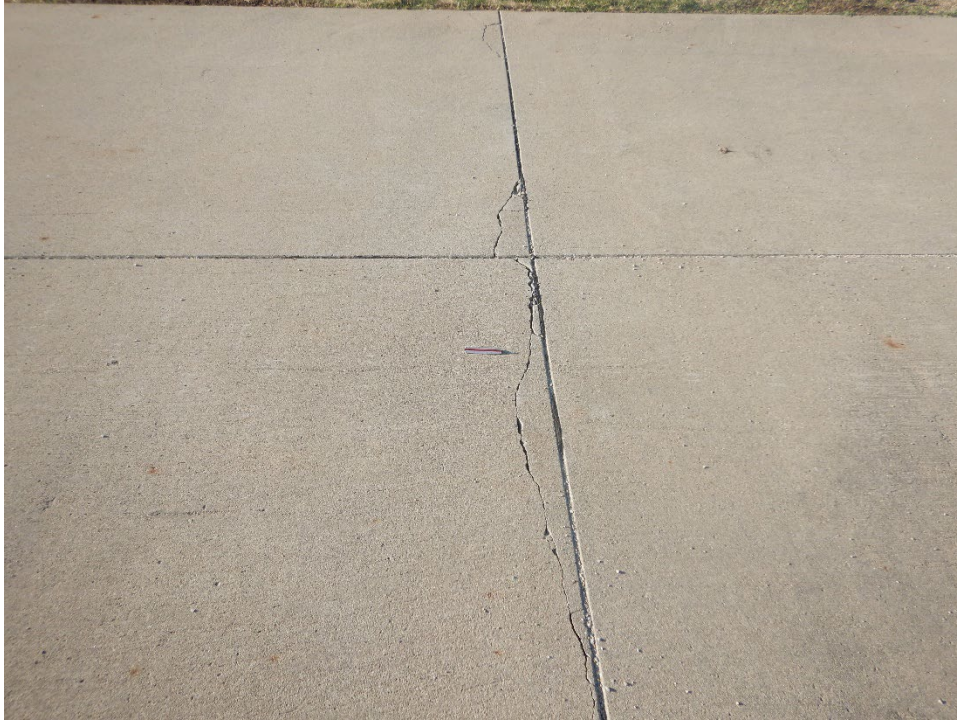
TH01OA-02. Joint Spalling (Additional Sample Unit No. 07).

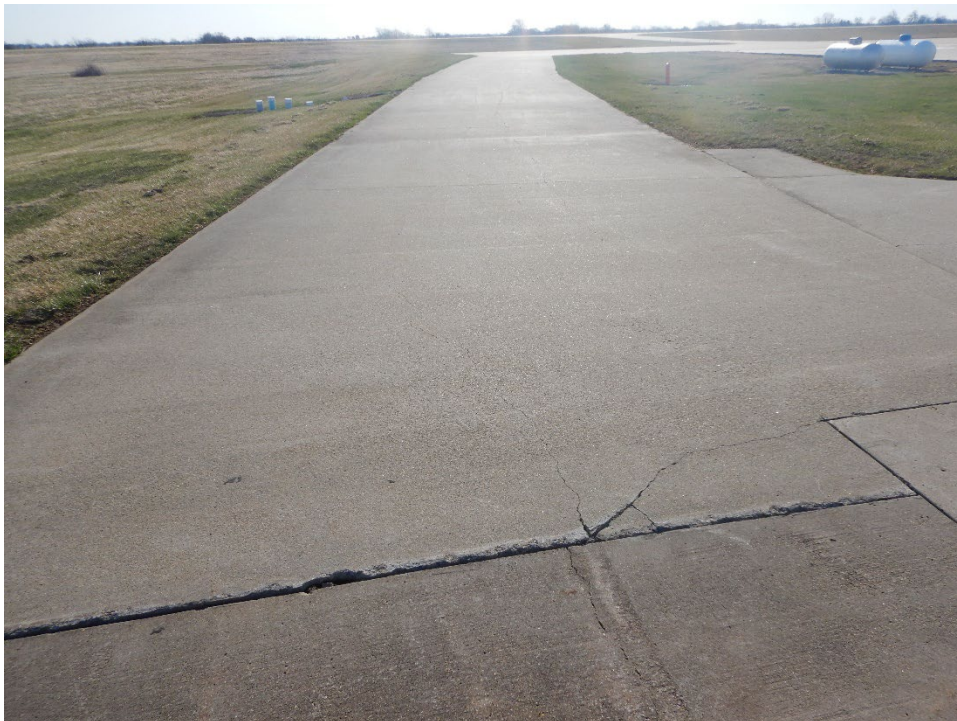
T-hangar 02 consisted of two sections. Section 01 was in *Poor* condition and had a variety of distress that included low-severity ASR, corner break, corner spalling, faulting, and large patching; high-severity joint seal damage; medium-severity joint spalling; low- and medium-severity LTD cracking, shattered slab, and small patching; and pumping. Section 02 was in *Excellent* condition with only low-severity ASR and joint seal damage recorded.

TH02OA-01. Overview.

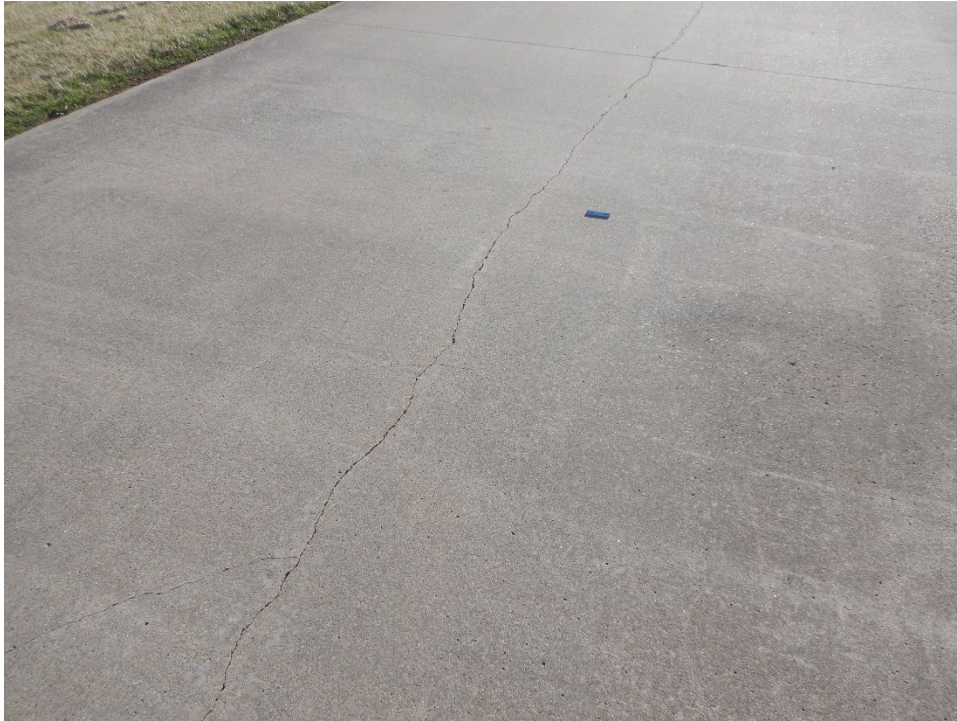
TH02OA-01. LTD Cracking (Sample Unit No. 01).

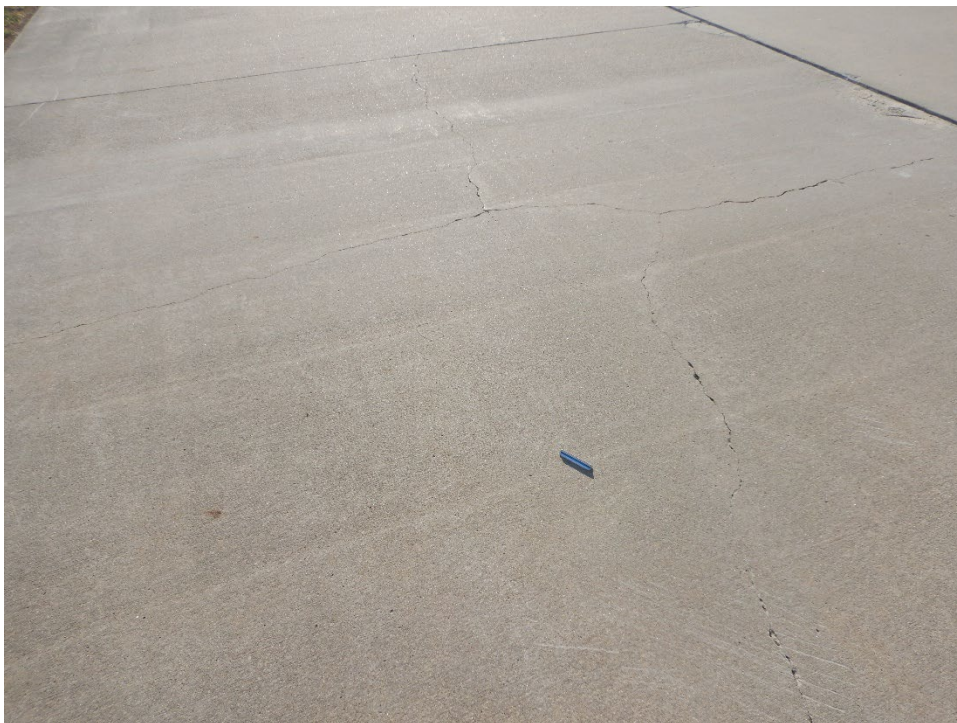
TH02OA-01. Shattered Slab (Sample Unit No. 01).

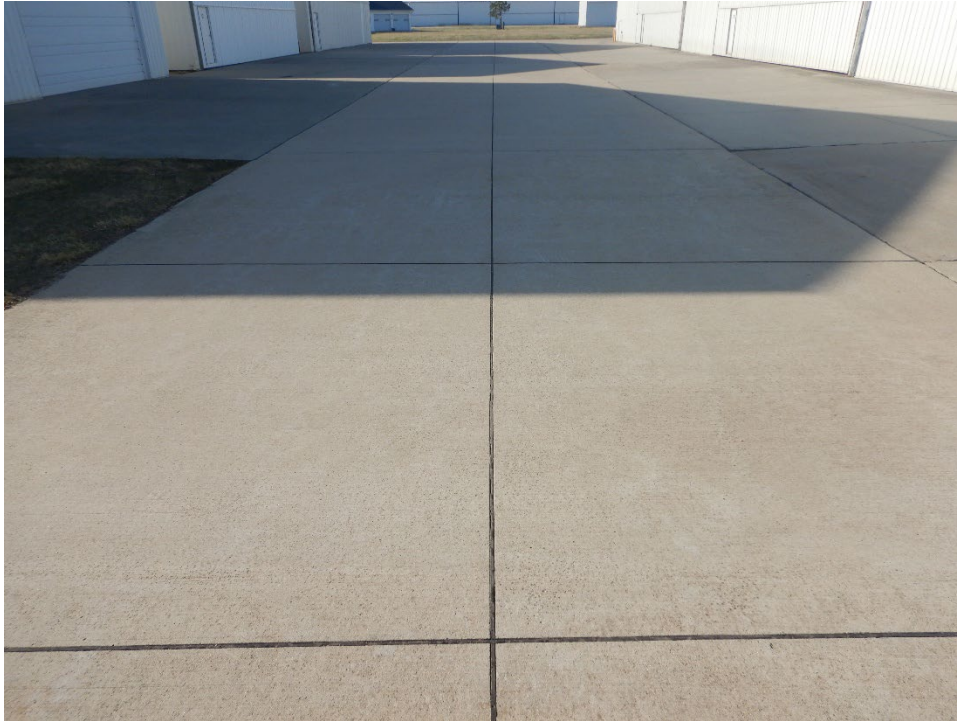
TH02OA-02. Overview.

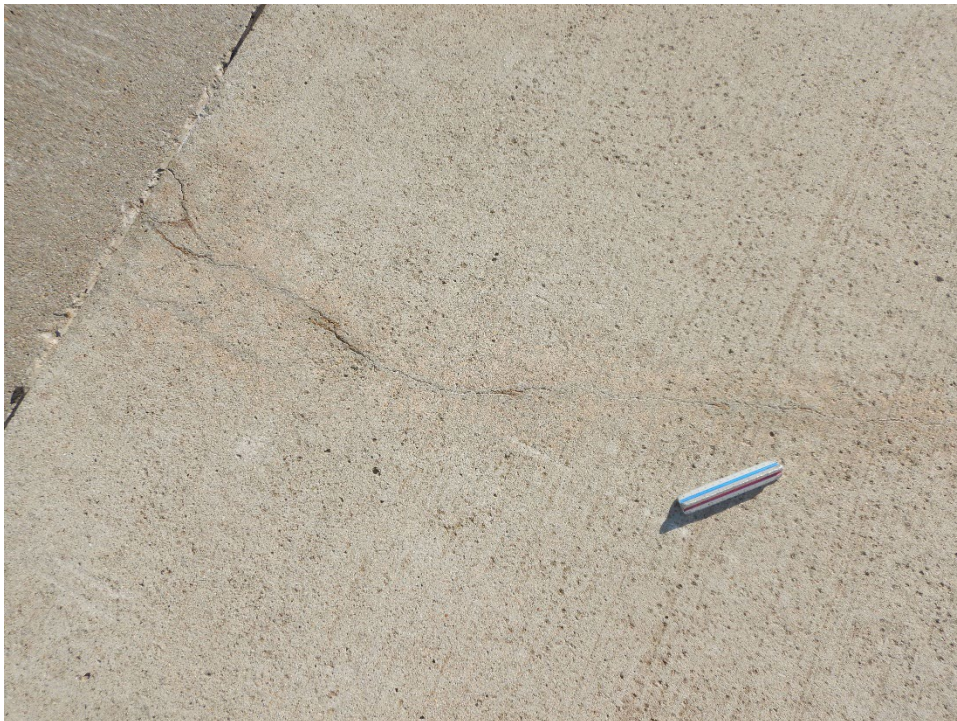
TH02OA-02. ASR (Sample Unit No. 02).
