# Oskaloosa Municipal Airport

## Pavement Management Report

**AUGUST 2025**

# OSKALOOSA MUNICIPAL AIRPORT PAVEMENT MANAGEMENT REPORT

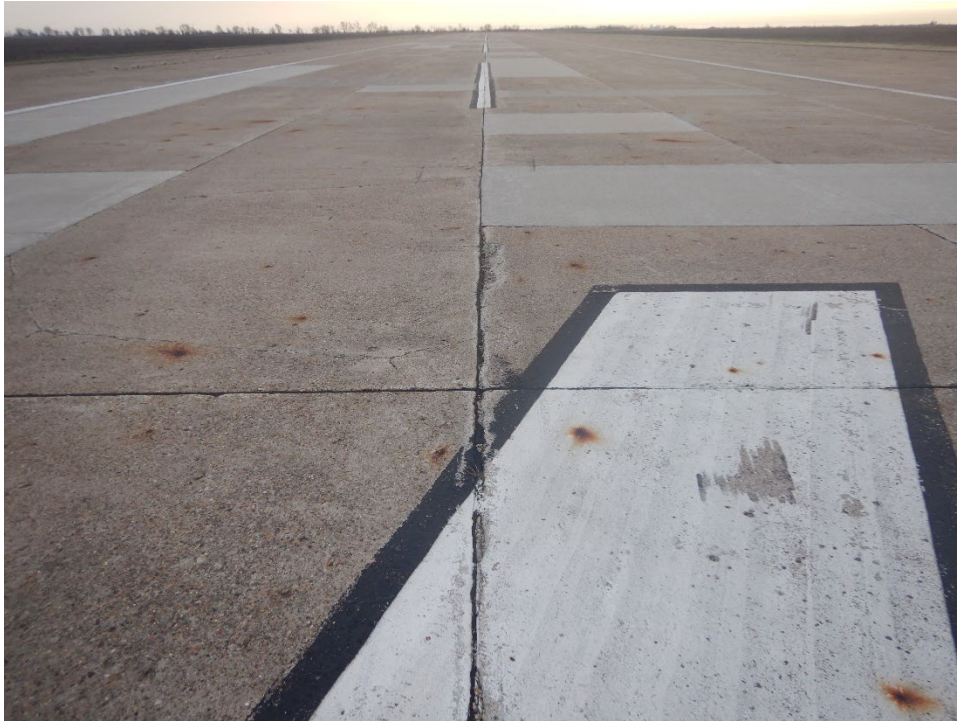
R04OK-01. Overview.

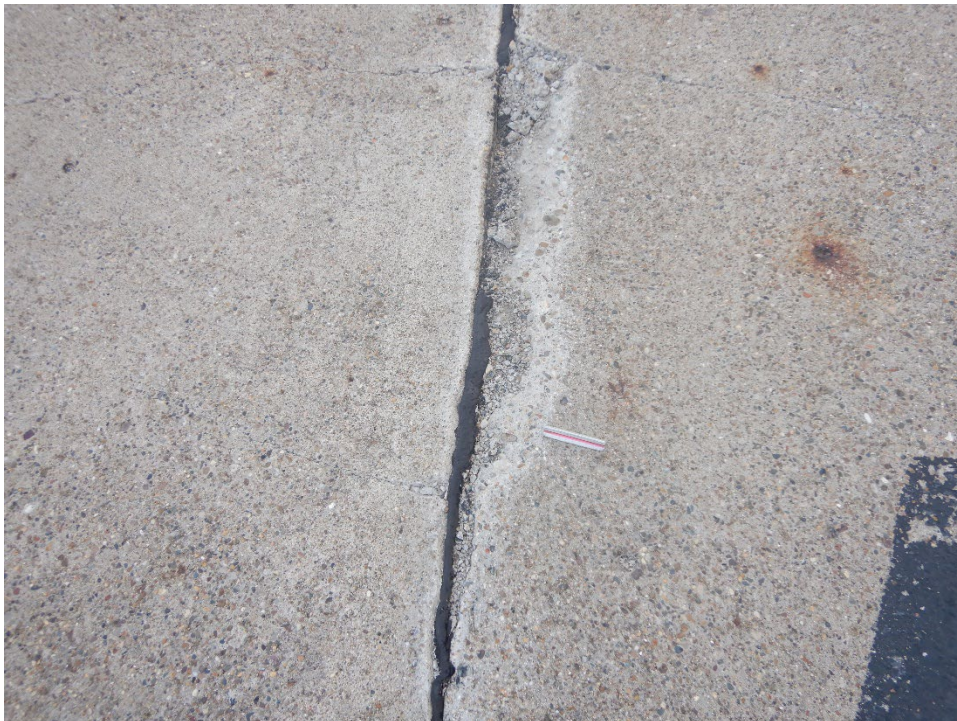
R04OK-01. Joint Spalling (Sample Unit No. 04).

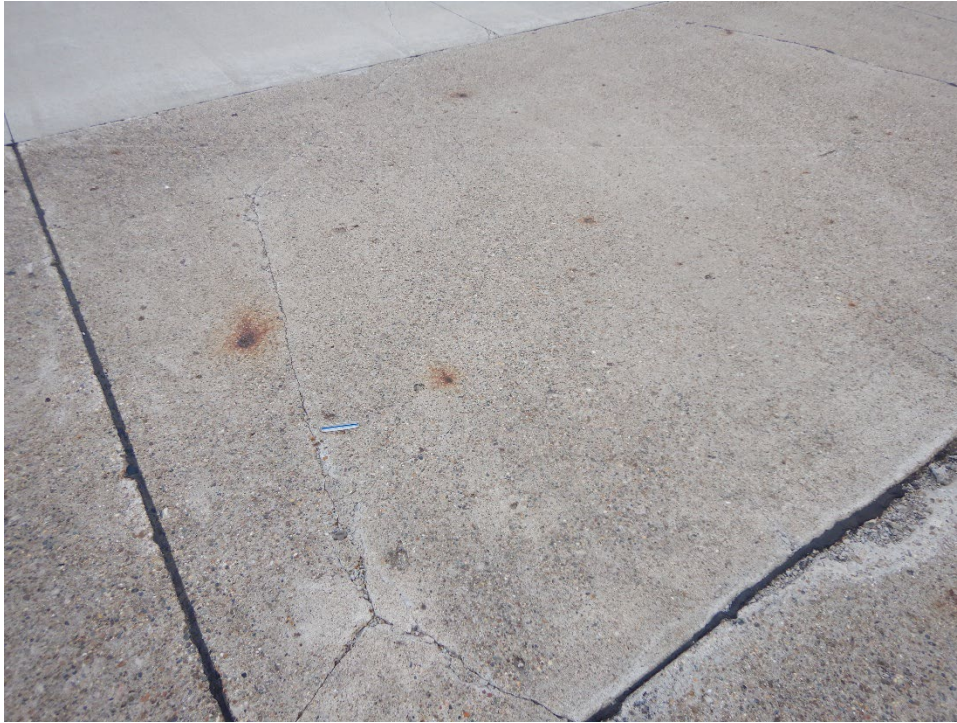
R04OK-01. Shattered Slab (Sample Unit No. 04).

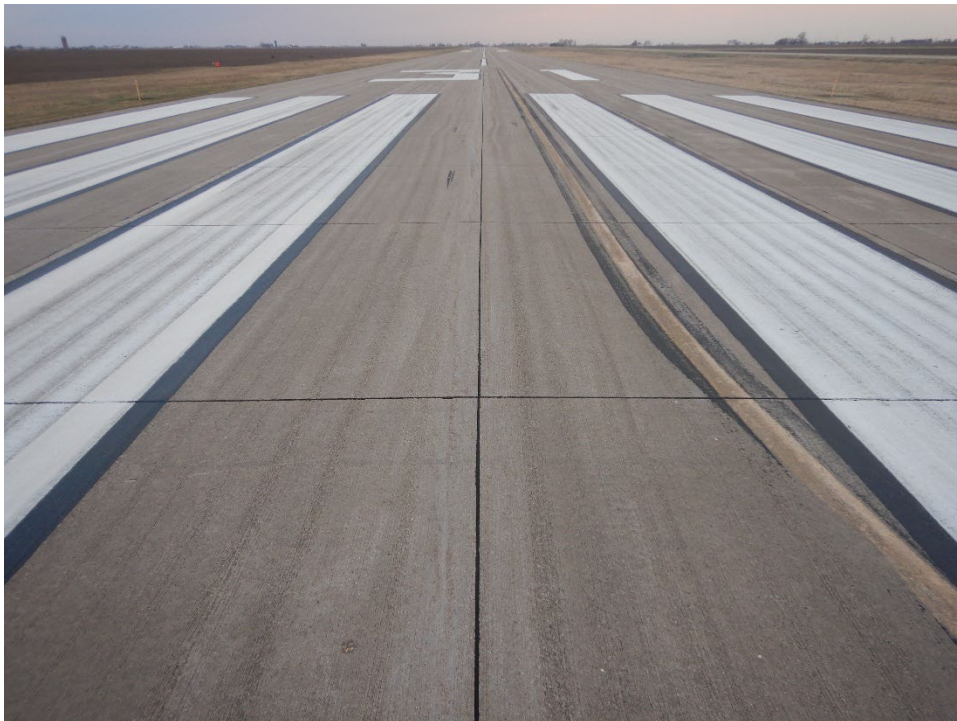
R13OK-01. Overview.

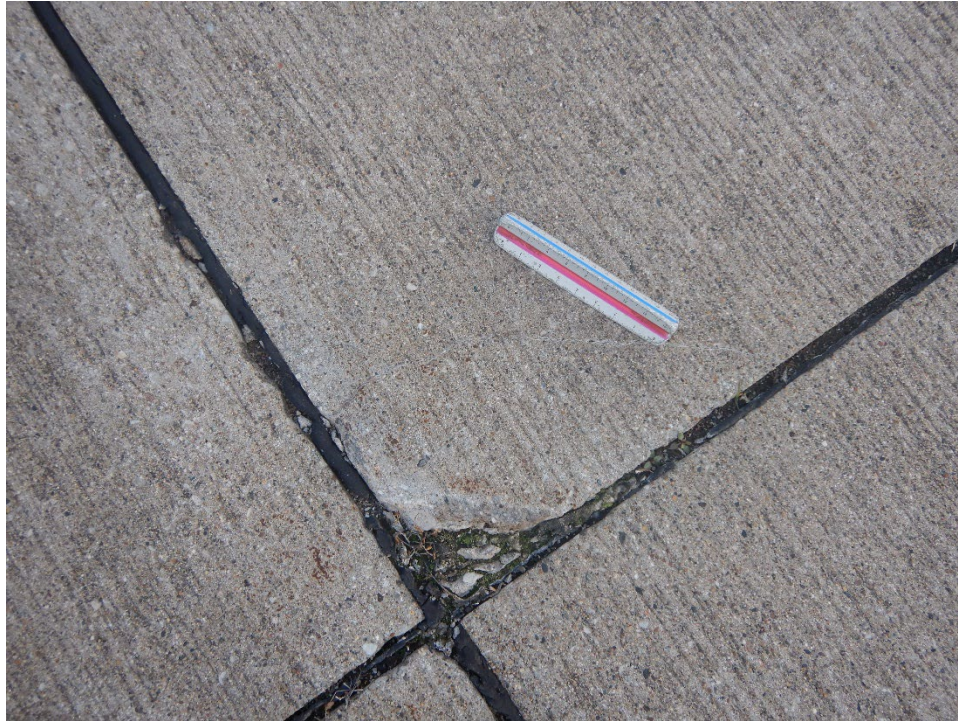
R13OK-01. ASR (Additional Sample Unit No. 66).

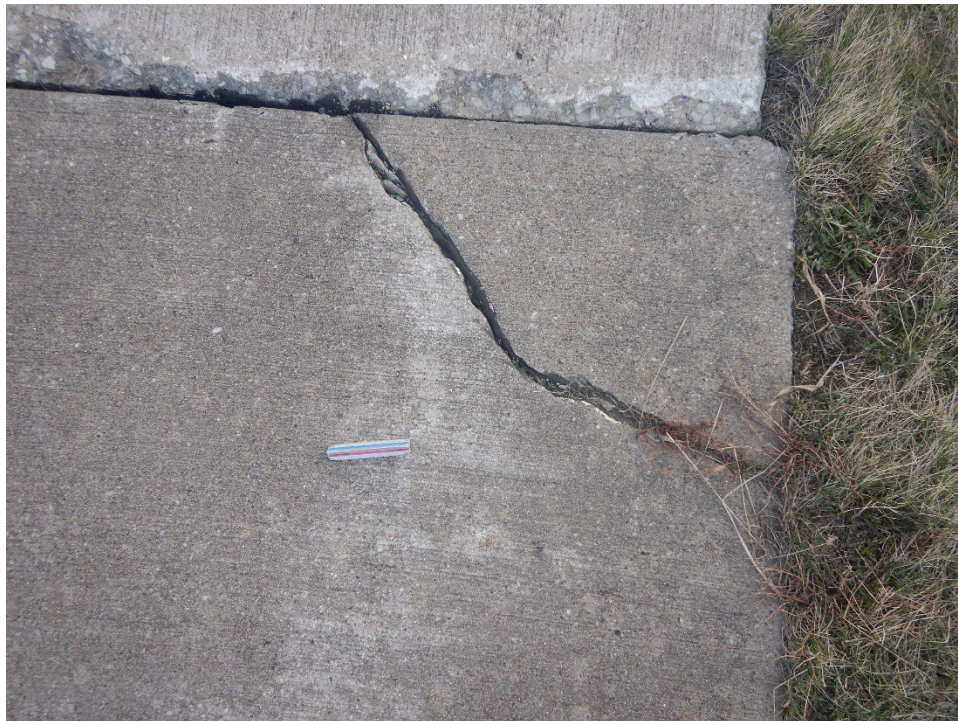
R13OK-01. Corner Break (Sample Unit No. 01).

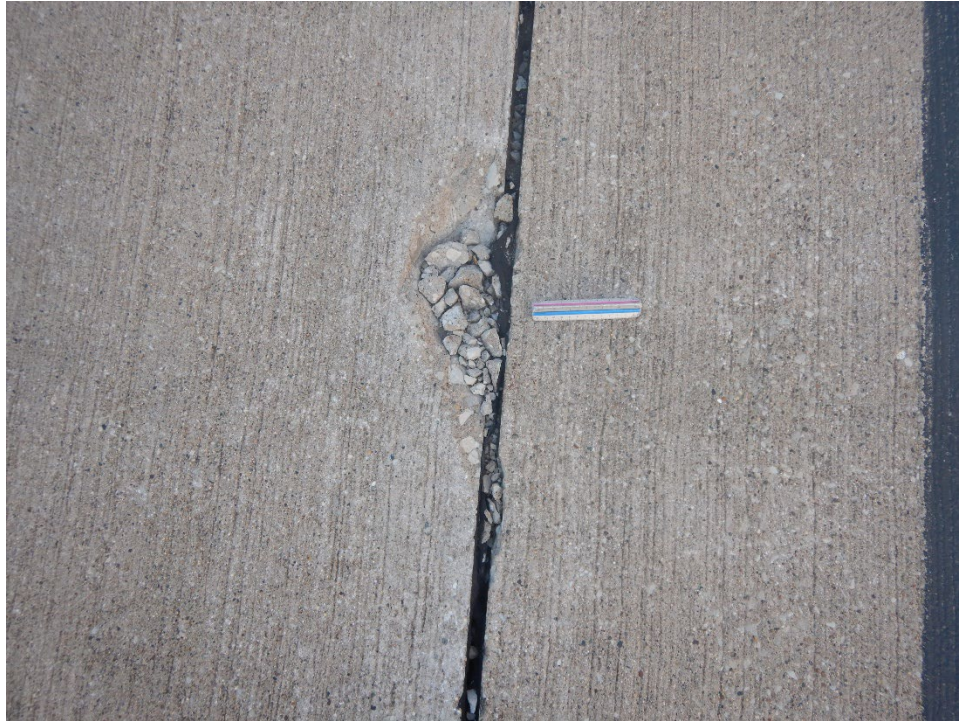
R13OK-01. Joint Spalling (Sample Unit No. 01).

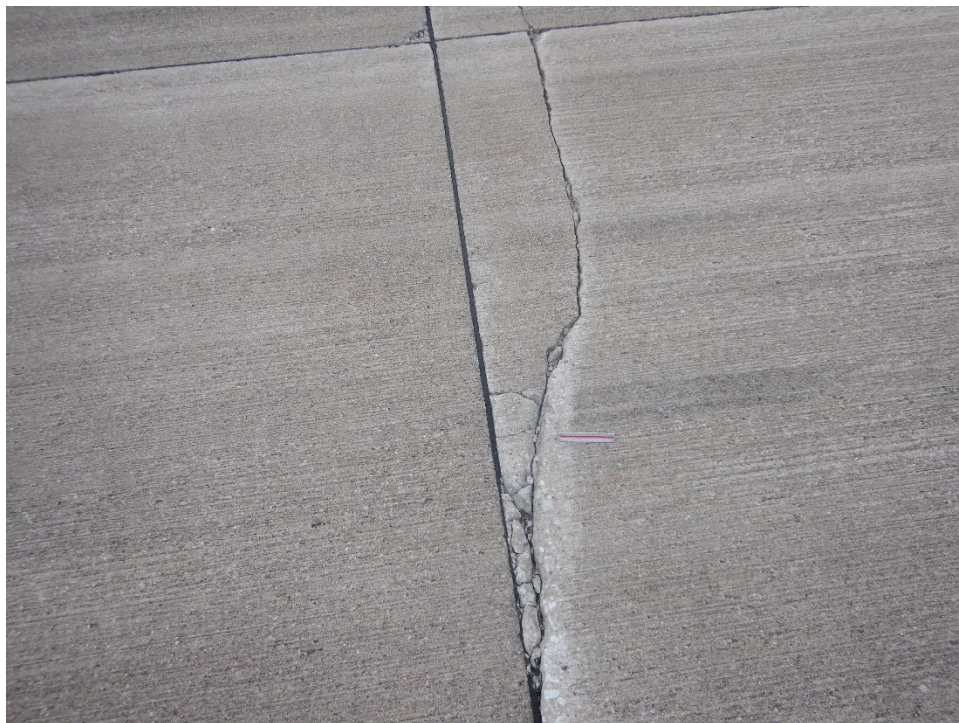
R13OK-01. LTD Cracking (Additional Sample Unit No. 66).

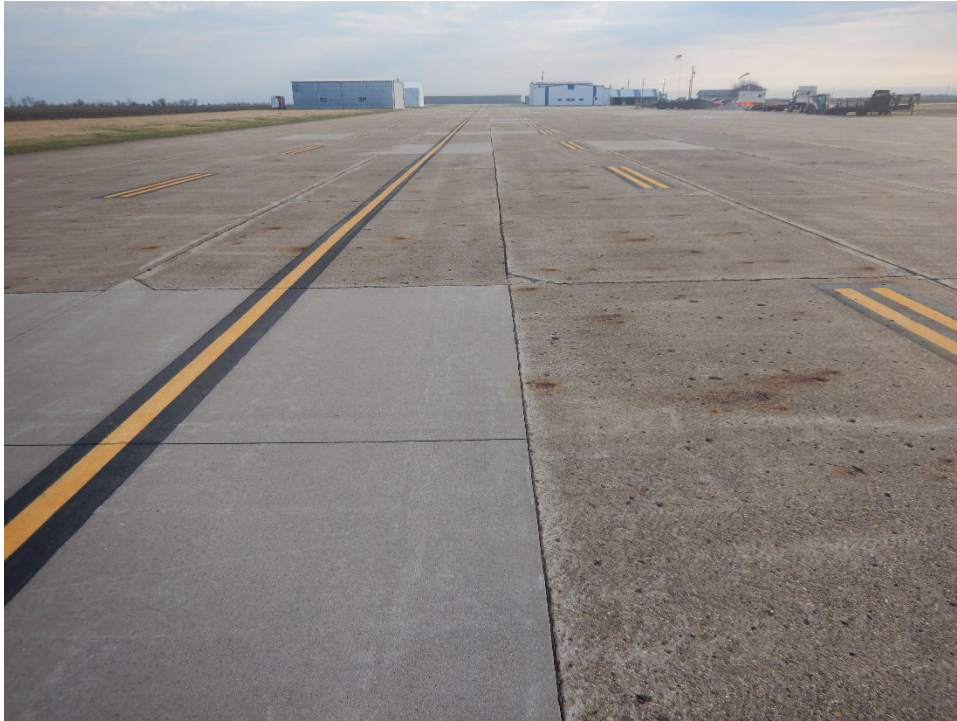
T01OK-01. Overview.

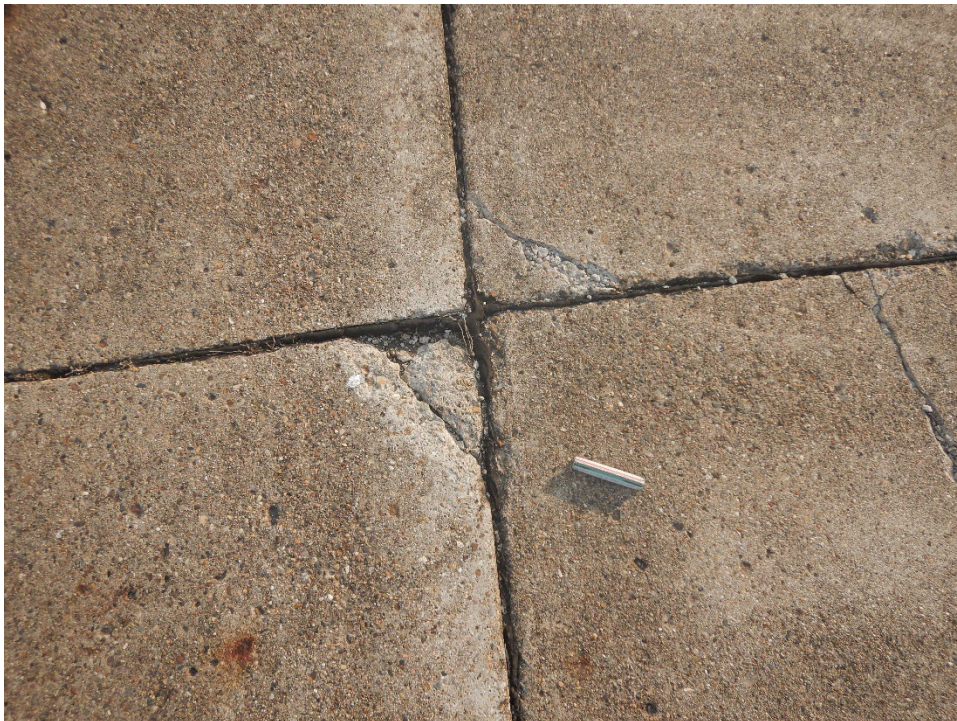
T01OK-01. Corner Spalling (Sample Unit No. 08).

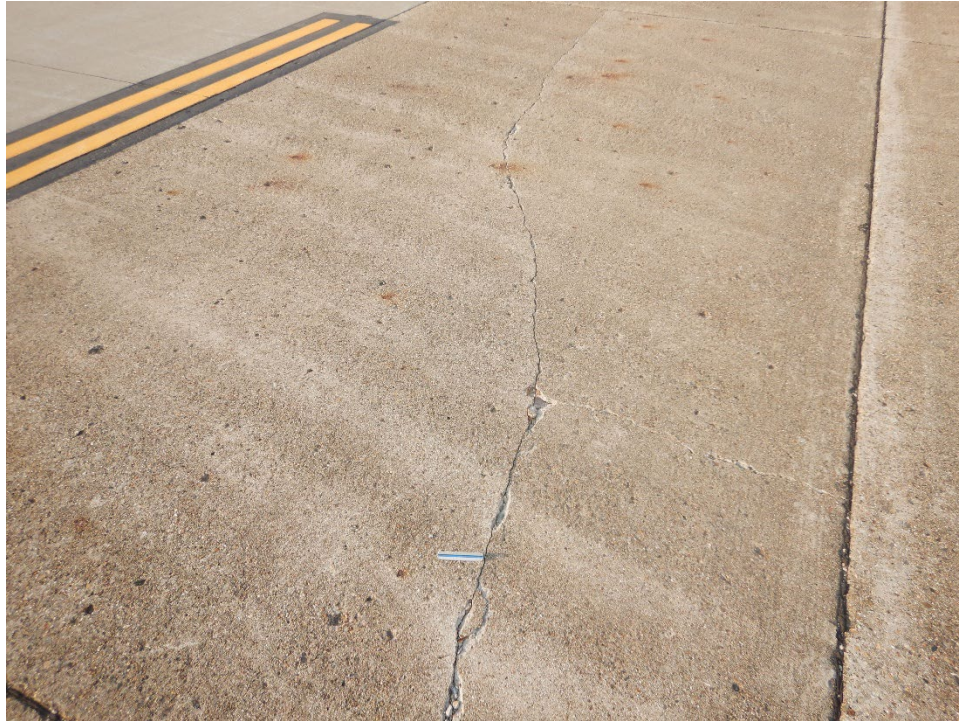
T01OK-01. LTD Cracking (Sample Unit No. 08).

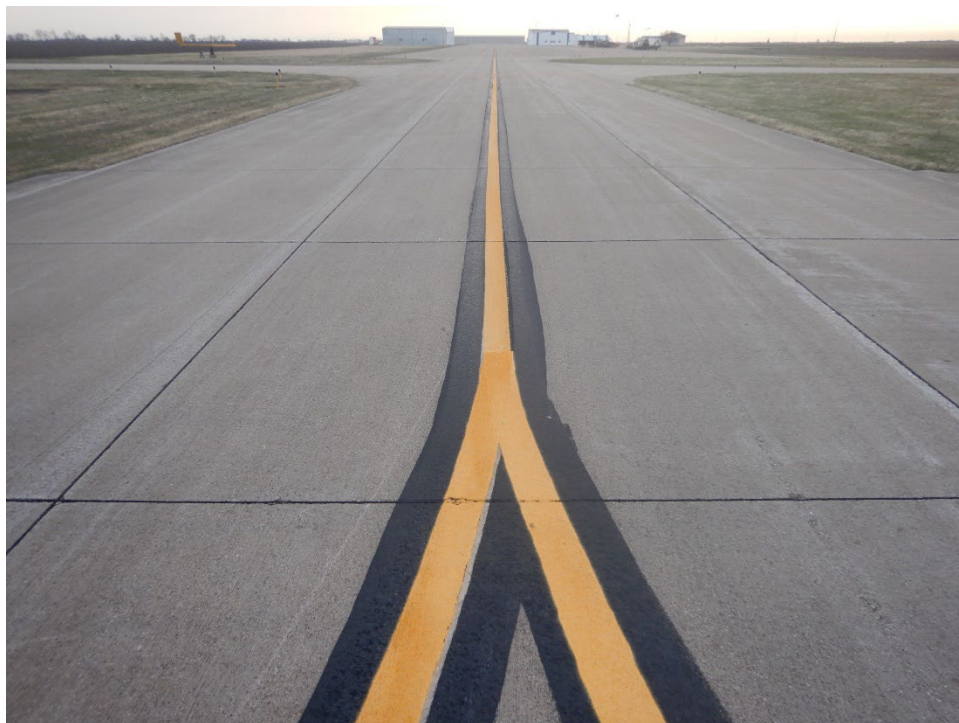
T01OK-02. Overview.

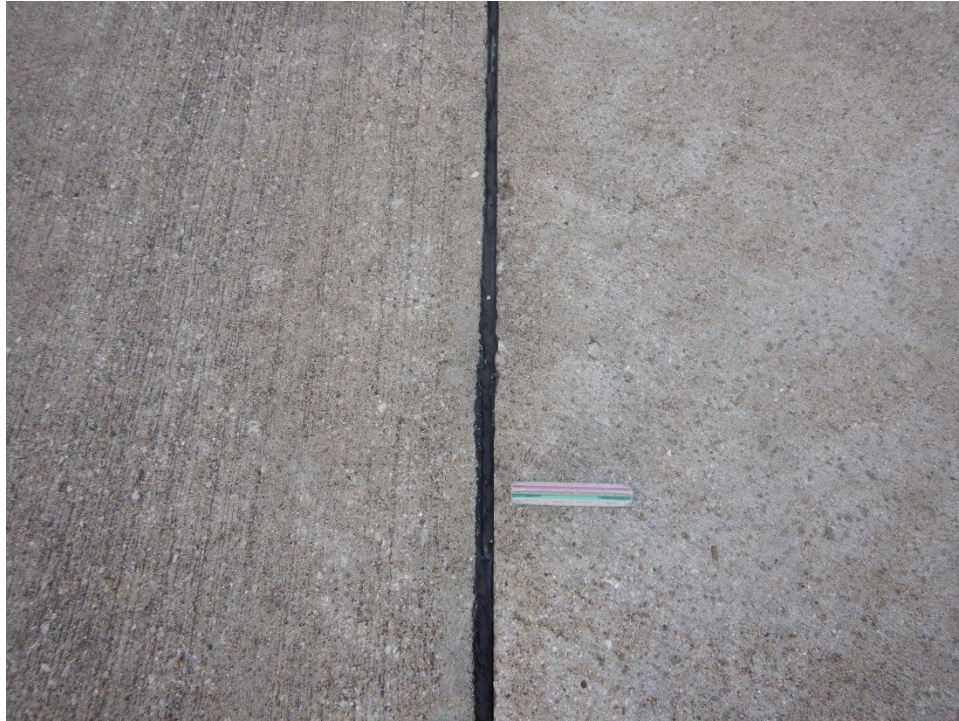
T01OK-02. Joint Seal Damage (Sample Unit No. 01).

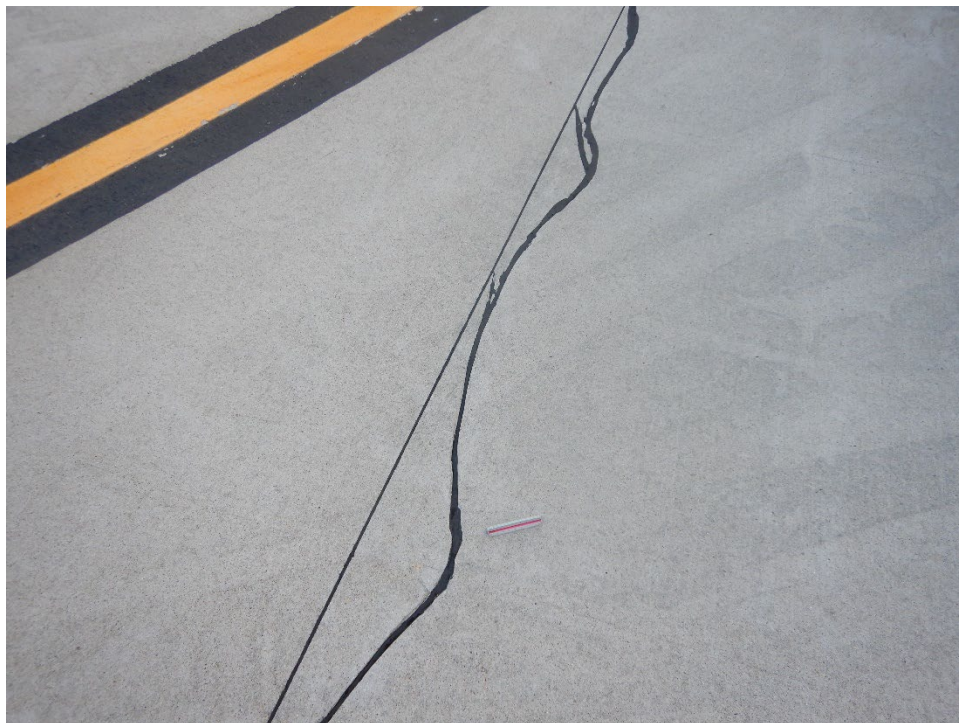
T01OK-02. Joint Spalling (Sample Unit No. 01).

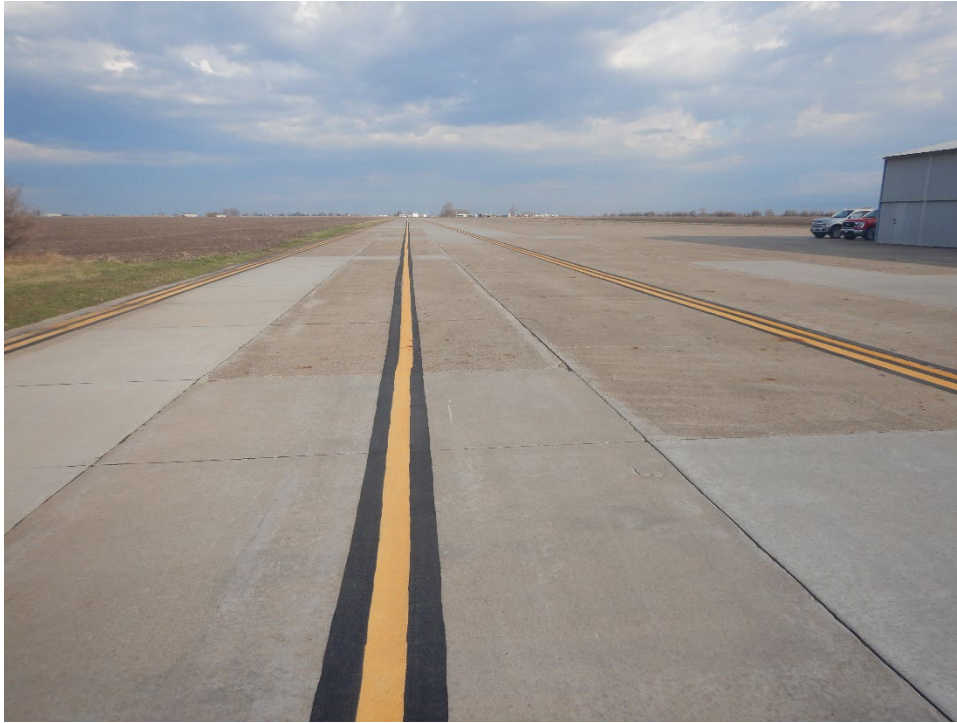
T01OK-03. Overview.

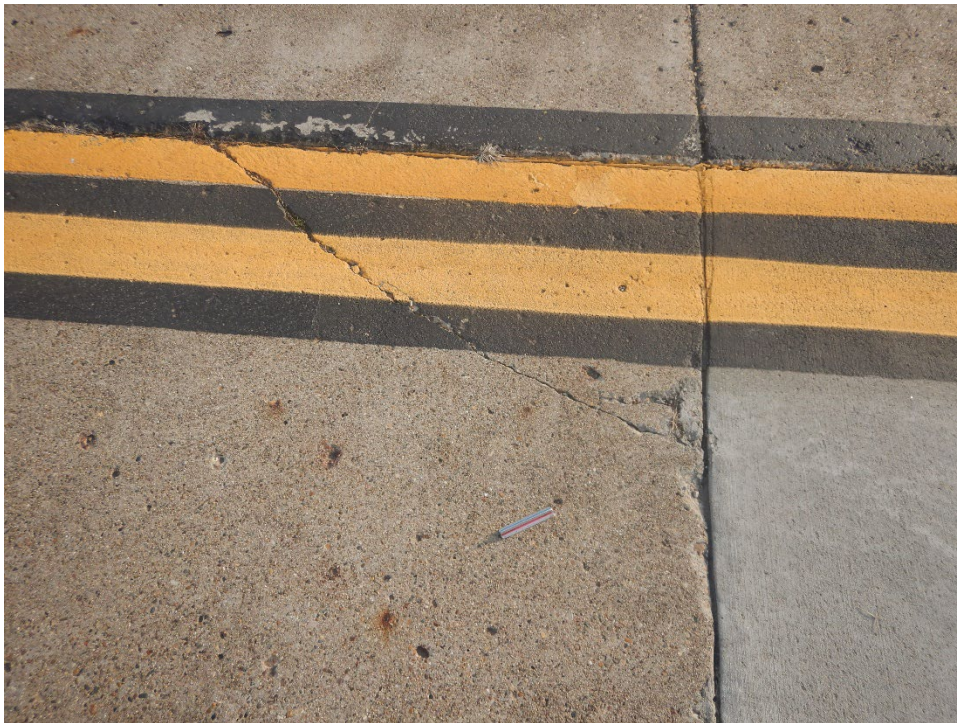
T01OK-03. Corner Break (Sample Unit No. 02).

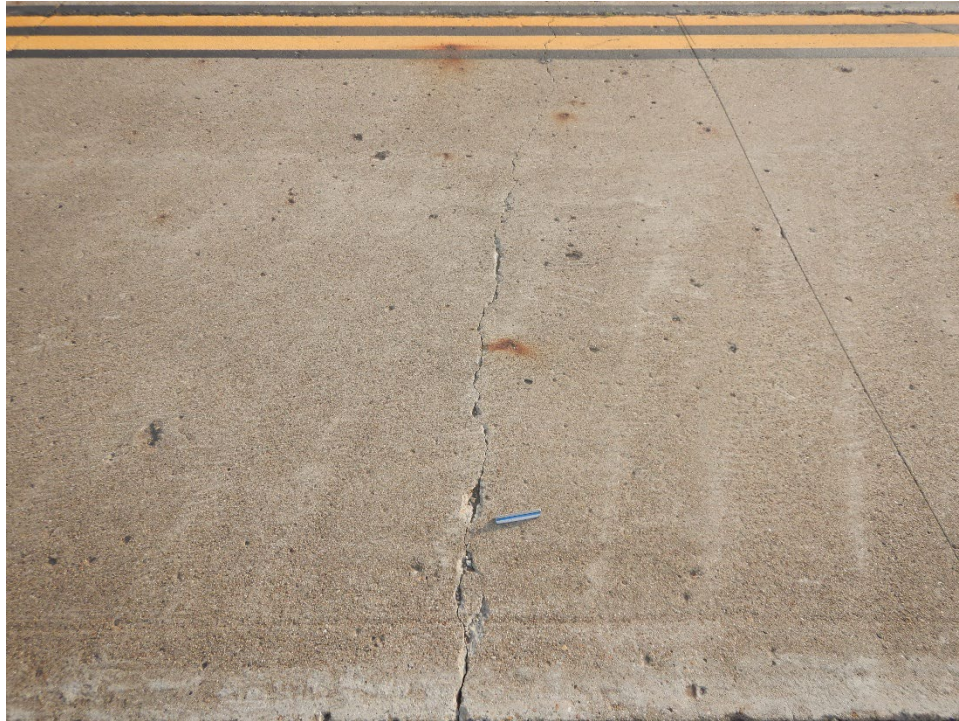
T01OK-03. LTD Cracking (Sample Unit No. 02).

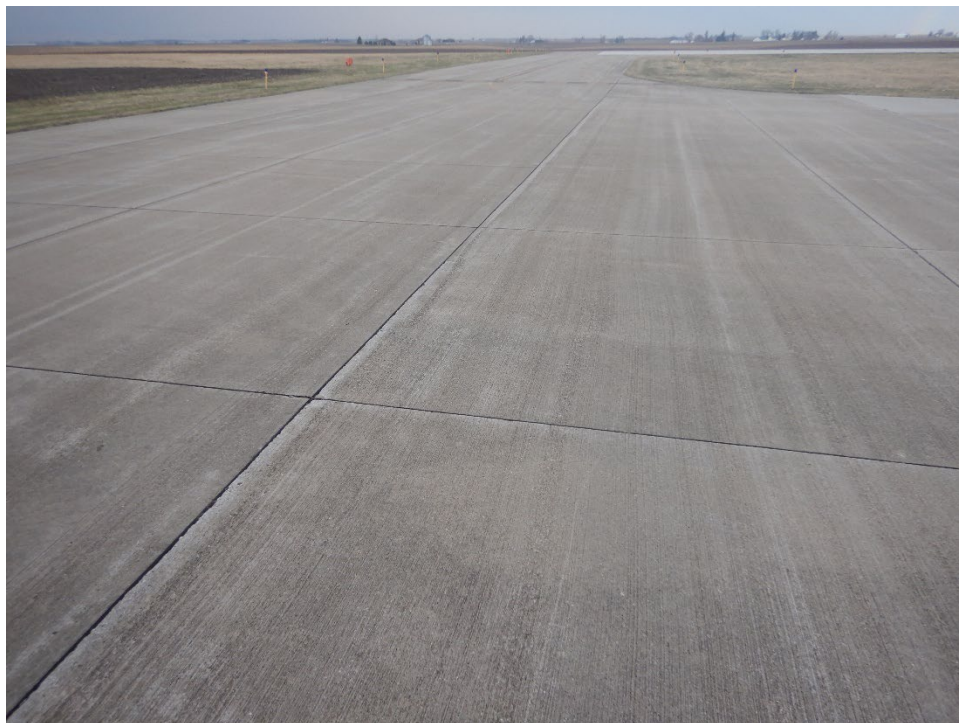
T02OK-01. Overview.

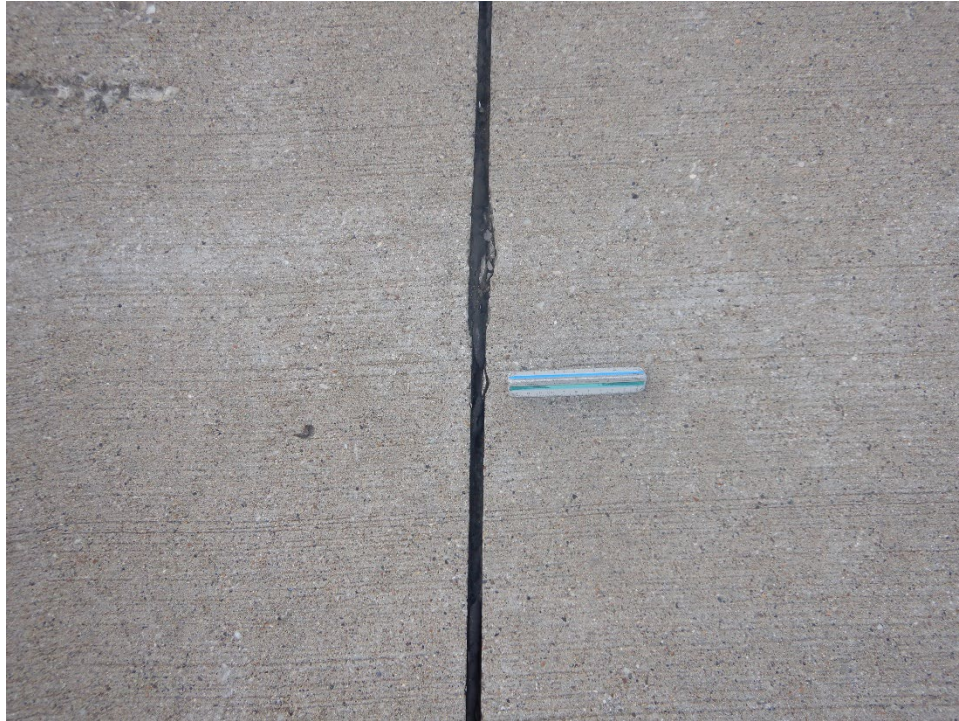
T02OK-01. Joint Seal Damage (Sample Unit No. 05).

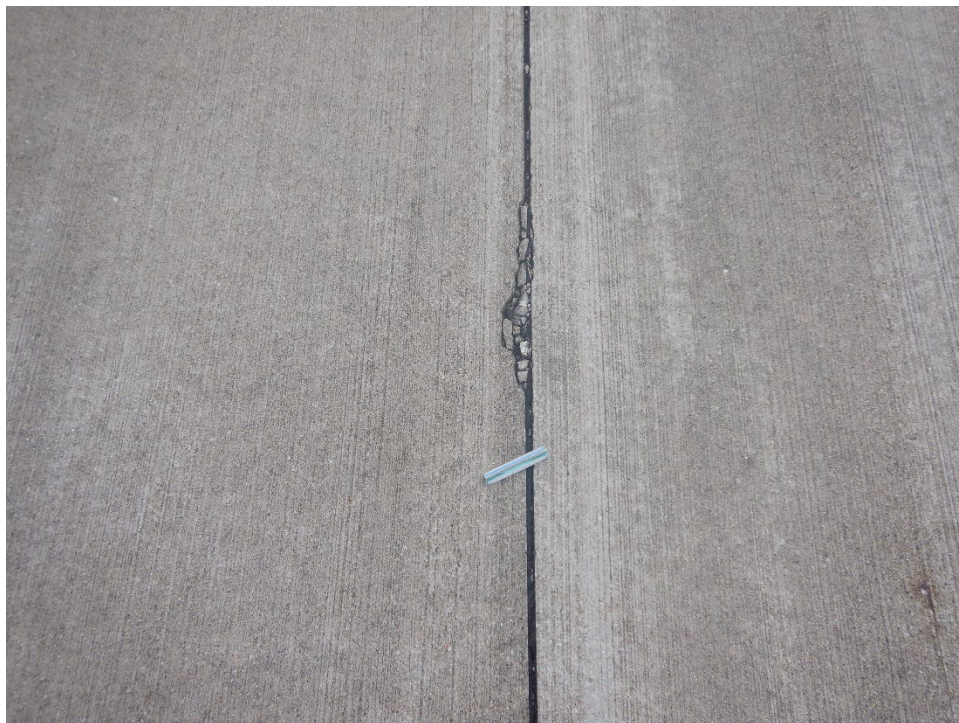
T02OK-01. Joint Spalling (Sample Unit No. 05).

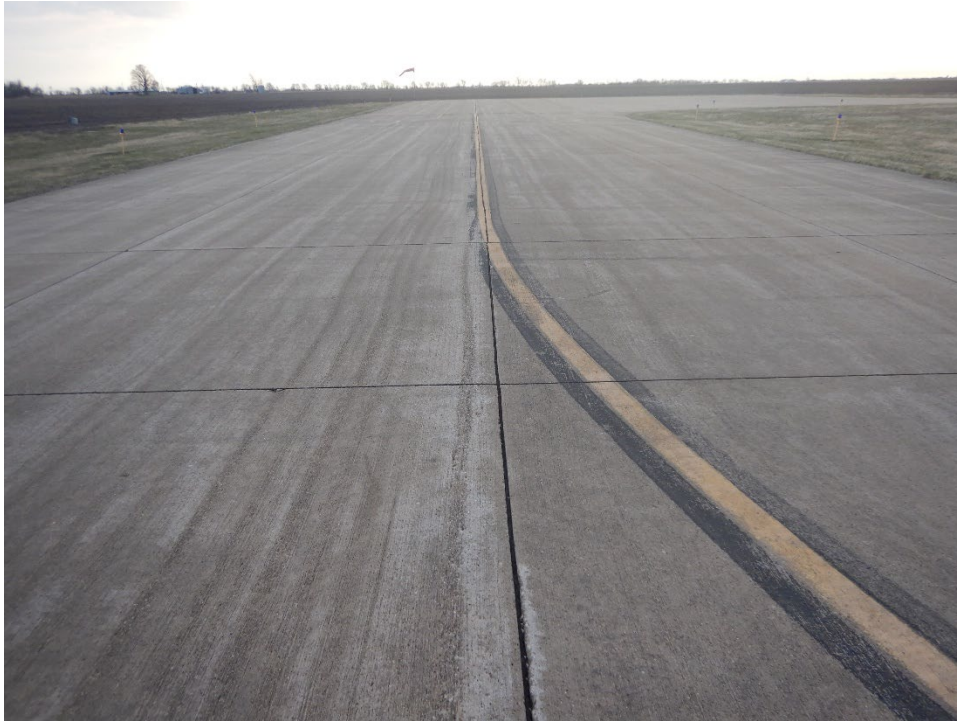
T03OK-01. Overview.

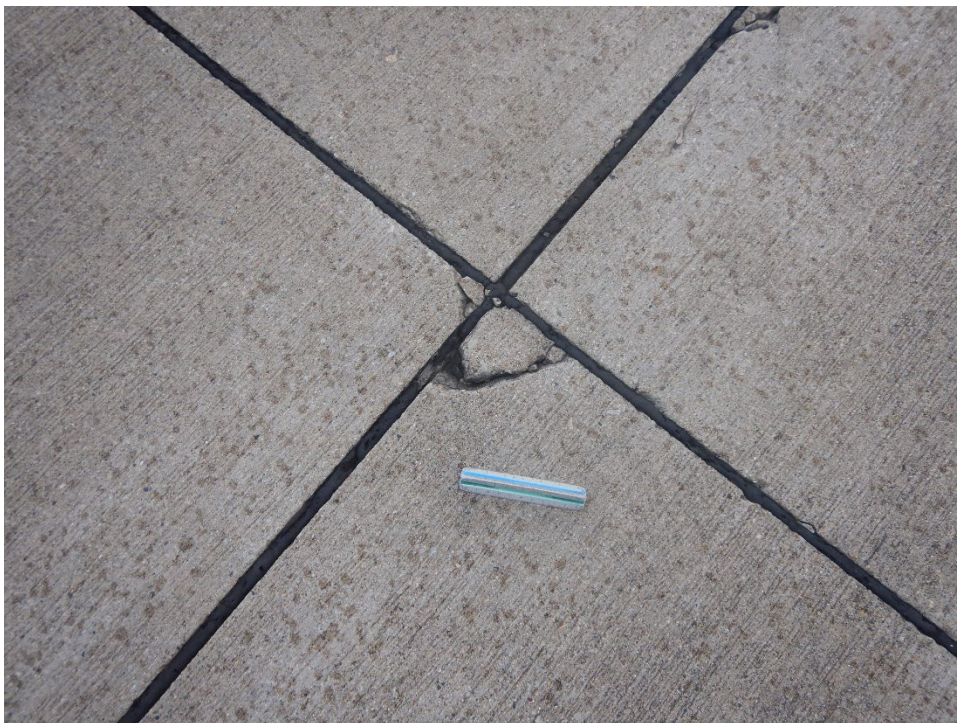
T03OK-01. Corner Spalling (Sample Unit No. 02).

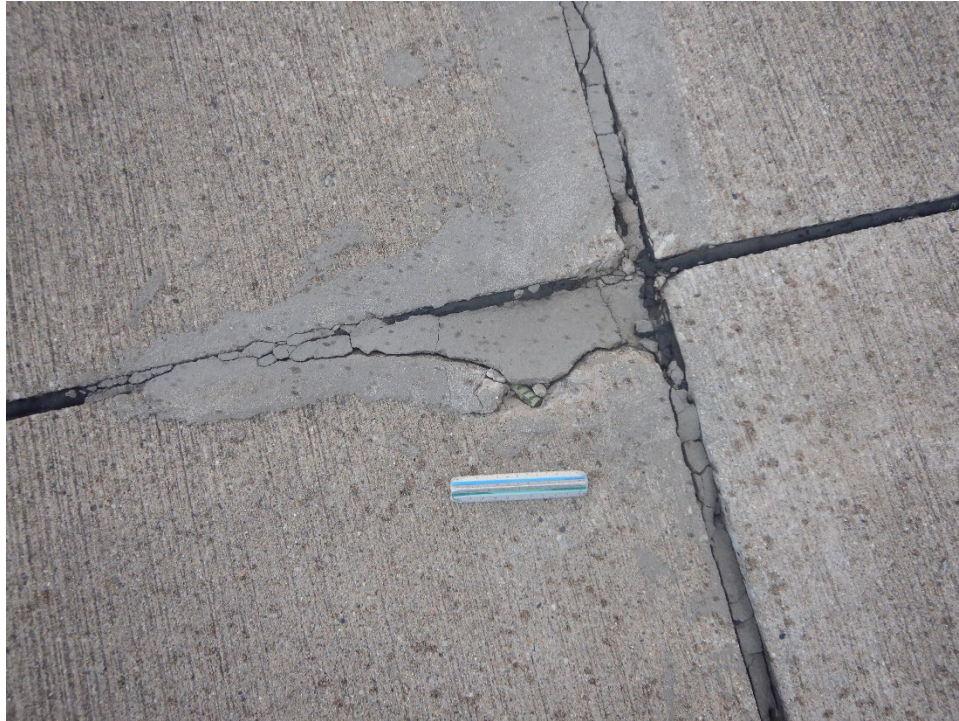
T03OK-01. Small Patching (Sample Unit No. 02).

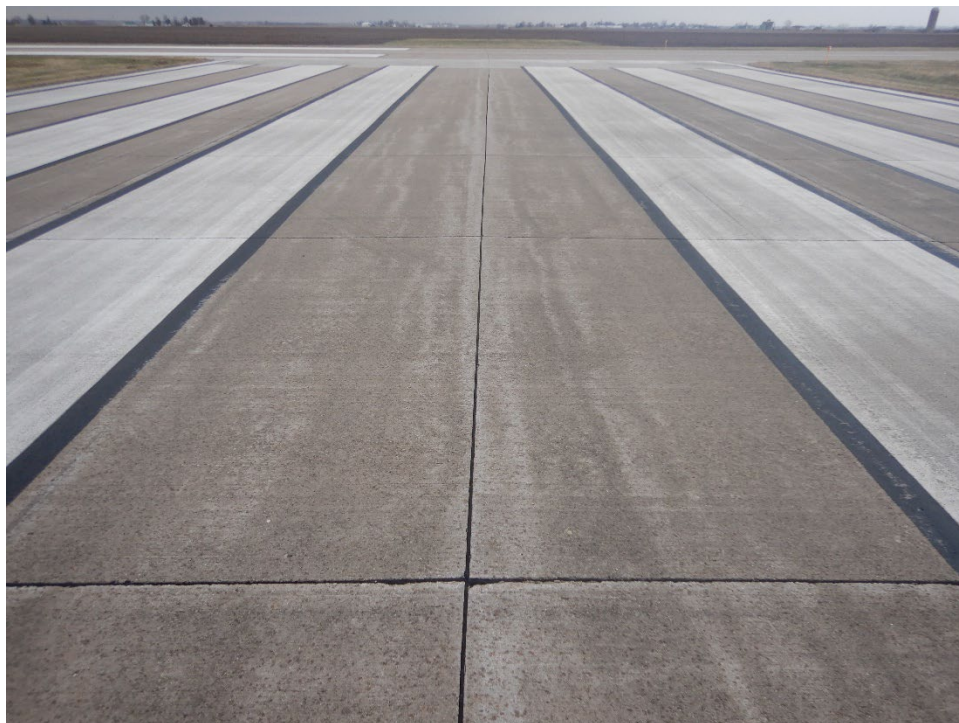
T04OK-01. Overview.

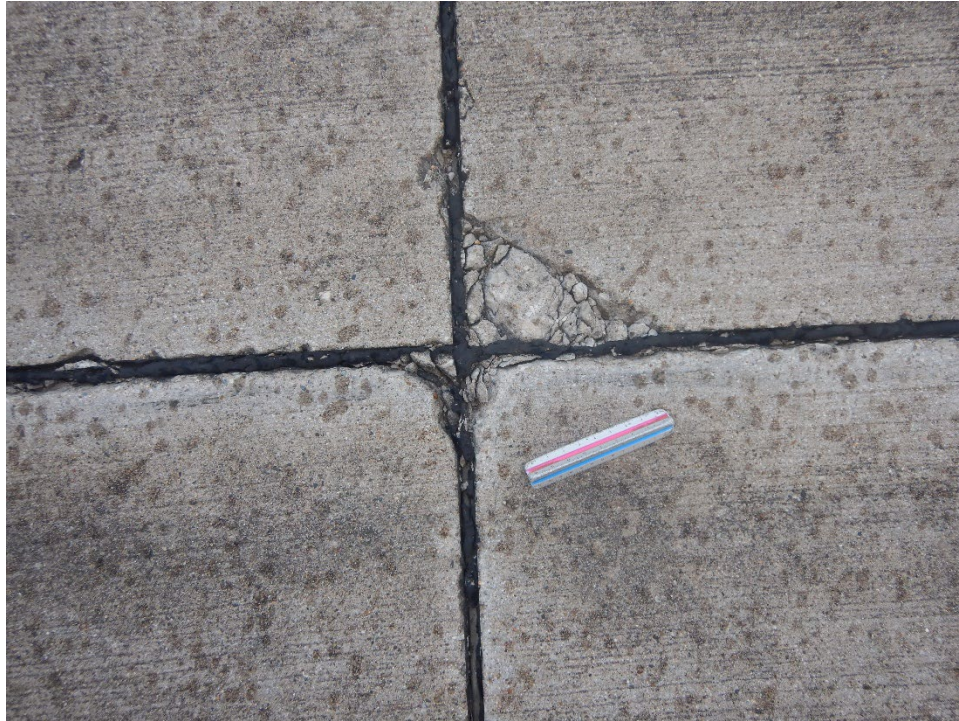
T04OK-01. Corner Spalling (Sample Unit No. 03).

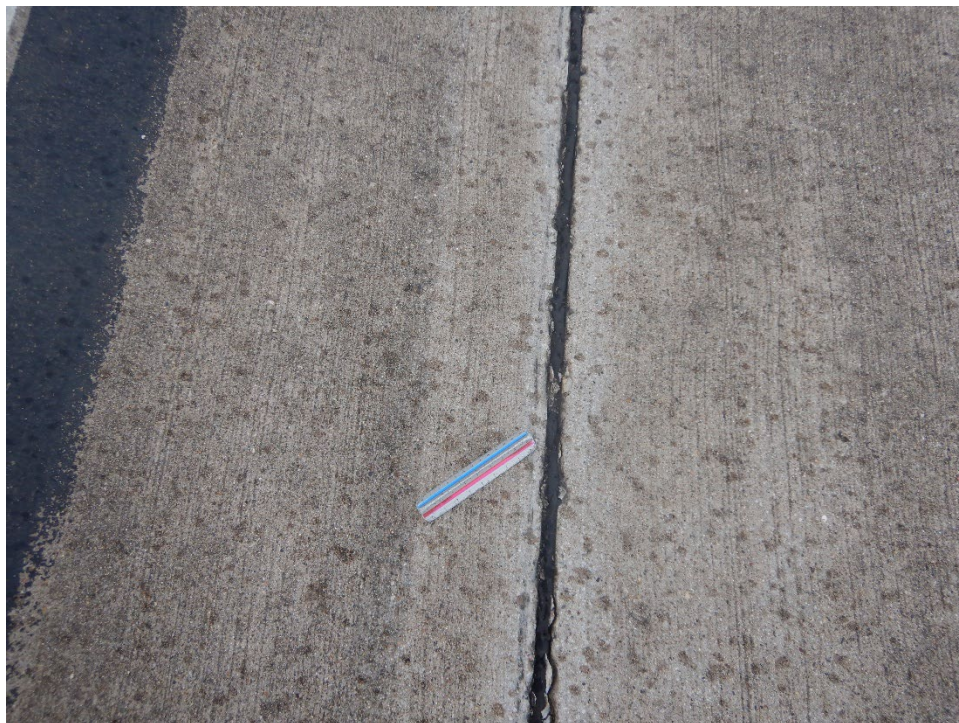
T04OK-01. Joint Seal Damage (Sample Unit No. 03).

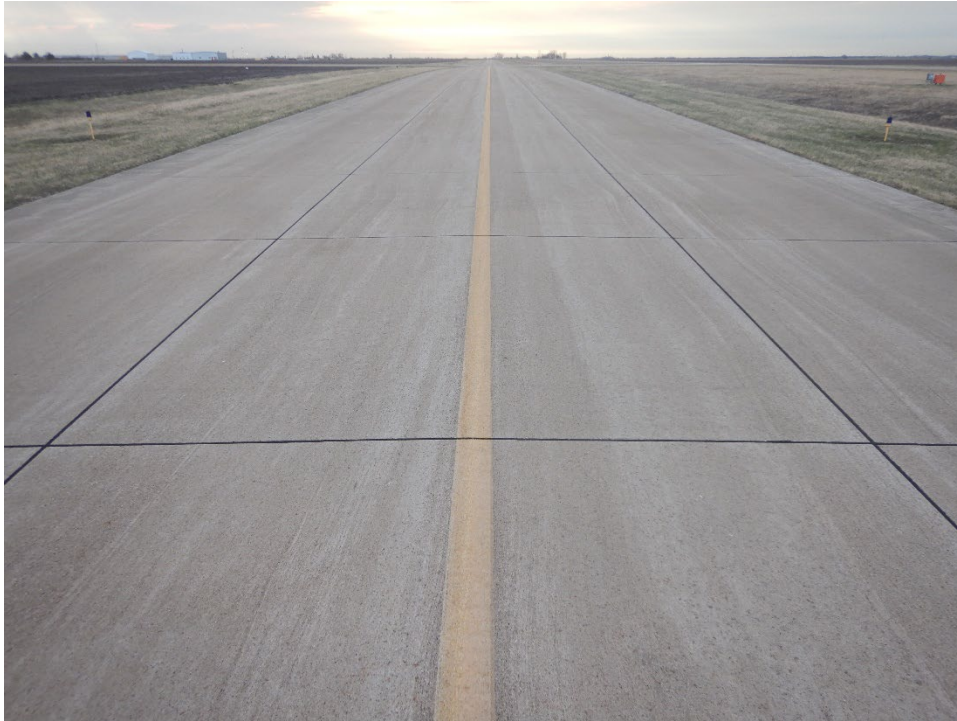
T05OK-01. Overview.

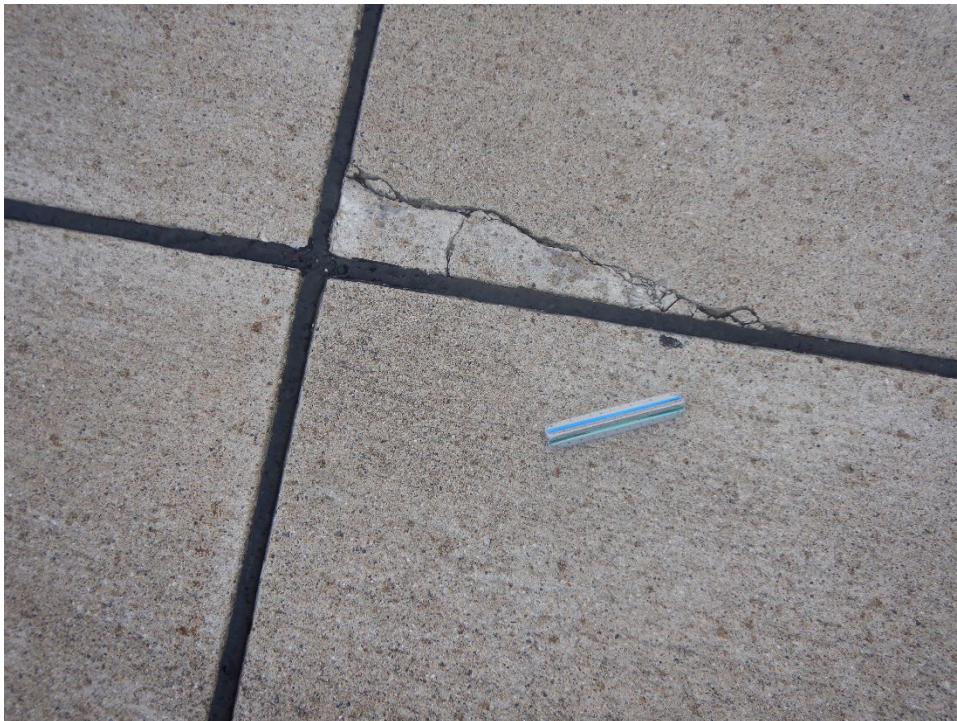
T05OK-01. Corner Spalling (Sample Unit No. 09).

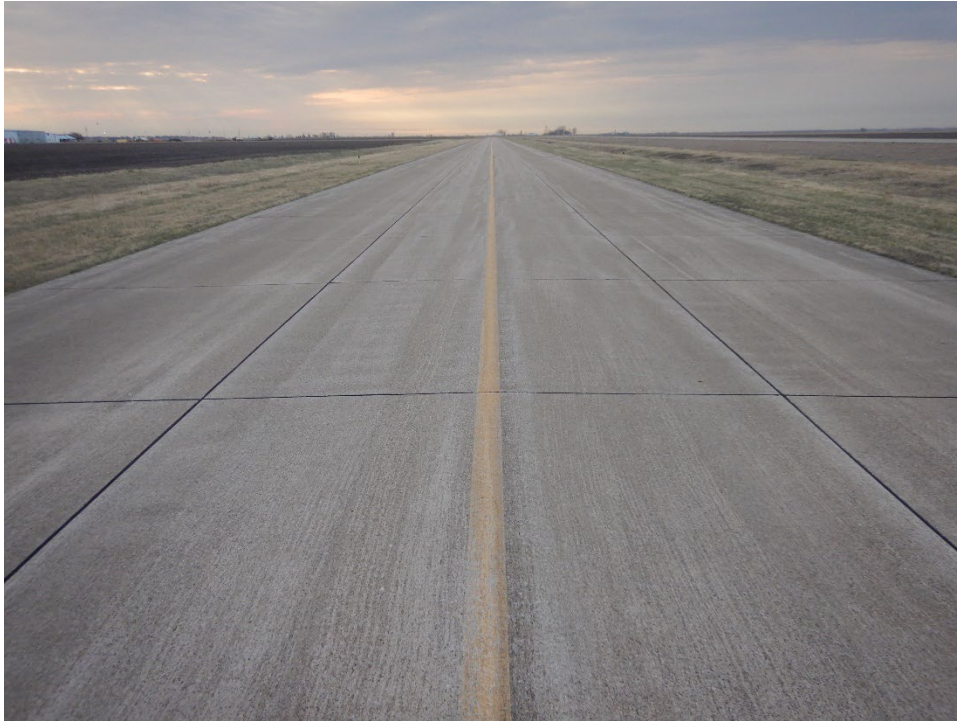
T05OK-02. Overview.

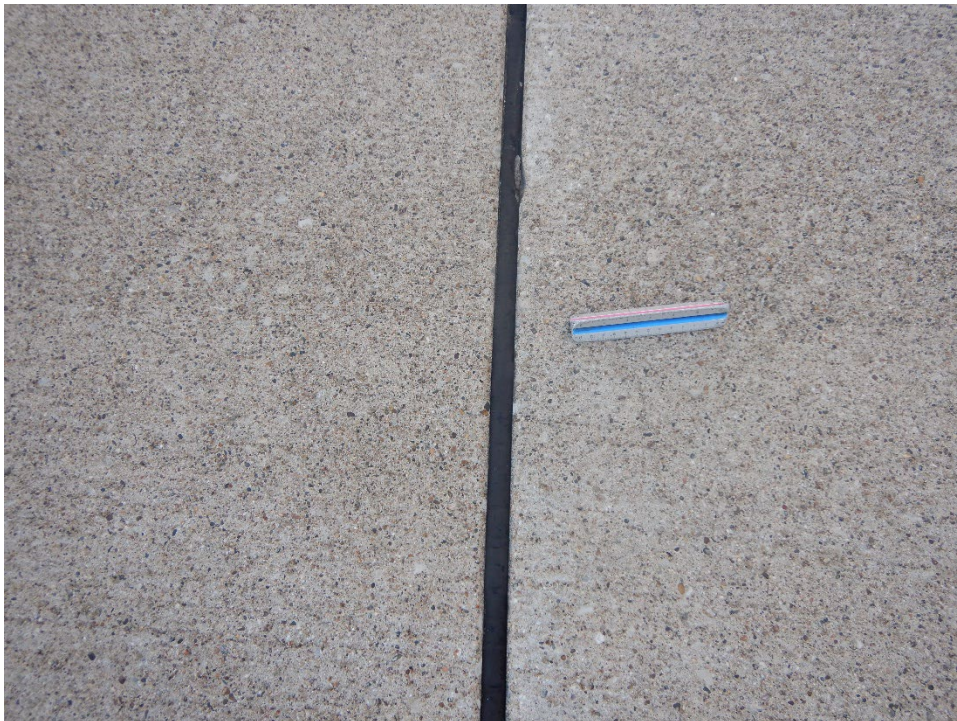
T05OK-02. Joint Seal Damage (Sample Unit No. 19).

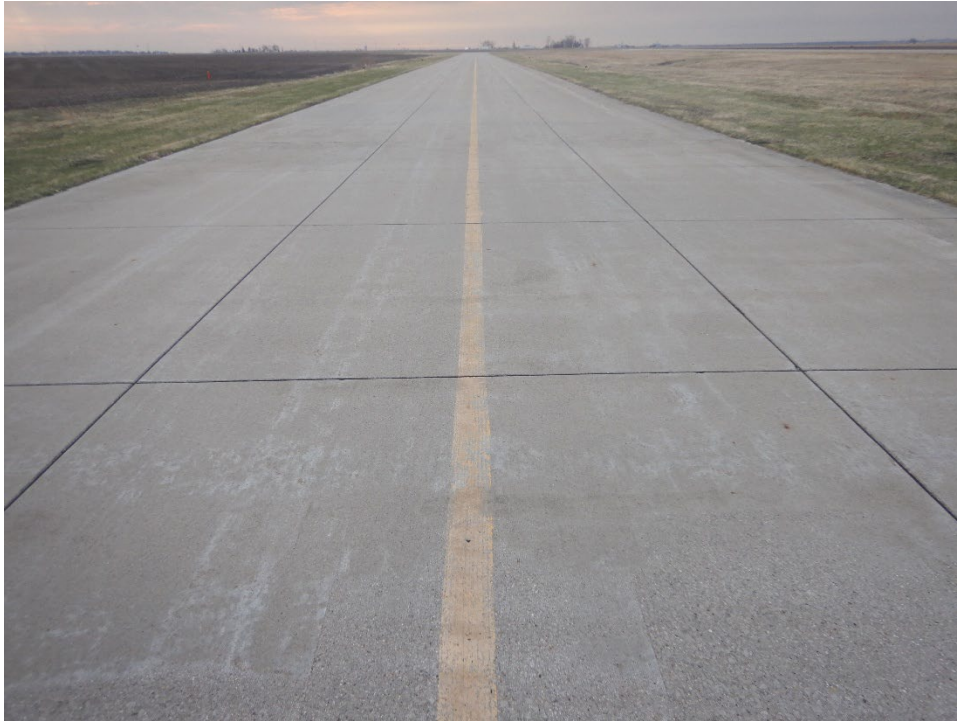
T05OK-03. Overview.

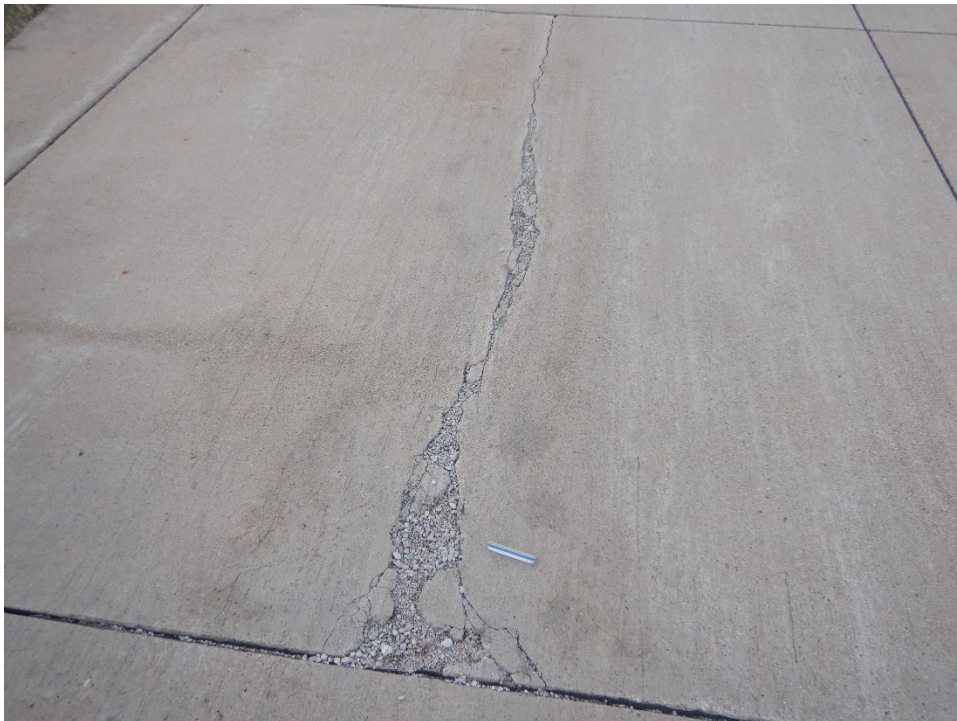
T05OK-03. ASR (Additional Sample Unit No. 01).

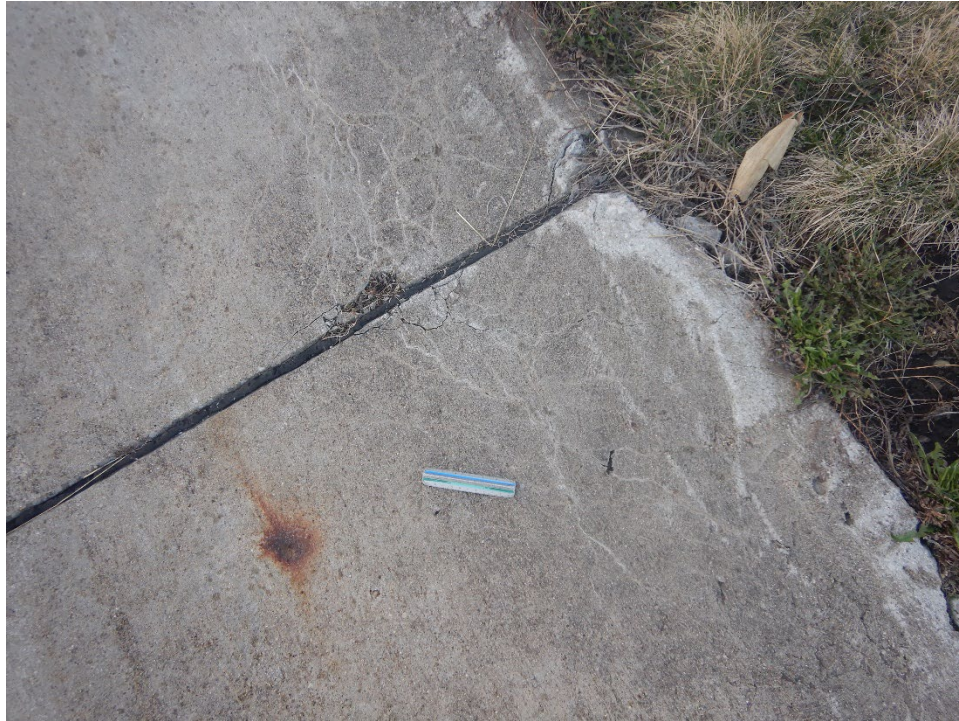
T05OK-03. ASR (Sample Unit No. 12).
