# Oskaloosa Municipal Airport

## Pavement Management Report

**AUGUST 2025**

# OSKALOOSA MUNICIPAL AIRPORT PAVEMENT MANAGEMENT REPORT

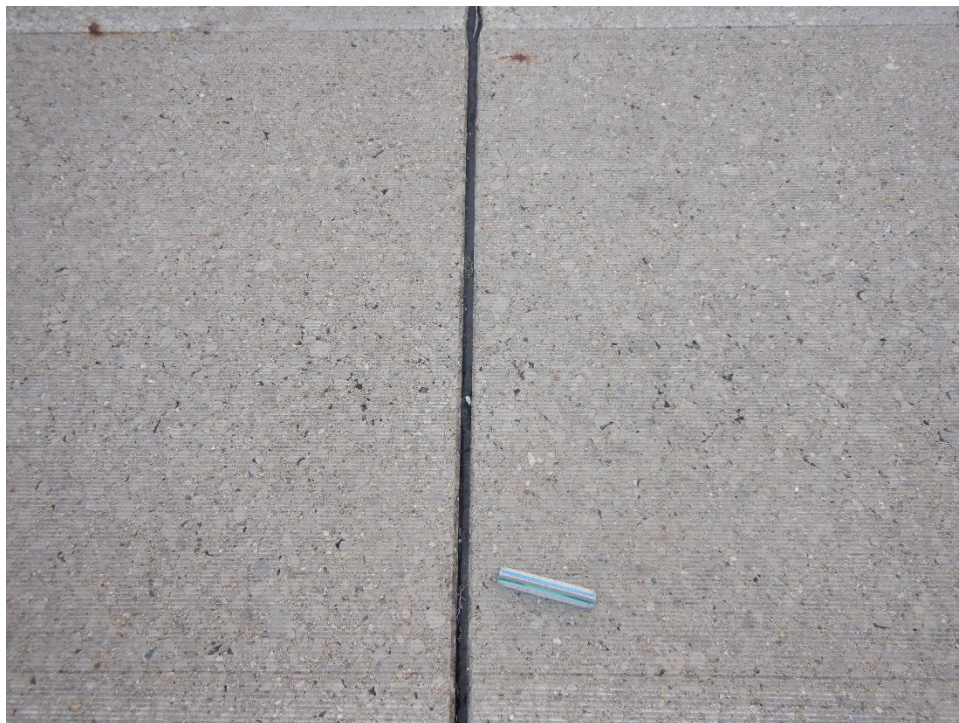
T05OK-03. Joint Seal Damage (Sample Unit No. 12).

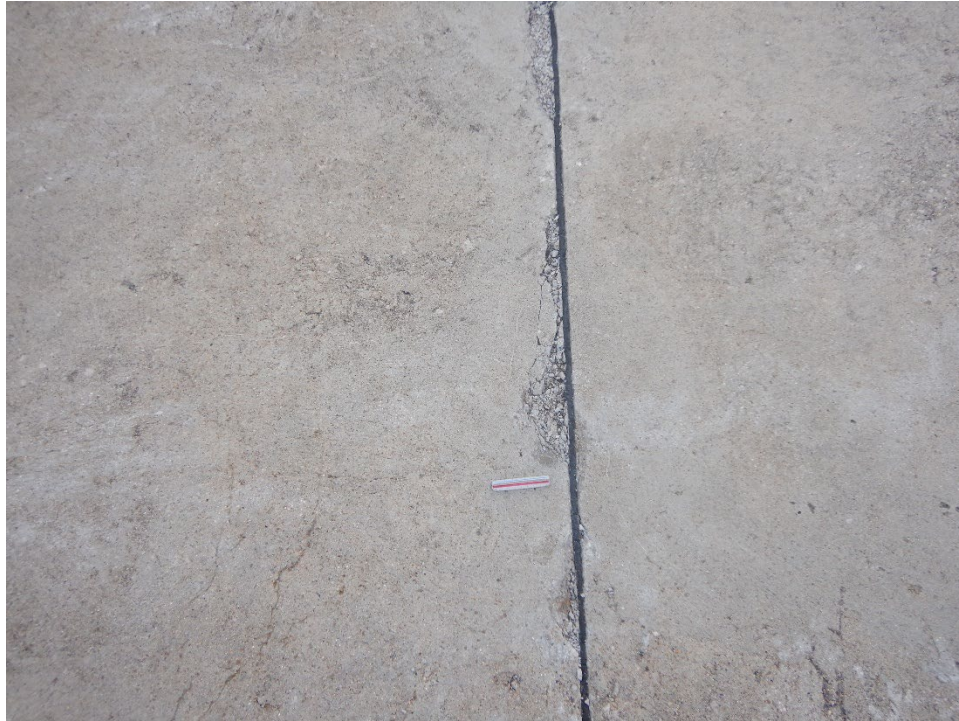
T05OK-03. Joint Spalling (Sample Unit No. 01).

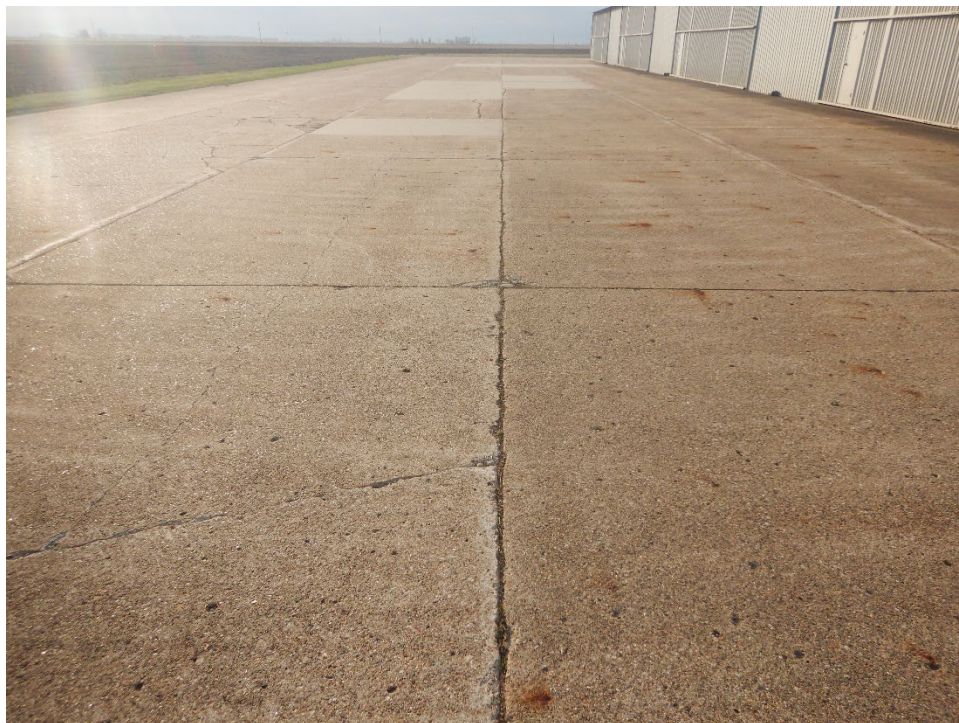
TH01OK-01. Overview.

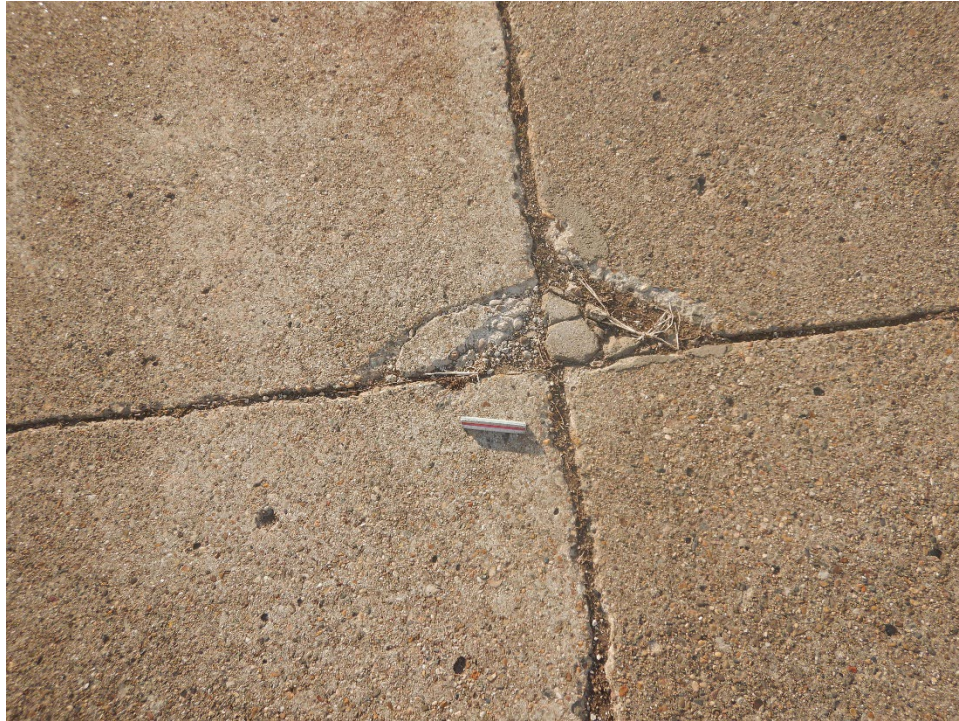
TH01OK-01. Corner Spalling (Sample Unit No. 01).

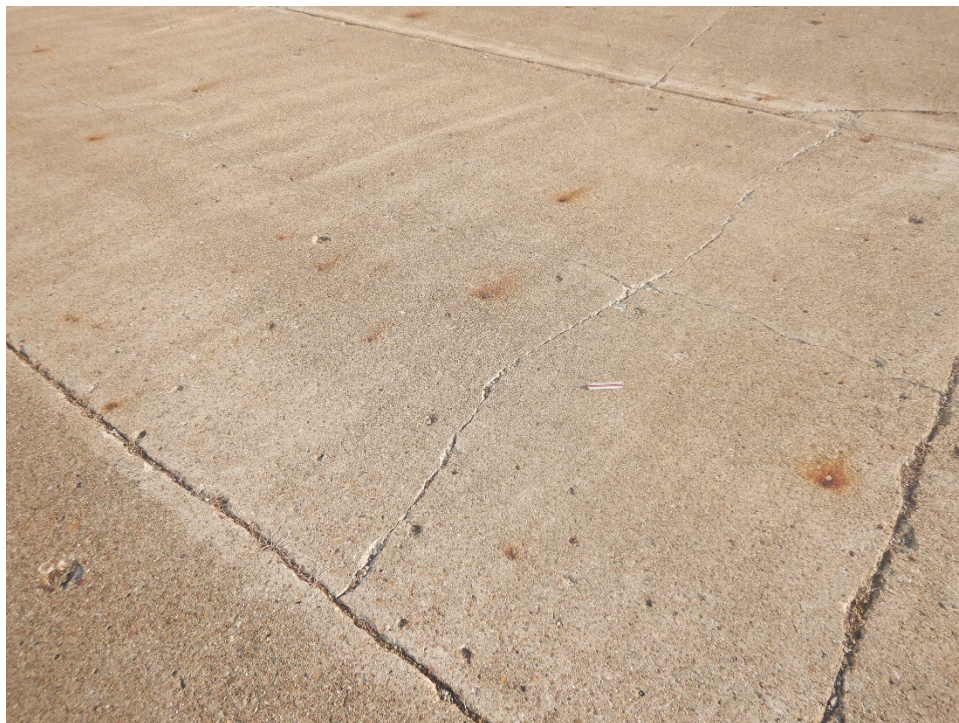
TH01OK-01. Shattered Slab (Sample Unit No. 02).
