Paullina Municipal Airport

Pavement Management Report

AUGUST 2025

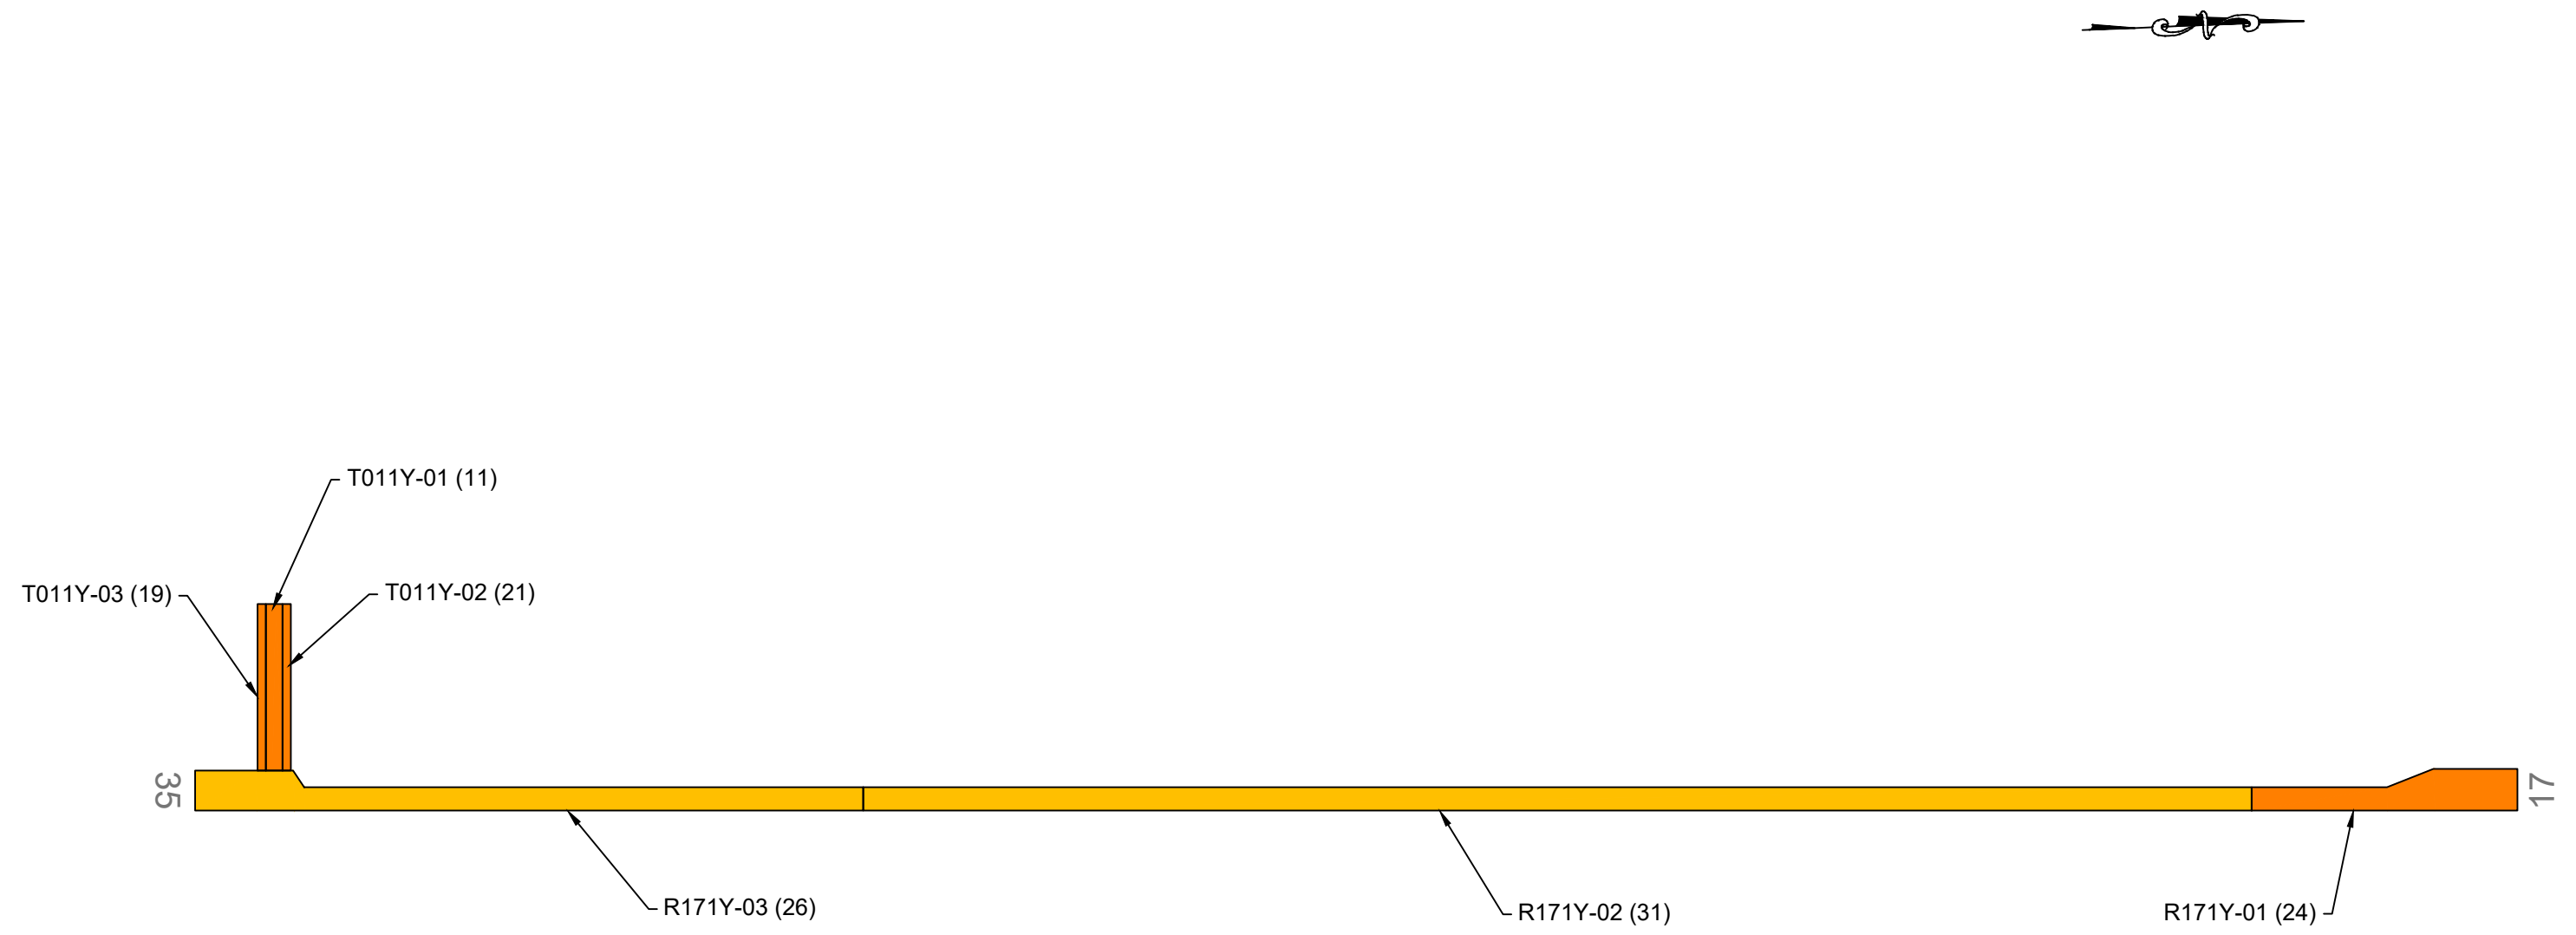
FIGURE 8. PCI MAP.

The pavements at Paullina Municipal Airport were inspected in March 2025. The 2025 area-weighted condition of Paullina Municipal Airport is 27, with conditions ranging from 11 to 31 (on a scale of 0 [failed] to 100 [excellent]). During the previous pavement inspection in 2018, the area-weighted PCI of the airport was 51.

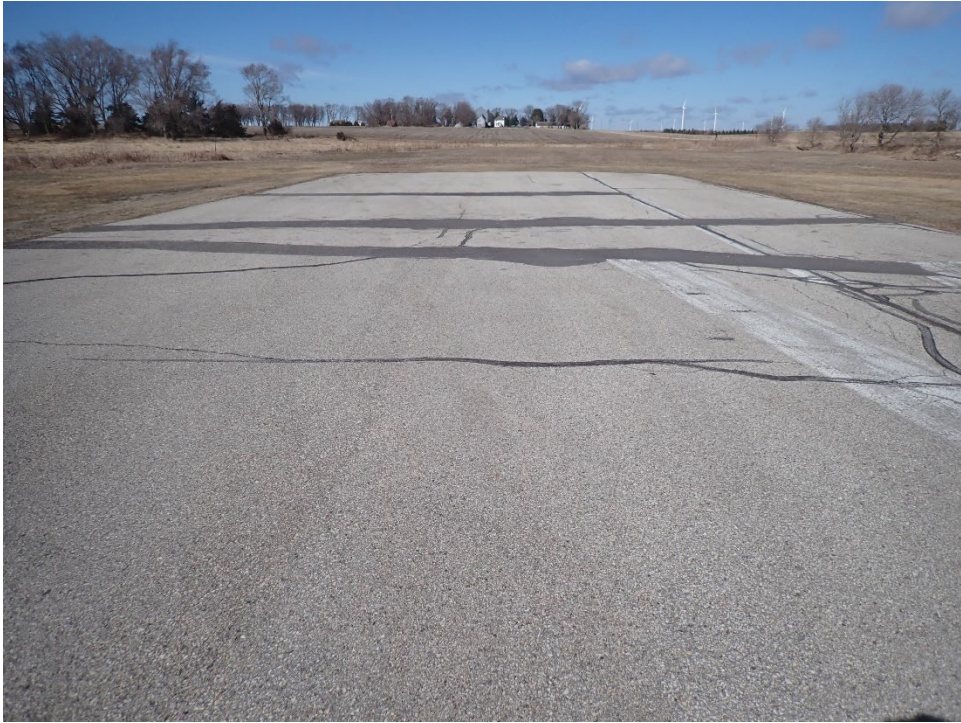
R171Y-01. Overview.

Runway 17/35 was defined by three sections in *Poor* condition. Section 01 was located at the northern approach of the runway. A substantial amount of medium-severity alligator cracking was observed. Additionally, low-severity patching and medium-severity longitudinal and transverse (L&T) cracking, rutting, and weathering were identified during the inspection. Section 02 contained low- and medium-severity of alligator cracking and L&T cracking, low-severity patching, high-severity raveling, and medium-severity weathering. The low-severity L&T cracking was unsealed, while the medium-severity L&T cracking was due to either unsealed crack widths that exceeded 1/4 inch, unsatisfactory crack sealant, or the development of secondary cracking. In Section 03, low- and medium-severity alligator cracking and L&T cracking, low-severity patching and raveling, and medium-severity weathering were identified.

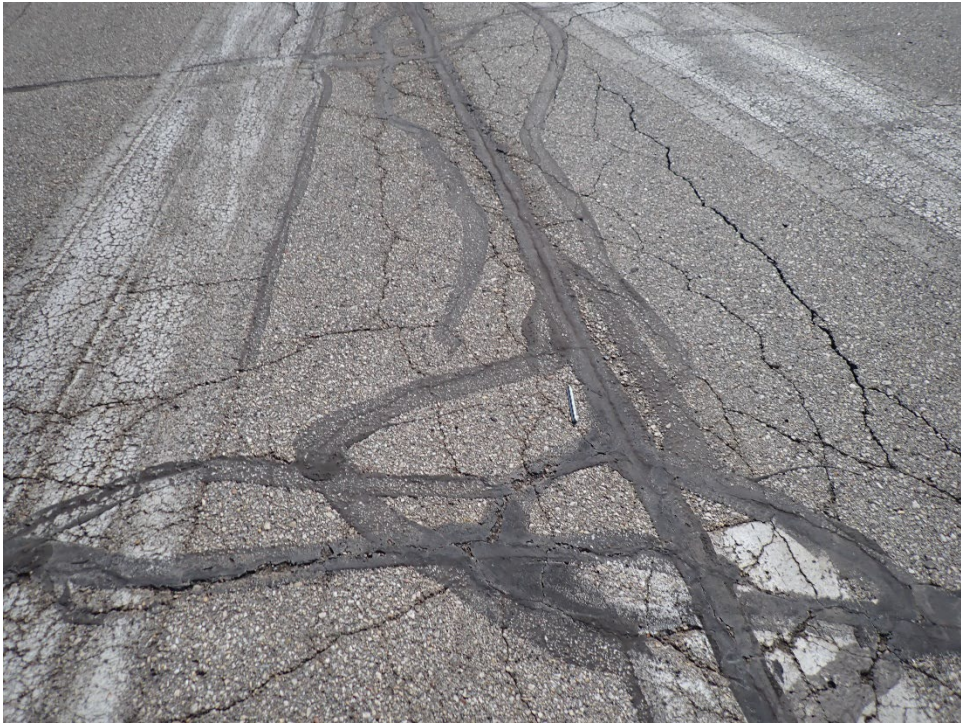
R171Y-01. Alligator Cracking (Sample Unit No. 01).

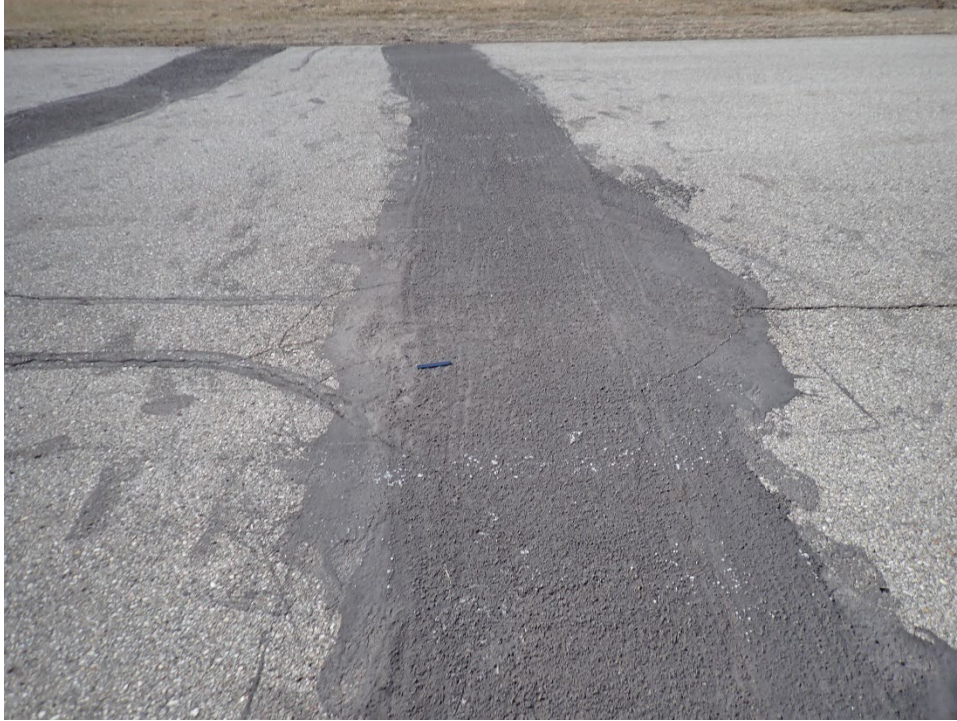
R171Y-01. Patching (Sample Unit No. 01).

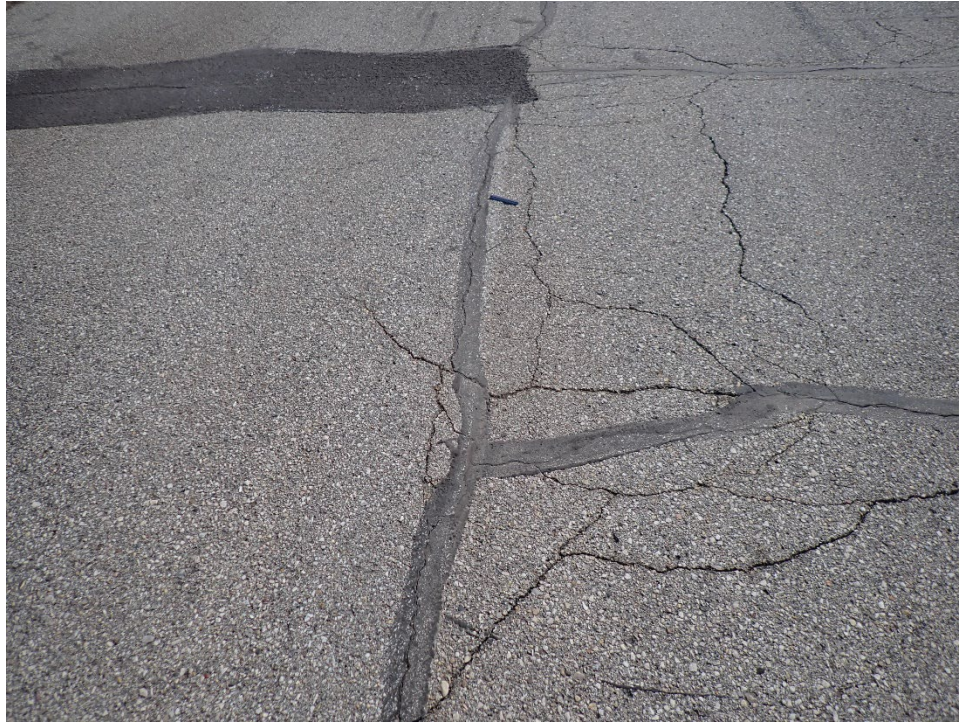
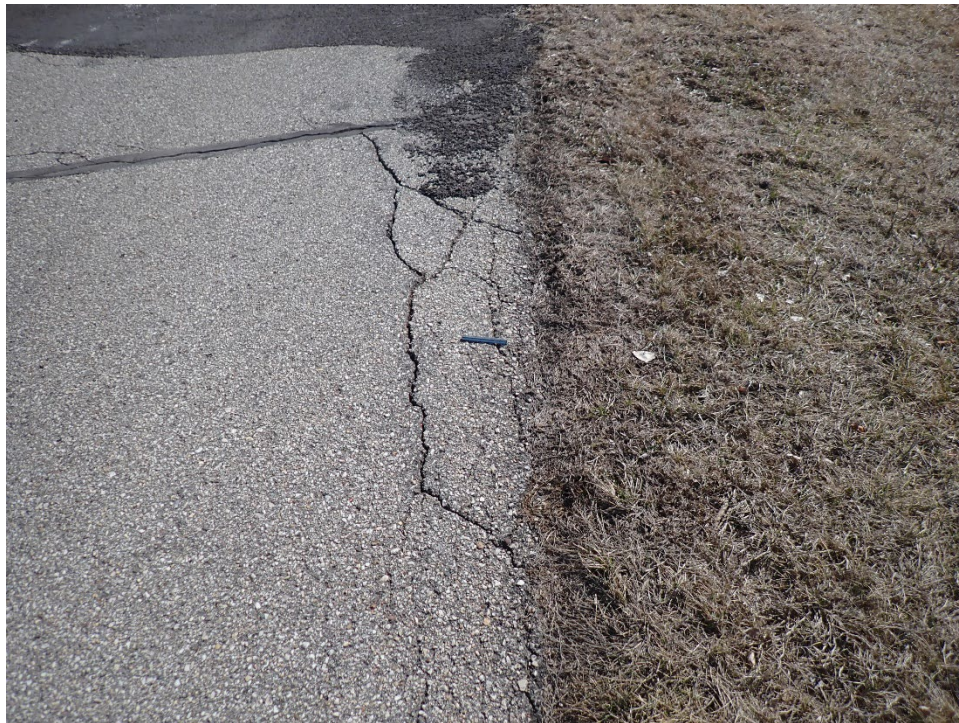
R171Y-02. Alligator Cracking (Sample Unit No. 06) (1).

R171Y-02. Alligator Cracking (Sample Unit No. 06) (2).

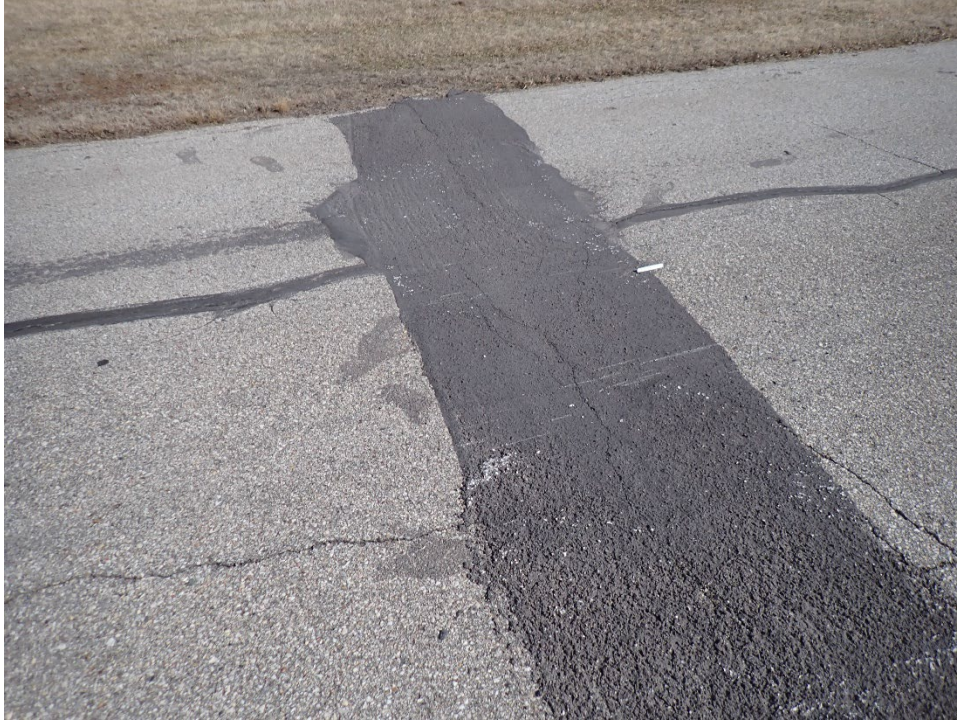
R171Y-02. Patching (Sample Unit No. 04).

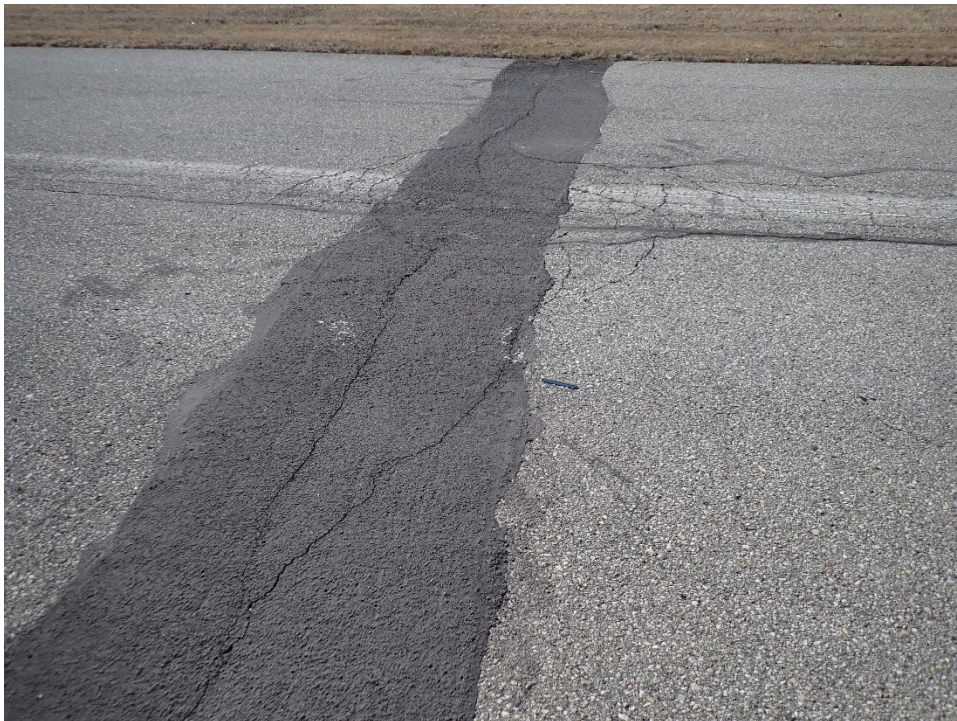
R171Y-02. Patching (Sample Unit No. 06).

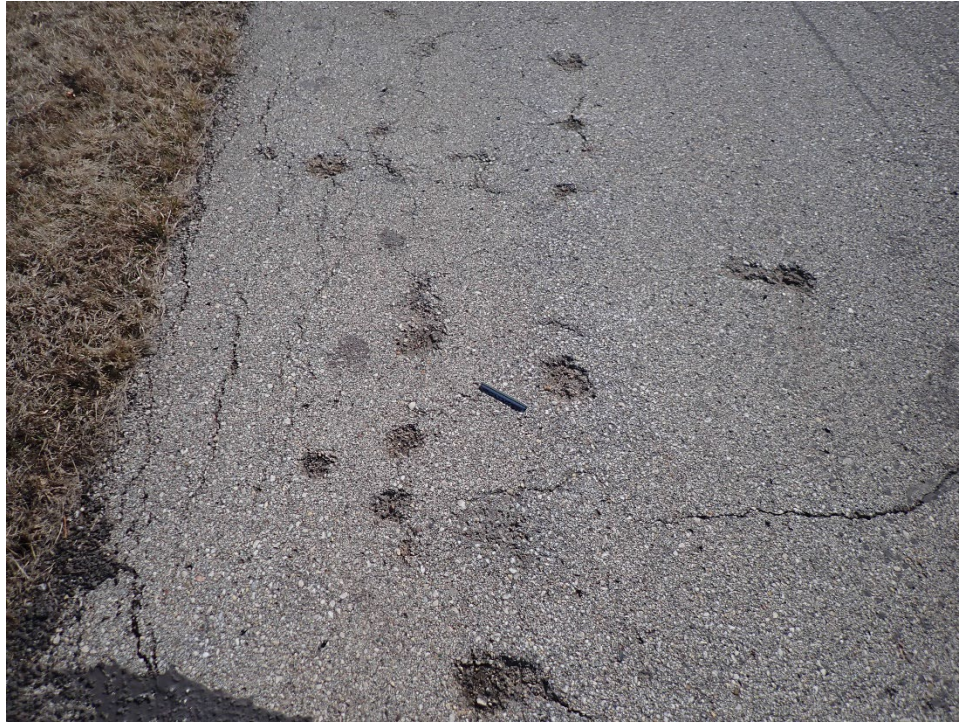
R171Y-02. Raveling (Sample Unit No. 04).

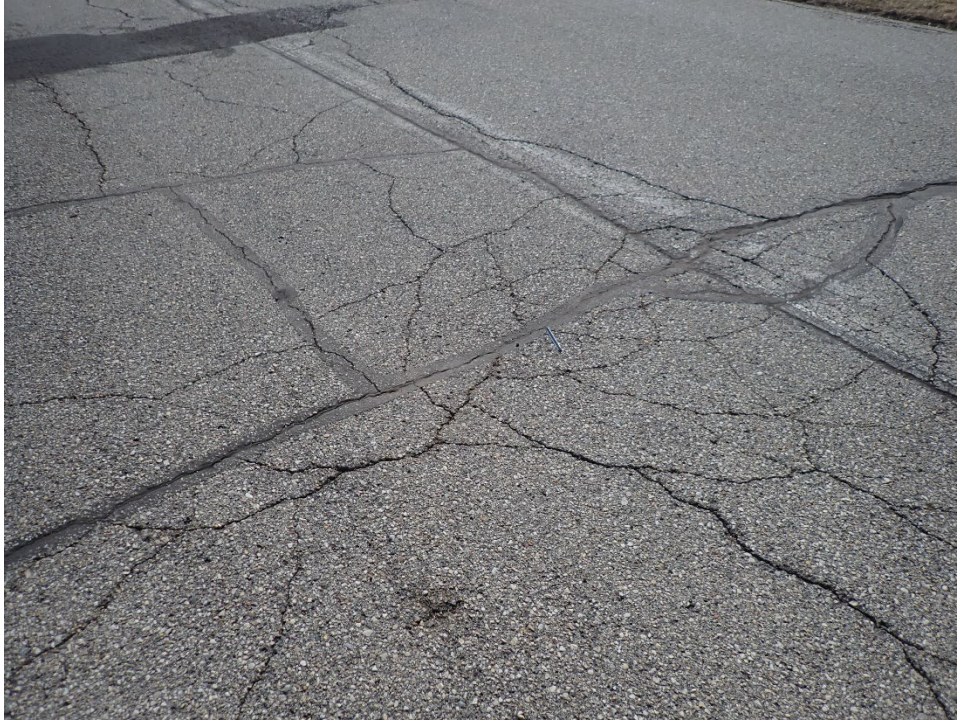
R171Y-03. Alligator Cracking (Sample Unit No. 01).

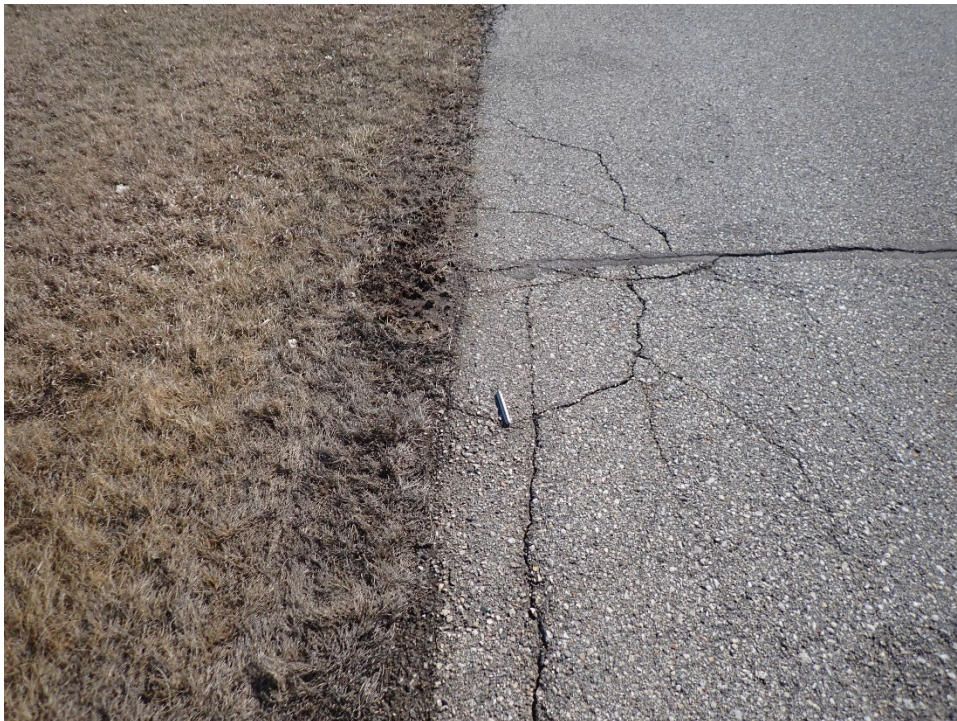
R171Y-03. Alligator Cracking (Sample Unit No. 02).

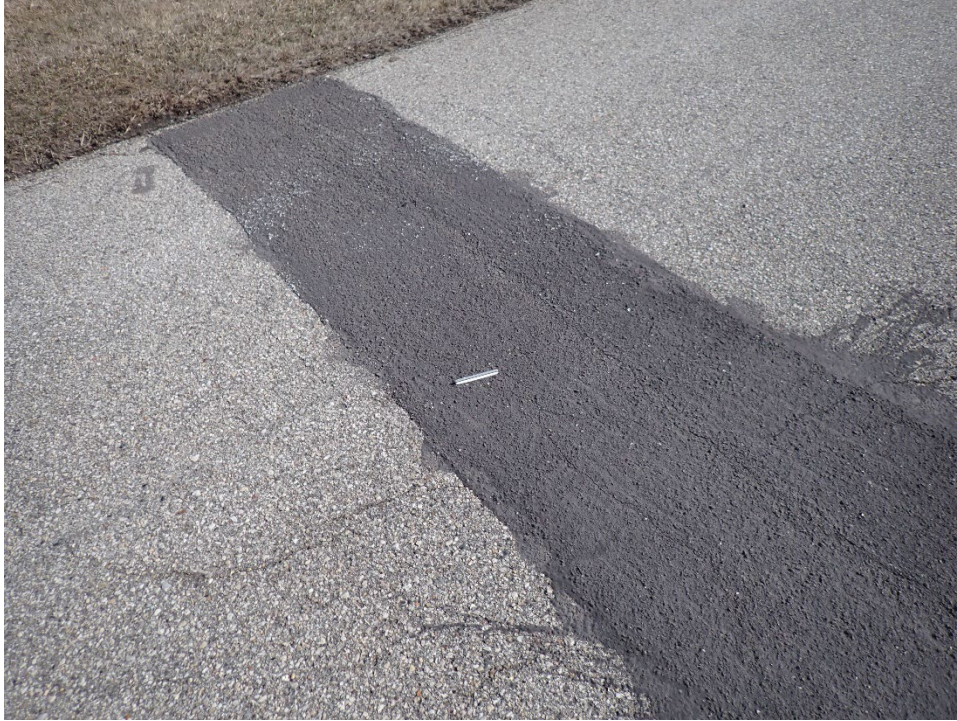
R171Y-03. Patching (Sample Unit No. 02).

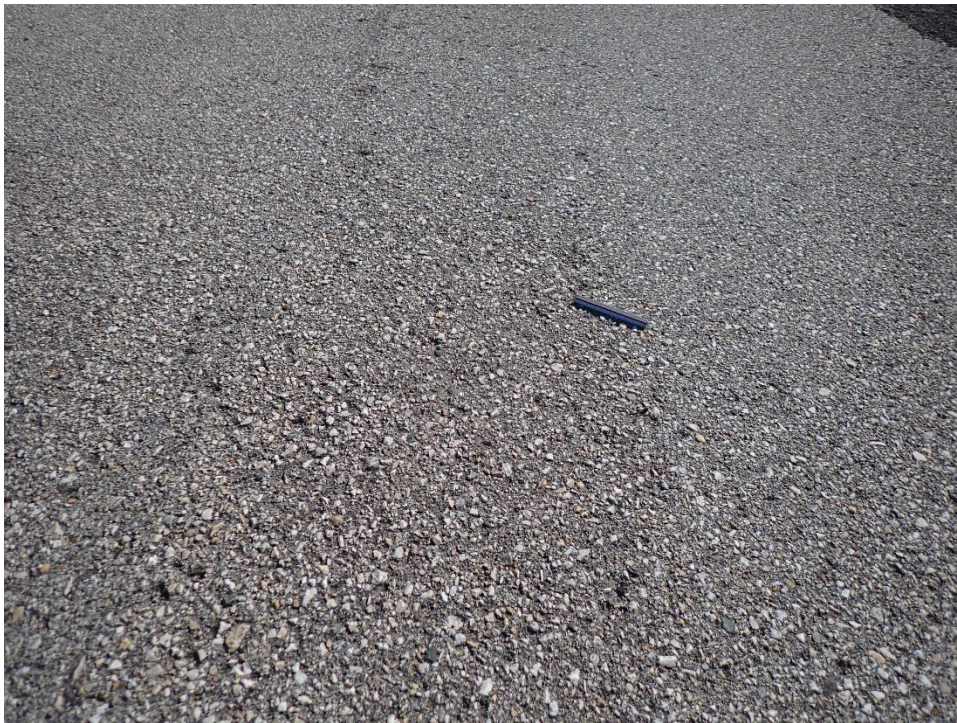
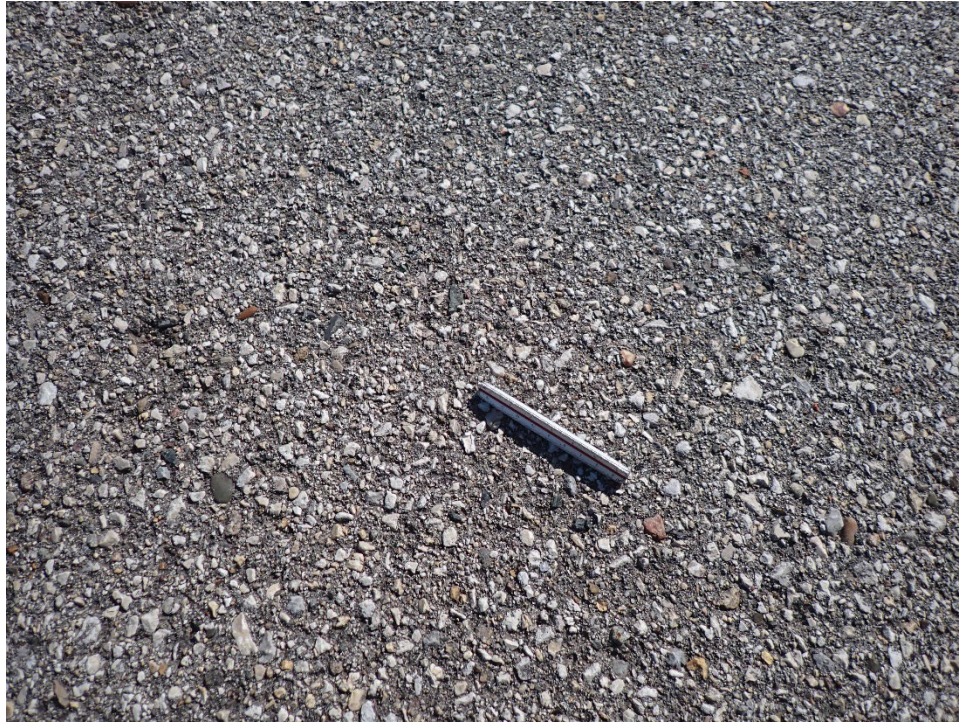
R171Y-03. Raveling (Sample Unit No. 03) (1).

R171Y-03. Raveling (Sample Unit No. 03) (2).

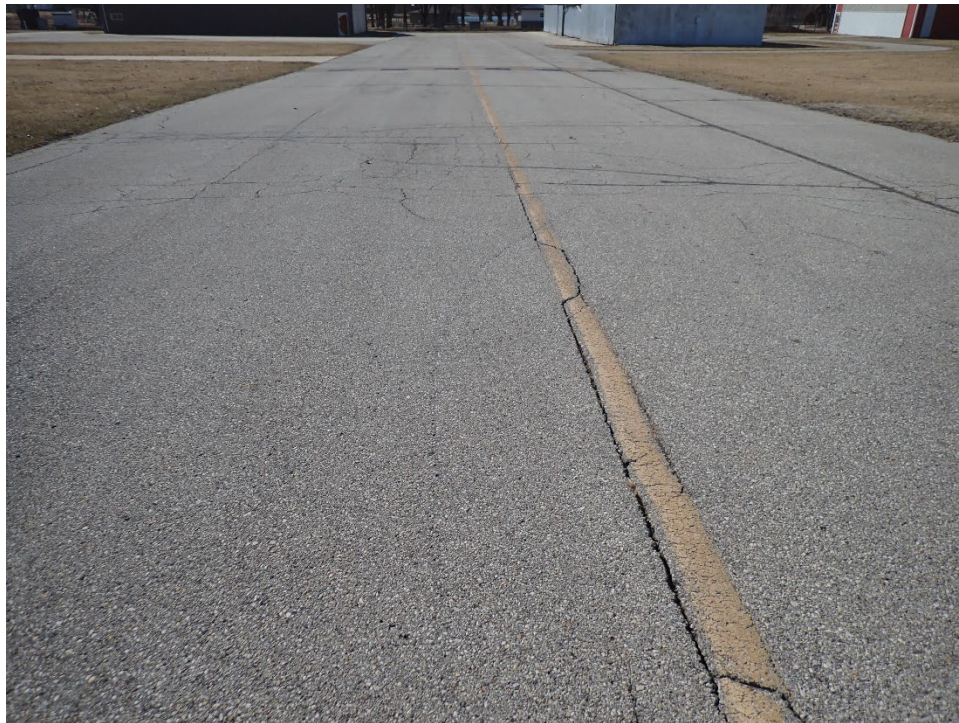
T011Y-01. Overview.

The taxiway contained three sections in *Poor* condition. Substantial amounts of medium-severity alligator cracking were observed in all three sections in addition to low- and medium-severity L&T cracking, low-severity raveling, and medium-severity weathering.

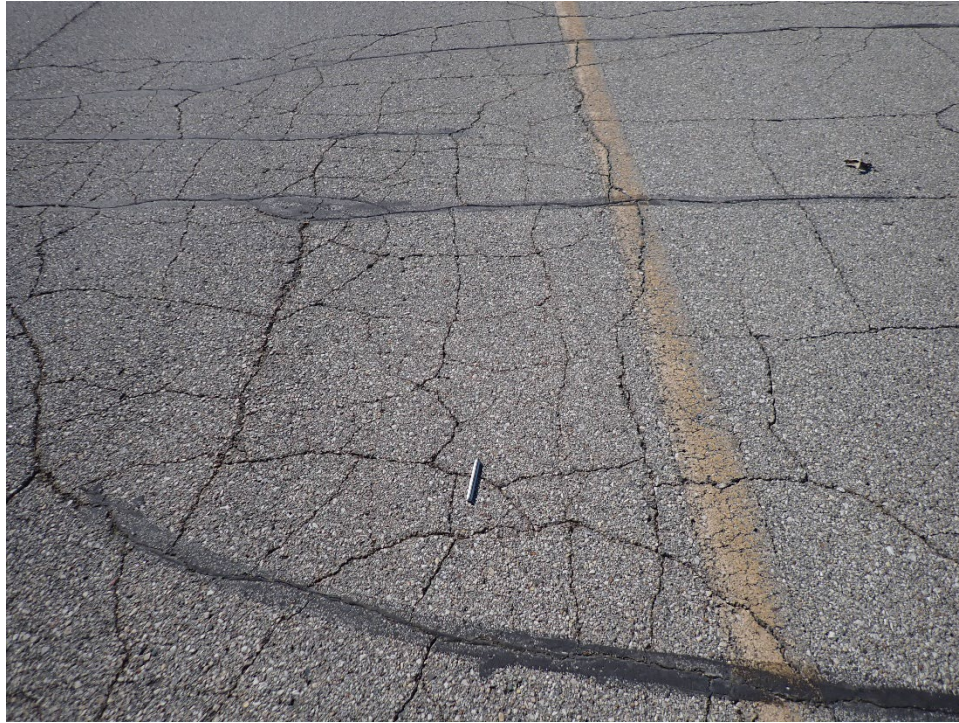
T011Y-01. Alligator Cracking (Sample Unit No. 01).

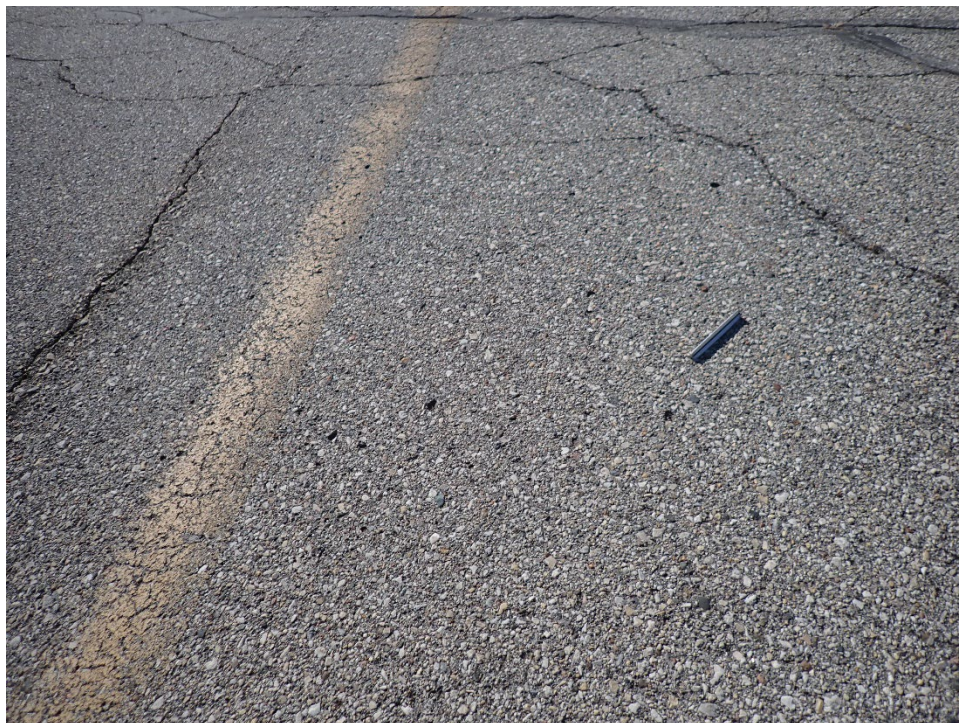
T011Y-01. Raveling (Sample Unit No. 01).

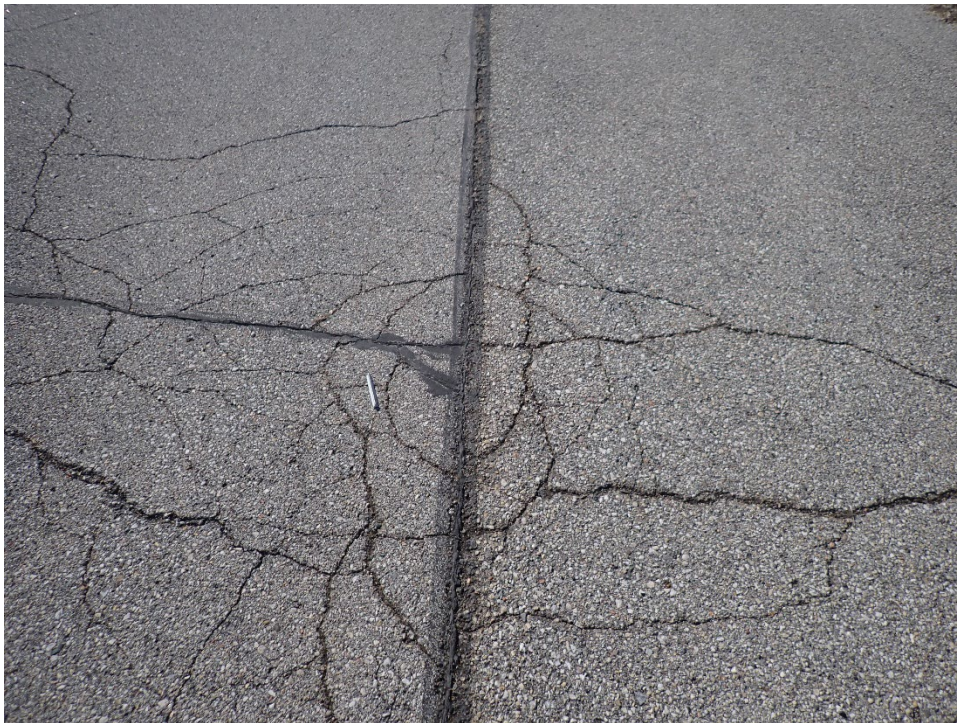
T011Y-02. Alligator Cracking (Sample Unit No. 01).

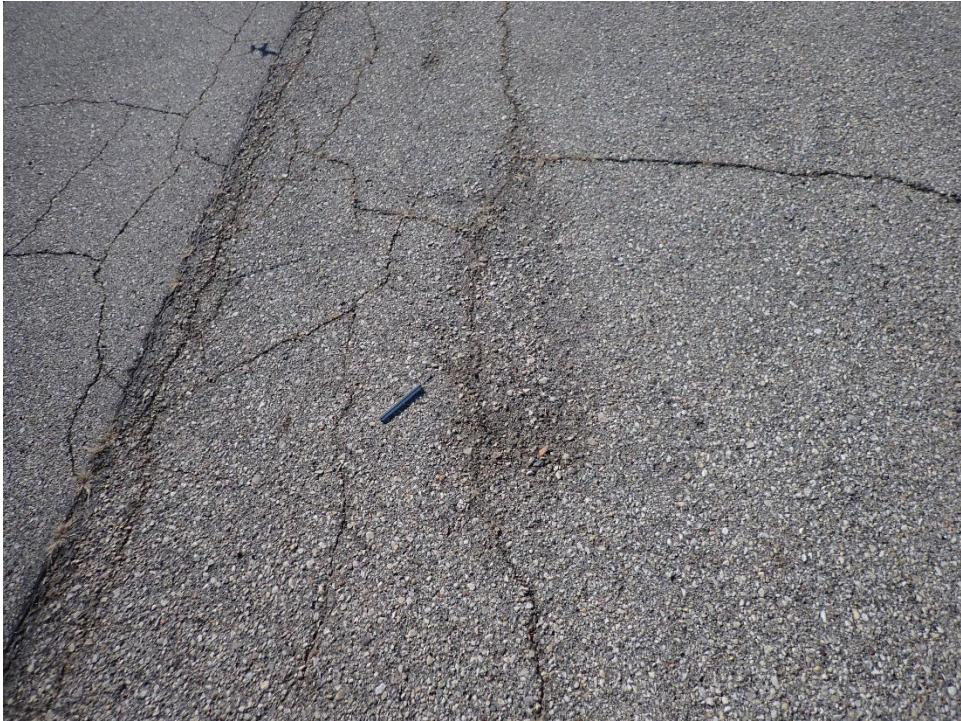
T011Y-02. Raveling (Sample Unit No. 01).

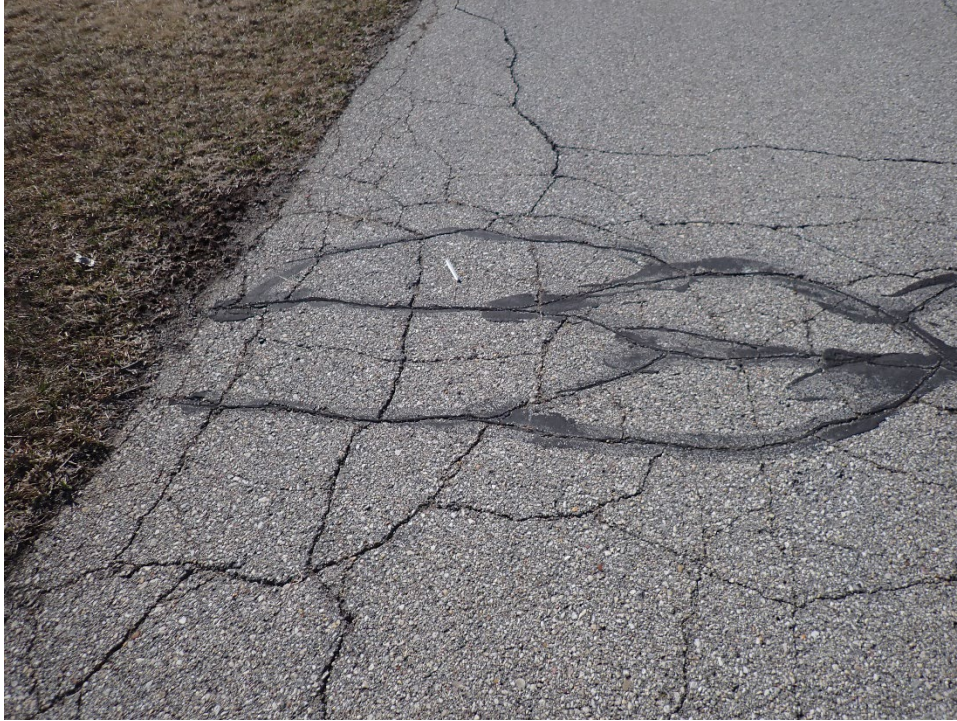
T011Y-03. Alligator Cracking (Sample Unit No. 01).

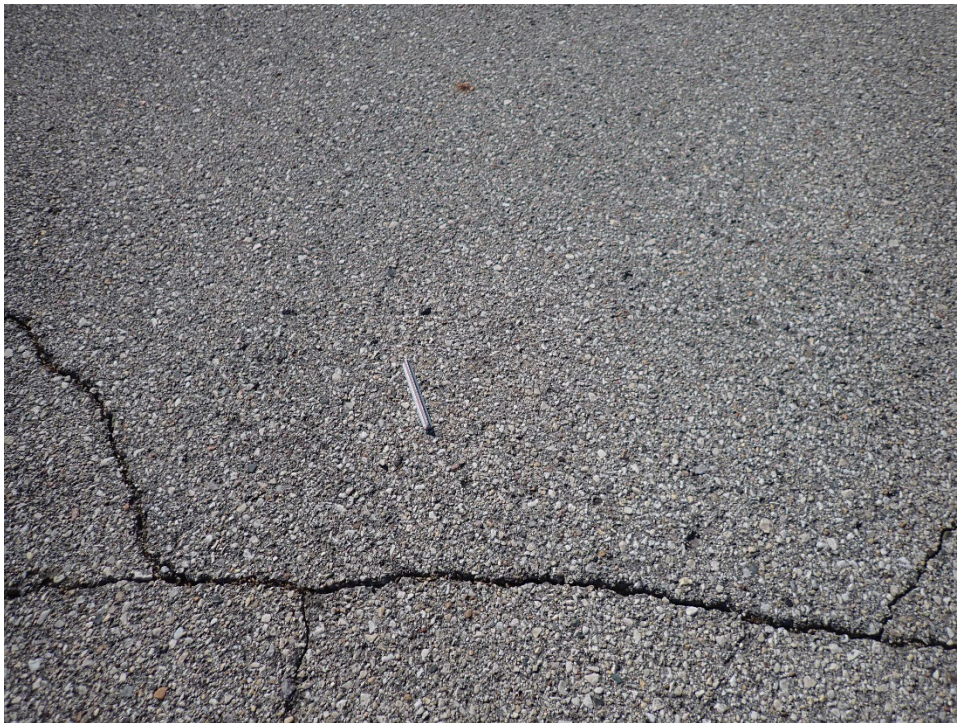
T011Y-03. Raveling (Sample Unit No. 01).
