# Pella Municipal Airport

## Pavement Management Report

**AUGUST 2025**

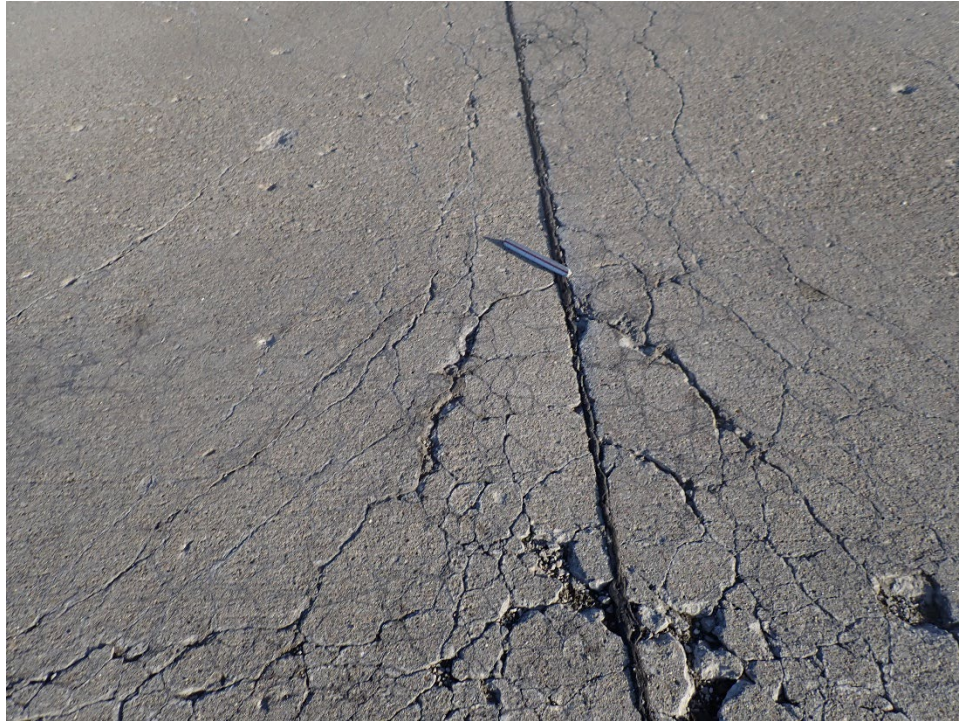
A01PE-01. ASR (Sample Unit No. 09).

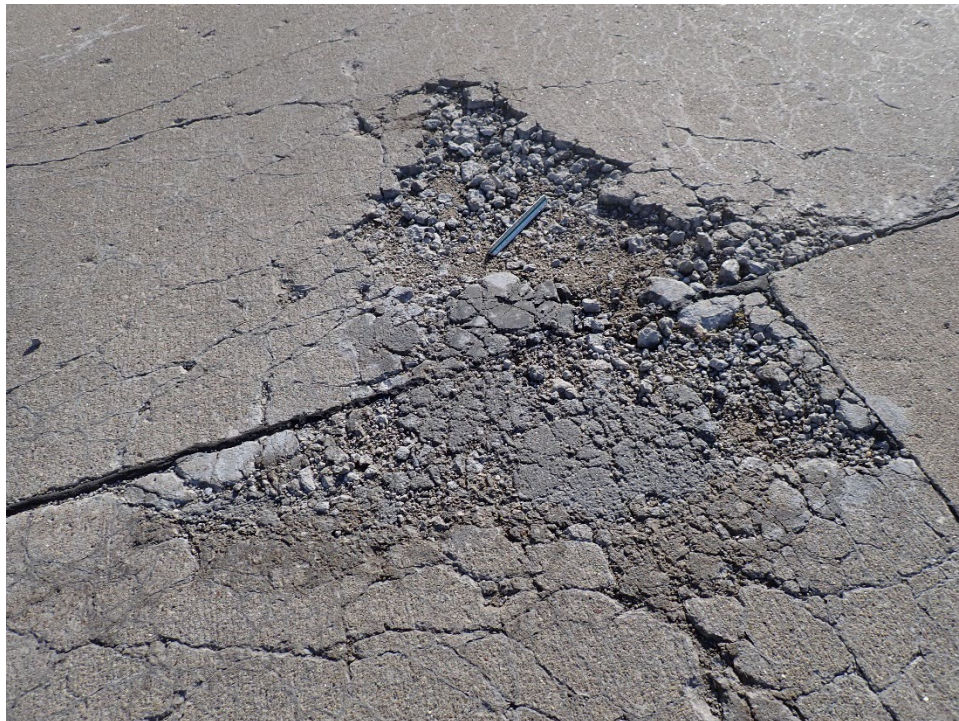
A01PE-01. ASR (Sample Unit No. 15).

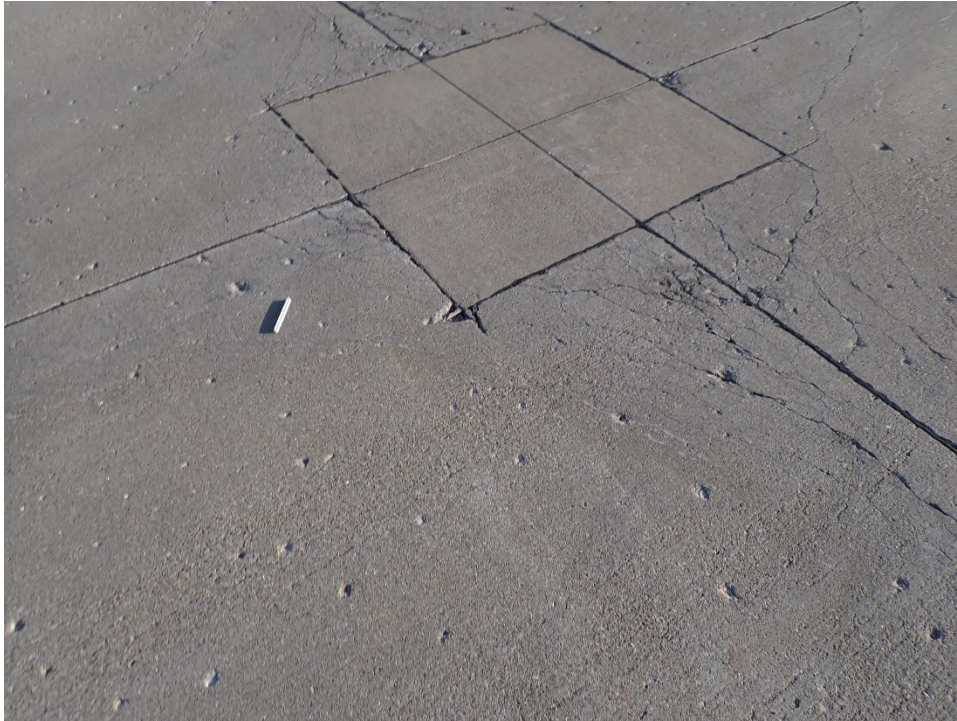
A01PE-01. Small Patching (Sample Unit No. 09).

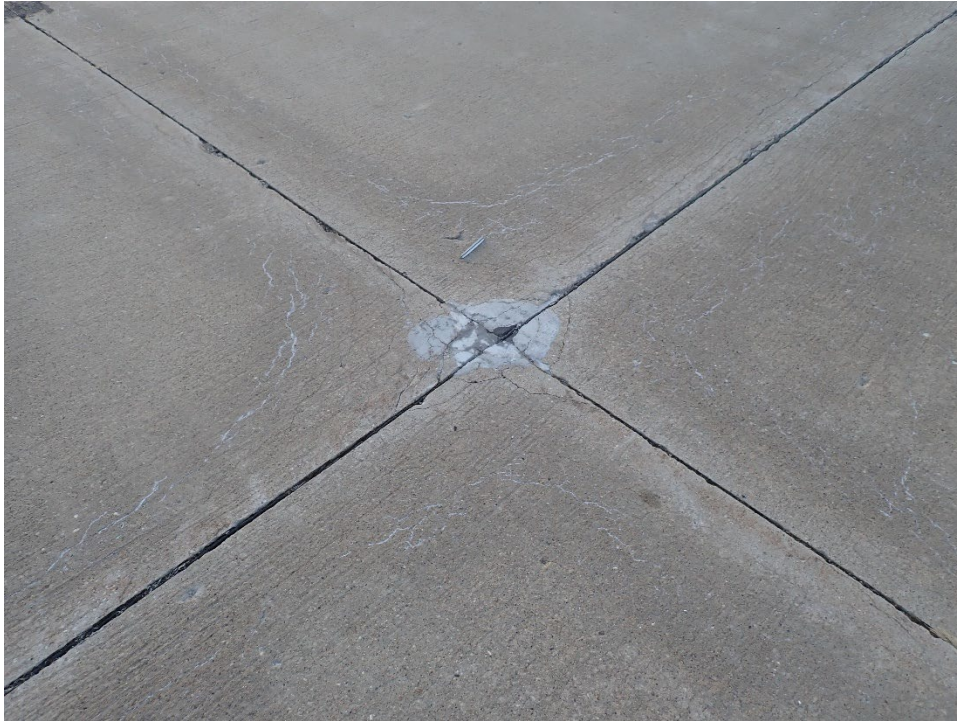
A01PE-02. ASR (Sample Unit No. 01).

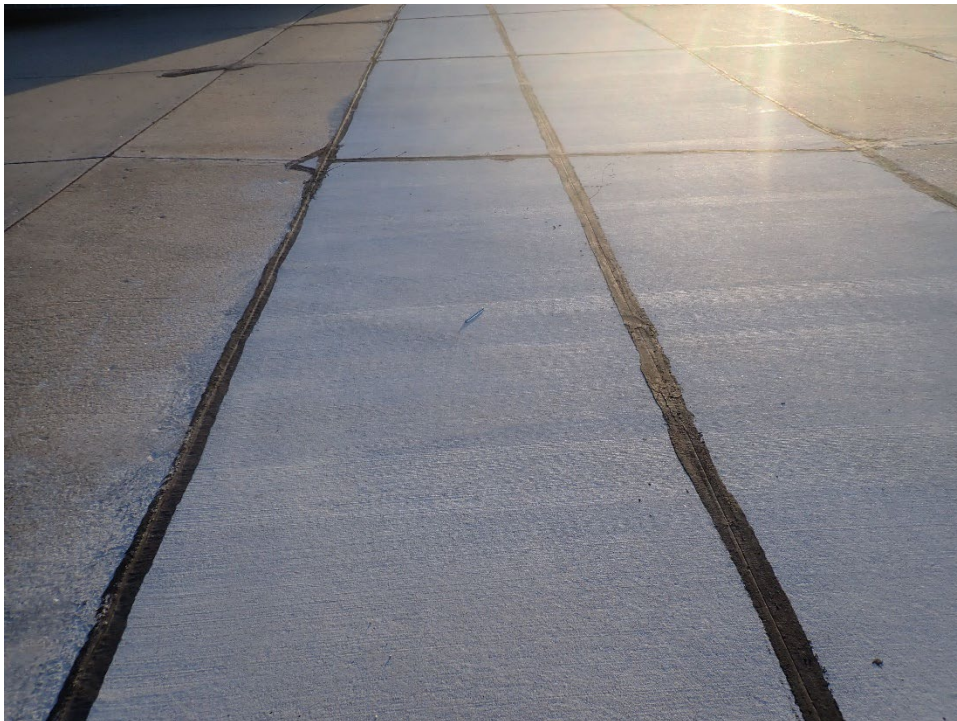
A01PE-02. Large Patching (Sample Unit No. 01).

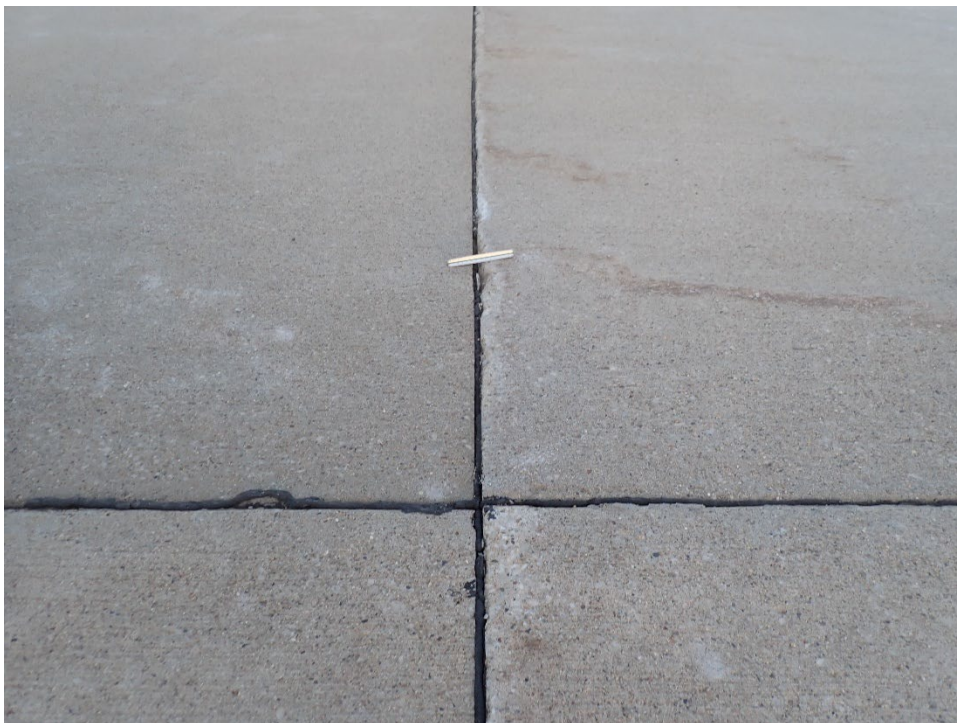
A01PE-03. Faulting (Sample Unit No. 03).

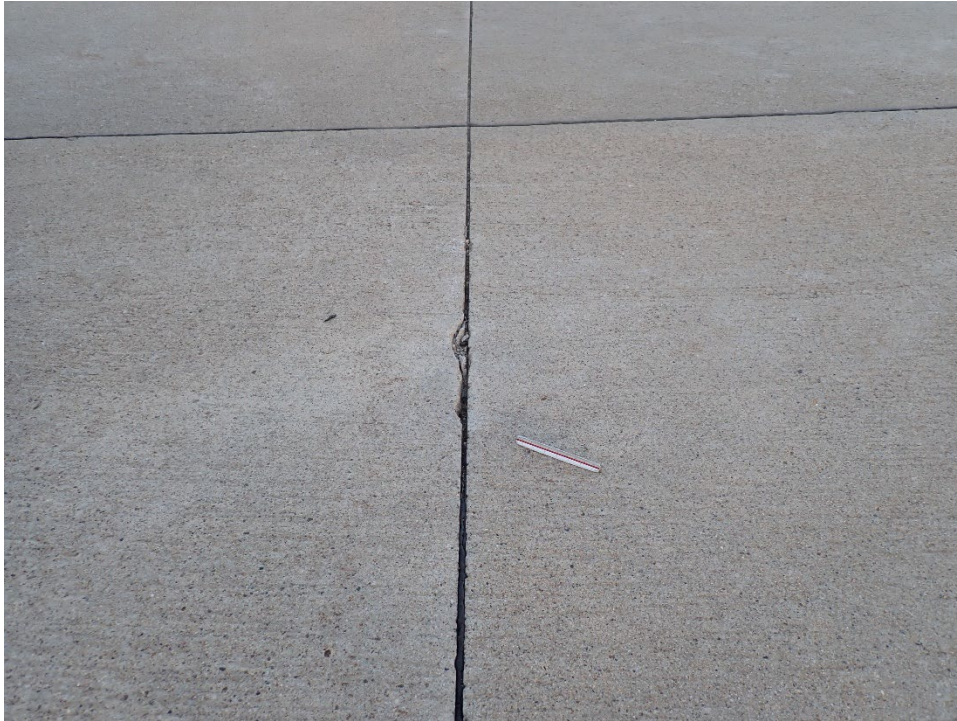
A01PE-03. Joint Seal Damage (Sample Unit No. 03).

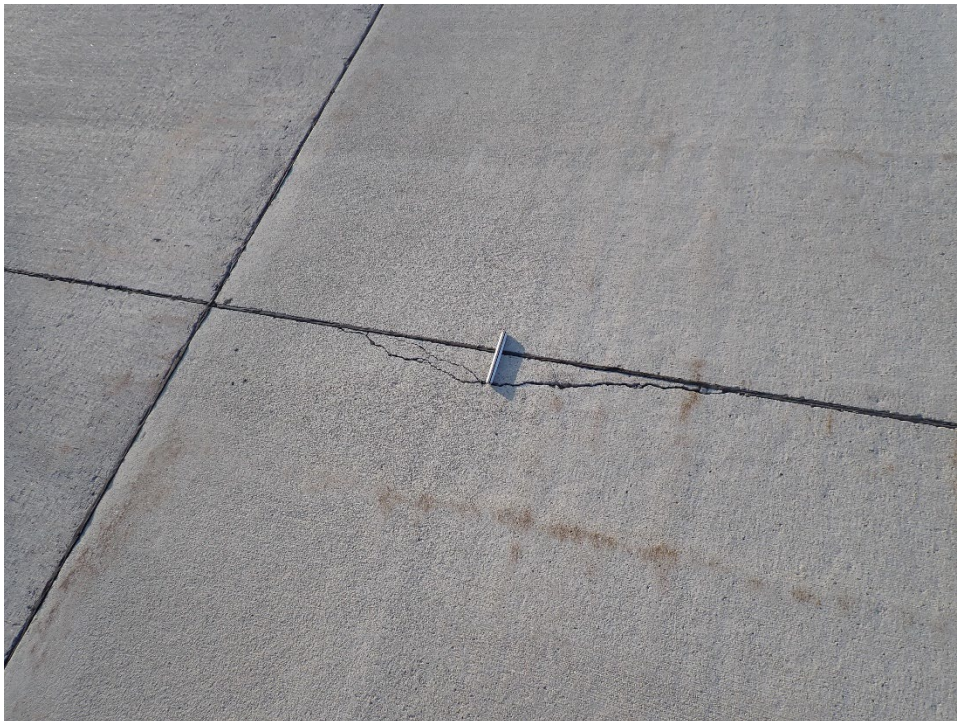
A01PE-03. Joint Spalling (Sample Unit No. 03).

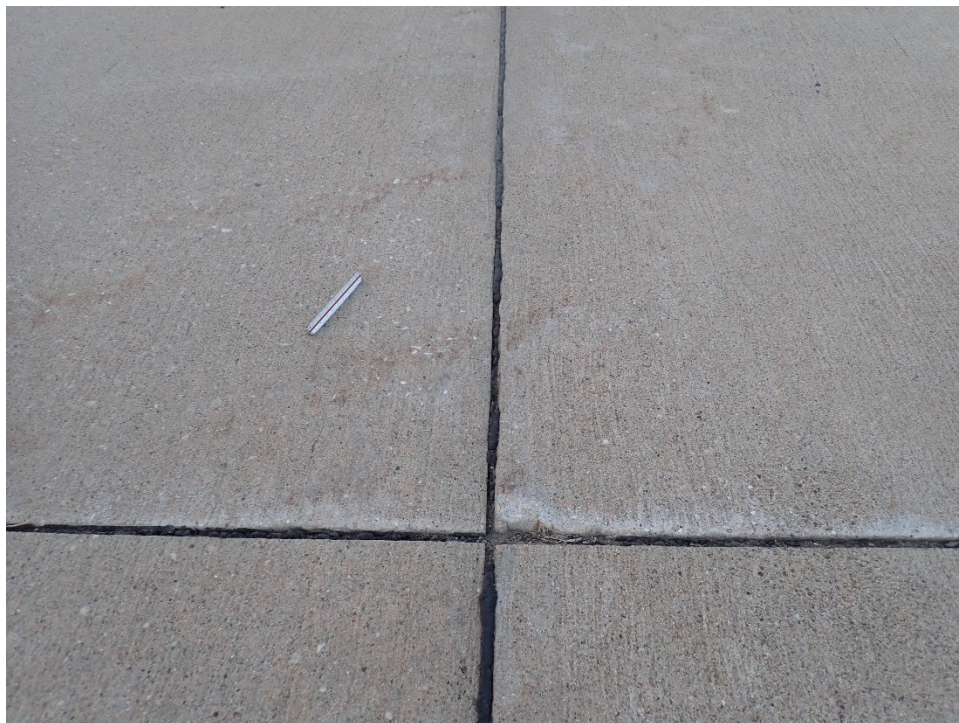
A01PE-04. Joint Seal Damage (Sample Unit No. 02).

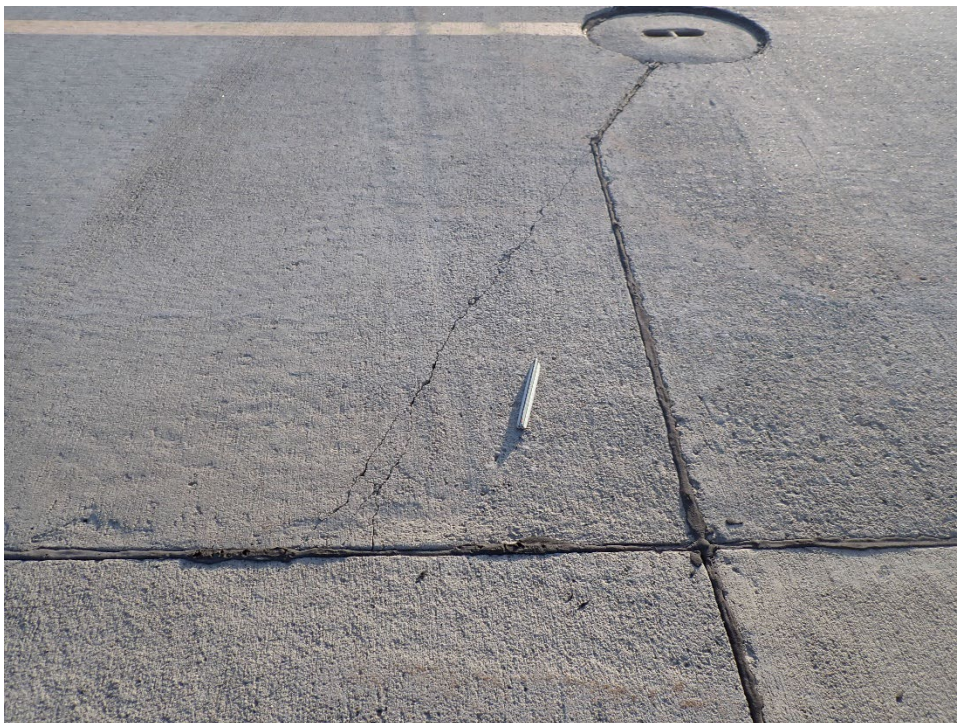
A01PE-05. Corner Break (Sample Unit No. 07).

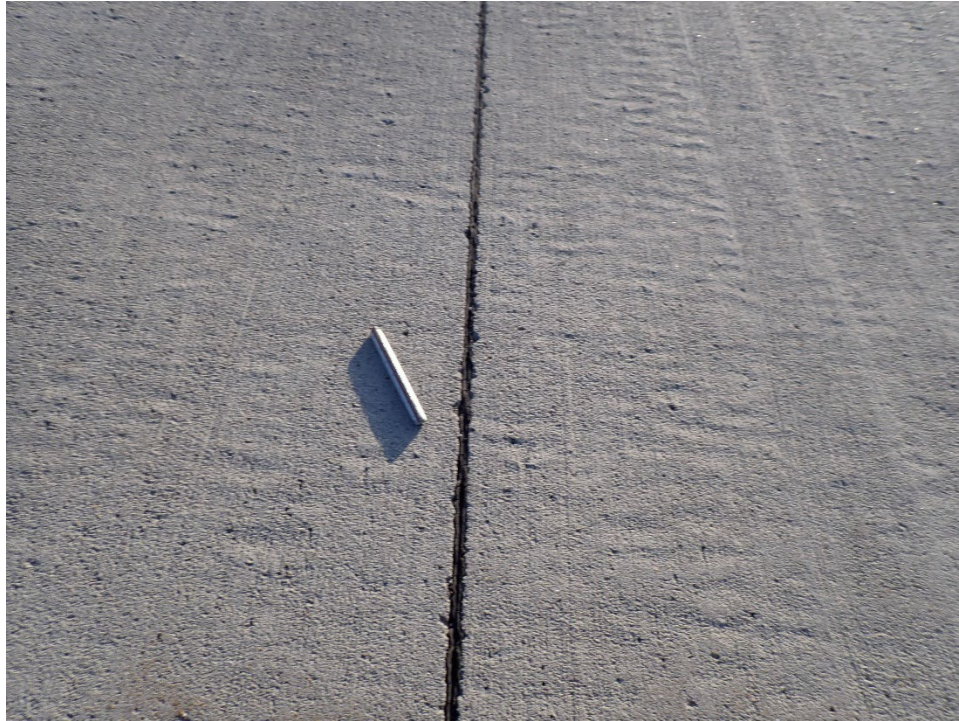
A01PE-05. Joint Seal Damage (Sample Unit No. 01).

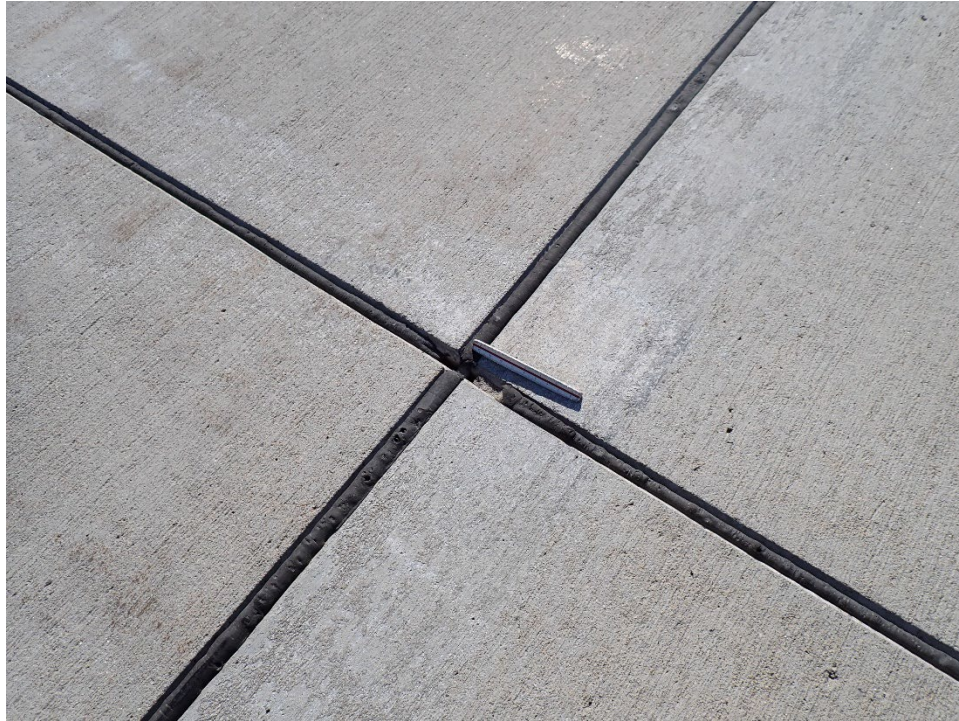
R16PE-01. Joint Seal Damage (Sample Unit No. 12).

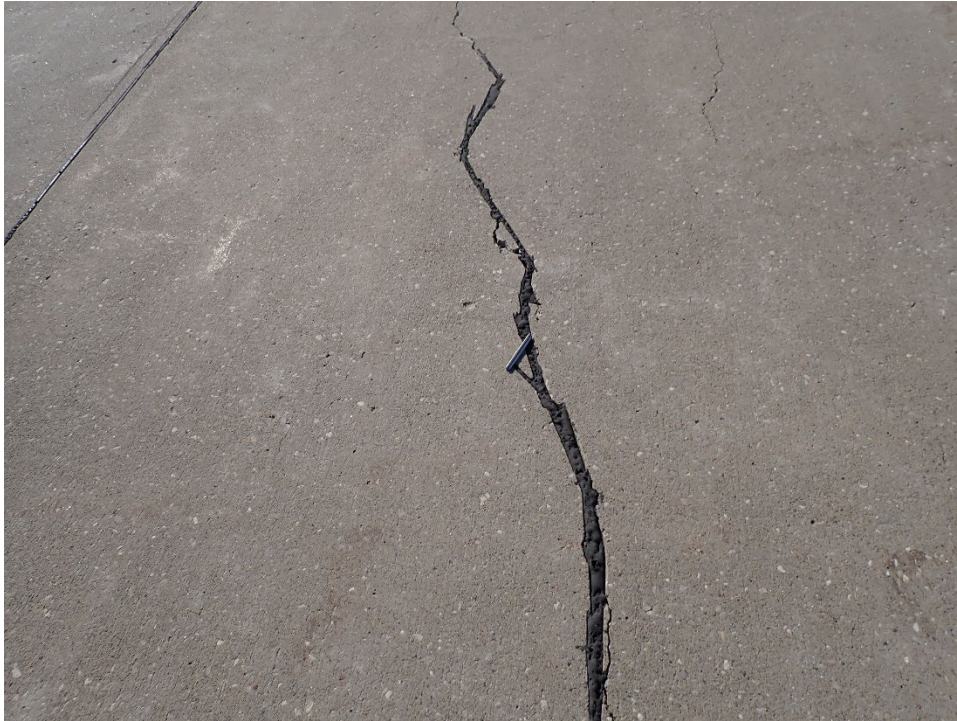
R16PE-03. LTD Cracking (Sample Unit No. 31).

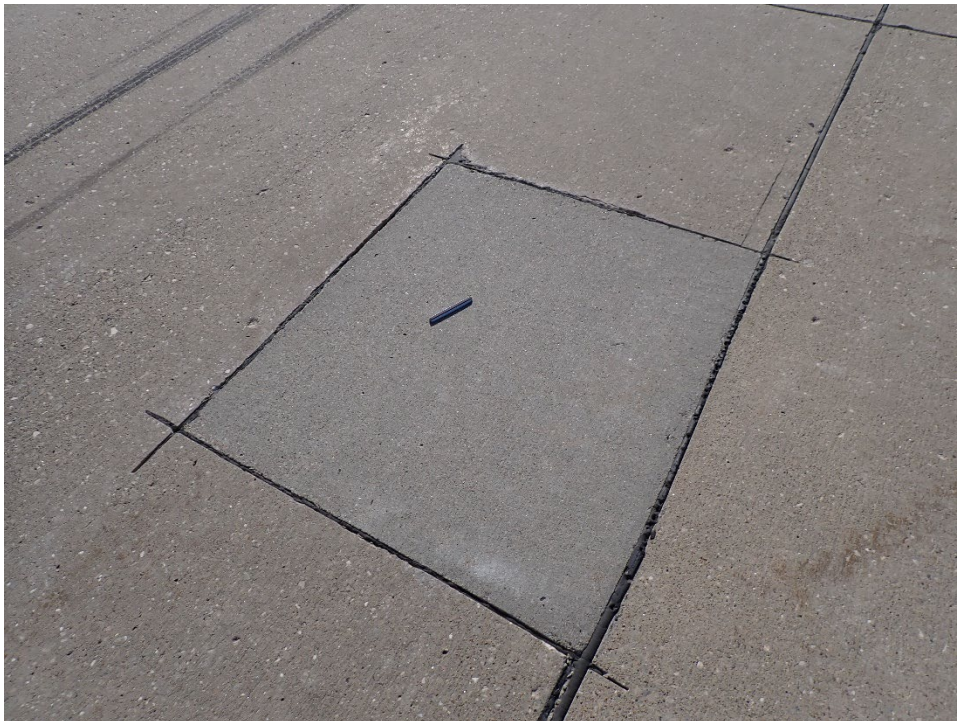
R16PE-03. Large Patching (Sample Unit No. 31).

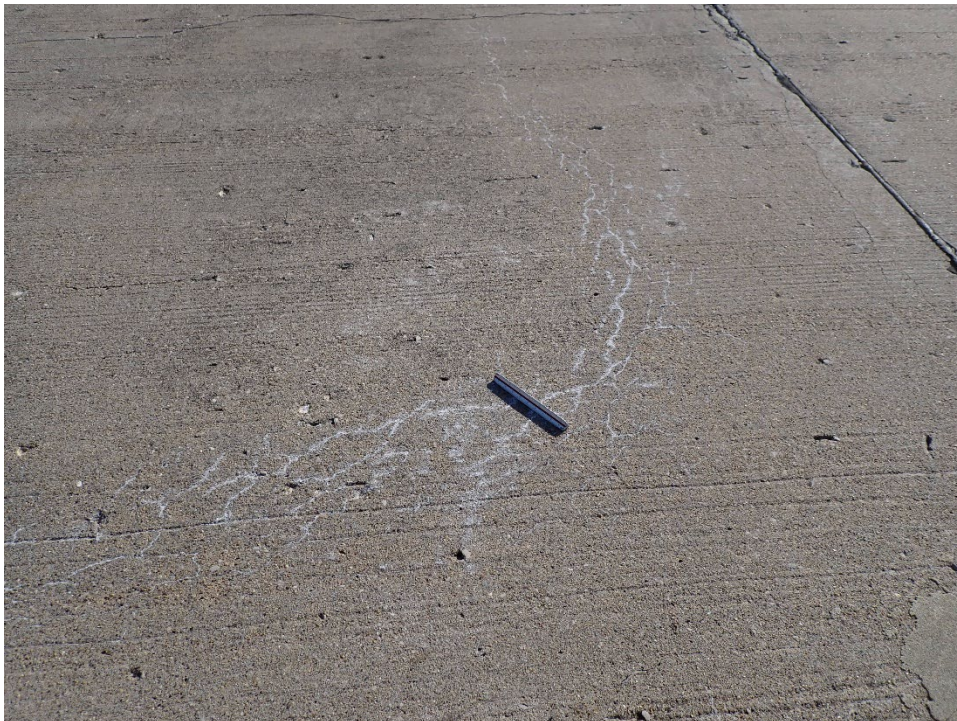
R16PE-05. ASR (Sample Unit No. 01) (1).

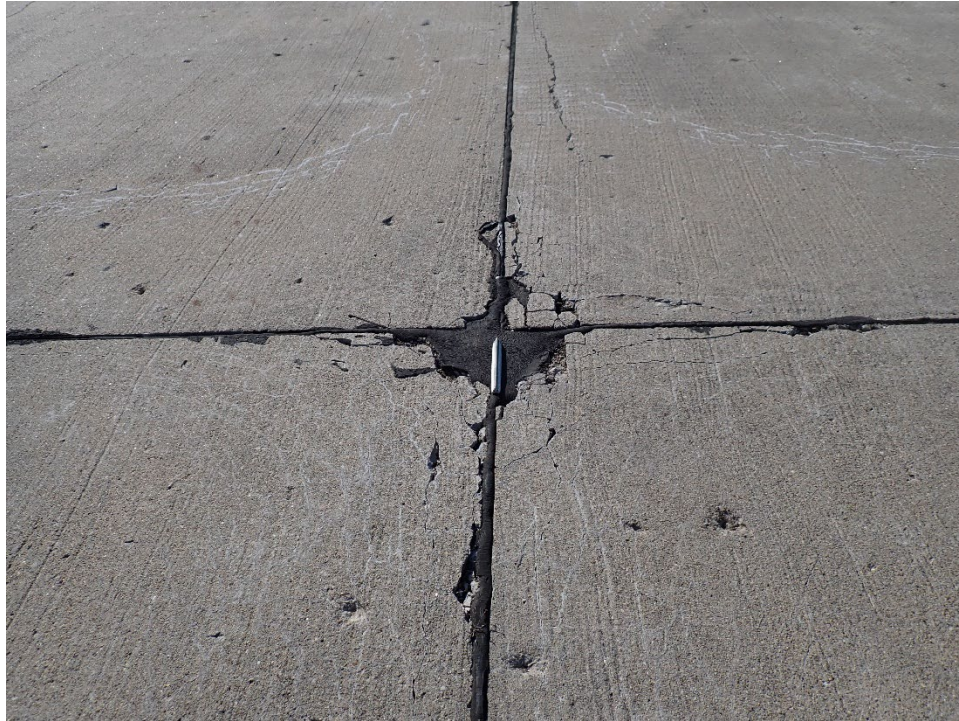
R16PE-05. ASR (Sample Unit No. 01) (2).

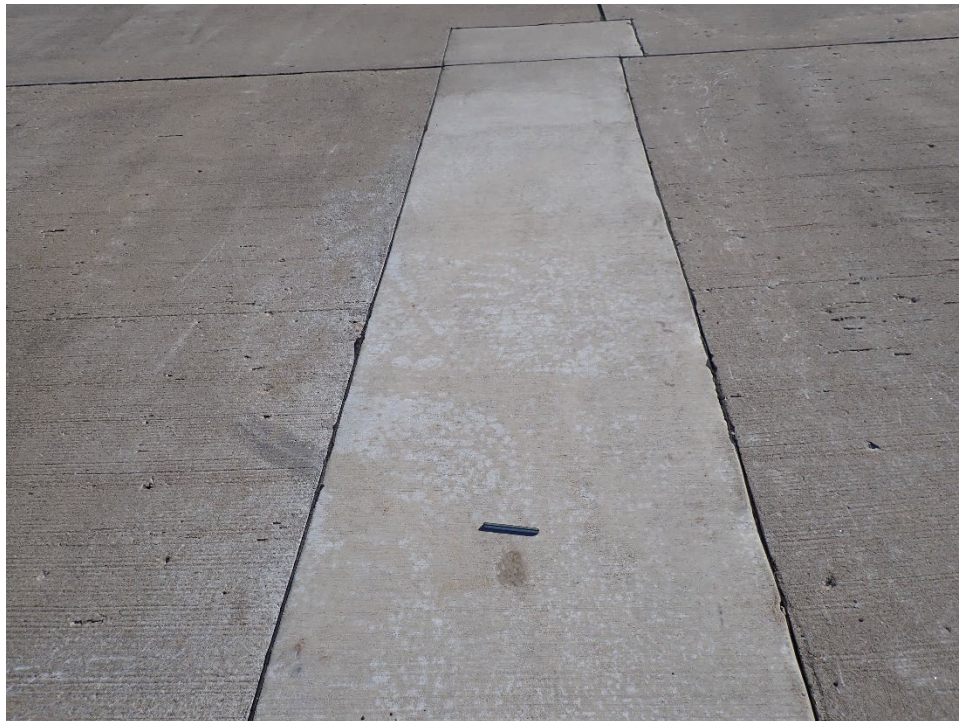
R16PE-05. Large Patching (Sample Unit No. 01).

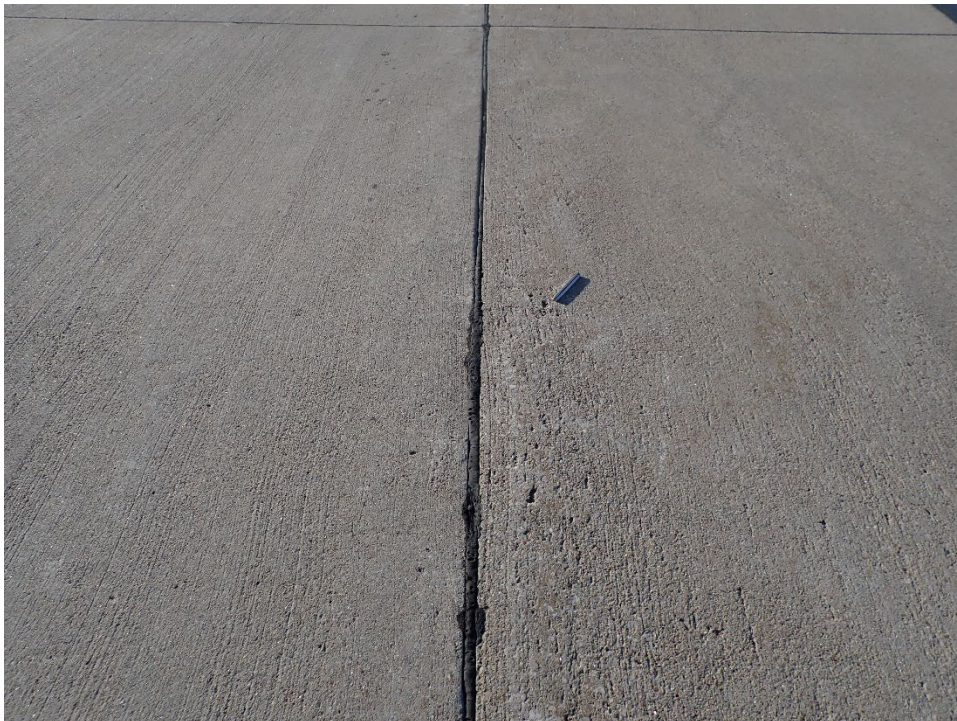
R16PE-06. Joint Seal Damage (Sample Unit No. 20).

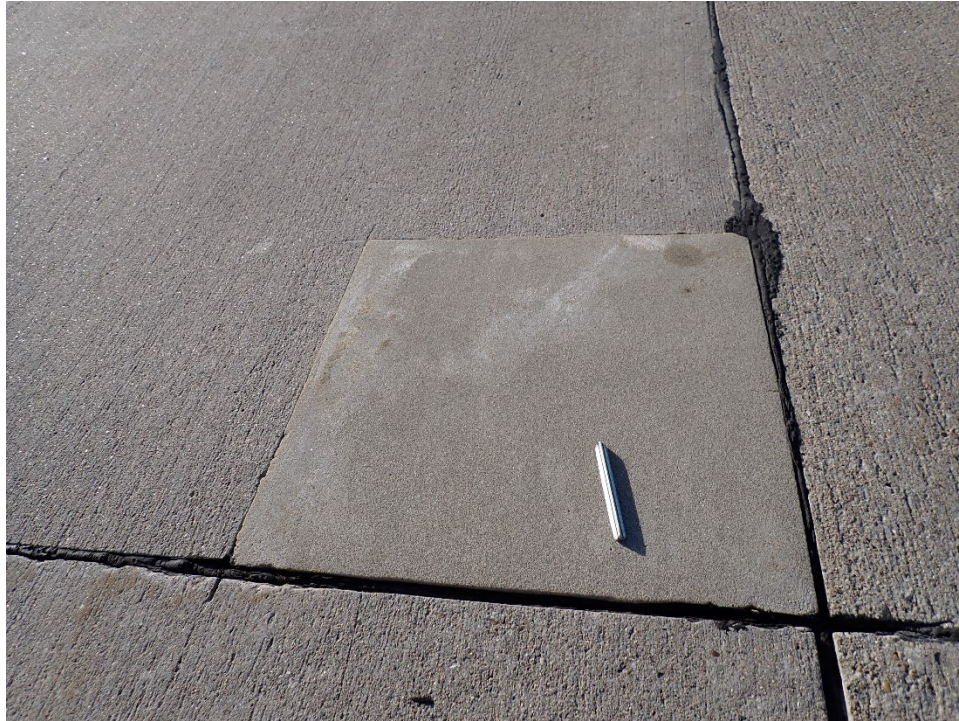
R16PE-06. Large Patching (Sample Unit No. 20).

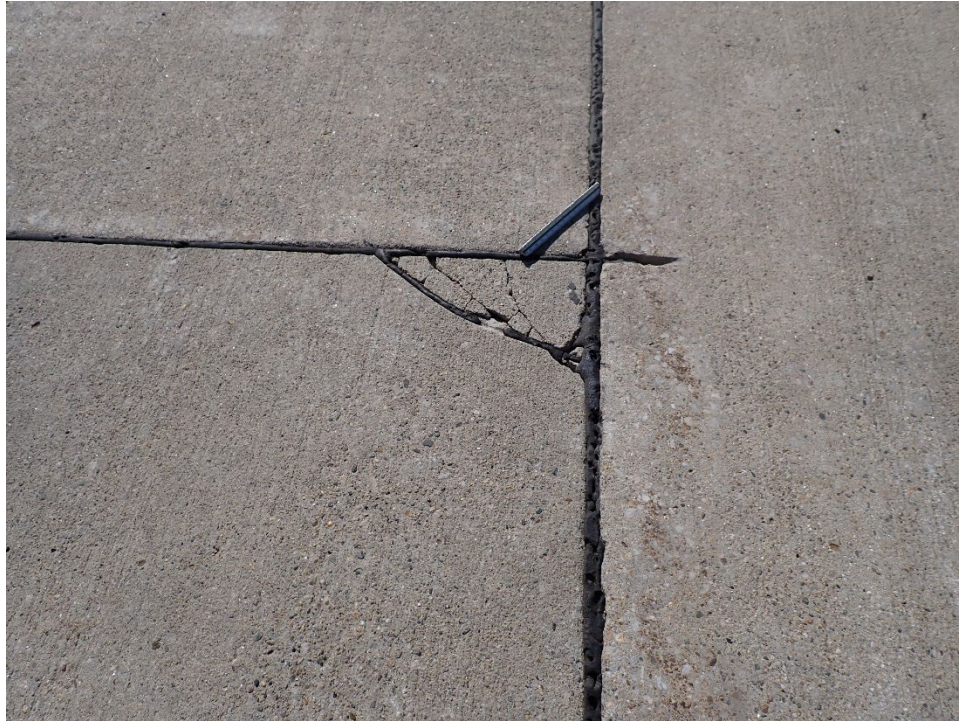
R16PE-07. Corner Spalling (Sample Unit No. 04).

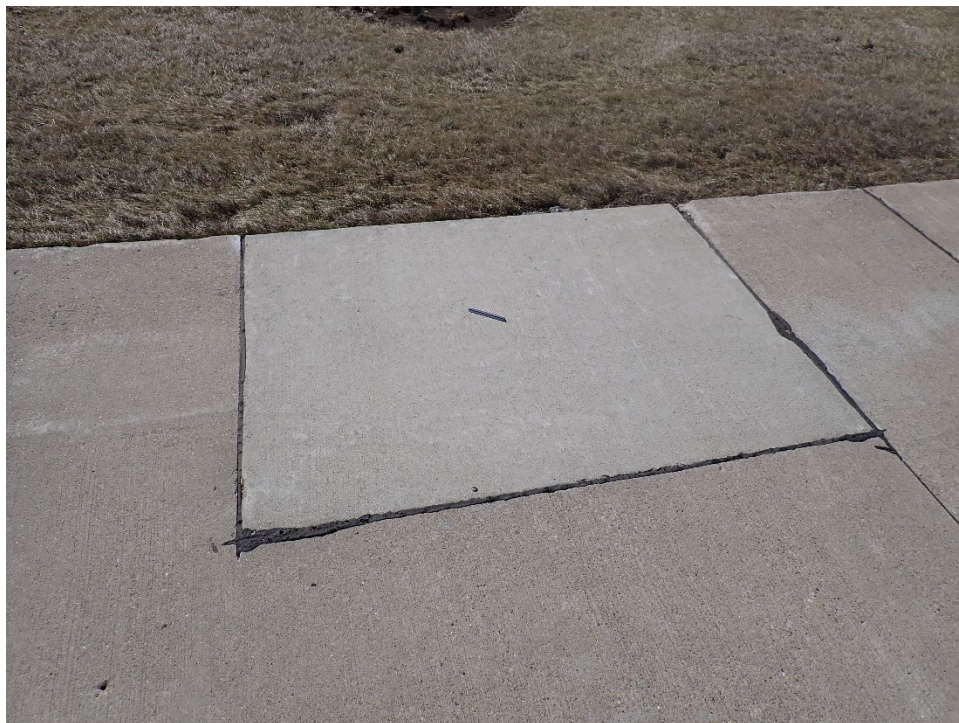
R16PE-07. Large Patching (Sample Unit No. 04).

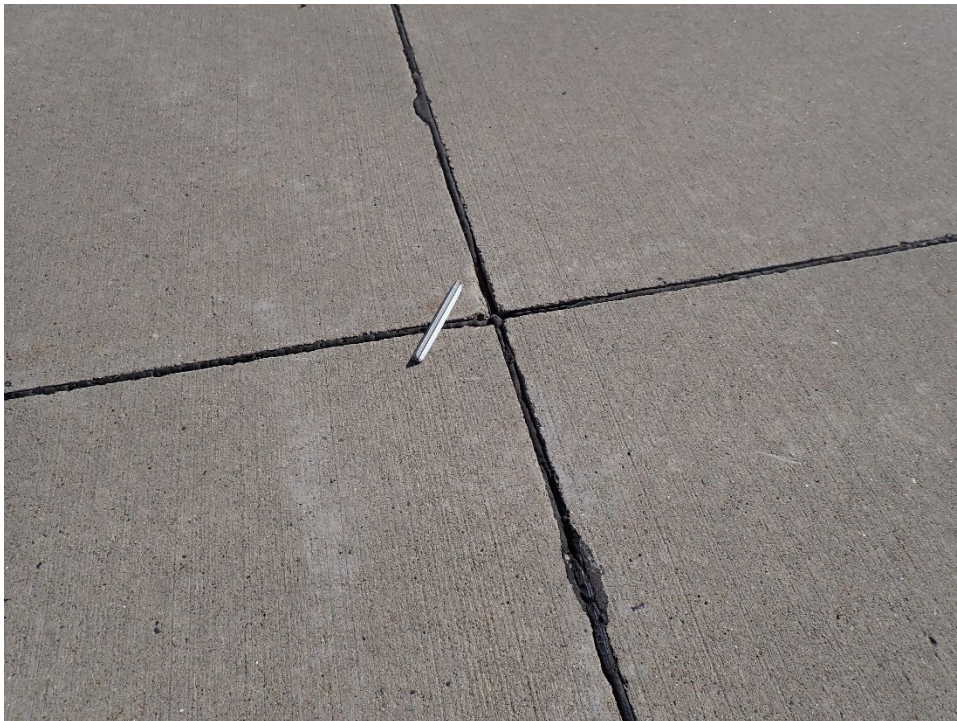
R16PE-08. Joint Seal Damage (Sample Unit No. 01).

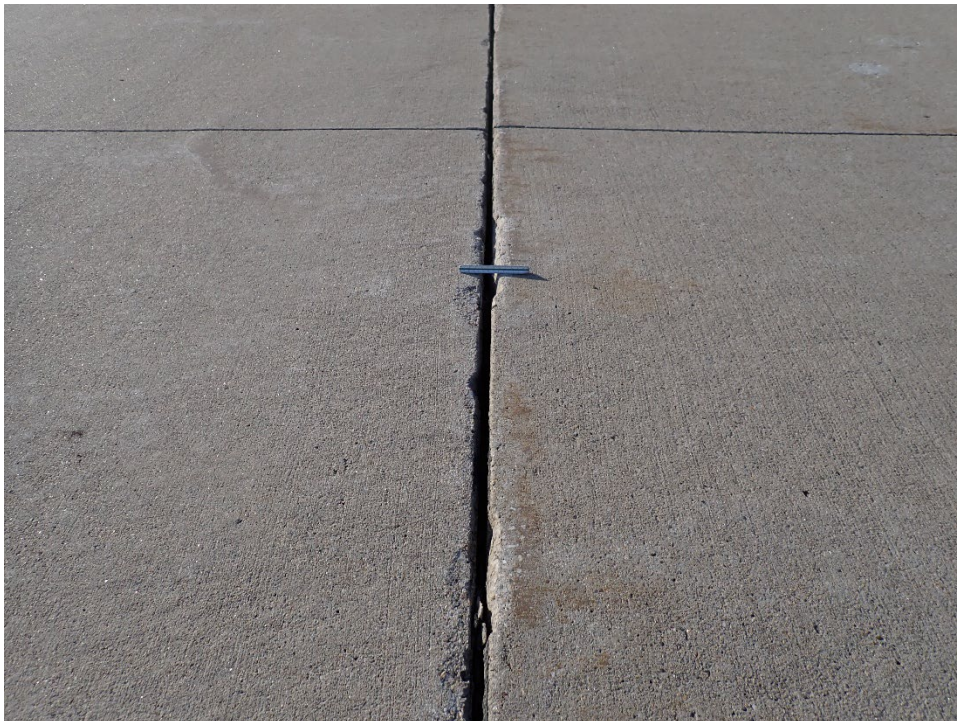
R16PE-09. Faulting (Sample Unit No. 05).

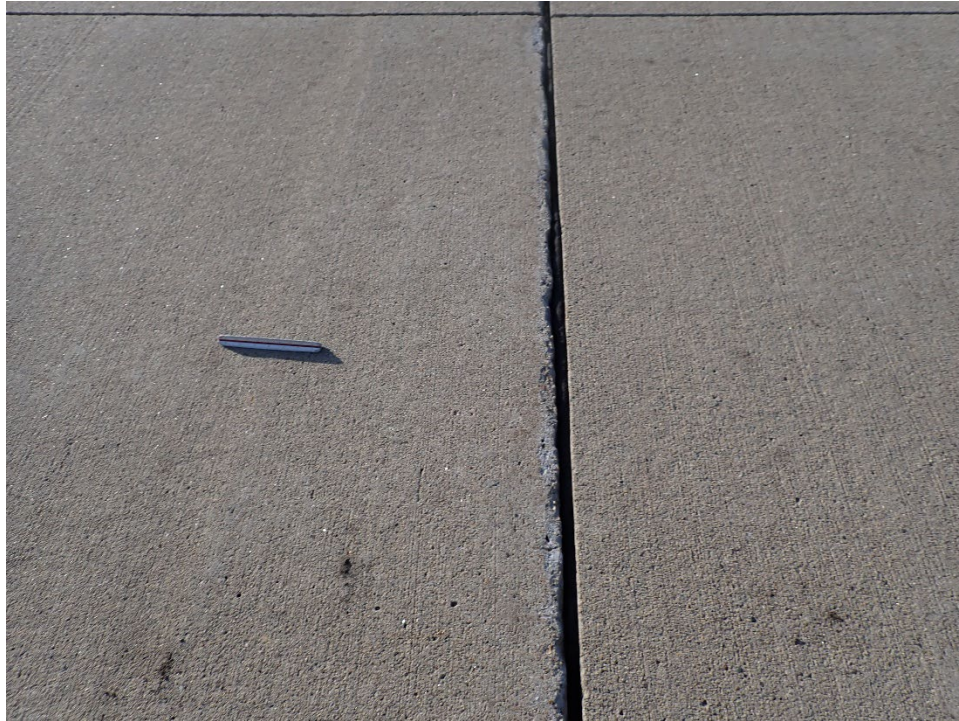
R16PE-09. Joint Seal Damage (Sample Unit No. 05).

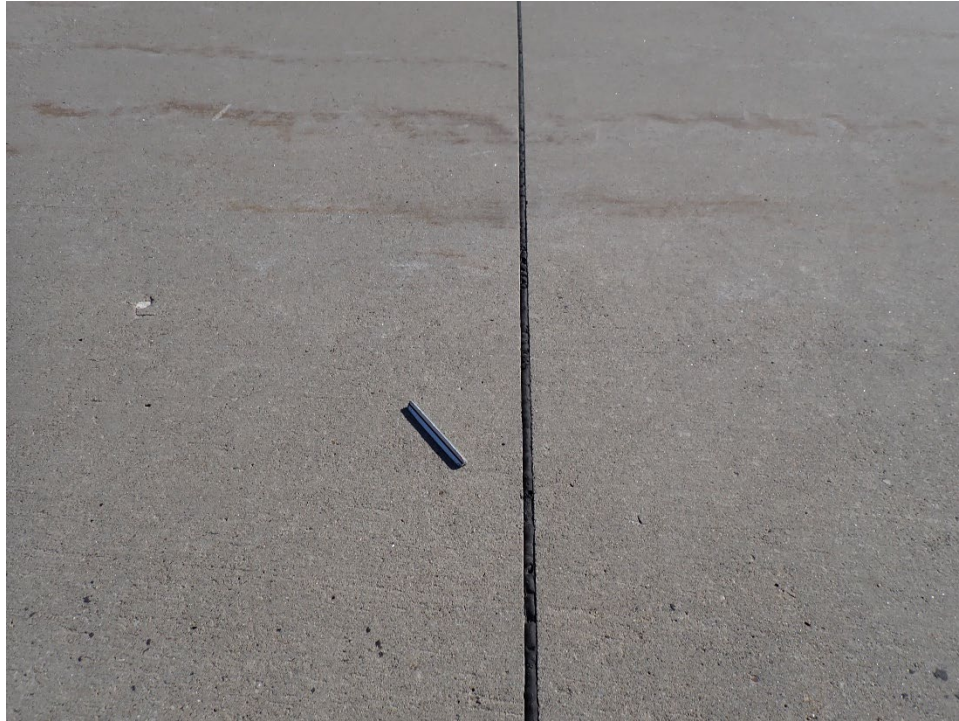
R16PE-10. Joint Seal Damage (Sample Unit No. 02).

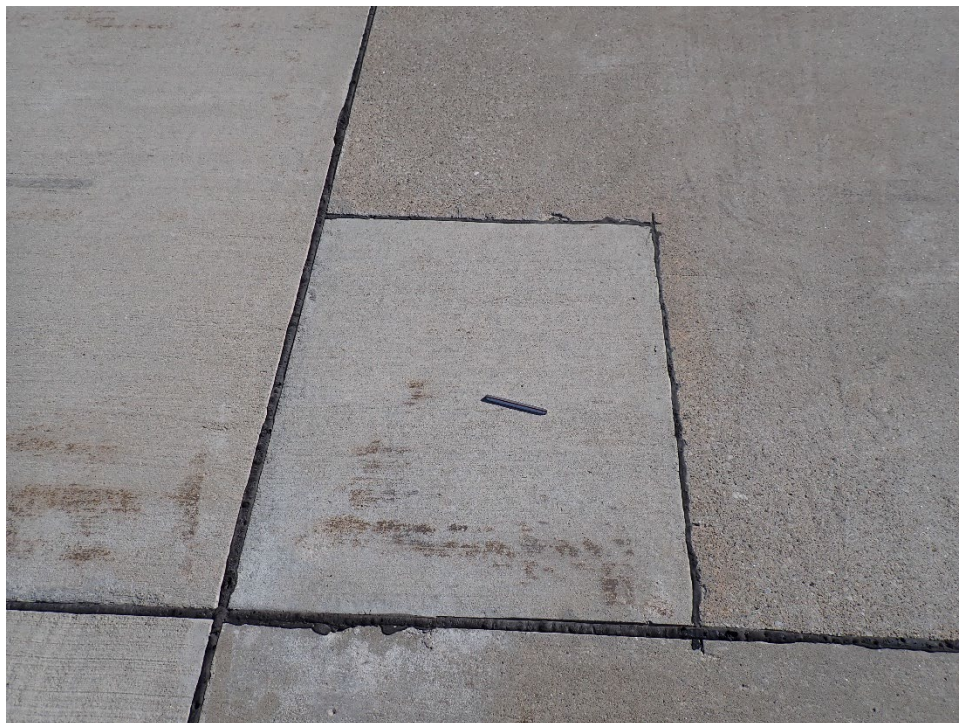
R16PE-10. Large Patching (Sample Unit No. 02).

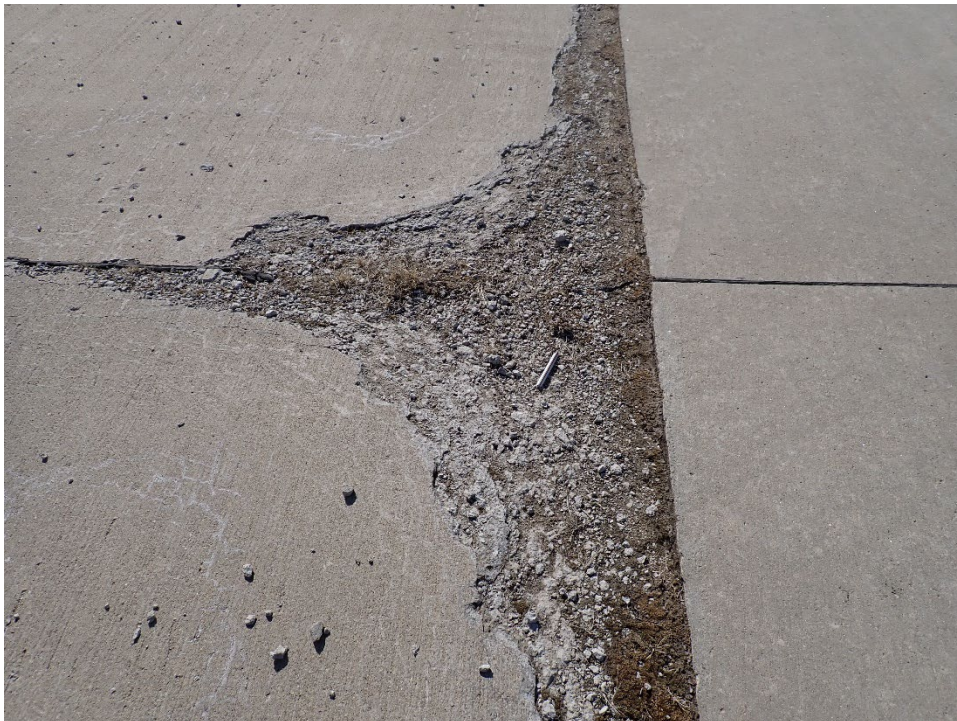
R16PE-11. ASR (Sample Unit No. 03).

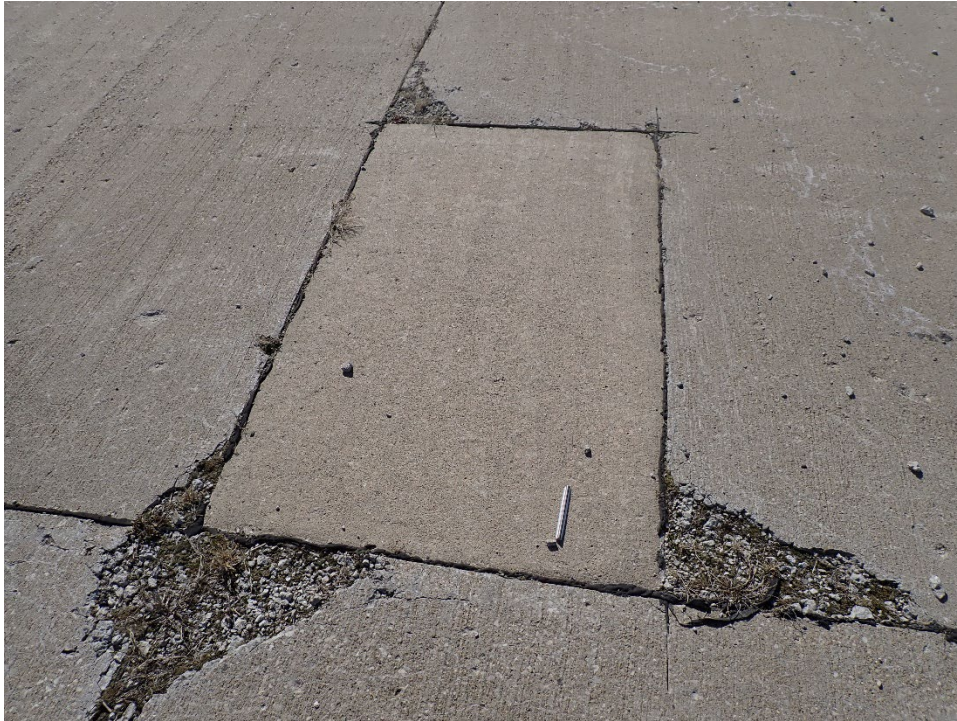
R16PE-11. Large Patching (Sample Unit No. 03).

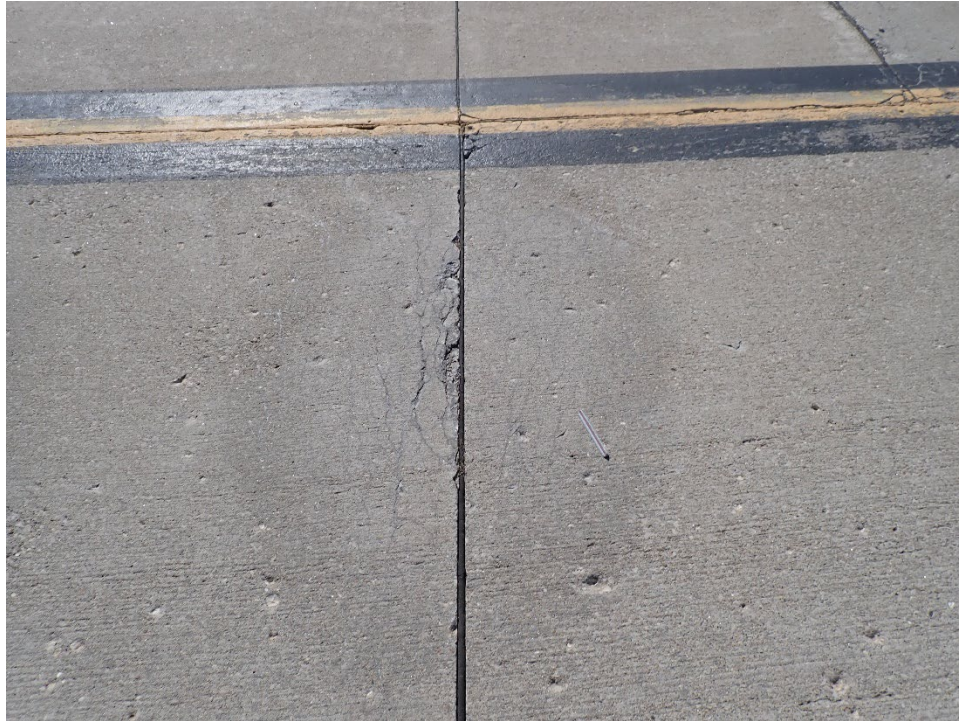
T01PE-01. ASR (Sample Unit No. 01).

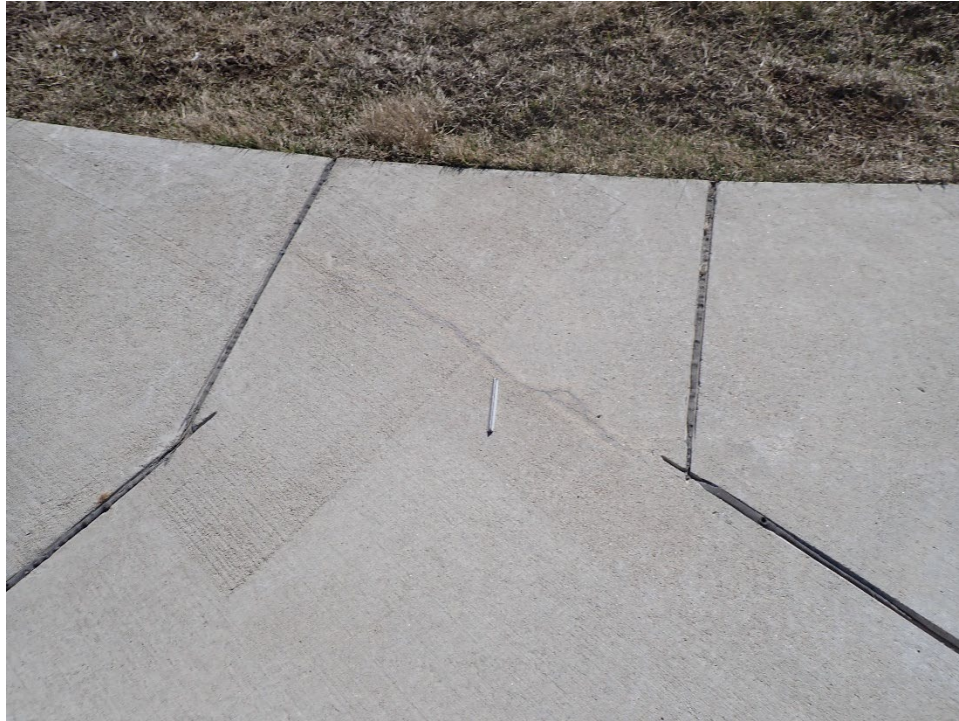
T01PE-02. ASR (Sample Unit No. 01).

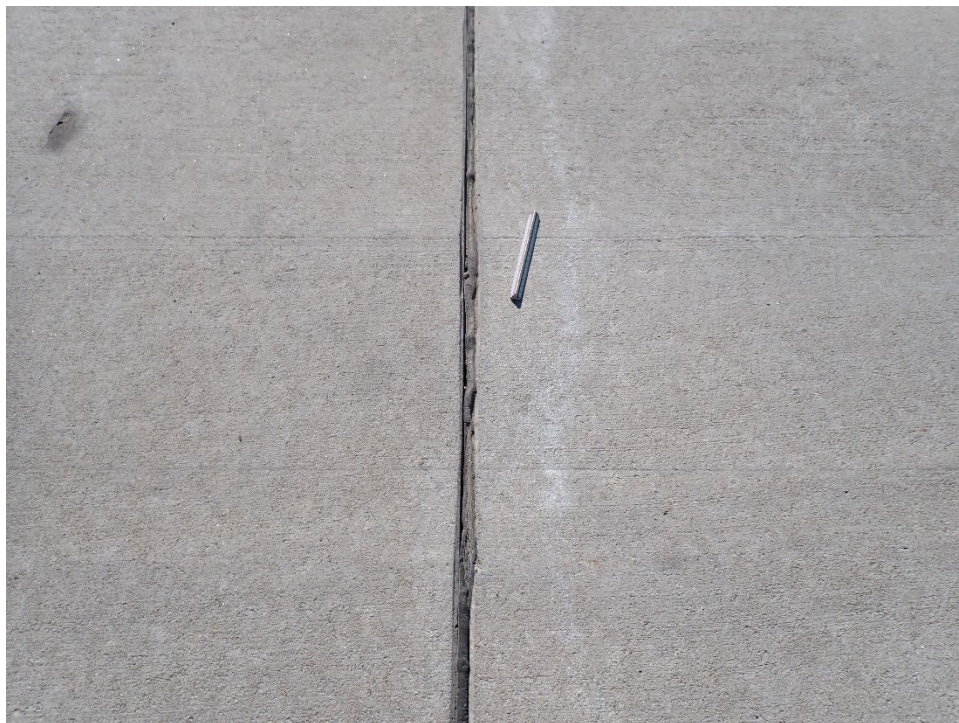
T01PE-02. Joint Seal Damage (Sample Unit No. 01).

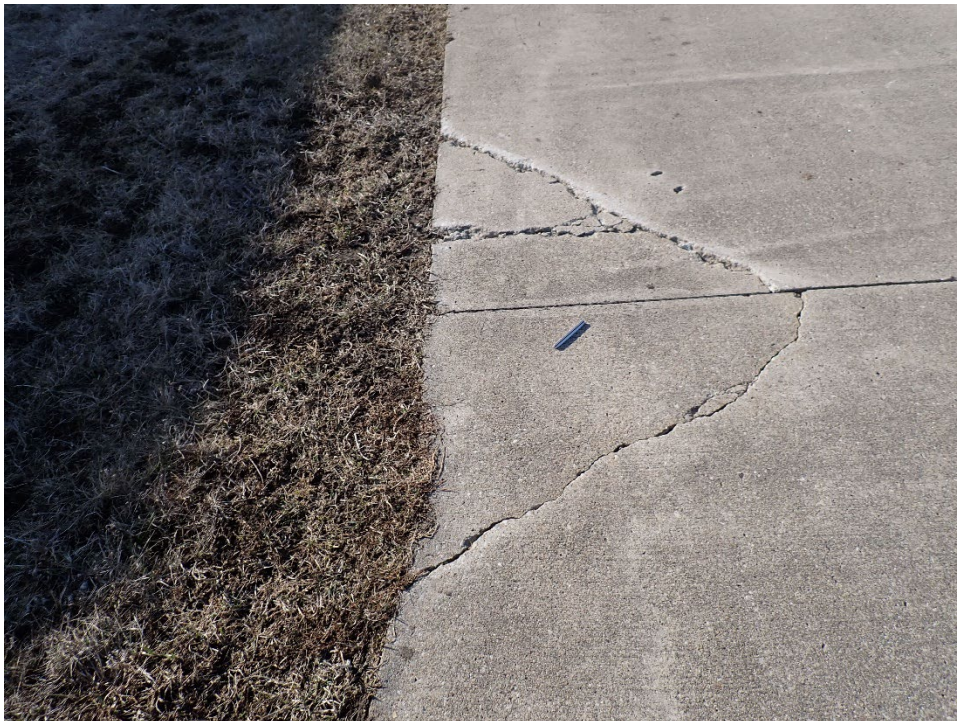
TH01PE-01. Corner Break (Sample Unit No. 09).

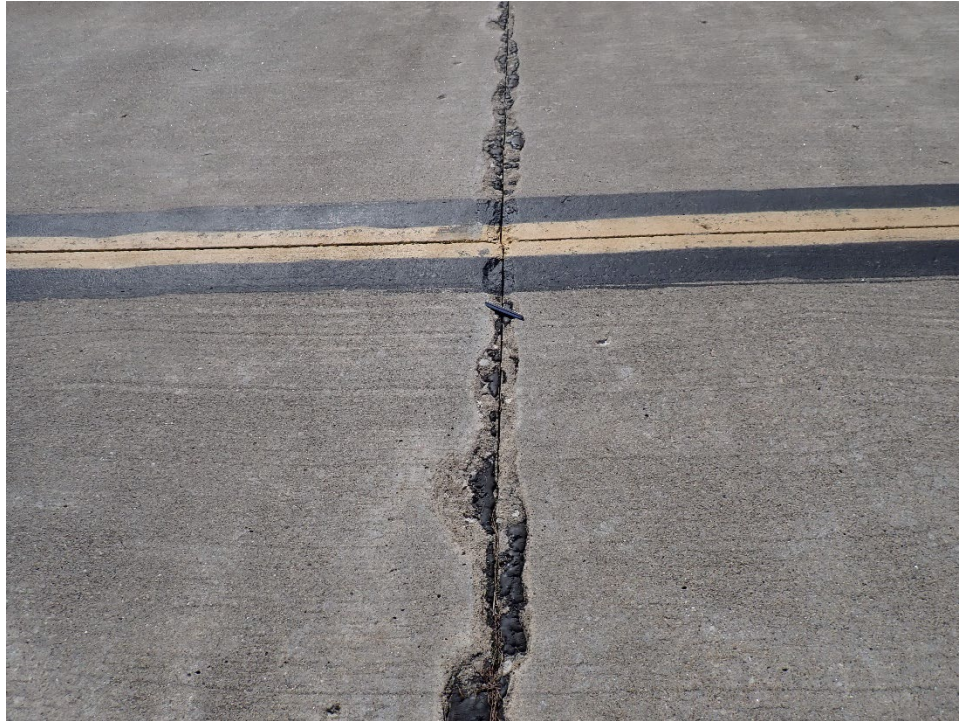
TH01PE-01. Joint Seal Damage (Sample Unit No. 01).
