# Pella Municipal Airport

## Pavement Management Report

**AUGUST 2025**

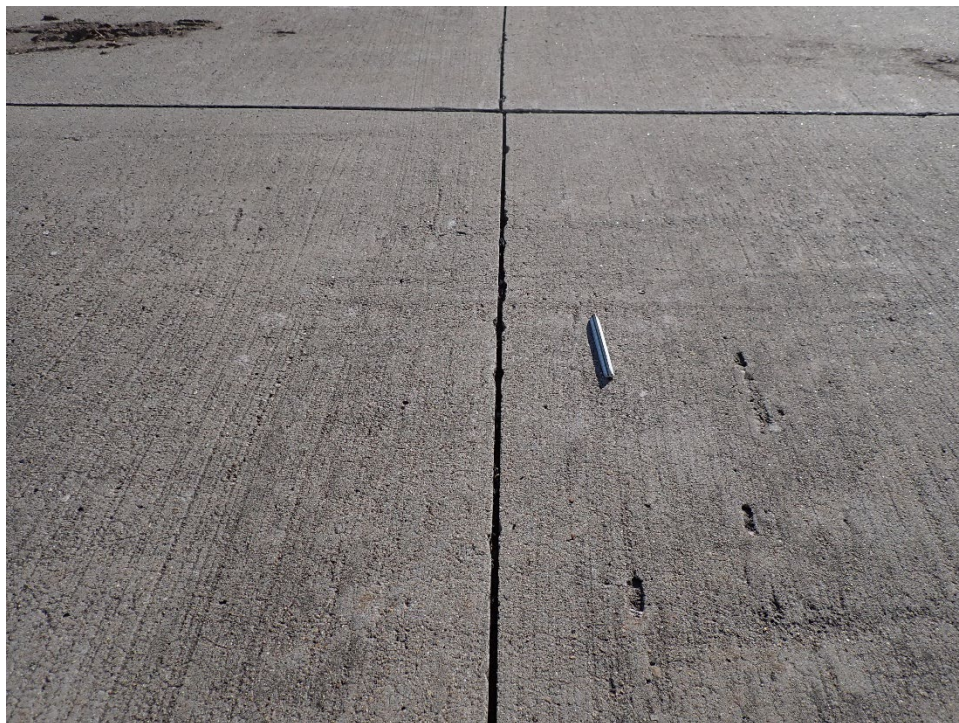
TH01PE-01. Joint Seal Damage (Sample Unit No. 05).

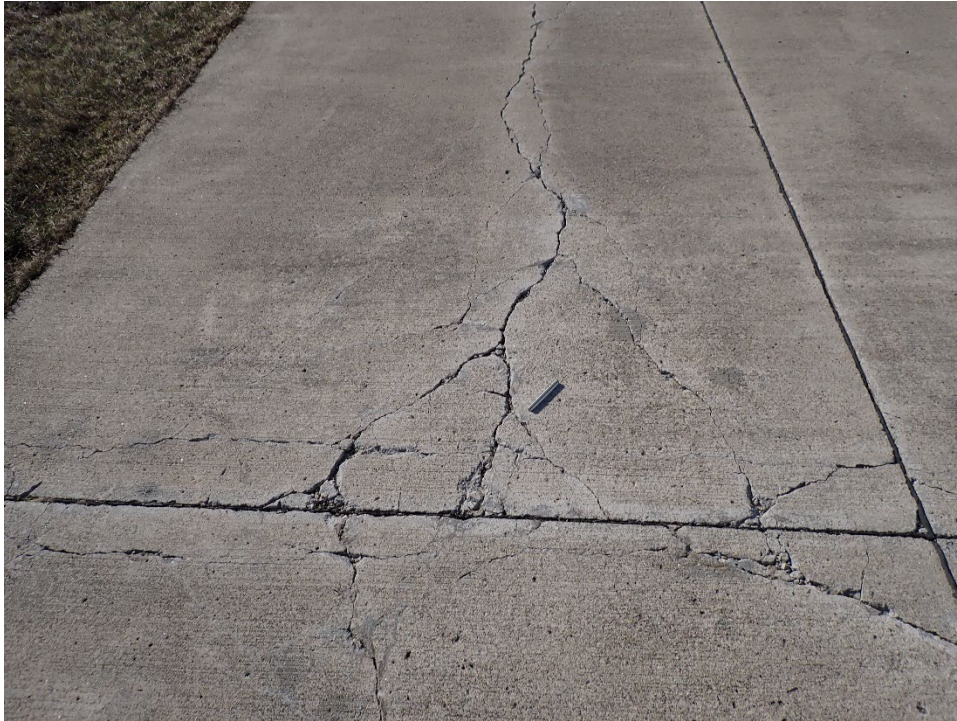
TH01PE-01. Shattered Slab (Sample Unit No. 06).

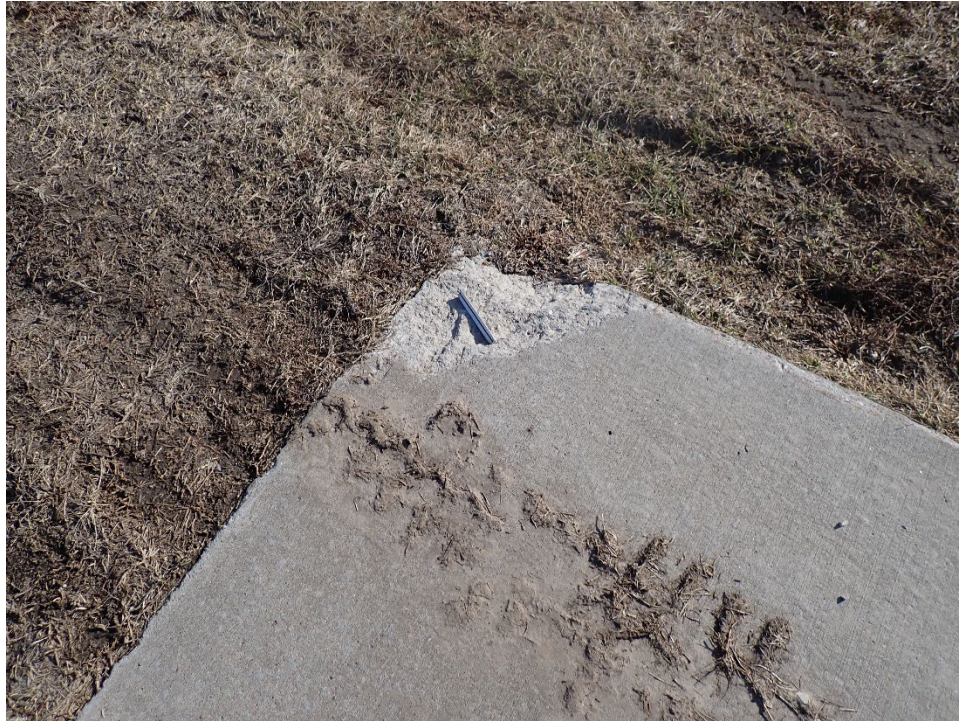
TH01PE-02. Corner Spalling (Sample Unit No. 02).

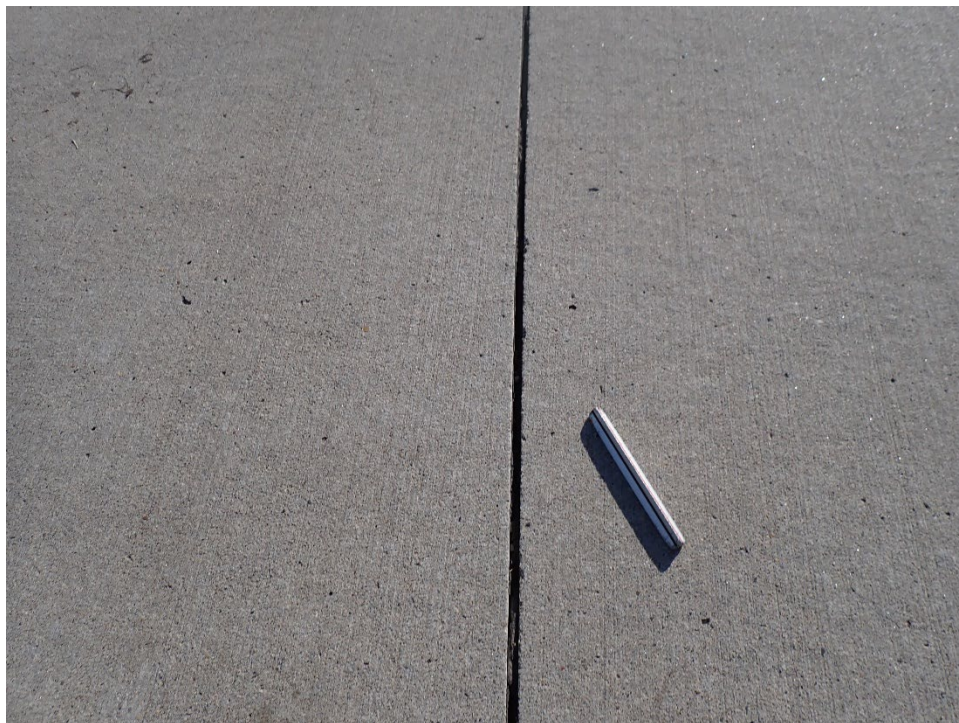
TH01PE-02. Joint Seal Damage (Sample Unit No. 01).
