# Pocahontas Municipal Airport

## Pavement Management Report

# POCAHONTAS MUNICIPAL AIRPORT PAVEMENT MANAGEMENT REPORT

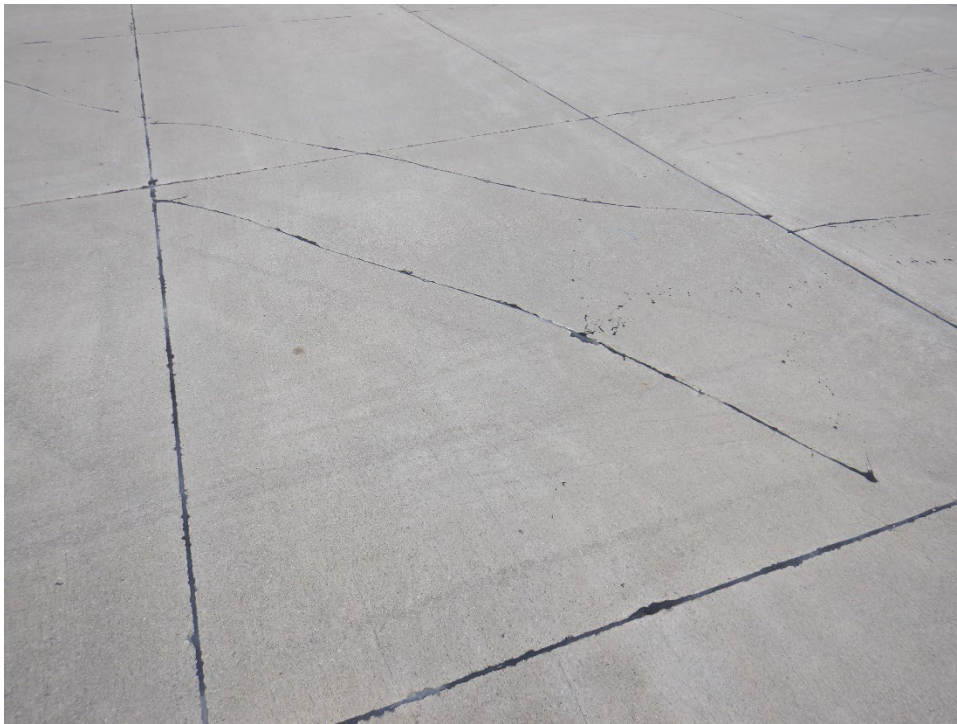
| Branch | Section | Surface Type | Section Area (sf) | LCD | 2026 PCI | % Distress Due to Load | % Distress Due to Climate/Durability | % Distress Due to Other | Type of Distress |
|---|---|---|---|---|---|---|---|---|---|
| A01PO | 01 | PCC | 42,301 | 6/1/2004 | 82 | 74 | 0 | 26 | Corner Break, Corner Spalling, Faulting, Joint Spalling, LTD Cracking |

A01PO-01. LTD Cracking (Sample Unit No. 03).

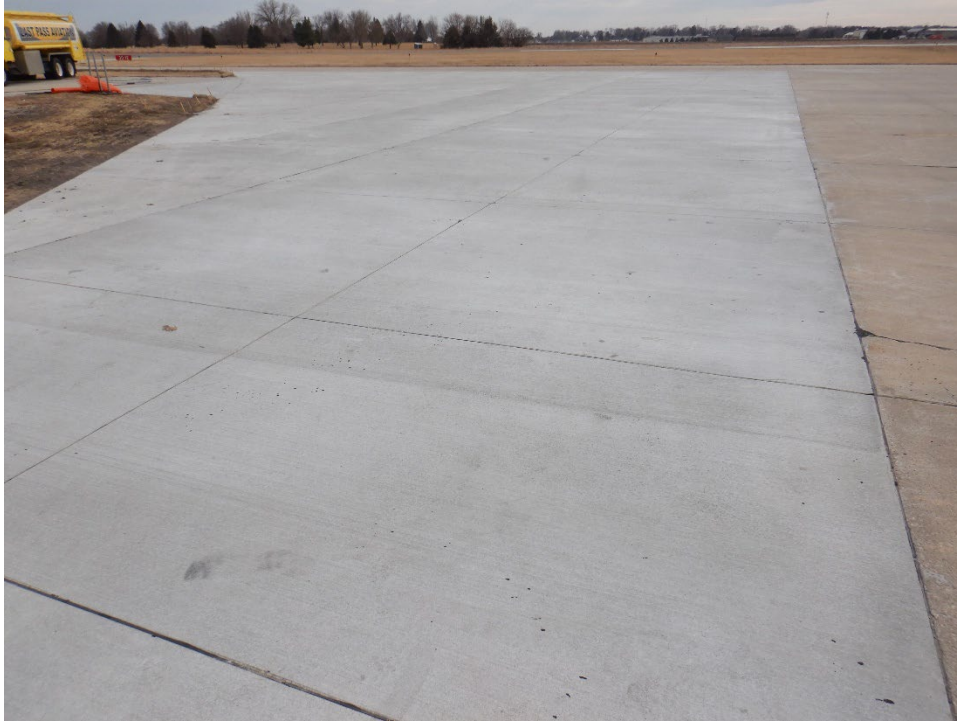
A01PO-02. Overview.

The apron area contained two sections. Section 01 contained low- and medium-severity corner break, joint spalling, and LTD cracking and low-severity corner spalling and faulting. Section 02 was in *Excellent* condition with no distress noted at the time of inspection.

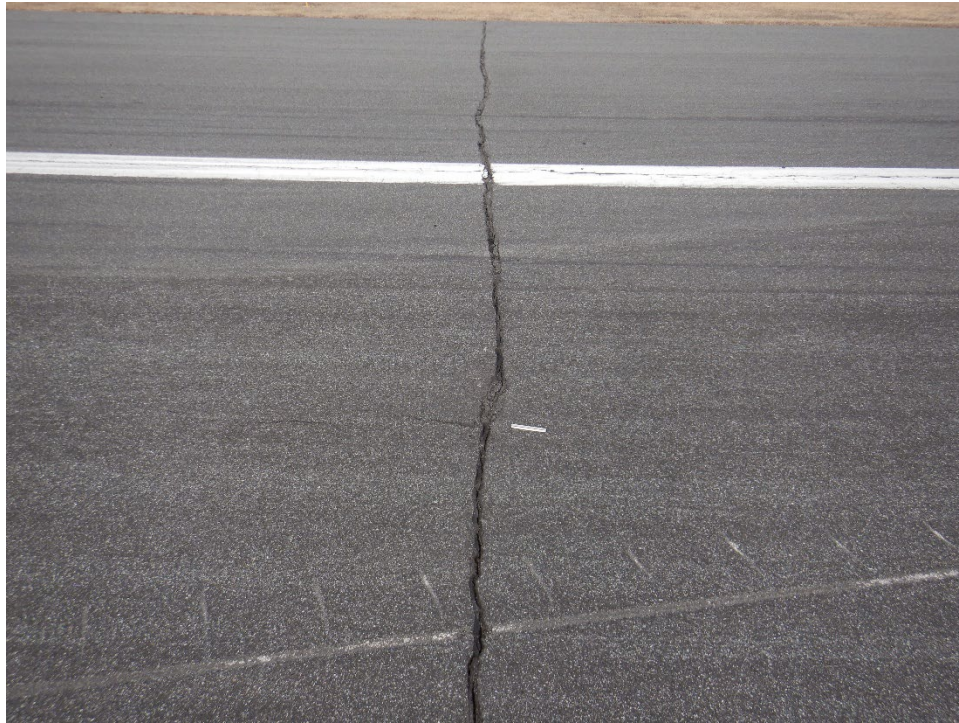
Runway 12/30 consisted of four sections. Low- and medium-severity joint reflection cracking, low-severity longitudinal and transverse (L&T) cracking, and high-severity raveling were observed in Section 01. Section 02 contained low- and medium-severity joint reflection cracking and low-severity L&T cracking. Section 03 had low- and medium-severity joint reflection cracking observed during the inspection. The low-severity cracking in Sections 01, 02, and 03 was unsealed, and the medium-severity cracking was due to unsealed crack widths greater than ¼ inch. High-severity joint seal damage and medium-severity LTD cracking and shattered slab were identified in Section 04.

R12PO-01. Joint Reflection Cracking (Sample Unit No. 28).

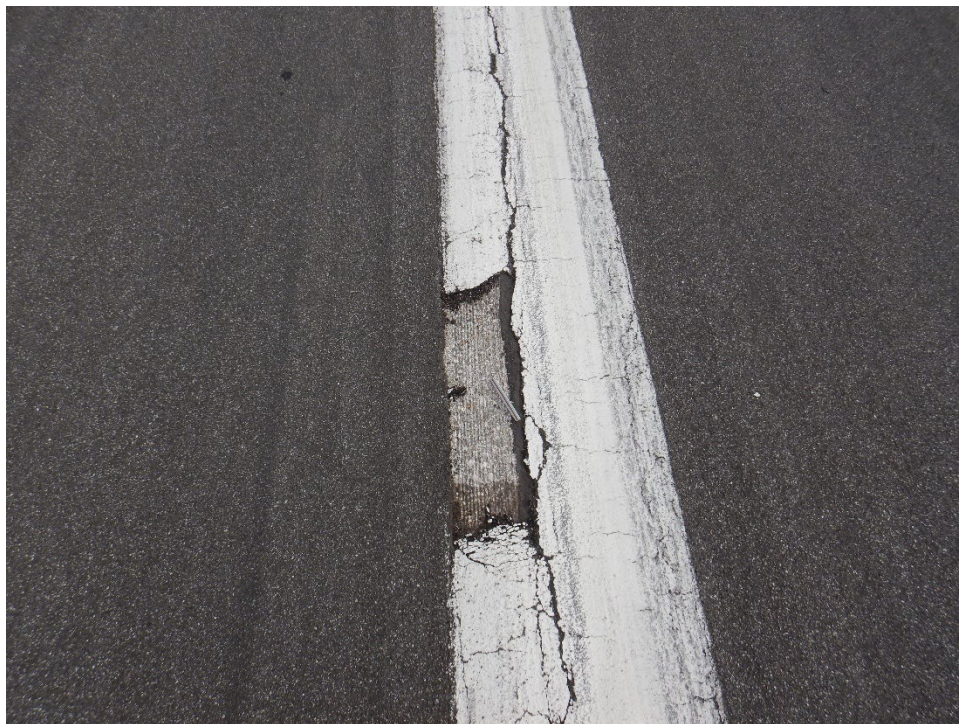
R12PO-01. Raveling (Sample Unit No. 28).

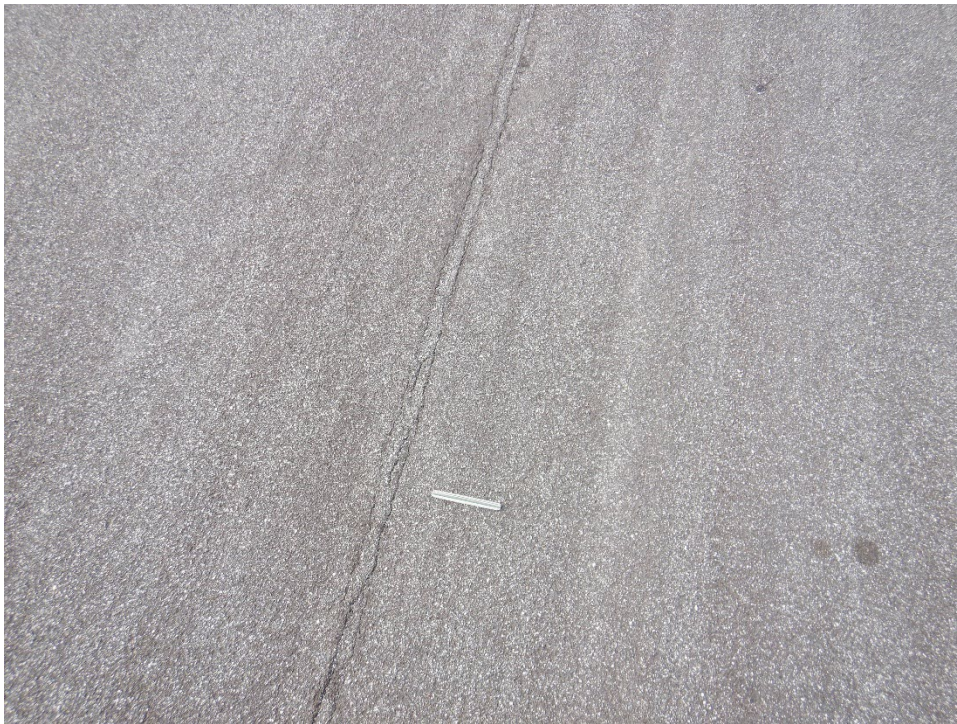
| Branch | Section | Surface Type | Section Area (sf) | LCD | 2026 PCI | % Distress Due to Load | % Distress Due to Climate/Durability | % Distress Due to Other | Type of Distress |
|---|---|---|---|---|---|---|---|---|---|
| R12PO | 02 | APC | 62,719 | 6/2/2015 | 79 | 0 | 100 | 0 | Joint Reflection Cracking, L&T Cracking |

R12PO-02. Joint Reflection Cracking (Sample Unit No. 08).

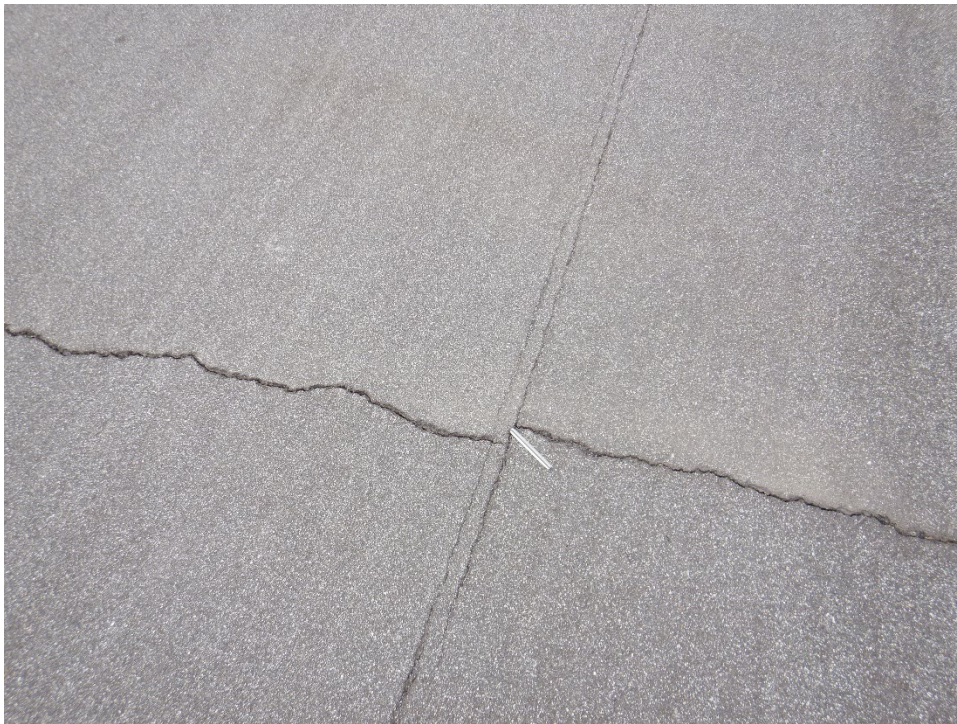
| Branch | Section | Surface Type | Section Area (sf) | LCD | 2026 PCI | % Distress Due to Load | % Distress Due to Climate/Durability | % Distress Due to Other | Type of Distress |
|---|---|---|---|---|---|---|---|---|---|
| R12PO | 03 | APC | 12,000 | 6/2/2015 | 82 | 0 | 100 | 0 | Joint Reflection Cracking |

R12PO-03. Joint Reflection Cracking (Sample Unit No. 02).

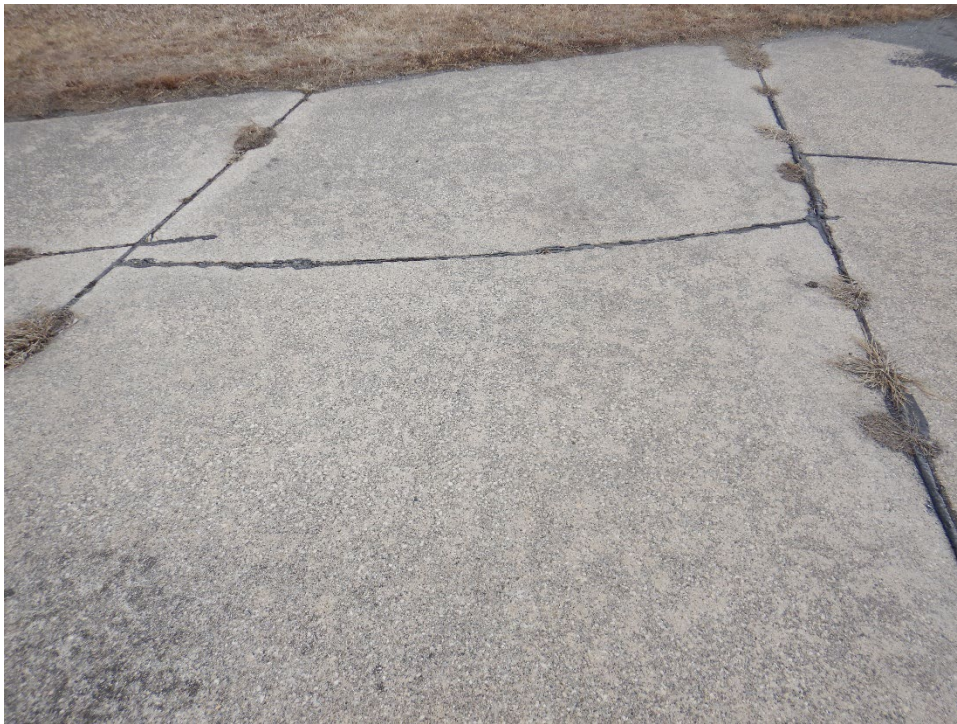
| Branch | Section | Surface Type | Section Area (sf) | LCD | 2026 PCI | % Distress Due to Load | % Distress Due to Climate/Durability | % Distress Due to Other | Type of Distress |
|---|---|---|---|---|---|---|---|---|---|
| R12PO | 04 | PCC | 2,871 | 6/1/1974 | 51 | 82 | 18 | 0 | Joint Seal Damage, LTD Cracking, Shattered Slab |

R12PO-04. LTD Cracking (Sample Unit No. 01).

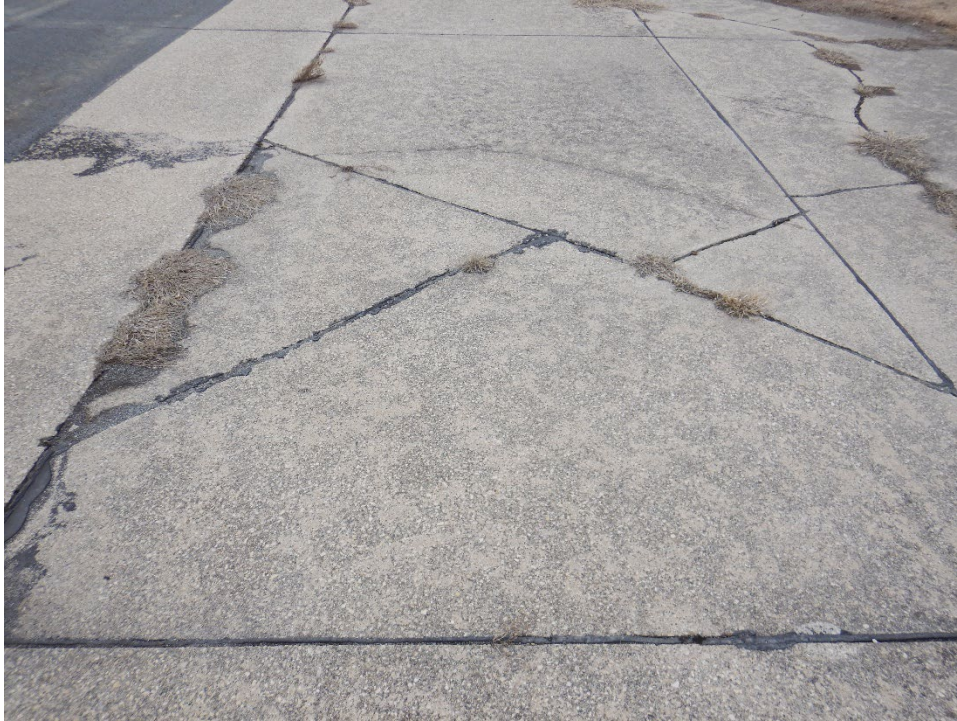
R12PO-04. Shattered Slab (Sample Unit No. 01).

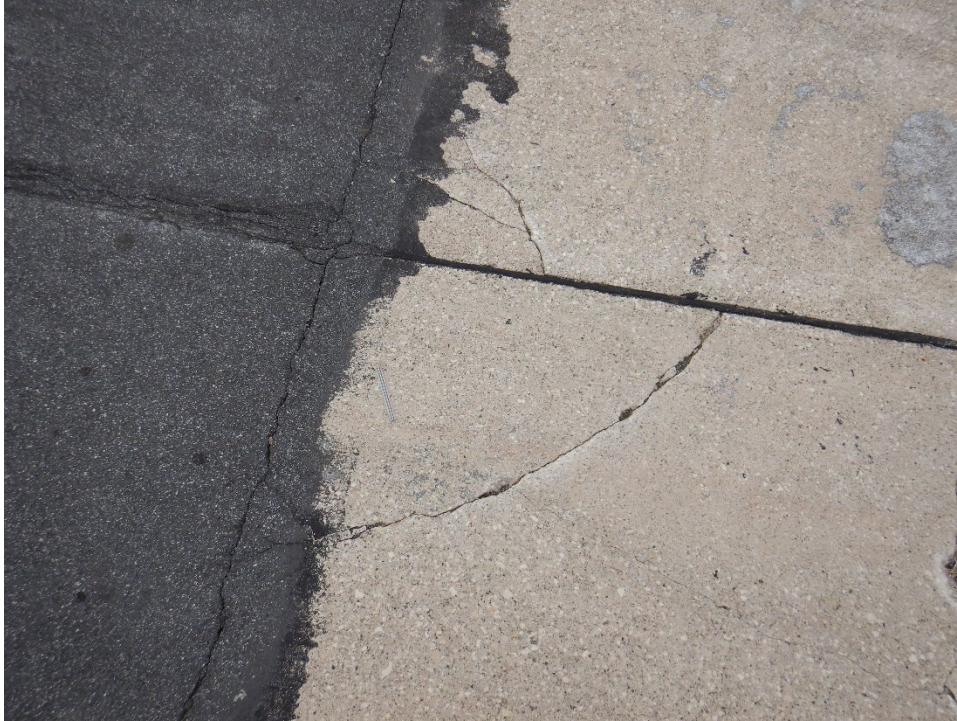
Taxiway 01 was defined by three sections. Section 01 contained low- and medium-severity corner break and longitudinal, transverse, and diagonal (LTD) cracking; low-severity faulting; high-severity joint seal damage; and medium-severity shattered slab. Low-severity corner break, medium-severity corner spalling, and low- and medium-severity LTD cracking were identified throughout Section 02. Section 03 had low- and medium-severity, unsealed joint reflection cracking recorded at the time of inspection.

T01PO-01. Corner Break (Sample Unit No. 01).

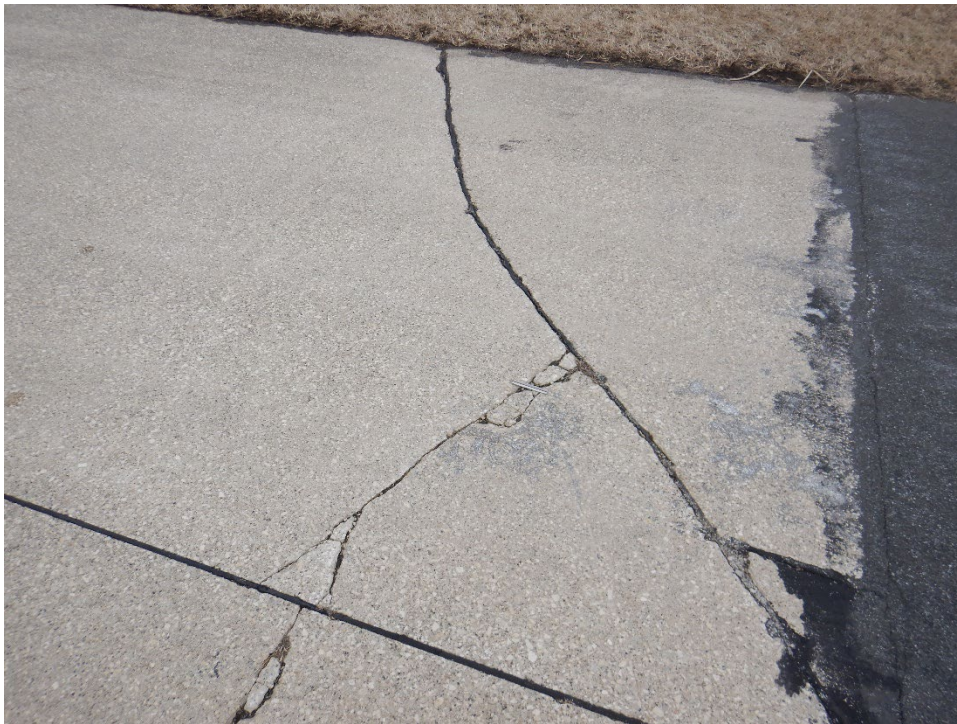
T01PO-01. LTD Cracking (Sample Unit No. 01).

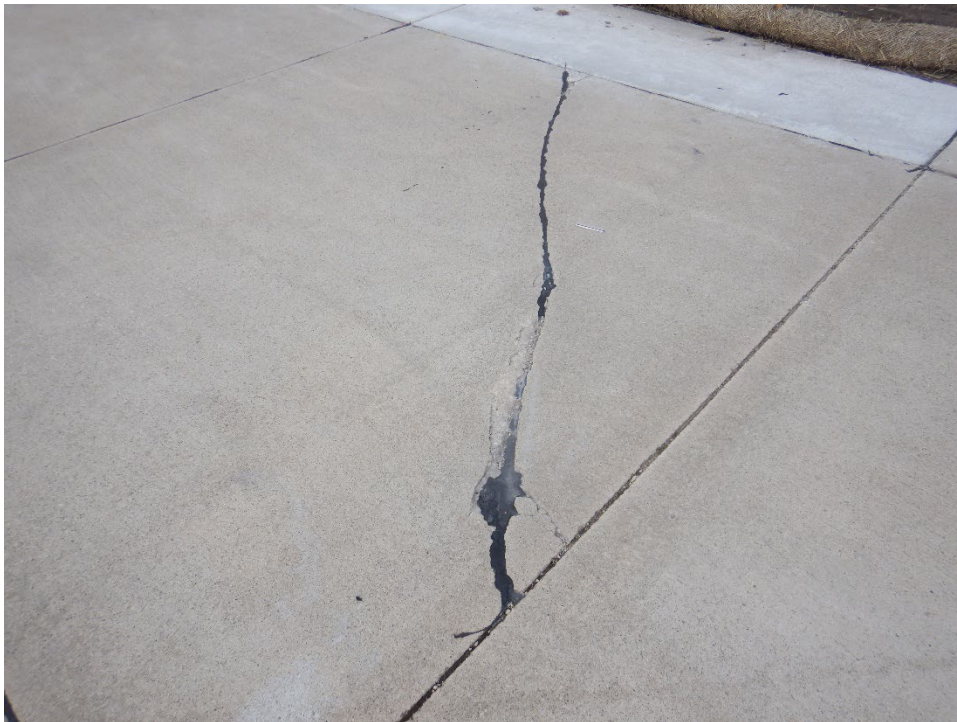
| Branch | Section | Surface Type | Section Area (sf) | LCD | 2026 PCI | % Distress Due to Load | % Distress Due to Climate/Durability | % Distress Due to Other | Type of Distress |
|---|---|---|---|---|---|---|---|---|---|
| T01PO | 02 | PCC | 7,363 | 5/1/2004 | 83 | 92 | 0 | 8 | Corner Break, Corner Spalling, LTD Cracking |

T01PO-02. LTD Cracking (Sample Unit No. 02).

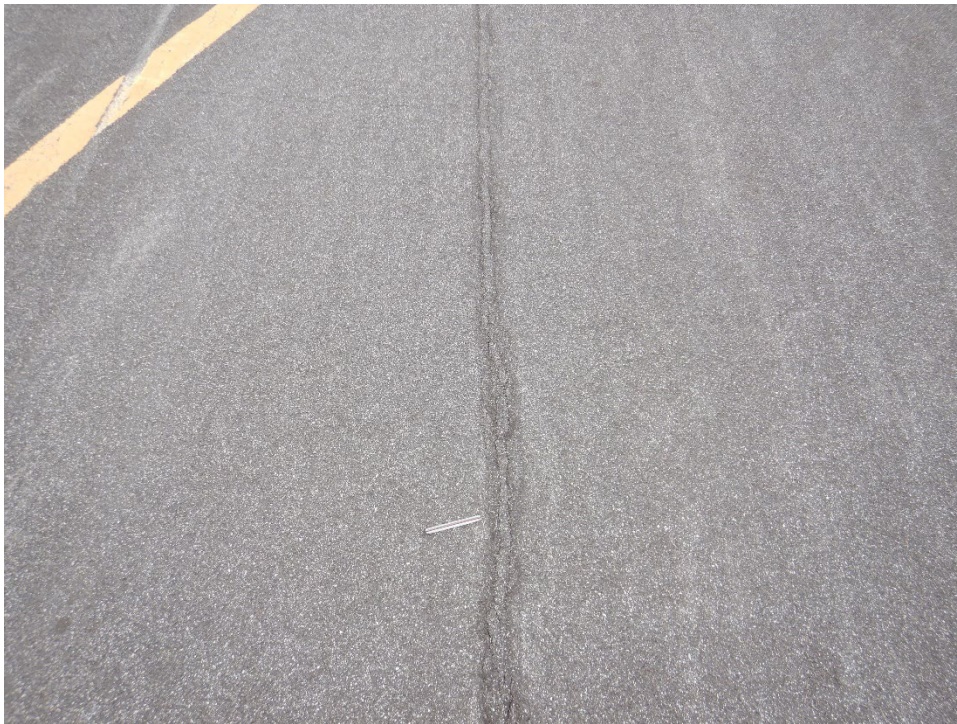
| Branch | Section | Surface Type | Section Area (sf) | LCD | 2026 PCI | % Distress Due to Load | % Distress Due to Climate/Durability | % Distress Due to Other | Type of Distress |
|---|---|---|---|---|---|---|---|---|---|
| T01PO | 03 | APC | 2,673 | 6/1/2015 | 86 | 0 | 100 | 0 | Joint Reflection Cracking |

T01PO-03. Joint Reflection Cracking (Sample Unit No. 01).

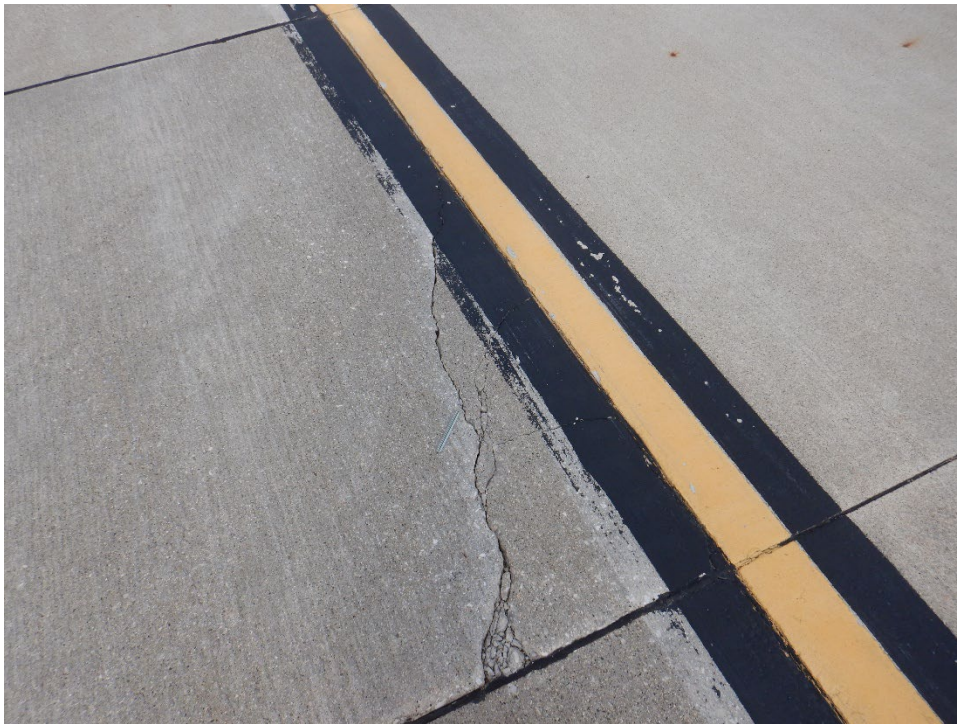
Taxiway 02 consisted of three sections. High-severity corner break and joint seal damage, low- and medium-severity faulting and LTD cracking, and high-severity joint seal damage were observed in Section 01. Section 02 contained low-severity corner spalling and LTD cracking and low- and medium-severity joint seal damage during the inspection. Areas of low- and medium-severity joint reflection cracking and low-severity L&T cracking were recorded in Section 03. The low-severity cracking was unsealed, and the medium-severity cracking was due to unsatisfactory crack sealant.

T02PO-01. Corner Break (Sample Unit No. 01).

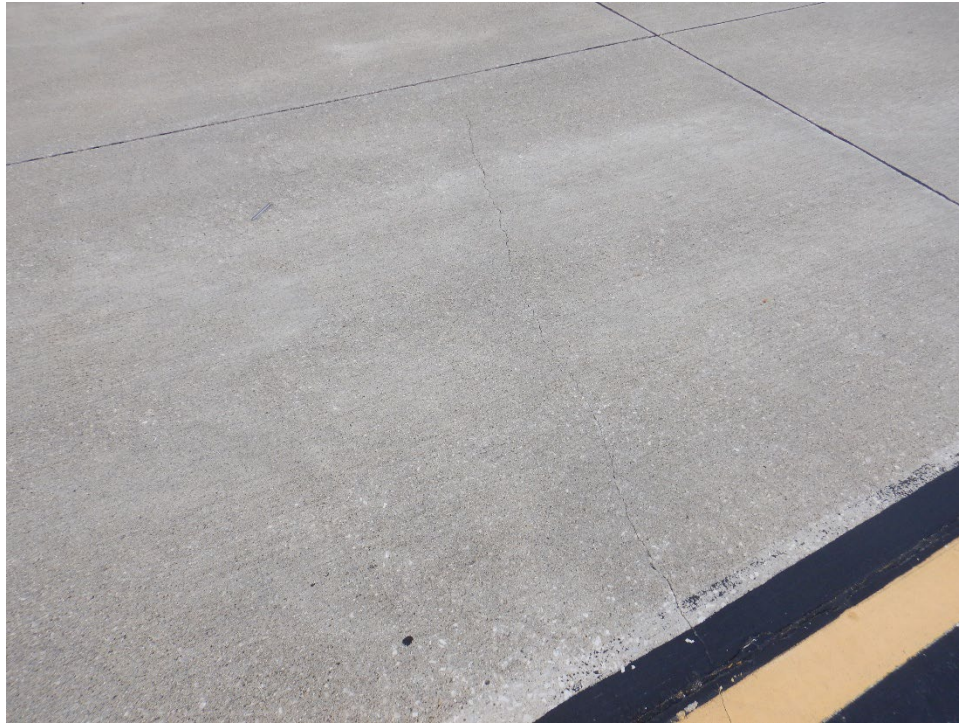
T02PO-01. LTD Cracking (Sample Unit No. 01).

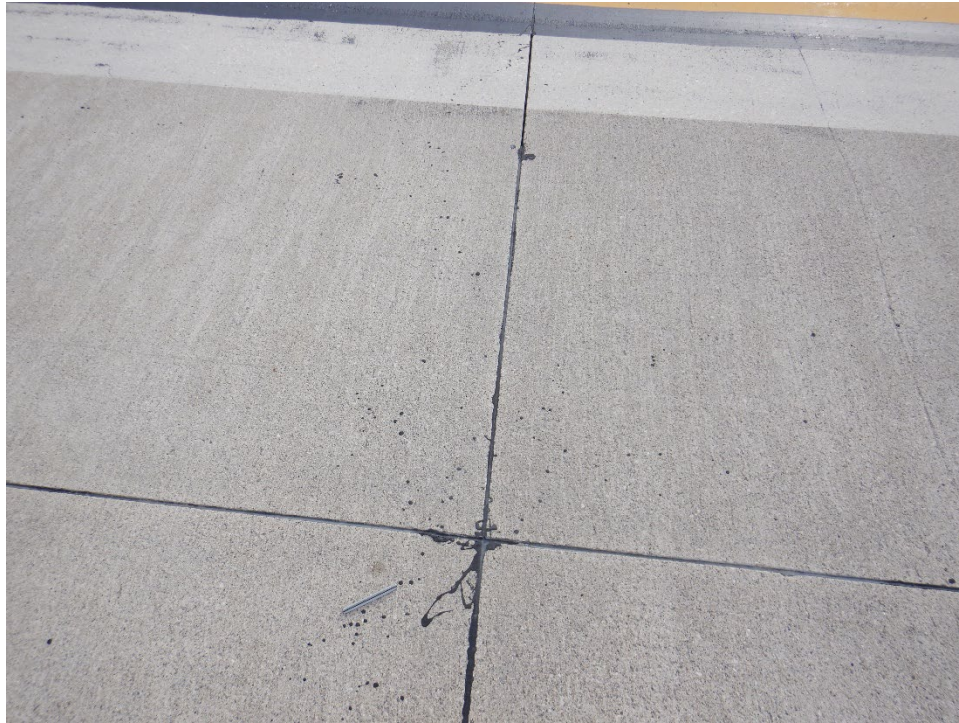
| Branch | Section | Surface Type | Section Area (sf) | LCD | 2026 PCI | % Distress Due to Load | % Distress Due to Climate/Durability | % Distress Due to Other | Type of Distress |
|---|---|---|---|---|---|---|---|---|---|
| T02PO | 02 | PCC | 5,743 | 5/1/2004 | 91 | 27 | 67 | 6 | Corner Spalling, Joint Seal Damage, LTD Cracking |

T02PO-02. Joint Seal Damage (Sample Unit No. 03).

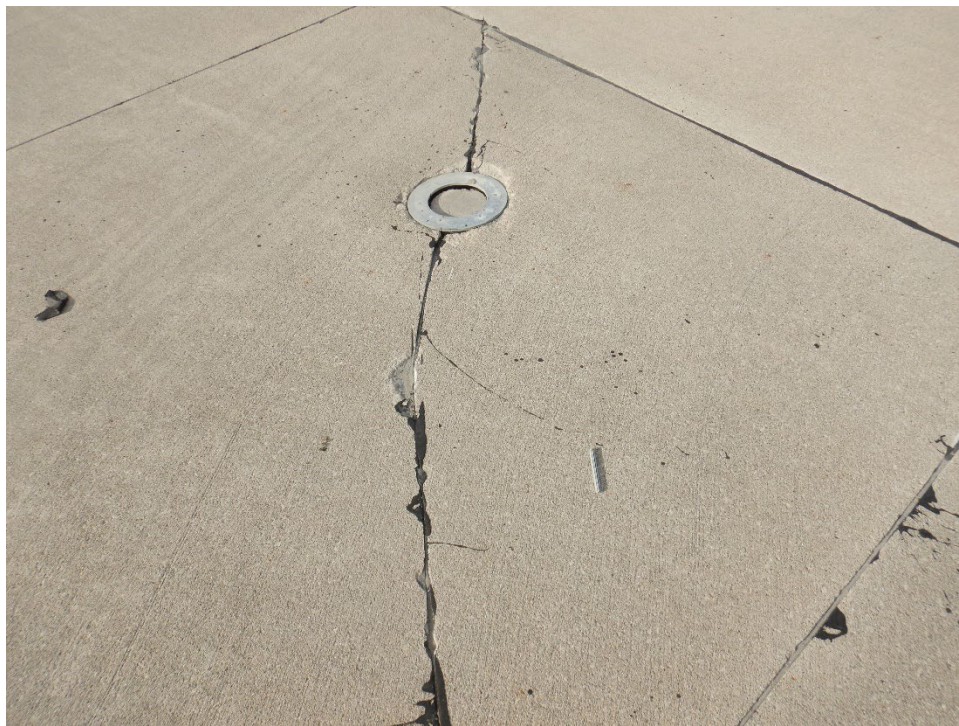
T02PO-02. LTD Cracking (Sample Unit No. 03).

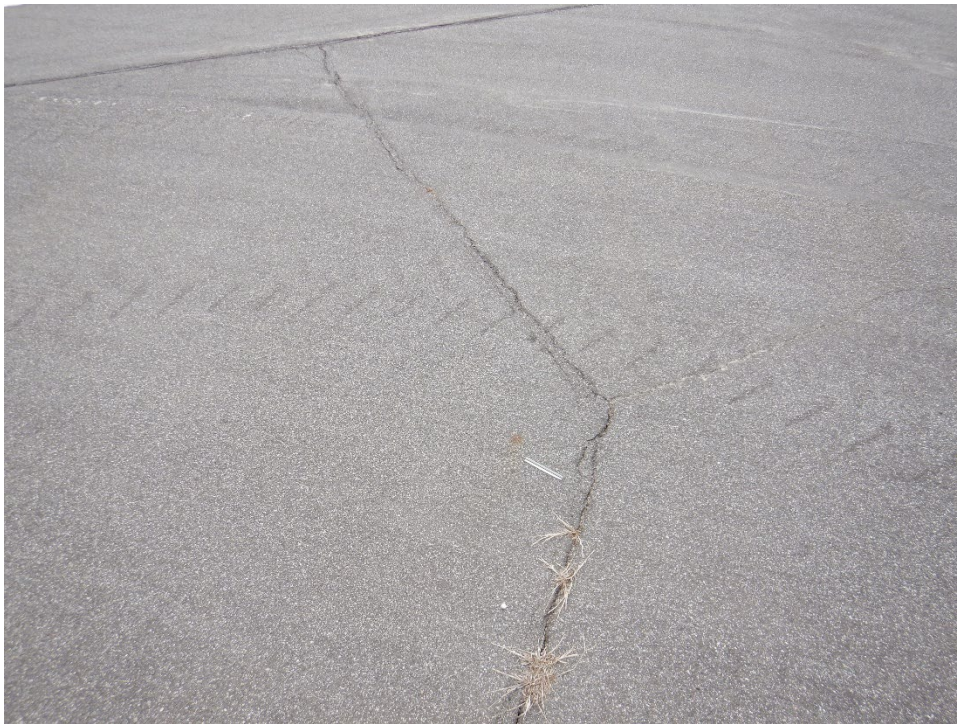
| Branch | Section | Surface Type | Section Area (sf) | LCD | 2026 PCI | % Distress Due to Load | % Distress Due to Climate/Durability | % Distress Due to Other | Type of Distress |
|---|---|---|---|---|---|---|---|---|---|
| T02PO | 03 | APC | 2,561 | 6/1/2015 | 79 | 0 | 100 | 0 | Joint Reflection Cracking, L&T Cracking |

T02PO-03. Joint Reflection Cracking (Sample Unit No. 01).

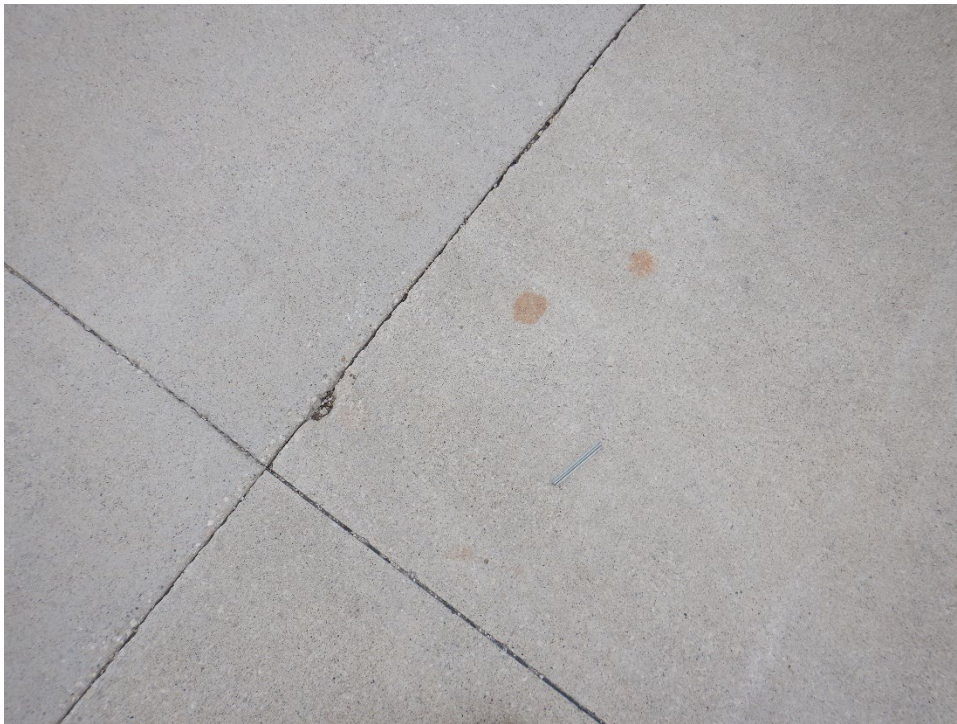
The T-hangar area was defined by four sections. Section 01 had low- and medium-severity corner break and LTD cracking, medium-severity corner spalling and joint spalling, low-severity faulting and large patching, and high-severity joint seal damage observed during the inspection. Medium-severity corner break and joint spalling, low-severity faulting, high-severity joint seal damage, and low- and medium-severity LTD cracking and shattered slab were identified in Section 02. Section 03 contained low-severity corner spalling and faulting and high-severity joint seal damage. Low-severity corner spalling and LTD cracking and high-severity joint seal damage were noted in Section 04.

TH01PO-01. Joint Seal Damage (Sample Unit No. 01).

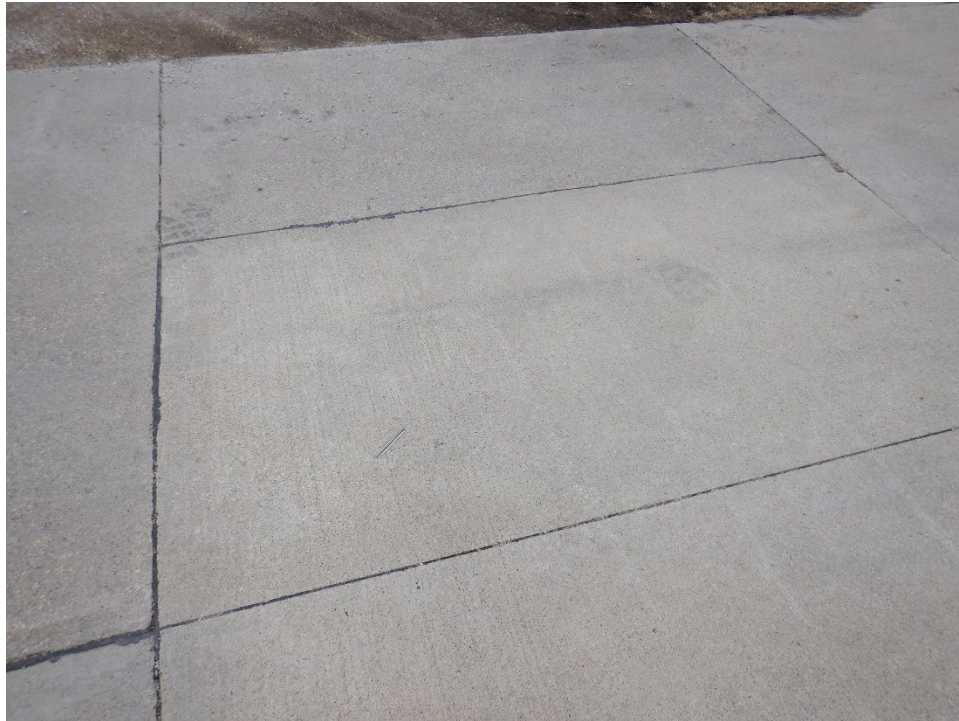
TH01PO-01. Large Patching (Sample Unit No. 01).

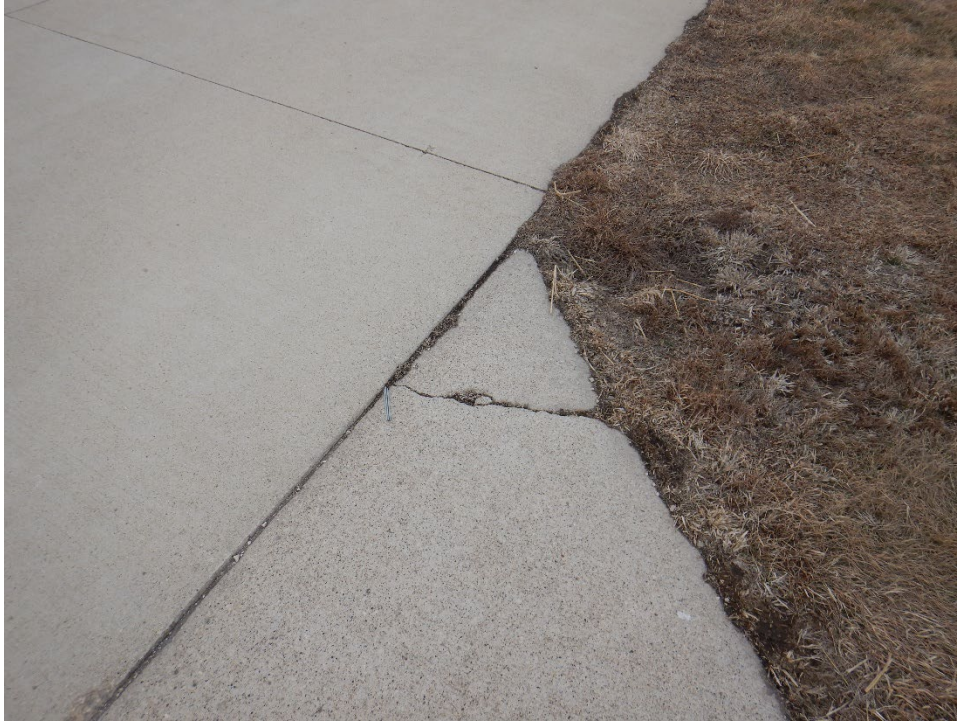
| Branch | Section | Surface Type | Section Area (sf) | LCD | 2026 PCI | % Distress Due to Load | % Distress Due to Climate/Durability | % Distress Due to Other | Type of Distress |
|---|---|---|---|---|---|---|---|---|---|
| TH01PO | 02 | PCC | 8,058 | 1/1/2011 | 62 | 74 | 20 | 6 | Corner Break, Faulting, Joint Spalling, Joint Seal Damage, LTD Cracking, Shattered Slab |

TH01PO-02. Corner Break (Sample Unit No. 01).

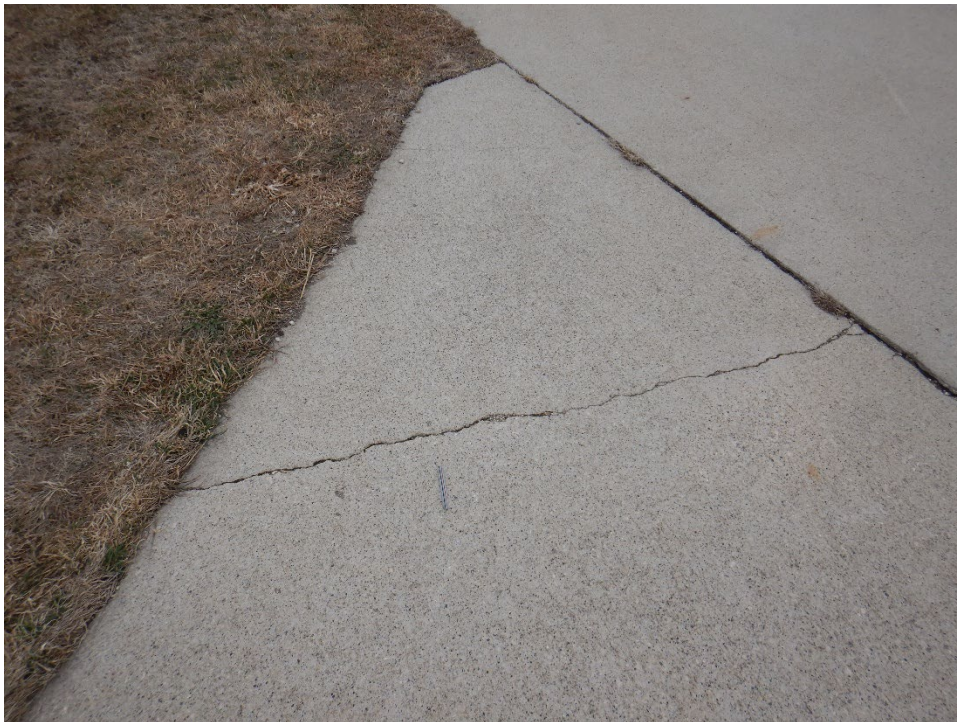
TH01PO-02. LTD Cracking (Sample Unit No. 01).

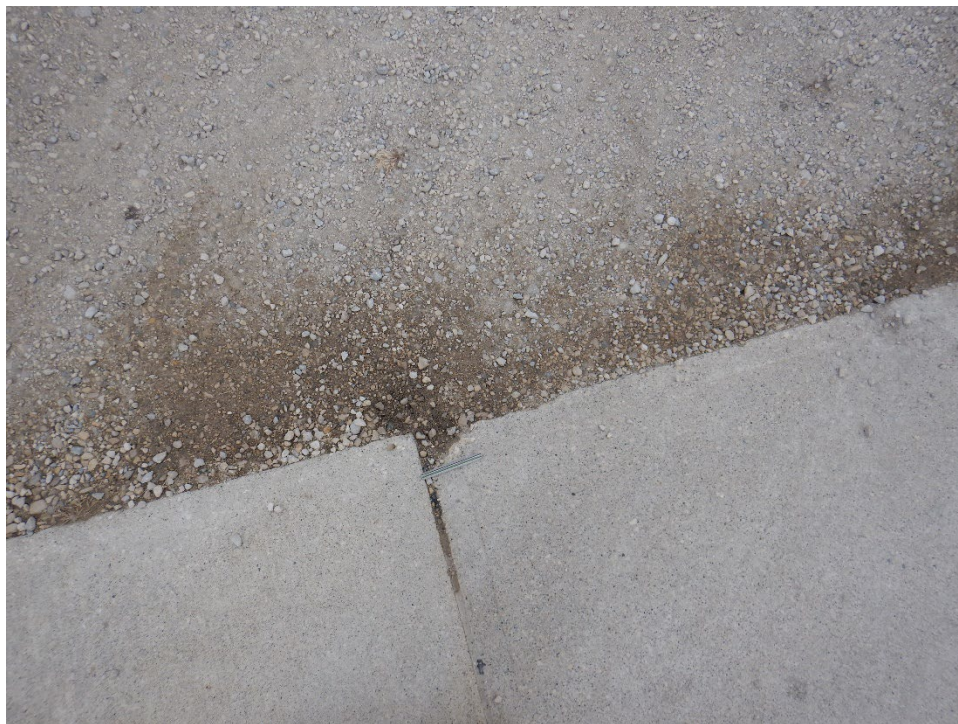
| Branch | Section | Surface Type | Section Area (sf) | LCD | 2026 PCI | % Distress Due to Load | % Distress Due to Climate/Durability | % Distress Due to Other | Type of Distress |
|---|---|---|---|---|---|---|---|---|---|
| TH01PO | 03 | PCC | 1,398 | 1/1/1995 | 73 | 0 | 33 | 67 | Corner Spalling, Faulting, Joint Seal Damage |

TH01PO-03. Corner Spalling (Sample Unit No. 01).

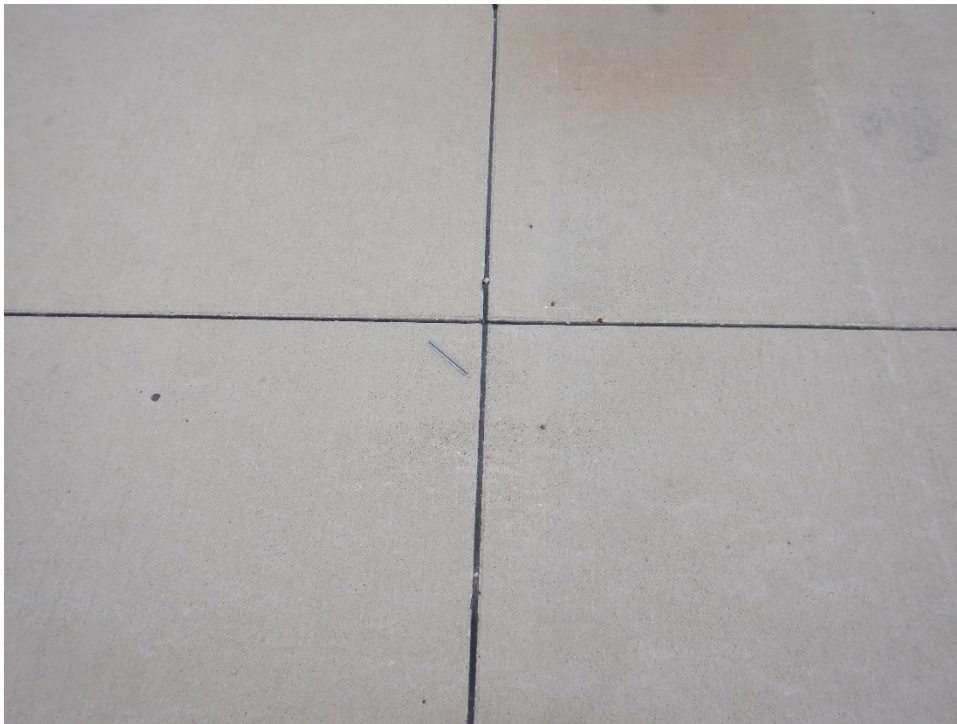
| Branch | Section | Surface Type | Section Area (sf) | LCD | 2026 PCI | % Distress Due to Load | % Distress Due to Climate/Durability | % Distress Due to Other | Type of Distress |
|---|---|---|---|---|---|---|---|---|---|
| TH01PO | 04 | PCC | 14,690 | 8/3/2018 | 87 | 14 | 83 | 3 | Corner Spalling, Joint Seal Damage, LTD Cracking |

TH01PO-04. Joint Seal Damage (Sample Unit No. 05).

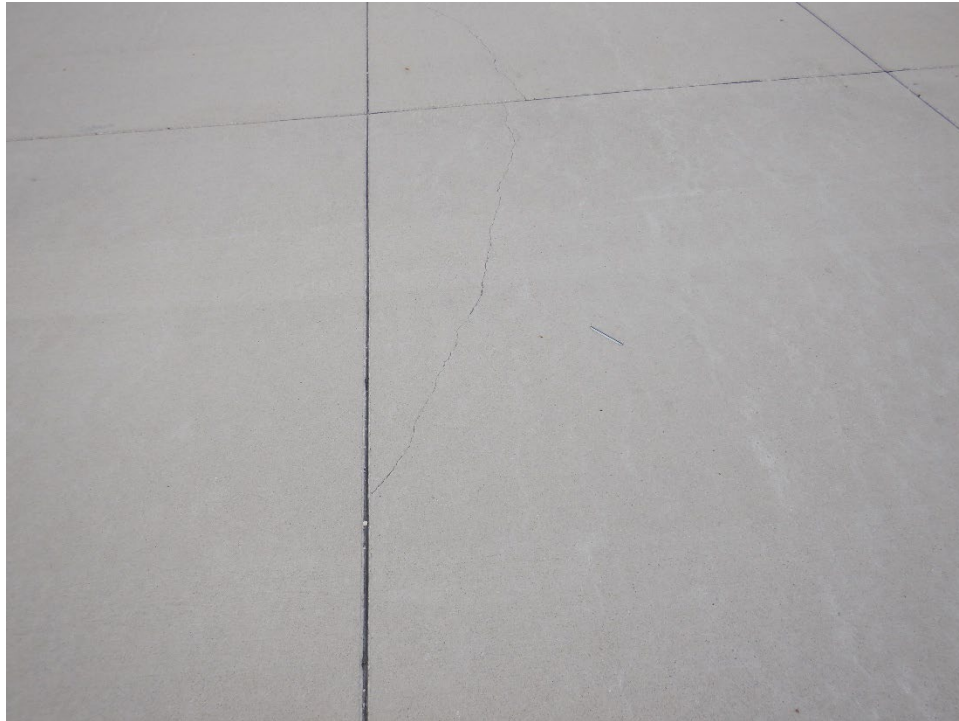
TH01PO-04. LTD Cracking (Sample Unit No. 05).
