# Rock Rapids Municipal Airport

## Pavement Management Report

**AUGUST 2025**

# ROCK RAPIDS MUNICIPAL AIRPORT PAVEMENT MANAGEMENT REPORT

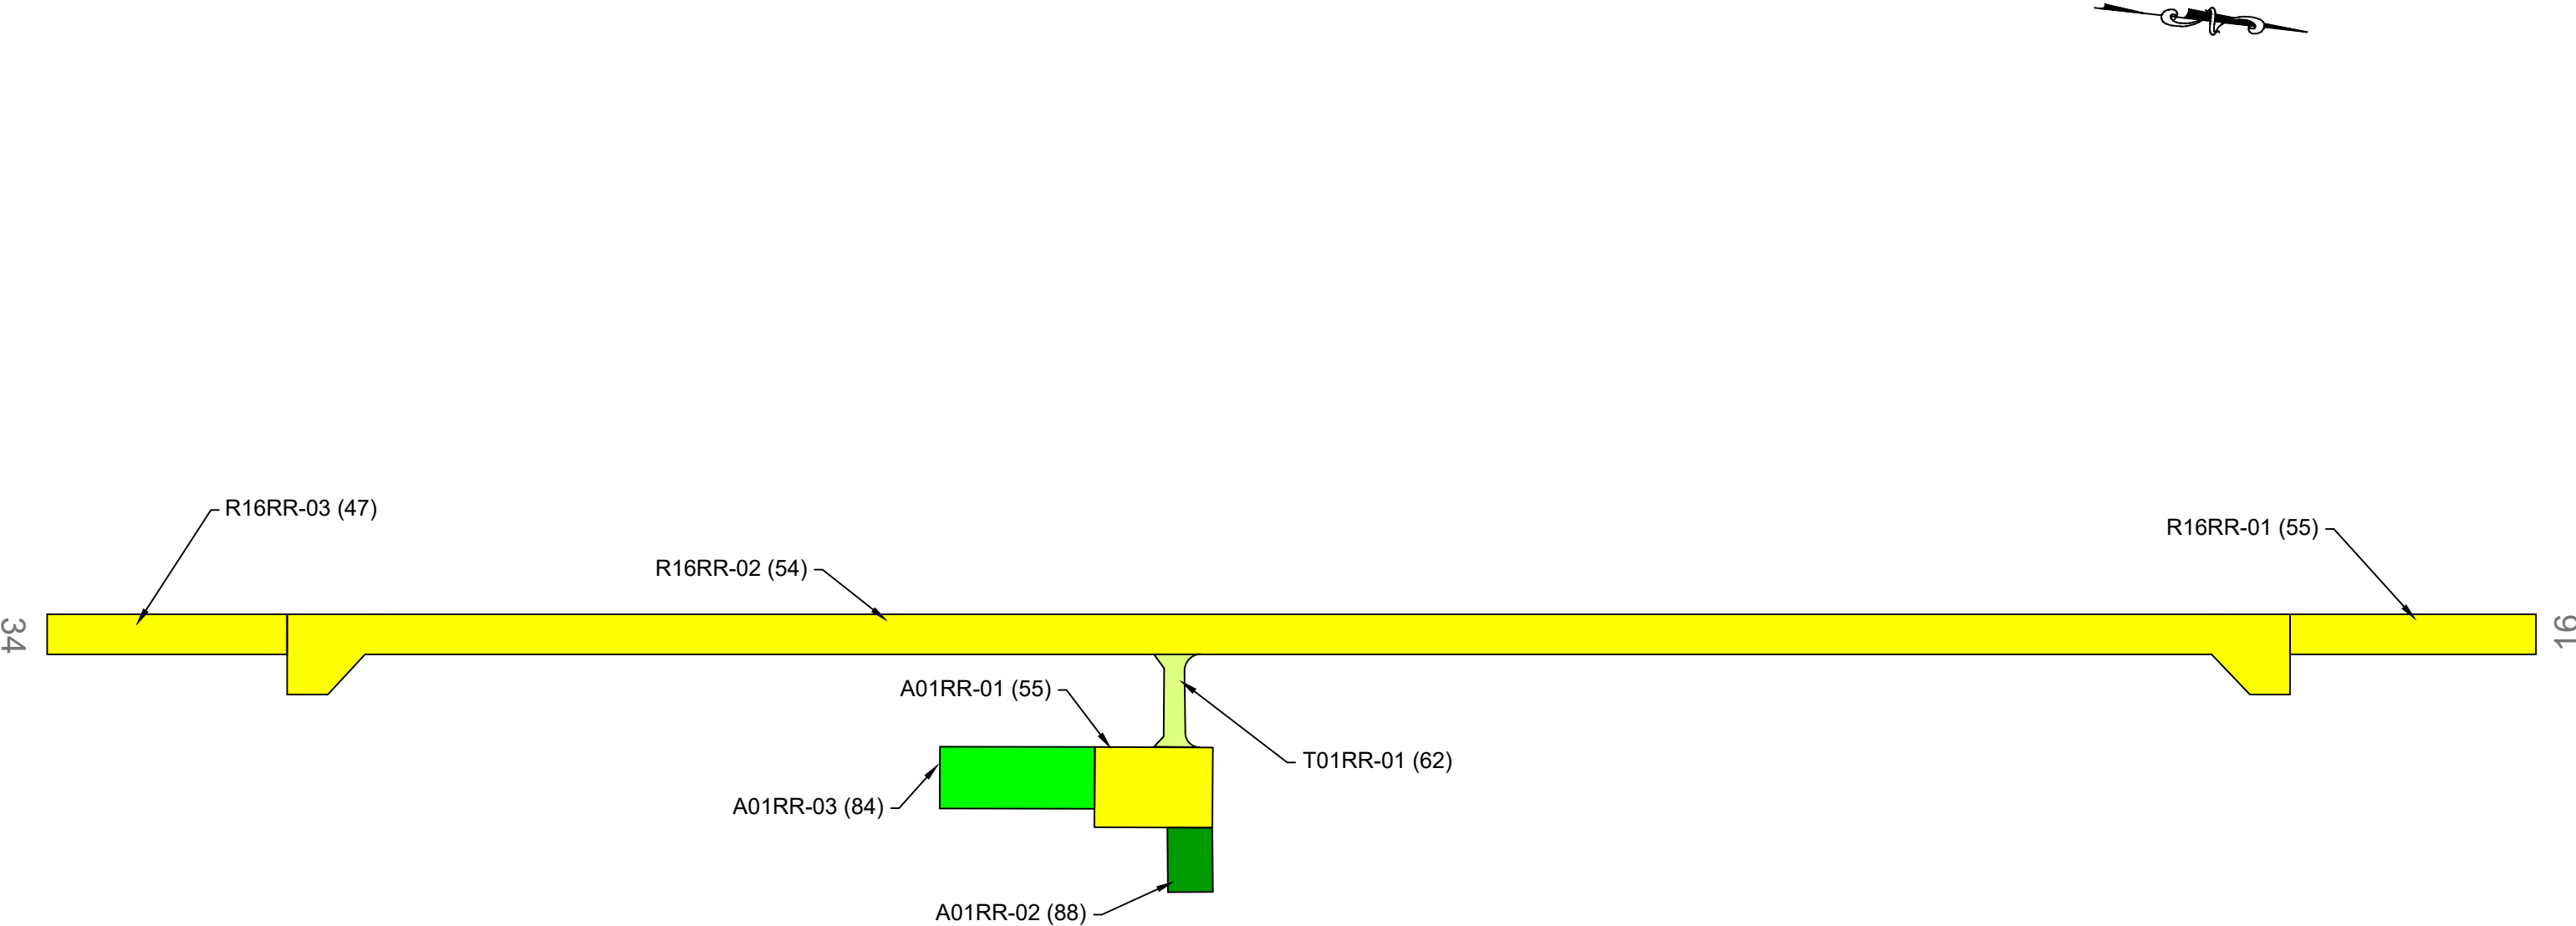
FIGURE 8. PCI MAP.

The pavements at Rock Rapids Municipal Airport were inspected in March 2025. The 2025 area-weighted condition of Rock Rapids Municipal Airport is 57, with conditions ranging from 47 to 88 (on a scale of 0 [failed] to 100 [excellent]). During the previous pavement inspection in 2018, the area-weighted PCI of the airport was 84.

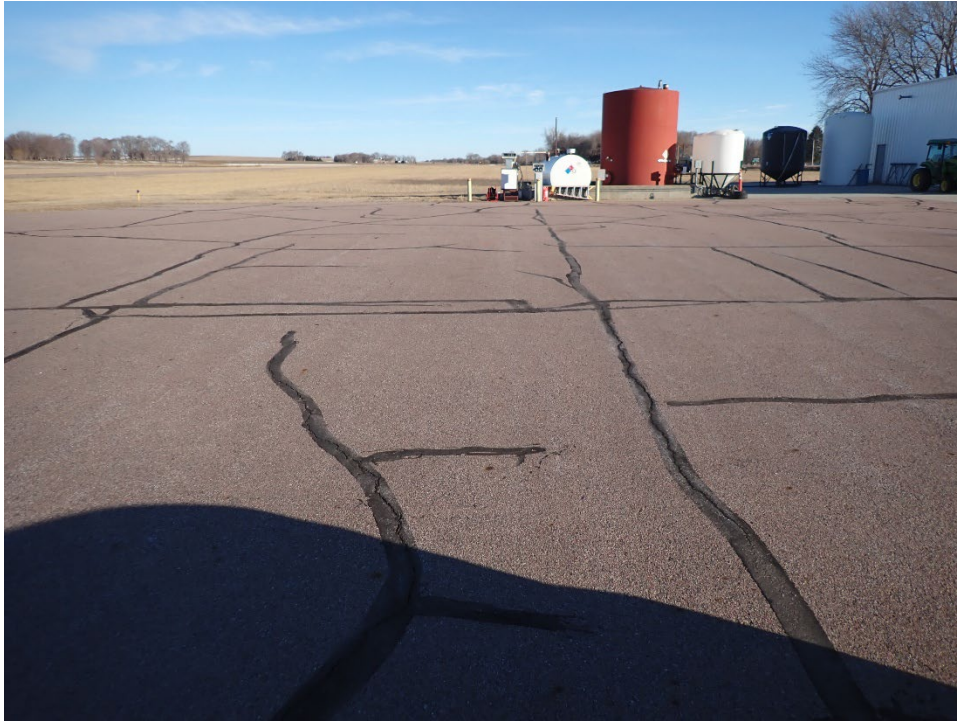
A01RR-01. Overview.

| Branch | Section | Surface Type | Section Area (sf) | LCD | 2025 PCI | % Distress Due to Load | % Distress Due to Climate/Durability | % Distress Due to Other | Type of Distress |
|---|---|---|---|---|---|---|---|---|---|
| A01RR | 01 | AAC | 14,700 | 2/1/2018 | 55 | 20 | 80 | 0 | Alligator Cracking, L&T Cracking, Raveling, Rutting, Weathering |

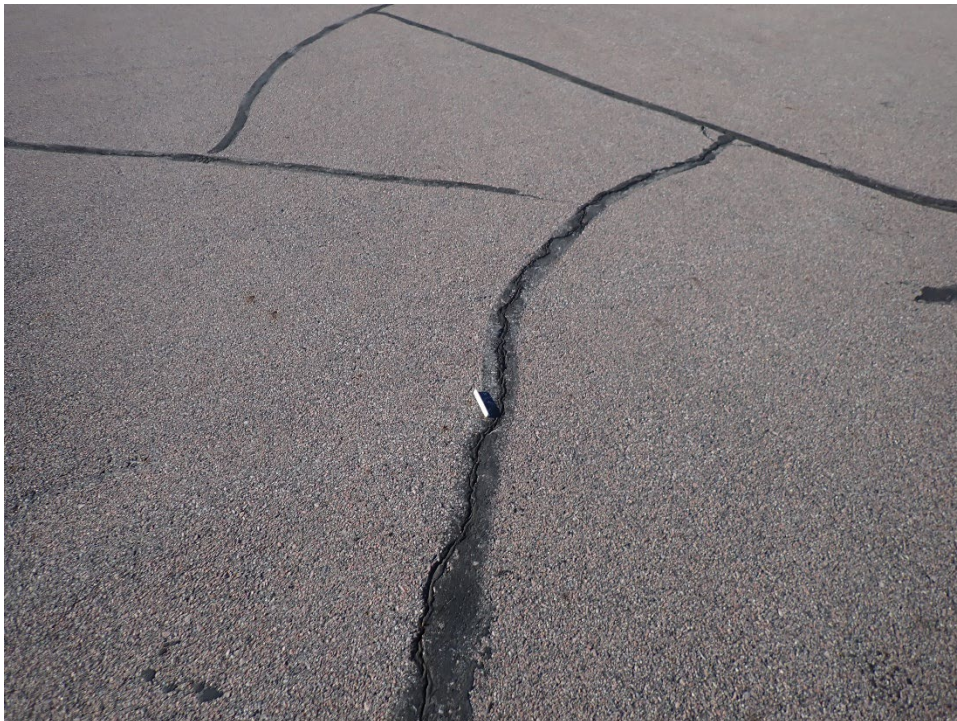
A01RR-01. L&T Cracking (Sample Unit No. 03).

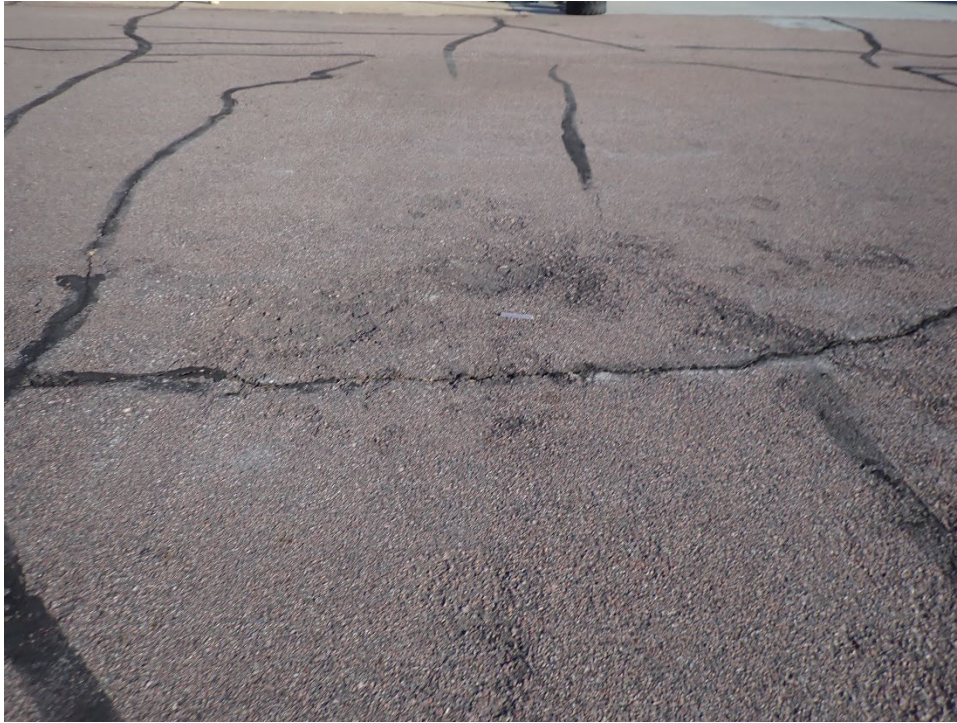
A01RR-01. Raveling (Sample Unit No. 03) (1).

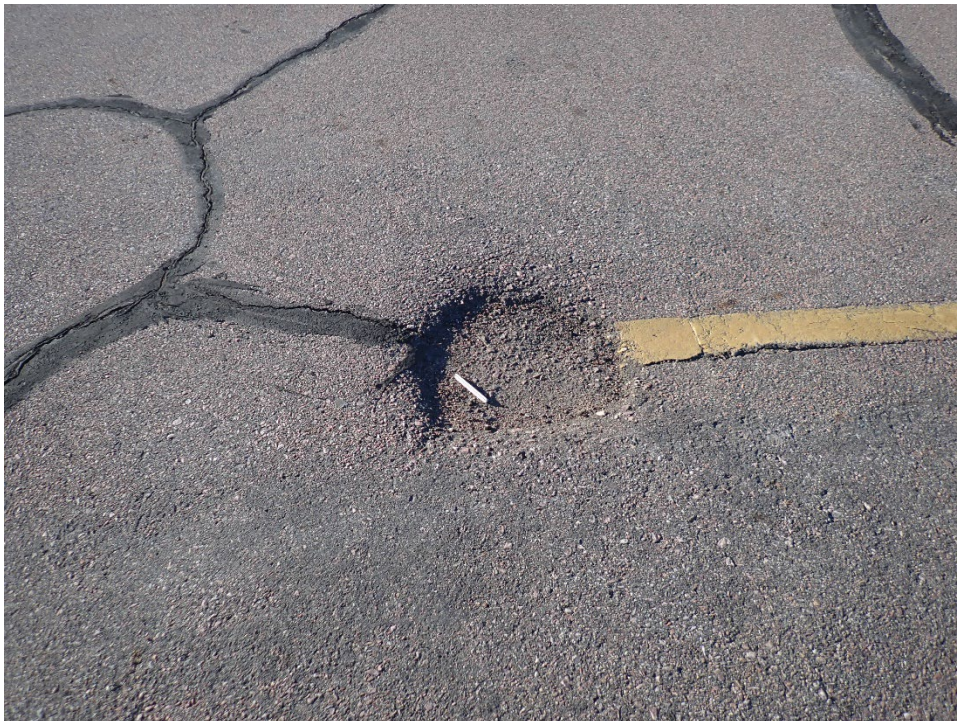
A01RR-01. Raveling (Sample Unit No. 03) (2).

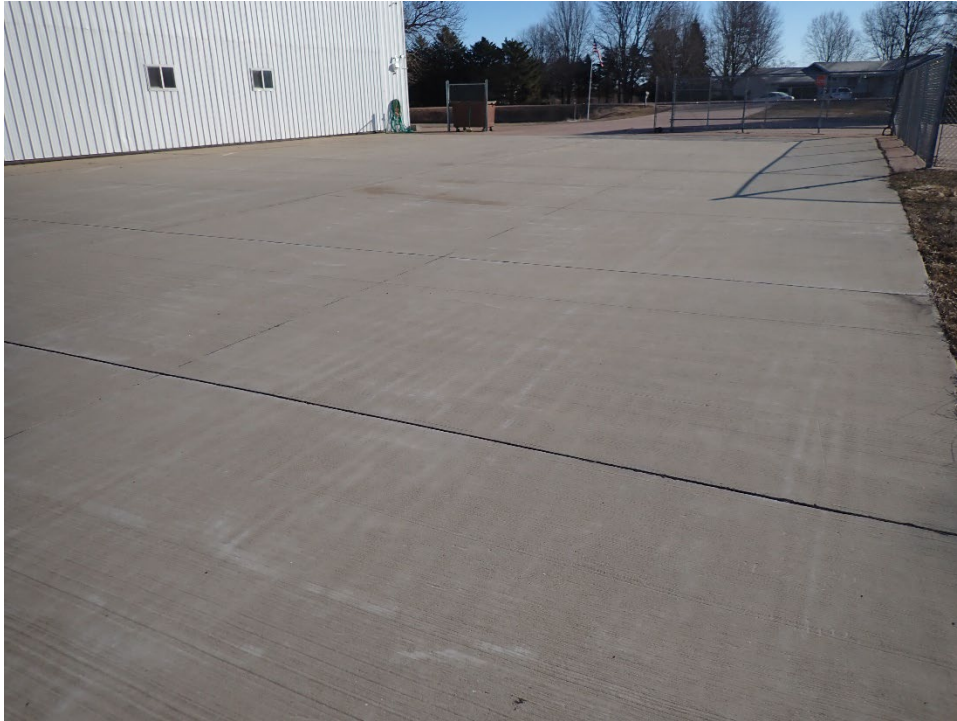
A01RR-02. Overview.

| Branch | Section | Surface Type | Section Area (sf) | LCD | 2025 PCI | % Distress Due to Load | % Distress Due to Climate/Durability | % Distress Due to Other | Type of Distress |
|---|---|---|---|---|---|---|---|---|---|
| A01RR | 02 | PCC | 4,496 | 4/1/2008 | 88 | 0 | 100 | 0 | Joint Seal Damage |

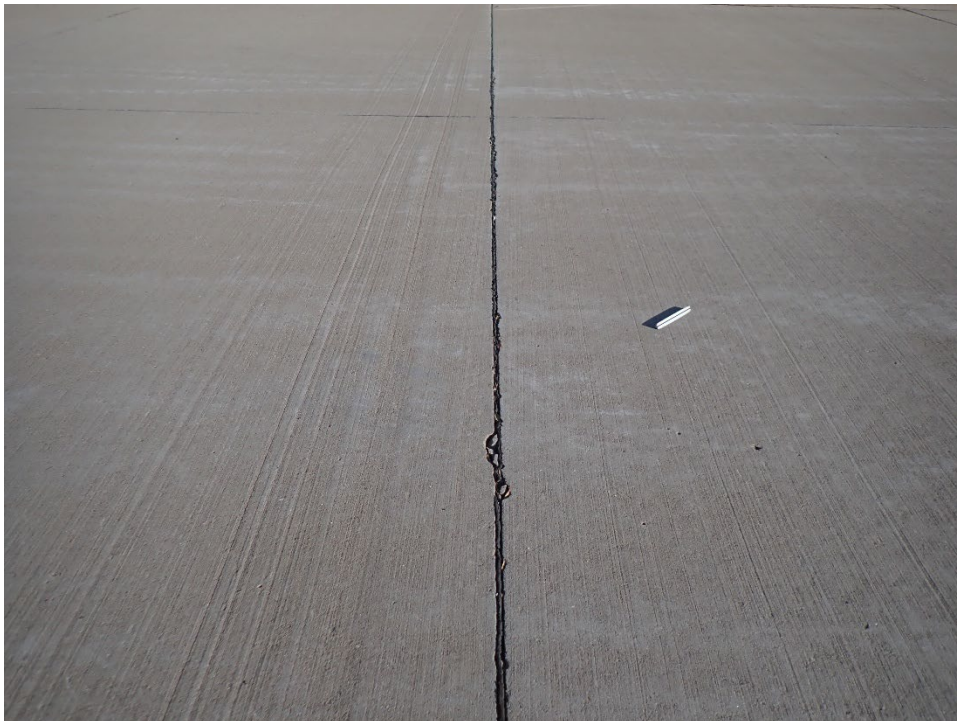
A01RR-02. Joint Seal Damage (Sample Unit No. 02).

| Branch | Section | Distress Type | Severity | Distress Quantity | Distress Unit | Maintenance Action | Unit Cost | 2025 Estimated Cost |
|---|---|---|---|---|---|---|---|---|
| A01RR | 02 | Joint Seal Damage | High | 48 | Slabs | Joint Seal (Localized) | \$3.27 | \$2,600 |

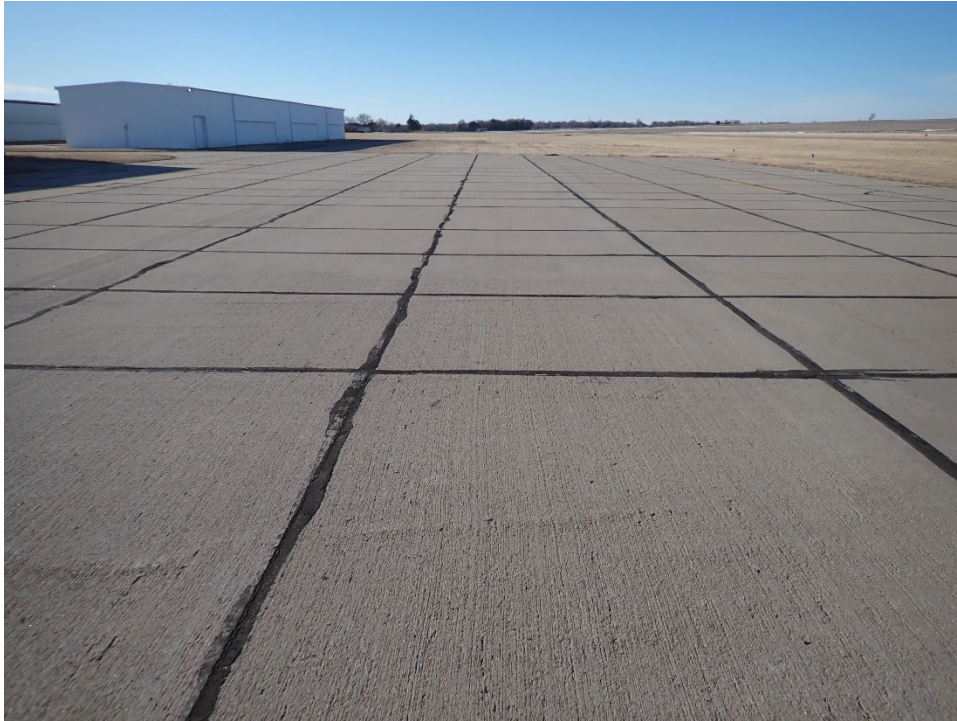
A01RR-03. Overview.

| Branch | Section | Surface Type | Section Area (sf) | LCD | 2025 PCI | % Distress Due to Load | % Distress Due to Climate/Durability | % Distress Due to Other | Type of Distress |
|---|---|---|---|---|---|---|---|---|---|
| A01RR | 03 | PCC | 14,861 | 10/1/2012 | 84 | 7 | 75 | 18 | Corner Spalling, Faulting, Joint Seal Damage, LTD Cracking |

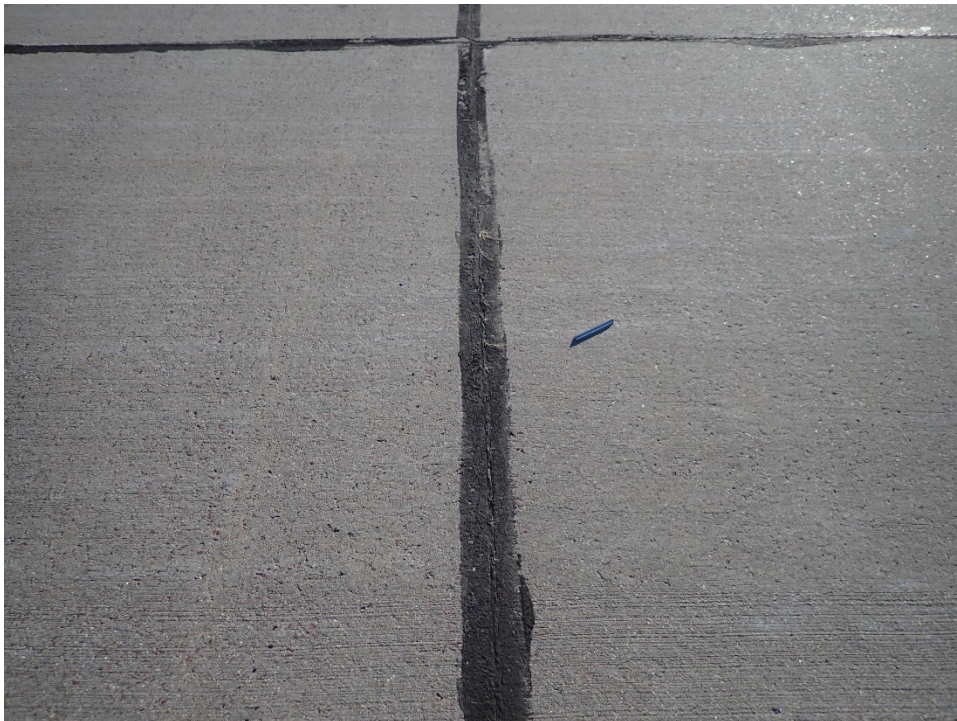
A01RR-03. Joint Seal Damage (Sample Unit No. 05).

| Branch | Section | Distress Type | Severity | Distress Quantity | Distress Unit | Maintenance Action | Unit Cost | 2025 Estimated Cost |
|---|---|---|---|---|---|---|---|---|
| A01RR | 03 | Joint Seal Damage | High | 144 | Slabs | Joint Seal (Localized) | \$3.27 | \$8,793 |

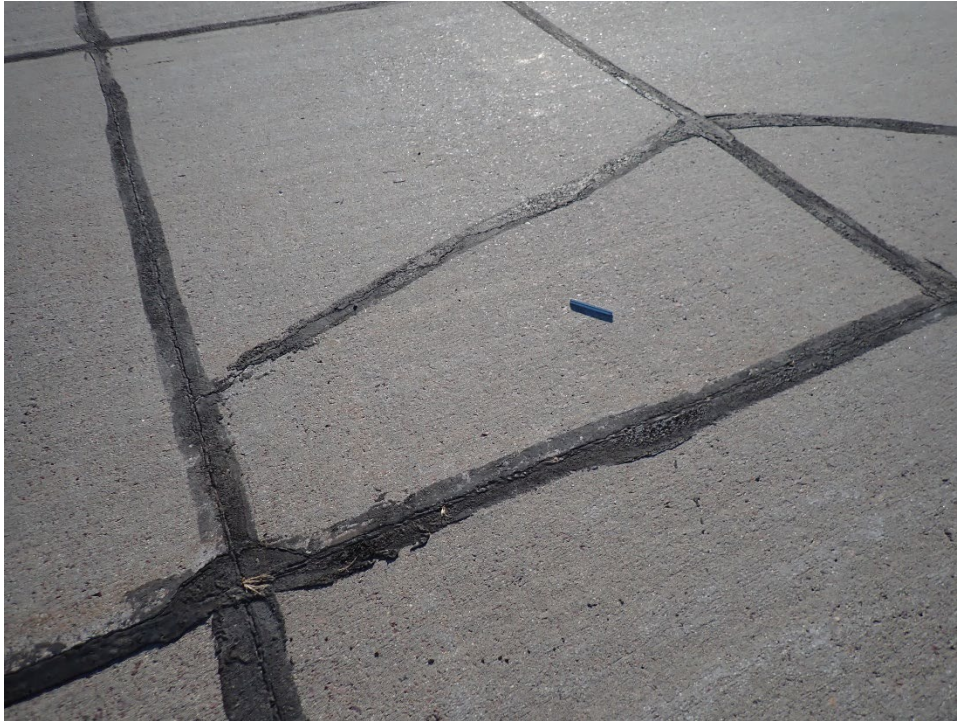
A01RR-03. LTD Cracking (Sample Unit No. 05).

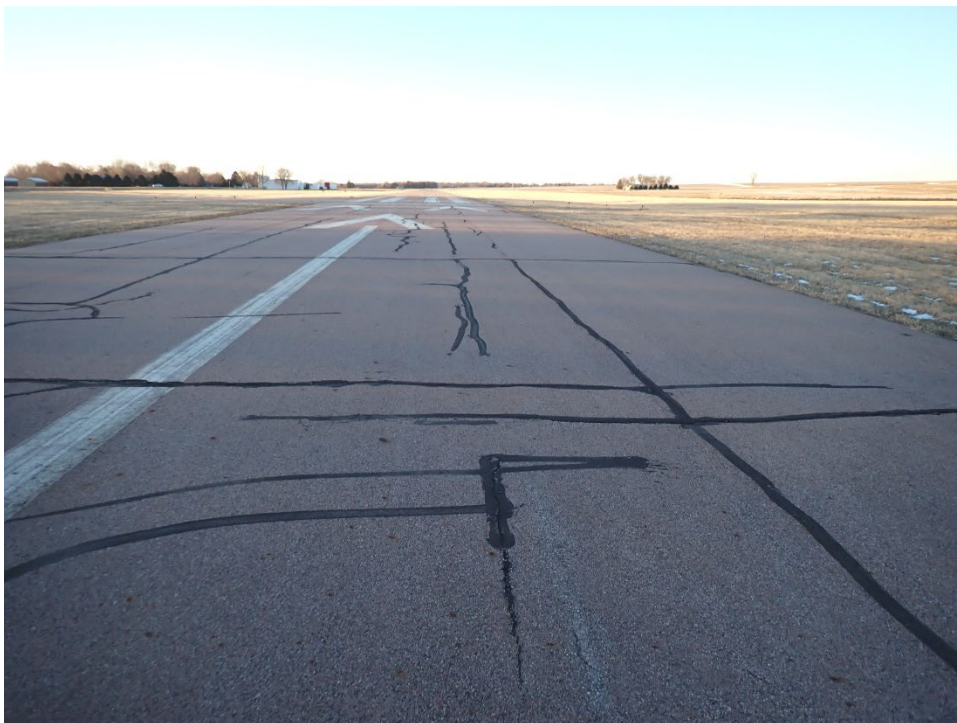
R16RR-01. Overview.

| Branch | Section | Surface Type | Section Area (sf) | LCD | 2025 PCI | % Distress Due to Load | % Distress Due to Climate/Durability | % Distress Due to Other | Type of Distress |
|---|---|---|---|---|---|---|---|---|---|
| R16RR | 01 | AAC | 15,300 | 2/1/2018 | 55 | 38 | 62 | 0 | Alligator Cracking, L&T Cracking, Raveling, Weathering |

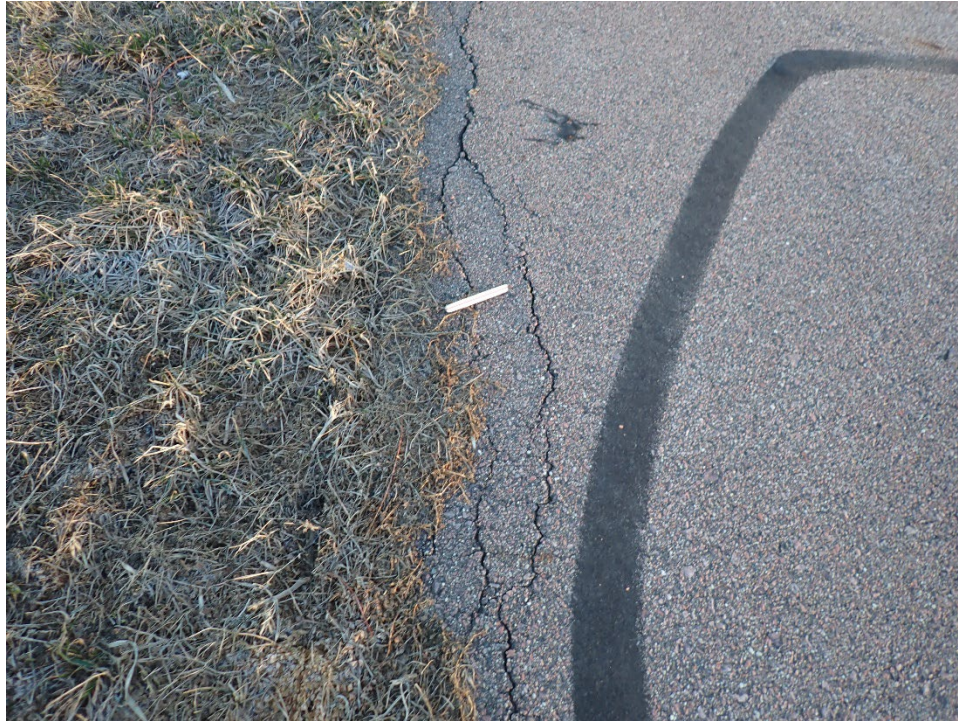
R16RR-01. Alligator Cracking (Sample Unit No. 03).

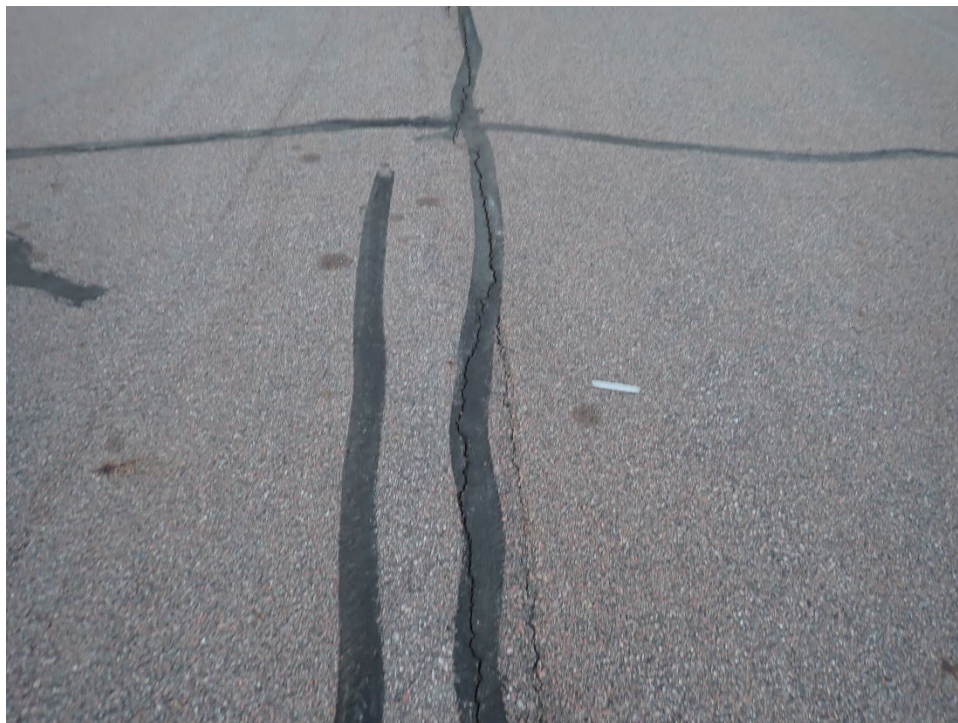
R16RR-01. L&T Cracking (Sample Unit No. 01).

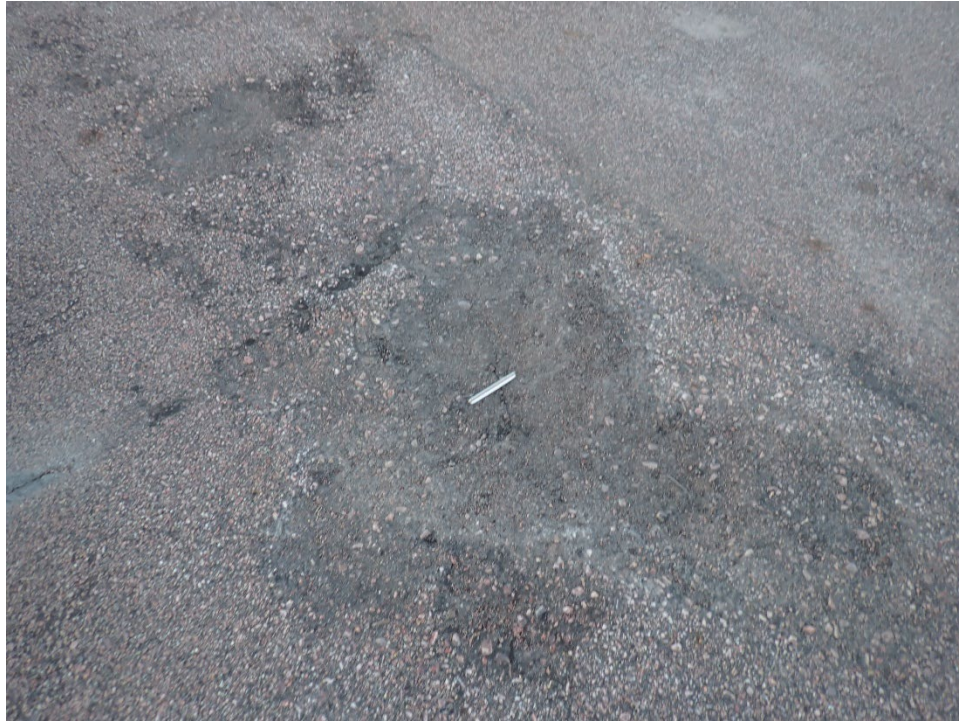
R16RR-01. Raveling (Sample Unit No. 01).

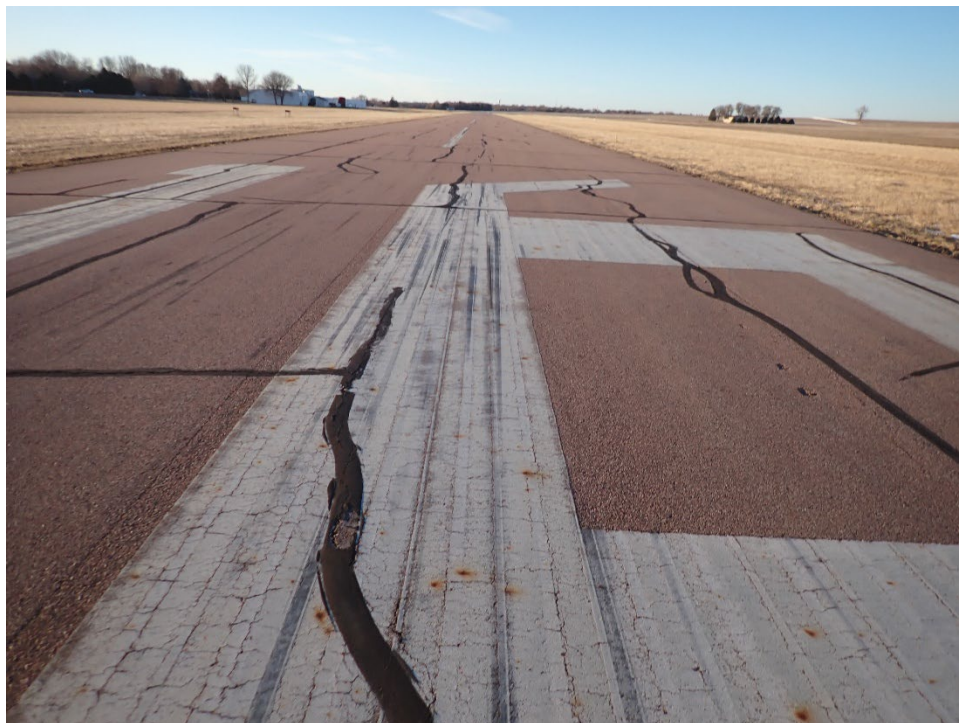
R16RR-02. Overview.

| Branch | Section | Surface Type | Section Area (sf) | LCD | 2025 PCI | % Distress Due to Load | % Distress Due to Climate/Durability | % Distress Due to Other | Type of Distress |
|---|---|---|---|---|---|---|---|---|---|
| R16RR | 02 | AAC | 132,165 | 2/1/2018 | 54 | 40 | 60 | 0 | Alligator Cracking, L&T Cracking, Raveling, Weathering |

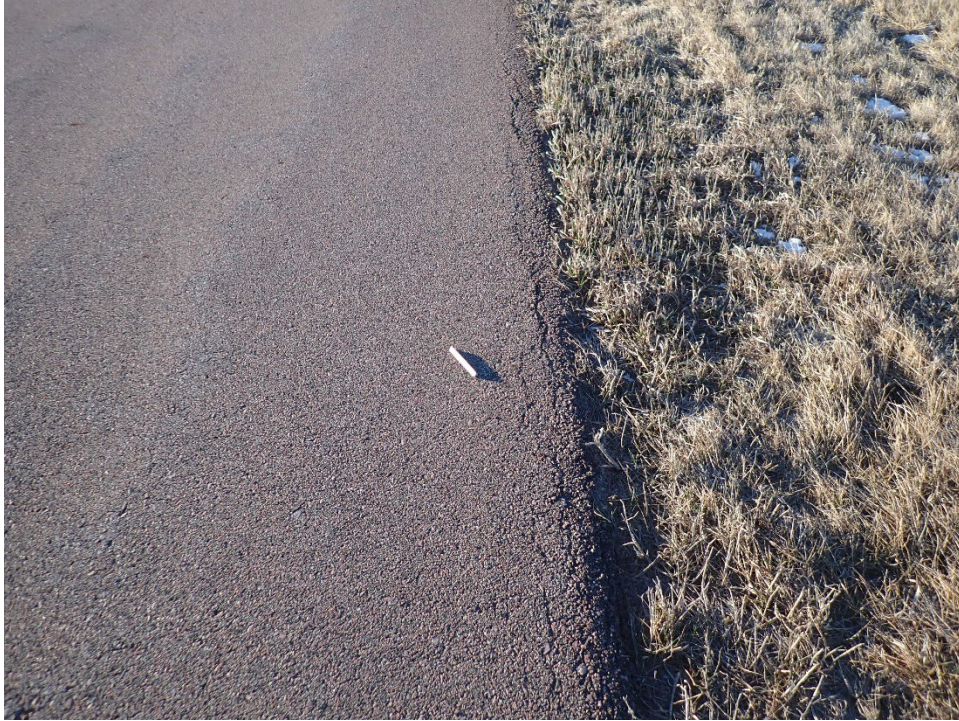
R16RR-02. Alligator Cracking (Sample Unit No. 17).

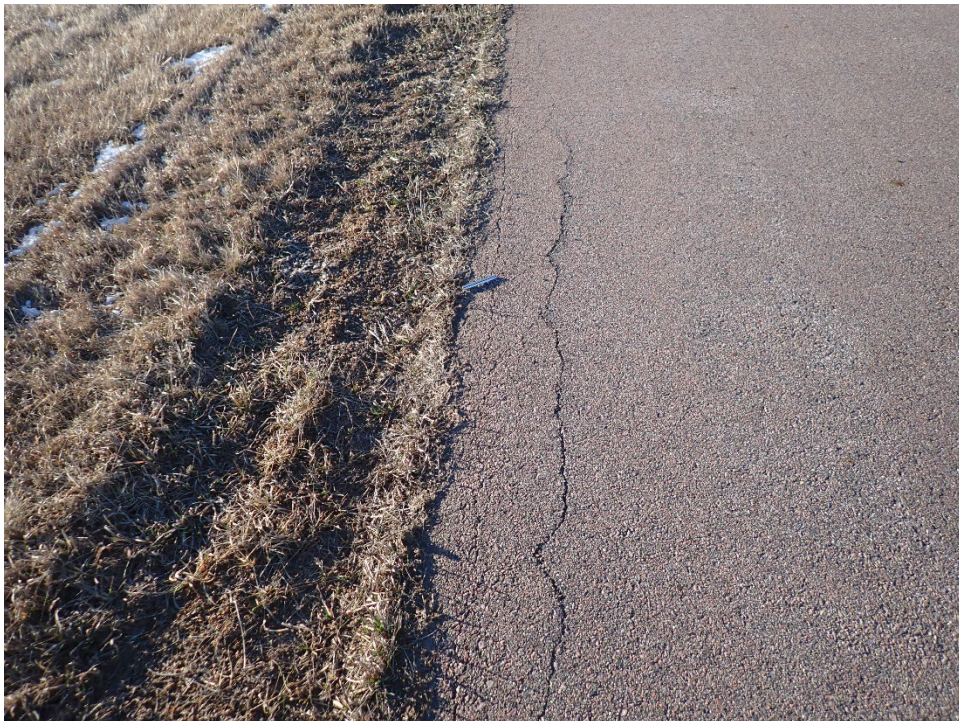
R16RR-02. Alligator Cracking (Sample Unit No. 21).

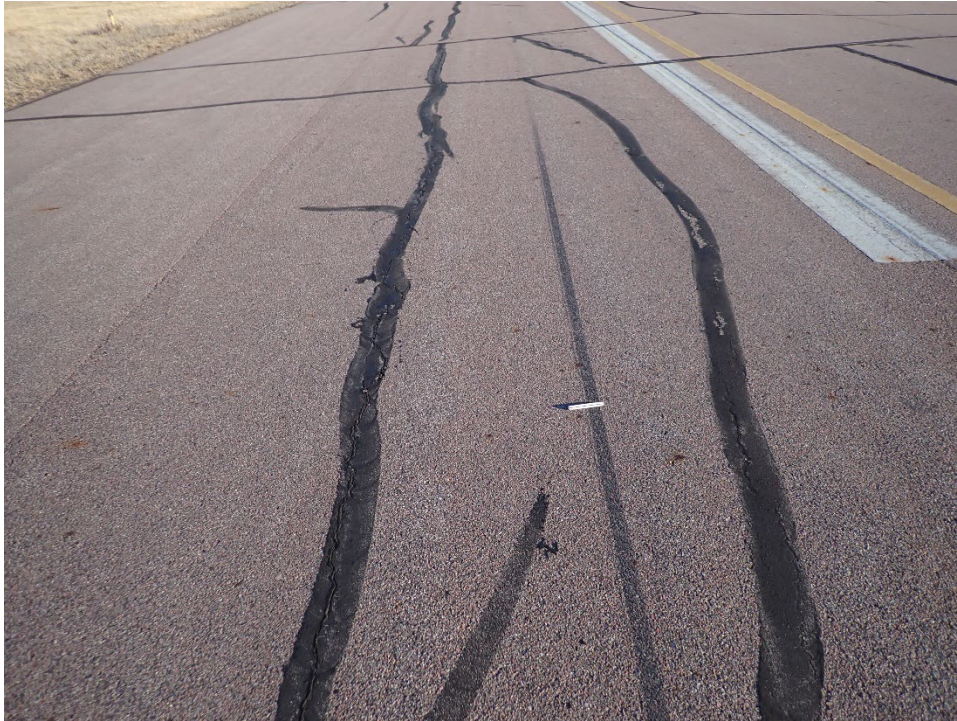
R16RR-02. L&T Cracking (Sample Unit No. 17).

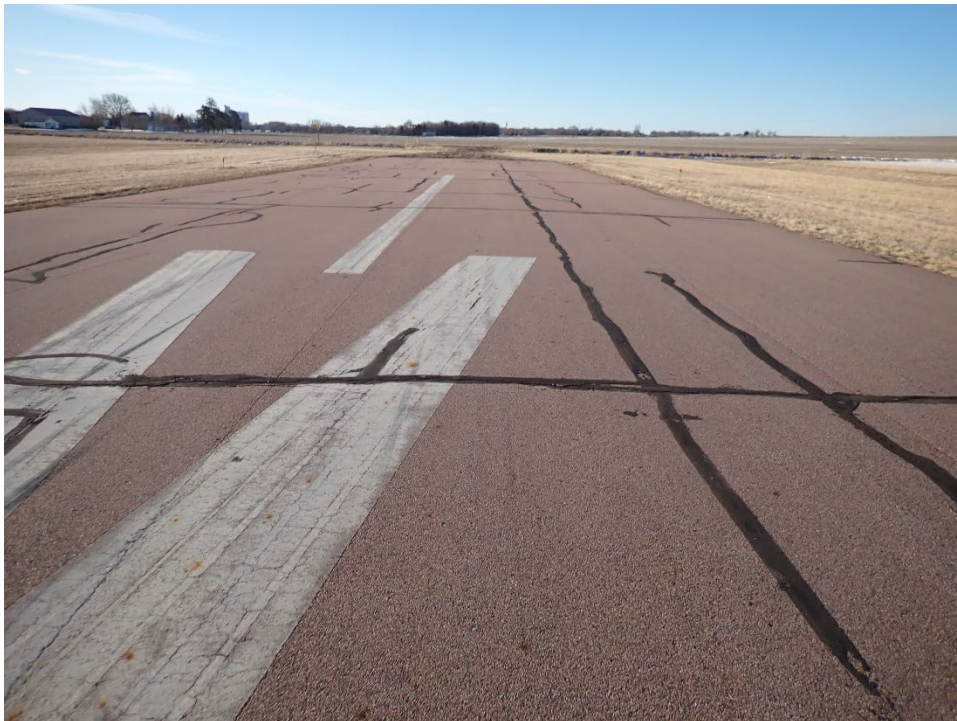
R16RR-03. Overview.

| Branch | Section | Surface Type | Section Area (sf) | LCD | 2025 PCI | % Distress Due to Load | % Distress Due to Climate/Durability | % Distress Due to Other | Type of Distress |
|---|---|---|---|---|---|---|---|---|---|
| R16RR | 03 | AAC | 14,950 | 2/1/2018 | 47 | 29 | 71 | 0 | Alligator Cracking, L&T Cracking, Raveling, Weathering |

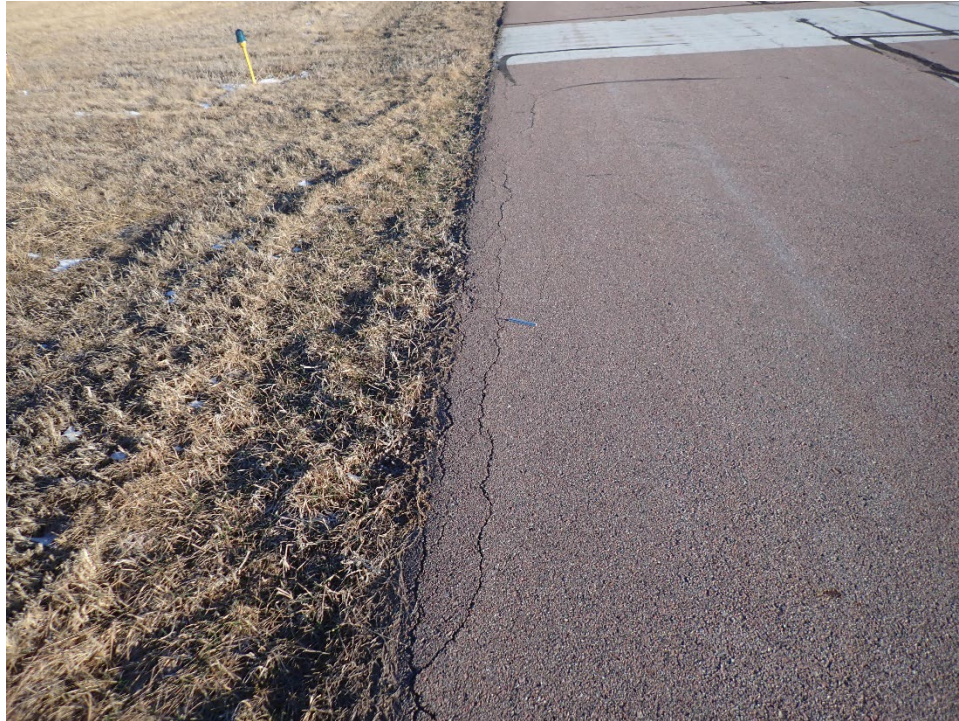
R16RR-03. Alligator Cracking (Sample Unit No. 01).

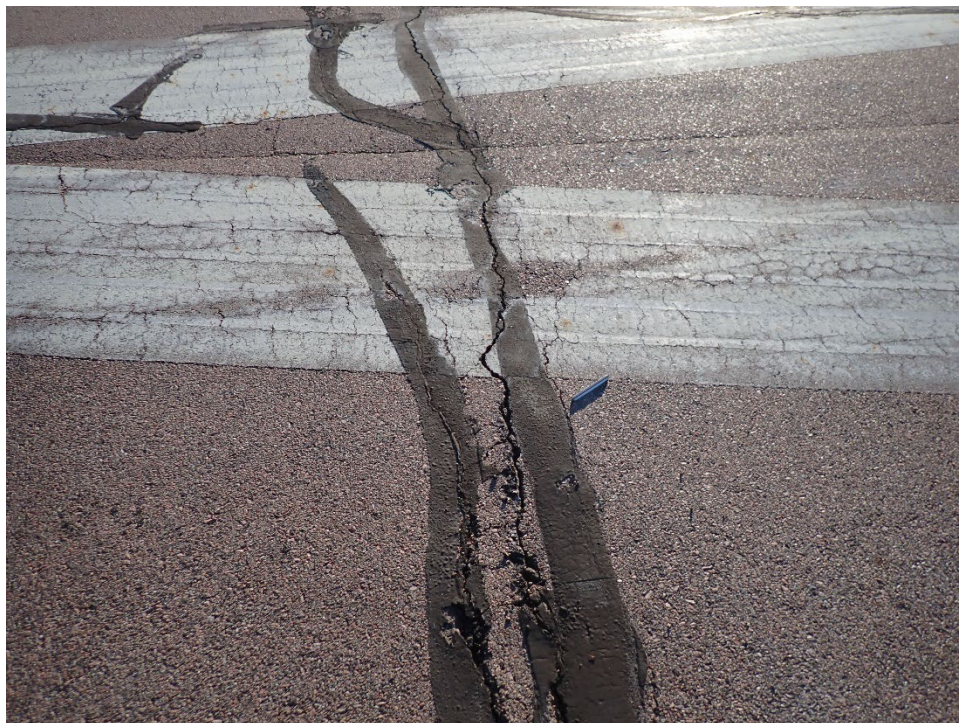
R16RR-03. L&T Cracking (Sample Unit No. 01).

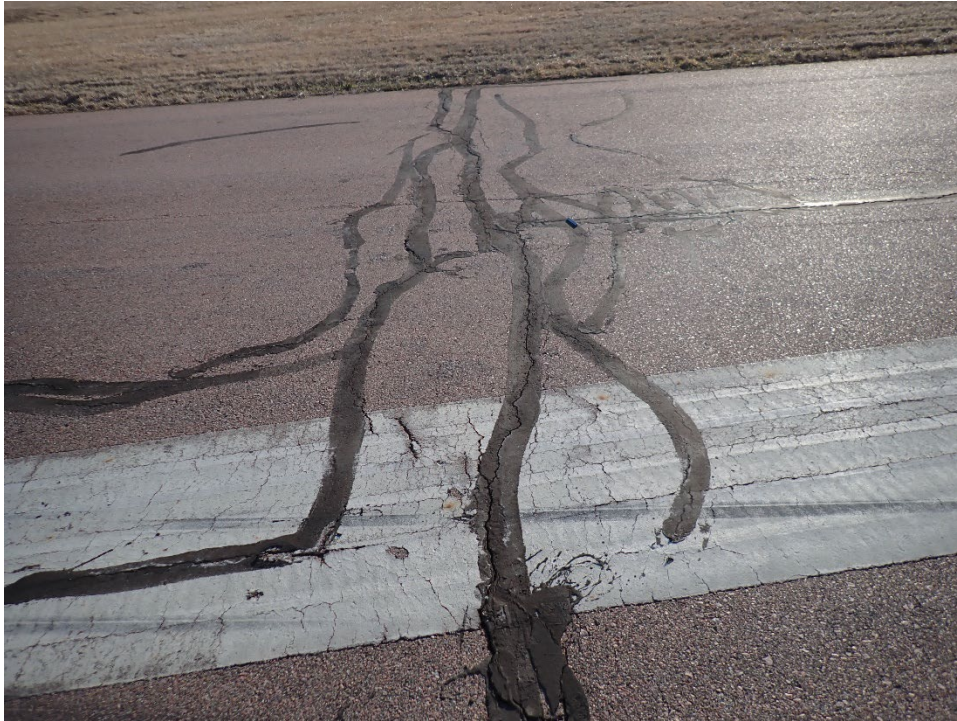
R16RR-03. L&T Cracking (Sample Unit No. 02).

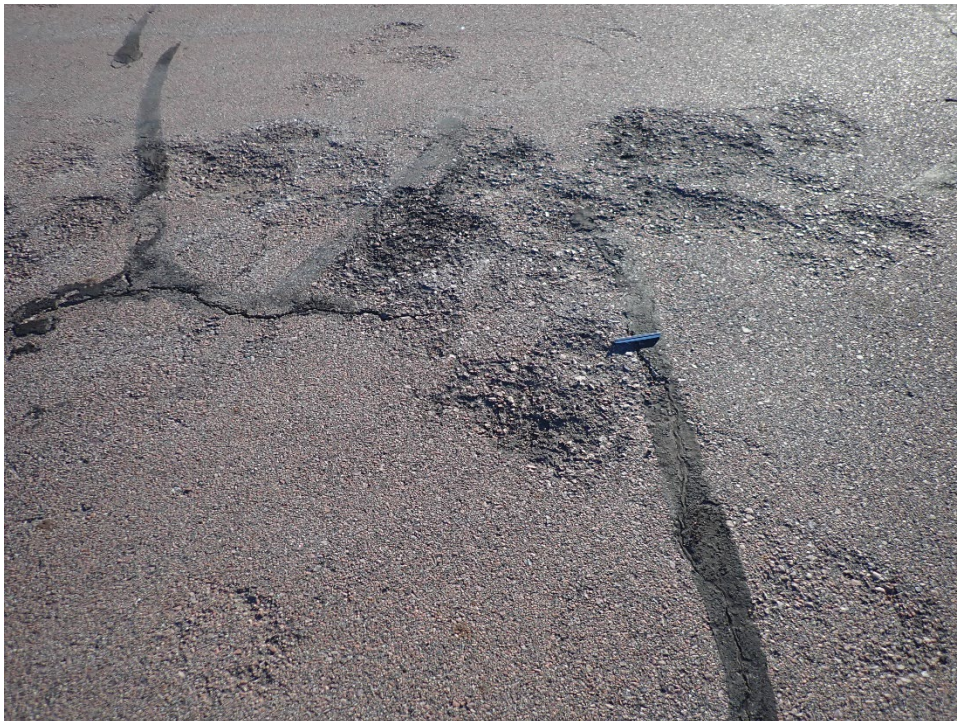
R16RR-03. Raveling (Sample Unit No. 03).

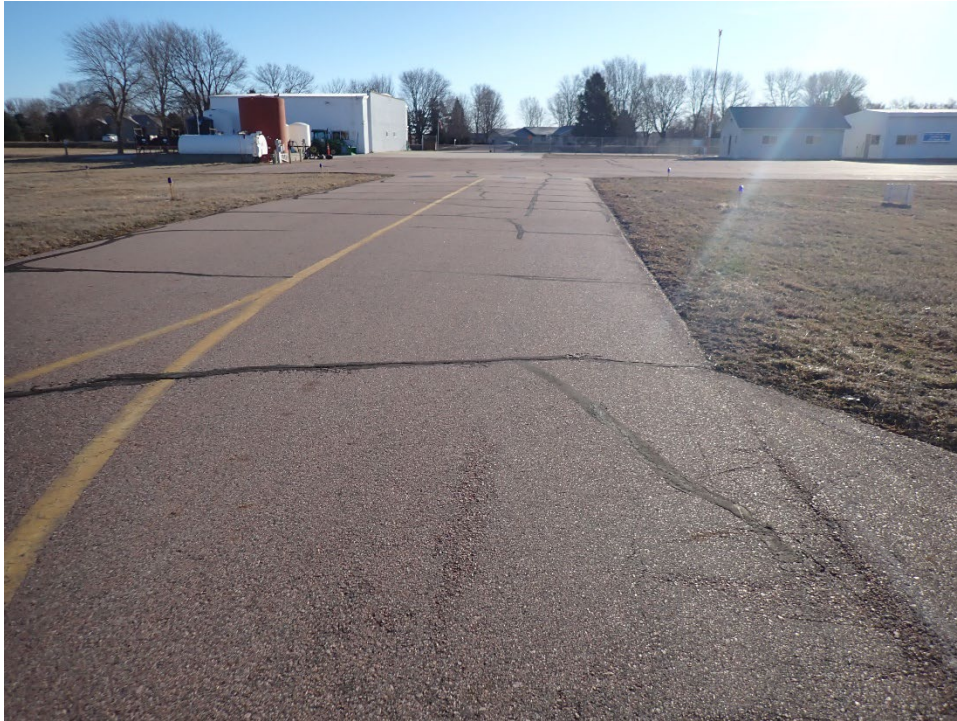
T01RR-01. Overview.

| Branch | Section | Surface Type | Section Area (sf) | LCD | 2025 PCI | % Distress Due to Load | % Distress Due to Climate/Durability | % Distress Due to Other | Type of Distress |
|---|---|---|---|---|---|---|---|---|---|
| T01RR | 01 | AAC | 3,377 | 2/1/2018 | 62 | 19 | 81 | 0 | Alligator Cracking, L&T Cracking, Weathering |

The taxiway was defined by one section with low- and medium-severity L&T cracking and low-severity alligator cracking and weathering observed at the time of inspection. The low-severity L&T cracking was both sealed and unsealed, while the medium-severity L&T cracking was recorded where either unsealed crack widths exceeded 1/4 inch, crack sealant was unsatisfactory, or secondary cracking associated with the primary crack had developed.

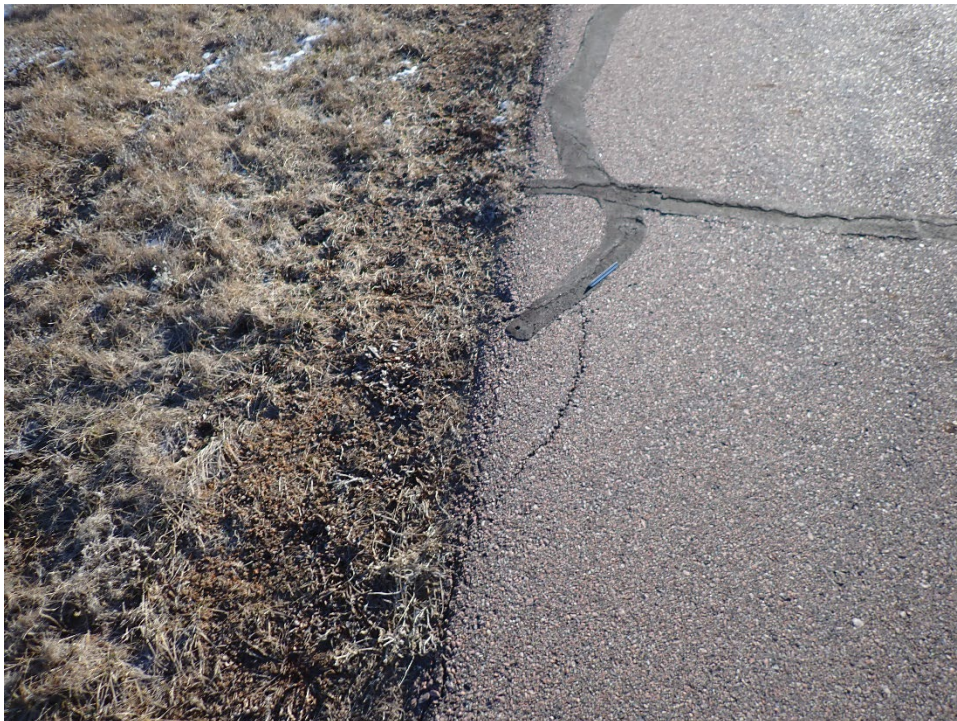
T01RR-01. Alligator Cracking (Sample Unit No. 01).

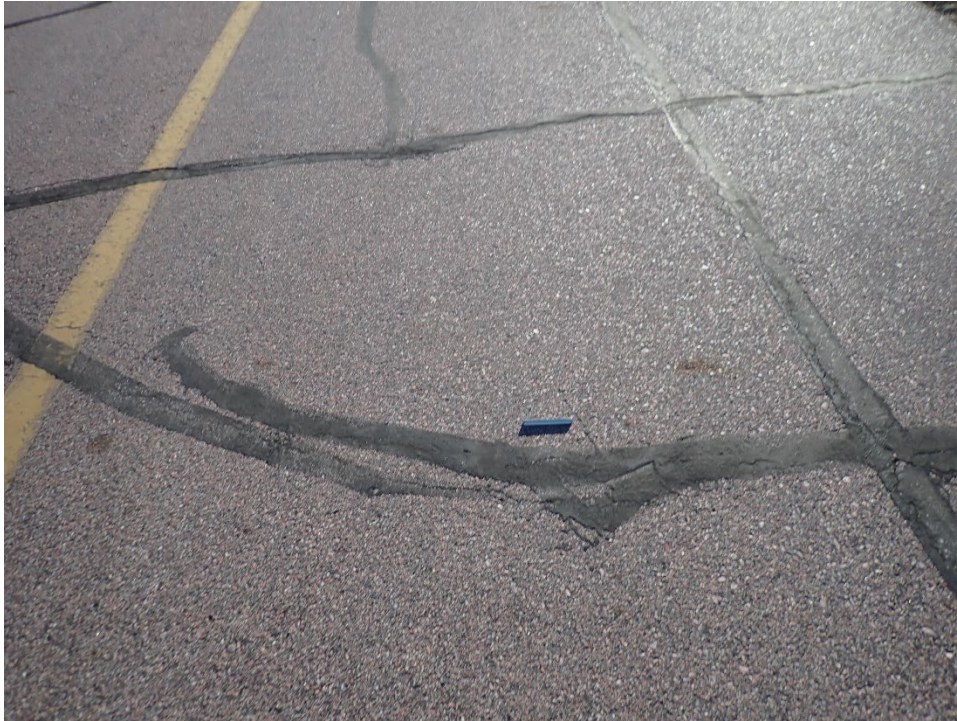
T01RR-01. L&T Cracking (Sample Unit No. 01).
