Sac City Municipal Airport

Pavement Management Report

JULY 2023

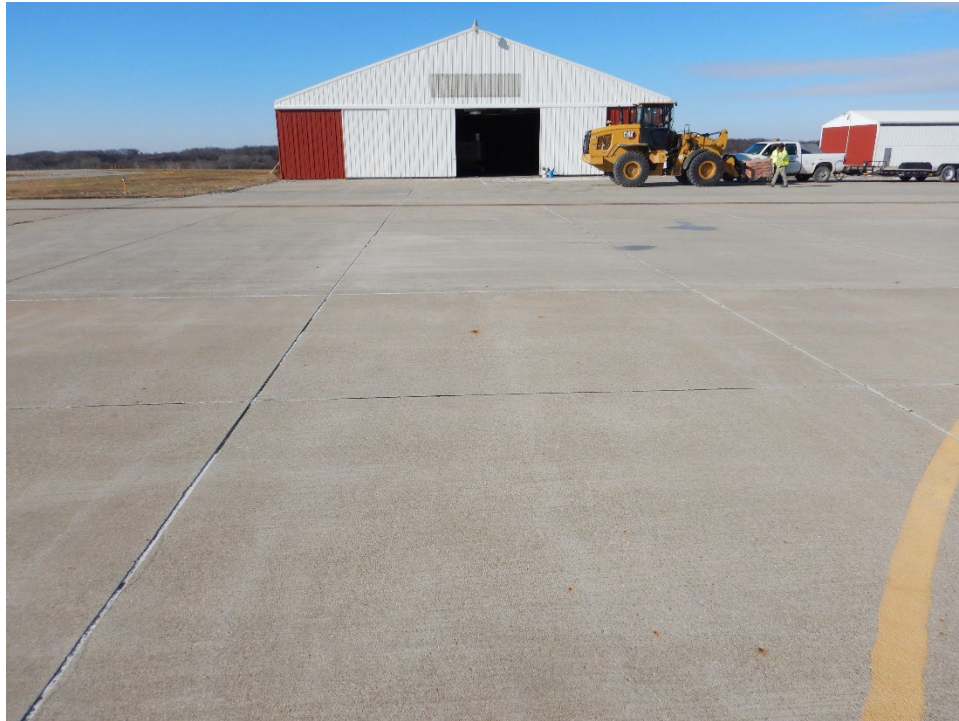
The apron area contained one section. Section 01 was in excellent condition with low-severity joint seal damage noted throughout during the inspection. An atypical area of shrinkage cracking and low-severity LTD cracking was observed and recorded as an additional sample unit in accordance with ASTM D5340-20.

A01SC-01. Overview.

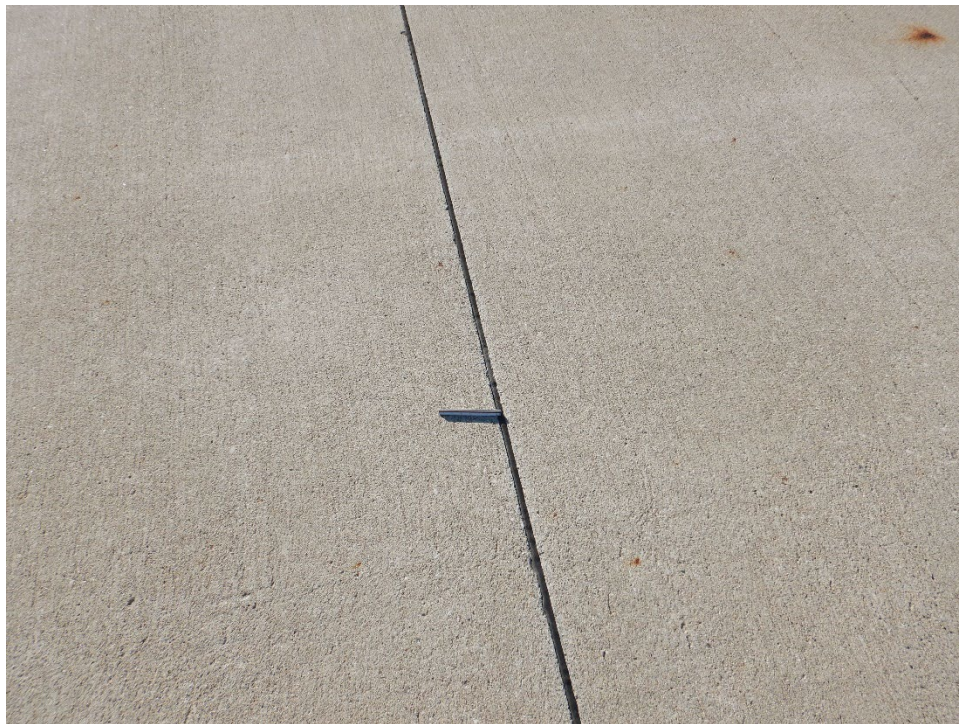
A01SC-01. Joint Seal Damage (Sample Unit No. 01).

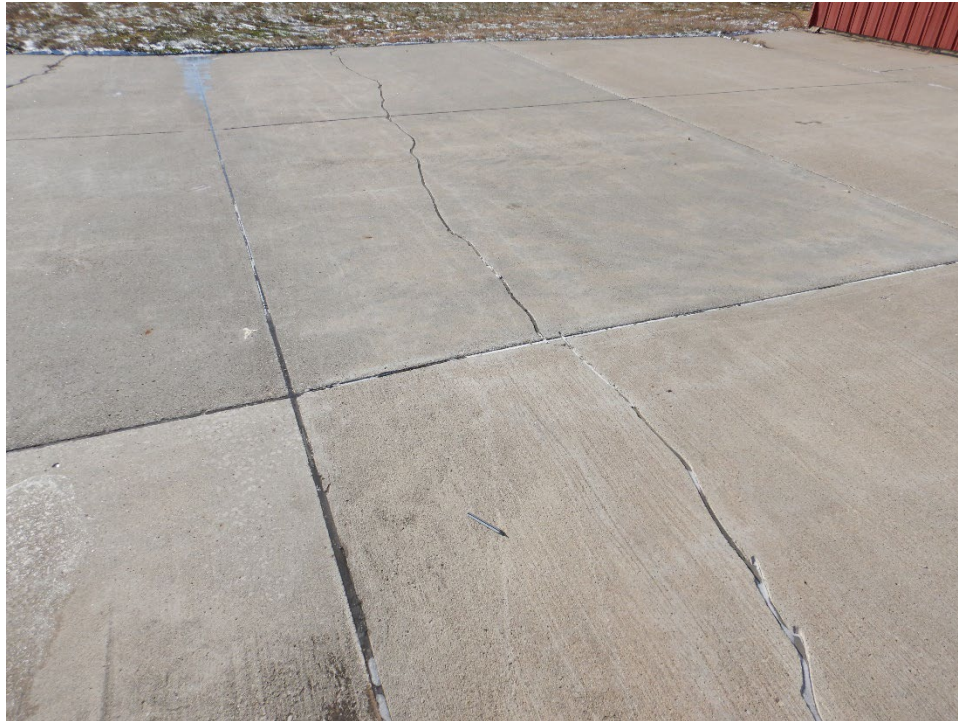
A01SC-01. LTD Cracking (Additional Sample Unit No. 08).

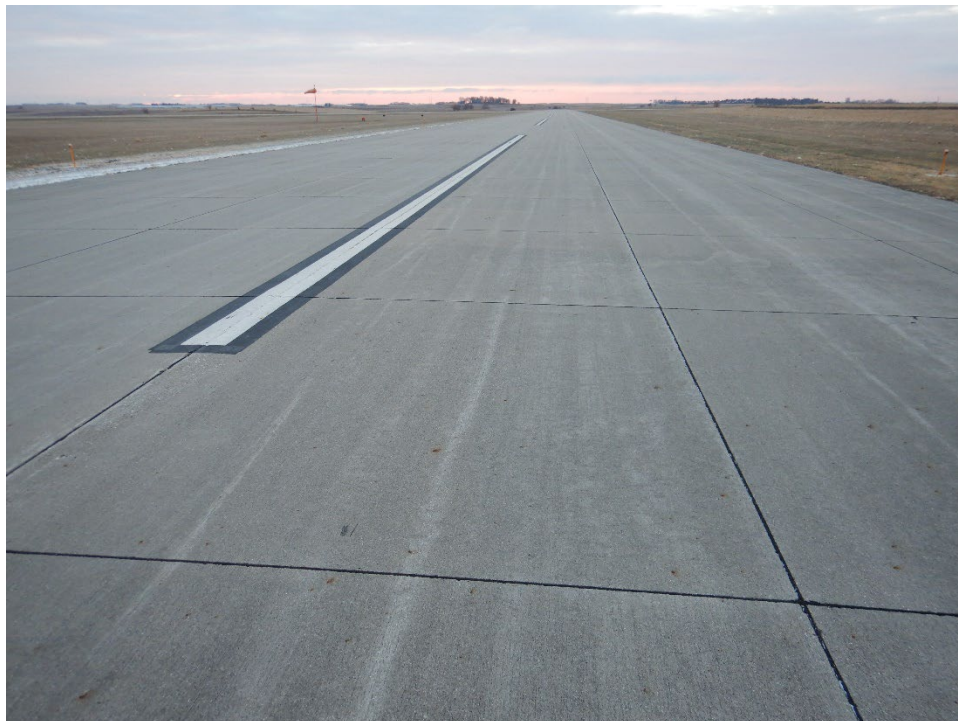
Runway 14/32 was defined by one section. Areas of low- and medium-severity corner spalling; medium- and high-severity joint seal damage; and medium-severity longitudinal, transverse, and diagonal (LTD) cracking were observed in Section 01.

R14SC-01. Overview.

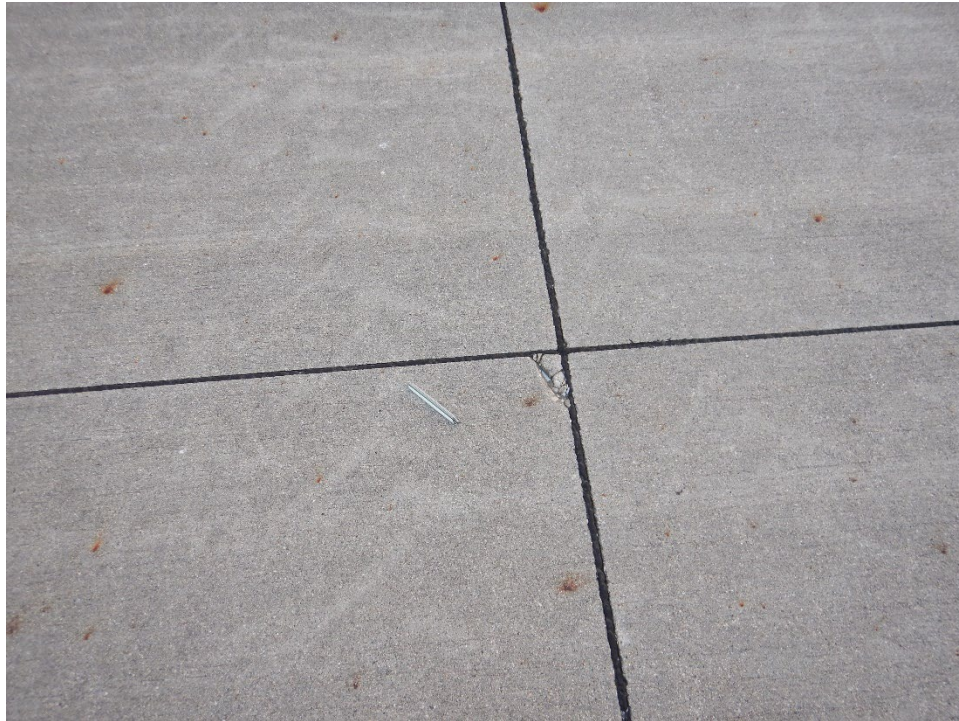
R14SC-01. Corner Spalling (Sample Unit No. 20).

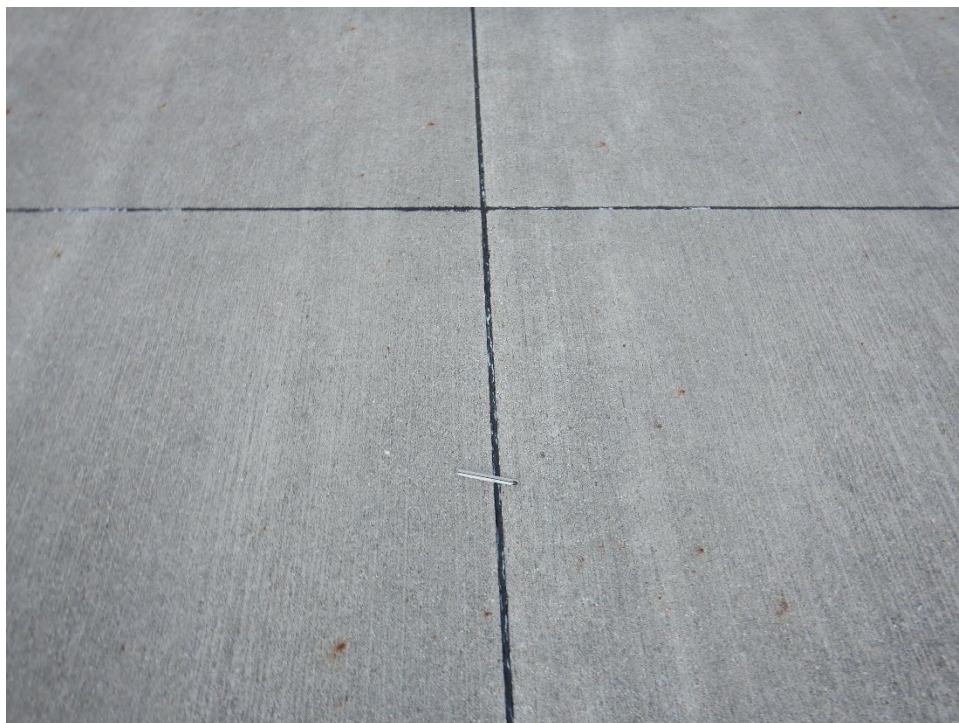
R14SC-01. Joint Seal Damage (Sample Unit No. 11).

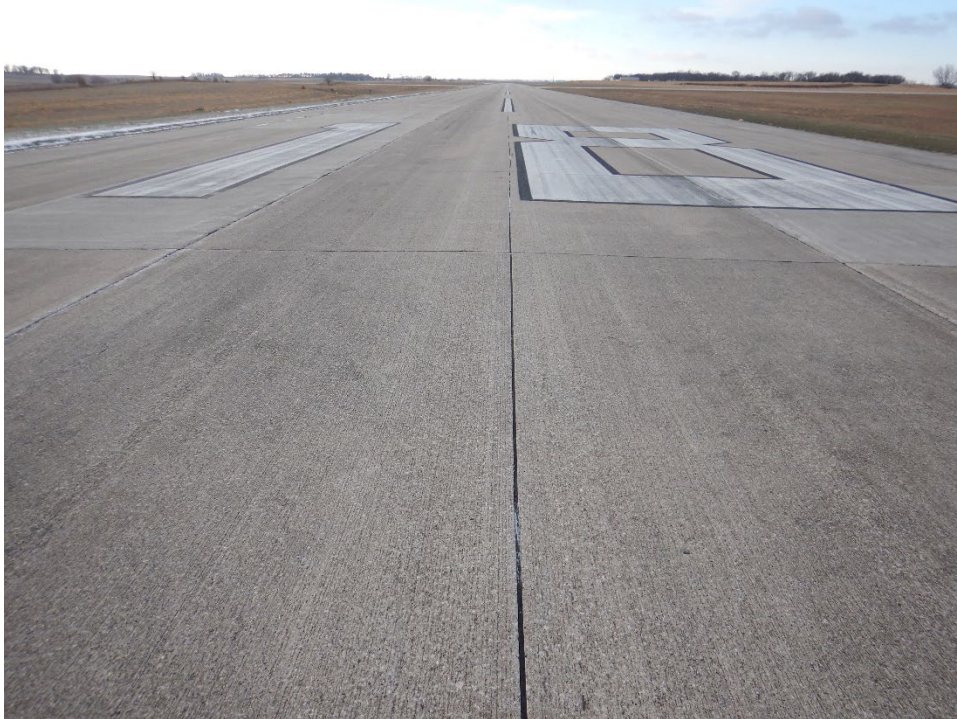
R18SC-01. Overview.

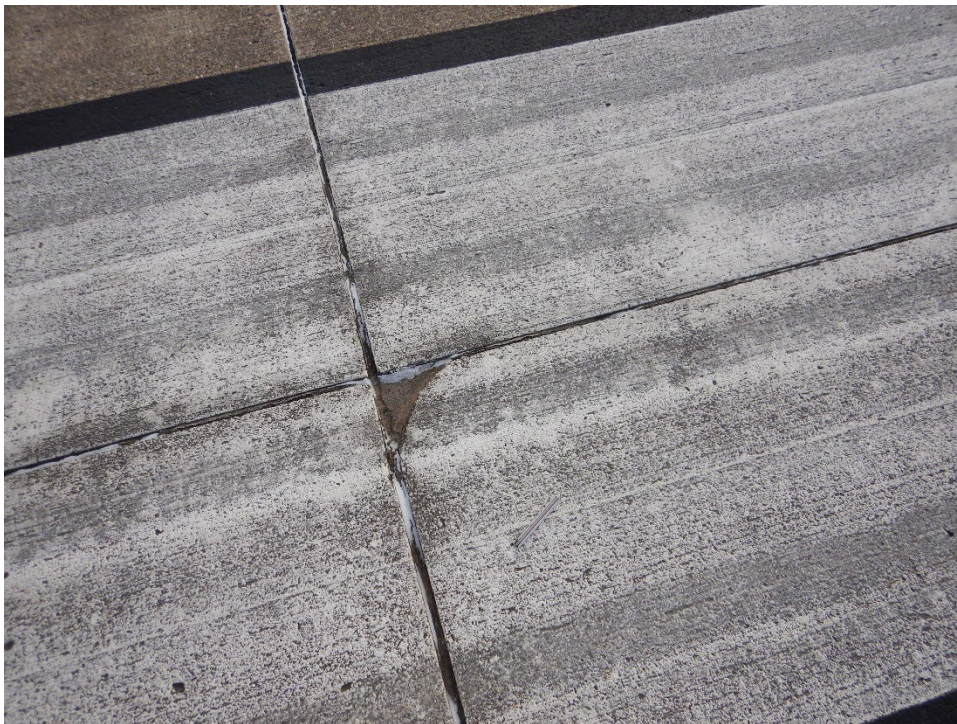
R18SC-01. Corner Spalling (Sample Unit No. 02).

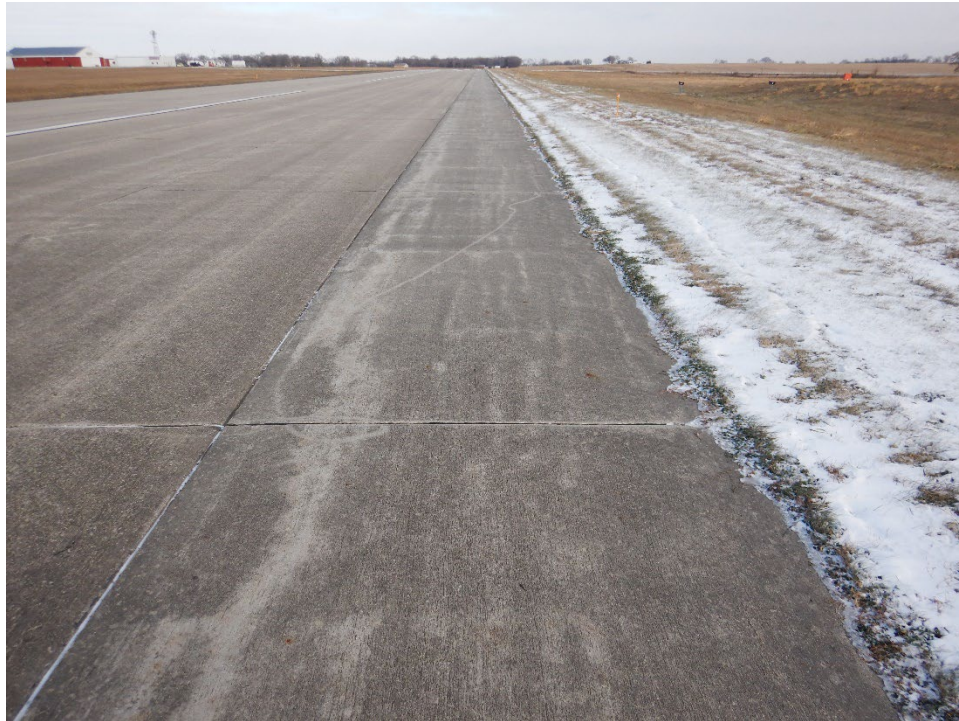
R18SC-02. Overview.

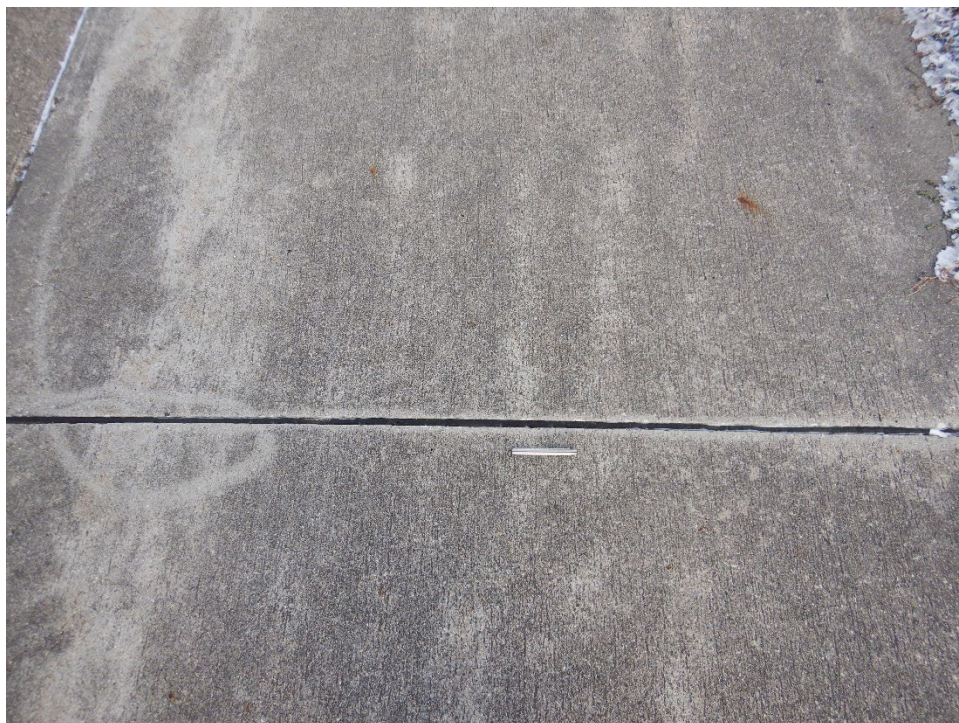
R18SC-02. Joint Seal Damage (Sample Unit No. 03).

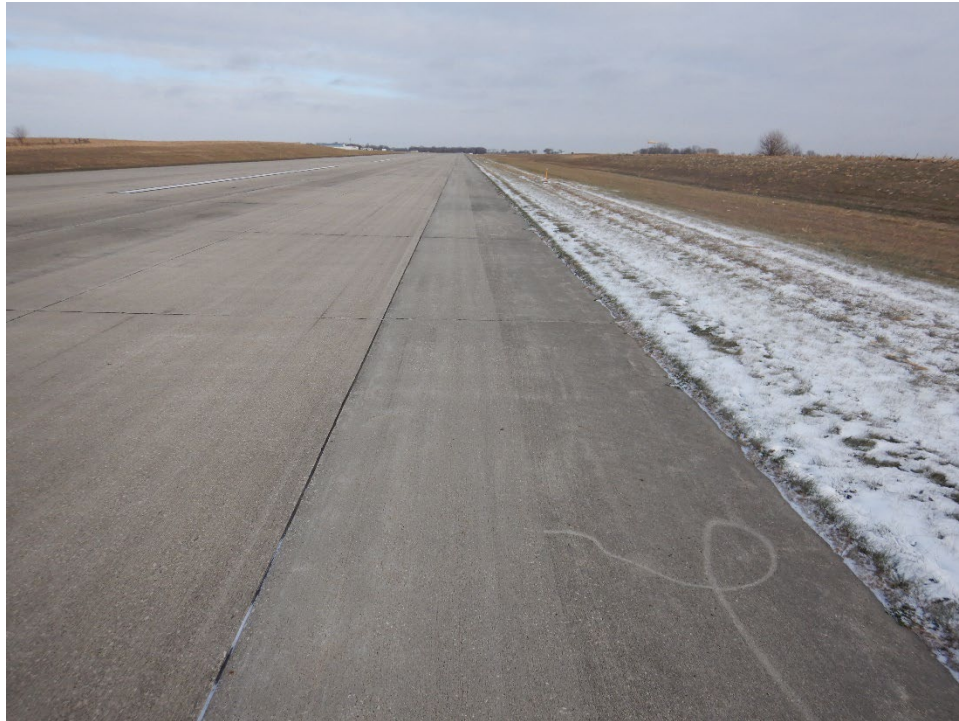
R18SC-03. Overview.

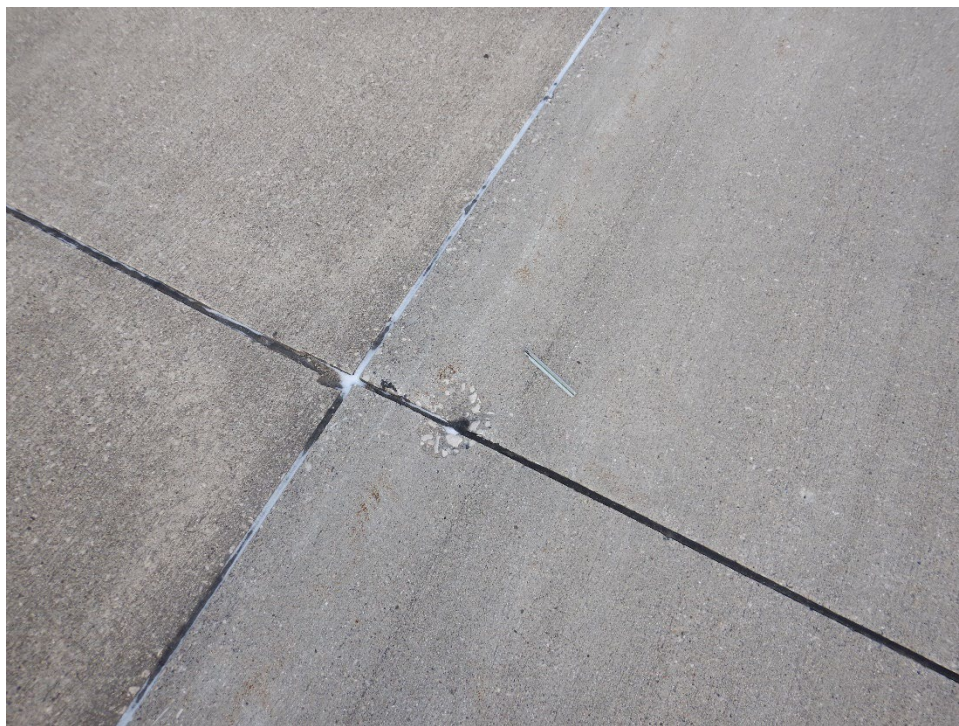
R18SC-03. Joint Spalling (Sample Unit No. 05).

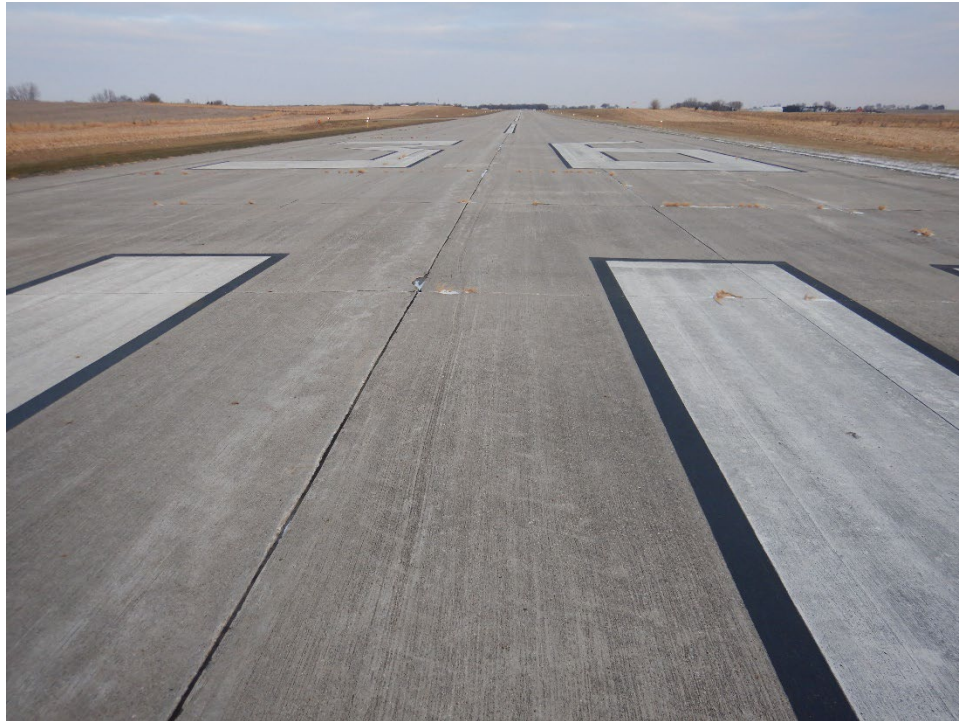
R18SC-04. Overview.

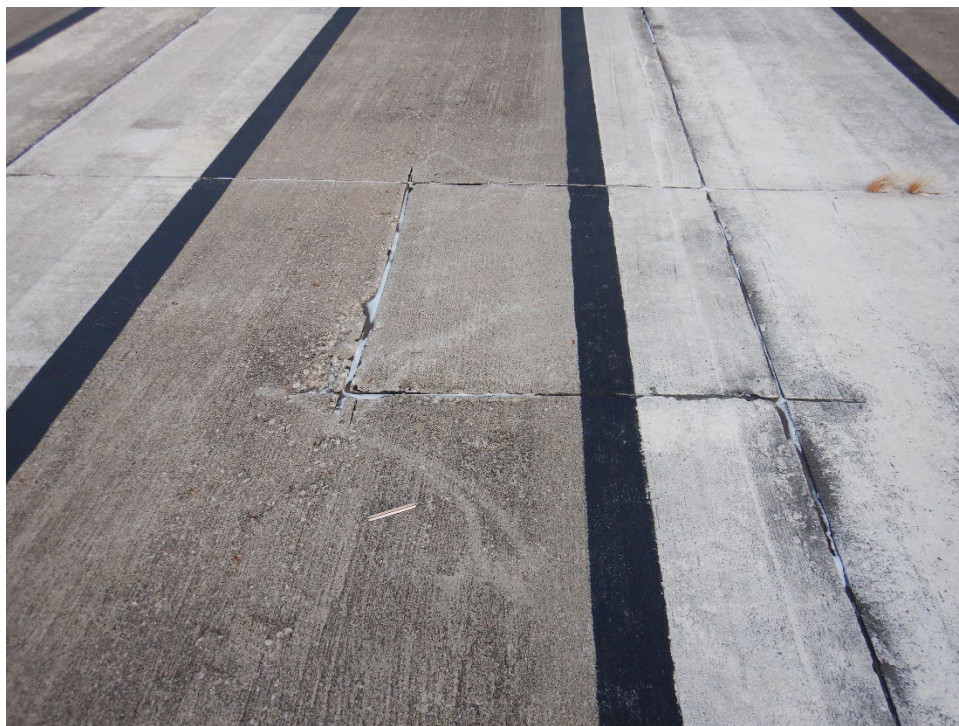
R18SC-04. Large Patching (Sample Unit No. 10).

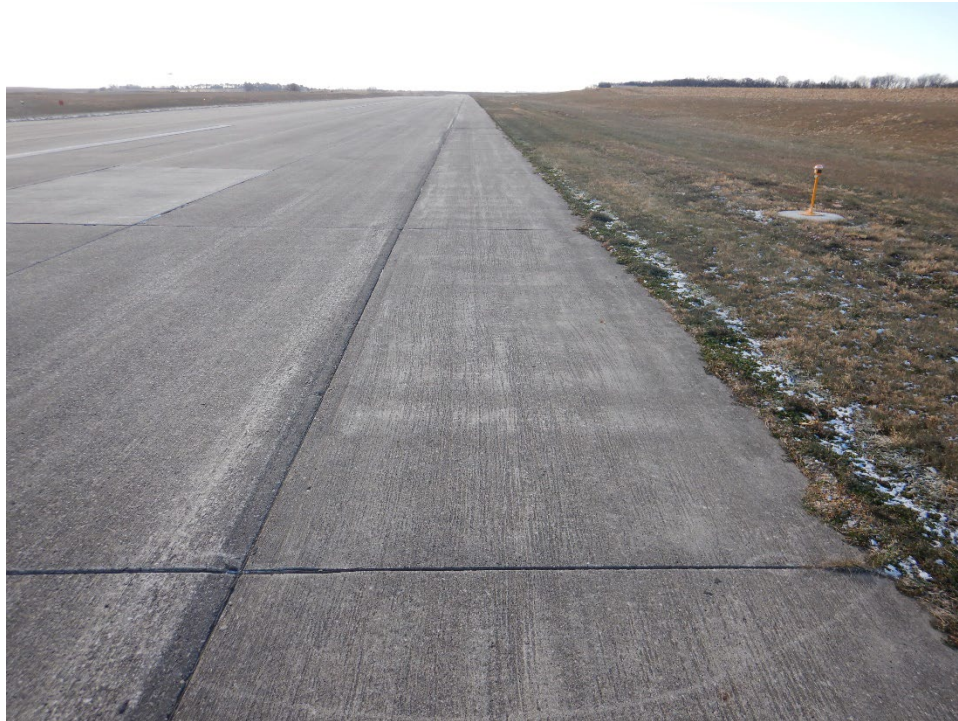
R18SC-05. Overview.

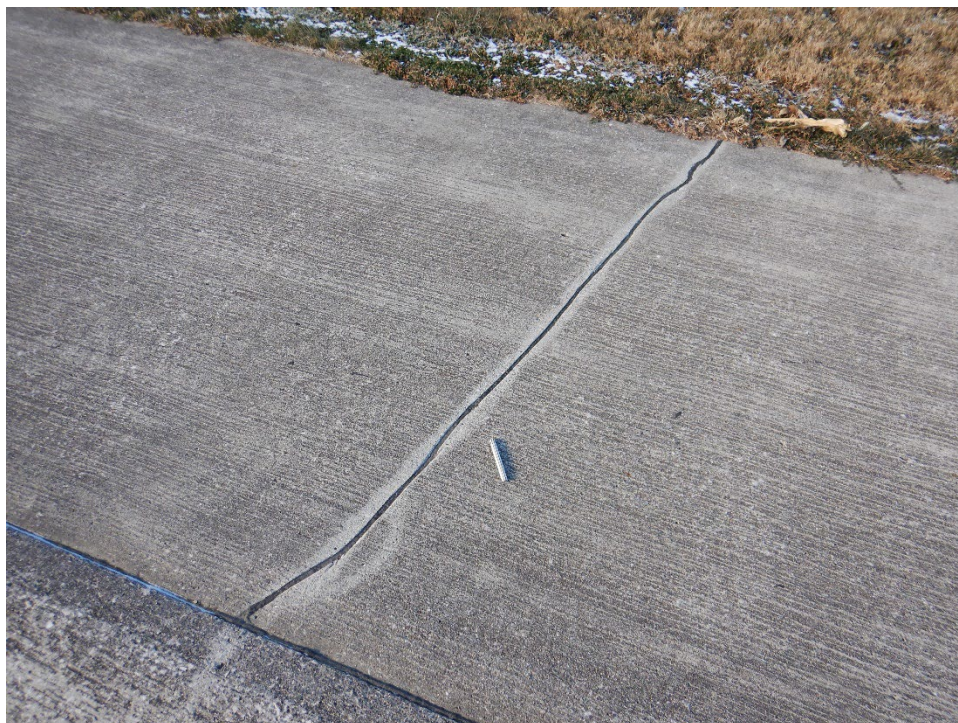
R18SC-05. LTD Cracking (Sample Unit No. 01).

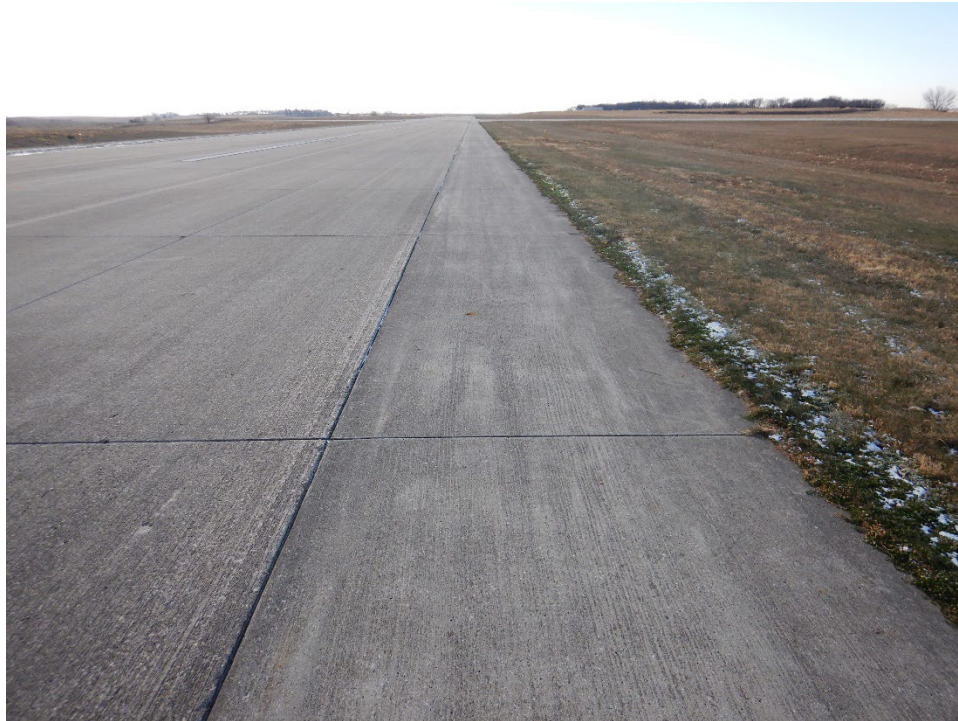
R18SC-06. Overview.

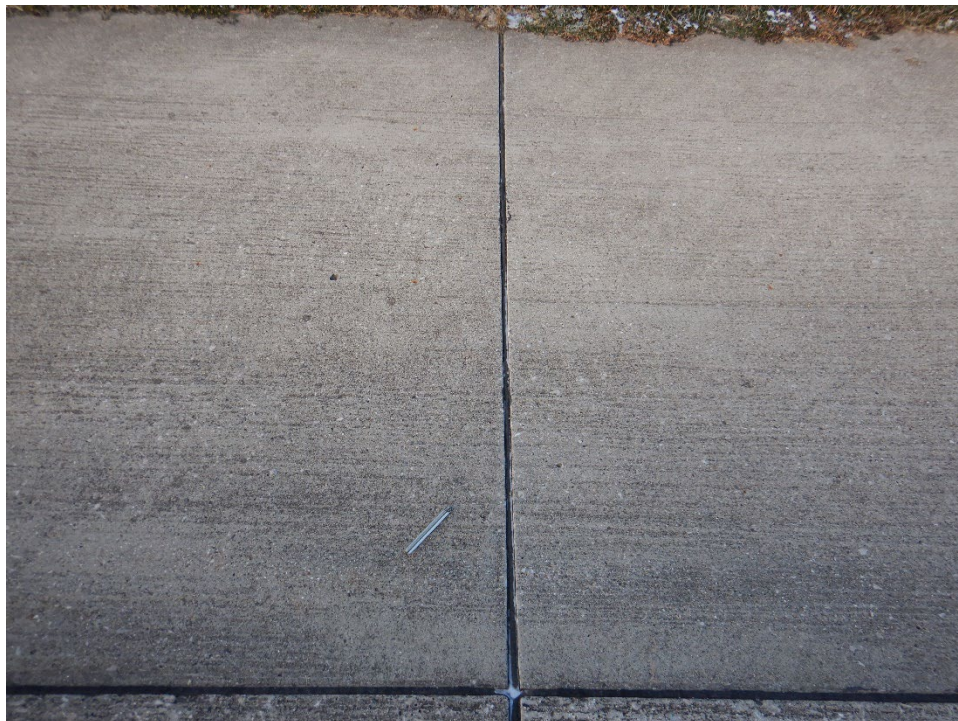
R18SC-06. Joint Seal Damage (Sample Unit No. 01).

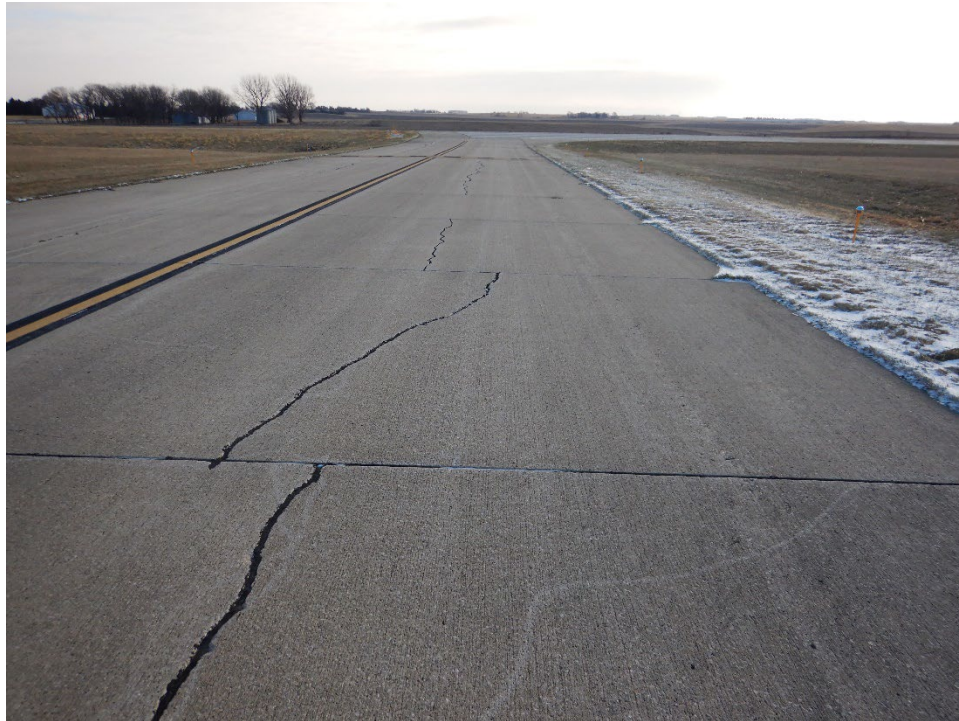
Taxiway 01 consisted of two sections. Section 01 contained areas of medium-severity shattered slab, corner break, and corner spalling; low-severity faulting, small patching, and joint seal damage; low- and medium-severity joint spalling and LTD cracking; and shrinkage cracking. Medium- and high-severity faulting, low-severity joint seal damage, and medium-severity joint spalling were identified in Section 02.

T01SC-01. Overview.

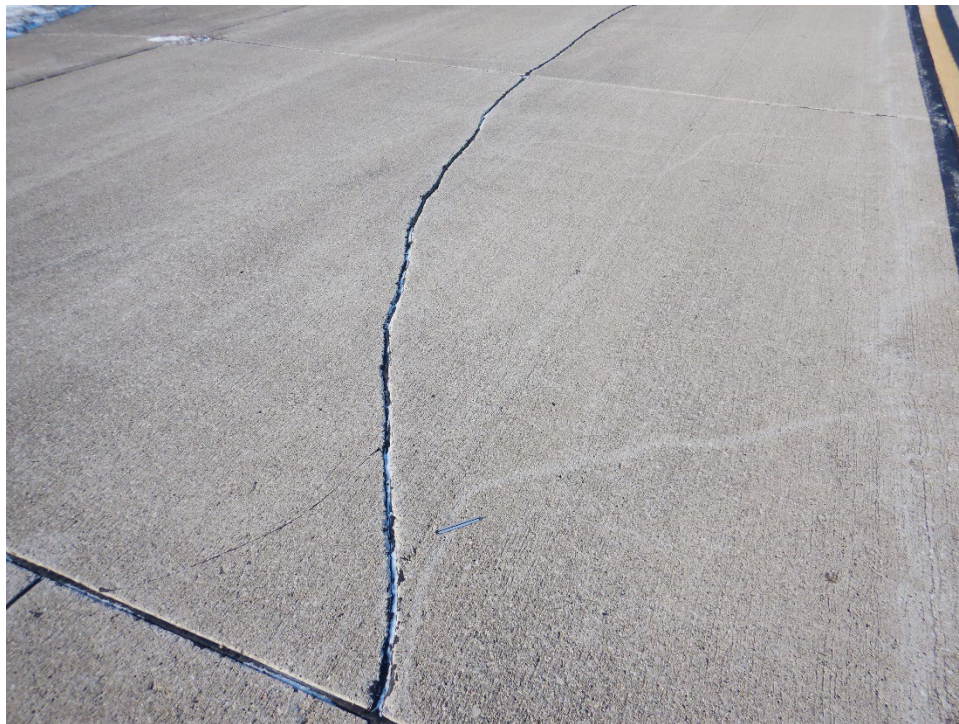
T01SC-01. LTD Cracking (Sample Unit No. 01).

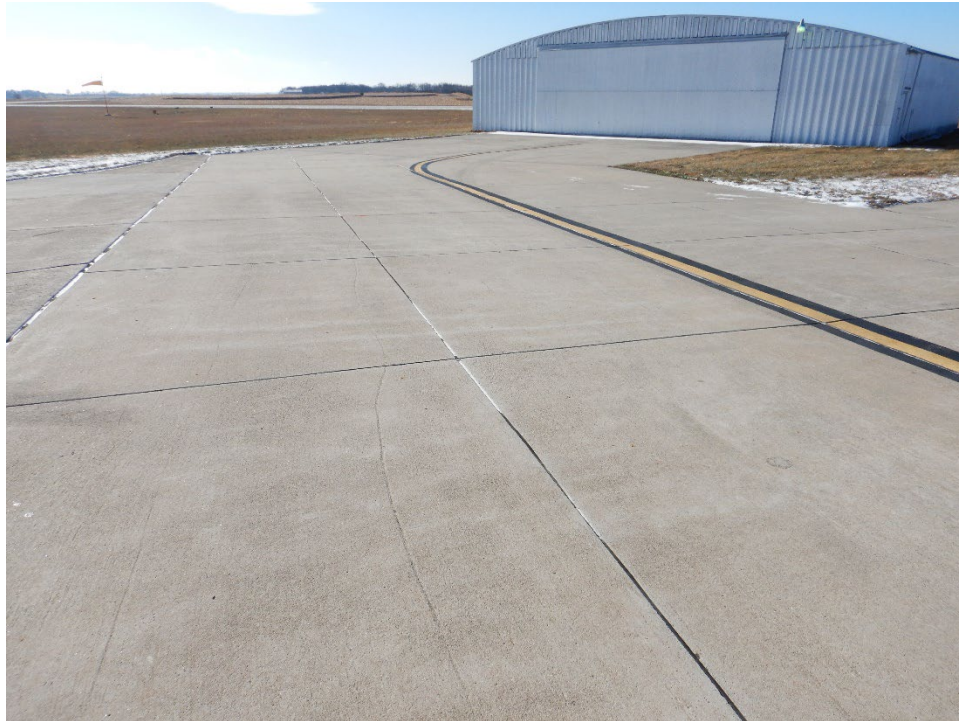
T01SC-02. Overview.

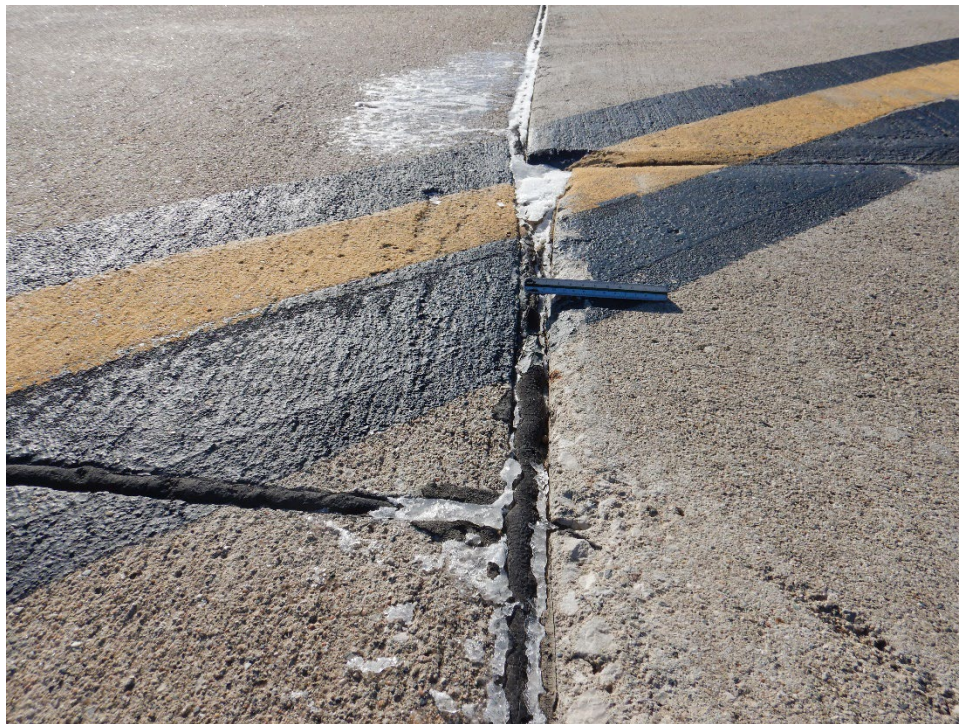
T01SC-02. Faulting (Sample Unit No. 02).

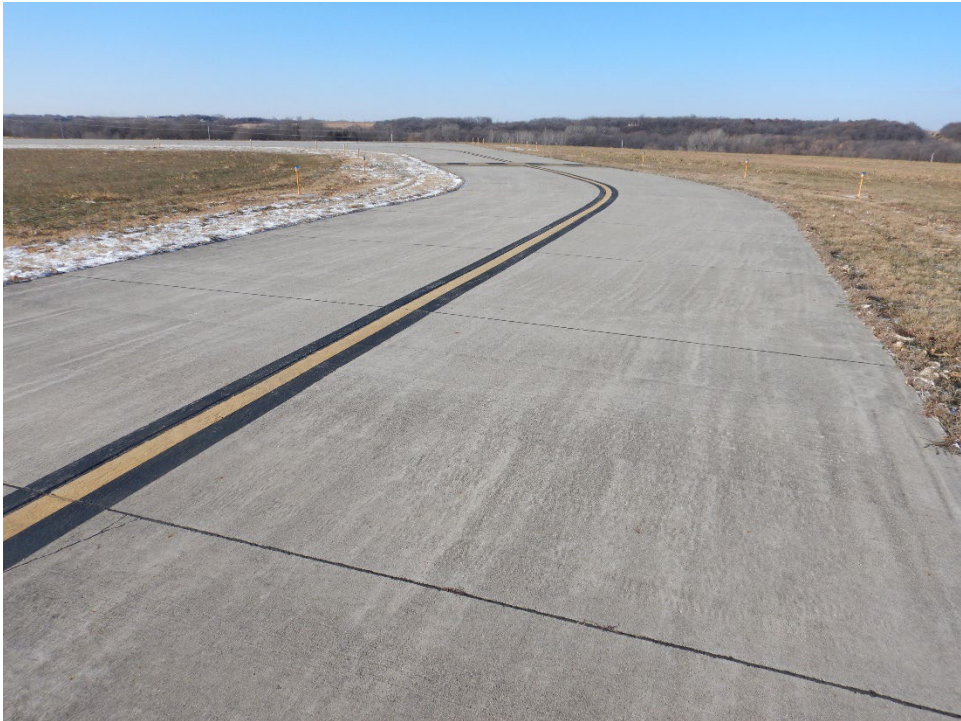
Taxiway 02 was defined by one section. Areas of medium-severity LTD cracking, joint seal damage, and corner break; low- and medium-severity corner spalling; low-severity faulting and joint spalling; and shrinkage cracking were observed in Section 01.

T02SC-01. Overview.

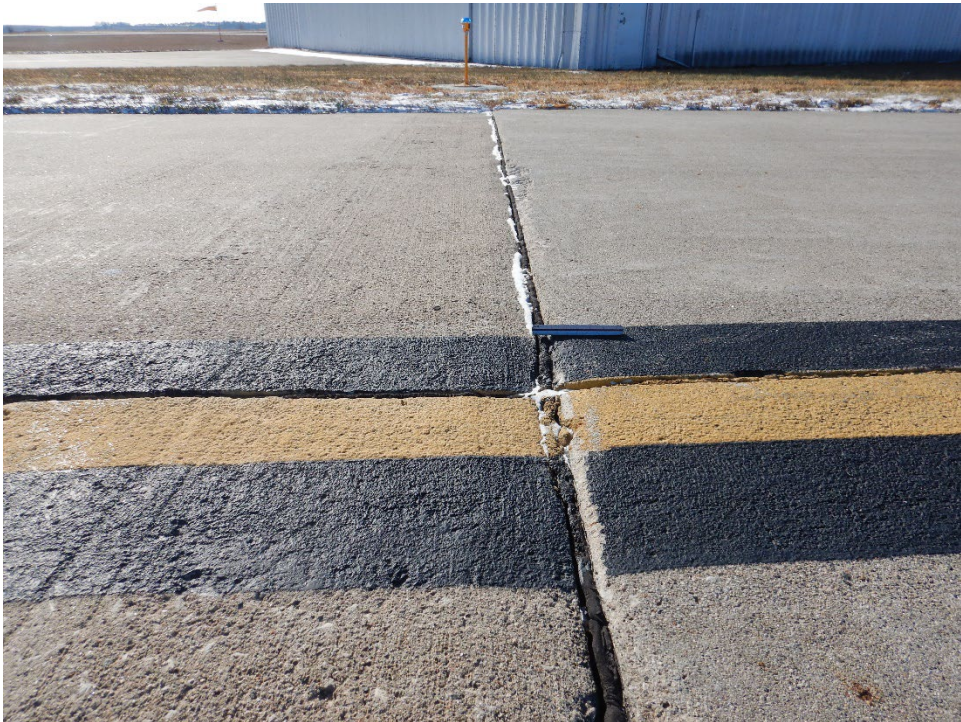
T02SC-01. Faulting (Sample Unit No. 01).

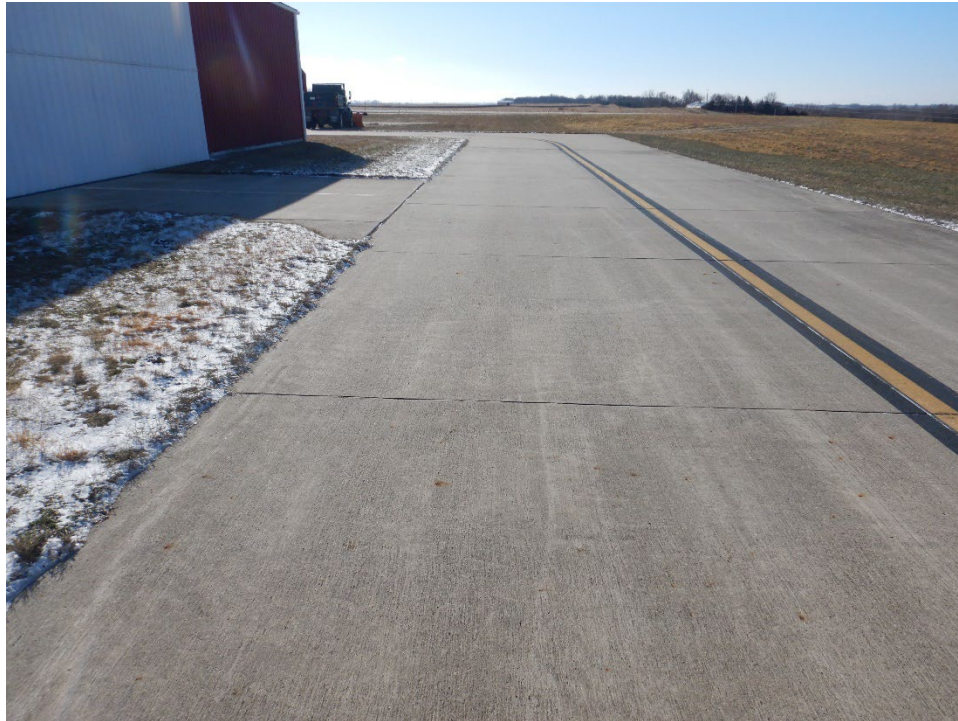
The T-hangar area was defined by one section. Section 01 contained areas of low-severity faulting and corner break, medium-severity corner spalling, low- and medium-severity joint seal damage and LTD cracking, and shrinkage cracking.

TH01SC-01. Overview.

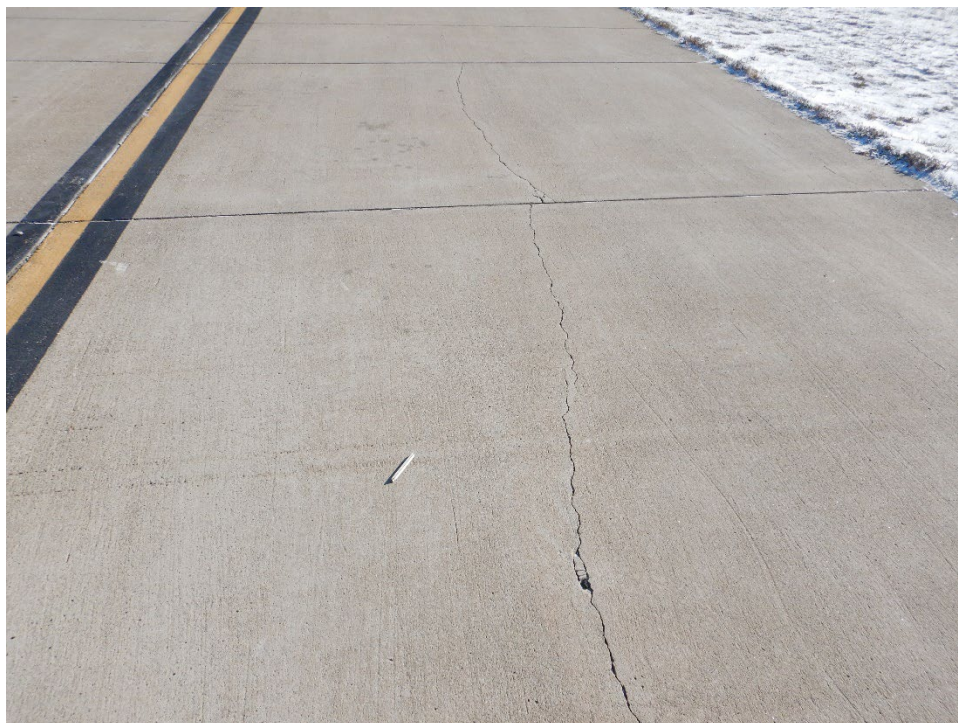
TH01SC-01. LTD Cracking (Sample Unit No. 01).
