# Sac City Municipal Airport

## Pavement Management Report

**AUGUST 2026**

# SAC CITY MUNICIPAL AIRPORT PAVEMENT MANAGEMENT REPORT

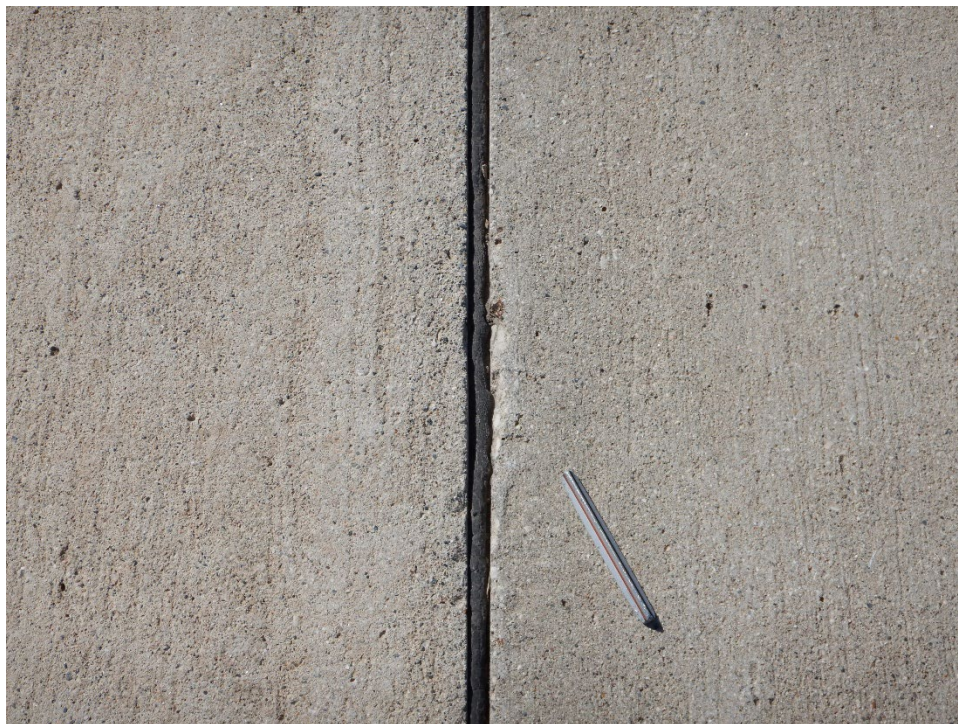
A01SC-01. Joint Seal Damage (Sample Unit No. 07).

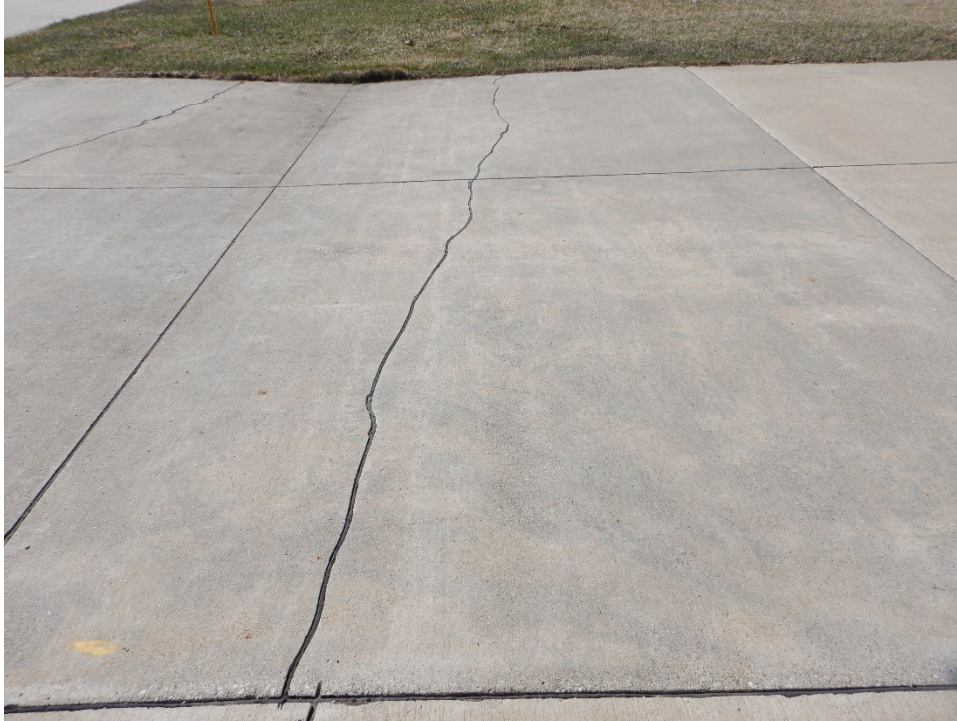
A01SC-01. LTD Cracking (Additional Sample Unit No. 08).

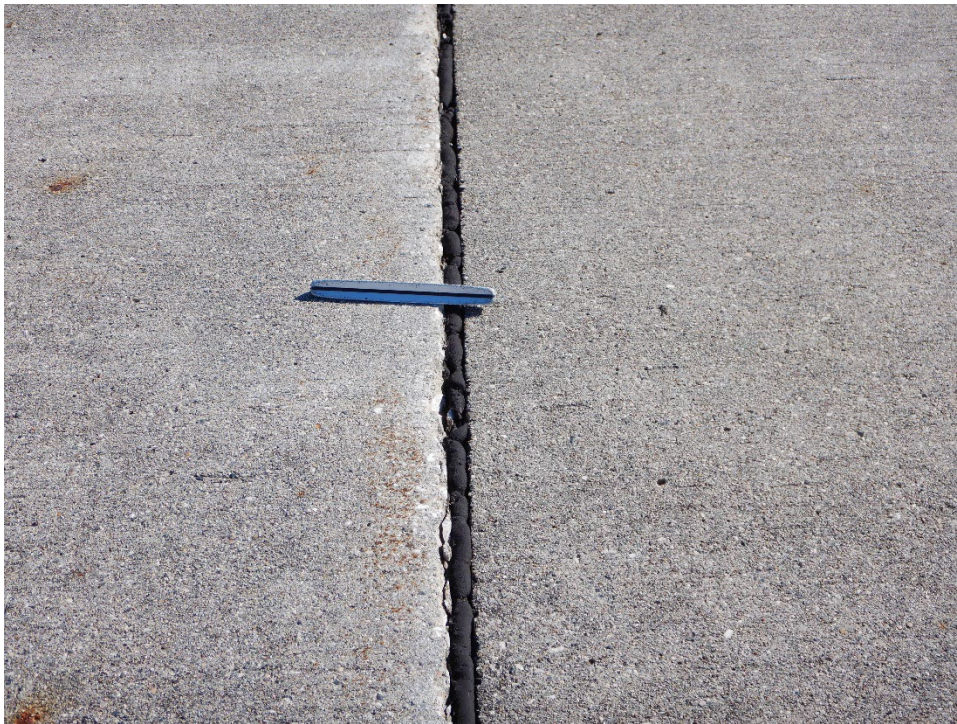
R14SC-01. Faulting (Sample Unit No. 25).

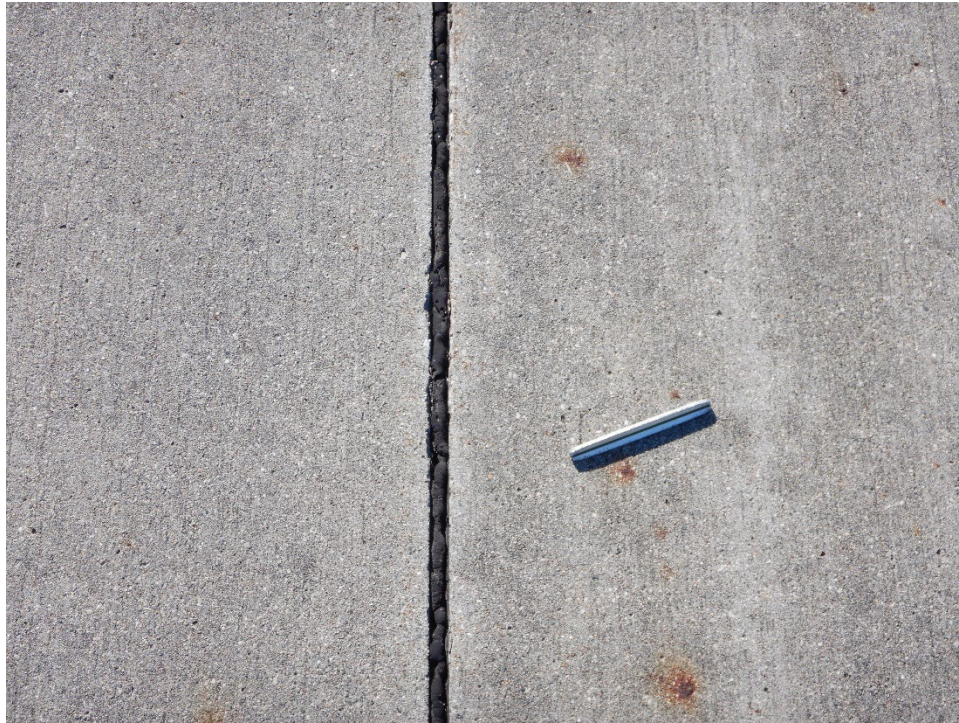
R14SC-01. Joint Seal Damage (Sample Unit No. 07).

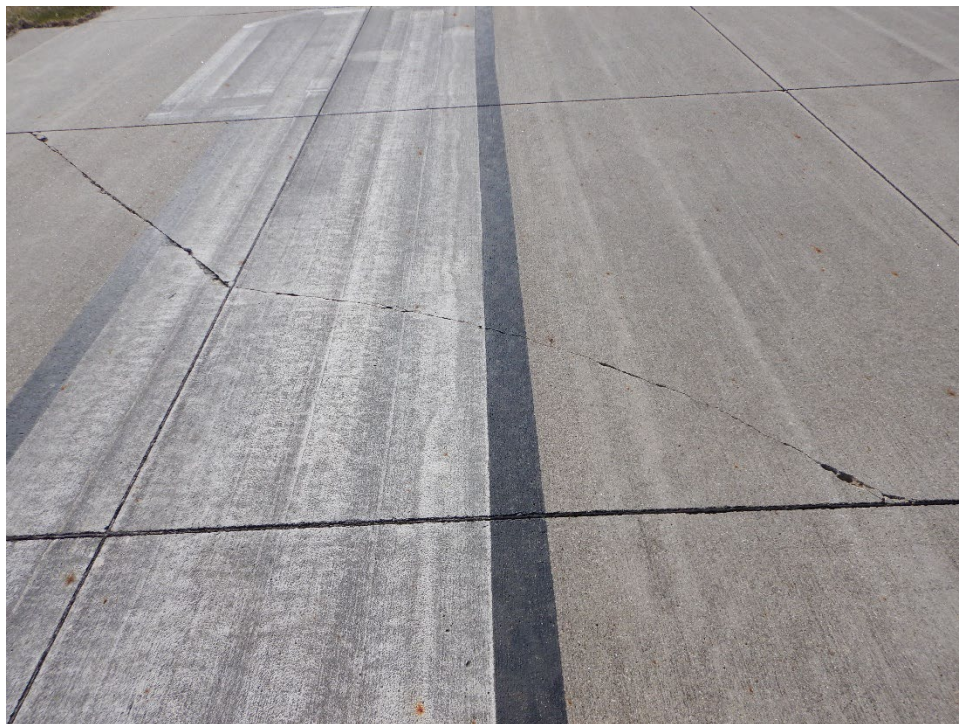
R14SC-01. LTD Cracking (Sample Unit No. 02).

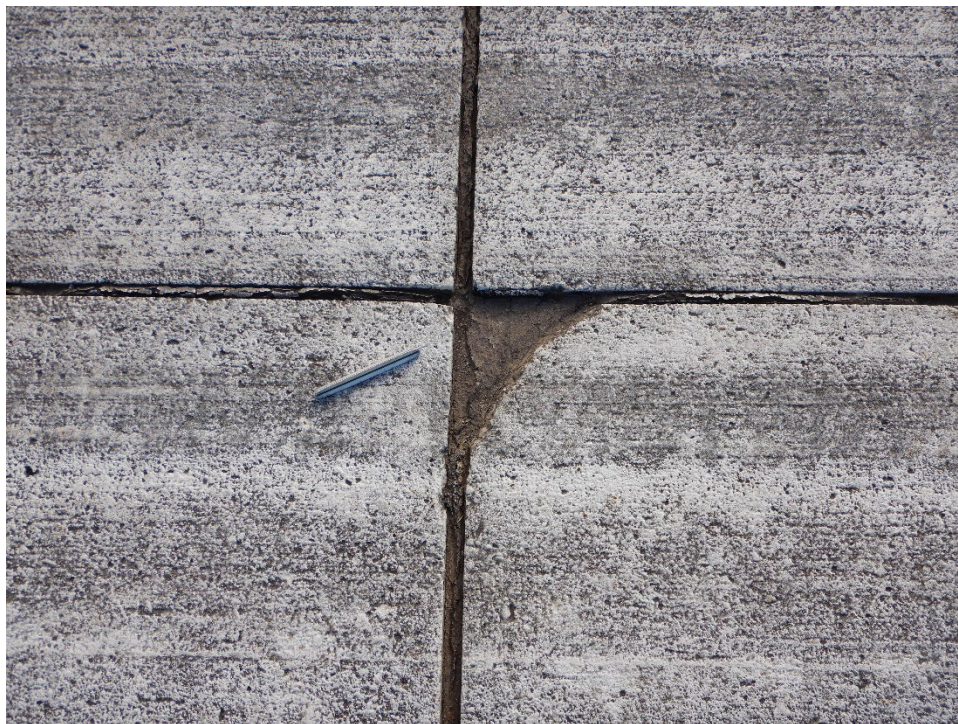
R18SC-01. Corner Spalling (Sample Unit No. 02).

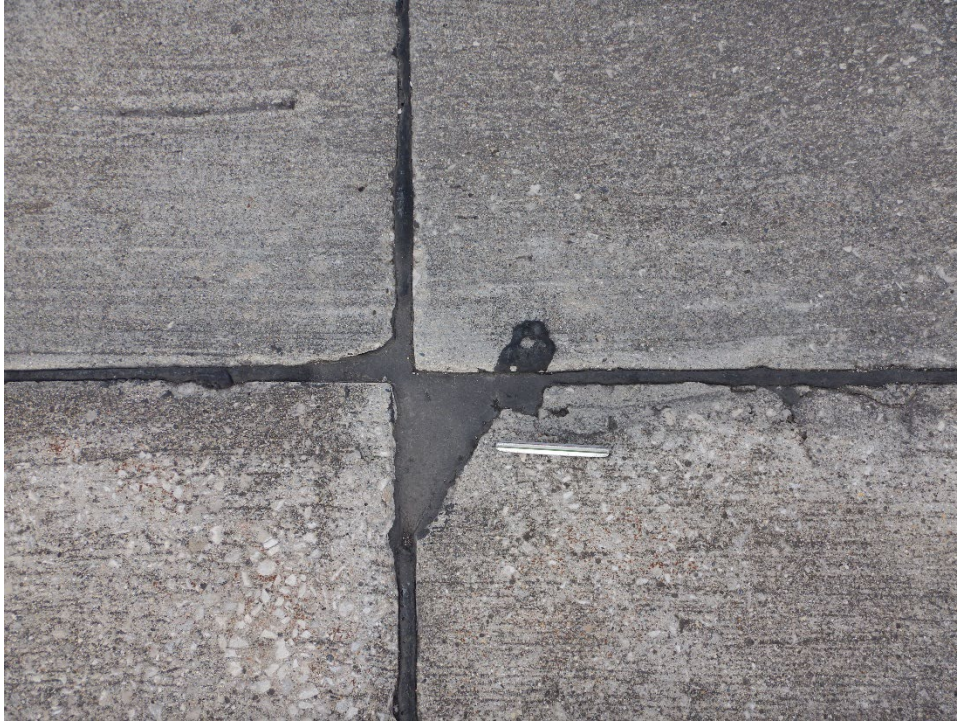
R18SC-01. Corner Spalling (Sample Unit No. 42).

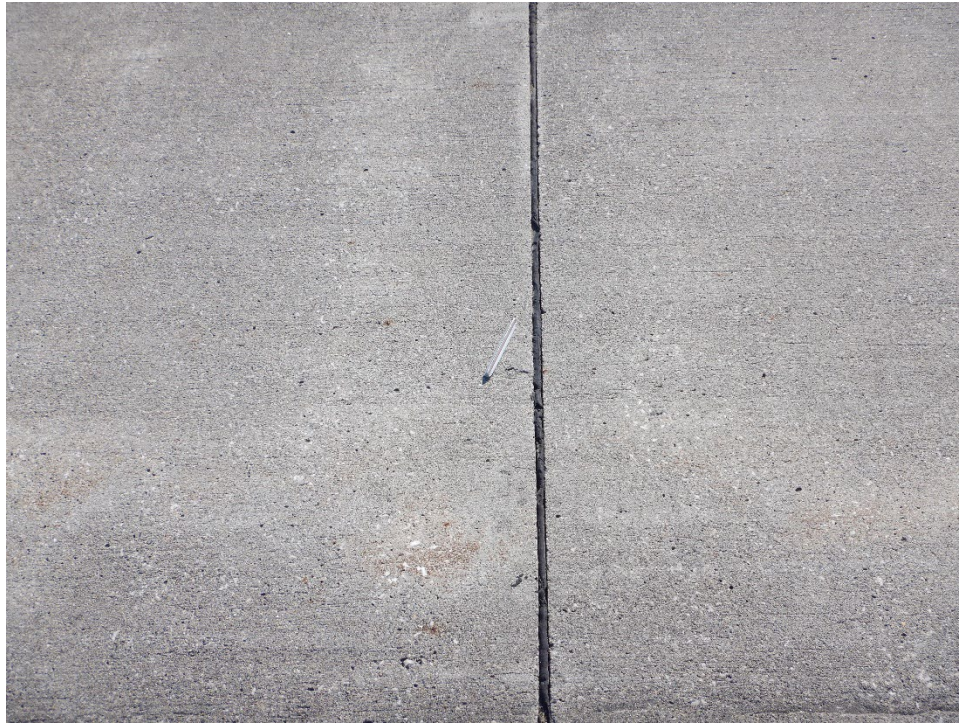
R18SC-02. Joint Seal Damage (Sample Unit No. 02).

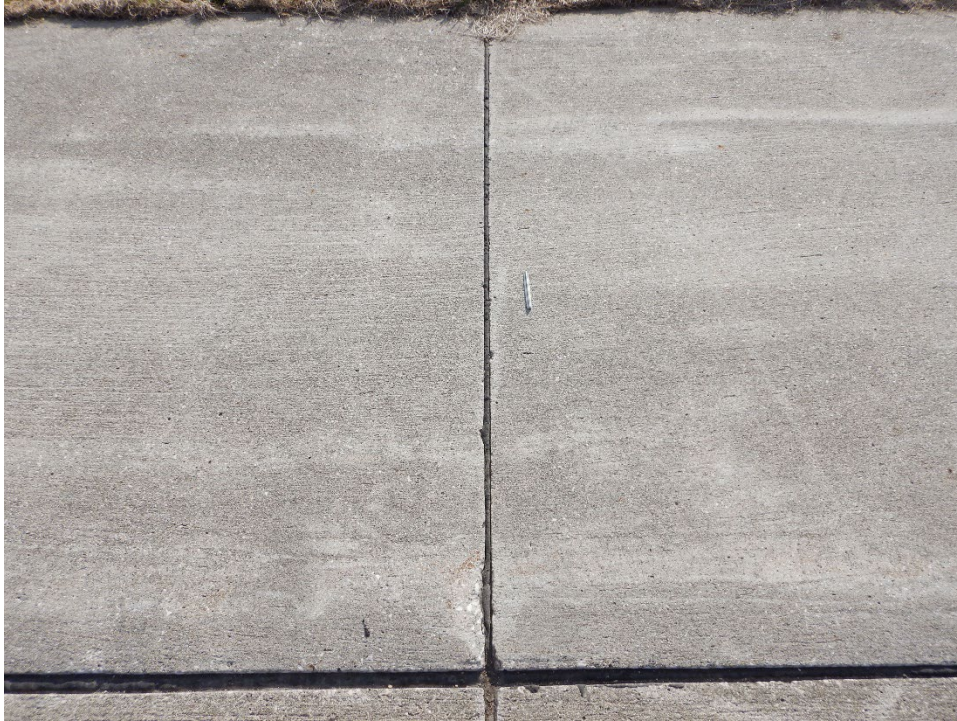
R18SC-03. Joint Seal Damage (Sample Unit No. 01).

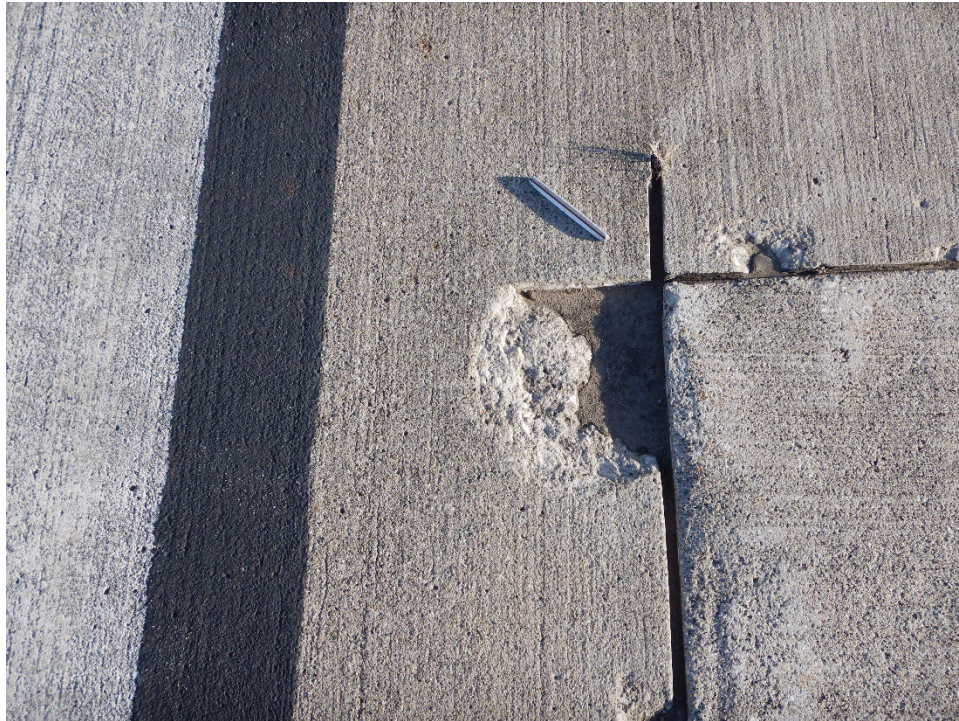
R18SC-04. Corner Spalling (Sample Unit No. 08).

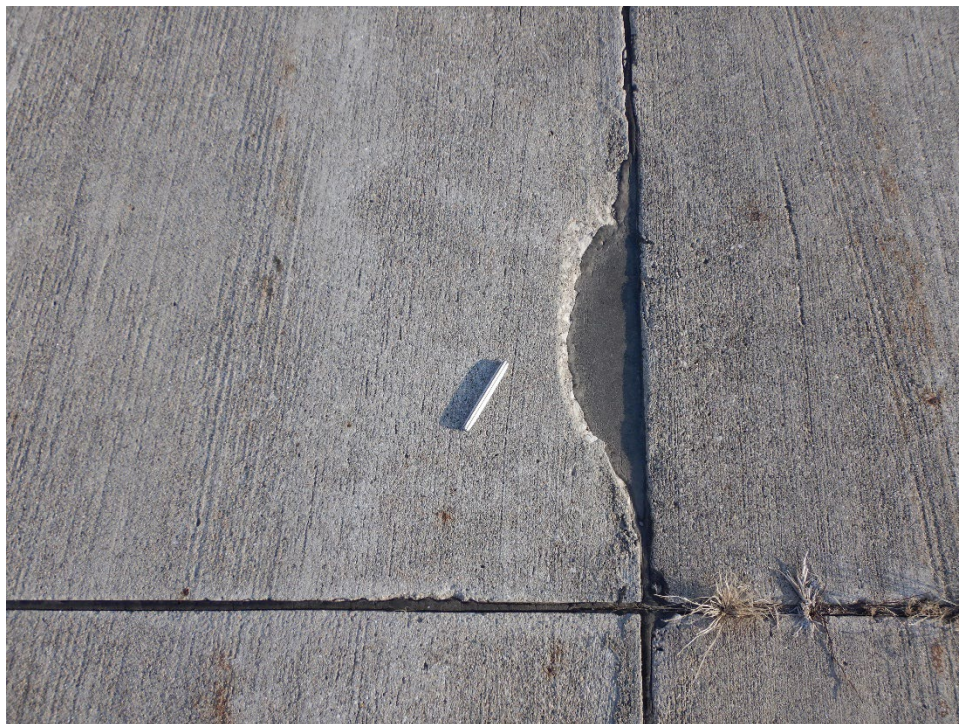
R18SC-04. Joint Spalling (Sample Unit No. 08).

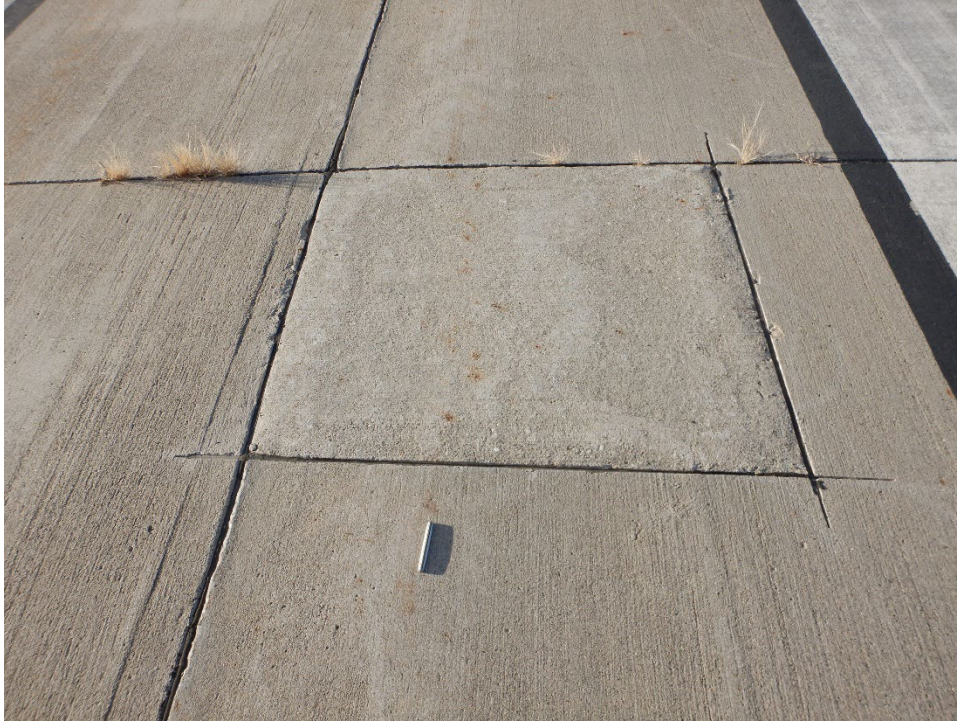
R18SC-04. Large Patching (Sample Unit No. 09).

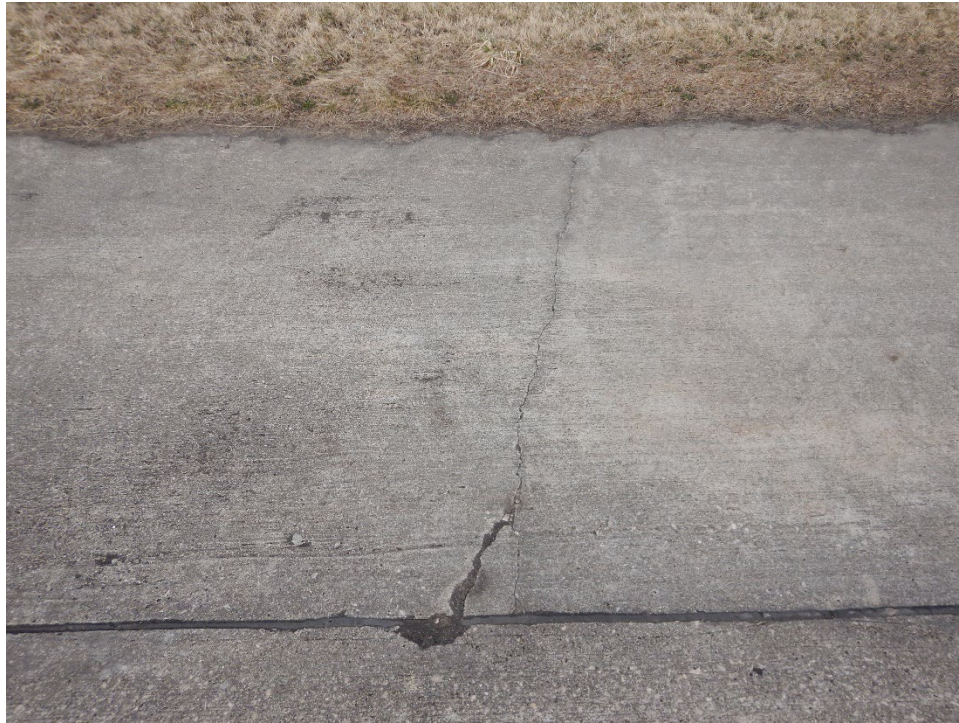
R18SC-05. LTD Cracking (Sample Unit No. 05).

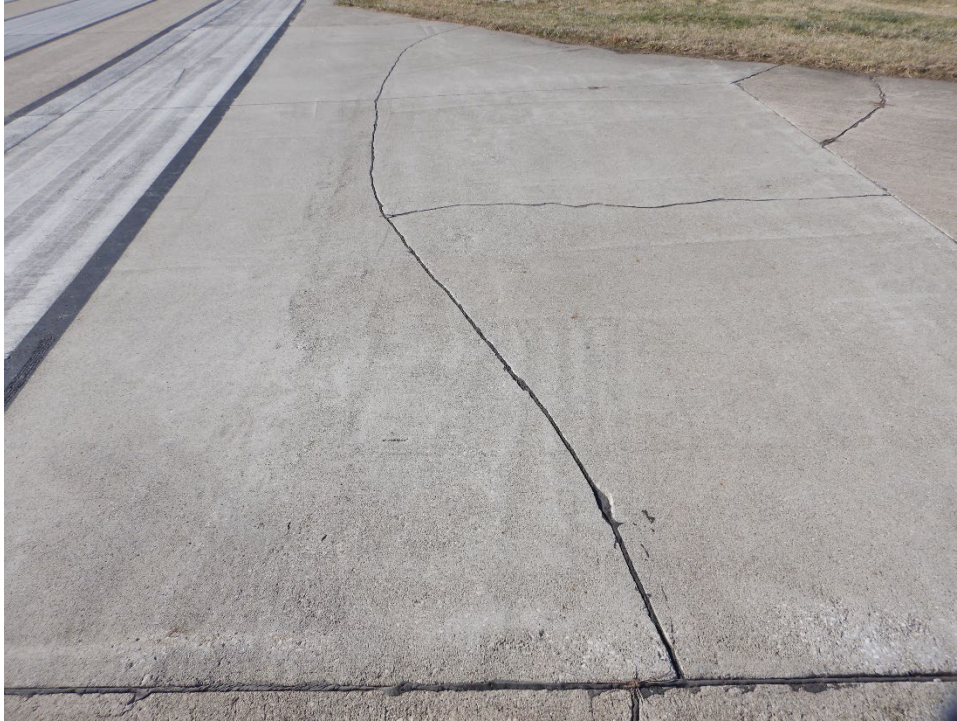
R18SC-06. LTD Cracking (Sample Unit No. 01).

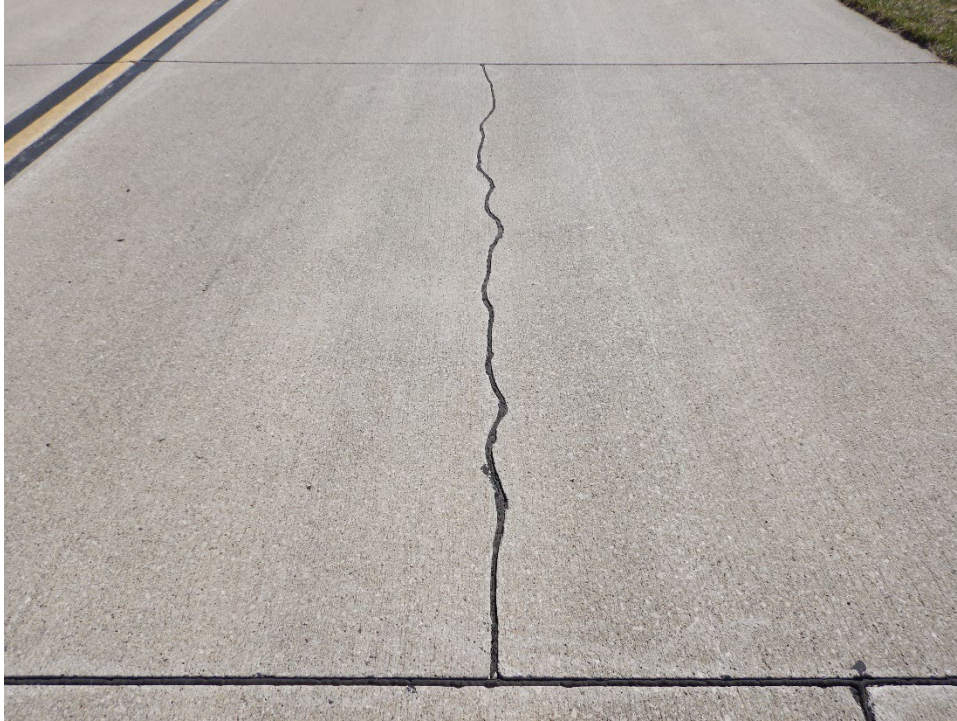
T01SC-01. LTD Cracking (Sample Unit No. 02).

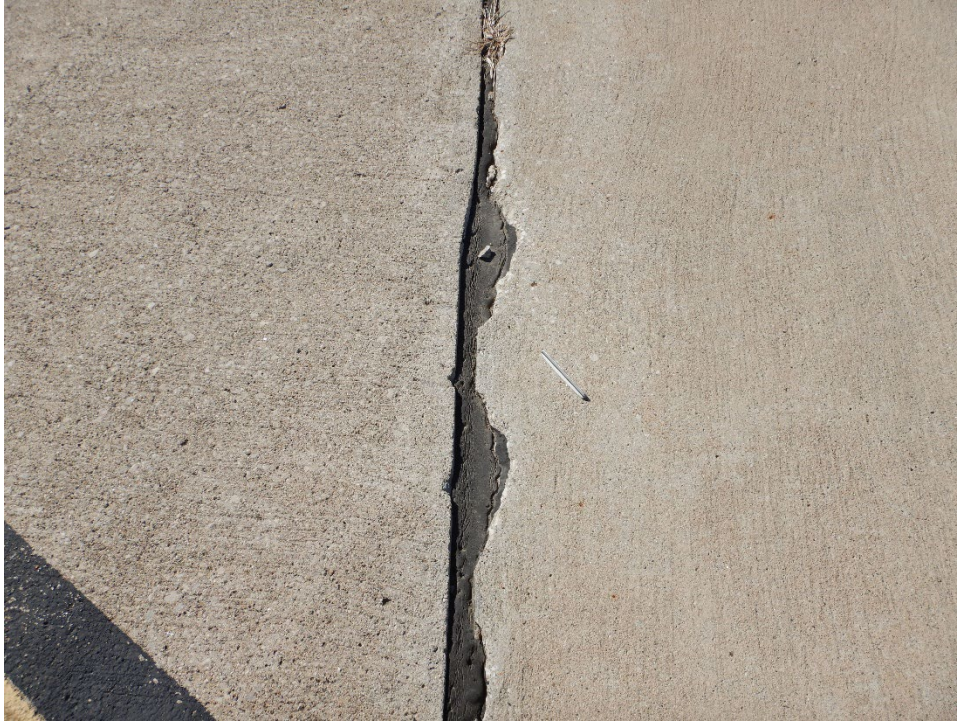
T01SC-02. Joint Spalling (Sample Unit No. 02).

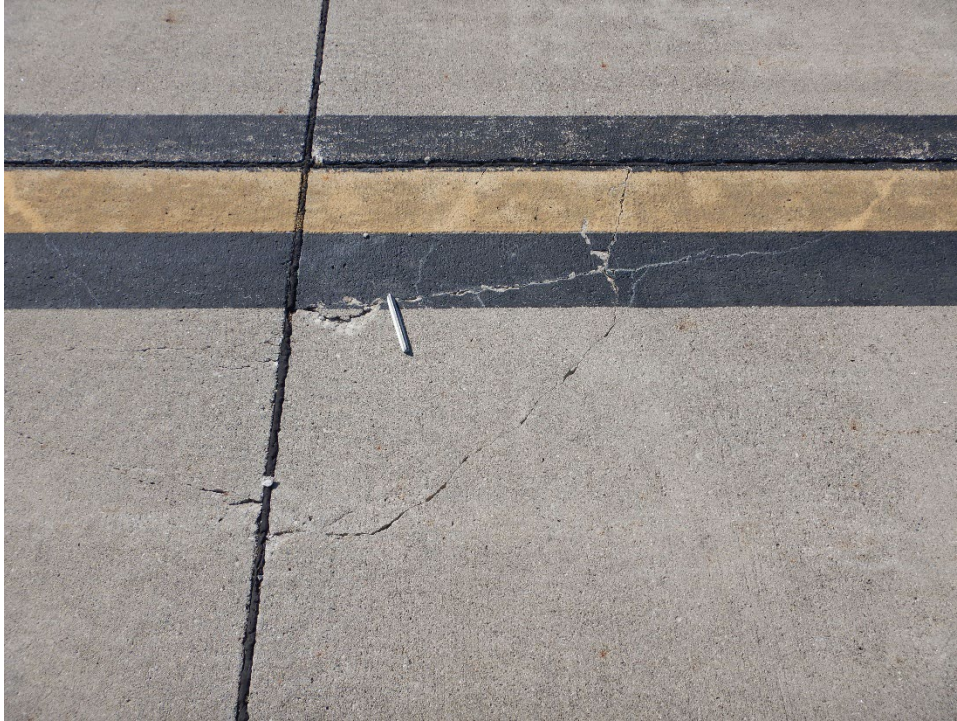
T02SC-01. Corner Break (Sample Unit No. 02).

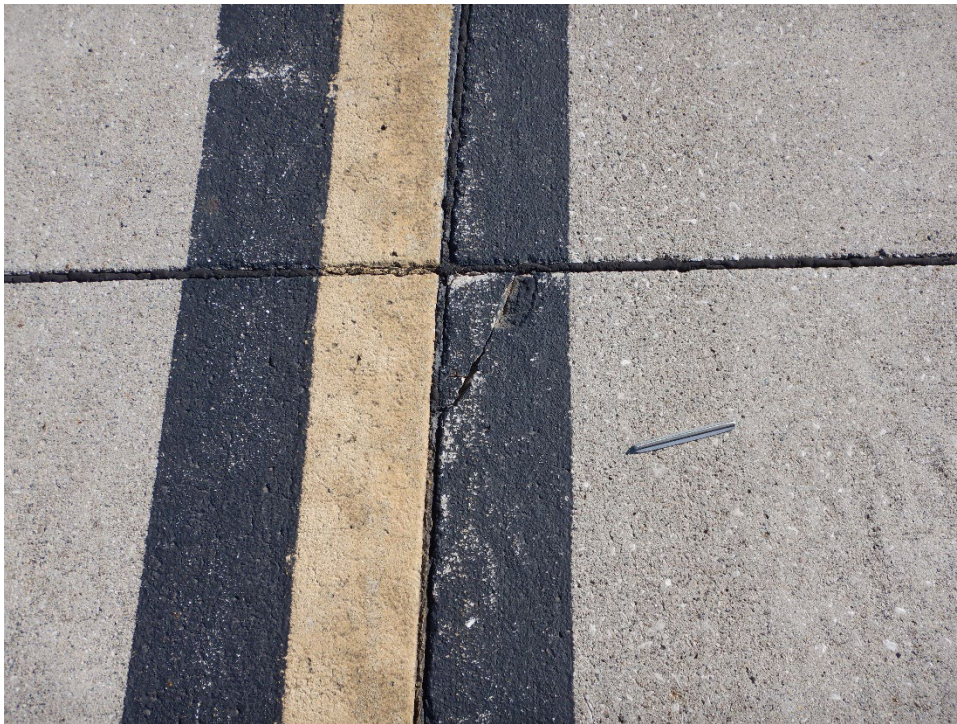
T02SC-01. Corner Spalling (Sample Unit No. 02).

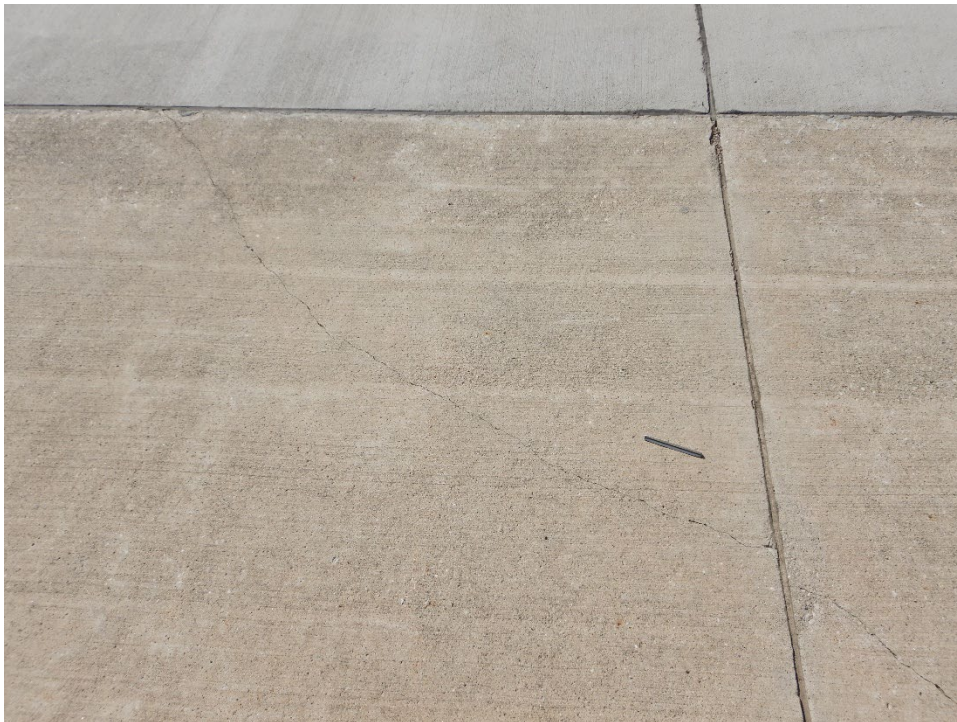
TH01SC-01. Corner Break (Sample Unit No. 02).

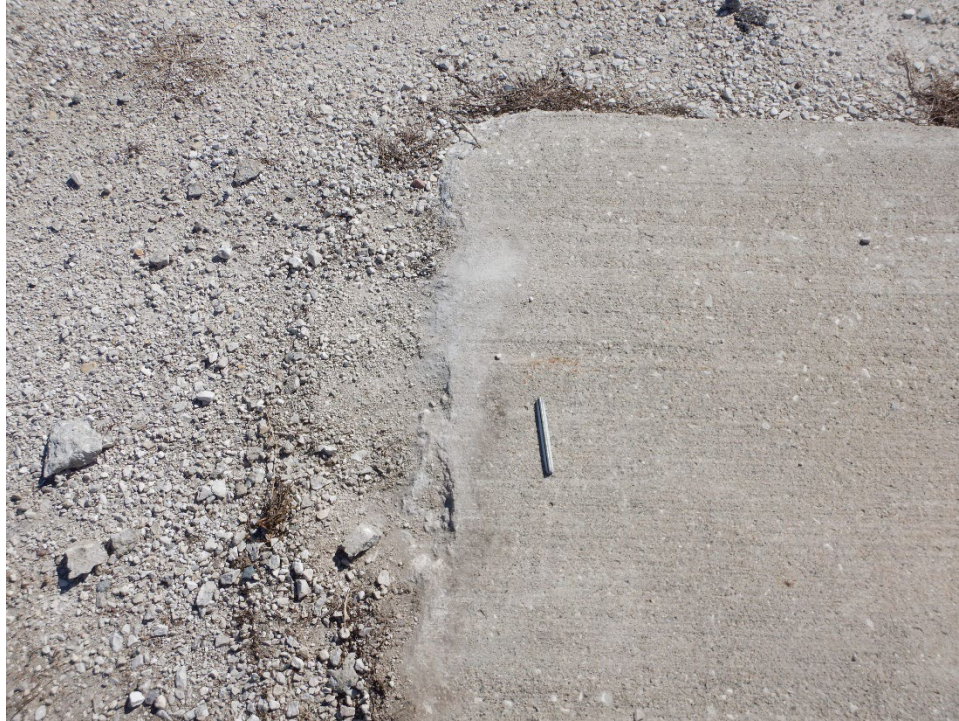
TH01SC-01. Joint Spalling (Sample Unit No. 06).

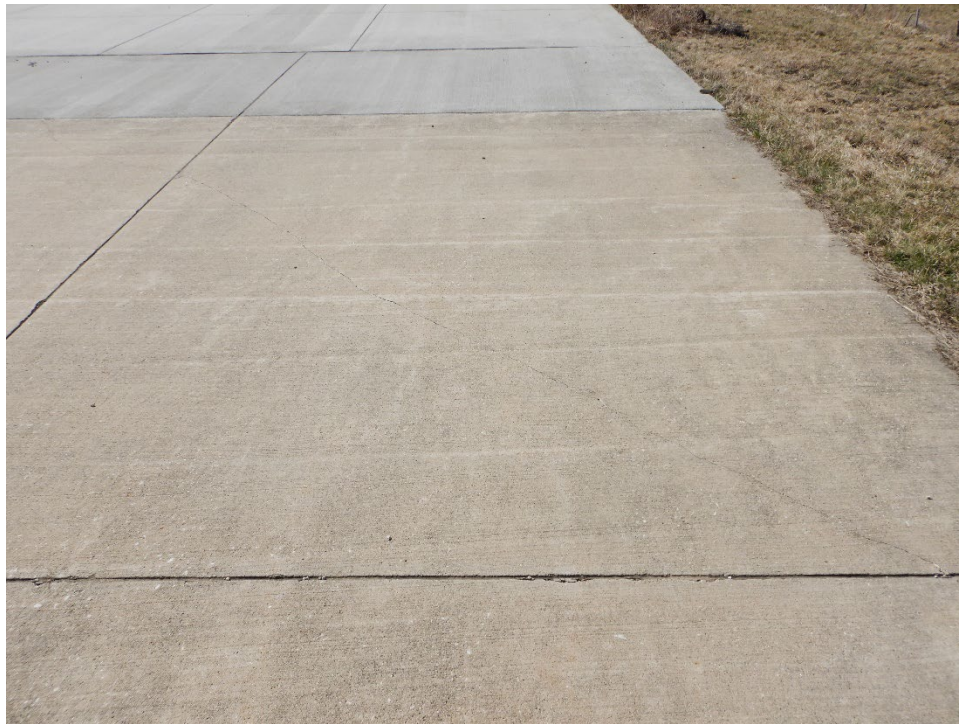
TH01SC-01. LTD Cracking (Sample Unit No. 02).
