Sheldon Regional Airport

Pavement Management Report

JULY 2023

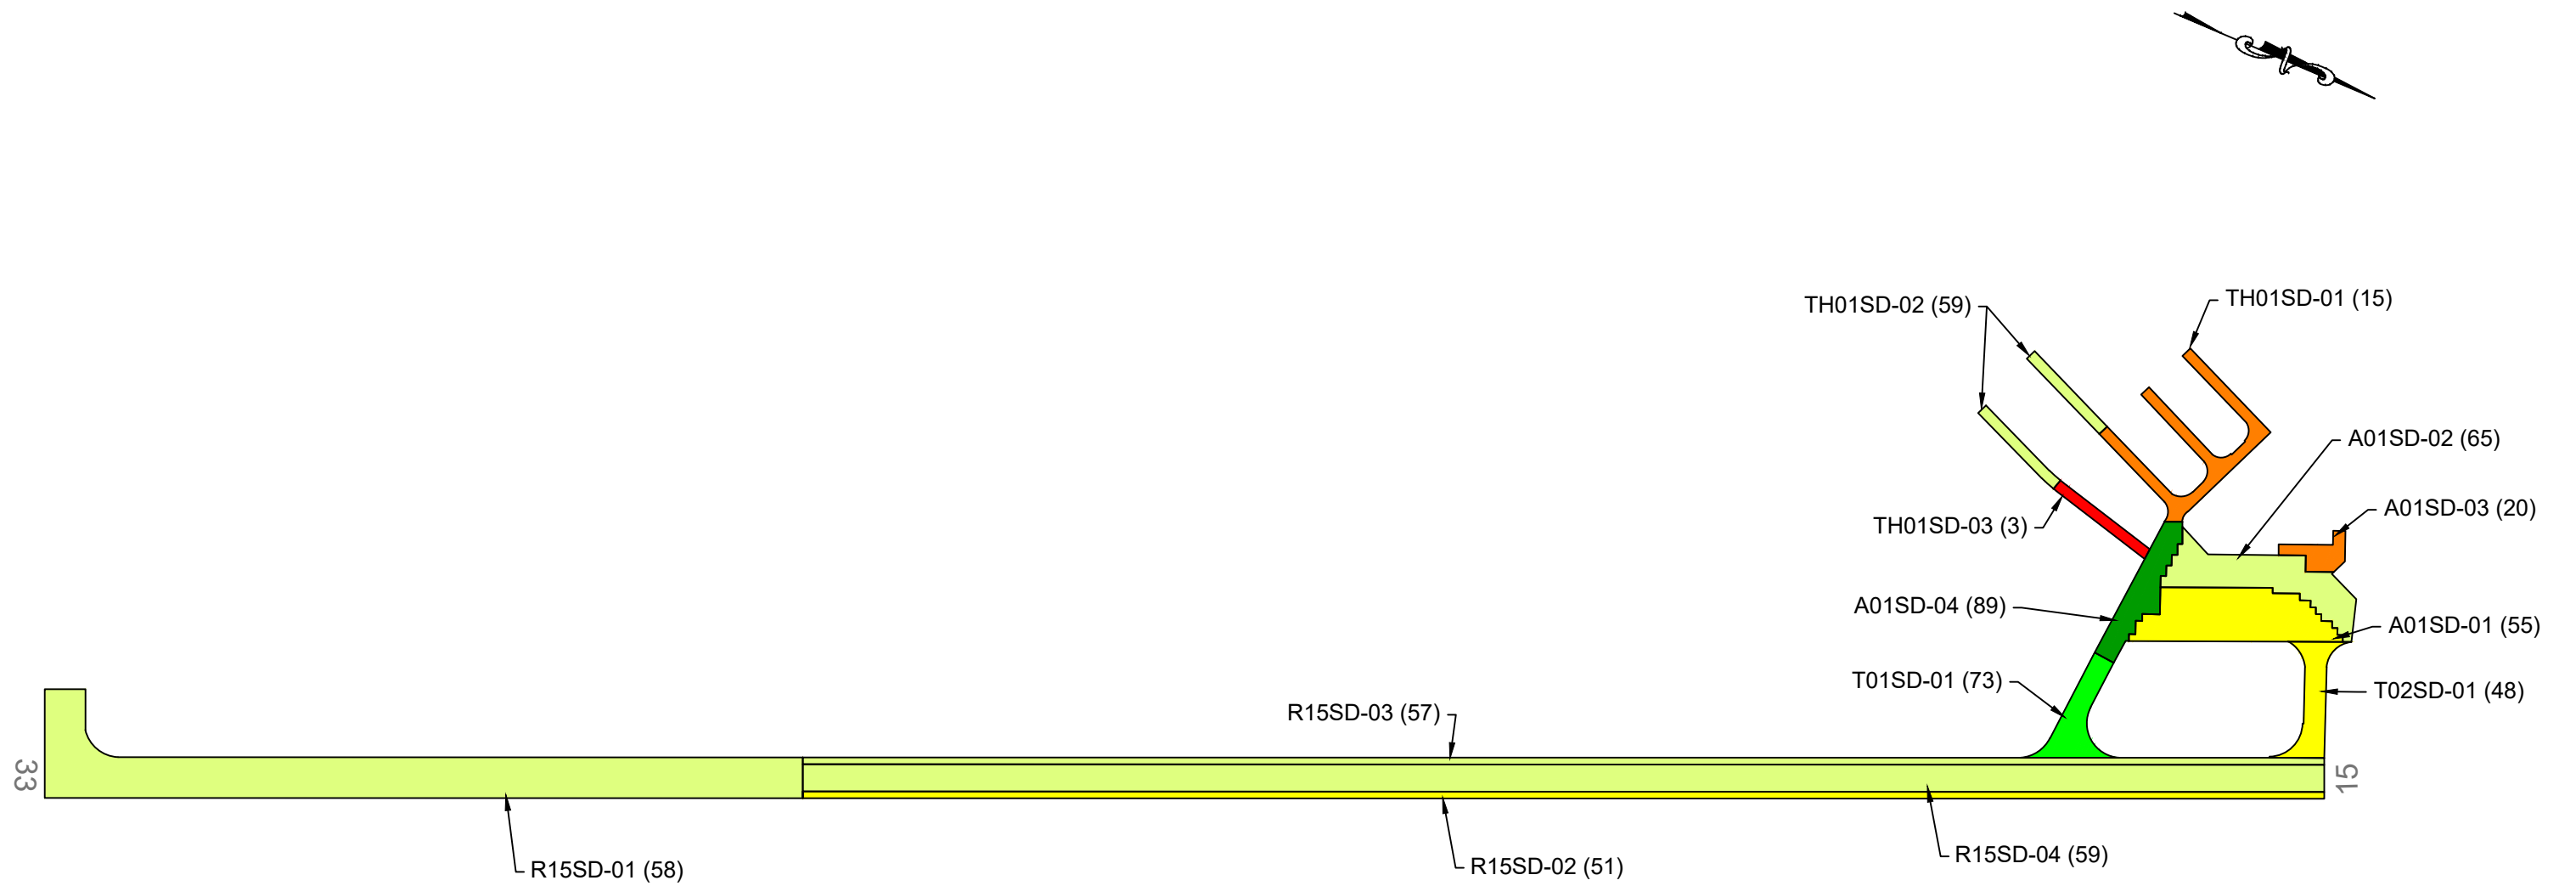
FIGURE 8. PCI MAP.

The pavements at Sheldon Regional Airport were inspected in November 2022. The 2022 area-weighted condition of Sheldon Regional Airport is 56, with conditions ranging from 3 to 89 (on a scale of 0 [failed] to 100 [excellent]). During the previous pavement inspection in 2019, the area-weighted PCI of the airport was 92.

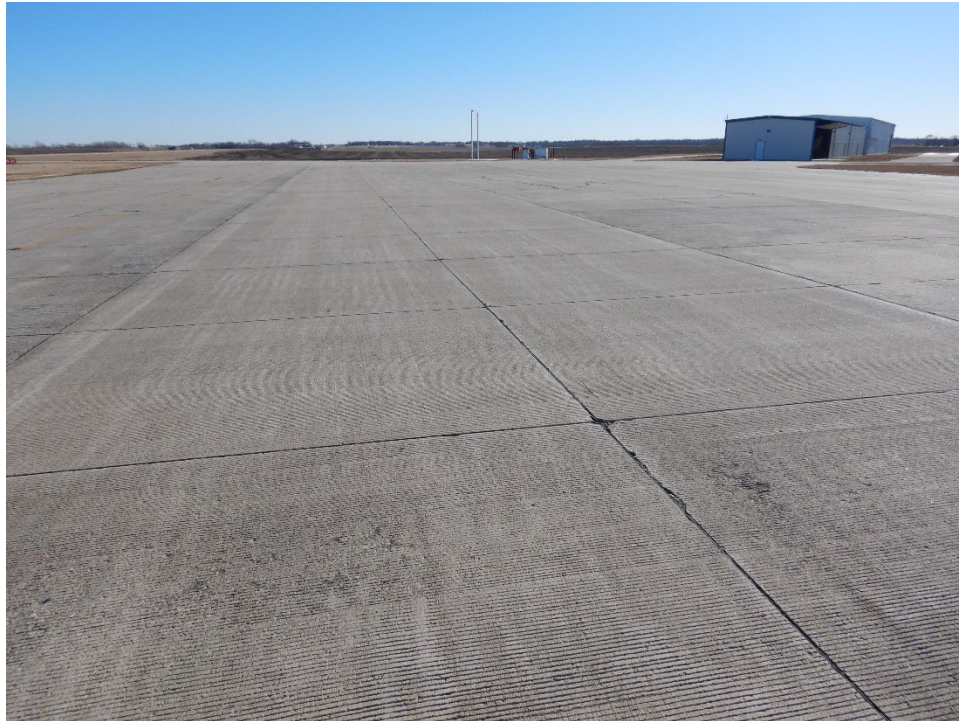
A01SD-01. Overview.

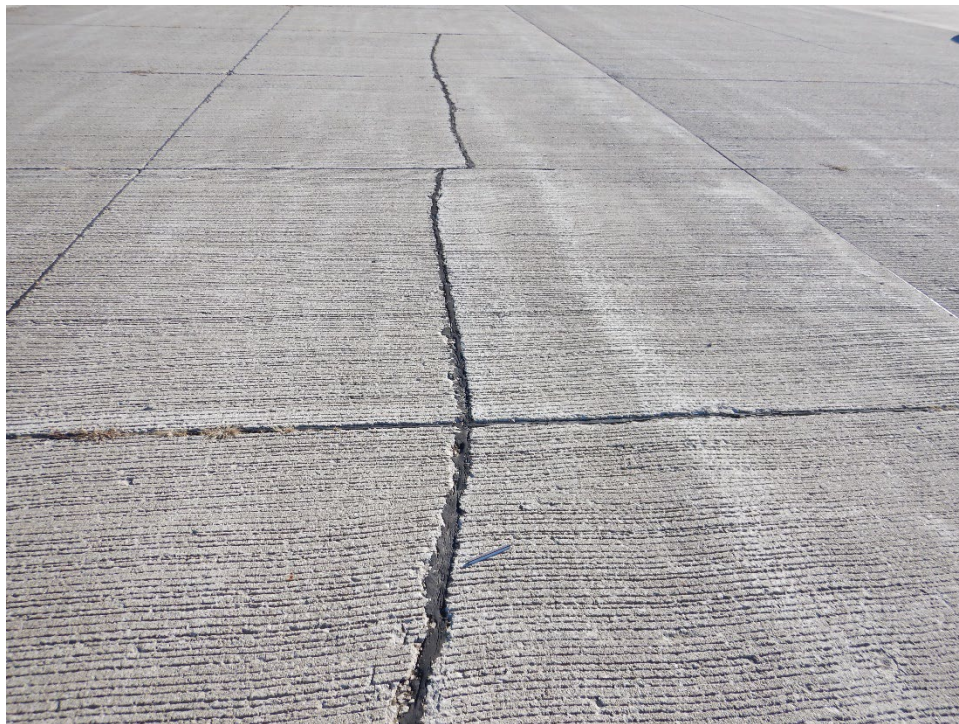
A01SD-01. LTD Cracking (Sample Unit No. 07).

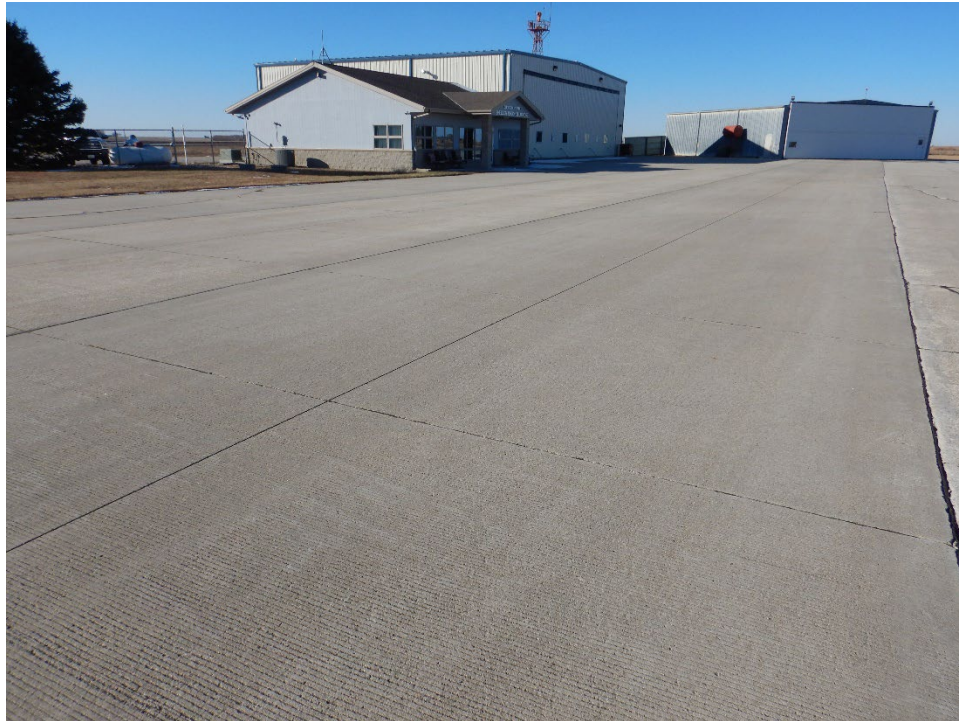
A01SD-02. Overview.

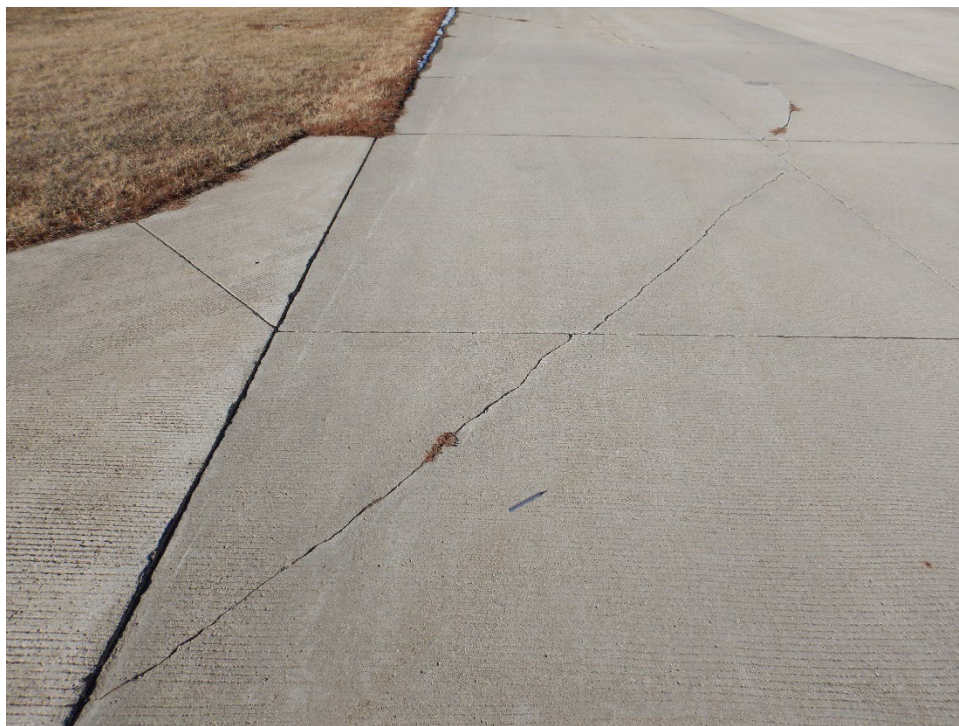
A01SD-02. Corner Break (Sample Unit No. 03).

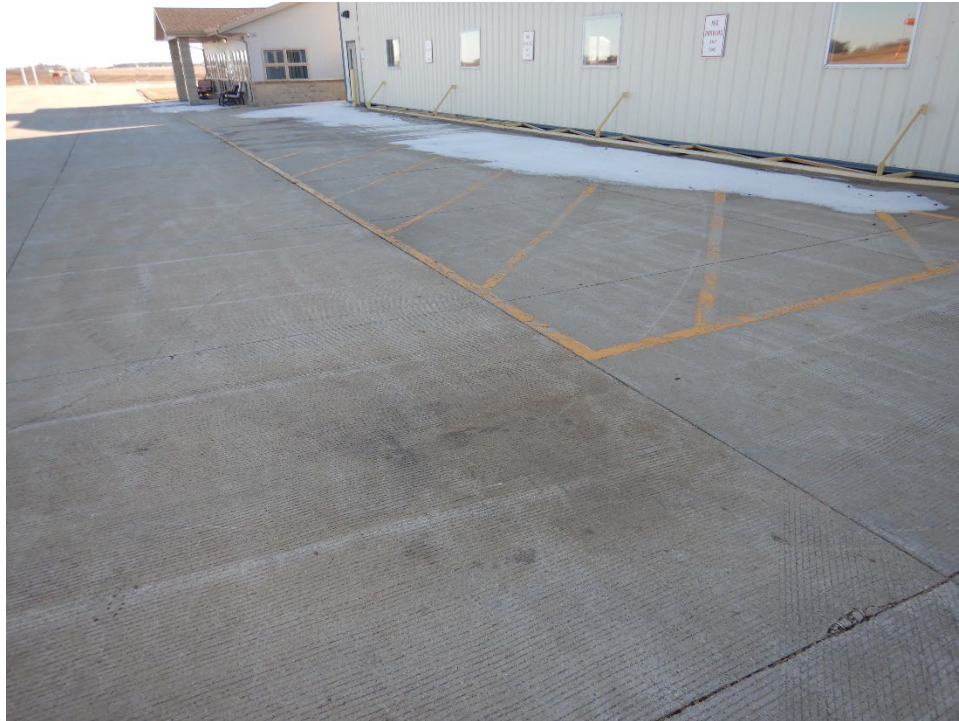
A01SD-03. Overview.

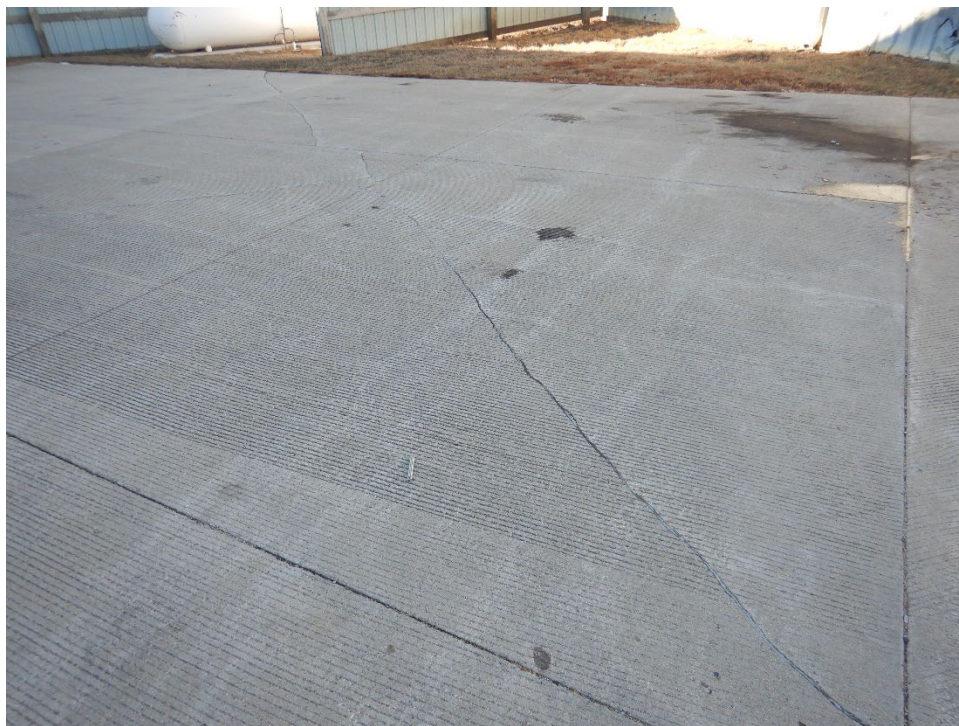
A01SD-03. LTD Cracking (Sample Unit No. 02).

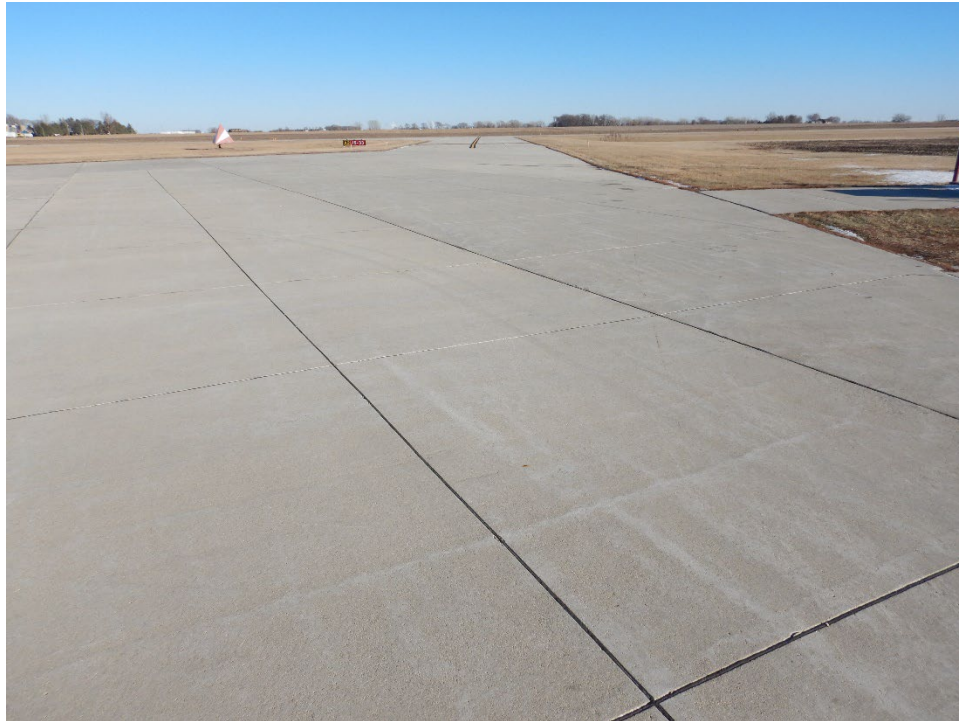
A01SD-04. Overview.

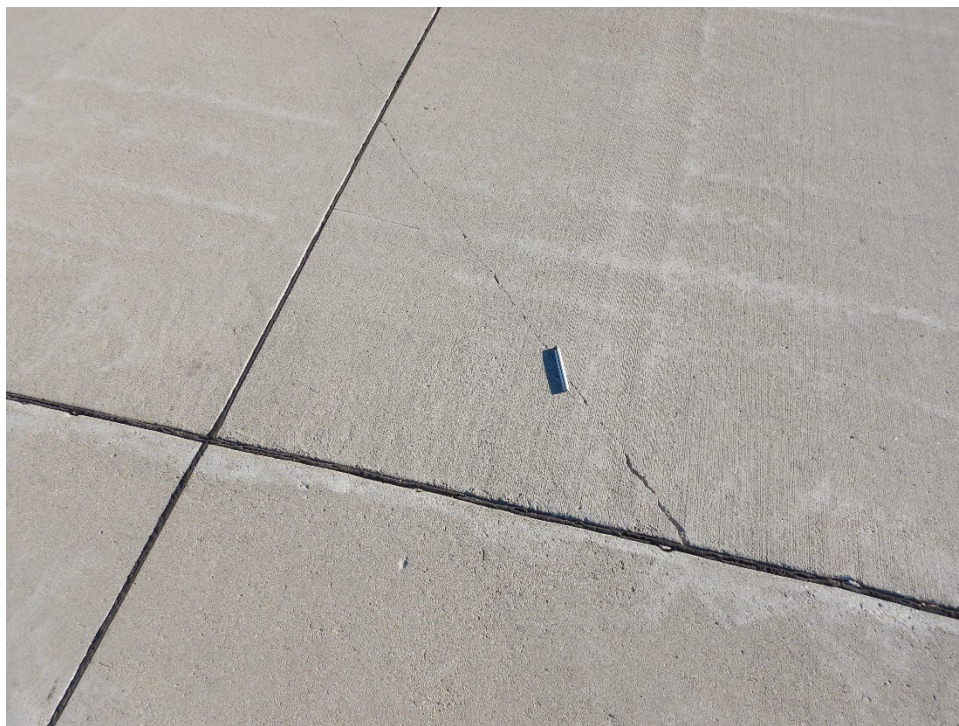
A01SD-04. Corner Break (Sample Unit No. 02).

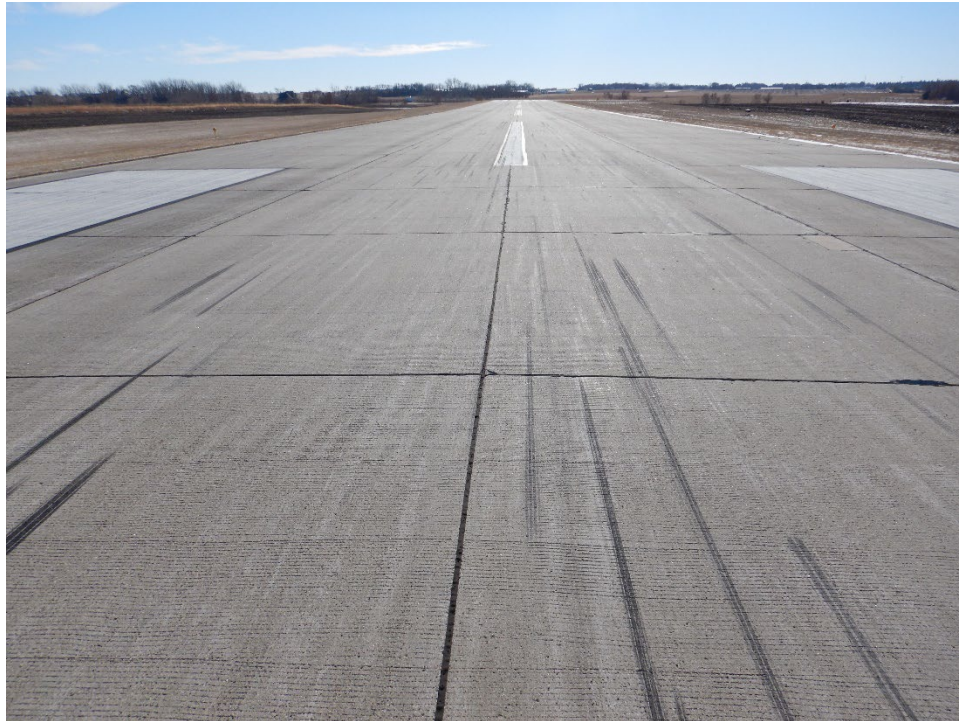
Runway 15/33 was defined by four sections. Section 01 contained areas of low- and medium-severity small patching; joint seal damage; corner break; and longitudinal, transverse, and diagonal (LTD) cracking. It also had areas of all severities of corner spalling and joint spalling as well as low-severity large patching. Areas of medium-severity LTD cracking and corner break, all severities of corner spalling and joint spalling, low- and medium-severity faulting, high-severity joint seal damage, and low-severity large patching and small patching were observed in Section 02. Areas of low- and medium-severity LTD cracking, corner spalling, and faulting; medium- and high-severity joint seal damage; low-severity small patching; and medium-severity joint spalling were recorded in Section 03. Medium- and high-severity corner break; all severities of LTD cracking, corner spalling, and joint spalling; low-severity faulting and durability cracking; low- and medium-severity small patching, joint seal damage, and large patching; medium-severity shattered slab; and shrinkage cracking were identified in Section 04. An atypical area of medium- and high-severity durability cracking was observed and recorded as an additional sample unit in accordance with ASTM D5340-20.

R15SD-01. Overview.

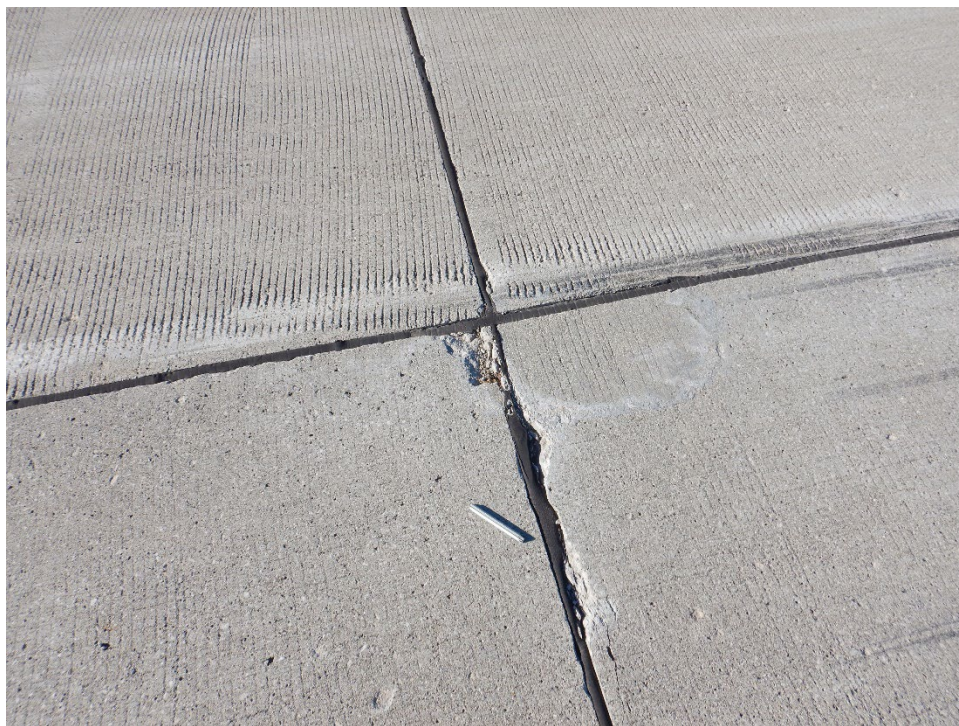
R15SD-01. Corner Spalling (Sample Unit No. 16).

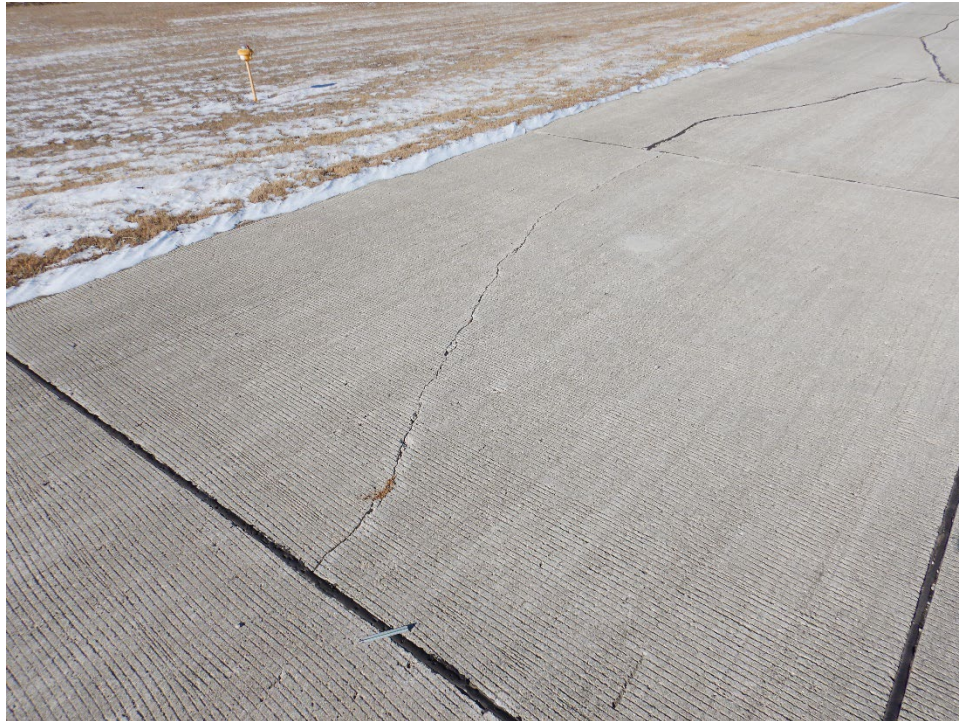
R15SD-01. LTD Cracking (Sample Unit No. 10).

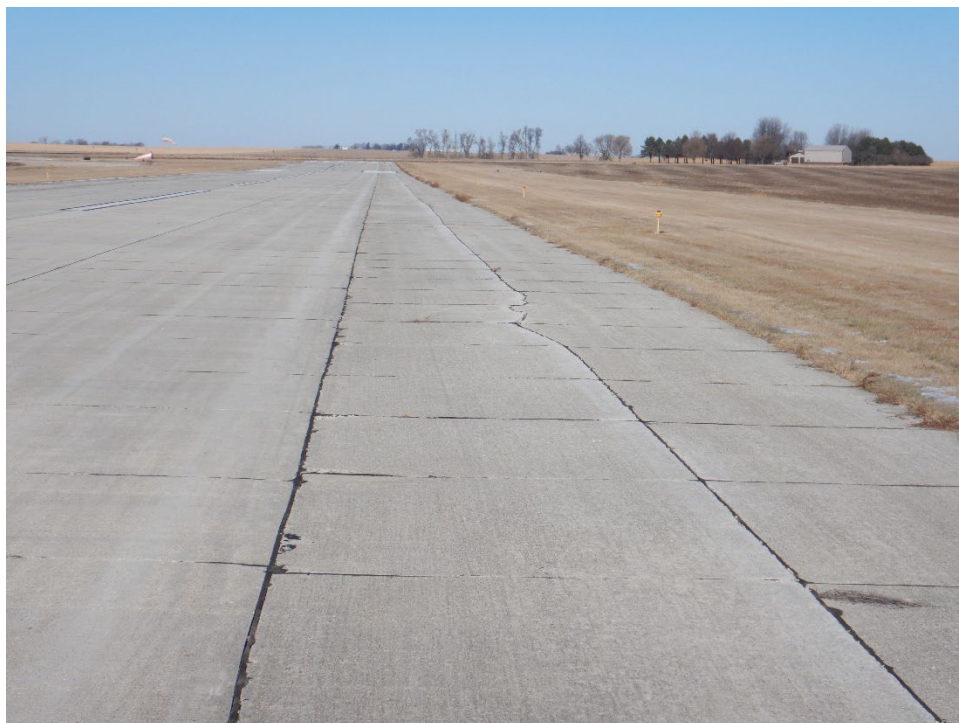
R15SD-02. Overview.

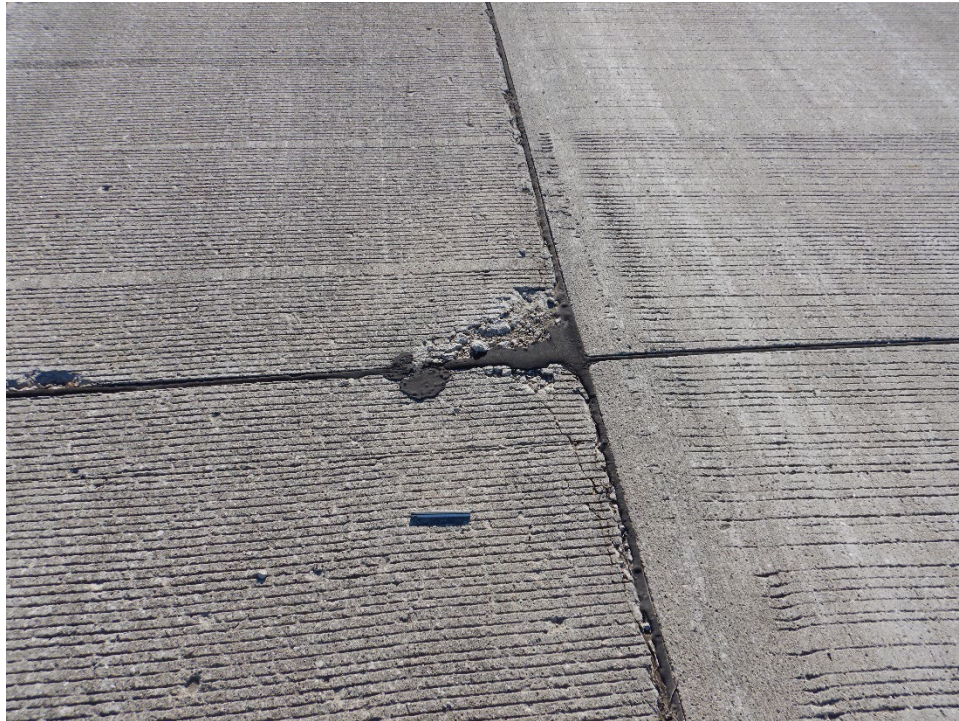
R15SD-02. Corner Spalling (Sample Unit No. 04).

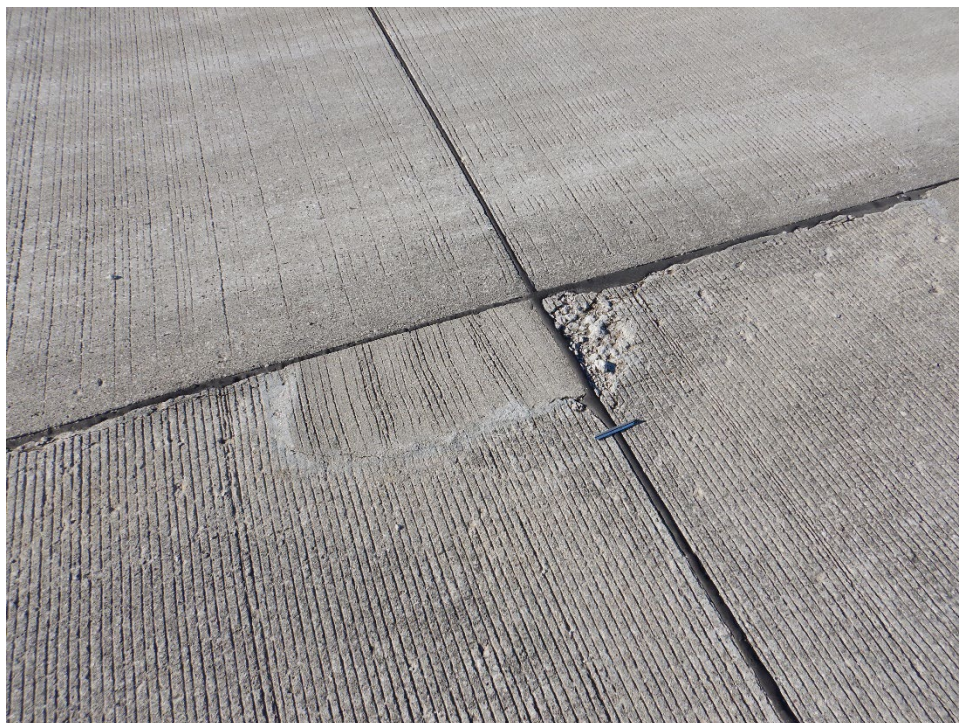
R15SD-02. Small Patching (Sample Unit No. 04).

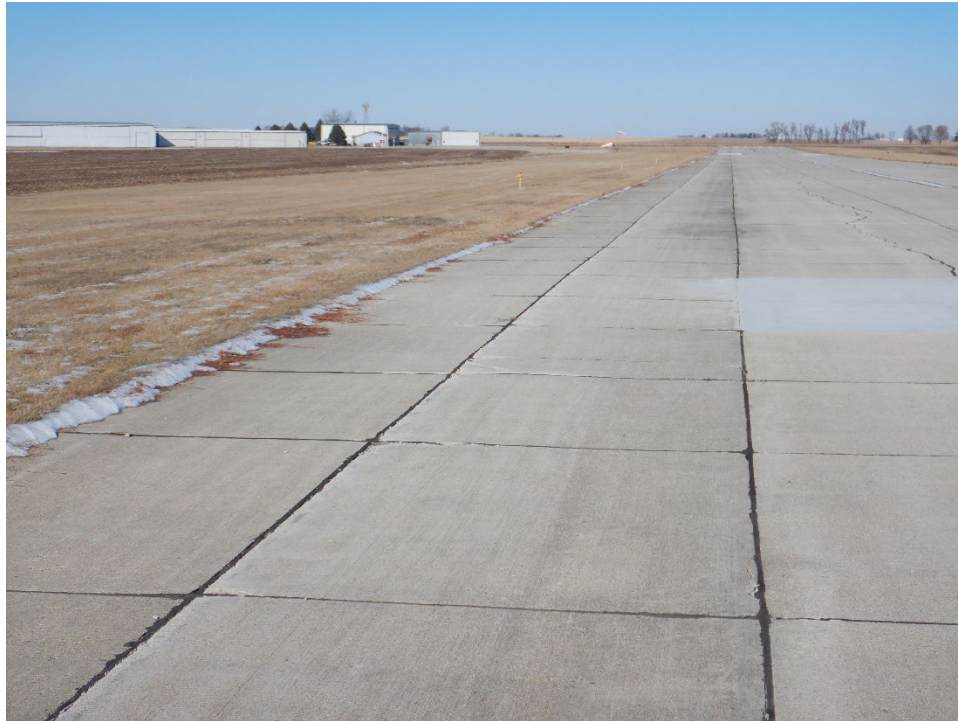
R15SD-03. Overview.

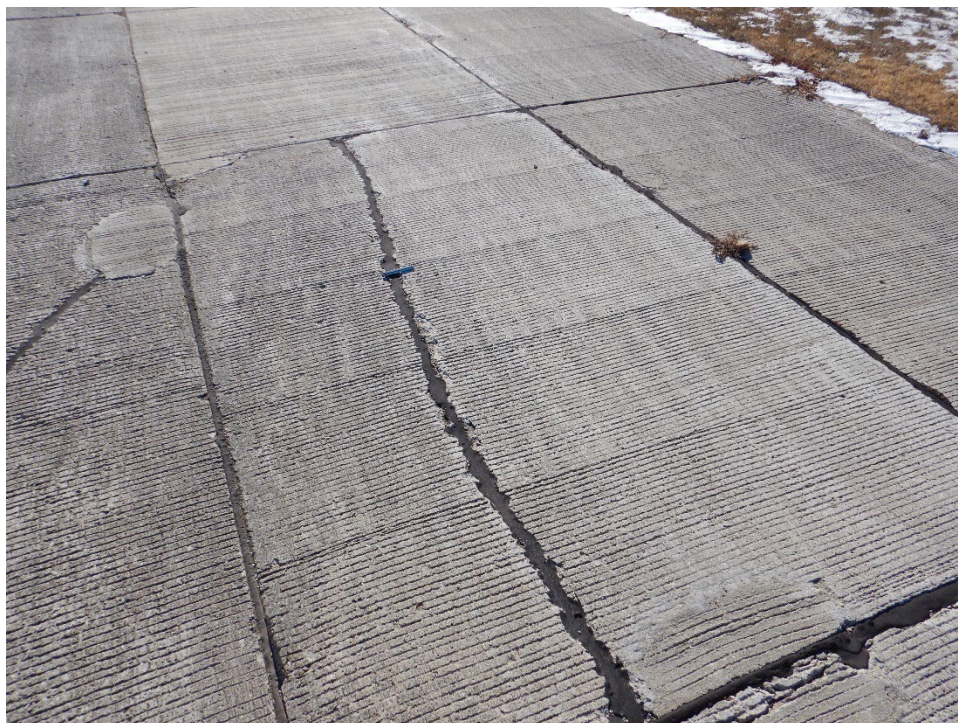
R15SD-03. LTD Cracking (Sample Unit No. 04).

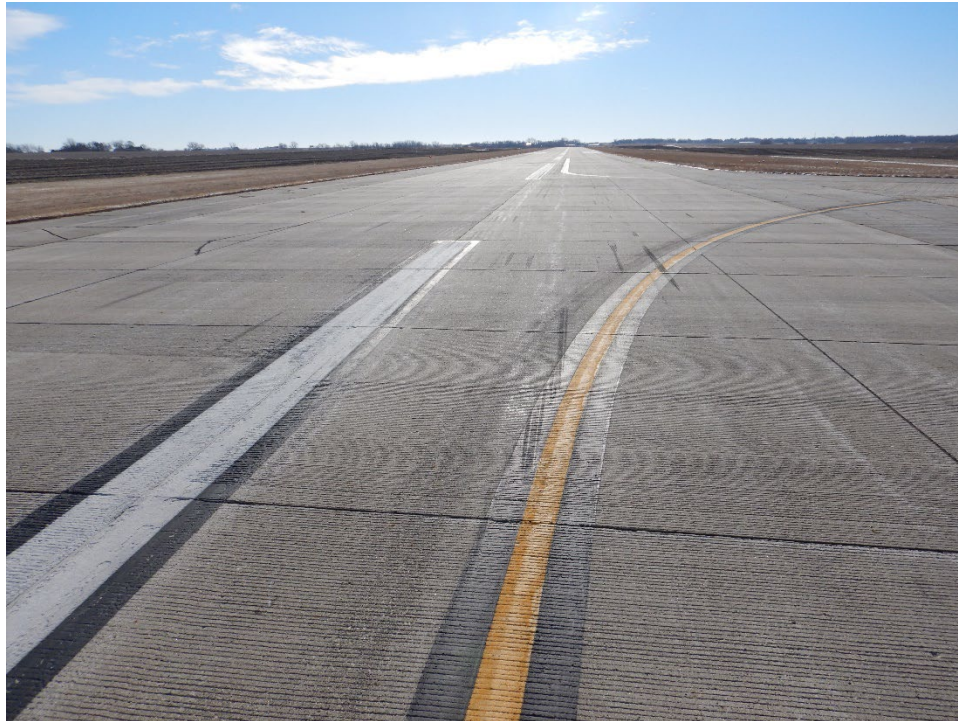
R15SD-04. Overview.

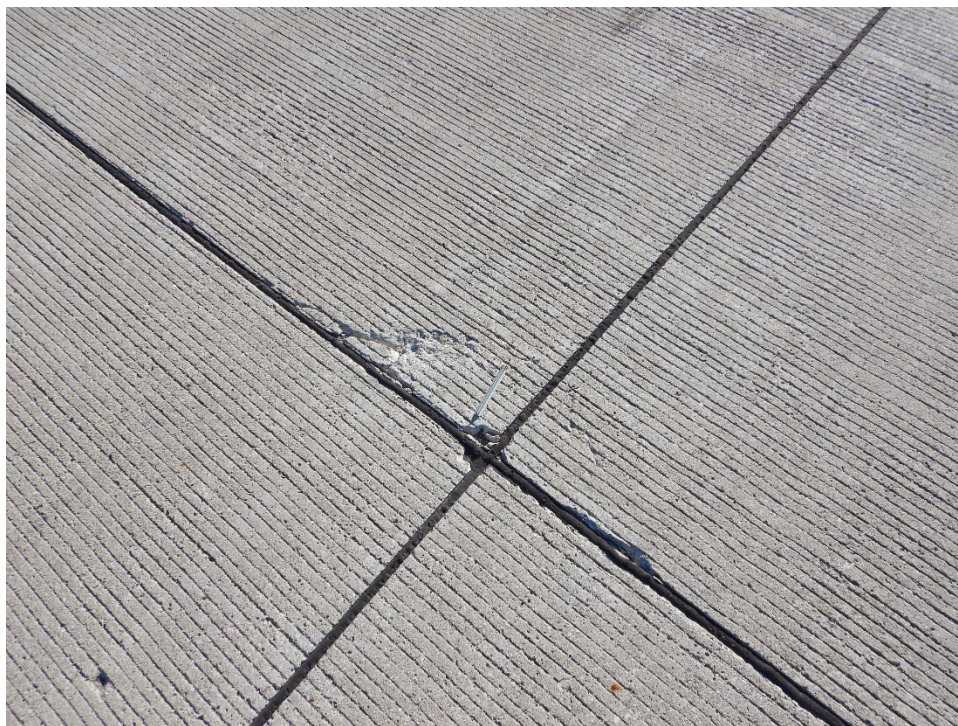
R15SD-04. Corner Spalling (Sample Unit No. 36).

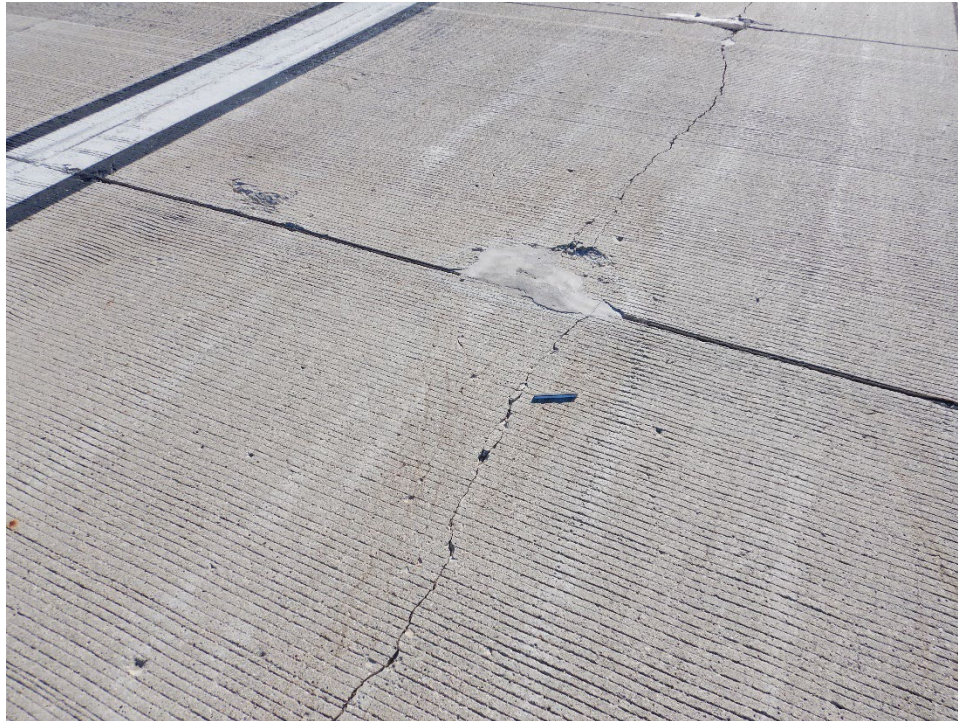
R15SD-04. Durability Cracking (Additional Sample Unit No. 06) (1).

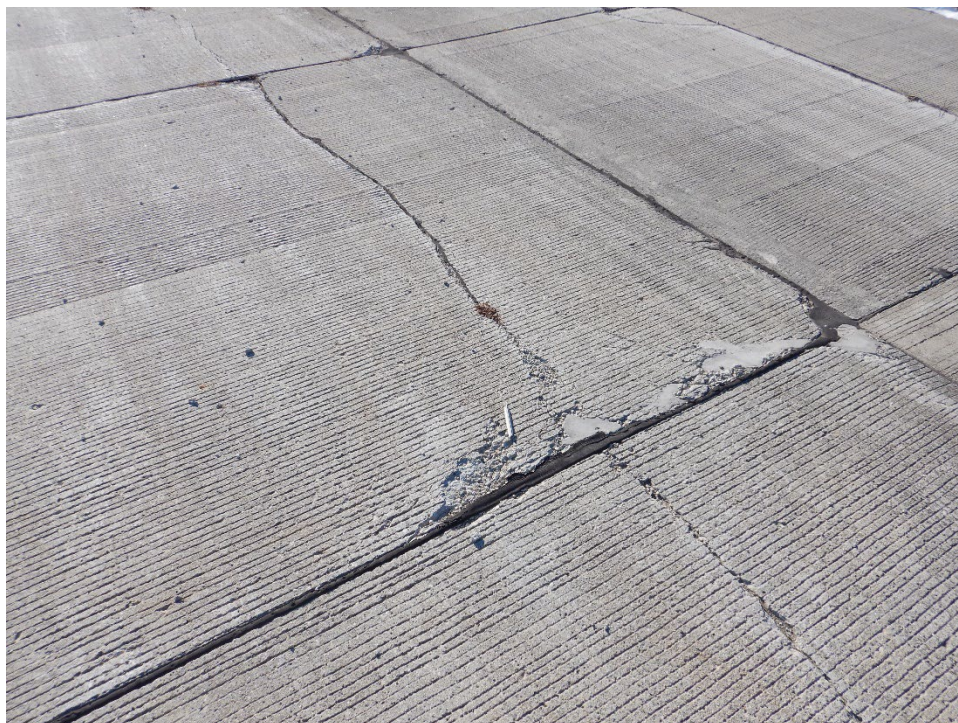
R15SD-04. Durability Cracking (Additional Sample Unit No. 06) (2).

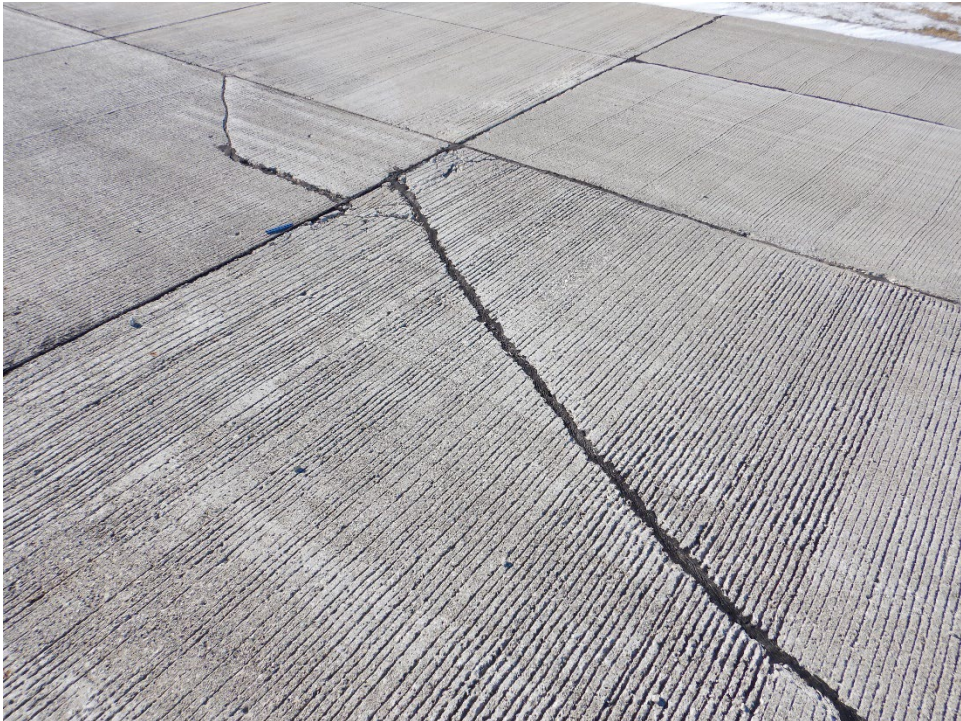
R15SD-04. LTD Cracking (Sample Unit No. 21).

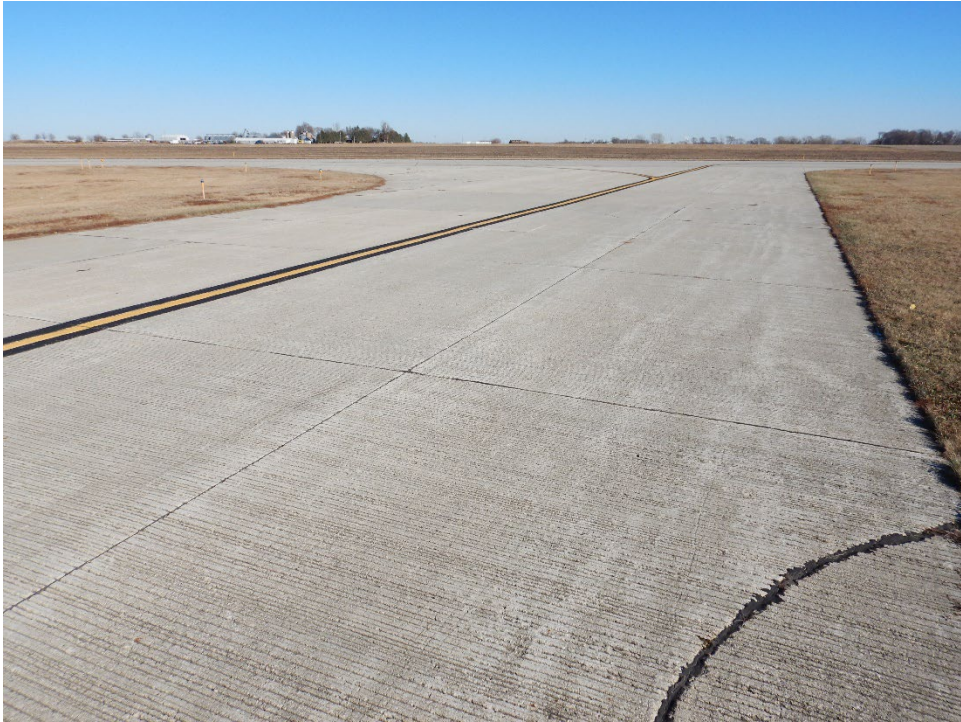
Taxiway 01 consisted of one section. Section 01 contained areas of medium- and high-severity joint seal damage and low- and medium-severity joint spalling, large patching, LTD cracking, corner break, and corner spalling.

T01SD-01. Overview.

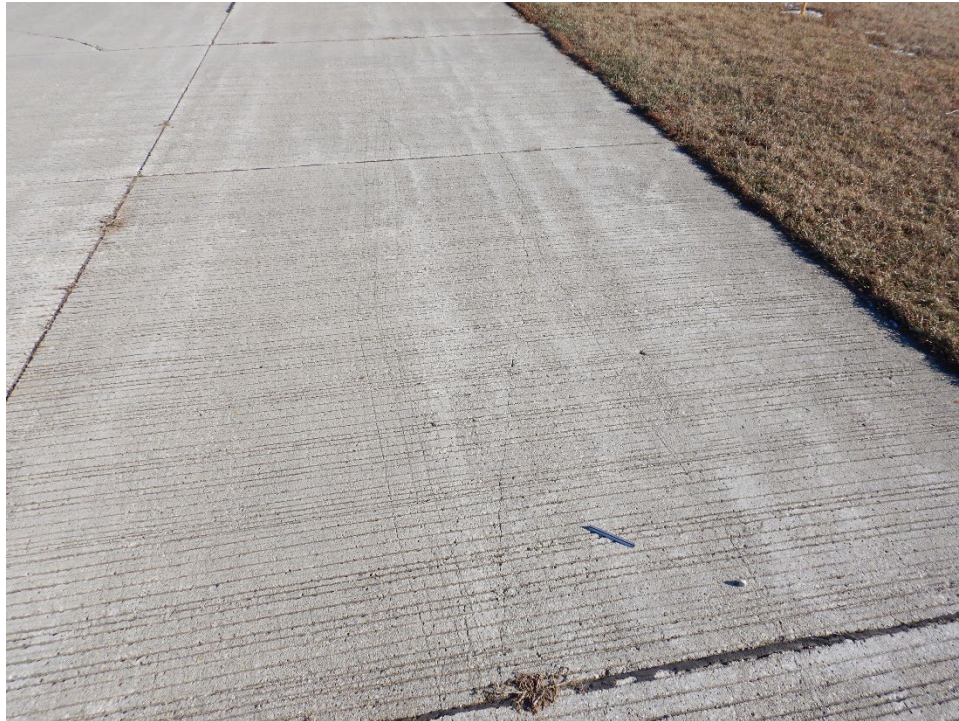
T01SD-01. LTD Cracking (Sample Unit No. 05).

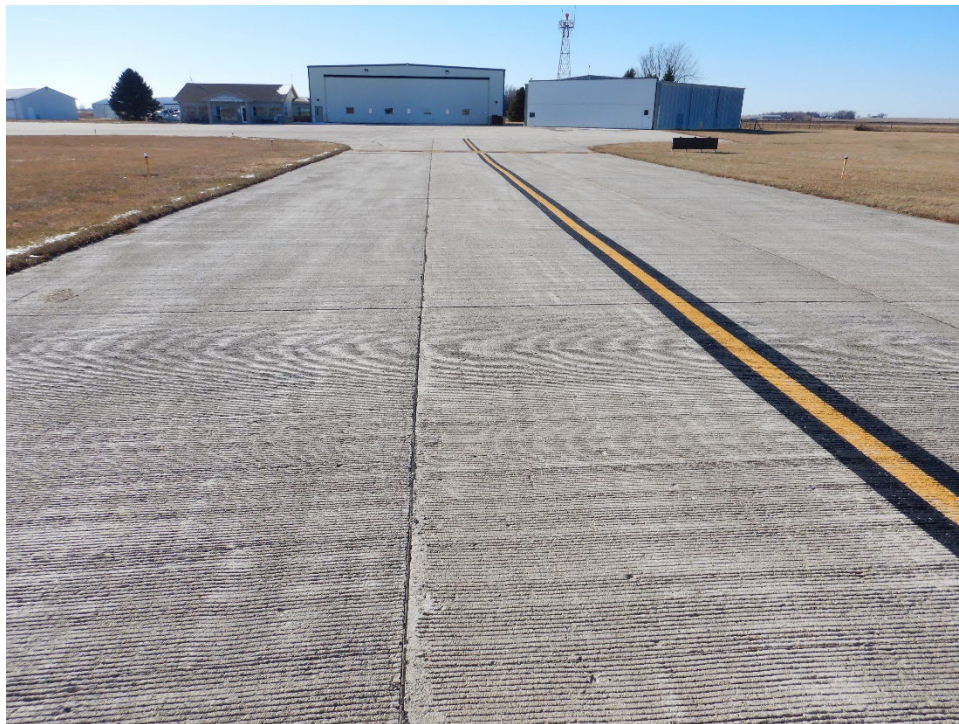
Taxiway 02 contained one section. Medium-severity corner break, joint spalling, and shattered slab; medium- and high-severity corner spalling and LTD cracking; low-severity faulting; and high-severity joint seal damage was observed in Section 01.

T02SD-01. Overview.

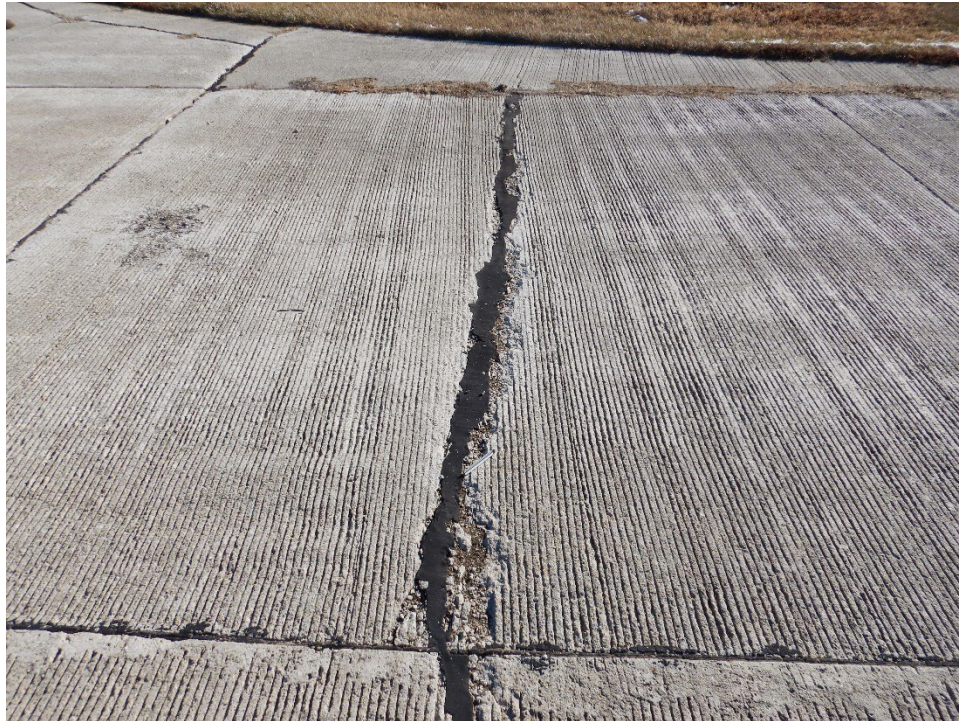
T02SD-01. LTD Cracking (Sample Unit No. 02).

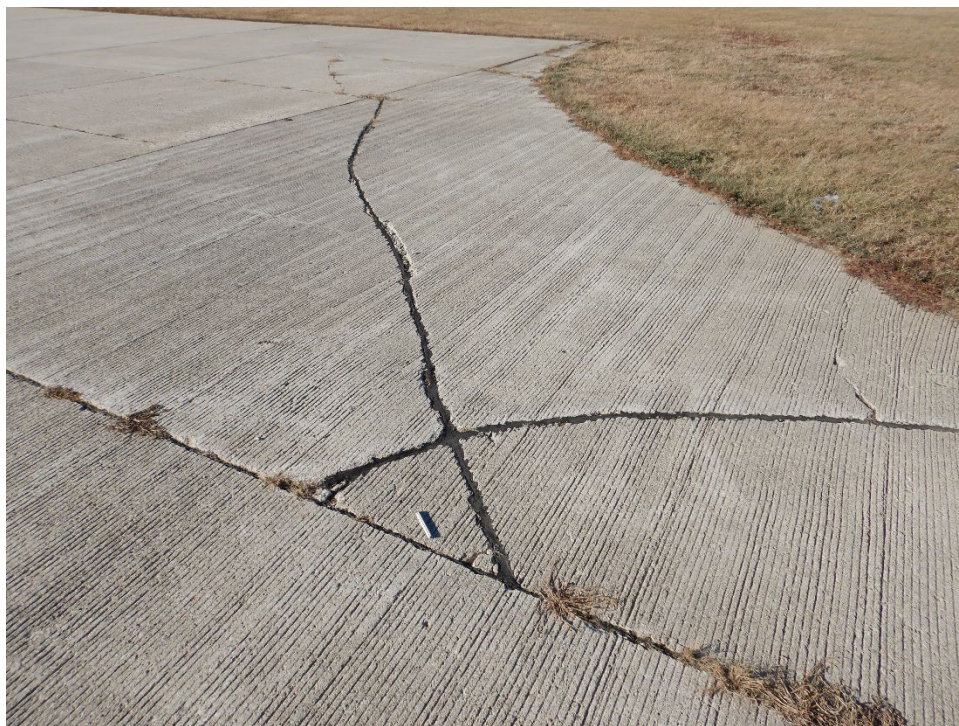
T02SD-01. Shattered Slab (Sample Unit No. 03).

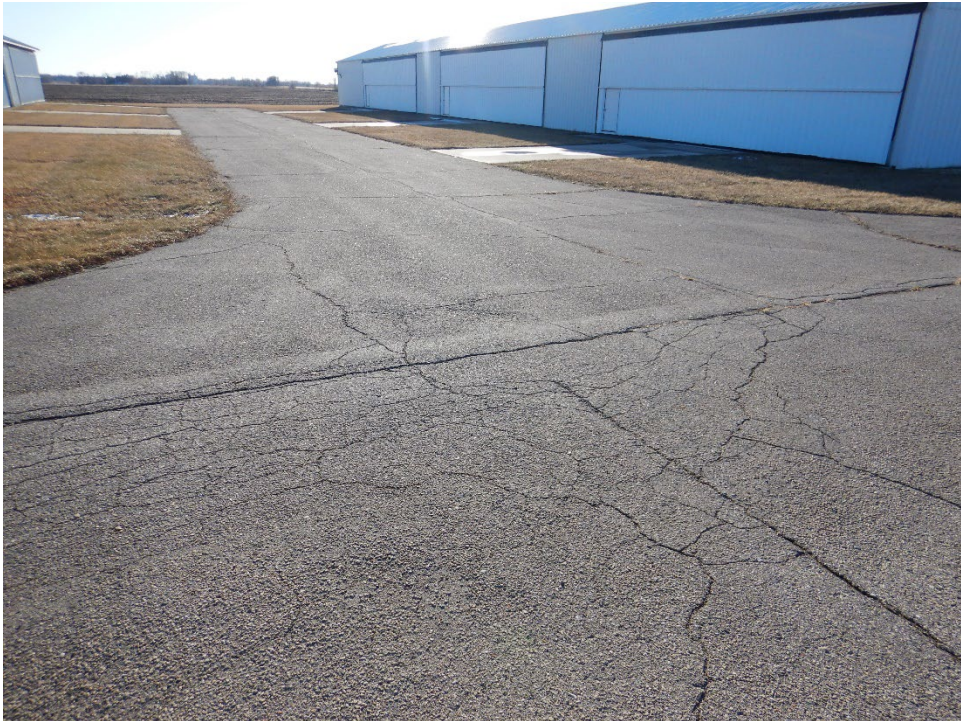
The T-hangar area consisted of three sections. Section 01 was in poor condition with medium-severity alligator cracking and joint reflection cracking, low-severity L&T cracking, low- and medium-severity patching and swelling, and high-severity weathering observed during the inspection. The low-severity L&T cracking in Section 01 was unsealed, and the medium-severity joint reflection cracking was due to either the development of secondary cracking or unsealed crack widths that exceeded $\frac{1}{4}$ in. Section 02 contained areas of medium-severity joint spalling

TH01SD-01. Overview.

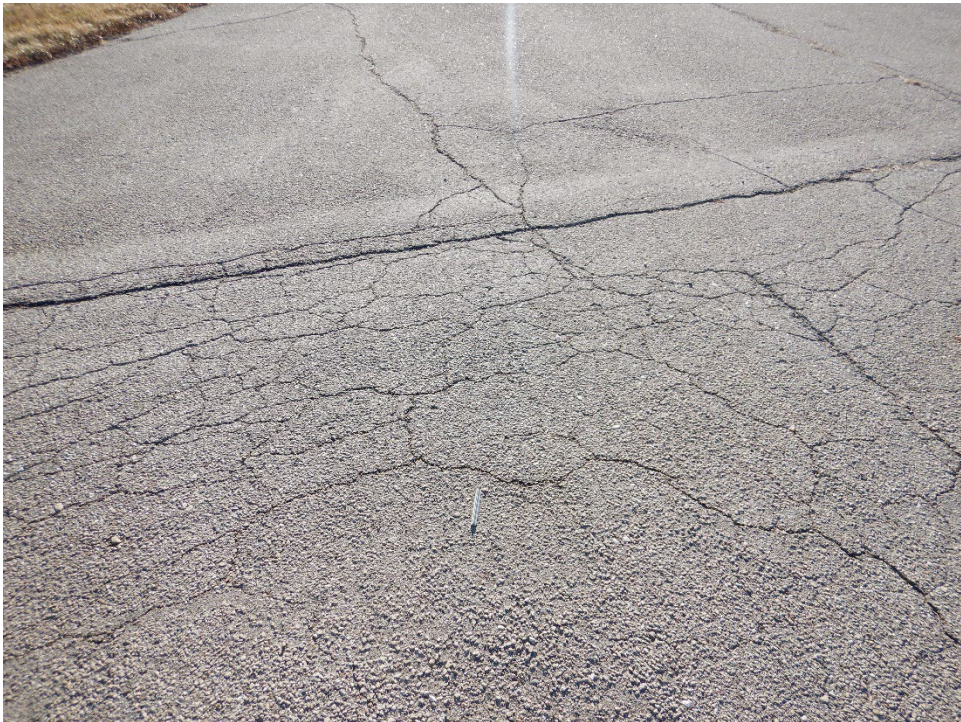
TH01SD-01. Alligator Cracking (Sample Unit No. 04).
