Sheldon Regional Airport

Pavement Management Report

JULY 2023

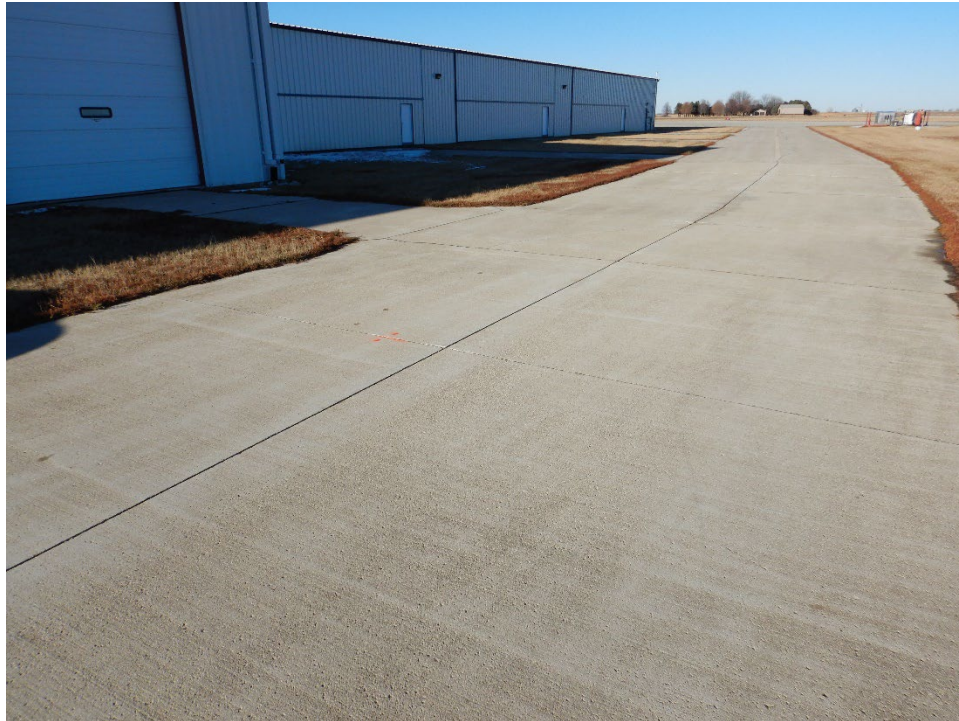
TH01SD-02. Overview.

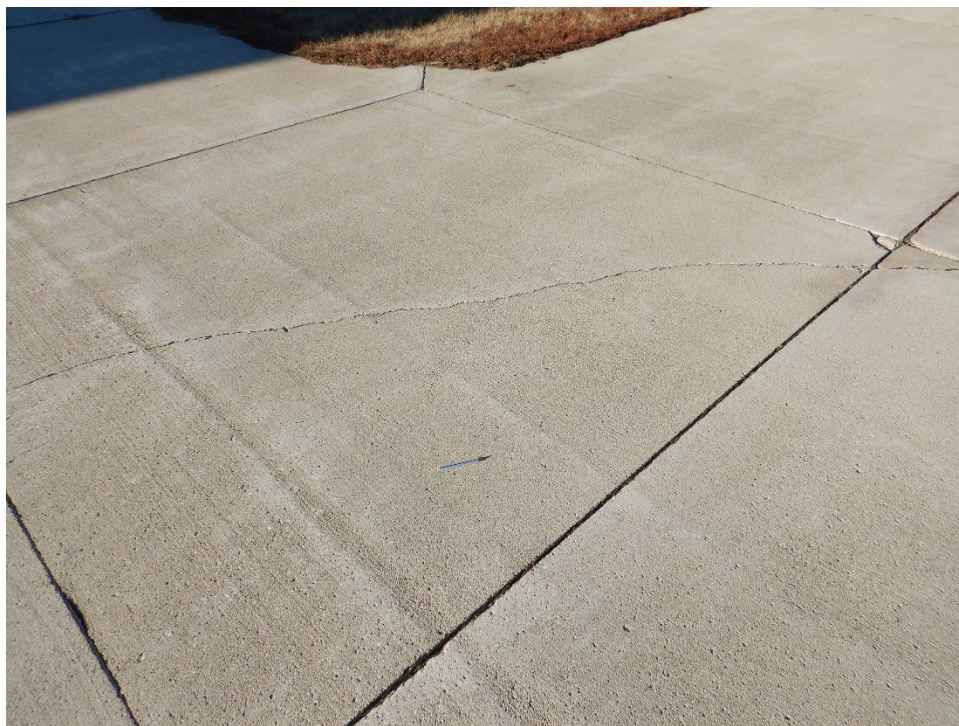
TH01SD-02. LTD Cracking (Sample Unit No. 03).

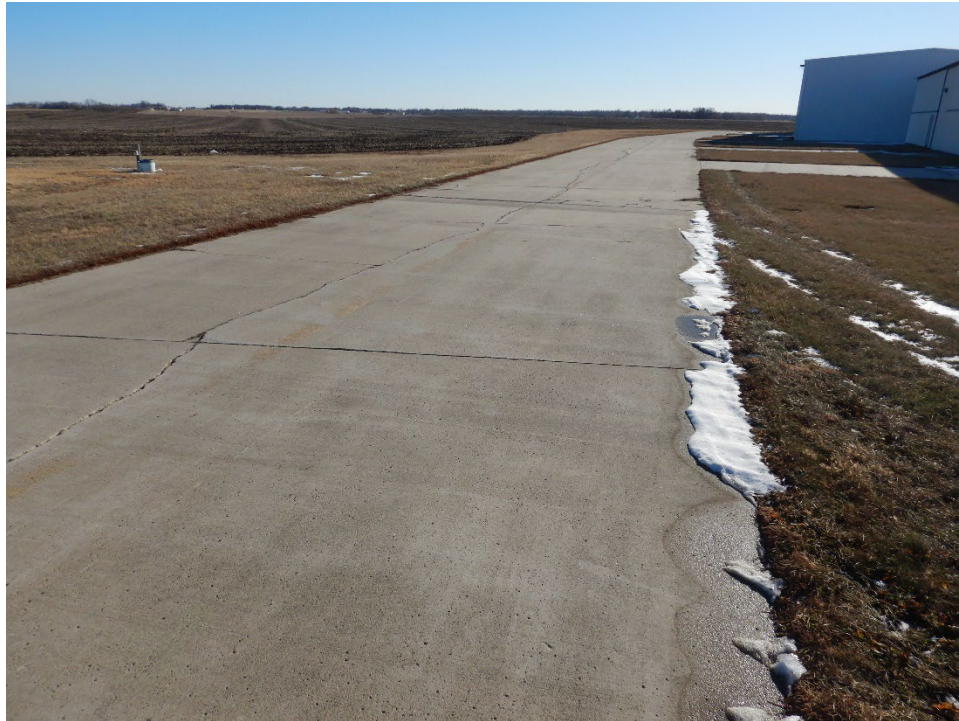
and corner spalling, low- and medium-severity corner break and LTD cracking, shrinkage cracking, low-severity faulting, and high-severity joint seal damage. Section 03 was in poor condition with low-severity faulting, high-severity joint seal damage, medium-severity LTD cracking, and medium- and high-severity shattered slab noted at the time of inspection.

TH01SD-03. Overview.

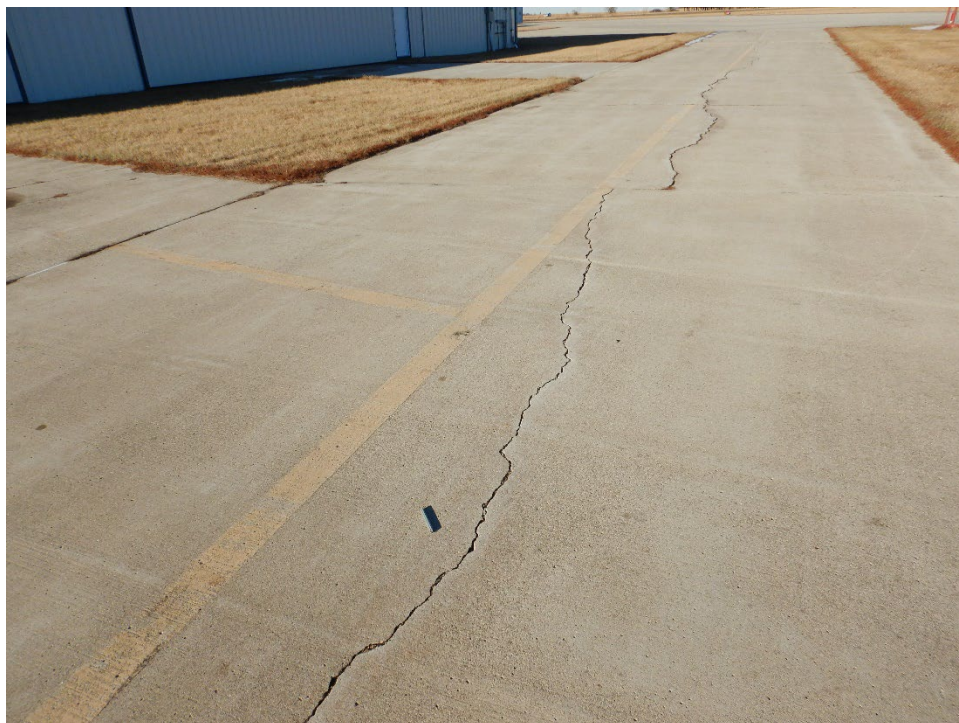
TH01SD-03. LTD Cracking (Sample Unit No. 01).
