# Sheldon Regional Airport

## Pavement Management Report

**AUGUST 2026**

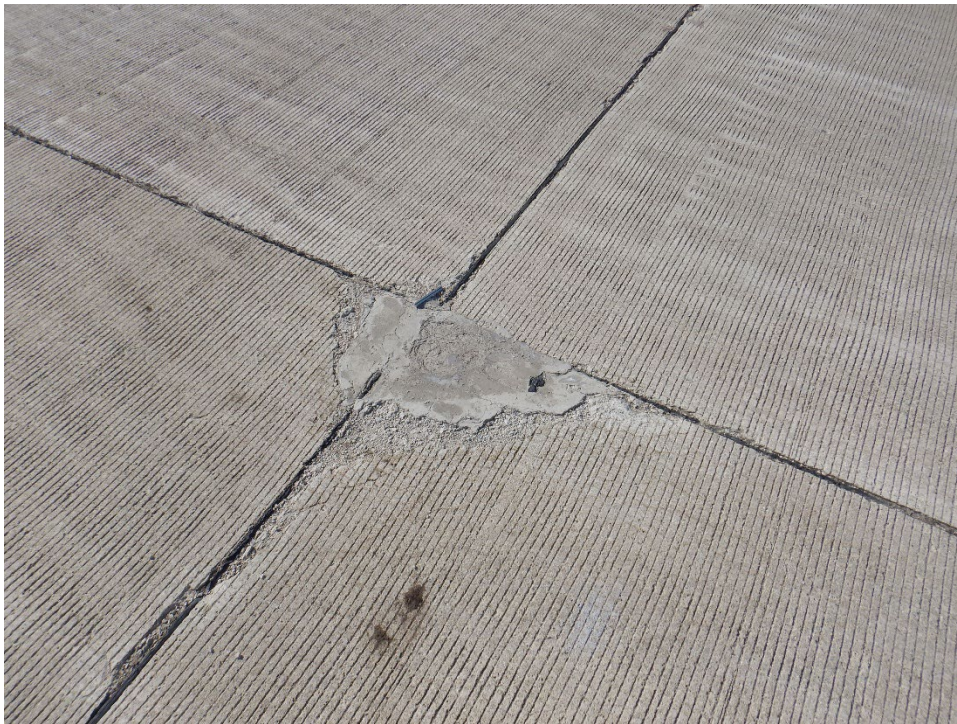
A01SD-01. Durability Cracking (Sample Unit No. 02).

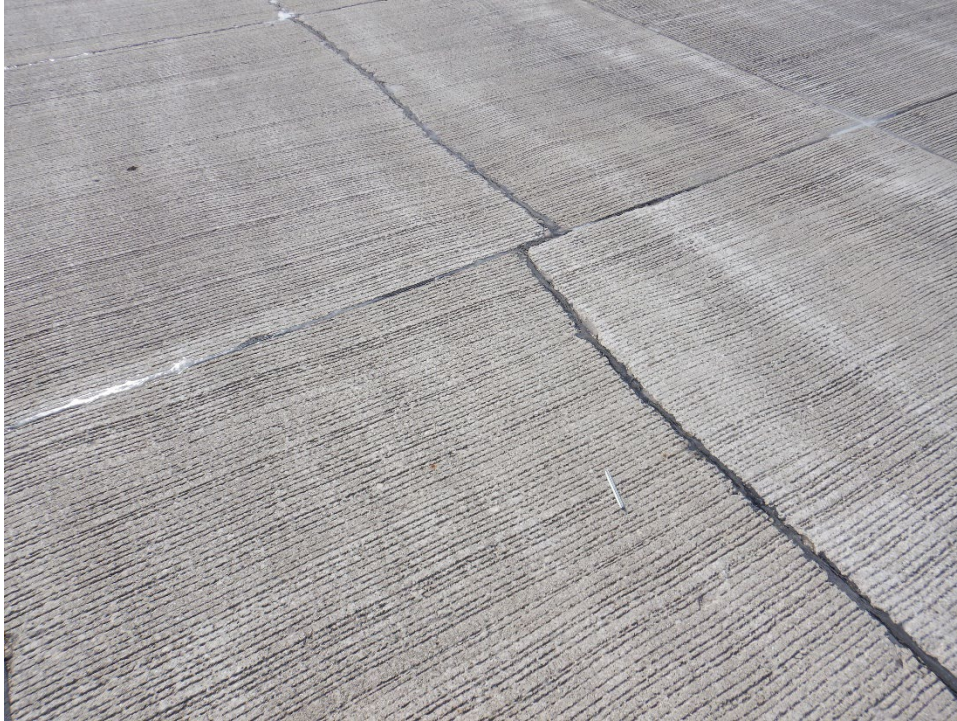
A01SD-01. LTD Cracking (Sample Unit No. 07).

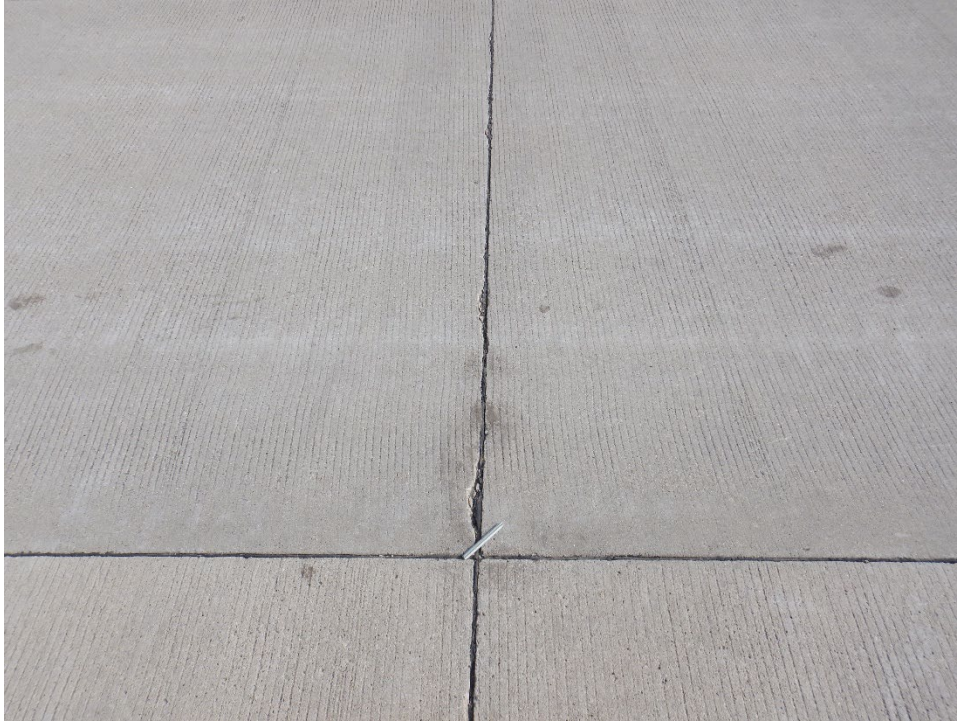
A01SD-02. Joint Seal Damage (Sample Unit No. 07).

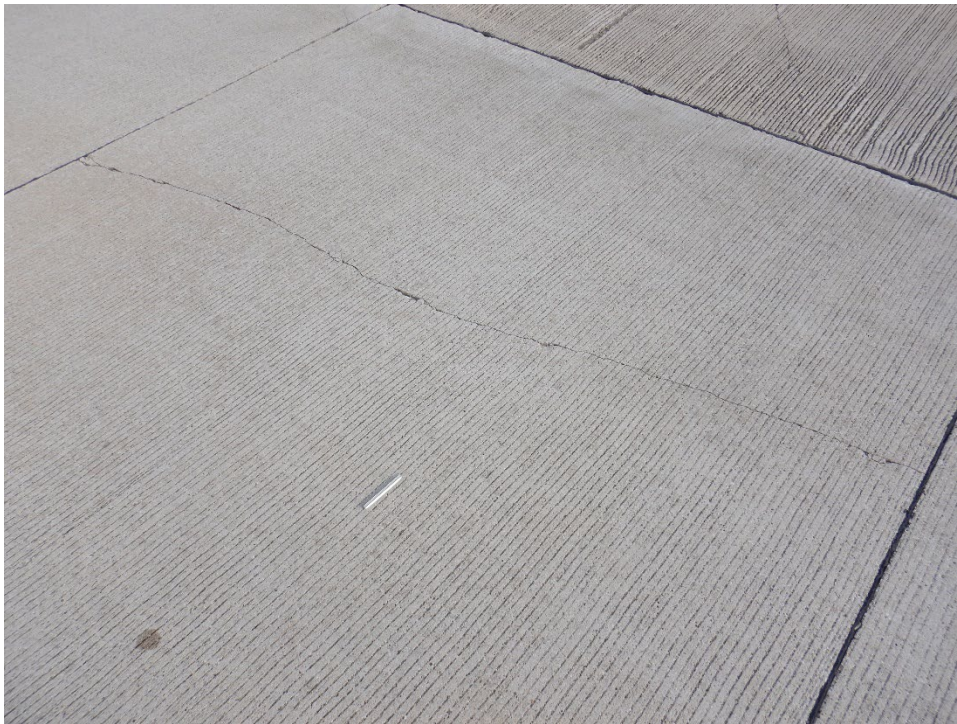
A01SD-02. LTD Cracking (Sample Unit No. 02).

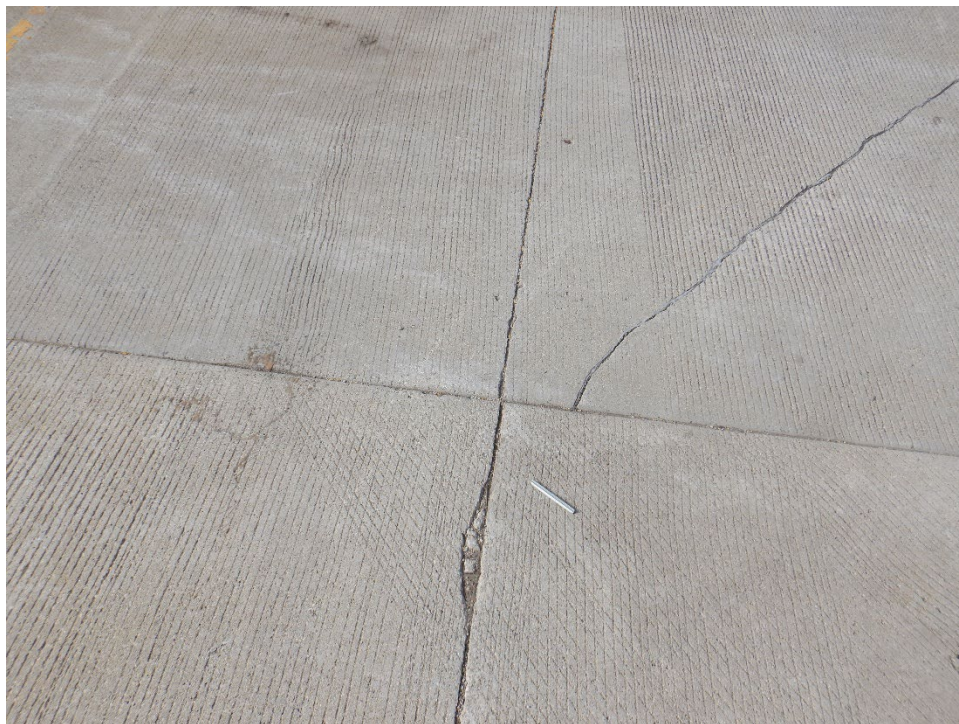
A01SD-03. Joint Seal Damage (Sample Unit No. 02).

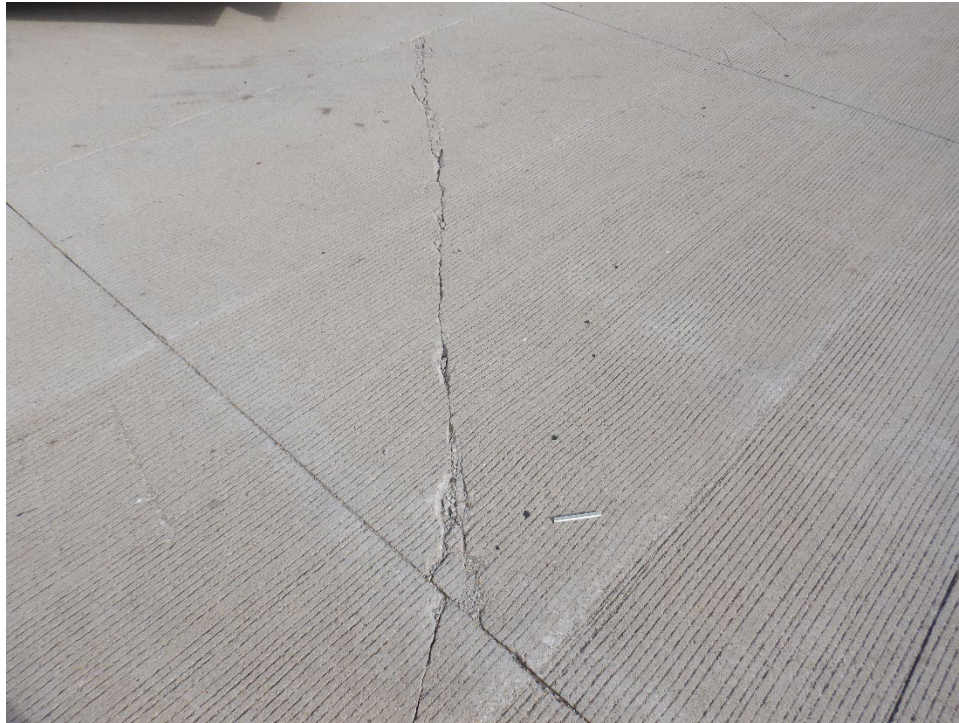
A01SD-03. LTD Cracking (Sample Unit No. 02).

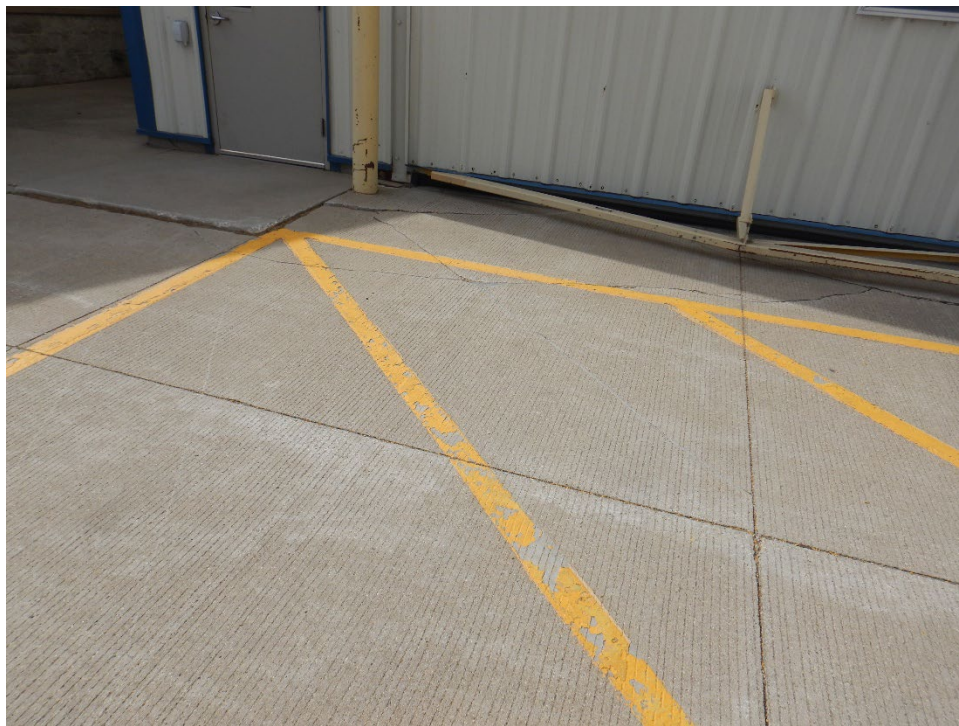
A01SD-03. Shattered Slab (Sample Unit No. 01).

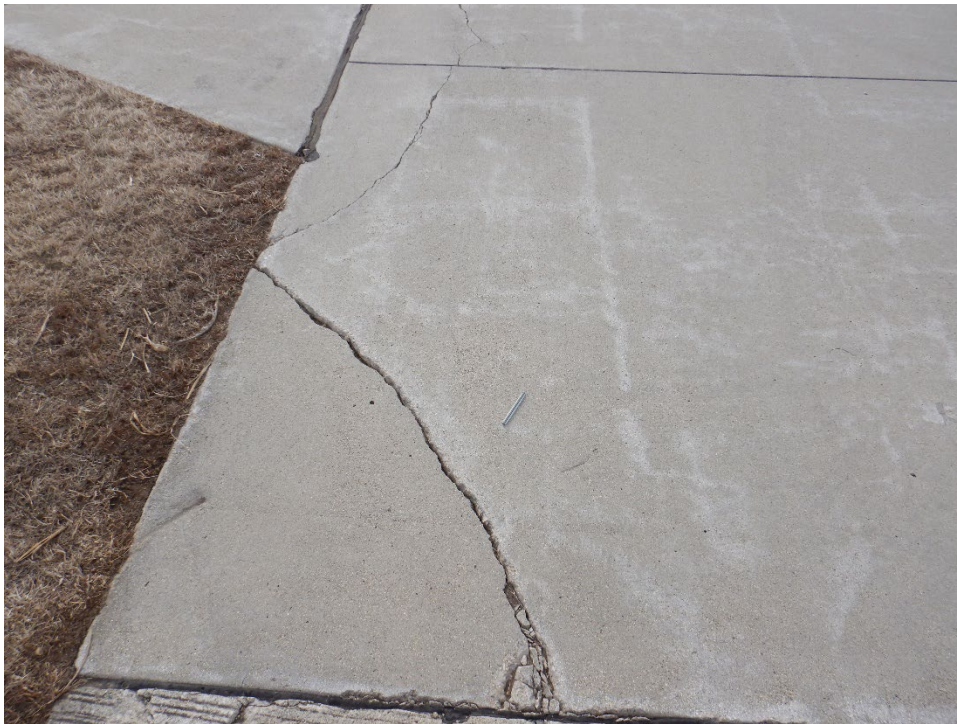
A01SD-04. Corner Break (Sample Unit No. 05).

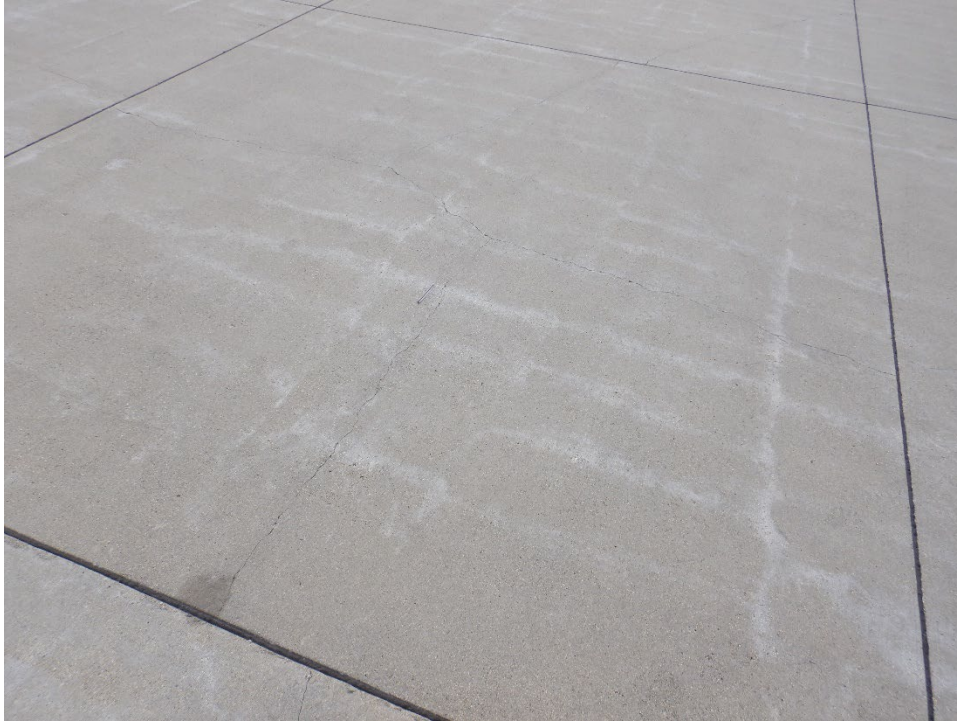
A01SD-04. Shattered Slab (Sample Unit No. 04).

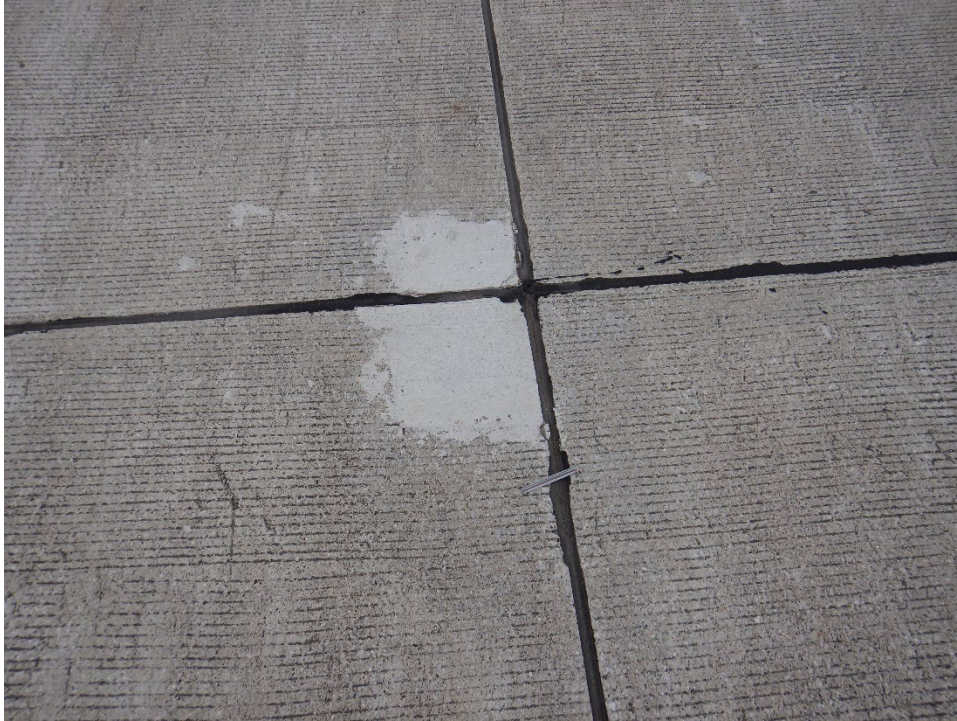
R15SD-01. Small Patching (Sample Unit No. 01).

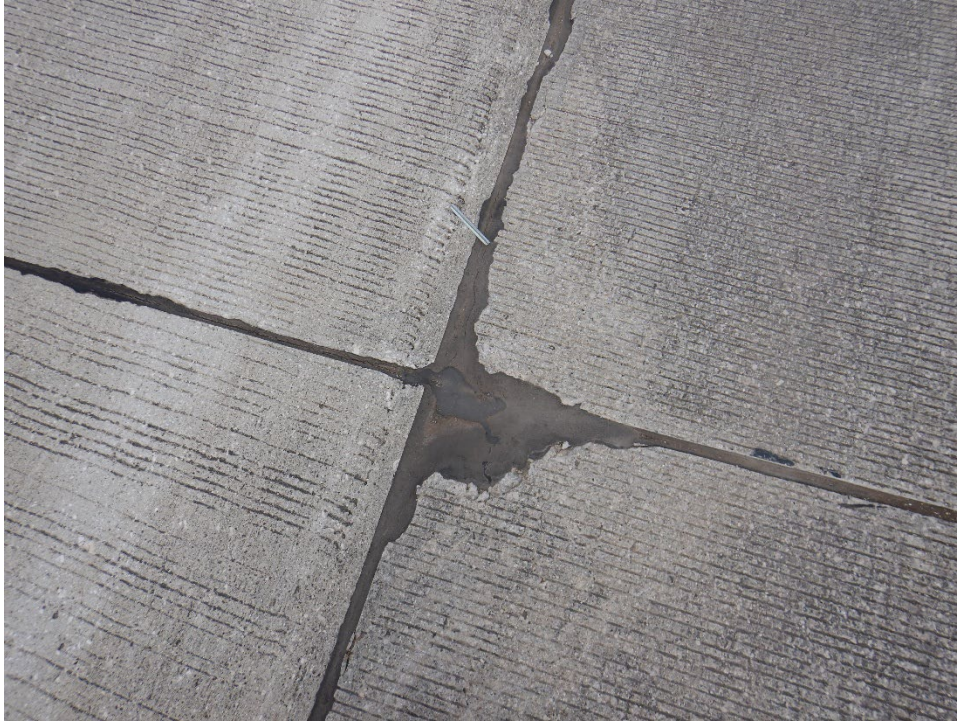
R15SD-02. Corner Spalling (Sample Unit No. 04).

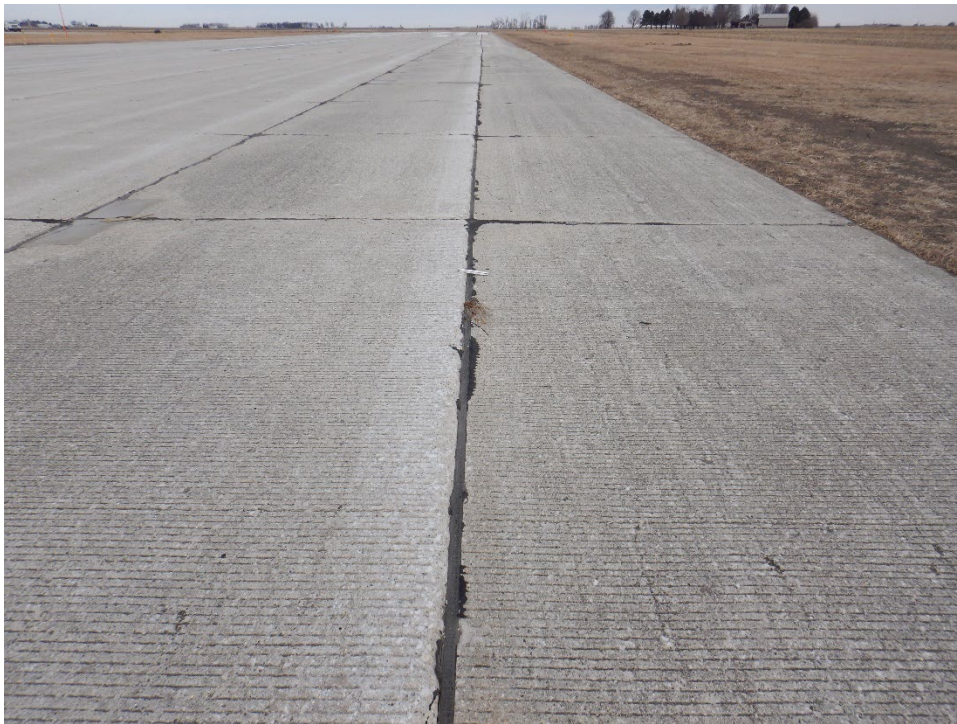
R15SD-02. Faulting (Sample Unit No. 20).

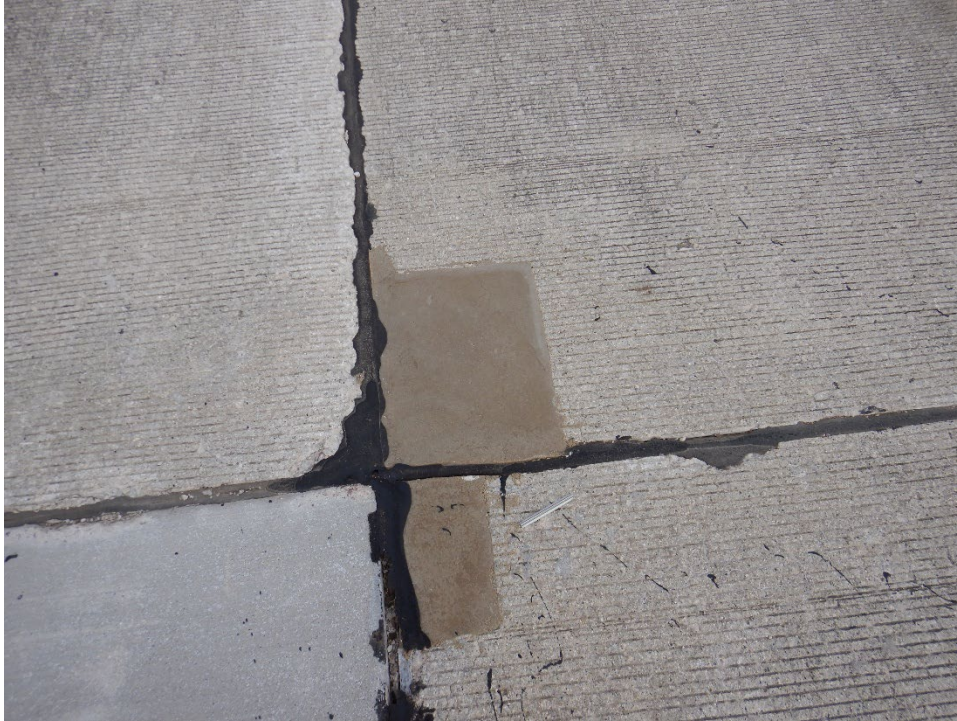
R15SD-02. Small Patching (Sample Unit No. 04).

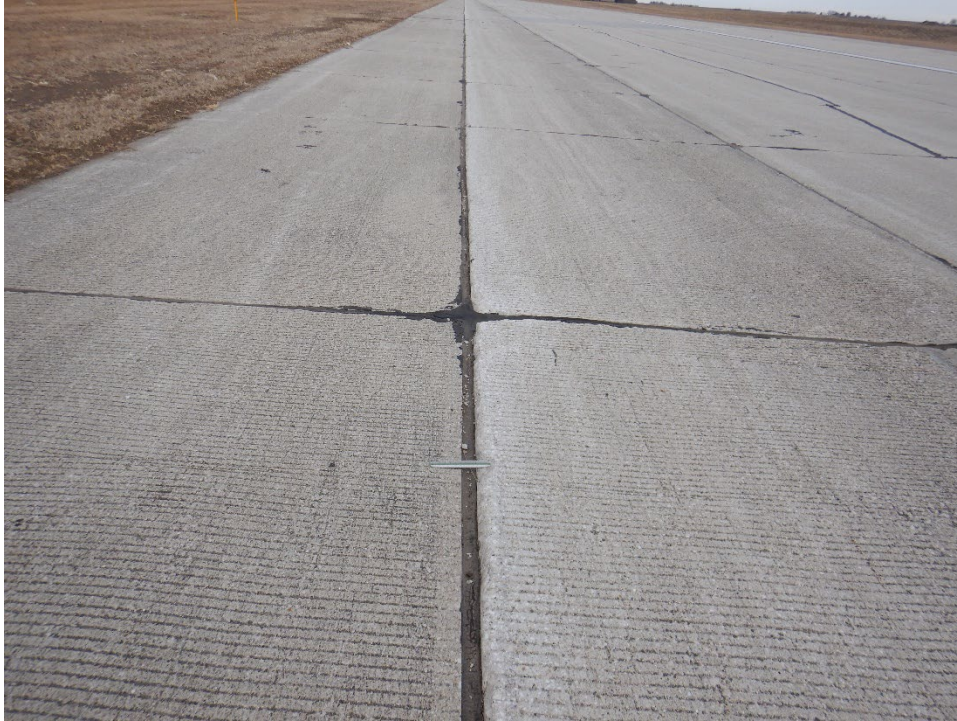
R15SD-03. Faulting (Sample Unit No. 04).

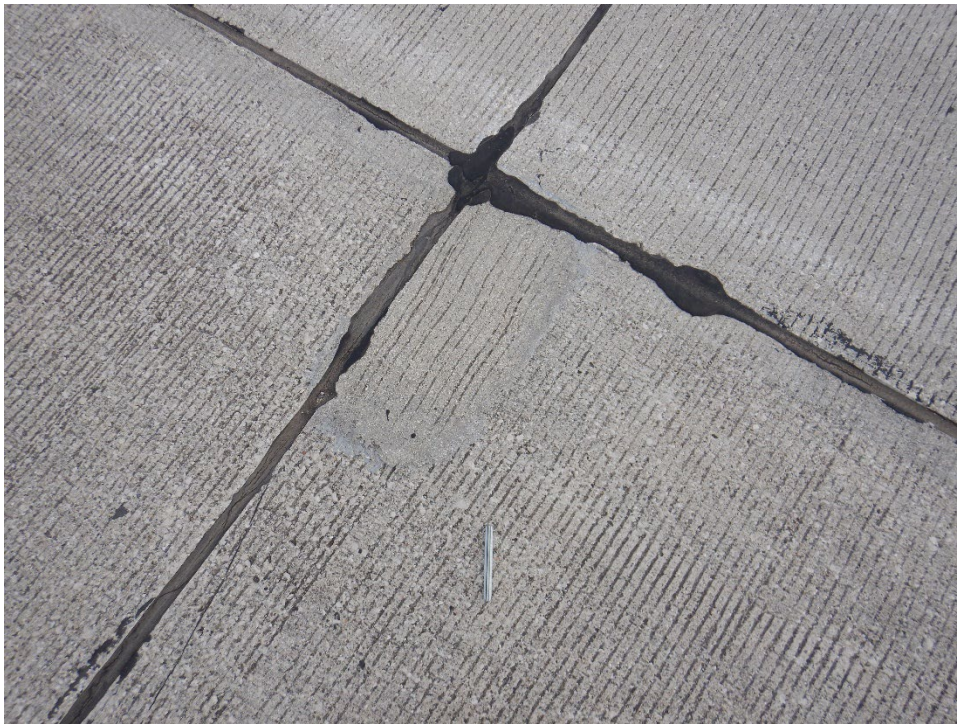
R15SD-03. Small Patching (Sample Unit No. 04).

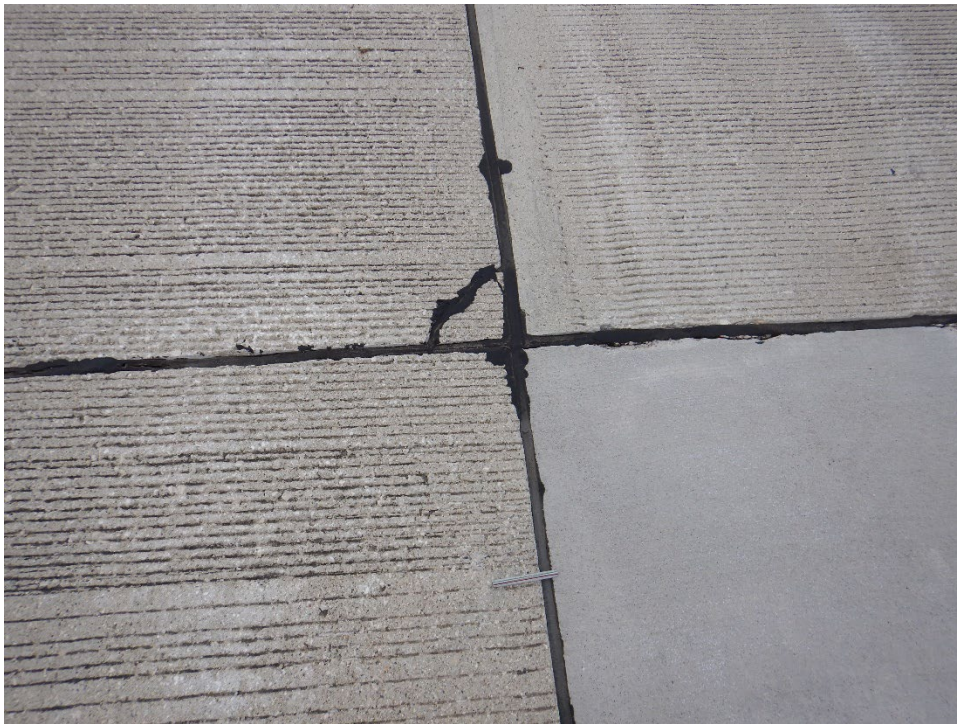
R15SD-04. Corner Spalling (Sample Unit No. 01).

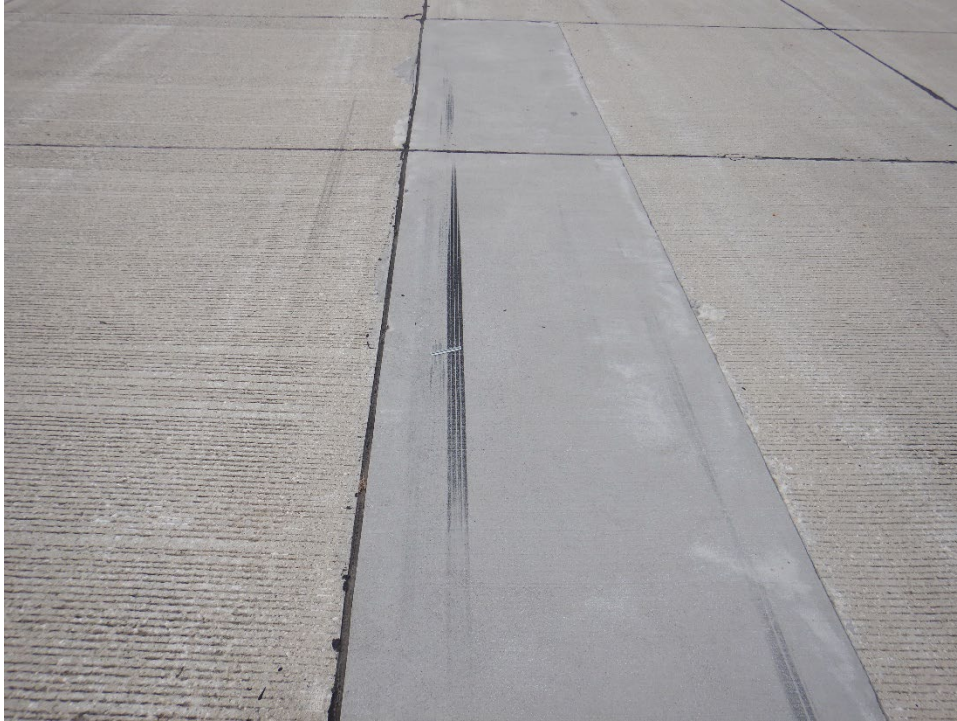
R15SD-04. Large Patching (Sample Unit No. 01).

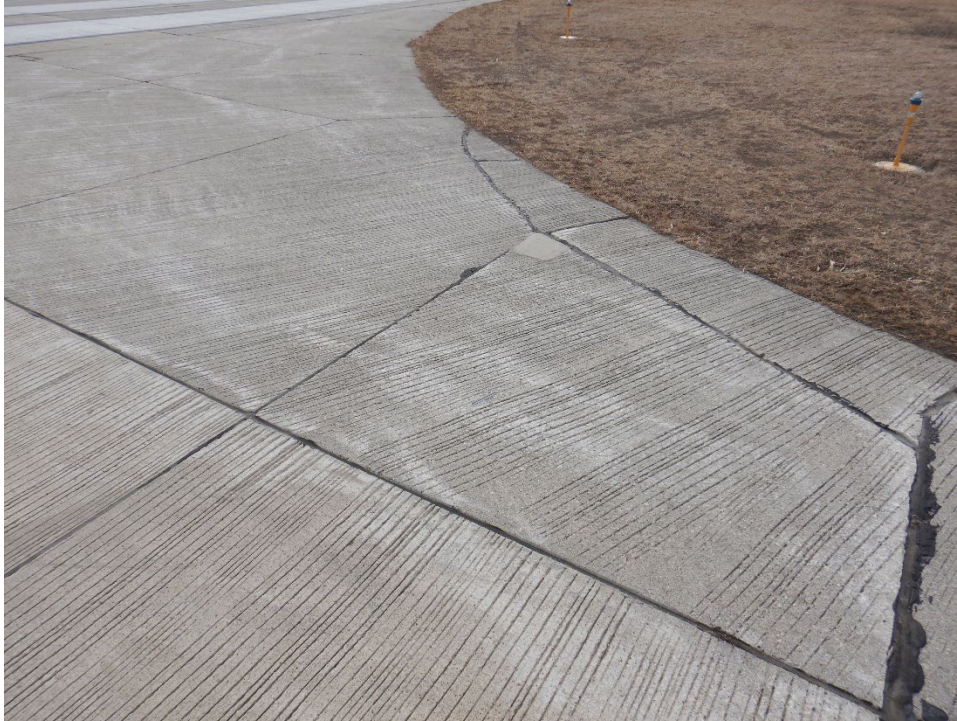
TA1SD-01. LTD Cracking (Sample Unit No. 01).

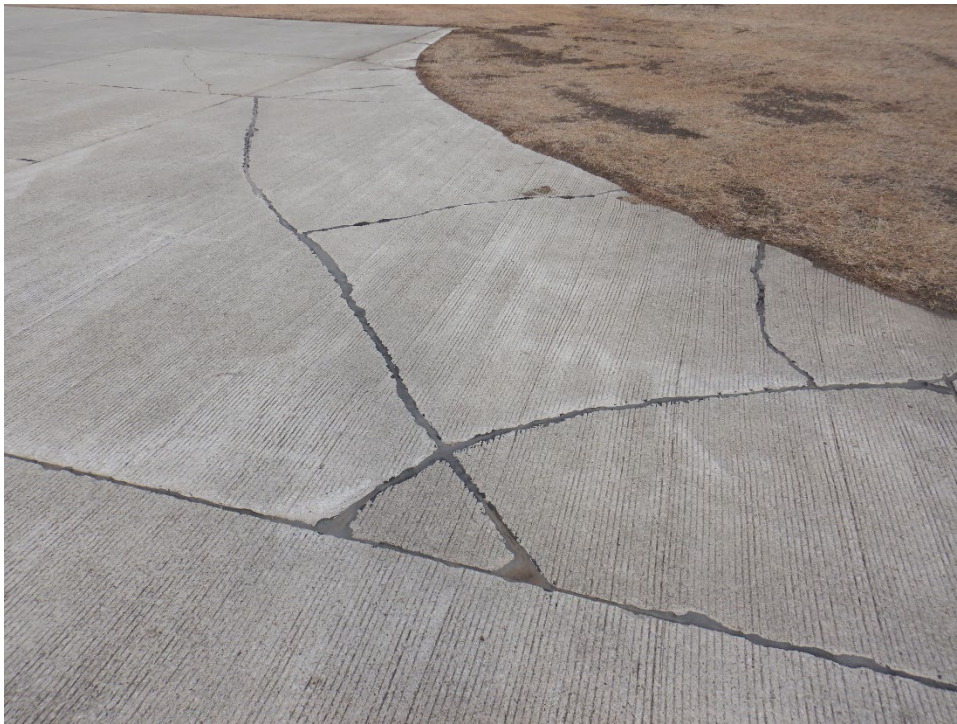
TA1SD-01. Shattered Slab (Sample Unit No. 03).

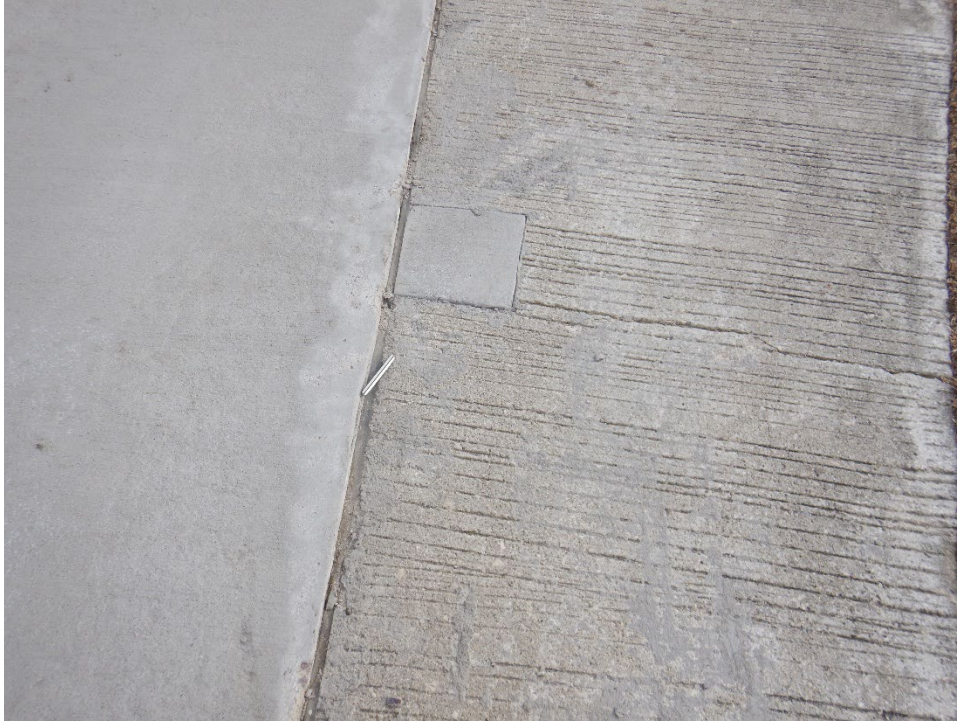
TA1SD-01. Small Patching (Sample Unit No. 02).

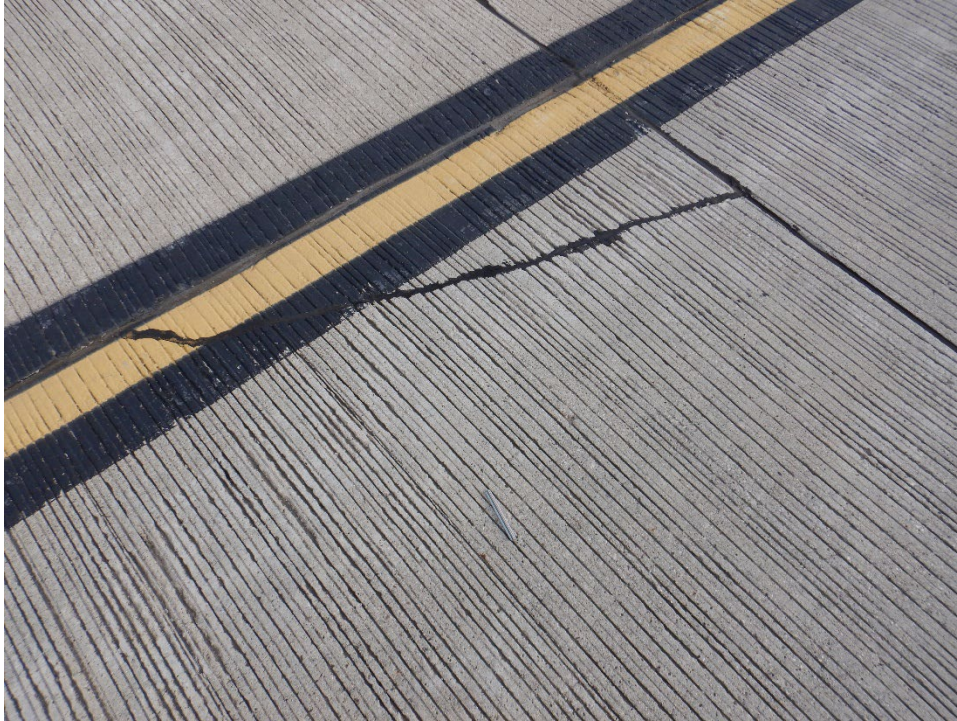
TA2SD-01. Corner Break (Sample Unit No. 05).

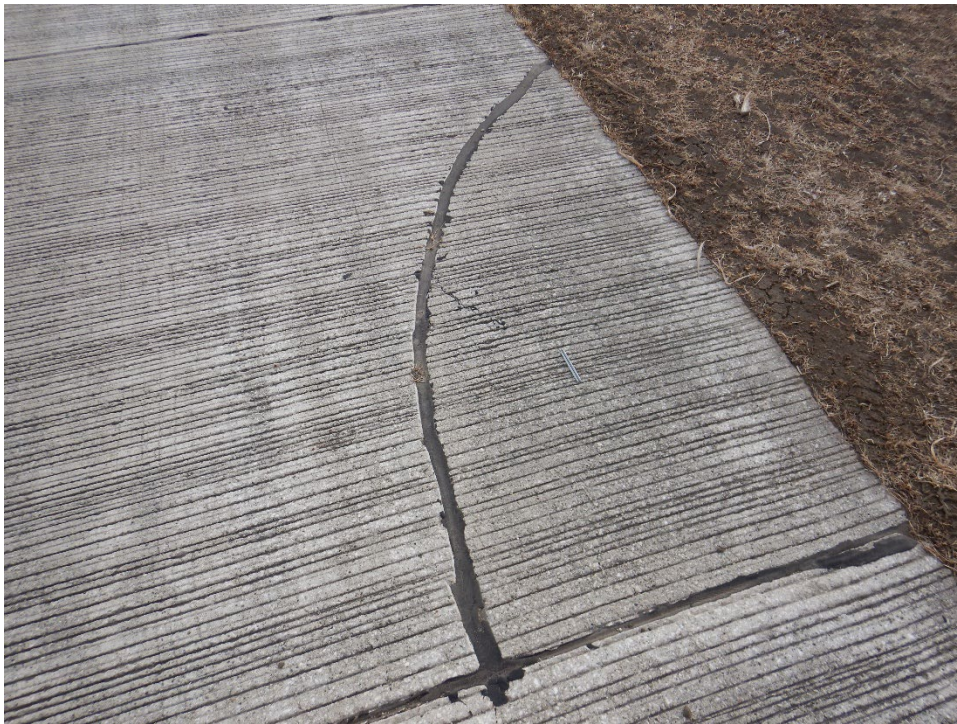
TA2SD-01. LTD Cracking (Sample Unit No. 05).

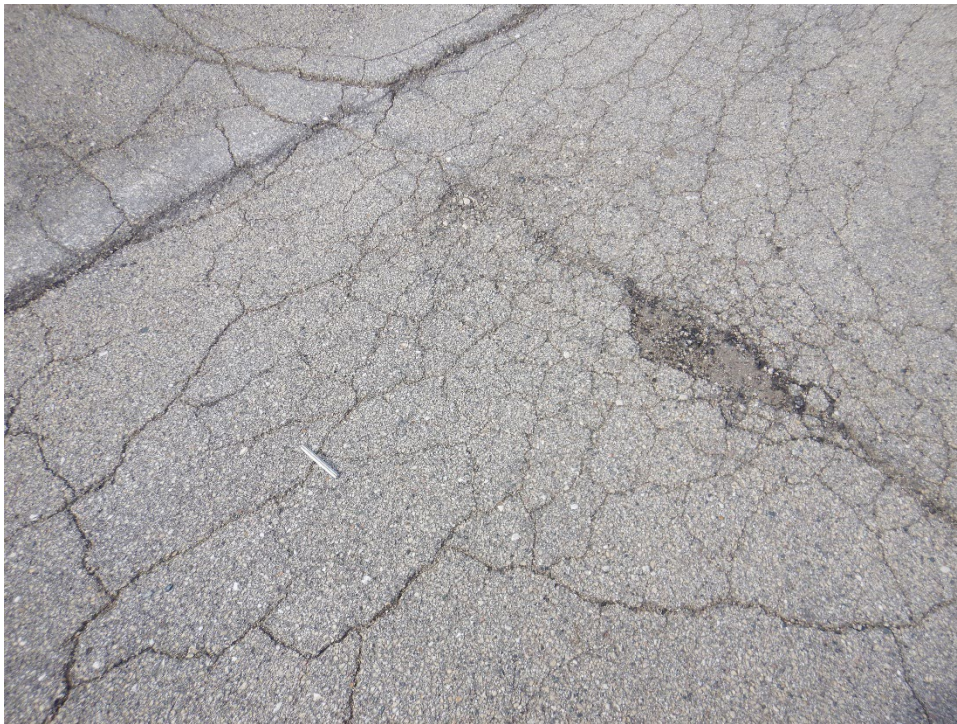
TH01SD-01. Alligator Cracking (Sample Unit No. 04).

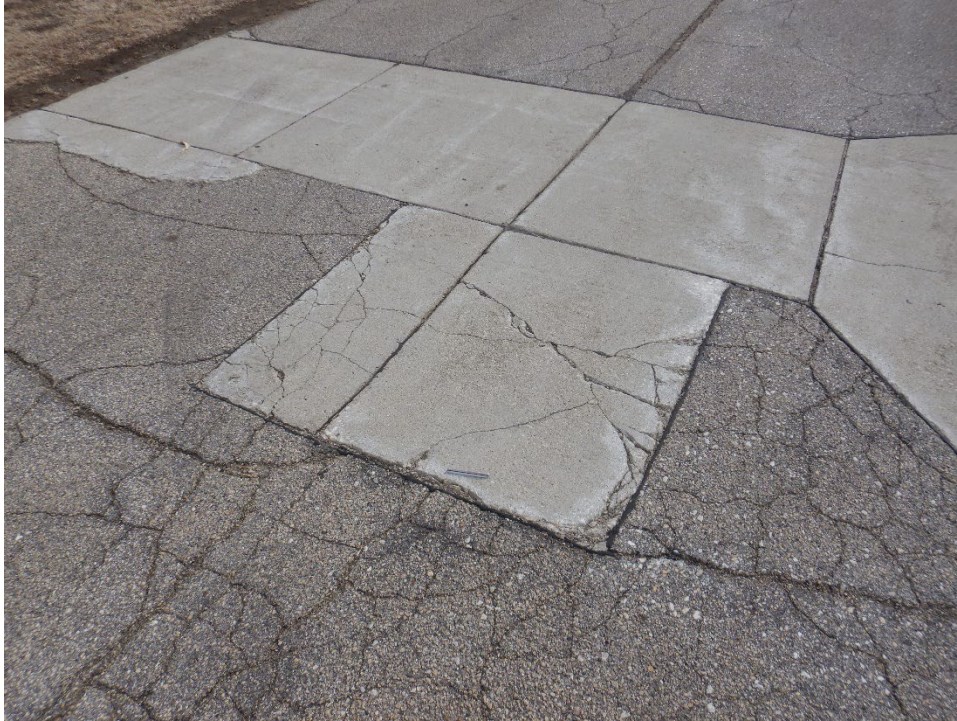
TH01SD-01. Patching (Sample Unit No. 04).

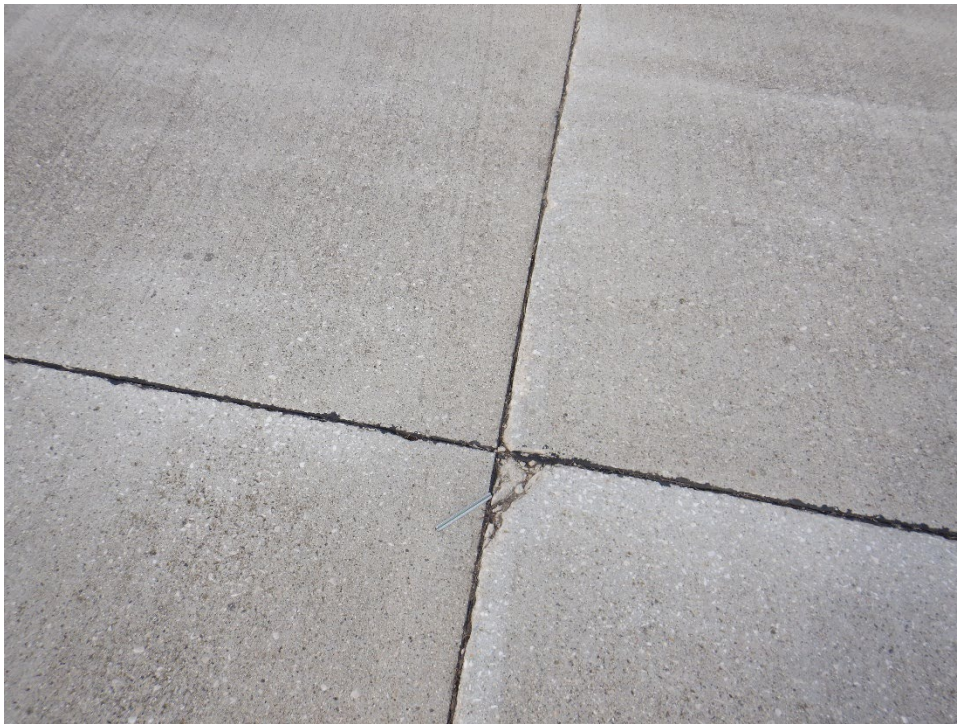
TH01SD-02. Corner Spalling (Sample Unit No. 03).

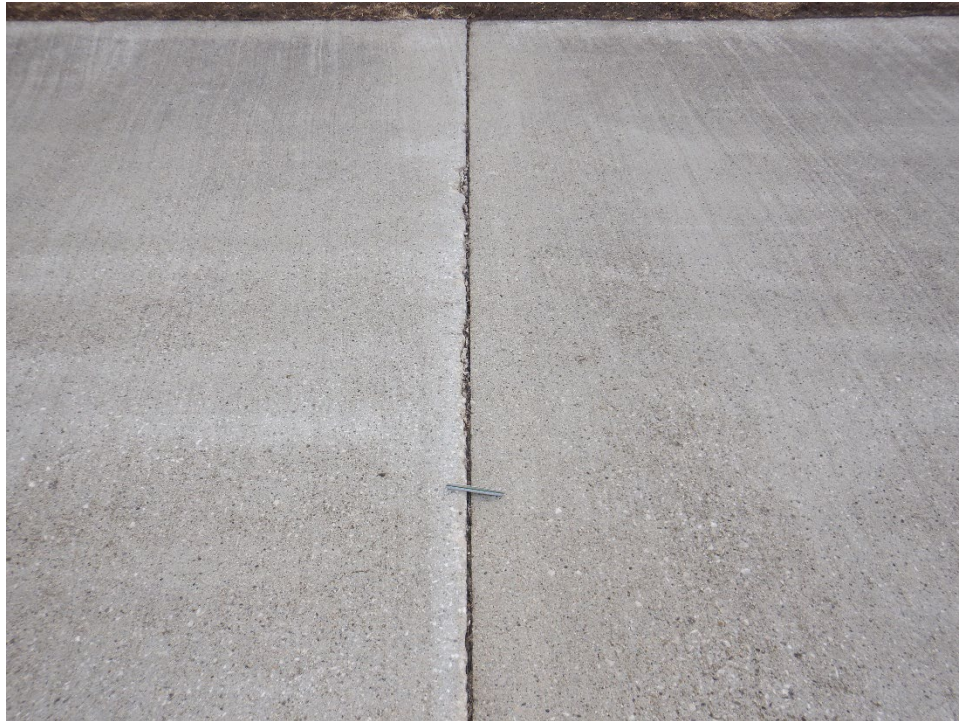
TH01SD-02. Faulting (Sample Unit No. 03).

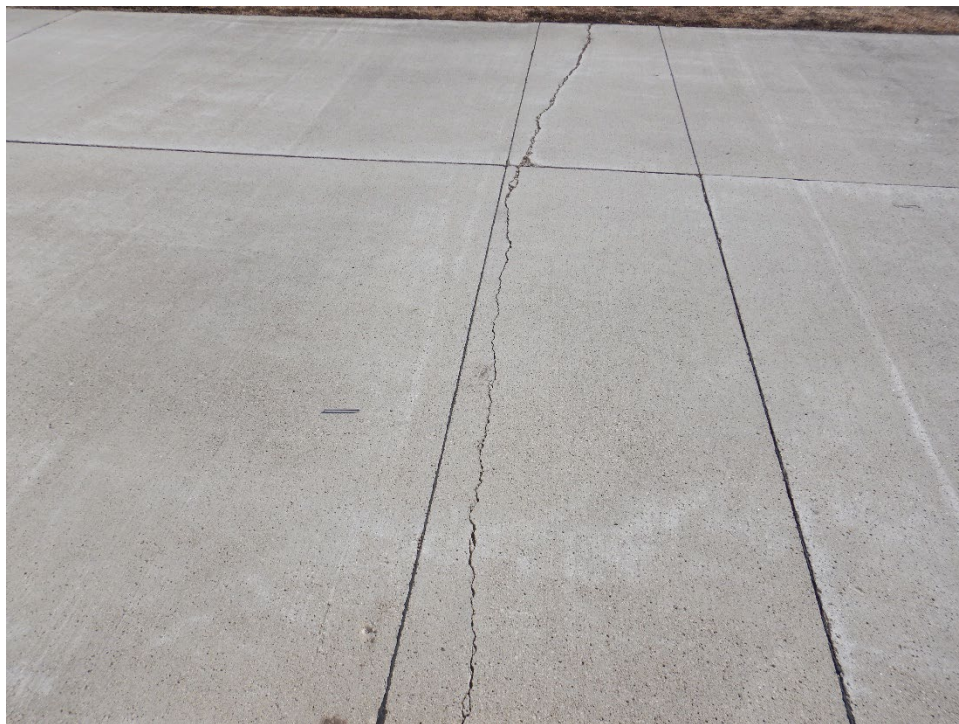
TH01SD-02. LTD Cracking (Sample Unit No. 04).

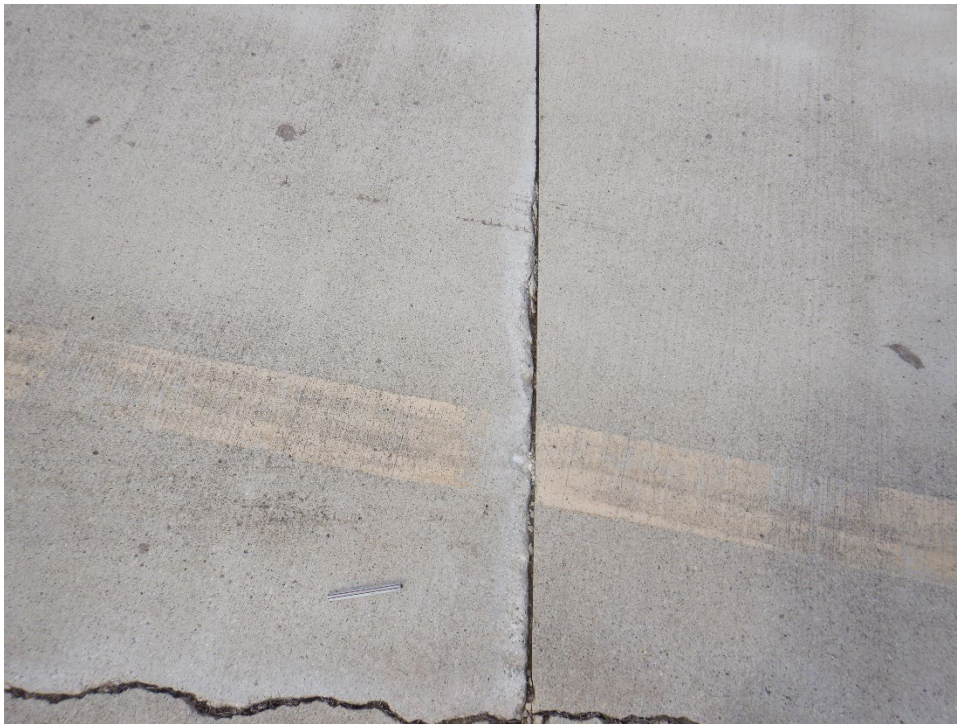
TH01SD-03. Joint Seal Damage (Sample Unit No. 01).

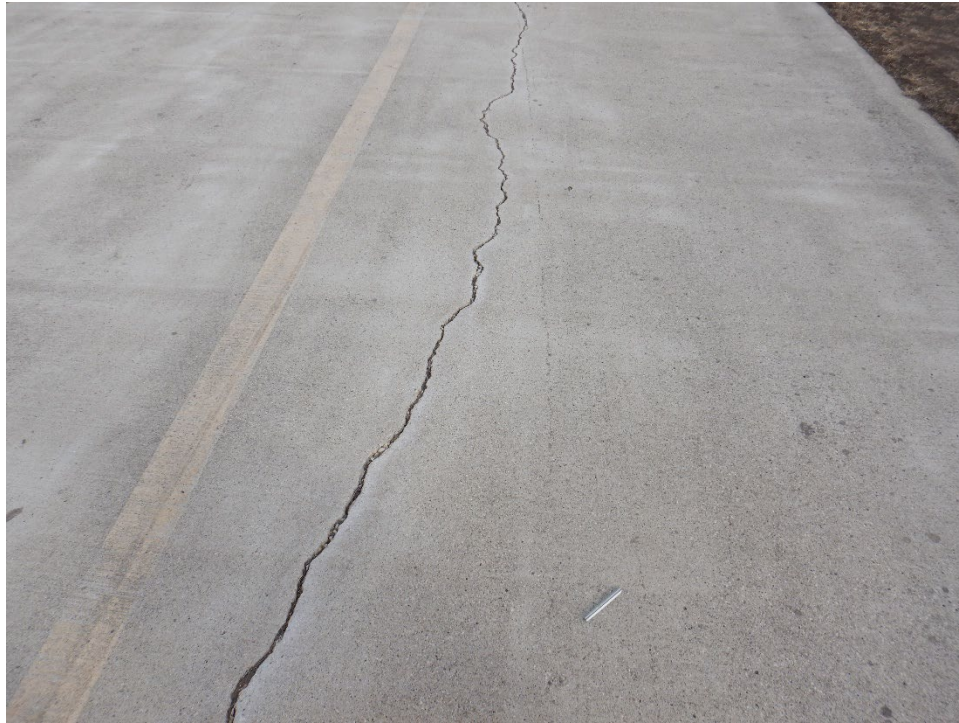
TH01SD-03. LTD Cracking (Sample Unit No. 01).
