# Sibley Municipal Airport

## Pavement Management Report

**AUGUST 2025**

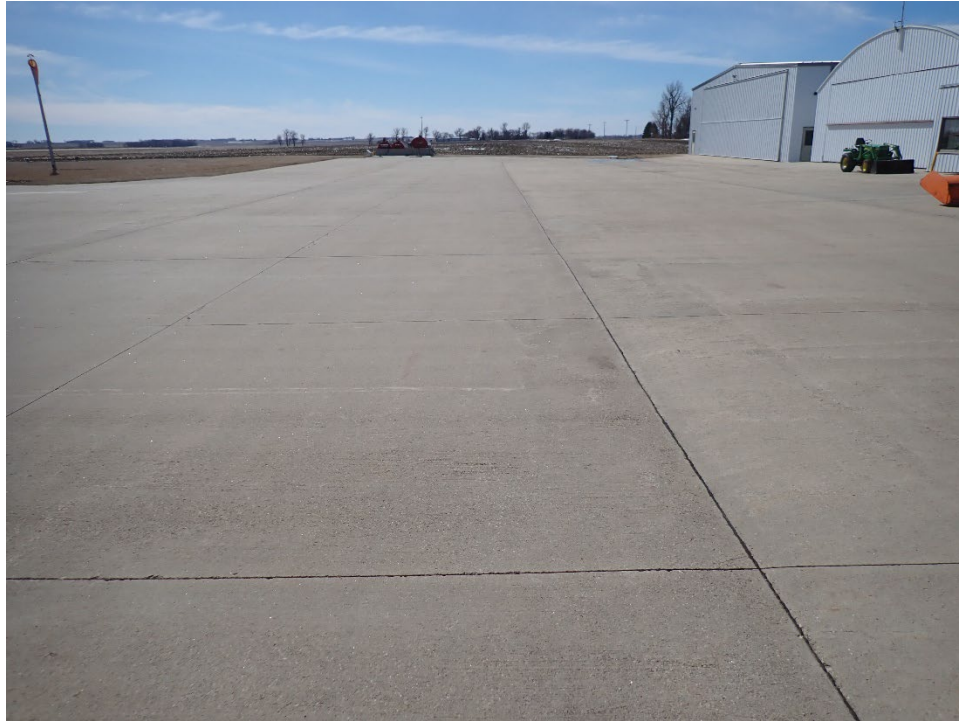
The apron area was defined by one section. Medium-severity corner break, LTD cracking, and shattered slab; low- and medium-severity corner spalling; low-severity faulting; high-severity joint seal damage; and medium- and high-severity joint spalling were recorded in Section 01.

A01IS-01. Overview.

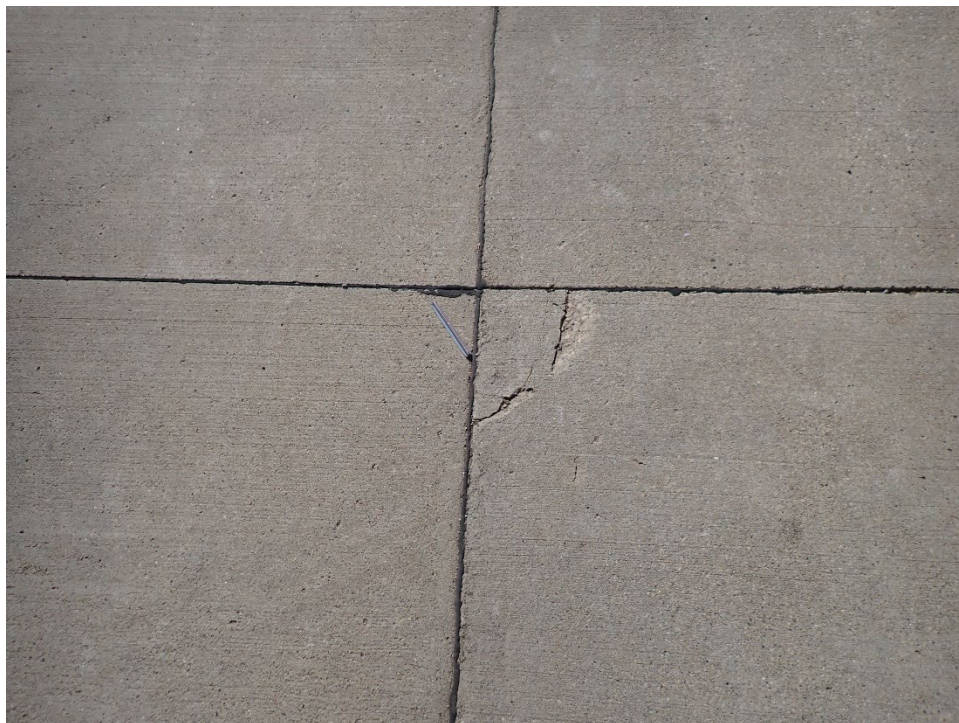
A01IS-01. Corner Spalling (Sample Unit No. 06).

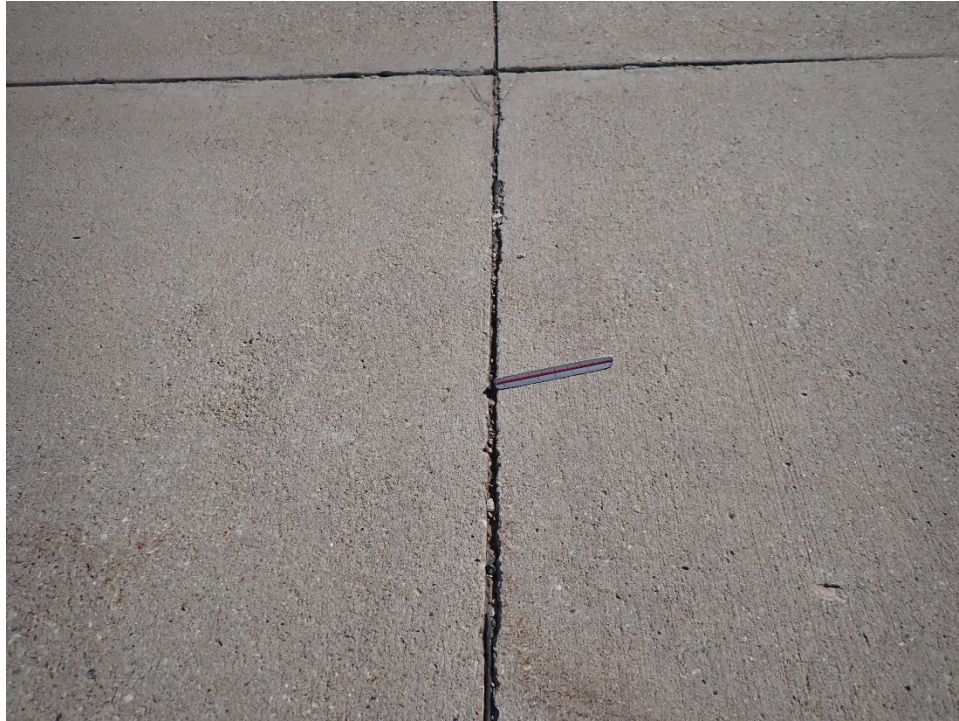
A01IS-01. Joint Seal Damage (Sample Unit No. 06).

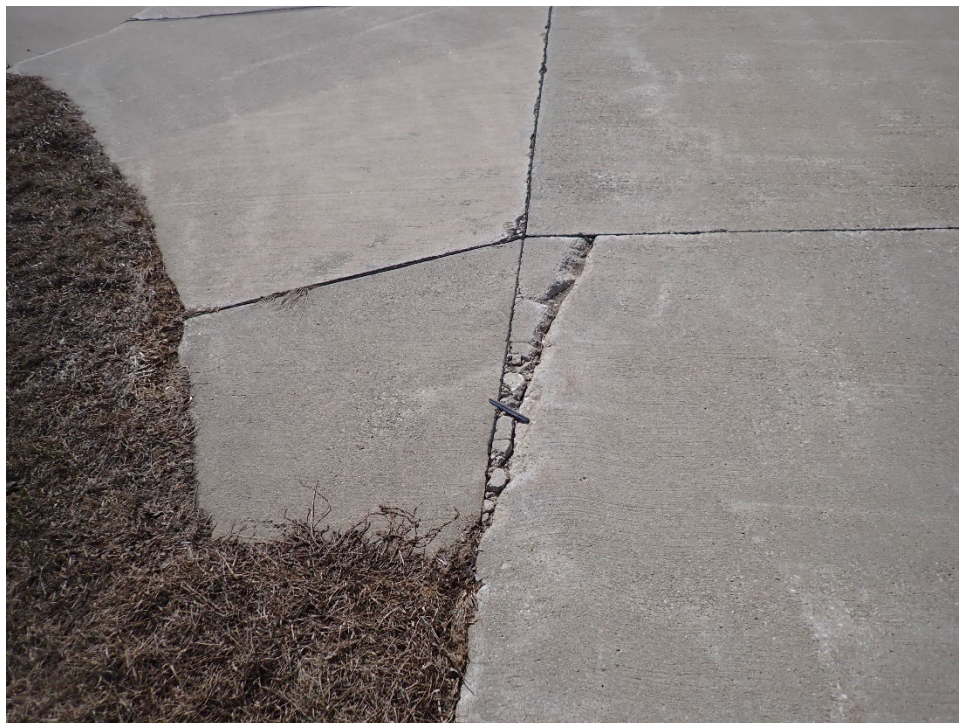
A01IS-01. Joint Spalling (Sample Unit No. 05).

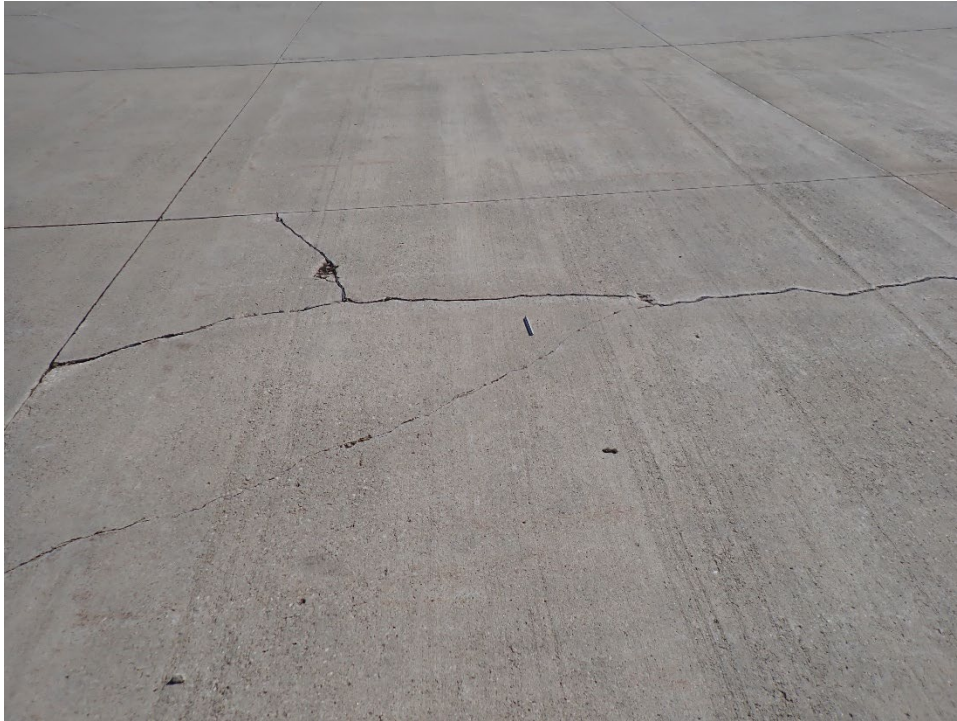
A01IS-01. Shattered Slab (Sample Unit No. 02).

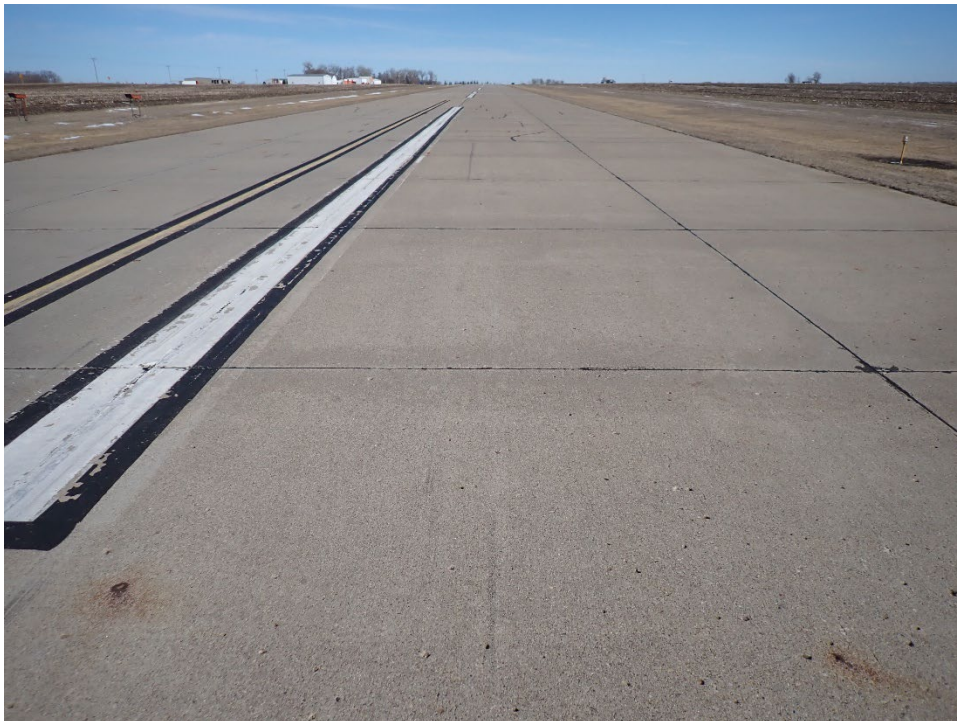
Runway 17/35 was defined by one section that was in *Poor* condition. Low- and medium-severity ASR, faulting, joint spalling, large patching, corner break, and longitudinal, transverse, and diagonal (LTD) cracking; medium- and high-severity corner spalling; high-severity joint seal damage; popouts; medium-severity shattered slab; and shrinkage cracking were recorded in Section 01 at the time of inspection.

R17IS-01. Overview.

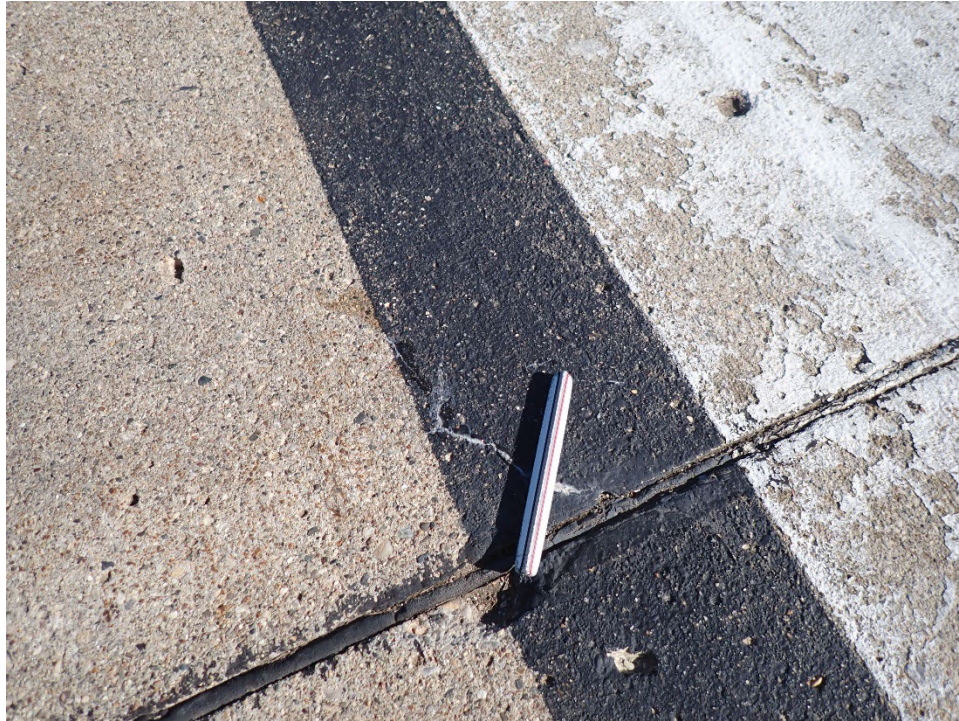
R17IS-01. ASR (Sample Unit No. 37).

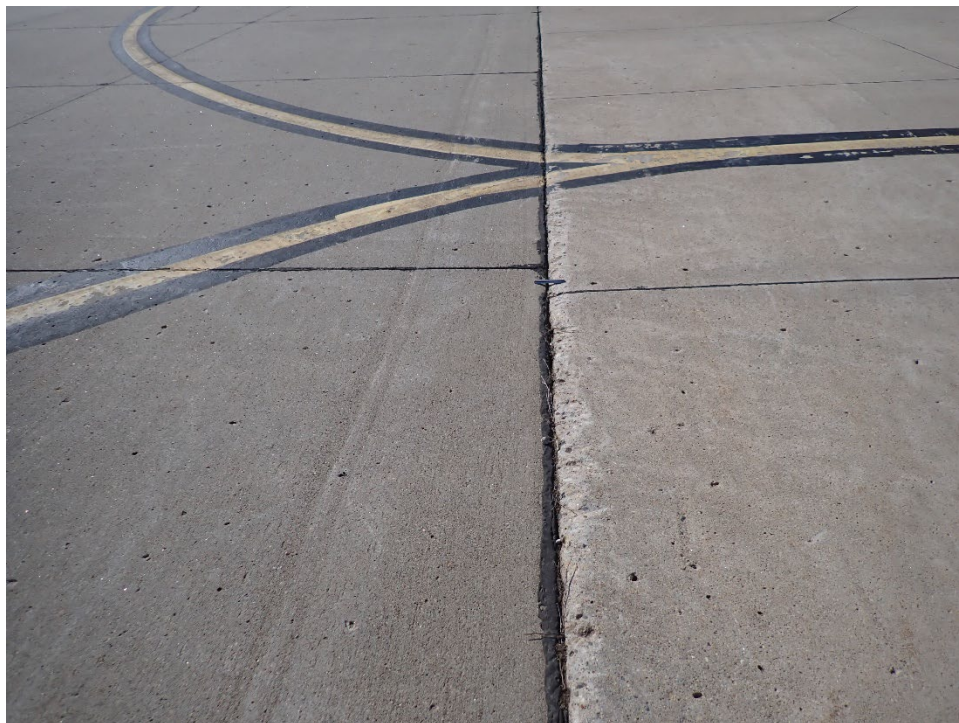
R17IS-01. Faulting (Sample Unit No. 12).

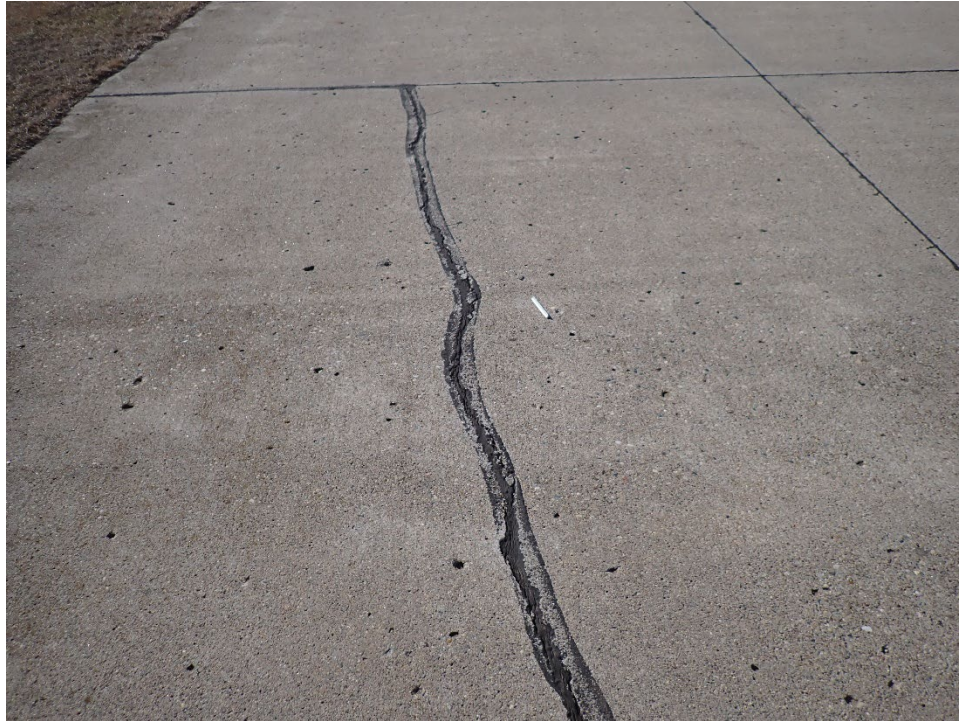
R17IS-01. LTD Cracking (Sample Unit No. 37).

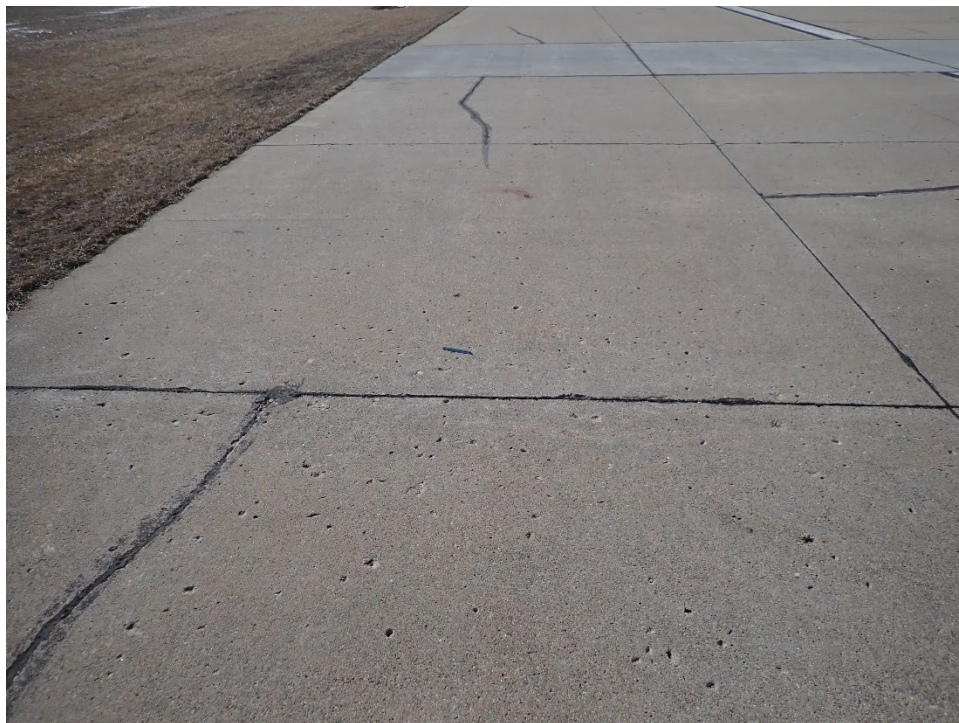
R17IS-01. Popouts (Sample Unit No. 32).

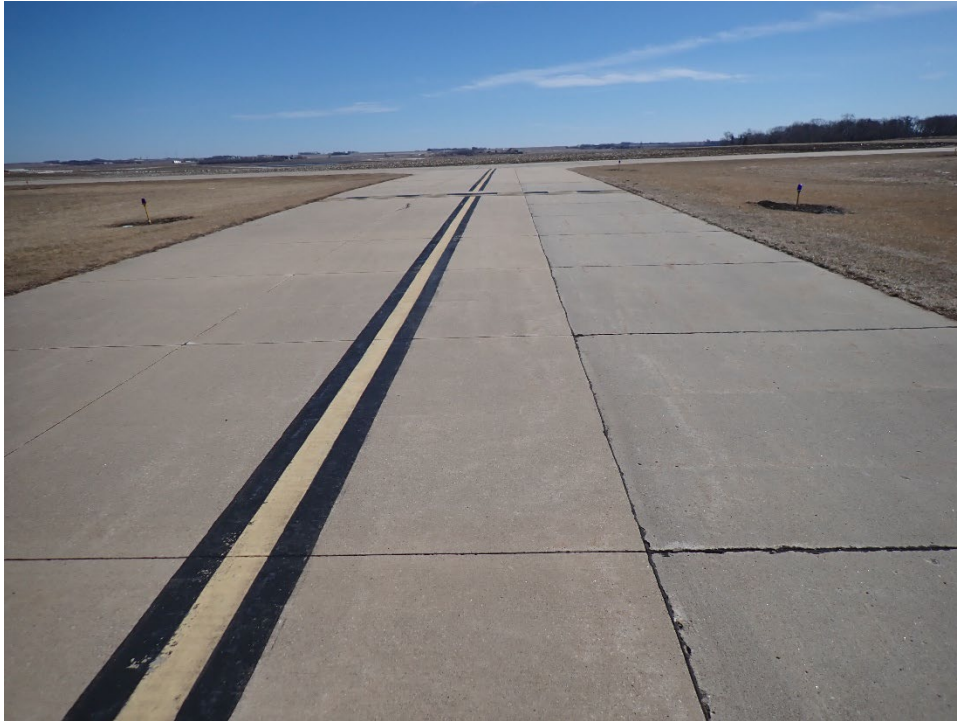
Taxiway 01 contained one section with multiple distresses identified during the inspection, including medium- and high-severity corner spalling; low-severity faulting and large patching; high-severity joint seal damage; and low- and medium-severity joint spalling and LTD cracking.

T01IS-01. Overview.

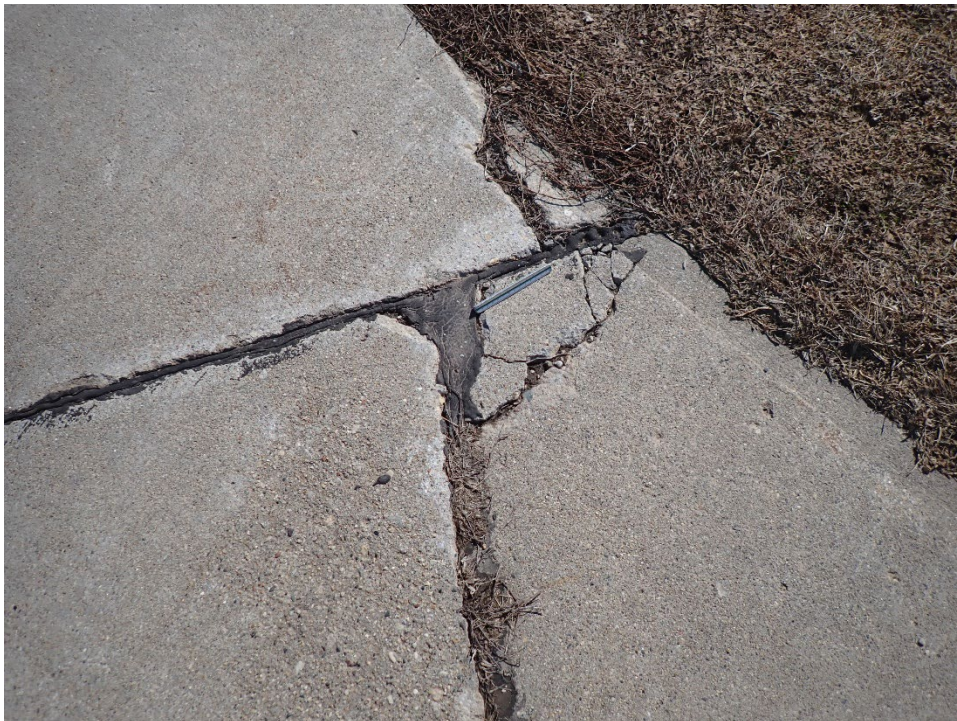
T01IS-01. Joint Spalling (Sample Unit No. 01).

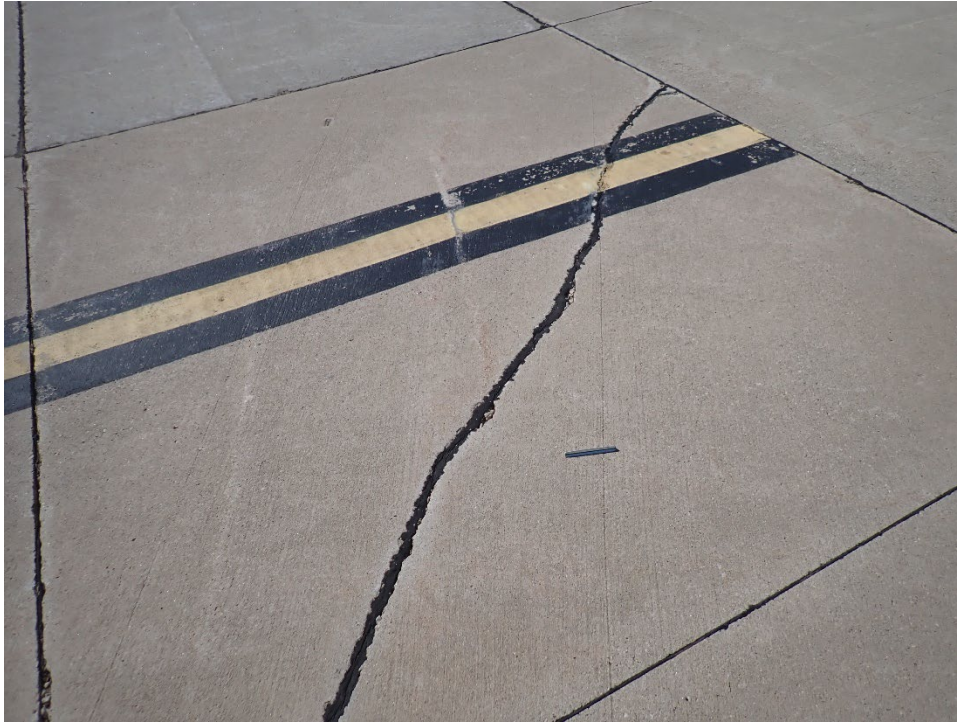
T01IS-01. LTD Cracking (Sample Unit No. 01).

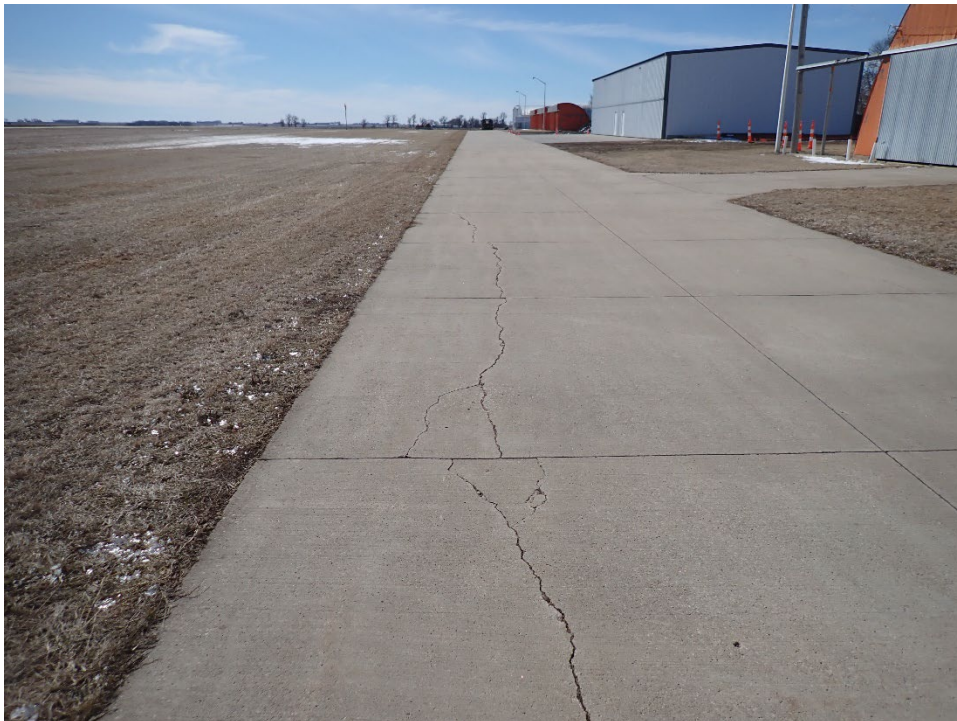
Taxiway 02 consisted of one section. Low- and medium-severity corner break, joint spalling, LTD cracking, and corner spalling; low-severity faulting; high-severity joint seal damage; and shrinkage cracking were recorded in Section 01.

T02IS-01. Overview.

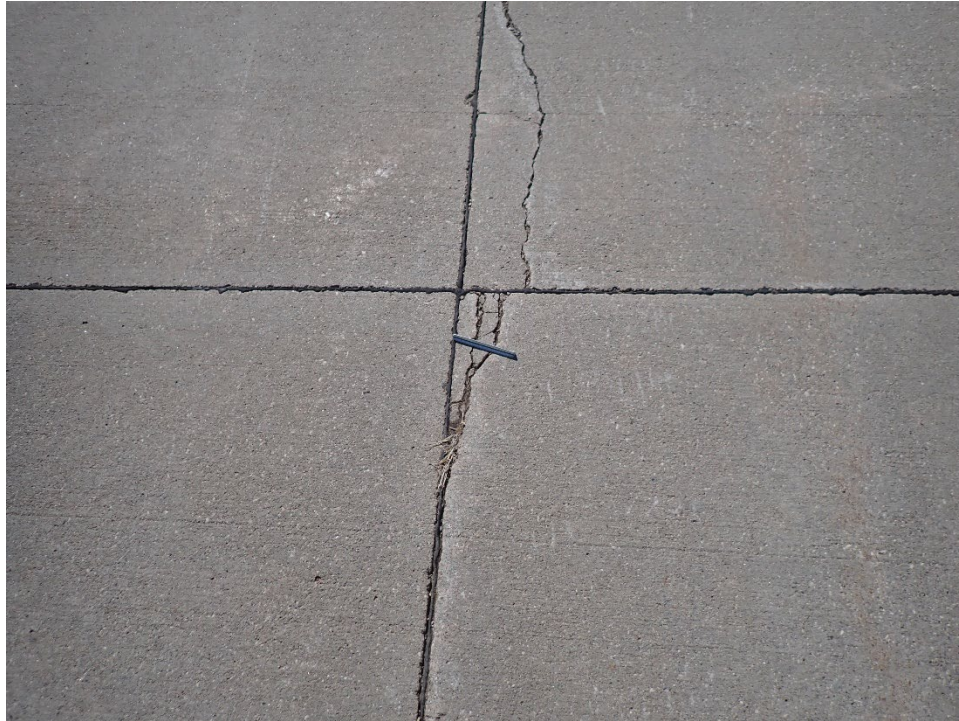
T02IS-01. Joint Spalling (Sample Unit No. 04).

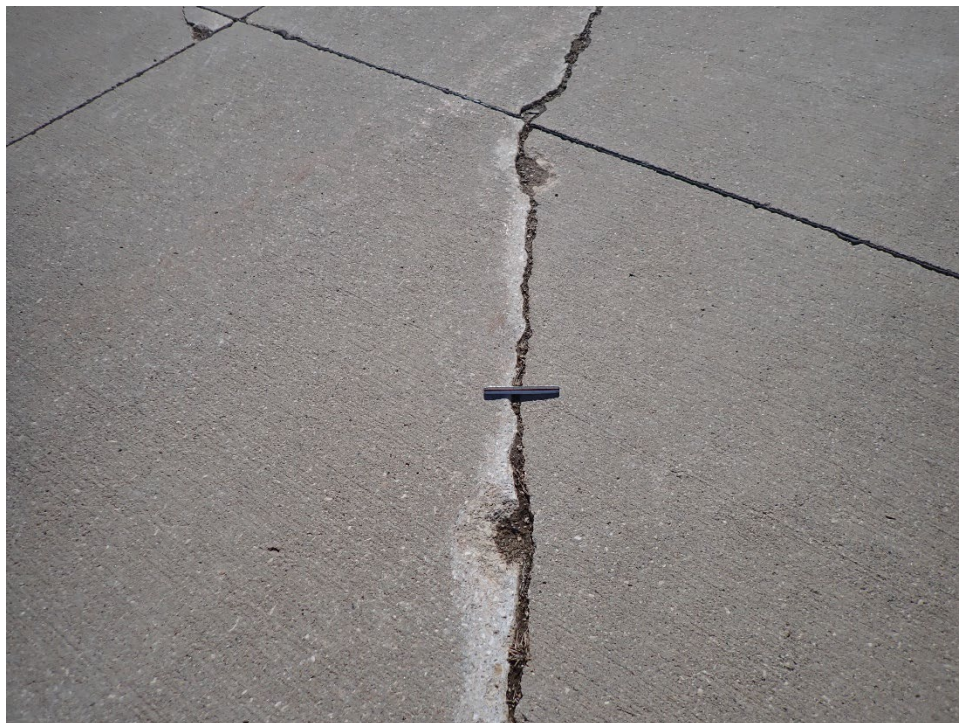
T02IS-01. LTD Cracking (Sample Unit No. 04).

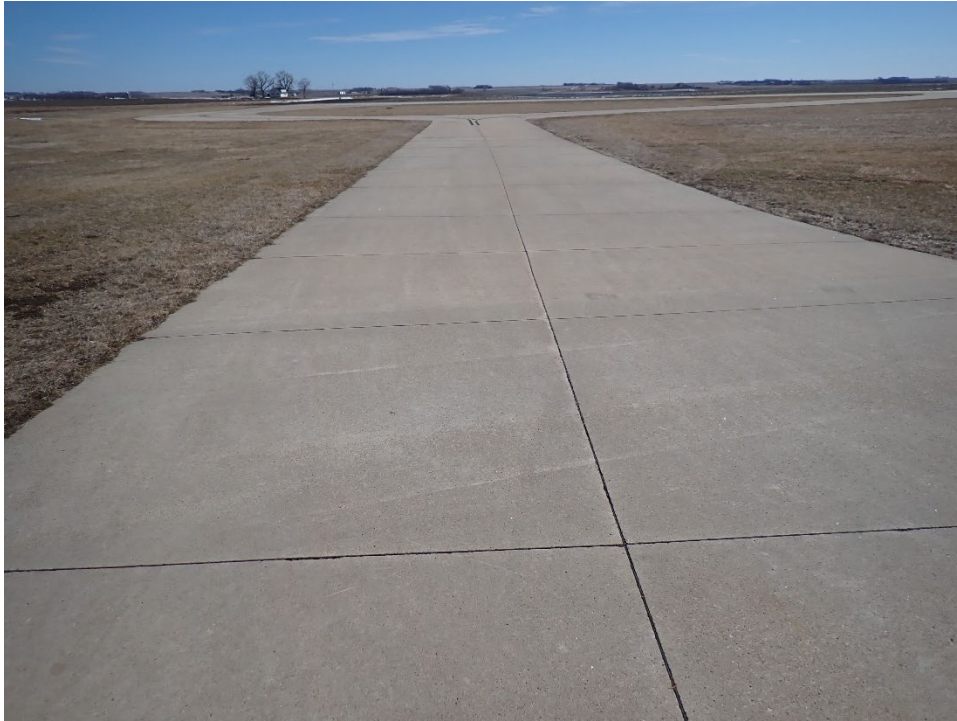
Taxiway 03 was defined by four sections. Medium-severity joint seal damage and low- and medium-severity joint spalling were identified in Section 01. Section 02 was in *Poor* condition with various distresses recorded at the time of inspection. These distresses included medium-severity corner break, LTD cracking, and joint spalling; low- and medium-severity faulting; high-severity joint seal damage; low-severity large patching and small patching; and popouts. In Section 03, popouts were identified along with low- and medium-severity ASR, corner spalling, and faulting; low-severity corner break; high-severity joint seal damage; and medium-severity joint spalling, large patching and LTD cracking. Section 04 was also in *Poor* condition. Low- and medium-severity ASR, shattered slab, and LTD cracking; all severities of corner break and joint seal damage; medium-severity faulting and joint spalling; and popouts were observed at the time of the inspection.

T03IS-01. Overview.

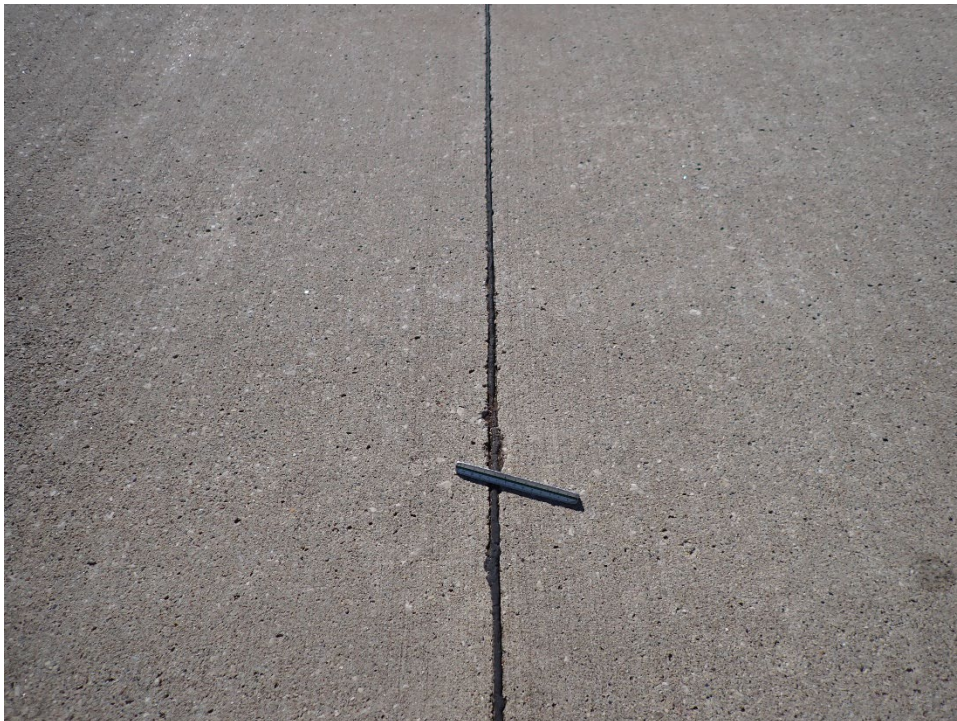
T03IS-01. Joint Seal Damage (Sample Unit No. 01).

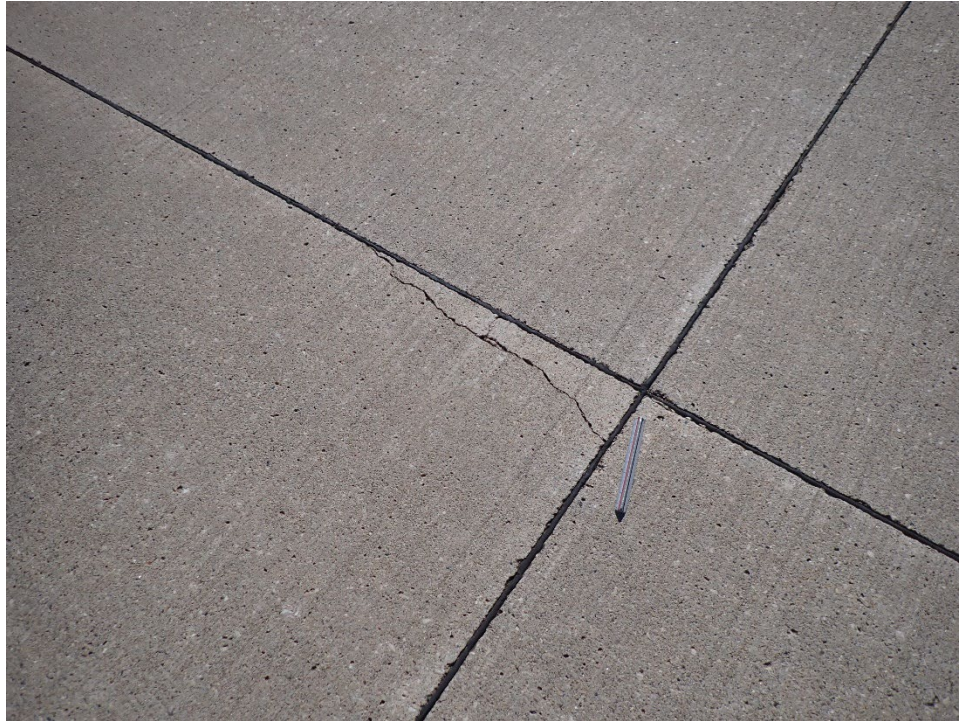
T03IS-01. Joint Spalling (Sample Unit No. 01).

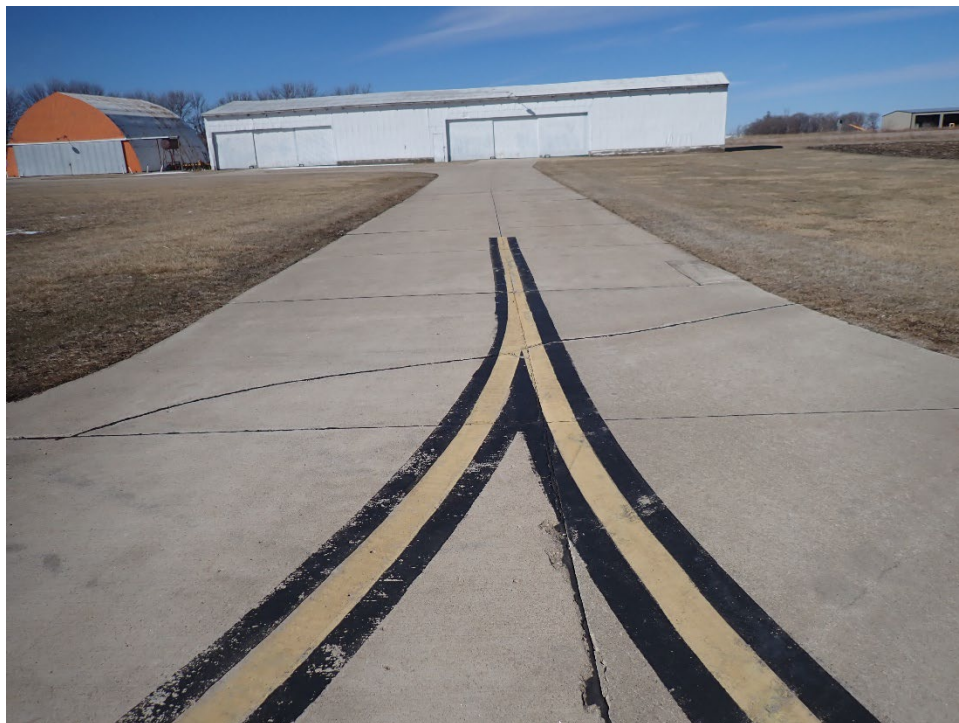
T03IS-02. Overview.

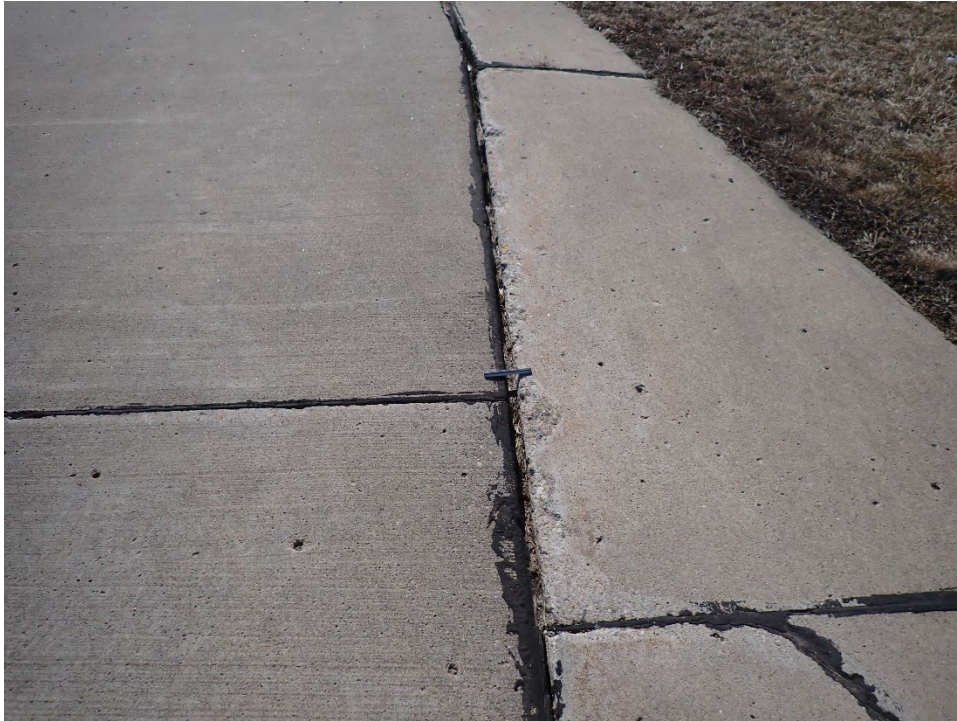
T03IS-02. Faulting (Sample Unit No. 01) (1).

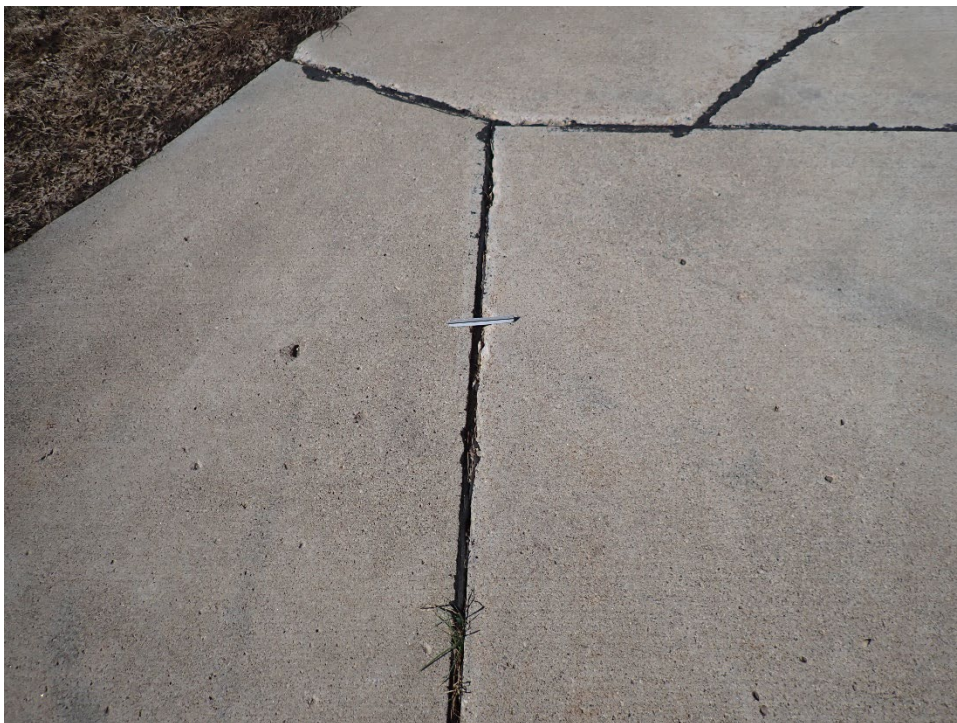
T03IS-02. Faulting (Sample Unit No. 01) (2).

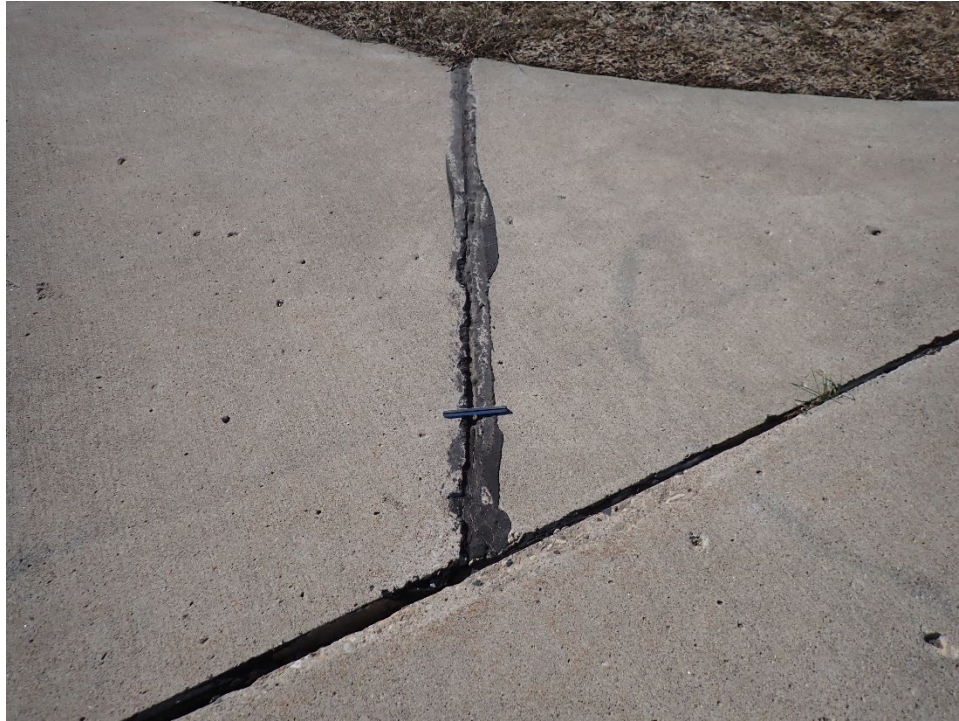
T03IS-02. LTD Cracking (Sample Unit No. 01).

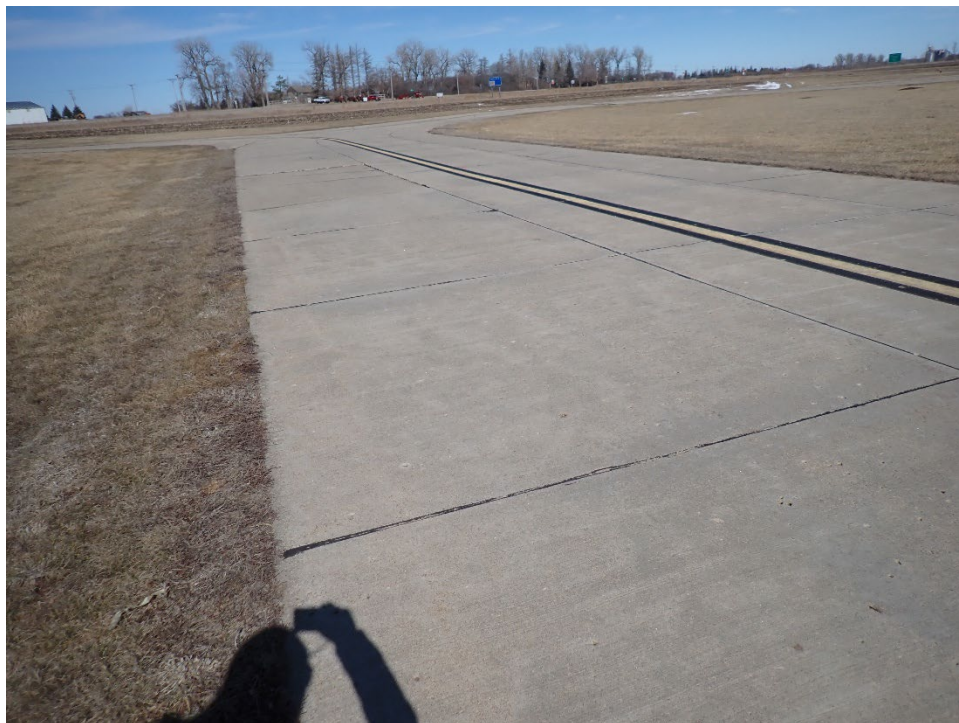
T03IS-03. Overview.

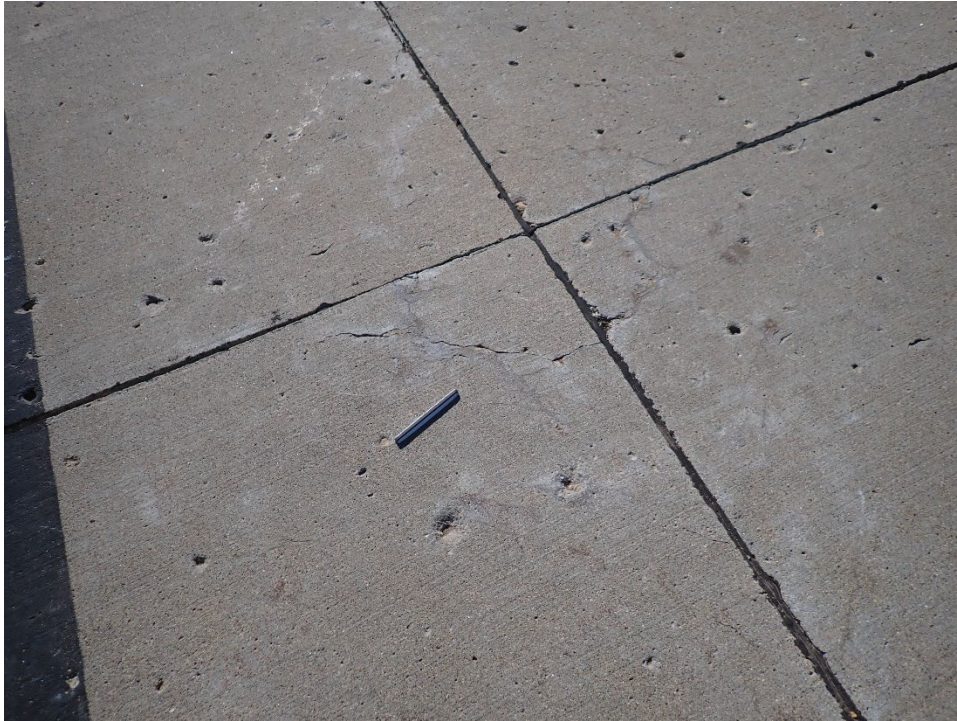
T03IS-03. ASR (Sample Unit No. 03).

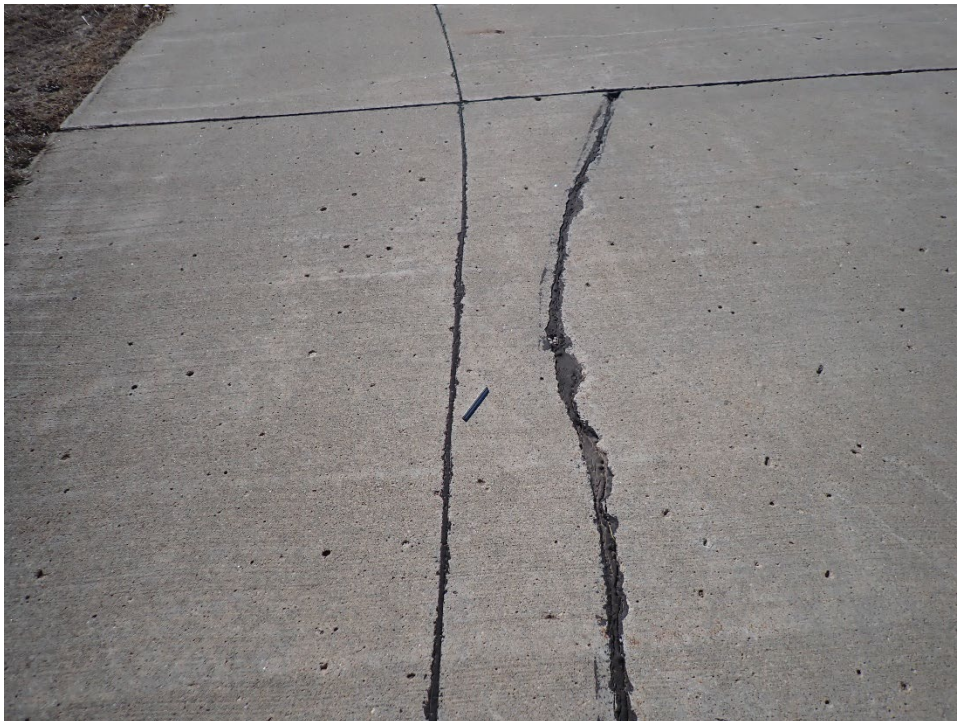
T03IS-03. LTD Cracking (Sample Unit No. 03).

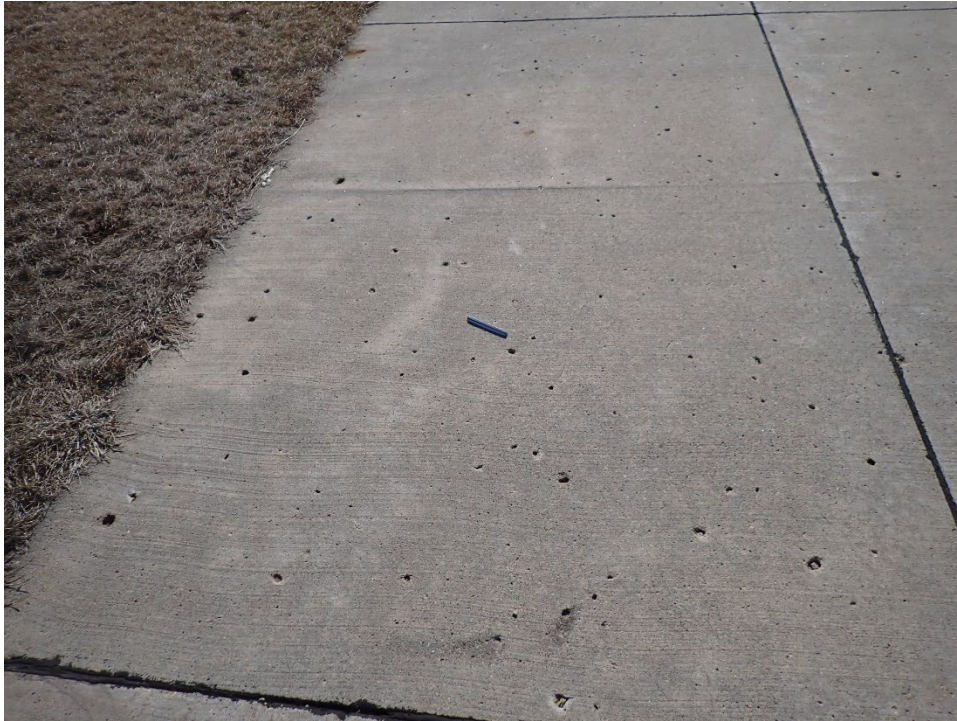
T03IS-03. Popouts (Sample Unit No. 01).

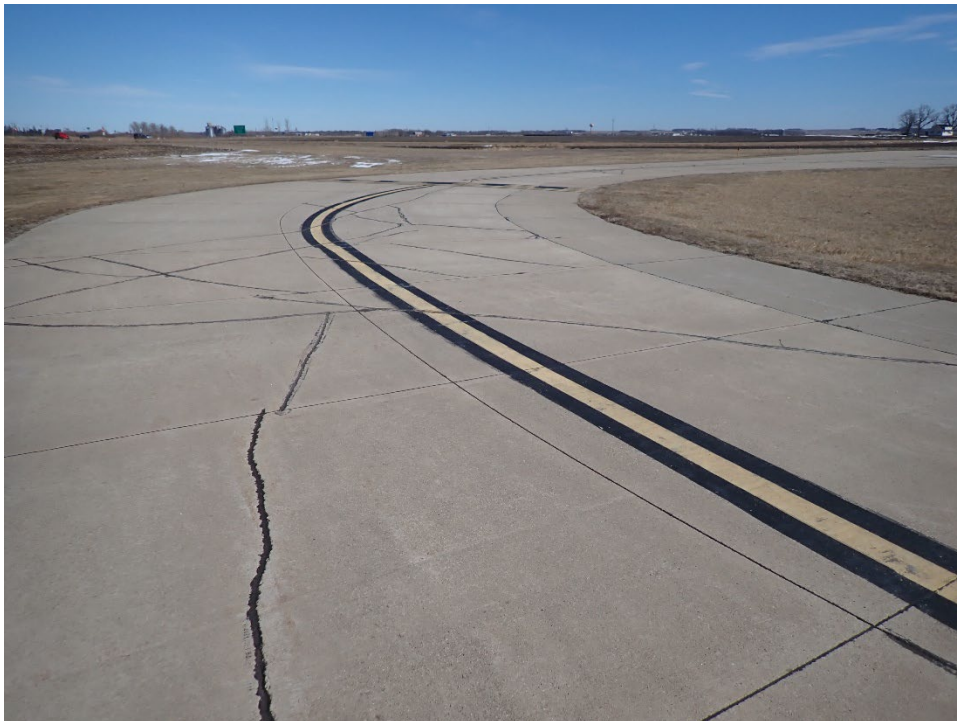
T03IS-04. Overview.

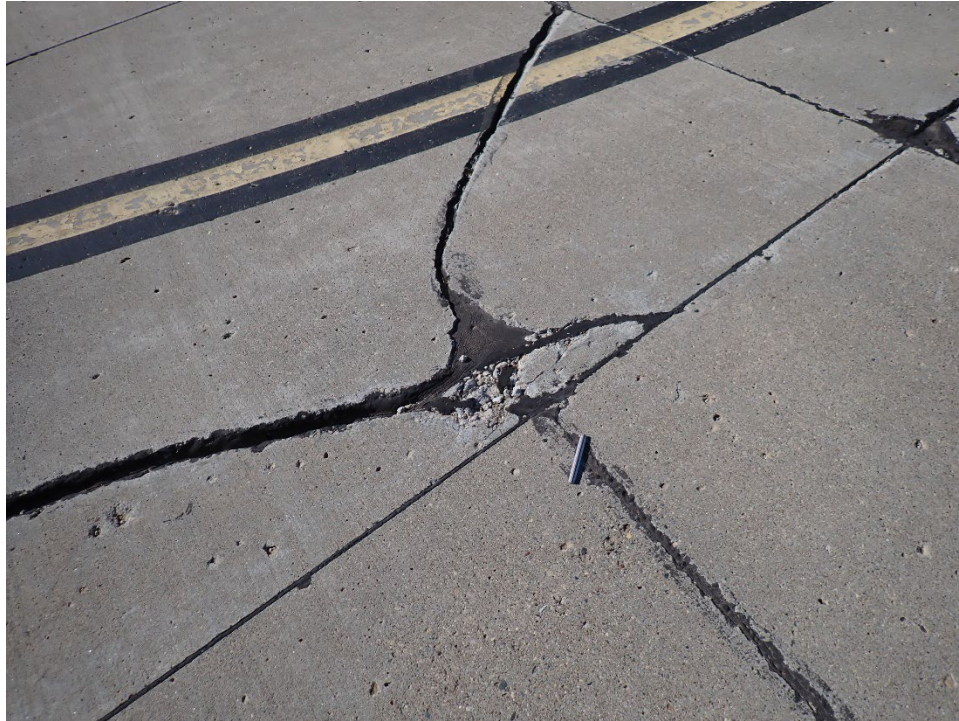
T03IS-04. ASR (Sample Unit No. 03).

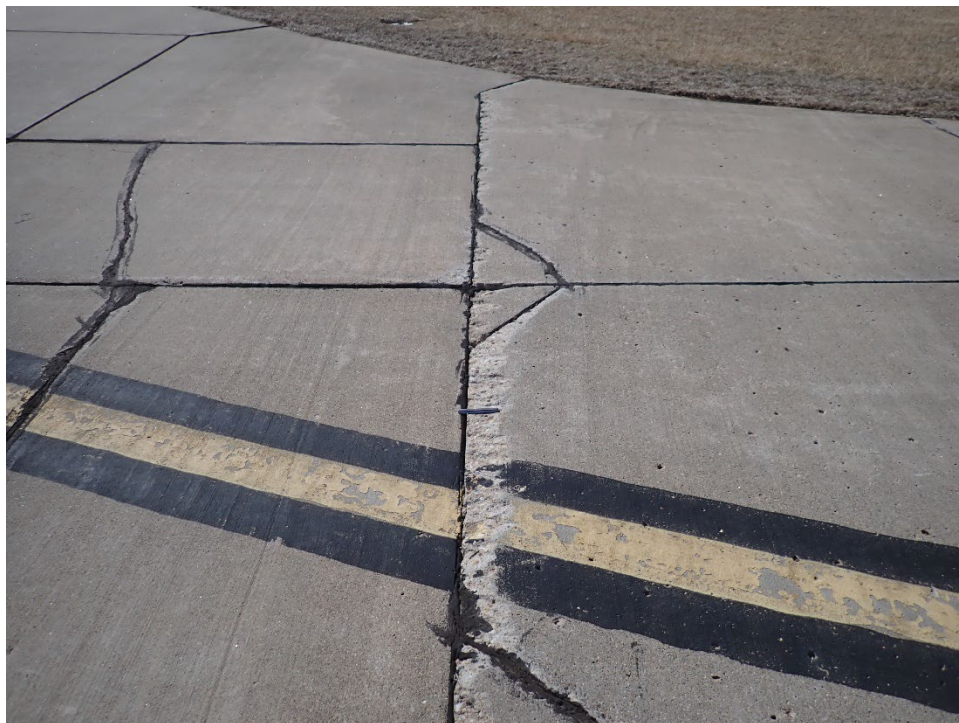
T03IS-04. Faulting (Sample Unit No. 03).

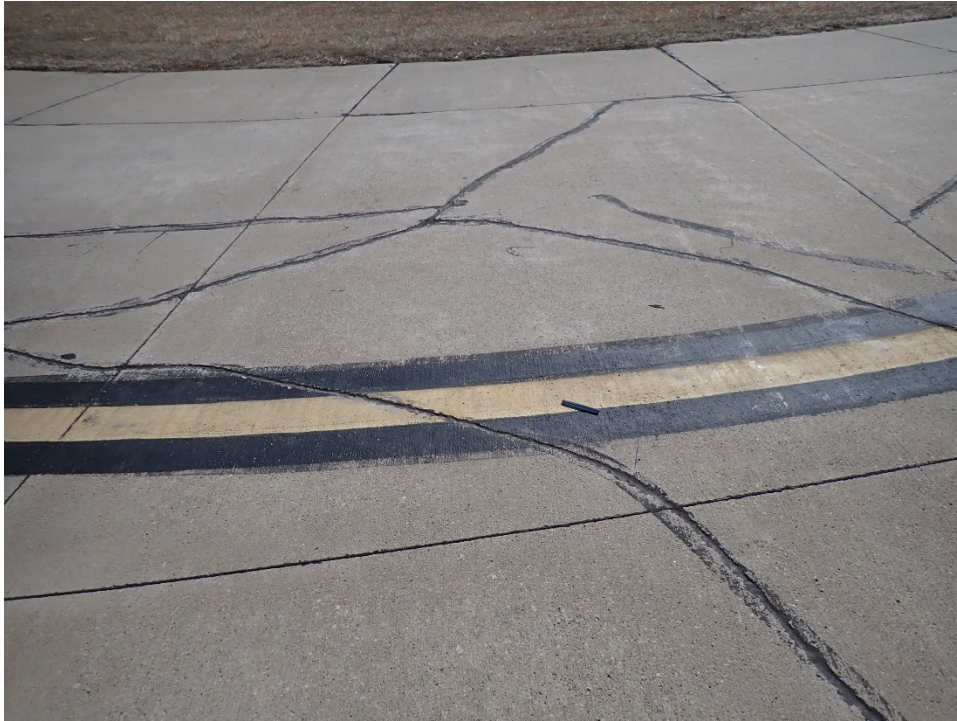
T03IS-04. Shattered Slab (Sample Unit No. 01).

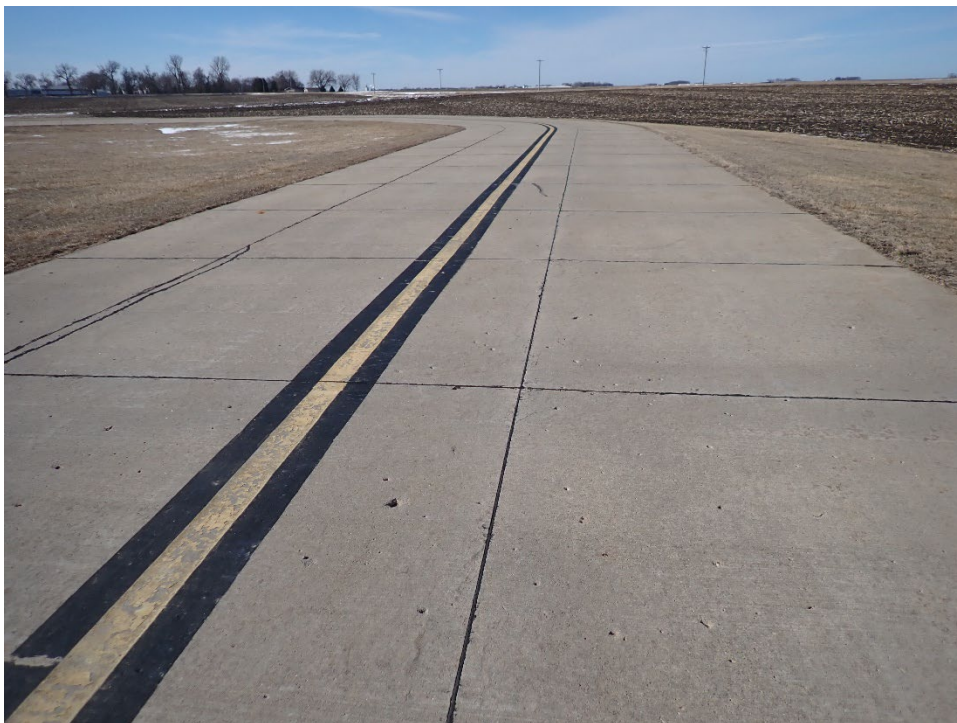
Taxiway 04 contained one section that was in *Poor* condition. Distresses recorded in the section included all severities of ASR, medium-severity corner spalling and joint spalling, low- and medium-severity faulting and LTD cracking, high-severity joint seal damage, popouts, and shrinkage cracking.

T04IS-01. Overview.
