# Sibley Municipal Airport

## Pavement Management Report

**AUGUST 2025**

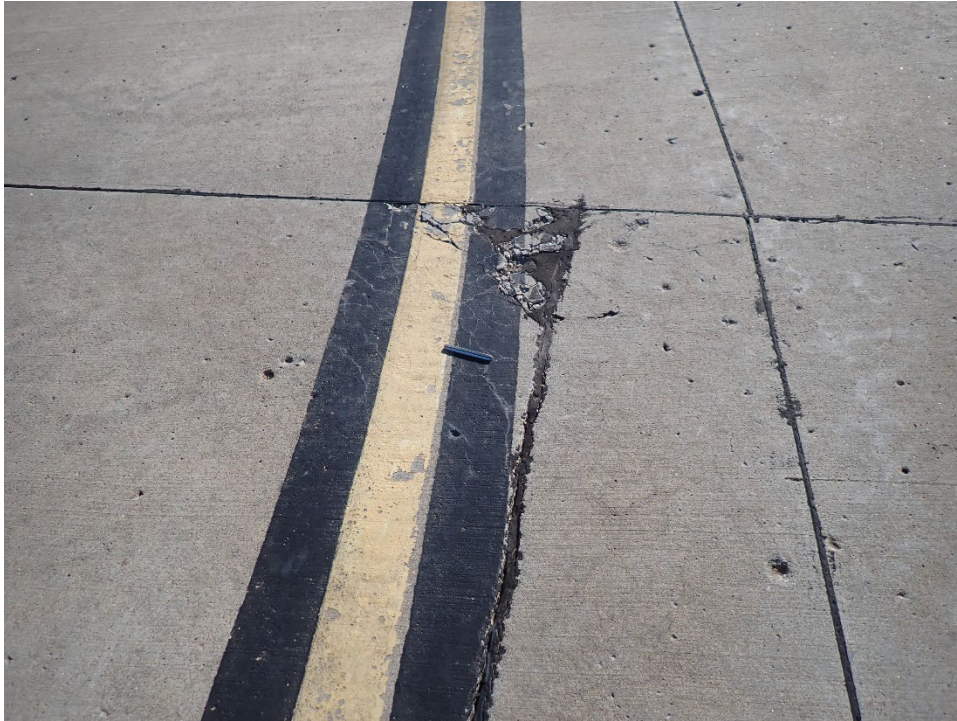
T04IS-01. ASR (Sample Unit No. 02).

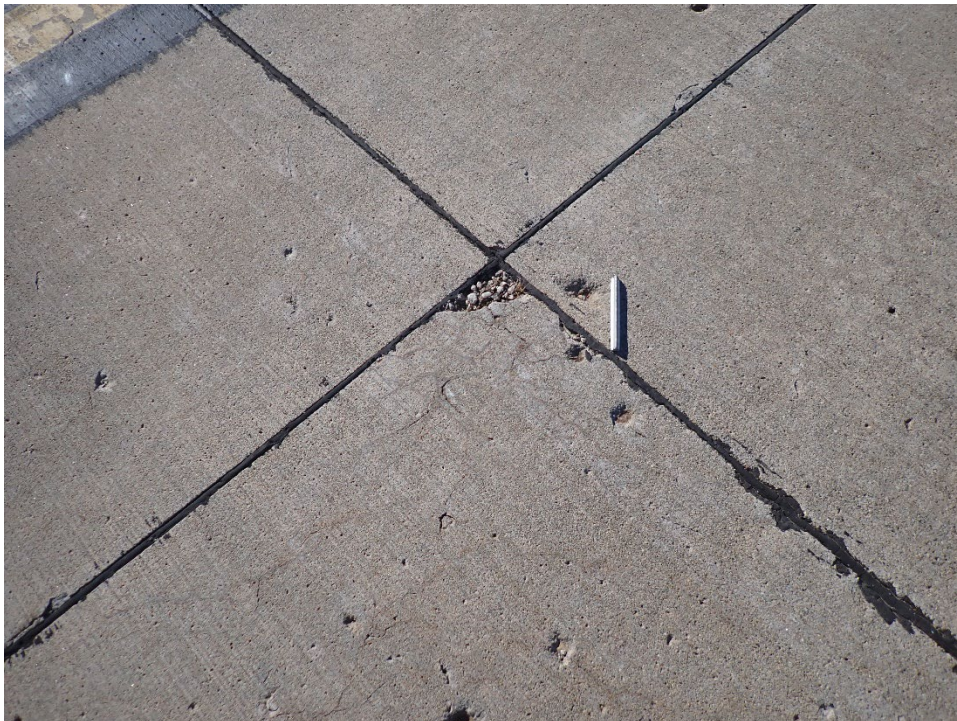
T04IS-01. ASR (Sample Unit No. 05).

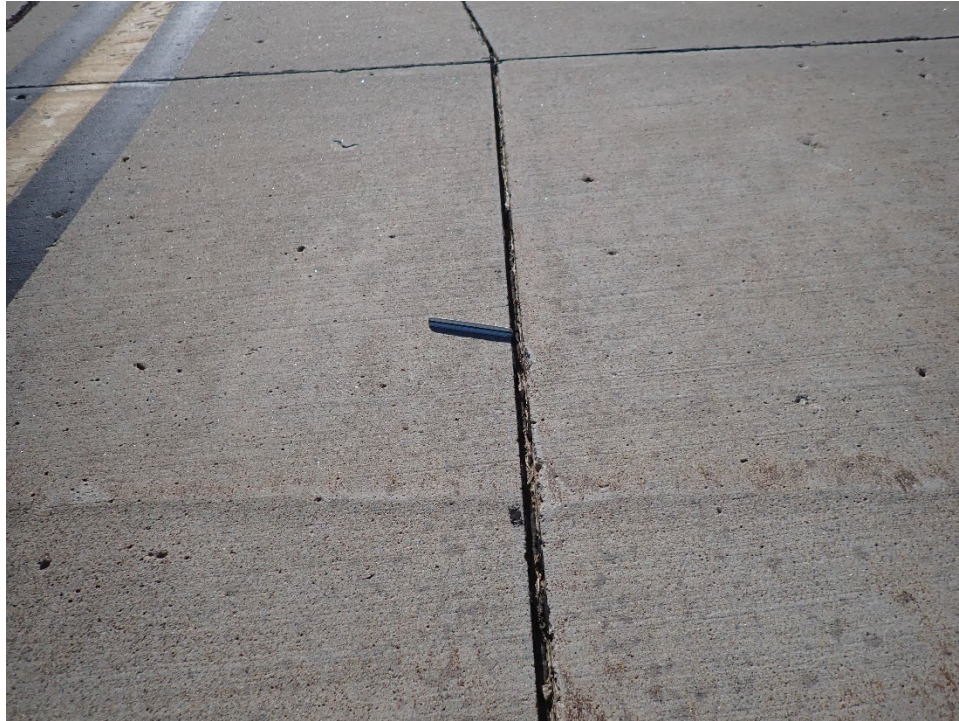
T04IS-01. Joint Seal Damage (Sample Unit No. 02).

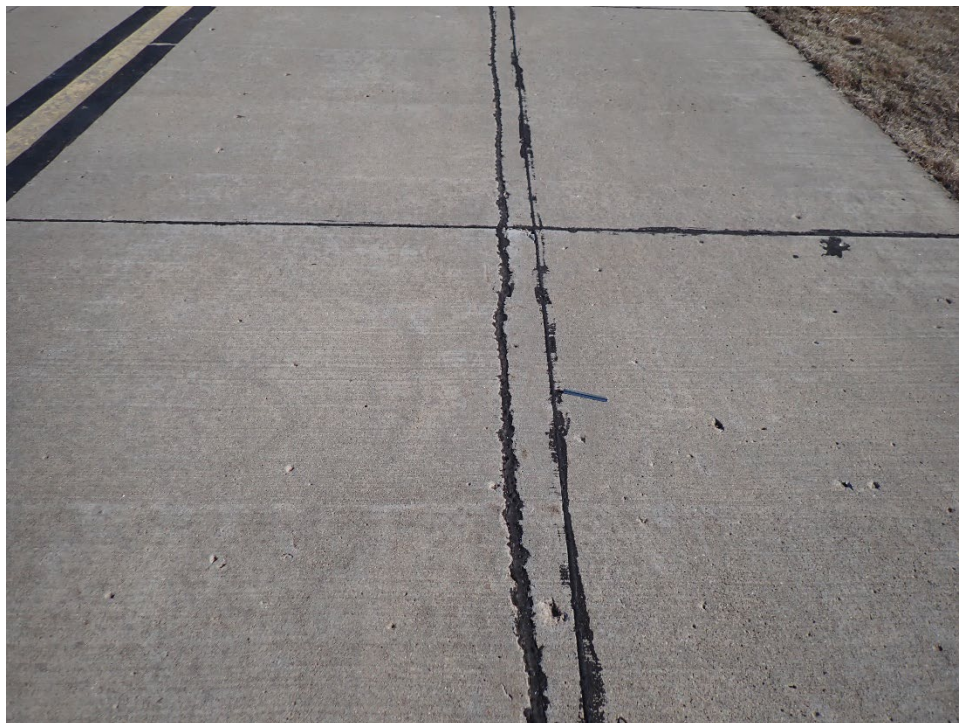
T04IS-01. LTD Cracking (Sample Unit No. 05).
