# Sioux County Regional Airport

## Pavement Management Report

**AUGUST 2026**

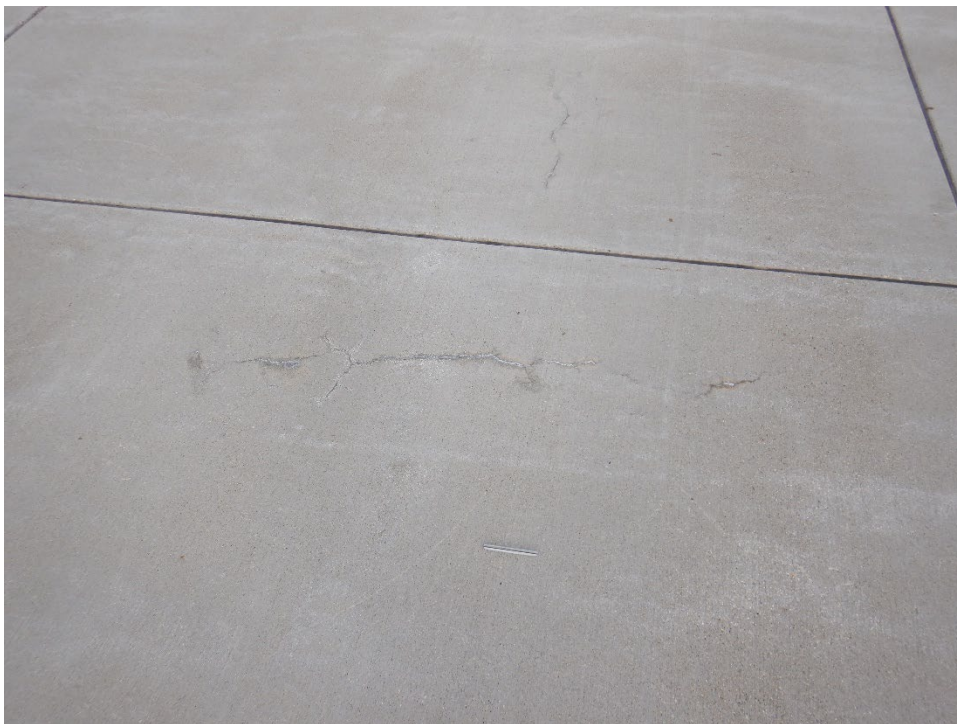
A01SX-01. ASR (Additional Sample Unit No. 41) (1).

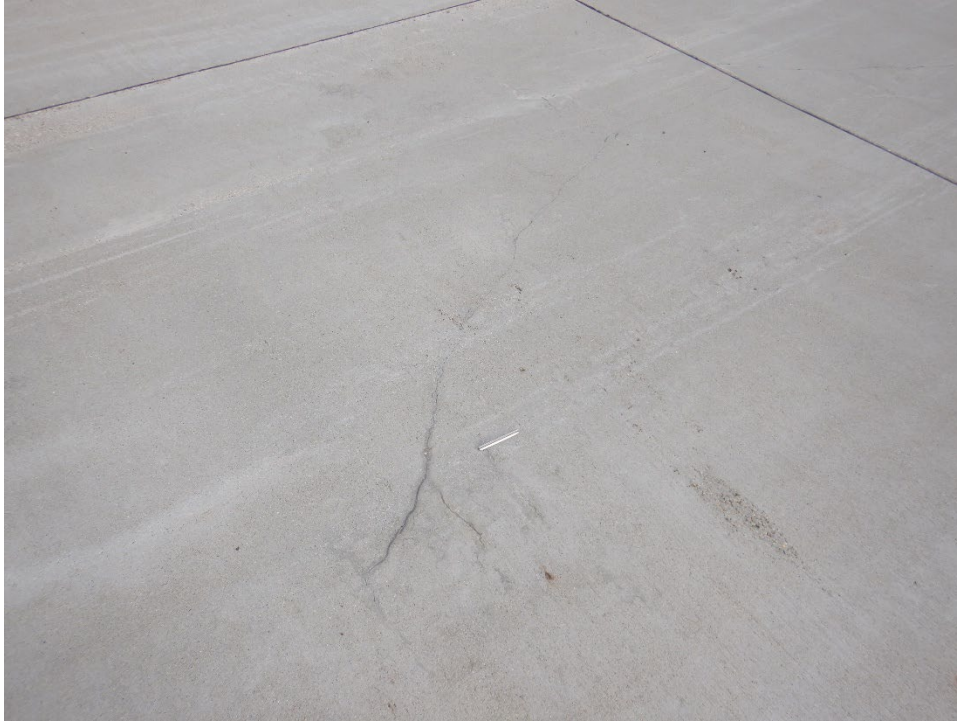
A01SX-01. ASR (Additional Sample Unit No. 41) (2).

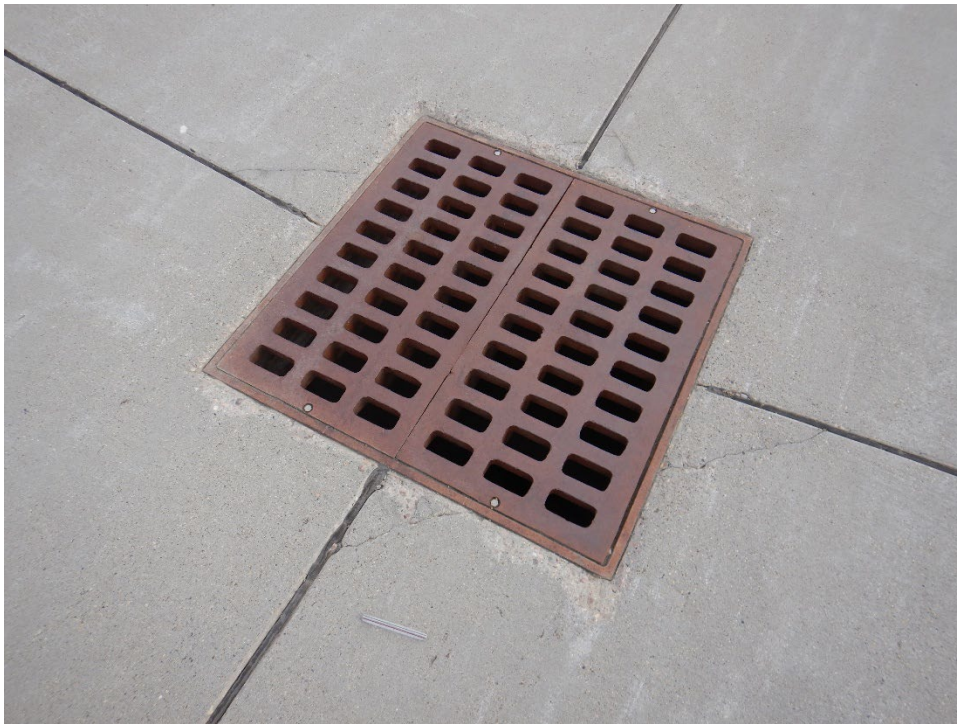
A01SX-01. Corner Spalling (Sample Unit No. 47).

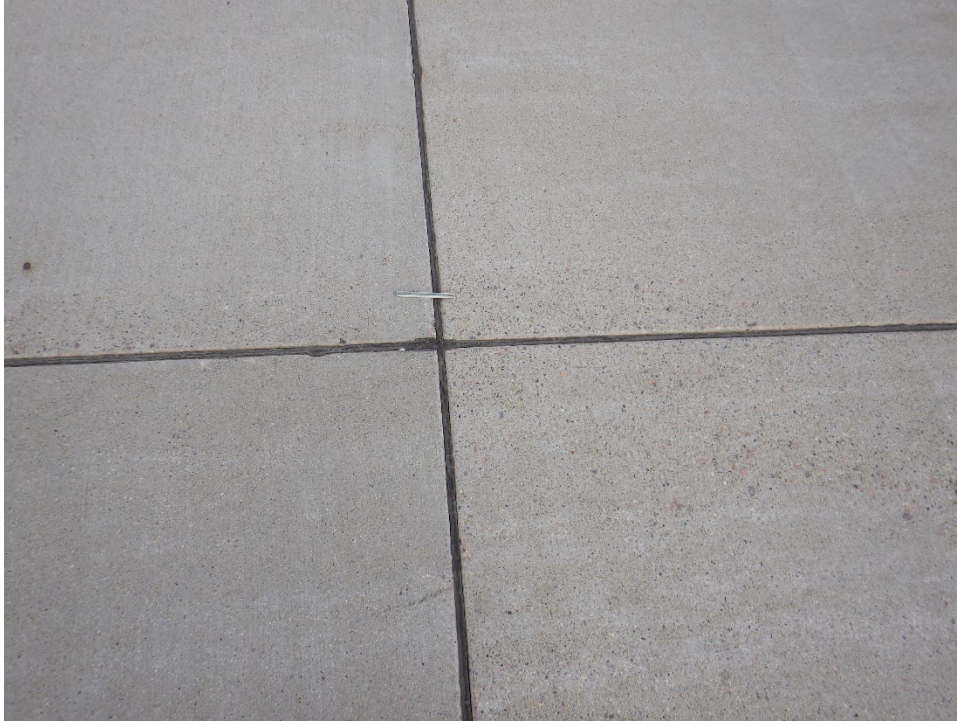
A01SX-01. Joint Seal Damage (Sample Unit No. 47).

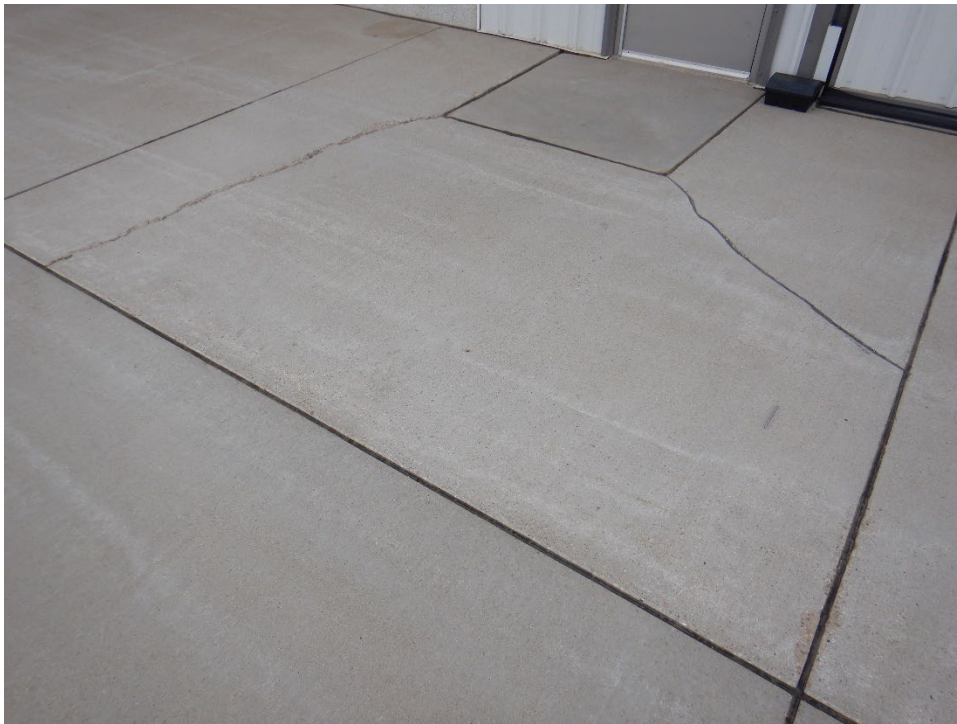
A01SX-01. LTD Cracking (Additional Sample Unit No. 56).

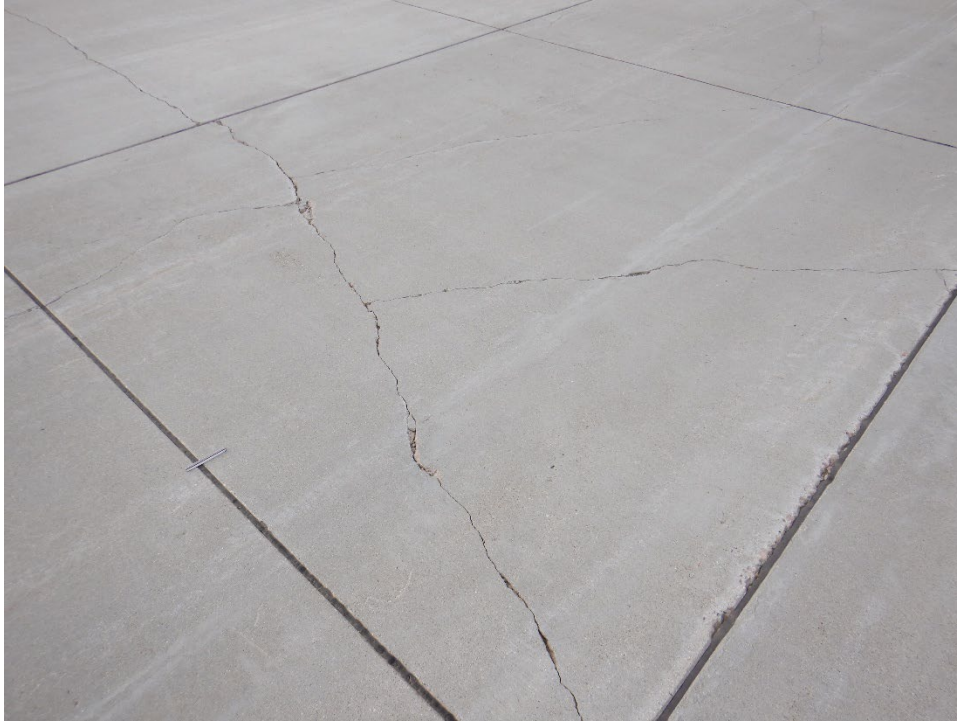
A01SX-01. Shattered Slab (Additional Sample Unit No. 41).

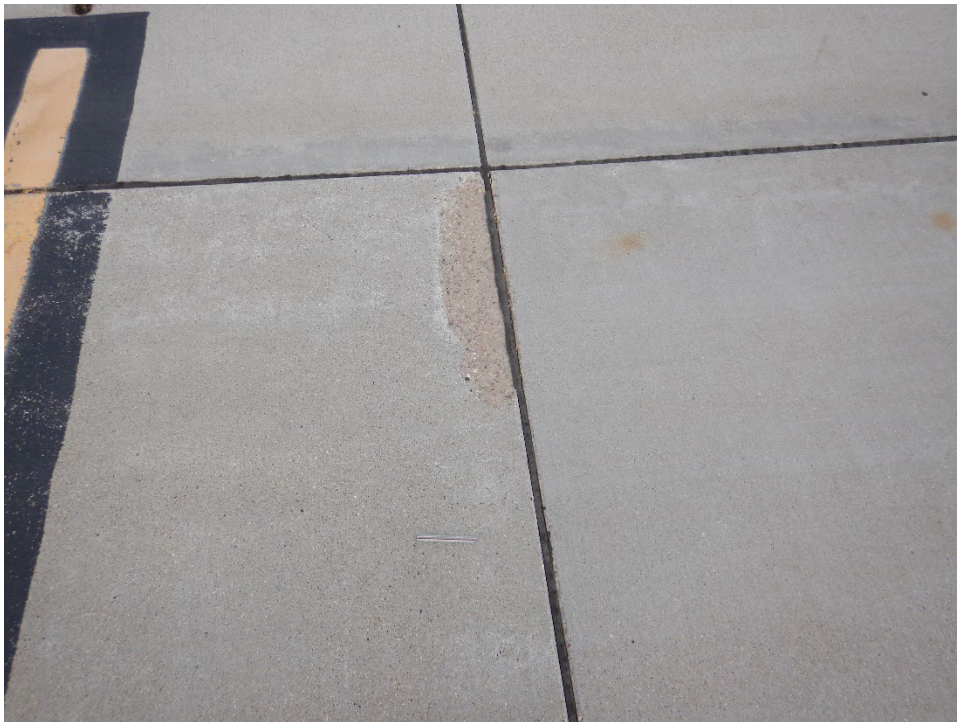
A01SX-01. Small Patching (Additional Sample Unit No. 14).

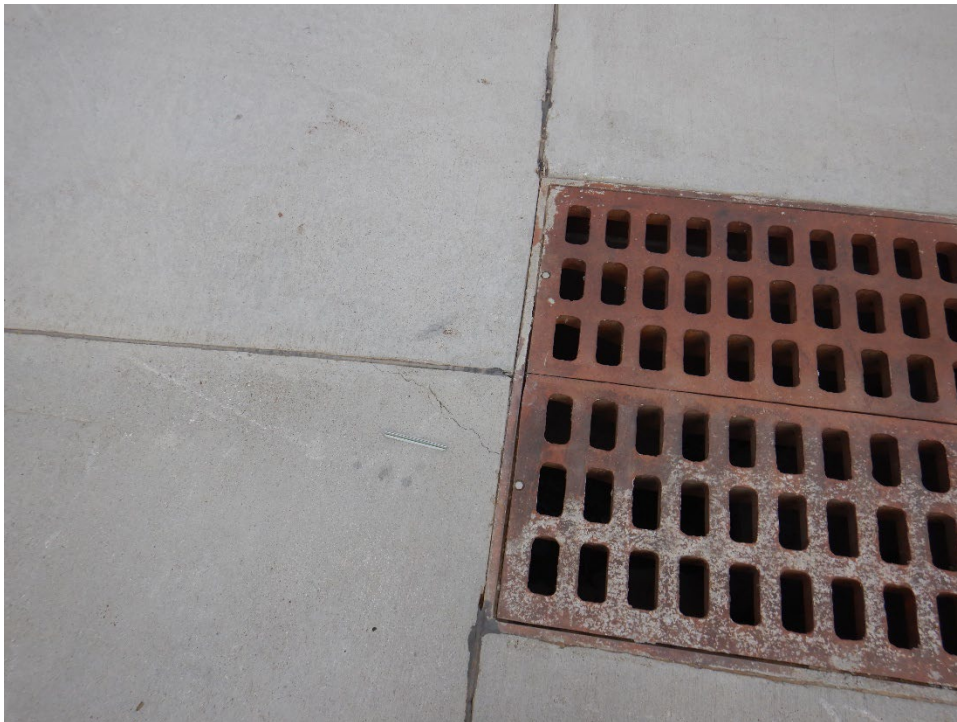
A01SX-02. Corner Spalling (Sample Unit No. 12).

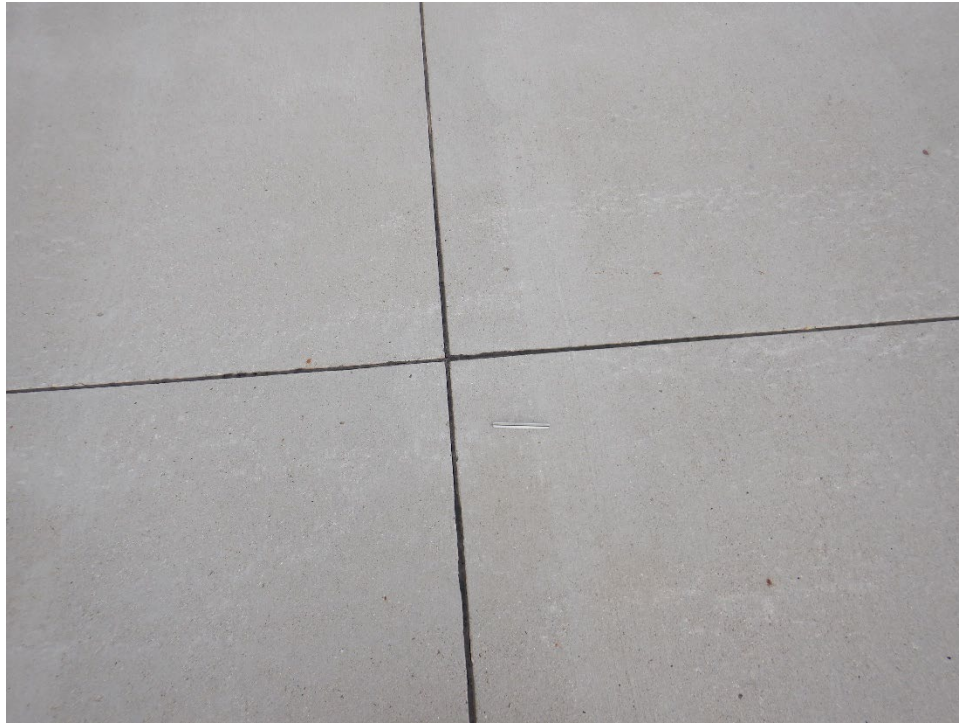
A01SX-02. Joint Seal Damage (Sample Unit No. 02).

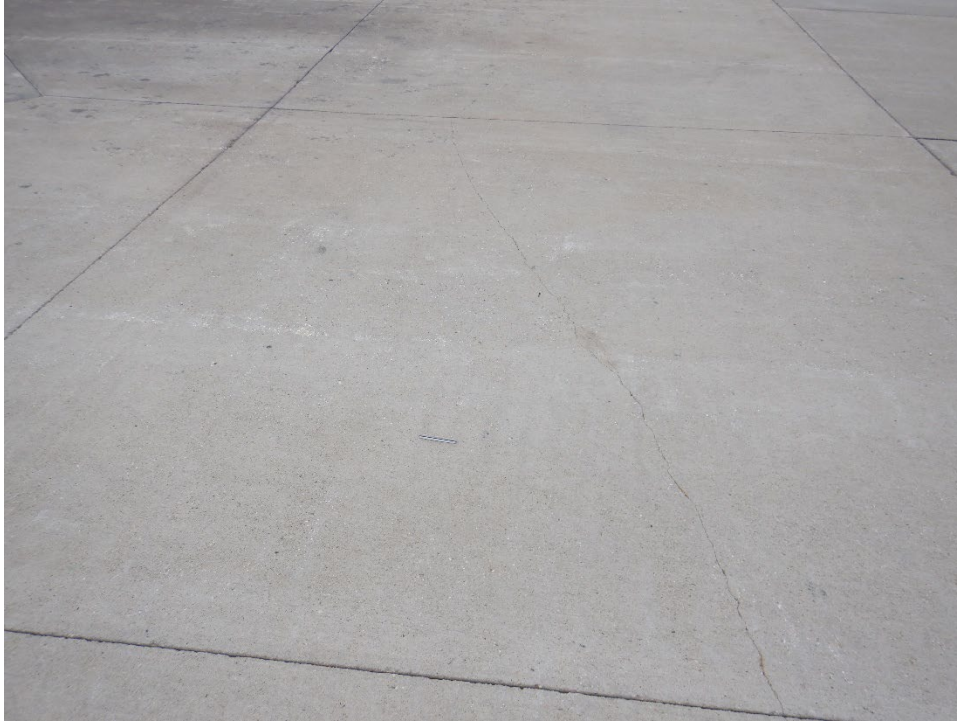
A01SX-03. LTD Cracking (Sample Unit No. 01).

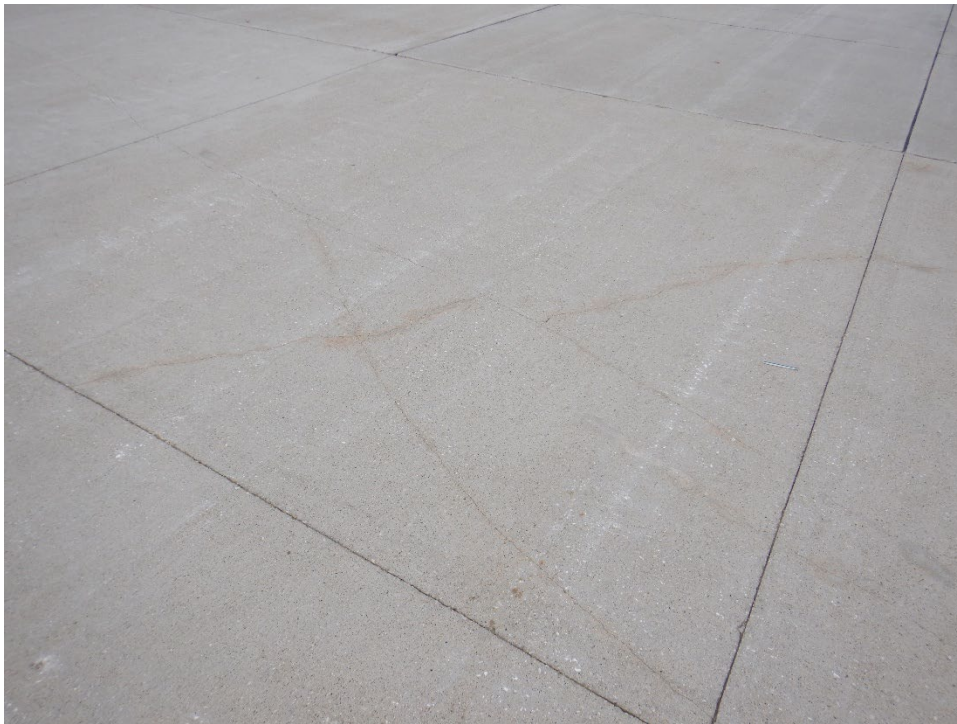
A01SX-03. Shattered Slab (Sample Unit No. 01).

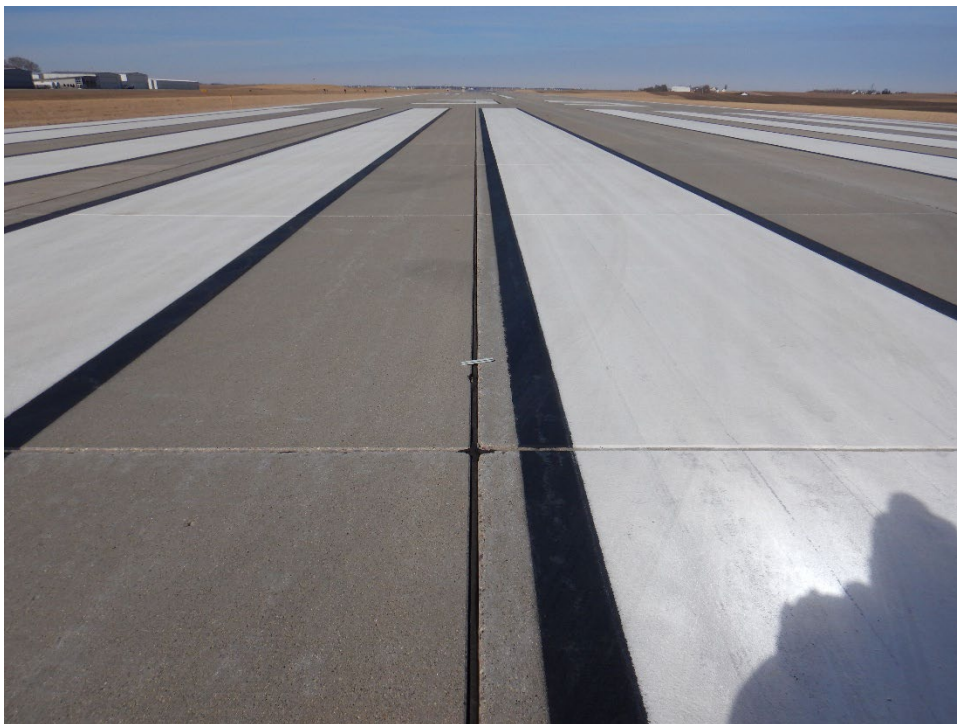
R17SX-01. Faulting (Sample Unit No. 78).

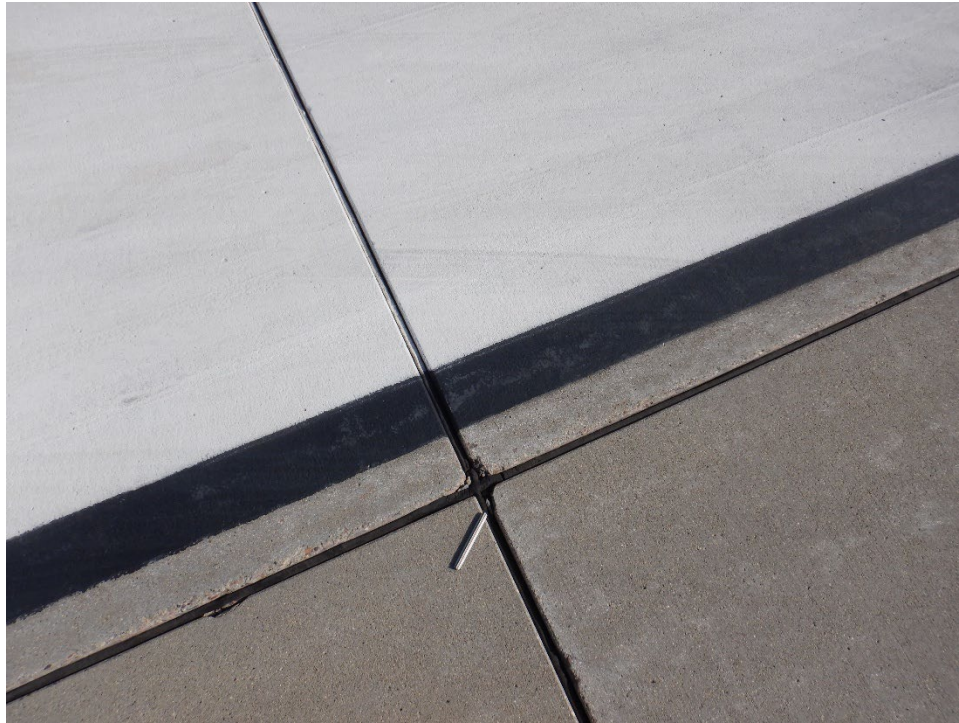
R17SX-01. Joint Seal Damage (Sample Unit No. 78).

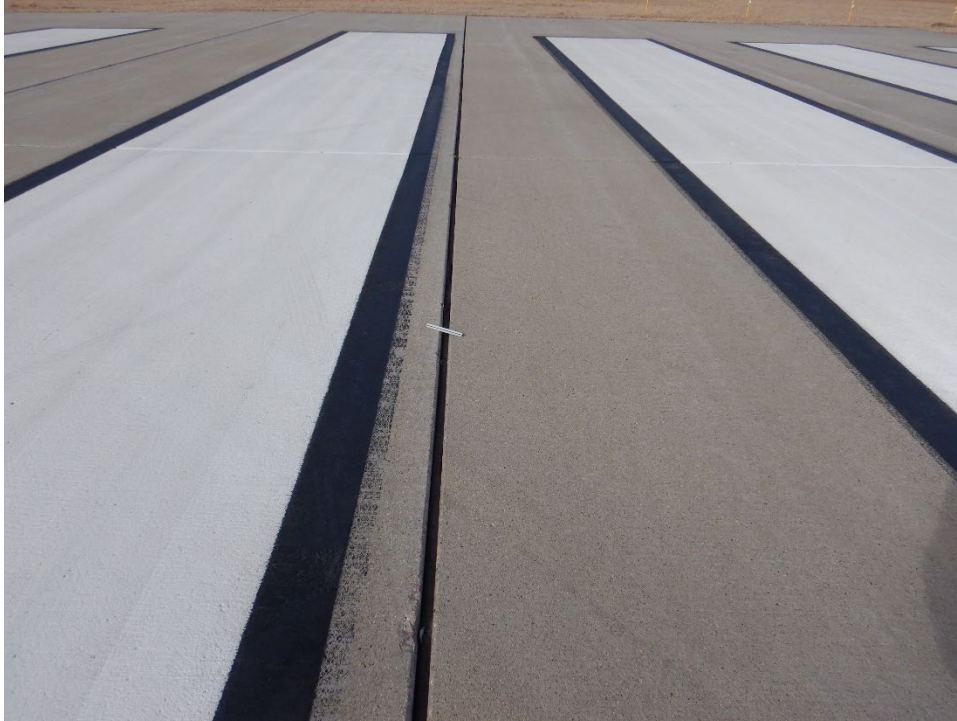
R17SX-02. Faulting (Additional Sample Unit No. 01).

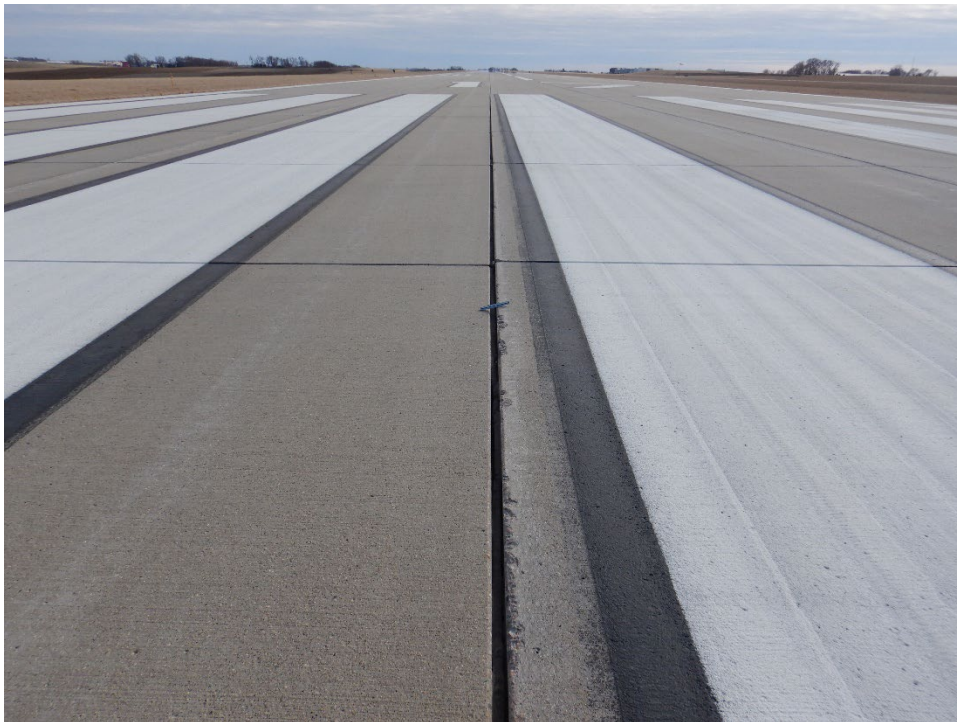
R17SX-02. Faulting (Additional Sample Unit No. 03).

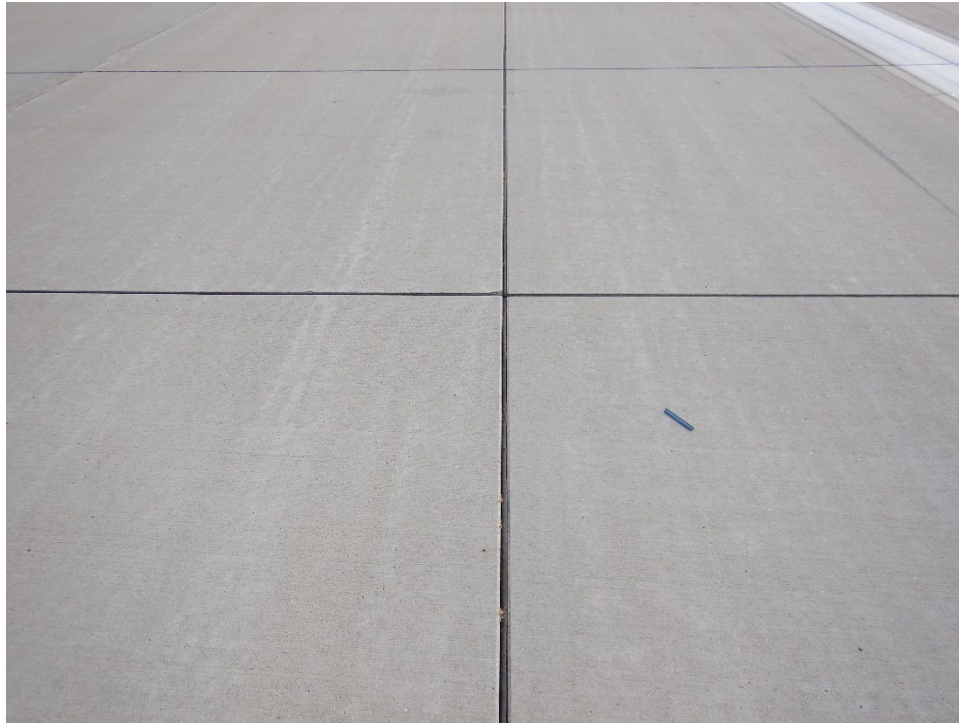
R17SX-02. Joint Seal Damage (Sample Unit No. 63).

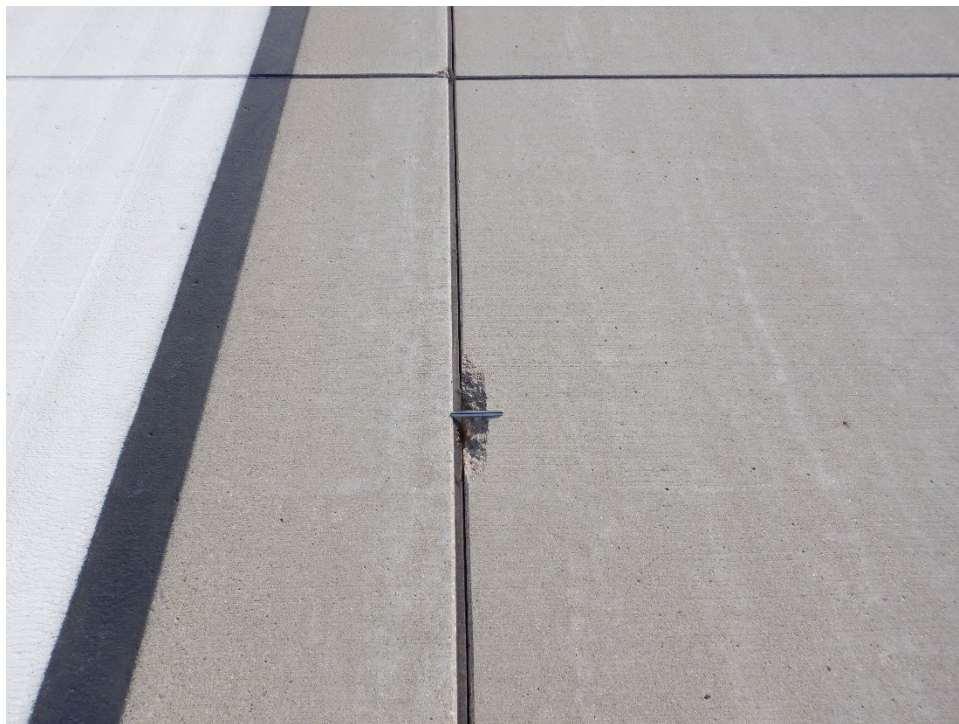
R17SX-02. Joint Spalling (Sample Unit No. 07).

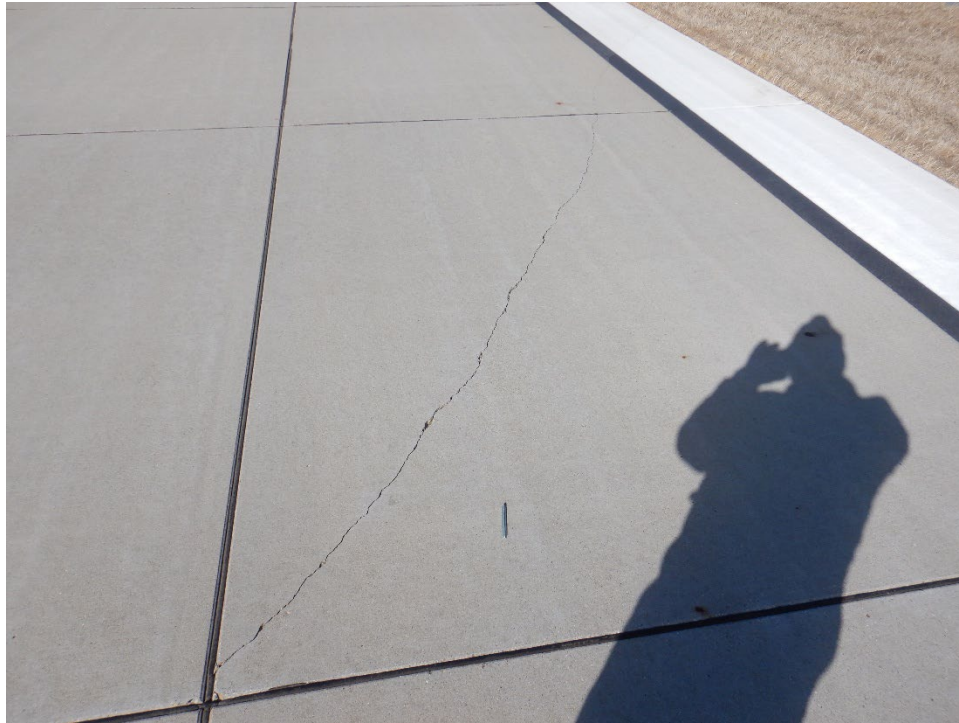
R17SX-02. LTD Cracking (Sample Unit No. 63).

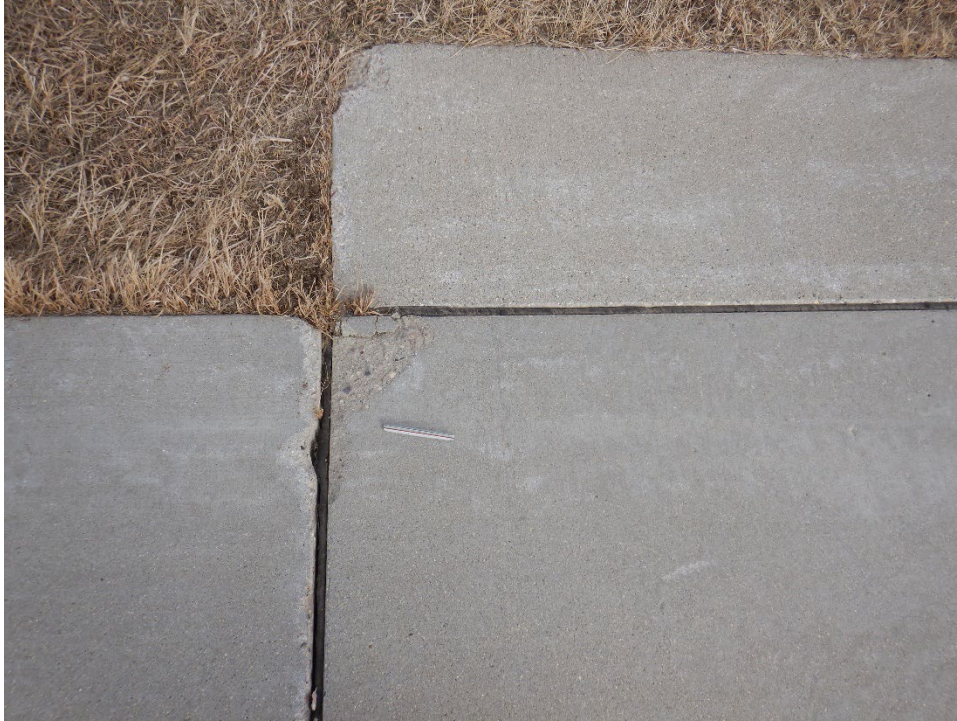
TASX-01. Corner Spalling (Sample Unit No. 06).

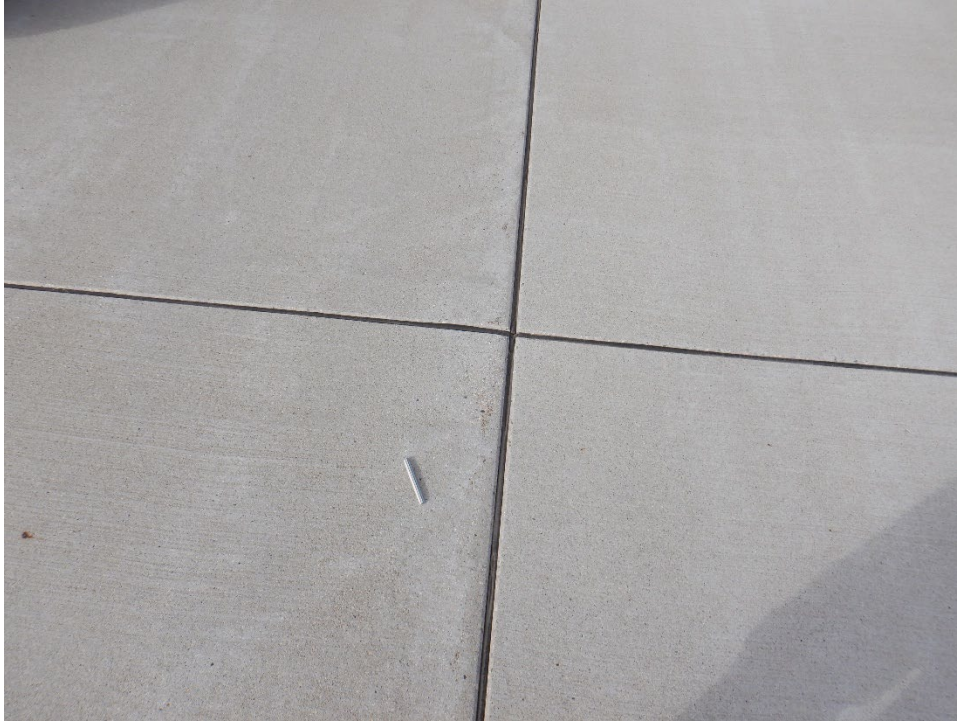
TASX-02. Joint Seal Damage (Sample Unit No. 02).

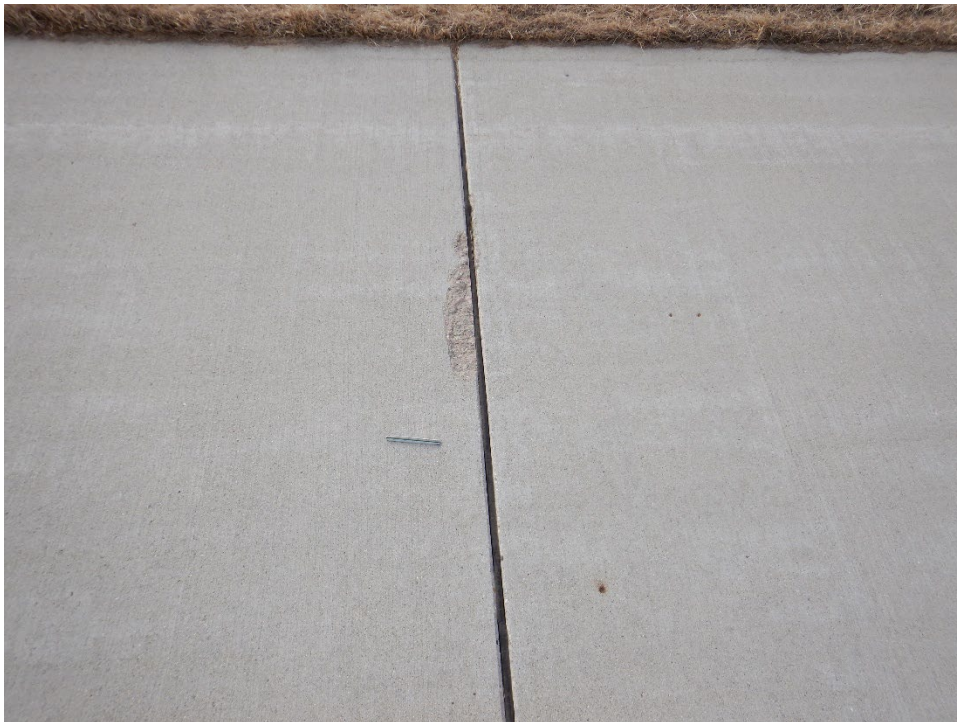
TASX-02. Joint Spalling (Sample Unit No. 02).

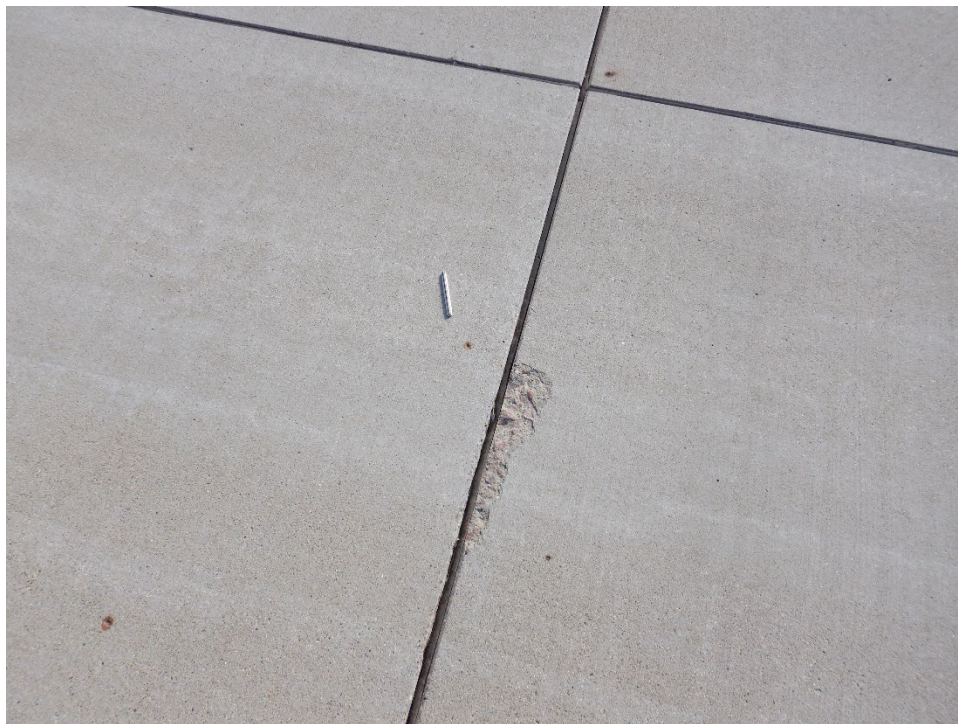
TBSX-01. Joint Spalling (Sample Unit No. 02).

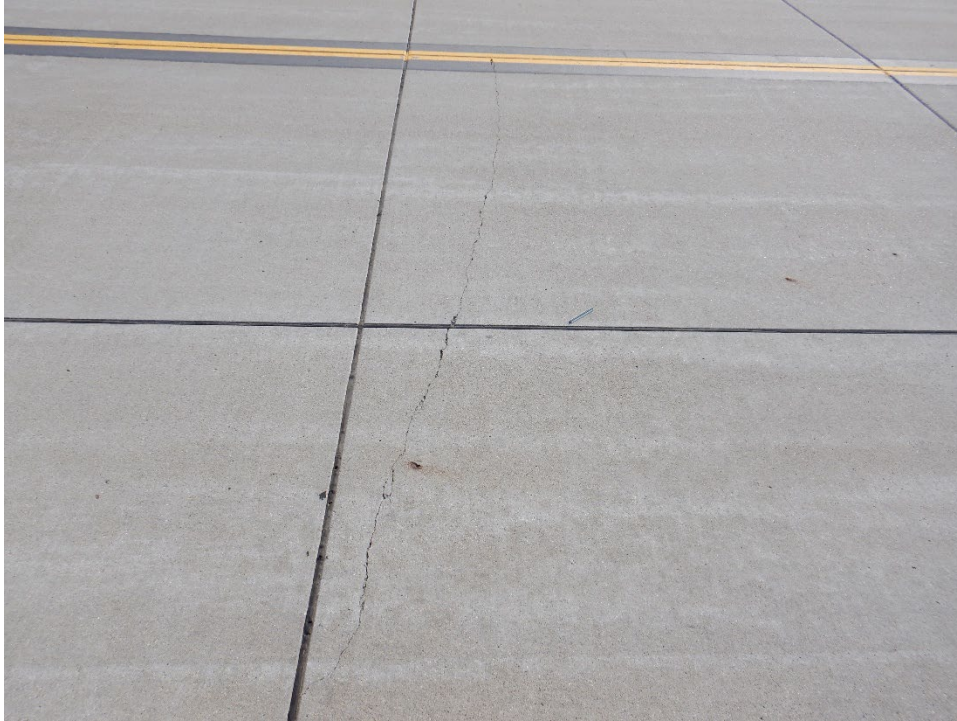
TBSX-01. LTD Cracking (Sample Unit No. 02).

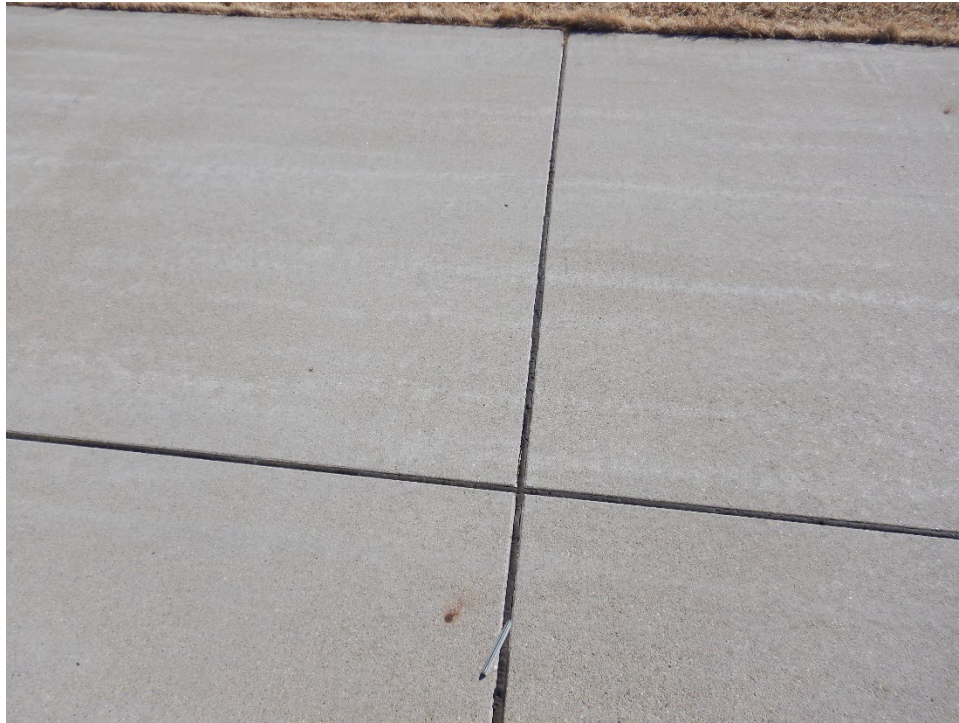
TCSX-01. Joint Seal Damage (Sample Unit No. 02).

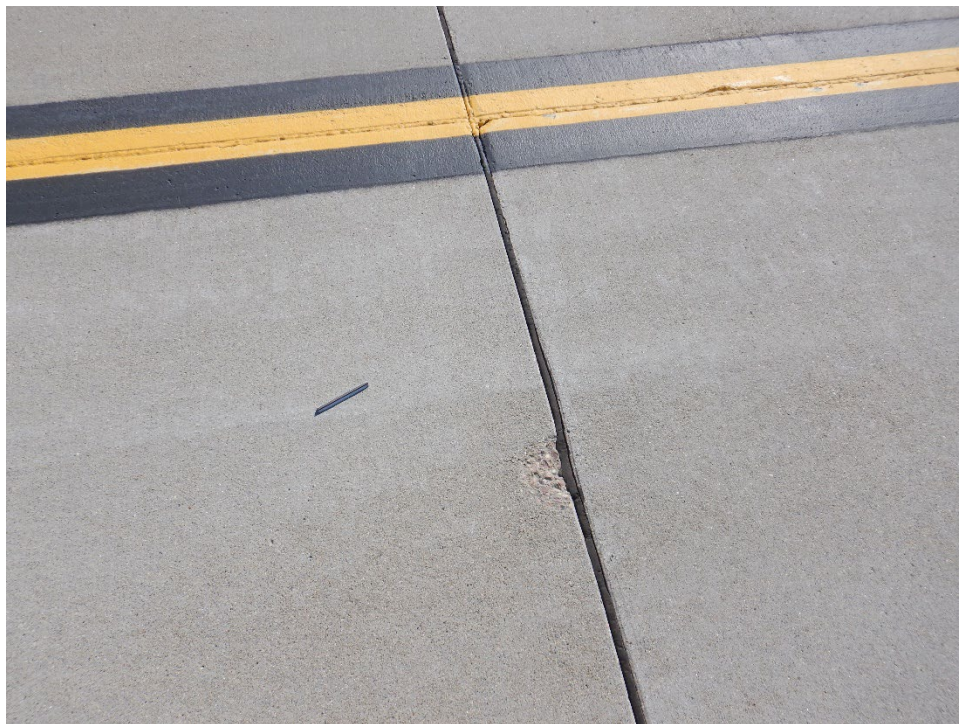
TCSX-01. Joint Spalling (Sample Unit No. 02).

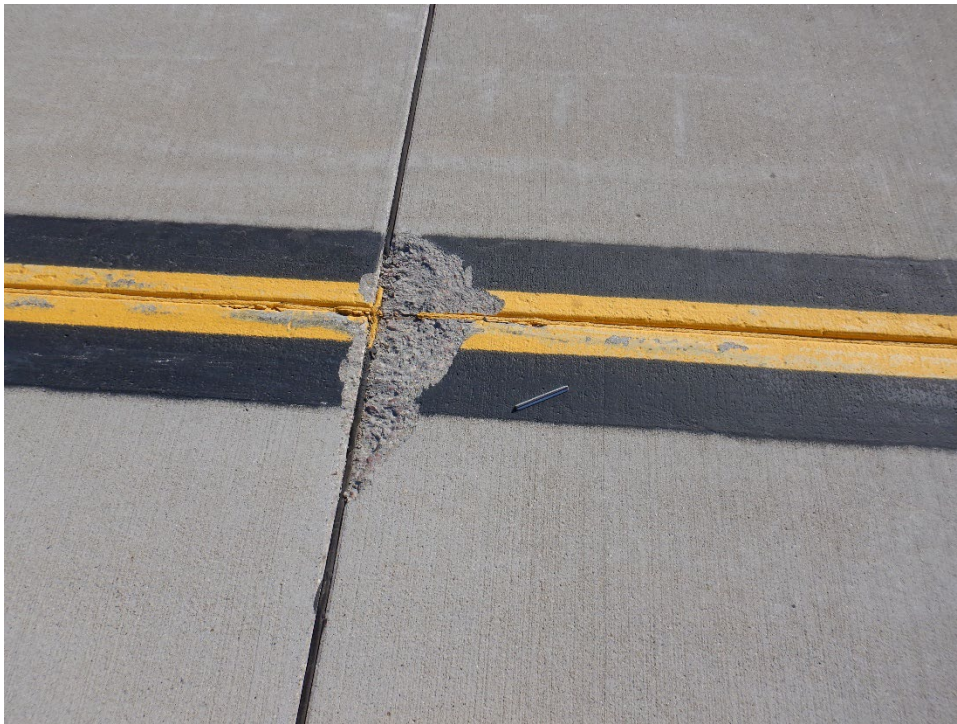
TDSX-01. Corner Spalling (Sample Unit No. 02).

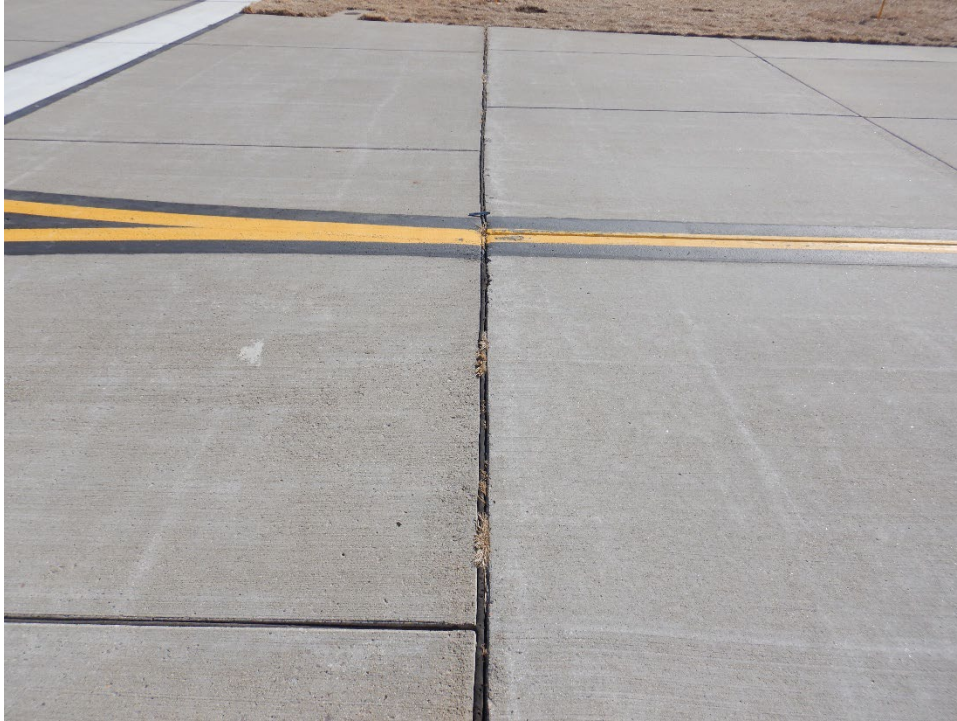
TDSX-01. Faulting (Sample Unit No. 01).

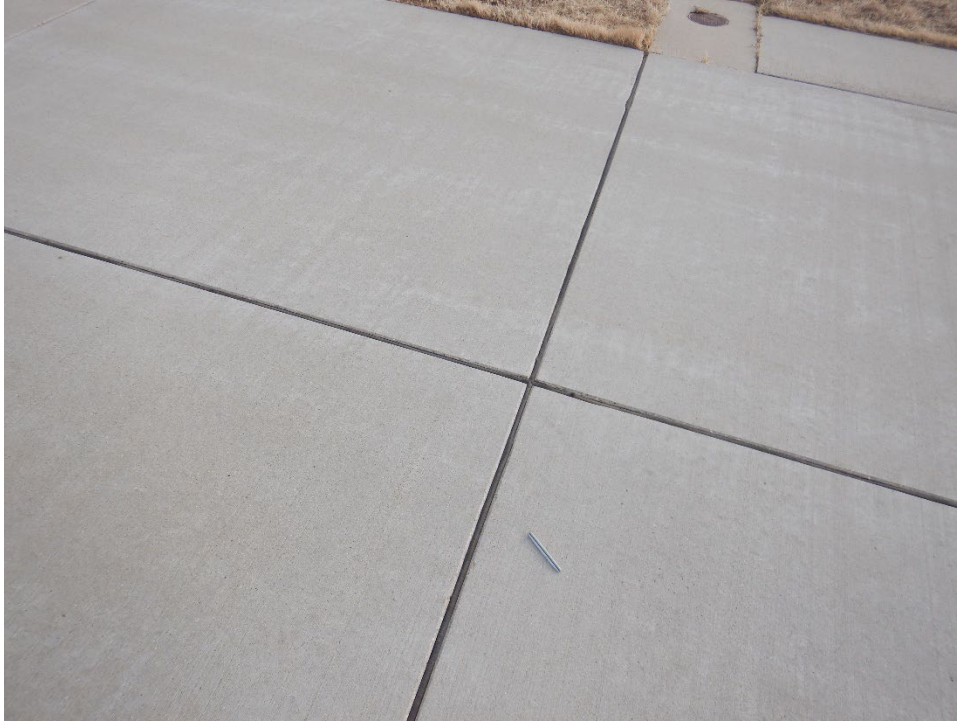
TESX-01. Joint Seal Damage (Sample Unit No. 06).

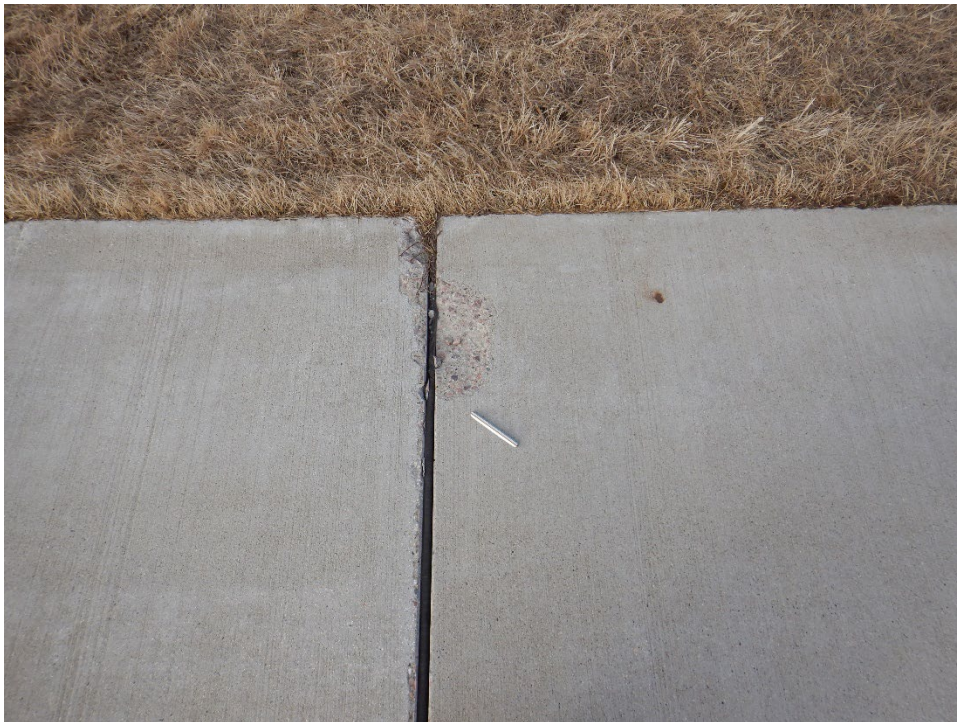
TESX-01. Joint Spalling (Sample Unit No. 06).

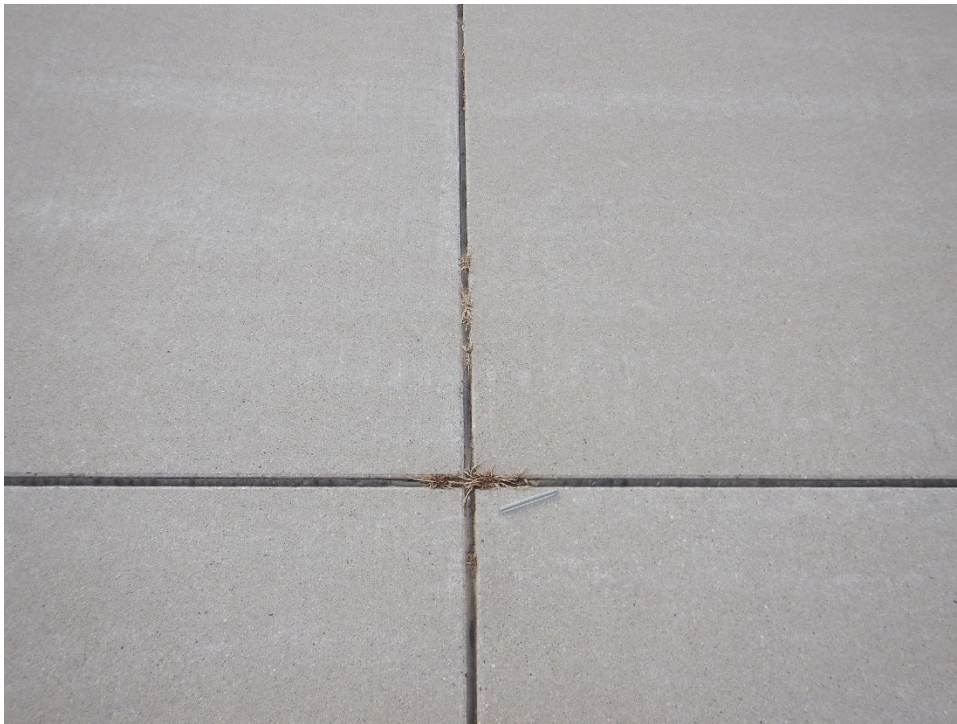
TH01SX-01. Joint Seal Damage (Sample Unit No. 11).

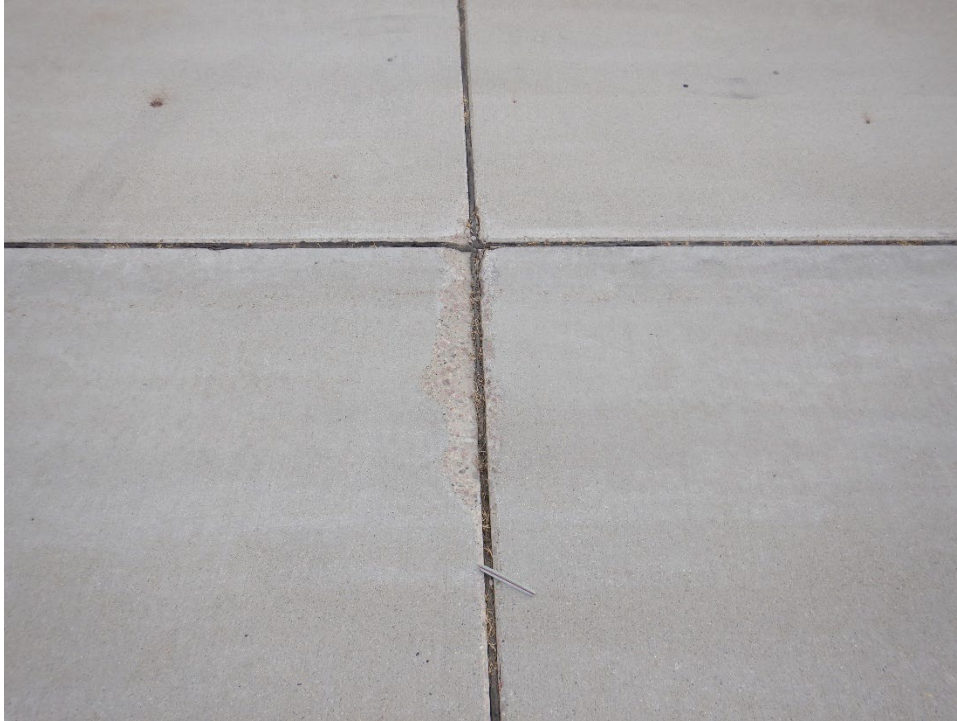
TH01SX-01. Joint Spalling (Additional Sample Unit No. 07).

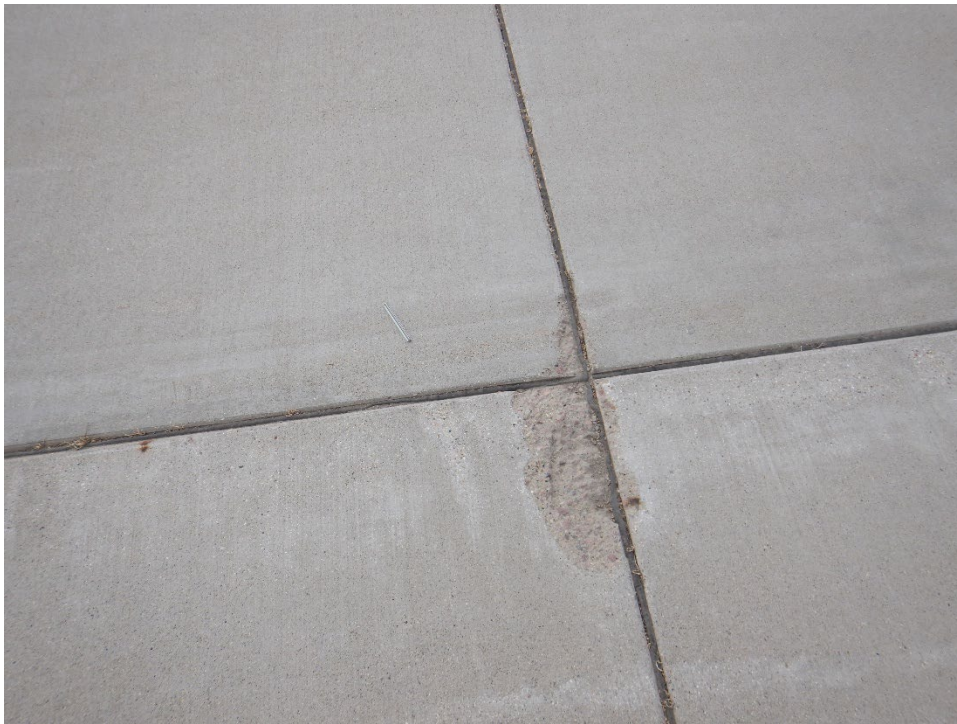
TH01SX-01. Joint Spalling (Sample Unit No. 26).
