# Spirit Lake Municipal Airport

## Pavement Management Report

**AUGUST 2025**

# SPIRIT LAKE MUNICIPAL AIRPORT PAVEMENT MANAGEMENT REPORT

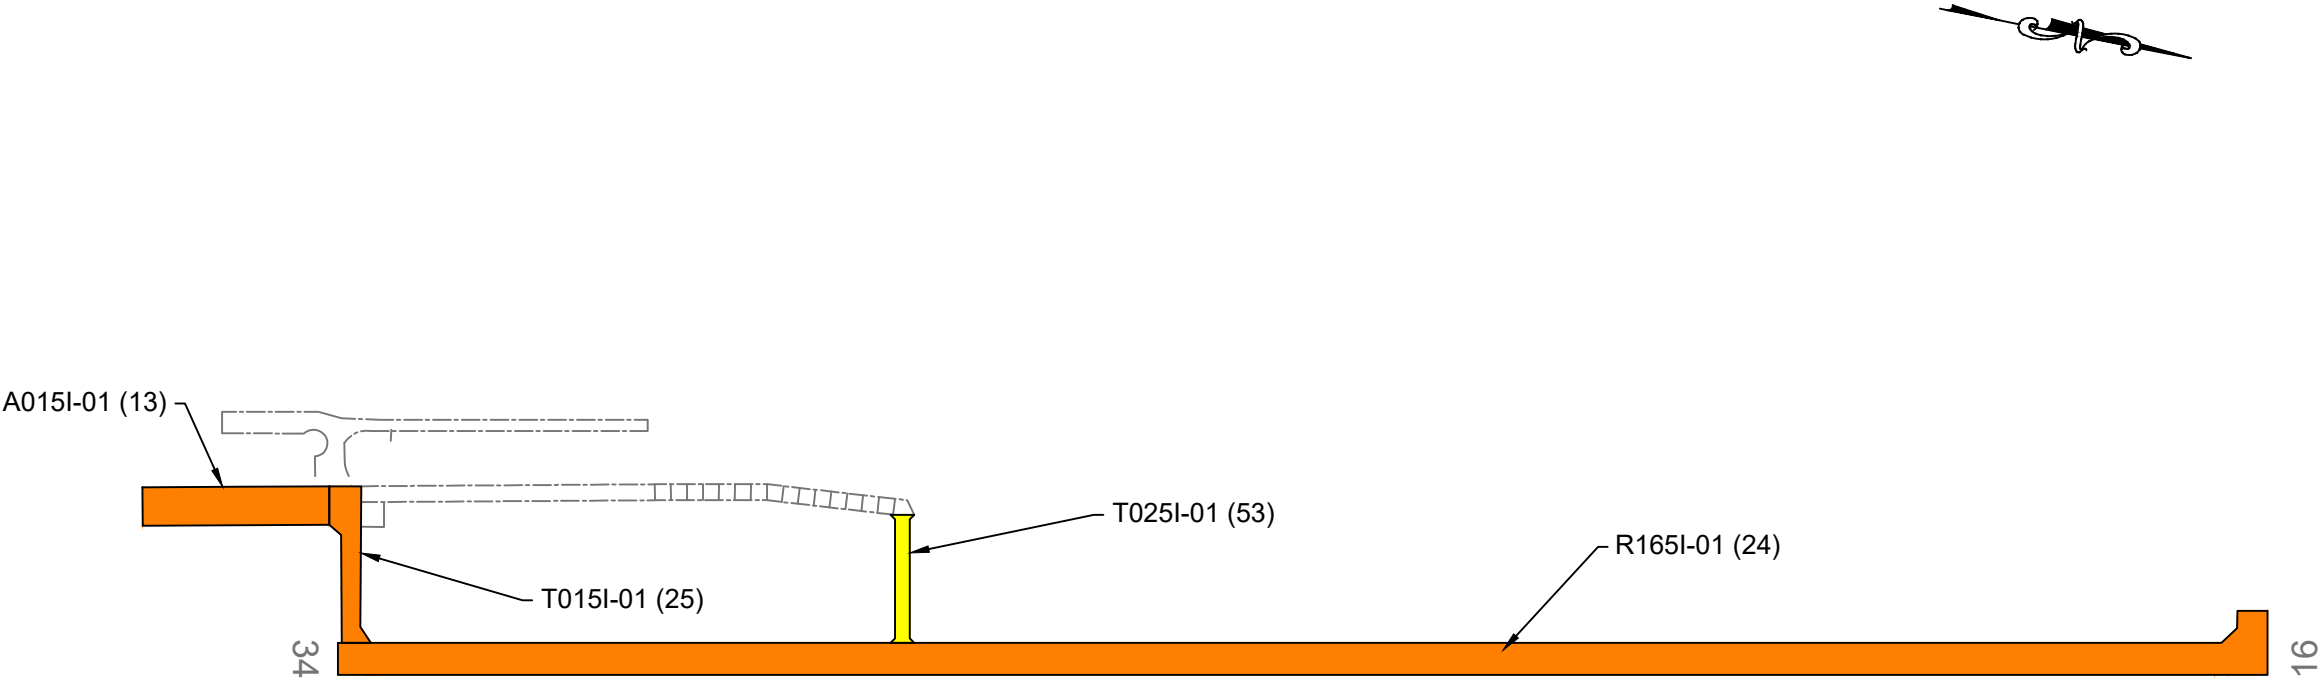
FIGURE 8. PCI MAP.

The pavements at Spirit Lake Municipal Airport were inspected in March 2025. The 2025 area-weighted condition of Spirit Lake Municipal Airport is 24, with conditions ranging from 13 to 53 (on a scale of 0 [failed] to 100 [excellent]). During the previous pavement inspection in 2018, the area-weighted PCI of the airport was 34.

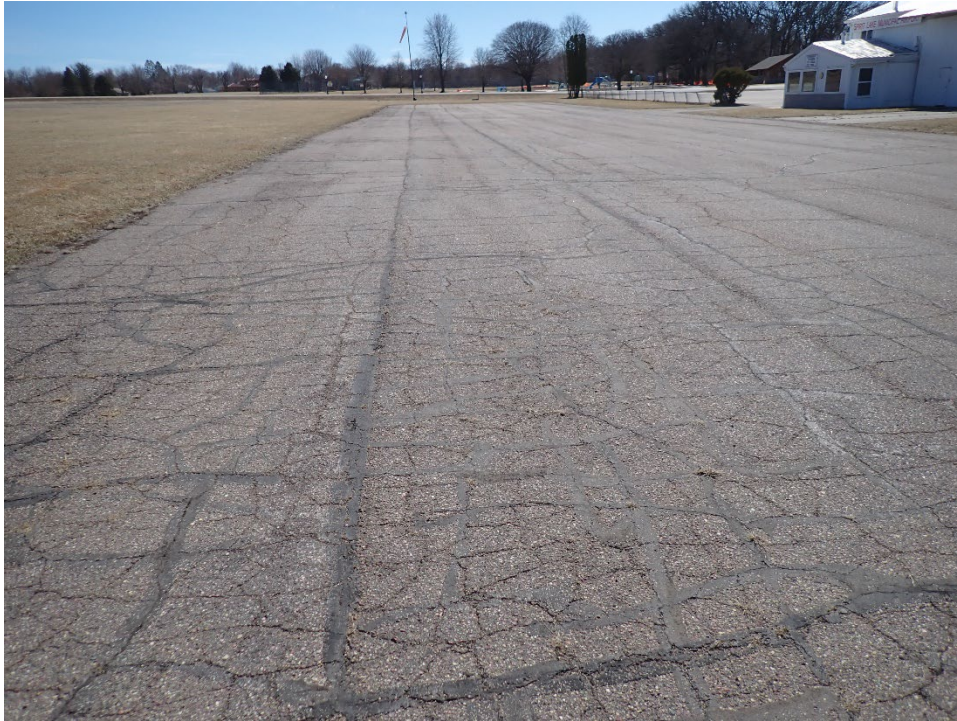
A015I-01. Overview.

| Branch | Section | Surface Type | Section Area (sf) | LCD | 2025 PCI | % Distress Due to Load | % Distress Due to Climate/Durability | % Distress Due to Other | Type of Distress |
|---|---|---|---|---|---|---|---|---|---|
| A015I | 01 | AAC | 17,520 | 1/1/2011 | 13 | 72 | 28 | 0 | Alligator Cracking, L&T Cracking, Weathering |

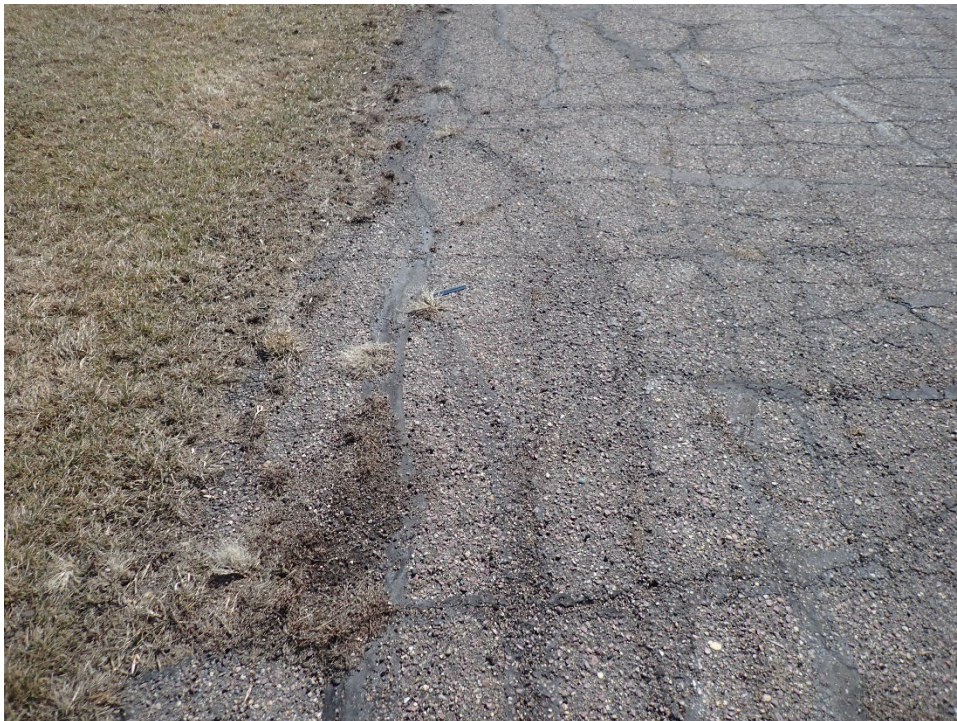
The apron area was defined by one section that was in *Poor* condition. Medium- and high-severity alligator cracking were recorded throughout Section 01. Areas of medium-severity L&T cracking and weathering were also observed at the time of inspection.

A015I-01. Alligator Cracking (Sample Unit No. 02).

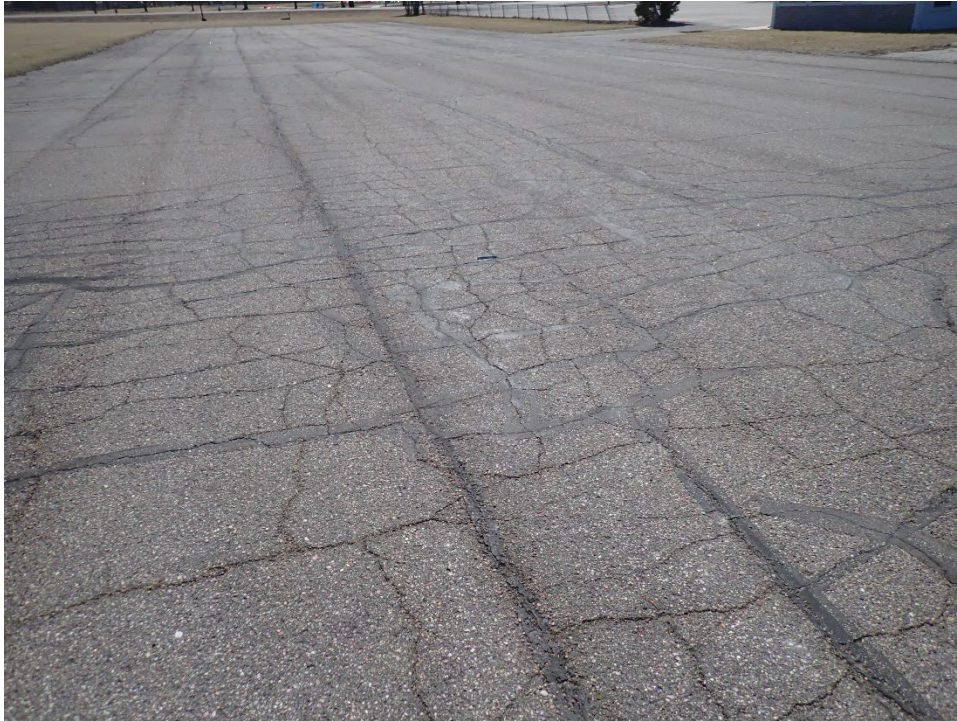
A015I-01. Alligator Cracking (Sample Unit No. 04).

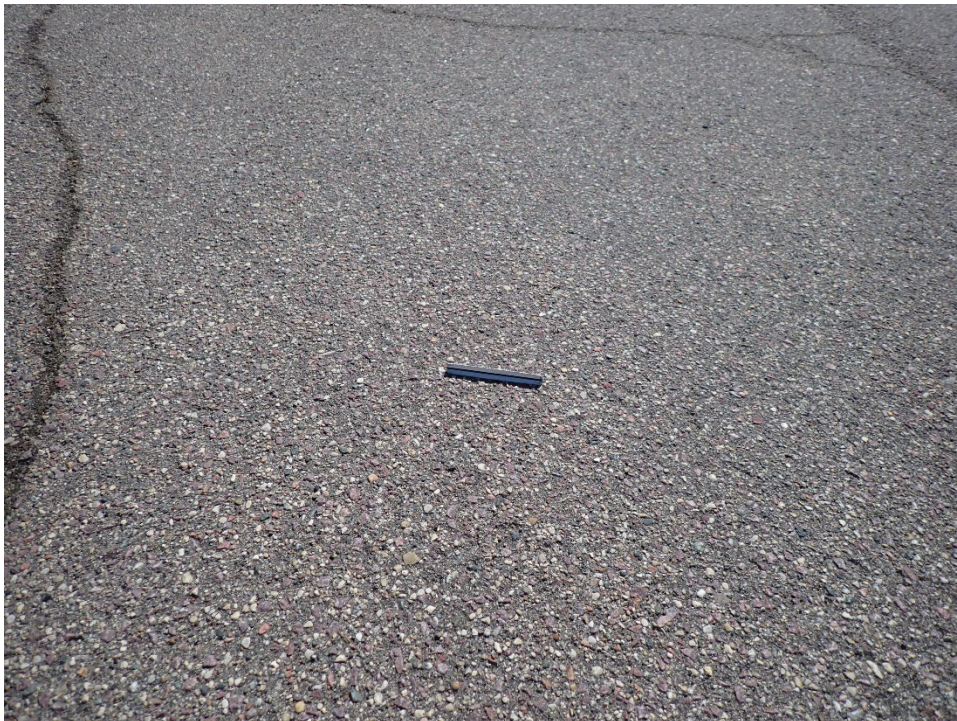
A015I-01. Weathering (Sample Unit No. 02).

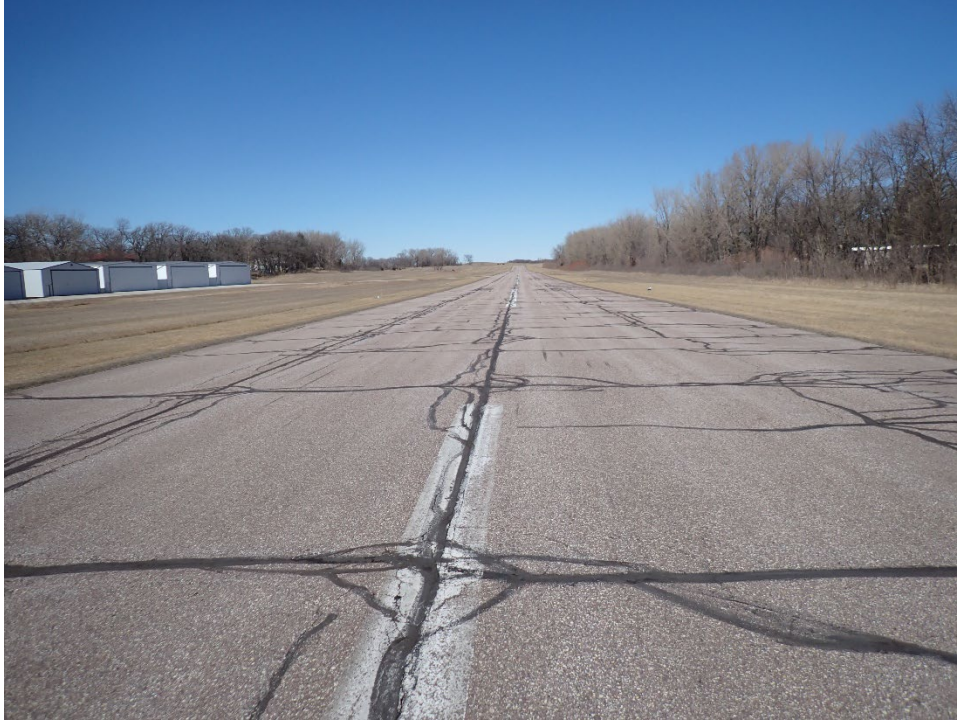
R165I-01. Overview.

| Branch | Section | Surface Type | Section Area (sf) | LCD | 2025 PCI | % Distress Due to Load | % Distress Due to Climate/Durability | % Distress Due to Other | Type of Distress |
|---|---|---|---|---|---|---|---|---|---|
| R165I | 01 | AAC | 153,672 | 1/1/2010 | 24 | 49 | 51 | 0 | Alligator Cracking, L&T Cracking, Raveling, Weathering |

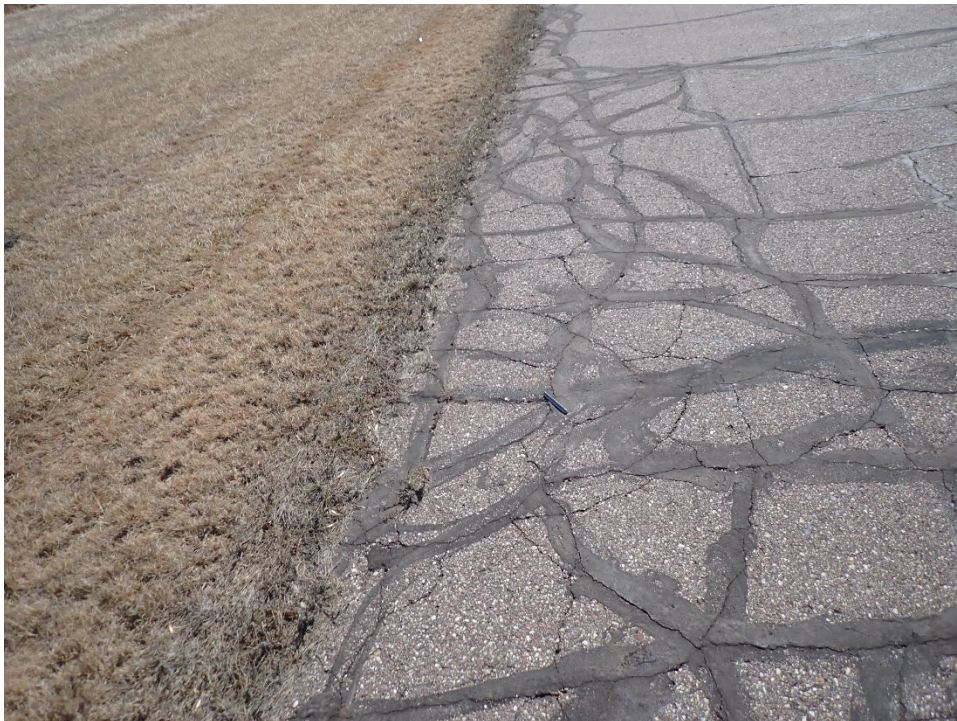
Runway 16/34 was defined by one section that was in *Poor* condition. Significant amounts of medium-severity alligator cracking were identified in Section 01. Low-severity, sealed longitudinal and transverse (L&T) cracking was also identified along with medium-severity L&T cracking where either unsealed crack widths exceeded 1/4 inch or crack sealant was unsatisfactory. Additionally, low-severity raveling and medium-severity weathering were recorded.

R165I-01. Alligator Cracking (Sample Unit No. 02).

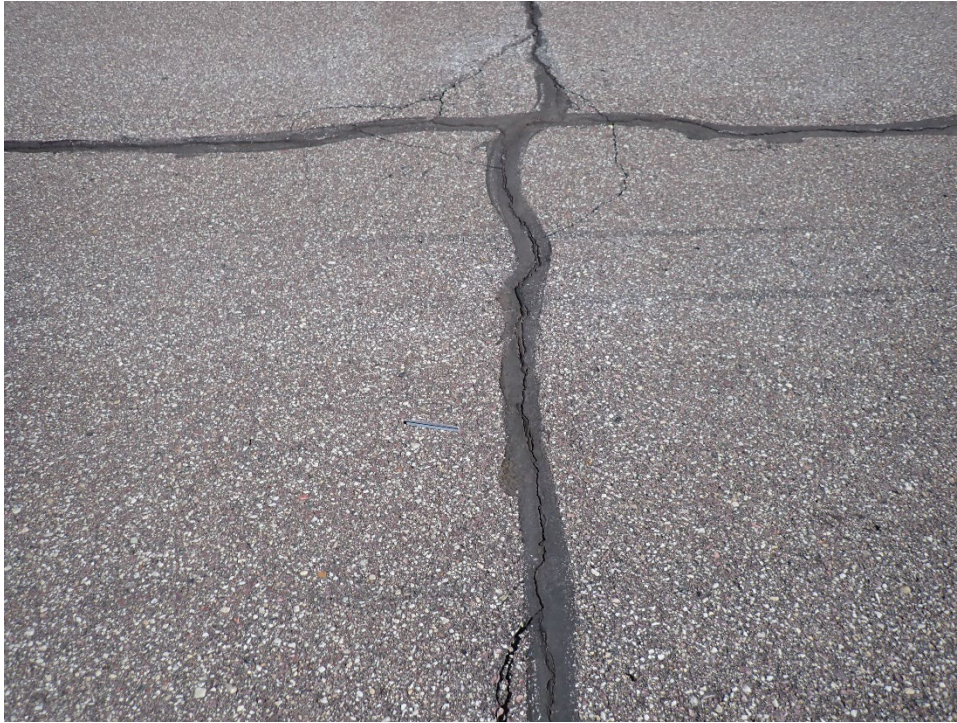
R165I-01. L&T Cracking (Sample Unit No. 07).

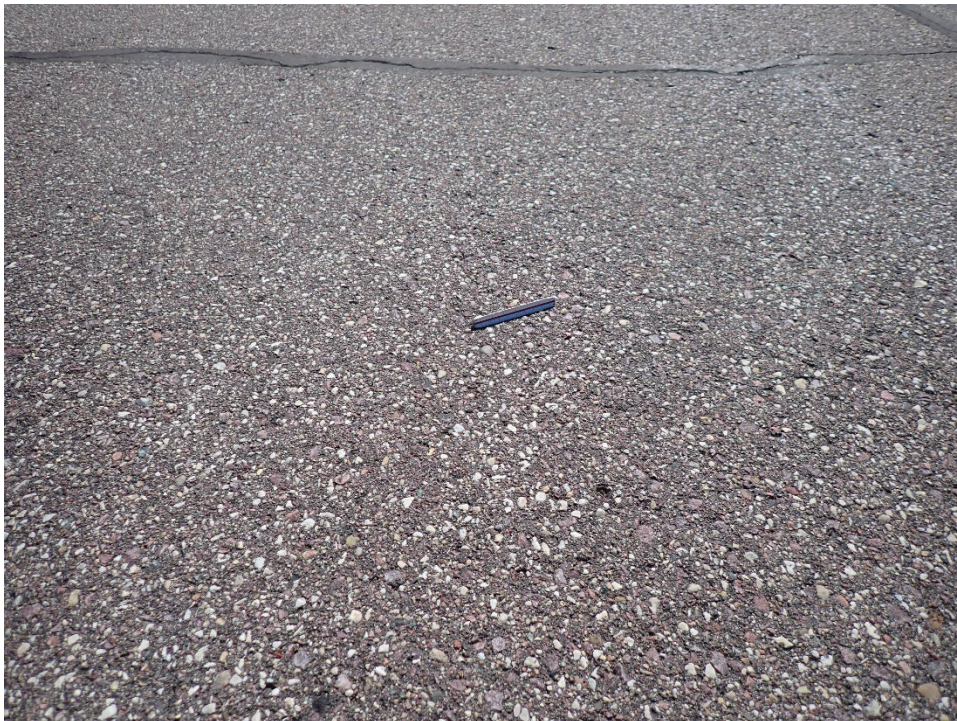
R165I-01. Weathering (Sample Unit No. 07).

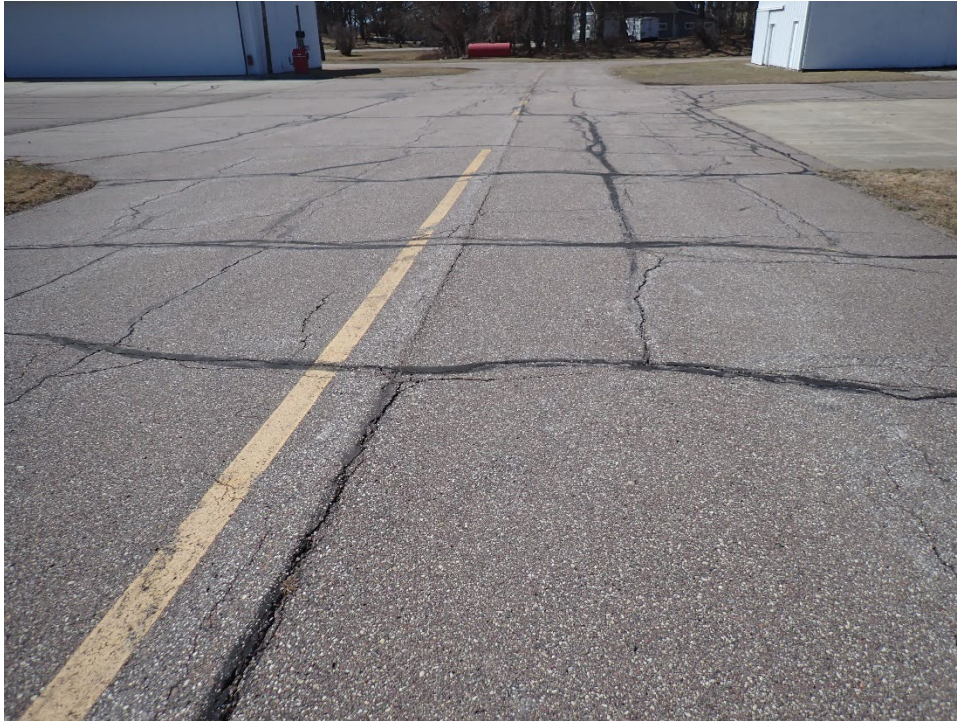
T015I-01. Overview.

| Branch | Section | Surface Type | Section Area (sf) | LCD | 2025 PCI | % Distress Due to Load | % Distress Due to Climate/Durability | % Distress Due to Other | Type of Distress |
|---|---|---|---|---|---|---|---|---|---|
| T015I | 01 | AAC | 8,858 | 1/1/2011 | 25 | 34 | 66 | 0 | Alligator Cracking, Block Cracking, L&T Cracking, Raveling, Weathering |

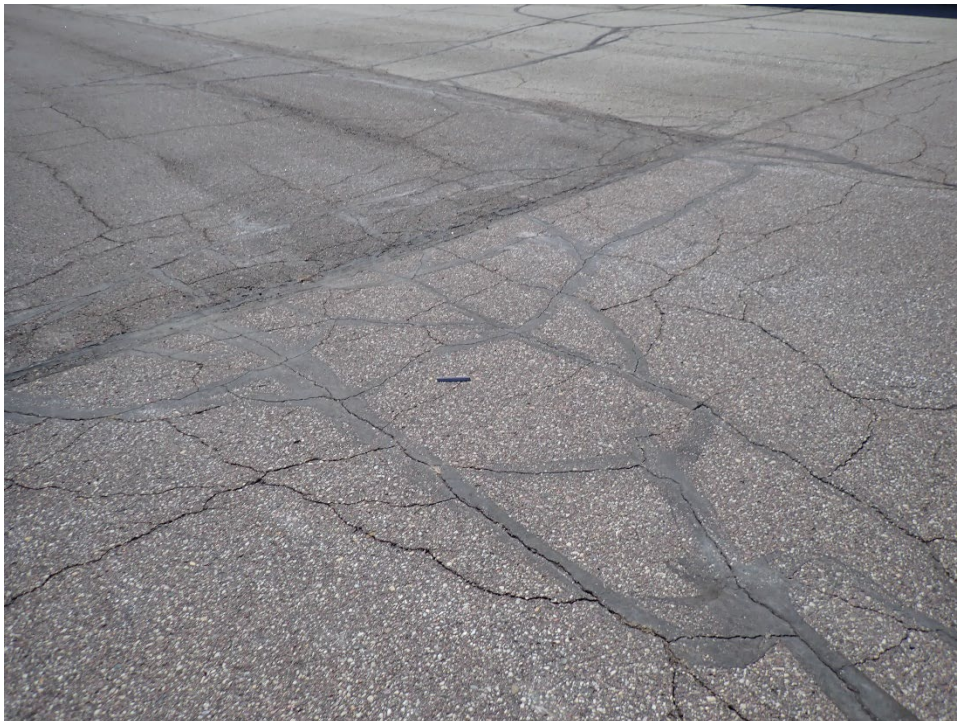
Taxiway 01 contained one section that was in *Poor* condition. Substantial amounts of medium-severity alligator cracking were recorded along with medium-severity block cracking and L&T cracking. Low-severity raveling and medium-severity weathering were also observed in Section 01.

T015I-01. Alligator Cracking (Sample Unit No. 02).

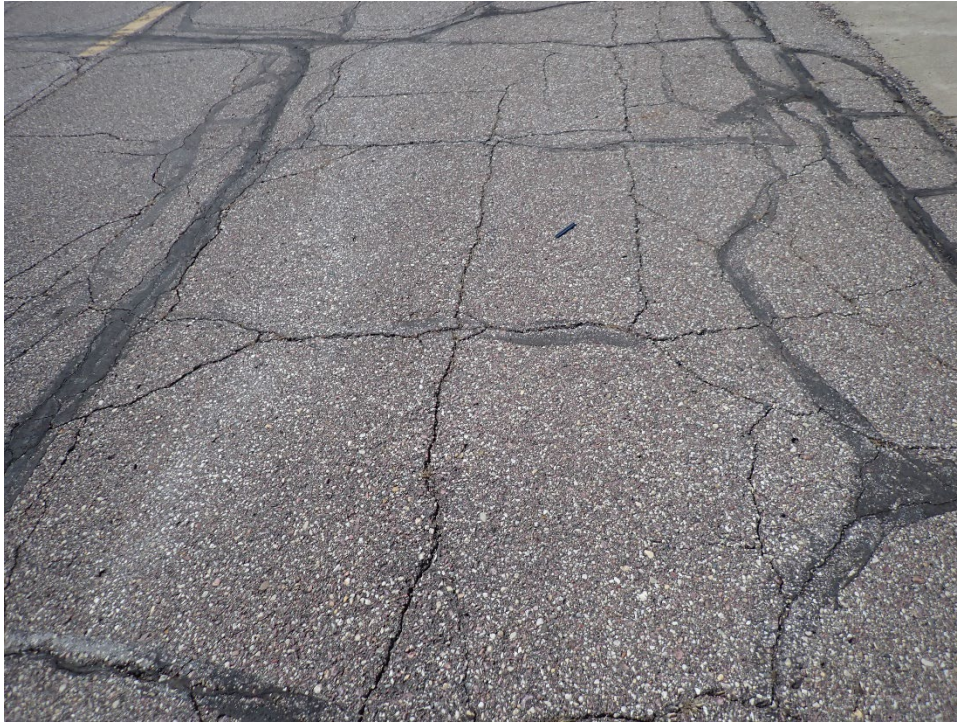
T015I-01. Block Cracking (Sample Unit No. 02).

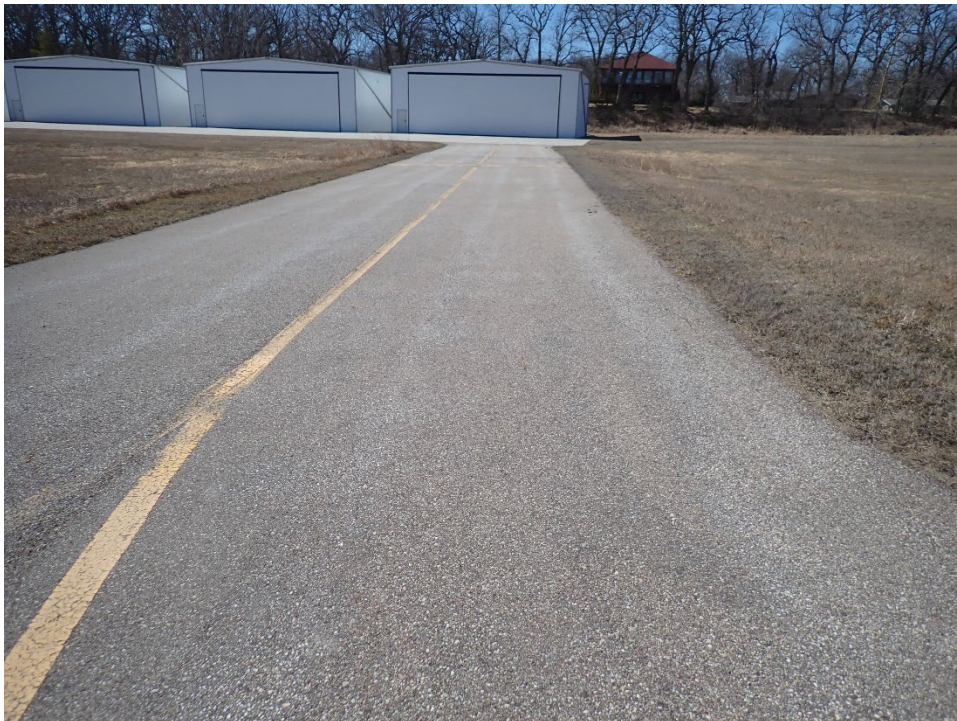
T025I-01. Overview.

| Branch | Section | Surface Type | Section Area (sf) | LCD | 2025 PCI | % Distress Due to Load | % Distress Due to Climate/Durability | % Distress Due to Other | Type of Distress |
|---|---|---|---|---|---|---|---|---|---|
| T025I | 01 | AC | 4,698 | 1/1/2018 | 53 | 47 | 53 | 0 | Alligator Cracking, L&T Cracking, Weathering |

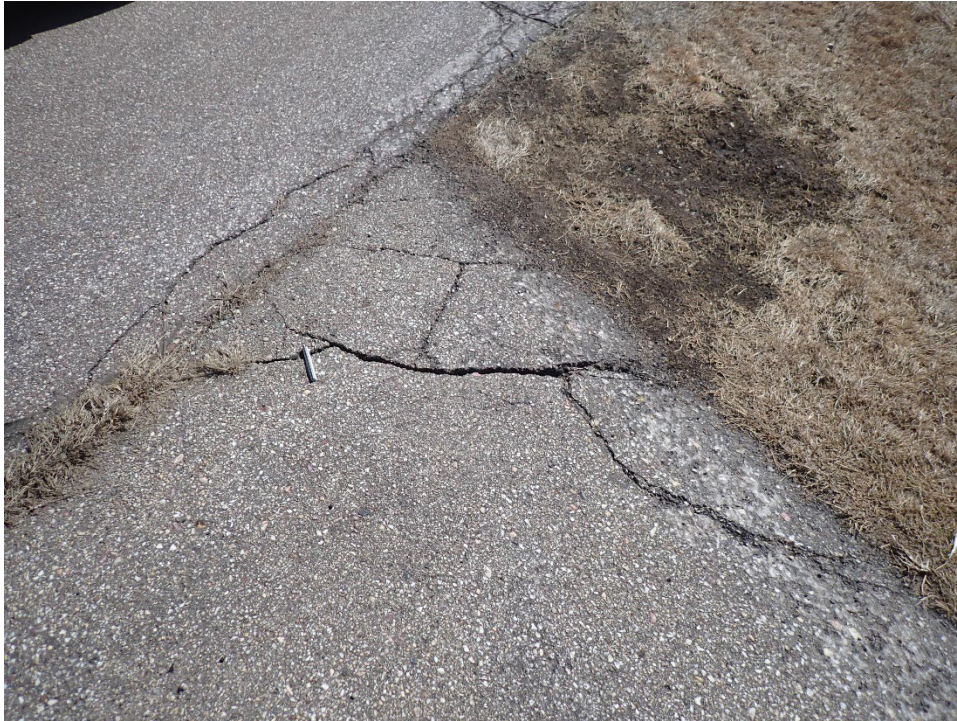
Taxiway 02 consisted of one section with medium-severity alligator cracking and weathering and low- and medium-severity L&T cracking. The low-severity L&T cracking was unsealed, and the medium-severity L&T cracking was identified where unsealed crack widths exceeded 1/4 inch.

T025I-01. Alligator Cracking (Sample Unit No. 01).

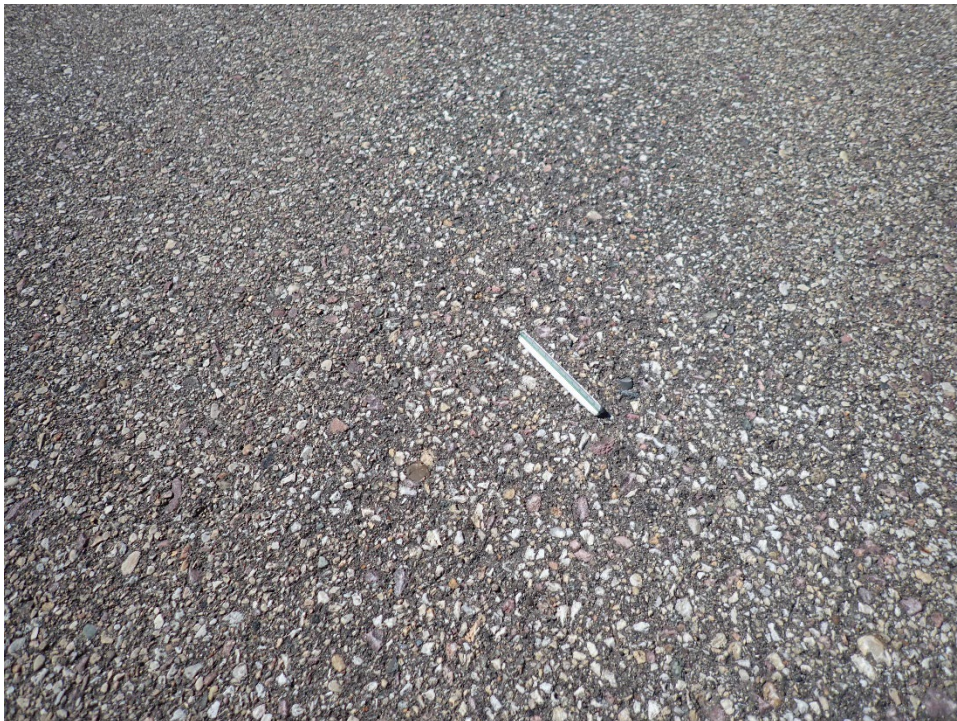
T025I-01. Weathering (Sample Unit No. 01).
