# Storm Lake Municipal Airport

## Pavement Management Report

# STORM LAKE MUNICIPAL AIRPORT PAVEMENT MANAGEMENT REPORT

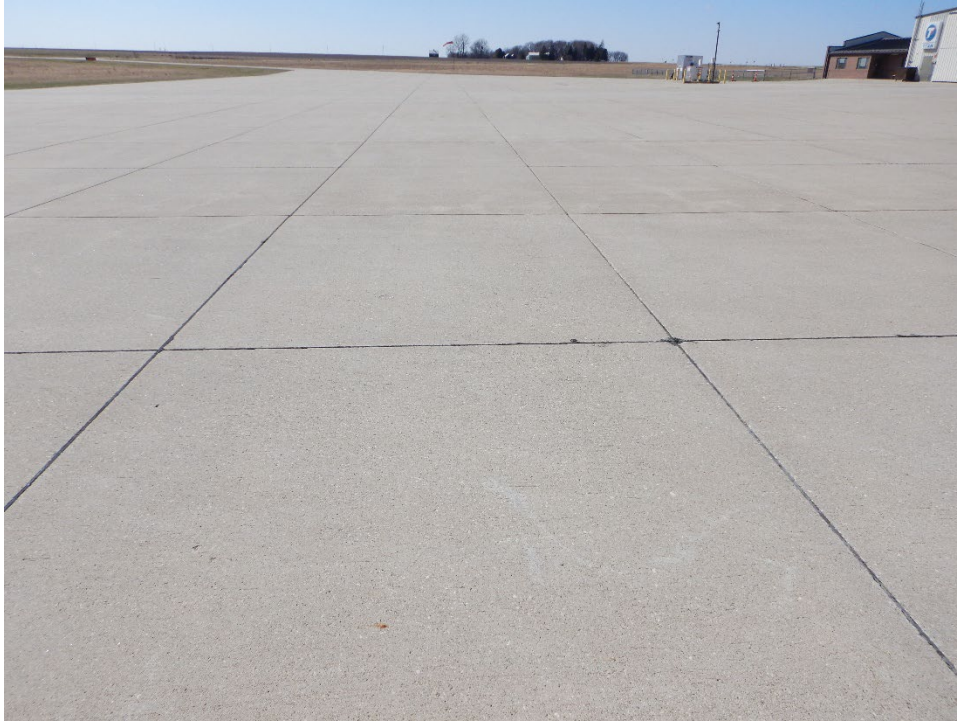
The apron area consisted of two sections. Section 01 contained medium-severity corner break; low-severity corner spalling, faulting, and small patching; medium- and high-severity joint seal damage; all severities of joint spalling; low- and medium-severity LTD cracking; and shrinkage cracking. Low- and medium-severity corner break and joint spalling; low-severity corner spalling, small patching, and large patching; high-severity joint seal damage; medium-severity LTD cracking and shattered slab; and shrinkage cracking were identified in Section 02.

A01SL-01. Overview.

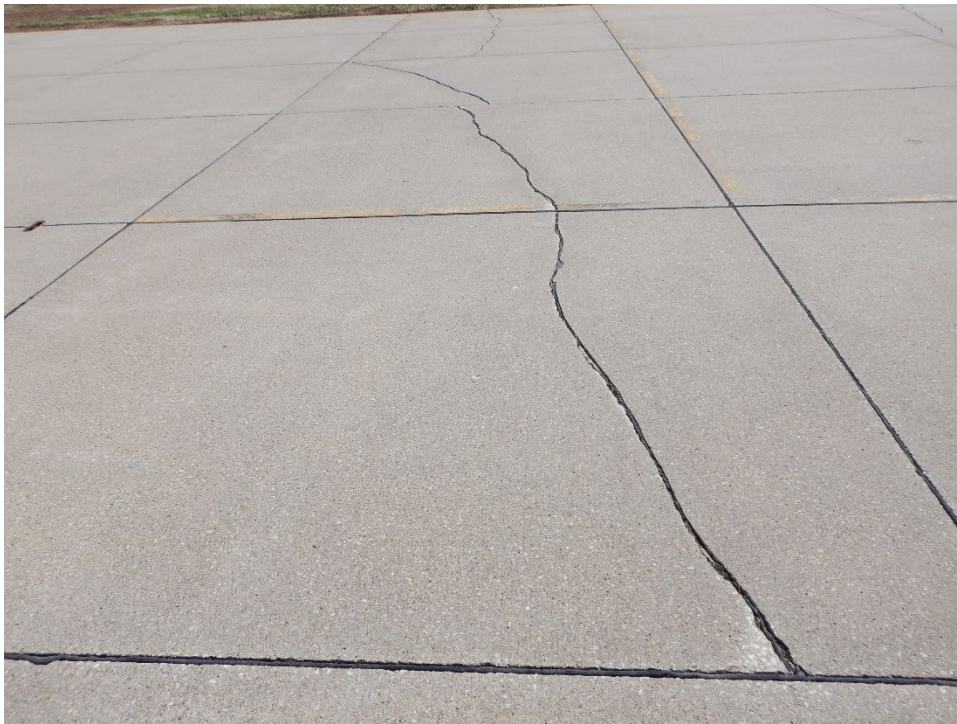
A01SL-01. LTD Cracking (Sample Unit No. 06).

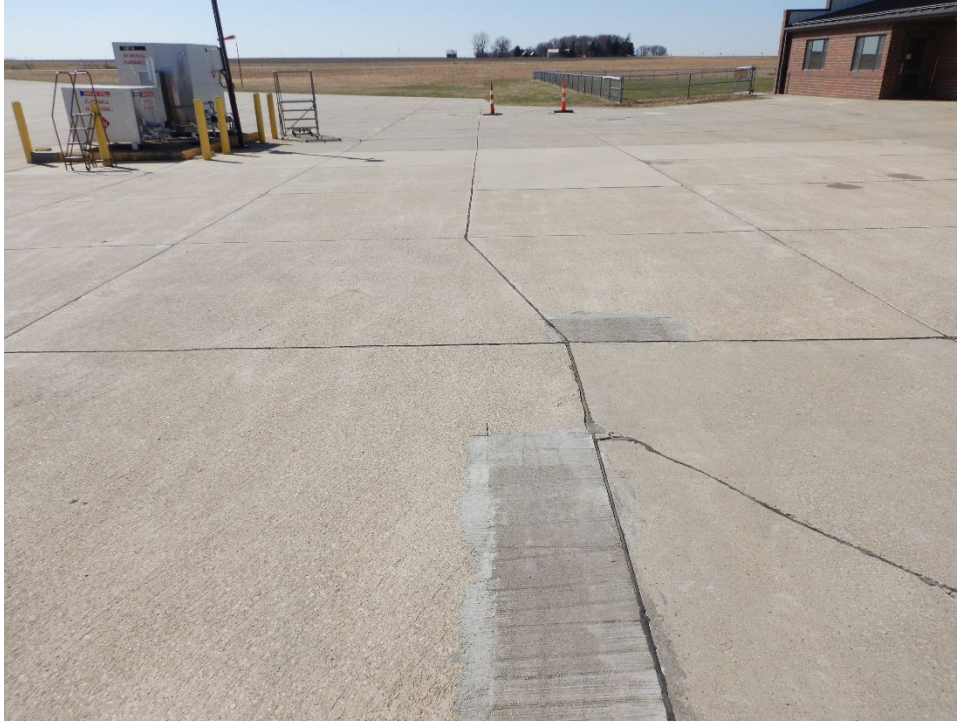
A01SL-02. Overview.

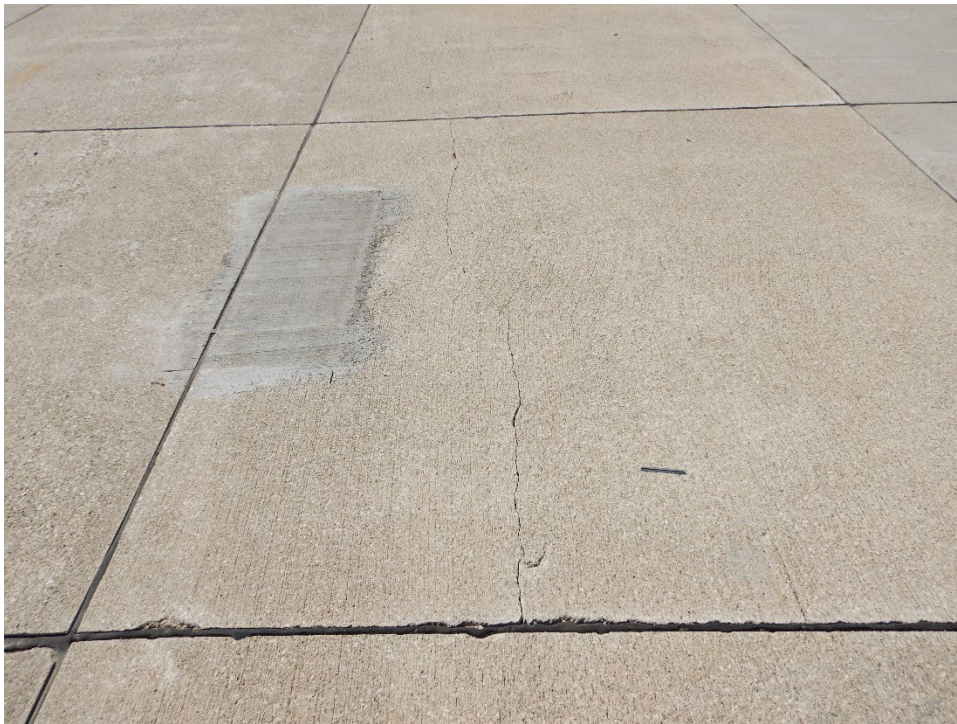
A01SL-02. LTD Cracking (Sample Unit No. 03).

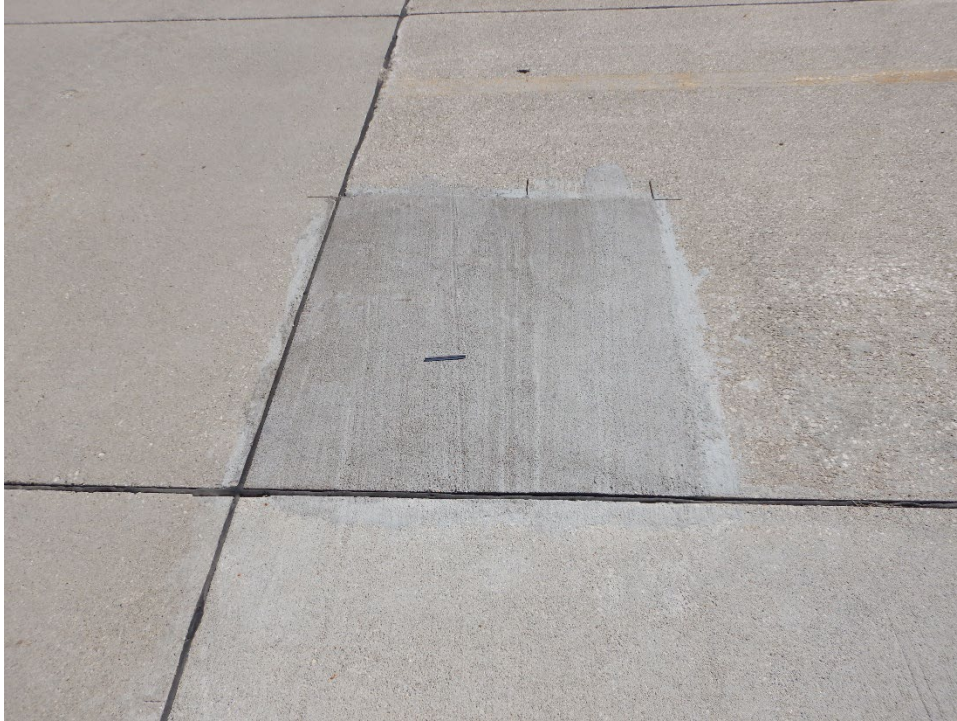
A01SL-02. Large Patching (Sample Unit No. 03).

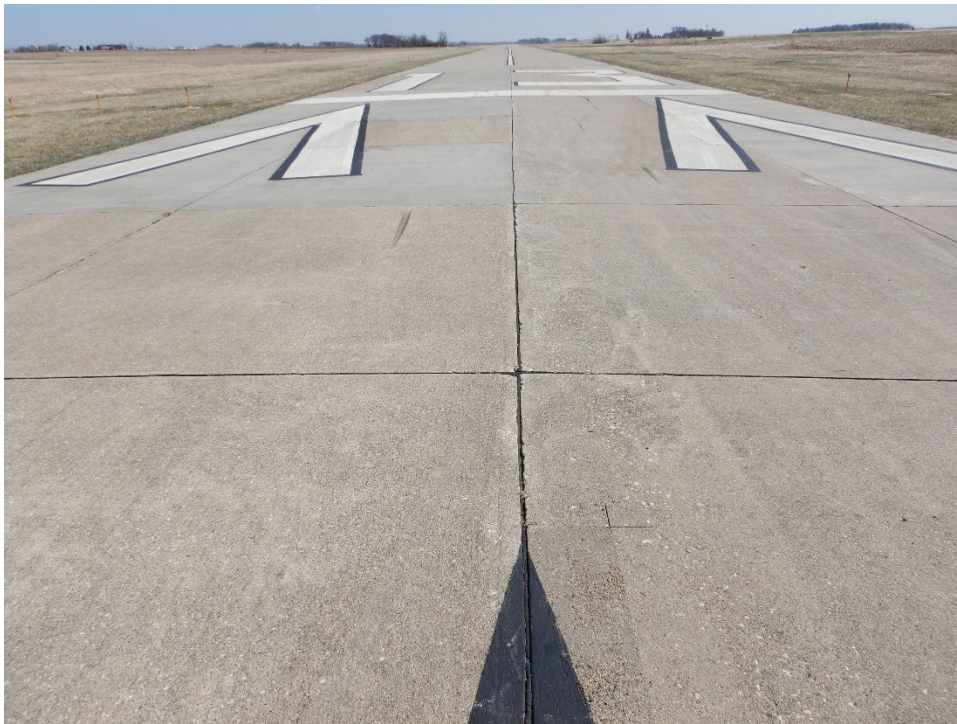
Runway 13/31 consisted of one section that contained areas of low- and medium-severity small patching, joint spalling, and corner spalling; medium- and high-severity joint seal damage; low-severity large patching, medium-severity shattered slab and longitudinal, transverse, and diagonal (LTD) cracking; and shrinkage cracking.

R13SL-01. Overview.

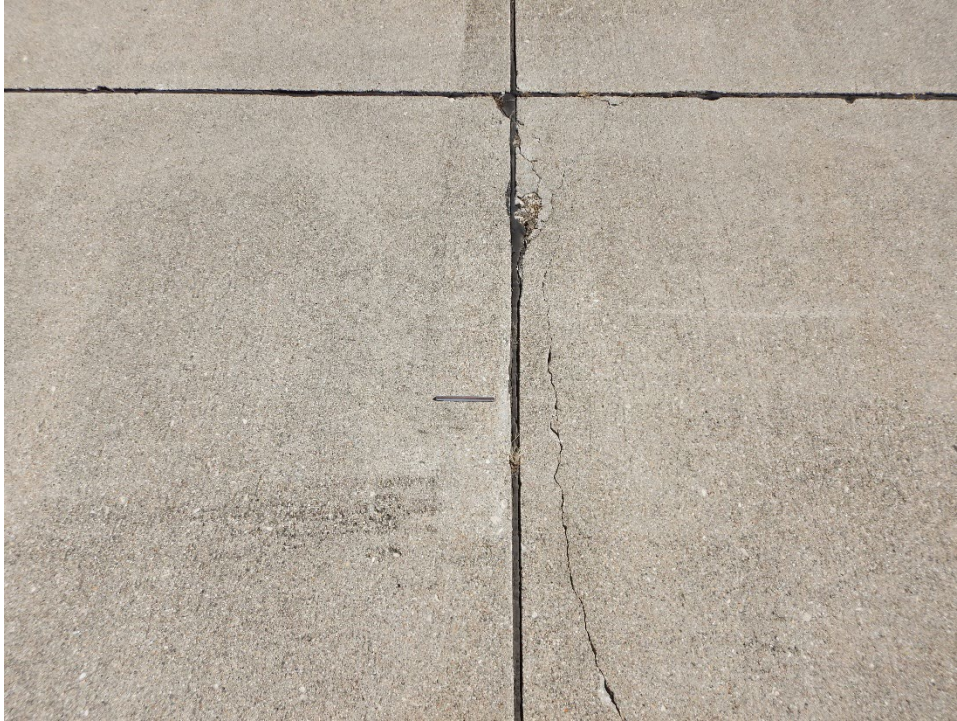
R13SL-01. Joint Spalling (Sample Unit No. 03).

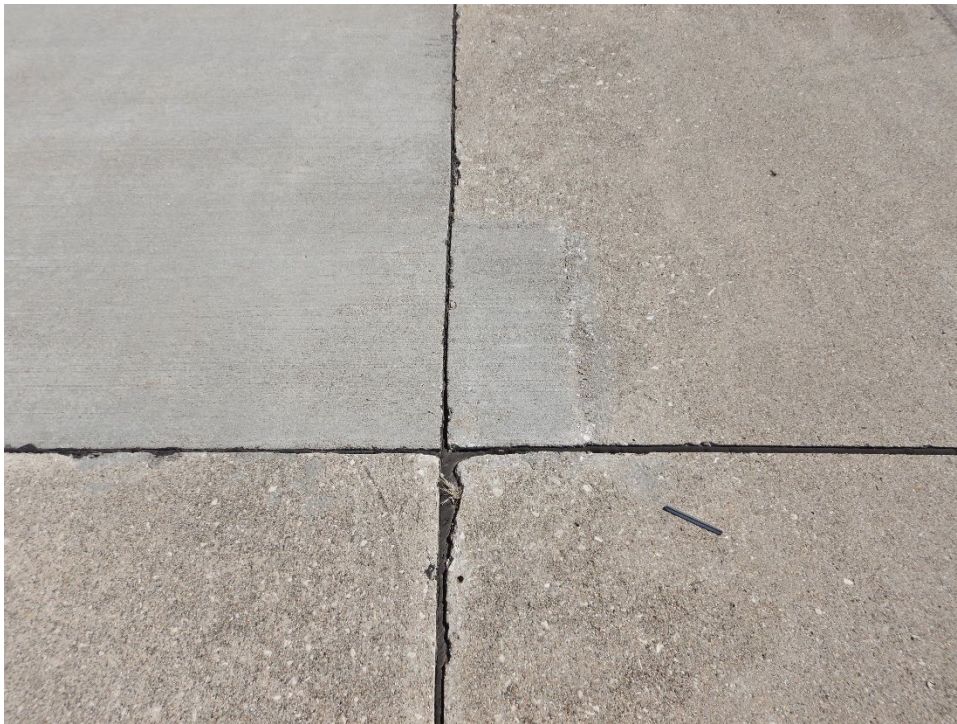
R13SL-01. Small Patching (Sample Unit No. 03).

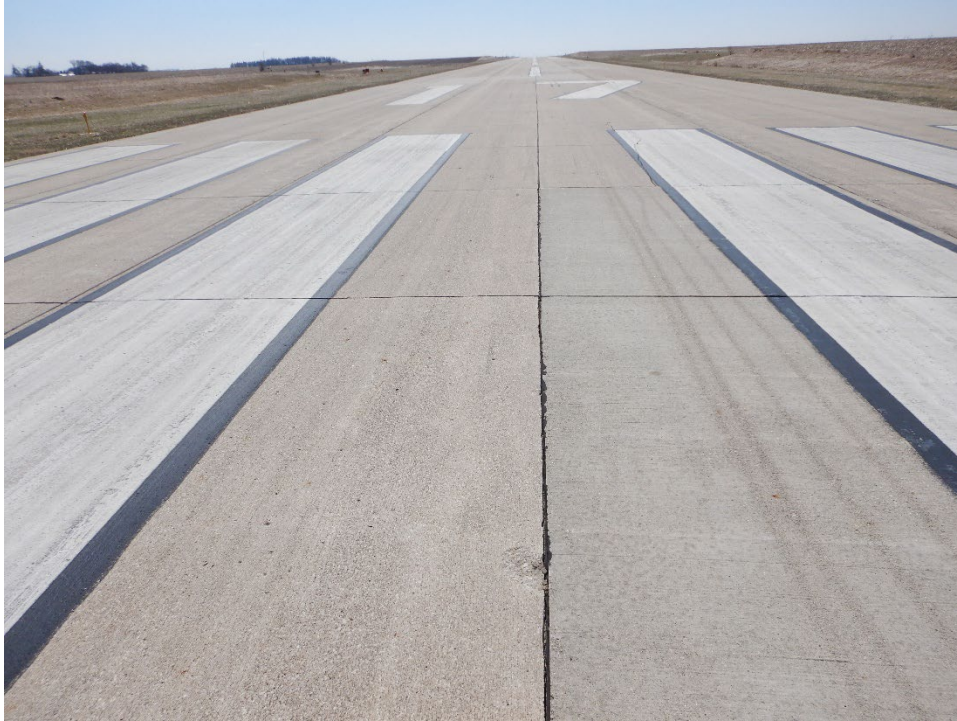
Runway 17/35 were defined by two sections. Section 01 contained low- and medium-severity corner break, all severities of joint spalling and corner spalling, low-severity faulting and large patching, medium- and high-severity joint seal damage, medium-severity LTD cracking and shattered slab, and shrinkage cracking. Low- and medium-severity joint spalling and medium-severity corner spalling, joint seal damage, and LTD cracking were identified in Section 02.

R17SL-01. Overview.

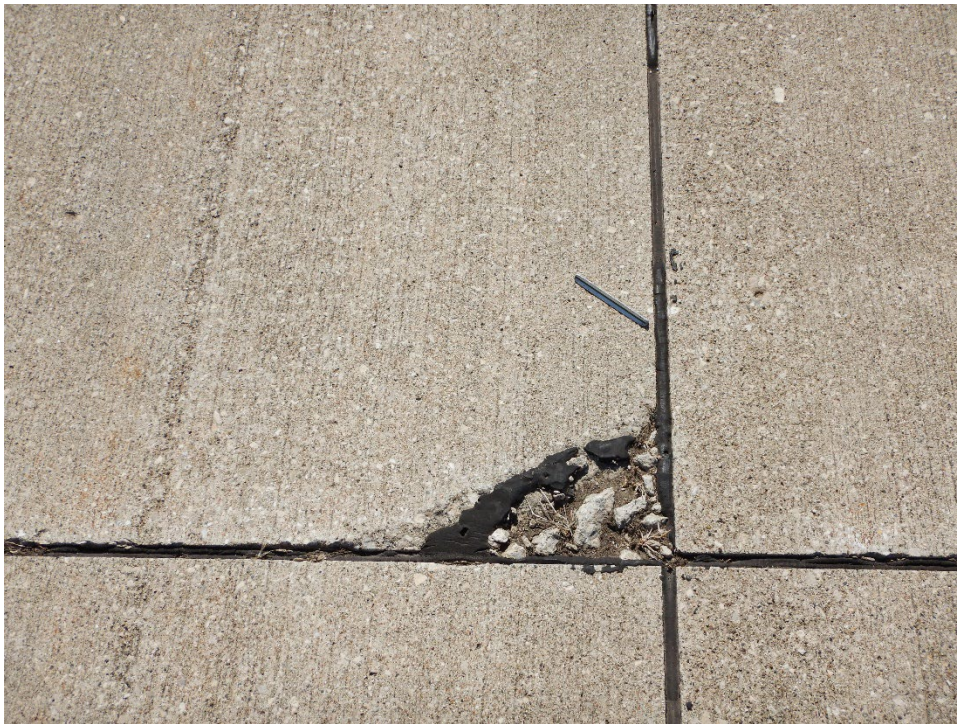
R17SL-01. Corner Spalling (Sample Unit No. 08).

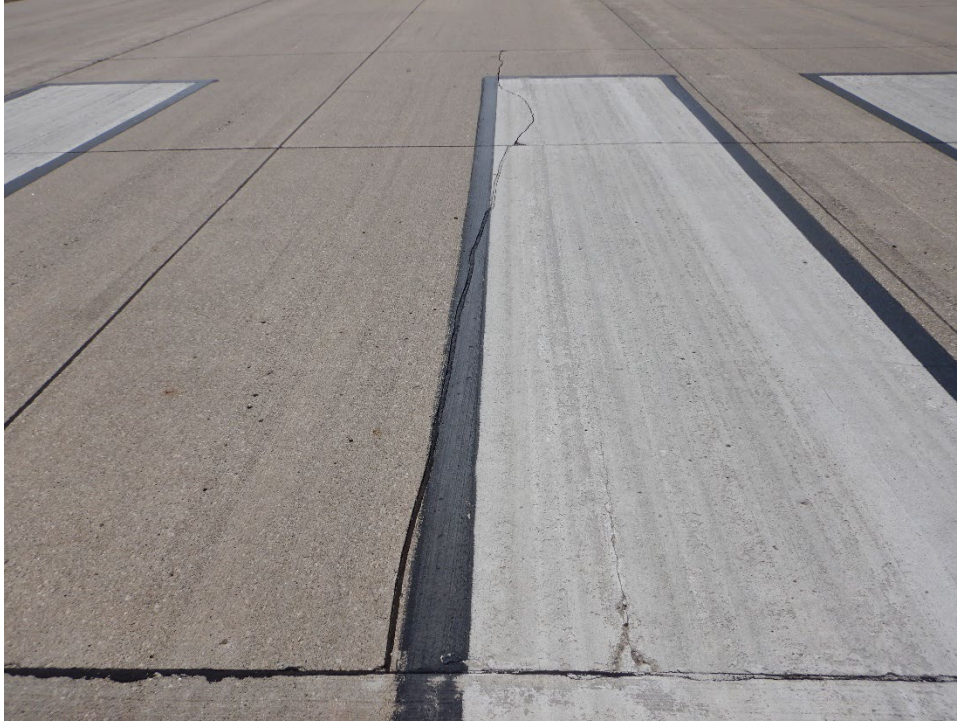
R17SL-01. LTD Cracking (Sample Unit No. 03).

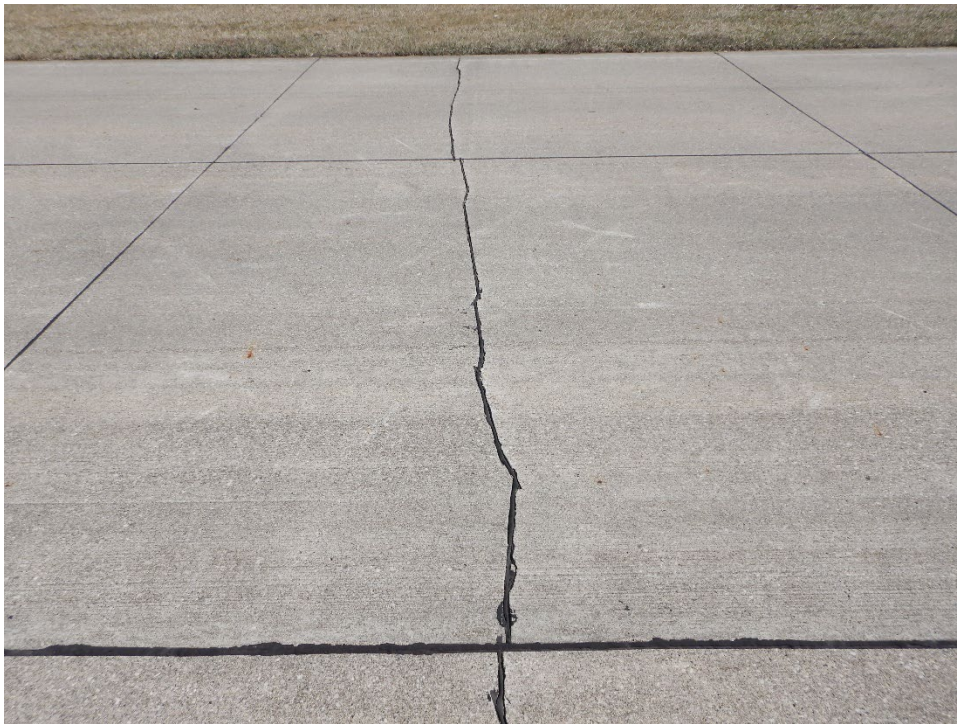
R17SL-01. LTD Cracking (Sample Unit No. 48).

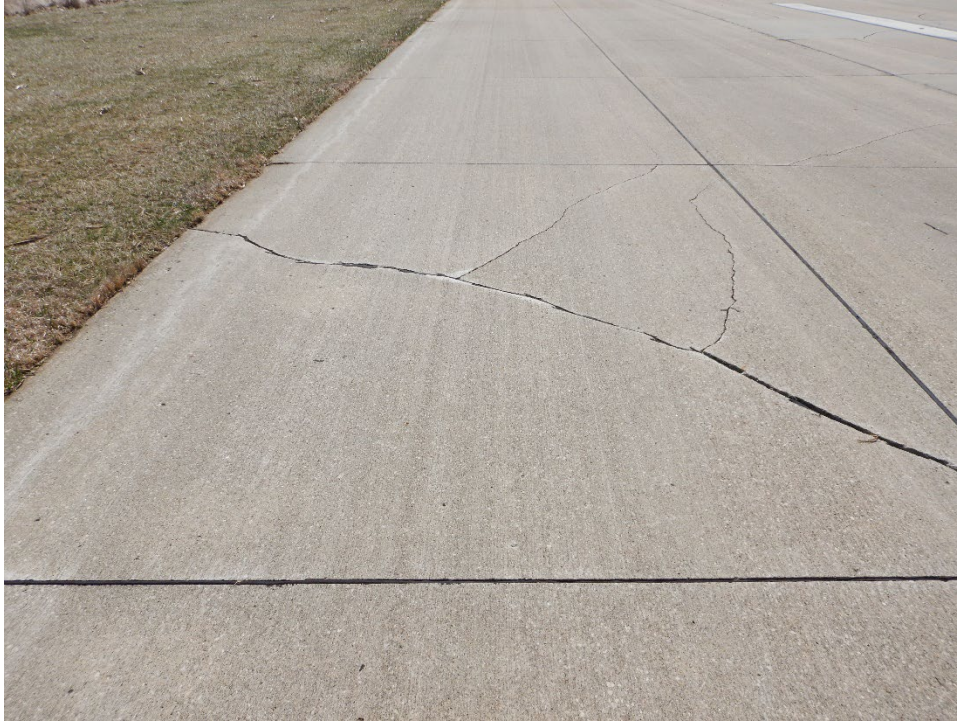
R17SL-01. Shattered Slab (Sample Unit No. 38).

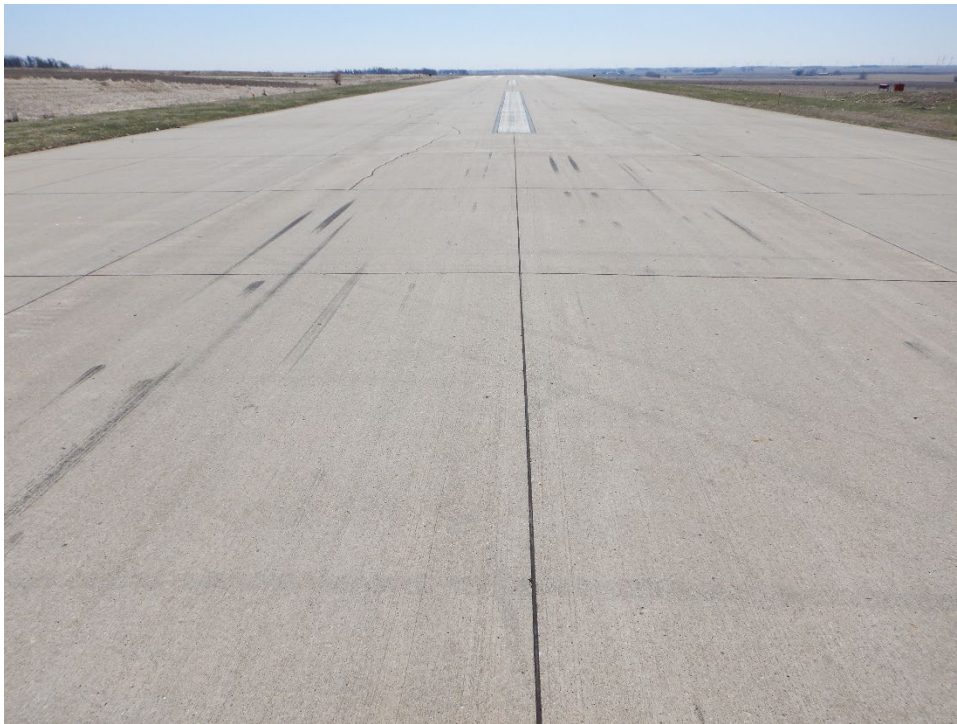
R17SL-02. Overview.

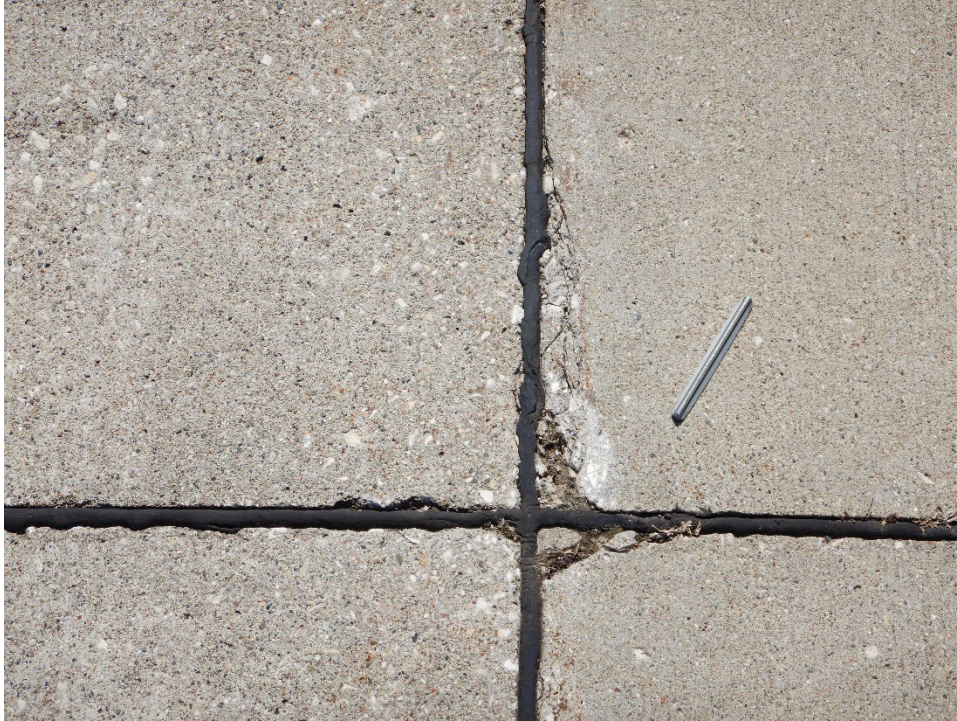
R17SL-02. Corner Spalling (Sample Unit No. 06).

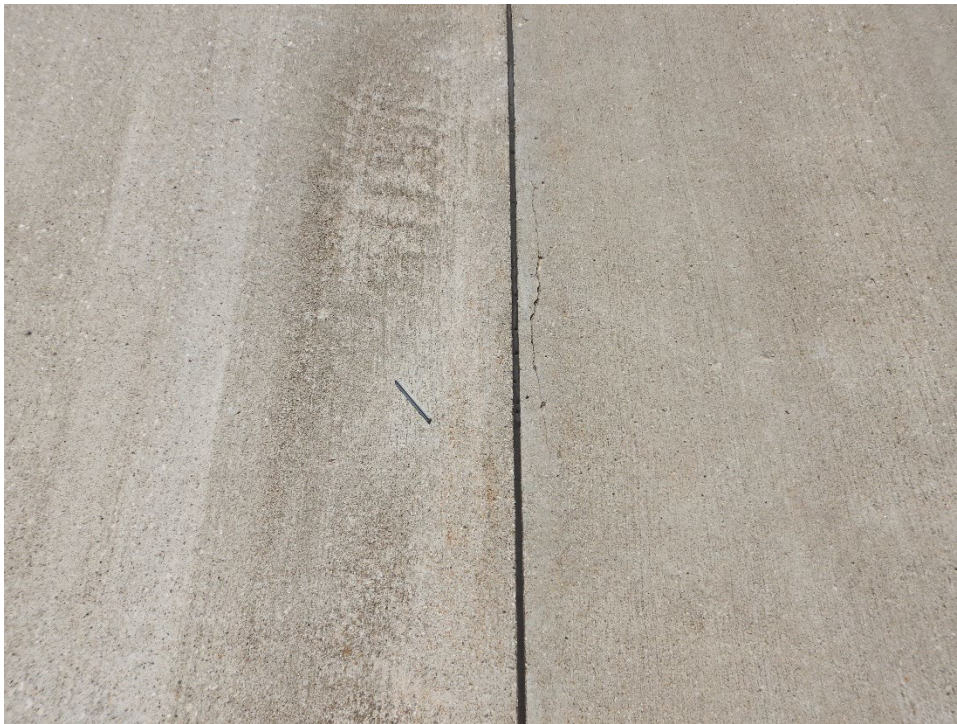
R17SL-02. Joint Spalling (Sample Unit No. 04).

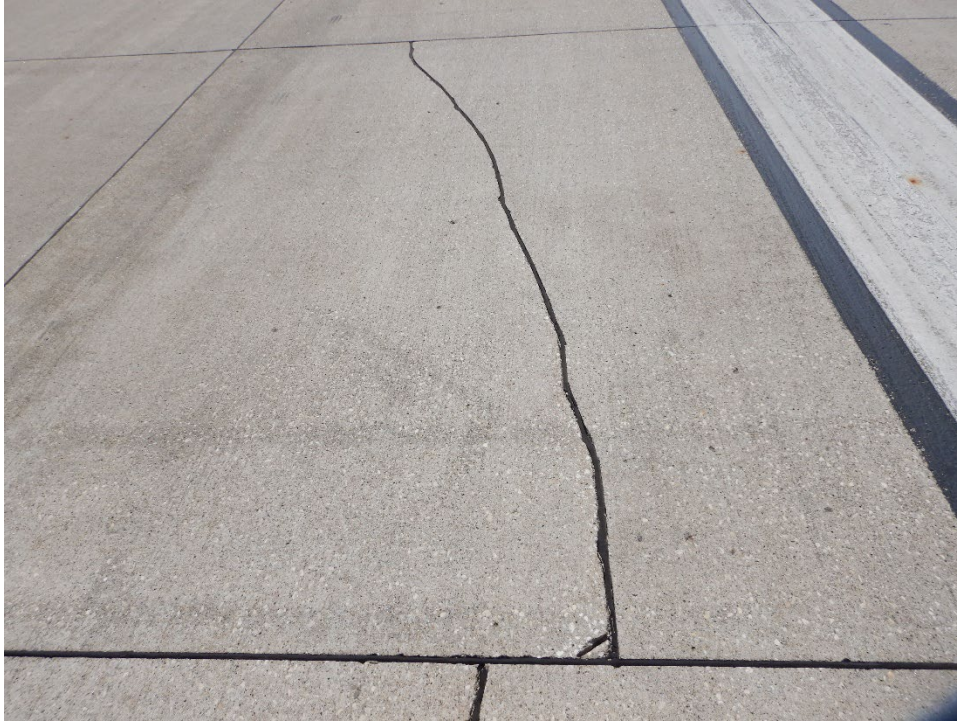
R17SL-02. LTD Cracking (Sample Unit No. 04).

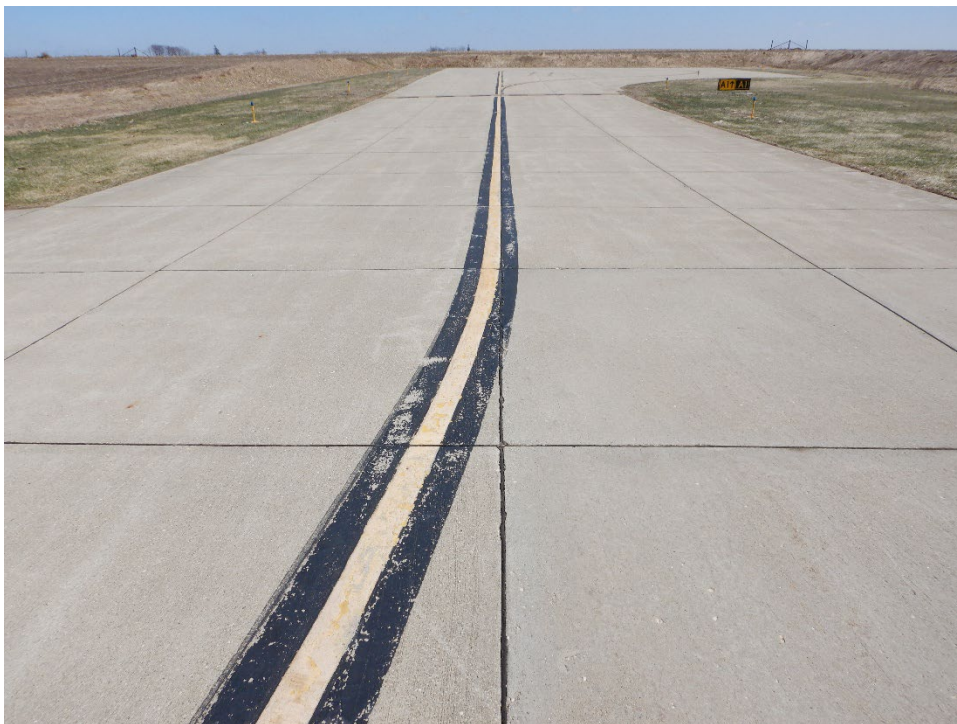
Taxiway A1 consisted of one section that contained low- and medium-severity corner break, faulting, and LTD cracking; high-severity joint spalling and corner spalling; and medium- and high-severity joint seal damage.

TA1SL-01. Overview.

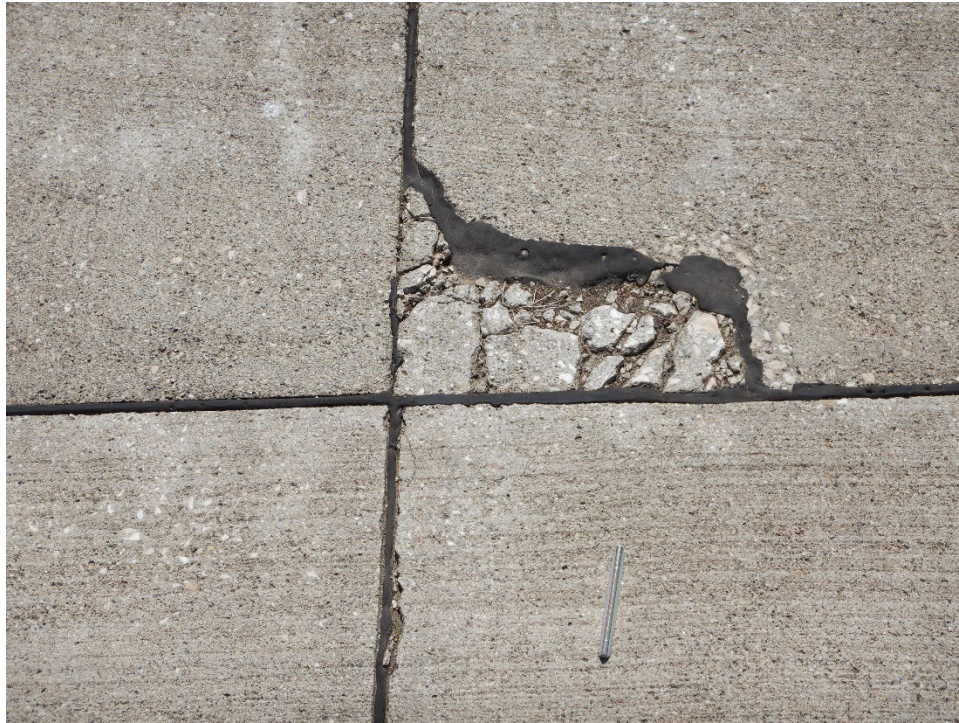
TA1SL-01. Corner Spalling (Sample Unit No. 04).

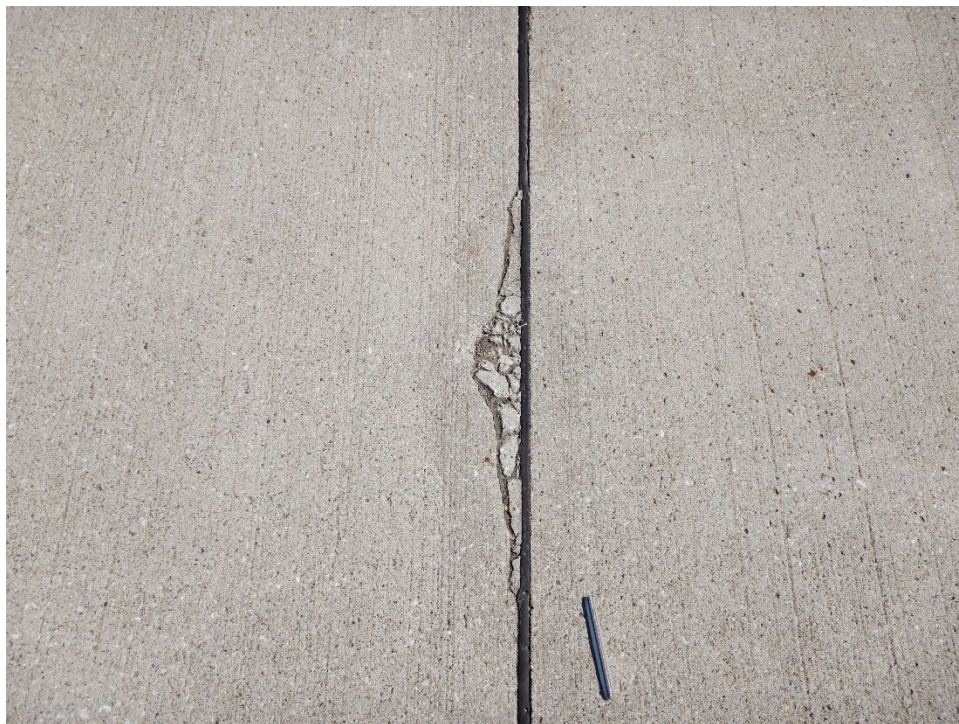
TA1SL-01. Joint Spalling (Sample Unit No. 02).

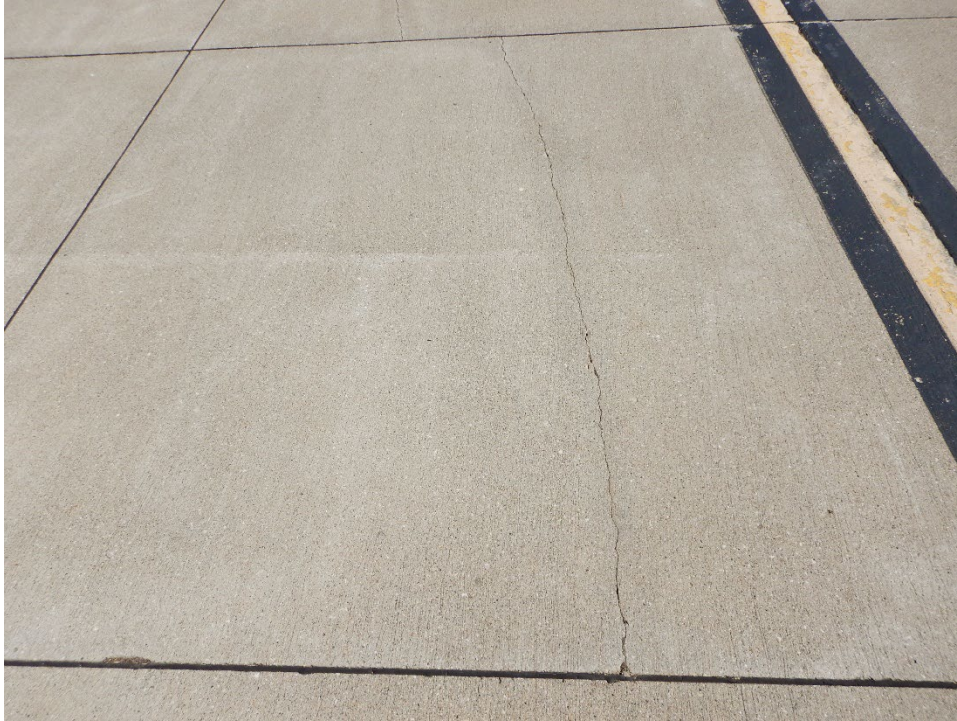
TA1SL-01. LTD Cracking (Sample Unit No. 04).

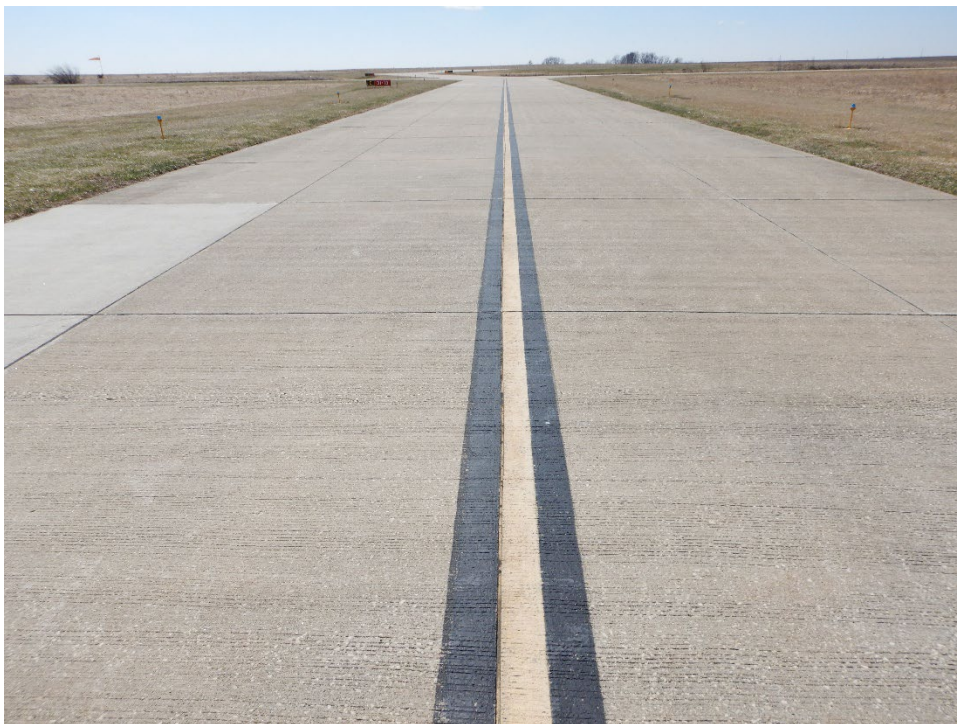
Taxiway C contained two sections. Medium-severity corner break, joint spalling, corner spalling, and joint seal damage; low-severity faulting, small patching, and large patching; all severities of LTD cracking; high-severity shattered slab; and shrinkage cracking were noted in Section 01. Low- and medium-severity corner break, joint spalling, corner spalling, and LTD cracking; medium- and high-severity joint seal damage; medium-severity shattered slab; and shrinkage cracking were recorded in Section 02.

TCSL-01. Overview.

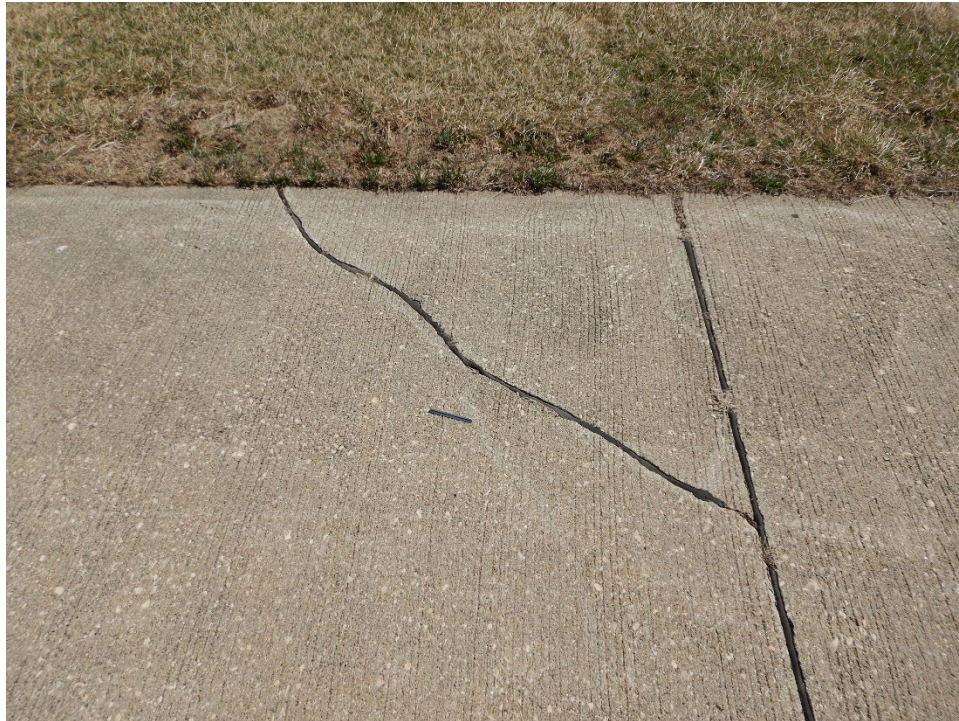
TCSL-01. Corner Break (Sample Unit No. 01).

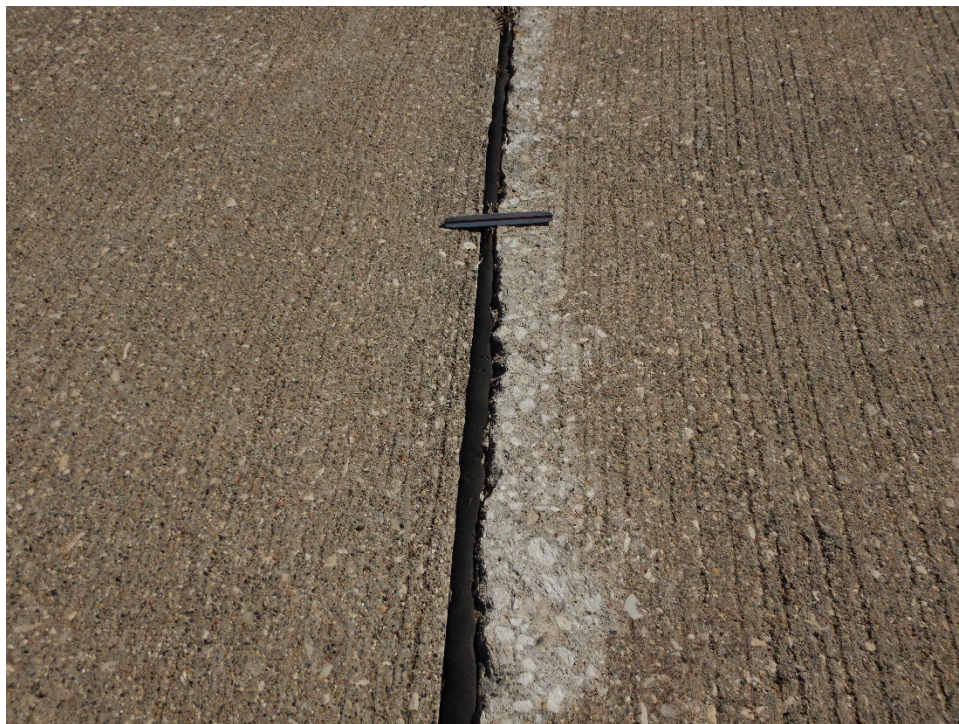
TCSL-01. Faulting (Sample Unit No. 02).

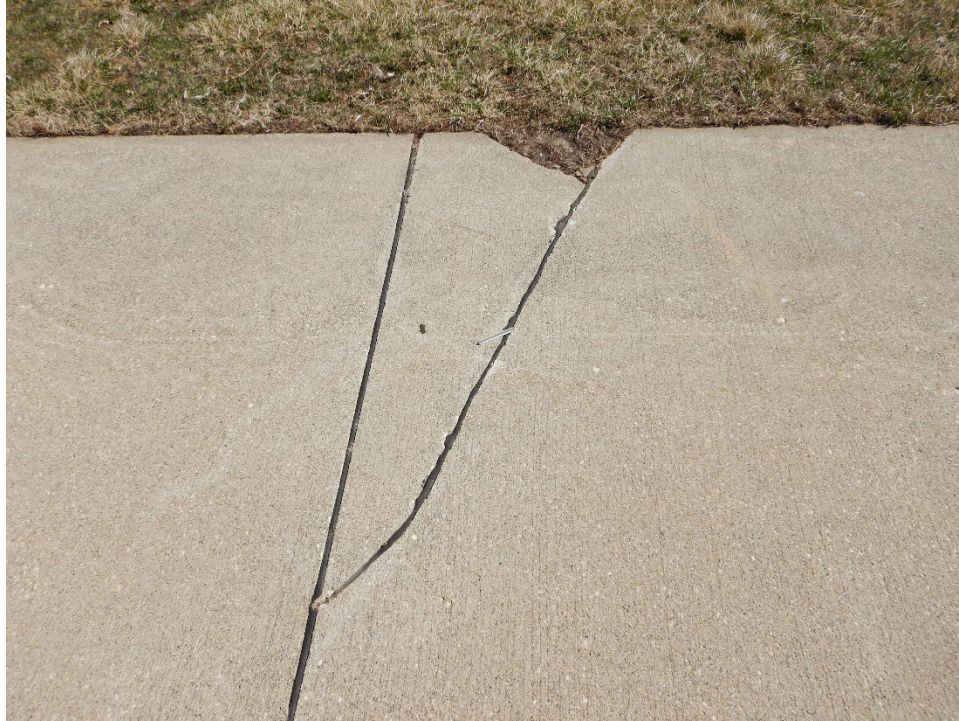
TCSL-01. LTD Cracking (Sample Unit No. 04).

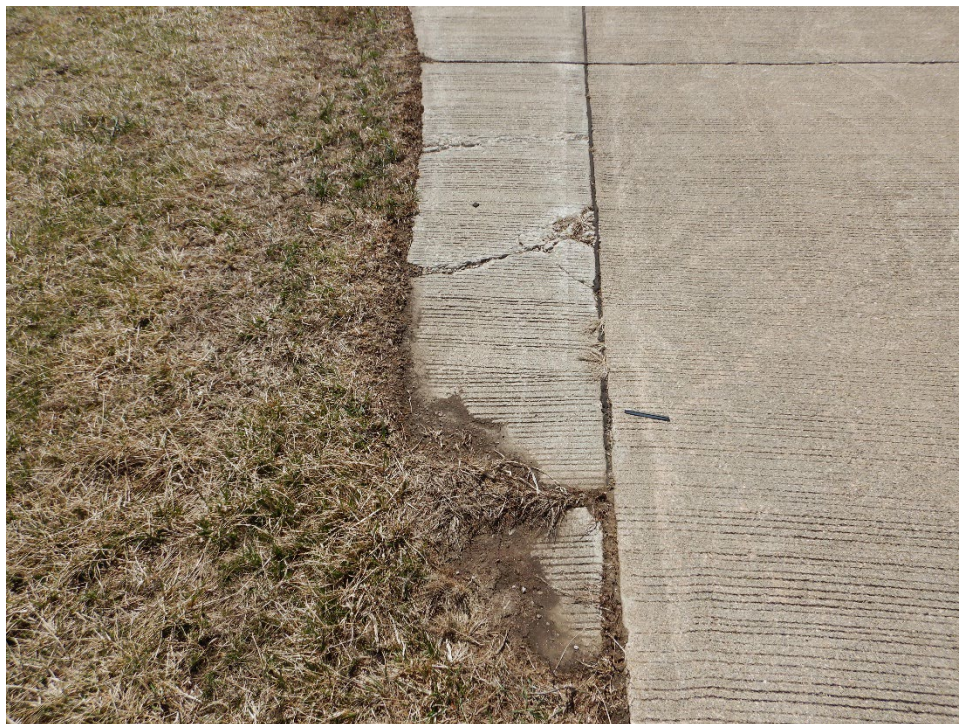
TCSL-01. Shattered Slab (Sample Unit No. 05).

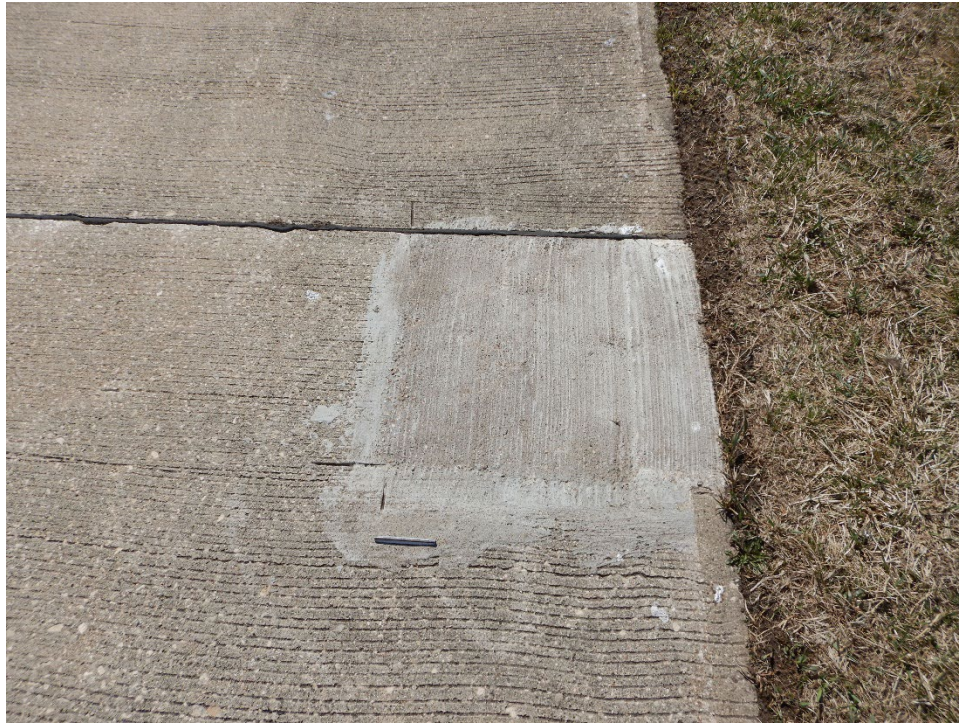
TCSL-01. Small Patching (Sample Unit No. 01).

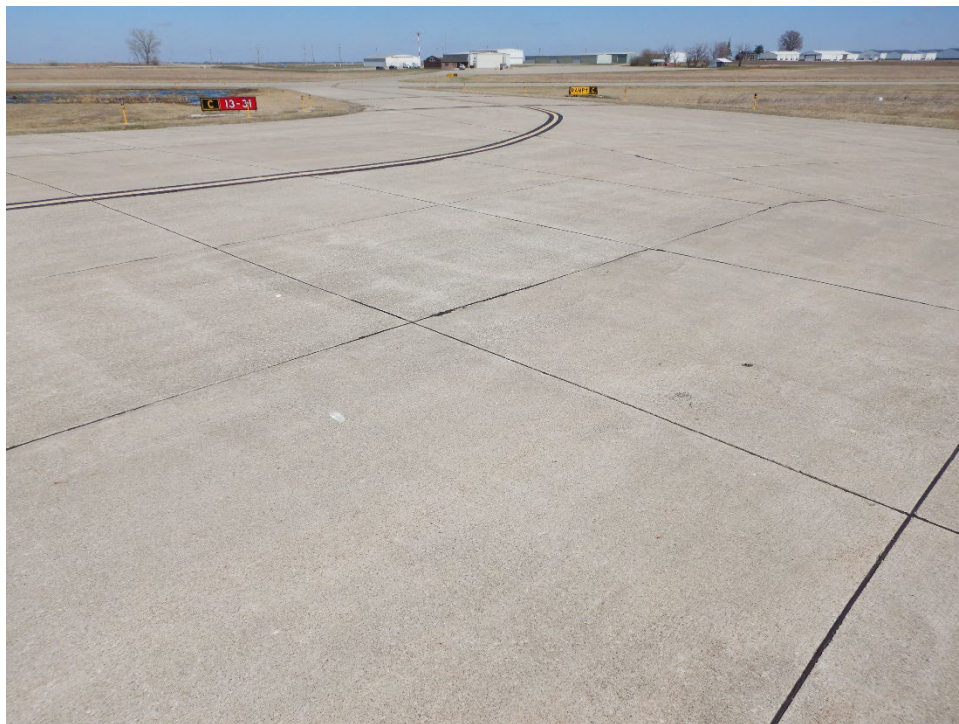
TCSL-02. Overview.

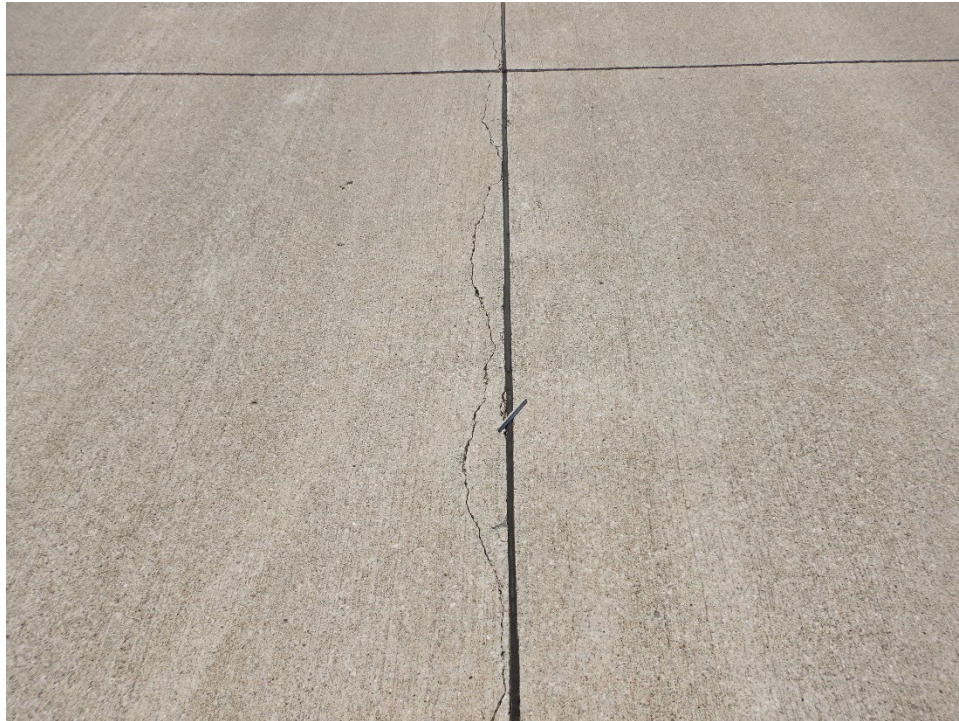
TCSL-02. Joint Spalling (Sample Unit No. 04).

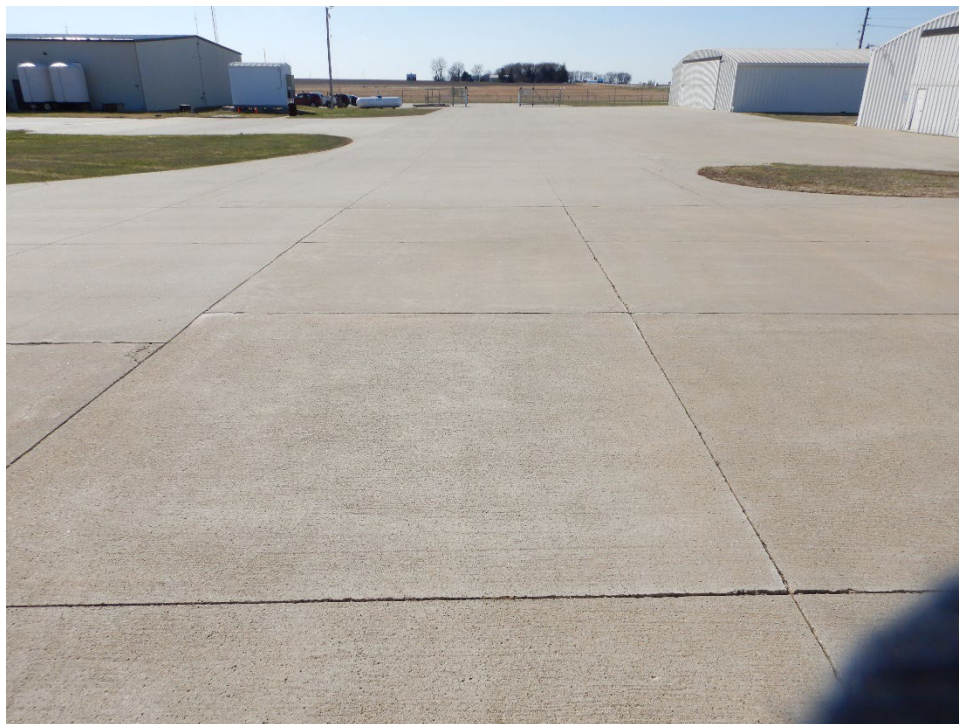
The T-hangar area was defined by four sections. Section 01 contained all severities of corner spalling, low-severity faulting, high-severity joint seal damage, medium- and high-severity joint spalling, medium-severity LTD cracking and small patching, and shrinkage cracking. Medium-severity corner spalling and shattered slab, high-severity joint seal damage, low- and high-severity joint spalling, low- and medium-severity LTD cracking, and shrinkage cracking were observed Section 02. Section 03 had high-severity joint seal damage and low- and medium-severity joint spalling recorded during the inspection. Low- and medium-severity corner break and joint spalling, medium-severity corner spalling and LTD cracking, high-severity joint seal damage, and shrinkage cracking were identified in Section 04.

TH01SL-01. Overview.

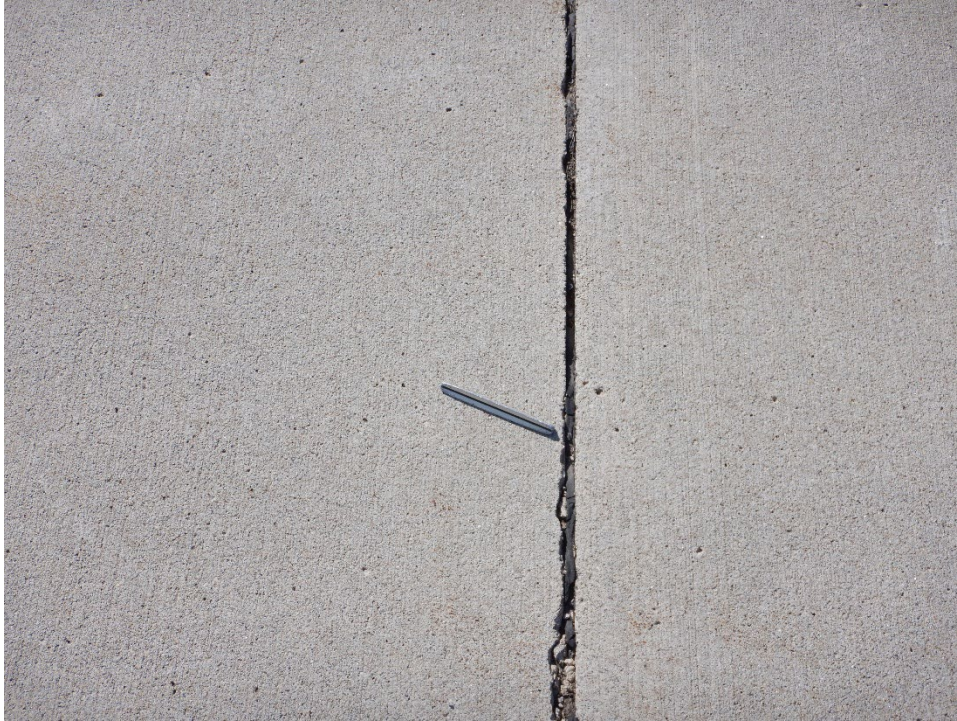
TH01SL-01. Joint Seal Damage (Sample Unit No. 01).

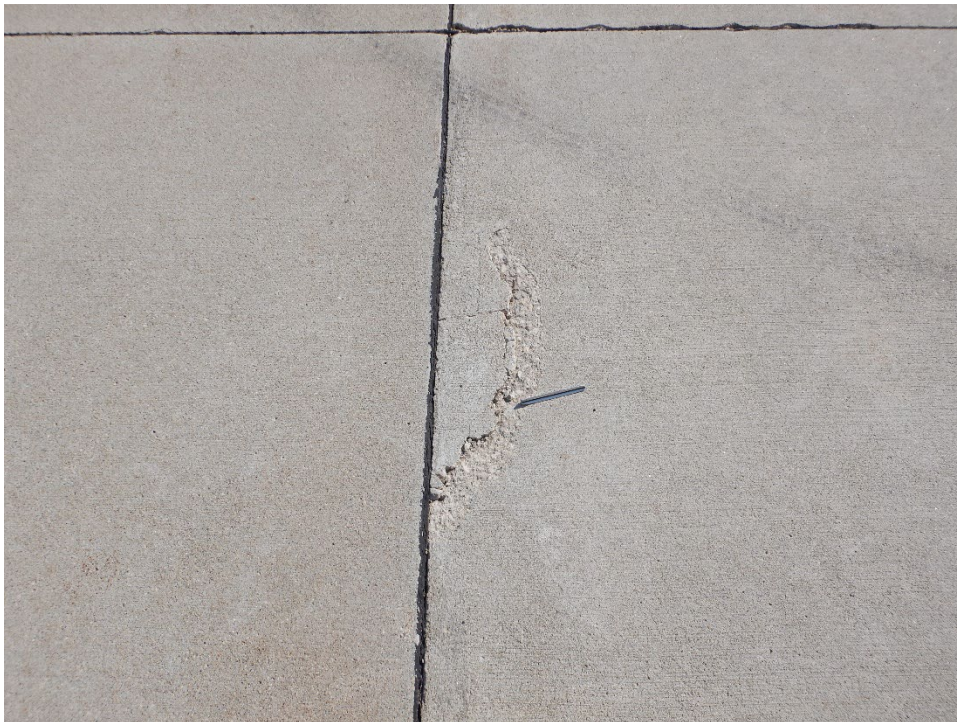
TH01SL-01. Joint Spalling (Sample Unit No. 01).
