# Storm Lake Municipal Airport

## Pavement Management Report

# STORM LAKE MUNICIPAL AIRPORT PAVEMENT MANAGEMENT REPORT

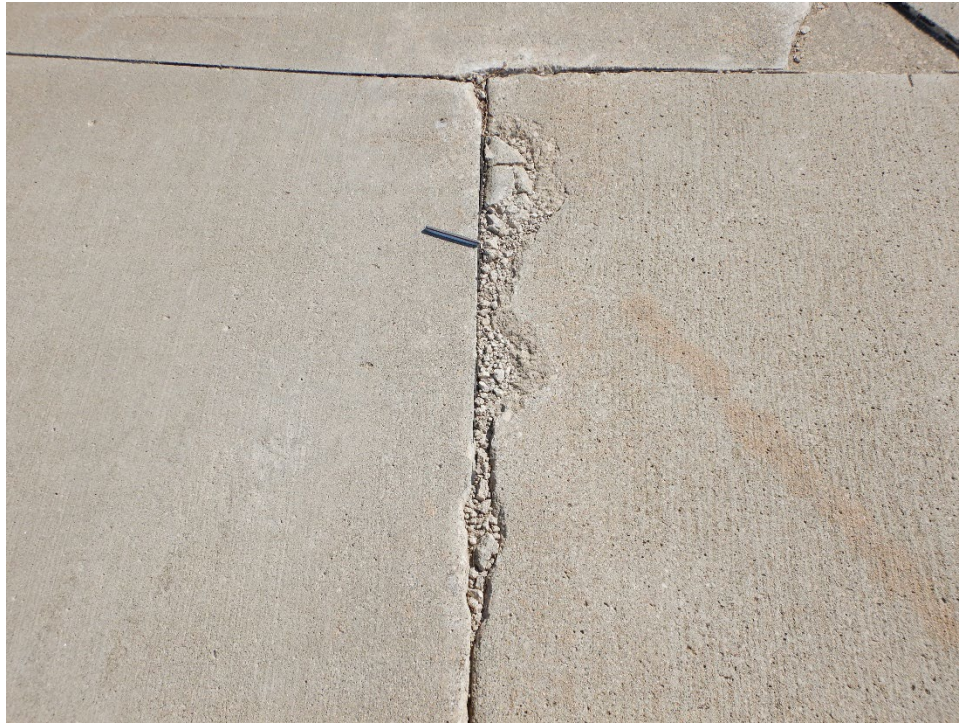
TH01SL-01. Joint Spalling (Sample Unit No. 04).

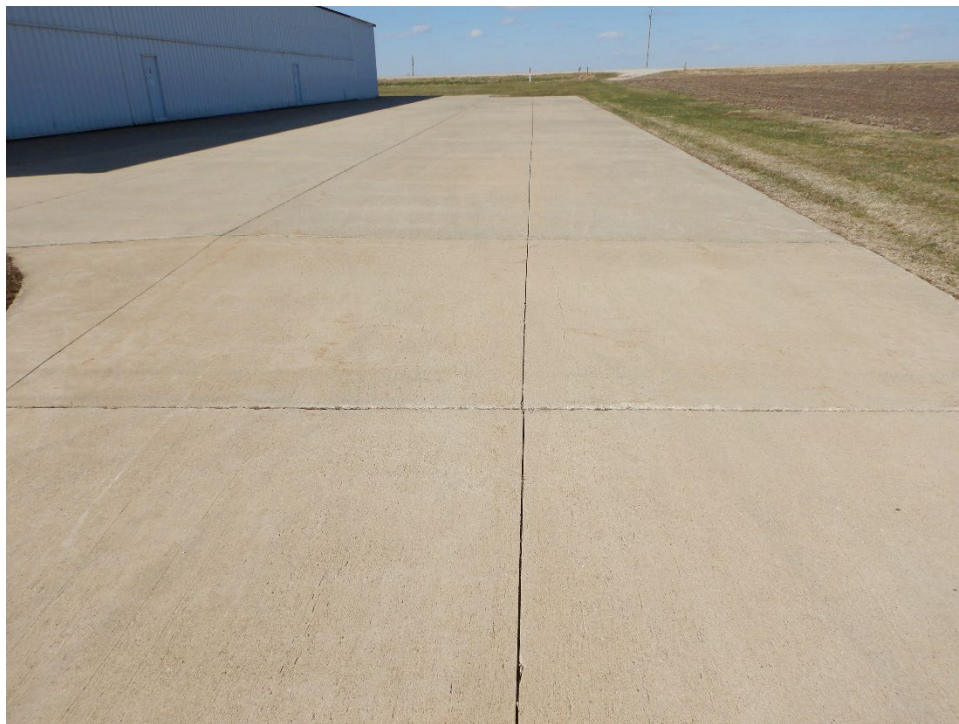
TH01SL-02. Overview.

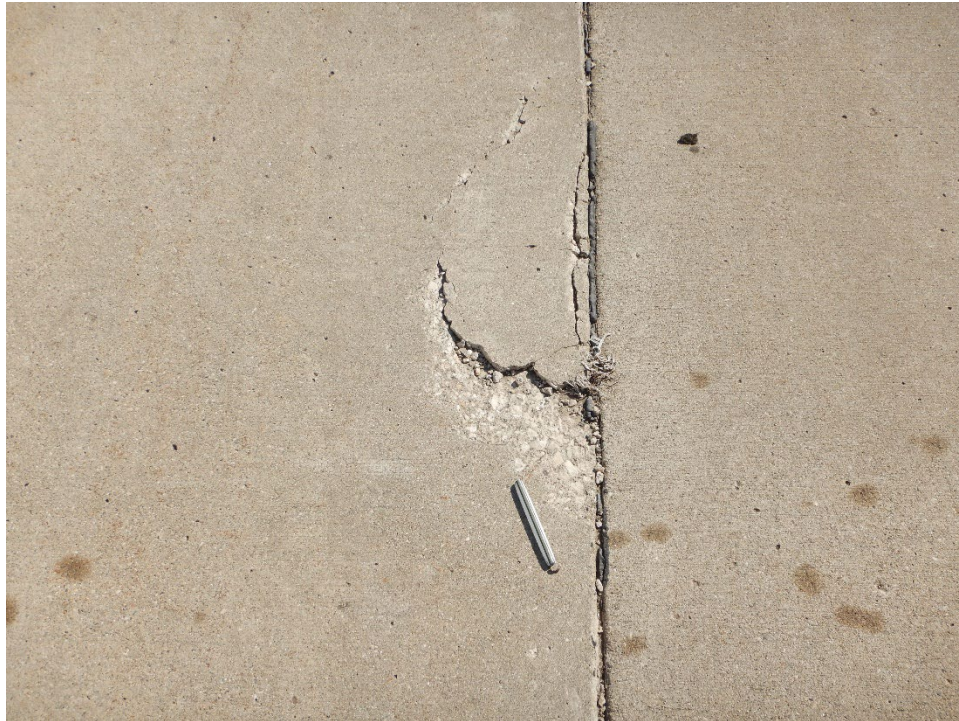
TH01SL-02. Joint Spalling (Sample Unit No. 05) (1).

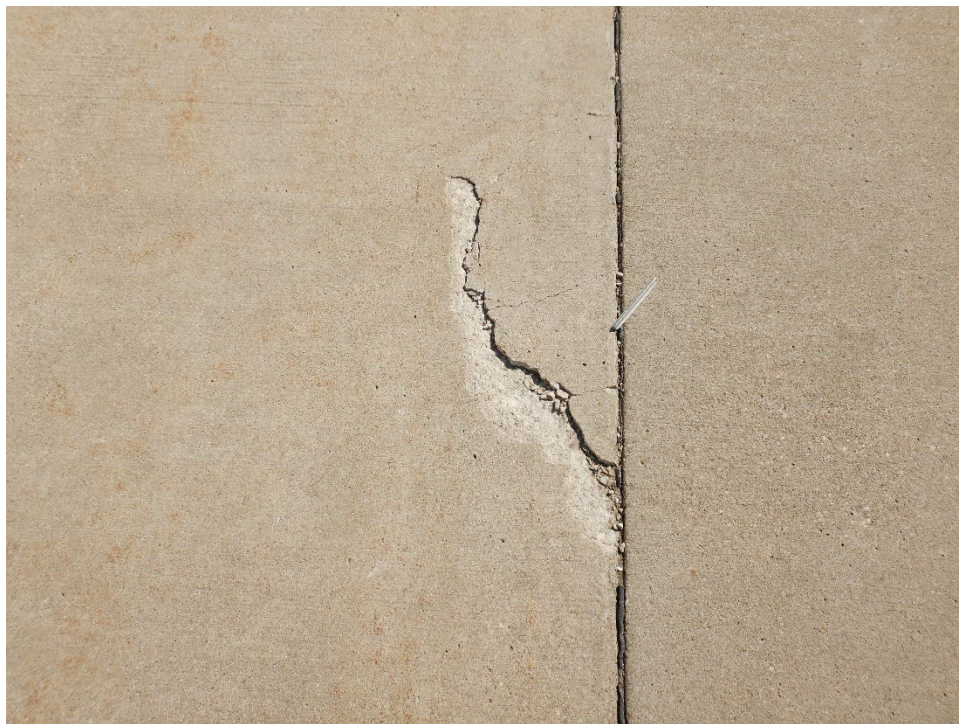
TH01SL-02. Joint Spalling (Sample Unit No. 05) (2).

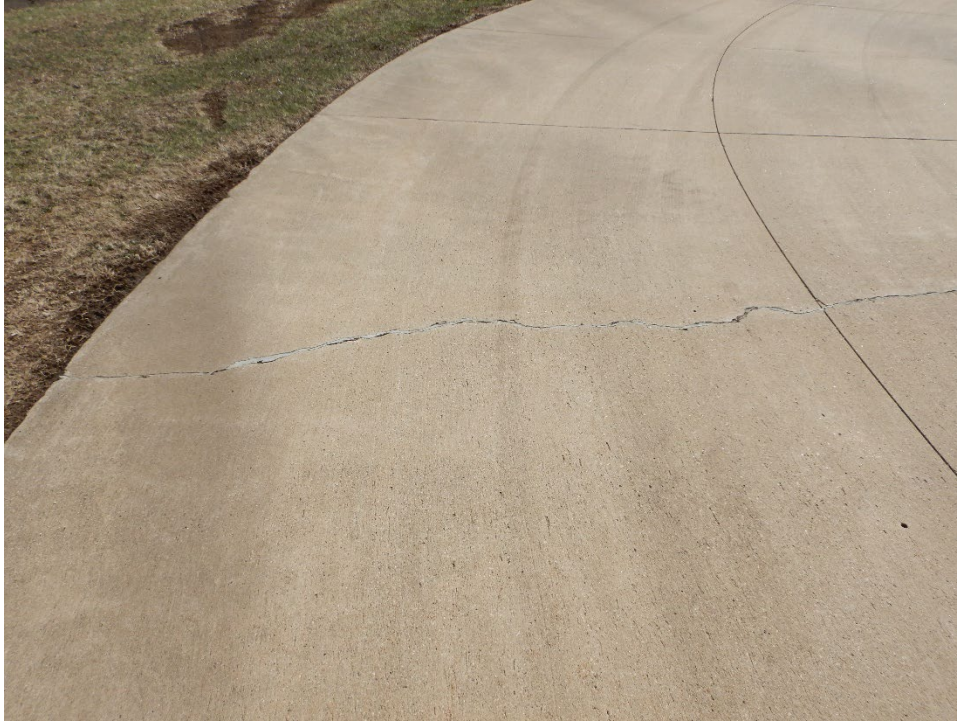
TH01SL-02. LTD Cracking (Sample Unit No. 02).

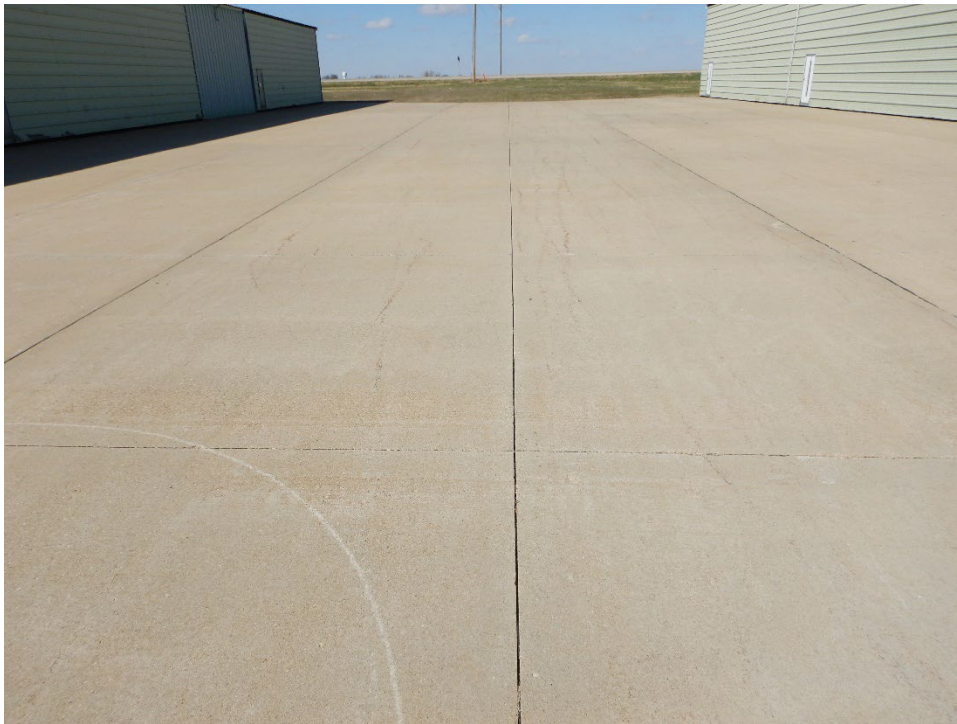
TH01SL-03. Overview.

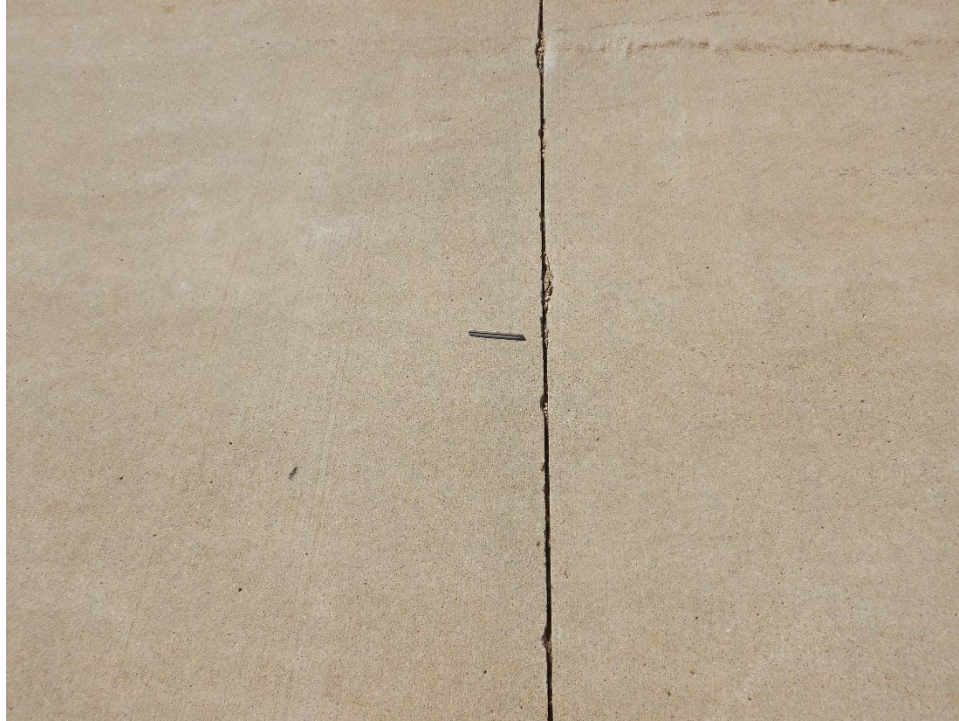
TH01SL-03. Joint Seal Damage (Sample Unit No. 01).

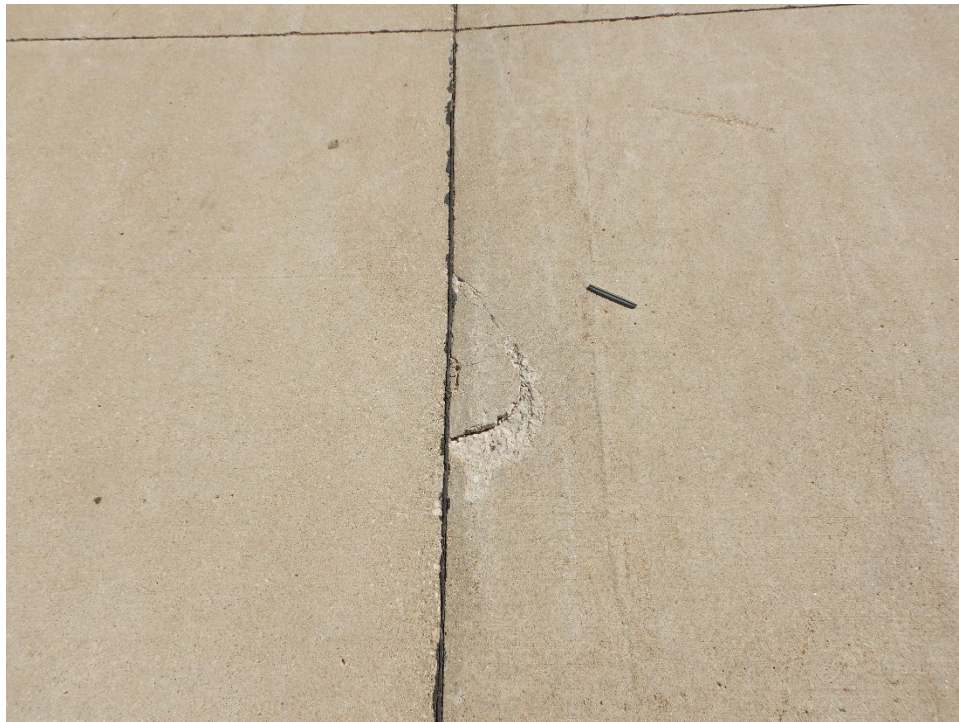
TH01SL-03. Joint Spalling (Sample Unit No. 01).

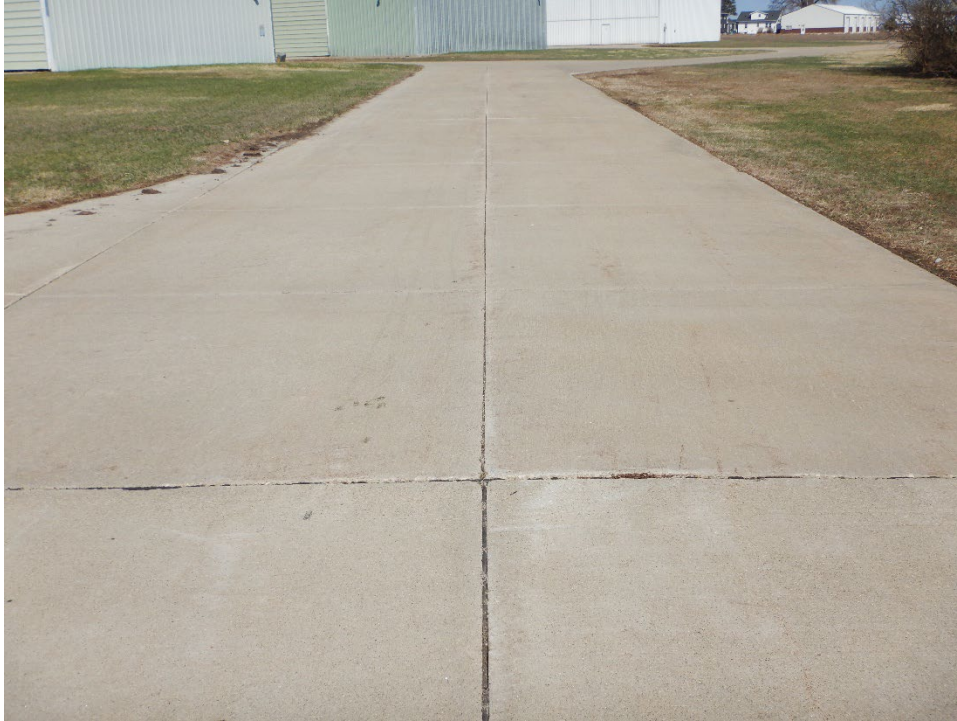
TH01SL-04. Overview.

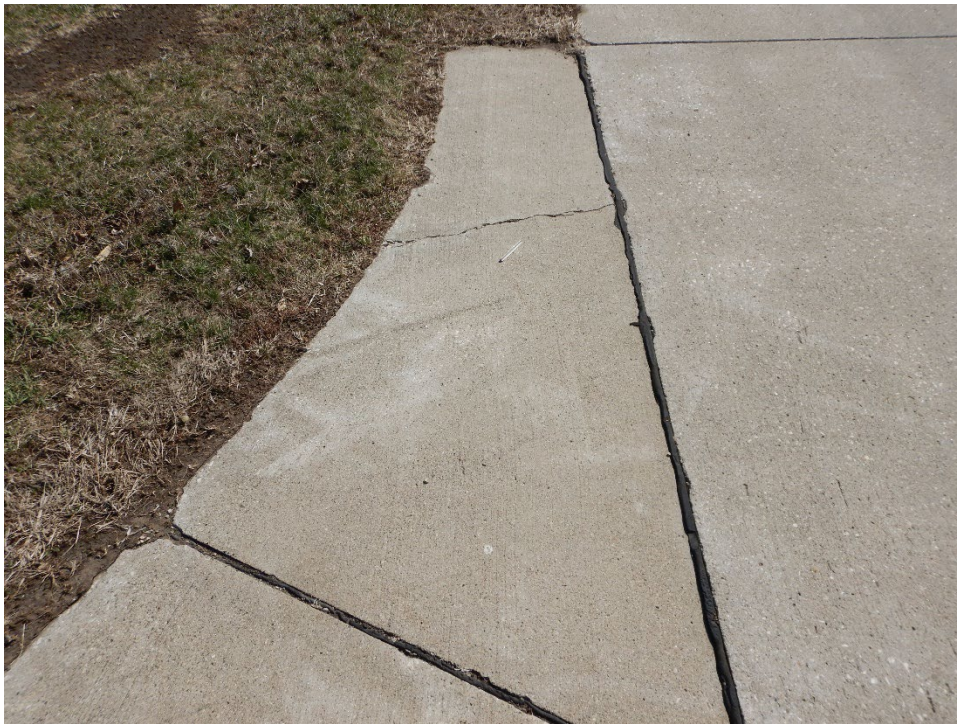
TH01SL-04. LTD Cracking (Sample Unit No. 01).
