# Washington Municipal Airport

## Pavement Management Report

**JULY 2023**

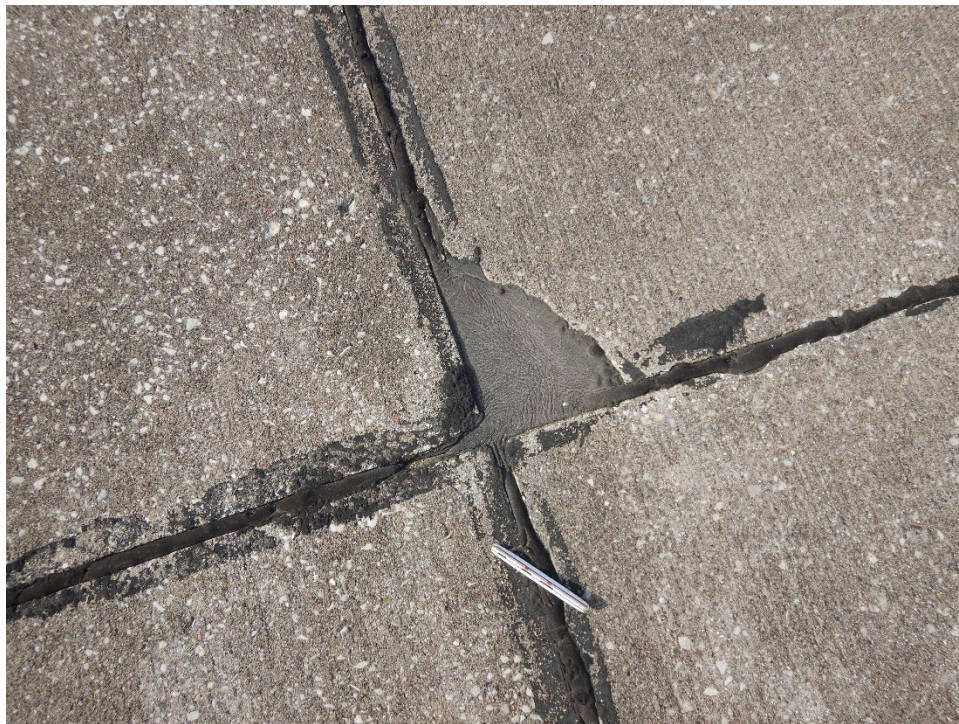
A01WA-01. Corner Spalling (Sample Unit No. 02).

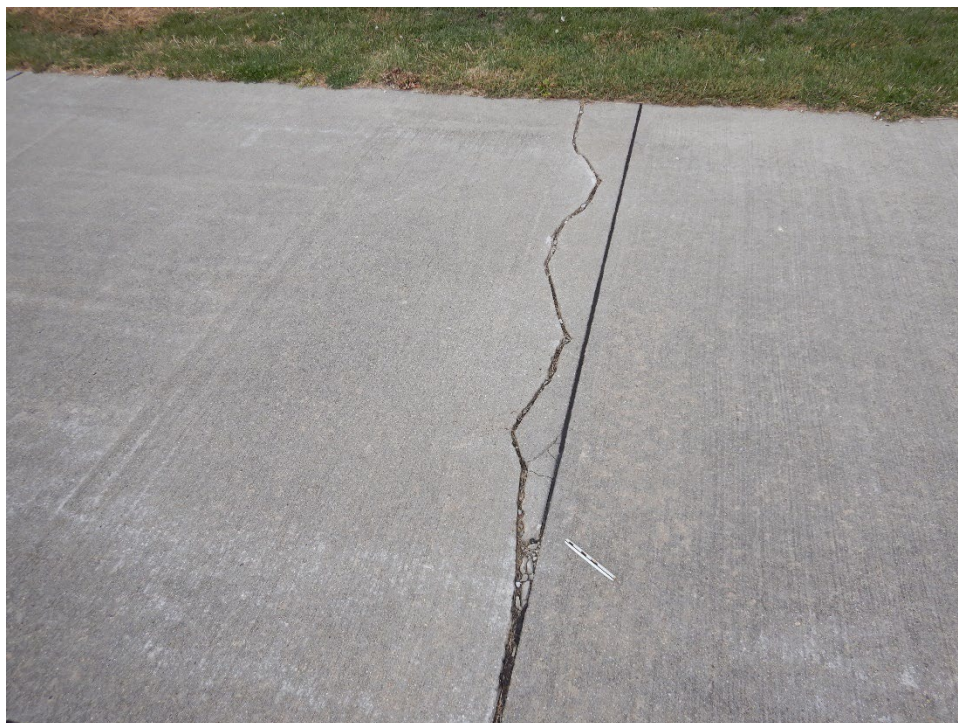
A01WA-02. Joint Spalling (Sample Unit No. 03).

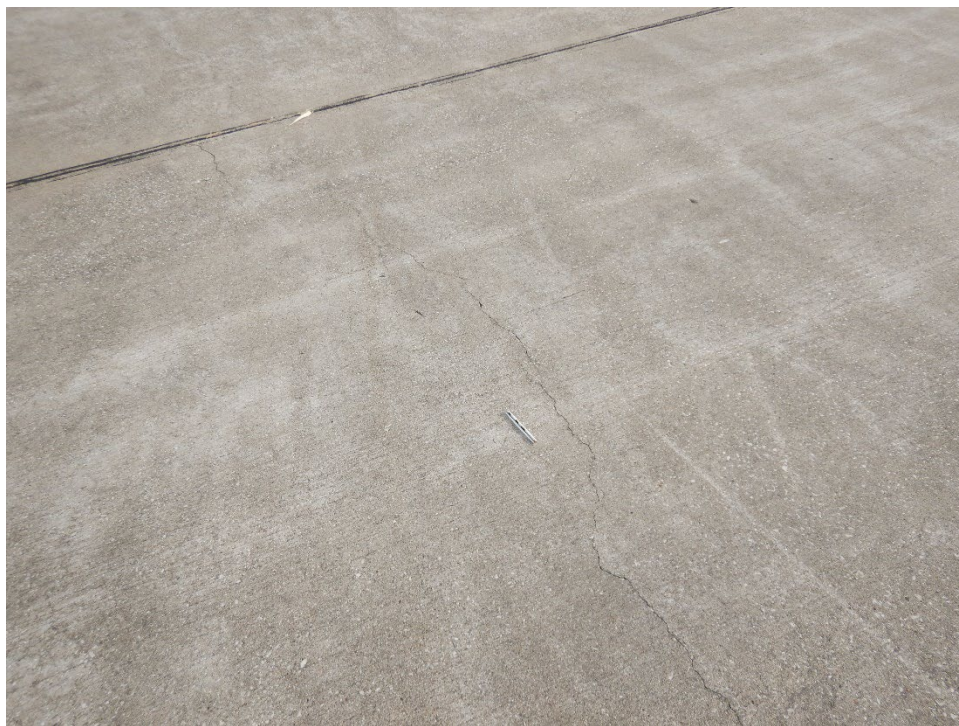
A01WA-03. LTD Cracking (Sample Unit No. 01).

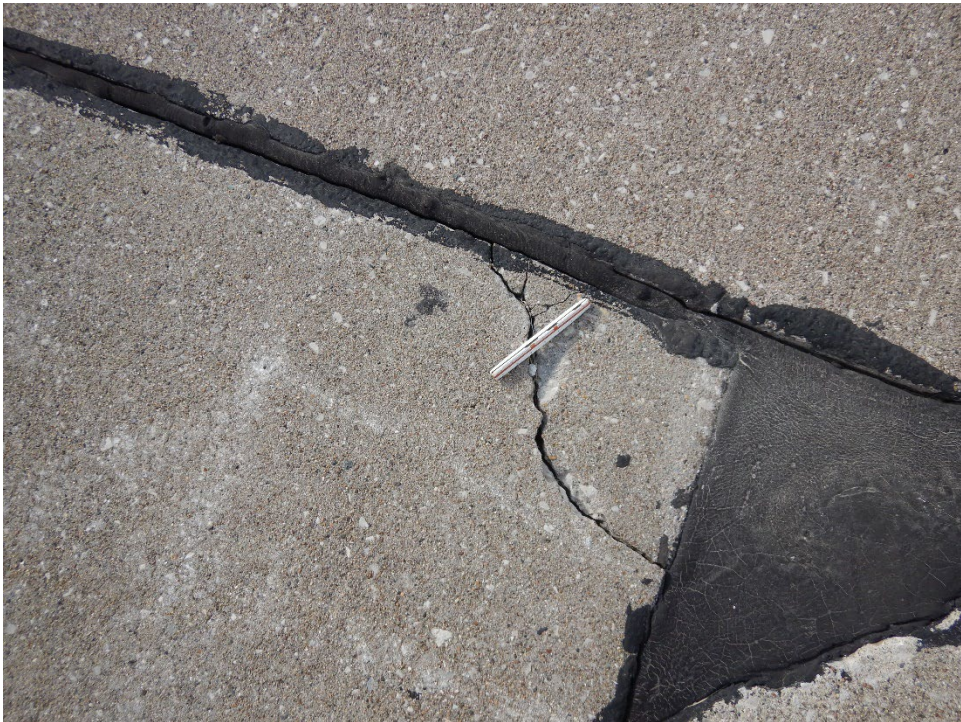
A01WA-04. Corner Spalling (Sample Unit No. 01).

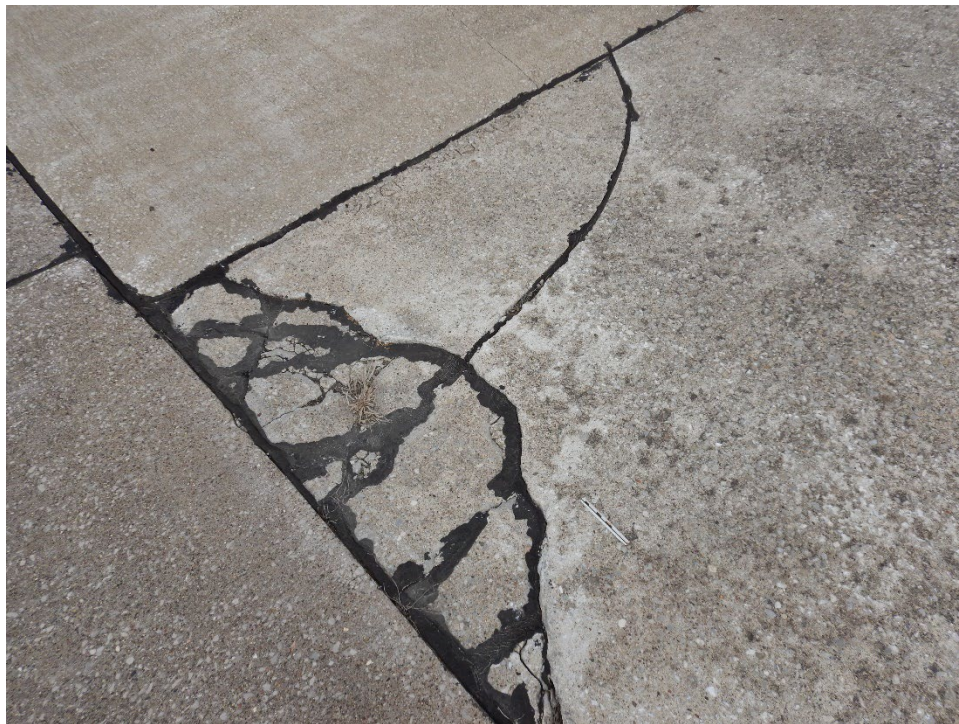
A01WA-05. Corner Break (Sample Unit No. 02).

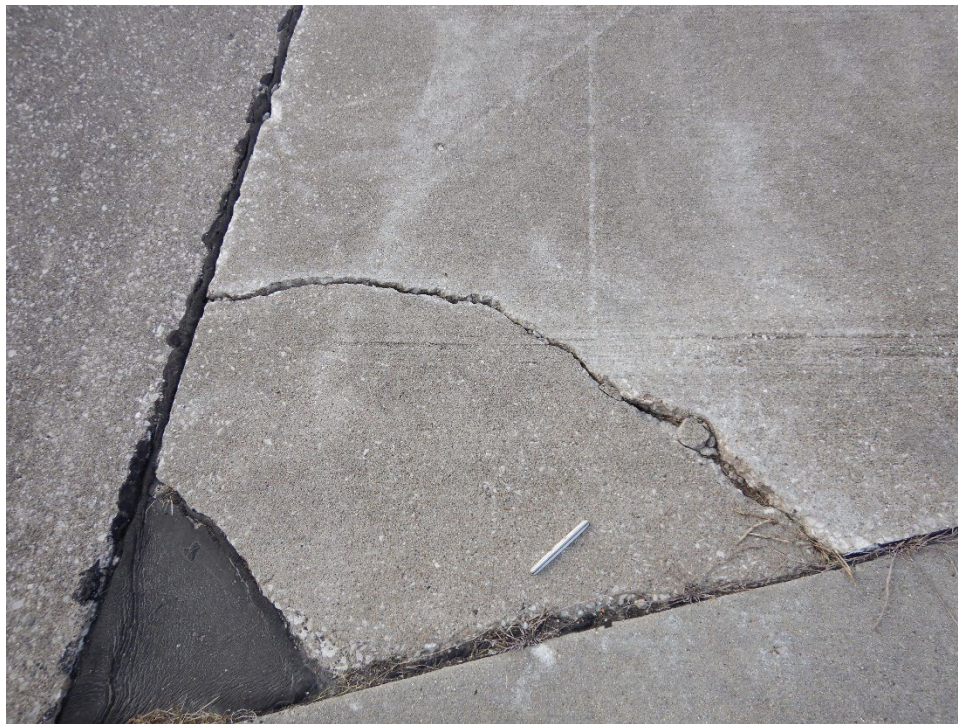
A01WA-06. Corner Break (Sample Unit No. 01).

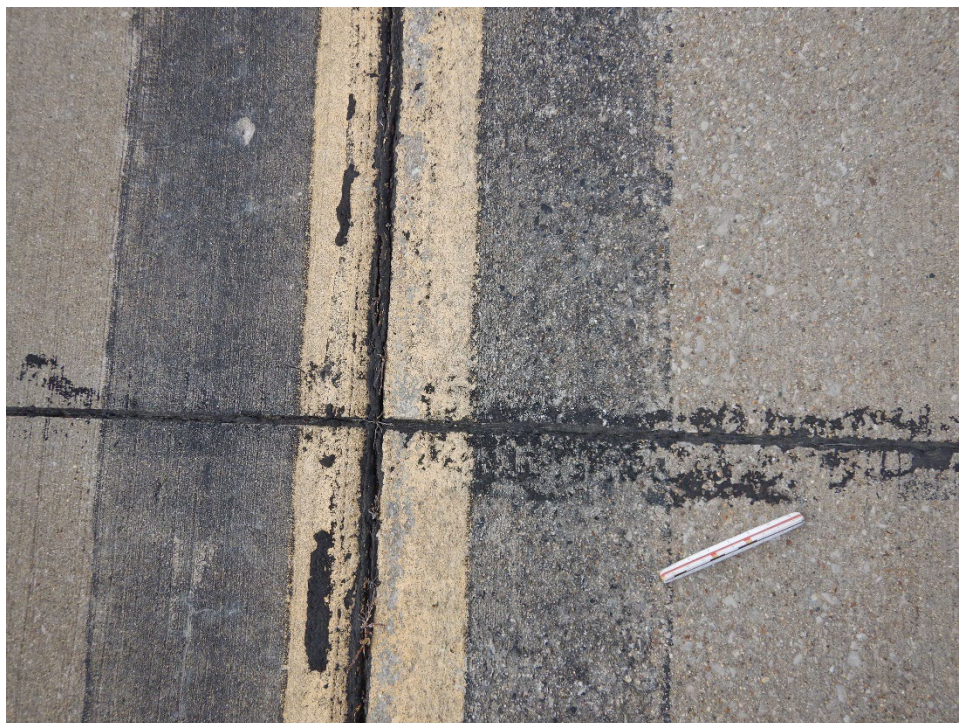
A01WA-07. Joint Seal Damage (Sample Unit No. 04).

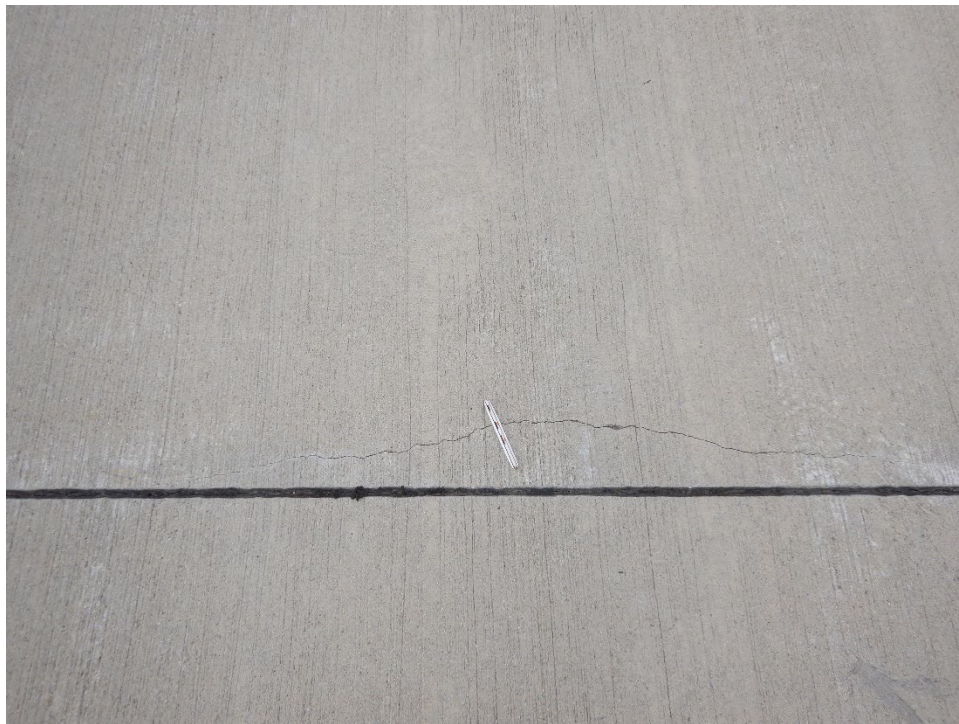
A01WA-08. Joint Spalling (Sample Unit No. 02).

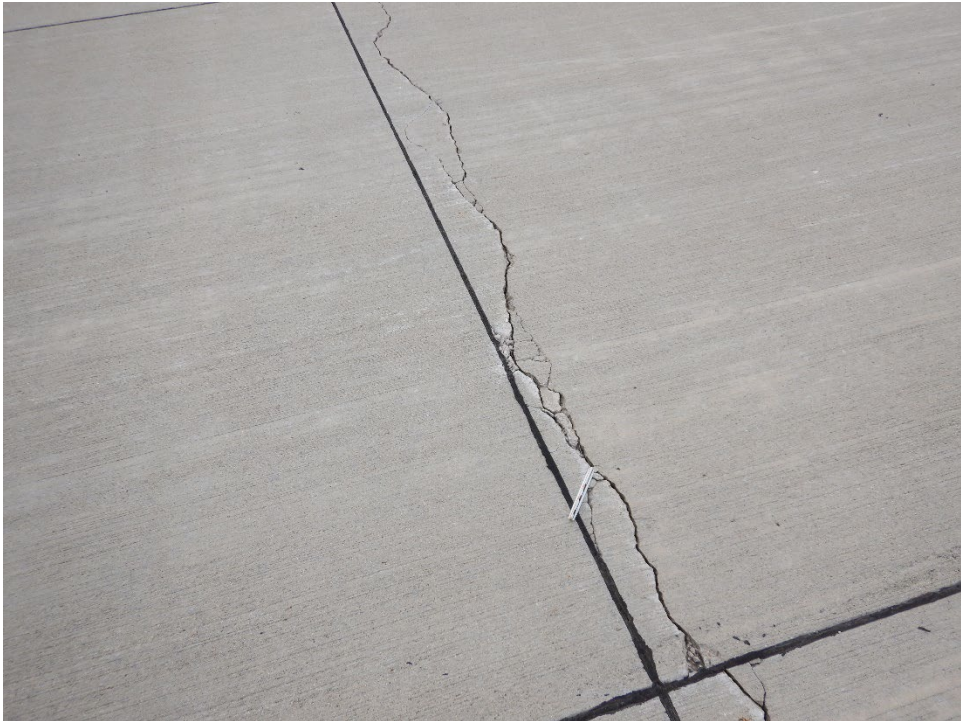
A01WA-08. Joint Spalling (Sample Unit No. 05).

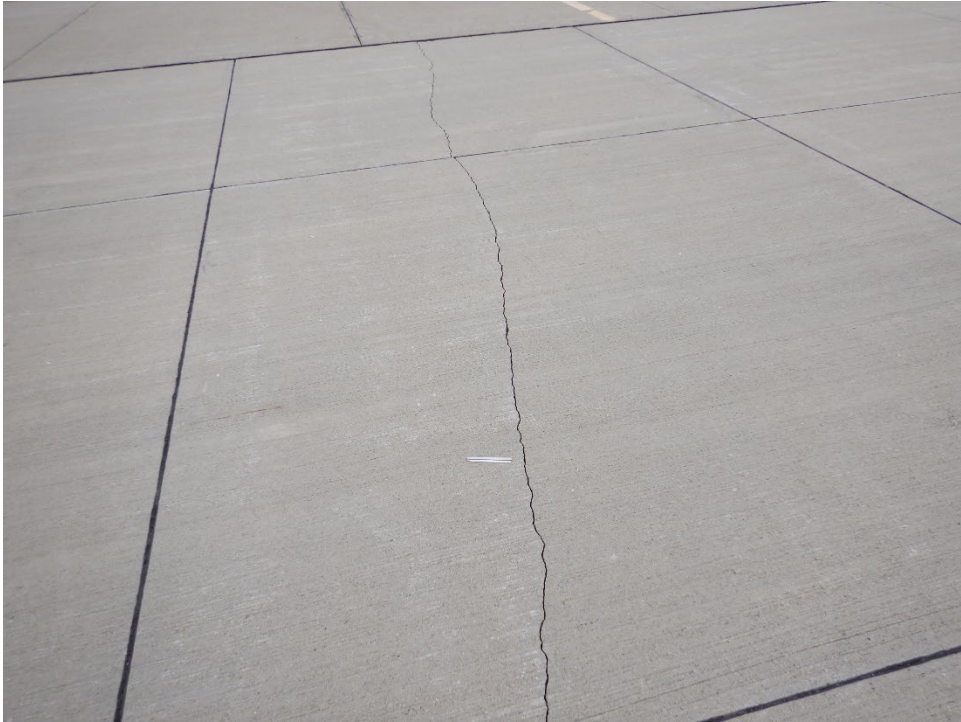
and low-severity corner spalling, small patching, and joint seal damage recorded. An atypical area of low-severity LTD cracking was observed and recorded as an additional sample unit in accordance with ASTM D5340-20. Section 09 contained areas of low-severity corner break and medium-severity joint seal damage, LTD cracking, and shattered slab.

A01WA-08. LTD Cracking (Additional Sample Unit No. 03).

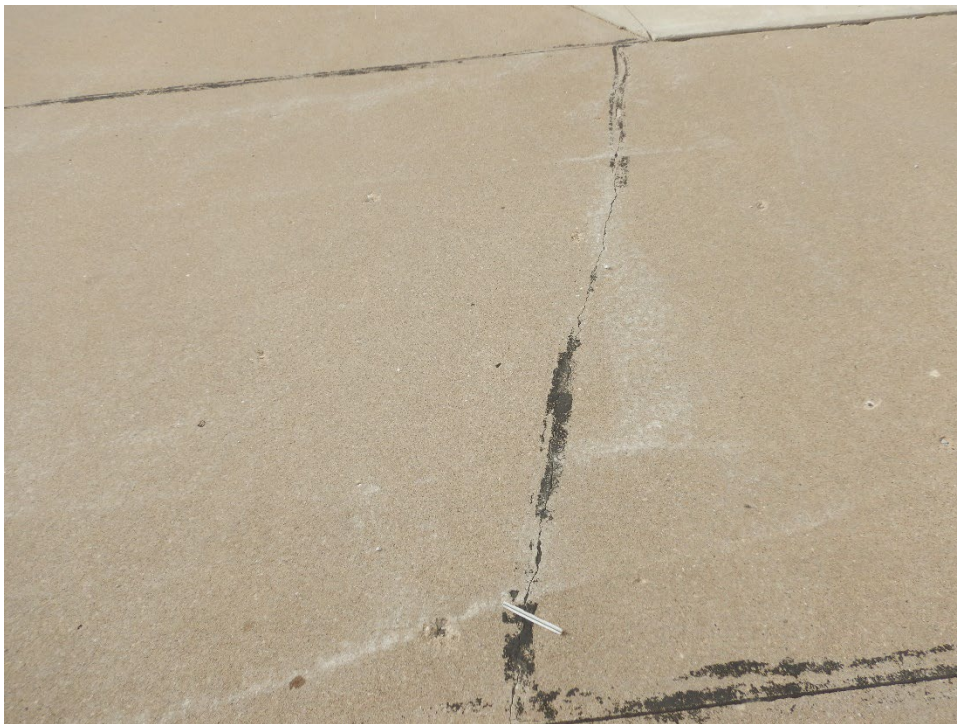
A01WA-09. LTD Cracking (Sample Unit No. 01).

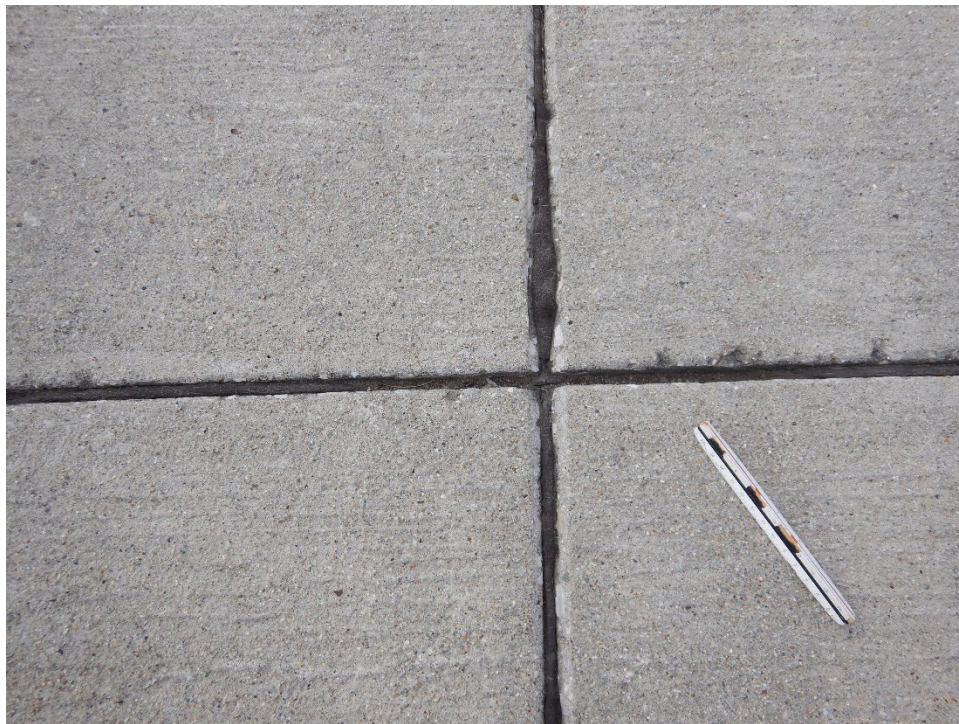
Runway 13/31 was defined by one section. Areas of medium-severity joint seal damage and low-severity joint spalling and corner spalling were recorded in Section 01 during the inspection.

R13WA-01. Joint Seal Damage (Sample Unit No. 15).

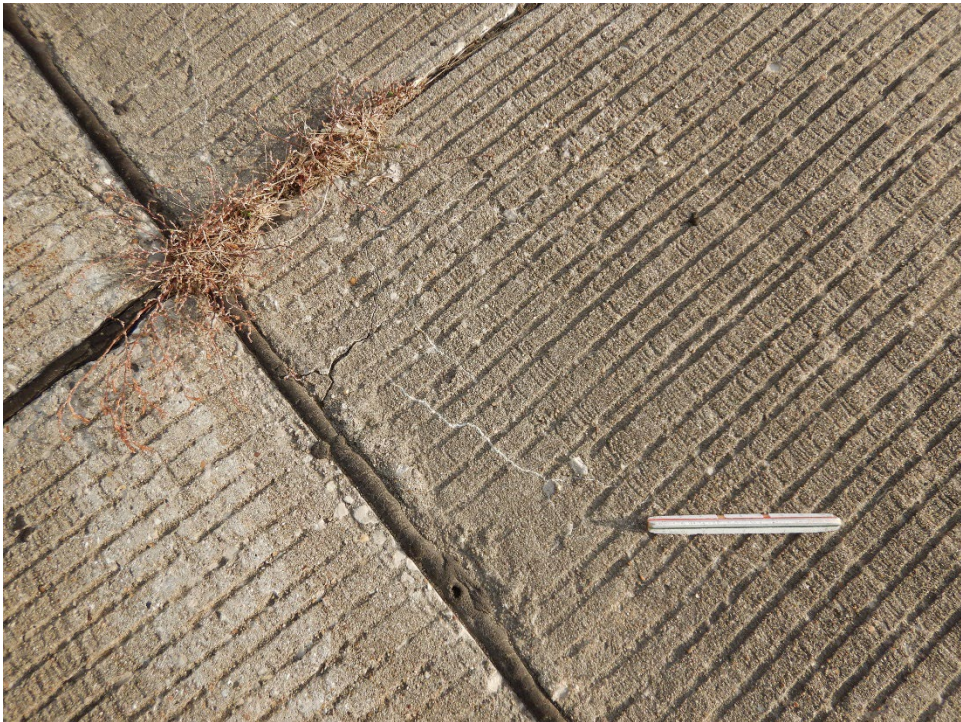
Runway 18/36 contained one section. Low- and medium-severity ASR, joint spalling, and corner spalling; low-severity faulting; and medium-severity joint seal damage were identified in Section 01. An atypical area of high-severity joint spalling was observed and recorded as an additional sample unit in accordance with ASTM D5340-20

R18WA-01. ASR (Additional Sample Unit No. 08).

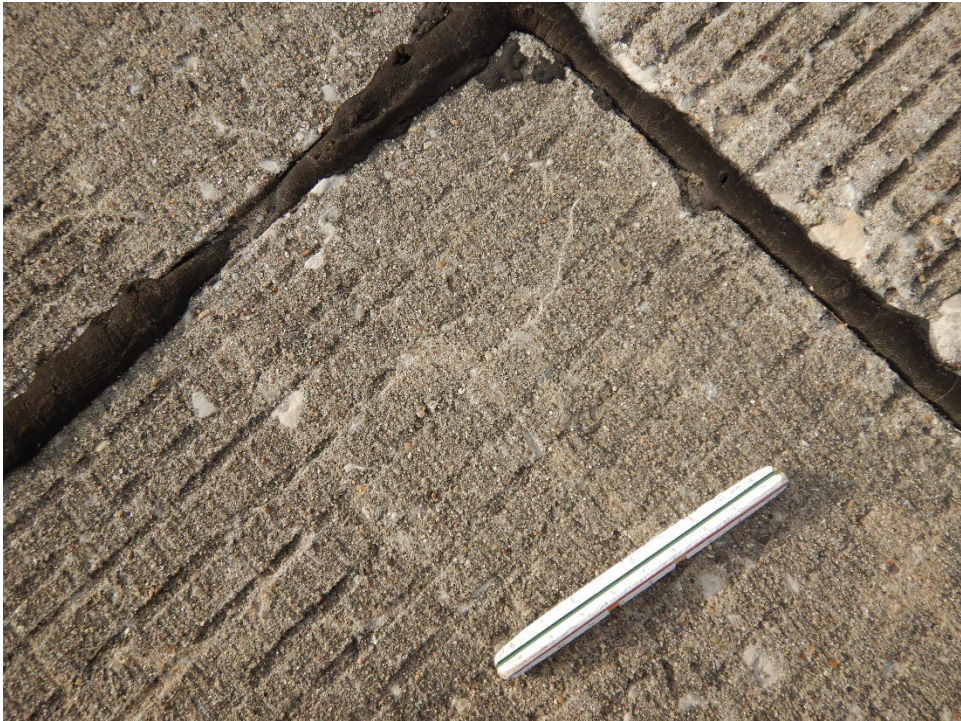
R18WA-01. ASR (Sample Unit No. 22).

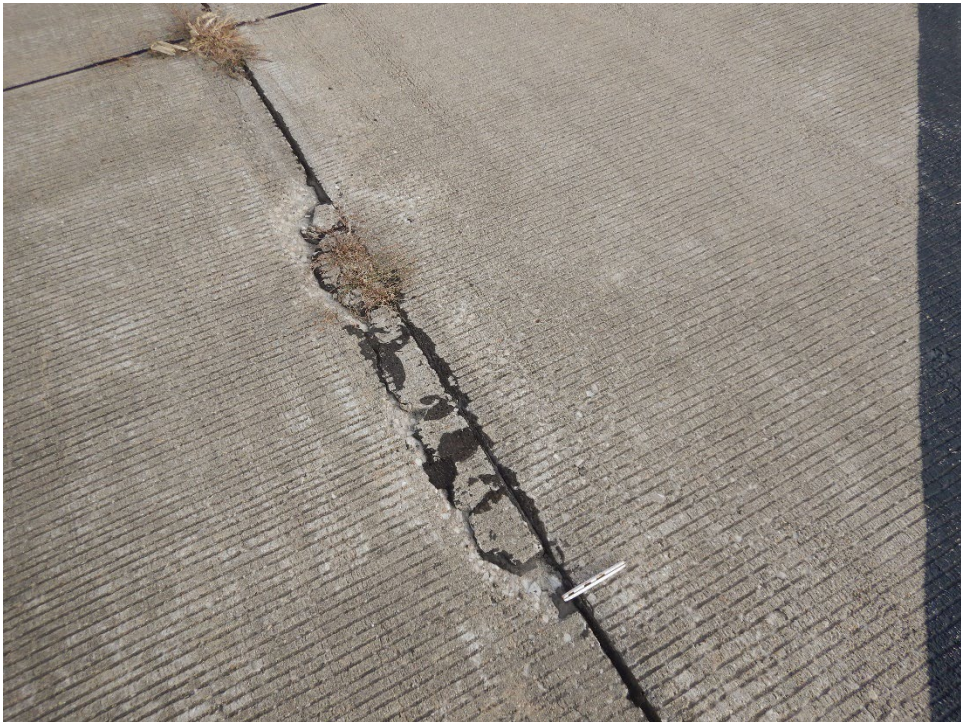
R18WA-01. Joint Spalling (Additional Sample Unit No. 08).

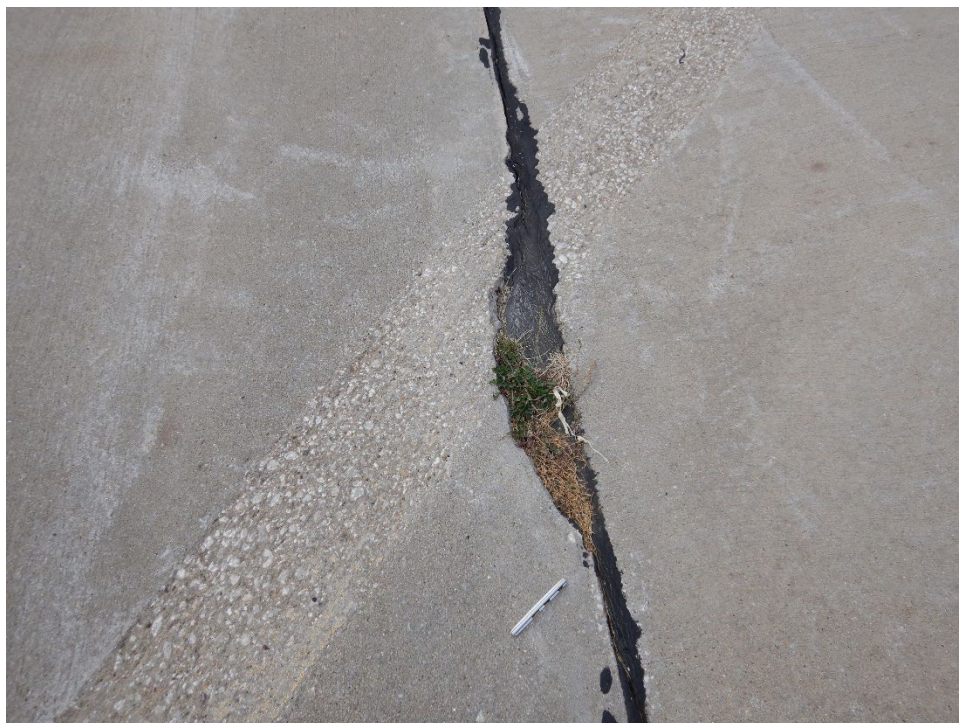
T01WA-01. Joint Spalling (Sample Unit No. 02).

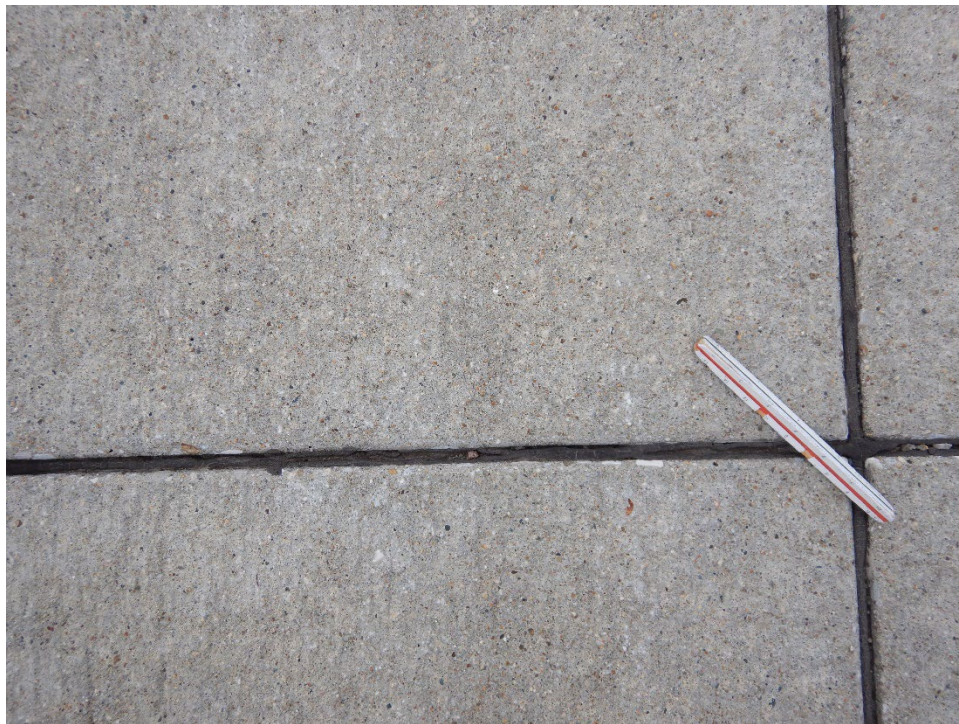
T01WA-02. Joint Seal Damage (Sample Unit No. 04).

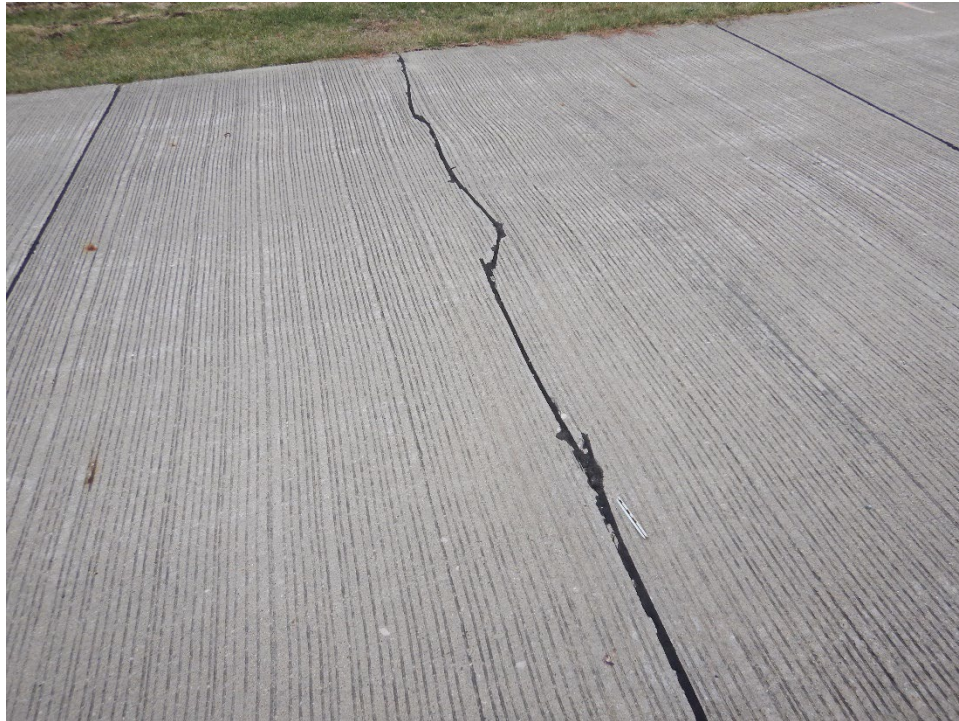
Taxiway 02 consisted of one section. Section 01 contained low-severity small patching, large patching, and corner spalling; medium-severity joint seal damage; and low- and medium-severity longitudinal, transverse, and diagonal (LTD) cracking.

T02WA-01. LTD Cracking (Sample Unit No. 06).

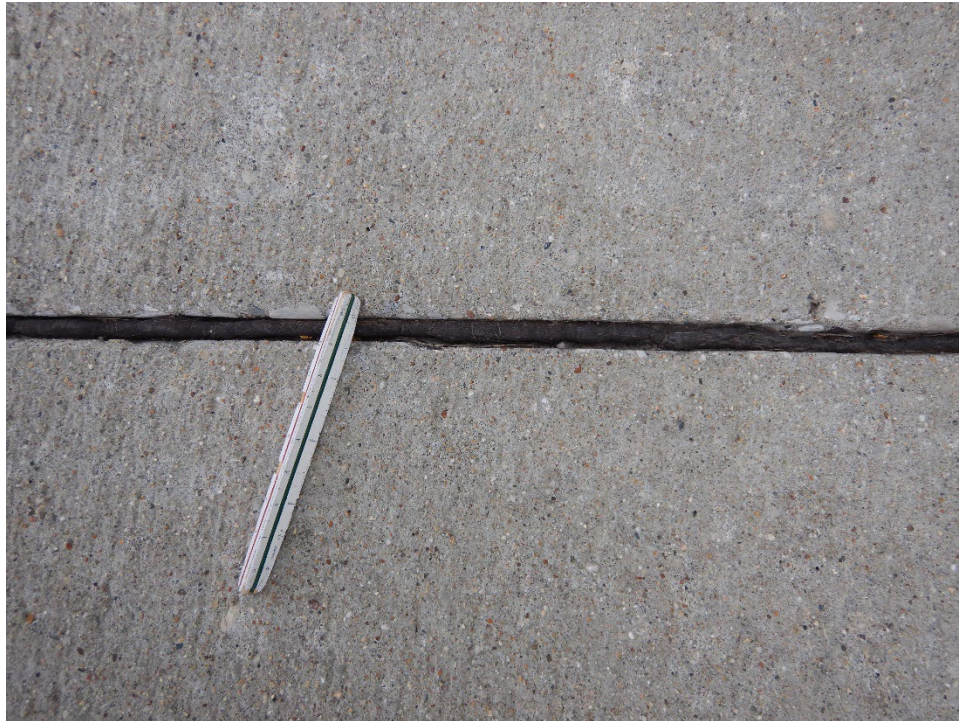
Taxiway 03 contained one section. Medium-severity joint seal damage was recorded throughout Section 01.

T03WA-01. Joint Seal Damage (Sample Unit No. 02).

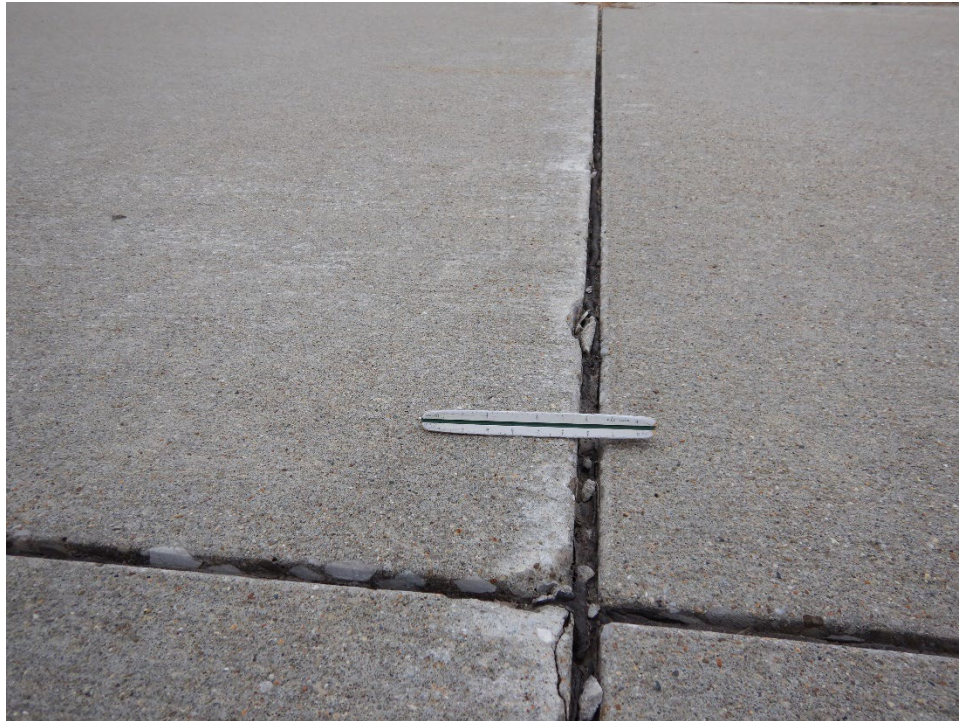
Taxiway 04 was defined by one section. Low-severity faulting and medium-severity joint seal damage were identified in Section 01.

T04WA-01. Faulting (Sample Unit No. 02).

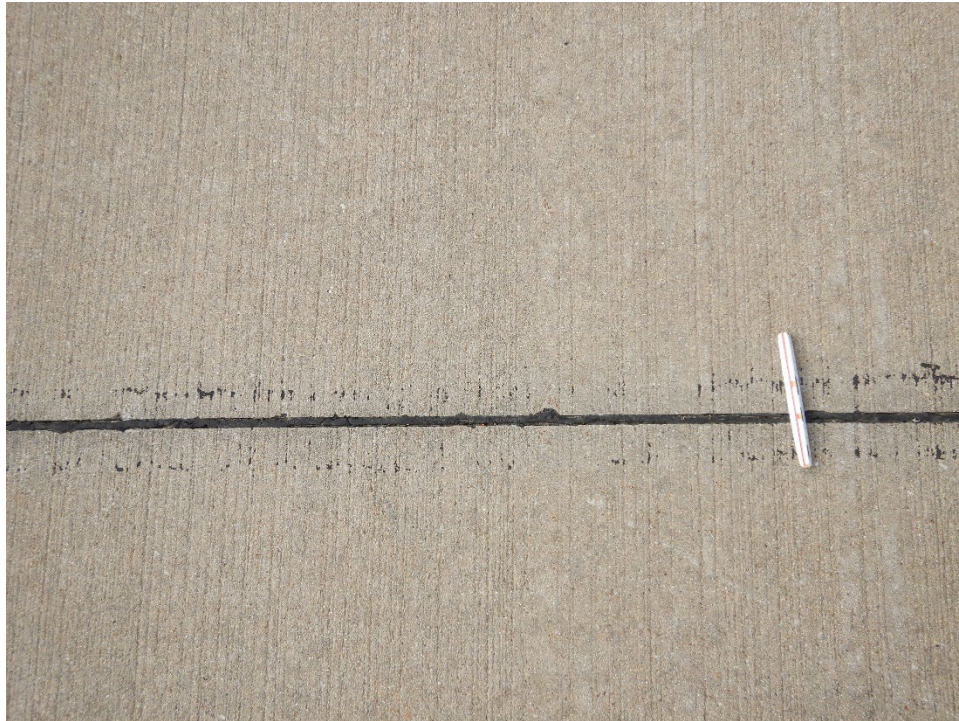
TH01WA-01. Joint Seal Damage (Sample Unit No. 05).

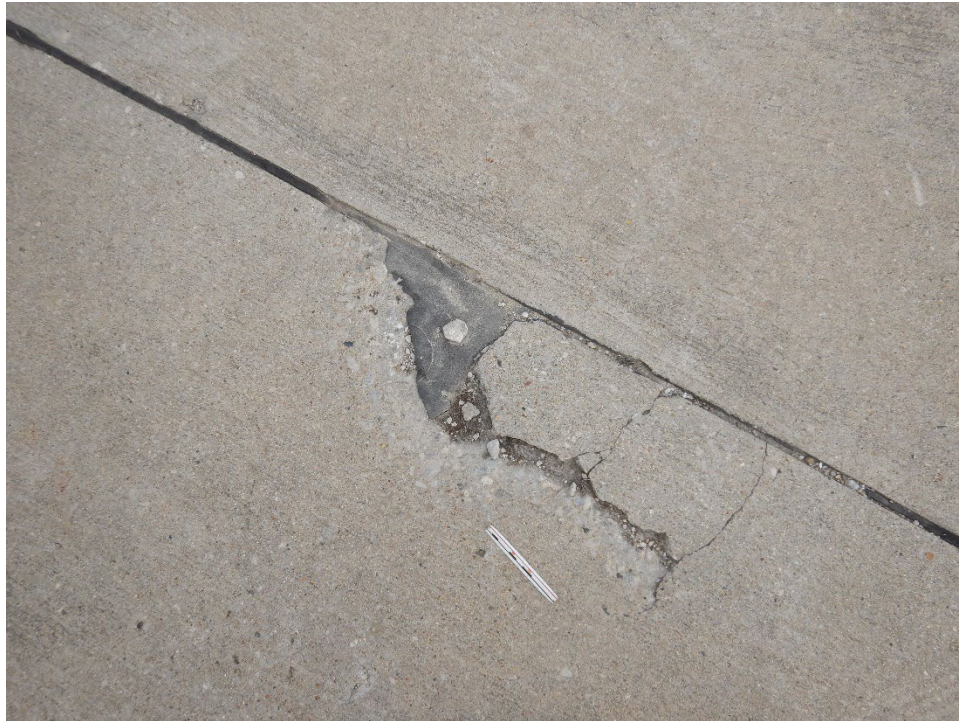
TH01WA-02. Joint Spalling (Sample Unit No. 01).

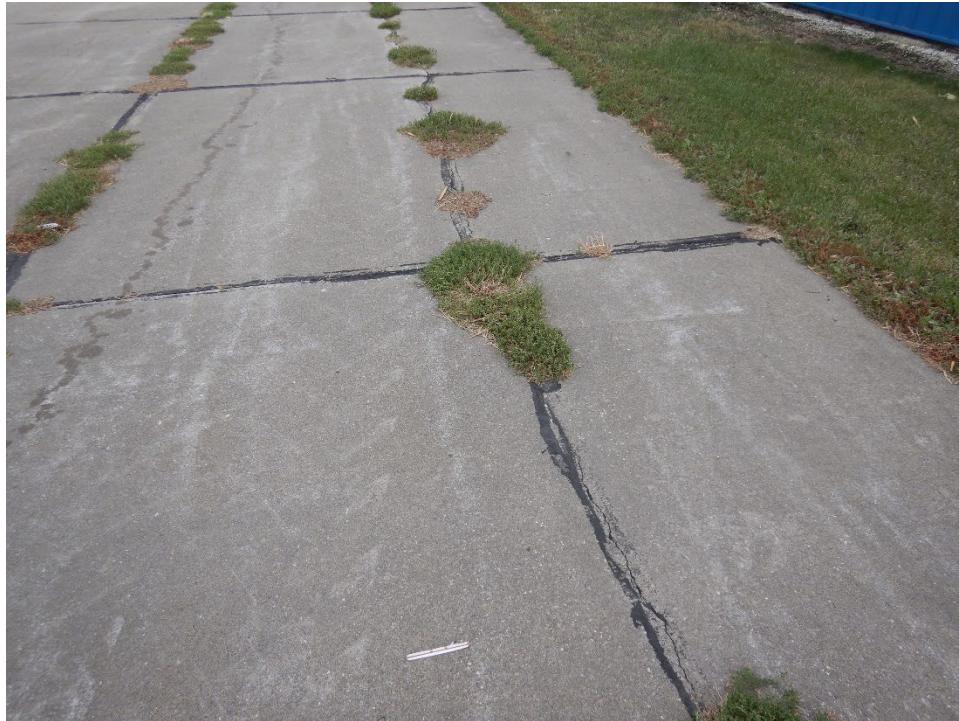
TH01WA-03. LTD Cracking (Sample Unit No. 01).
