# Washington Municipal Airport

## Pavement Management Report

**AUGUST 2026**

# WASHINGTON MUNICIPAL AIRPORT PAVEMENT MANAGEMENT REPORT

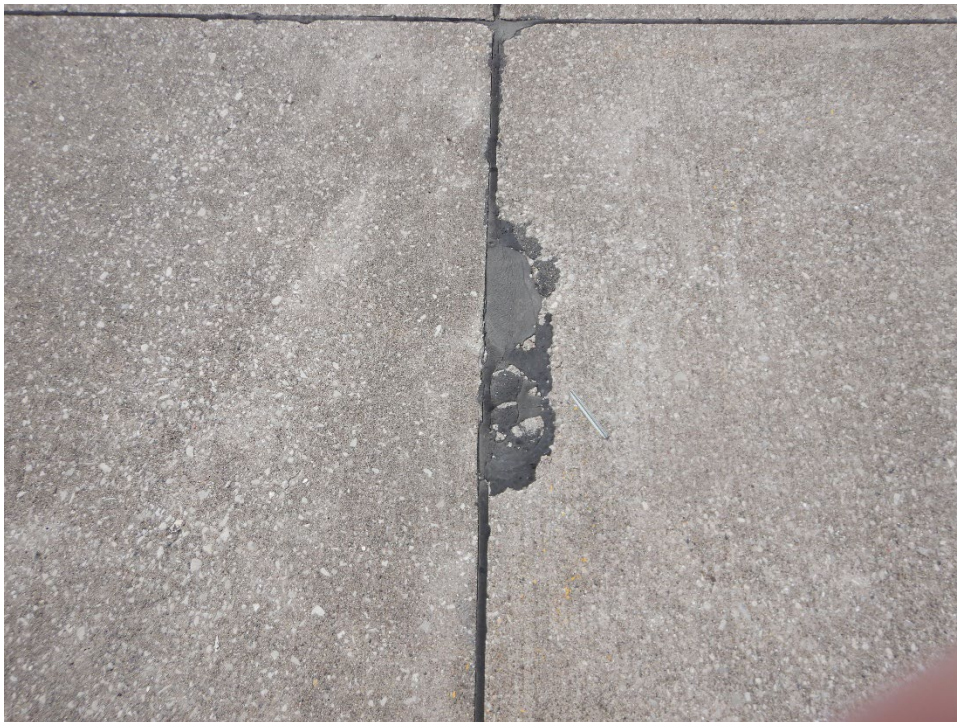
A01WA-01. Joint Spalling (Sample Unit No. 01).

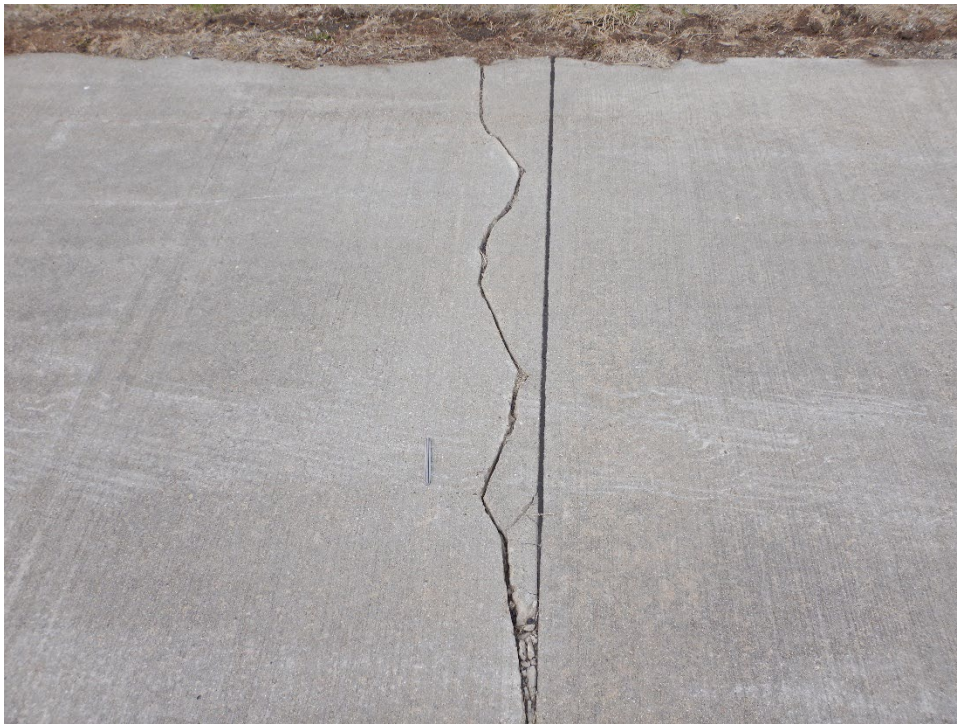
A01WA-02. Joint Spalling (Sample Unit No. 03).

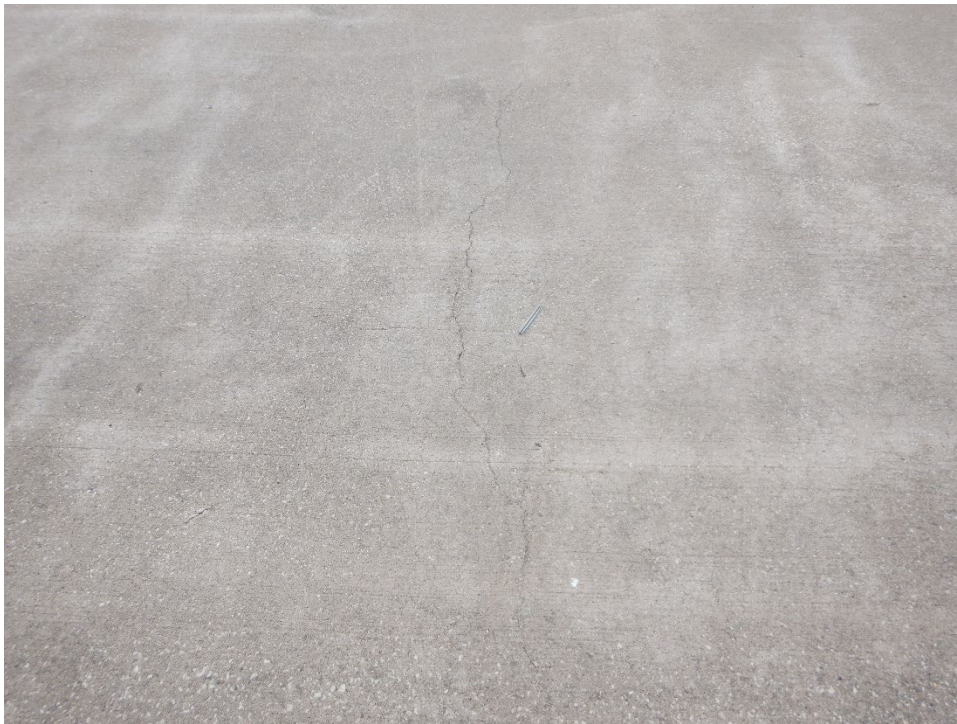
A01WA-03. LTD Cracking (Sample Unit No. 01).

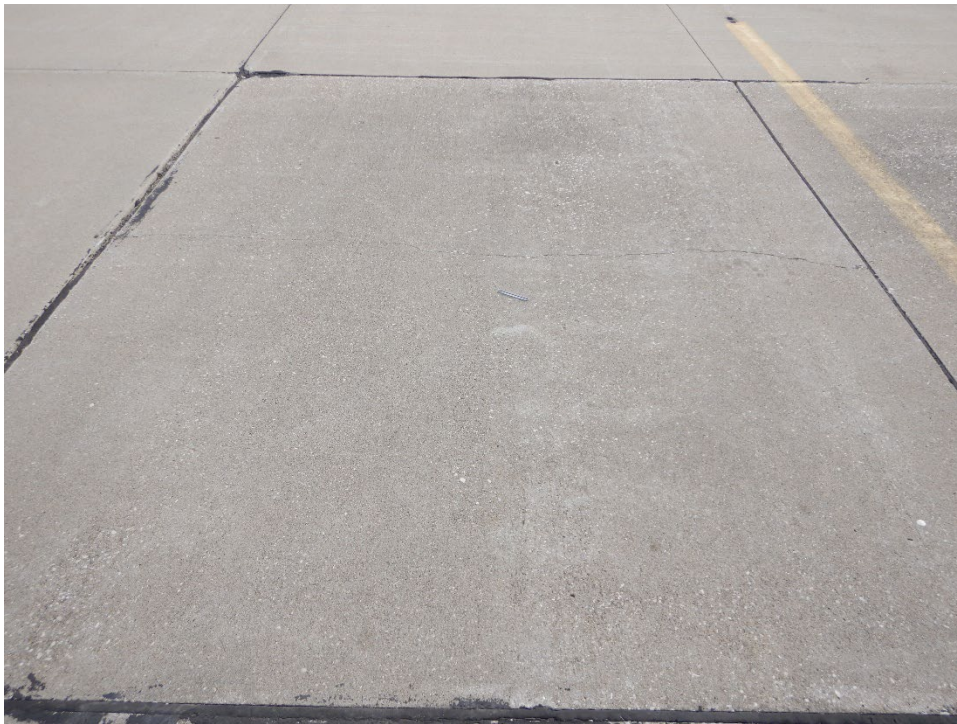
A01WA-04. LTD Cracking (Sample Unit No. 01).

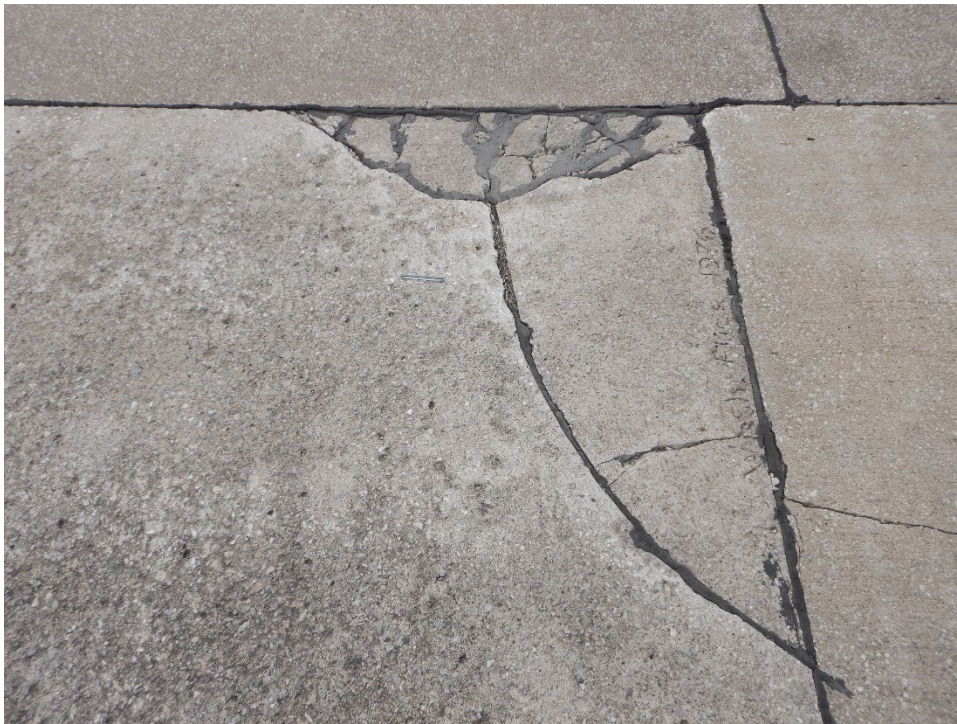
A01WA-05. Corner Break (Sample Unit No. 02).

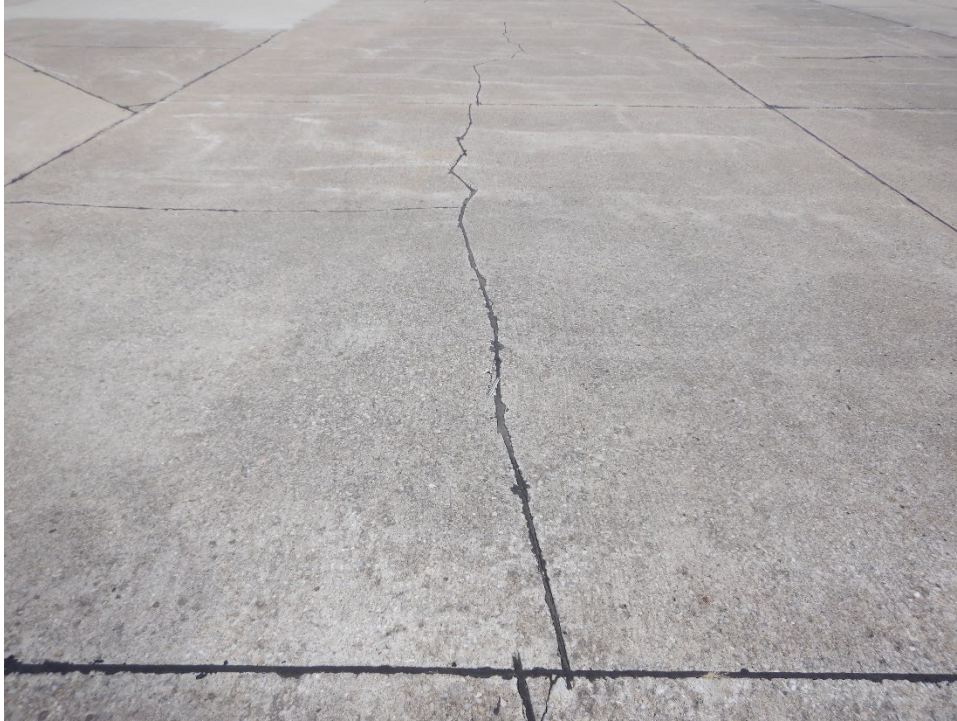
A01WA-05. LTD Cracking (Sample Unit No. 02).

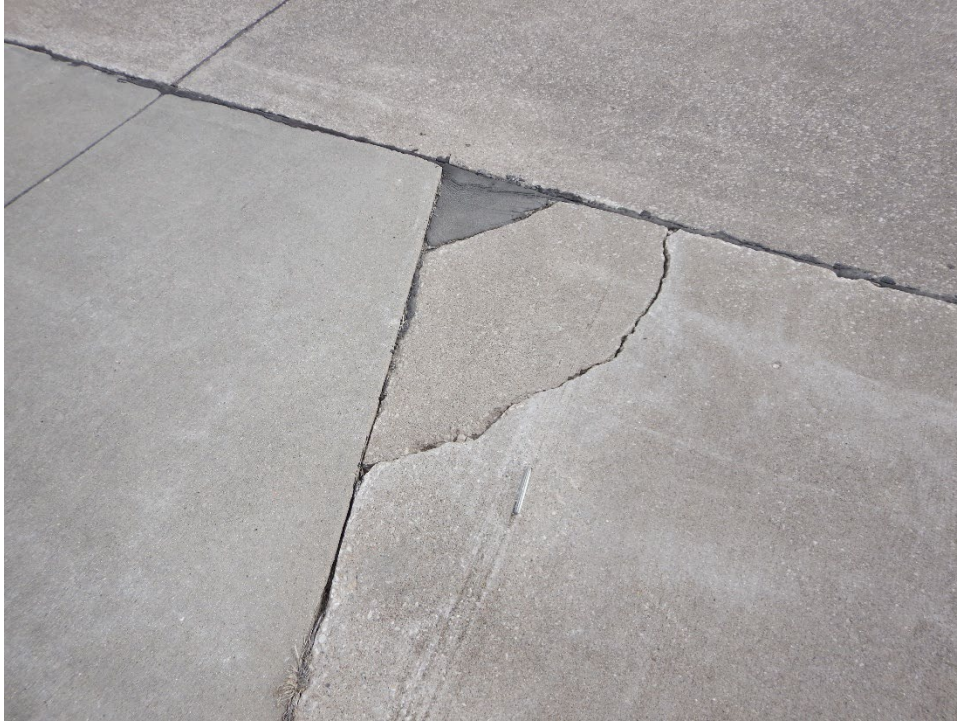
A01WA-06. Corner Break (Sample Unit No. 01).

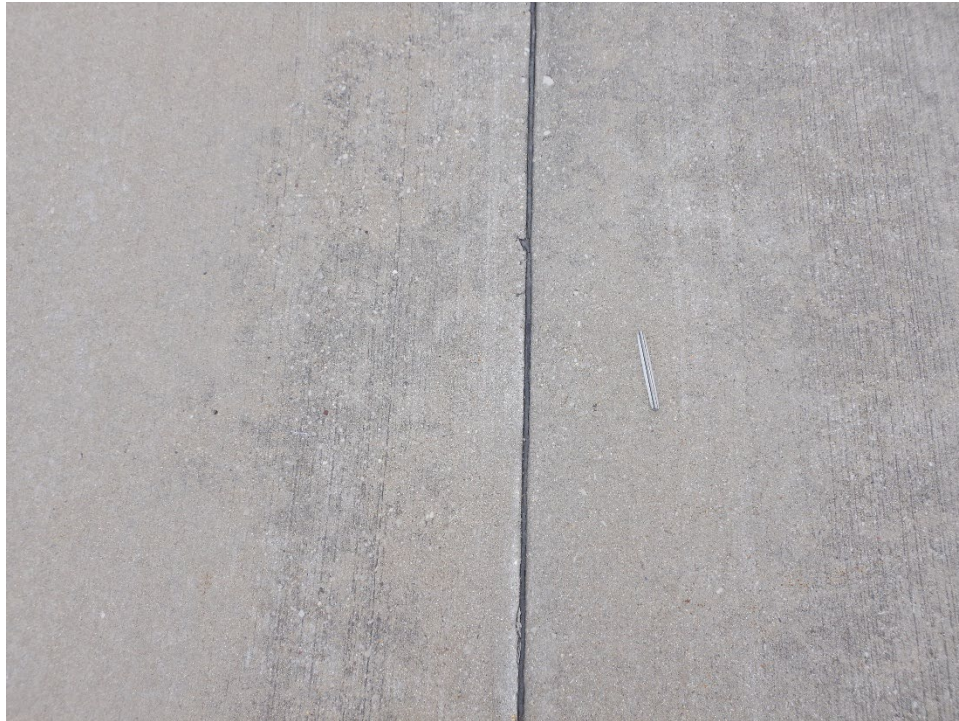
Taxiway 03 consisted of one section. Medium- and high-severity joint seal damage were observed throughout Section 01.

A01WA-07. Joint Seal Damage (Sample Unit No. 17).

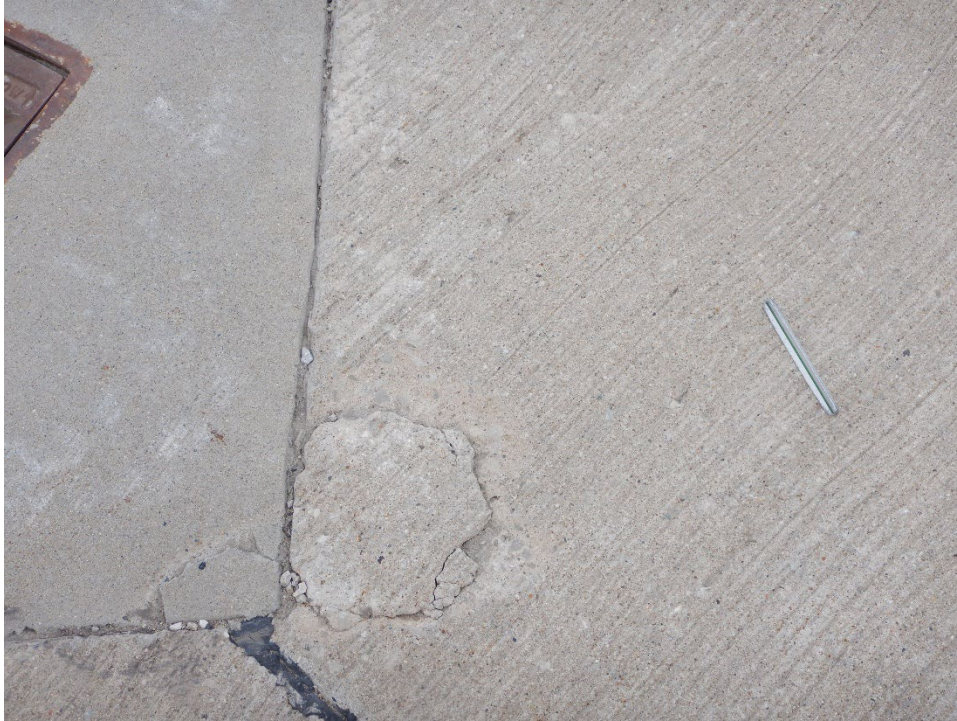
A01WA-08. Joint Spalling (Sample Unit No. 02).

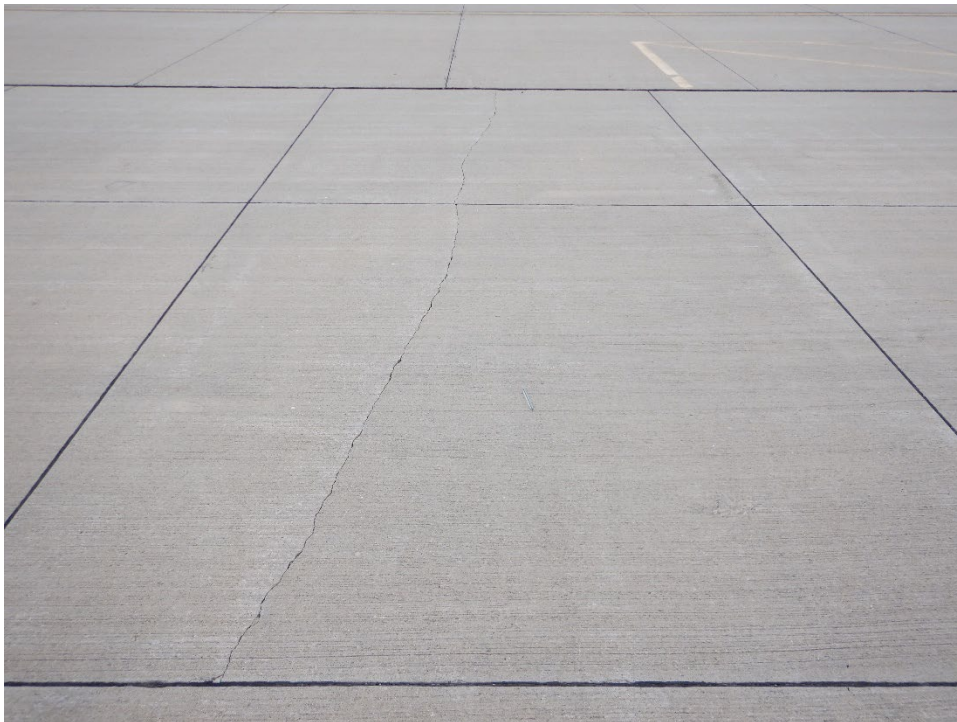
A01WA-08. LTD Cracking (Additional Sample Unit No. 03).

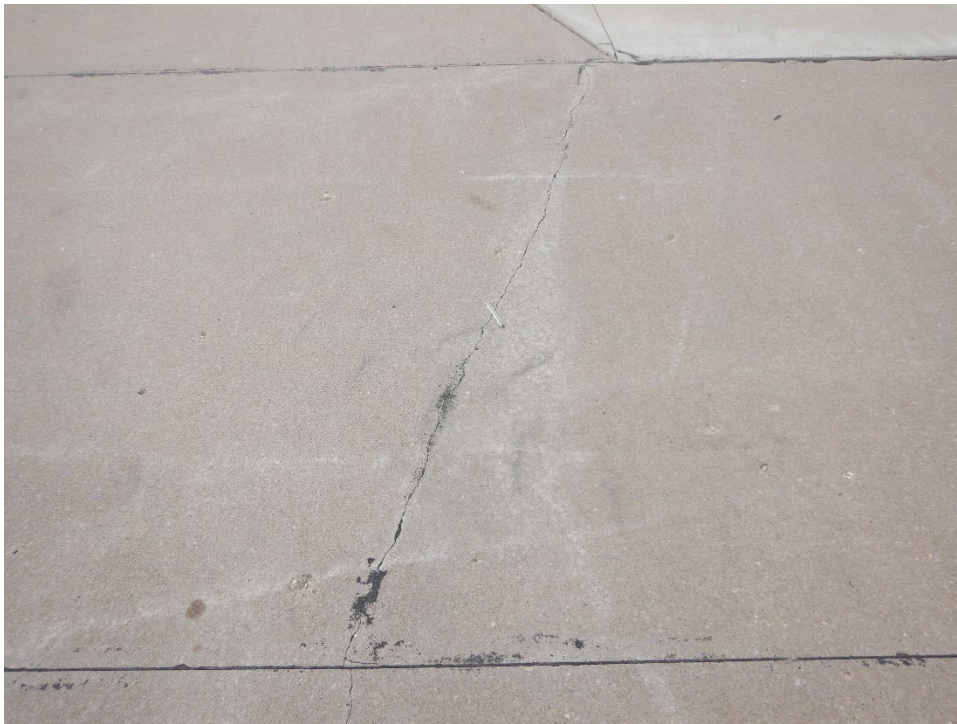
A01WA-09. LTD Cracking (Sample Unit No. 01).

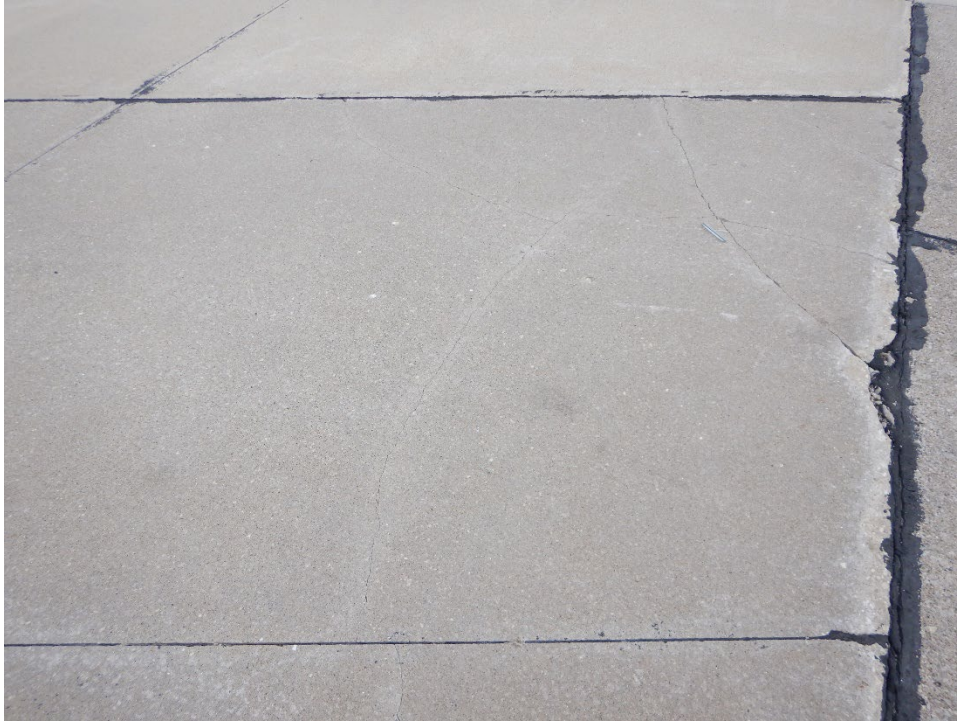
A01WA-09. Shattered Slab (Sample Unit No. 01).

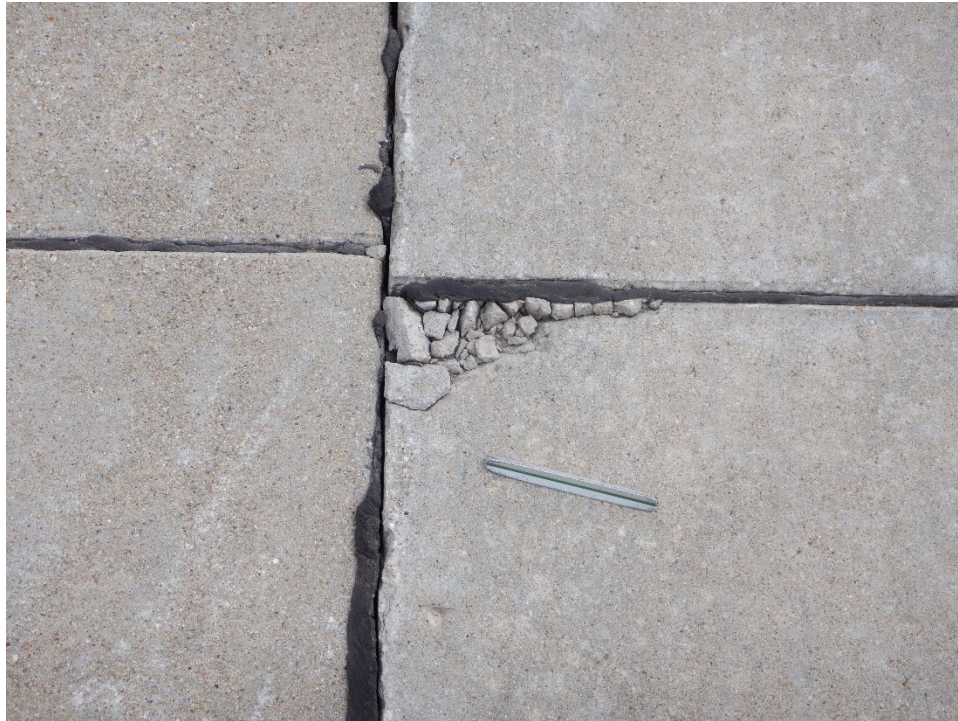
Runway 13/31 consisted of one section that contained low- and high-severity corner spalling, medium- and high-severity joint seal damage, and low-severity joint spalling.

R13WA-01. Corner Spalling (Sample Unit No. 85).

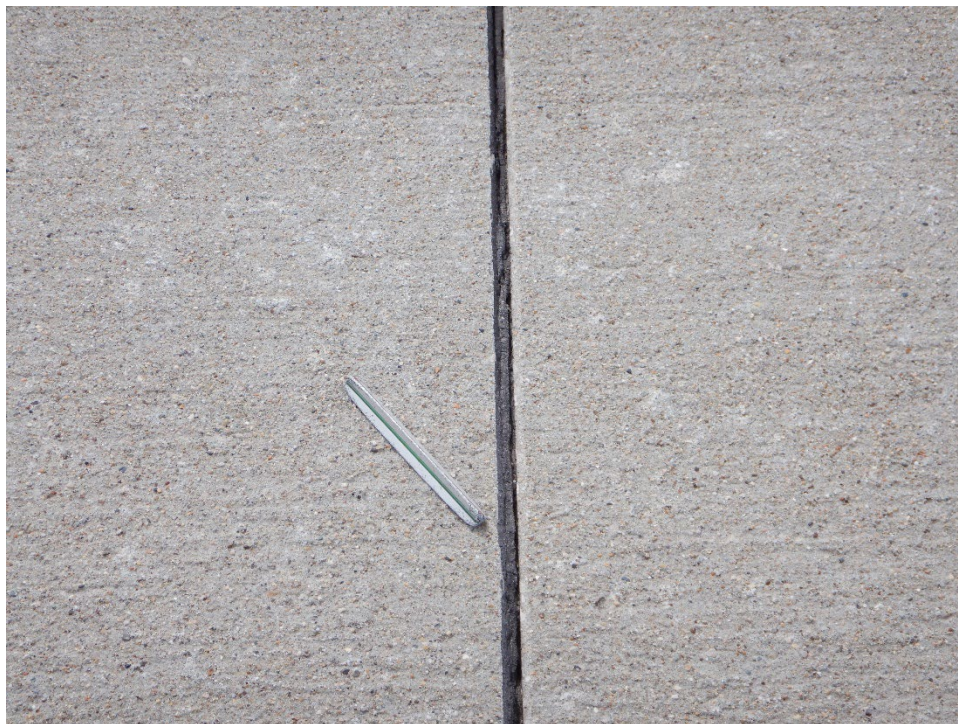
R13WA-01. Joint Seal Damage (Sample Unit No. 45).

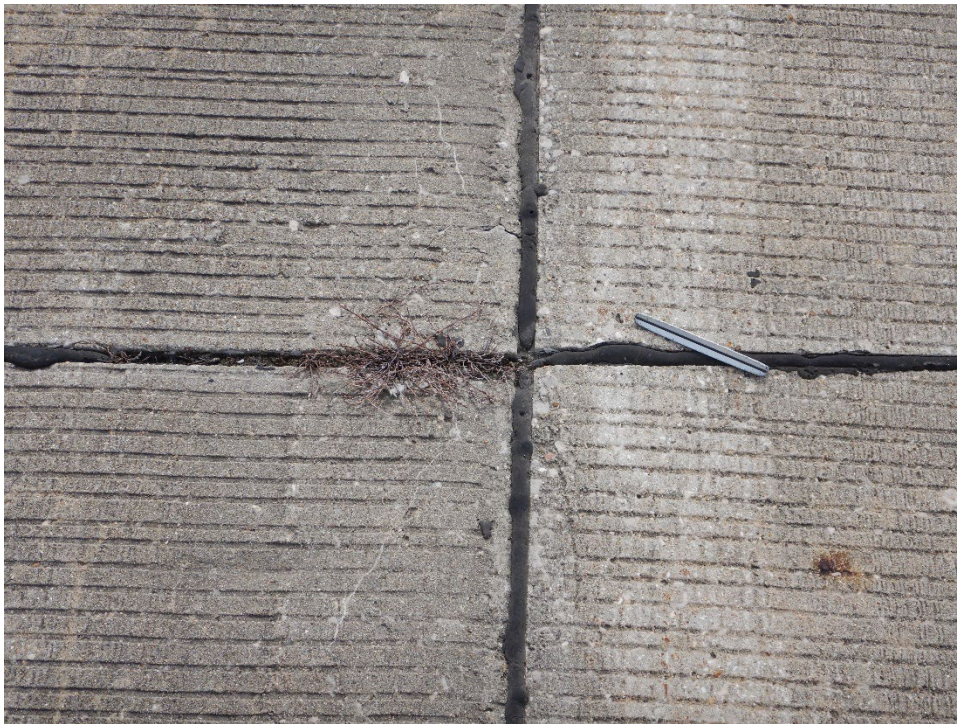
Runway 18/36 was defined by one section. Section 01 had low- and medium-severity ASR, joint spalling, and corner spalling; low-severity faulting; and medium- and high-severity joint seal damage identified. An atypical area of high-severity joint spalling was observed and recorded as an additional sample unit in accordance with ASTM D5340.

R18WA-01. ASR (Additional Sample Unit No. 08).

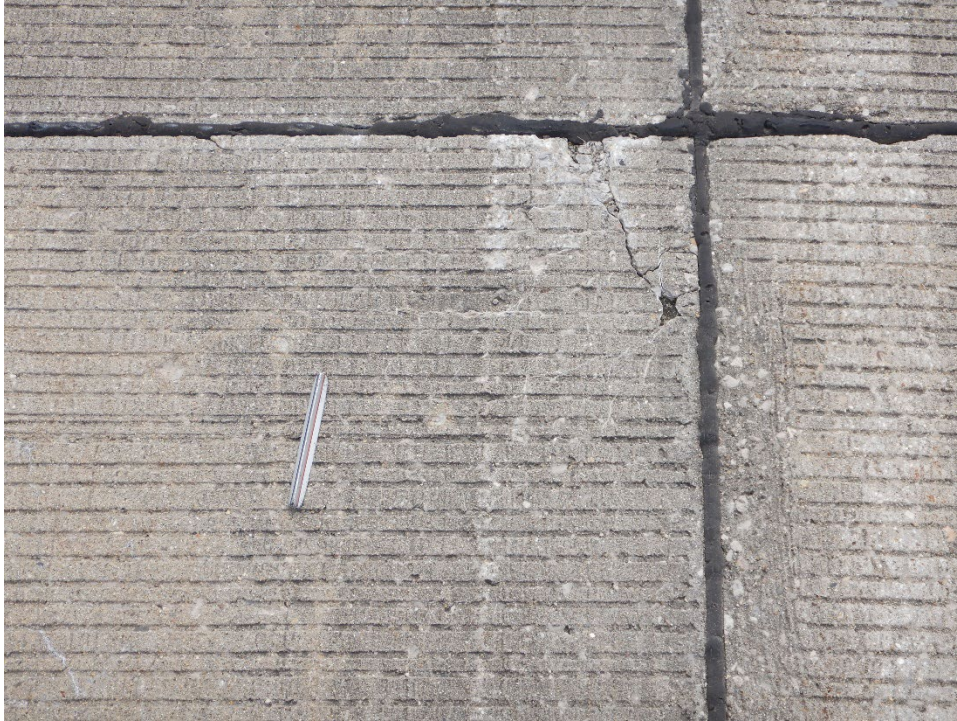
R18WA-01. ASR (Sample Unit No. 12).

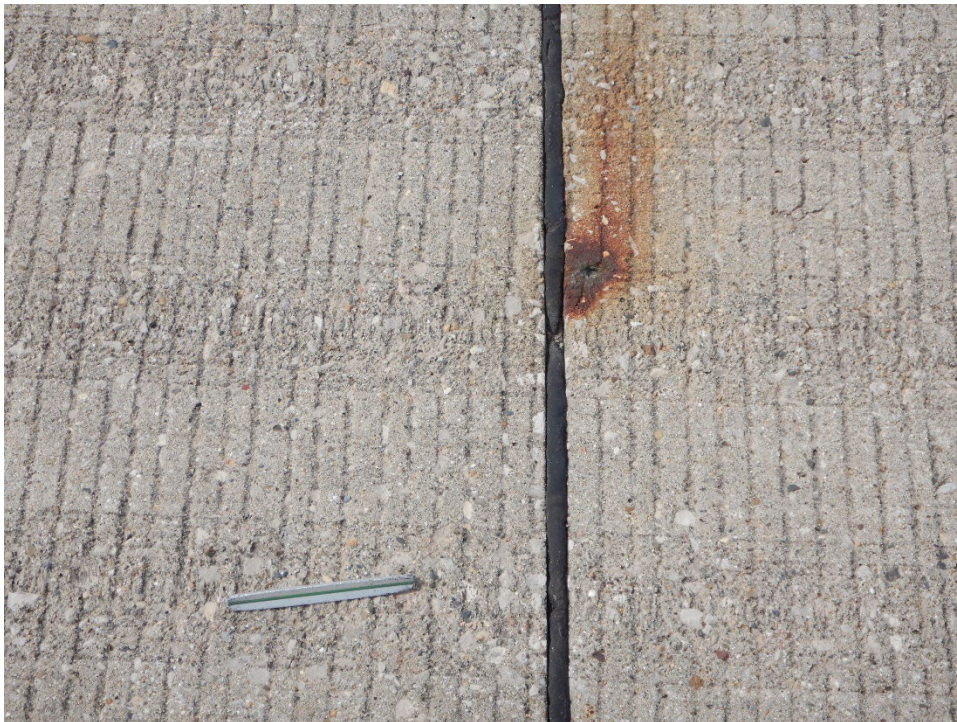
R18WA-01. Joint Seal Damage (Sample Unit No. 03).

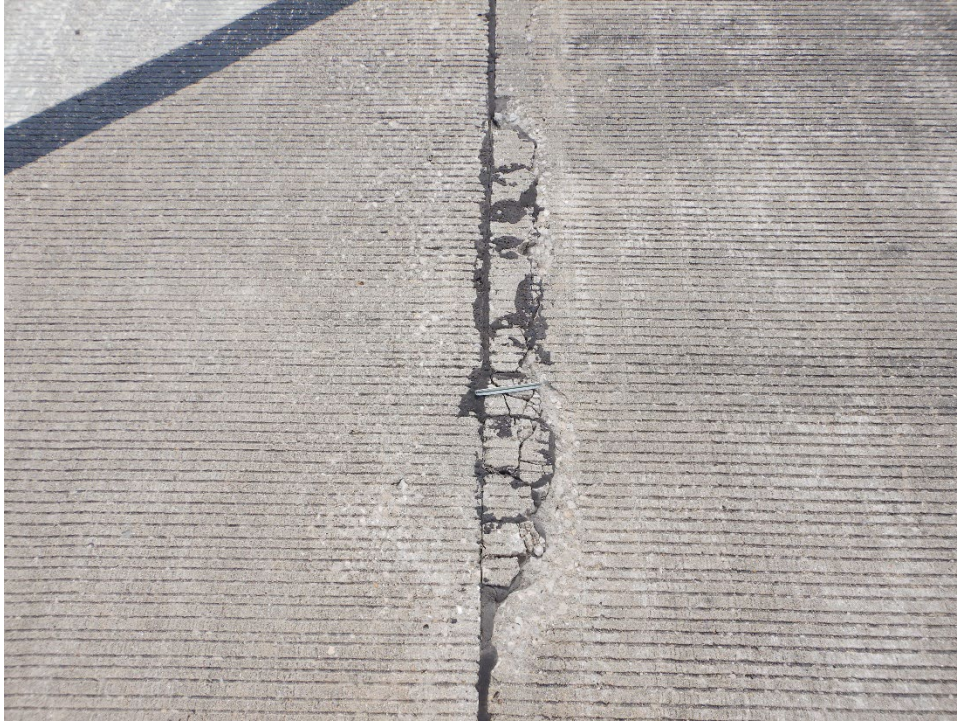
R18WA-01. Joint Spalling (Additional Sample Unit No. 08).

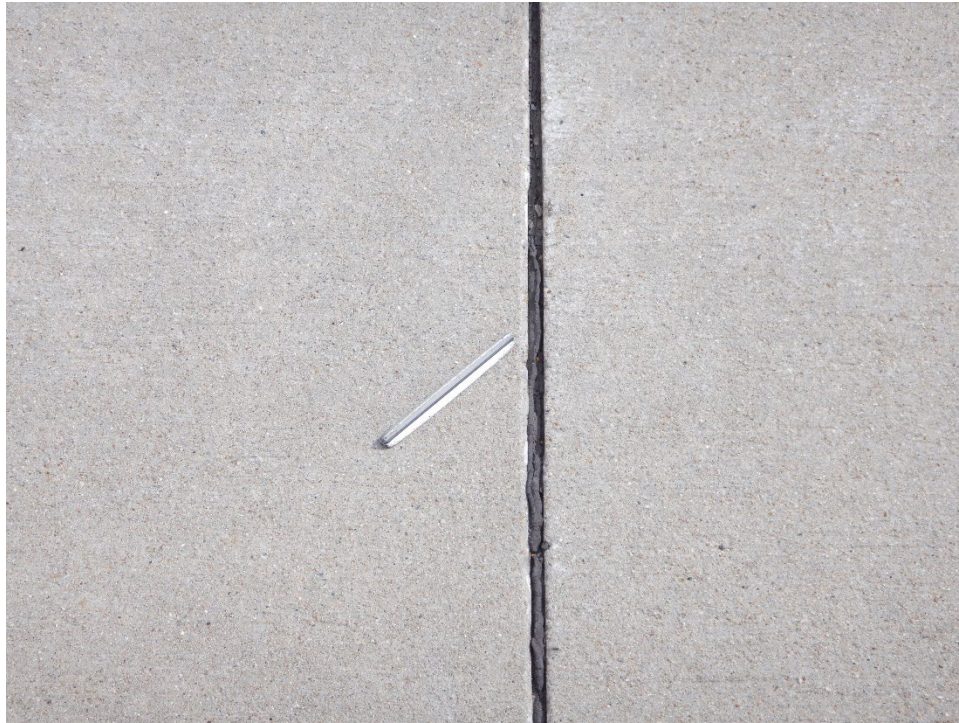
T03WA-01. Joint Seal Damage (Sample Unit No. 02).

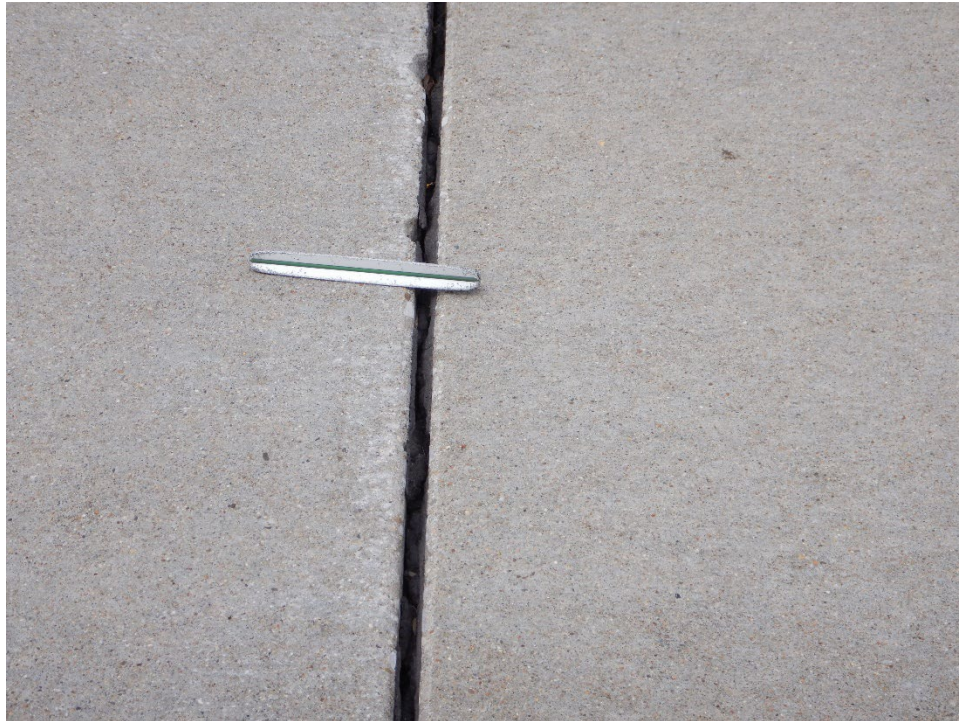
Taxiway 04 contained one section. Section 01 had low-severity faulting and medium- and high-severity joint seal damage recorded during the inspection.

T04WA-01. Faulting (Sample Unit No. 02).

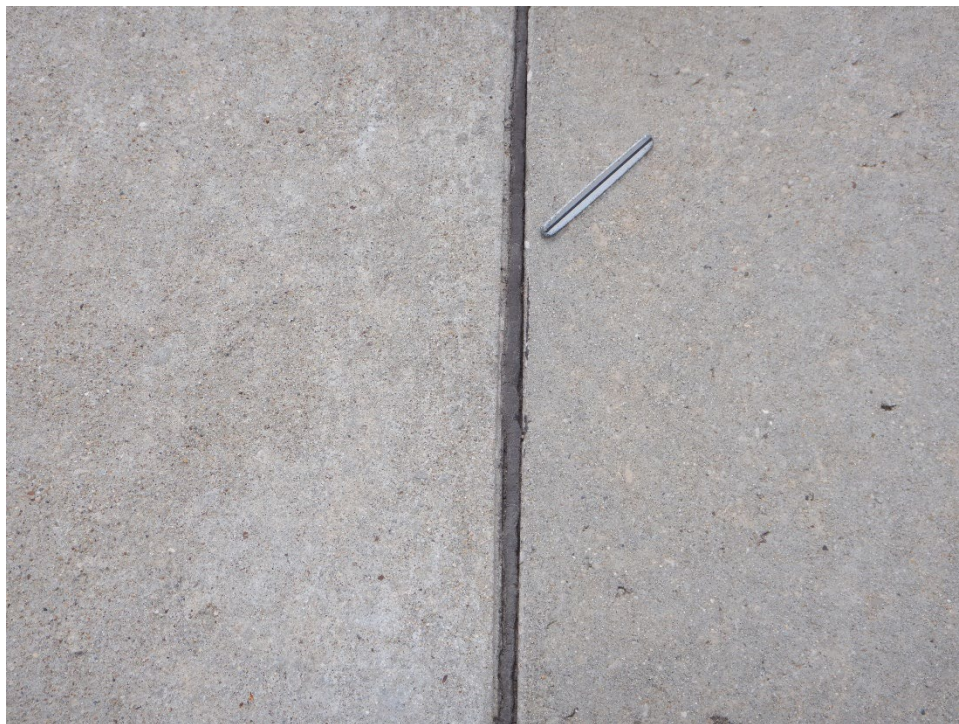
T04WA-01. Joint Seal Damage (Sample Unit No. 09).

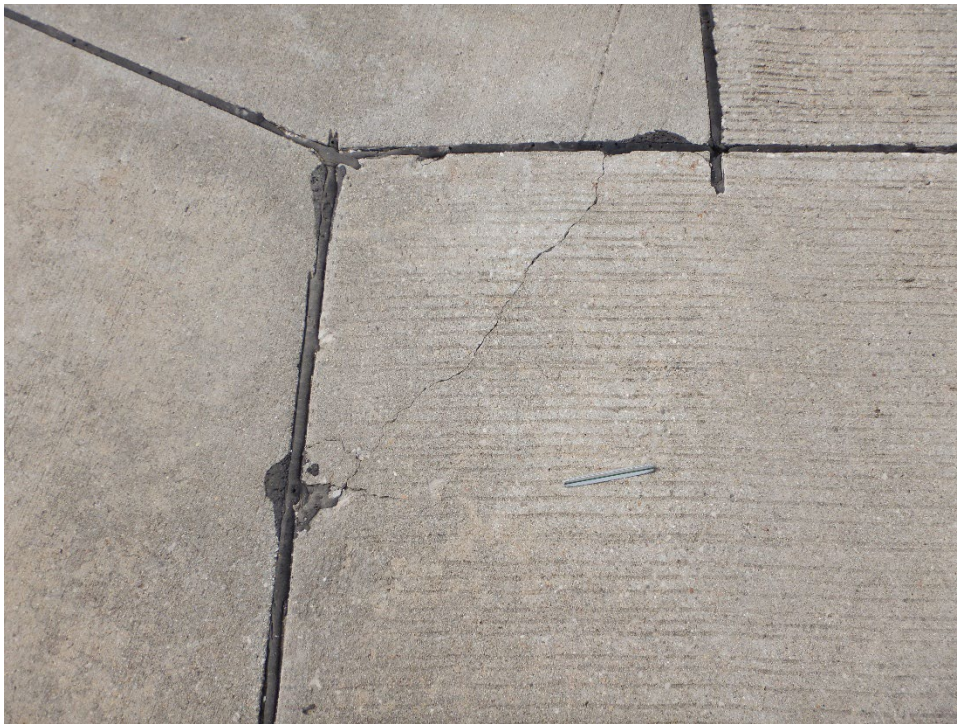
Taxiway A1 was defined by one section containing low-severity corner break, corner spalling, and large patching; medium-severity joint seal damage and small patching; and low- and medium-severity longitudinal, transverse, and diagonal (LTD) cracking.

TA1WA-01. Corner Break (Sample Unit No. 02).

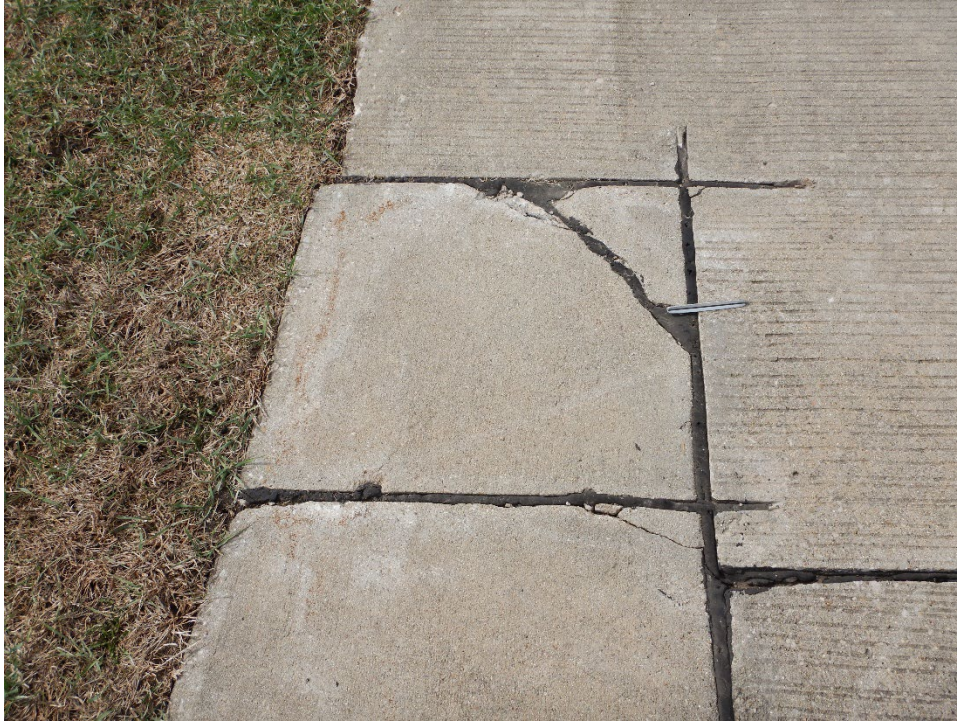
TA1WA-01. Small Patching (Sample Unit No. 02).

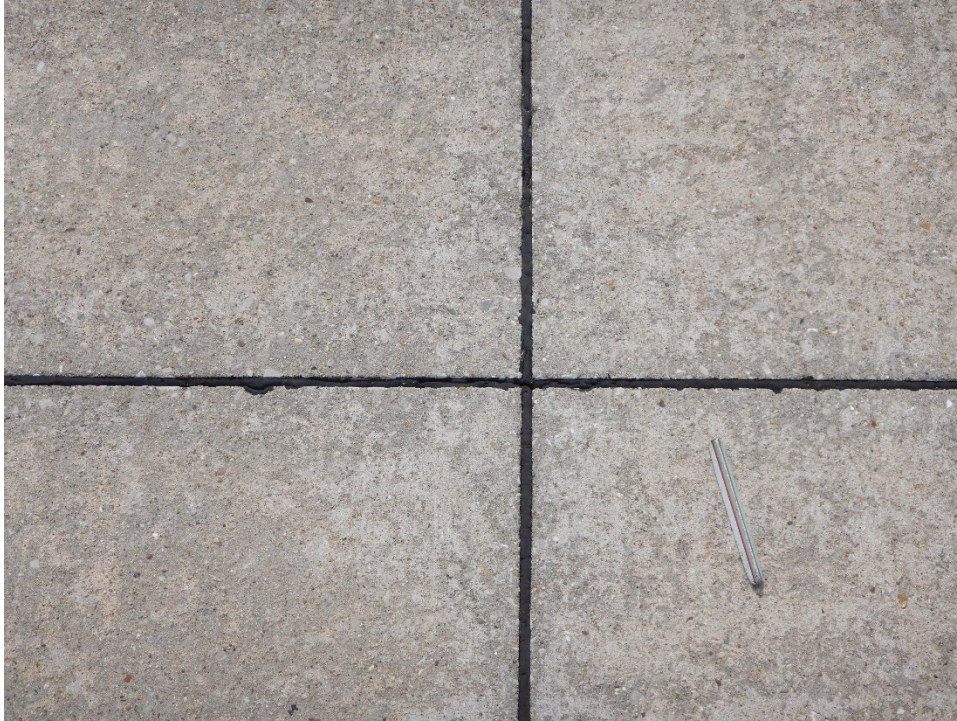
Taxiway B consisted of three sections. Section 01 contained low- and medium-severity corner spalling and joint seal damage and medium- and high-severity joint spalling. Medium-severity joint seal damage and joint spalling and low-severity LTD cracking were observed in Section 02. Section 03 was in *Excellent* condition with no distress except for two atypical areas that contained low-severity ASR, corner break, and joint spalling. These areas were recorded as additional sample units in accordance with ASTM D5340.

TBWA-01. Joint Seal Damage (Sample Unit No. 05).

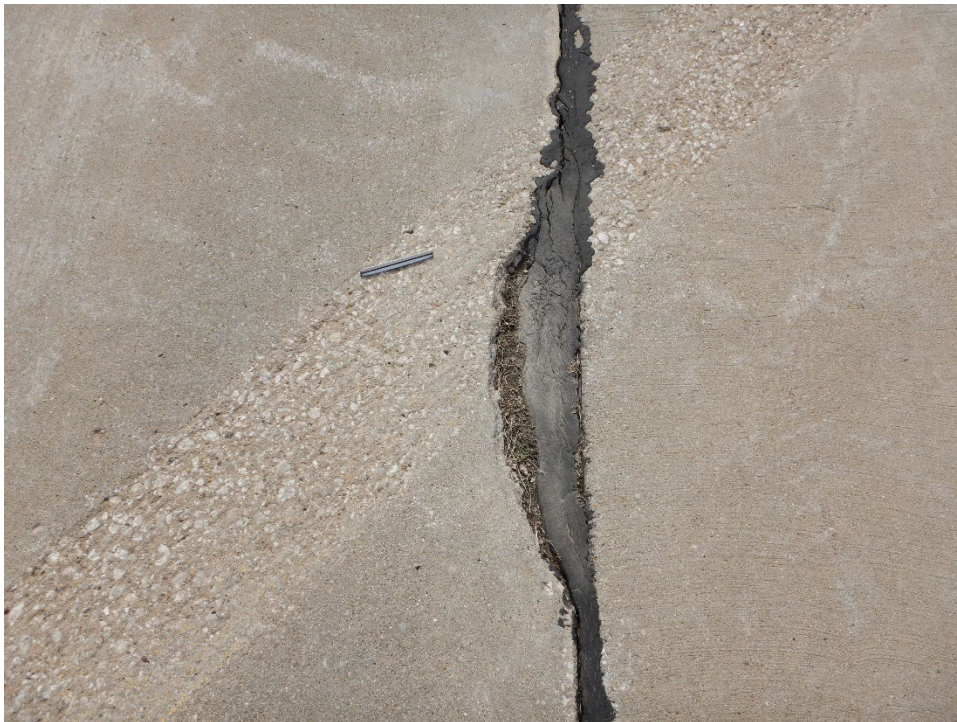
TBWA-01. Joint Spalling (Sample Unit No. 02).

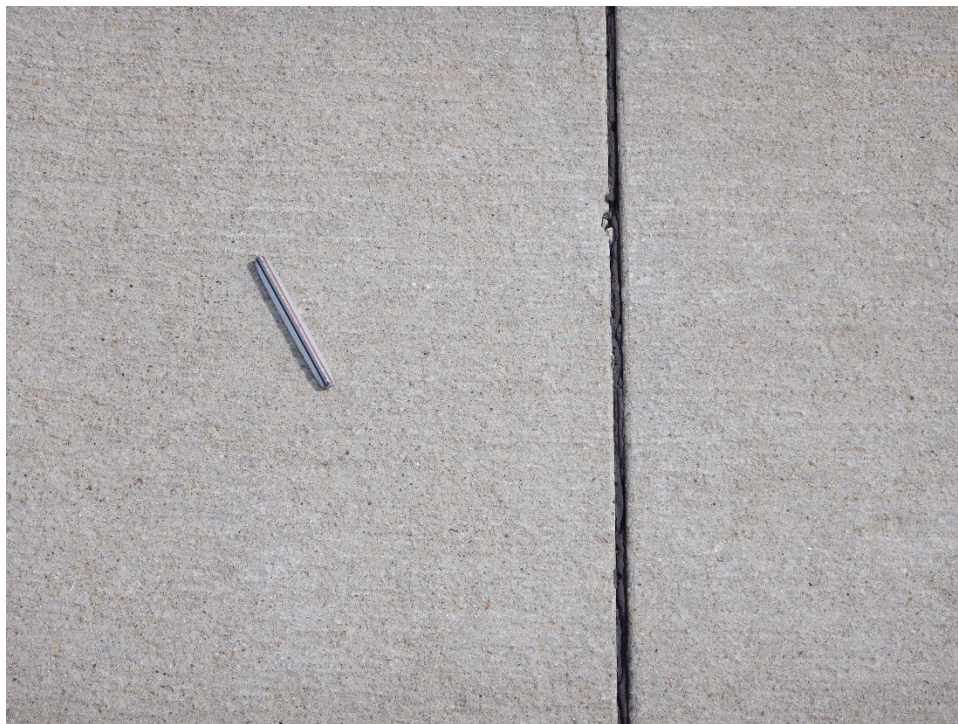
TBWA-02. Joint Seal Damage (Sample Unit No. 02).

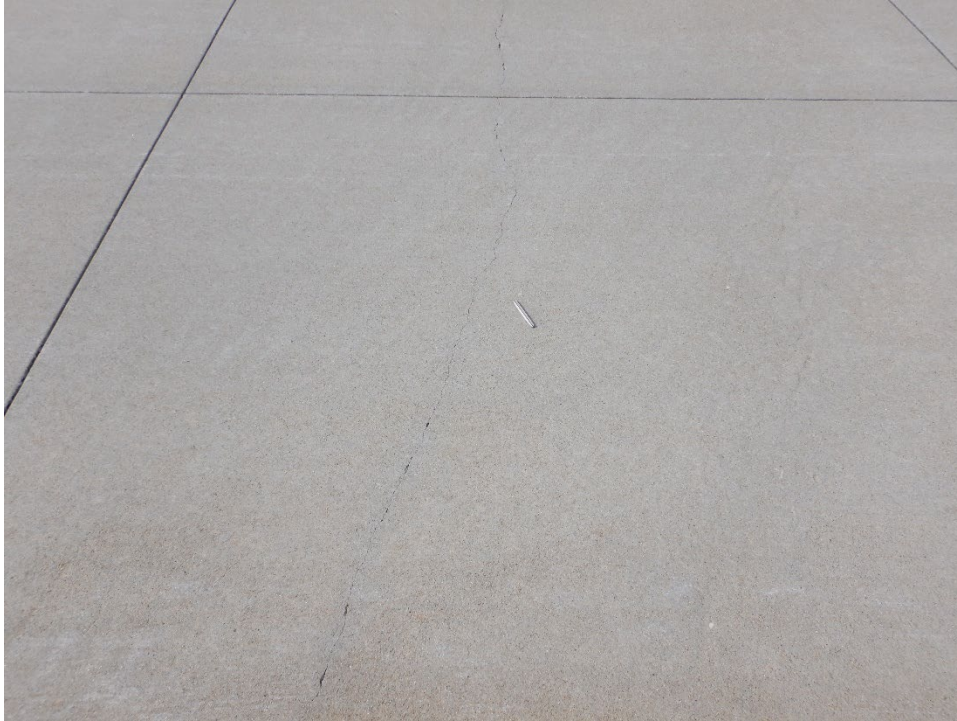
TBWA-02. LTD Cracking (Sample Unit No. 03).

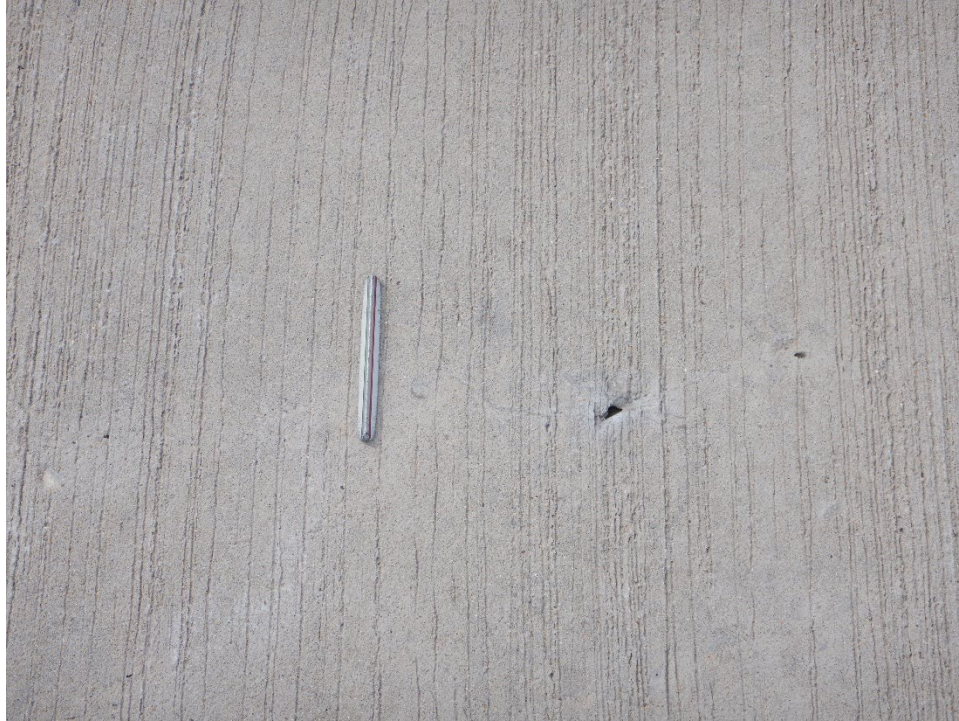
TBWA-03. ASR (Additional Sample Unit No. 10).

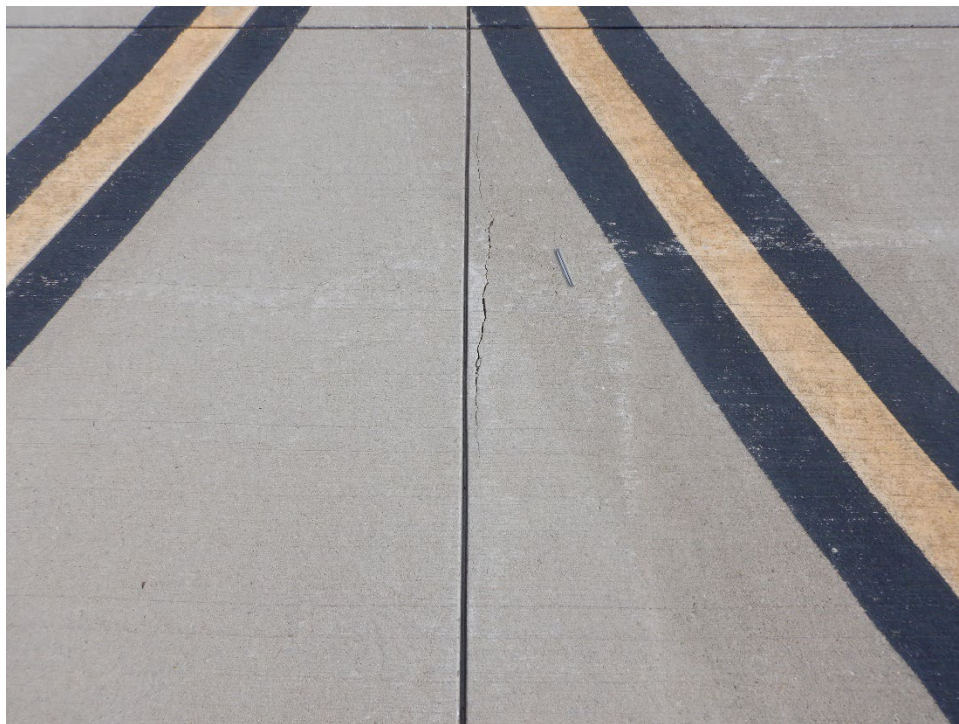
TBWA-03. Joint Spalling (Additional Sample Unit No. 12).

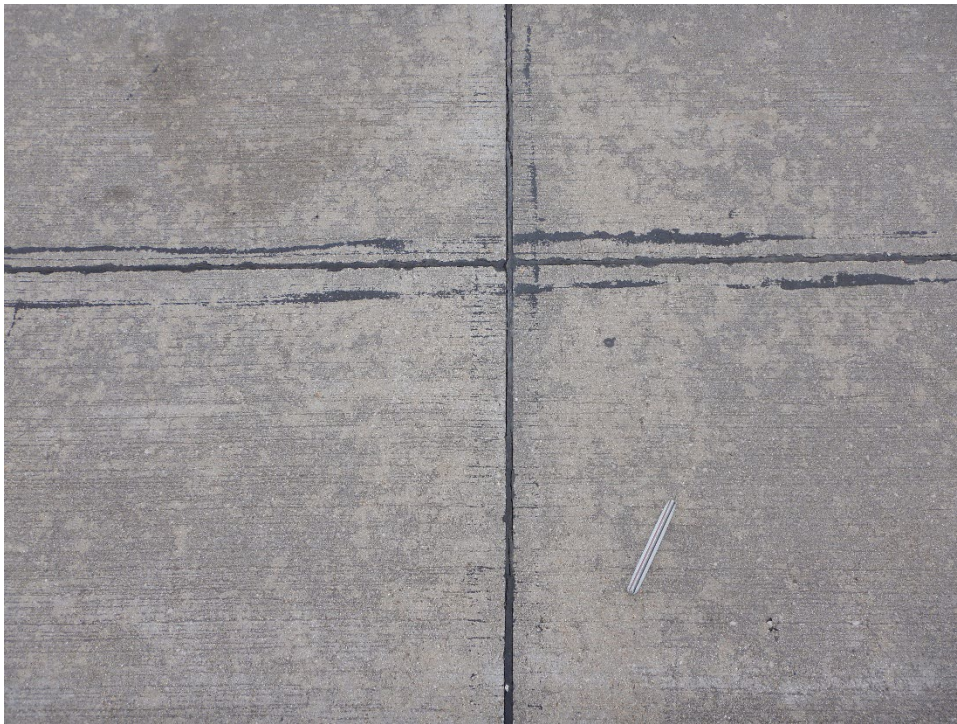
The T-hangar area consisted of three sections. Section 01 contained medium-severity joint seal damage. Section 02 had medium- and high-severity joint seal damage, high-severity joint spalling, and low-severity LTD cracking and small patching identified. Low-severity faulting, high-severity joint seal damage, and low- and medium-severity LTD cracking were noted in Section 03.

TH01WA-01. Joint Seal Damage (Sample Unit No. 02).

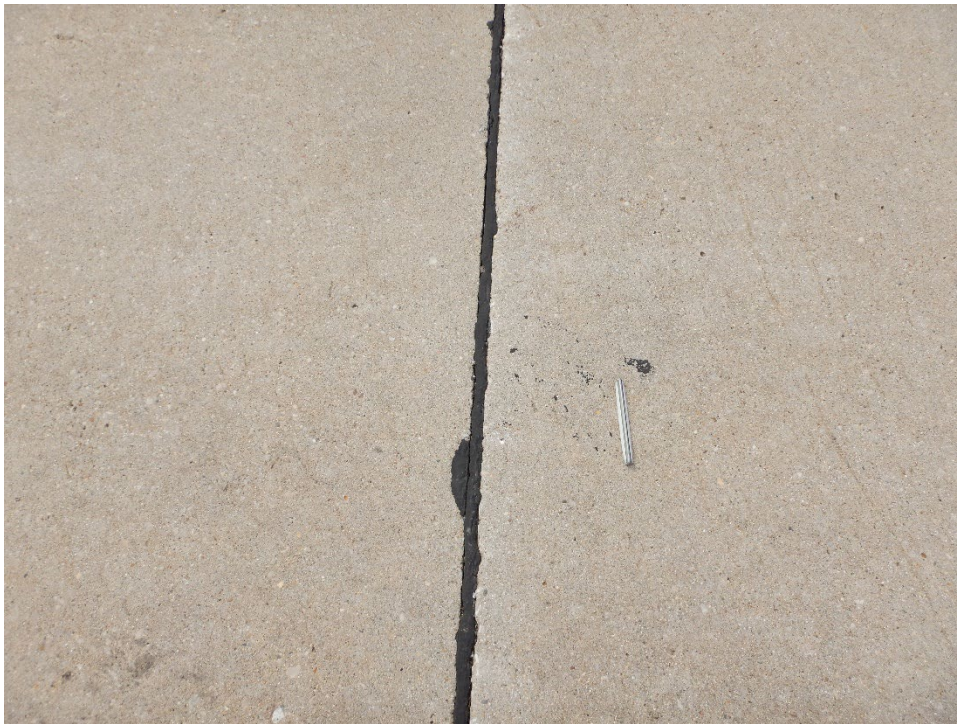
TH01WA-02. Joint Seal Damage (Sample Unit No. 02).

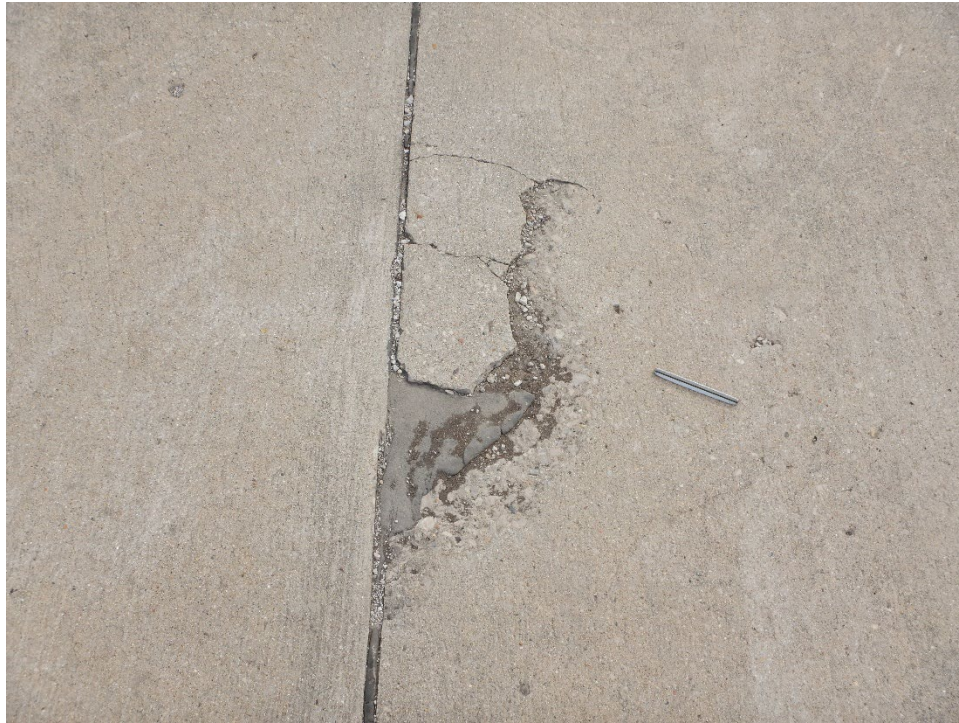
TH01WA-02. Joint Spalling (Sample Unit No. 01).
