# Washington Municipal Airport

## Pavement Management Report

**AUGUST 2026**

# WASHINGTON MUNICIPAL AIRPORT PAVEMENT MANAGEMENT REPORT

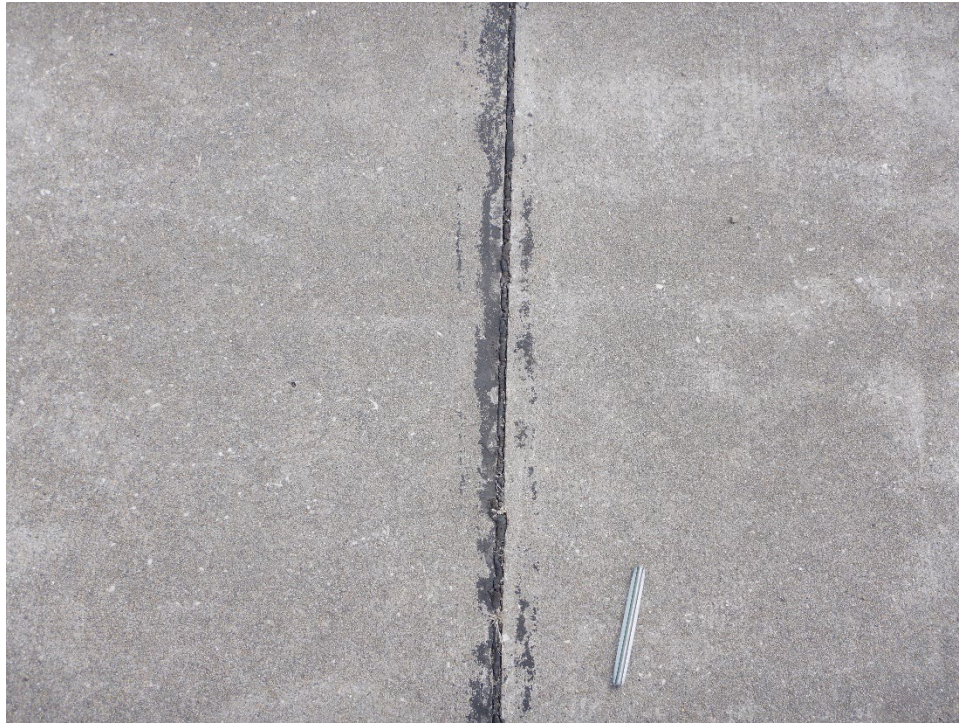
TH01WA-03. Joint Seal Damage (Sample Unit No. 01).

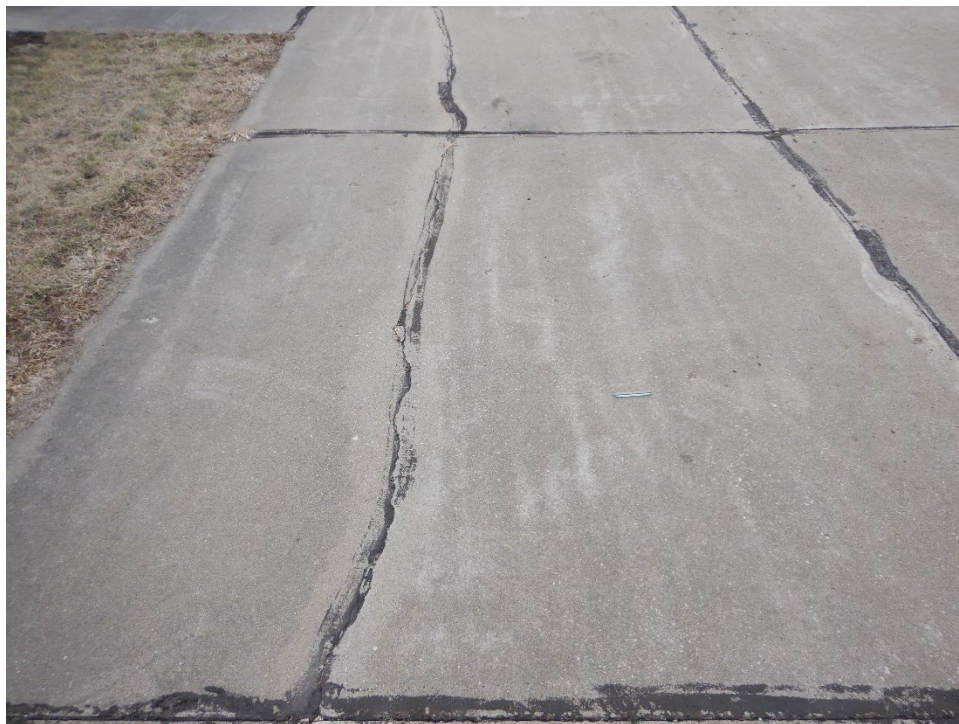
TH01WA-03. LTD Cracking (Sample Unit No. 01).
