# Waukon Municipal Airport

**PAVEMENT MANAGEMENT REPORT**

**AUGUST 2019**

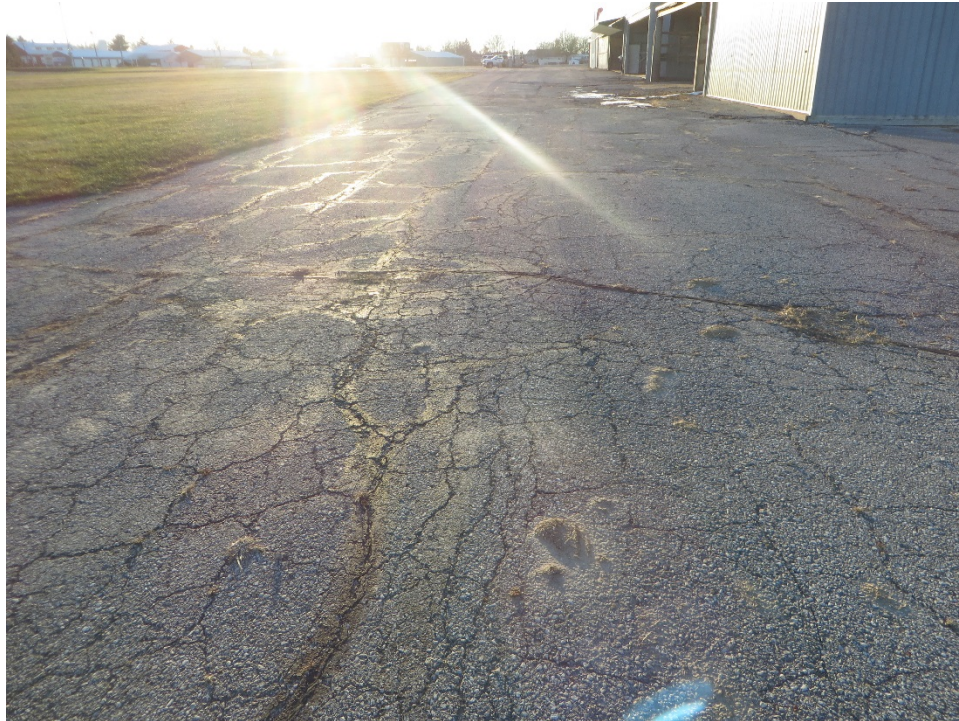
The apron area was defined by one section in poor condition. Low- and medium-severity block cracking, all severities of depression, and medium- and high-severity alligator cracking, raveling, and weathering were identified in Section 01. The low-severity block cracking was unsealed, while the medium-severity block cracking was due to unsatisfactory crack sealant.

A01WK-01. Overview.

Year	Branch <sup>1</sup>	Section <sup>1</sup>	Surface Type <sup>2</sup>	Type of Repair <sup>3</sup>	Estimated Cost <sup>4</sup>
2019	A01WK	01	AC	Major Rehabilitation	\$227,077
2019	R07WK	01	AC	Major Rehabilitation	\$833,959
2019	T02WK	01	AC	Major Rehabilitation	\$11,236

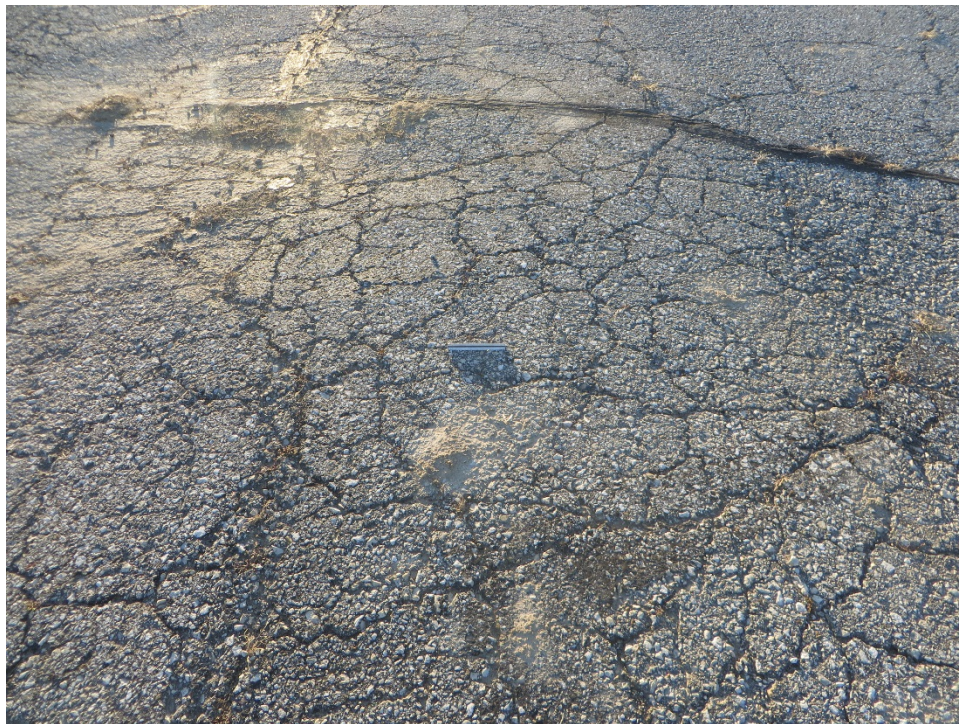
A01WK-01. Alligator Cracking (Sample Unit No. 04).

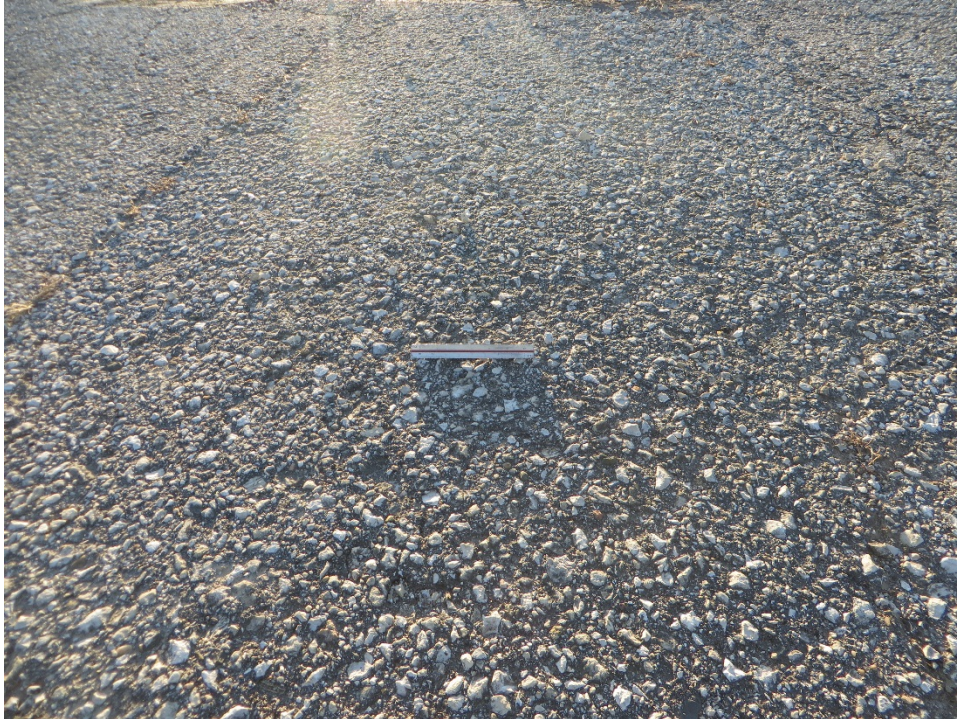
A01WK-01. Raveling (Sample Unit No. 04).

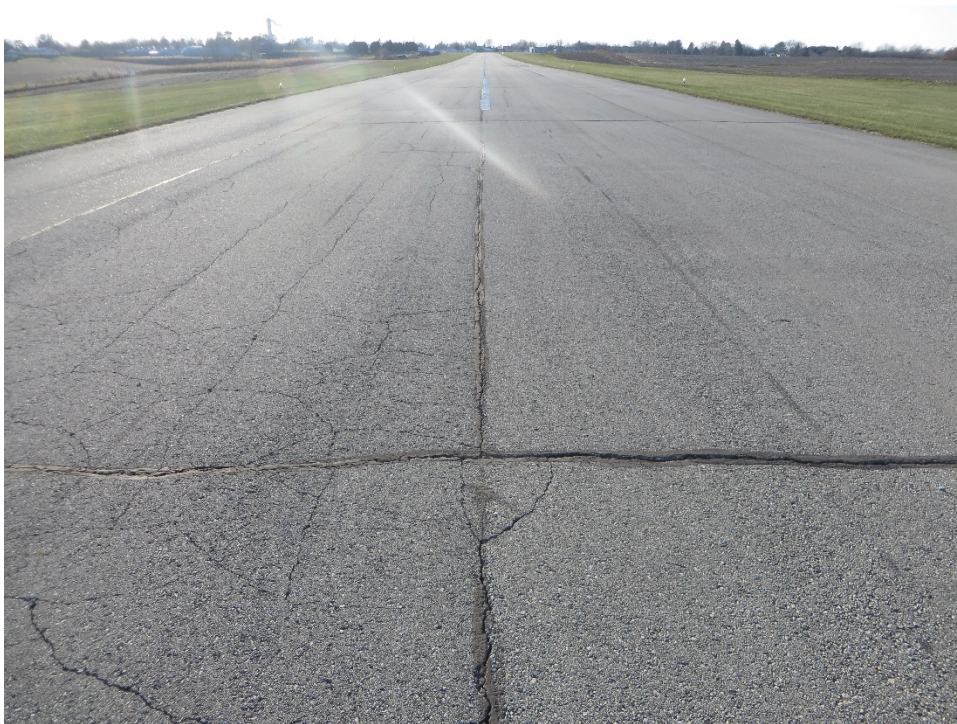
Runway 07/25 consisted of one section with medium-severity alligator cracking, low- and medium-severity longitudinal and transverse (L&T) cracking, medium- and high-severity raveling, and low-severity rutting and weathering recorded throughout. The low-severity L&T cracking was unsealed, and the medium-severity L&T cracking was due to either failed crack sealant, unsealed crack widths greater than 1/4 in, or the development of secondary cracking.

R07WK-01. Overview.

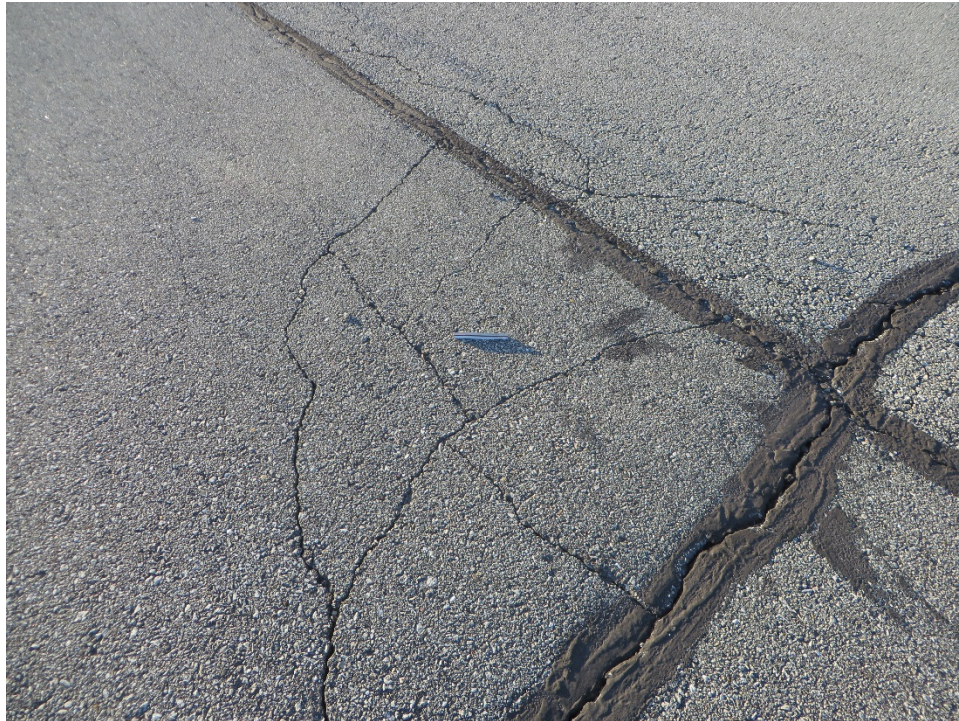
R07WK-01. Alligator Cracking (Sample Unit No. 03) (1).

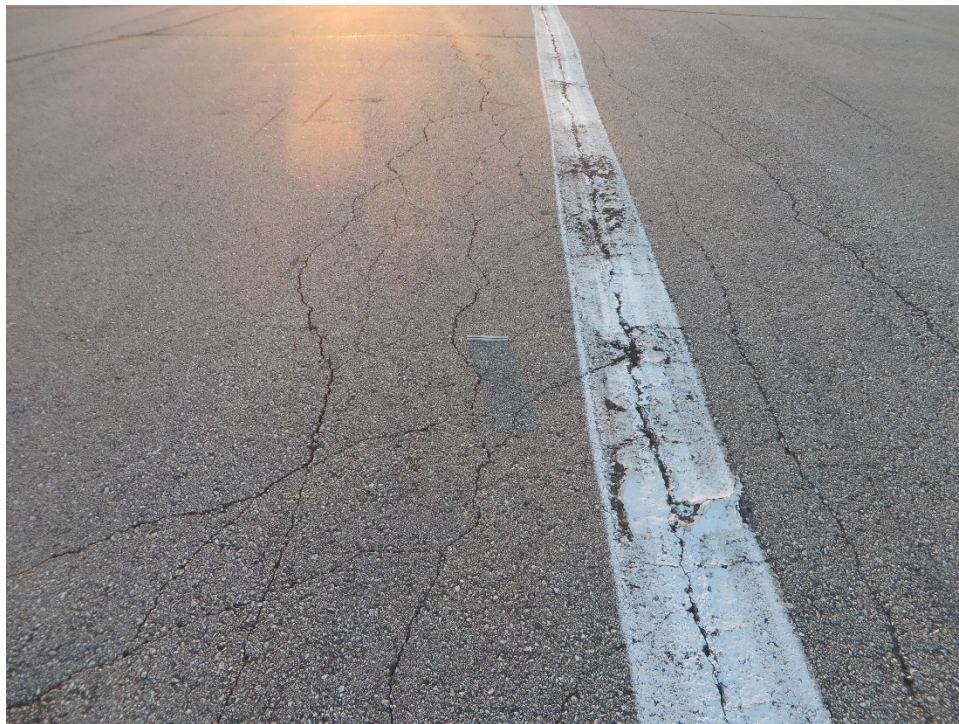
R07WK-01. Alligator Cracking (Sample Unit No. 03) (2).

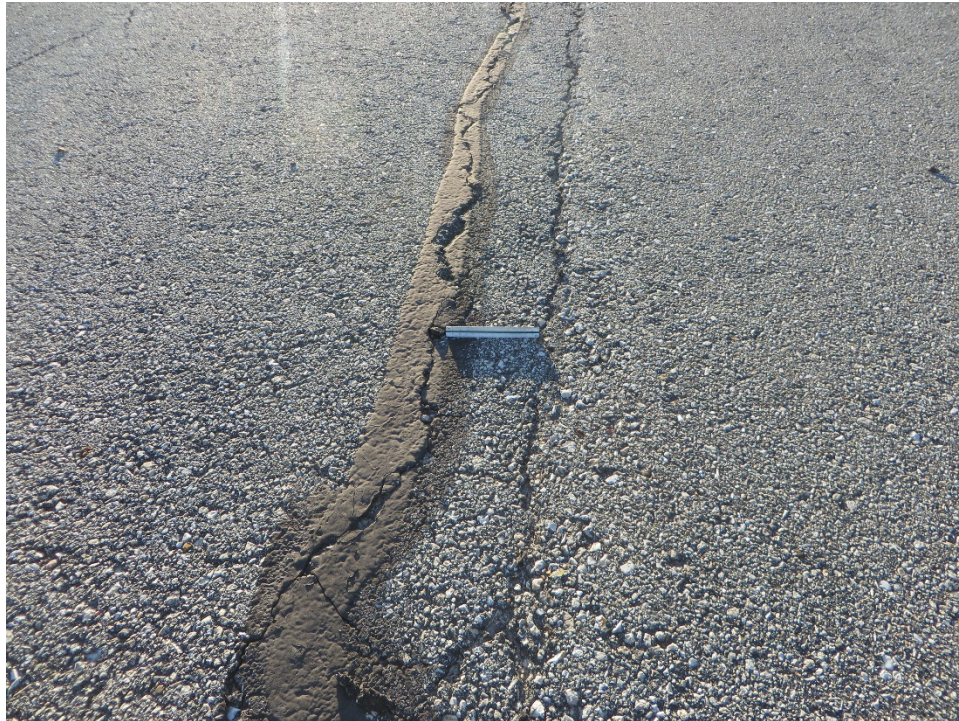
R07WK-01. L&T Cracking (Sample Unit No. 07).

Sample Number: 007 Type: R Area: 6,000.00SqFt PCI = 63  
Sample Comments:  
48 LONGITUDINAL/TRANSVERSE CRACKING M 338.00 Ft Comments:fs; 2ndy  
48 LONGITUDINAL/TRANSVERSE CRACKING L 237.00 Ft Comments:lu  
57 WEATHERING L 6,000.00 SqFt Comments:

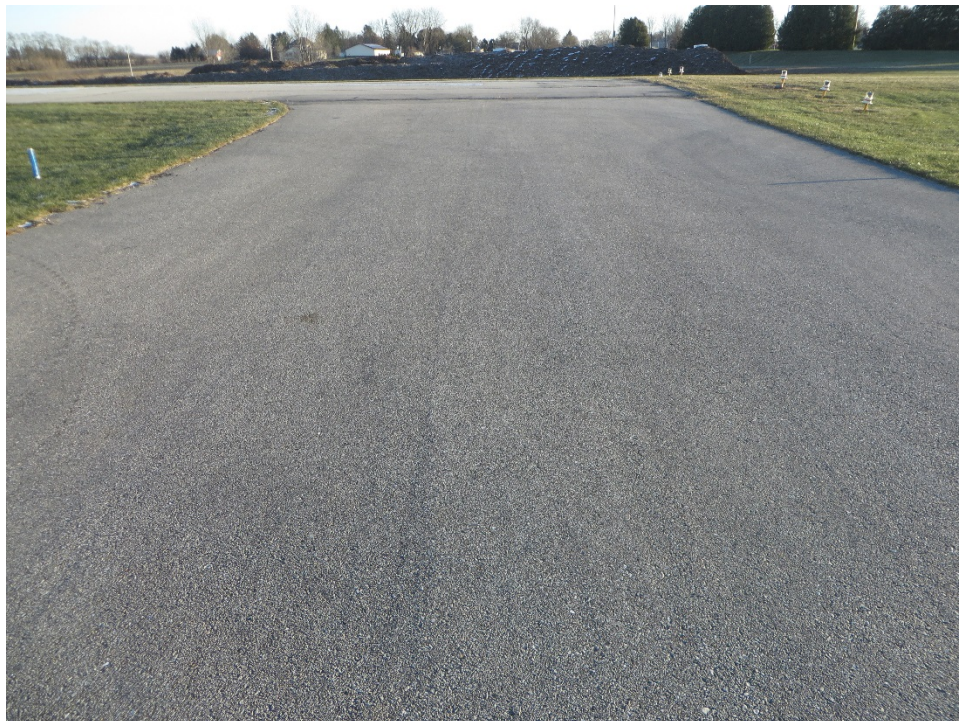
Taxiway 02 contained one section that was located between the apron area and the Runway 07 approach. Medium-severity alligator cracking, low-severity L&T cracking in an unsealed condition, medium-severity L&T cracking due to unsatisfactory crack sealant, and low-severity weathering were observed in Section 01.

T02WK-01. Overview.

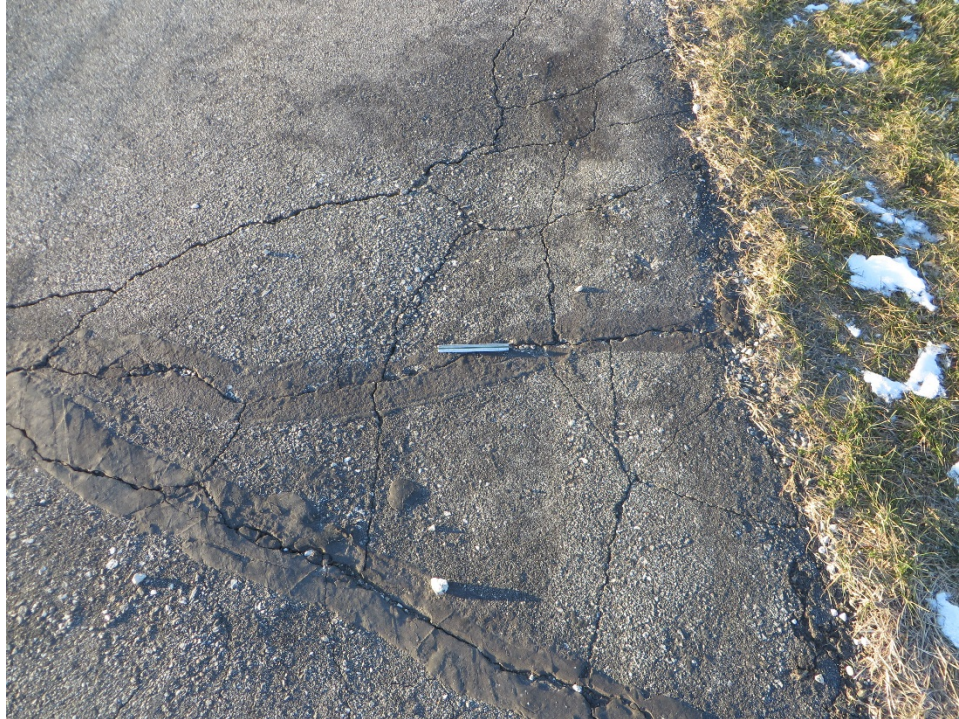
T02WK-01. Alligator Cracking (Sample Unit No. 01).

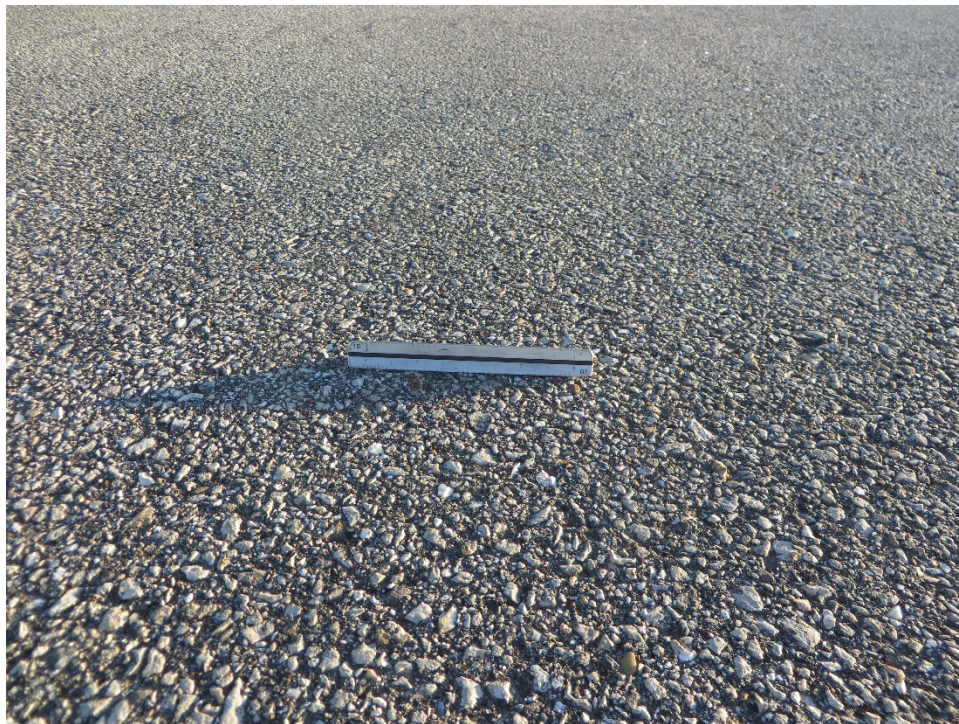
T02WK-01. Weathering (Sample Unit No. 01).
