# Waukon Municipal Airport

## Pavement Management Report

**AUGUST 2025**

# WAUKON MUNICIPAL AIRPORT PAVEMENT MANAGEMENT REPORT

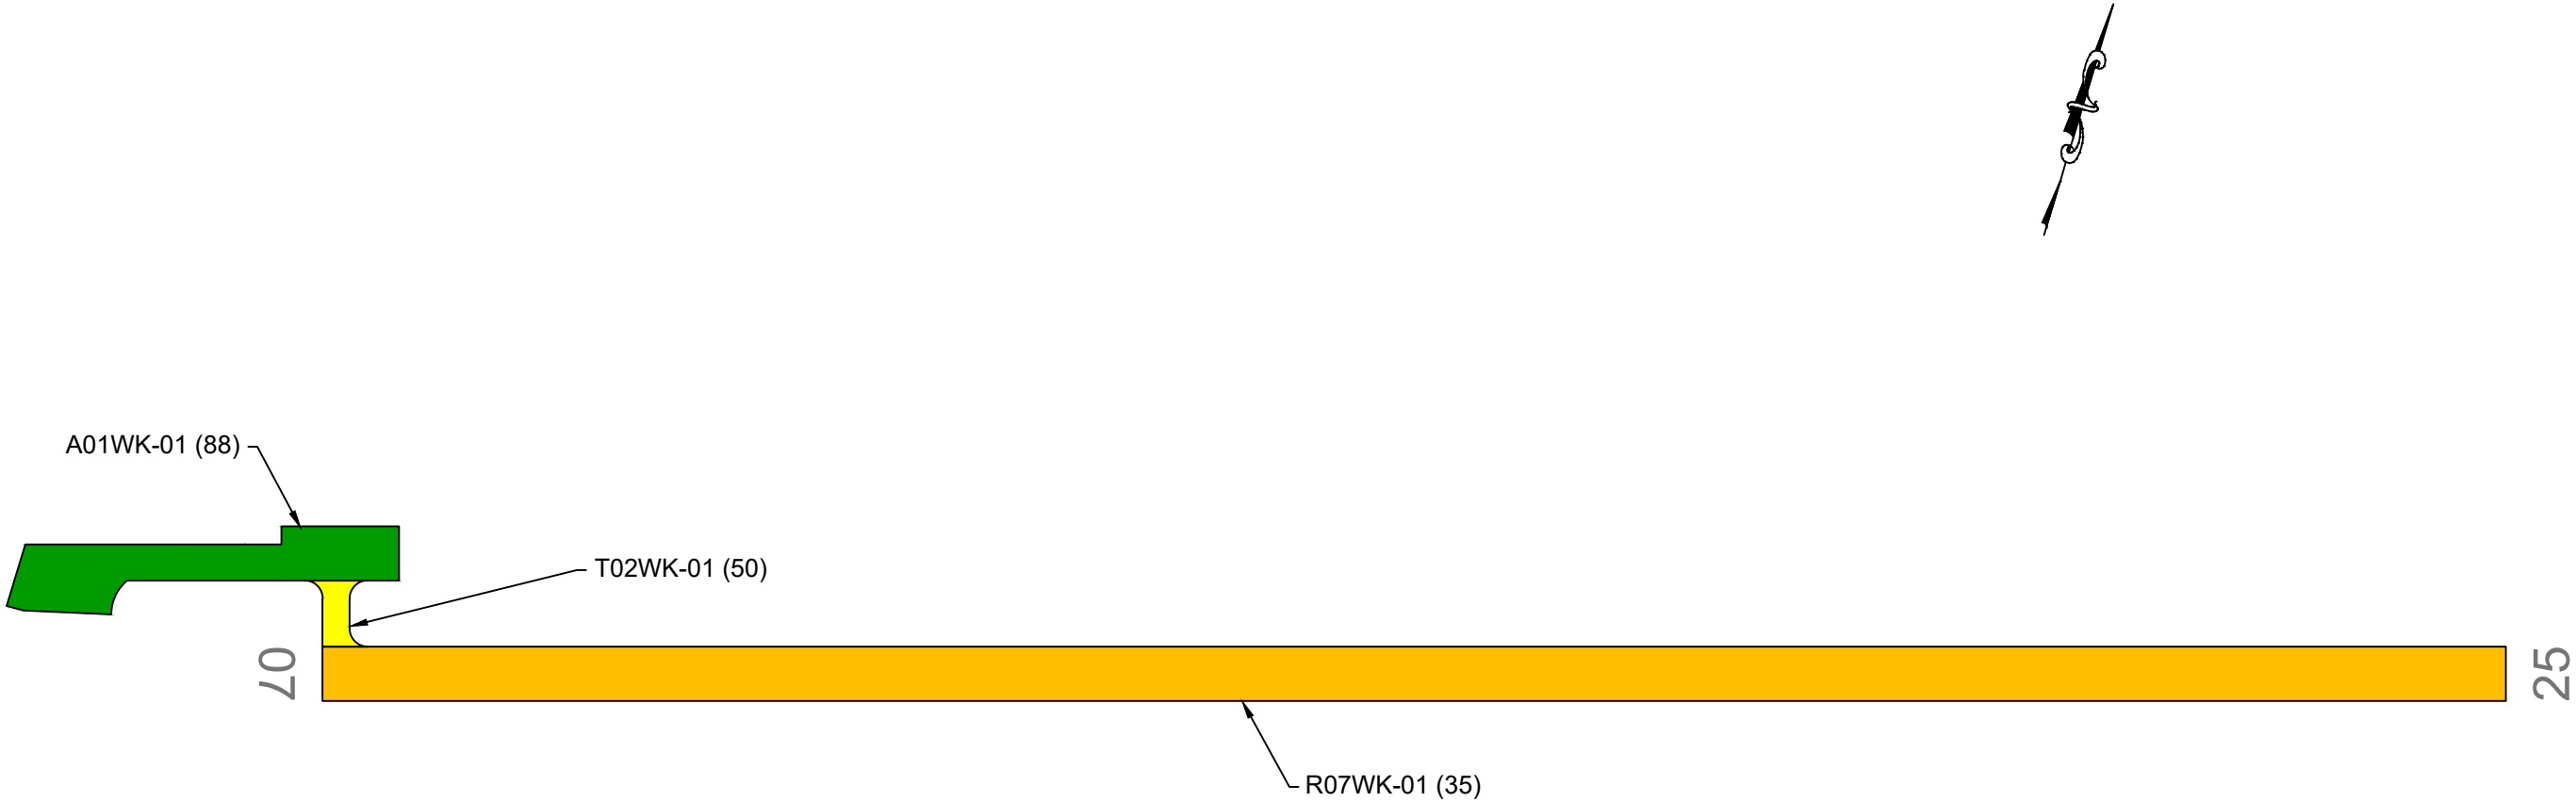
FIGURE 8. PCI MAP.

The pavements at Waukon Municipal Airport were inspected in March 2025. The 2025 area-weighted condition of Waukon Municipal Airport is 42, with conditions ranging from 35 to 88 (on a scale of 0 [failed] to 100 [excellent]). During the previous pavement inspection in 2018, the area-weighted PCI of the airport was 43.

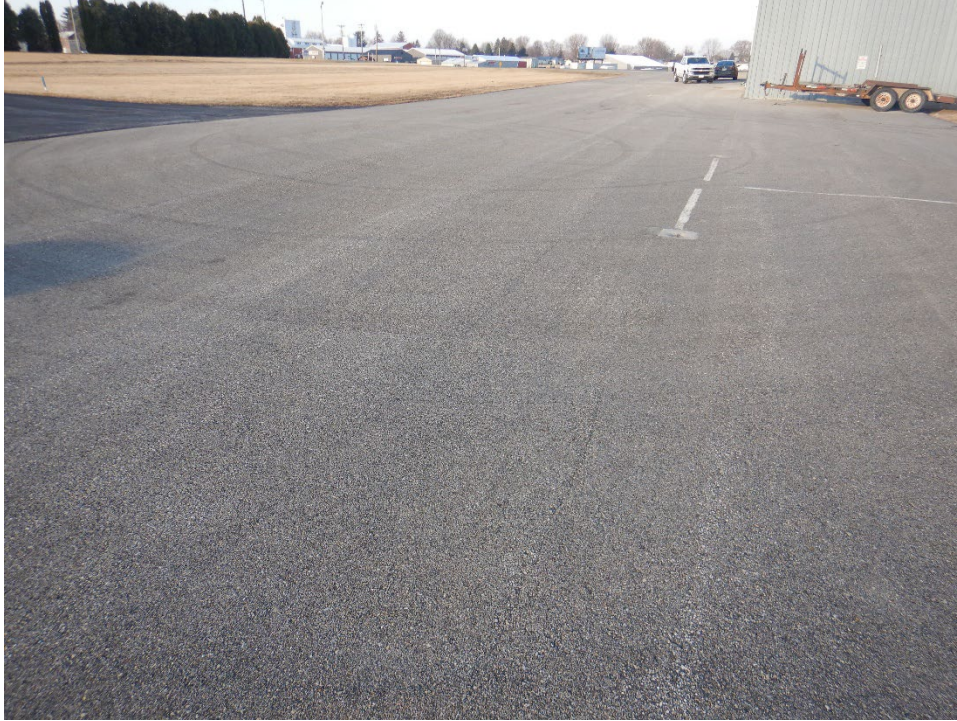
The apron area was defined by one section that contained areas of low- and medium-severity L&T cracking, medium- and high-severity raveling, and low-severity weathering. The low-severity L&T cracking was unsealed, while the medium-severity L&T cracking was where the cracking was due to unsealed crack widths greater than 1/4 inch.

A01WK-01. Overview.

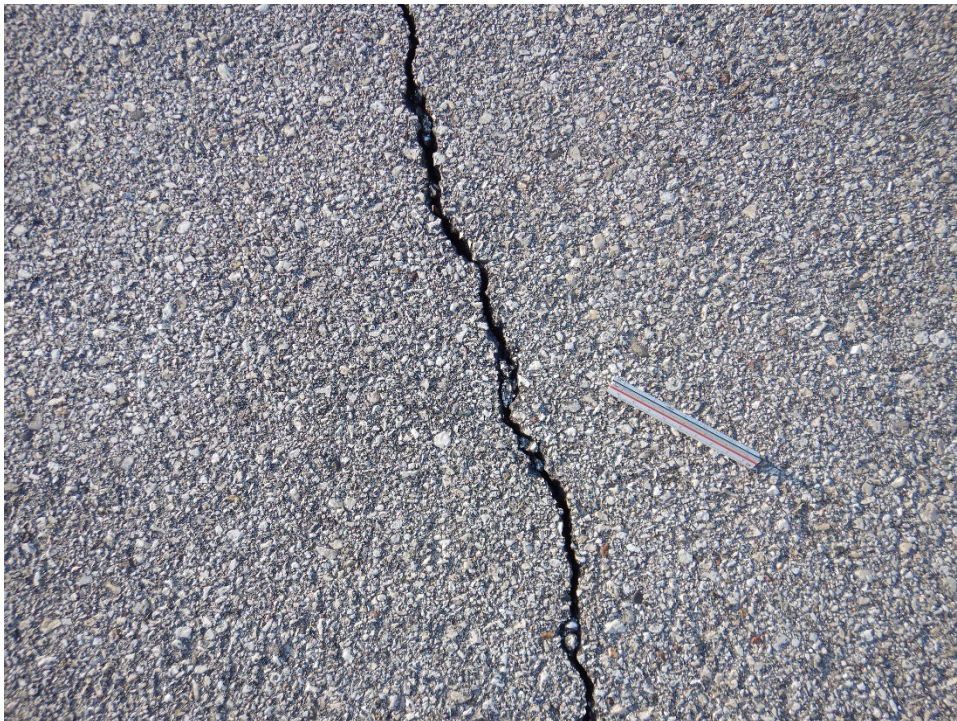
A01WK-01. L&T Cracking (Sample Unit No. 03).

| Branch | Section | Distress Type | Severity | Distress Quantity | Distress Unit | Maintenance Action | Unit Cost | 2025 Estimated Cost |
|---|---|---|---|---|---|---|---|---|
| A01WK | 01 | L&T Cracking | Medium | 15 | Ft | Crack Sealing - AC | \$2.72 | \$41 |

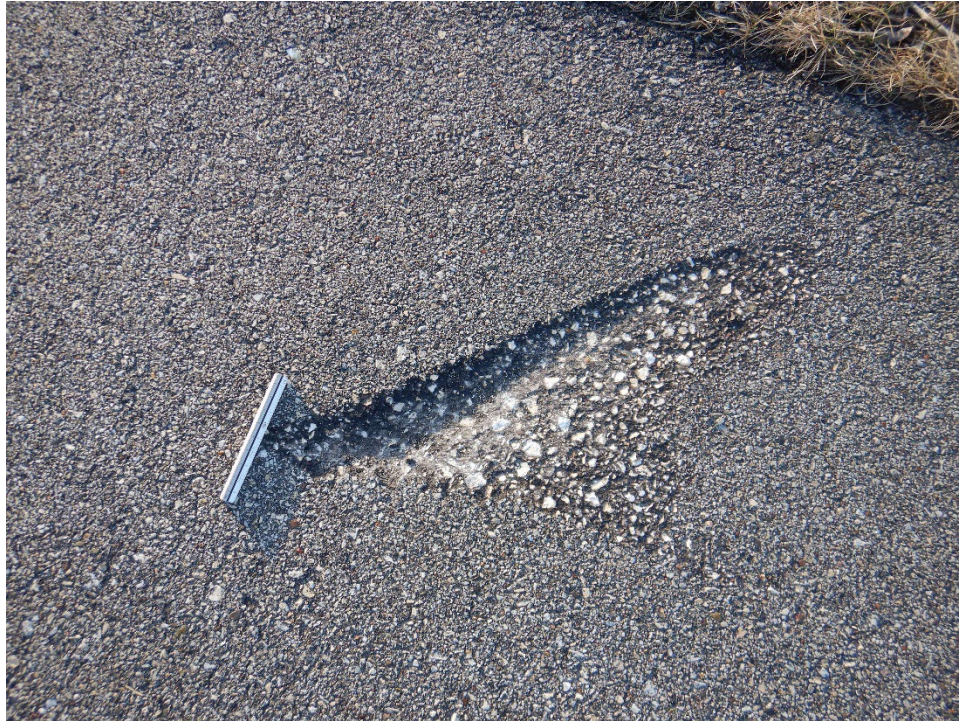
A01WK-01. Raveling (Sample Unit No. 04).

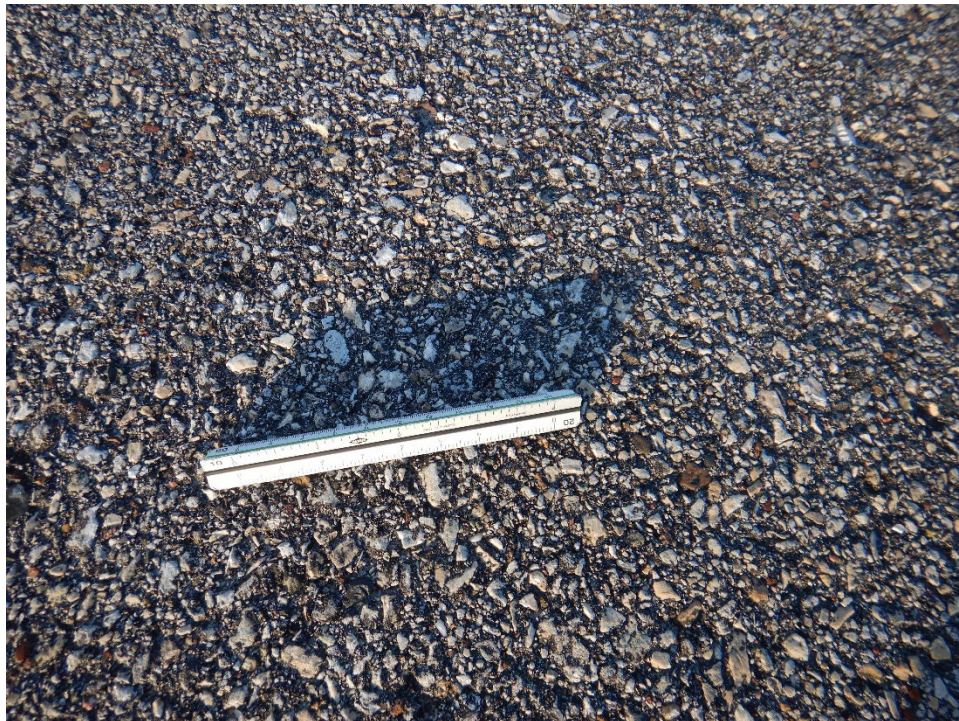
A01WK-01. Weathering (Sample Unit No. 04).

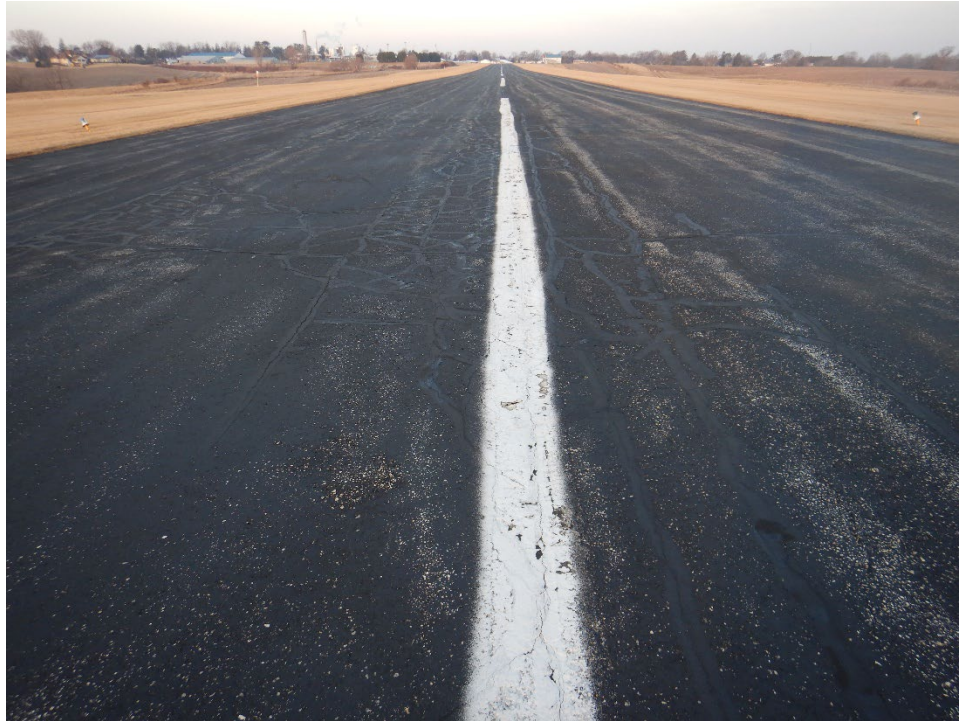
Runway 07/25 consisted of one section that was in *Poor* condition. Distresses identified during the inspection included medium-severity alligator cracking, high-severity weathering, and all severities of longitudinal and transverse (L&T) cracking. Some medium-severity alligator cracking was recorded in the wheel path. The low-severity L&T cracking was unsealed; the medium-severity L&T cracking was either due to crack sealant that was no longer satisfactory, unsealed crack widths that exceeded 1/4 inch, or the development of secondary cracking; and the high-severity L&T cracking was recorded in areas where the crack width was greater than 3 inches.

R07WK-01. Overview.

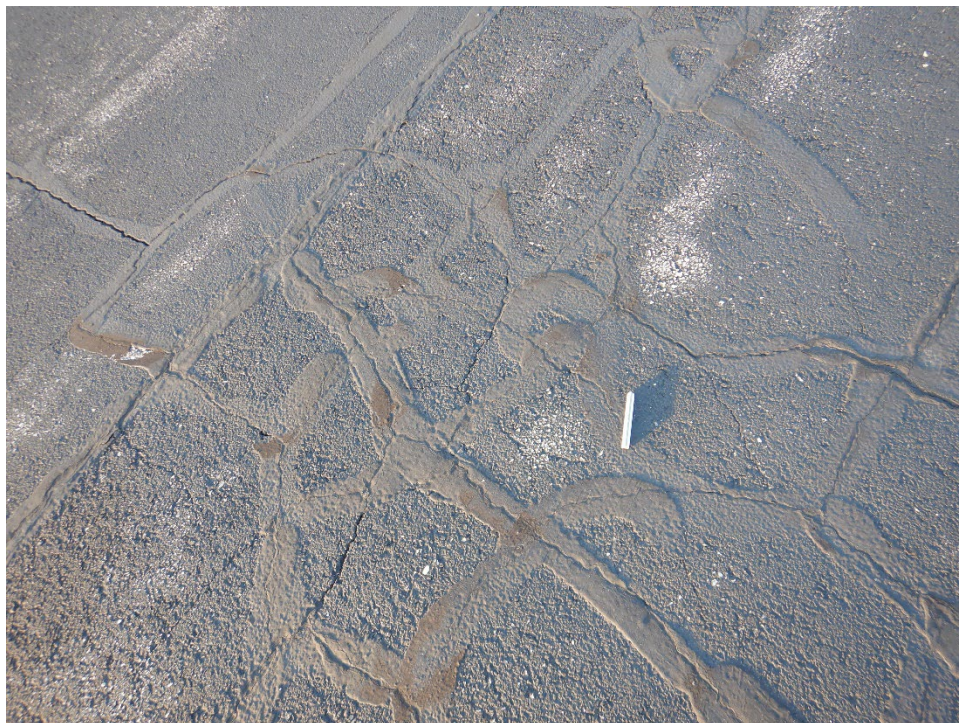
R07WK-01. Alligator Cracking (Sample Unit No. 15).

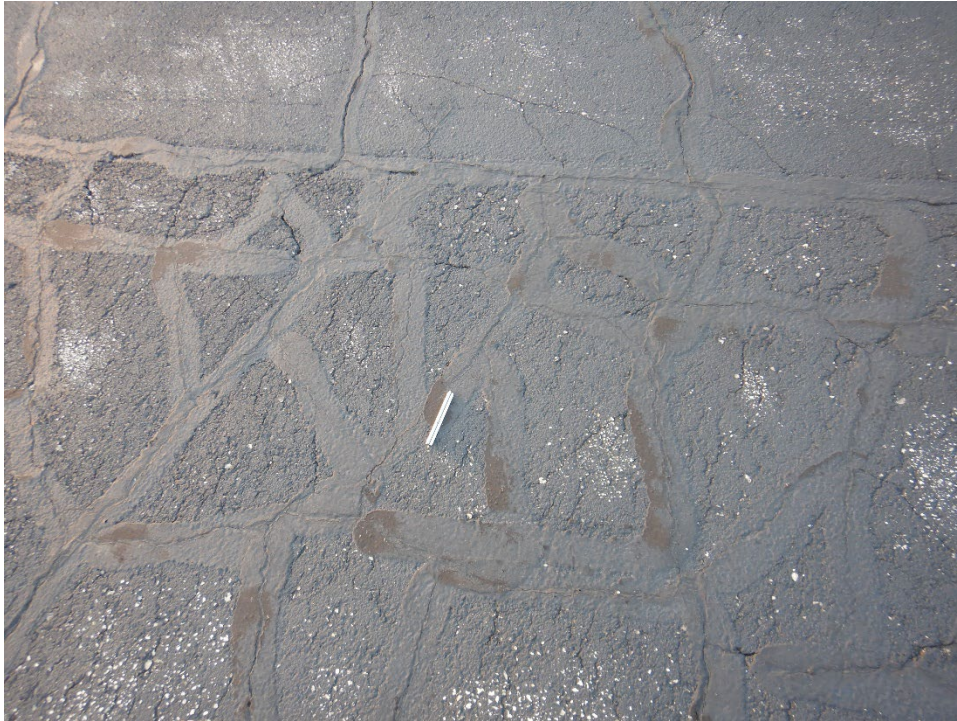
R07WK-01. Alligator Cracking (Sample Unit No. 23).

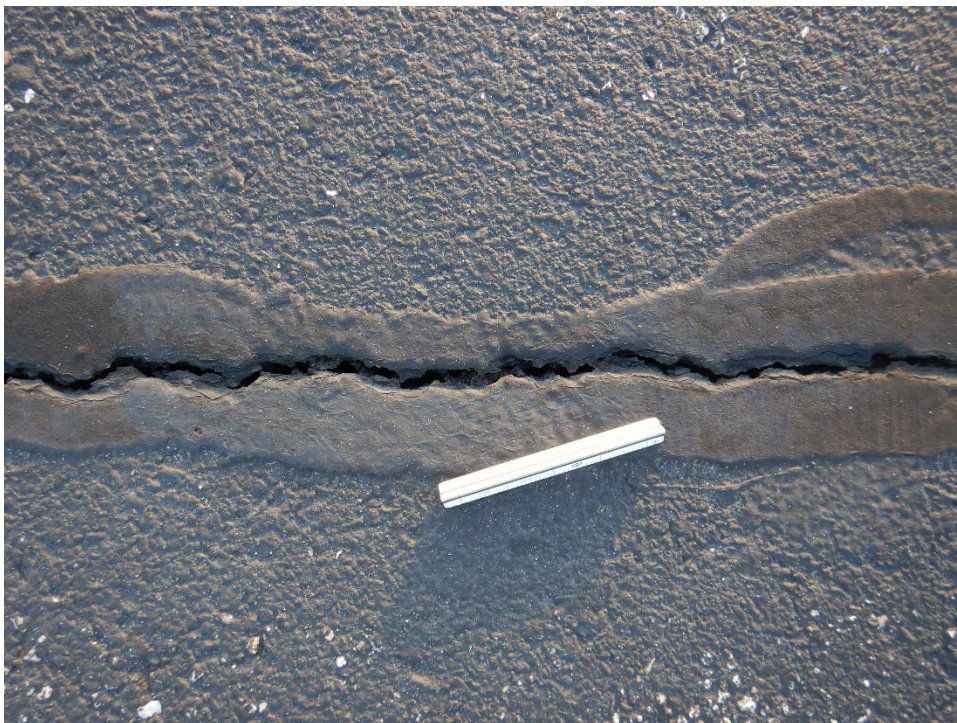
R07WK-01. L&T Cracking (Sample Unit No. 03).

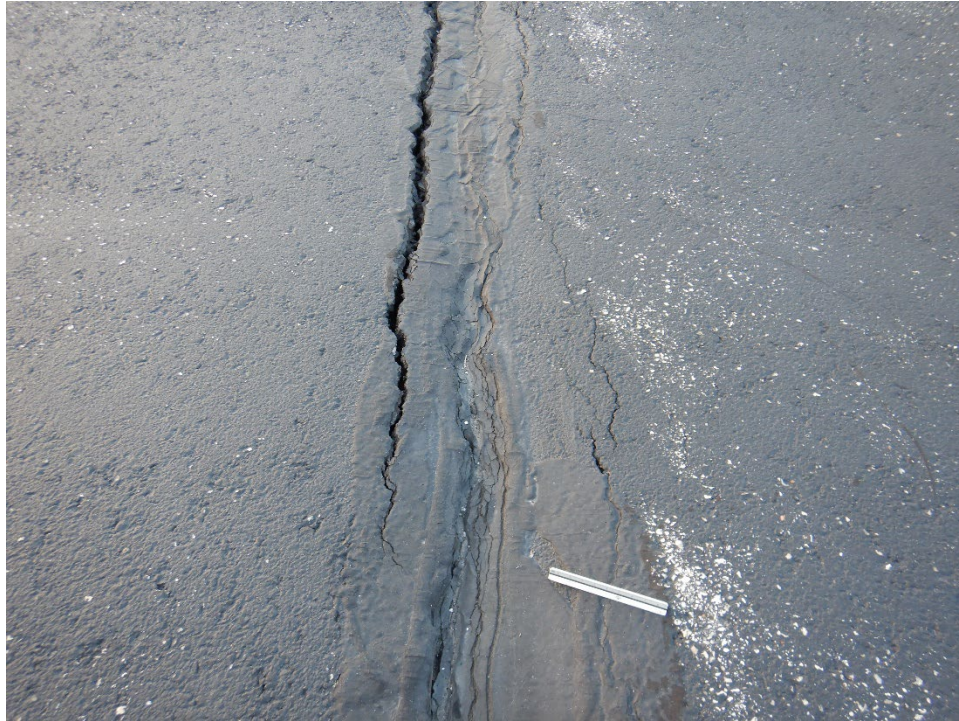
R07WK-01. L&T Cracking (Sample Unit No. 19).

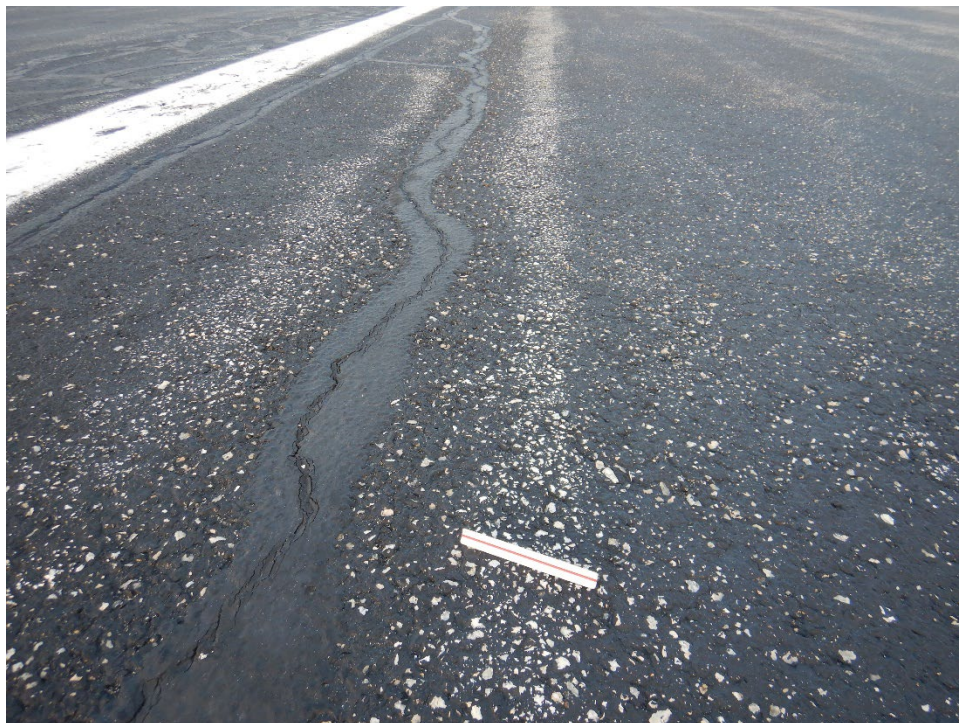
R07WK-01. Weathering (Sample Unit No. 23).

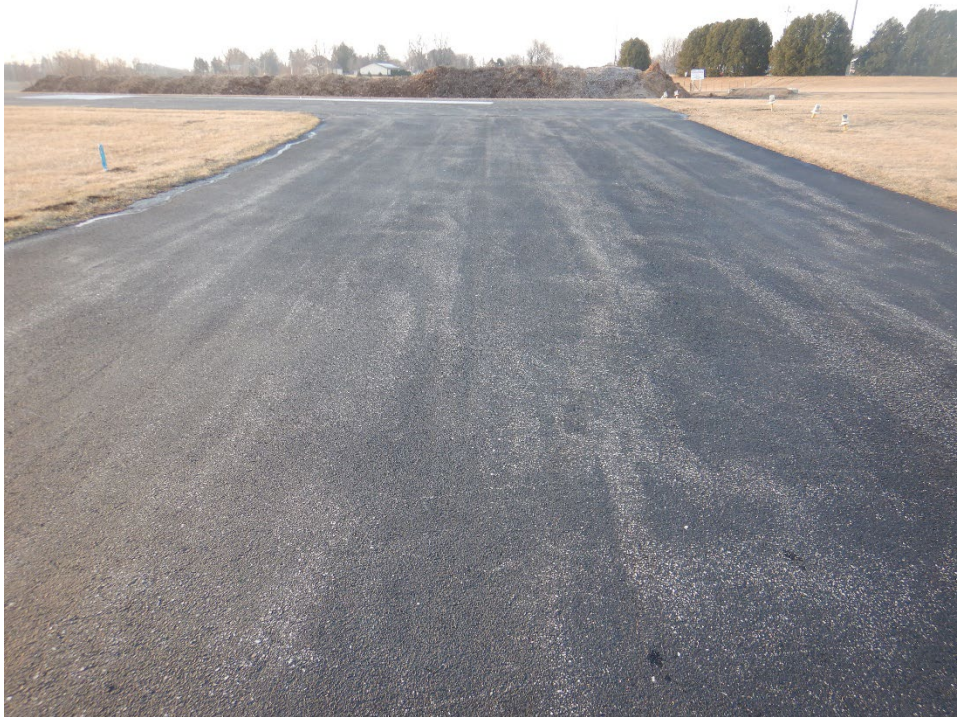
The taxiway contained one section with medium-severity alligator cracking, high-severity weathering, and low- and medium-severity L&T cracking recorded during the inspection. Some medium-severity alligator cracking was recorded in the wheel path. The low-severity L&T cracking was sealed, while the medium-severity L&T cracking was due to unsatisfactory crack sealant.

T02WK-01. Overview.

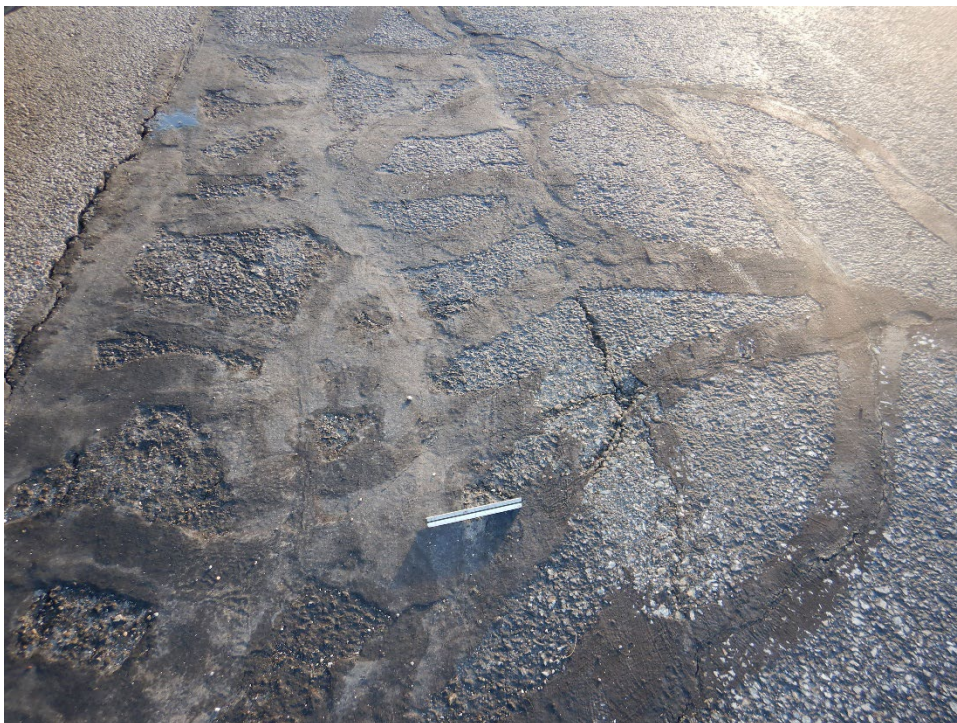
T02WK-01. Alligator Cracking (Sample Unit No. 01).

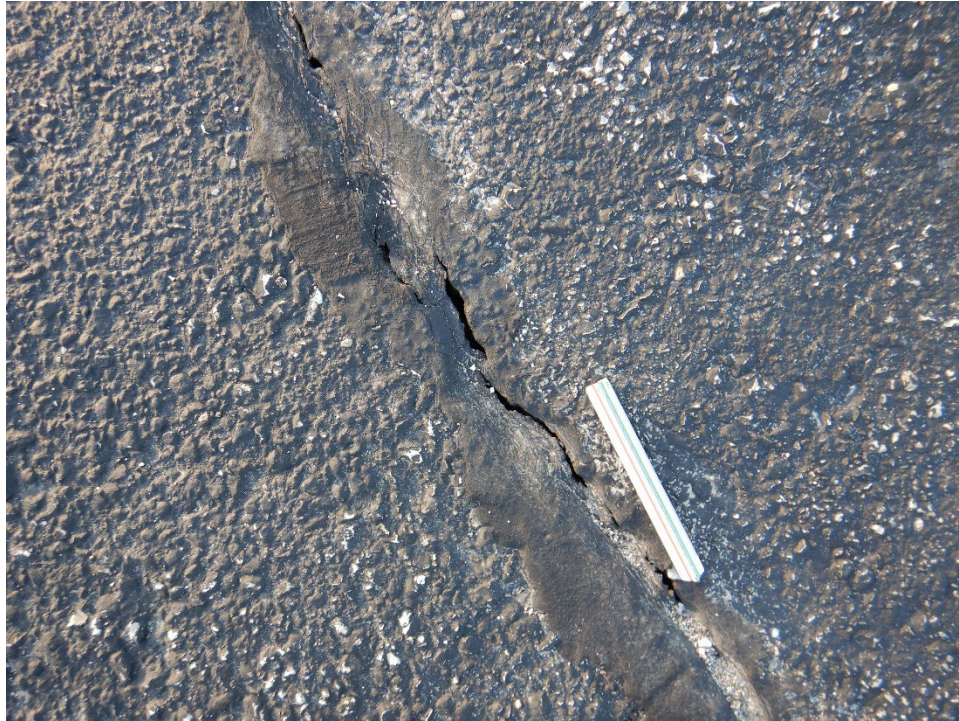
T02WK-01. L&T Cracking (Sample Unit No. 01).

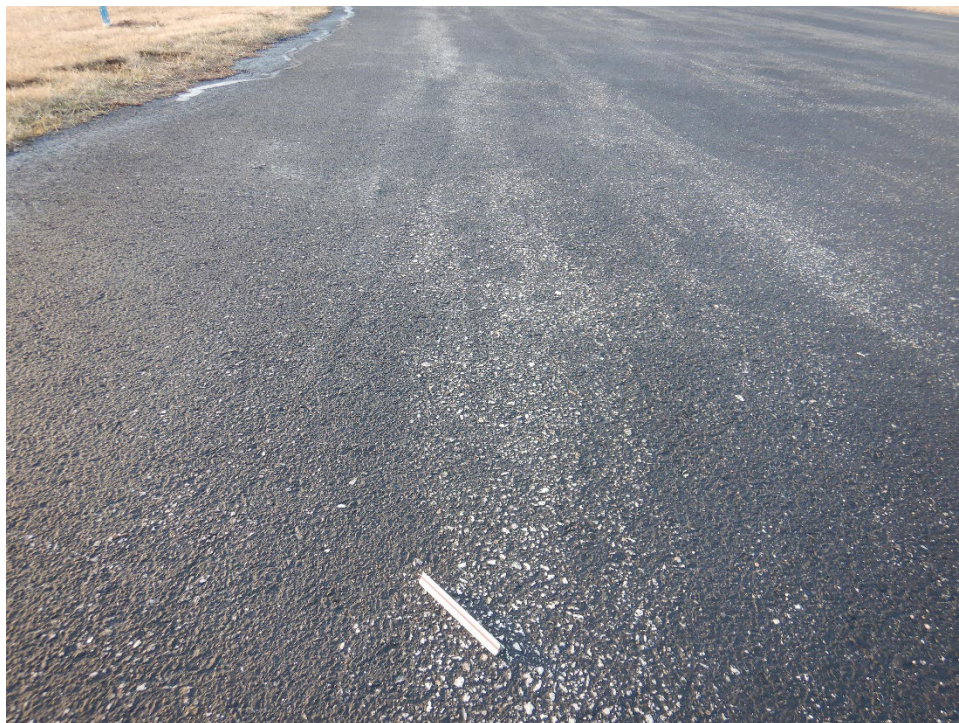
T02WK-01. Weathering (Sample Unit No. 01).
