Waverly Municipal Airport

Pavement Management Report

JULY 2023

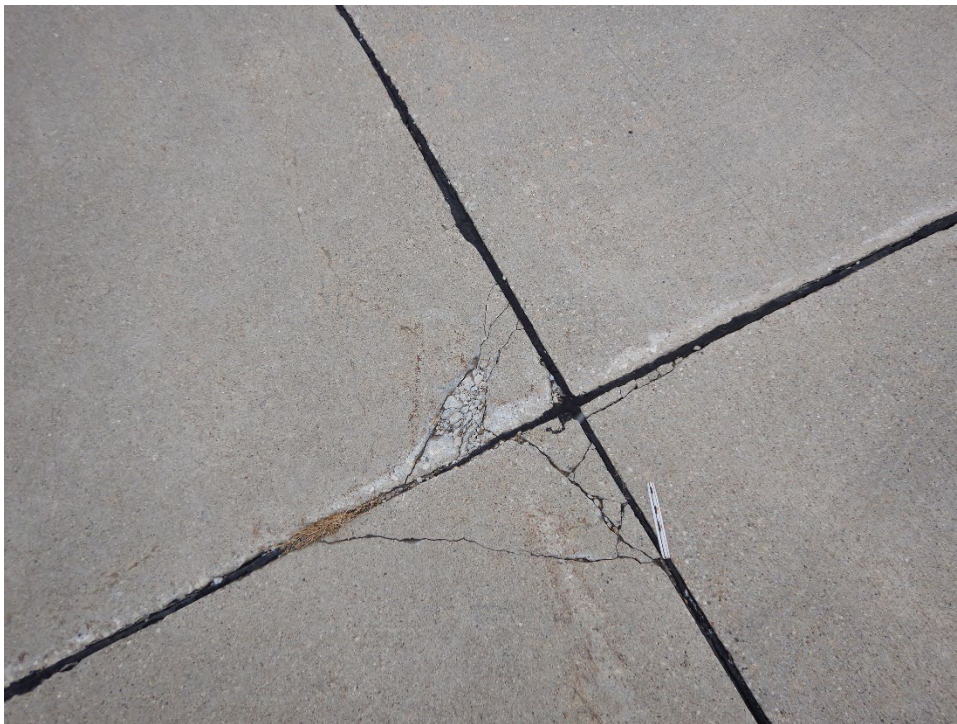
A01WV-01. Durability Cracking (Sample Unit No. 02).

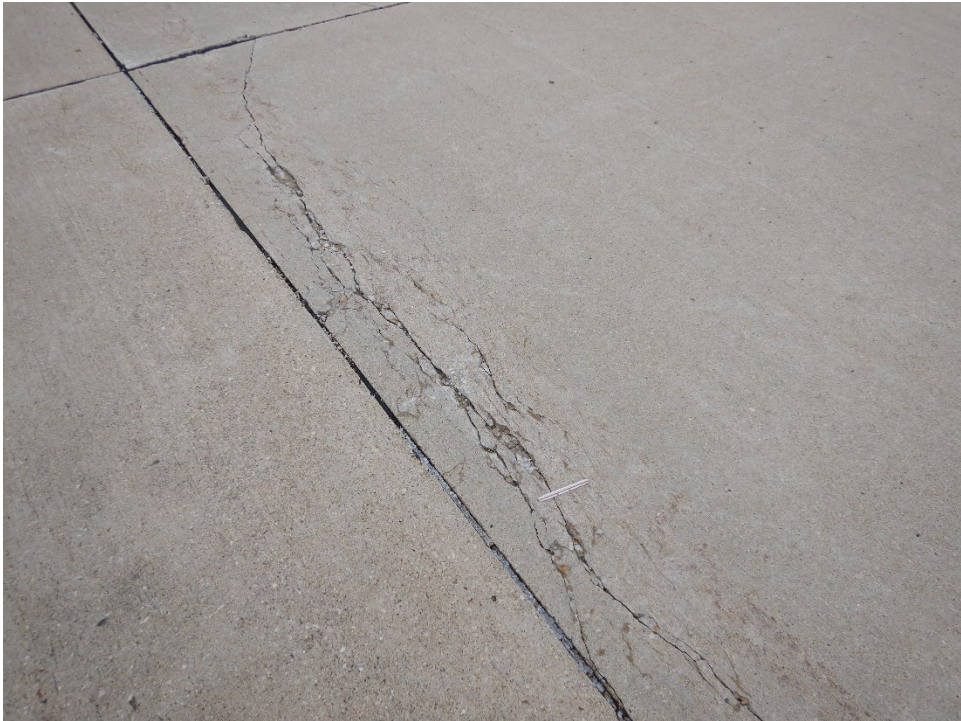
A01WV-01. Durability Cracking (Sample Unit No. 04).

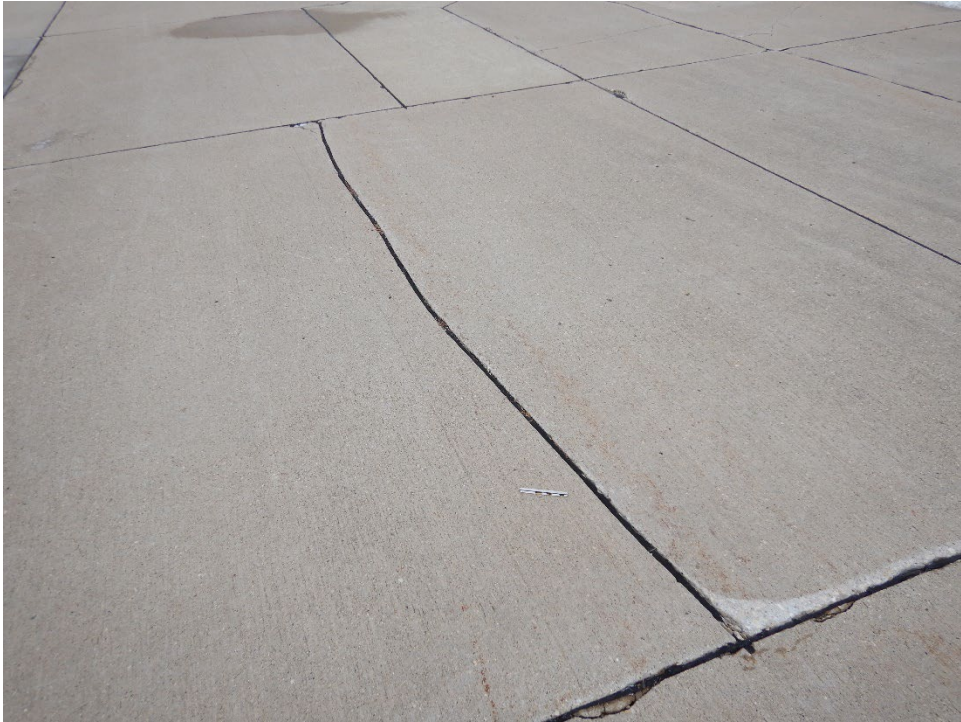
A01WV-01. LTD Cracking (Sample Unit No. 04).

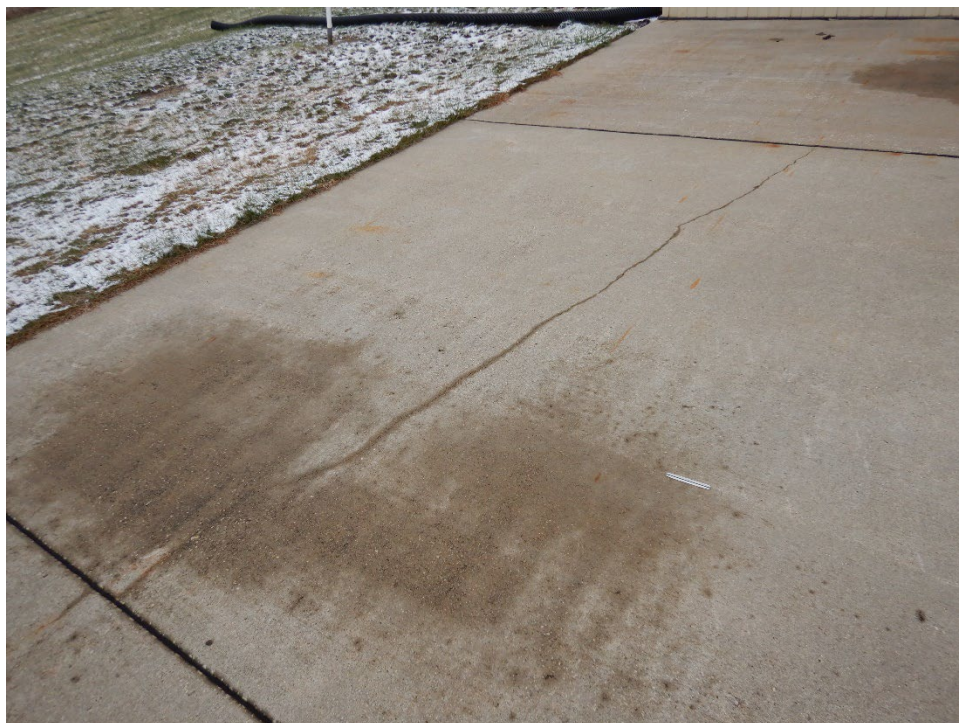
A01WV-02. LTD Cracking (Sample Unit No. 12).

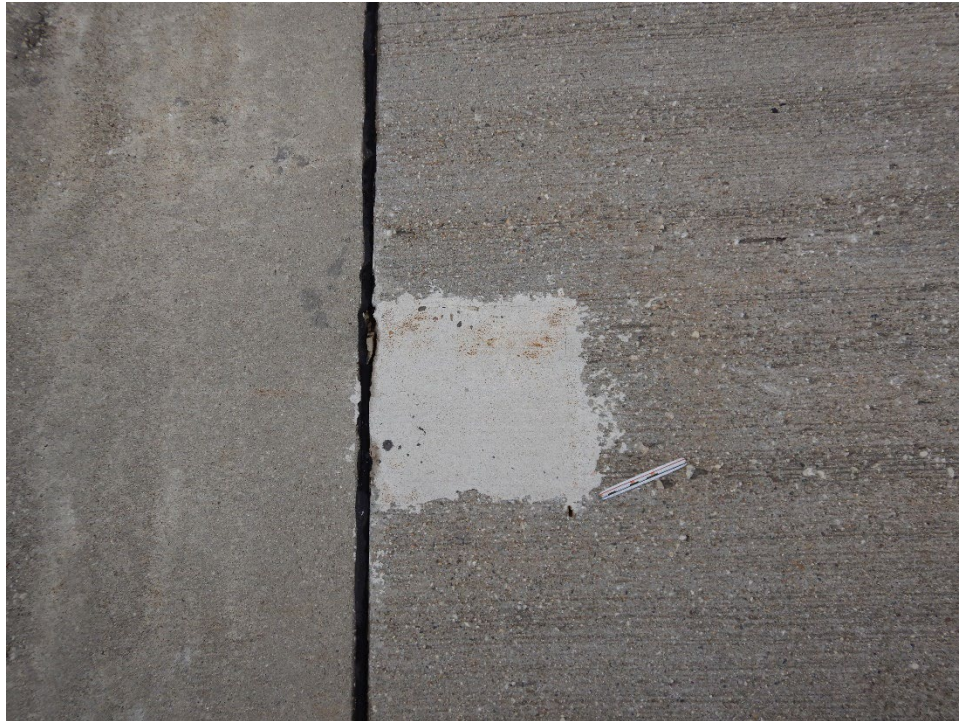
A01WV-02. Small Patching (Sample Unit No. 12).

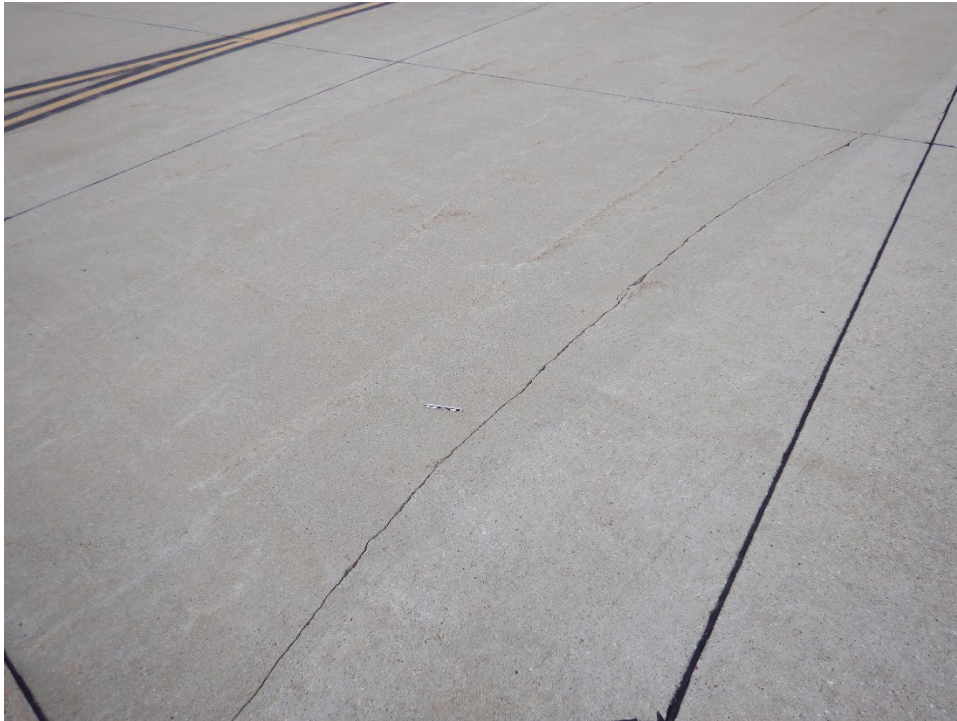
A01WV-03. LTD Cracking (Sample Unit No. 02).

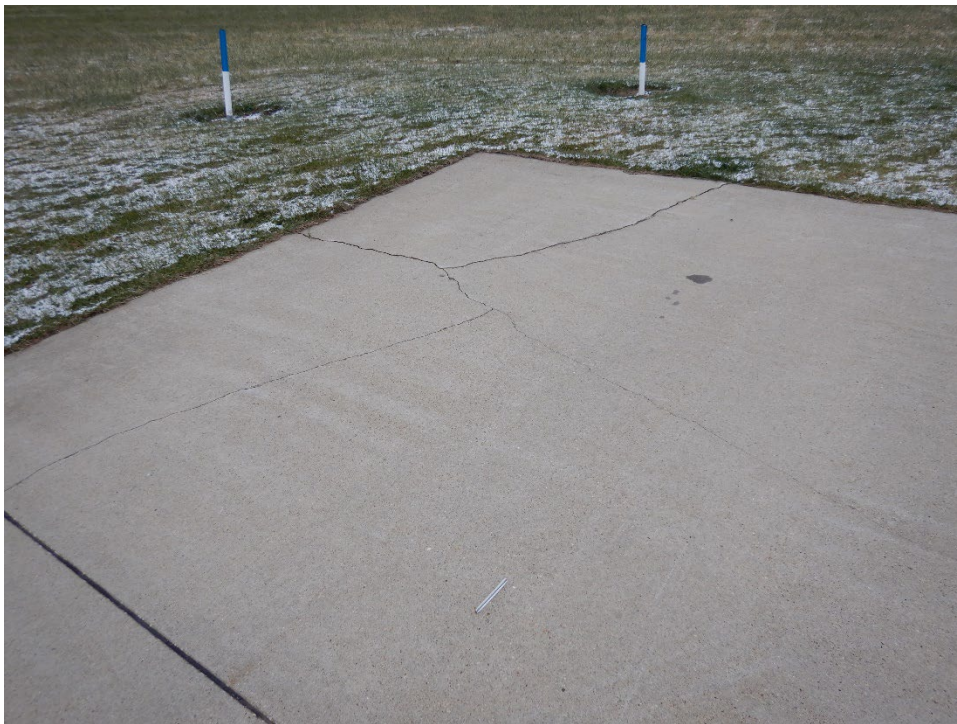
A01WV-03. Shattered Slab (Sample Unit No. 01).

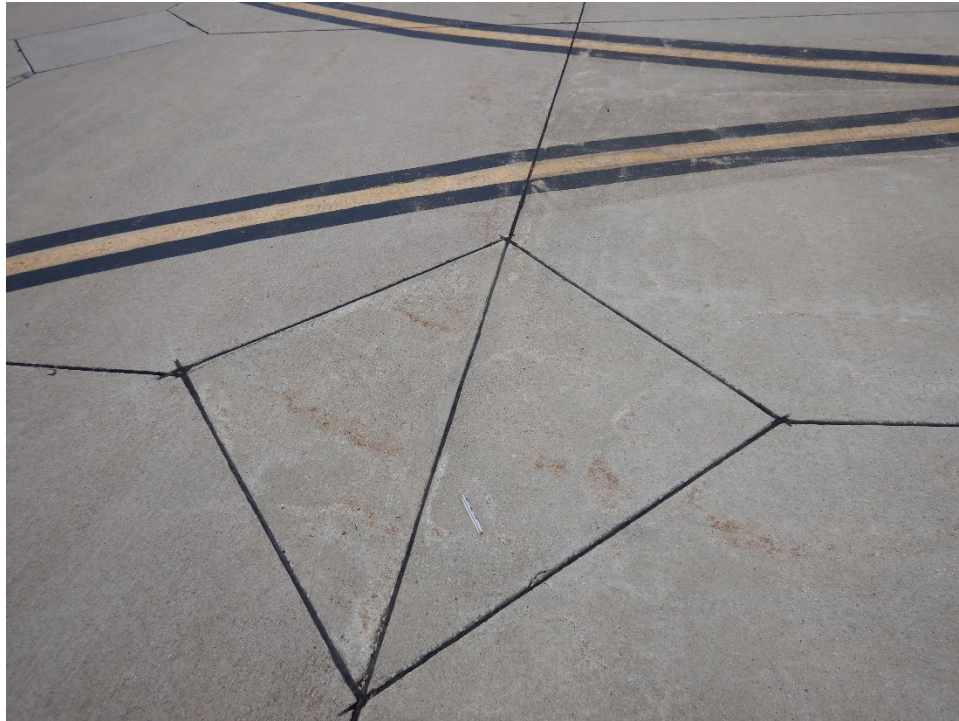
A01WV-03. Small Patching (Sample Unit No. 02).

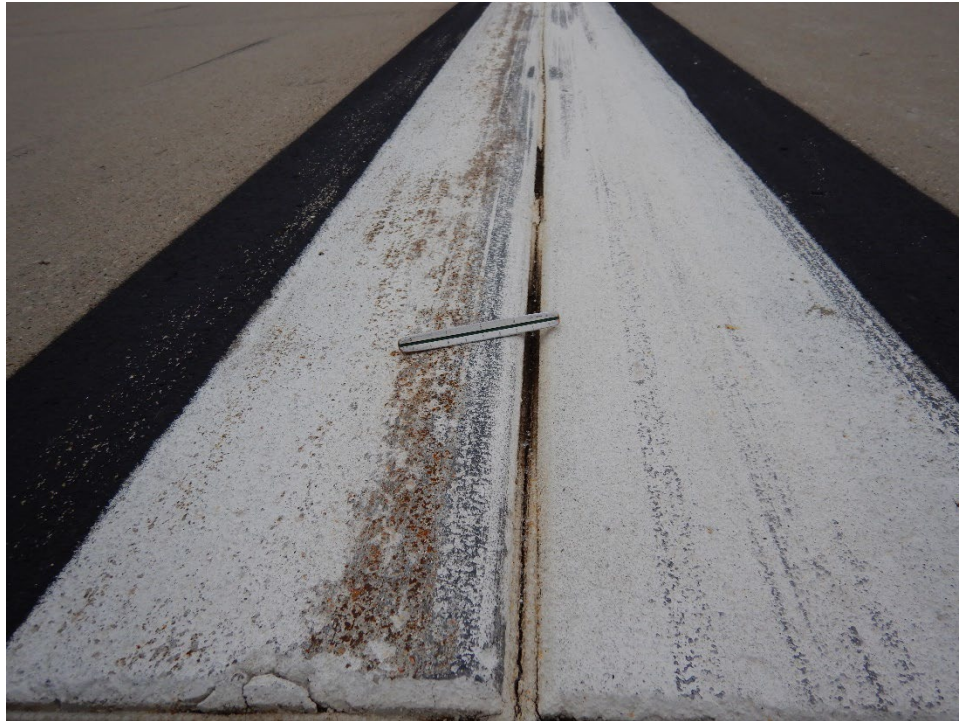
Runway 11/29 contained two sections. Section 01 was in excellent condition with only areas of low-severity faulting recorded. Section 02 was also in excellent condition with no distress observed at the time of inspection.

R11WV-01. Faulting (Sample Unit No. 57).

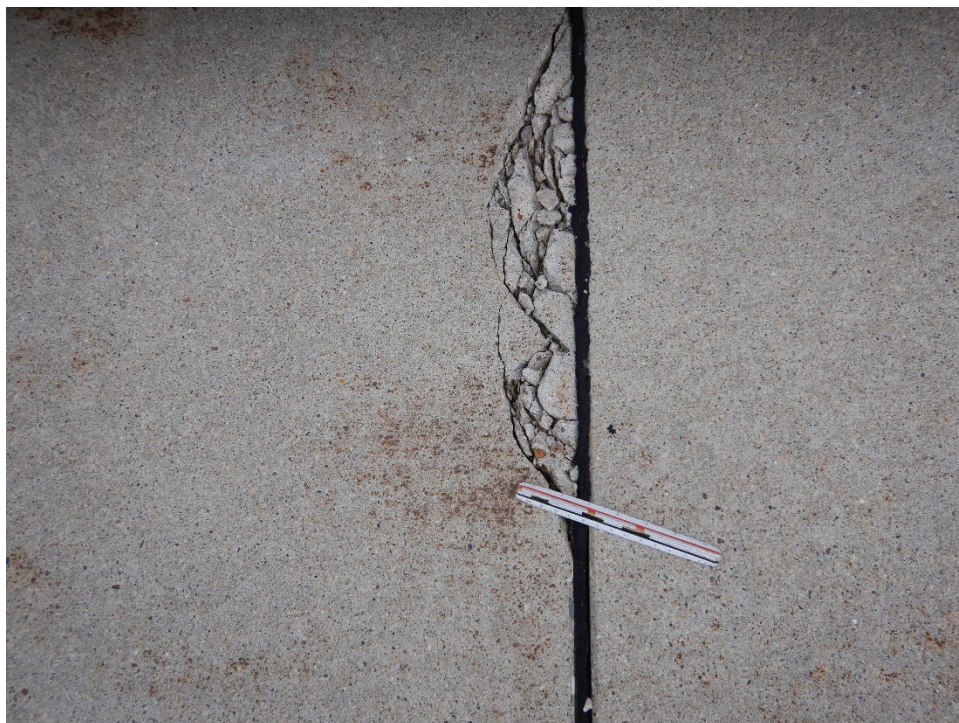
Taxiway 01 consisted of one section. Section 01 contained areas of low- and medium-severity joint spalling and low-severity corner spalling and joint seal and damage.

T01WV-01. Joint Spalling (Sample Unit No. 02).

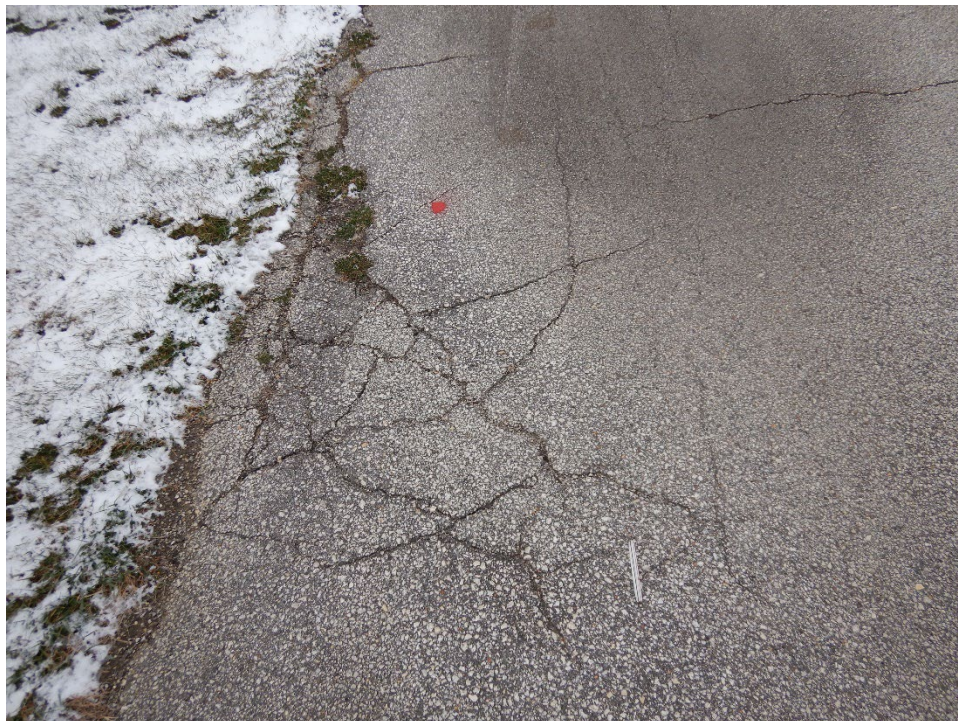
TH01WV-01. Alligator Cracking (Sample Unit No. 02).

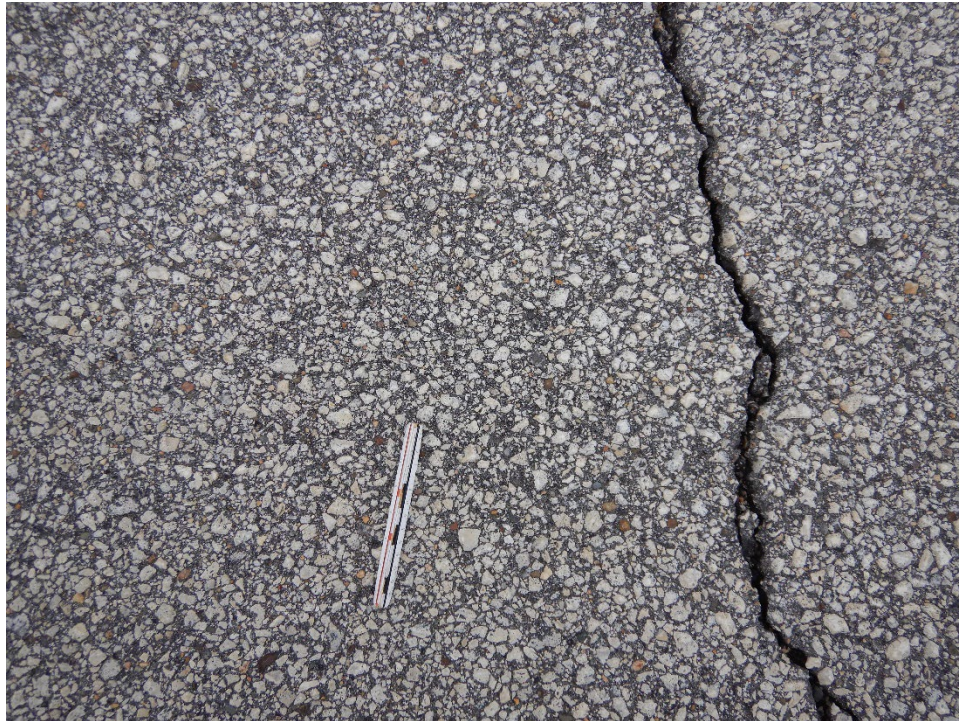
TH01WV-01. L&T Cracking (Sample Unit No. 02).

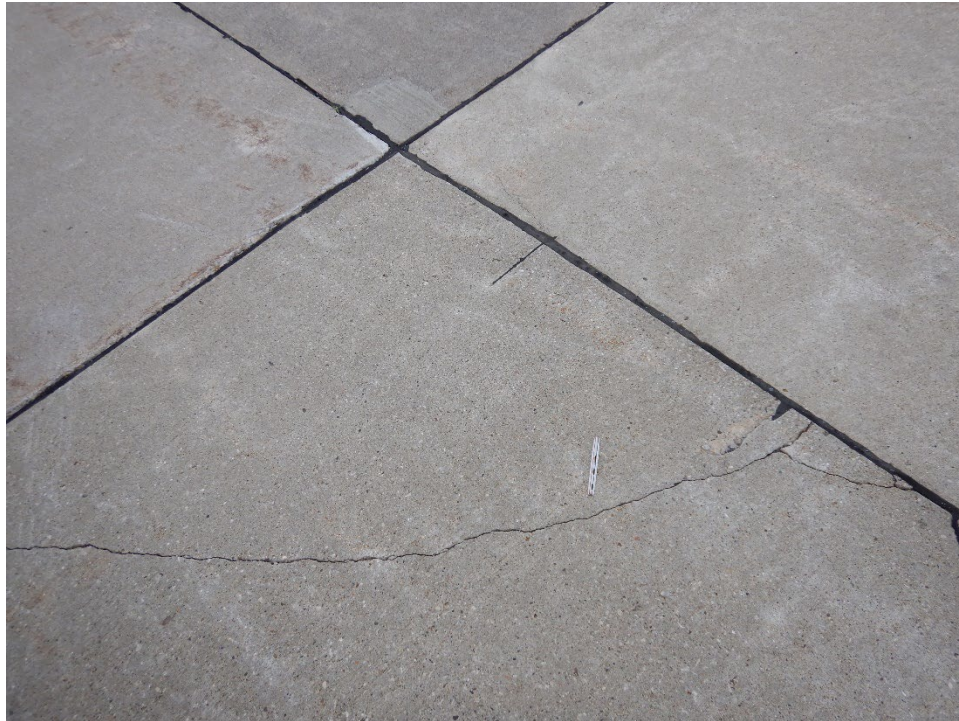
TH01WV-02. Corner Break (Sample Unit No. 01).

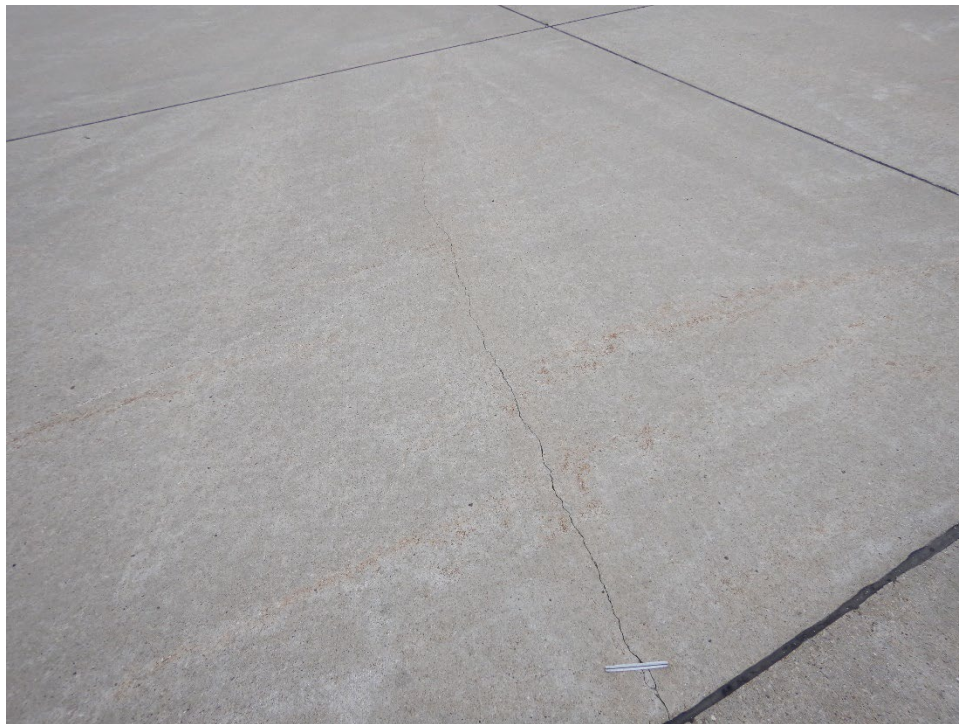
TH01WV-02. LTD Cracking (Sample Unit No. 01).

TH01WV	02	LTD Cracking	Medium	1	Slabs	Crack Sealing - PCC	\$3.14	\$35
