# Waverly Municipal Airport

## Pavement Management Report

**AUGUST 2026**

# WAVERLY MUNICIPAL AIRPORT PAVEMENT MANAGEMENT REPORT

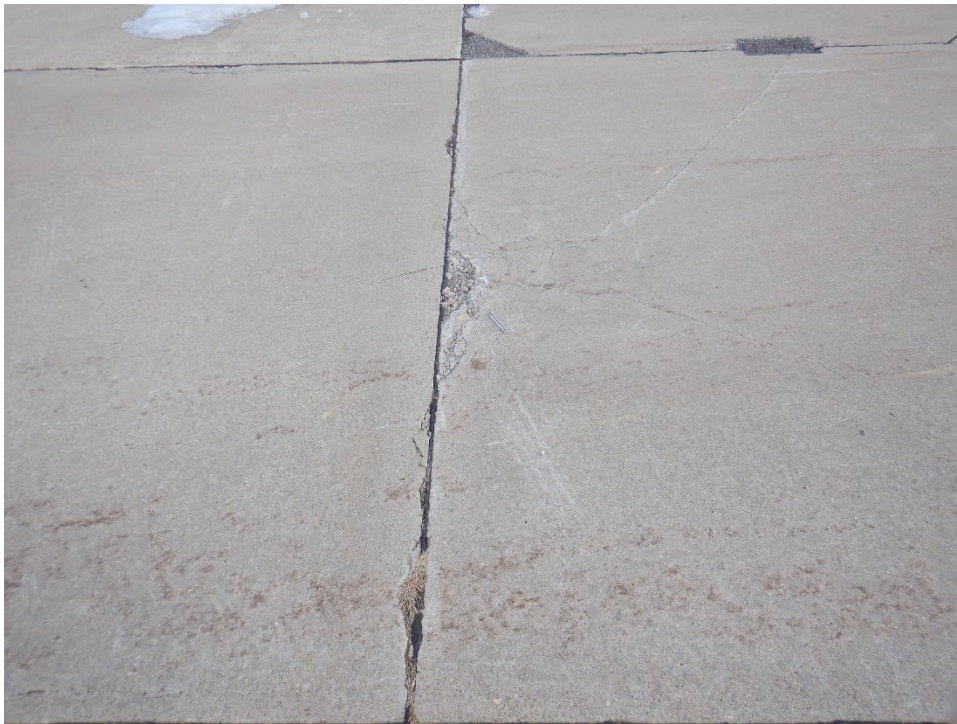
| <b>Distress Type</b> | <b>Probable Cause of Distress</b> |
|---|---|
| Durability Cracking | Concrete's inability to withstand environmental factors, such as freeze-thaw cycles. |

A01WV-01. Durability Cracking (Sample Unit No. 02).

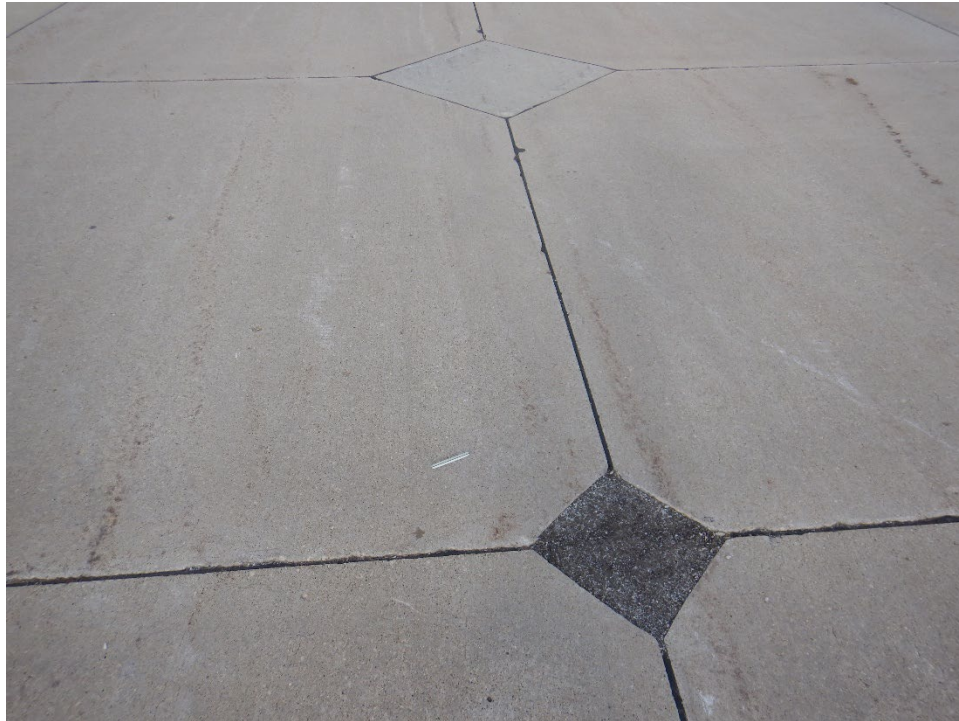
A01WV-01. Small Patching (Sample Unit No. 02).

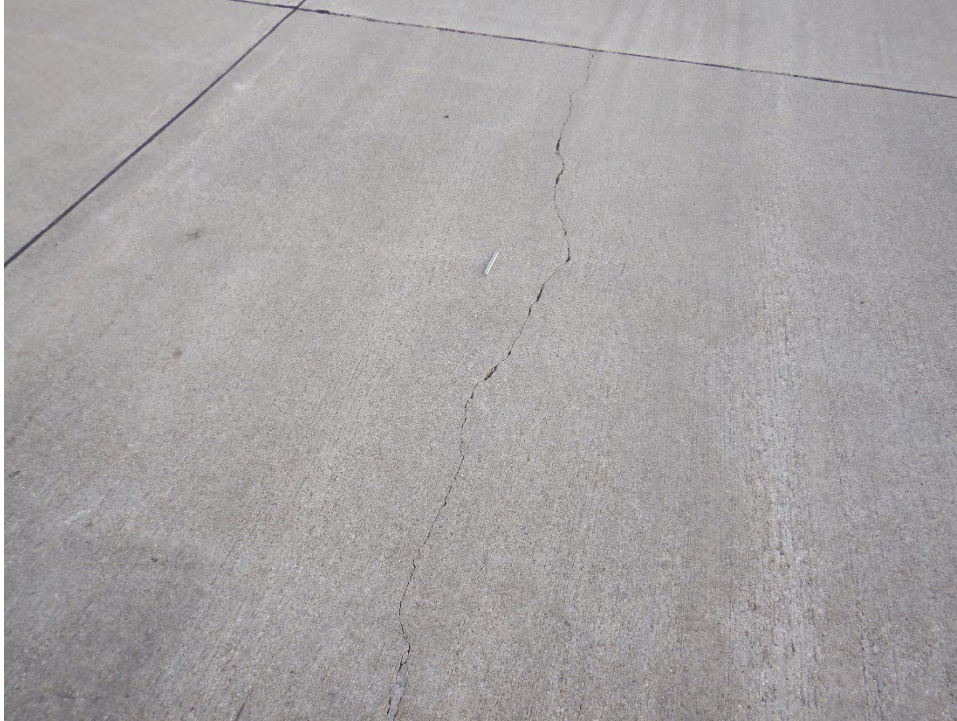
| <b>Distress Type</b> | <b>Probable Cause of Distress</b> |
|---|---|
| LTD Cracking | Combination of load repetition, curling stresses, and shrinkage stresses. |

A01WV-02. LTD Cracking (Sample Unit No. 05).

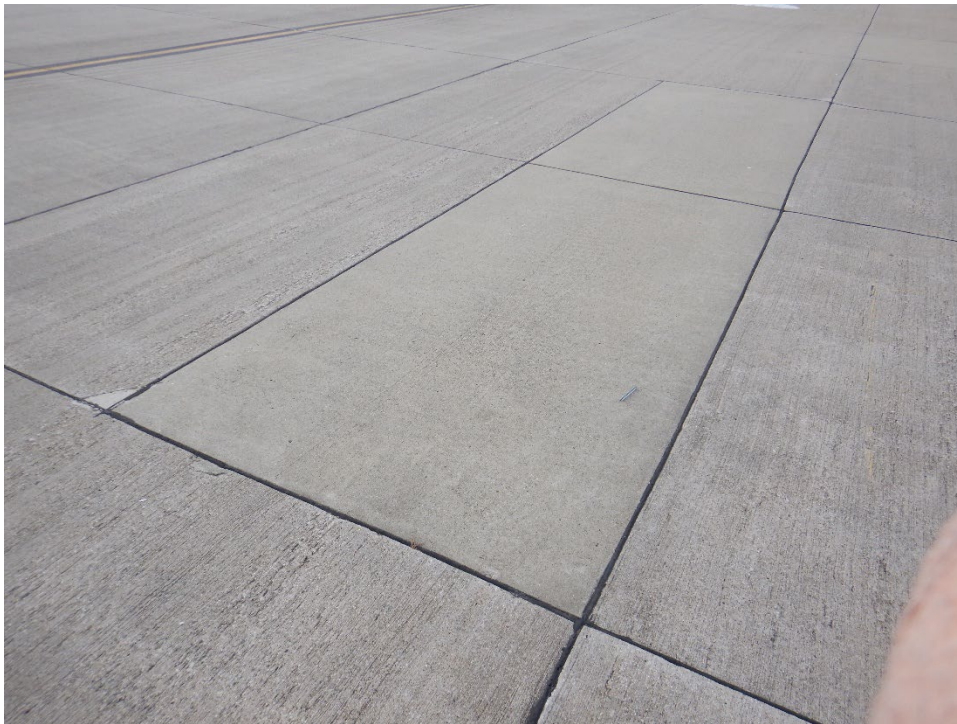
A01WV-02. Large Patching (Sample Unit No. 06).

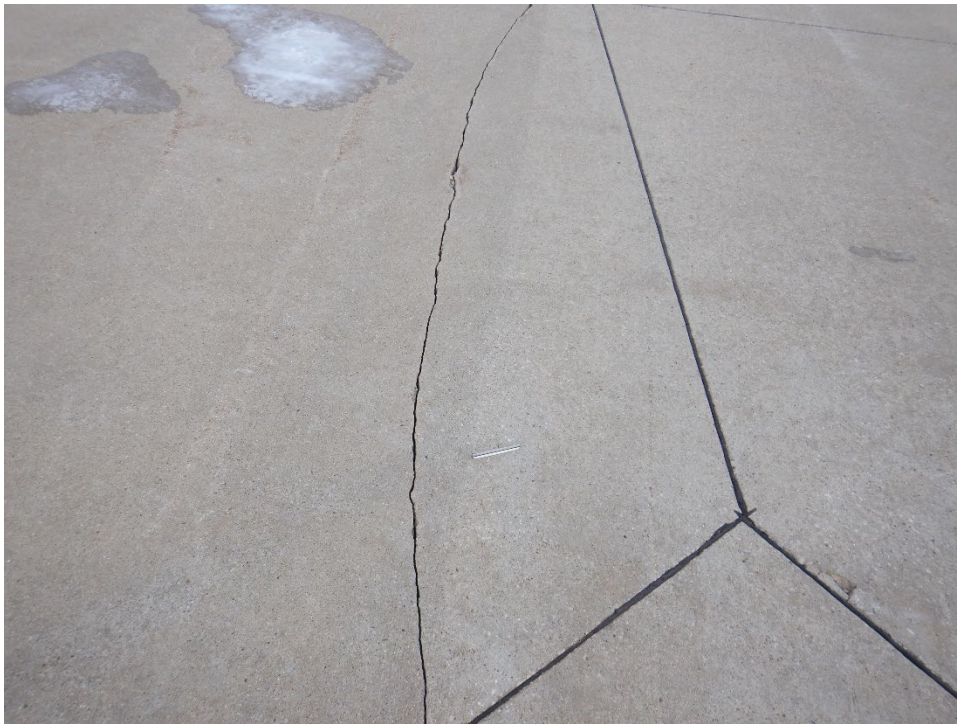
A01WV-03. LTD Cracking (Sample Unit No. 02).

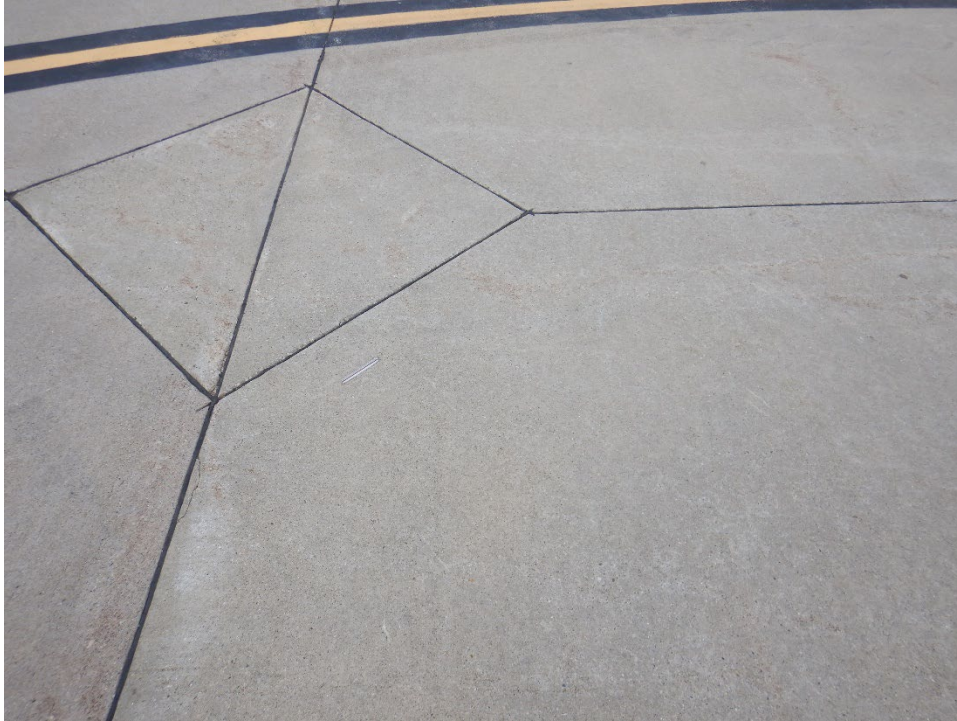
A01WV-03. Small Patching (Sample Unit No. 02).

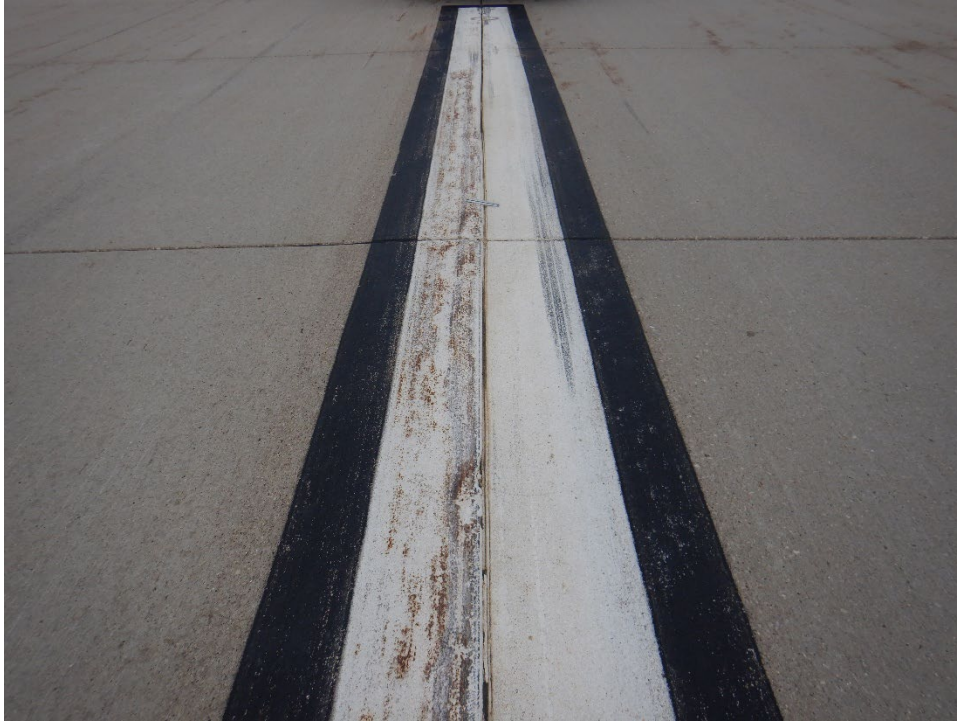
Runway 11/29 consisted of two sections that were both in *Excellent* condition. Section 01 contained only low-severity faulting. Section 02 had no distress observed at the time of inspection.

R11WV-01. Faulting (Sample Unit No. 57).

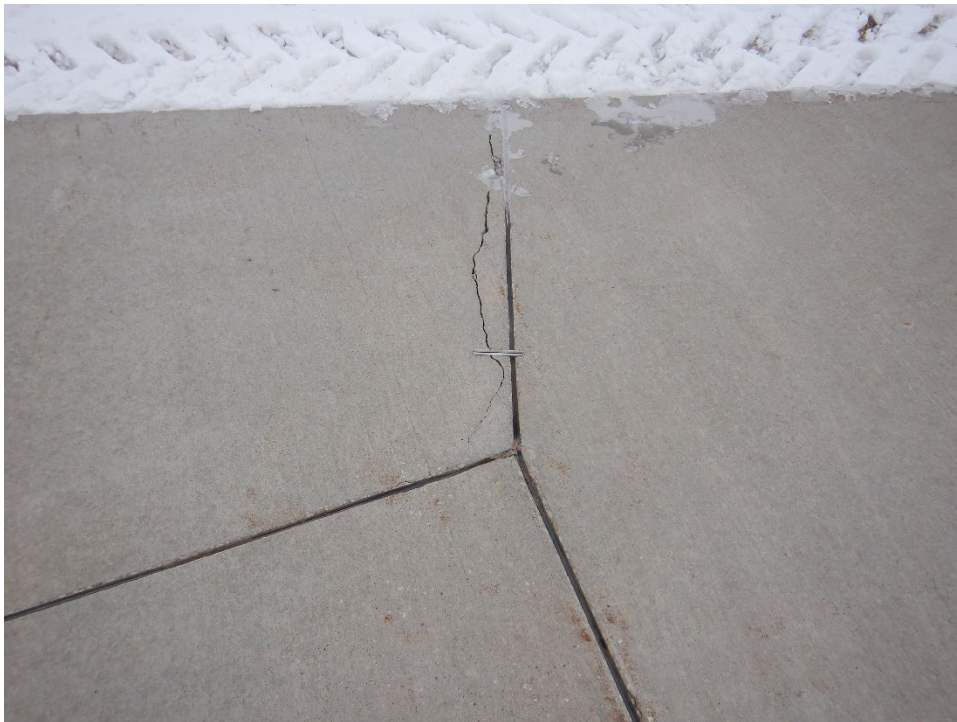
Taxiway 02 contained one section that was in *Excellent* condition. Low-severity faulting and joint spalling were identified in Section 02.

| <b>Distress Type</b> | <b>Probable Cause of Distress</b> |
|---|---|
| Spalling<br>(Joint and Corner) | Excessive stresses at the joint caused by infiltration of incompressible materials or traffic loads; weak concrete at the joint combined with traffic loads. |

T02WV-02. Joint Spalling (Sample Unit No. 01).

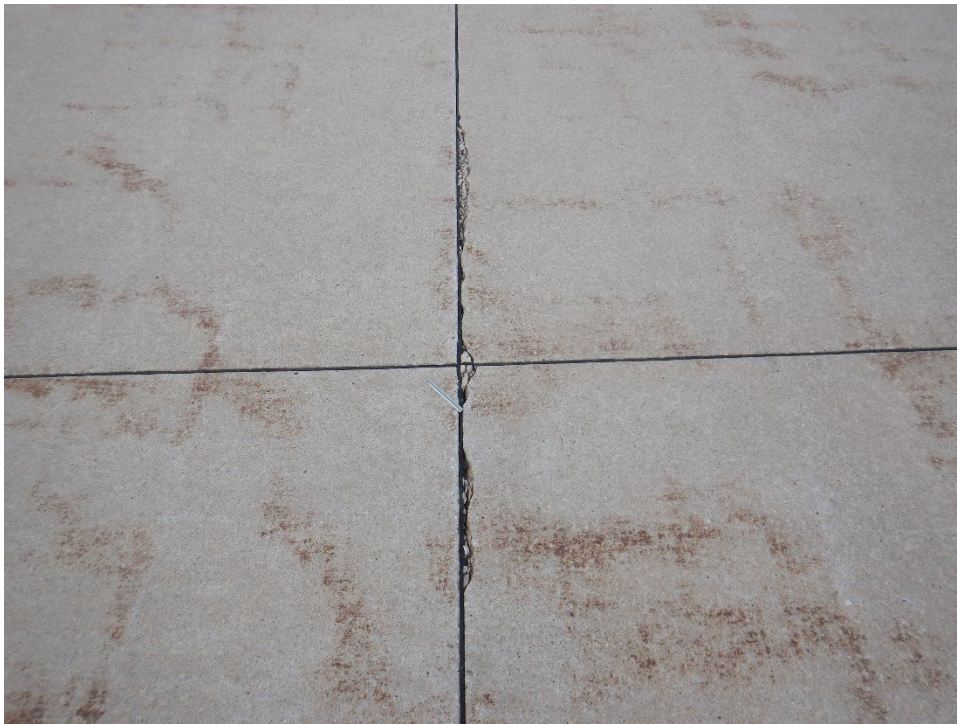
Taxiway A was defined by one section. Section 01 contained areas of medium-severity joint seal damage and low- and medium-severity corner spalling and joint spalling.

| <b>Distress Type</b> | <b>Probable Cause of Distress</b> |
|---|---|
| Joint Seal Damage | Stripping of joint sealant, extrusion of joint sealant, weed growth, hardening of the filler (oxidation), loss of bond to the slab edges, or absence of sealant in the joint. |

TAWV-01. Joint Seal Damage (Sample Unit No. 02).

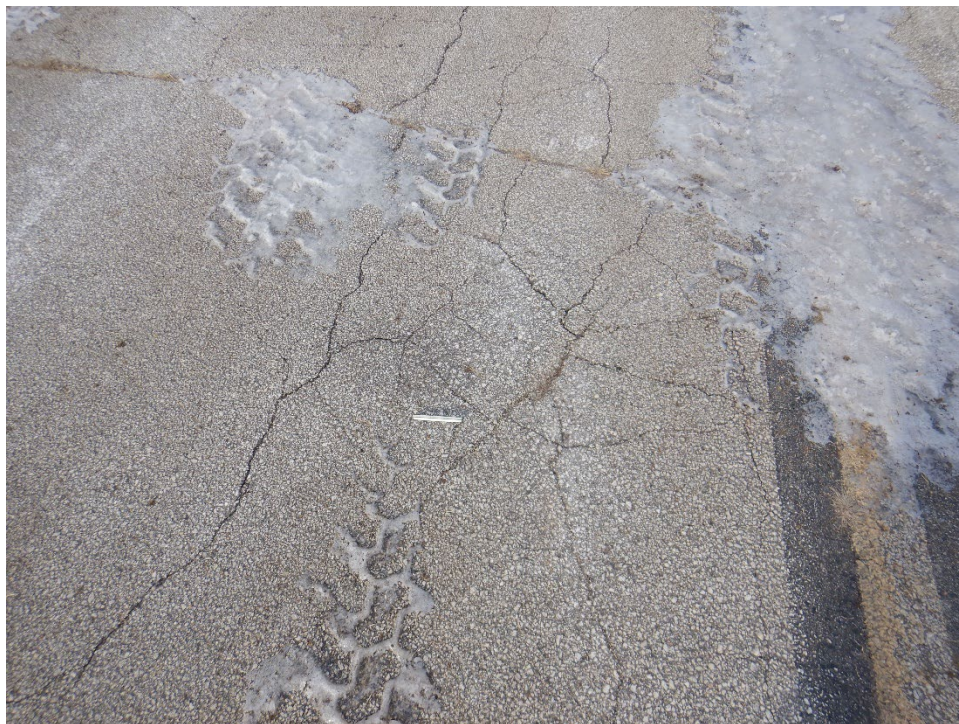
The T-hangar area consisted of three sections. Section 01 was in *Poor* condition and contained medium-severity alligator cracking and weathering, low- and medium-severity longitudinal and transverse (L&T) cracking, and low-severity rutting. The low-severity L&T cracking was unsealed, and the medium-severity L&T cracking was due to unsealed crack widths greater than ¼ inch. Medium-severity joint seal damage, low- and medium-severity joint spalling, and low-severity LTD cracking were identified in Section 02. Section 03 was in *Excellent* condition with no distress noted at the time of inspection.

| <b>Distress Type</b> | <b>Probable Cause of Distress</b> |
|---|---|
| Alligator Cracking | Fatigue failure of the asphalt surface under repeated traffic loading. |

TH01WV-01. Alligator Cracking (Sample Unit No. 01).

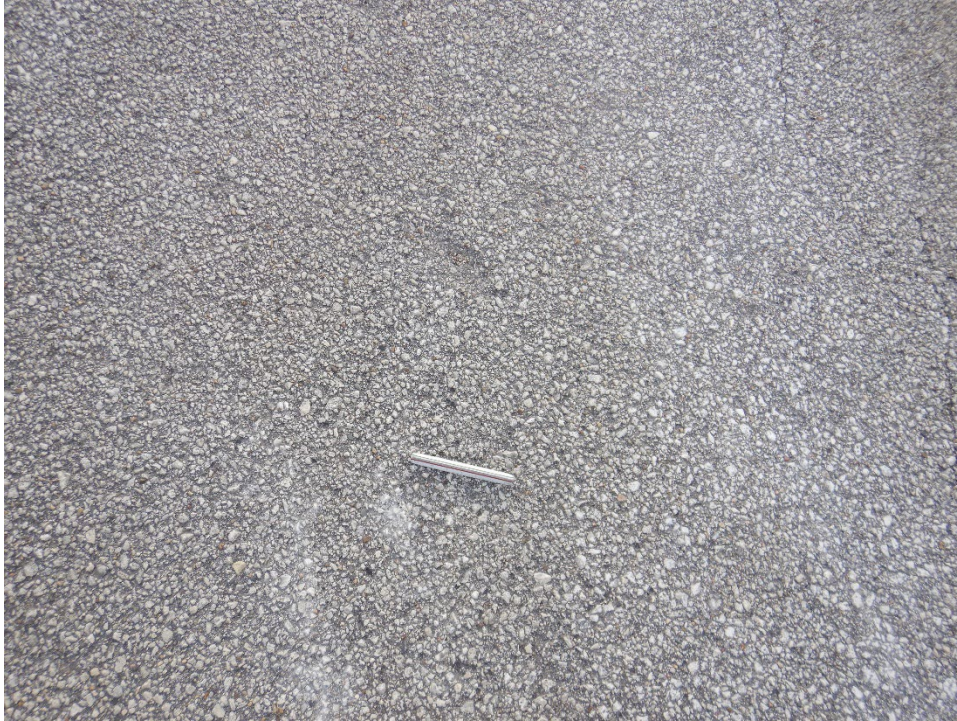
| <b>Distress Type</b> | <b>Probable Cause of Distress</b> |
|---|---|
| Weathering | Asphalt binder and/or fine aggregate may wear away as the pavement ages and hardens. |

TH01WV-01. Weathering (Sample Unit No. 01).

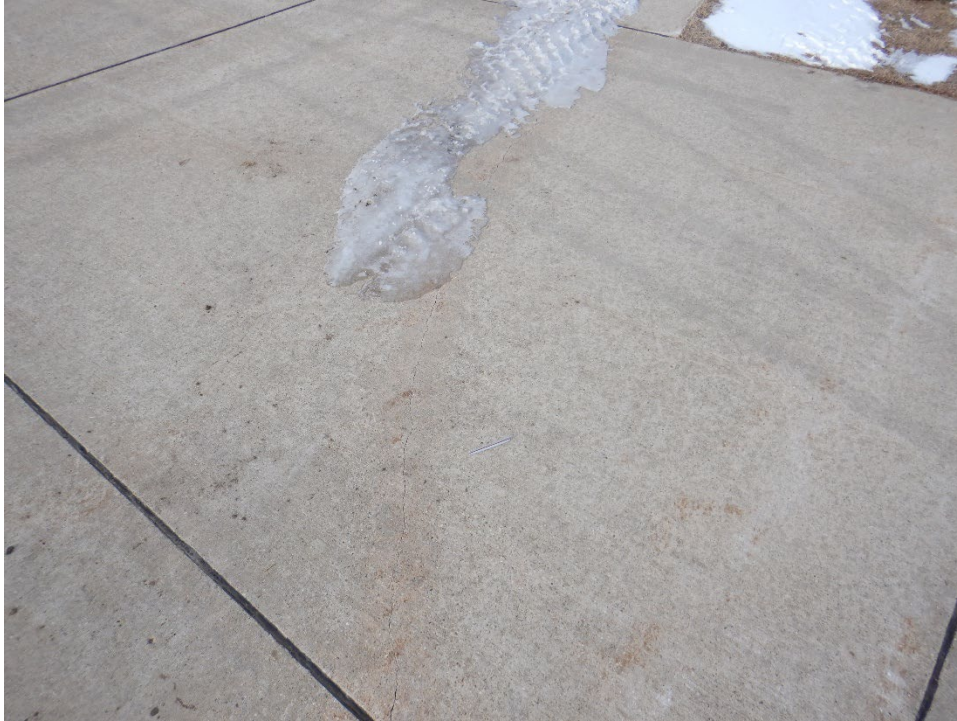
TH01WV-02. LTD Cracking (Sample Unit No. 01).
