# Webster City Municipal Airport

## Pavement Management Report

**AUGUST 2026**

# WEBSTER CITY MUNICIPAL AIRPORT PAVEMENT MANAGEMENT REPORT

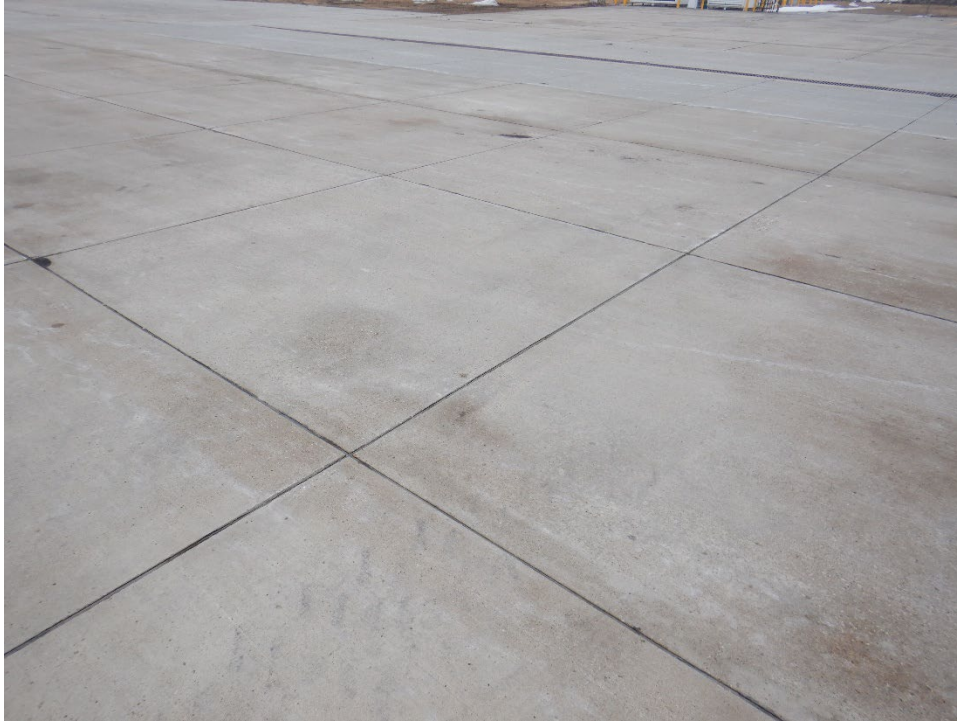
A01WC-01. Overview.

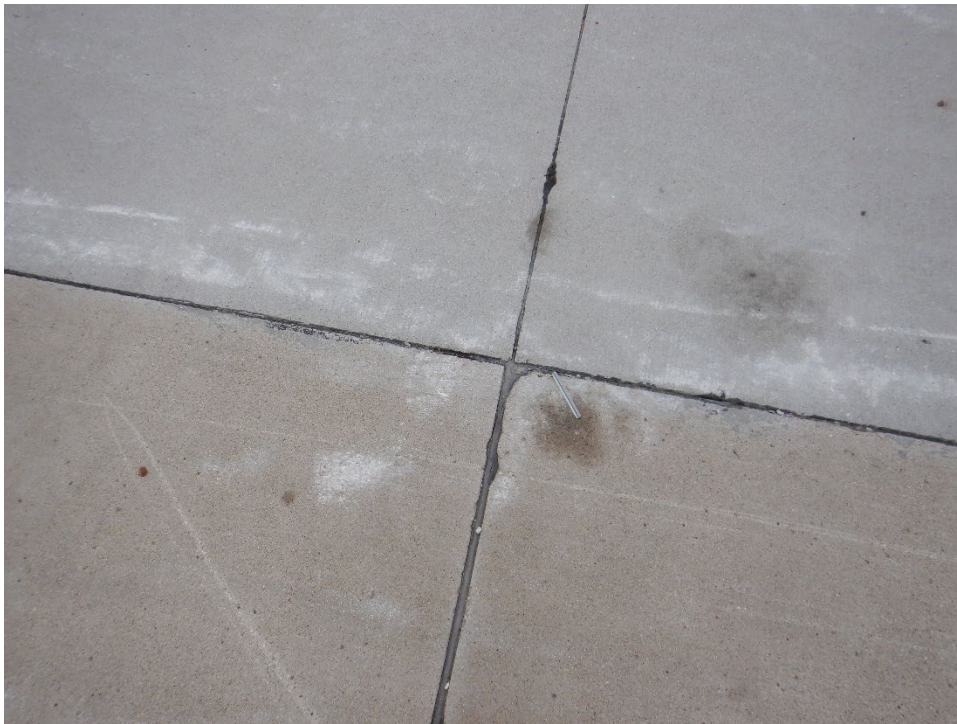
A01WC-01. Joint Seal Damage (Sample Unit No. 05).

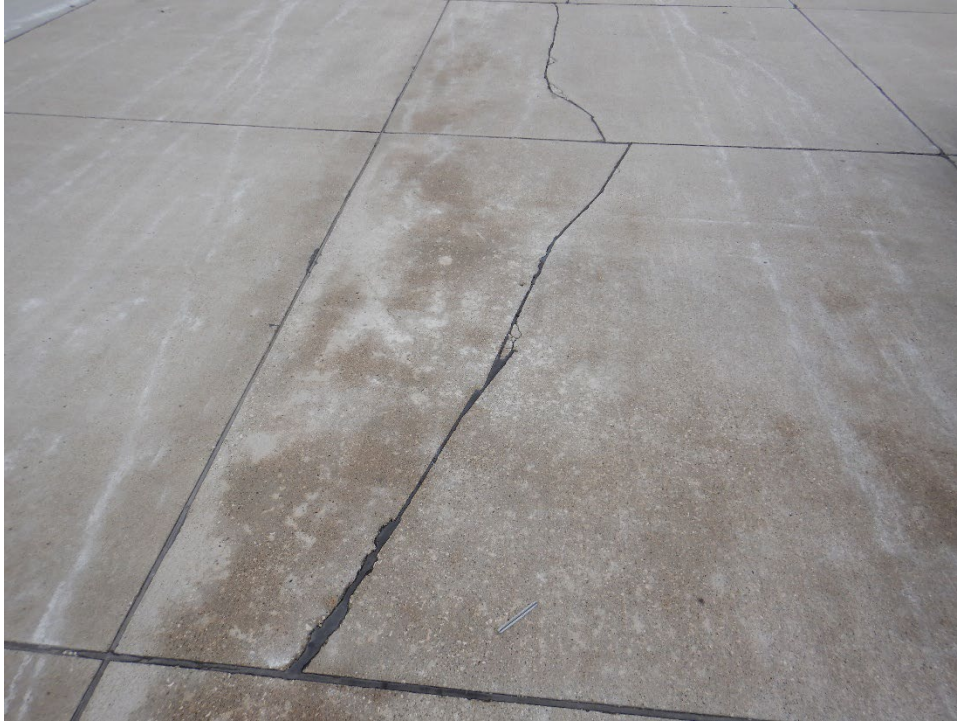
A01WC-01. LTD Cracking (Sample Unit No. 05).

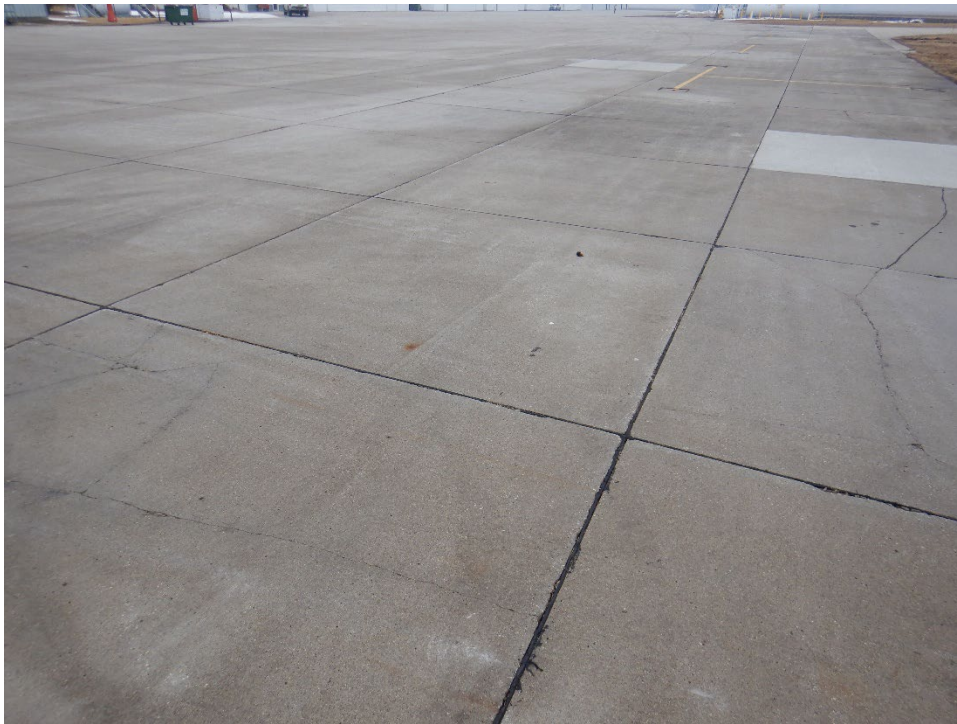
A01WC-02. Overview.

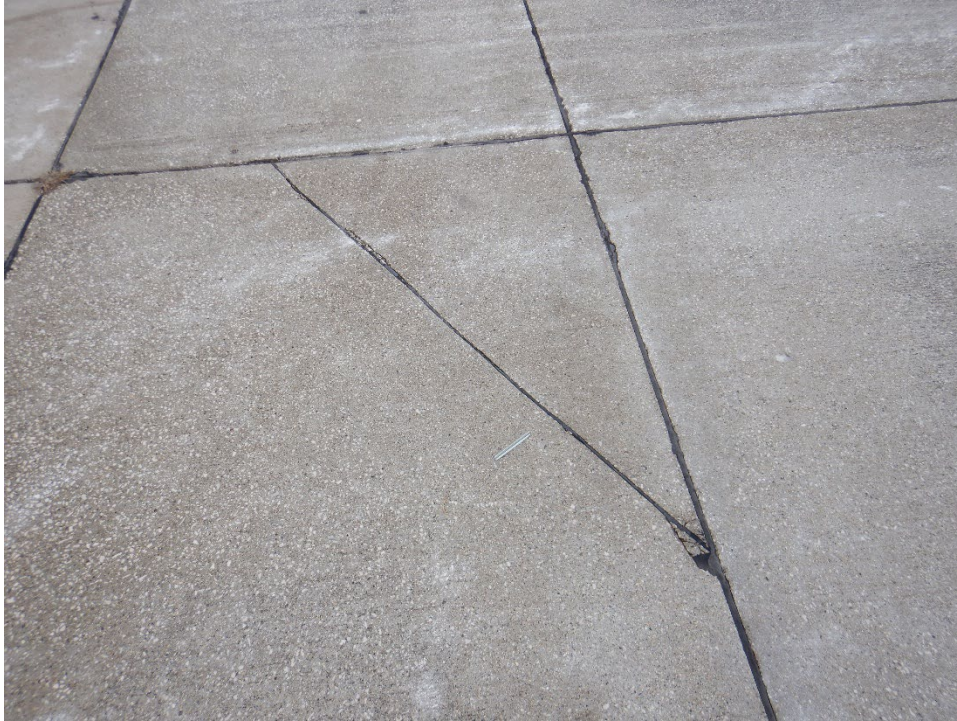
A01WC-02. LTD Cracking (Sample Unit No. 12).

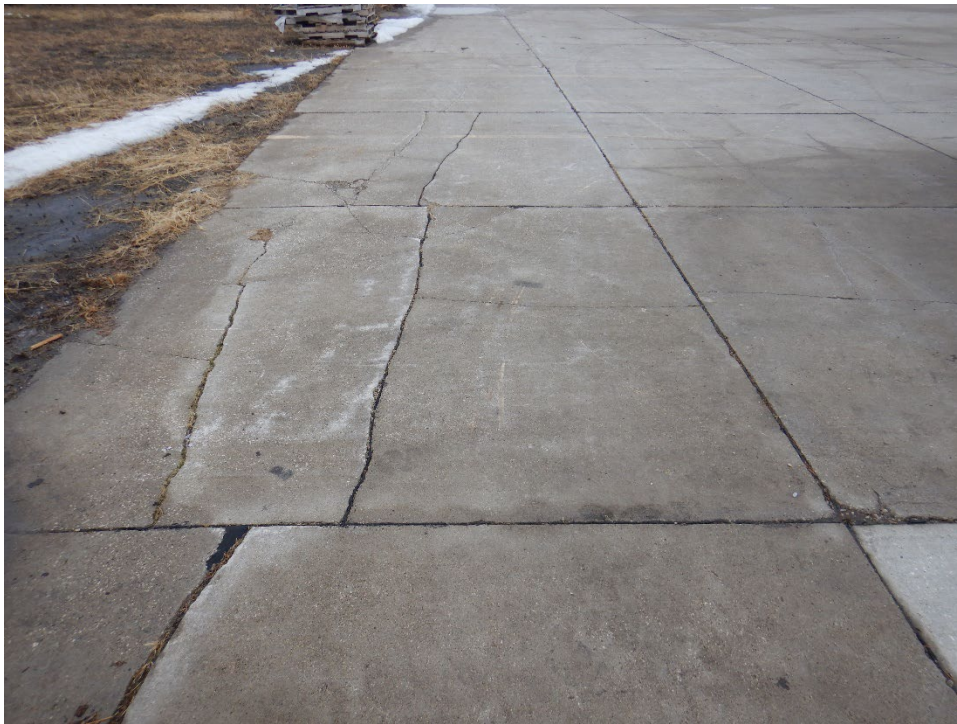
A01WC-02. Shattered Slab (Additional Sample Unit No. 17).

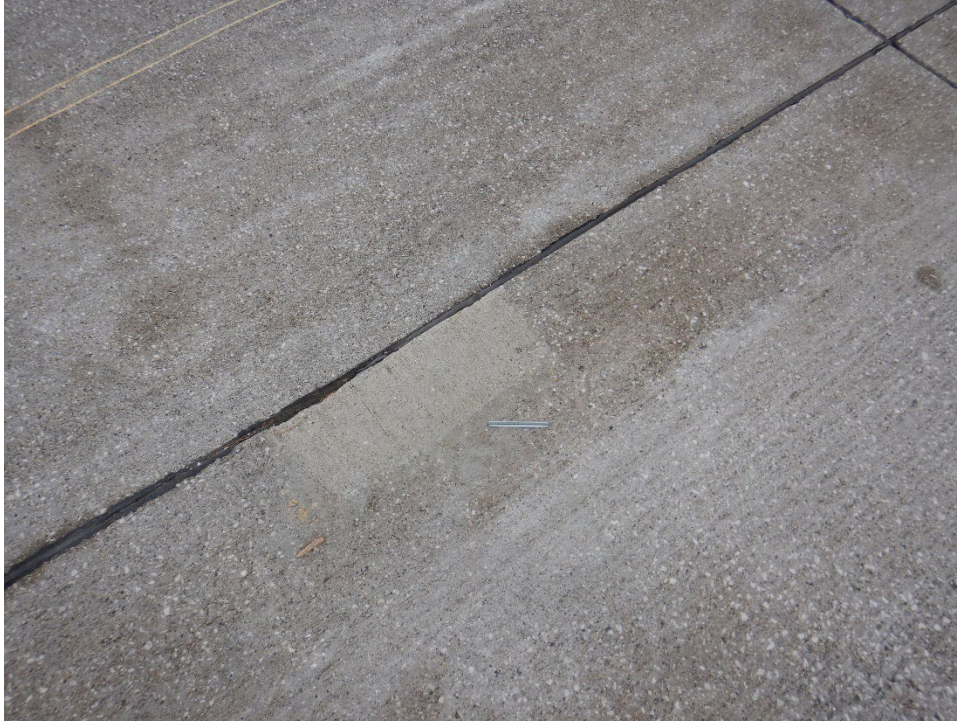
A01WC-02. Small Patching (Sample Unit No. 04).

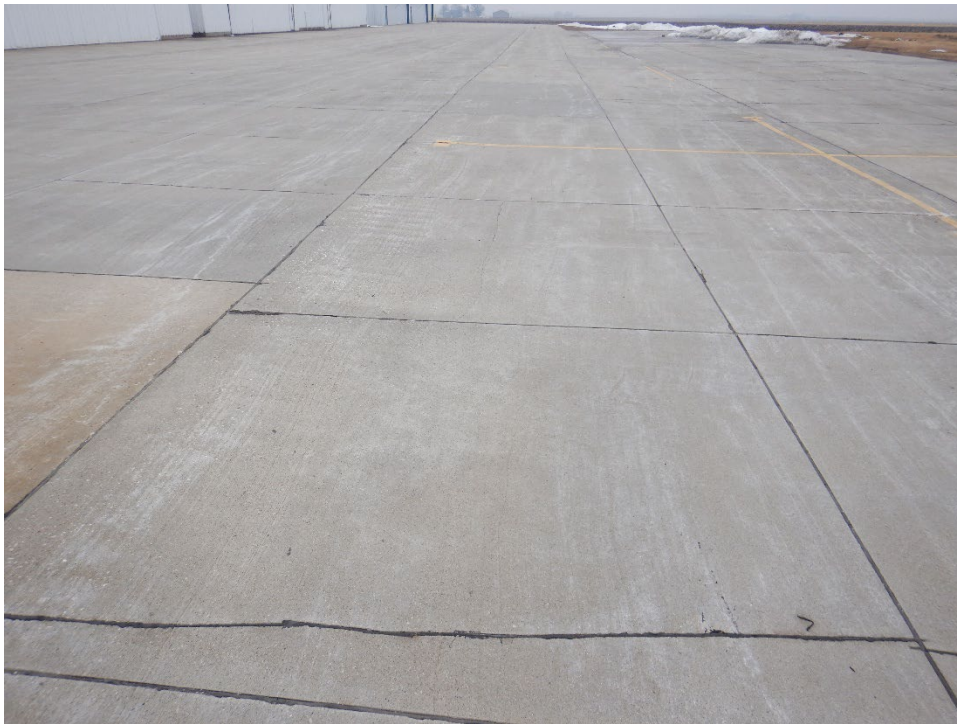
A01WC-03. Overview.

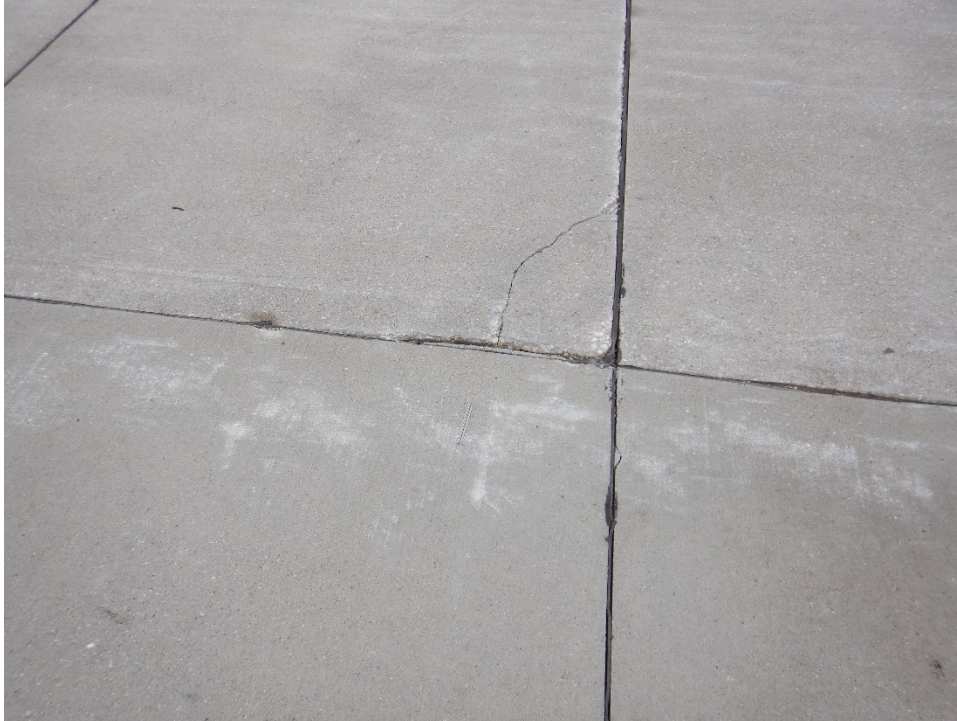
A01WC-03. Corner Break (Sample Unit No. 06).

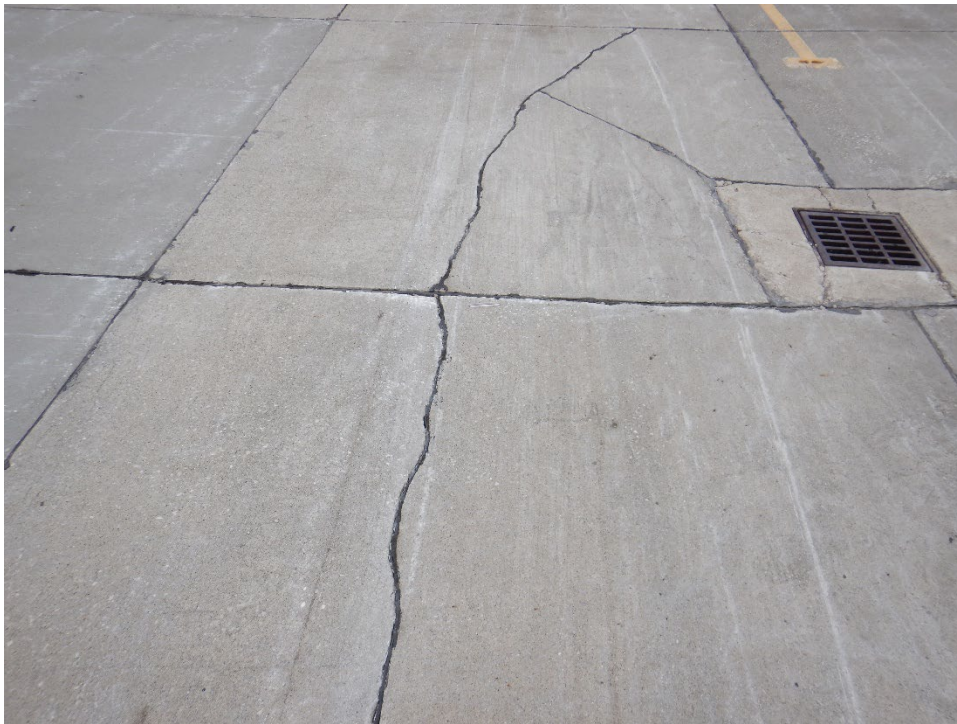
A01WC-03. LTD Cracking (Sample Unit No. 06).

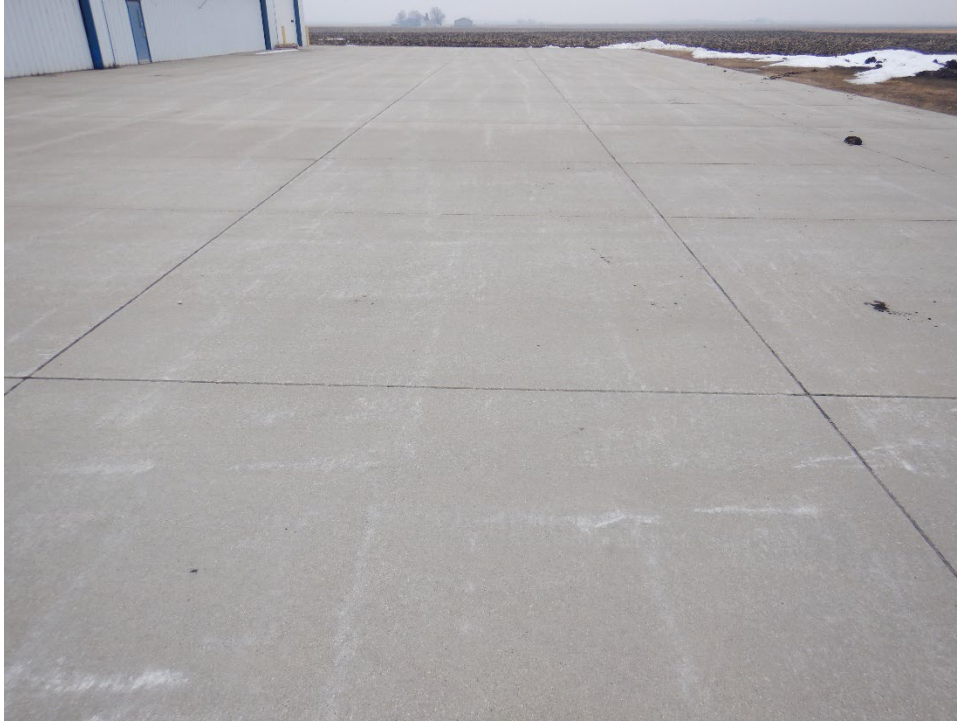
A01WC-04. Overview.

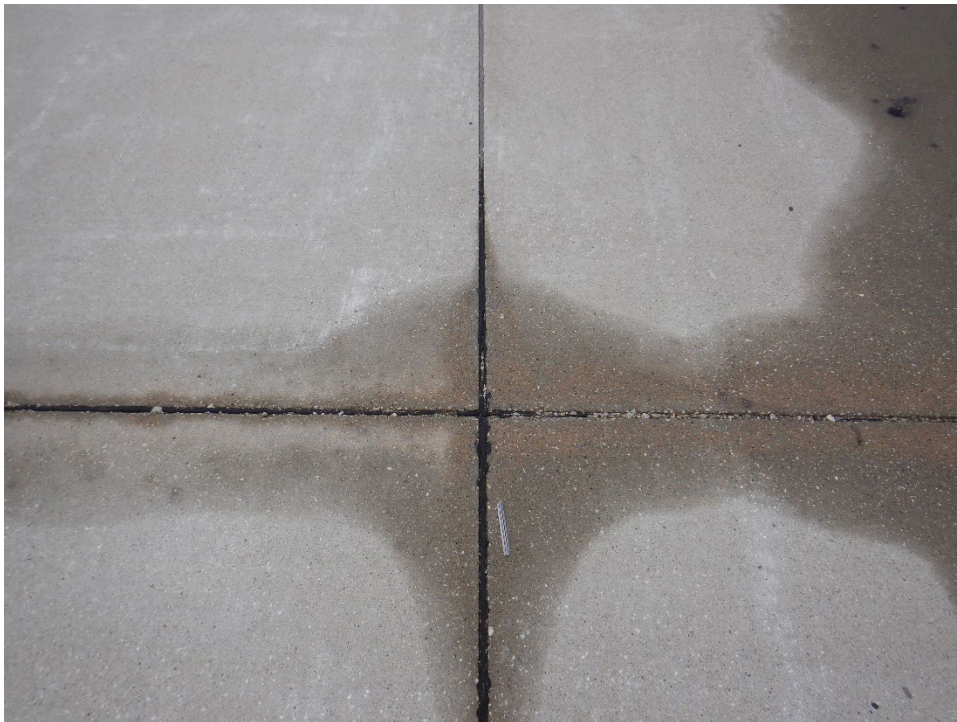
A01WC-04. Joint Seal Damage (Sample Unit No. 02).

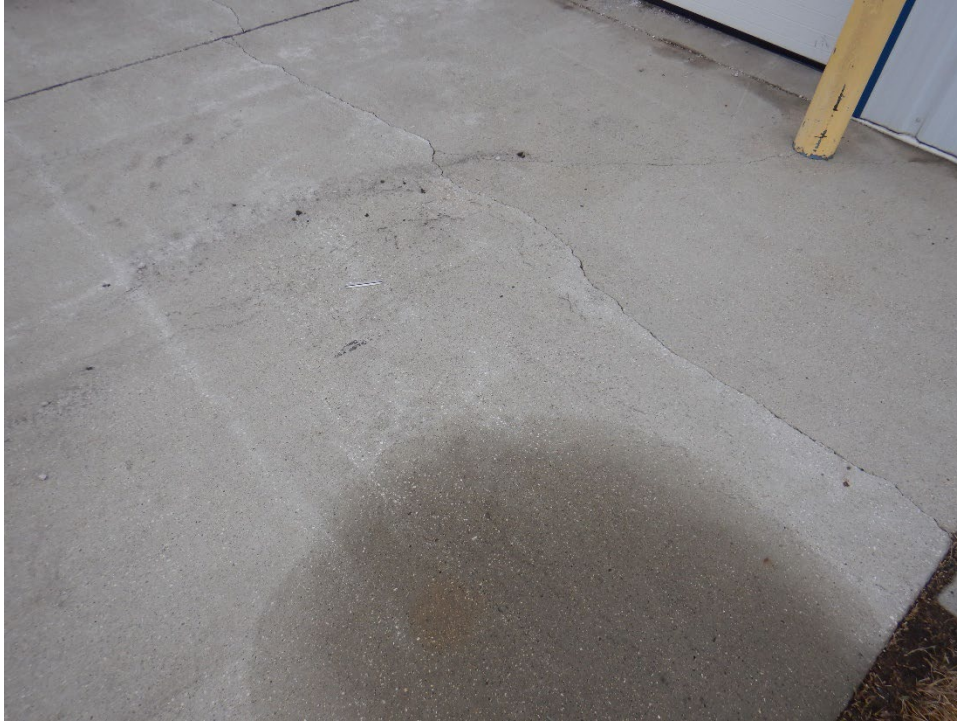
A01WC-04. LTD Cracking (Sample Unit No. 02).

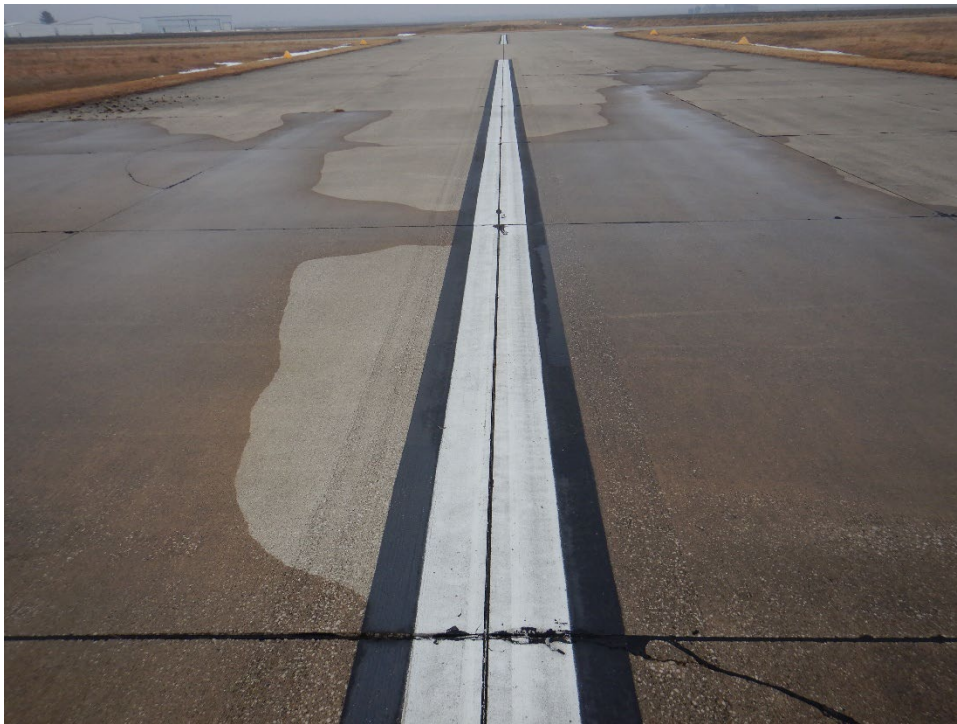
Runway 05/23 consisted of one section. Low-severity corner break; joint seal damage; joint spalling; small patching; and longitudinal, transverse, and diagonal (LTD) cracking were identified in Section 01 during the inspection.

R05WC-01. Overview.

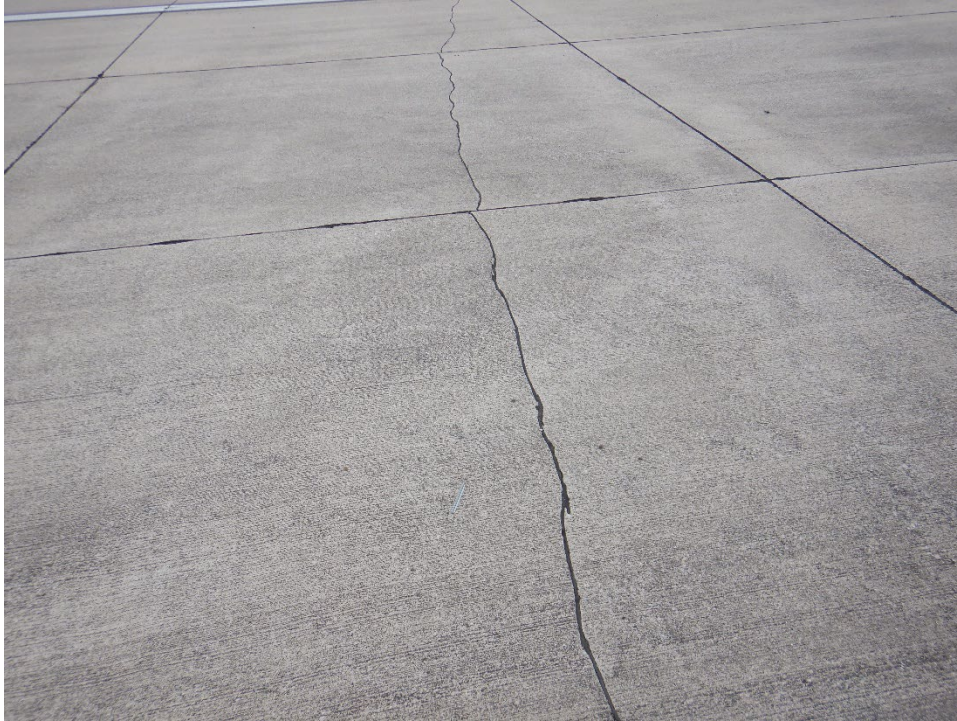
R05WC-01. LTD Cracking (Sample Unit No. 02).

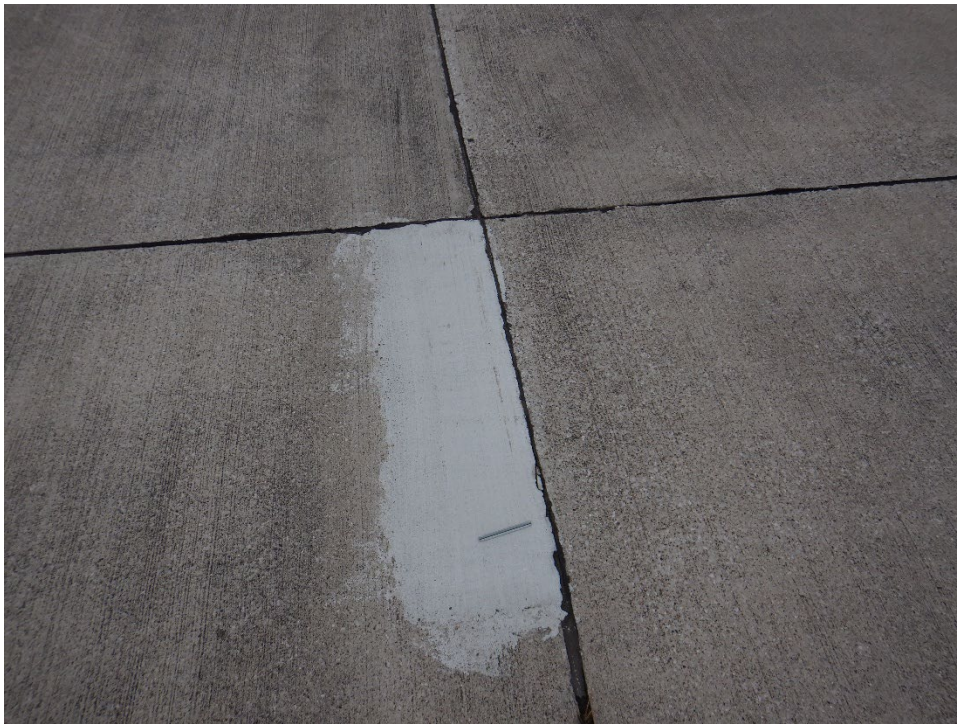
R05WC-01. Small Patching (Sample Unit No. 01).

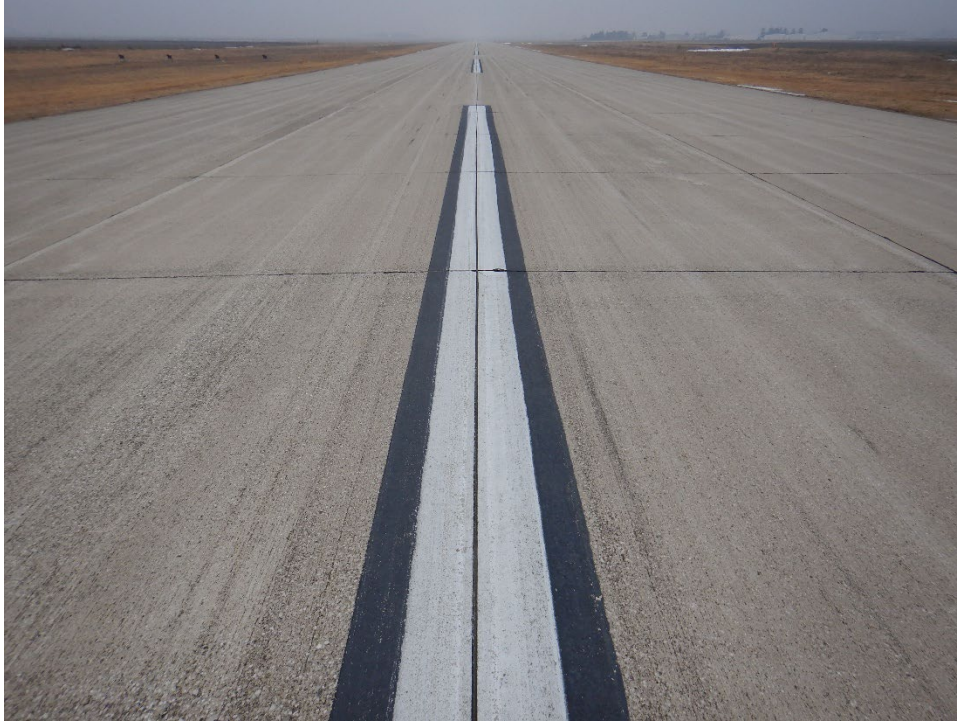
Runway 14/32 was defined by one section. Section 01 contained medium-severity joint spalling and low-severity faulting, joint seal damage, large patching, small patching, and LTD cracking.

R14WC-01. Overview.

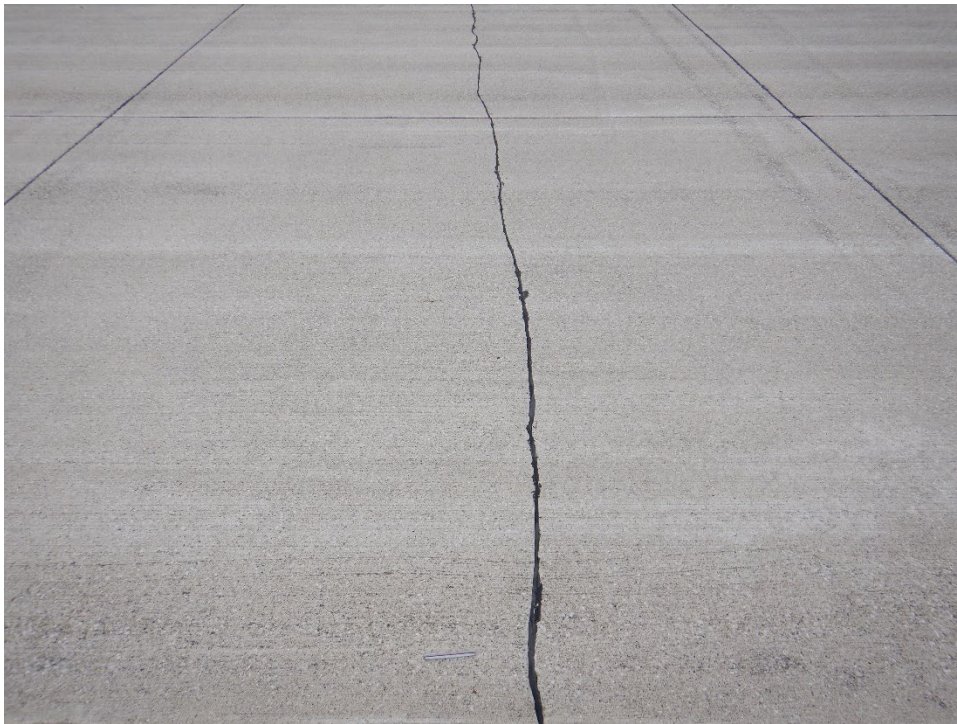
R14WC-01. LTD Cracking (Sample Unit No. 12).

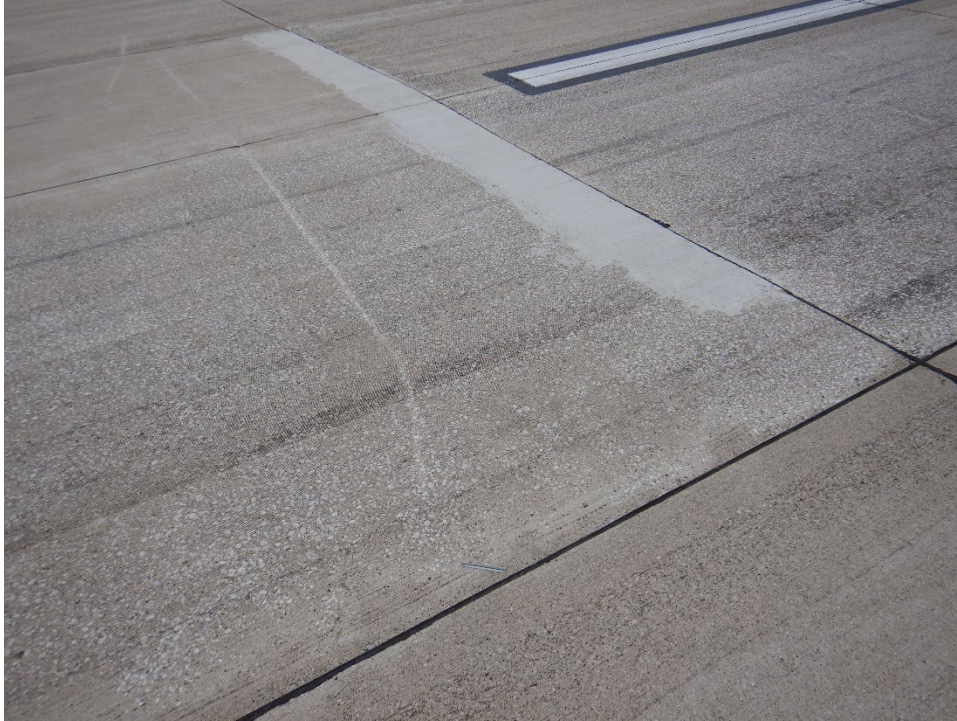
R14WC-01. Large Patching (Sample Unit No. 12).

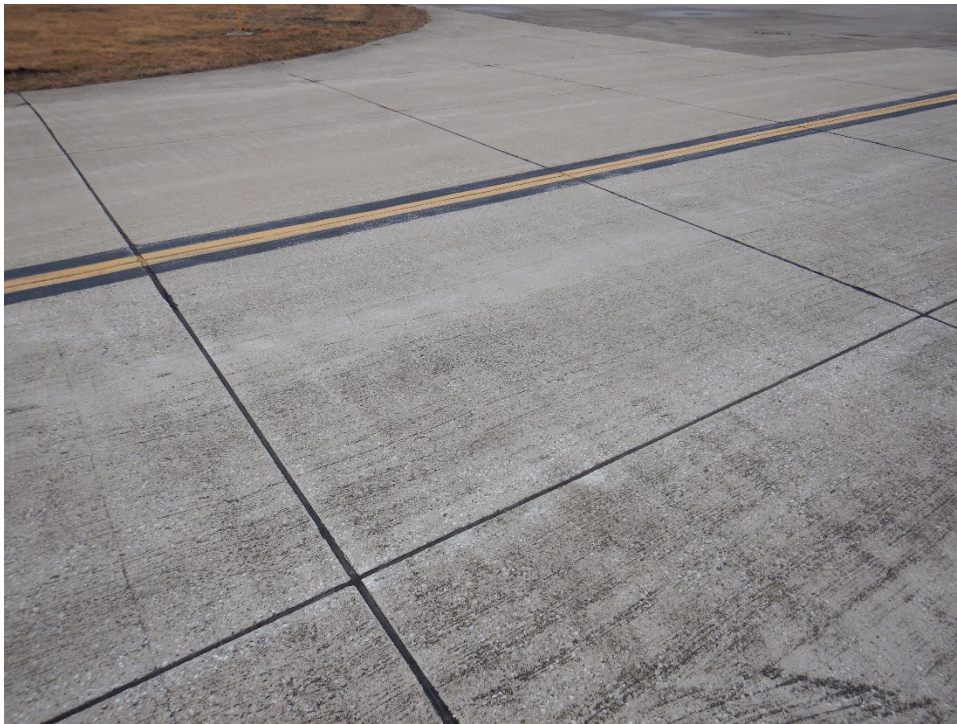
Taxiway 01 consisted of two sections. High-severity corner break; low-severity corner spalling, joint seal damage, and LTD cracking; and medium-severity joint spalling were identified in Section 01. Section 02 was in *Excellent* condition and had low- and medium-severity LTD cracking and low-severity joint seal damage, joint spalling, and small patching noted during the inspection.

T01WC-01. Overview.

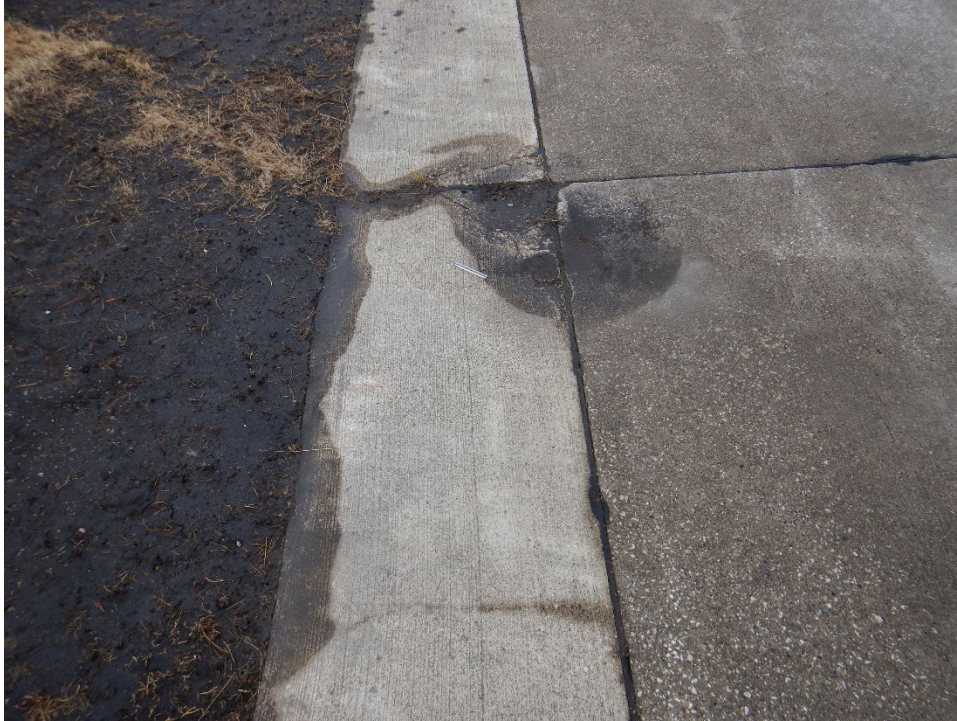
T01WC-01. Corner Break (Sample Unit No. 01).

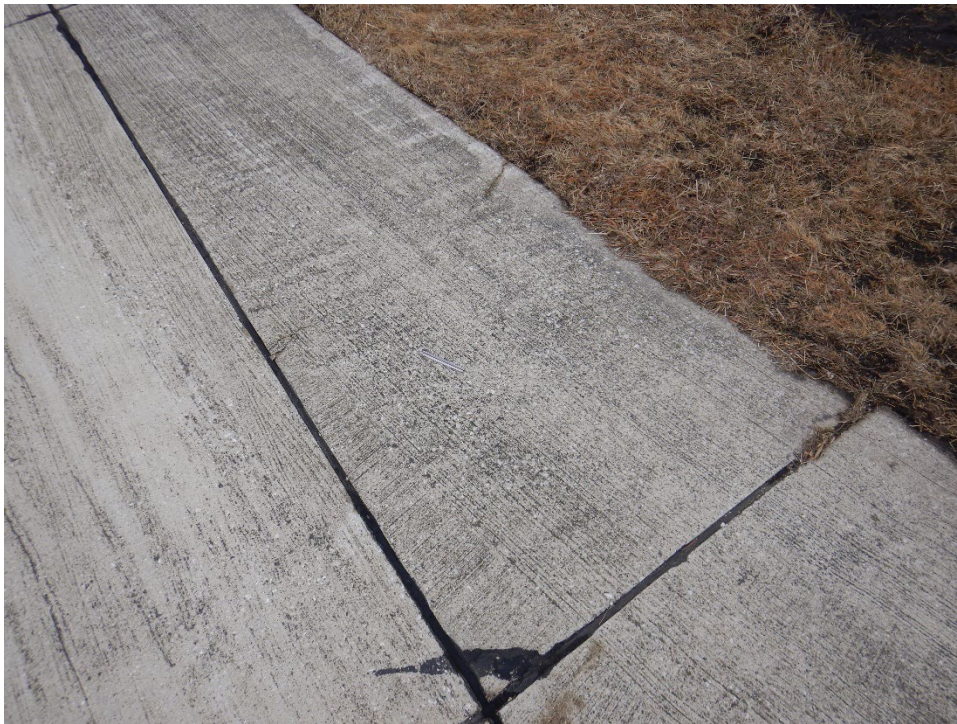
T01WC-01. LTD Cracking (Sample Unit No. 01).

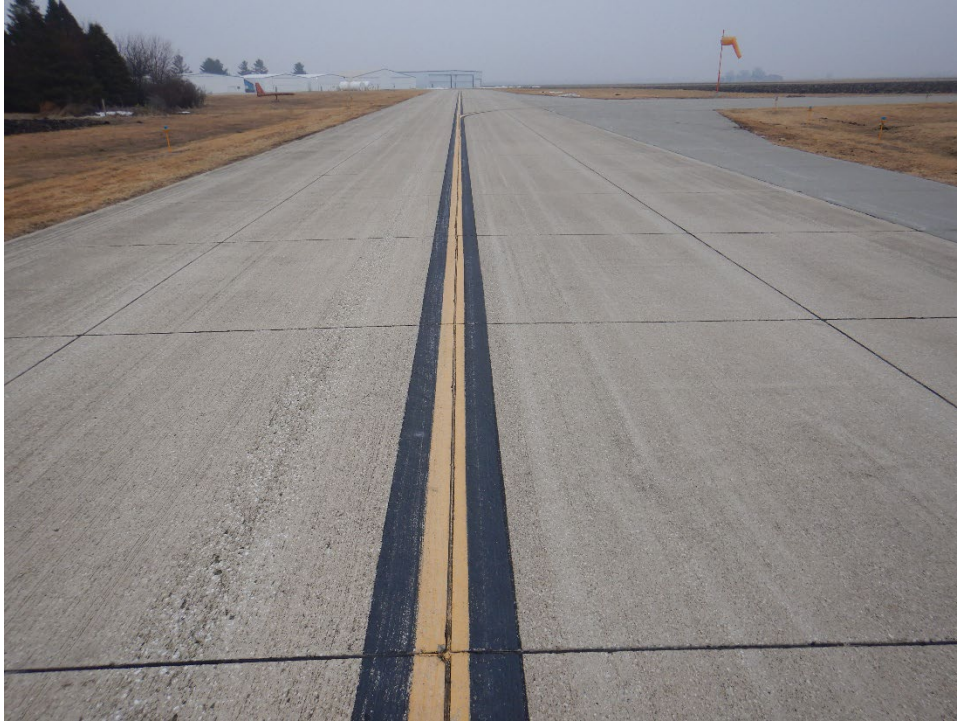
T01WC-02. Overview.

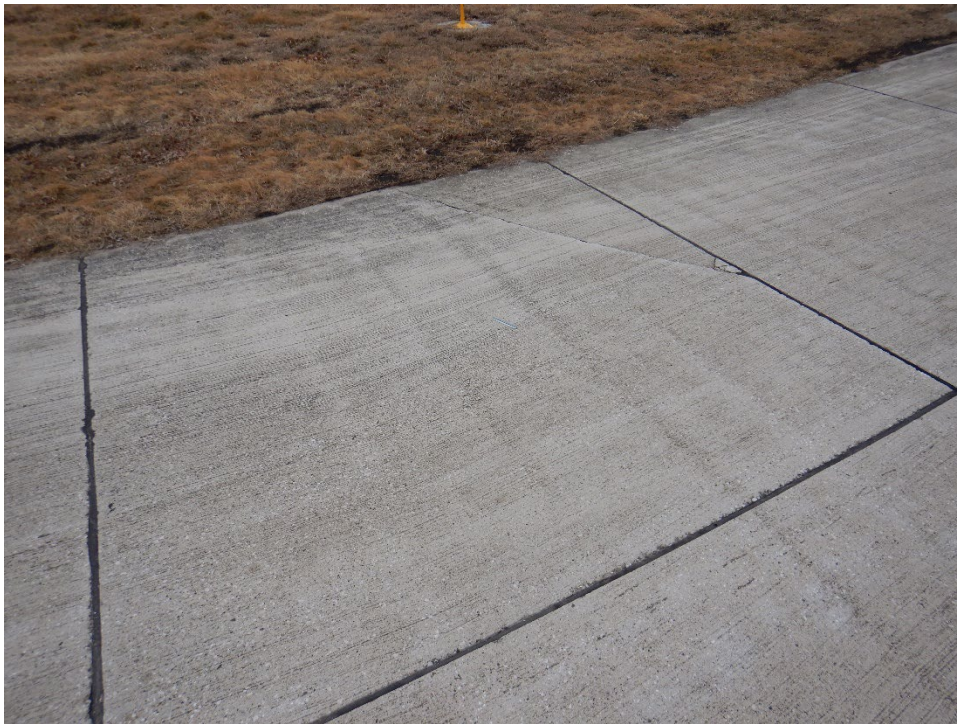
T01WC-02. LTD Cracking (Sample Unit No. 02).

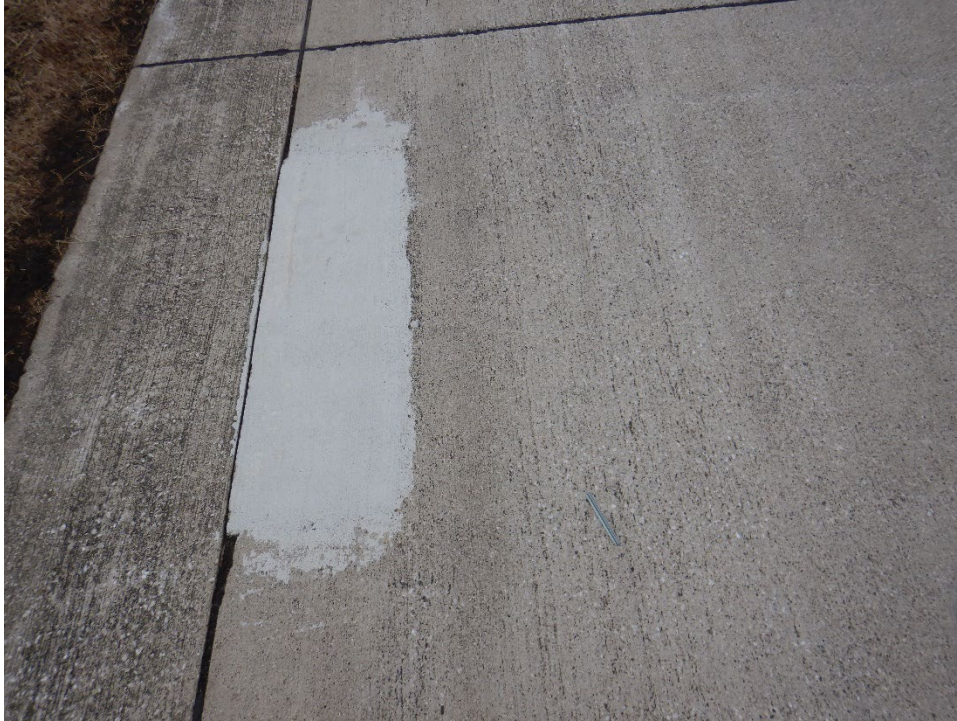
T01WC-02. Small Patching (Sample Unit No. 16).

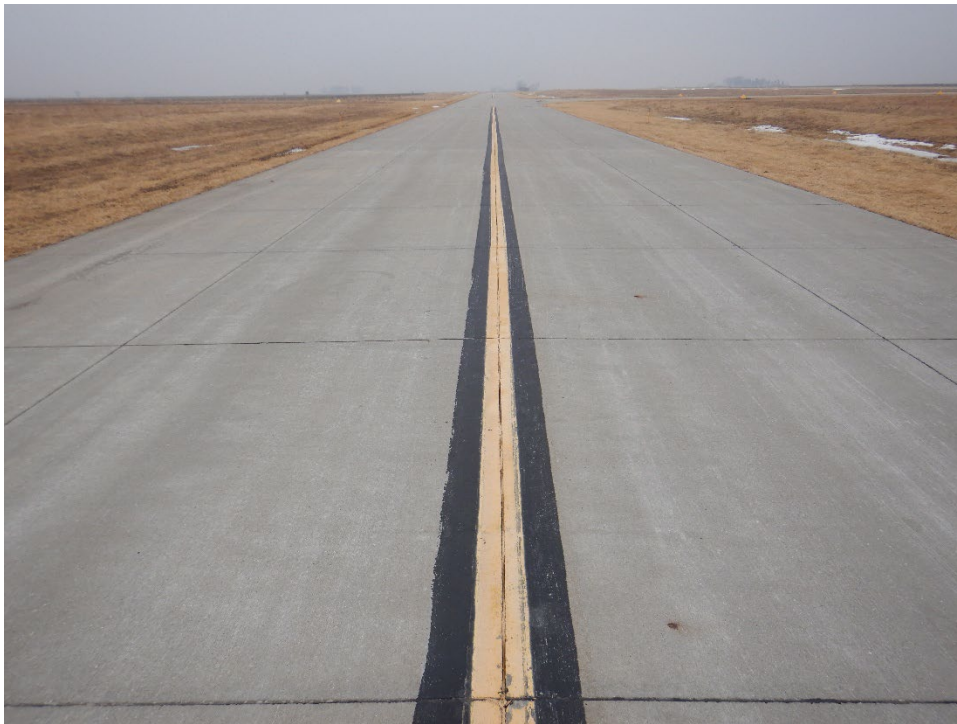
Taxiway 02 contained one section. Section 01 was in *Excellent* condition with only low-severity joint seal damage and shrinkage cracking observed.

T02WC-01. Overview.

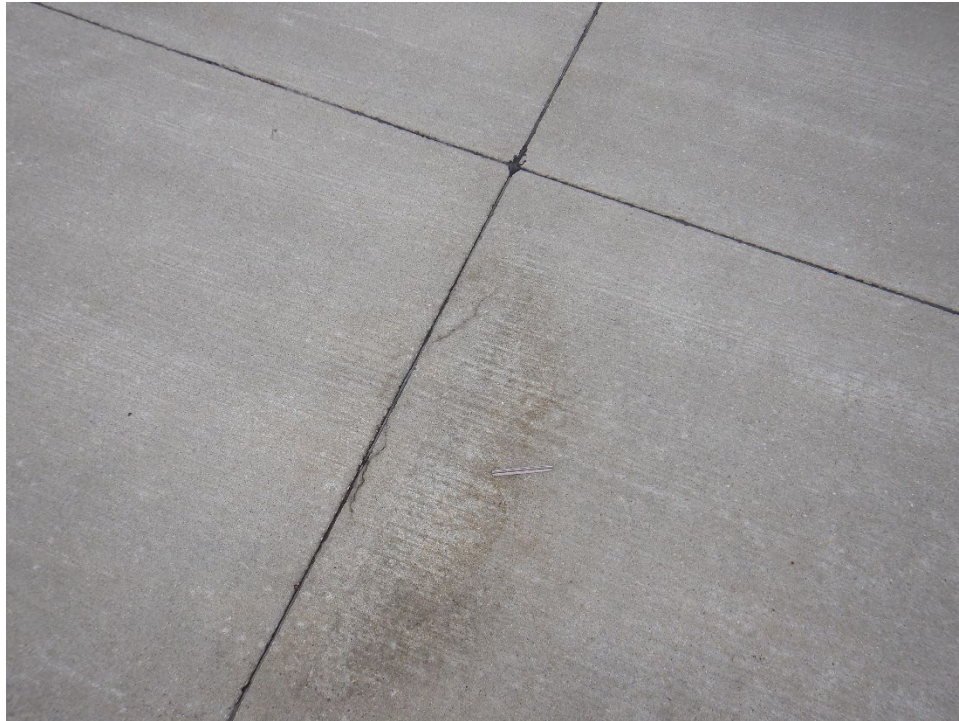
T02WC-01. Shrinkage Cracking (Sample Unit No. 11).

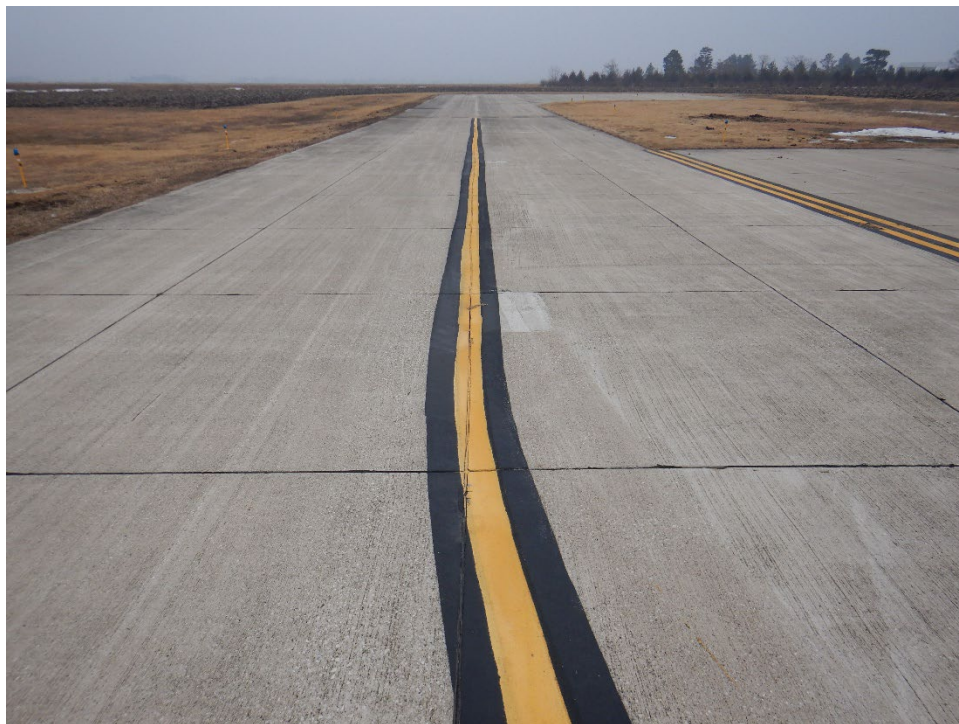
Taxiway 03 consisted of one section. Shrinkage cracking and low-severity faulting, joint seal damage, large patching, LTD cracking, and small patching were recorded in Section 01.

T03WC-01. Overview.

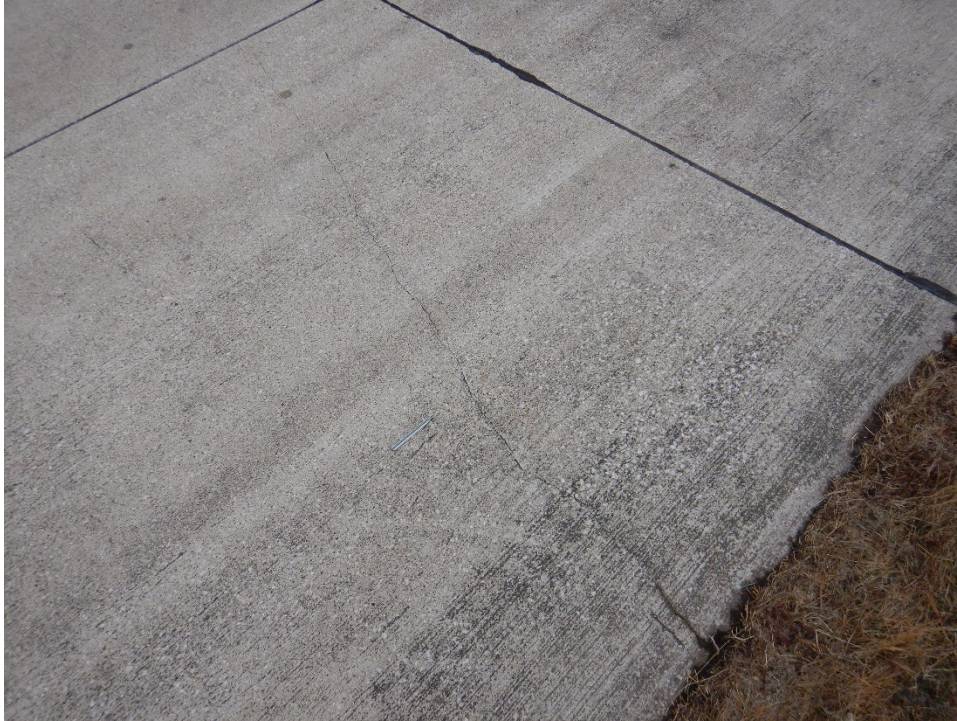
T03WC-01. LTD Cracking (Sample Unit No. 04).

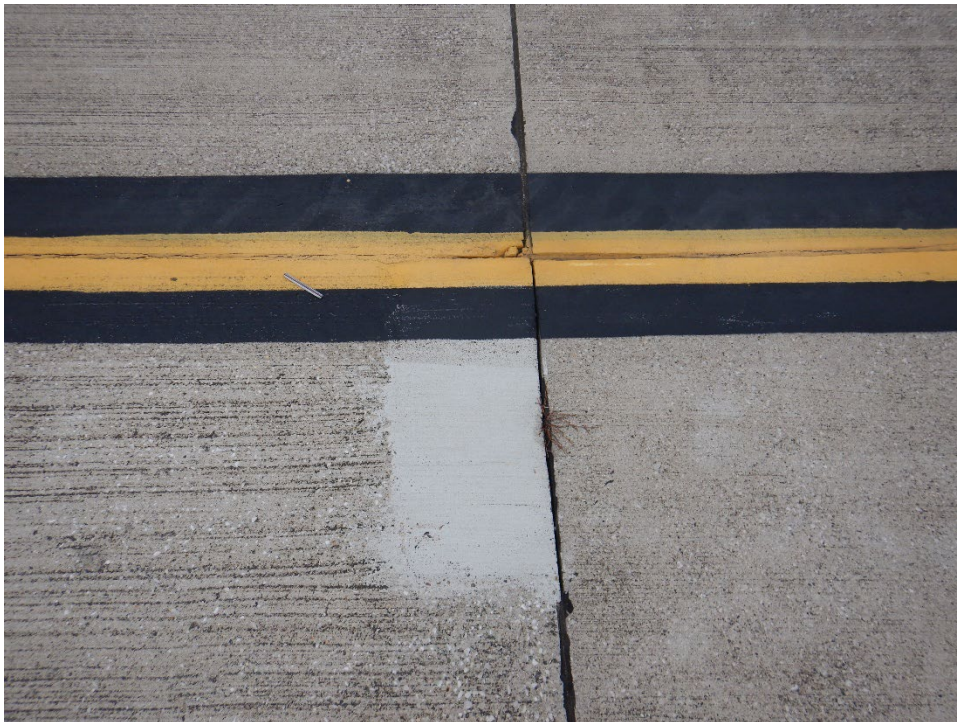
T03WC-01. Small Patching (Sample Unit No. 04).

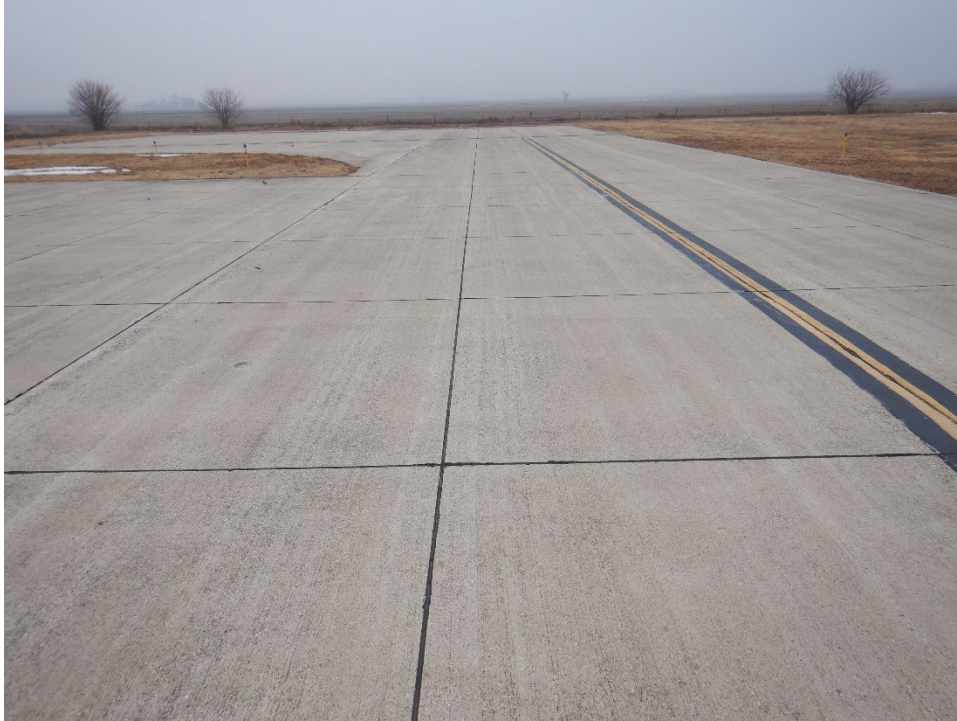
Taxiway 04 was defined by one section. Areas of low-severity faulting, joint seal damage, and small patching; medium-severity joint spalling; and shrinkage cracking were noted in Section 01 during the inspection.

T04WC-01. Overview.

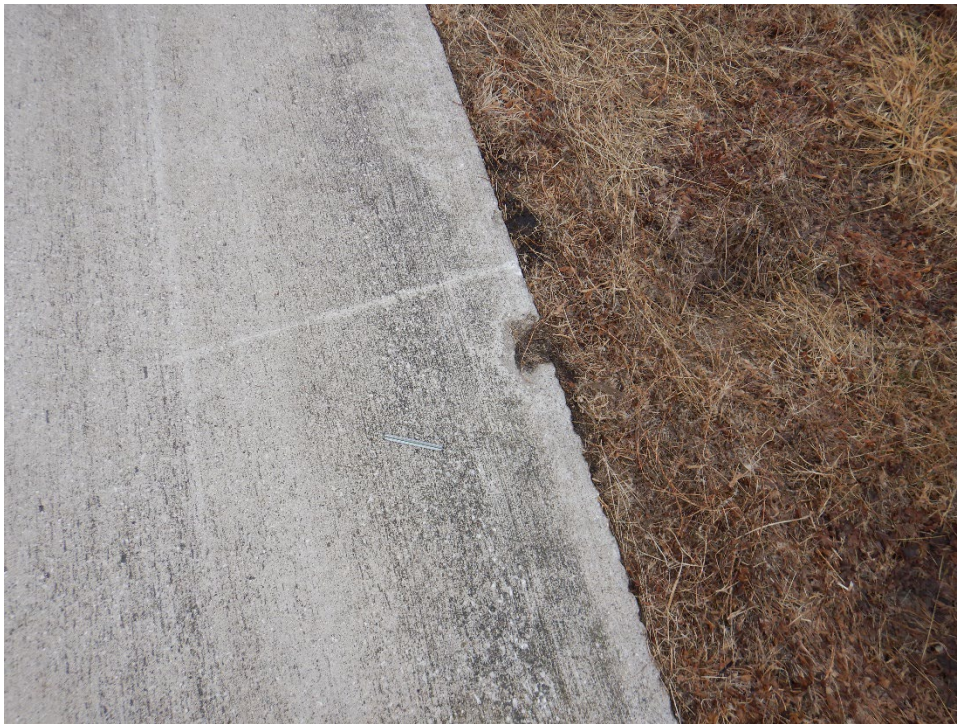
T04WC-01. Joint Spalling (Sample Unit No. 04).
