# Webster City Municipal Airport

## Pavement Management Report

**AUGUST 2026**

# WEBSTER CITY MUNICIPAL AIRPORT PAVEMENT MANAGEMENT REPORT

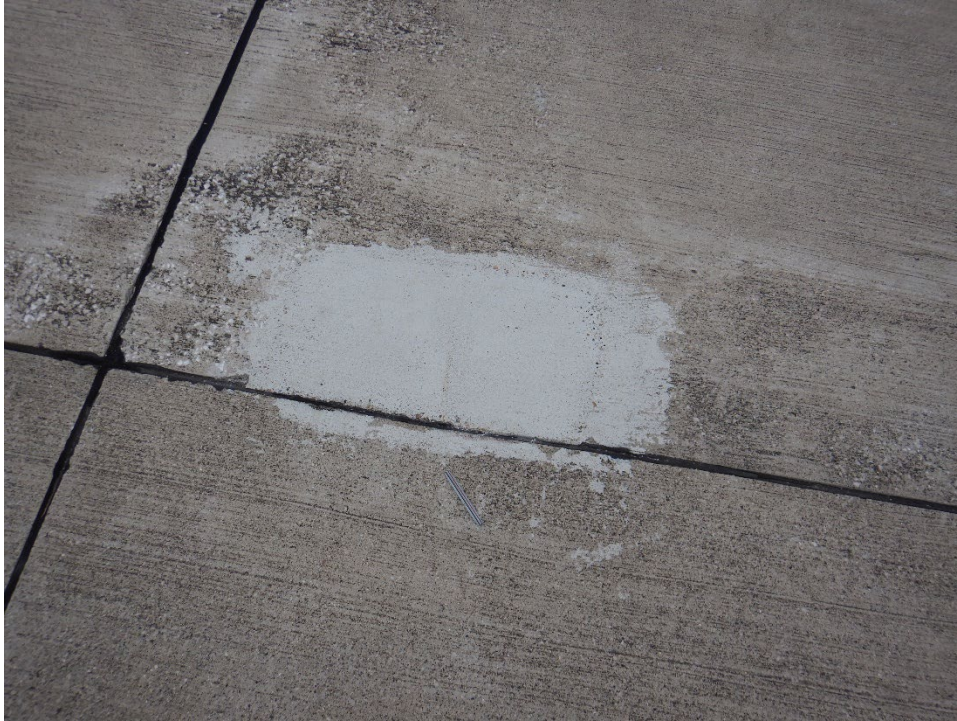
T04WC-01. Small Patching (Sample Unit No. 09).
