# Strengthening of Steel Girder Bridges Using FRP

This paper documents two projects funded through the Federal Highway Administration's Innovative Bridge Research and Construction (IBRC) program. The IBRC program was developed to assist bridge owners in applying emerging technologies in bridge engineering. In these projects, the Iowa Department of Transportation employed techniques for strengthening steel girder bridges using carbon fiber reinforced polymers (CFRP). Two bridges were strengthened using CFRP composite materials in an effort to improve the live load carrying capacity of the bridges. In one case, a bridge was strengthened using CFRP post-tensioning rods in the positive moment regions. In the other case, a bridge was strengthened by installing CFRP plates to the bottom flange of girders in the positive moment regions.

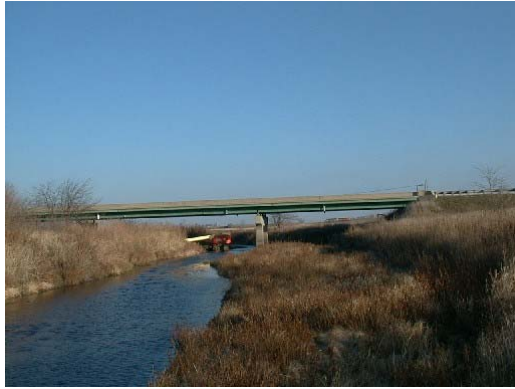
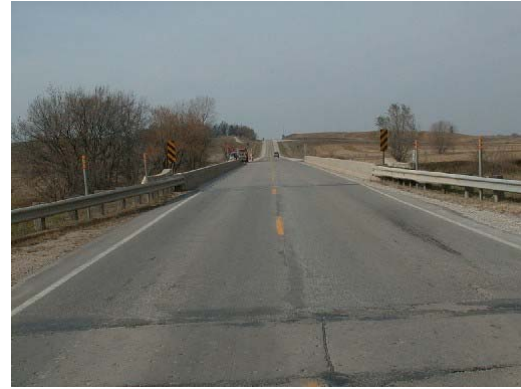
**FIGURE 1. Photographs of the Bridge 1**

(a) Side view

(b) Road way

Bridge 1 (number 3903.0S 141) which was strengthened with post-tensioning (P-T) CFRP rods is a 210 ft x 26 ft three span continuous rolled shape steel girder-bridge in Guthrie County, Iowa, on State Highway 141. The bridge is currently rated with an HS 11.0 Inventory Rating and an HS 18.7 Operating Rating. The bridge has a total length of 210 ft consisting of two end spans of 64 ft and a center span of 82 ft with four beams spaced at 8 ft -3 in. on center. The roadway width is 26 ft allowing two traffic lanes and a narrow shoulder. This bridge is considered to be a borderline case which may soon require posting.

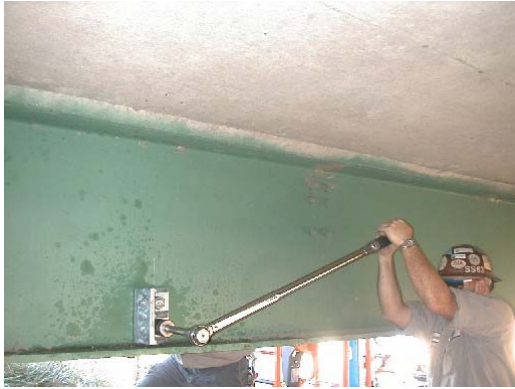
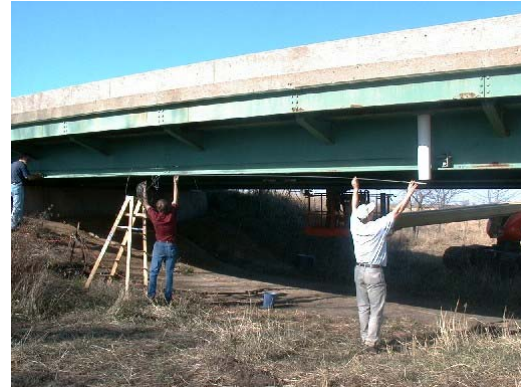
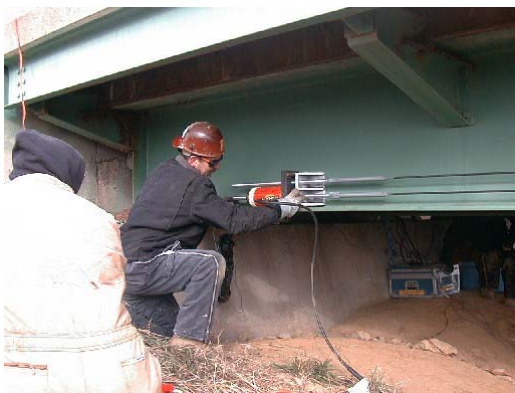
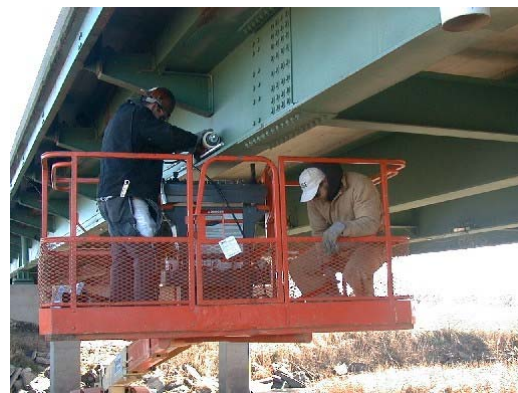
**FIGURE 2. Photographs of the Installation of the P-T System on Bridge 1**

(a) Installation of anchorage assembly

(b) Placement of CFRP rod

(c) Application of P-T force in West-end span

(d) Application of P-T force in Center span.

The P-T system was installed in the positive moment region of the exterior girders in all three spans. The anchorage assemblies were bolted to the webs of the beams with 1 in. diameter A325, high-strength bolts torqued in accordance with the manufacturer’s recommendation (Figure 2a) at locations based on design calculations and field measurements. The CFRP post-tensioning rods were then placed in position between each pair of anchorage assemblies on both sides of the web (Figure 2b). Application of the post-tensioning force was completed in several steps at each location (subsequently referred to as “events”). A nominal force of 12 kips was applied to all rods (four rods per location) in a symmetrical manner. Photographs of the application of P-T force in West and Center span are shown in Figure 2 (c) and (d) while the location of the post-tensioning system and photographs of the completed installation are presented in Figures 3 and 4, respectively.

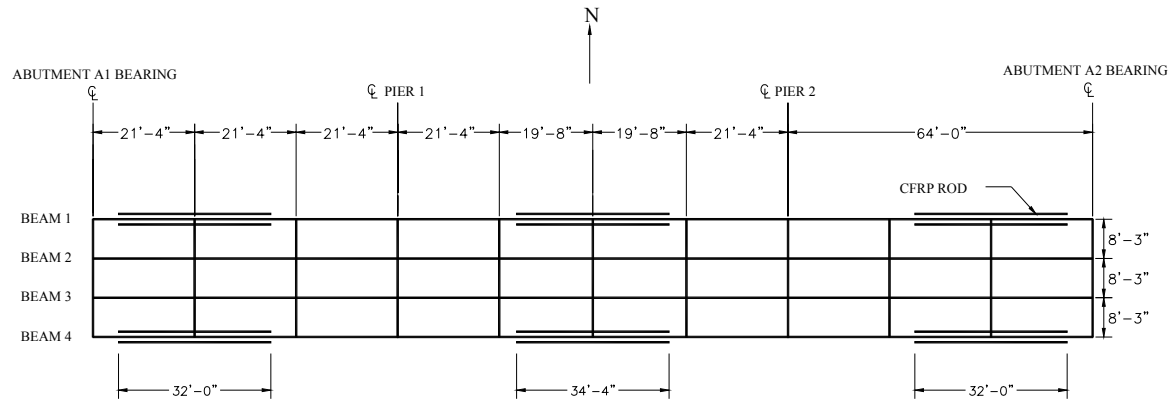
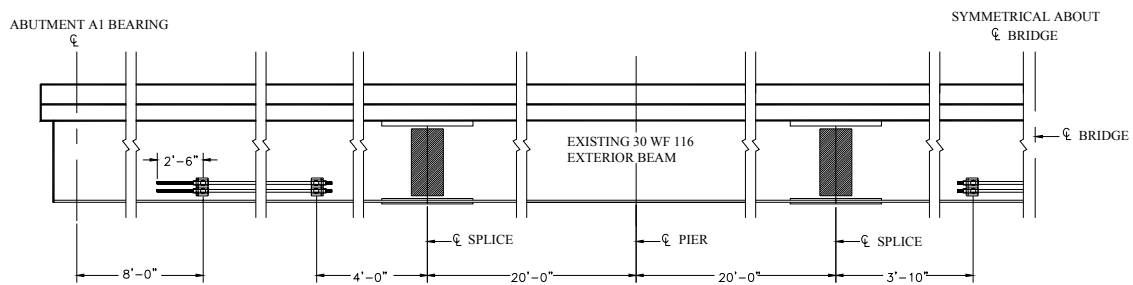
**FIGURE 3. Location of the Post-Tensioning System**

(a) Plan view

(b) Side view

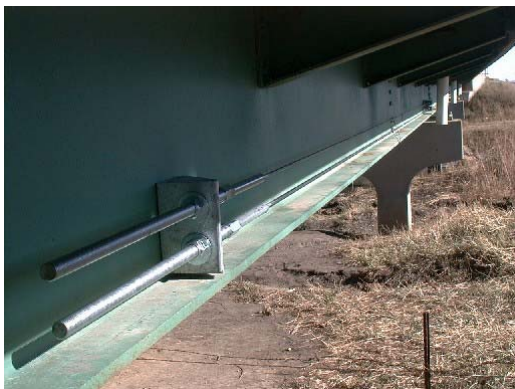
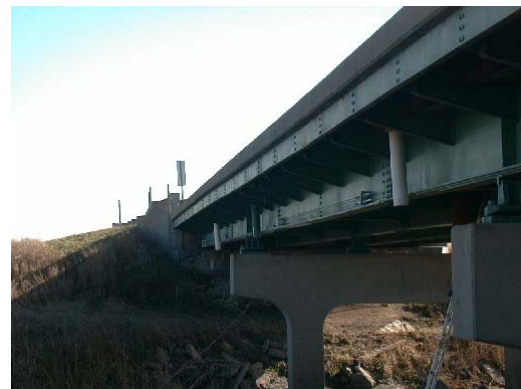
**FIGURE 4. Photographs of the Completed CFRP P-T System on Bridge 1**

(a) CFRP Rods on West-end span

(b) CFRP rods on Center span

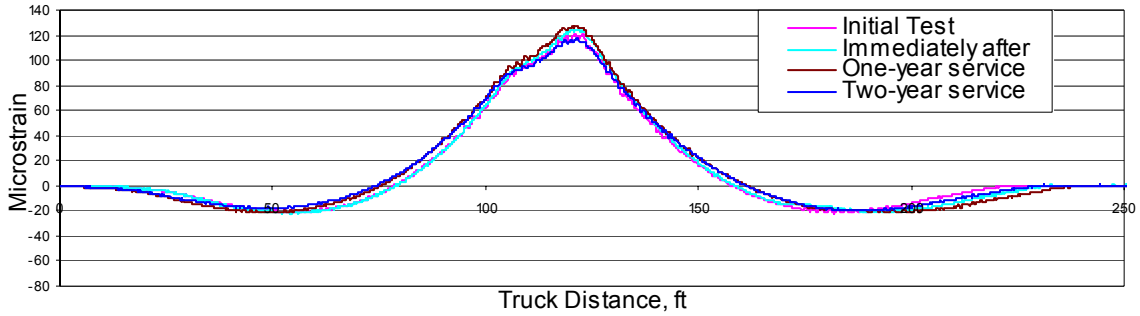
**FIGURE 7. Bottom Flange Strain Data (Path Y2, Beam 1 on Center Span of Bridge 1)**

Typical bottom flange strain data at the center span from each load test are presented in Figure 7. The increase of strain due to the P-T force applied on Beam 1 in the Center span is illustrated in Figure 8 where each “event” defines a specific step of the overall P-T process.

Each load test produced fairly consistent strain readings. This consistency in strain is informative in that it indicates that the P-T system did not alter the behavior of the bridge over the two years of service. Although it is not possible to precisely account for all the sources of strain, it is evident from the consistency of the strain data that the installation of the P-T system had negligible impact on changing the stiffness of the bridge. In general, good agreements in strain data were observed.

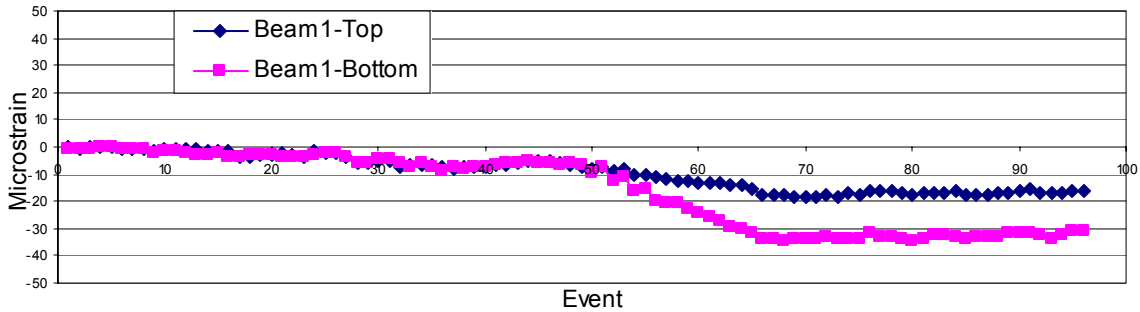
**FIGURE 8. Increase of Strain Due to the Post-Tensioning Force on Bridge 1**

Post-tensioning the positive moment region generates strain opposite in sign to those produced by dead and secondary load. During the application of the P-T system, strain was measured to investigate the response of the structure due to the application of the P-T force. When the force was applied to a certain location on the exterior beam, that beam would experience more strain than other location. For example, when the north exterior beam (Beam 1 in Figure 5) on the Center span was post-tensioned (between the events 48 and 64 in Figure 8), the strain due to the P-T force increased significantly compared to other locations where the increase in strain were minimal.

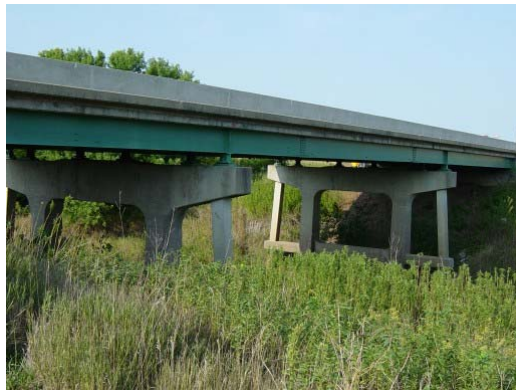
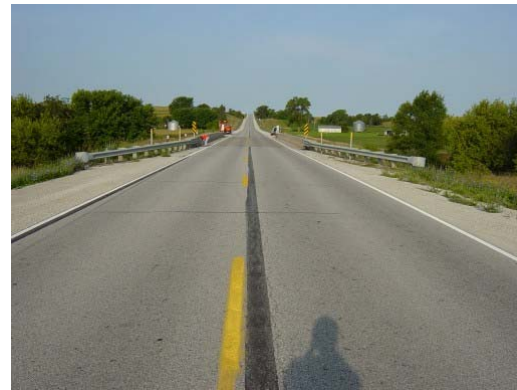
**FIGURE 9. Photographs of Bridge 2**

(a) Side View

(b) Road way

Bridge 2 (number 7838.5S092) strengthened with CFRP plates is a 150 ft x 30 ft three-span continuous I-beam bridge in Pottawattamie County, Iowa, on State Highway 92. Originally the bridge was a non-composite structure. In 1965, the bridge was widened with the addition of exterior girders that were made composite with the deck. The bridge has a total length of 150 ft consisting of two end spans of 45.5 ft and a center span of 59 ft and is supported by six beams: two W27x84 exterior I-beams installed in 1967, two W27 x91, and two W27x98 interior I-beams. The roadway width is 30 ft allowing two traffic lanes and a narrow shoulder.

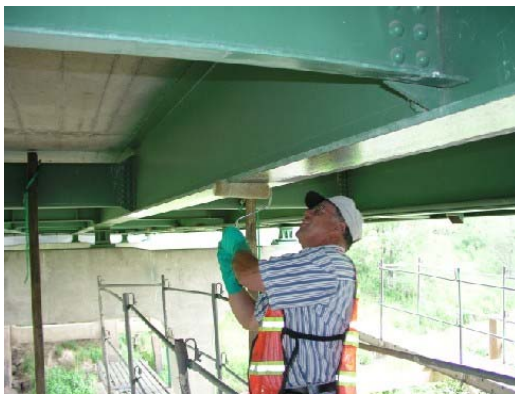
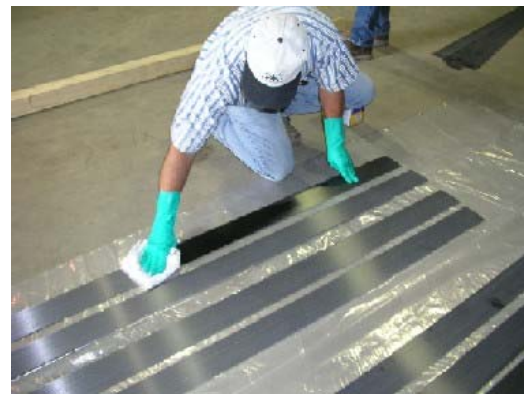
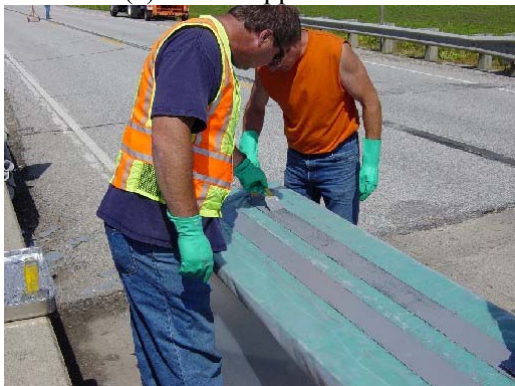
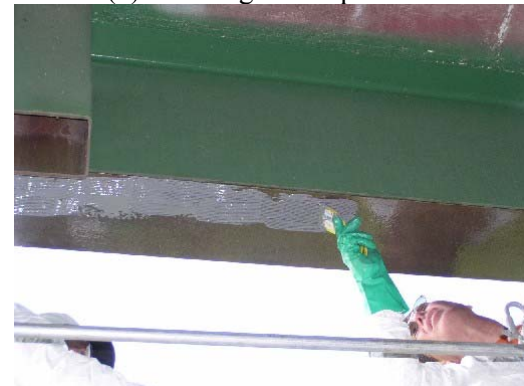
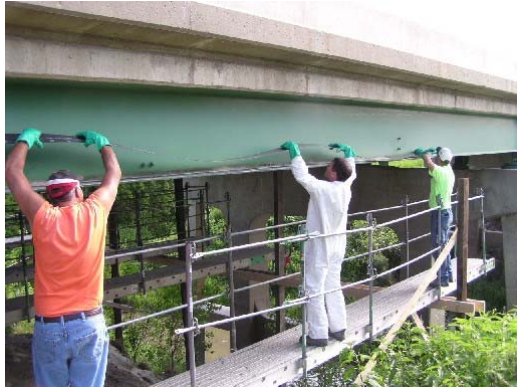
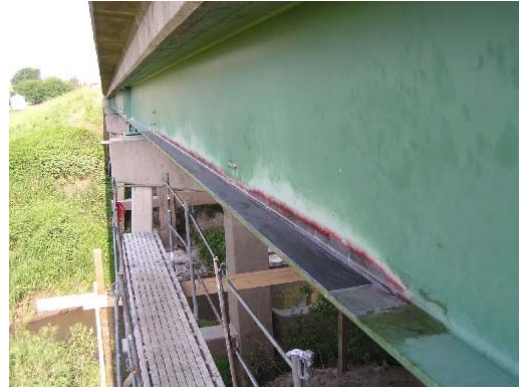
(a) Primer application

(b) Cleaning CFRP plates

(c) Epoxy application on CFRP plates

(d) Epoxy application on beam

(e) Placement of CFRP plate

(f) CFRP plate installed.

**FIGURE 10. Installation of CFRP Plates on Bridge 2**

The CFRP plates were installed on both interior and exterior beams in the positive moment region of all three spans. A successful installation is highly dependent upon careful surface preparation and maintenance of adequate bond conditions. The steel beam surface to which the CFRP plates were to be bonded was roughened to a ‘coarse sandpaper’ texture by sandblasting with high-pressure air jets to remove the paint and any unsound materials on the bonding surface. Both the sandblasted beam surface and bonding surface (sanded side) of the CFRP plates were cleaned with acetone to remove all dirt and debris. The prepared beam surface was treated with a thin layer of primer to prevent potential galvanized corrosion induced by a galvanic reaction between the beam surface and carbon fibers and to provide an improved substrate for the epoxy adhesive. After the primer was set and tack-free, an appropriate amount of epoxy was applied evenly across

the surface of both the beam and the sanded side of the CFRP plates. Finally, the CFRP plates were placed on the designated surface and then pressed and rolled thoroughly to remove any trapped air pockets in the epoxy adhesives. Some of installation procedures are illustrated in Figure 10, and a detailed layout of the plates used can be seen in Figure 11.

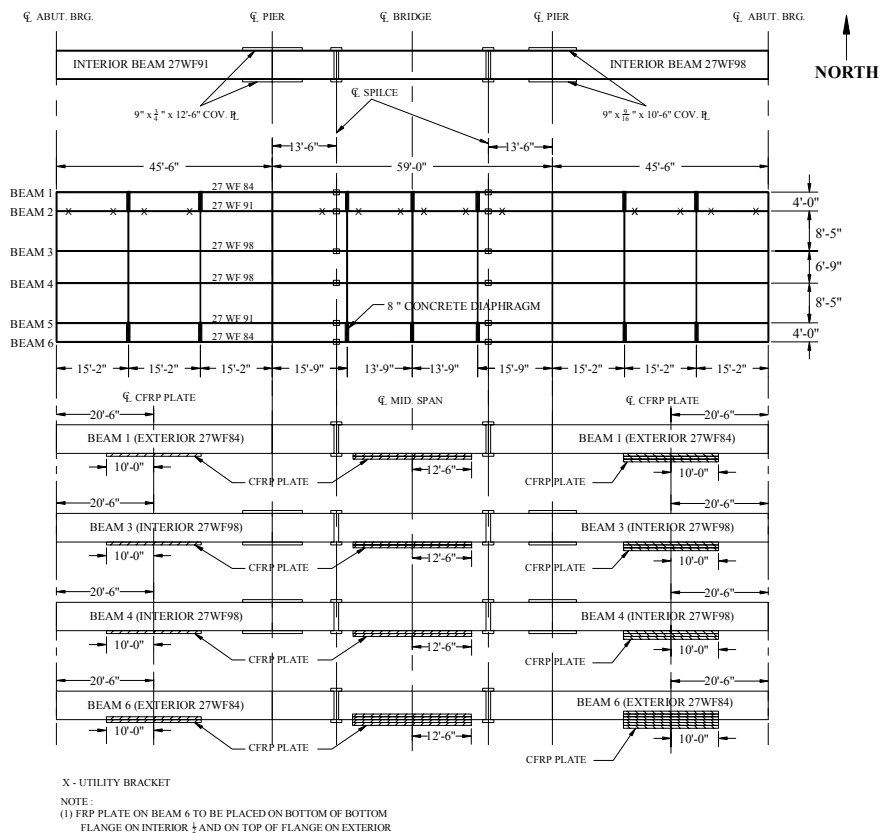
**FIGURE 11. Detailed Layout of CFRP Plates on Bridge 2**

A different number of CFRP plates were used on each span to investigate the effect of varying amount of CFRP plates, to compare the response of the different scheme used in different conditions, to investigate the ease of construction of multiple layers, and to evaluate the durability of the installation. In the West end span, a pair of 20 ft long CFRP plates (1 layer) were installed, side by side with a space of approximately  $\frac{1}{2}$  in. in between, in the positive moment regions of Beams 1, 3, and 4. Three layers of CFRP plates 20 ft in length were installed on East end span. The center span was strengthened with two layers of CFRP plate 25 ft in length. Beam 6, in all spans, had half of the plates installed on the bottom of the bottom flange and half on the top of the bottom flange. This was done to investigate the performance and in-service durability under detrimental environmental conditions (i.e., direct exposure to sunlight, rain, etc.).
