Test and Evaluation Report

Laboratory Testing of Precast Paving Notch System

February 25, 2008

**Iowa Department
of Transportation**

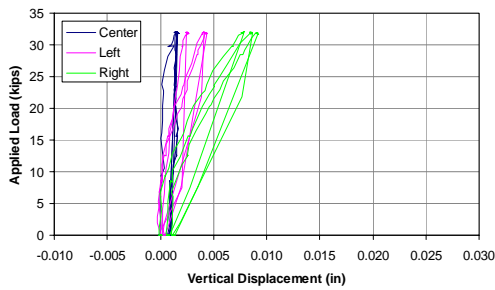
Figure 3. Load-slip test results for Phase 1

(a) PT force: 77 kips

(b) PT force: 64 kips

(b) PT force: 51 kips

(c) PT force: 38 kips

(e) PT force: 26 kips

(f) PT force: 13 kips

Before the first static load test started, the paving notch system was post-tensioned at 77 kips, which is equivalent to approximately 60 % of the ultimate strength of the Dywidag PT rods [1]. During testing, a single point load, using a hydraulic jack placed under the center of the paving notch specimen, was slowly applied up to 32 kips. The force was then slowly released to zero and this loading sequence was repeated three times. A total of six static load tests were conducted with each test completed in a similar manner with the exception of the PT force applied to the system; the next static load test involved the specimen with 10% less PT force applied to the system (i.e., 50% of the ultimate strength of the rods). The static load test was repeated until the PT force was down to 13 kips (i.e., approximately 10% of the ultimate strength of the rods). The load-slip measurements were made for each static load test and are presented in Fig. 3.

Before testing, it was expected that, when there was adequate frictional resistance, any displacement induced by an applied load would return to zero when the load was removed. This was confirmed by the first static load testing where virtually no residual displacement (slip) occurred at the connection of the paving notch system when the specimen was attached to the abutment with 77 kips of PT force. The initial indication of slippage was observed at 26 kips of PT force and the slippage continued to increase as the PT force was further reduced. The testing was stopped at 13 kips of the PT force as the manifestation of residual displacement (slip) was obvious.

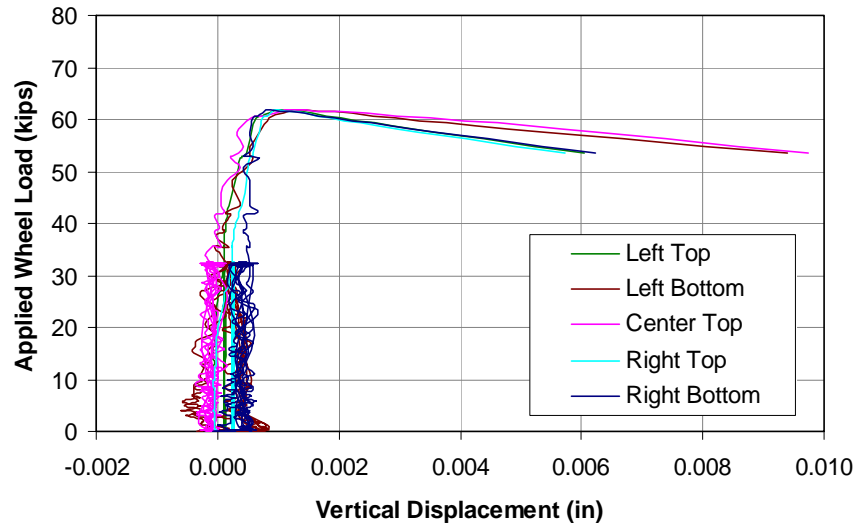
Figure 5. Load-slip test results for Phase 2.

During testing, the specimen was instrumented with five displacement transducers: three on the top surface of the paving notch specimen and two on the bottom surface of the specimen. The specimen was then loaded with two hydraulic jacks placed directly below the stainless rods as shown in Fig. 4b. The same basic loading procedure used in Phase 1 was used except, in this test, the zero-to-32-kip load cycle (16 kips for each jack) was repeated four times. After the four cycles of the test, the specimen was loaded to failure. Presented in Fig. 5 are the results of this testing. As shown, virtually no slip was observed during the four cyclic loadings and the specimen failed at approximately 62 kips.

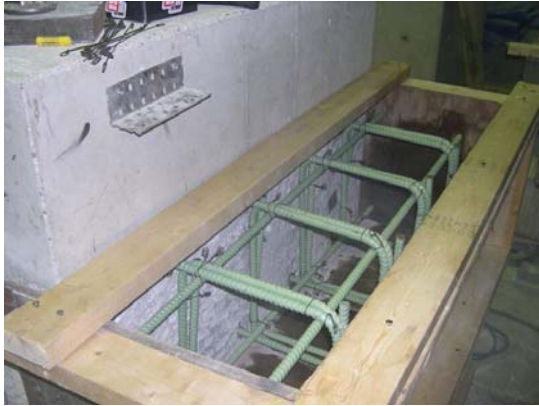
Figure 7. Construction of the cast-in-place repair specimen.

(a) Reinforcement inside a wooden form

(b) Concrete placement

At the end of Phase 2, the Iowa DOT desired to compare the strength of the proposed system to their current CIP repair system. Based on the details provided by the Iowa DOT, a CIP paving notch repair system was constructed as show in Fig. 7. The Iowa DOT's CIP repair specimen consists of bent epoxy-coated reinforcing bars inserted into drilled holes and fastened with epoxy adhesive. Conventional plywood forms were

constructed around the cage for the placement of normal weight concrete to complete the construction of the paving notch. Upon the completion of the construction, the CIP repair system was loaded to failure with two hydraulic jacks placed at the same location where the stainless steel threaded rods would have been located in the previous static load tests. The CIP repair system failed at approximately 46 kips.

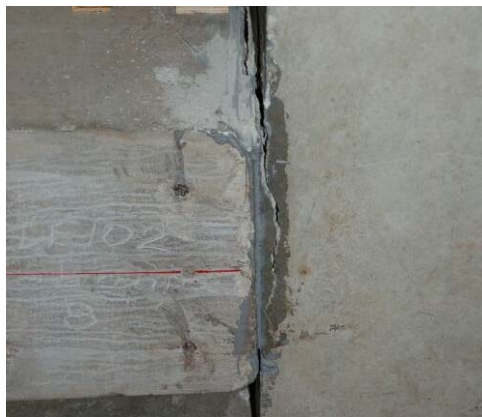
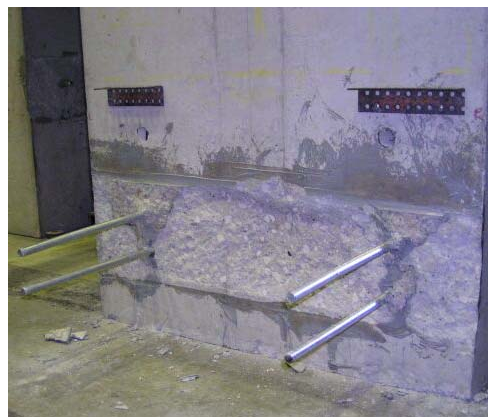
Figure 10. Posttest specimen illustrating typical cracking failure.

(a) Side view of the failed specimen

(b) Failed abutment concrete

Based upon the post-test visual inspection of the failed specimen, it appeared that the failure of the system was a result of the abutment concrete cracking that initiated at the connection due to tension stresses developed at the connection. It was noted that the crack propagated along the abutment concrete. After the initial failure, the research team continued to load the specimen until the paving notch specimen broke away from the abutment for a close-up inspection. In general, the failure pattern was similar to what was observed in Phase 2.
