US 30 Cedar and Clinton Counties PLANNING AND ENVIRONMENTAL LINKAGES (PEL) STUDY

Existing Conditions Memorandum

Office of Location and Environment | March 2019

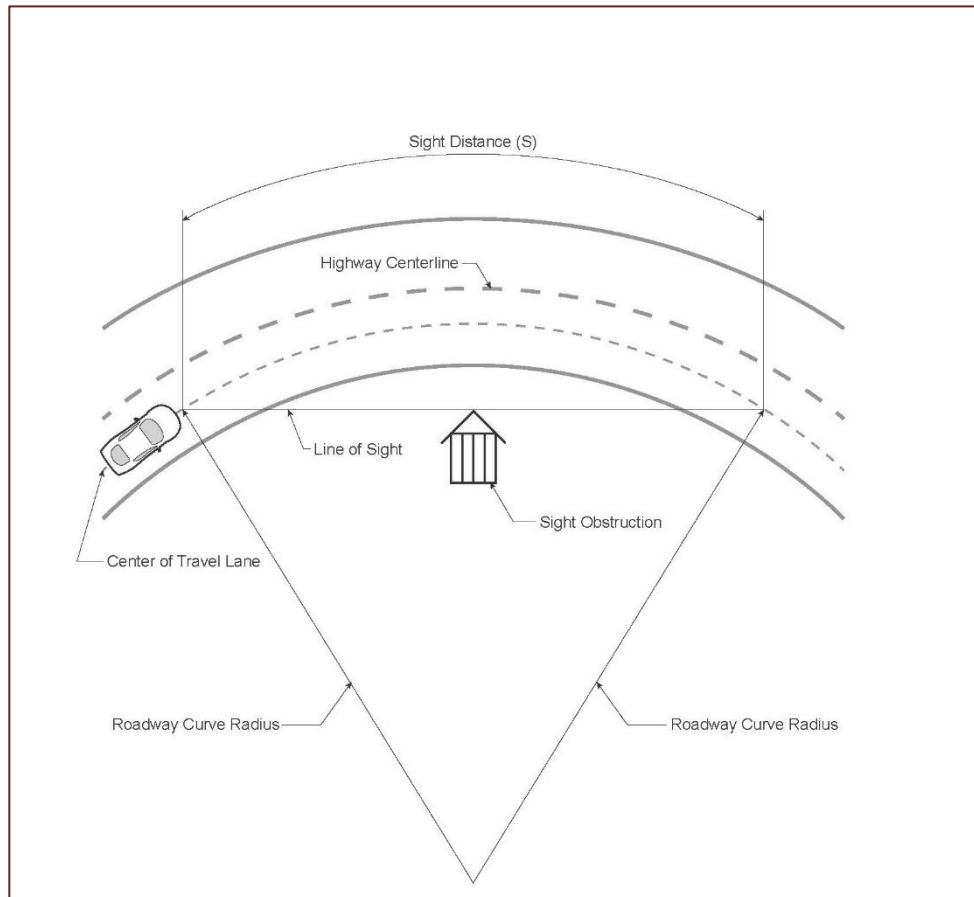
Figure 3. Stopping Sight Distance Line of Sight at a Horizontal Curve

Stopping sight distance (SSD) is the distance required for a driver to detect an object or hazard within the traveled way and react, brake, and stop the vehicle prior to coming into conflict with the object or hazard. When considering SSD in relation to a roadway’s horizontal geometry, the ability of a driver to see around the roadway curve is the critical consideration. Figure 3 depicts a driver’s line of sight around a roadway curve; the line of sight depicted would provide the distance needed to meet SSD criteria and should remain free of obstacles that could block a driver’s view. Lines of sight at horizontal curves were estimated and compared to aerial photography and observed during the onsite field review; no locations with SSD concerns related to horizontal geometry were identified. Rows of trees, crops, buildings, billboards, and all other possible sight obstructions appear to be at a sufficient distance away from the roadway as to not obstruct a driver’s line of sight around the curve.

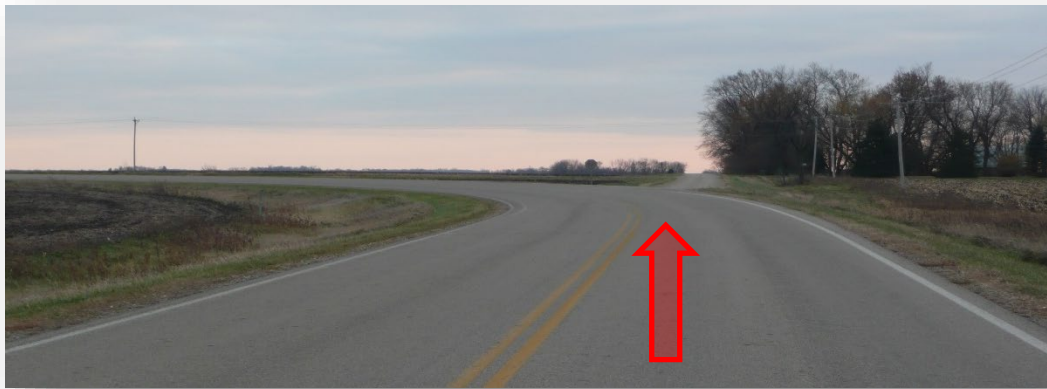
Figure 4. Example of a Visual Trap at a Horizontal Roadway Curve

A visual trap is a term used to describe a situation where a feature that is separate from the roadway creates the appearance that the roadway continues straight when, in fact, there is an approaching curve in the road. To an inattentive driver or during periods where visibility may be limited, a visual trap could lead to potential run-off-the-road or cross-centerline crashes. Roadside features that can create such an appearance may include other roadways, tree lines, railroads, utility poles (power poles), or other objects that parallel a roadway and continue at the same bearing as the roadway curves away. An example of a visual trap is shown in Figure 4; in this example, the local roadway and tree line may create an appearance of the roadway continuing straight rather than curving to the left. Often such areas can be mitigated by providing advanced curve-warning signs, chevrons, or other visual features that break the linear appearance of the roadside feature.

Local sideroad and tree line create the appearance that the highway continues straight.

A review of aerial photography and observations during the onsite field review identified a few locations (see Table 5) along the US 30 Study corridor where a visual trap may be present and identified the traffic signs and devices in place to identify the US 30 roadway curve, mitigating the risk of an approaching driver missing the curve in the roadway.

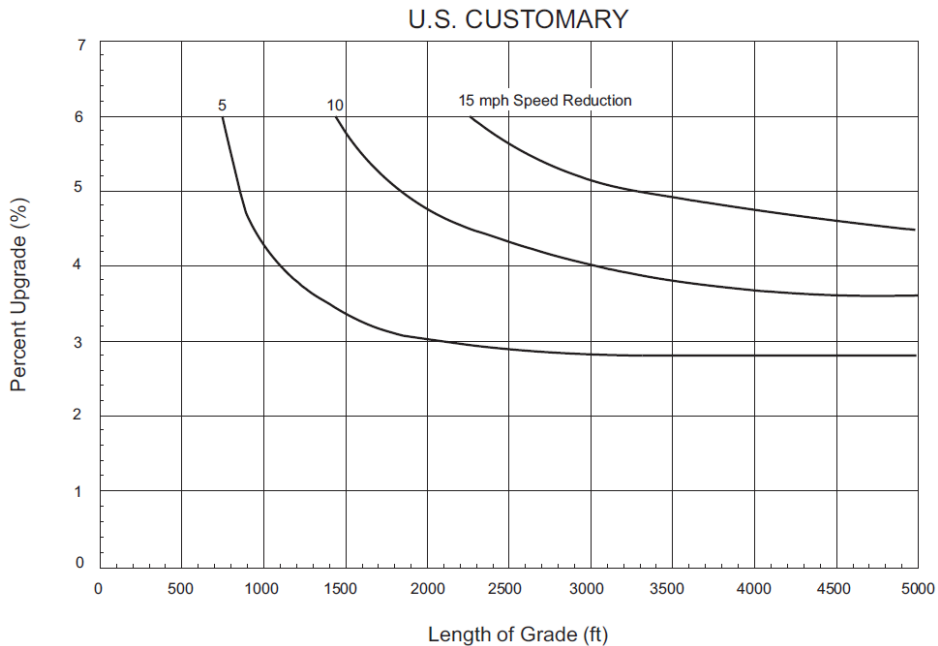
Figure 5. AASHTO Suggested Travel Speed Impacts of Steep Roadway Grades

Roadway grade can influence the free-flow travel speeds along a roadway and is important when considering pavement drainage needs during rain events. For two-lane highways, Iowa DOT design guidance suggests a preferred maximum grade of 3 percent, but grades of up to 5 percent are acceptable and not uncommon. Maintaining steep grades over an extended length of roadway can result in a degradation of travel speeds and overall operational performance of the highway, particularly if there is a high percentage of heavy trucks in the vehicle mix. This degradation can result in added travel delay, formation of vehicle queues, and potentially a reduction in passing opportunities. AASHTO's *A Policy on Geometric Design of Highways and Streets* (2011) provides guidance on what reduction in travel speeds can be expected for steeper grades over a given length of roadway (Figure 5). AASHTO guidance suggests that maintaining a 3 percent roadway grade should not result in travel-speed reduction of more than 5 mph for heavy vehicles. Grades above 3 percent, maintained over longer distances, can cause a more significant drop in speed.

There are several locations within the corridor where the maximum roadway grade is greater than 3 percent, but no roadway grade in the Study area exceeds the maximum acceptable grade of 5 percent for new construction specified in current Iowa DOT design policy. Table 6 summarizes the locations of roadway grades that exceed the preferred maximum for new roadway construction (greater than 3%), including the length at which that grade is maintained and what reduction in travel speed for heavy trucks would be expected per AASHTO guidance. As shown in Table 6, these relatively short grades that exceed 3 percent are expected to result in minimal, if any, reduction in travel speed; existing roadway grades are not expected to contribute to any degradation of travel efficiency within the corridor by reducing travel speed of heavy trucks and other large vehicles.

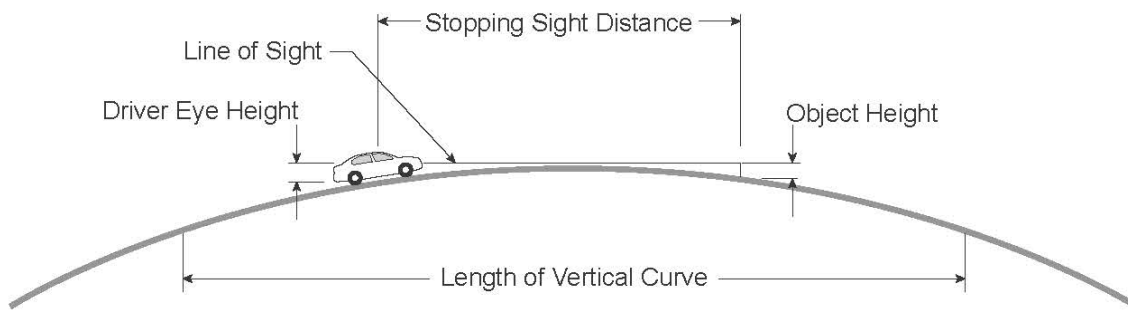
Figure 6. Schematic of a Typical Crest Vertical Curve and Line of Sight Needs for SSD

A crest vertical curve, depicted in Figure 6, is a parabolic curve used to smoothly transition a change in roadway grade. SSD at a crest vertical curve is based on the distance a driver is able to see over the highest point of the parabolic curve. The length of the vertical curve must create a flat enough transition between roadway grades to allow for a line of sight from the driver's eye, past the high point of the pavement surface, to an object in the traveled lane that is at least 2 feet high.

Of the 103 crest vertical curves within the Study corridor, the majority meet minimum acceptable criteria for new construction and are rated as good. The remaining crest curves, listed in Table 7, are below new construction criteria but still meet 3R criteria and are rated as fair. No existing crest vertical curves were identified as poor.

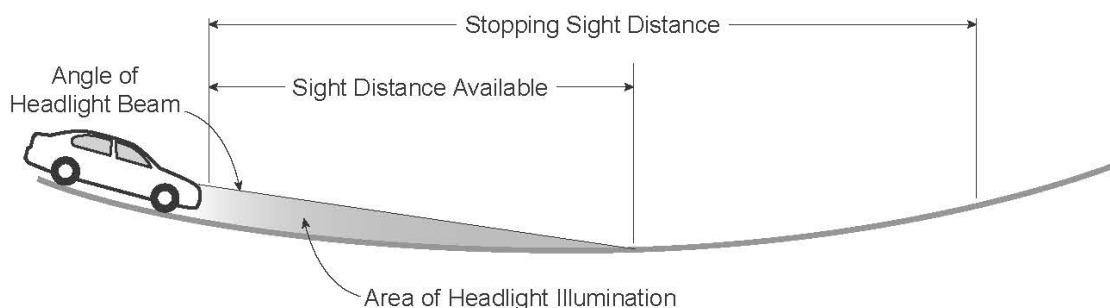
Figure 7. Schematic of a Typical Sag Vertical Curve and Line of Sight Needs for SSD

A sag vertical curve is also a parabolic curve used to smoothly transition the roadway grade as depicted in Figure 7. SSD needs at a sag vertical curve are based on the distance a vehicle's headlight beams can illuminate the roadway in dark conditions. If the length of vertical curve is too short, a vehicle's headlights may not illuminate the sag vertical curve for sufficient distance to allow for a driver to react, brake, and stop if an obstacle is in the vehicle's path. If roadway lighting is present to illuminate the pavement surface through the sag vertical curve in lieu of relying on a vehicle's headlights, a shorter sag curve with a more abrupt transition in roadway grade is acceptable. In general, existing roadway lighting is not present in the Study corridor.

Of the 99 sag vertical curves in the Study area, the majority meet the minimum acceptable criteria for new roadway construction and are considered good. Like the crest vertical curves, the sag vertical curves that do not meet criteria for new construction still meet the acceptable 3R parameters and are rated as fair. No existing sag vertical curves were identified as poor. Table 8 summarizes the locations where sag vertical curves meet 3R criteria and are rated as fair.

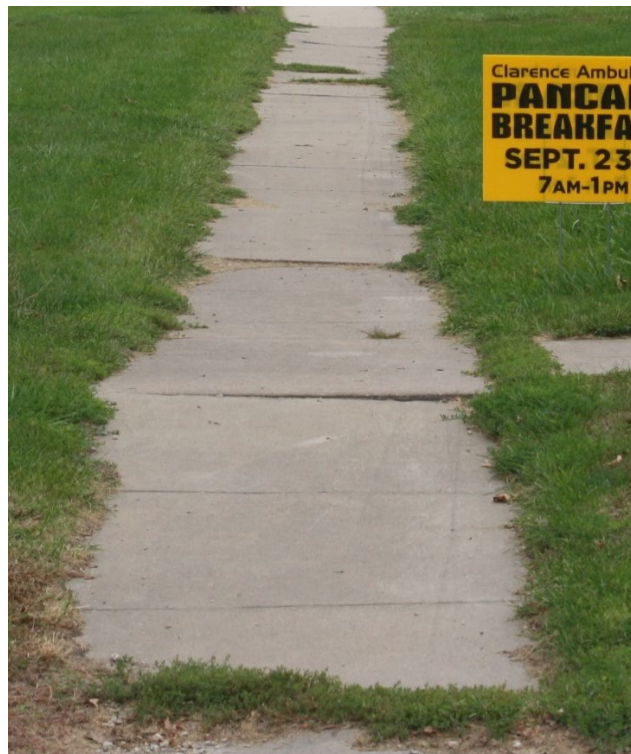
Figure 8. Typical Sidewalk along US 30 in Residential Areas of Clarence

US 30 in Clarence is the only location within the Study corridor that provides specific pedestrian accommodations in the form of sidewalk. In the residential areas of Clarence, there is generally a grassy buffer area of about 13 feet between the curb and sidewalk. Existing sidewalk widths are typically a minimum of 4 feet wide and are considered to be in fair condition with some signs of deterioration, cracking, and heaving. Figure 8 is a picture from the onsite windshield survey and depicts a typical section of sidewalk along residential sections of US 30 in Clarence.

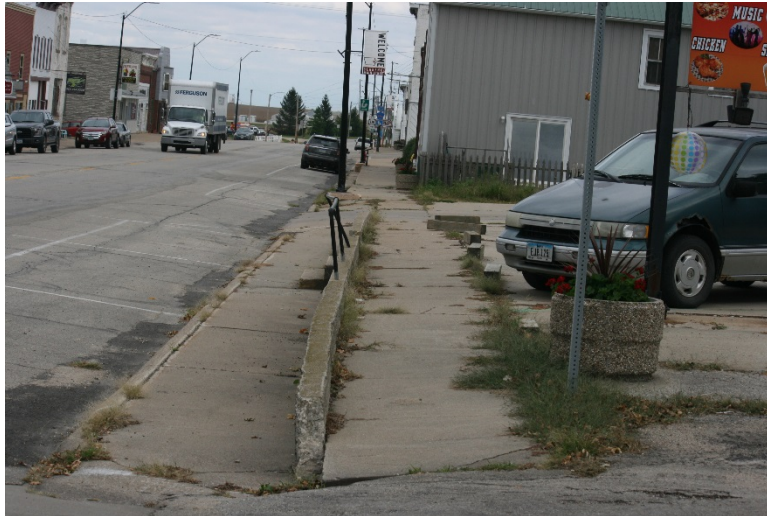
Figure 9. Sidewalk and Parking Lanes along US 30 in the Clarence Business District

Through the business district of the US 30 corridor in Clarence, the sidewalk widens and extends to the back of curb. In some areas, two levels of existing sidewalk are present, one adjacent to the parking lanes along US 30, and the second along existing store and business fronts (Figure 9). In these areas, pedestrians need to make a vertical step, up or down, between the two levels of sidewalk or to walk along the parking and travel lane until a location where steps or a pedestrian ramp/curb transition is present at a cross-street location.

Portions of the sidewalk are discontinuous and end abruptly throughout Clarence. In some locations, sidewalk is present on both the north and south sides of US 30, while in other locations, it is only present on one side of US 30.

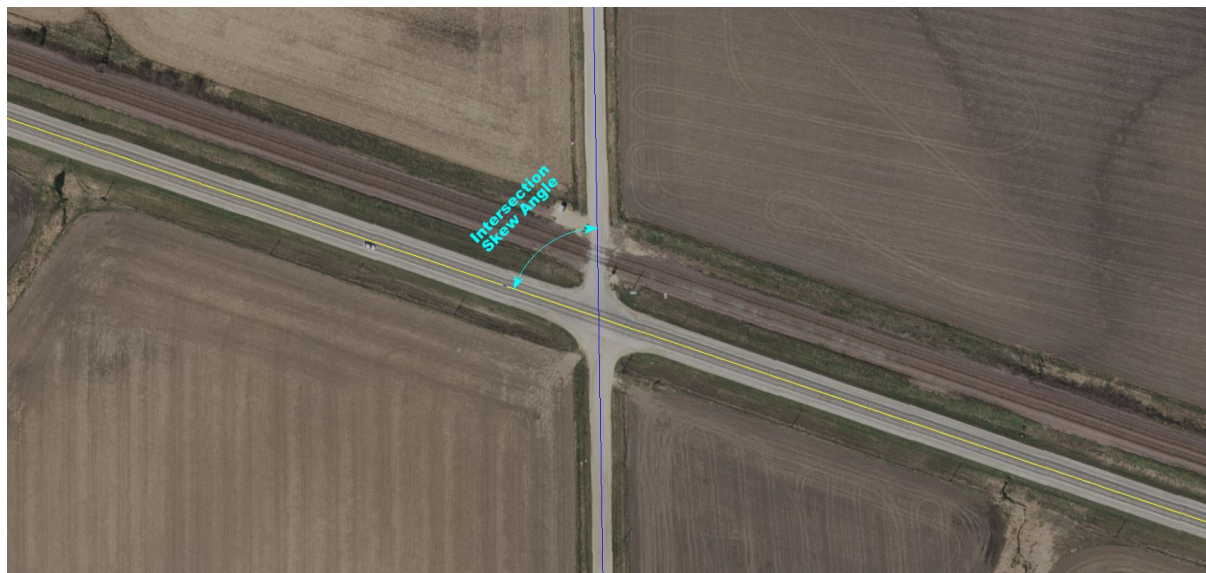
Figure 10. Example of Intersection Skew

Most of the intersections within the Study corridor have intersecting roadways that are nearly perpendicular, or 90 degrees, to each other. However, there are some intersections that have skew angles below 75 degrees and some with angles less than 60 degrees. Table 10 summarizes the intersections with skew angles of less than 60 degrees and notes whether any horizontal roadway curves are at or near the skewed intersection. Table 10 also summarizes the intersection-related crash history at these locations between 2013 and 2017; in general, the crashes that did occur were relatively minor, with a few resulting in reported minor injuries.

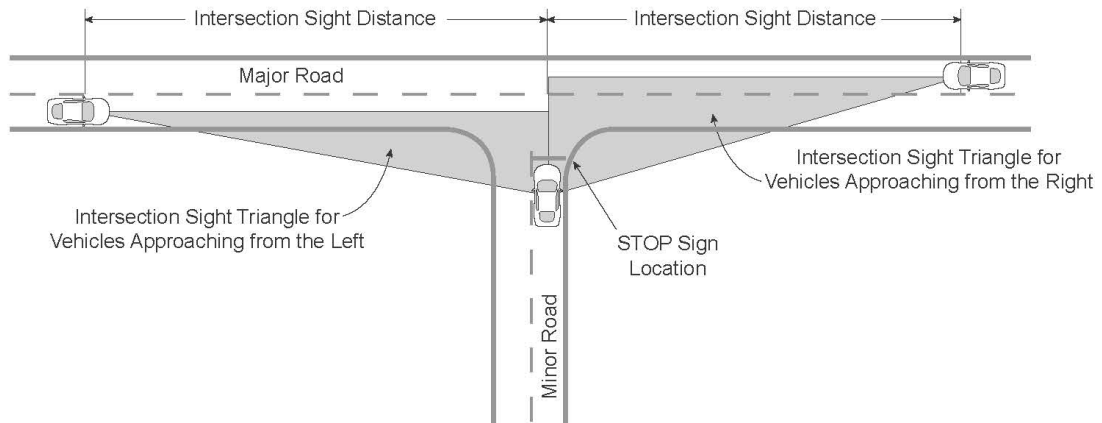
Figure 11. Schematic of Intersection Sight Distance Needs

Review of aerial photography and as-built plan information did not identify any intersection locations of great concern; however, during the onsite field review, some intersections were noted as having a potential sight triangle obstruction(s), assuming a vehicle is stopped at the current location of the painted stop bar and/or stop sign on the minor roadway approach(s). Possible sight-distance obstructions include adjacent embankments, trees, crops, or other vegetative growth, railroad equipment, and billboards/signs. Table 11 lists the locations identified during the onsite field review with possible sight-distance limitations from the existing stop sign location. Table 11 also lists other characteristics of these intersections that may also influence the ability of a driver to see oncoming traffic and pick a safe gap to maneuver through the intersection from a minor approach roadway, including intersection skew and roadway curvature. Appendix B contains photographs taken during the onsite windshield survey at these locations. Overall, no notable crash histories were noted at these intersections; crashes that did occur were relatively minor, with only a few minor injuries reported.

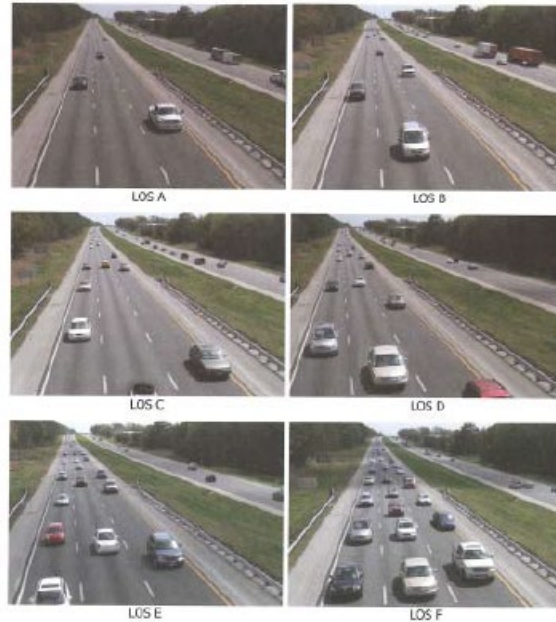
Figure 13. Representative Comparison of Various LOS Conditions

The operational performance of roadways and intersections is based on a measure of effectiveness known as level of service (LOS). LOS is a performance measure that represents quality of service for traffic operations. The Highway Capacity Manual (HCM) defines six levels of LOS, ranging from A to F. LOS A represents the best operating conditions from the traveler's perspective and LOS F, the worst. LOS values in the range of LOS A to LOS C are generally considered acceptable and preferred conditions, whereas LOS D to LOS E indicate rising levels of congestion and less stable traffic flow. LOS F indicates fully congested conditions with total breakdown in traffic flow. Current Iowa DOT practice is to achieve an LOS B or better on rural two-lane highway corridors, and LOS C or better is preferred on urban two-lane highways (however, LOS D is considered acceptable on two-lane urban roads).
