US 30 Cedar and Clinton Counties PLANNING AND ENVIRONMENTAL LINKAGES (PEL) STUDY

Existing Conditions Memorandum

Office of Location and Environment | March 2019

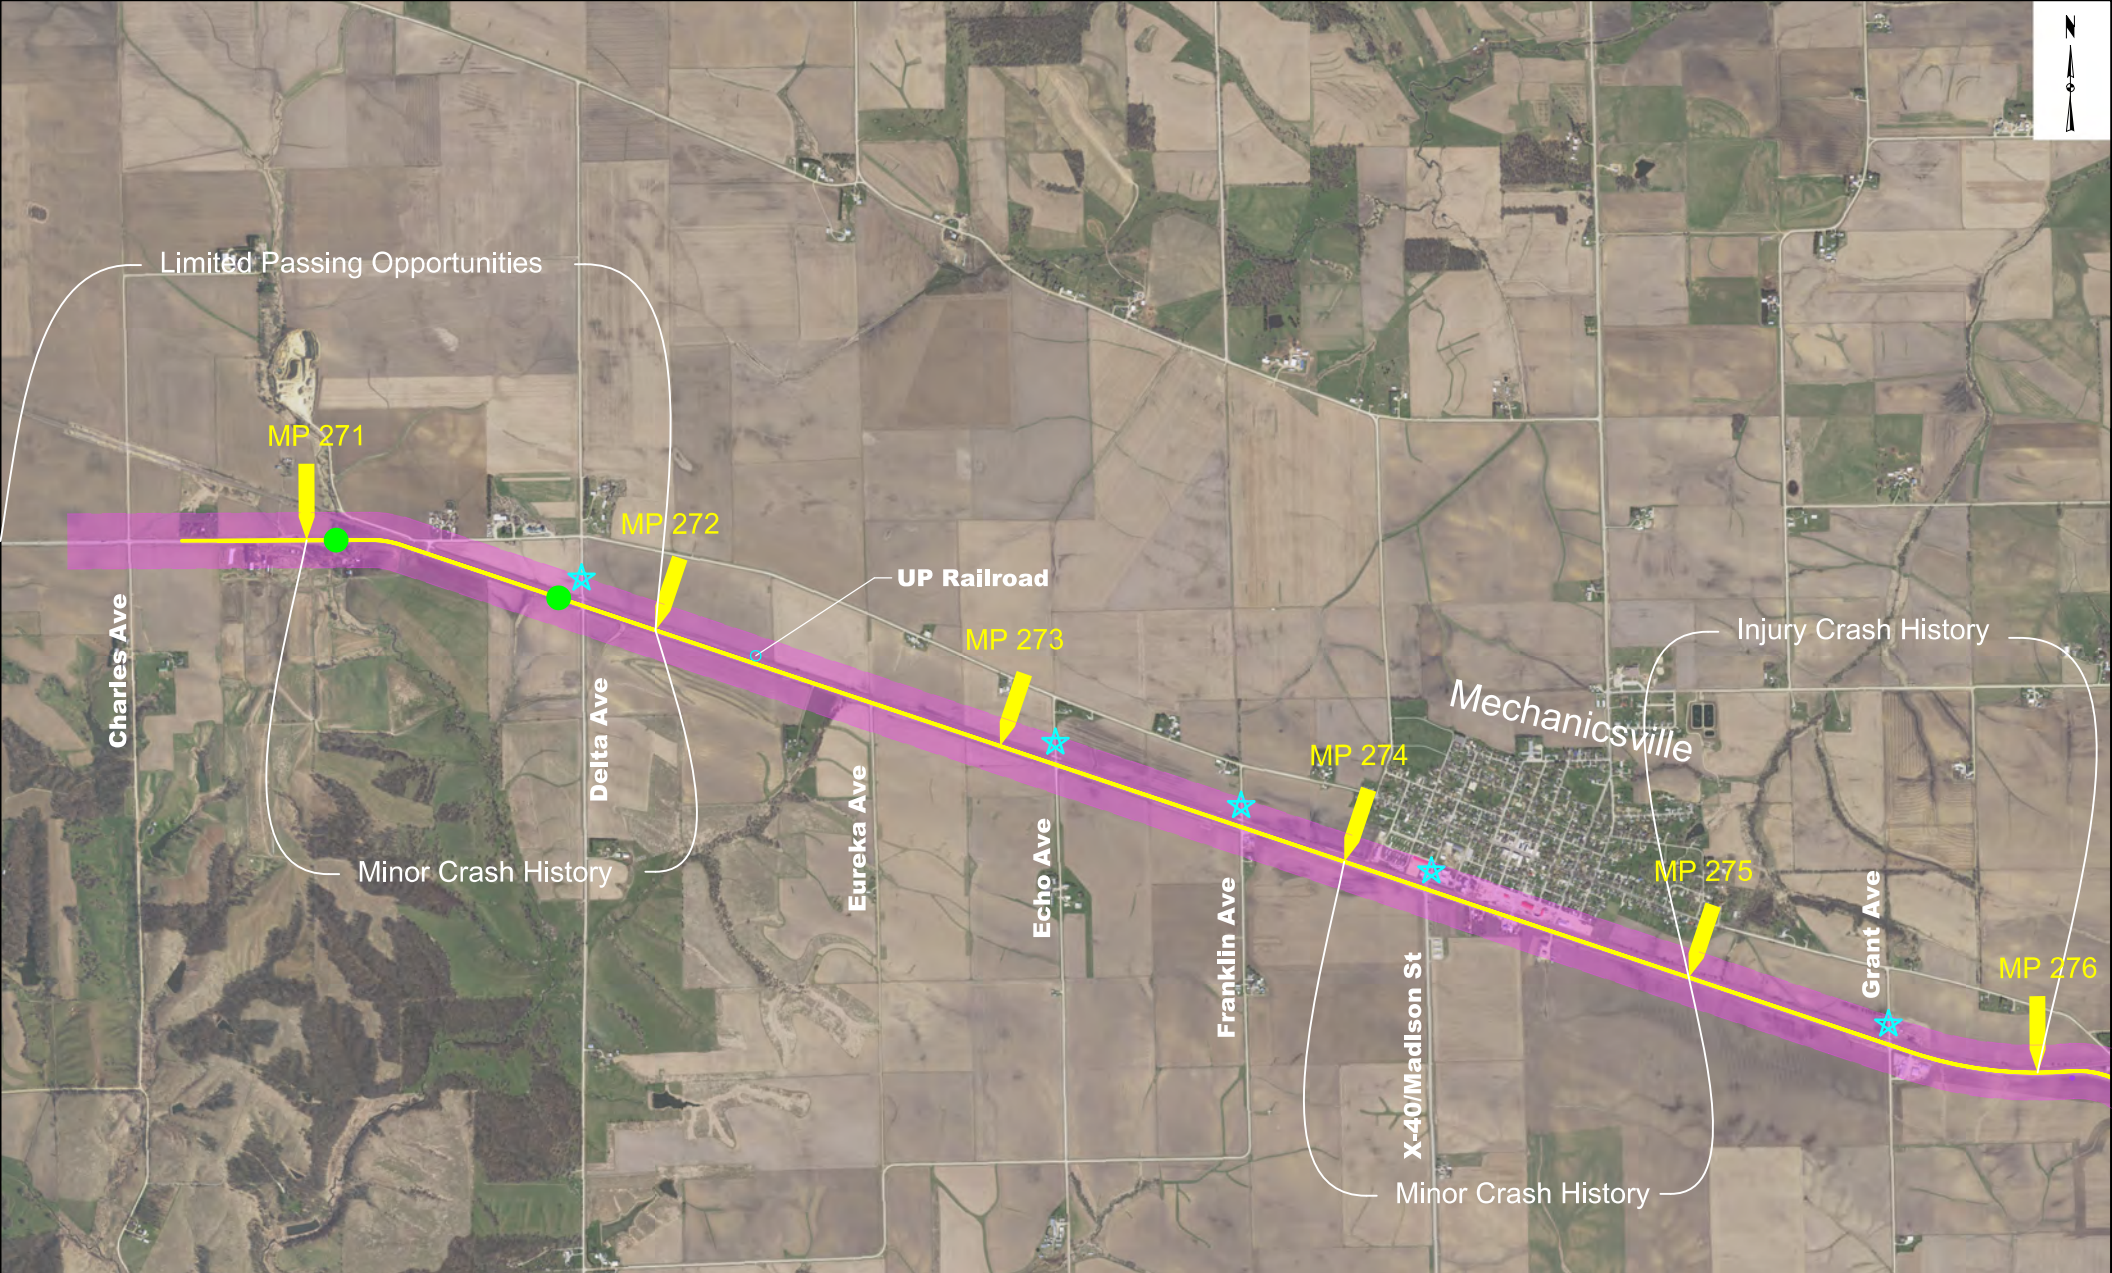
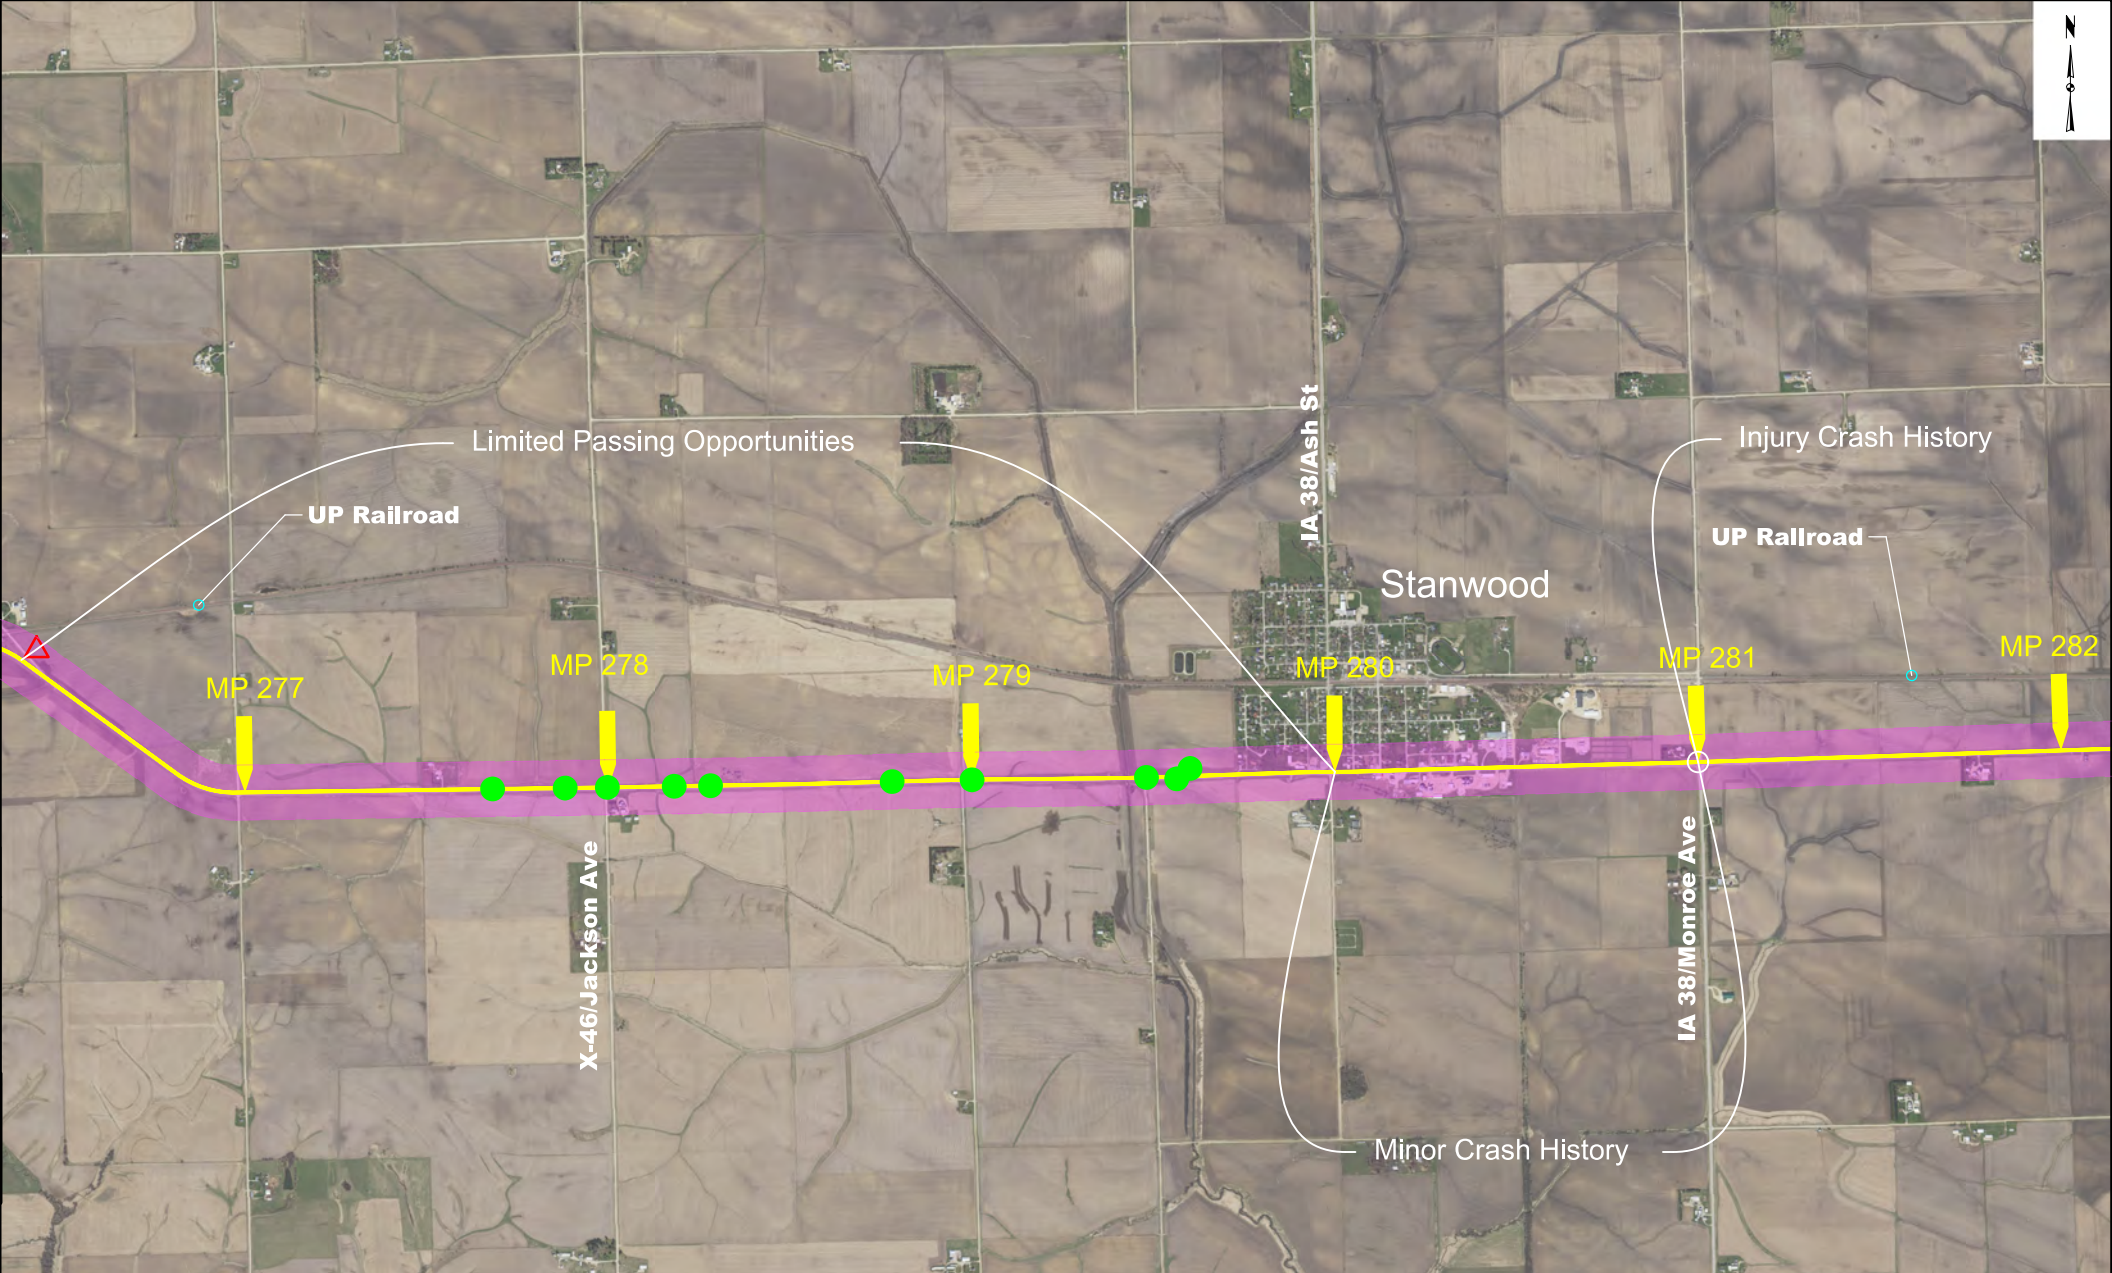
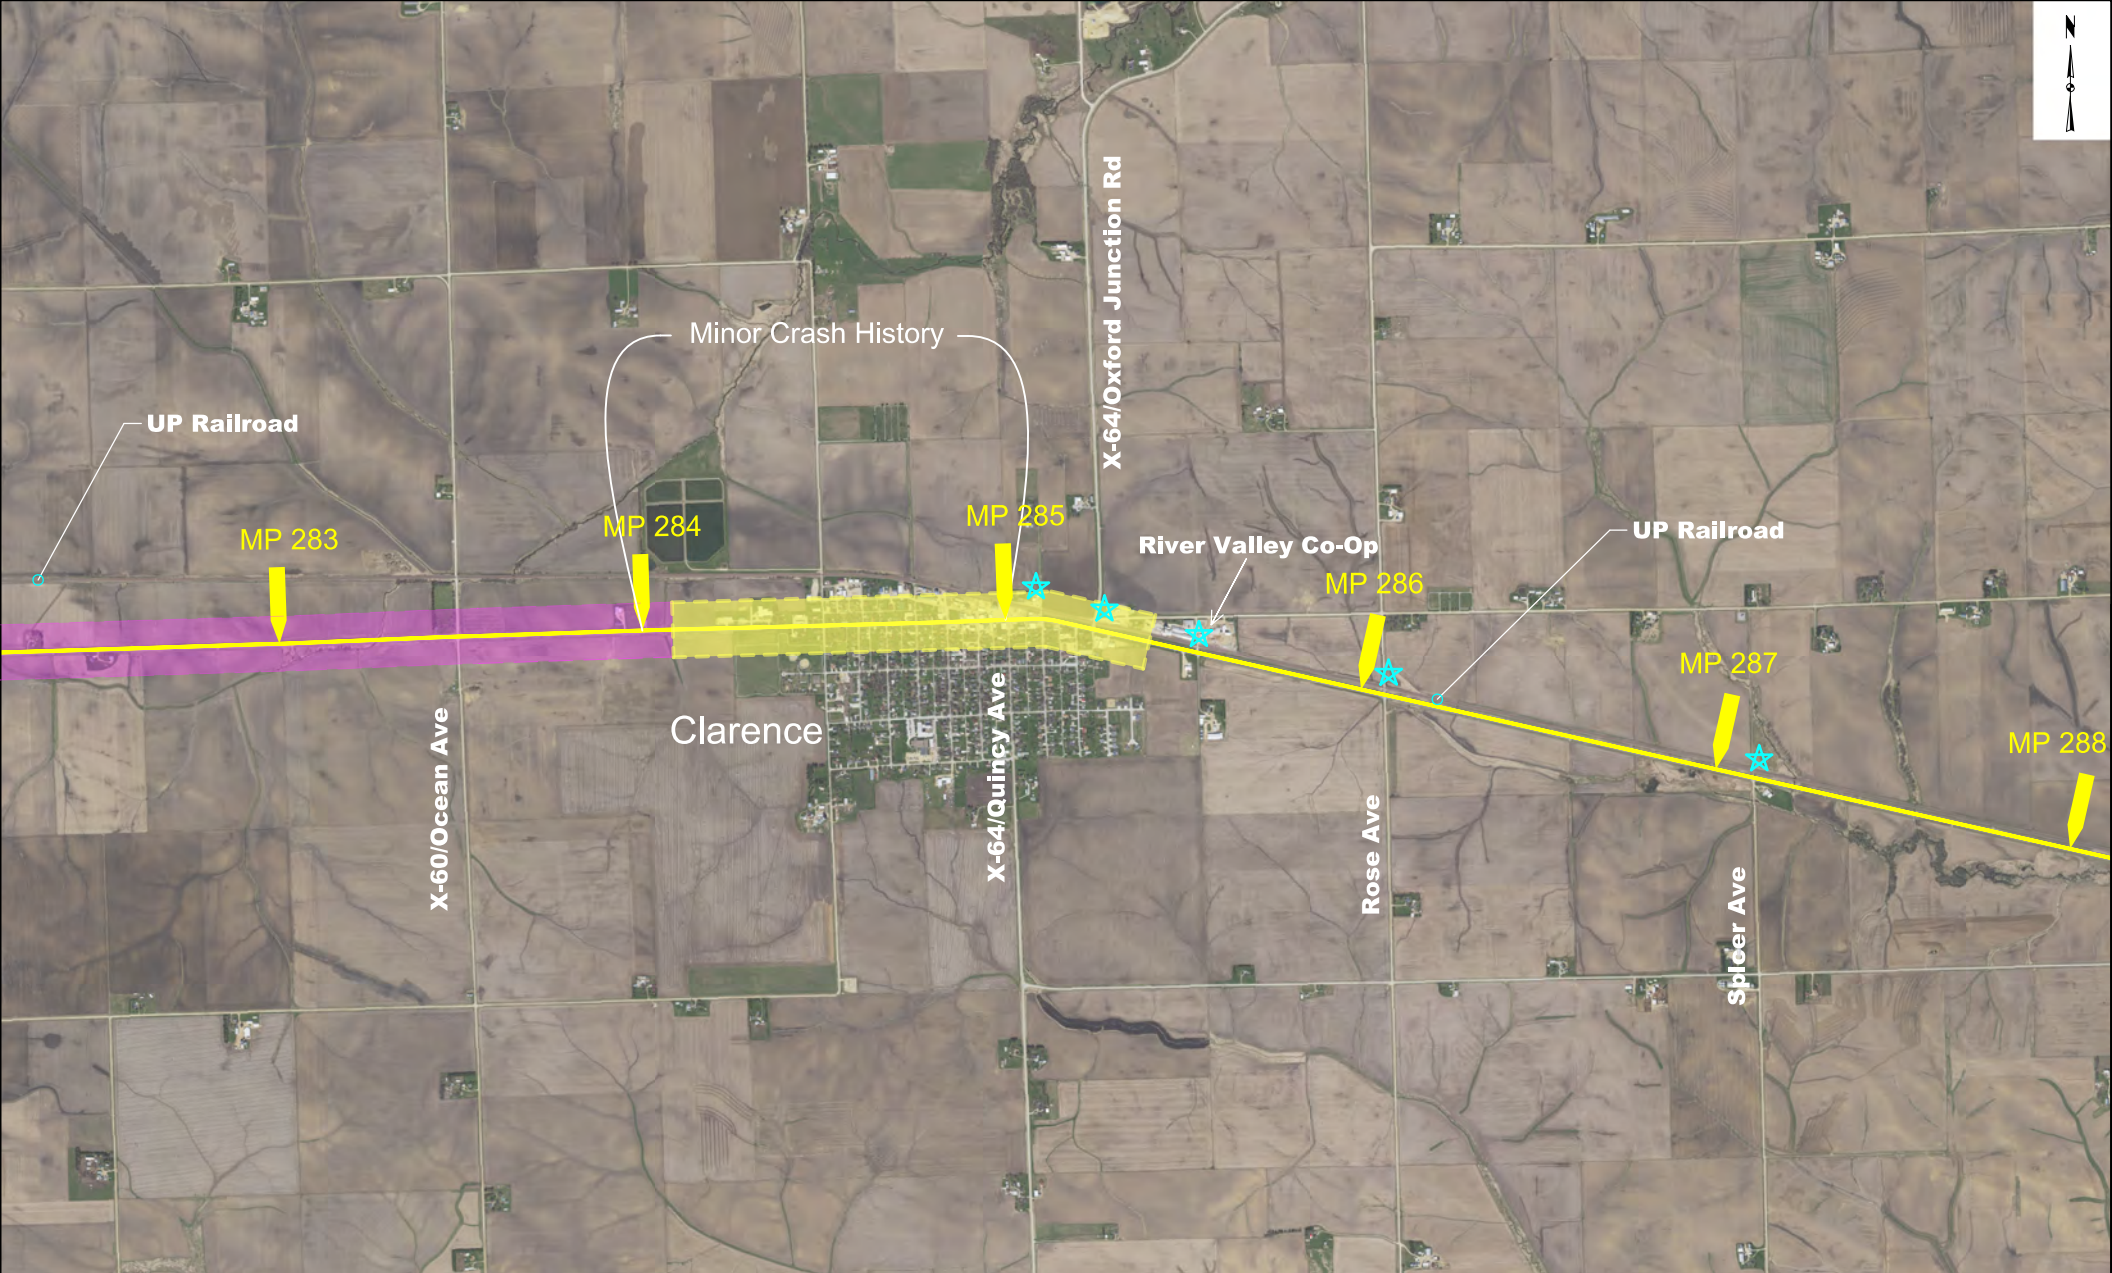
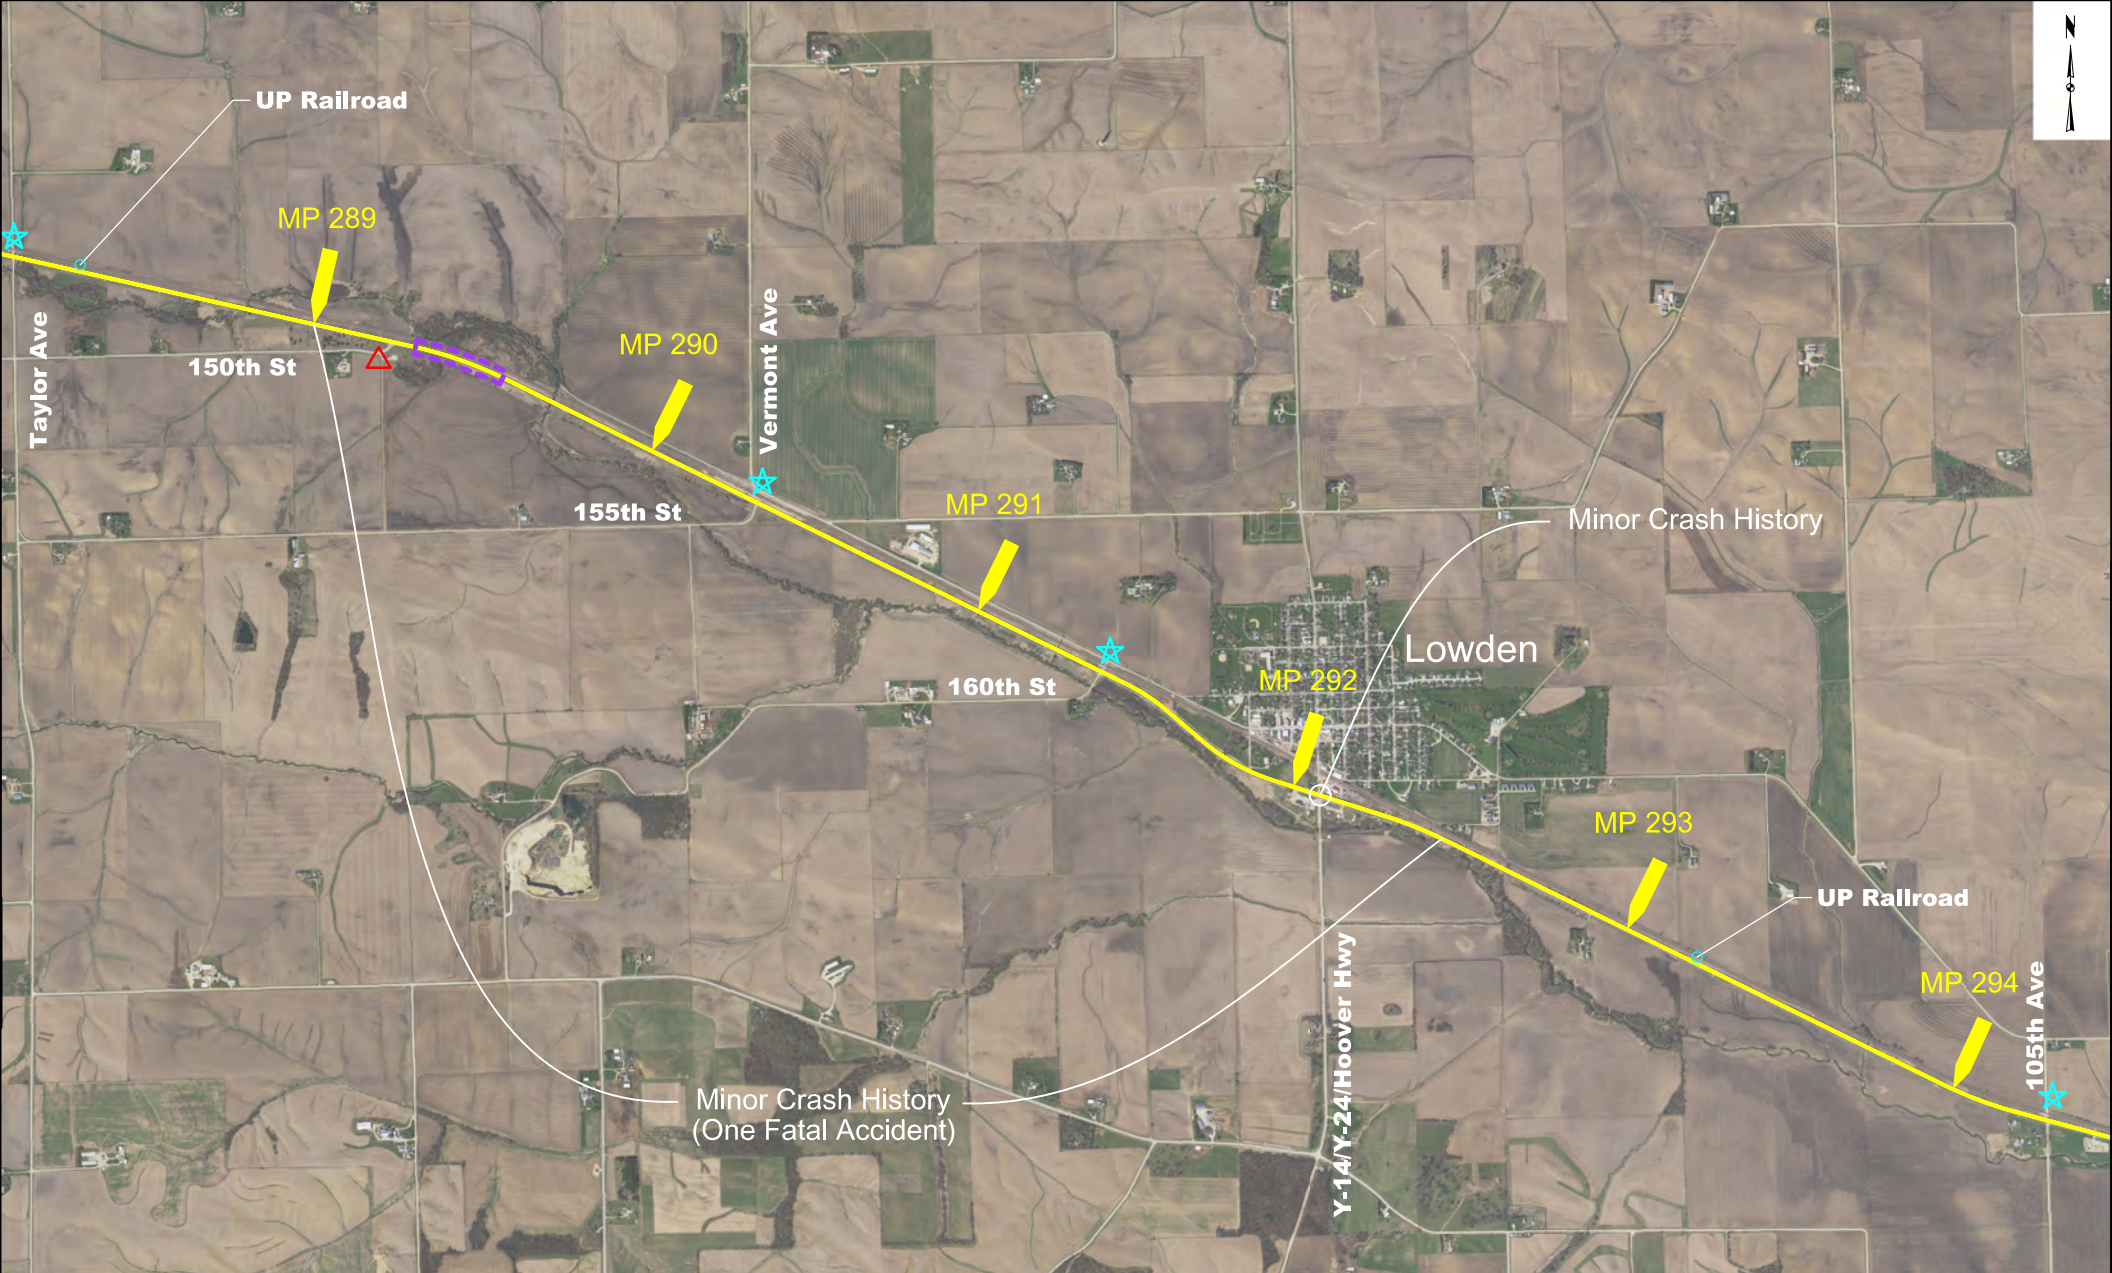
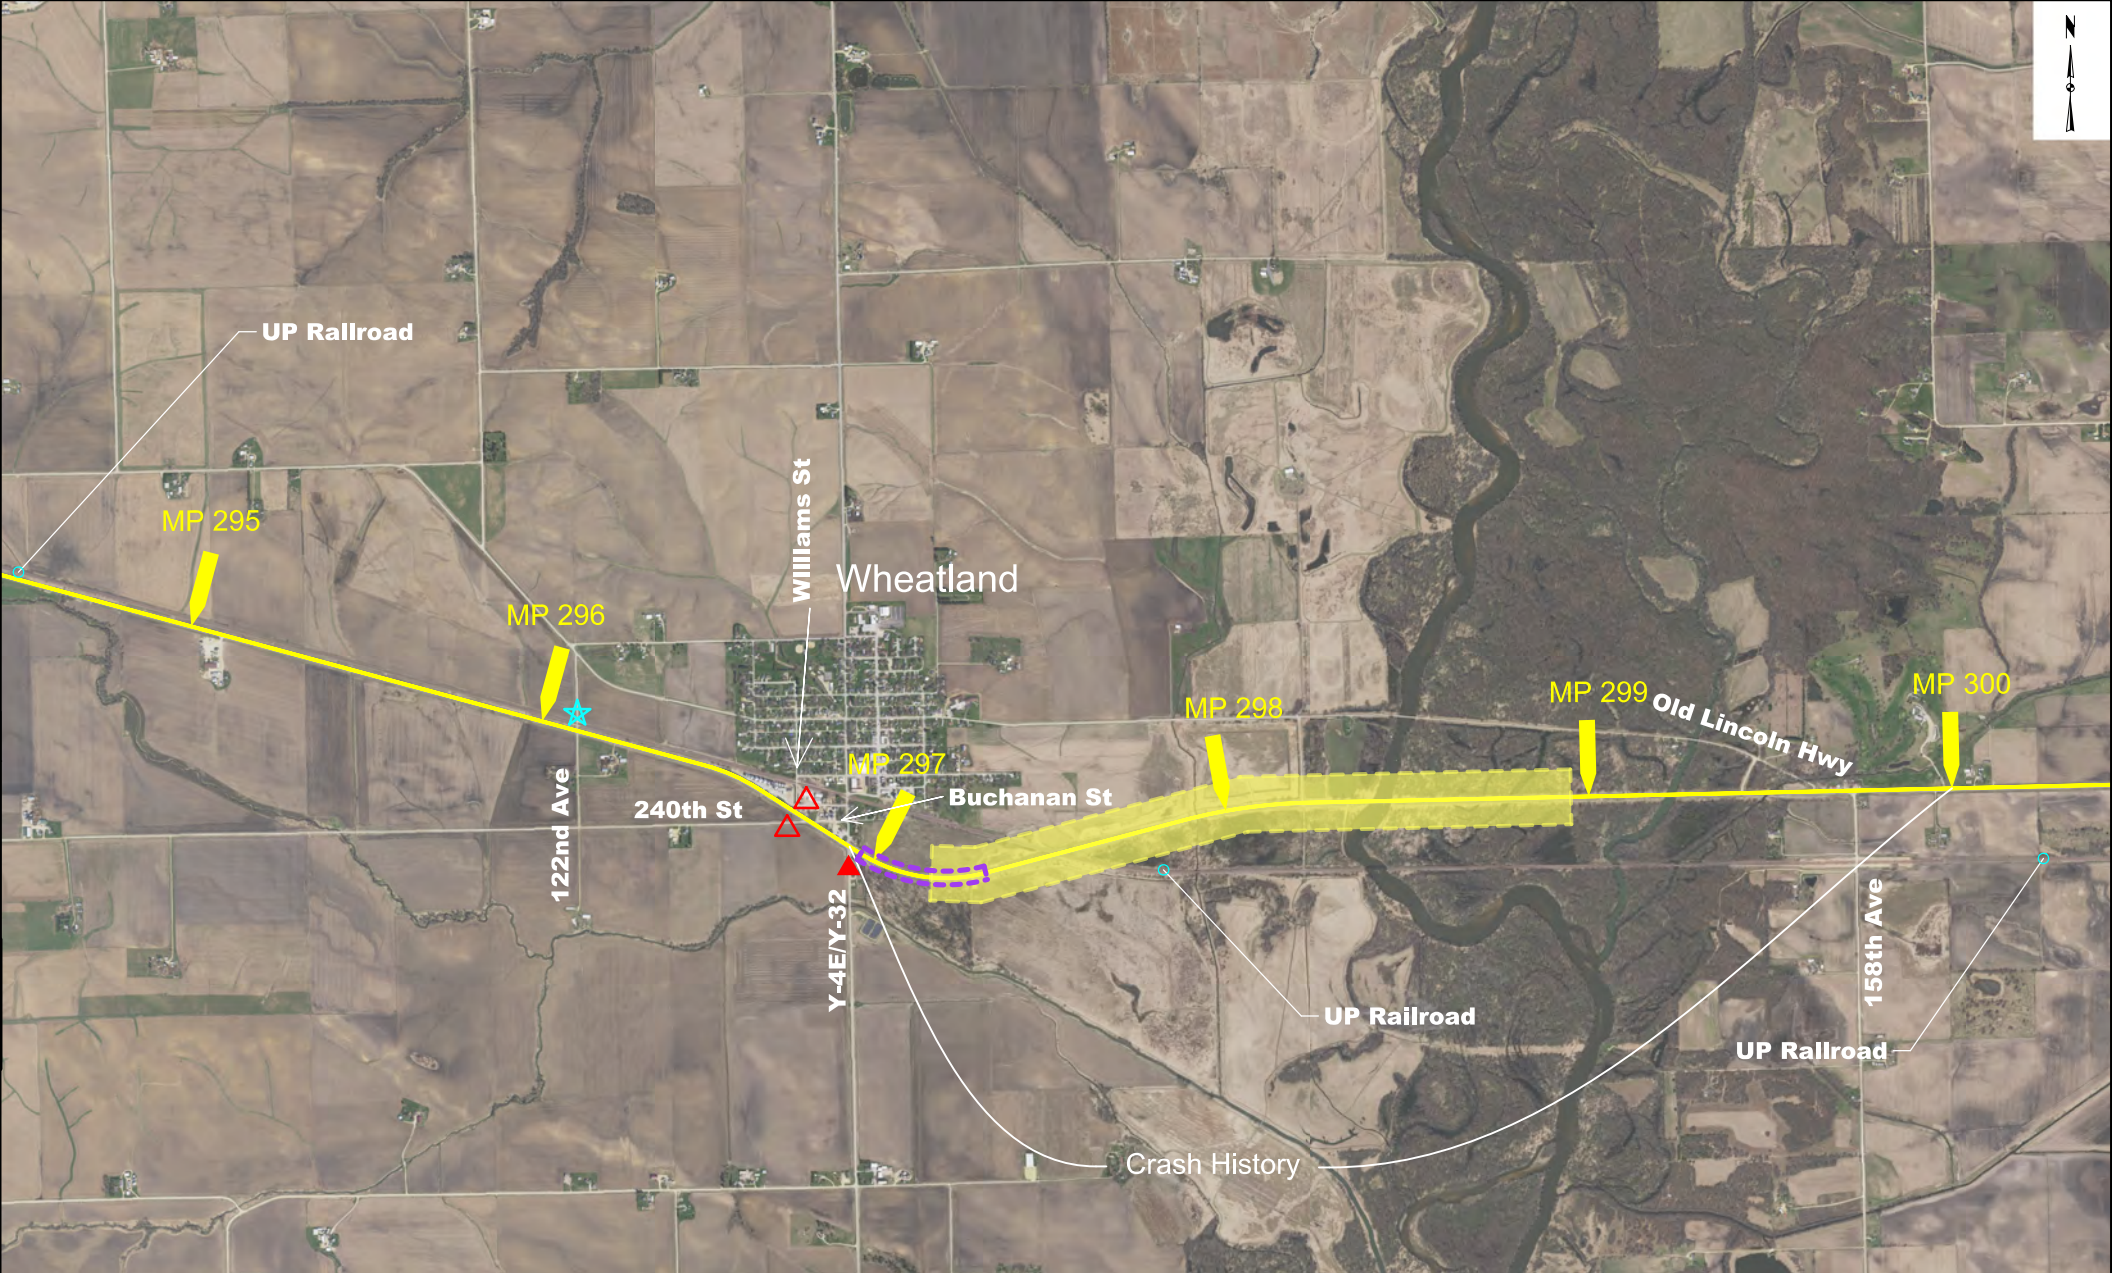
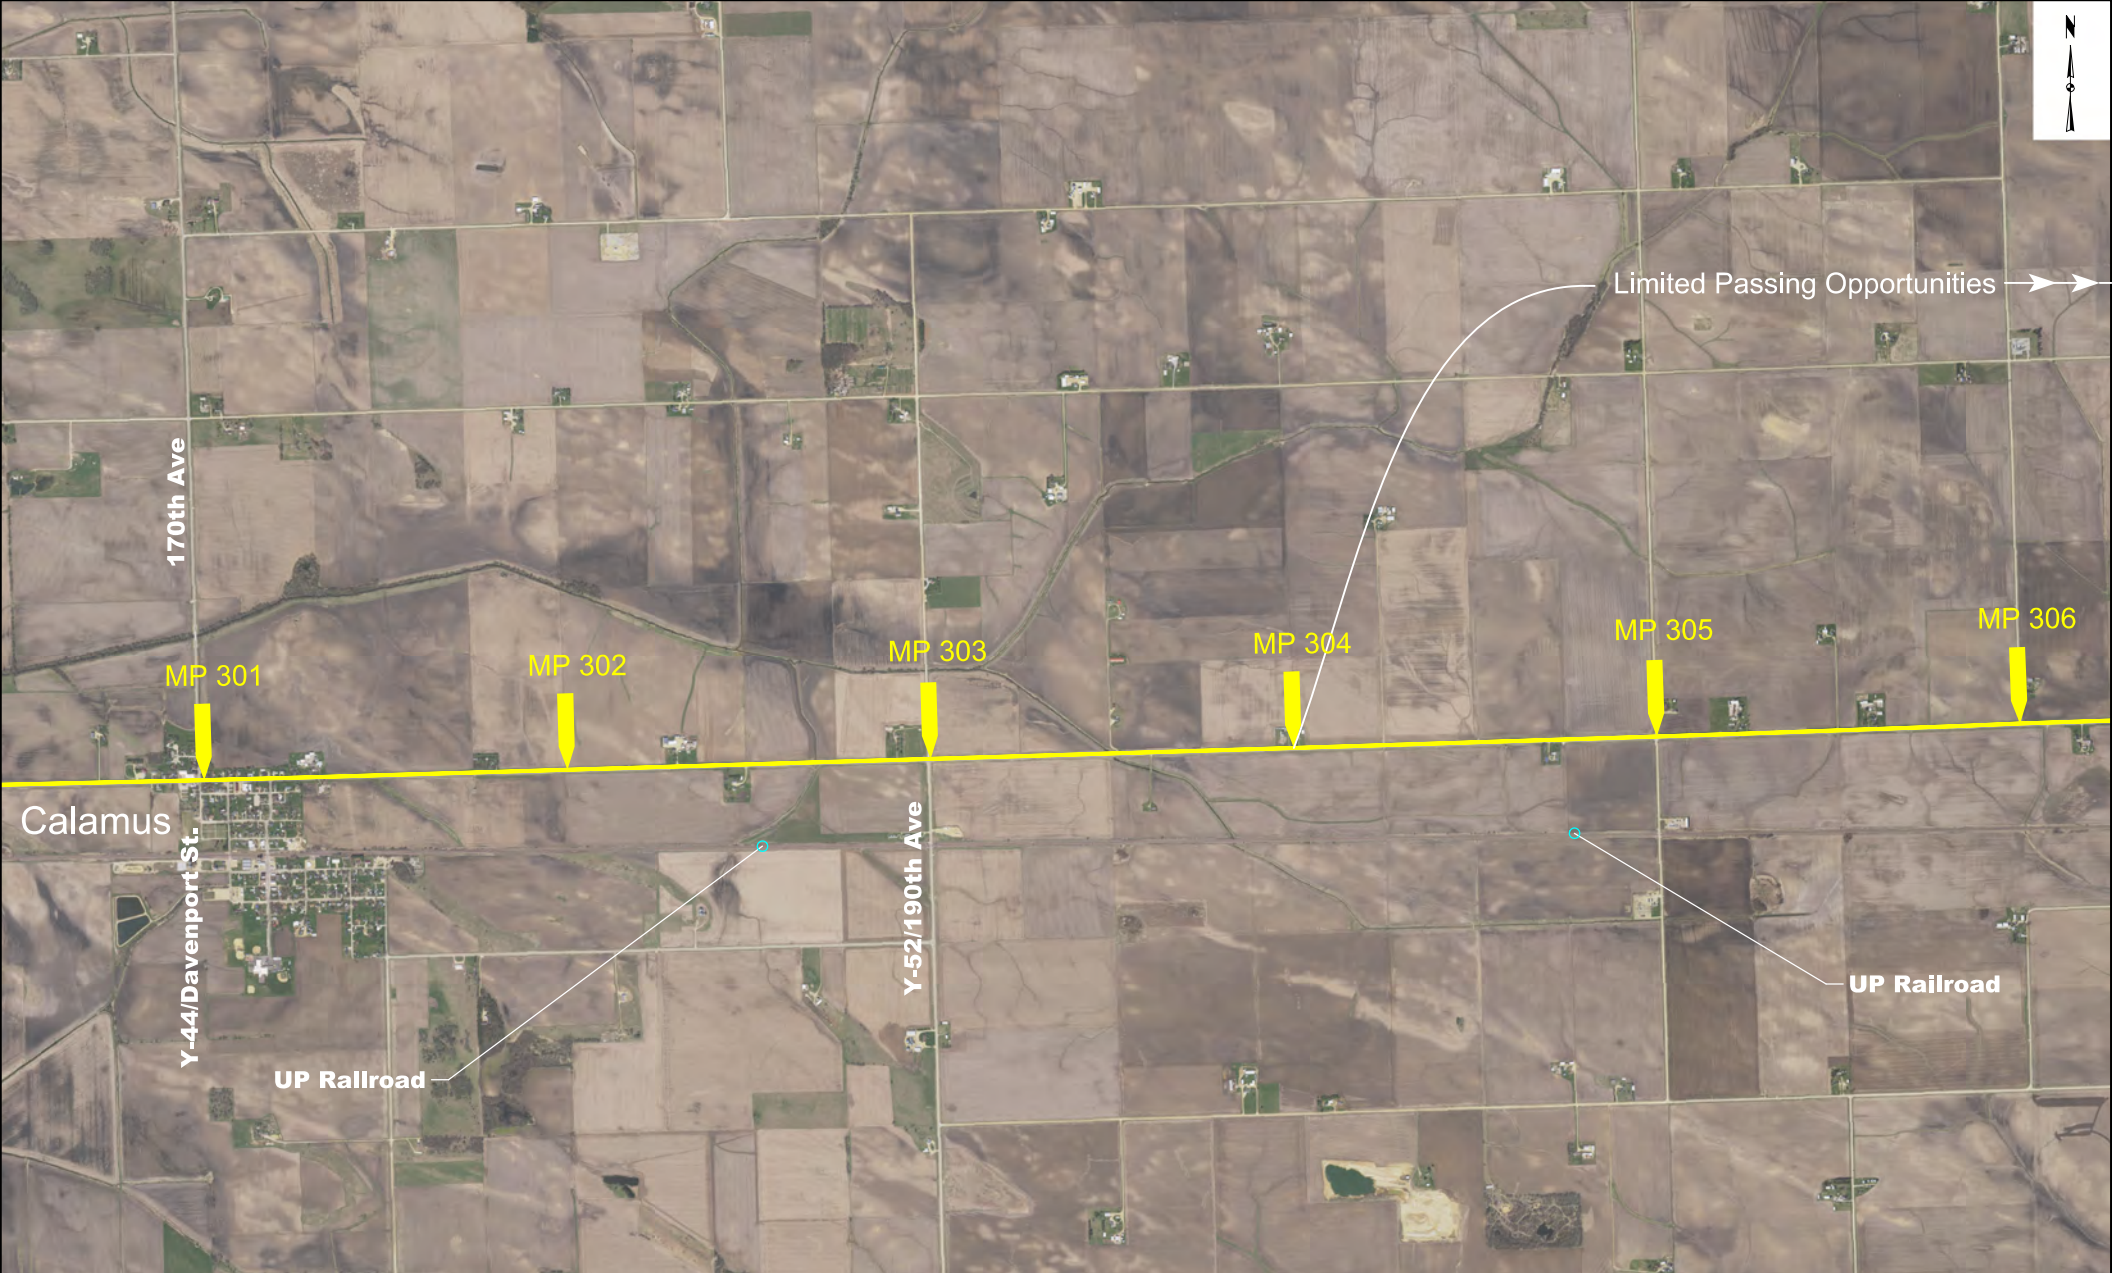
**APPENDIX A – US 30 STUDY CORRIDOR MAPS WITH SUMMARY OF EXISTING
CONDITIONS EVALUATION FINDINGS**

NOTE:
 Limited Passing Opportunities=Passing Zones Generally < 1 Mile in Length
 Minor Crash History=Below Average Crash Rate, but Higher Crash Totals in US 30 Study Corridor*
 Injury Crash History=Above Average Injury Crash Rate*
 Crash History=Above Average Total Crash Rate*
 * Refer to Section 3 for Additional Details

Table ES-1 summarizes the findings of the existing conditions analysis. Appendix A includes a series of corridor maps that also summarizes the key findings of the existing conditions analysis.

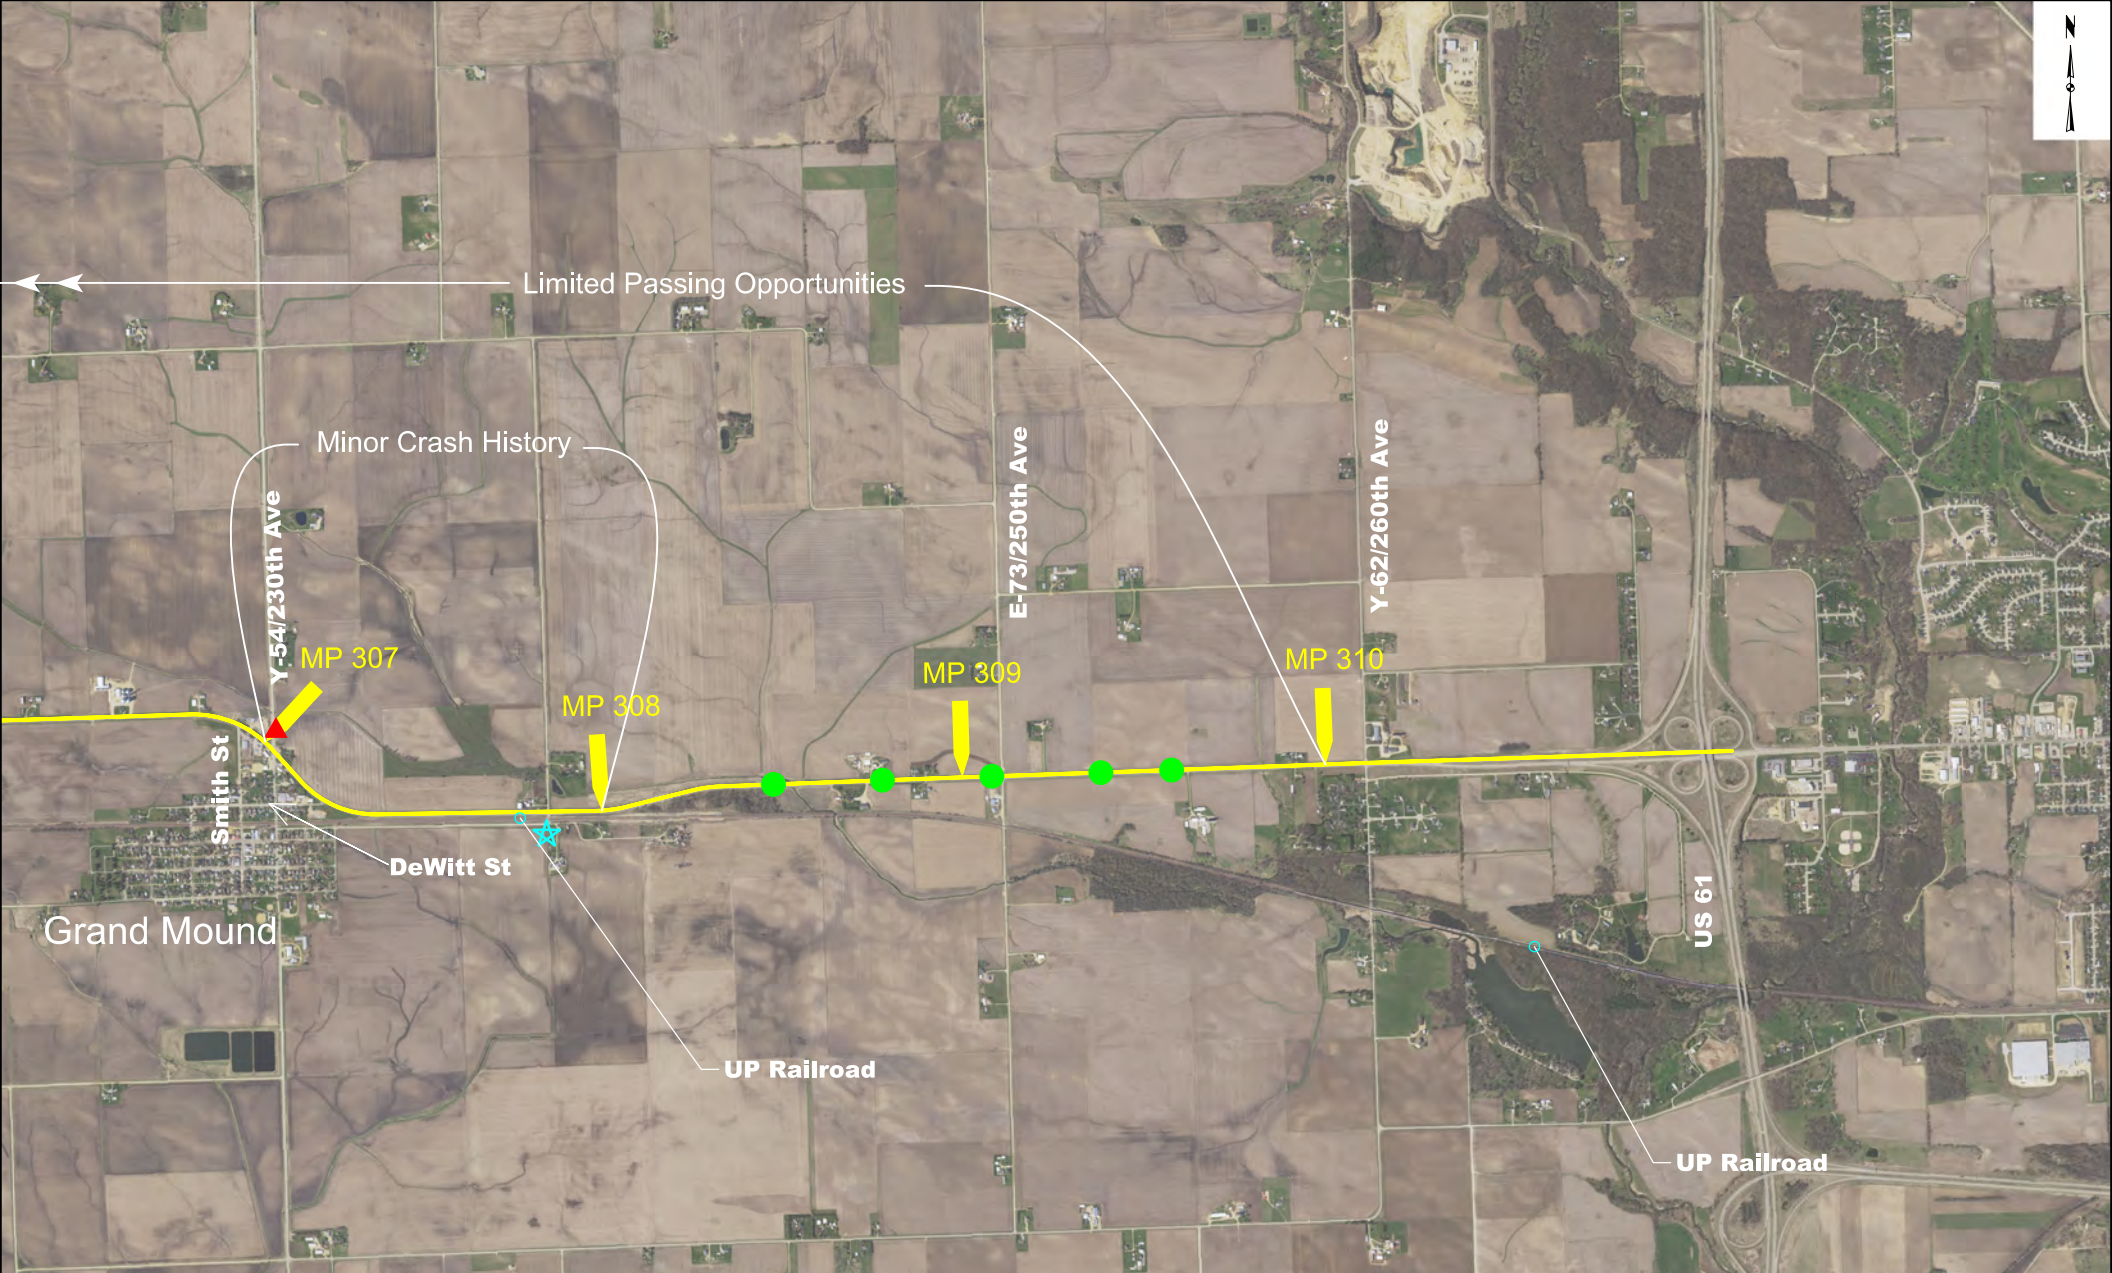
NOTE:
 Limited Passing Opportunities=Passing Zones Generally < 1 Mile in Length
 Minor Crash History=Below Average Crash Rate, but Higher Crash Totals in US 30 Study Corridor*
 Injury Crash History=Above Average Injury Crash Rate*
 Crash History=Above Average Total Crash Rate*
 * Refer to Section 3 for Additional Details

LEGEND	
	Fair Vertical Curve
	RR Crossing Sideroad
	Skewed Intersection
	Skewed Intersection with Crash History
	Poor Pavement Condition (ICE<60)
	Fair Pavement Condition (60<ICE<80)
	Fair Horizontal Curve
