# Albia Municipal Airport

## Pavement Management Report

**AUGUST 2025**

# ALBIA MUNICIPAL AIRPORT PAVEMENT MANAGEMENT REPORT

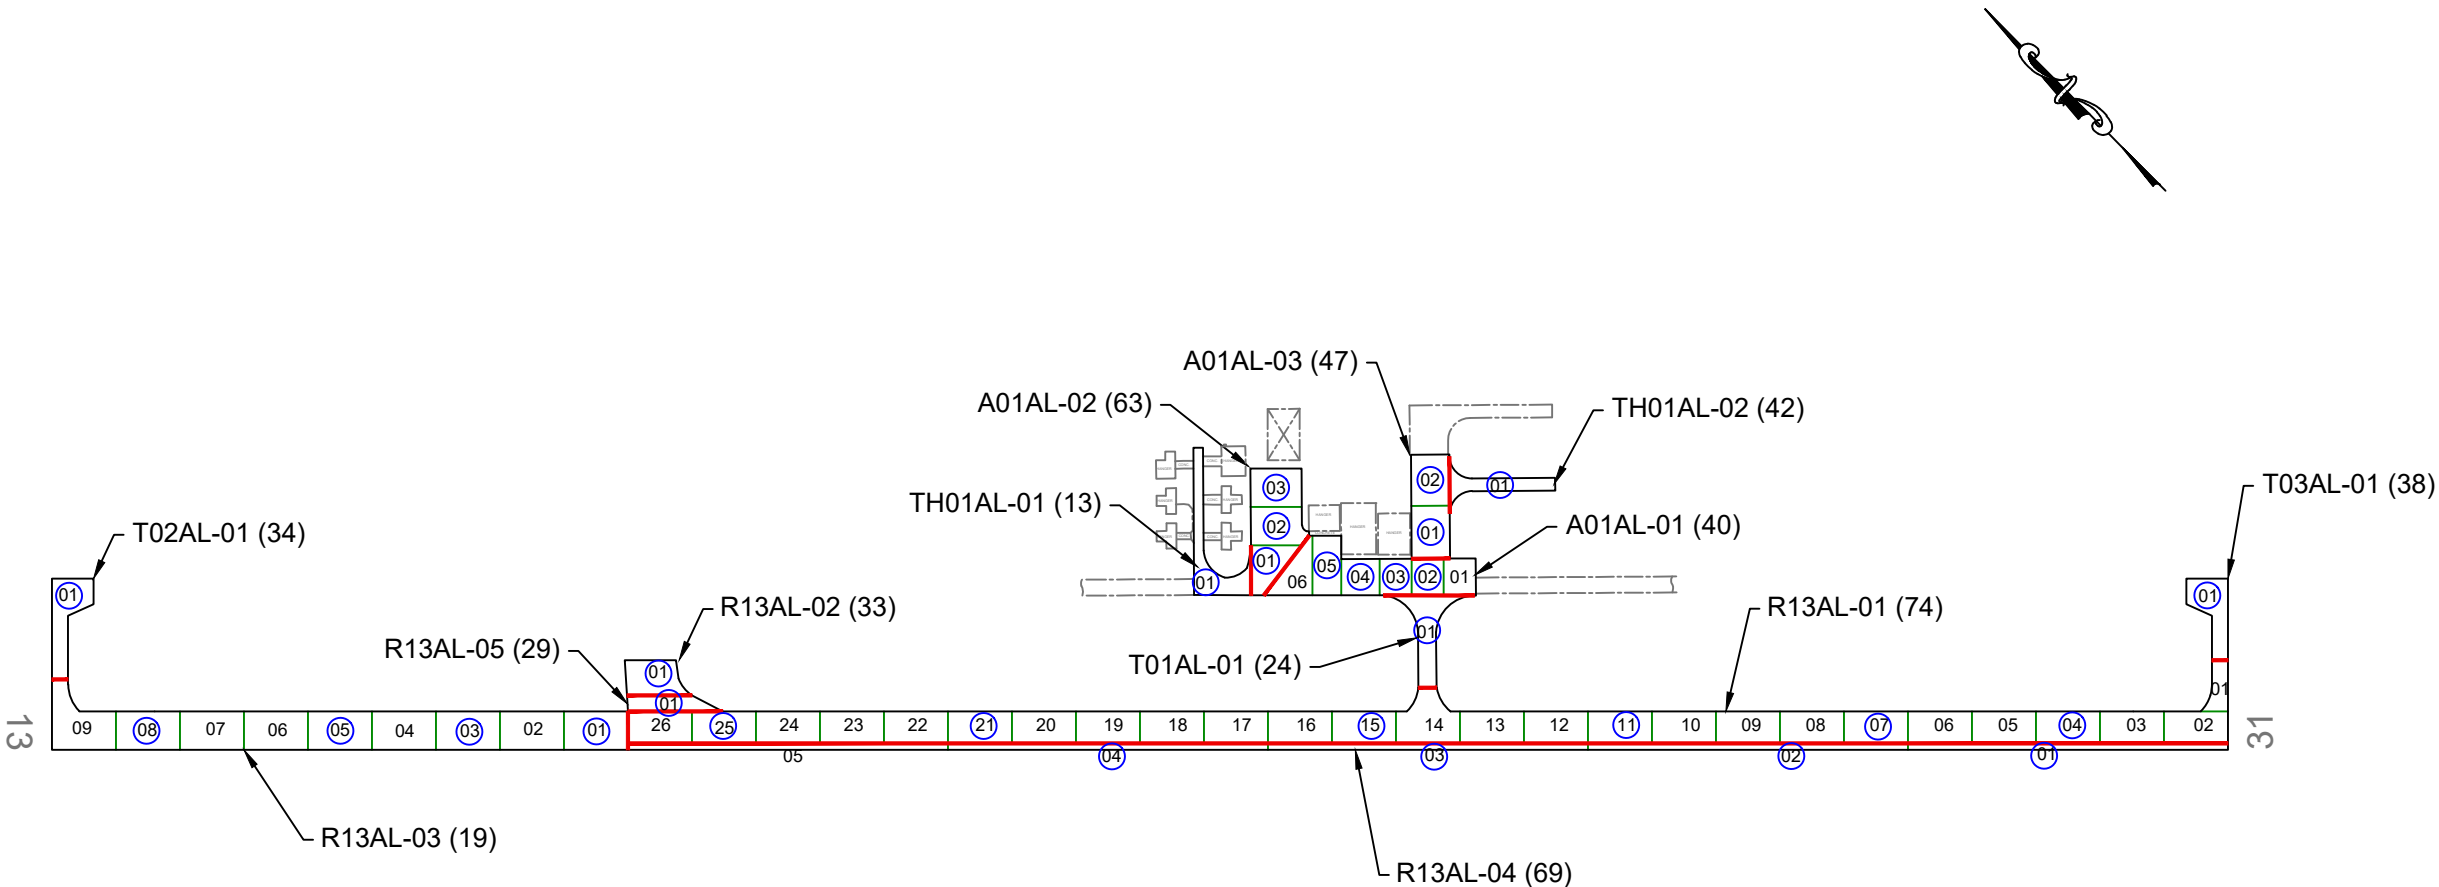
FIGURE 3. NETWORK DEFINITION MAP.

Approximately 287,600 square feet of pavement were evaluated at Albia Municipal Airport, as illustrated in Figure 2. This figure also shows the area-weighted age in years of the pavements at the time of the inspection. Figure 3 provides a map that details how the pavement network was divided into management units and identifies the sample units that were evaluated during the pavement inspection at Albia Municipal Airport.

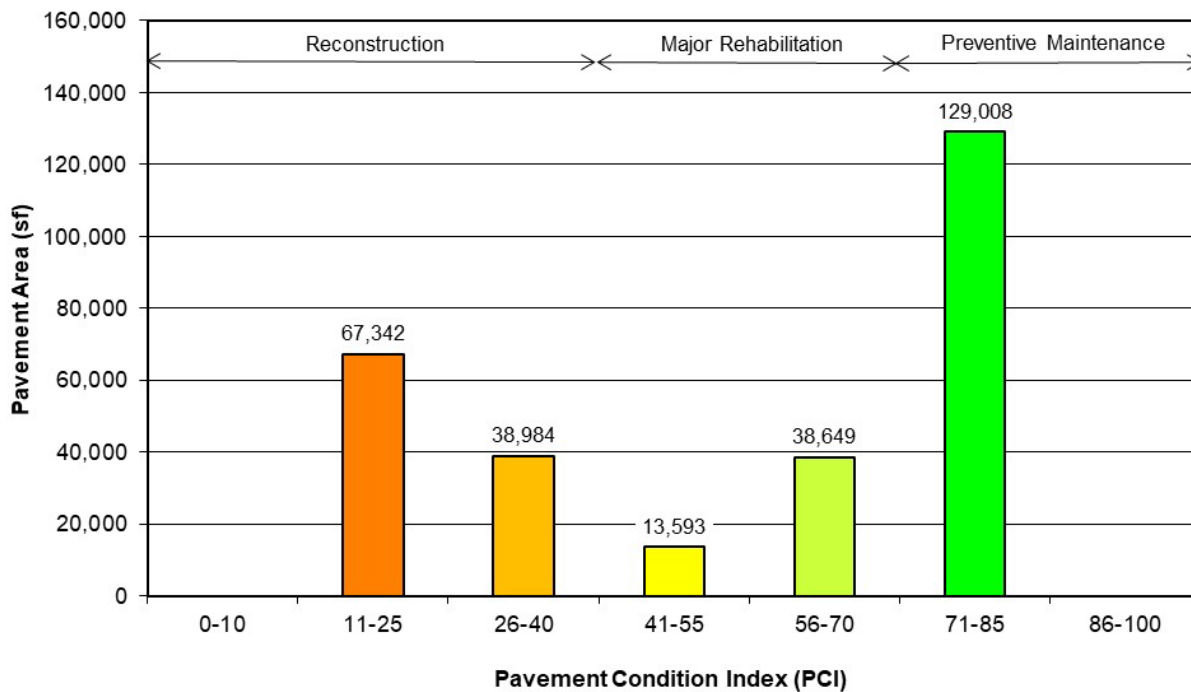
Figure 6. Pavement area by PCI range at Albia Municipal Airport.

The pavements at Albia Municipal Airport were inspected in March 2025. The 2025 area-weighted condition of Albia Municipal Airport is 54, with conditions ranging from 13 to 74 (on a scale of 0 [failed] to 100 [excellent]). During the previous pavement inspection in 2021, the area-weighted PCI of the airport was 56.

Figure 6 summarizes the overall condition of the pavements at Albia Municipal Airport, and Figure 7 presents area-weighted condition (average PCI adjusted to account for the relative size of the pavement sections) by branch use. Figure 8 is a map that displays the condition of the evaluated pavements. Table 1 summarizes the results of the pavement evaluation. Appendix B presents photographs taken during the PCI inspection, and Appendix C contains detailed information on the distress types observed during the visual survey. Appendix D includes detailed work history information that was collected during the record review process.
