Algona Municipal Airport

Pavement Management Report

JULY 2023

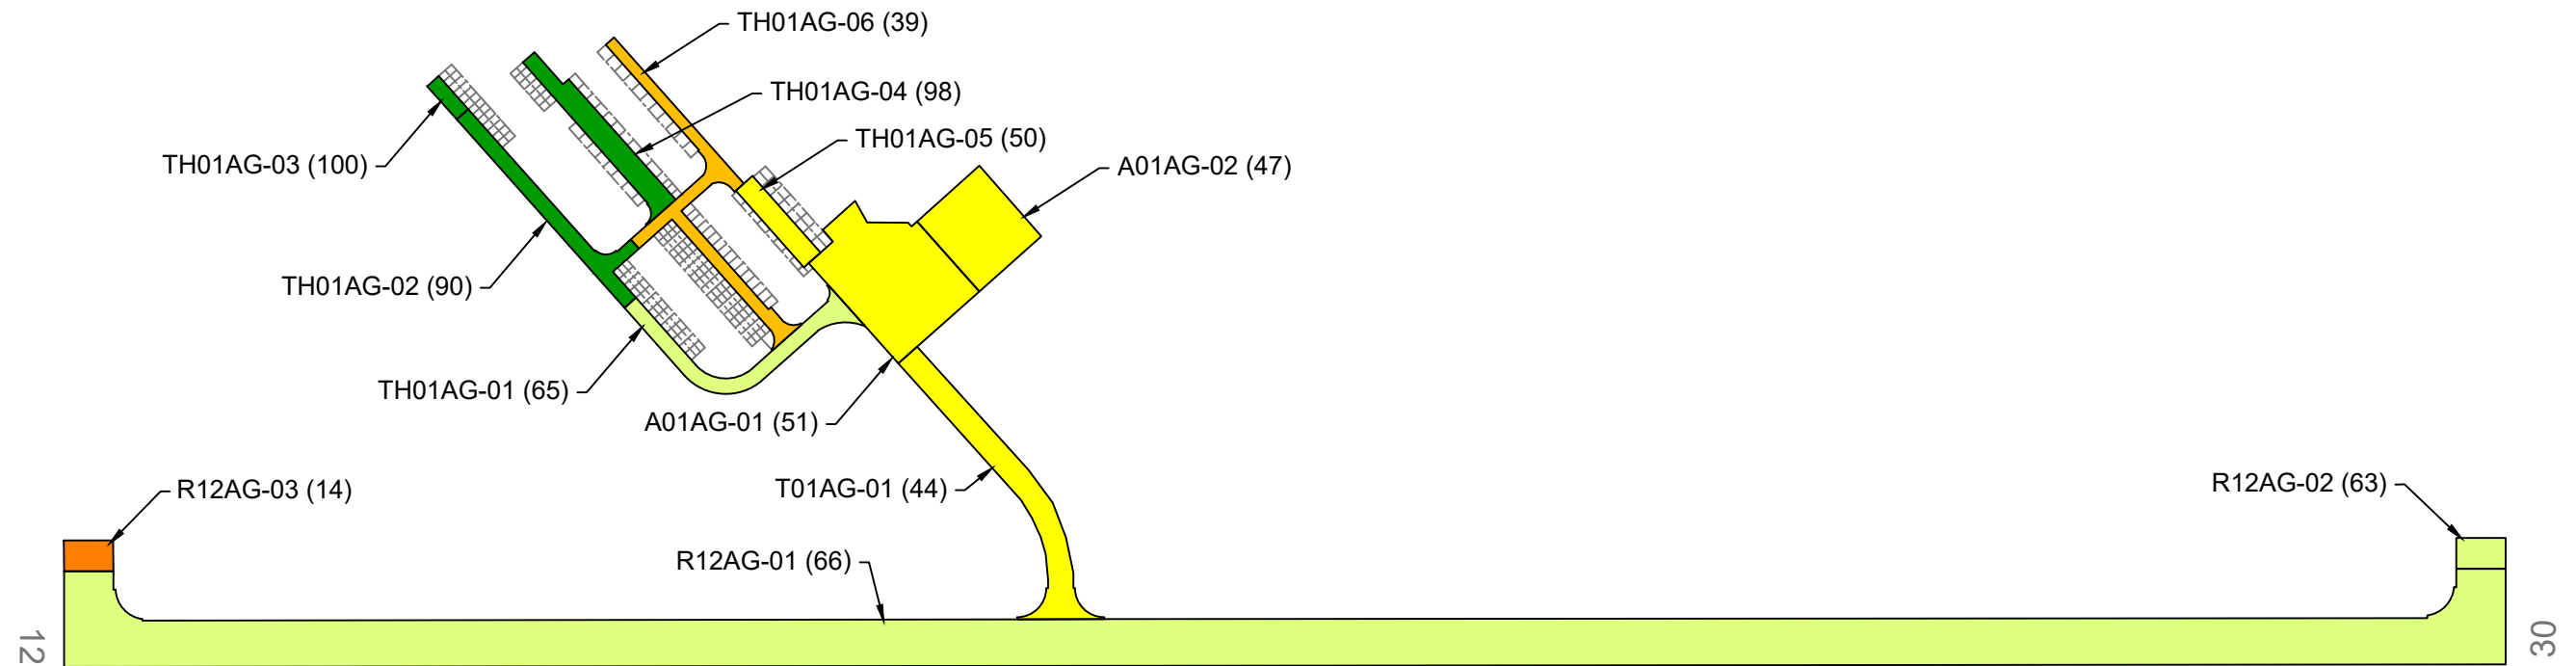
FIGURE 8. PCI MAP.

The pavements at Algona Municipal Airport were inspected in November 2022. The 2022 area-weighted condition of Algona Municipal Airport is 63, with conditions ranging from 14 to 100 (on a scale of 0 [failed] to 100 [excellent]). During the previous pavement inspection in 2019, the area-weighted PCI of the airport was 68.

Figure 6 summarizes the overall condition of the pavements at Algona Municipal Airport, and Figure 7 presents area-weighted condition (average PCI adjusted to account for the relative size of the pavement sections) by branch use. Figure 8 is a map that displays the condition of the evaluated pavements. Table 1 summarizes the results of the pavement evaluation. Appendix B presents photographs taken during the PCI inspection, and Appendix C contains detailed information on the distress types observed during the visual survey. Appendix D includes detailed work history information that was collected during the record review process.
