# Algona Municipal Airport

## Pavement Management Report

**AUGUST 2026**

# ALGONA MUNICIPAL AIRPORT PAVEMENT MANAGEMENT REPORT

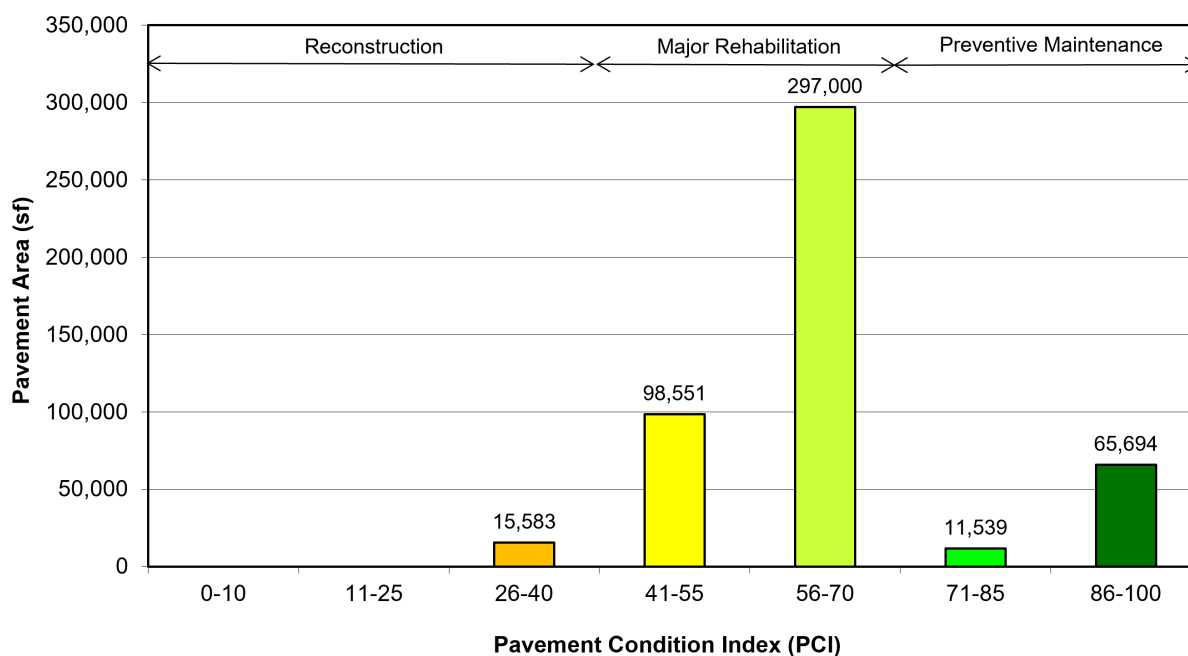
Figure 6. Pavement area by PCI range at Algona Municipal Airport.

The pavements at Algona Municipal Airport were inspected in February 2026. The 2026 area-weighted condition of Algona Municipal Airport is 67, with conditions ranging from 34 to 100 (on a scale of 0 [*Failed*] to 100 [*Excellent*]). During the previous pavement inspection in 2022, the area-weighted PCI of the airport was 63.

Figure 6 summarizes the overall condition of the pavements at Algona Municipal Airport, and Figure 7 presents area-weighted condition (average PCI adjusted to account for the relative size of the pavement sections) by branch use. Figure 8 is a map that displays the condition of the evaluated pavements. Table 1 summarizes the results of the pavement evaluation. Appendix B presents photographs taken during the PCI inspection, and Appendix C contains detailed information on the distress types observed during the visual survey. Appendix D includes detailed work history information that was collected during the record review process.
