# Ames Municipal Airport

## Pavement Management Report

**AUGUST 2026**

# AMES MUNICIPAL AIRPORT PAVEMENT MANAGEMENT REPORT

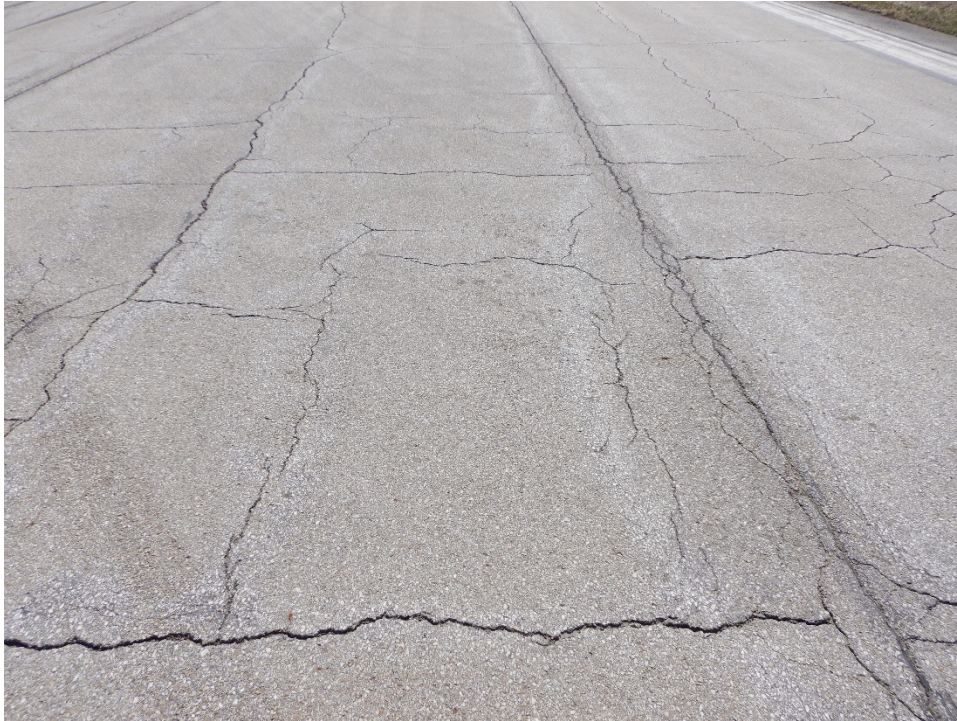
R01AM-01. Block Cracking (Sample Unit No. 91).

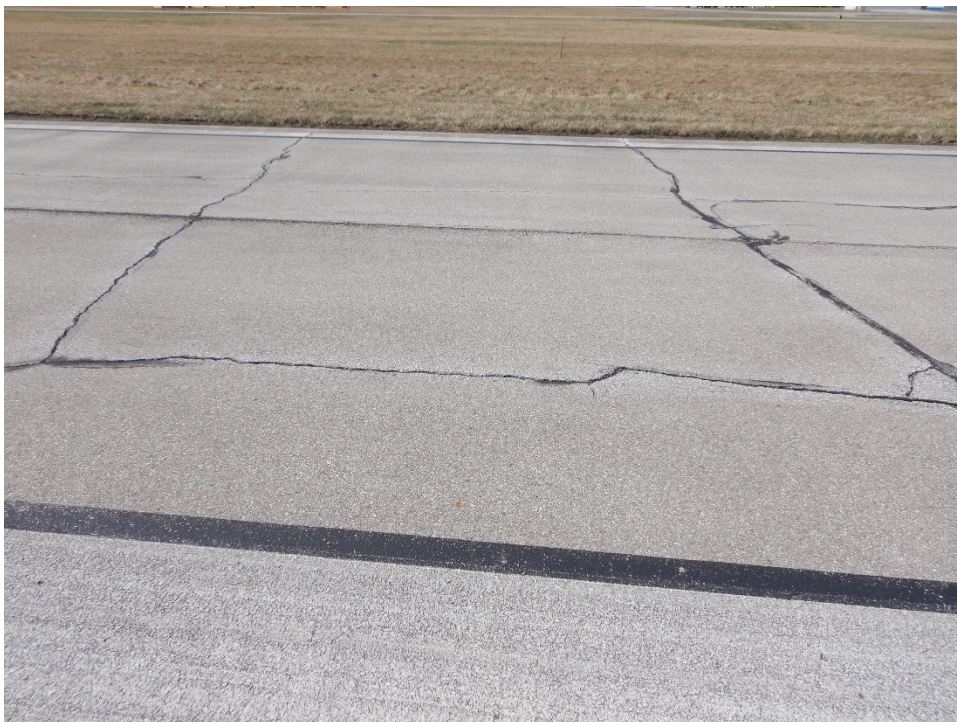
R01AM-01. Joint Reflection Cracking (Sample Unit No. 109).

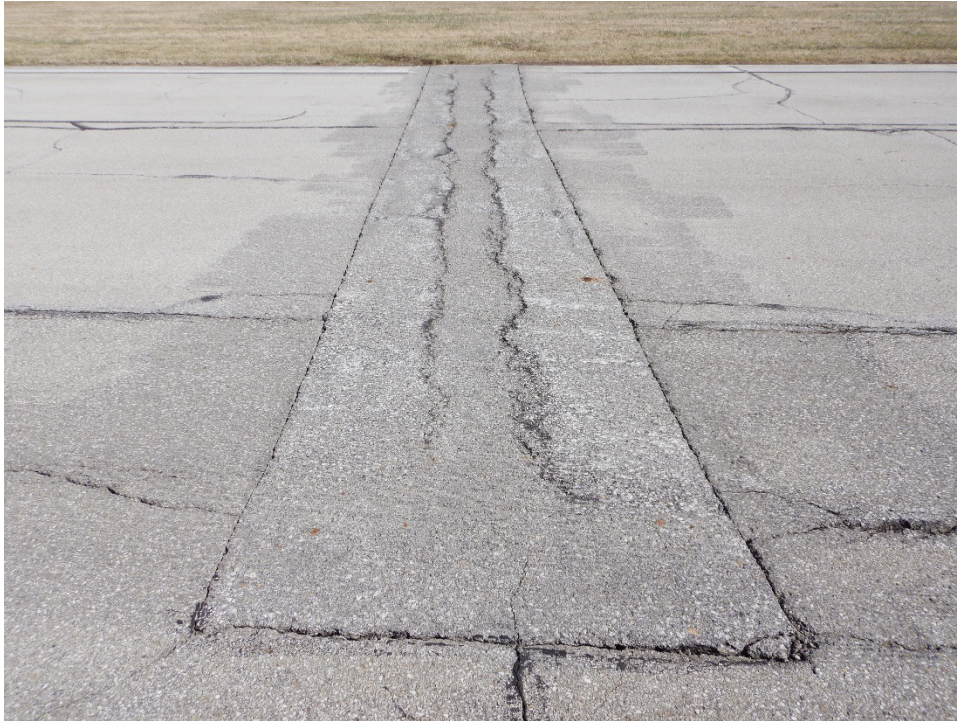
R01AM-01. Patching (Sample Unit No. 76).

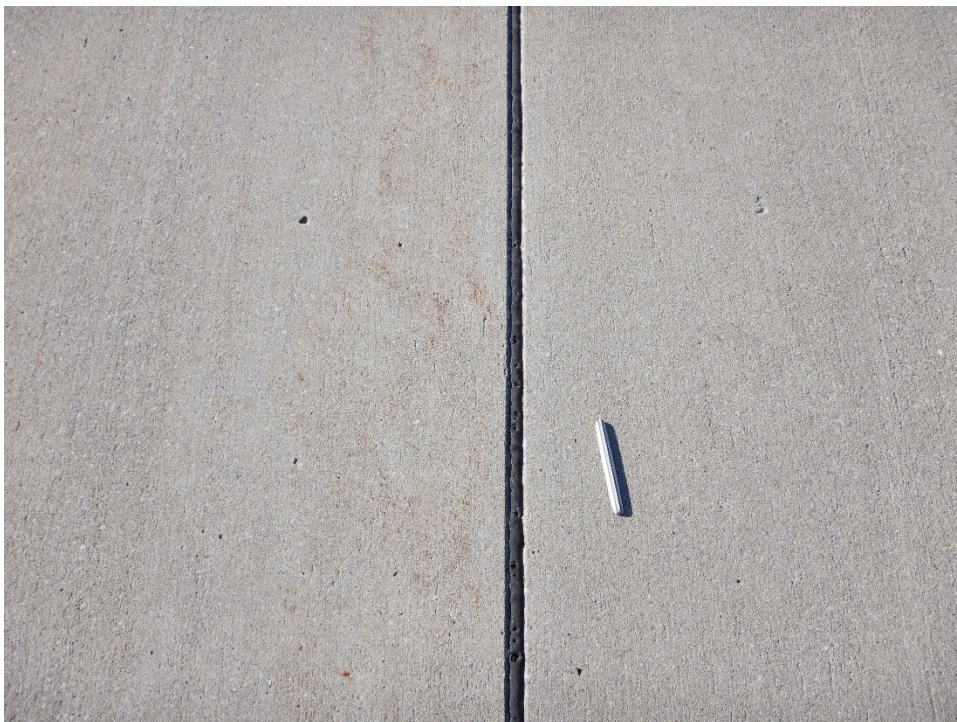
R13AM-01. Joint Seal Damage (Sample Unit No. 12).

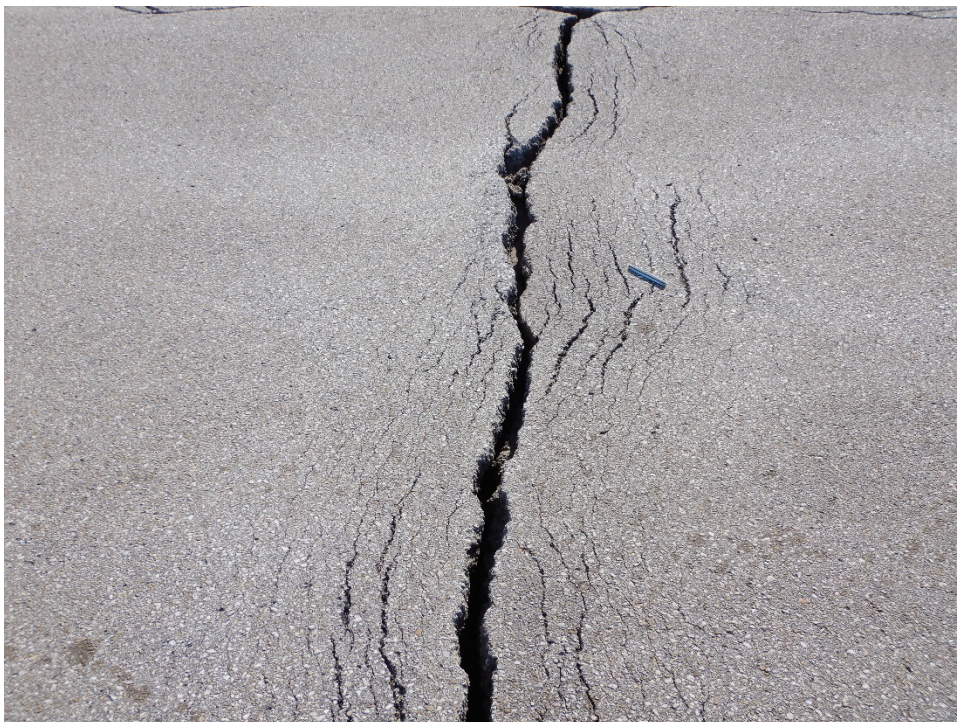
R13AM-03. L&T Cracking (Sample Unit No. 01) (1).

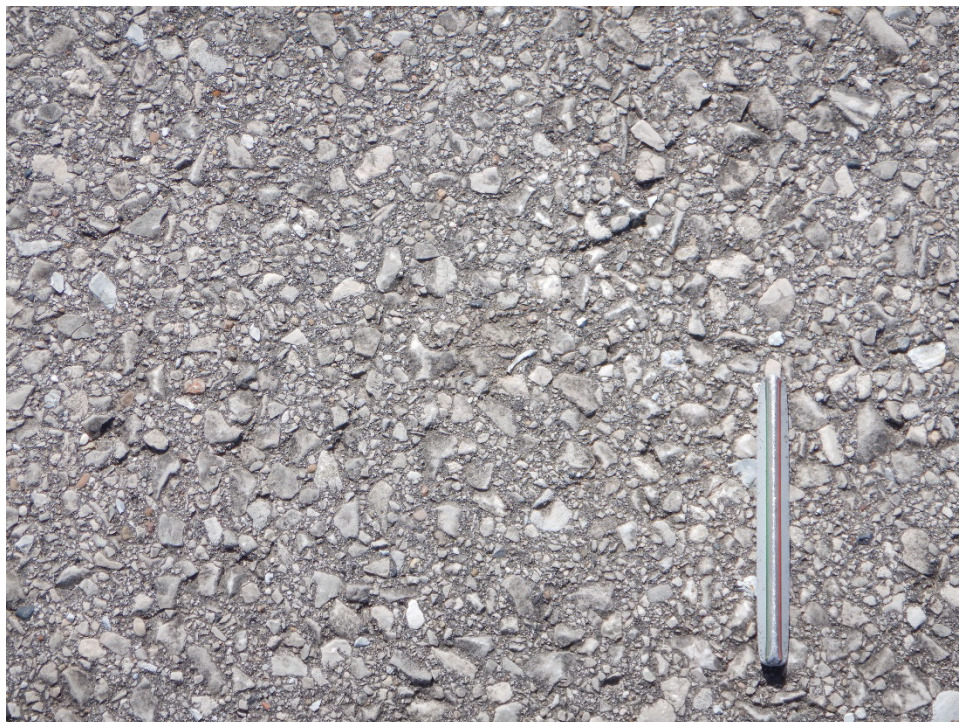
T13AM-02. Weathering (Sample Unit No. 02).

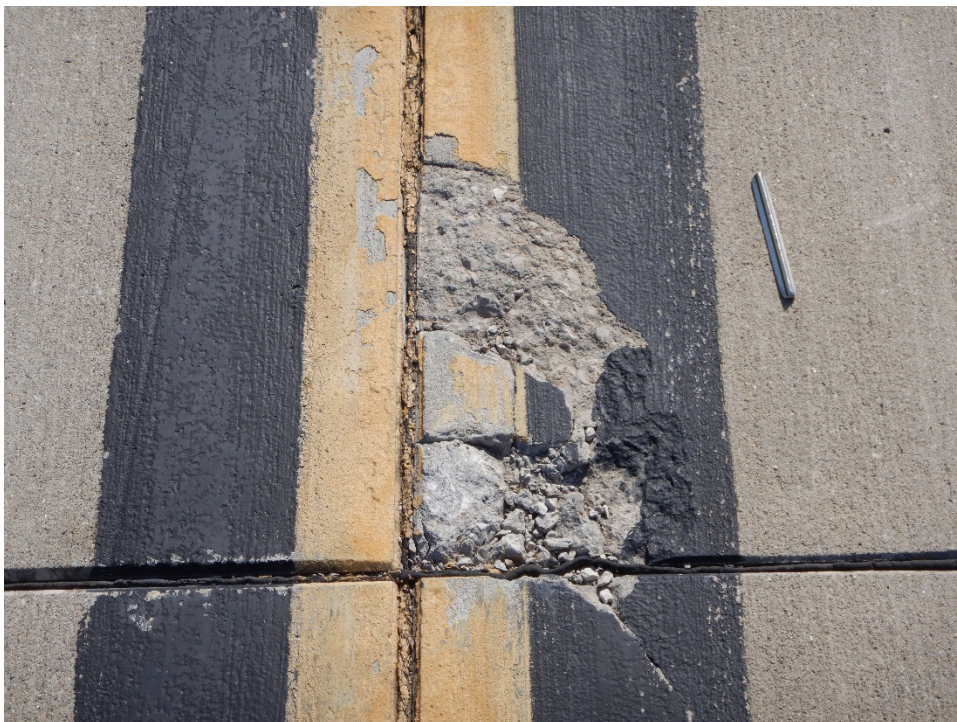
TA1AM-01. Corner Spalling (Sample Unit No. 06).

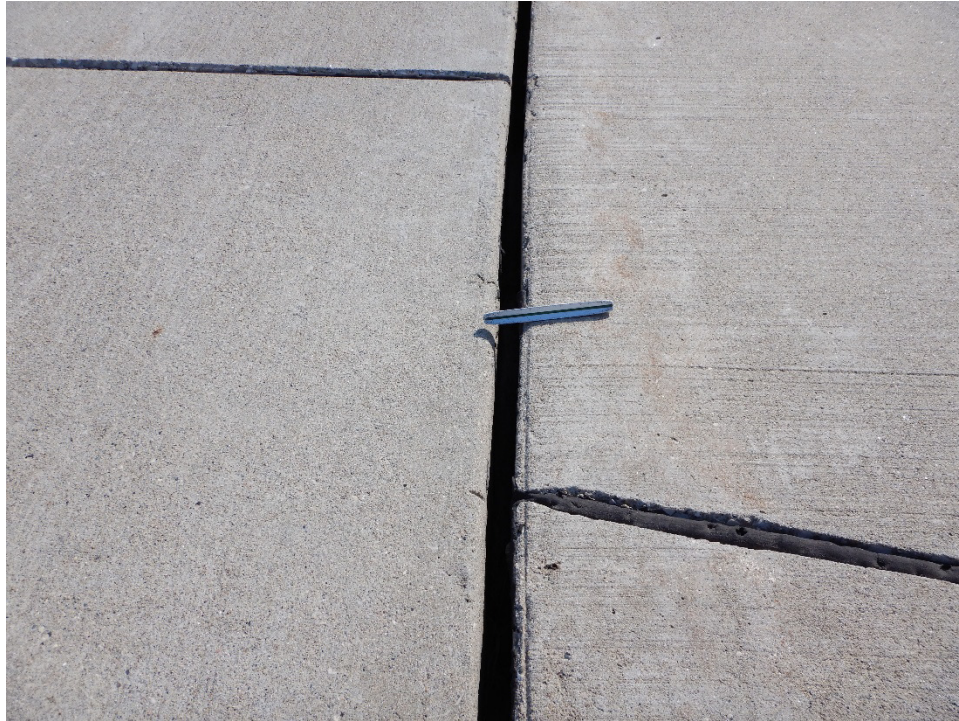
TA1AM-01. Faulting (Sample Unit No. 09).

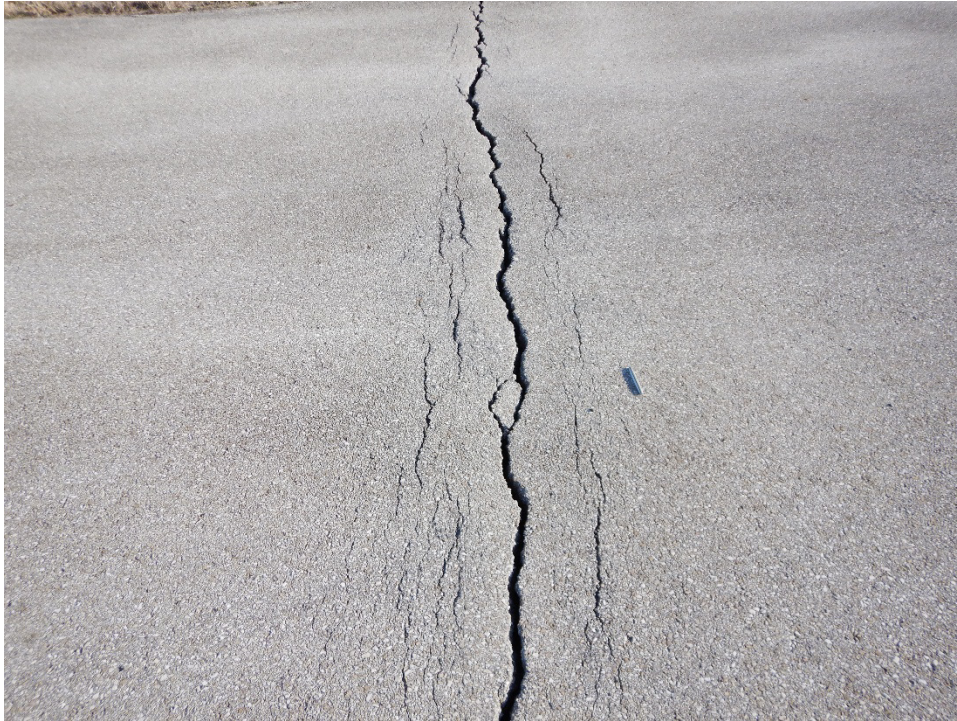
TA2AM-02. L&T Cracking (Sample Unit No. 01).

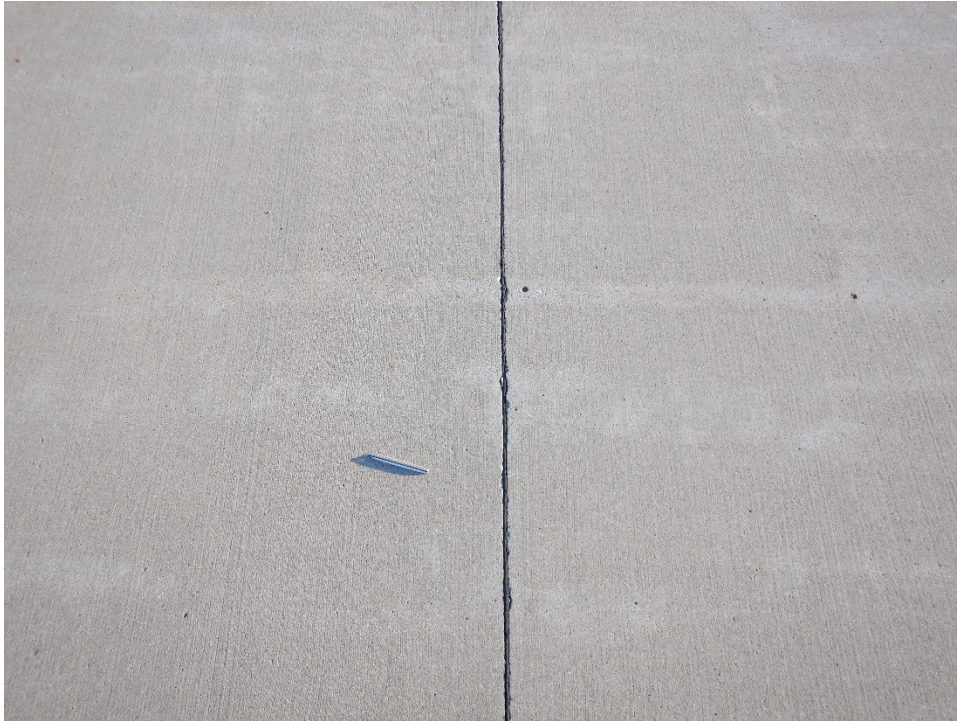
TA3AM-01. Joint Seal Damage (Sample Unit No. 06).

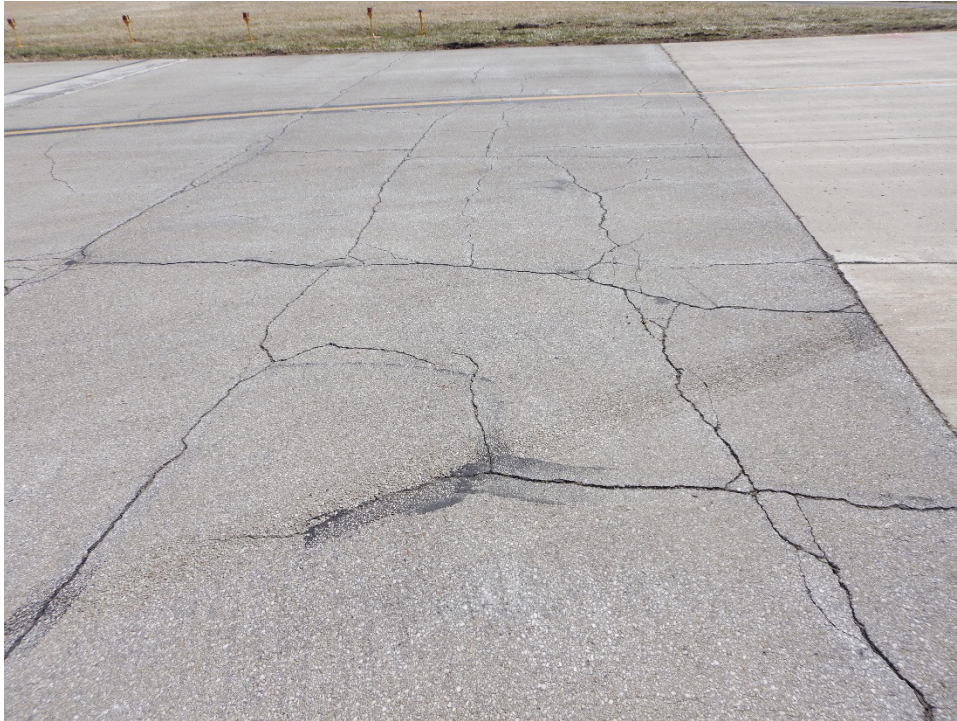
TA4AM-02. L&T Cracking (Sample Unit No. 01) (1).

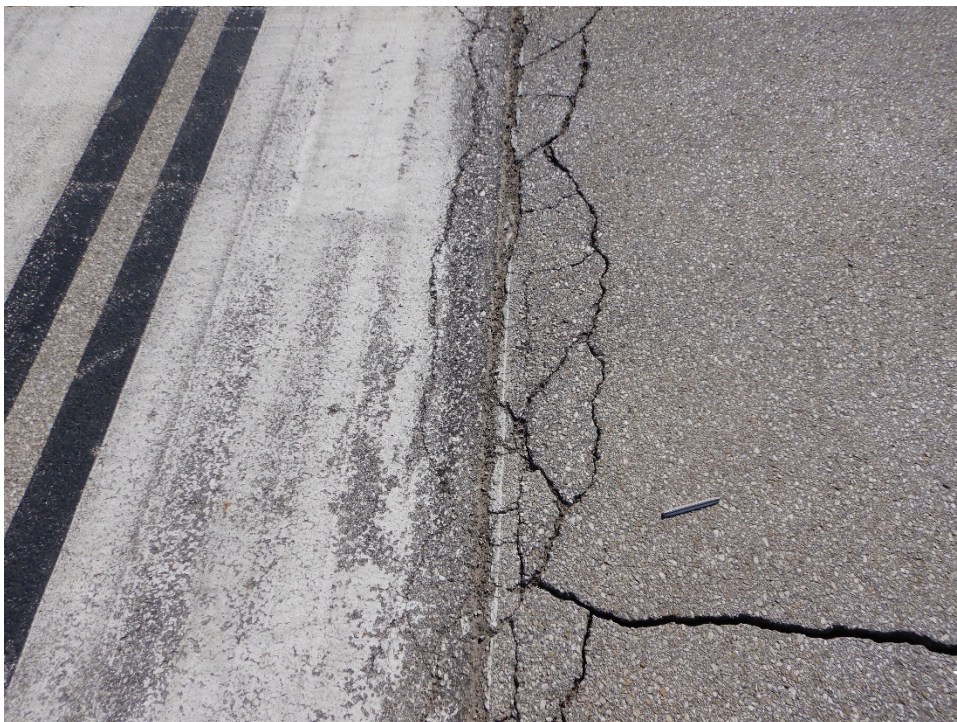
TA4AM-02. L&T Cracking (Sample Unit No. 01) (2).

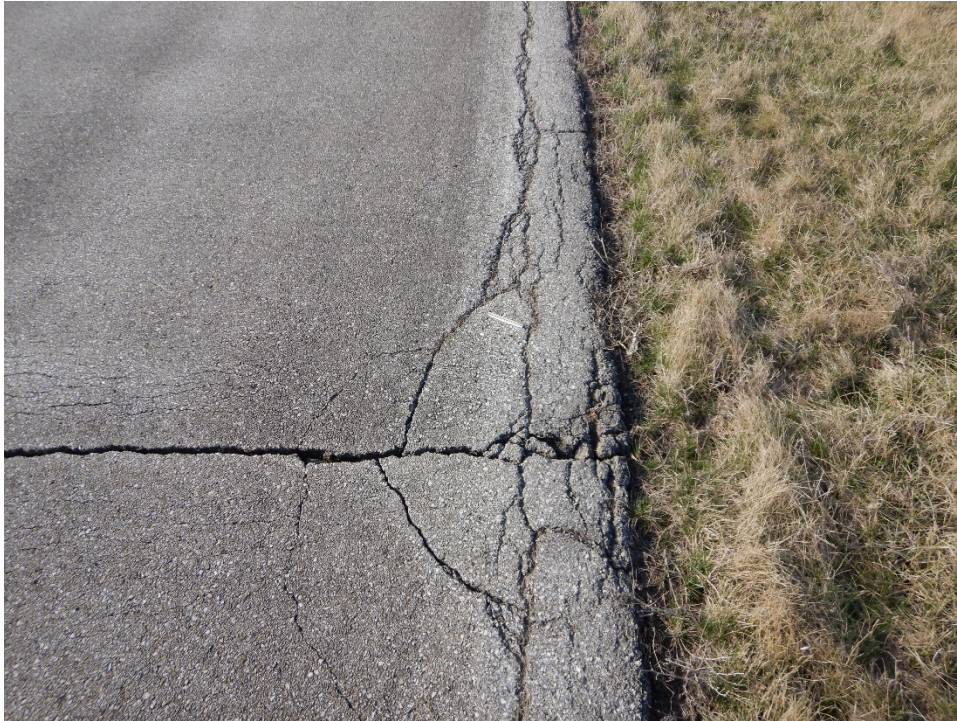
TAAM-02. L&T Cracking (Sample Unit No. 04) (1).

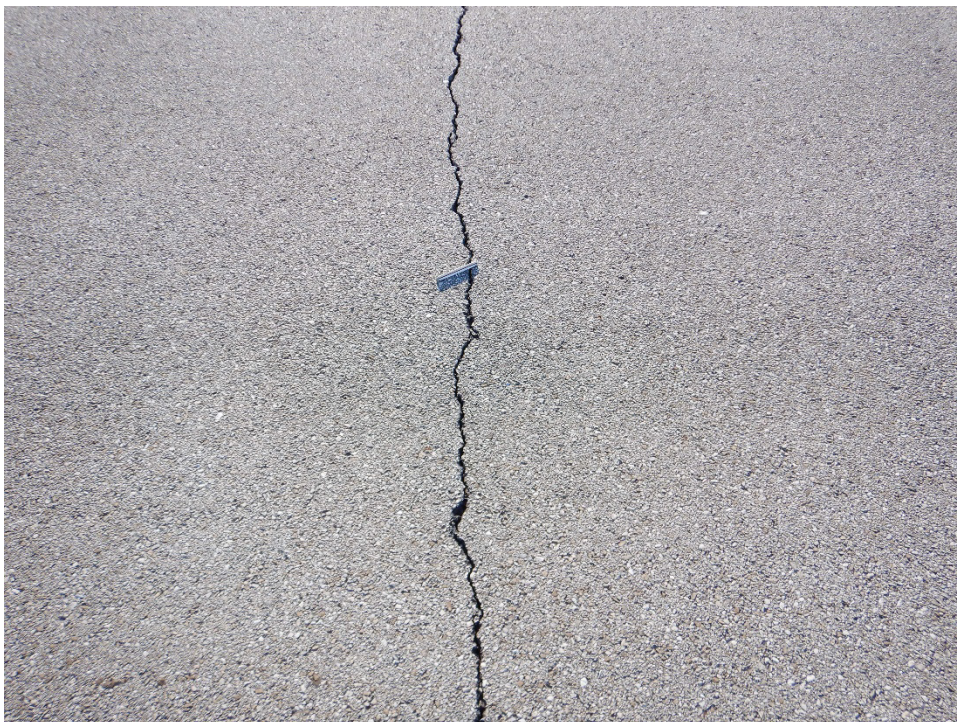
TAAM-02. L&T Cracking (Sample Unit No. 04) (2).

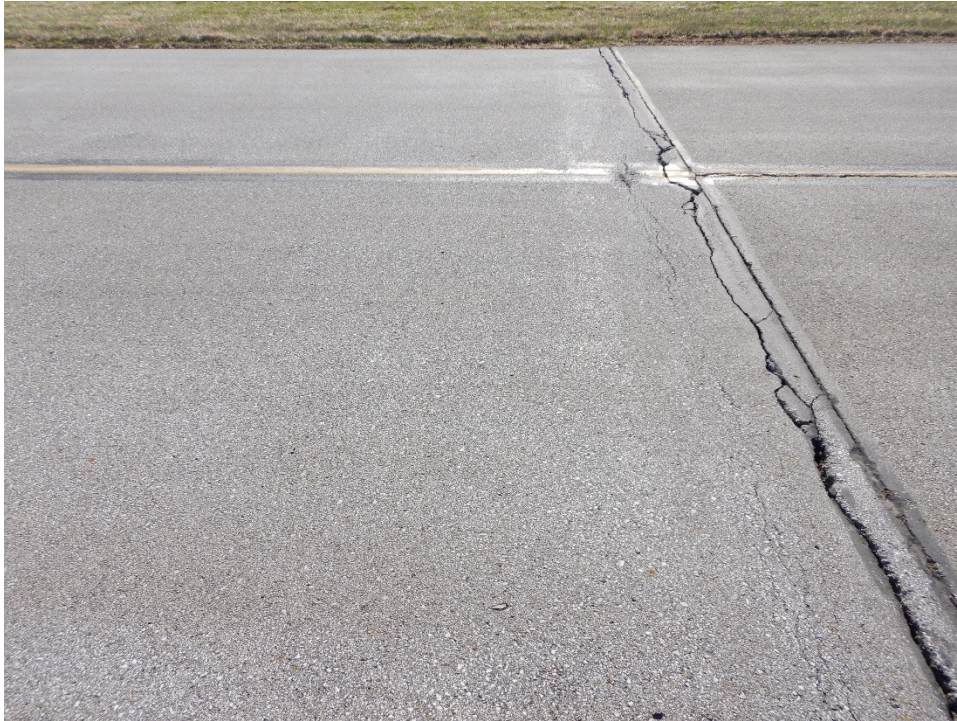
TAAM-02. Patching (Additional Sample Unit No. 18).

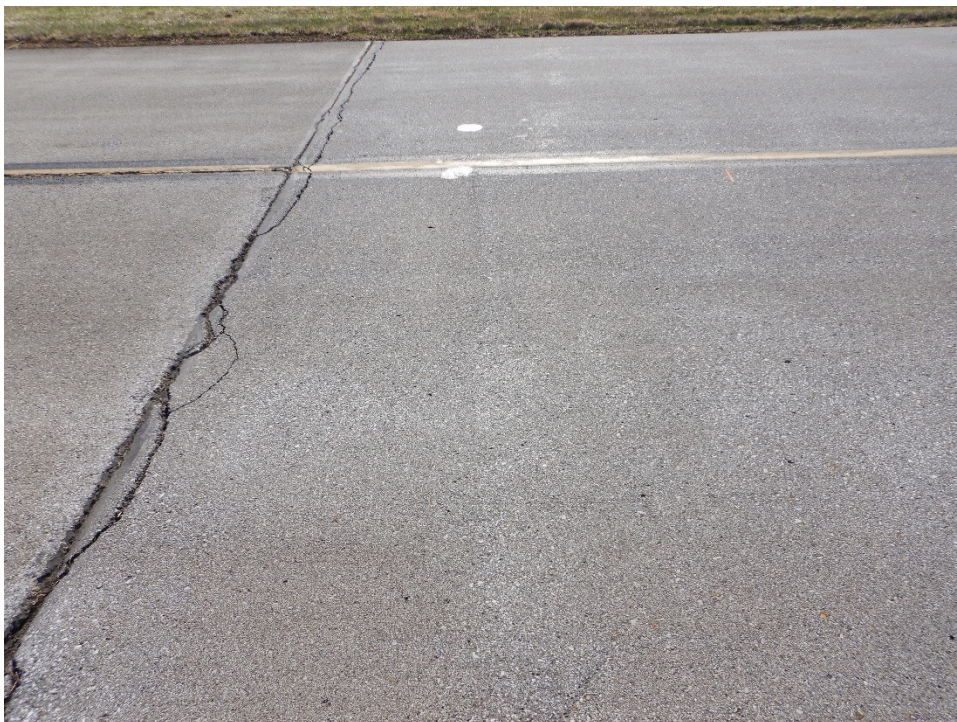
TAAM-03. Overview.

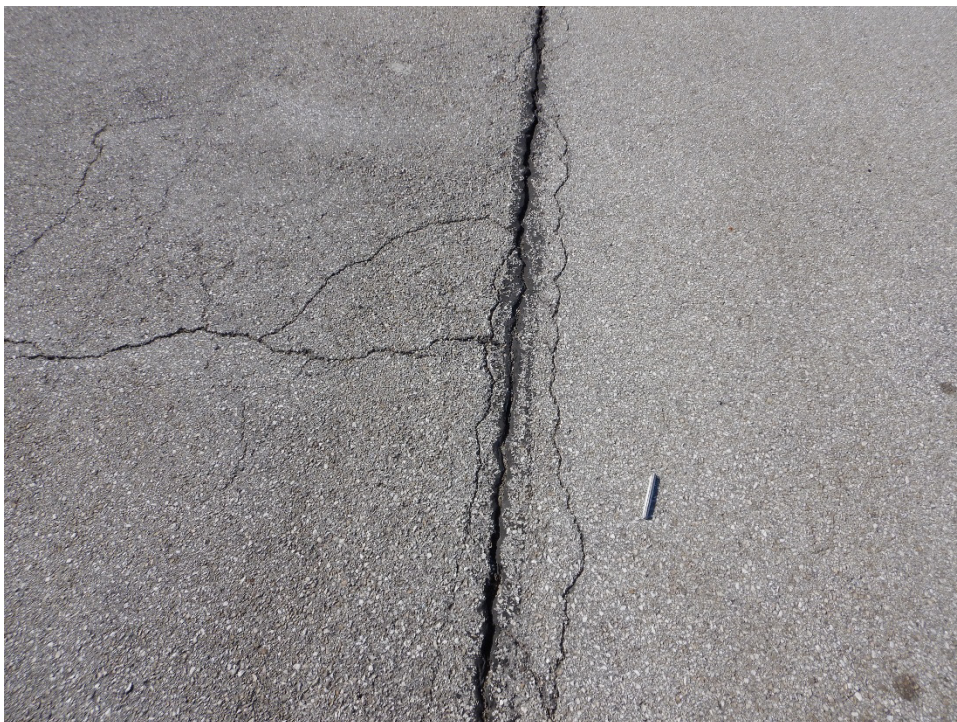
TAAM-03. Raveling (Sample Unit No. 01).

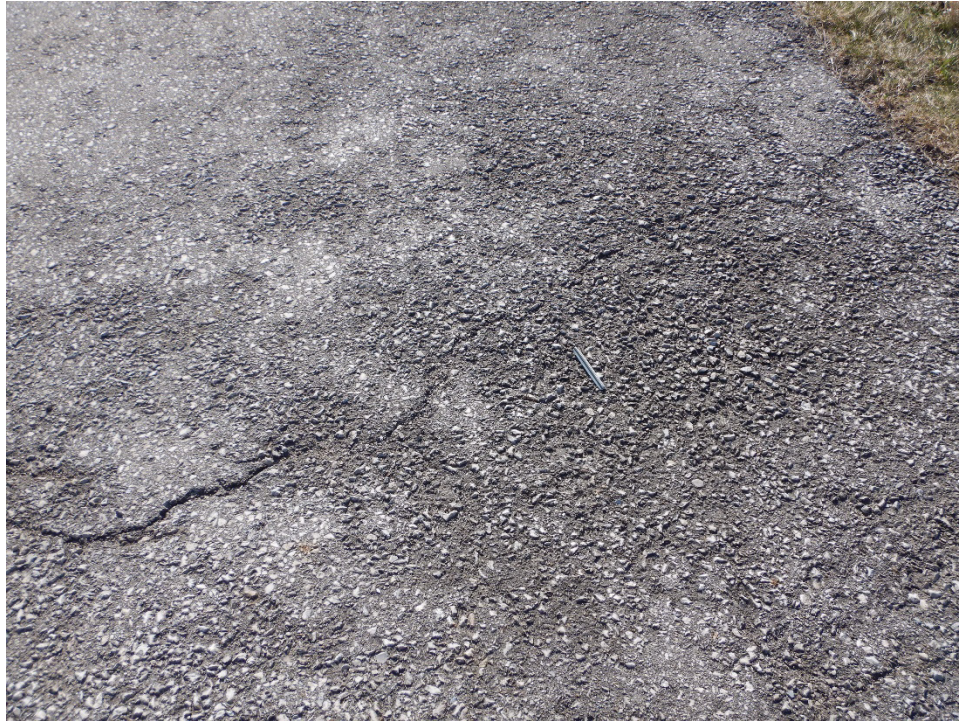
TAAM-03. Weathering (Sample Unit No. 01).

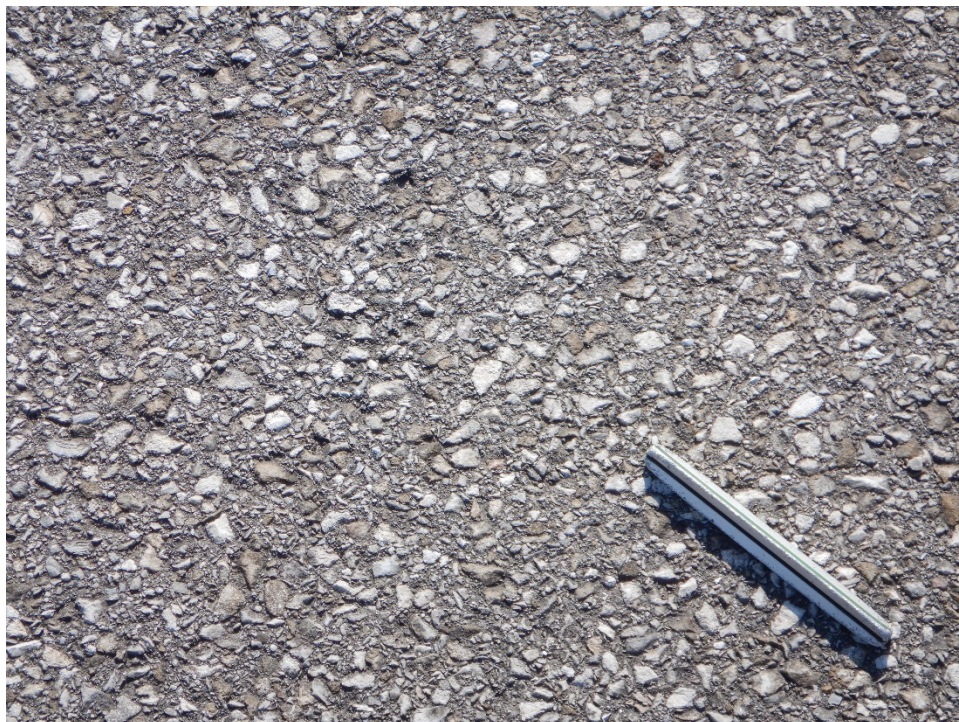
TAAM-04. Overview.

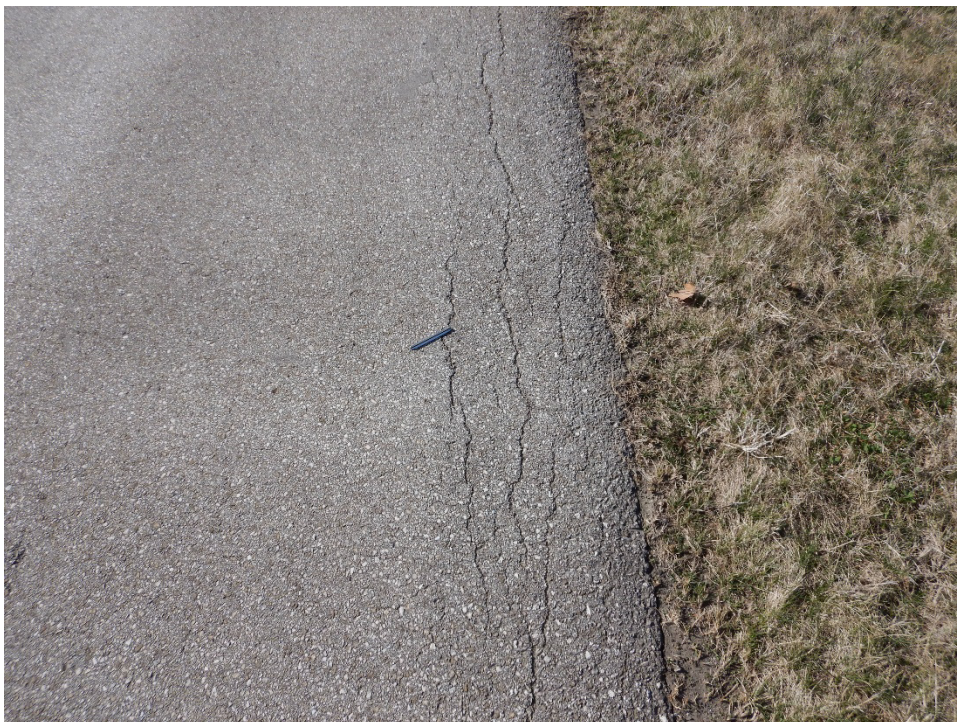
TAAM-04. L&T Cracking (Sample Unit No. 04).

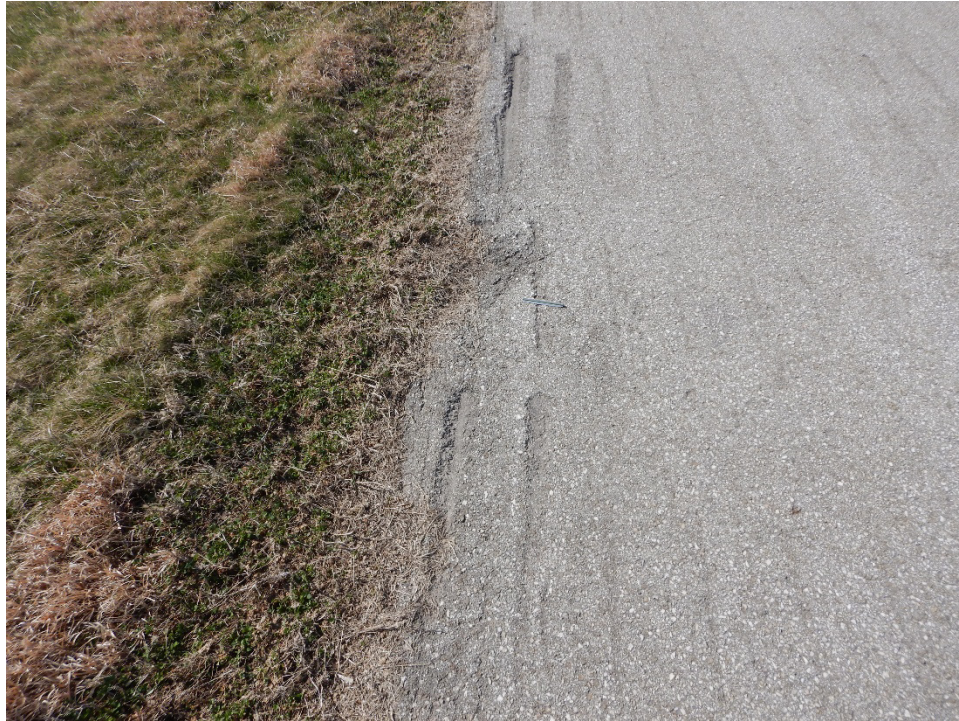
TAAM-05. Overview.

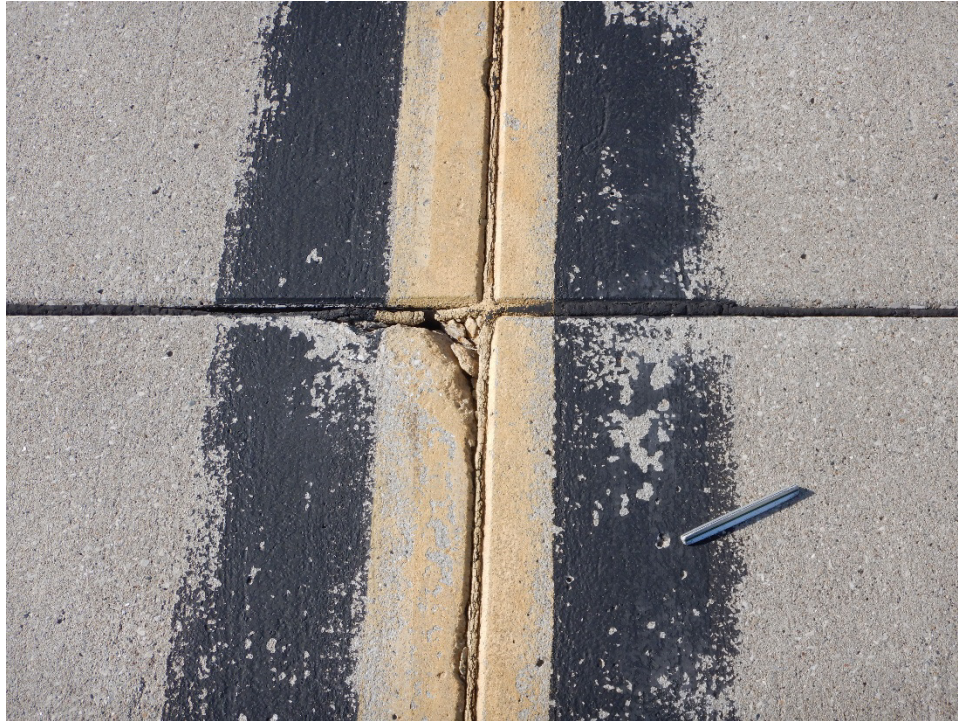
TAAM-05. Joint Seal Damage (Sample Unit No. 04).

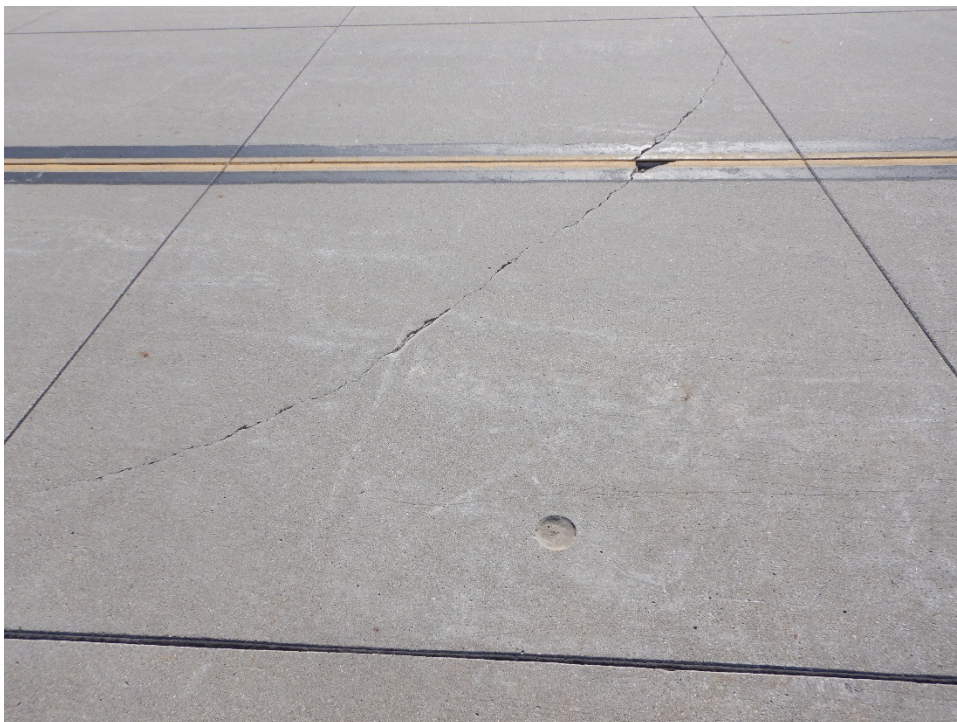
TAAM-06. Small Patching (Sample Unit No. 03).

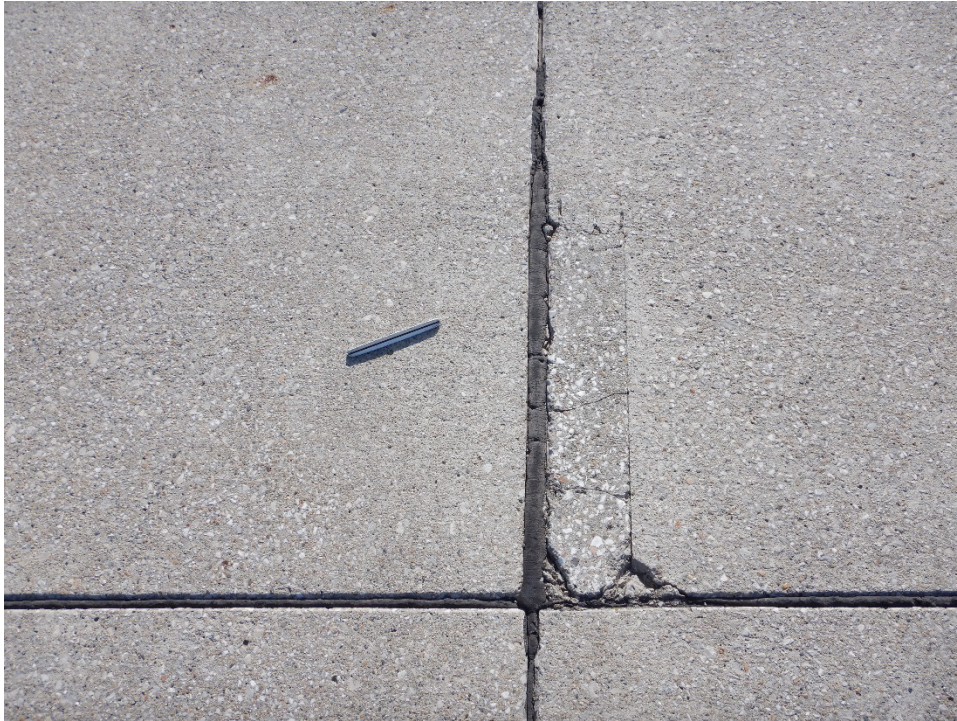
TAAM-07. Overview.

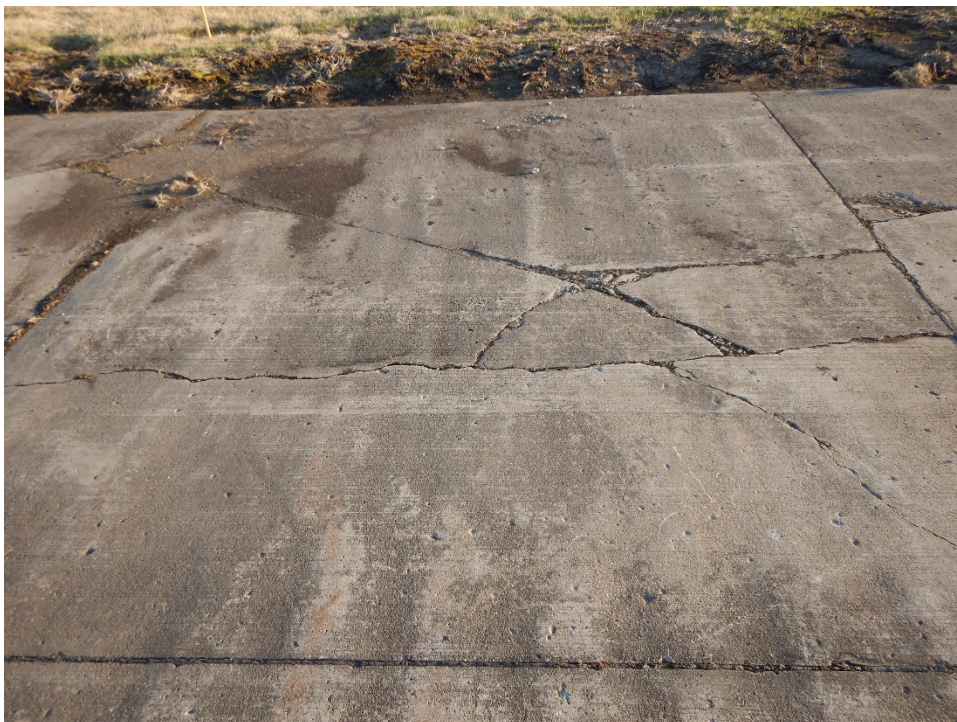
TAAM-10. Shattered Slab (Additional Sample Unit No. 07) (2).

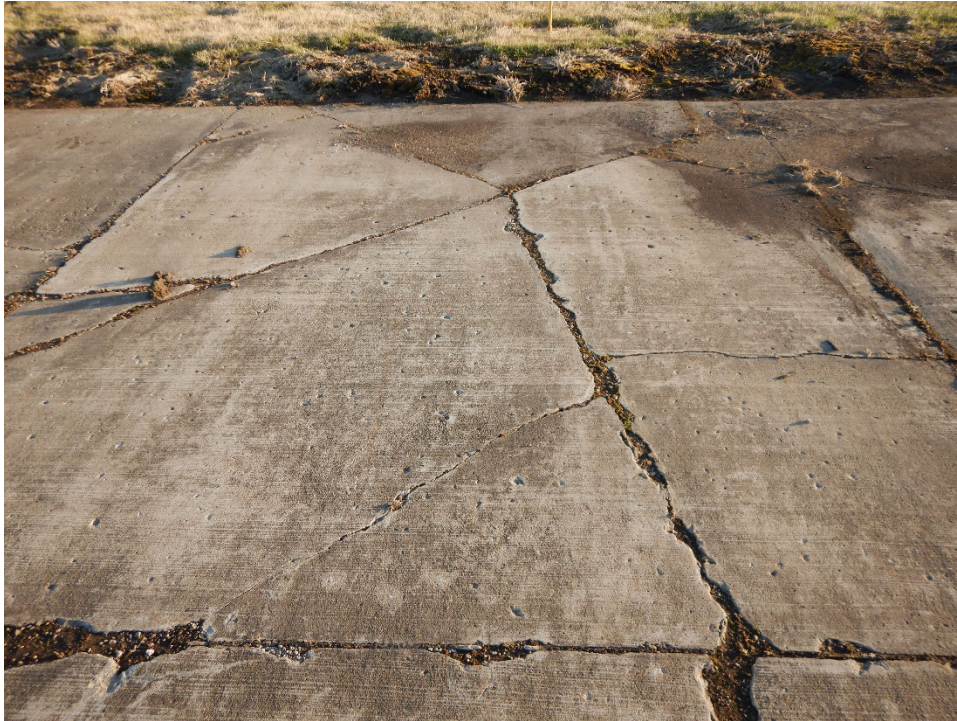
TB1AM-01. Overview.

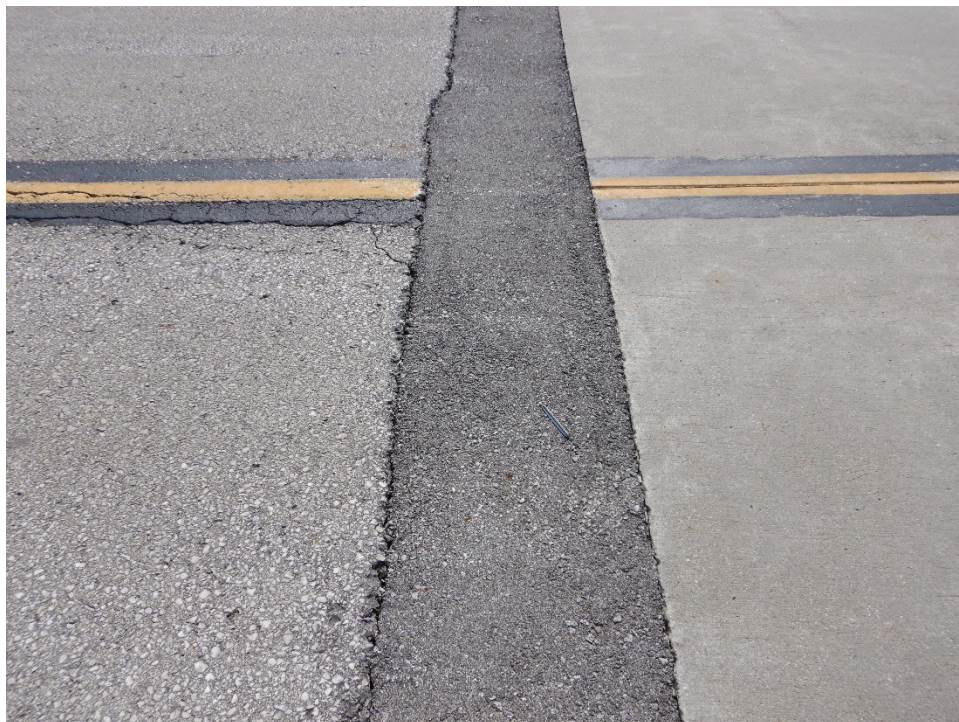
TB1AM-01. Weathering (Sample Unit No. 02).

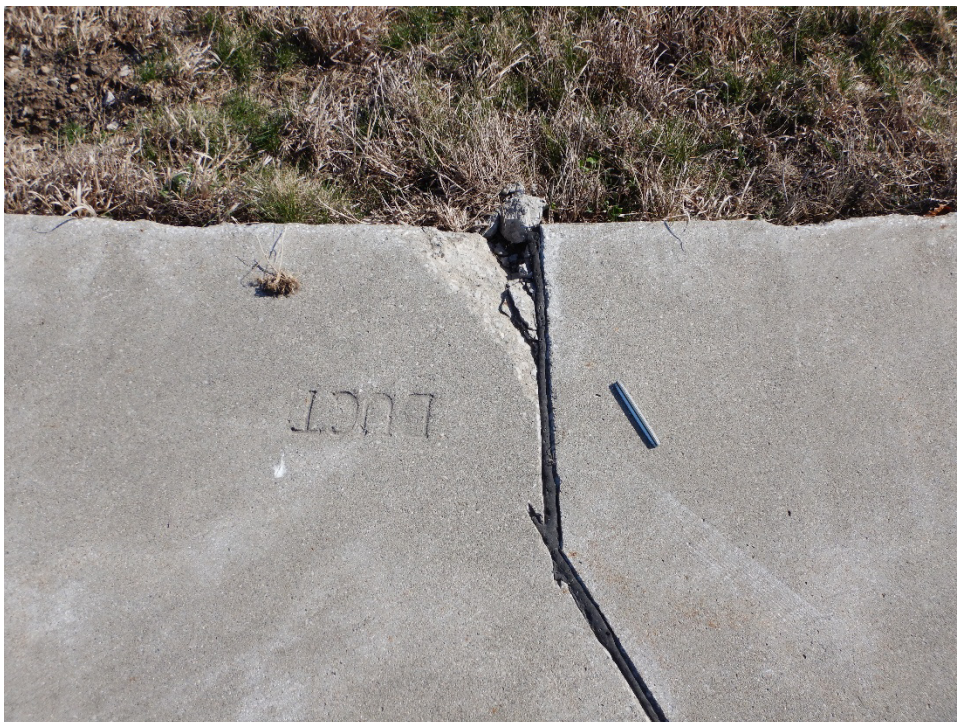
TB1AM-03. Faulting (Sample Unit No. 02).

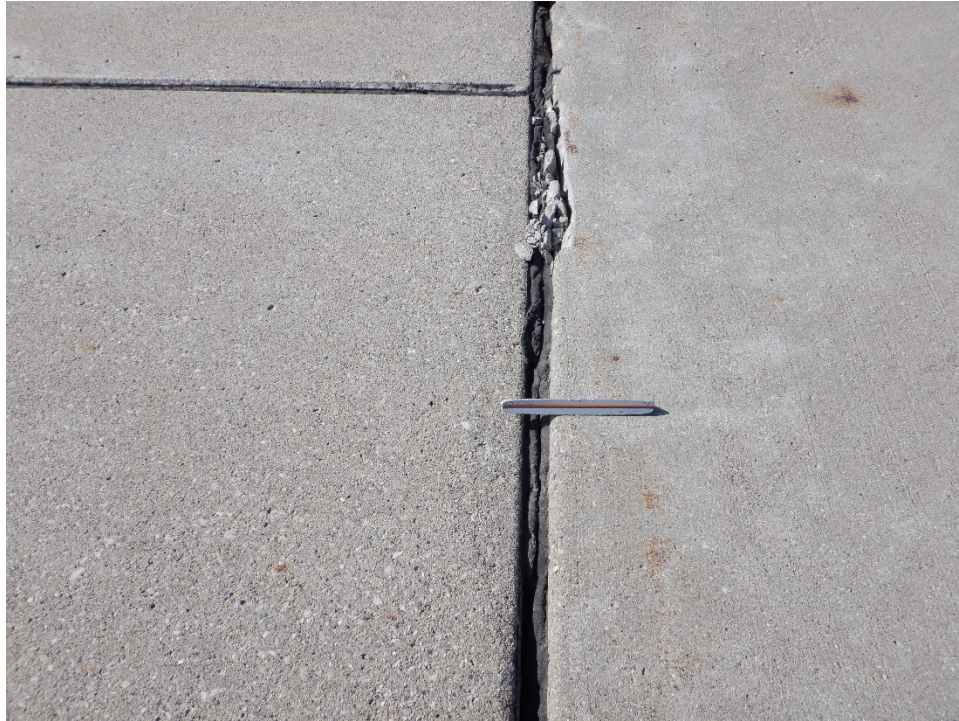
TB1AM-04. Overview.

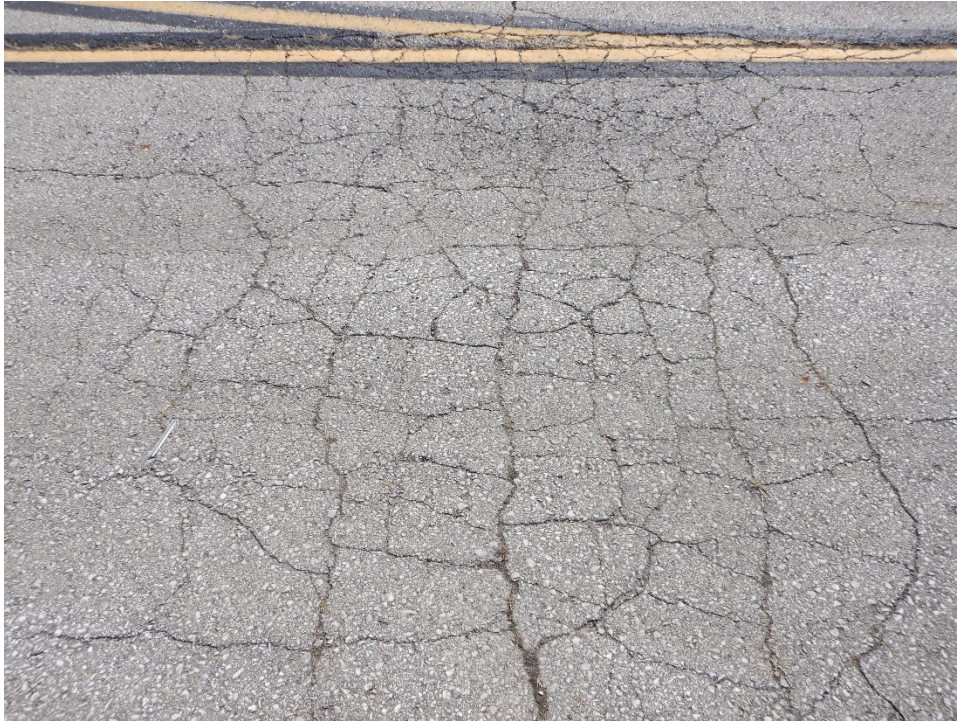
TB2AM-01. L&T Cracking (Sample Unit No. 01).

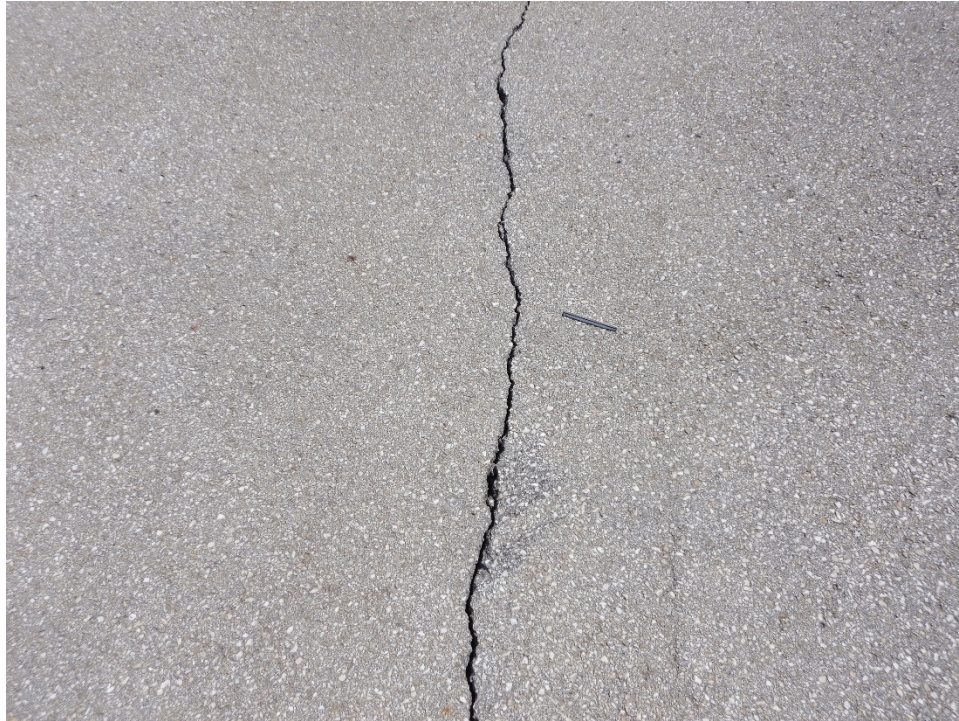
TBAM-02. L&T Cracking (Sample Unit No. 01) (2).

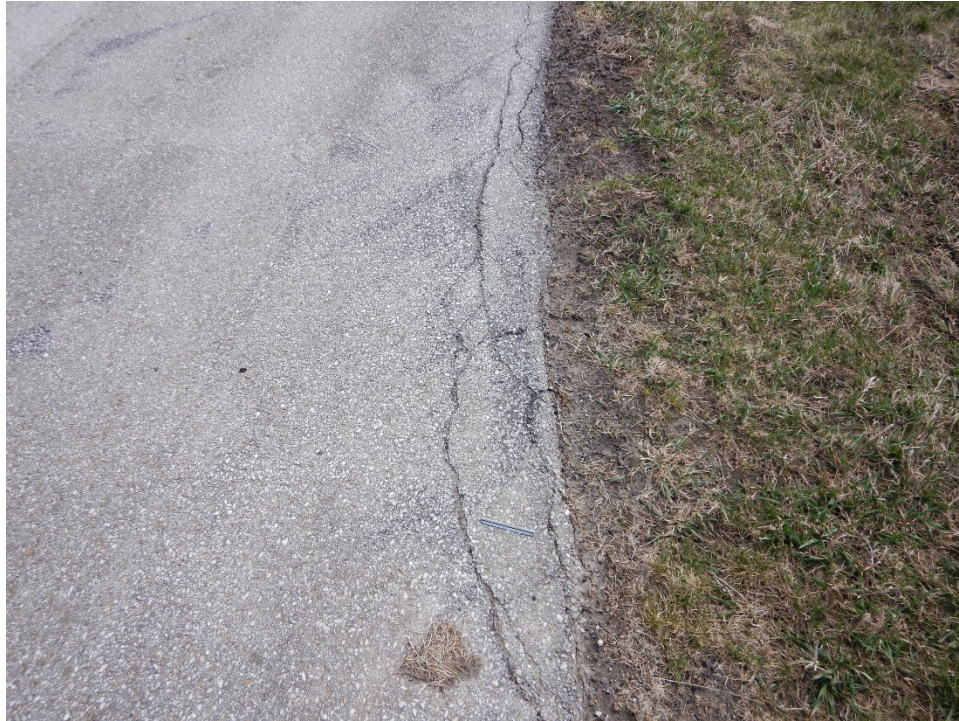
TBAM-03. L&T Cracking (Sample Unit No. 01).

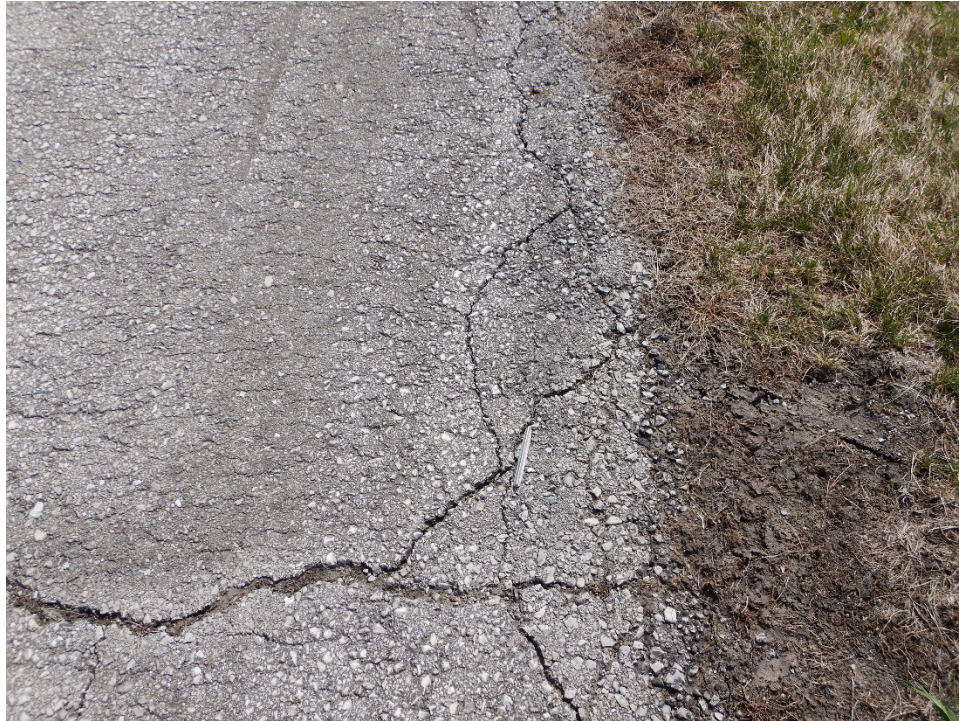
TBAM-04. L&T Cracking (Sample Unit No. 02).
