# Ames Municipal Airport

## Pavement Management Report

**AUGUST 2026**

# AMES MUNICIPAL AIRPORT PAVEMENT MANAGEMENT REPORT

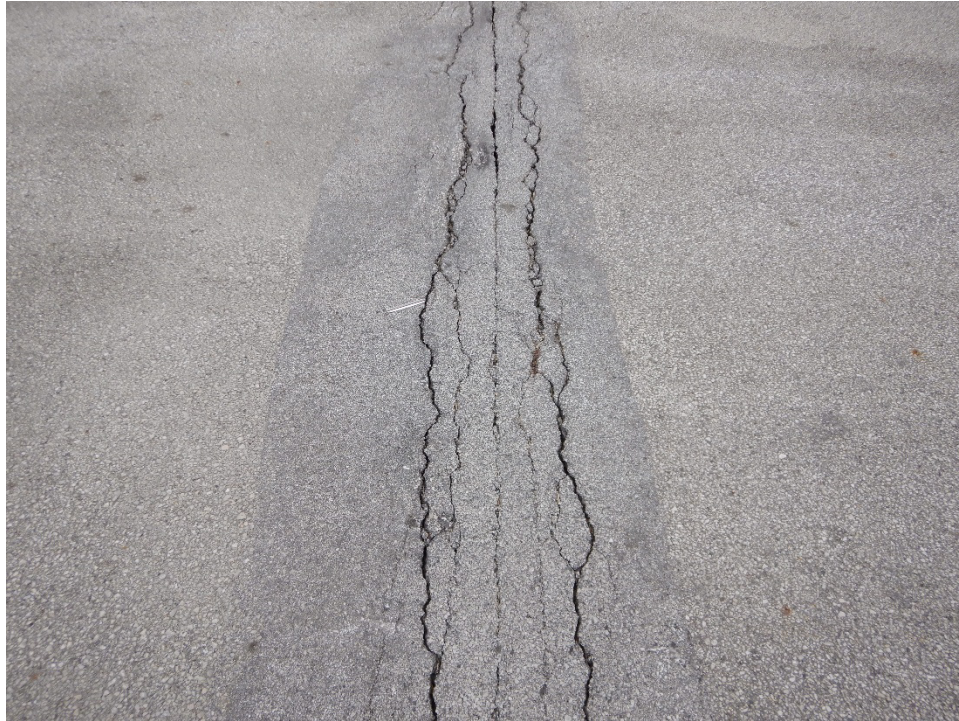
TH01AM-01. Patching (Sample Unit No. 02).

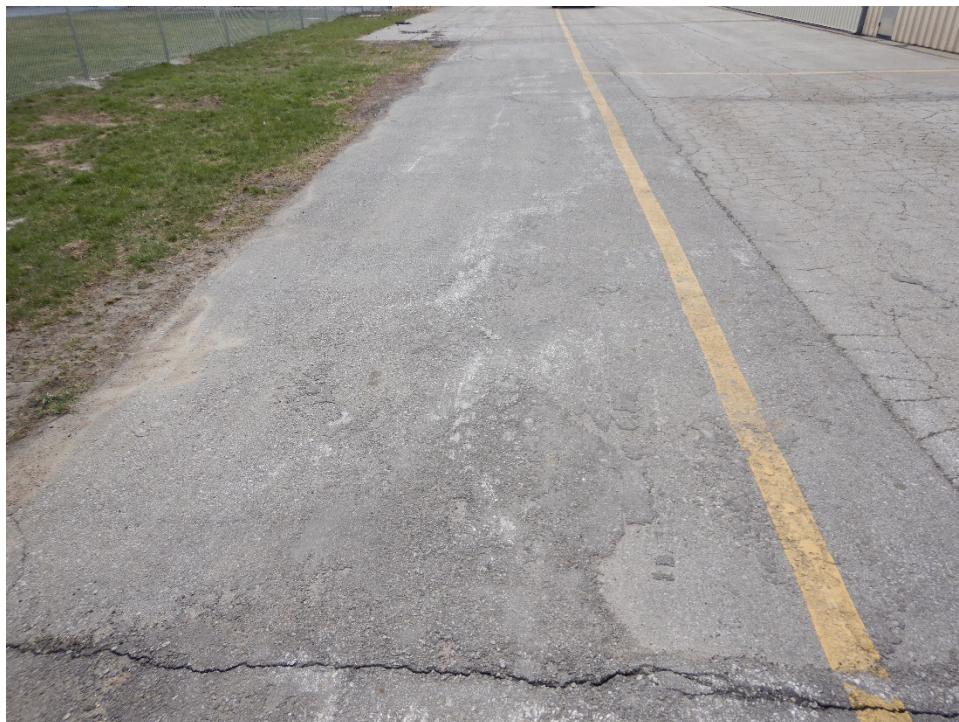
TH01AM-01. Weathering (Sample Unit No. 02).
