# Ankeny Regional Airport

## Pavement Management Report

**AUGUST 2025**

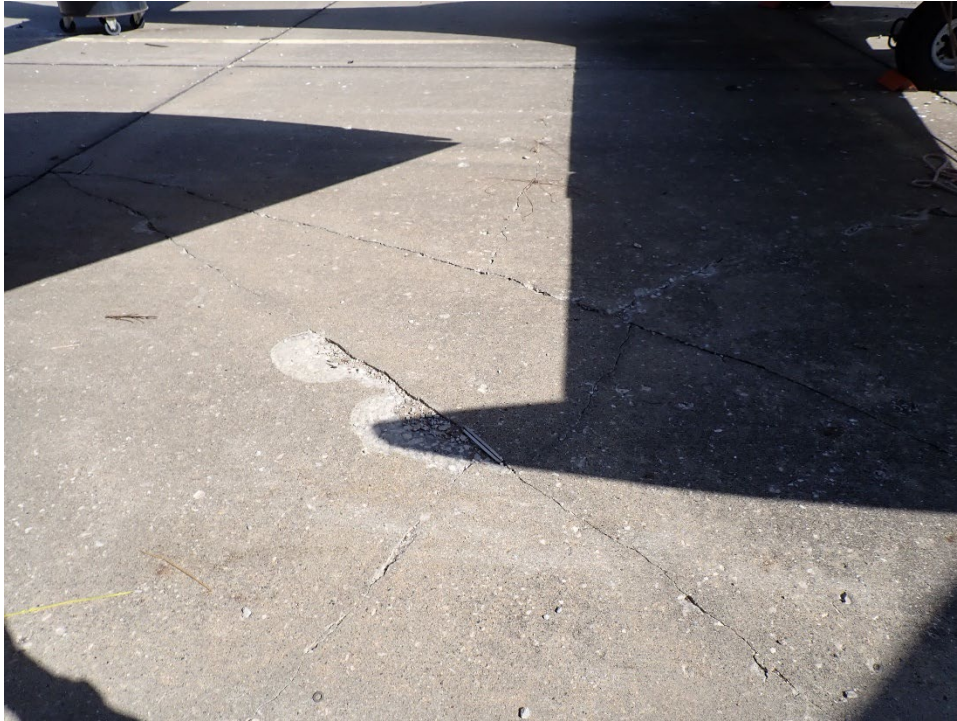
A01AN-01. Shattered Slab (Sample Unit No. 36) (1).

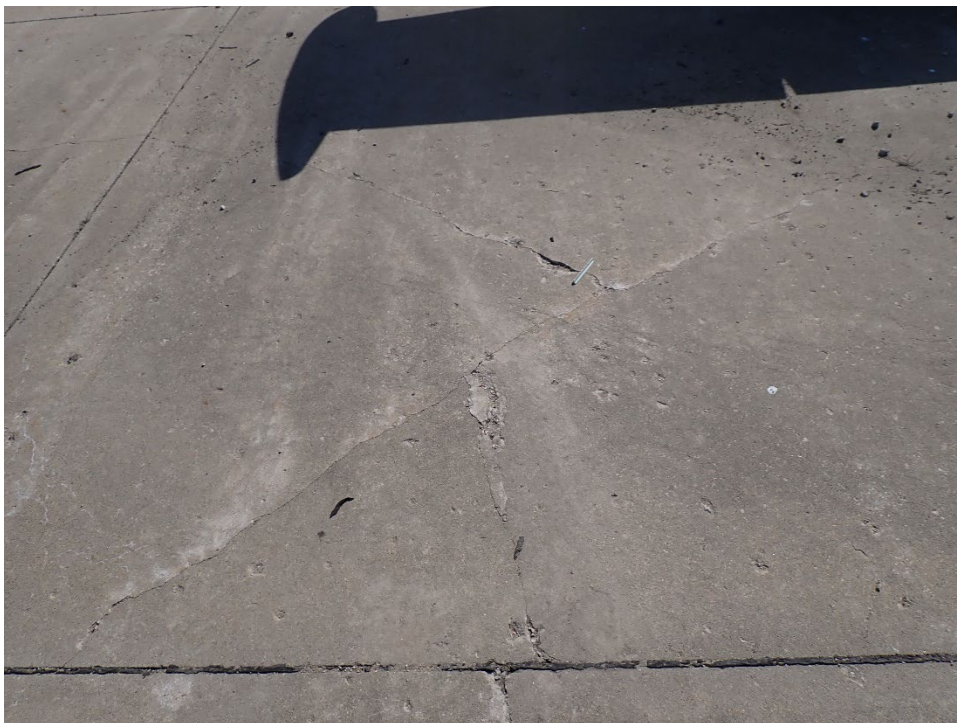
A01AN-01. Shattered Slab (Sample Unit No. 36) (2).

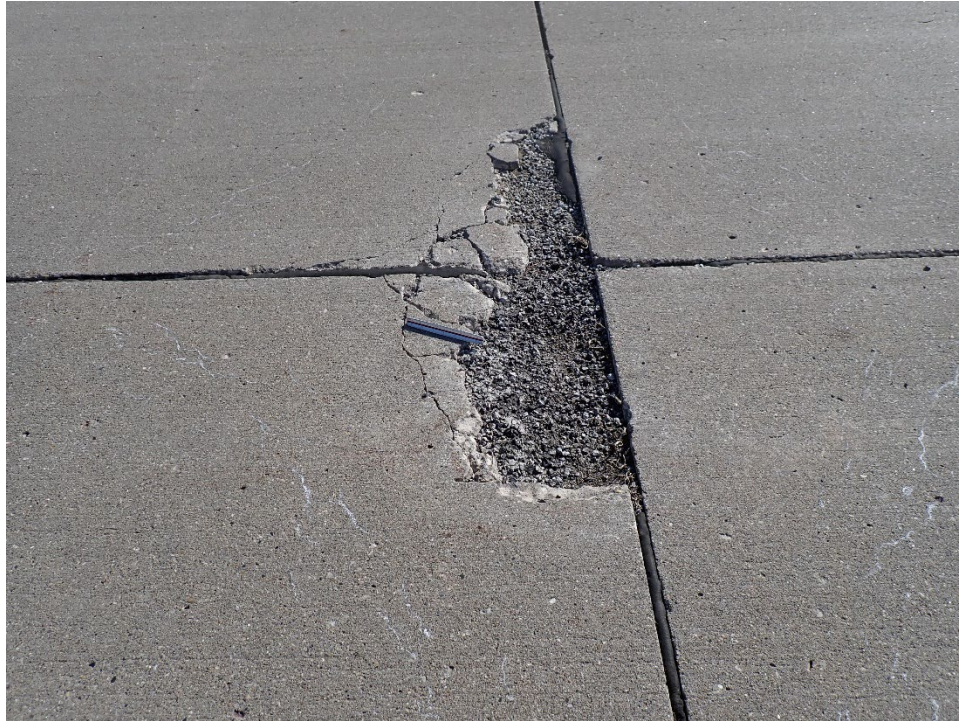
T04AN-01. Small Patching (Additional Sample Unit No. 18).

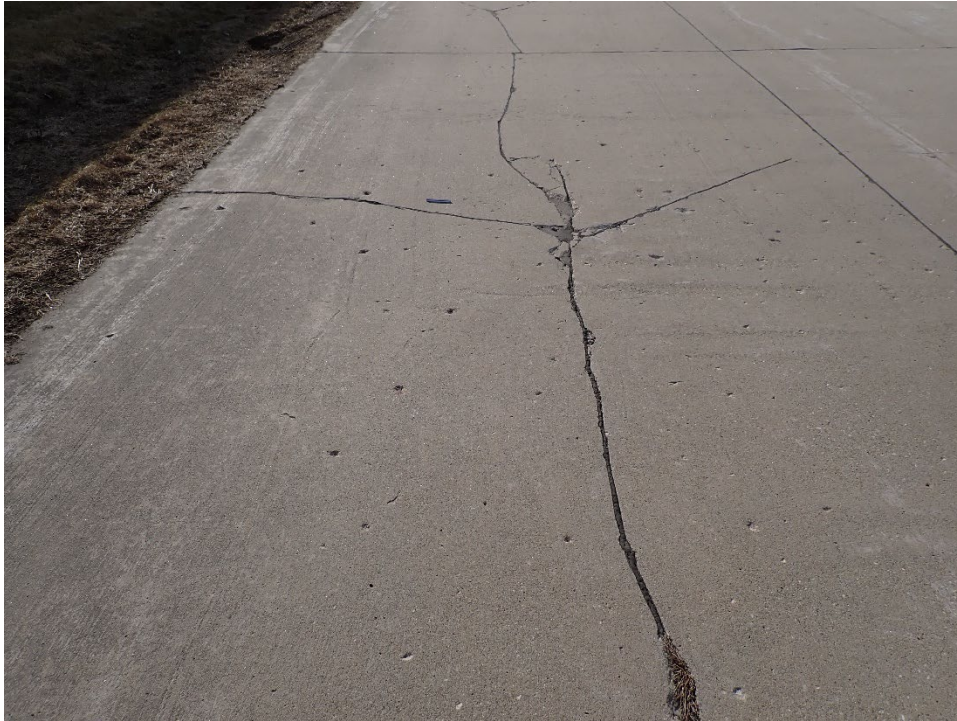
TH01AN-02. Small Patching (Sample Unit No. 18).
